PROJECT REPORT

Bank Stabilization East Branch Rondout Creek Demonstration Project Ulster County Highway Garage

Report produced by John G. Perrella, Construction Supervisor

Fall/Winter 2011

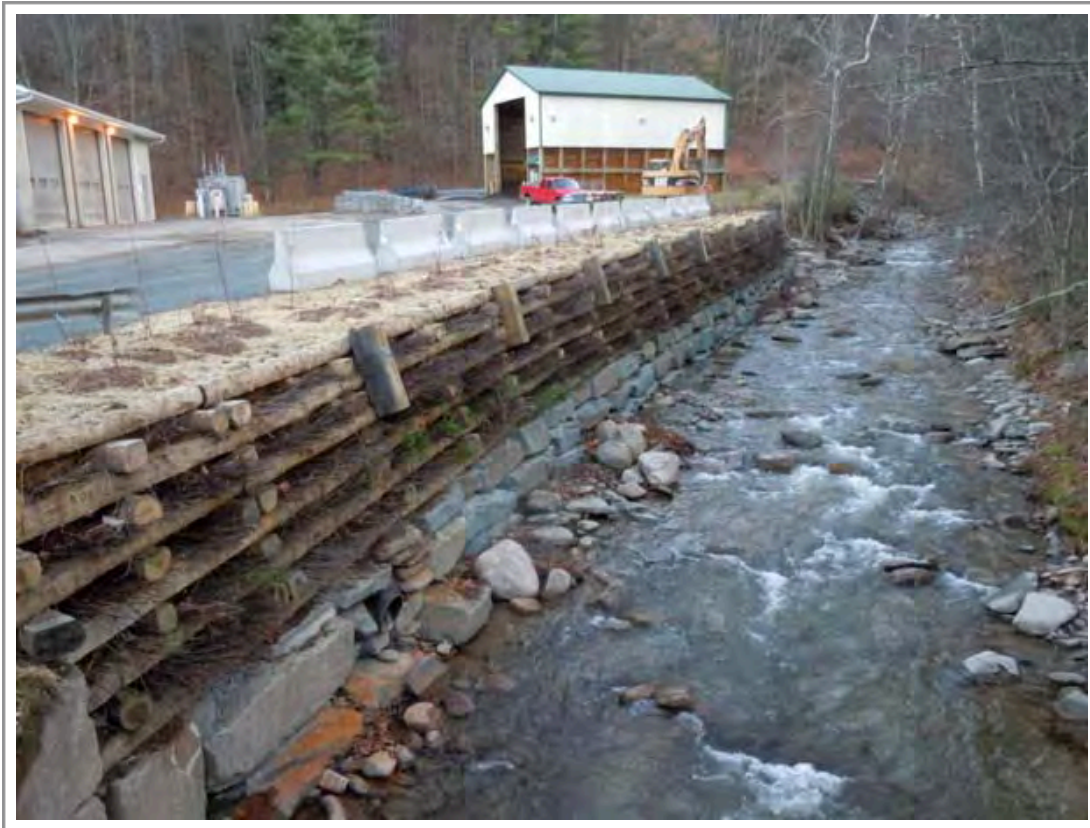
The finished project exhibits the live willow planted oak crib wall atop the stone base with native plants and traffic barriers at the top.

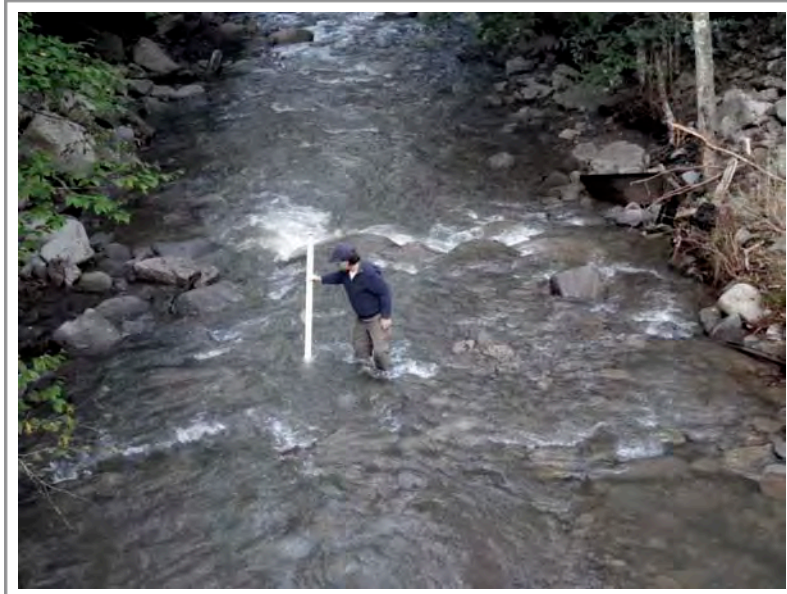
On July 28, 2011 Tropical Storm Irene swept through the Catskills and inflicted major damage to much of the area. This storm affected the demonstration site by scouring a substantial amount of material from the stream bank of the demonstration site. The photo above left shows existing conditions just upstream of the demonstration site before storm event. On the right hand photo above it can clearly be seen that a large amount of material was removed from the bank resulting in a change order to the contract (Appendix I).

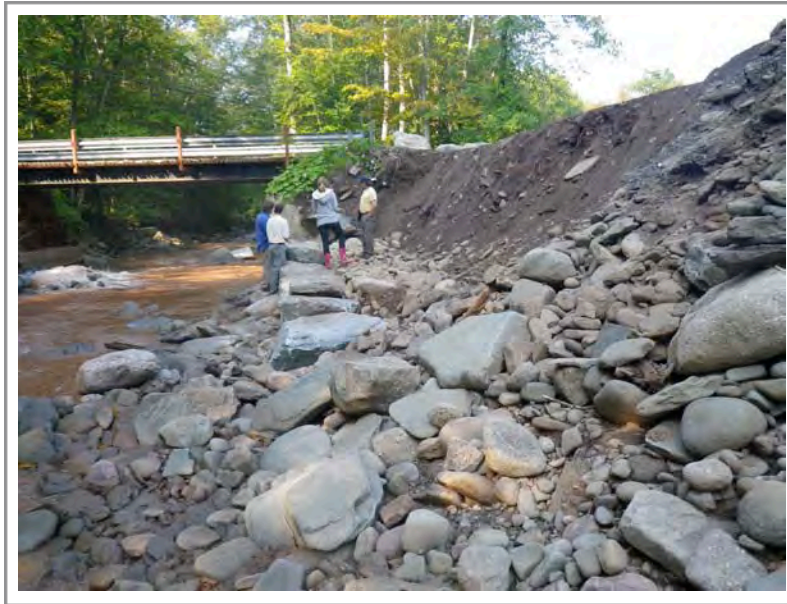
Ultimately, Thompson 12JSCJ-DJDST-45H-MC ENVIROPRIME® Solids Handling Jet Pumps designed for flows up to 7,800 gallons per minute (17.4 cfs) were used at the site. A temporary coffer dam was built just upstream of the work area. Water was pumped via two 12' pipes past the work site. The turbidity in the stream is the result of the very heavy rains and subsequent damage caused by Tropical Storm Irene.

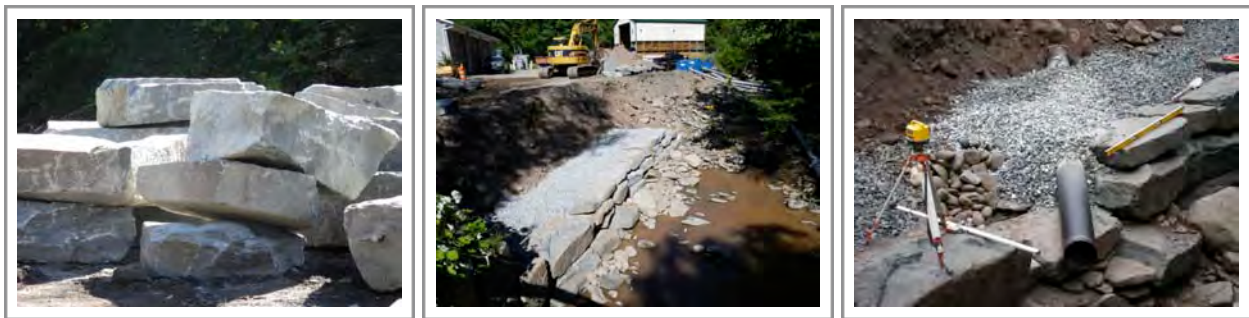
An early meeting with Mark Vian and Osterhoudt Contracting to discuss the manner and placement of the base stones for the large stone portion of the project. The stones were keyed 18” below grade at the line of the stone wall. This photo further illustrates conditions of the stream bank at the start of the project.

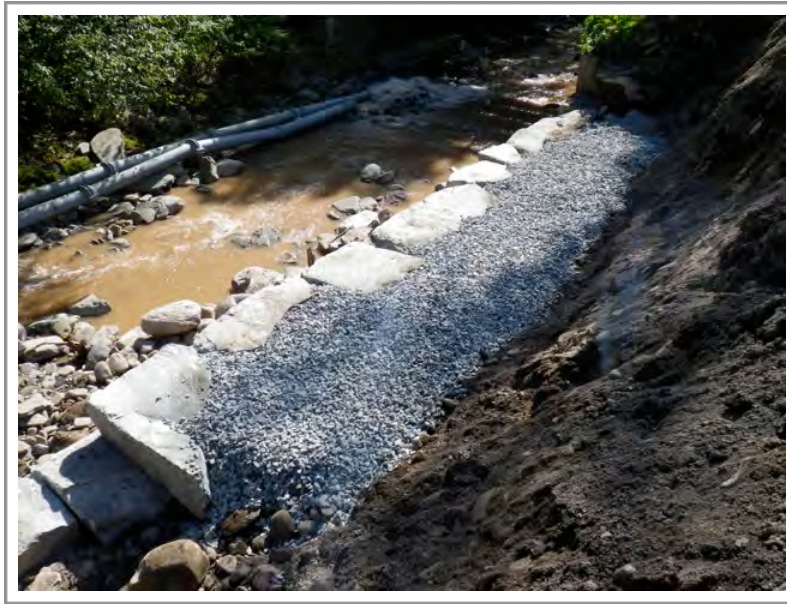
Large quarried stones were shipped to the site to be used in the construction of the base stone wall. The first section of wall with its gravel fill used to create a base for the installation of the first oak cribbing logs. This ductile iron drain pipe being set connects to the catch basin at the end of the trench drain.

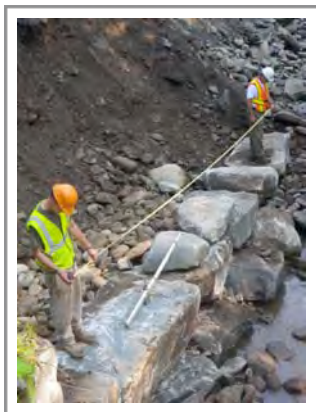
This is the first section of the stone wall that has been brought up to height and is ready for the beginning of the white oak crib wall. It is pitched back one foot for every four foot in height. The wall follows a 2% grade which matched the grade of the stream at this location.

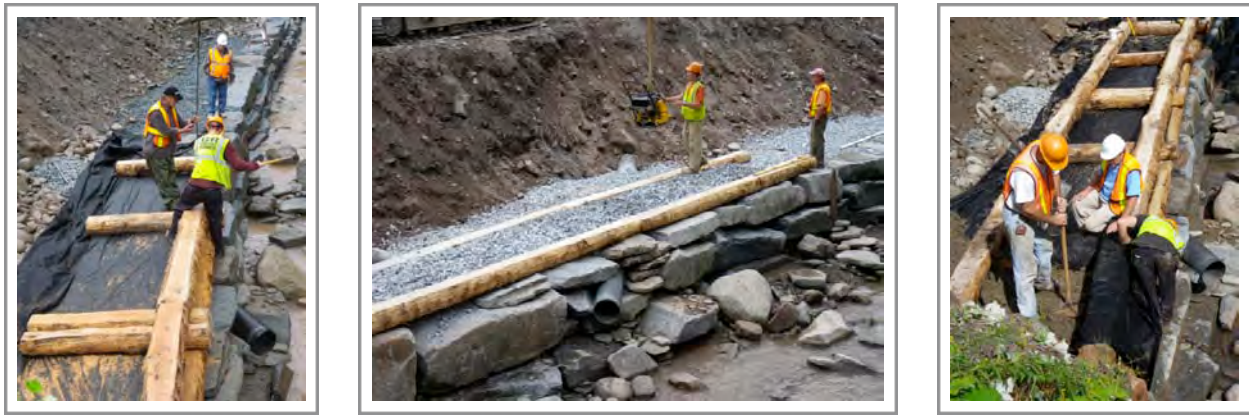
The first white oak logs are set on top of the stone wall. Landscape fabric is applied over the first layer. The logs are drilled and pinned with #6 reinforcing bar. The first layer of soil is being placed and compacted.

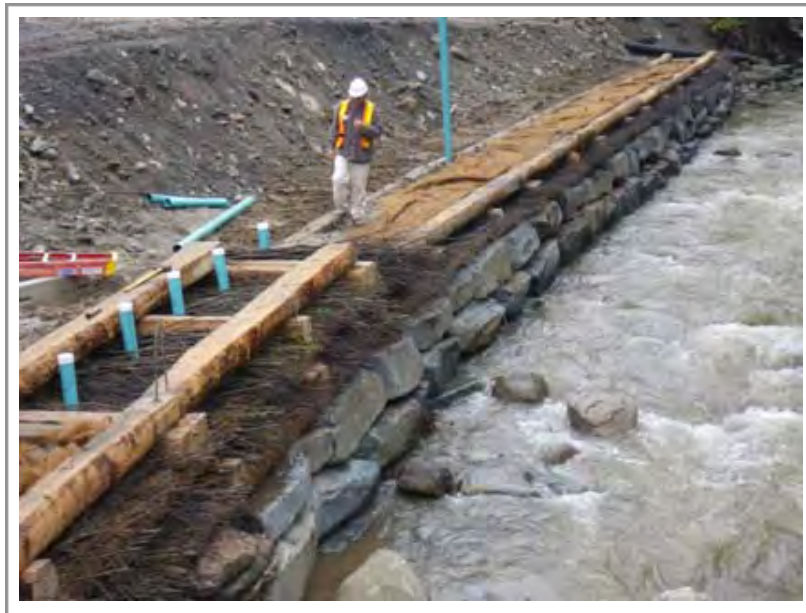
This photo illustrates the various components in the wall. The base stone rising to bank full height. The crib wall being constructed layer by layer each course composed of willows, soil and fabric. Note the blue watering pipes just in front of the rear oak log. The soil can be observed to fill the entire void behind the crib wall.

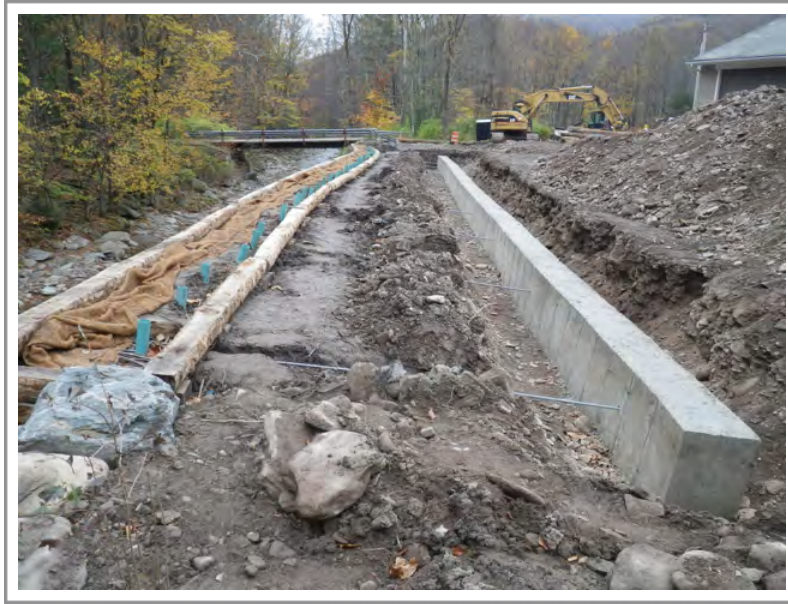
As illustrated in these photographs the crib wall was constructed layer upon layer until the final height was obtained. Each layer comprised of soil wrapped in biodegradable fabric, the willows embedded on the soil and logs forming the structural element that holds it all together. Below is the stone wall, built to the height of the East Branch of the Rondout Creek bank full level. The ductile iron drain pipe, which is attached to a catch basin, will channel excessive water that may accumulate on top of the structure safely to the stream. The blue watering pipes are spaced at four foot intervals for the entire length of the structure to assist in watering which will foster root growth in dry conditions.

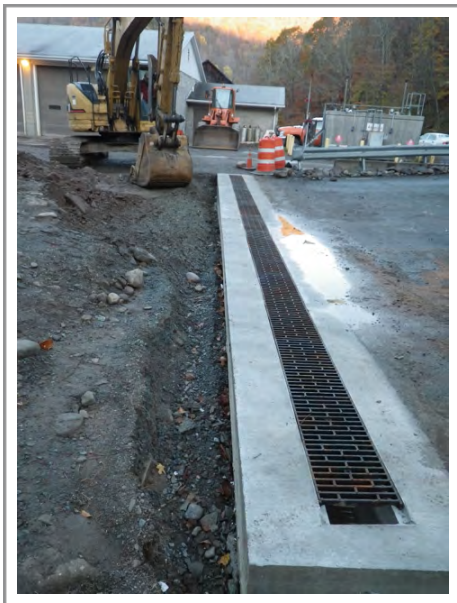
A concrete dead man running most of the length of the crib wall was poured about eighteen feet back from the face of the wall and positioned 18" below final grade. Anchored to the face of the crib wall by nine 1" galvanized steel threaded rods and galvanized steel plates attached to the concrete on one end and to the face of the crib wall by being threaded through nine 12"x12"x 42" long pressure treated timbers. The concrete is steel reinforced and was poured tilted back to accommodate the angle of the threaded rod. Tension was applied by tightening the nuts on the crib wall end of the threaded rod.

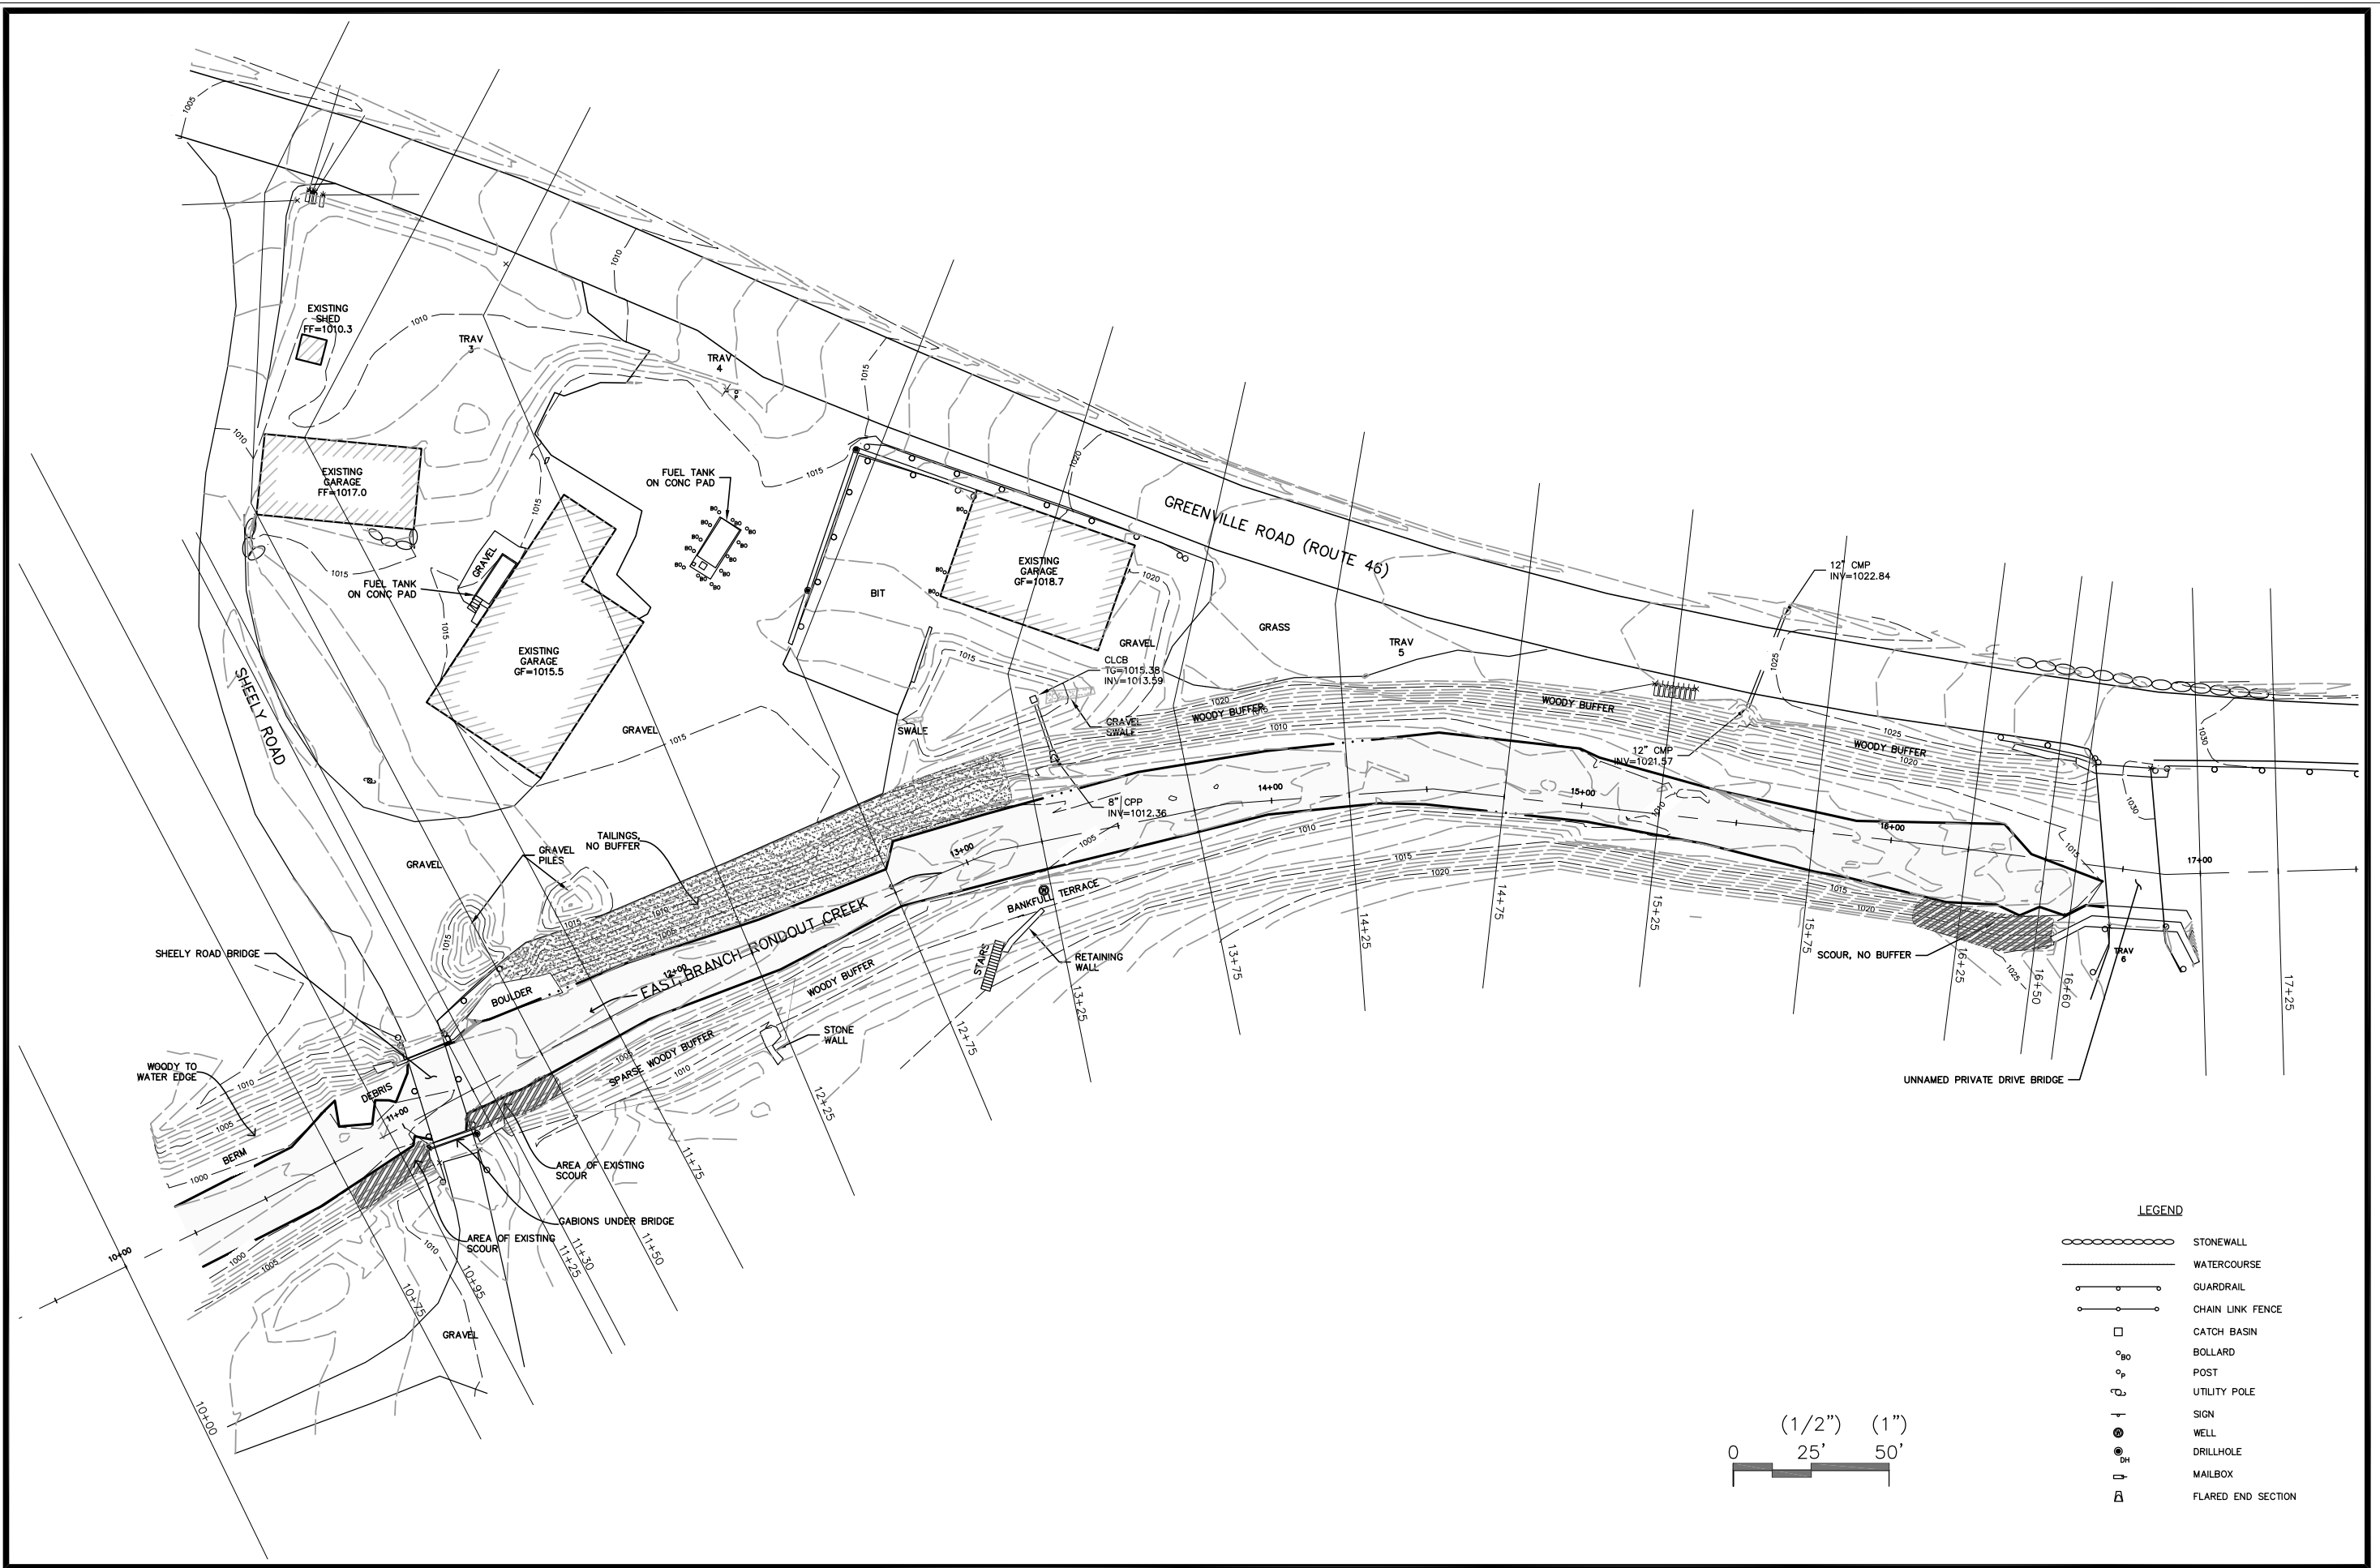
The study reach is characterized as being confined by high ground, straight alignment, and having a rocky rapids bed. The mean bed slope is 2.6%. The right bank downstream of the private drive bridge has a 2:1 slope with a sparse woody buffer extending from the bankfull height to the top of the bank. Near station 14+00, the woody buffer is replaced with fine gravel and sand deposited by surficial runoff from the eastern edge of the DPW garage staging area. From the Sheely Road Bridge to station 13+25, the right bank has a combination of stone retaining wall and placed riprap on the lower slope and gravel cover on the upper slope at the DPW garage. About 175 linear feet of the right bank has had a slope failure between station 11+50 and station 13+25 (Photo 1).

Photo 1: Bank Failure site on right bank upstream of Sheely Road Bridge.
