HISTORIC STRUCTURES REPORT FOR
HIGH BRIDGE

BRONX AND MANHATTAN, NEW YORK

VOLUME III
APPENDICES I-0

REHABILITATION OF THE HIGH BRIDGE OVER THE HARLEM RIVER BOROUGH OF MANHATTAN AND BRONX, NEW YORK

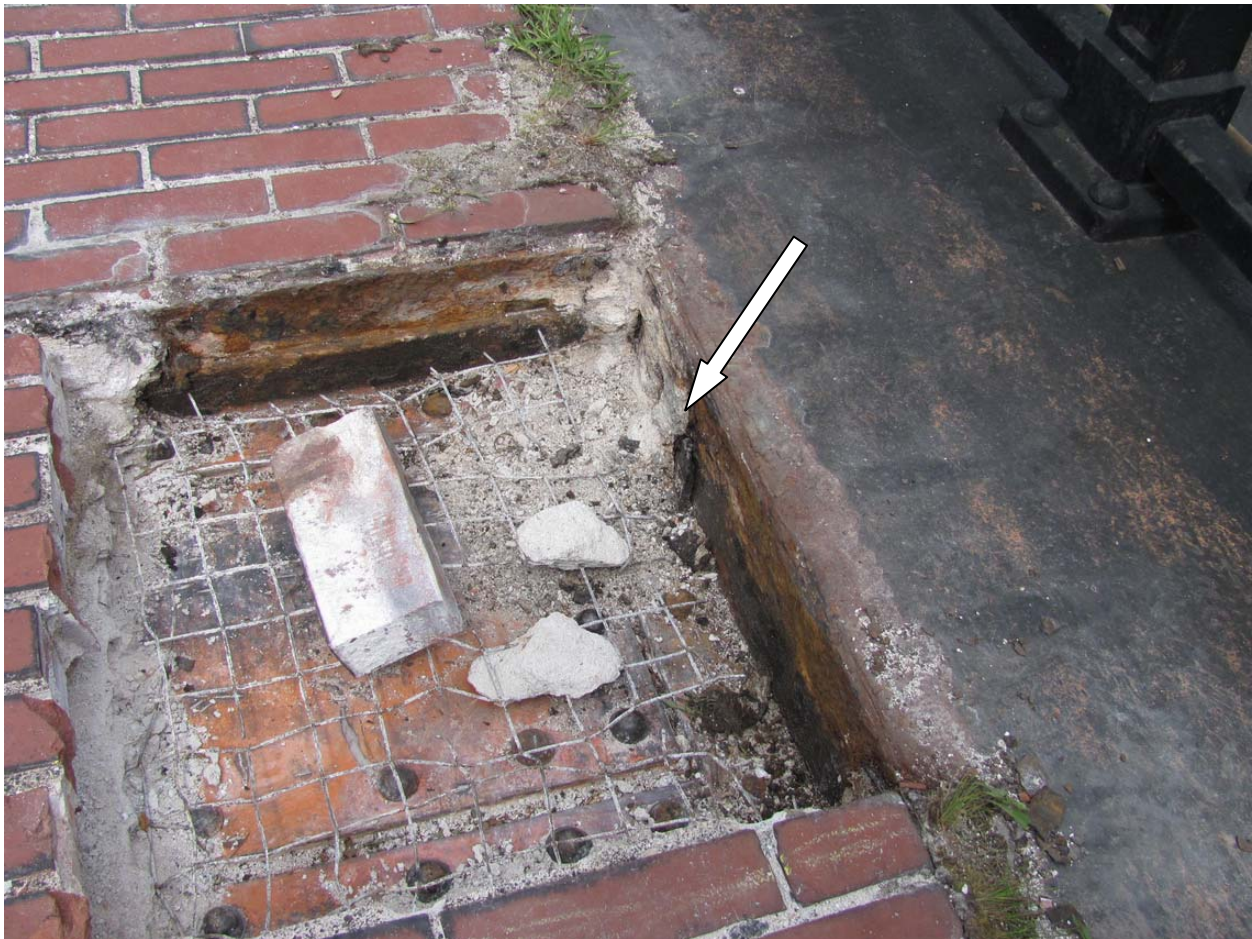
Photo ACM #1: Location of Asbestos-containing bituminous joint filler material present at joint between steel deck of bridge and the brick walkway. This material is present at the entire joint between piers 1 and 2. Note: the transverse expansion joints in the brick work contain similar joint filler materials. The transverse joint filler material was tested separately and did not test positive for asbestos.

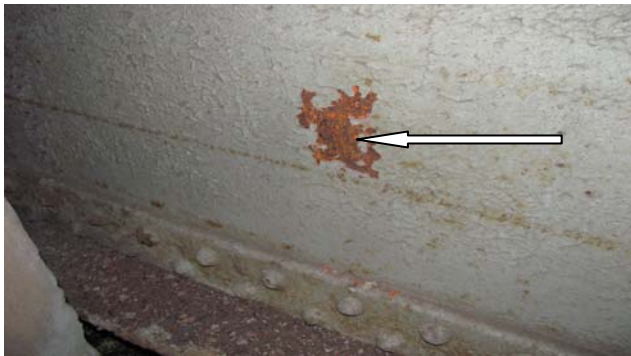
Photo LCM #1: **Gray over orange primer paint** present on the structural steel of the three-hinged steel arched bridge.

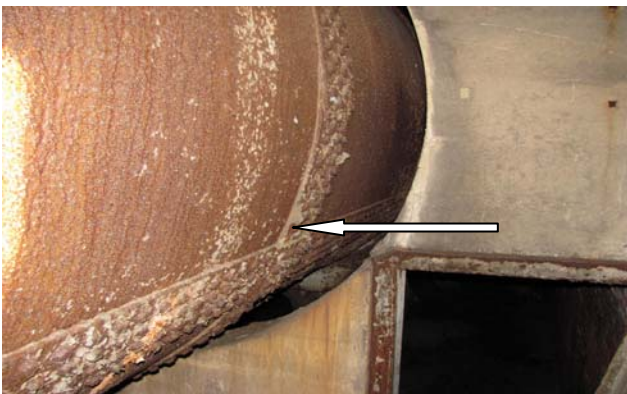
Photo LCM #2: **Dark gray coating/paint** on 90 inch water main beneath three-hinged steel arched bridge.

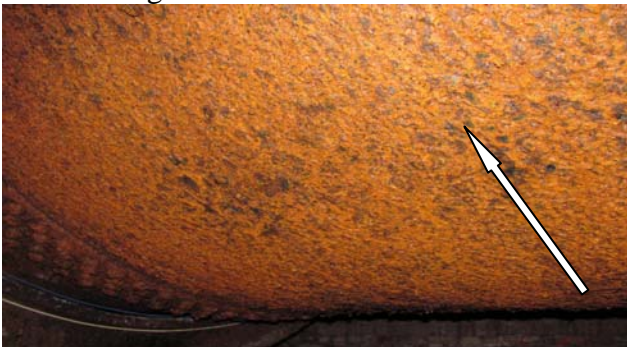
Photo LCM #3: **Black coating** present on 90 inch water main located in the east attic, east of pier 2.

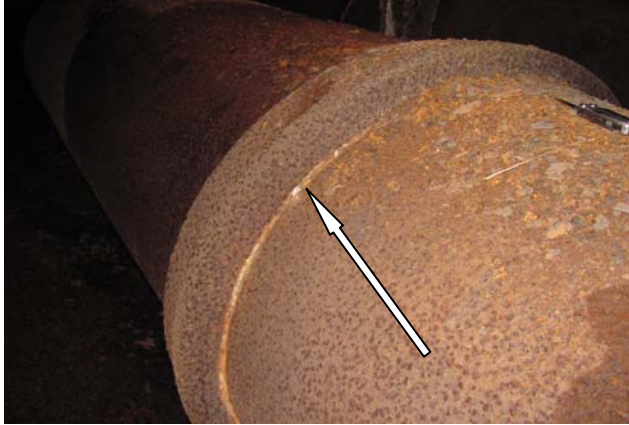
Photo LCM #4: **Silver metal (lead solder) material** present at bell fitting of abandoned 36 inch water mains located beneath the west abutment in the west attic. This material is also present at small diameter pipes and valves in the attic beneath the west and east gate houses.

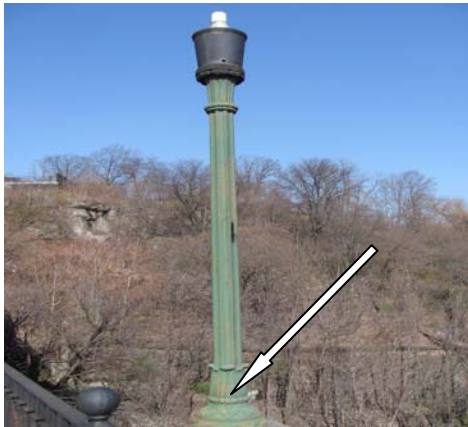
Photo LCM #5: **Light green paint** over orange primer present on seventeen (17) old abandoned light poles along the sides of the walkway.

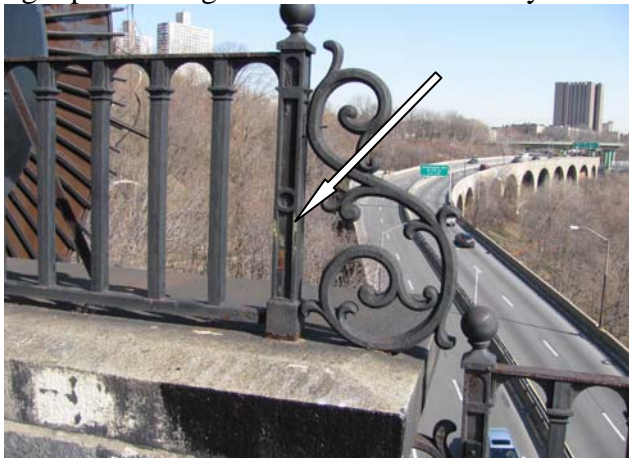
Photo LCM #6: **Black over yellow over orange primer paint** present on railings throughout the walkway.

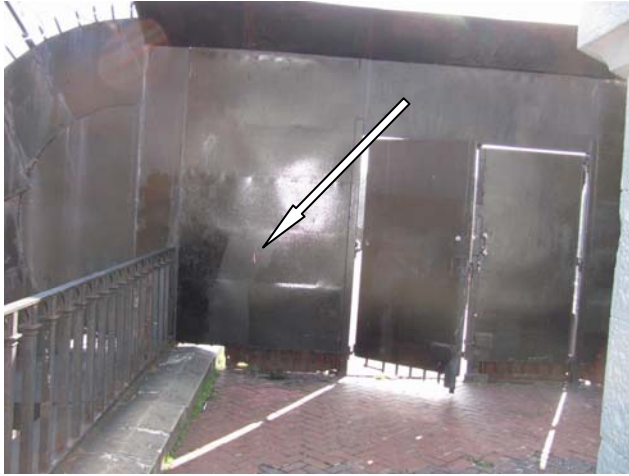
Photo LCM #7: **Black over silver paint** present on west abutment security gate. This paint is also present on the east abutment security gate.

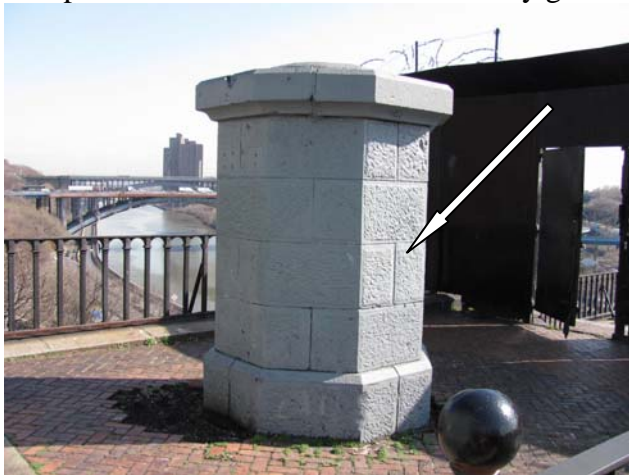
Photo LCM #8: **Gray over brown paint** present on masonry tower located between the security gate and the Westgate house.

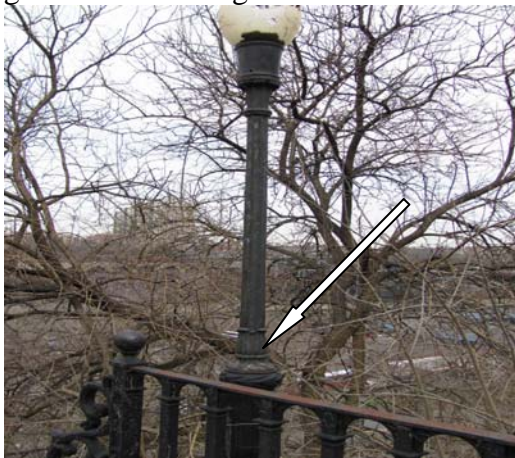
Photo LCM #9: **Black over dark green paint** present on one old light pole near the east security gate.

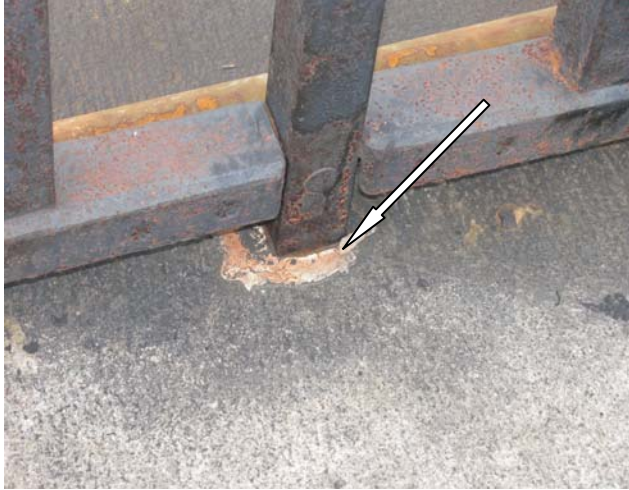
Photo LCM #10: **Silver metal (lead solder) material** present at railing post insets located in the vicinity of the west gate house fence (47 posts), west abutment/pier1 fence(13 posts), over pier 2 fence (10 posts) , and in the vicinity of the east gate house fence (22 posts). This includes remnant lead solder at old post holes.

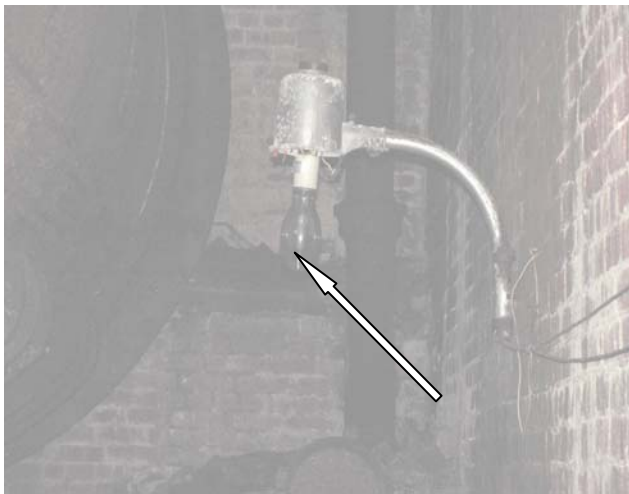
Photo UW #1: Typical high intensity bulb. There are a total of eleven (11) fixtures/bulk in the east and west attic. Each fixture is assumed to contain one PCB containing ballast.

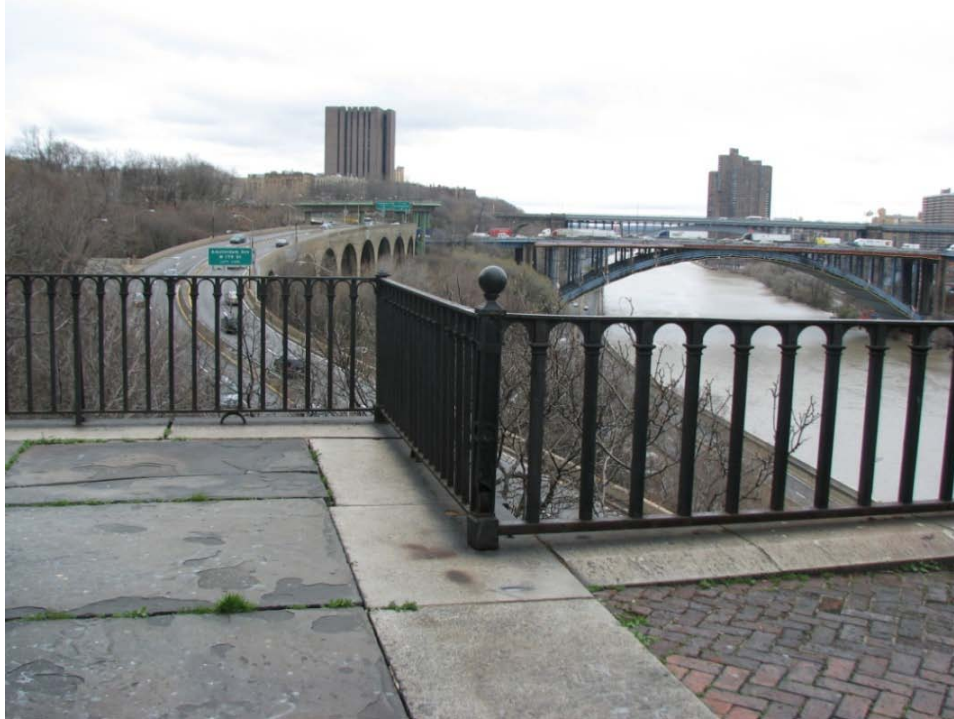
FIGURE 19. Detail view of the 1850 railing (left and center) and 1864 railing (right) at the Manhattan gatehouse plaza. Note the variance in picket spacing and formation of the arches.

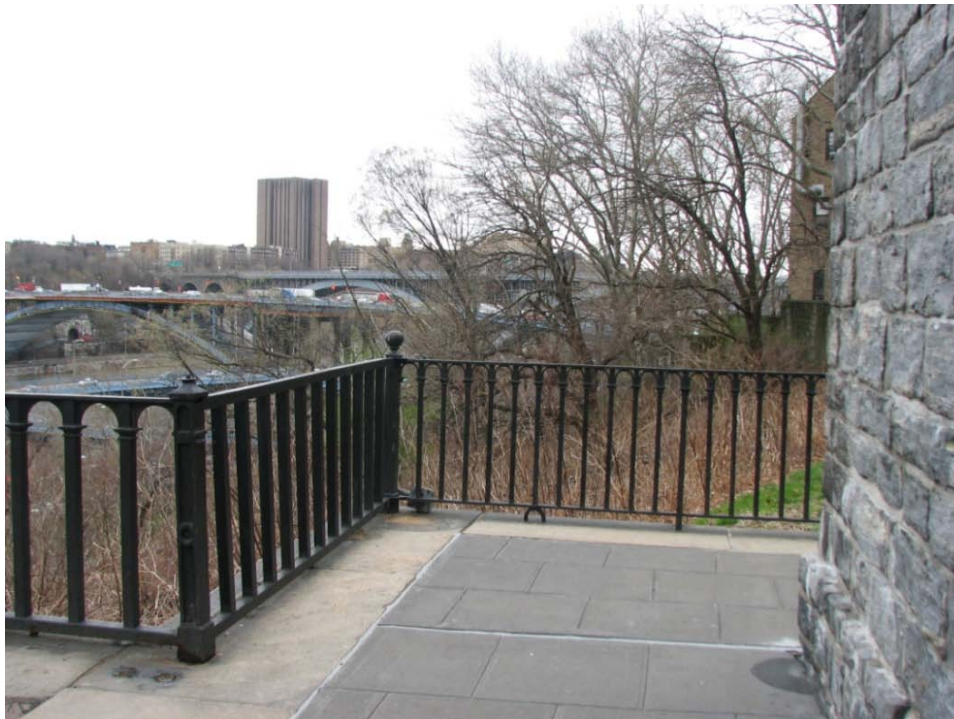
FIGURE 20. Detail view of the 1864railing (left), the non-historic in-fill railing (center), and the 1850(right) and 1864 railing (right) at the Bronx gatehouse plaza. Note the variance in picket spacing and formation of the arches.

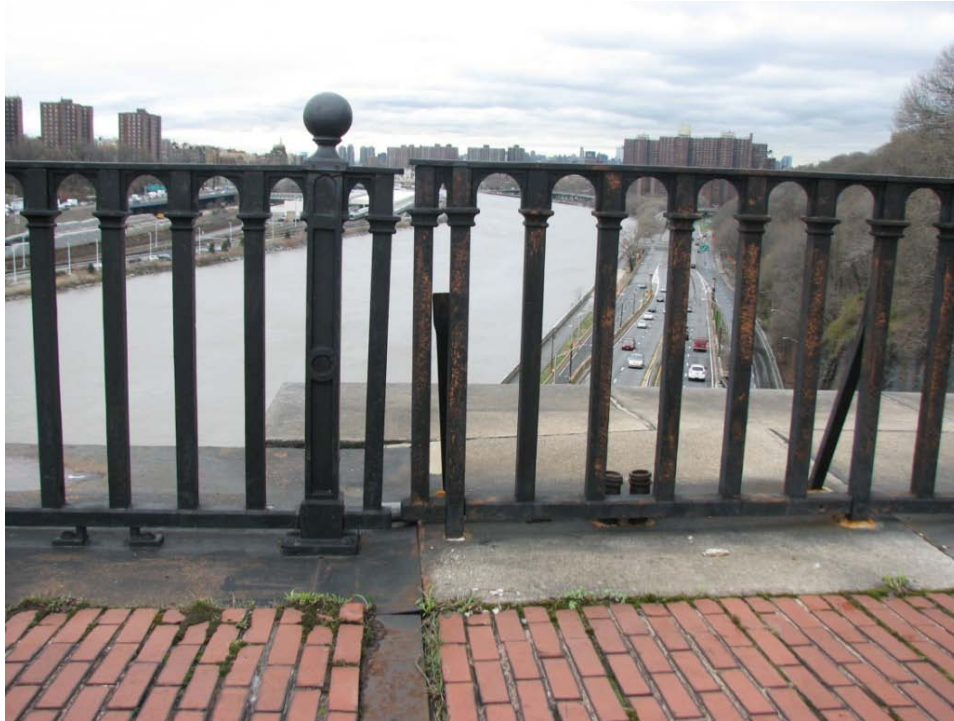
FIGURE 23. Elevation view of the transition between the 1928 railing (left) and the 1864 railing (right). Note the change between metal copings and granite copings and the metal expansion joint.

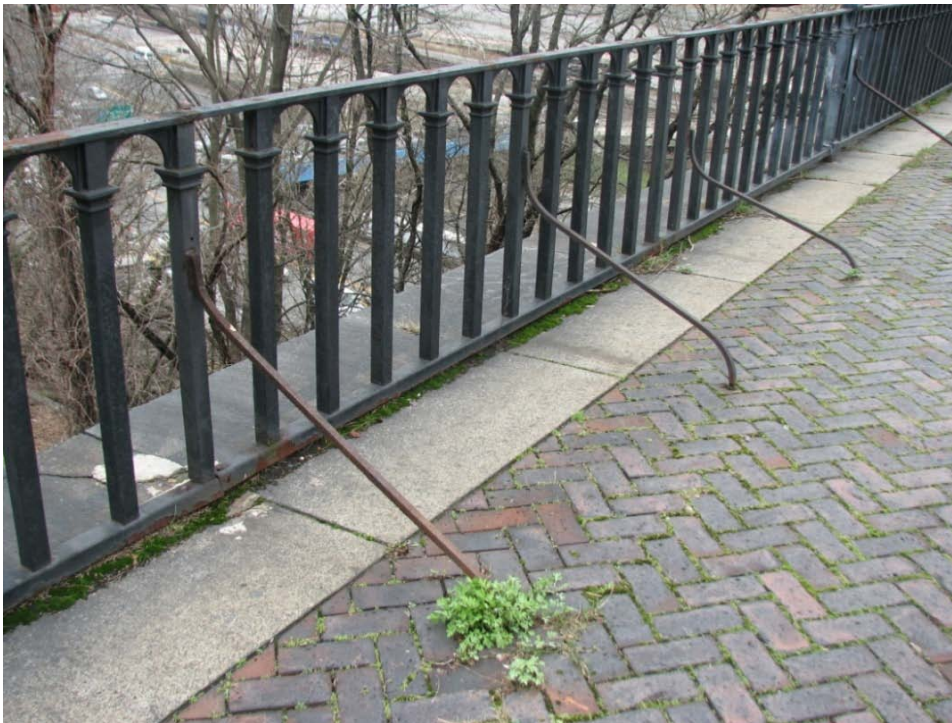
FIGURE 26. *View of non-historic metal bracing at the 1864 railings.*

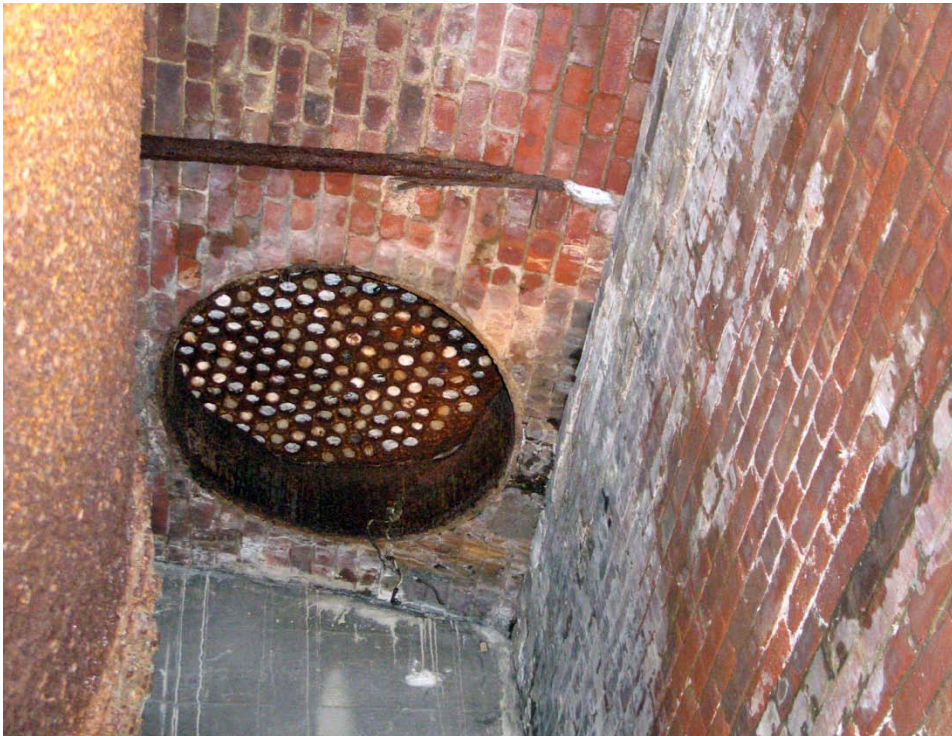
FIGURE35. *Detail view of a historic vault light as seen from below in the attic.*
