# NYC WASTEWATER RESILIENCY PLAN

## CLIMATE RISK ASSESSMENT AND ADAPTATION STUDY

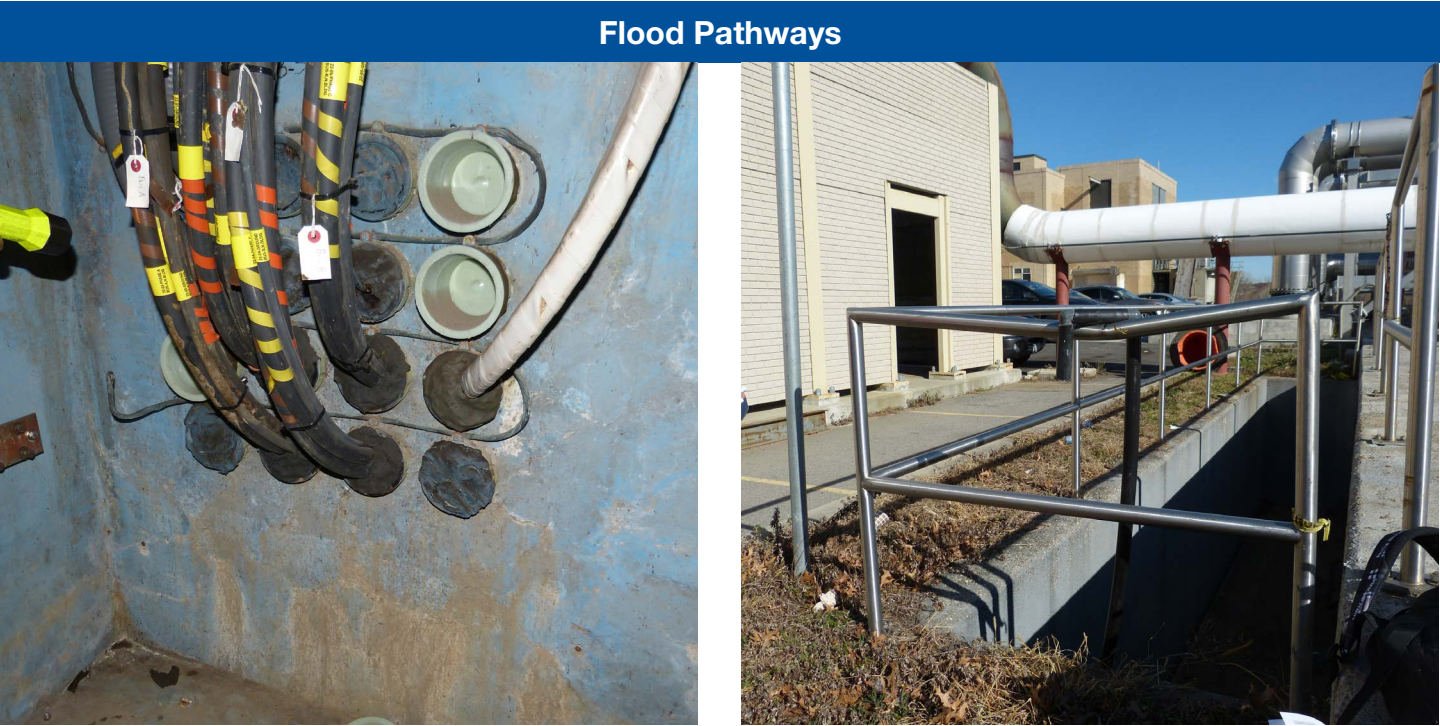
Electrical conduits in the basement of the Main Building provided a pathway for floodwaters during Hurricane Sandy.

A basement access way leading to the Primary Sludge Gallery would be a flood pathway during the critical flood event.

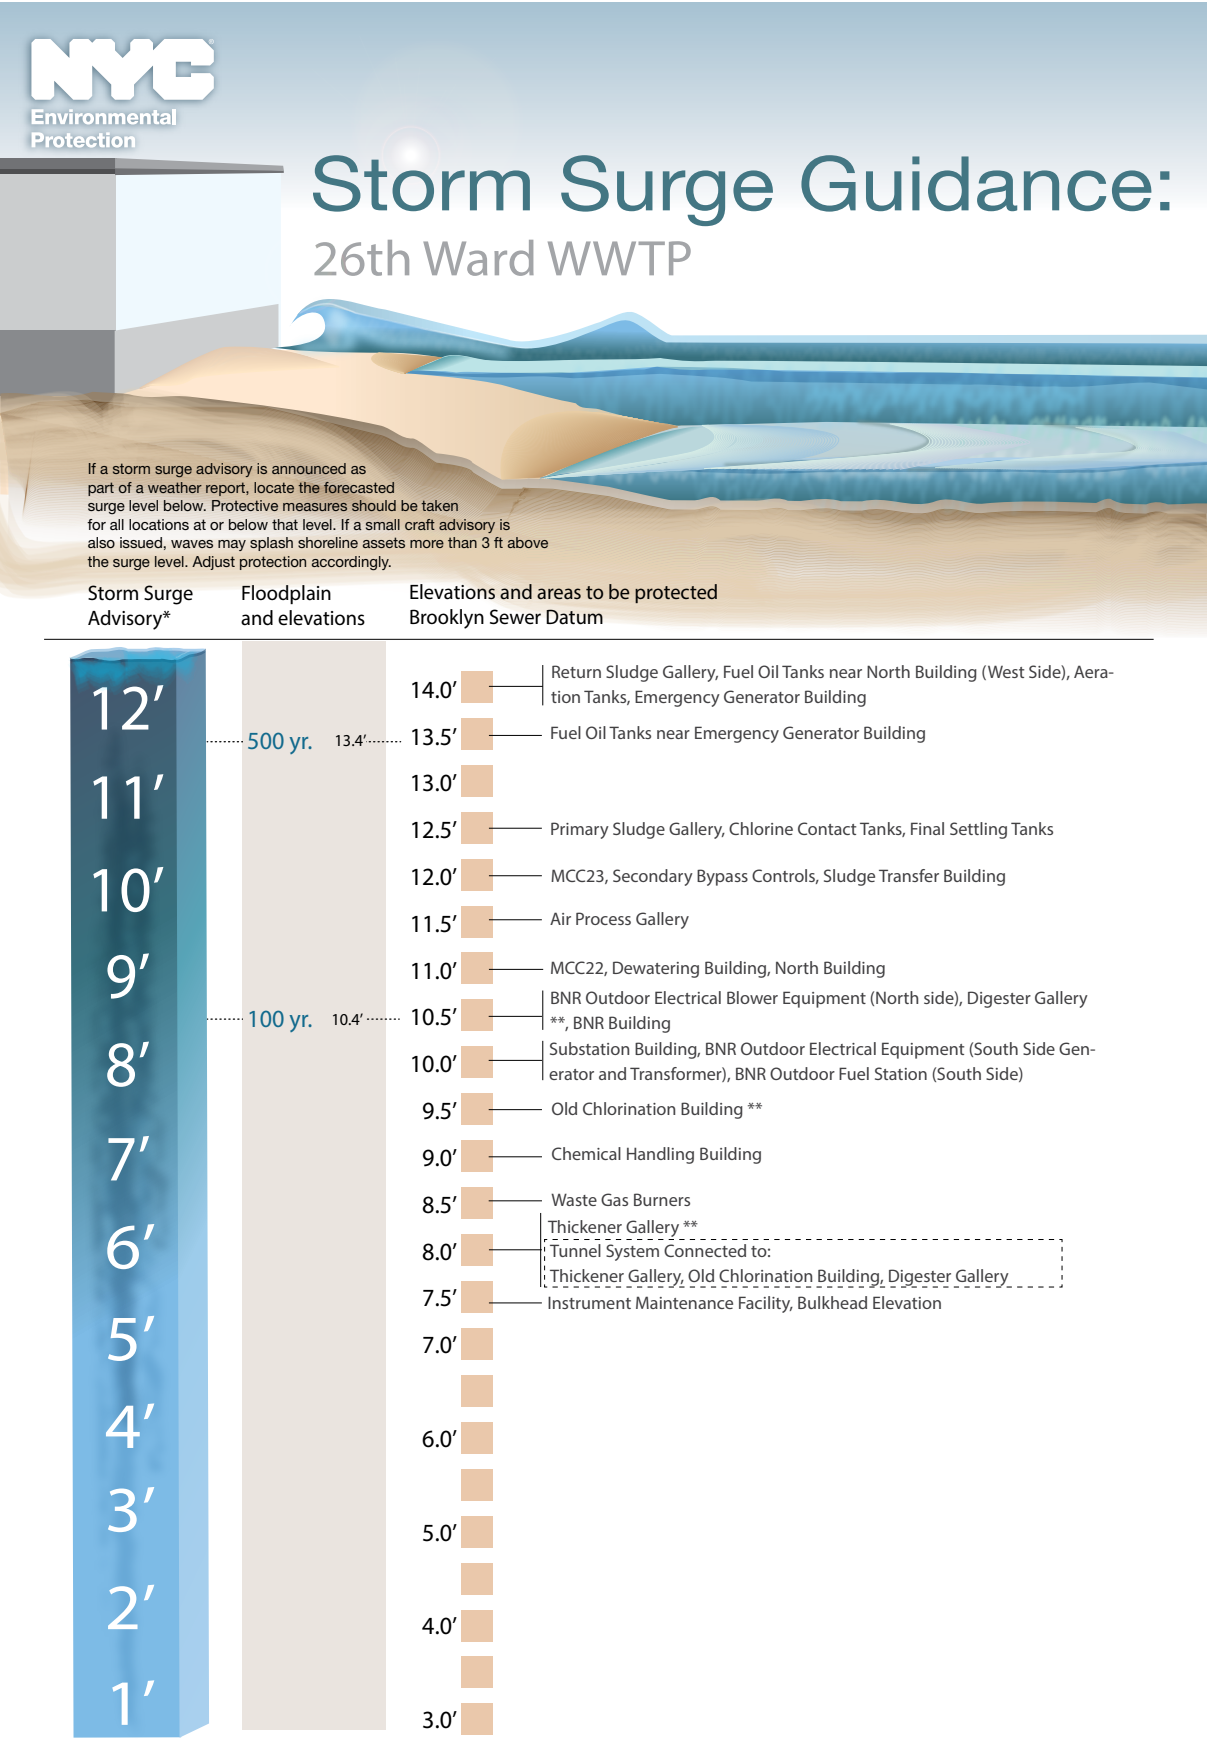
\*Storm surge added to Mean Higher High Water at Sandy Hook as of 2012, which is 1.77 ft Brooklyn Sewer Datum. Sea level is expected to rise up to 30 inches by 2050. This storm surge advisory is for current conditions.  
\*\*One of the multiple flood pathways into the tunnel system. To protect tunnels, ensure all pathways are protected.

This storm surge placard provides a quick reference for operators to prepare their plant in advance of a surge event. The guidance enables an operator to rapidly locate at-risk locations based on storm surge warnings. Once at-risk areas are identified, plant staff may proactively protect locations at or below the forecasted surge levels.

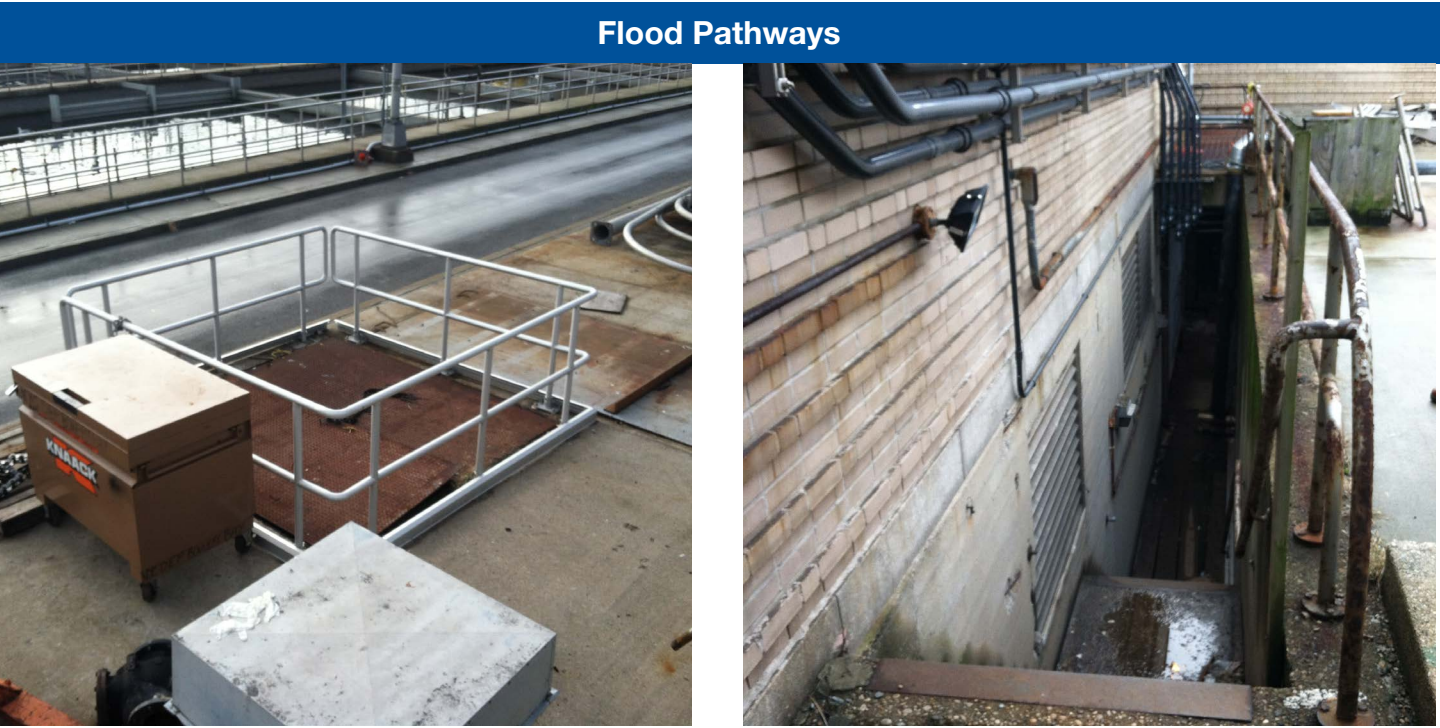
Typical hatch at grade level leading to tunnel system

Stairway at grade leading to the Main Building

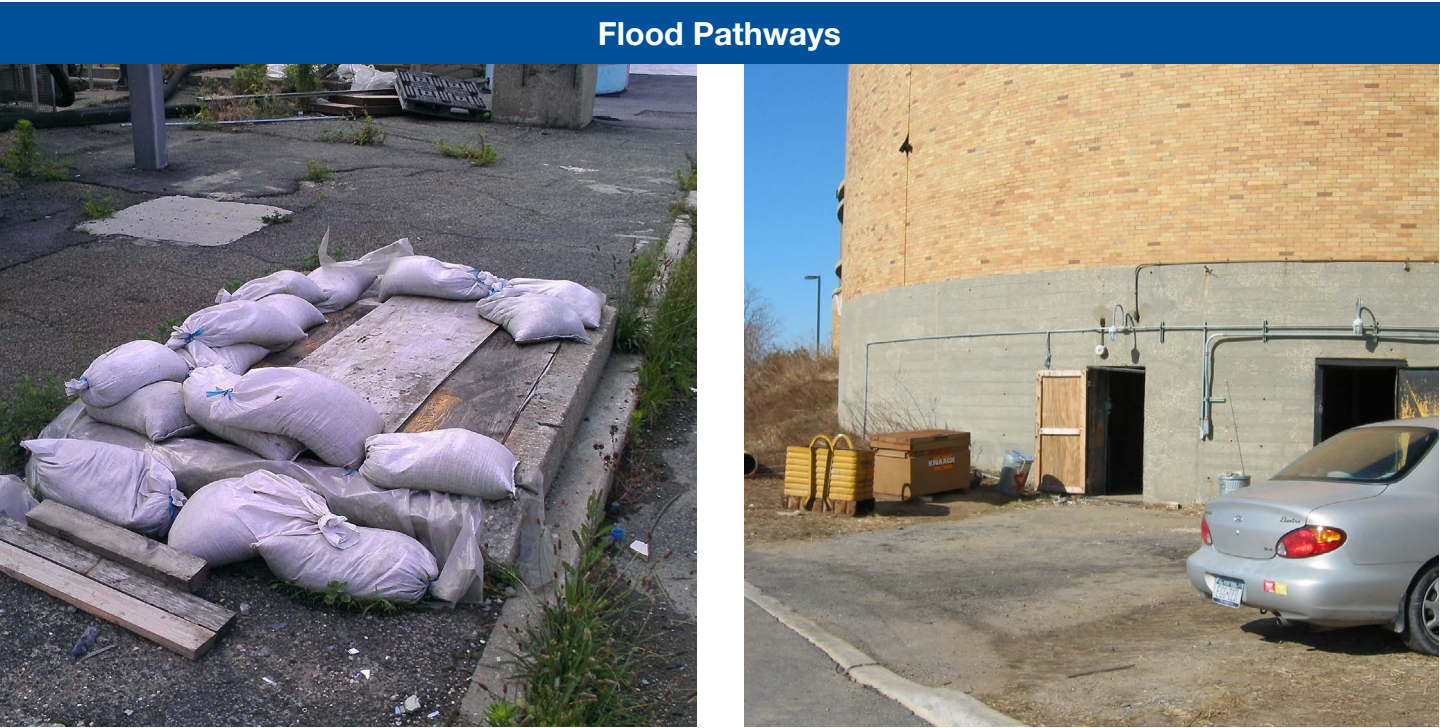
The overhead grate above the Aeration Gallery is a potential flood pathway to the sludge pumps.

Access doors to the Sludge Storage Tanks next to the East River

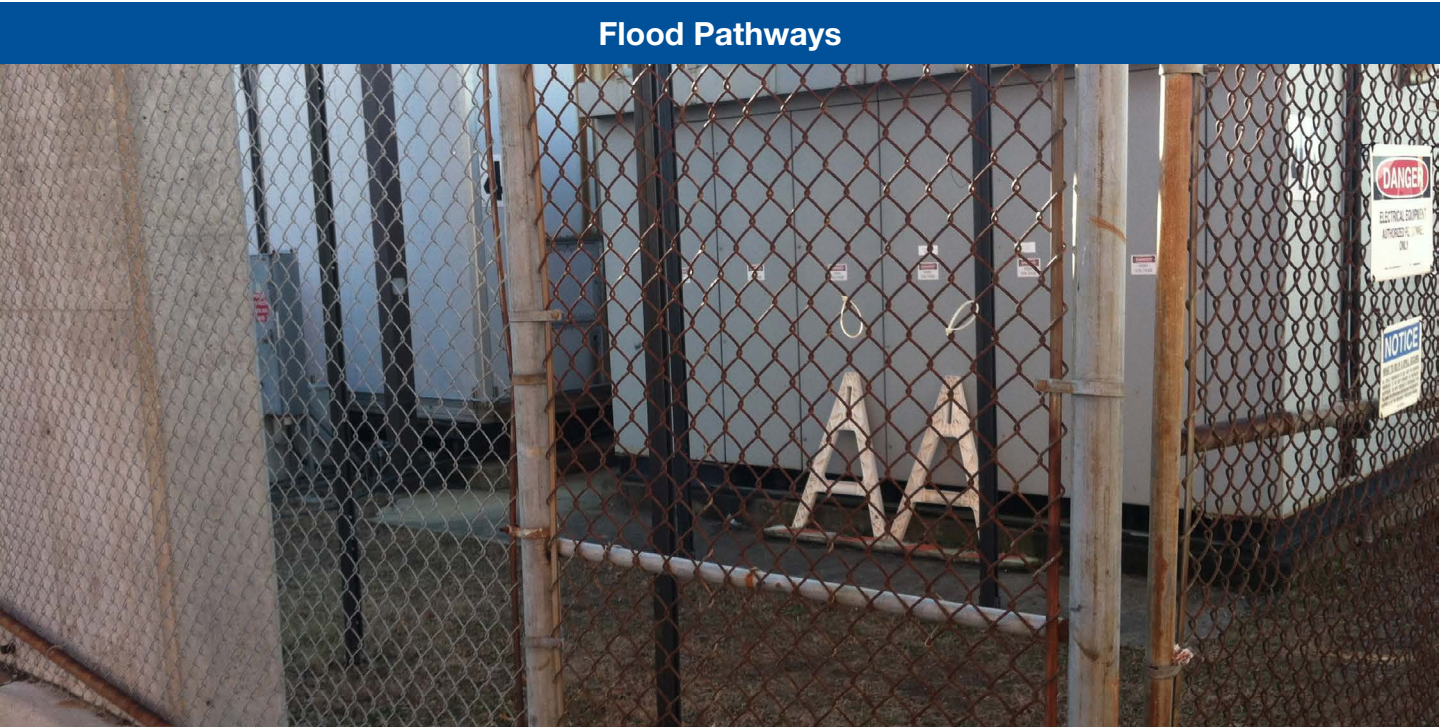
The Unit Substation adjacent to the Return Sludge Pump Station #3 would be flooded at grade level during the critical flood event.

The critical flood event would only result in half a foot of flooding near the Unit Substation; therefore, sandbagging around the Substation is recommended. This strategy is regularly employed at the Substation, already as staff know this area has the greatest potential for flooding. This option can be implemented as needed prior to large flood events. It is also affordable and provides an adequate level of protection for the Substation.

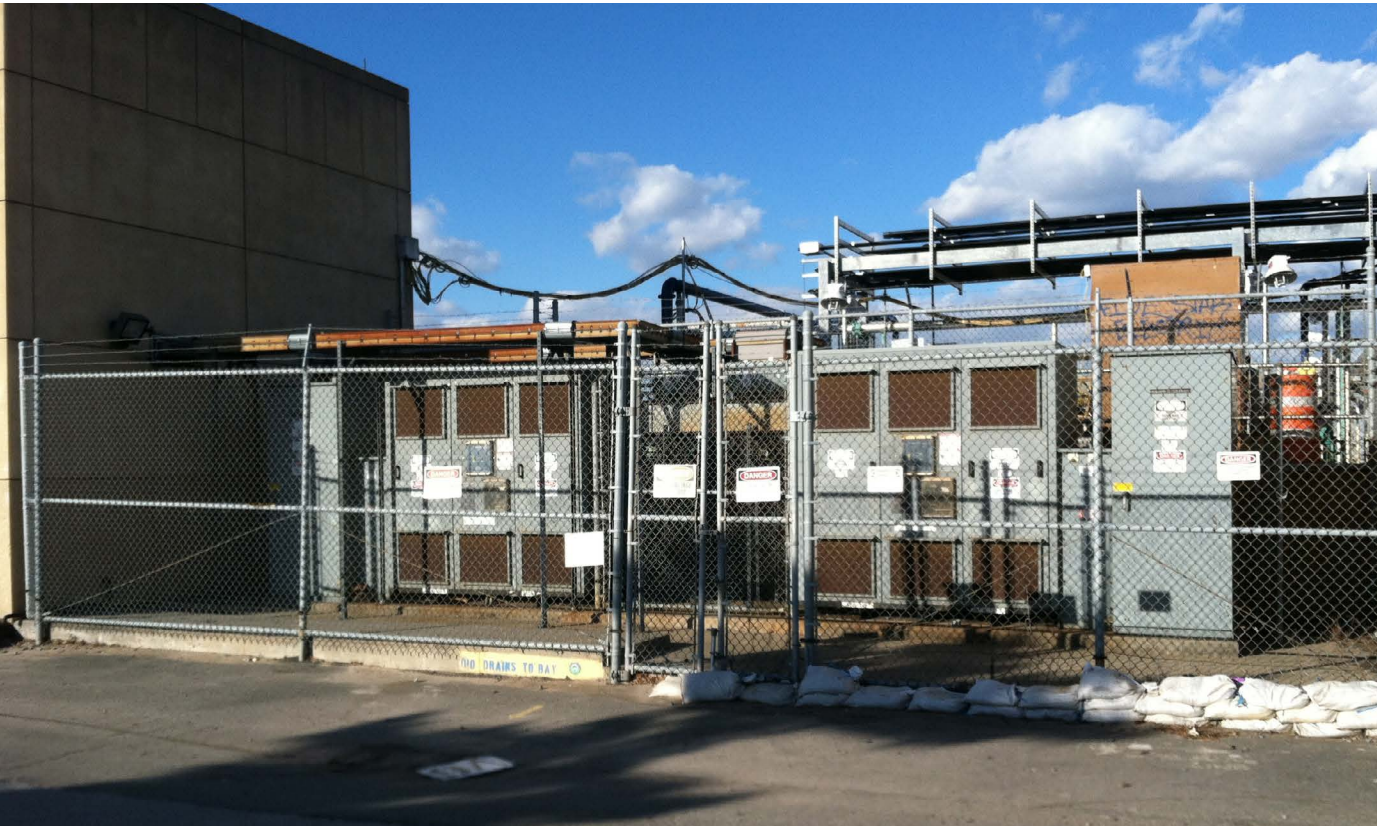
The Unit Substation (USS 1533) is currently protected with sandbags.

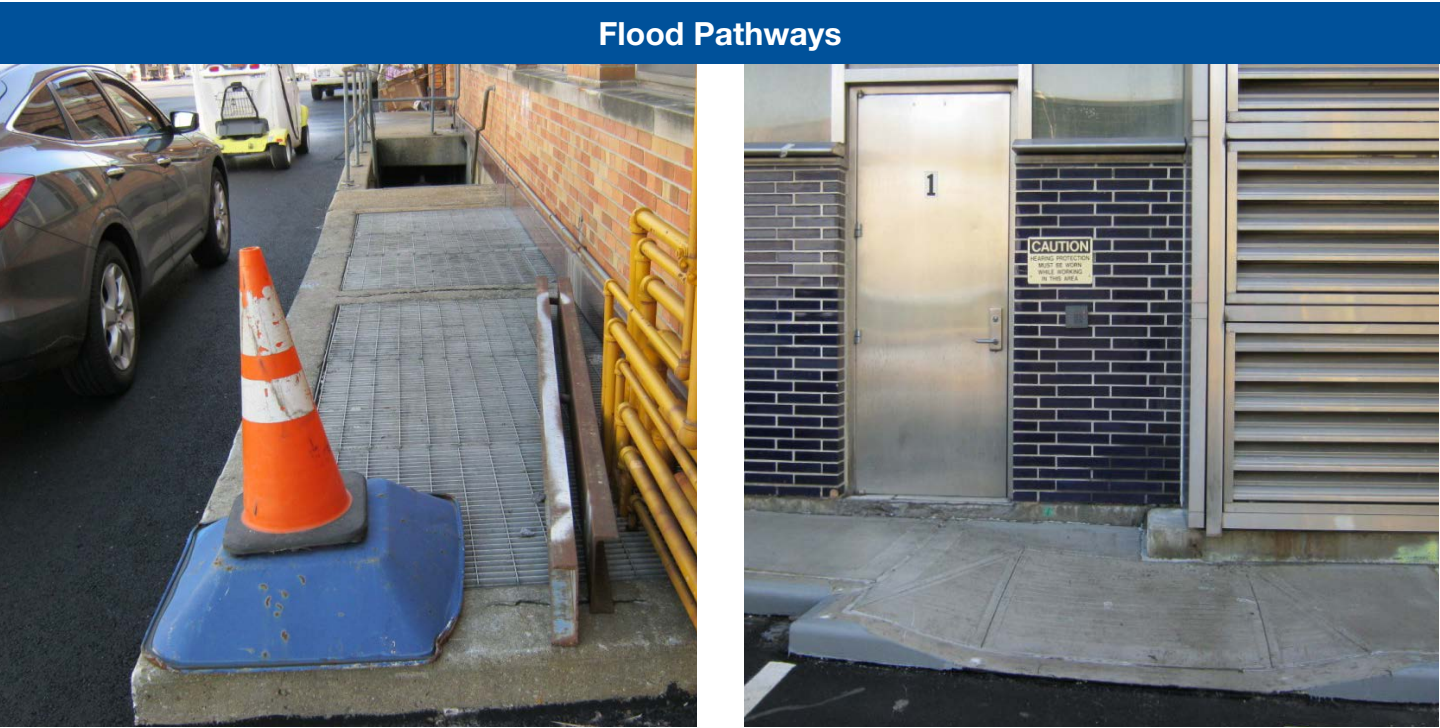
Basement access and floor grates on the perimeter of the Main Building

Low-lying louvers along-side the Main Building

The Main Building contains several rooms that are susceptible to flooding under the critical flood event, such as the Main Pump Room, Old Facility Room, and Electrical Substation area. It is recommended to seal the building with water-tight doors and windows and flood-proof target pieces of equipment to provide adequate protection during the critical flood event and smaller storms.

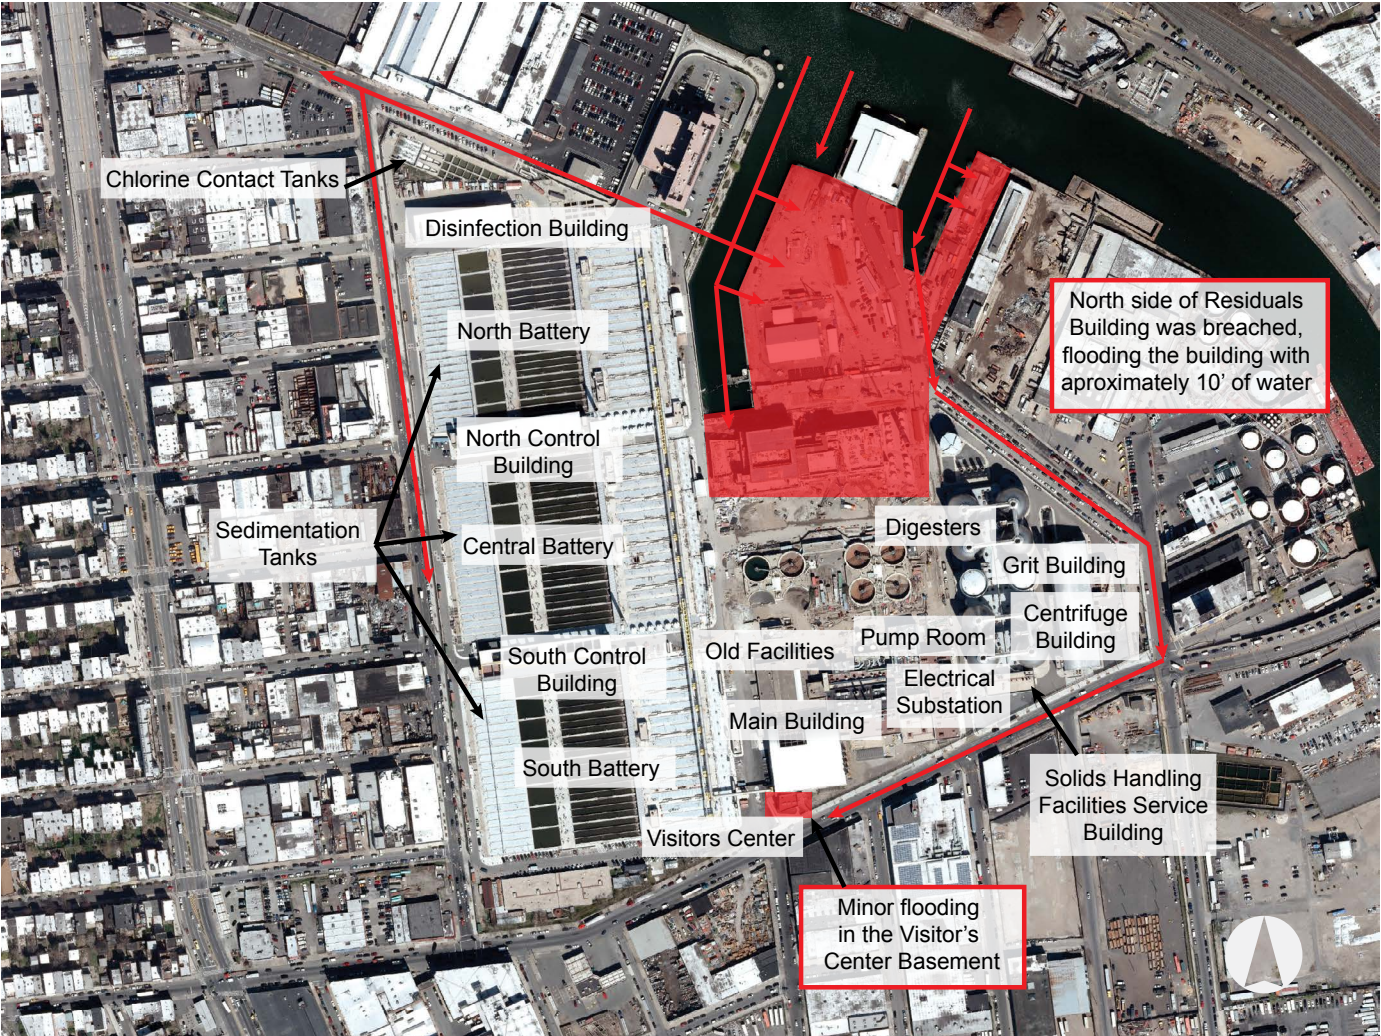
A significant area of Newtown Creek experienced flooding as a result of Hurricane Sandy, however damage was minor. During the peak of the storm, floodwaters entered the site from Whale Creek Canal and Newtown Creek over the bulkheads. Floodwaters inundated Paidge Avenue, Kingsland Avenue, and Greenpoint Avenue, leading up to the plant Visitor’s Center. Water reached the doorway of the Visitor’s Center but did not breach the entrance. However, there was minor flooding in the basement of the Visitor’s Center, as water backed up through the drain system and electrical conduits. These valves were shut during the storm to minimize additional flooding.

Flood pathways and areas flooded during Hurricane Sandy are highlighted in red.

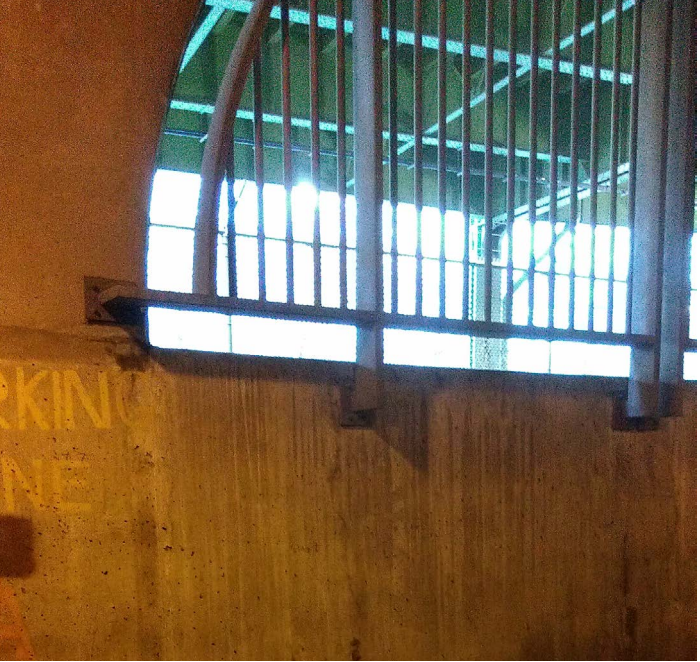
Arched windows around the perimeter of the ground level (EL 5) are considered pathways for flooding.

Since the first floor elevation (EL 5) at North River contains critical infrastructure, flood-proofing is recommended since it provides a high degree of protection. In areas of the first floor where not all infrastructure could be flood-proofed, sealing the openings to the building is recommended. Fortifying the manhole covers, driveway entrance, and arch openings along the perimeter of the building will greatly reduce the plant’s risk and prevent floodwaters from entering the first floor, traveling throughout the plant, and damaging target pieces of equipment.

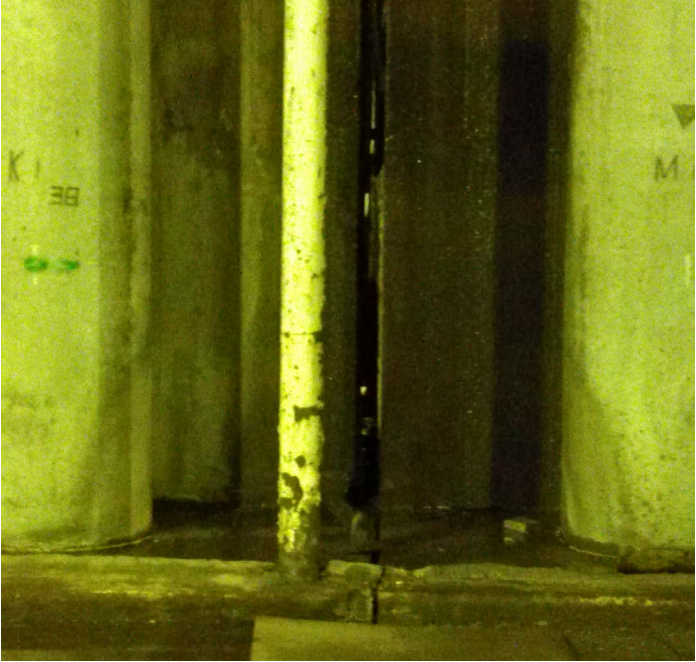
Expansion joints are flood pathways as experienced during Hurricane Sandy.

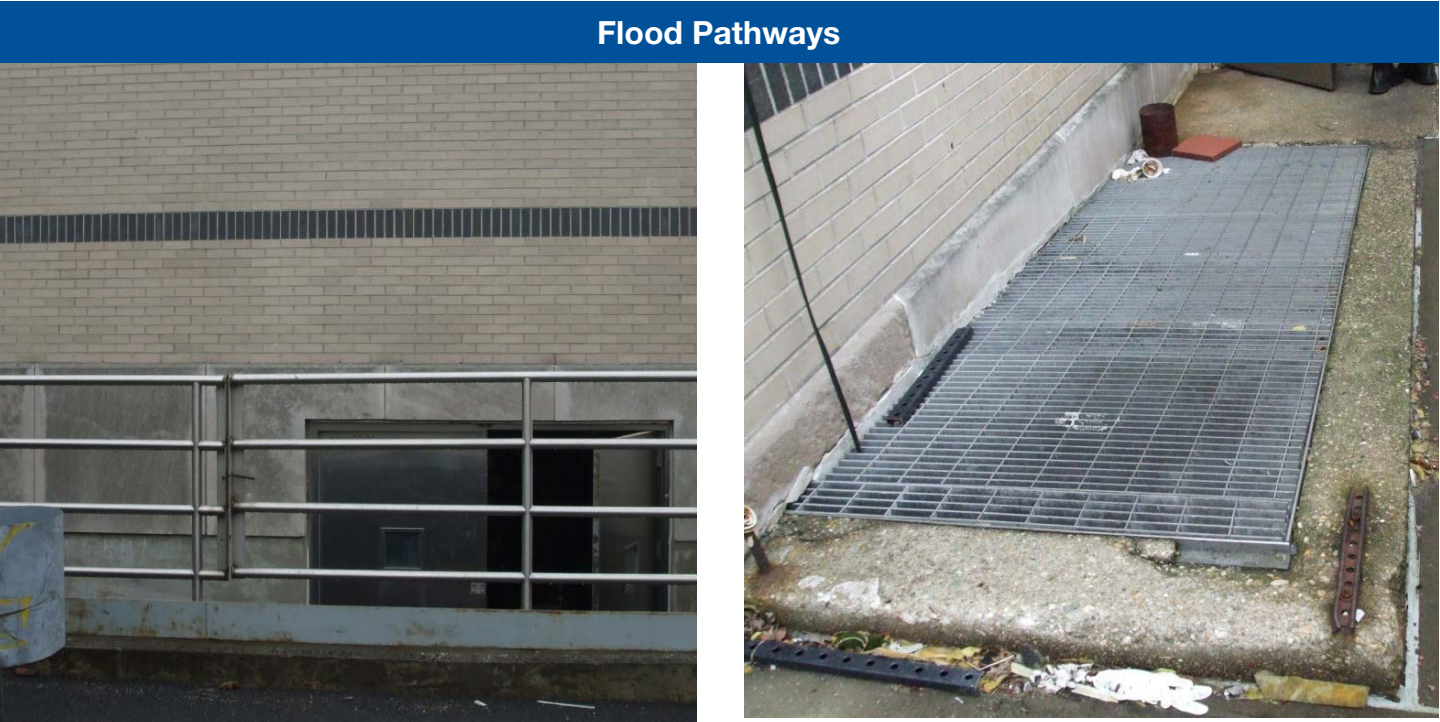
A pathway for flooding is around the perimeter of the Administration Building.

Floor grates near the Generator Room may allow floodwater to enter.

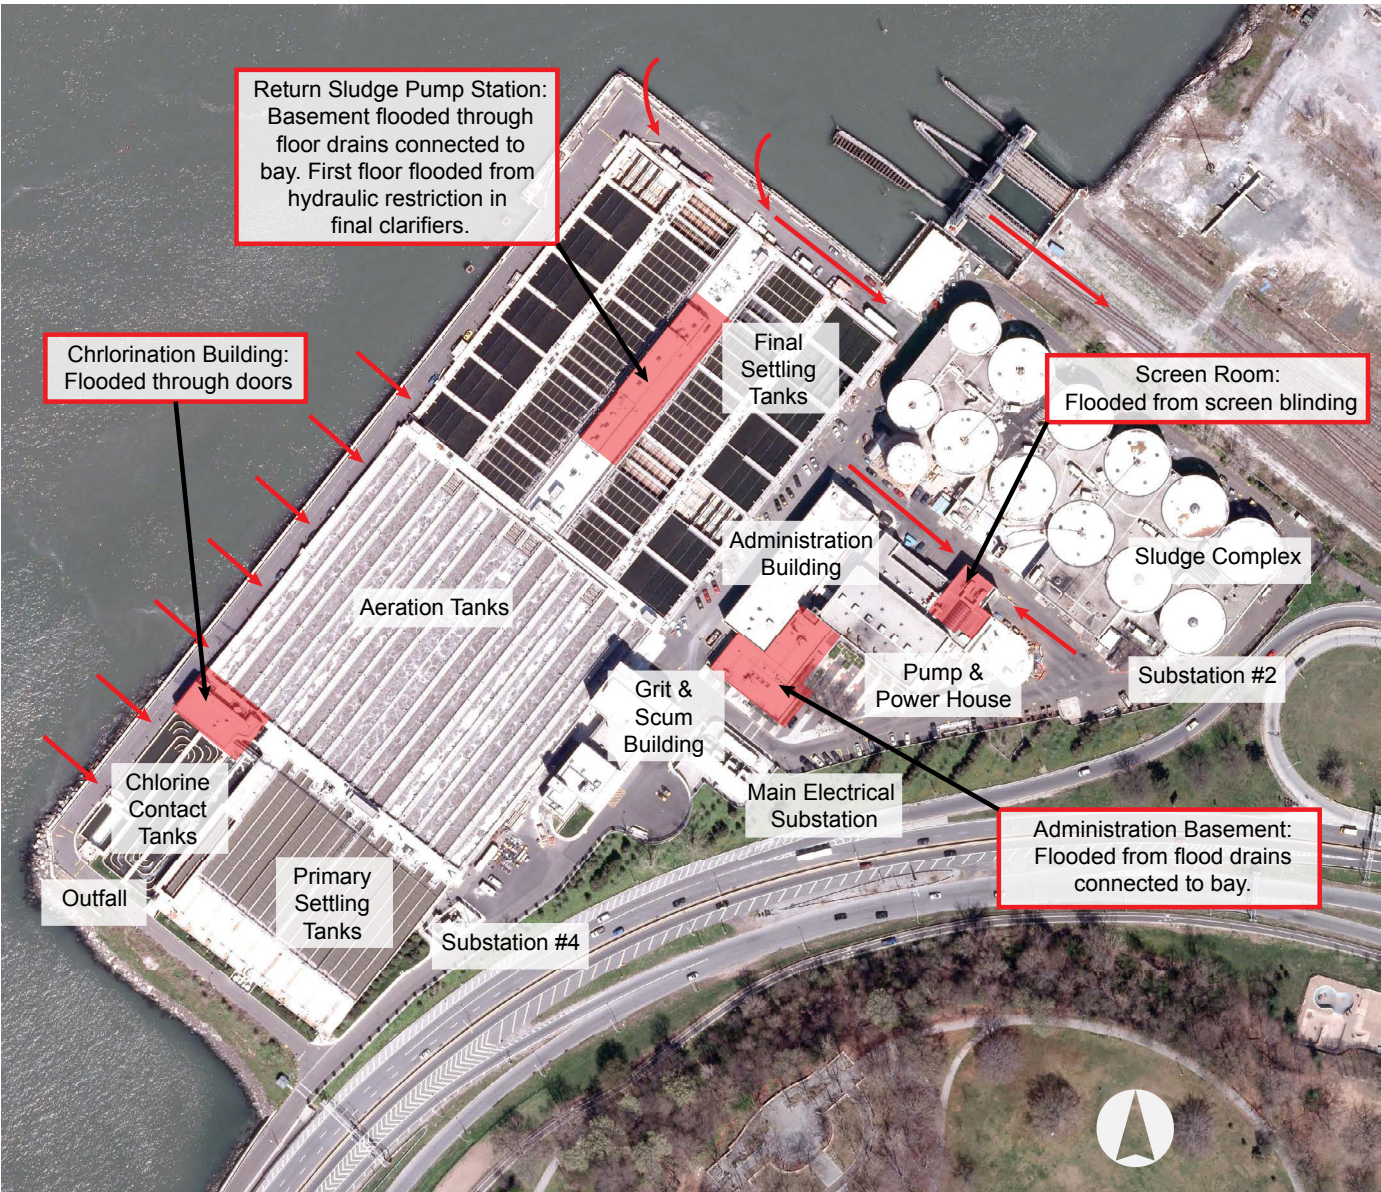
Flood pathways and areas flooded during Hurricane Sandy are highlighted in red.

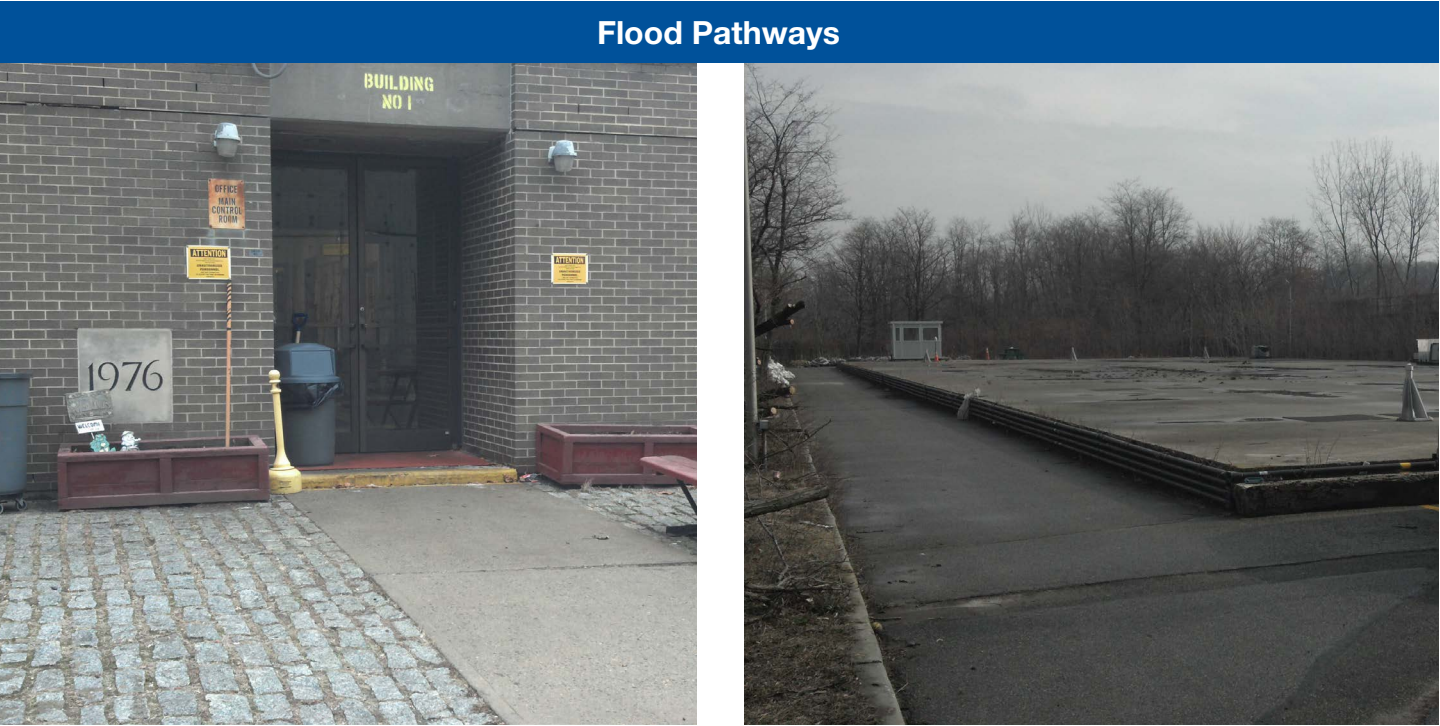
Entrance to Main Building

Chlorine Contact Tanks are potentially at risk of flooding during a large storm event.

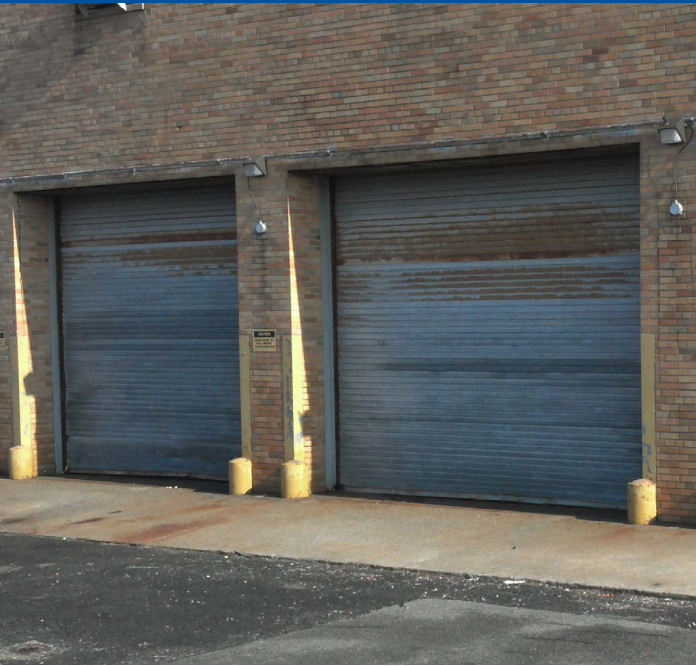
Rollup doors on the Sludge Storage Building adjacent to Jamaica Bay are potential pathways for flooding as experienced during Hurricane Sandy. The Sludge Storage Building is also an access point into the plant's interconnected tunnel system.

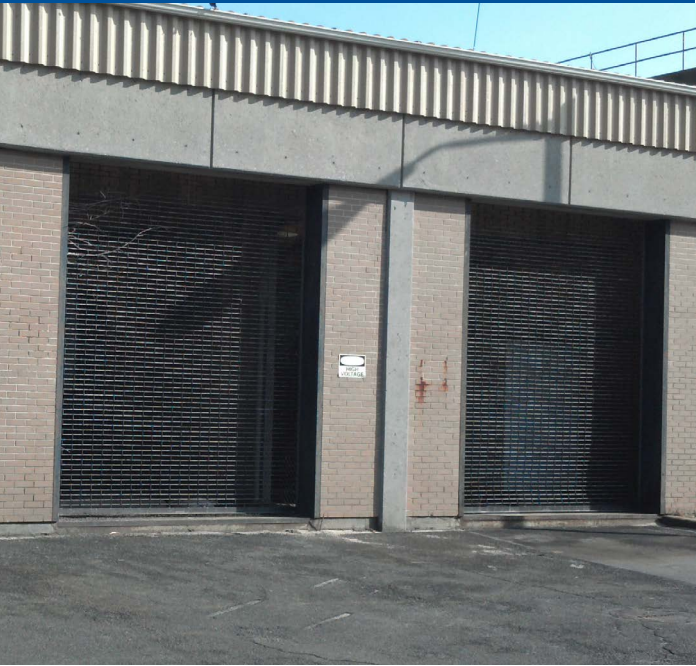
Rollup doors at the Electrical Substation Building

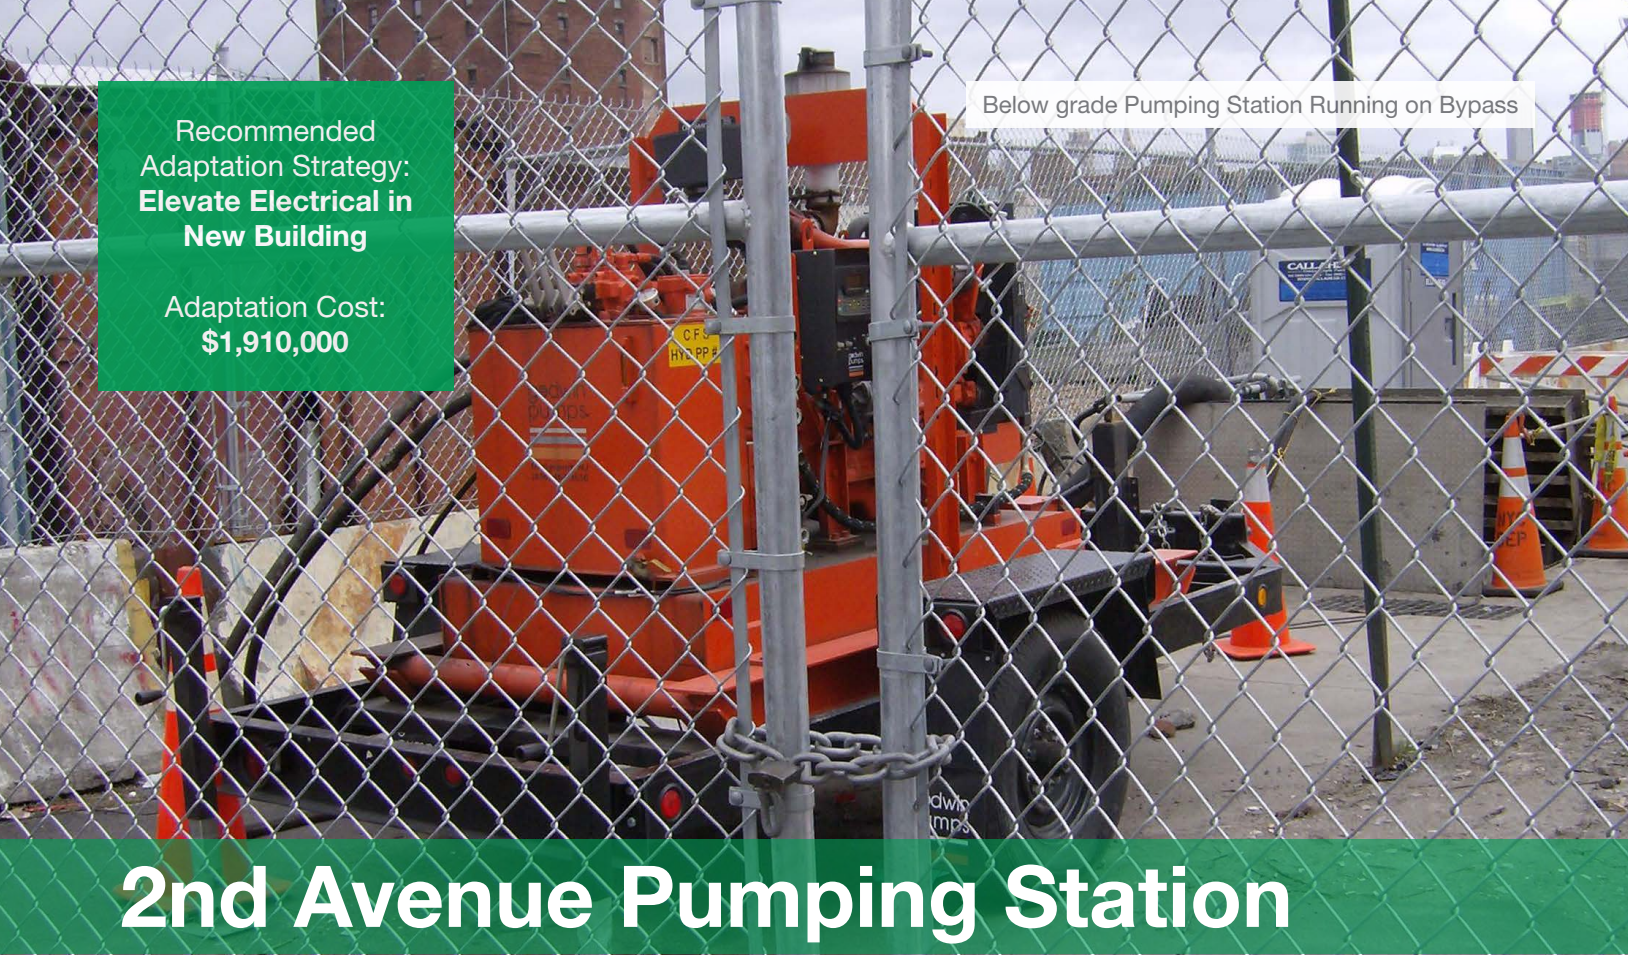
The 2nd Avenue combined pumping station is located near the intersection of 2nd Avenue and 5th Street in Brooklyn. It is a below grade station that was running on a bypass pump at the time of the site visit.

At the time of the station visit in March 2013, the station was running on a bypass pump due to damage caused by flooding during Hurricane Sandy. Streets nearby the station flood during smaller storm events, but the station itself does not have a history of flooding.

evation (ABFE) 100-year flood plus 30 inches of sea level rise (critical flood elevation). The critical flood elevation would completely inundate the below grade station; the surrounding flood would be more than 6 feet above local grade. This would flood and damage the electrical controls. The submersible pumps should withstand flooding. A visit to the pumping station to view its exterior confirmed that it appears consistent with the plan drawings.

The 2nd Avenue pumping station requires adaptive measures to withstand the critical flood elevation. Potential strategies were evaluated against such factors as flood depth, equipment location, and space. Viable strategies were reviewed to identify the most cost-effective, resilient option. Due to the critical flood depth of more than 6 feet, the recommended strategy at 2nd Avenue is to elevate controls in a new building. Residual risk is related to the potential for larger storms or more extreme climate change.

Recommended  
Adaptation Strategy:  
**Elevate Electrical in  
New Building**

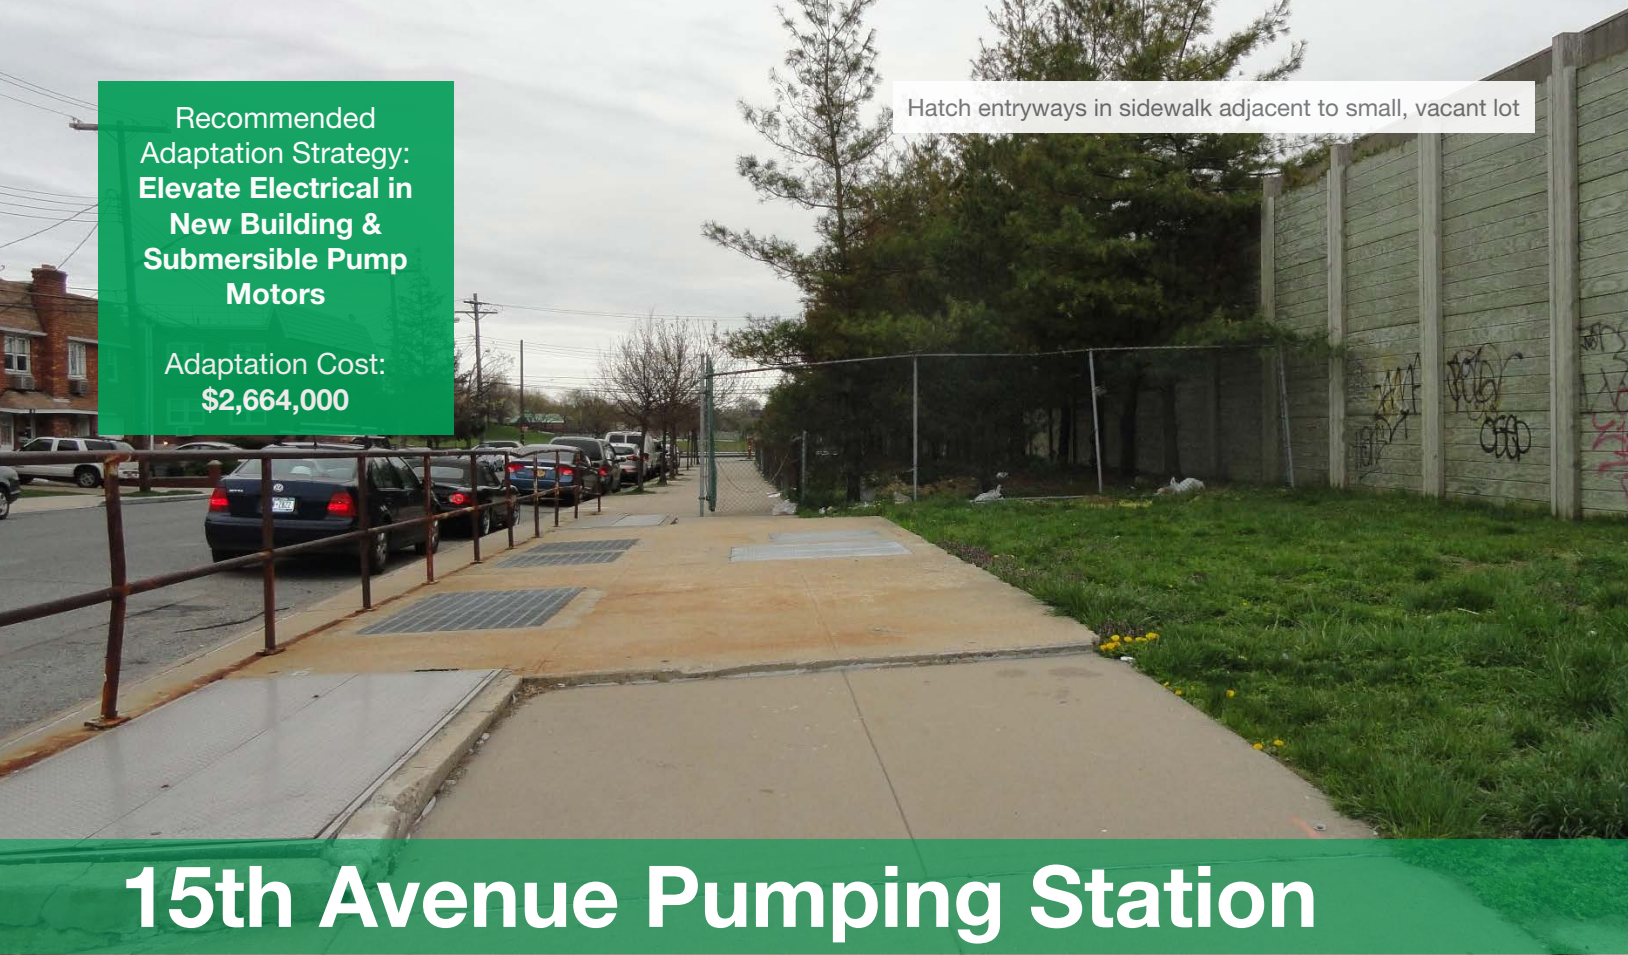
The 15th Avenue sanitary pumping station is located near the southeast corner of 15th Avenue and 131st Street in Queens. The station is completely below grade with grates and hatch entryways located in the sidewalk along 15th Avenue. There is a small grassy area between the pumping station and a concrete wall.

The critical flood elevation would flood the local grade to a depth of about 4 inches. Because the station is entirely below grade, and access hatches and grating are very near to grade level, even this minor flood could significantly affect the station. Electrical controls and non-submersible pumps could be damaged if flood waters enter the pumping station.

The 15th Avenue pumping station requires adaptive measures to withstand the critical flood elevation. Potential strategies were evaluated against such factors as flood depth, equipment location, and space. Viable strategies were reviewed to identify the most cost-effective, resilient option. The station entrances are currently located in a sidewalk, there is a plot of vacant land bordering the sidewalk, and a concrete wall approximately 15 feet high runs along the back of the lot. With space available and no apparent limitations on structure height, the recommended strategy at 15th Avenue is to elevate the electrical controls in a new building and install submersible pumps. Residual risk is related to a greater depth of flooding from larger storms or more extreme climate change.

Recommended  
Adaptation Strategy:  
**Seal Building**

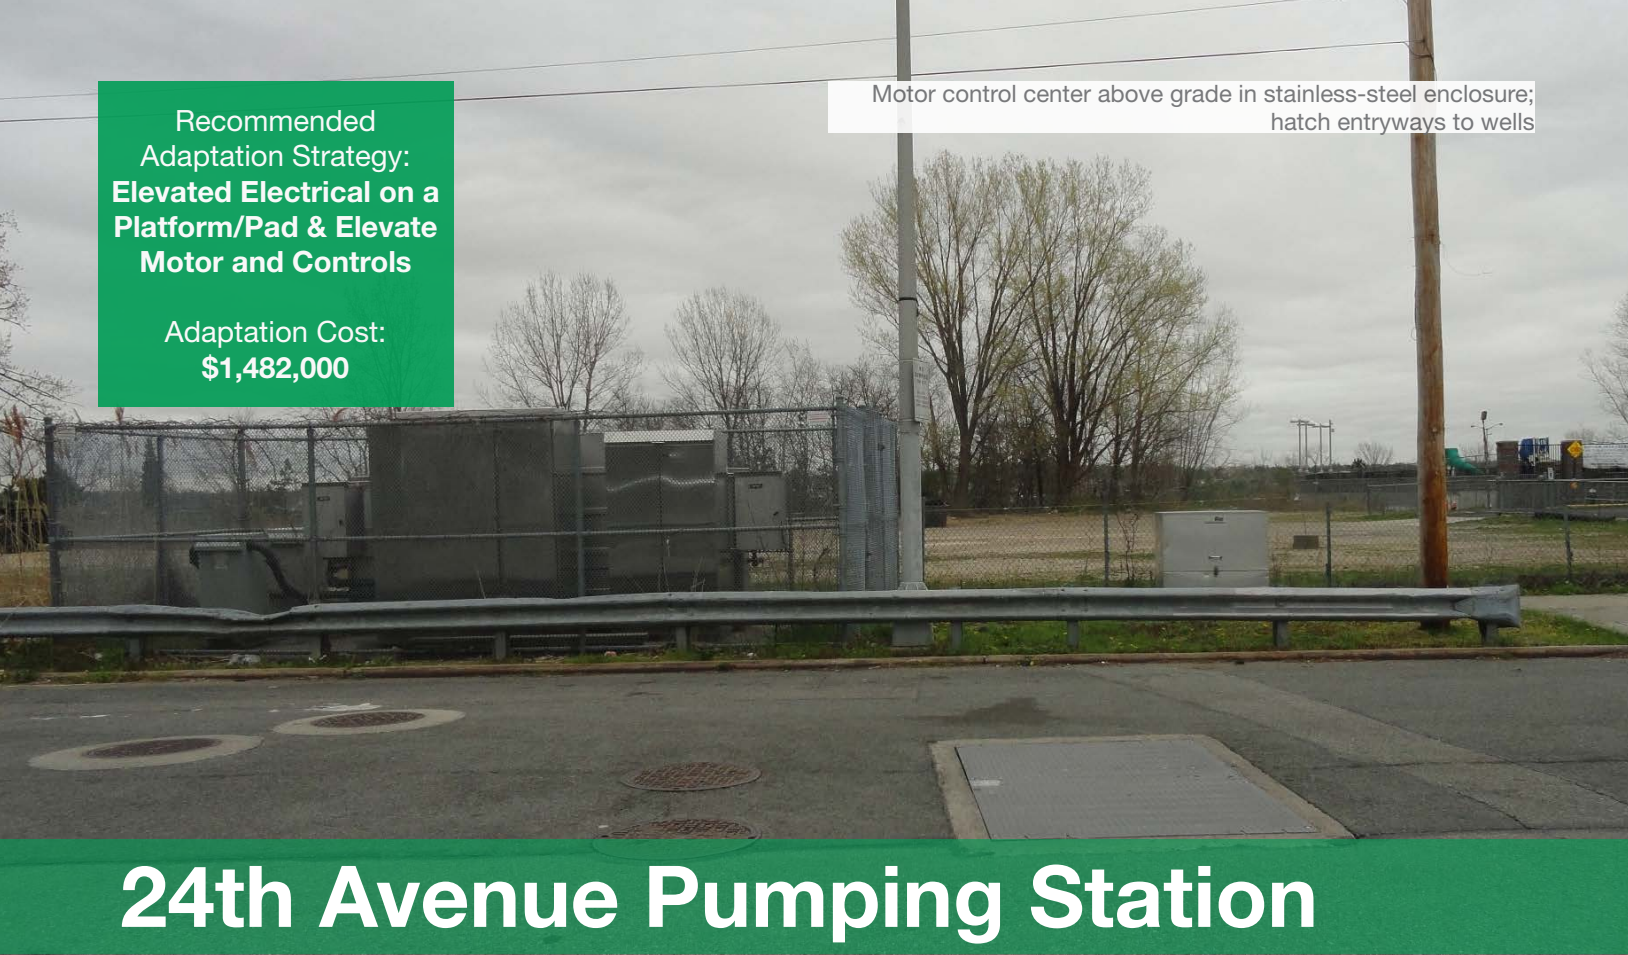
# 24th Avenue Pumping Station

The 24th Avenue sanitary pumping station is located near the intersection of 24th Avenue and 217th Street in Queens, near the dead end of 24th Avenue; 217th Street is labeled Waters Edge Drive on street signs. The motor control center (MCC) sits above grade in a fenced-in stainless-steel enclosure. There are hatch entryways to the wells in the roadway of Waters Edge Drive as well as in the adjacent sidewalk.

The critical flood elevation would flood the local grade to a depth of nearly 4 feet. This would completely inundate the wells, damaging the non-submersible pumps. It would also submerge and damage the MCC and other grade-level electrical components.

The 24th Avenue pumping station requires adaptive measures to withstand the critical flood elevation. Potential strategies were evaluated against such factors as flood depth, equipment location, and space. Viable strategies were reviewed to identify the most cost-effective, resilient option. The pumping station's electrical components are visible in their current location above grade, and the station borders an empty lot. Because the appearance of elevated components should not be a concern, the recommended strategy at 24th Avenue is to elevate both the electrical controls and the pump motors on a platform. This would achieve resiliency without the expense of constructing a building or replacing pumps. Elevating pump motors and replacing existing motors with submersibles are both acceptable solutions, however elevating pump motors may be a more cost-effective adaptation for this pumping station. Residual risk is related to the potential for greater storms or climate change impacts.
