# NYC WASTEWATER RESILIENCY PLAN

## CLIMATE RISK ASSESSMENT AND ADAPTATION STUDY

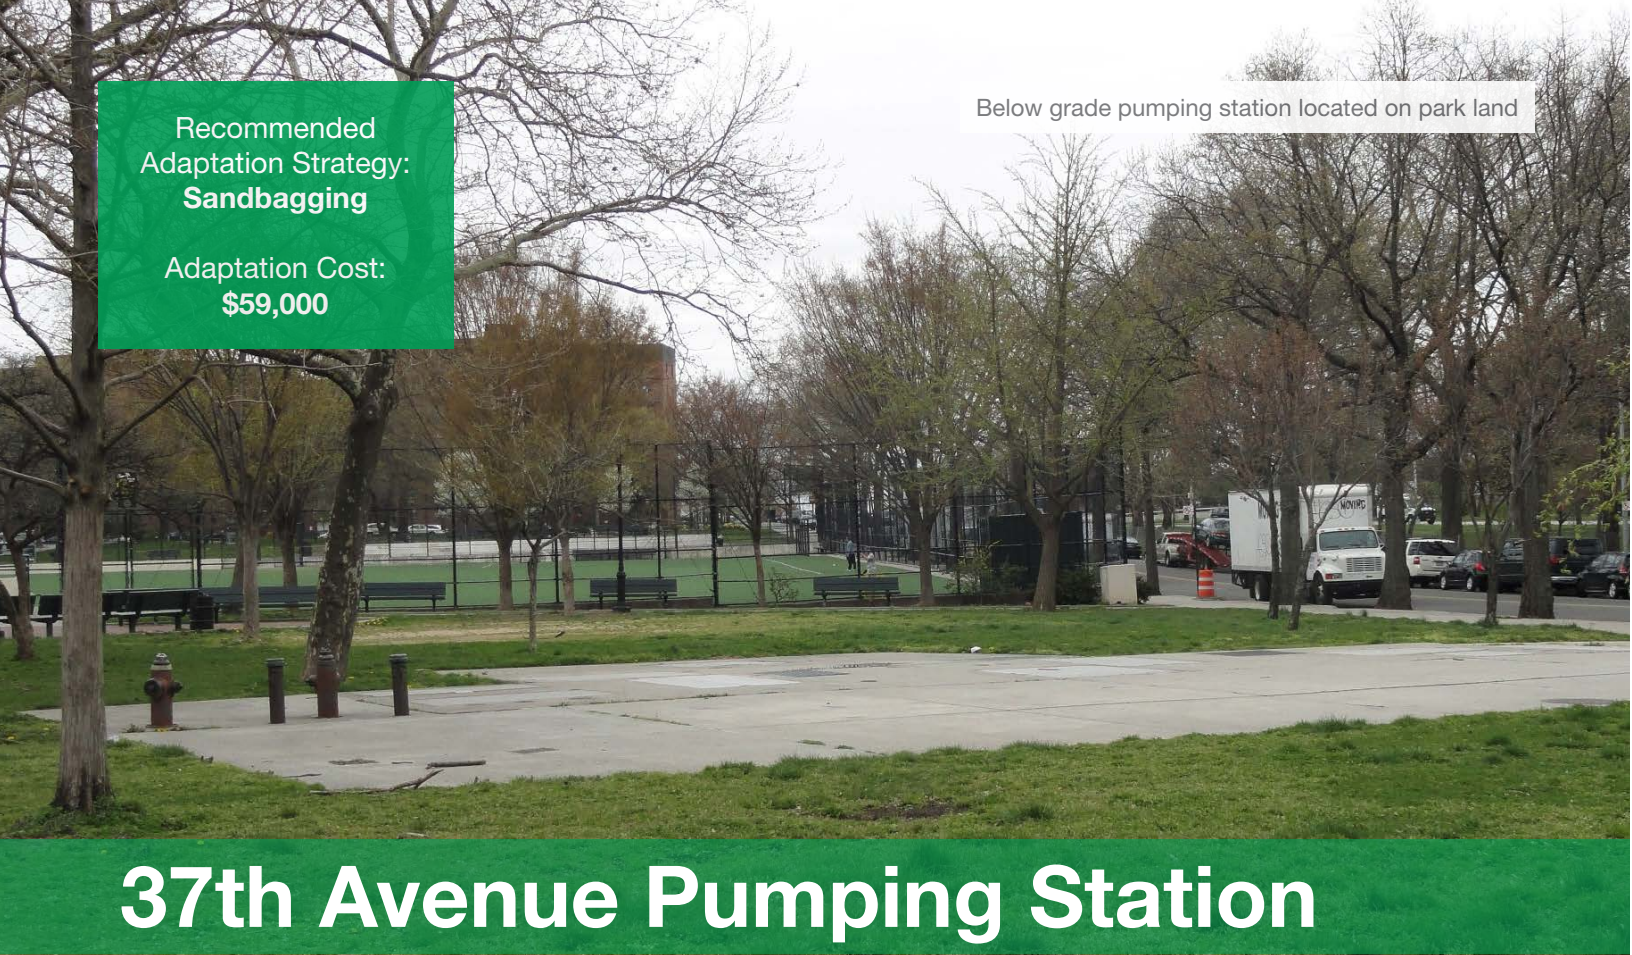
# 37th Avenue Pumping Station

The critical flood elevation would result in a flood depth of 1.6 feet above grade, and it would inundate the below grade station. This would damage electrical controls but would not affect the submersible pumps.

Below grade pumping station located on park land

The 37th Avenue pumping station requires adaptive measures to withstand the critical flood elevation. Potential strategies were evaluated against such factors as flood depth, equipment location, and space. Viable strategies were reviewed to identify the most cost-effective, resilient option. Due to the shallow flood depth and the station's location, in park land out of the way of vehicles and pedestrians, the recommended strategy is to place sandbags around potential water-entry points prior to flooding events. Residual risk is related to sandbags being stacked improperly or being disturbed by residents.

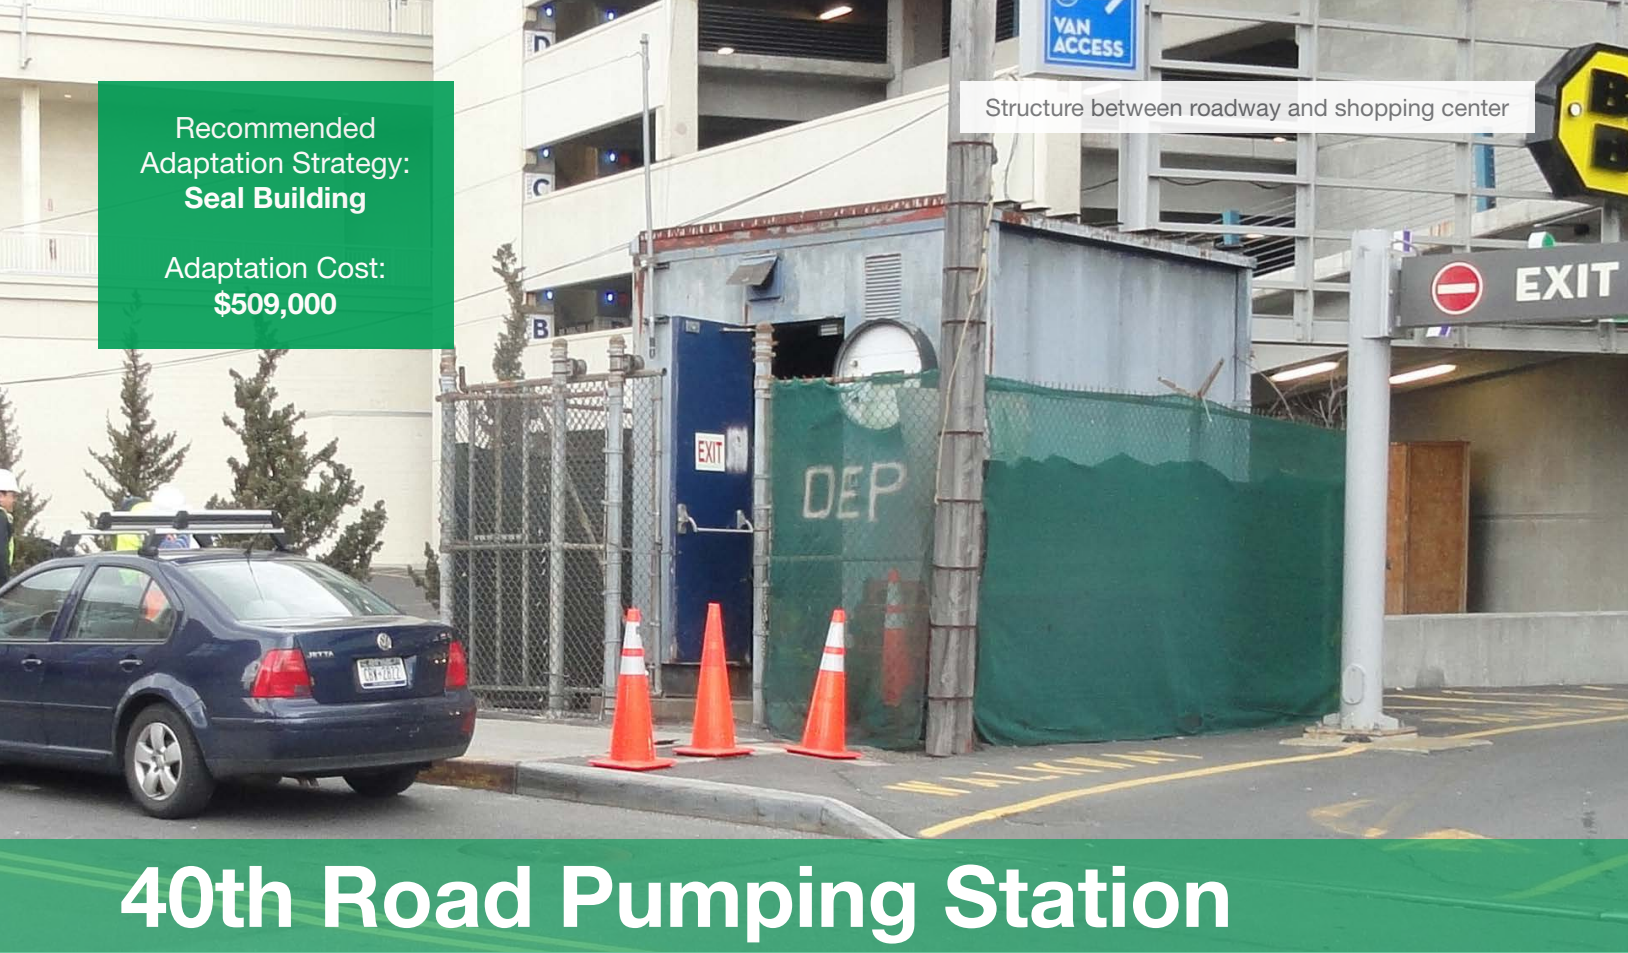
# 40th Road Pumping Station

The 40th Road sanitary pumping station is near the corner of 40th Road and College Point Boulevard, between 40th Road and a shopping plaza, in Queens. Controls are located in a small metal structure next to the sidewalk. The dry and wet wells are accessible through hatches in the sidewalk. The Pumping Station Summary table lists the general characteristics of the 40th Road pumping station, the potential effect of its failure, and the recommended adaptation strategy. The station is located in a commercial area. Failure of the station would affect an area of approximately 66 acres. There are four critical facilities within that area that could be affected if the station failed.

This pumping station flooded during Hurricane Sandy. The control room flooded to a depth of approximately 3 inches, and the surrounding area was flooded to a depth of 2 to 3 feet. The station suffered damage to lighting and ventilation equipment, but the submersible pumps remained operating throughout the storm and were not damaged. There is no history of flooding aside from Hurricane Sandy.

The critical flood elevation would completely inundate the station, and the surrounding flood would be more than 6 feet above local grade. This would flood and damage the pump controls, a compressor, and the lighting panel. The submersible pumps should withstand flooding.

The 40th Road pumping station requires adaptive measures to withstand the critical flood elevation. Potential strategies were evaluated against such factors as flood depth, equipment location, and space. Pumps are submersible and do not require any modifications, but electrical controls, located in the existing above grade structure, are vulnerable to flood water. Property size and location limits the potential for a new, larger structure. Viable strategies include moving controls to the walls or roof of the existing structure as well as sealing the building; these strategies were reviewed to identify the most cost-effective, resilient option. The recommended strategy at 40th Road is to seal the existing building and add sluice gates to restrict inflows. Because water tight cases, doors, and building sealants are only rated up to a certain pressure, if flood depth is greater than expected the water pressure could exceed the rating and the building sealing could fail. Therefore, residual risk is related to a greater depth of flooding from larger storms or more extreme climate change and the potential for water pressure to exceed the rating of the sealing measures.

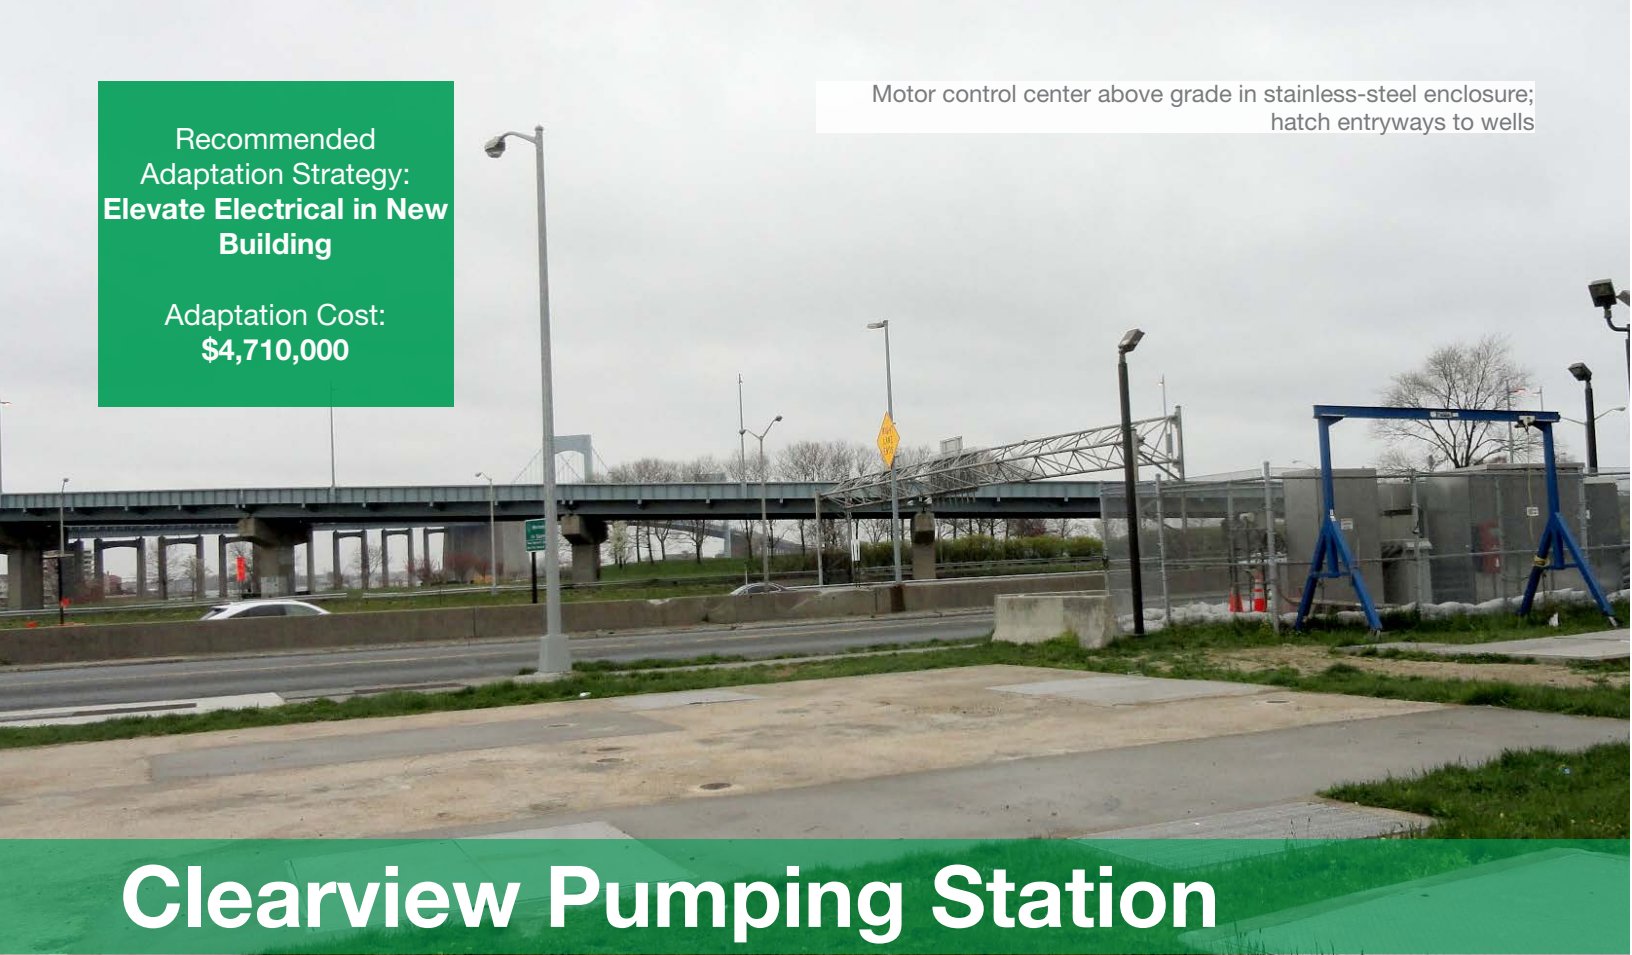
Motor control center above grade in stainless-steel enclosure;  
hatch entryways to wells

Recommended  
Adaptation Strategy:  
**Elevate Electrical in New  
Building**

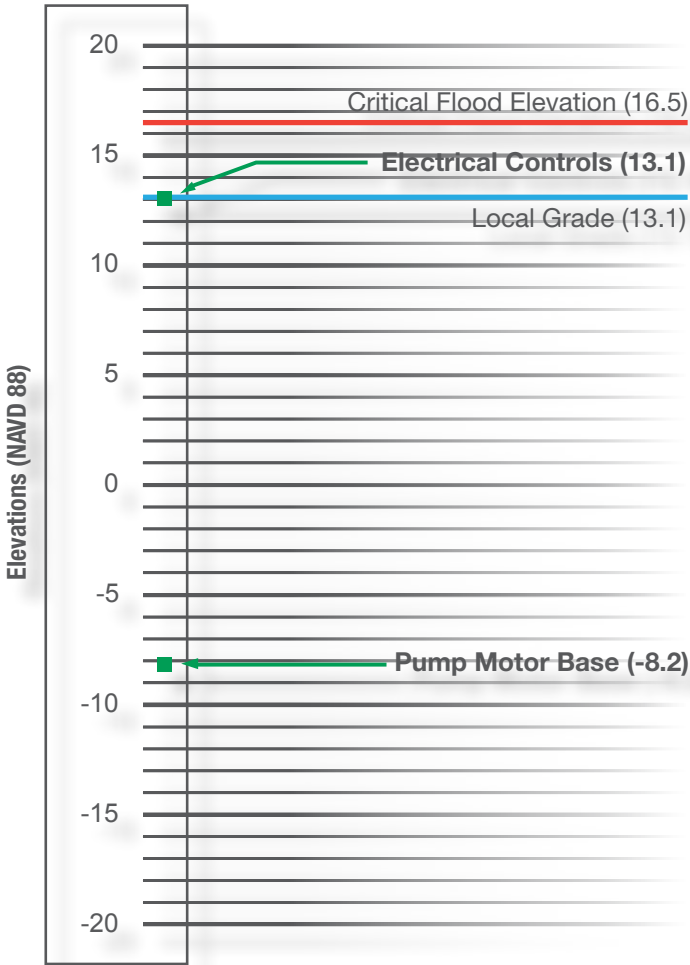
## Critical Elevations

that of the March 2013 FEMA Advisory Base Flood Elevation (ABFE) 100-year flood plus 30 inches of sea level rise (critical flood elevation). A visit to the pumping station to view its exterior revealed that the Motor Control Center (MCC) and other electrical controls, which were shown below grade in the drawings, had been moved to a slab above grade. DEP data also indicate that the pumps had been replaced with submersibles.

The critical flood elevation would be more than 3 feet above grade. This would flood and damage the grade-level motor control center and pump.

The Clearview pumping station requires adaptive measures to withstand the critical flood elevation. Potential strategies were evaluated against such factors as flood depth, equipment location, and space. Viable strategies were reviewed to identify the most cost-effective, resilient option. Due to the critical flood depth and the lack of an existing structure, the recommended strategy at Clearview is to elevate the pumping station's controls in a new building. Residual risk is related to a greater depth of flooding from larger storms or more extreme climate change.

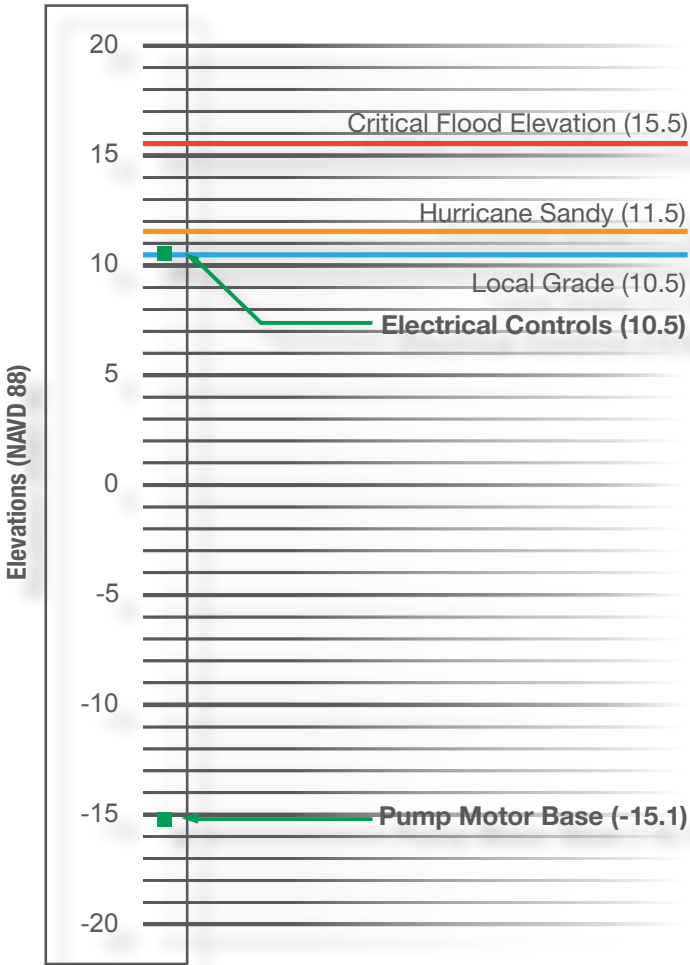
### Critical Elevations

Base Flood Elevation (ABFE) 100- year flood plus 30 inches of sea level rise (critical flood elevation). A visit to the pumping station to view its exterior revealed that the electrical controls, which are shown below grade in the drawings, have been moved to a slab above grade. The critical flood elevation would be 5 feet above grade. Water would flood and damage the motor control center. The submersible pumps should withstand flooding.

The Commerce Avenue pumping station requires adaptive measures to withstand the critical flood elevation. Potential strategies were evaluated against such factors as flood depth, equipment location, and space. Viable strategies were reviewed to identify the most cost-effective, resilient option. Controls should be elevated to withstand the critical flood, and there is ample space to do so on the current lot. Because the station is located in an industrial area, a building is not necessary for aesthetic reasons. Components are currently exposed above grade, and there have been no known incidents of vandalism, so a building should not be necessary for security reasons, either. Therefore, the recommended strategy at Commerce Avenue is to elevate electrical controls onto a platform. Residual risk is related to a greater depth of flooding from larger storms or more extreme climate change.

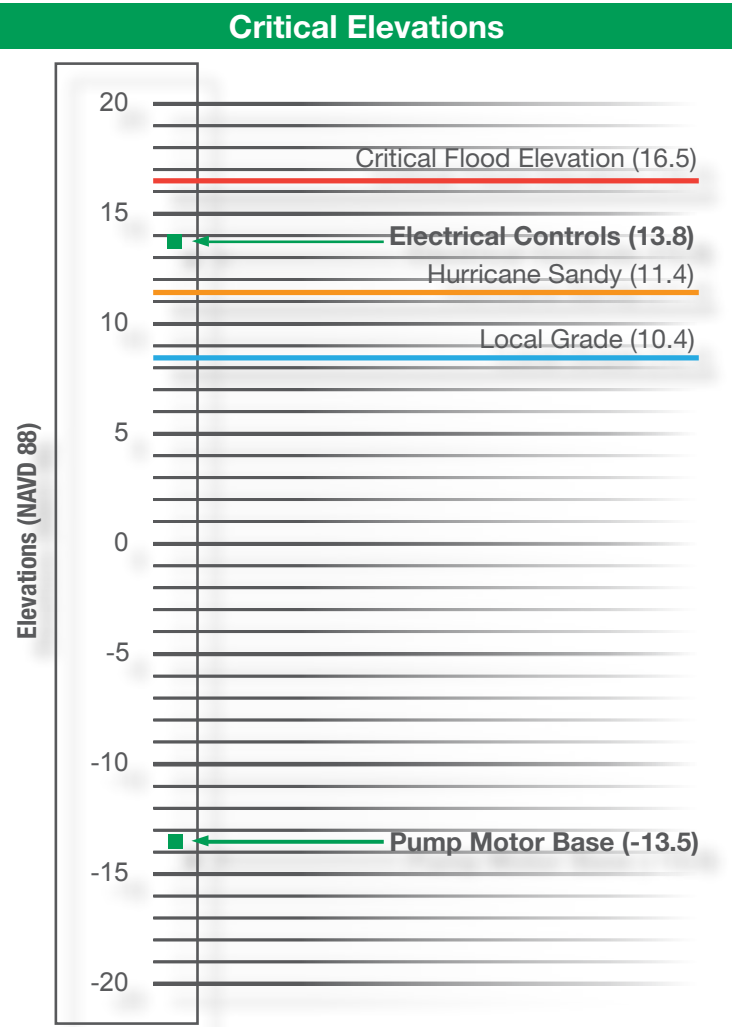
This station has experienced multiple flooding events during which water approached the station from the adjacent Hutchinson River. During Hurricane Sandy, the lot surrounding the station flooded to a depth of around 1 foot. Fuses on the poles supporting the overhead power lines blew out, cutting power before it reached the transformers. At the time of the visit, ventilation in the wet well was not working due to flooding damage.

The Conner Street pumping station requires adaptive measures to withstand the critical flood elevation. Potential strategies were evaluated against such factors as flood depth, equipment location, and space. Viable strategies were reviewed to identify the most cost-effective, resilient option. Because there is an existing structure, but there are extensive controls which could not easily be moved, the recommended strategy at Conner Street is to construct a barrier. The installation of a backup generator is also recommended, and when pumps need to be replaced as part of regular maintenance, submersible pumps should be installed. Residual risk is related to a greater depth of flooding from larger storms or more extreme climate change.

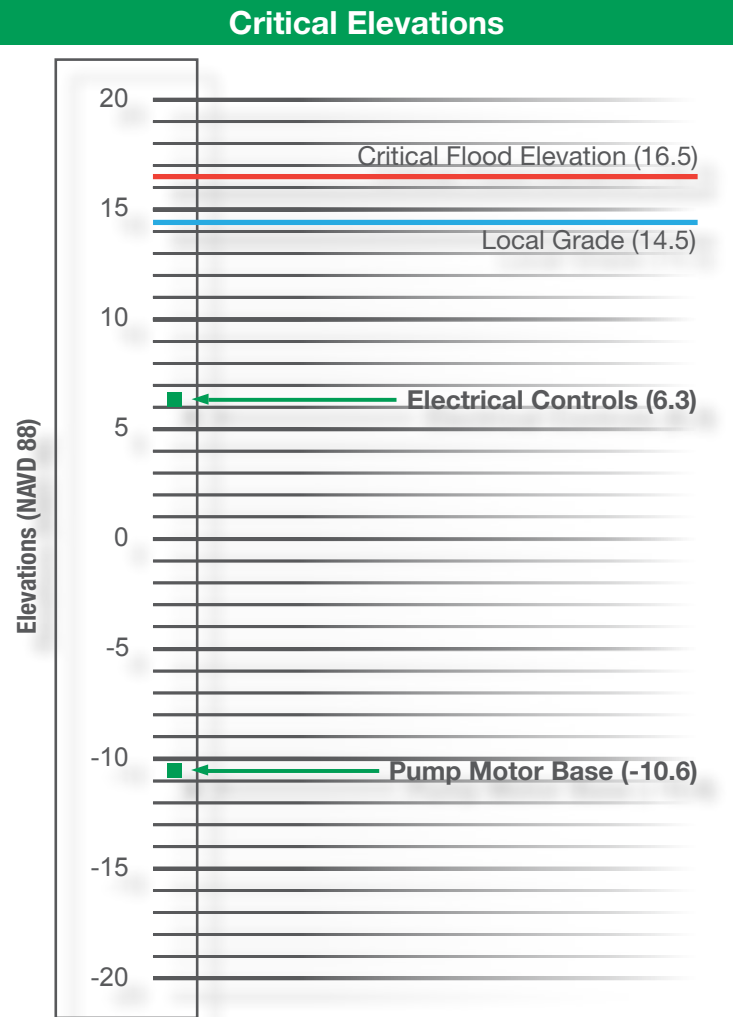
The critical flood elevation would be 2 feet above local grade. Electrical controls are below grade within the structure, and the doorway threshold into the structure is about 1 foot above grade, which is 1 foot below the critical flood elevation. Flood waters could enter the structure and damage the electrical controls. The submersible pumps should withstand flooding. The Co-op City North pumping station has the ability to receive flow from another pumping station. Therefore, loss of function at Co-op City North increases the vulnerability of an additional pumping station, tributary area, and population.

The Co-op City North pumping station requires adaptive measures to withstand the critical flood elevation. Potential strategies were evaluated against such factors as flood depth, equipment location, and space. Viable strategies were reviewed to identify the most cost-effective, resilient option. Because there is a significant existing structure, the recommended strategy at Co-op City North is to seal the building. Because water tight cases, doors, and building sealants are only rated up to a certain pressure, if flood depth is greater than expected the water pressure could exceed the rating and the building sealing could fail. Therefore, residual risk is related to a greater depth of flooding from larger storms or more extreme climate change and the potential for water pressure to exceed the rating of the sealing measures.

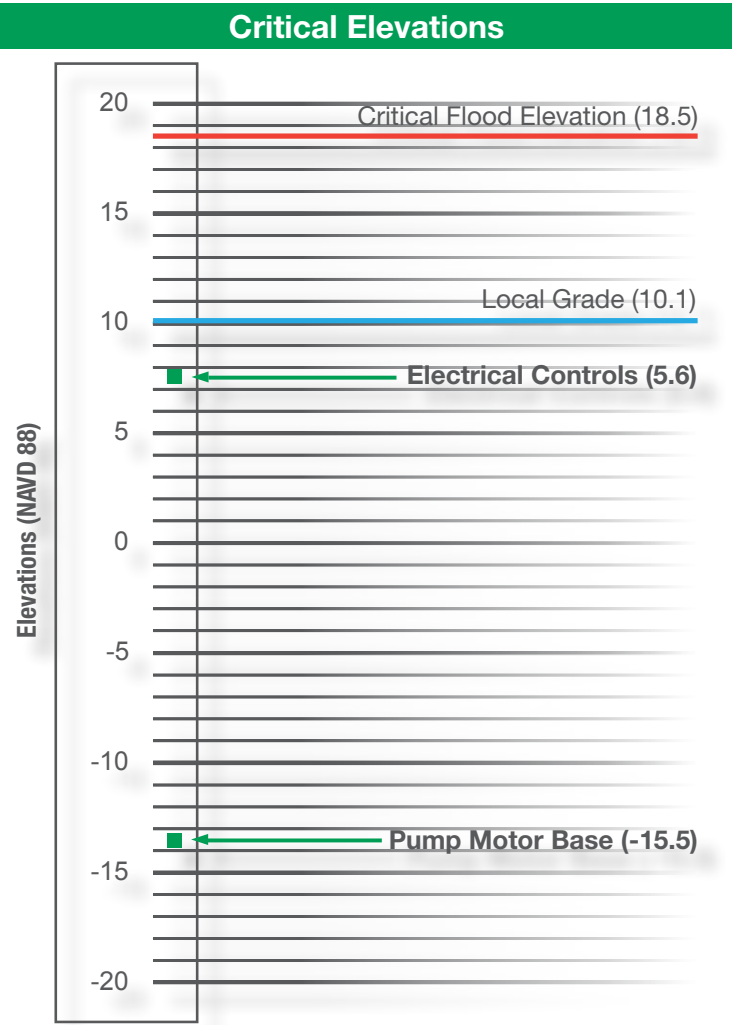
Collection Systems staff provided further details on the station’s flooding history and vulnerability. The critical flood elevation would be more than 8 feet above local grade, completely inundating the entire station. The electrical controls, which are below grade, would be flooded and damaged. The submersible pumps should withstand flooding.

The Doug Bay pumping station requires adaptive measures to withstand the critical flood elevation. Potential strategies were evaluated against such factors as flood depth, equipment location, and space. Viable strategies were reviewed to identify the most cost-effective, resilient option. Due to the 8-foot depth of the critical flood and the lack of an existing structure, the recommended strategy at Doug Bay is to elevate electrical controls in a new building. Residual risk is related to a greater depth of flooding from larger storms or more extreme climate change.

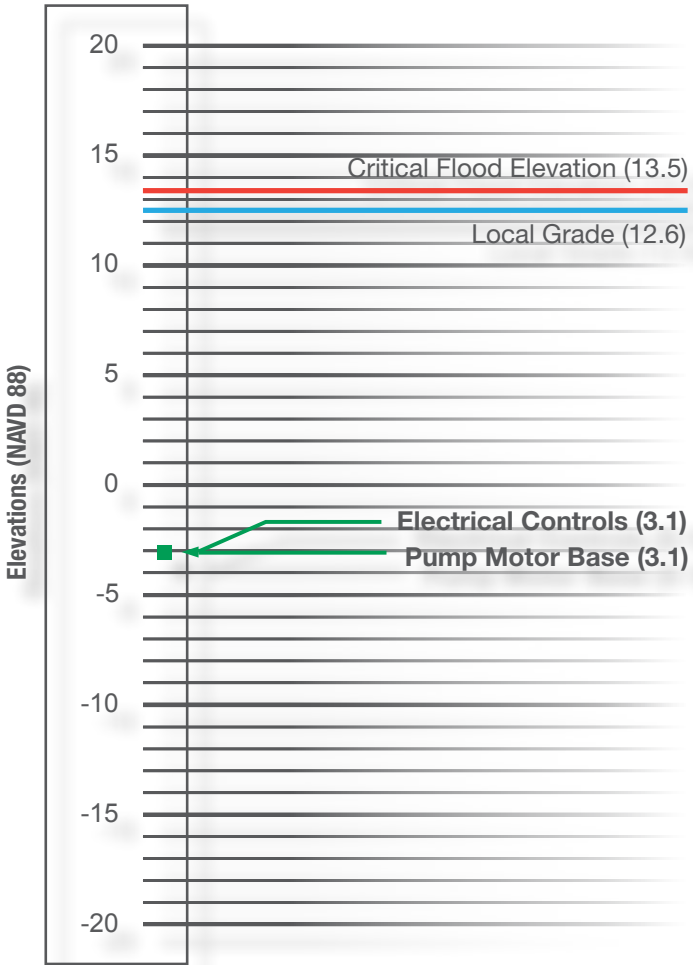
### Critical Elevations

The critical flood elevation would be just under 1 foot above local grade. Because electrical controls and non-submersible pumps are located below grade and below the flood elevation, they could be damaged if water enters the structure.

The Eltingville pumping station requires adaptive measures to withstand the critical flood elevation. Potential strategies were evaluated against such factors as flood depth, equipment location, and space. Viable strategies were reviewed to identify the most cost-effective, resilient option. Because there is a significant existing structure, the recommended strategy at Eltingville is to seal the building so that flood waters cannot enter; this is a less expensive option than those that involve moving electrical controls or motors. While this strategy will provide resilient protection, there is the potential for leaks, inflows to the wells, or unidentified flow paths. DEP will consider replacing the non-submersible pumps with submersibles as normal replacement is needed as part of regular maintenance. Because water tight cases, doors, and building sealants are only rated up to a certain pressure, if flood depth is greater than expected the water pressure could exceed the rating and the building sealing could fail. Therefore, residual risk is related to a greater depth of flooding from larger storms or more extreme climate change and the potential for water pressure to exceed the rating of the sealing measures.

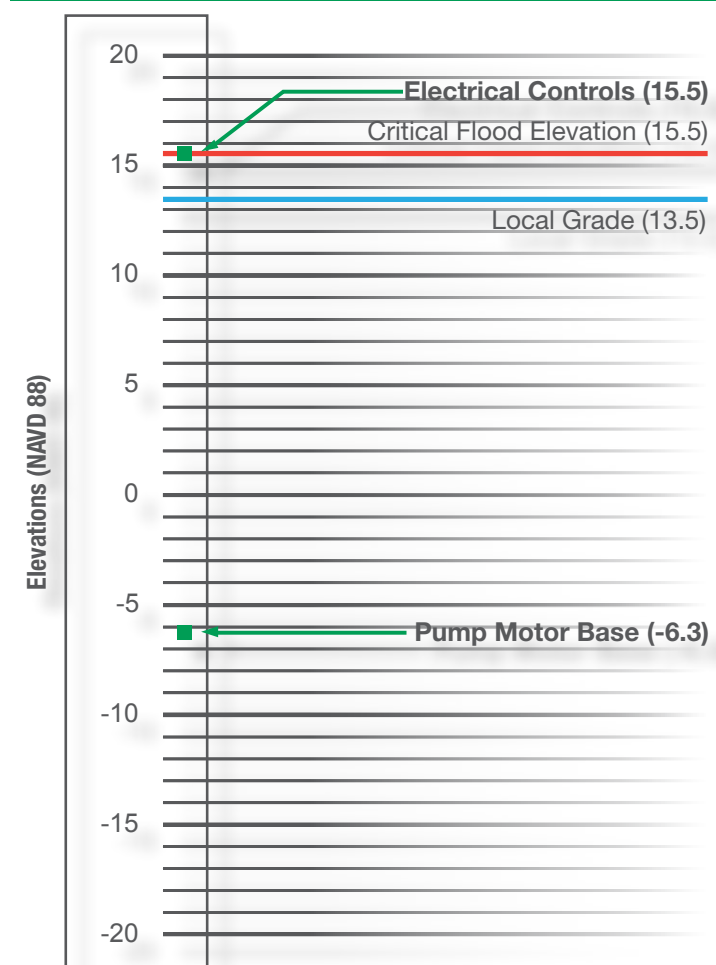
## Critical Elevations

The critical flood elevation would be 2 feet above local grade, which is equal to the elevation of the main floor of the structure where electrical controls are housed. This could cause damage to the electrical controls; submersible pumps should be unaffected.

The Ely Avenue pumping station requires adaptive measures to withstand the critical flood elevation. Potential strategies were evaluated against such factors as flood depth, equipment location, and space. Viable strategies were reviewed to identify the most cost-effective, resilient option. Because there is a substantial existing structure with entrances above the critical flood elevation, the recommended strategy at Ely Avenue is to seal the building. Because water tight cases, doors, and building sealants are only rated up to a certain pressure, if flood depth is greater than expected the water pressure could exceed the rating and the building sealing could fail. Therefore, residual risk is related to a greater depth of flooding from larger storms or more extreme climate change and the potential for water pressure to exceed the rating of the sealing measures.

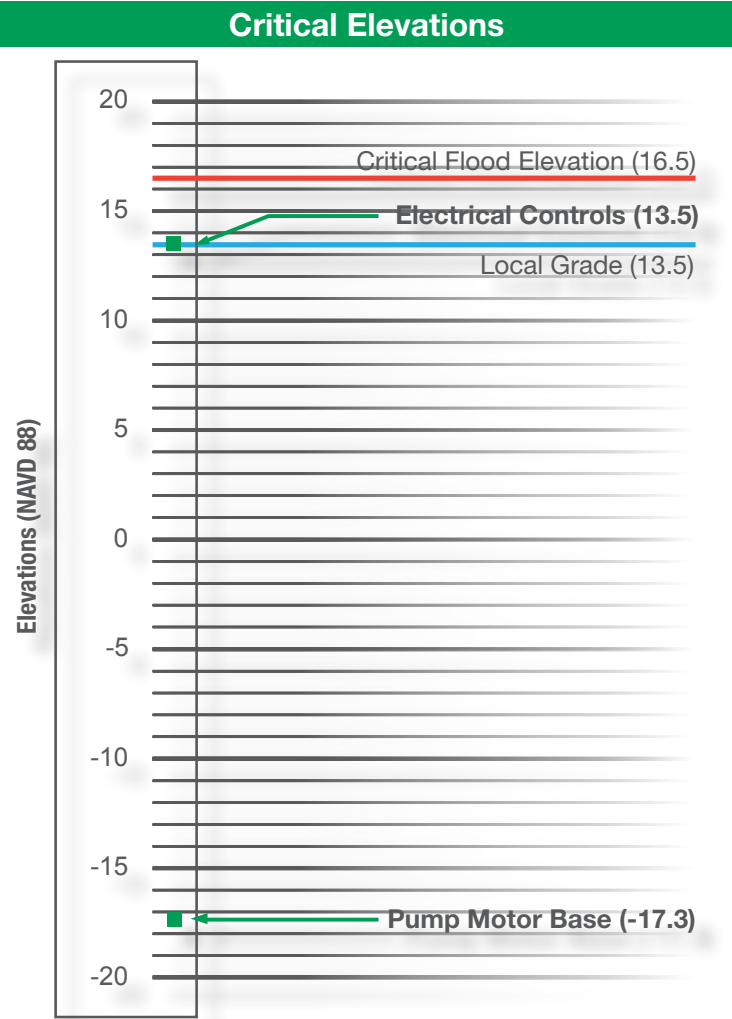
The critical flood elevation would be 3 feet above local grade. Electrical controls sit only a few inches above grade on the sidewalk, and they would be damaged. The submersible pumps should withstand flooding.

The Gildersleeve Avenue pumping station requires adaptive measures to withstand the critical flood elevation. Potential strategies were evaluated against such factors as flood depth, equipment location, and space. Viable strategies were reviewed to identify the most cost-effective, resilient option. Due to the flood depth and the fact that exposed above grade components are acceptable in this location, the recommended strategy at Gildersleeve Avenue is to elevate electrical controls on a platform. Residual risk is related to a greater depth of flooding from larger storms or more extreme climate change.

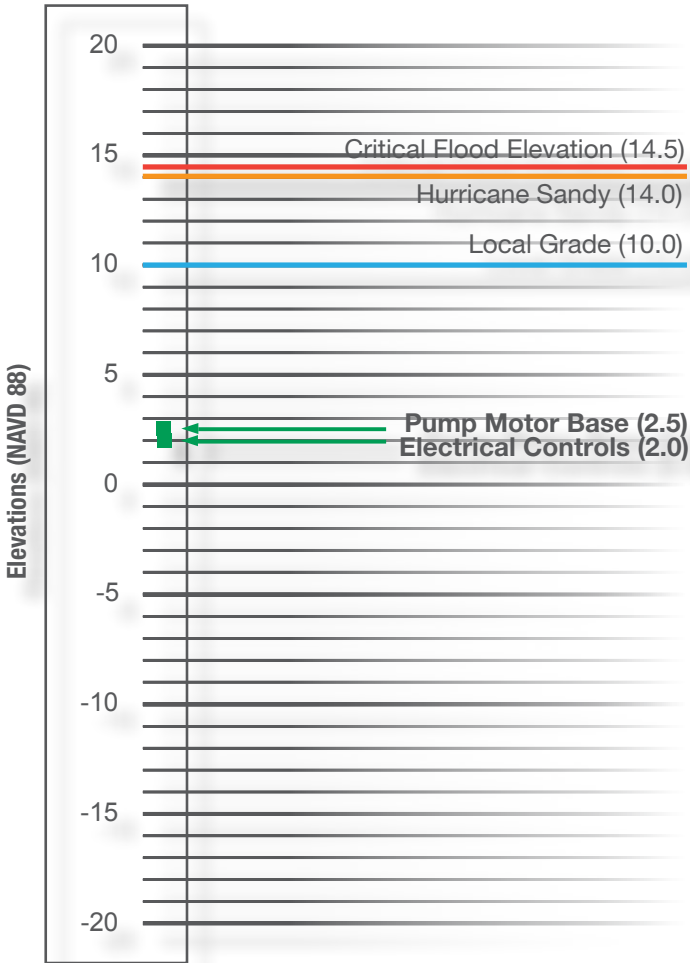
## Critical Elevations

The Hannah Street pumping station requires adaptive measures to withstand the critical flood elevation. Potential strategies were evaluated against such factors as flood depth, equipment location, and space. Viable strategies were reviewed to identify the most cost-effective, resilient option. The Hannah Street pumping station is currently in design to be rebuilt. To add resiliency, the new plans should include elevating electrical controls and installing submersible pumps. Residual risk is related to a greater depth of flooding from larger storms or more extreme climate change.

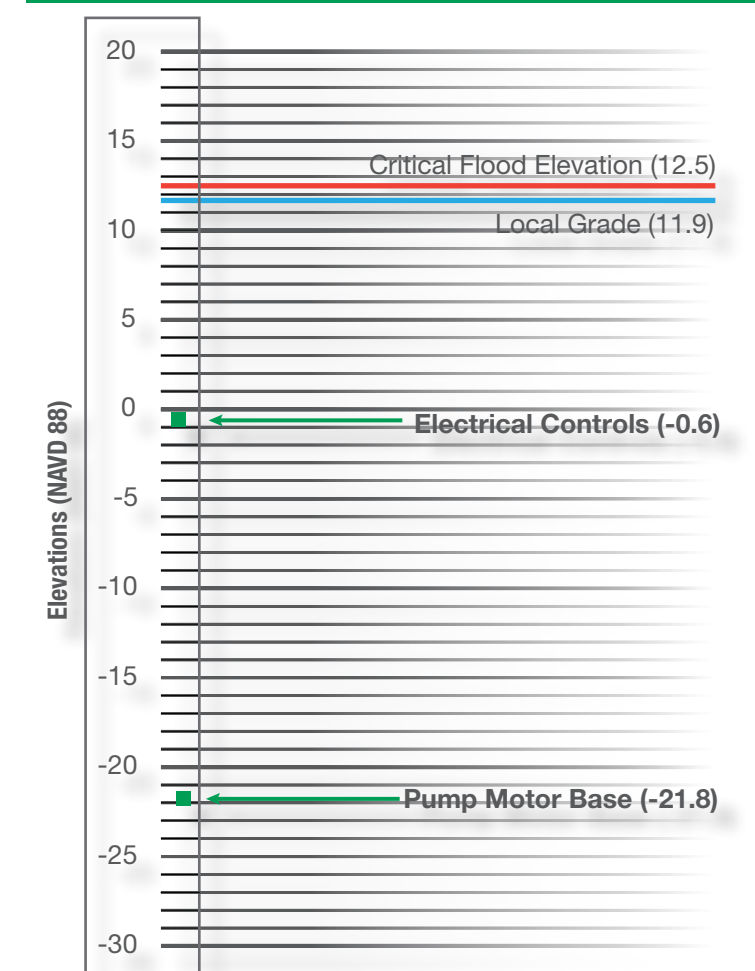
## Critical Elevations

The critical flood elevation would be about 7 inches above local grade. While entrances are elevated above the flood height, the structure is not flood-proof, and the below grade electrical controls and non-submersible pumps could be flooded and damaged.

The Howard Beach pumping station requires adaptive measures to withstand the critical flood elevation. Potential strategies were evaluated against such factors as flood depth, equipment location, and space. Viable strategies were reviewed to identify the most cost-effective, resilient option. Because of the shallow depth of the critical flood and the location of most entrances above the flood elevation, the recommended strategy at Howard Beach is to add watertight doors in the existing wall at pedestrian and vehicle entry points. Sandbagging is also a potential option but water tight access doors provide a permanent and more resilient solution. The installation of emergency generators is also recommended. Residual risk is related to a greater depth of flooding from larger storms or more extreme climate change.

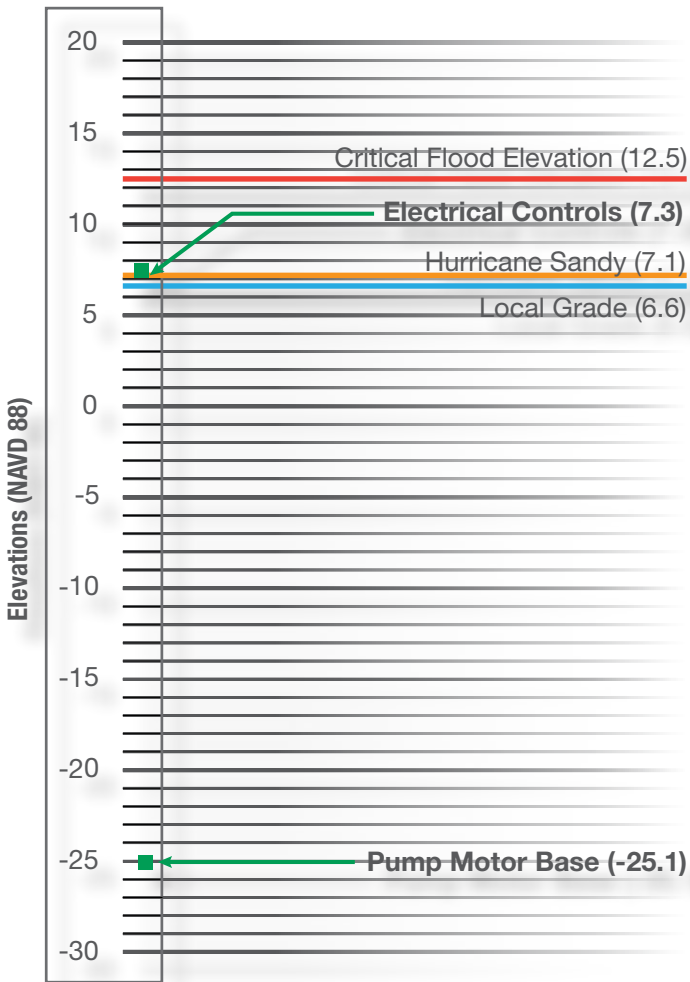
## Critical Elevations

During Hurricane Sandy nearby areas flooded to a depth of about 6 inches and the station experienced minor impacts. There is no history of flooding at this location beyond flooding caused by Hurricane Sandy.

The Marble Hill pumping station requires adaptive measures to withstand the critical flood elevation. Potential strategies were evaluated against such factors as flood depth, equipment location, and space. Viable strategies were reviewed to identify the most cost-effective, resilient option. Because there is a significant existing structure, the recommended strategy at Marble Hill is to seal the building so that flood waters cannot enter. This is a less expensive option than those that involve moving electrical controls or motors. Because water tight cases, doors, and building sealants are only rated up to a certain pressure, if flood depth is greater than expected the water pressure could exceed the rating and the building sealing could fail. Therefore, residual risk is related to a greater depth of flooding from larger storms or more extreme climate change and the potential for water pressure to exceed the rating of the sealing measures.

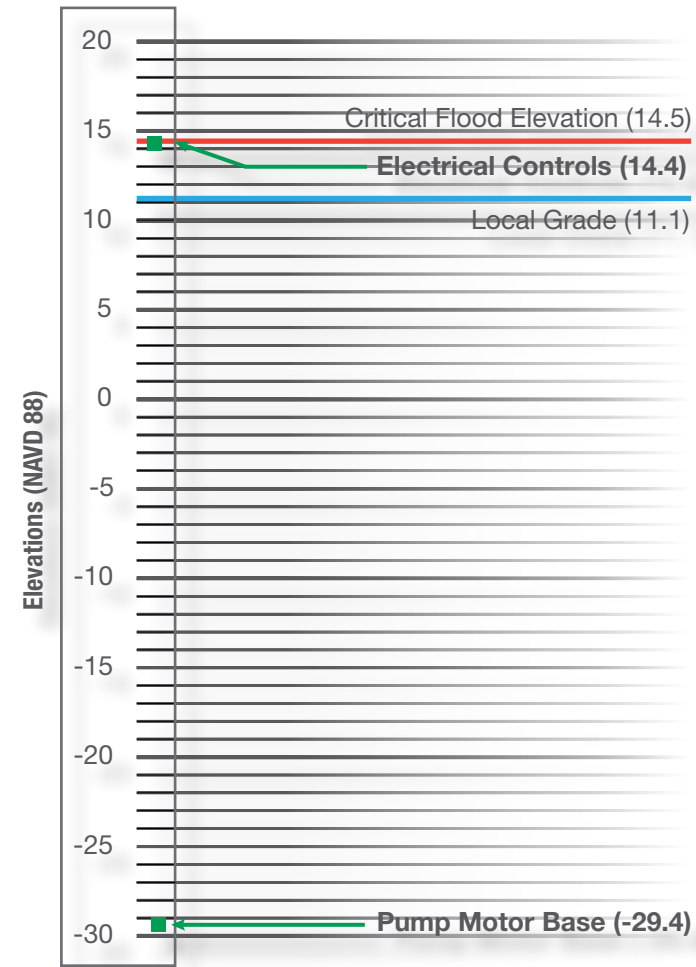
## Critical Elevations

The critical flood elevation would inundate the area surrounding the facility with over 3 feet of water. If flood waters were able to find a pathway into the pumping station, electrical controls and motors could be damaged.

The Mayflower Avenue pumping station requires minor adaptive measures to withstand the critical flood elevation. Potential strategies were evaluated against such factors as flood depth, equipment location, and space. Viable strategies were reviewed to identify the most cost-effective, resilient option. Because there is a substantial existing structure and most entryways are elevated, the recommended strategy at Mayflower Avenue is to sandbag potential flood entry points. Residual risk is related to a greater depth of flooding from larger storms, more extreme climate change, failure of the sandbag barrier, or leakage through alternative flow pathways.

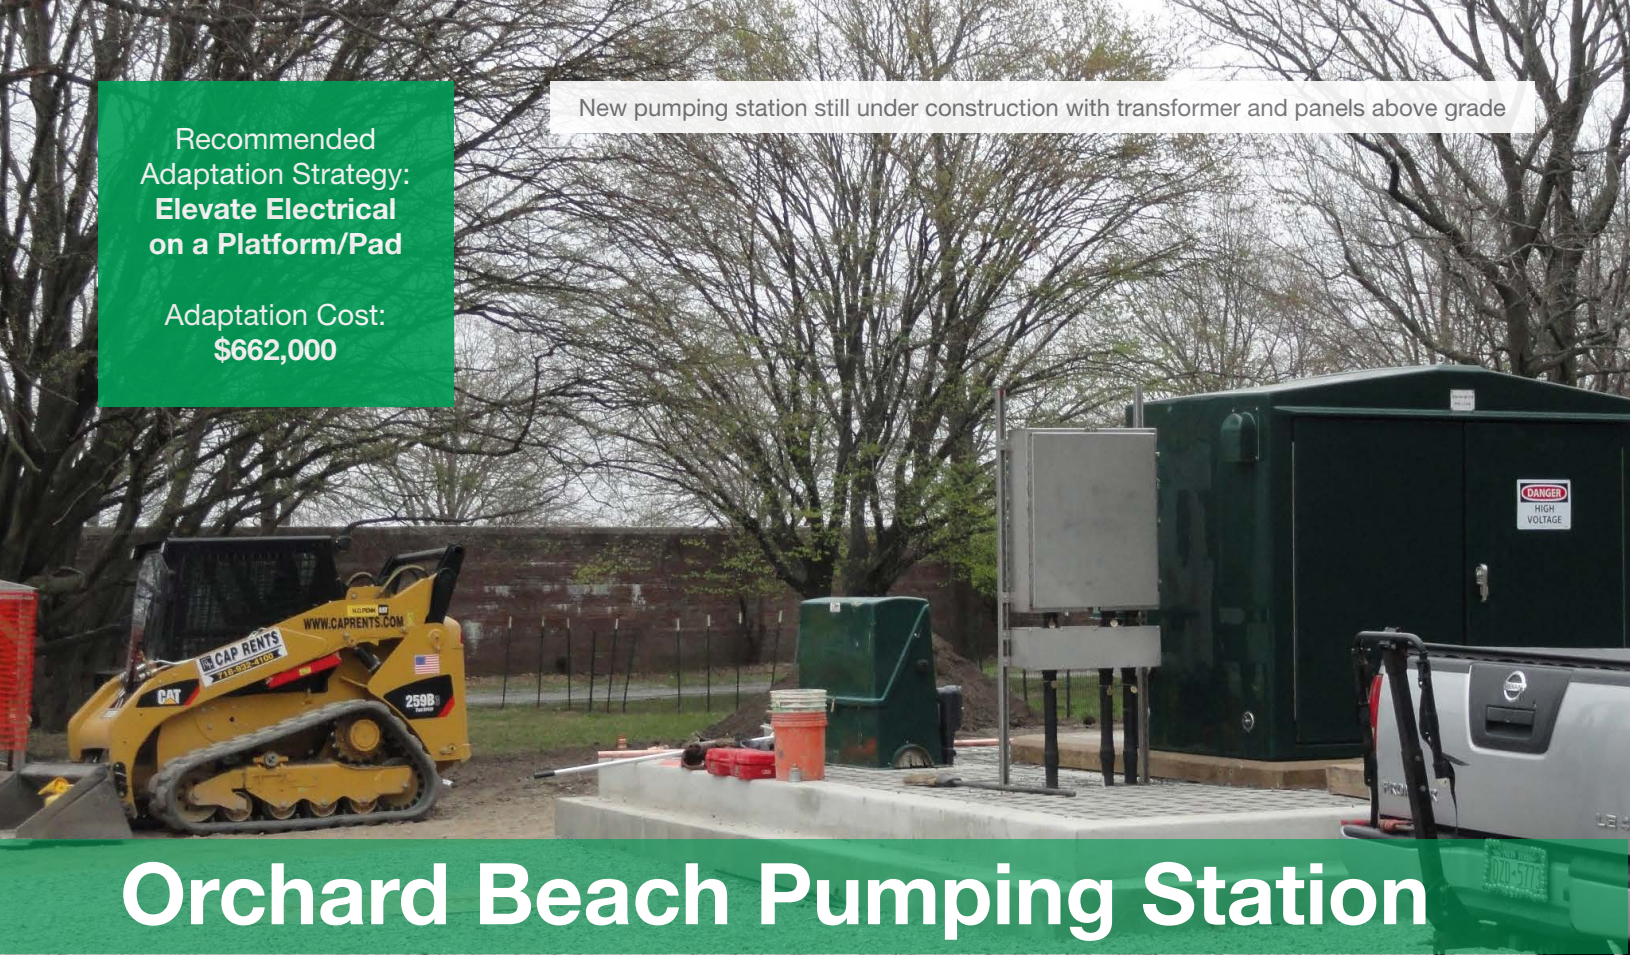
New pumping station still under construction with transformer and panels above grade

Recommended  
Adaptation Strategy:  
**Elevate Electrical  
on a Platform/Pad**

Adaptation Cost:  
**\$662,000**

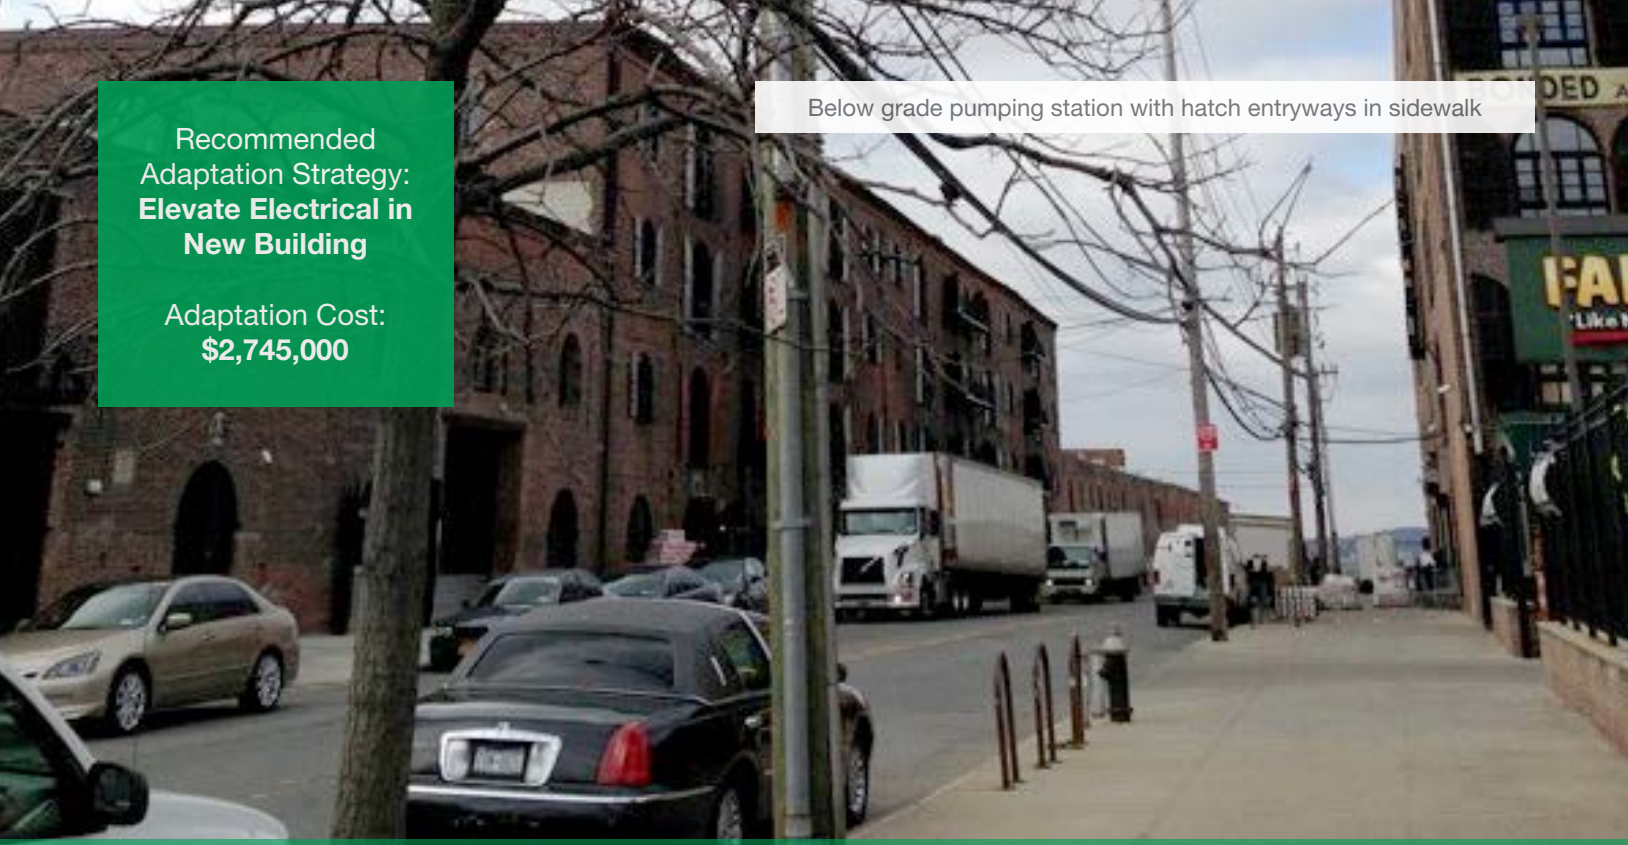
The critical flood elevation would completely inundate the station, and the surrounding flood would be 5 feet above local grade. This would damage electrical controls but would not affect the submersible pumps.

Below grade pumping station with hatch entryways in sidewalk

The Throgs Neck pumping station requires adaptive measures to withstand the critical flood elevation. Potential strategies were evaluated against such factors as flood depth, equipment location, and space. Viable strategies were reviewed to identify the most cost-effective, resilient option. Because the extensive electrical controls would be difficult and expensive to move, the recommended strategy at Throgs Neck is to construct a barrier around the station. Residual risk is related to a greater depth of flooding from larger storms or more extreme climate change.

Recommended  
Adaptation Strategy:  
**Elevate Electrical in  
New Building**
