**Re: Integrated Sentinel Monitoring Report Calendar Year 2023**

# INTEGRATED SENTINEL MONITORING REPORT CALENDAR YEAR 2023

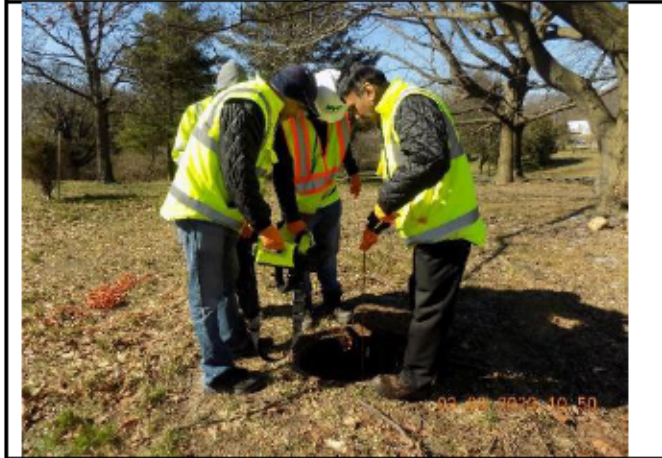
<p>CMS collecting samples in the sewer area</p>	<p>CMS collecting samples at TI-684 outfall.</p>

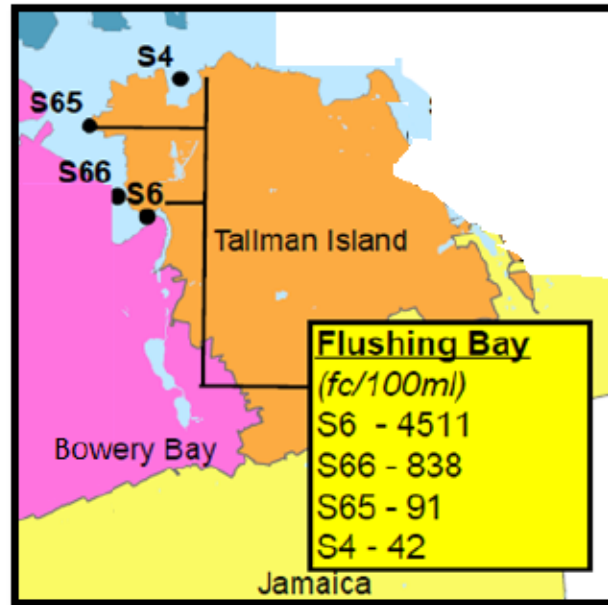
S66 and the lack of sewers in the sentinel station area

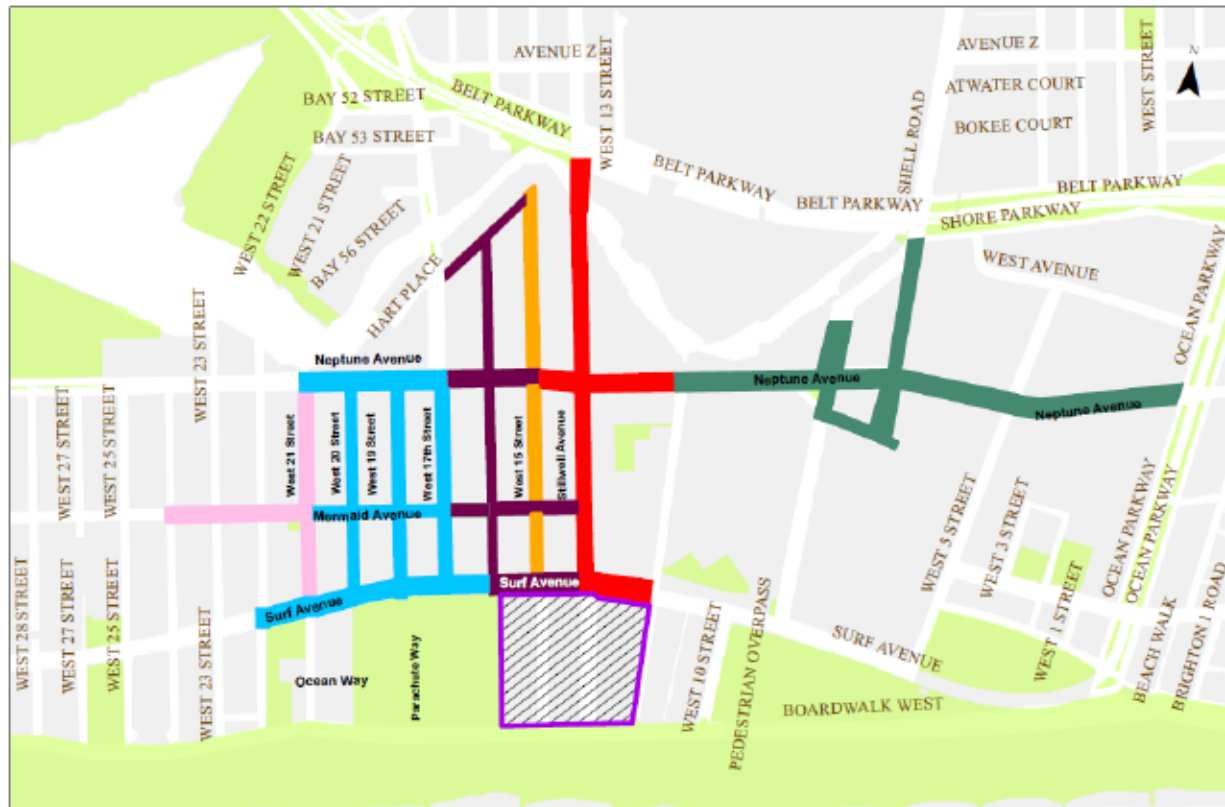
- CONISPH01-CLOSEOUT (11/30/21)  
Cost-\$28M
- CONISPH2B - SUB.COMP.(12/23/21)  
Cost-\$45M
- CONEYWEST- SUB.COMP.  
Cost-\$82M (EDC Project)
- FUTURE EDC PROJECT  
(AMUSEMENT PARK) FY'27  
Cost-TBD
- CONISPH2A- CLOSEOUT (12/15/21)  
Cost-\$25M
- CONISPH3A-CONSTRUCTION (FY'18)  
Cost-\$50M
- CONISPH04- DESIGN (FY'25)  
Cost-\$28M (Estimated)

Construction phase diagram for Coney Island Creek storm outfalls

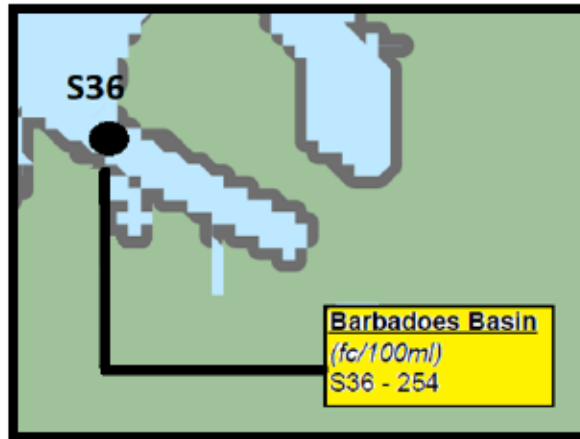
Sentinel monitoring station S36 exhibits exceedance in fecal coliform values as per baseline values. No active cases are present in the waterbody. Barbadoes Basin contains several businesses and industries in the area that are to be investigated by CMS personnel. The sewer maps are being changed to reflect new construction in the area.

S36 and the sewers in the sentinel station area. The sewer map requires changing.

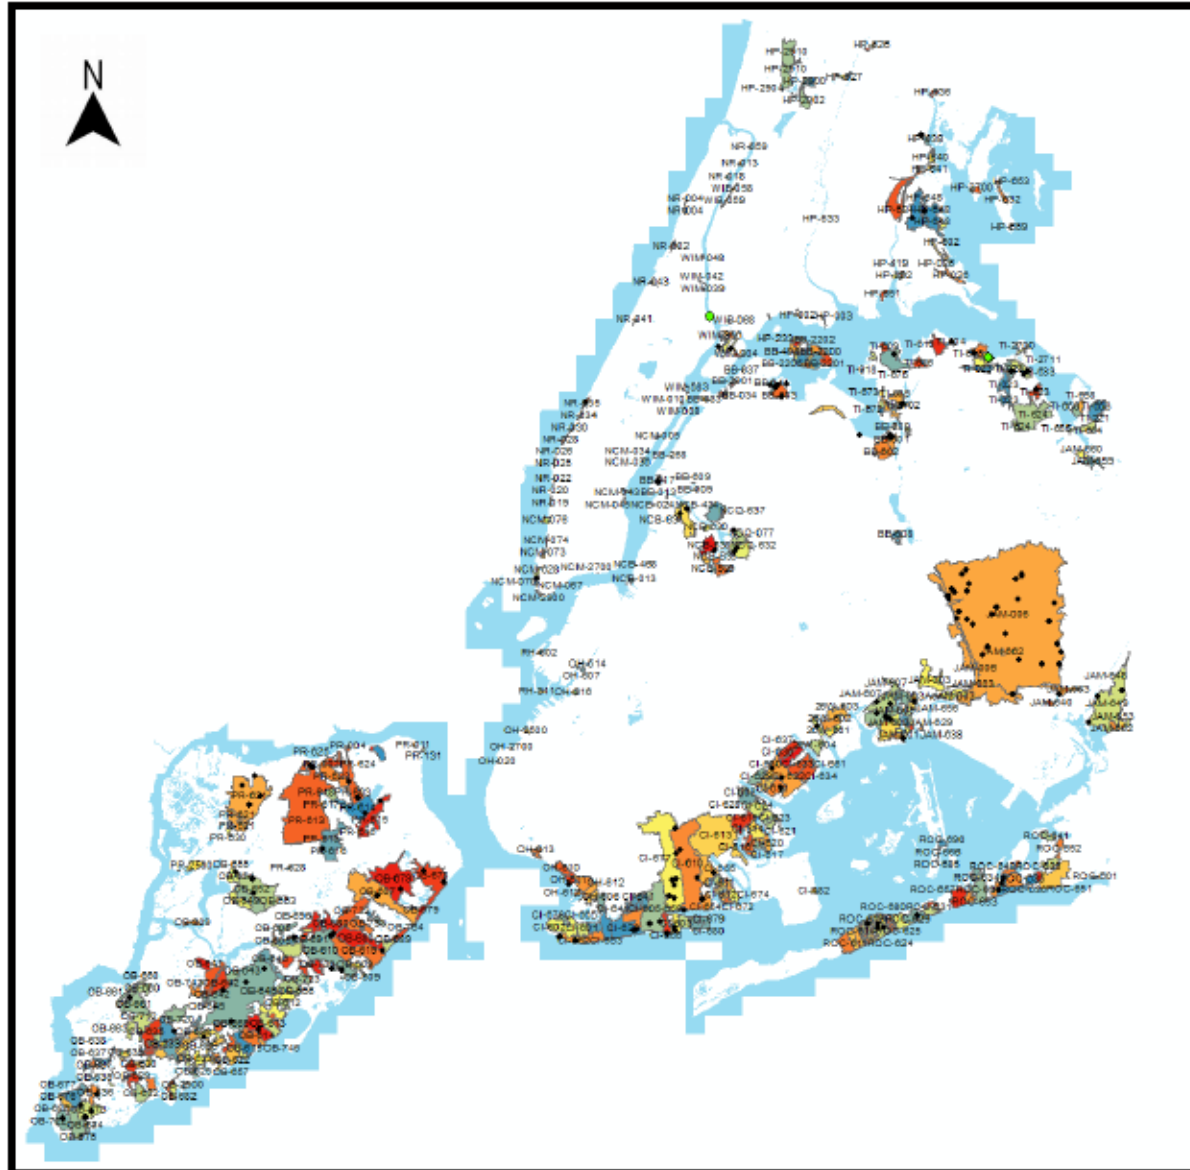
**Figure 1.** Map showing the MS4 and CSO drainage areas throughout New York City and the locations where illicit discharges to the MS4 or CSO were identified during 2023

Out of the 2129 unauthorized non-storm water discharge investigations, ERU completed inspections for discharge cases that lie within the NYC MS4. The list of discharges to the MS4 are shown below. Approximately 195 cases as listed in Table 2, were within one of the city's MS4 drainage areas, and 50 Commissioner's Orders were issued. A list of problem descriptions, the resolution of each case and the MS4 drainage area outfall to which each discharged are shown in pages 4-61. For most of the cases, the illicit discharge did not reach the waterway or was contained within catch basins. A map showing the locations for each case is presented in Figure 1.
