New York City
Department of Buildings

**51st Street Crane
Investigation**

March 2009

Ove Arup & Partners Consulting Engineers PC
155 Avenue of the Americas, New York NY 10013
Tel +1 212 229 2669 Fax +1 212 229 1056
www.arup.com

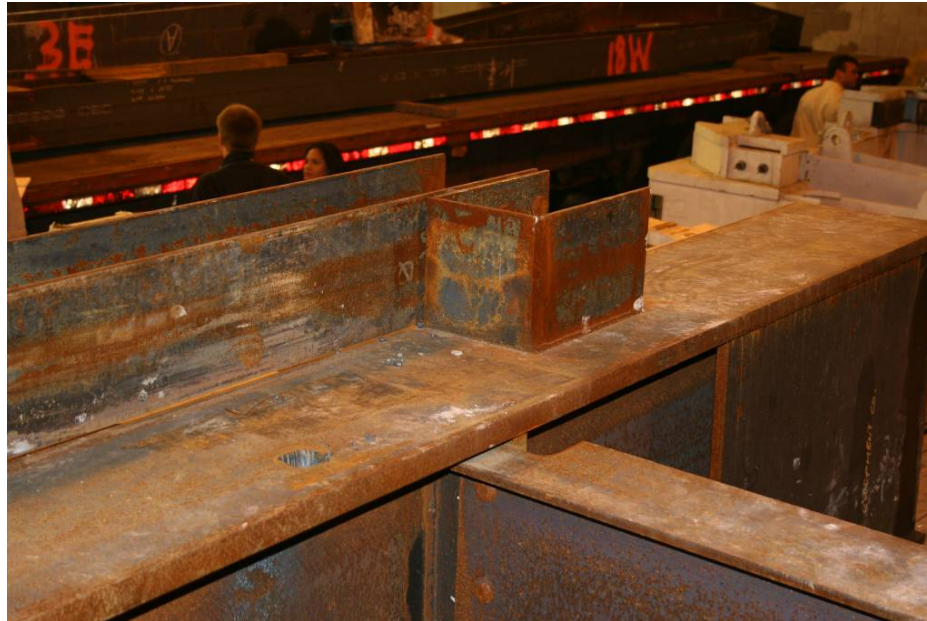
Photograph 1.1 - Dunnage steel at the base of the tower crane (source: lmg_0282 from April 18, 2008 visit to OEM warehouse by Arup). Visible in the photo are a W24x194 dunnage beam with a W24x55 cross-brace and W8x31 sections to create lateral restraint for the tower legs. Note the absence of anchorage for tower legs, which rested in the nooks created by the W8x31's.

The main dunnage beams (x2) are W24x194 steel sections with W24x55 bracing members (x2) between the main beams. The legs of the tower were restrained in the horizontal direction by W8x31 steel sections, which were welded to the top of the dunnage beams. The tower legs were not anchored to the top of the dunnage steel and as such were free to lift. Note that if the legs lift above the W8 restraints, friction between the top of the dunnage and the tower legs becomes the only restraint against sliding, which did occur during the tower crane collapse as shown in Photographs 1.3 through 1.6.

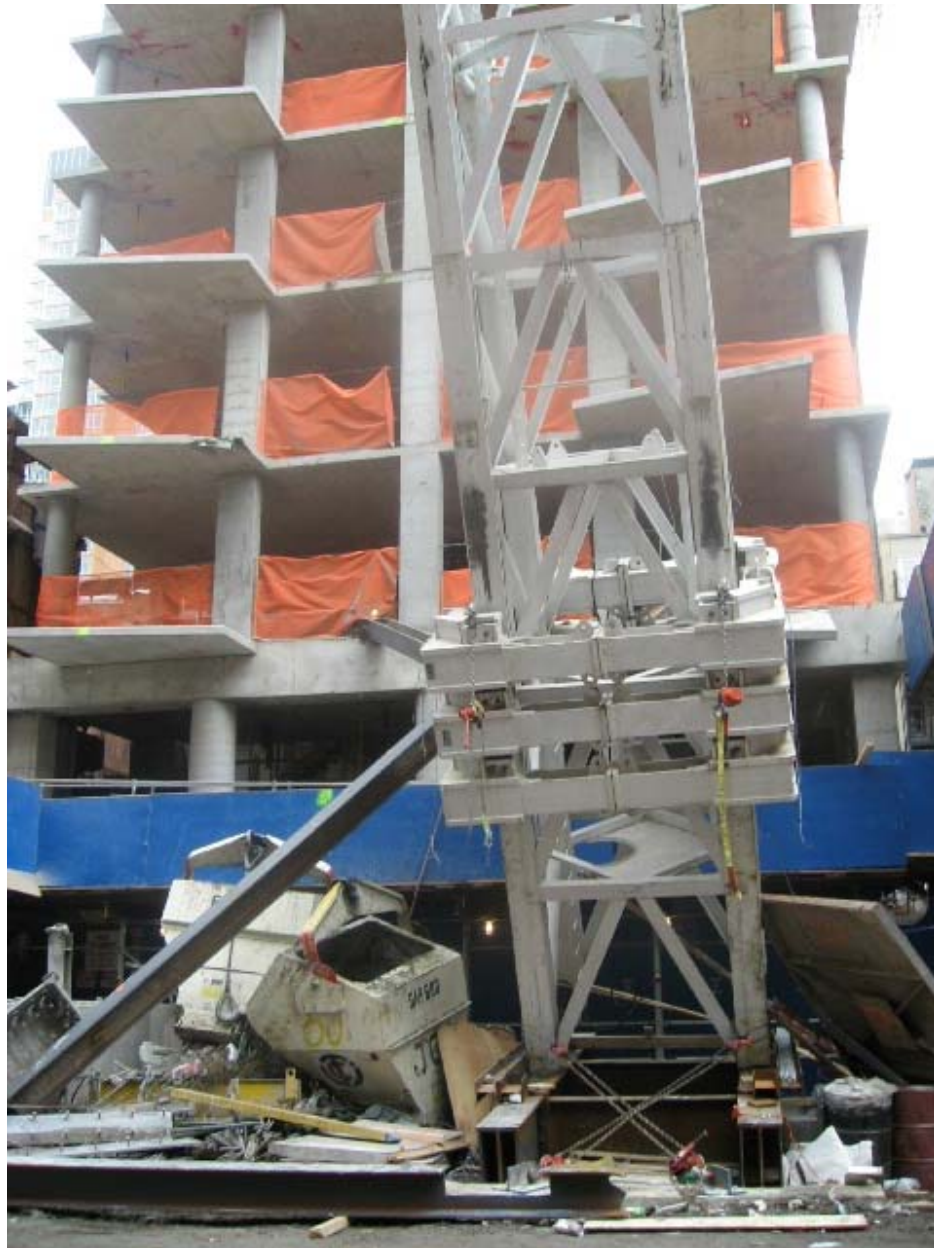
Photograph 1.4 – Photograph showing conditions at tower base following the collapse (source: New York County District Attorney’s Office, Photograph ID No. IMG-0332-062).

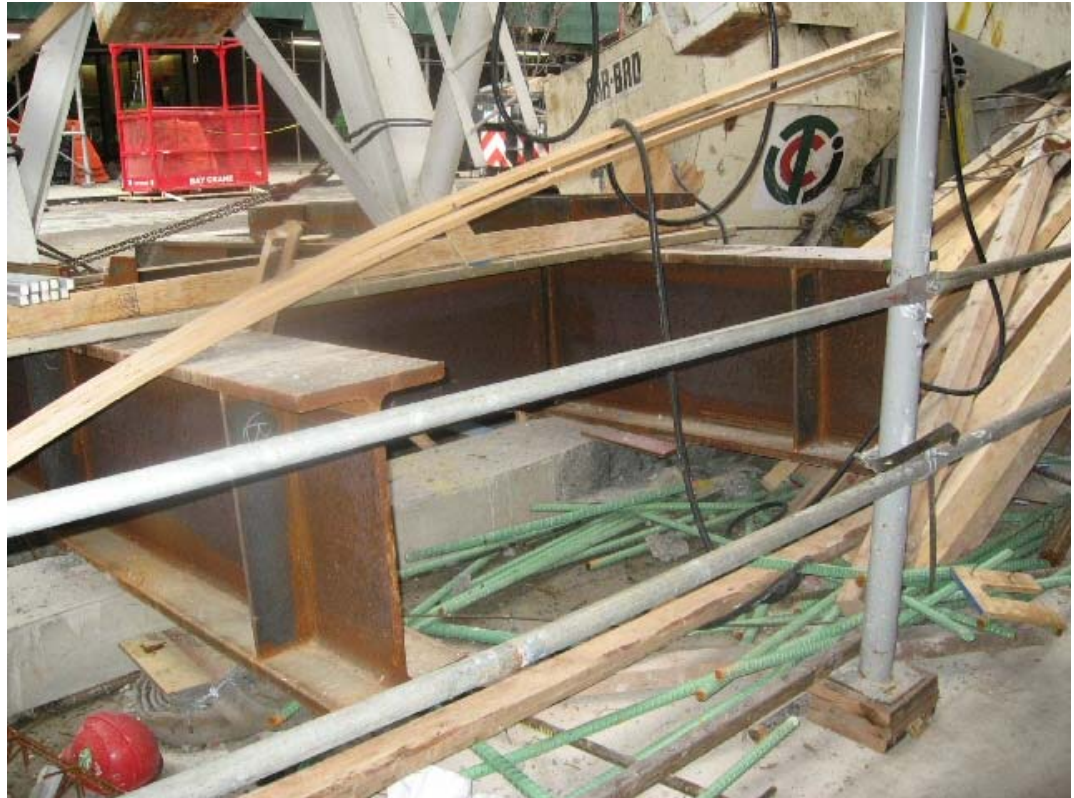
Photograph 1.5 – Photograph showing conditions at tower base following the collapse (source: New York County District Attorney’s Office, Photograph ID No. IMG-0372-102).

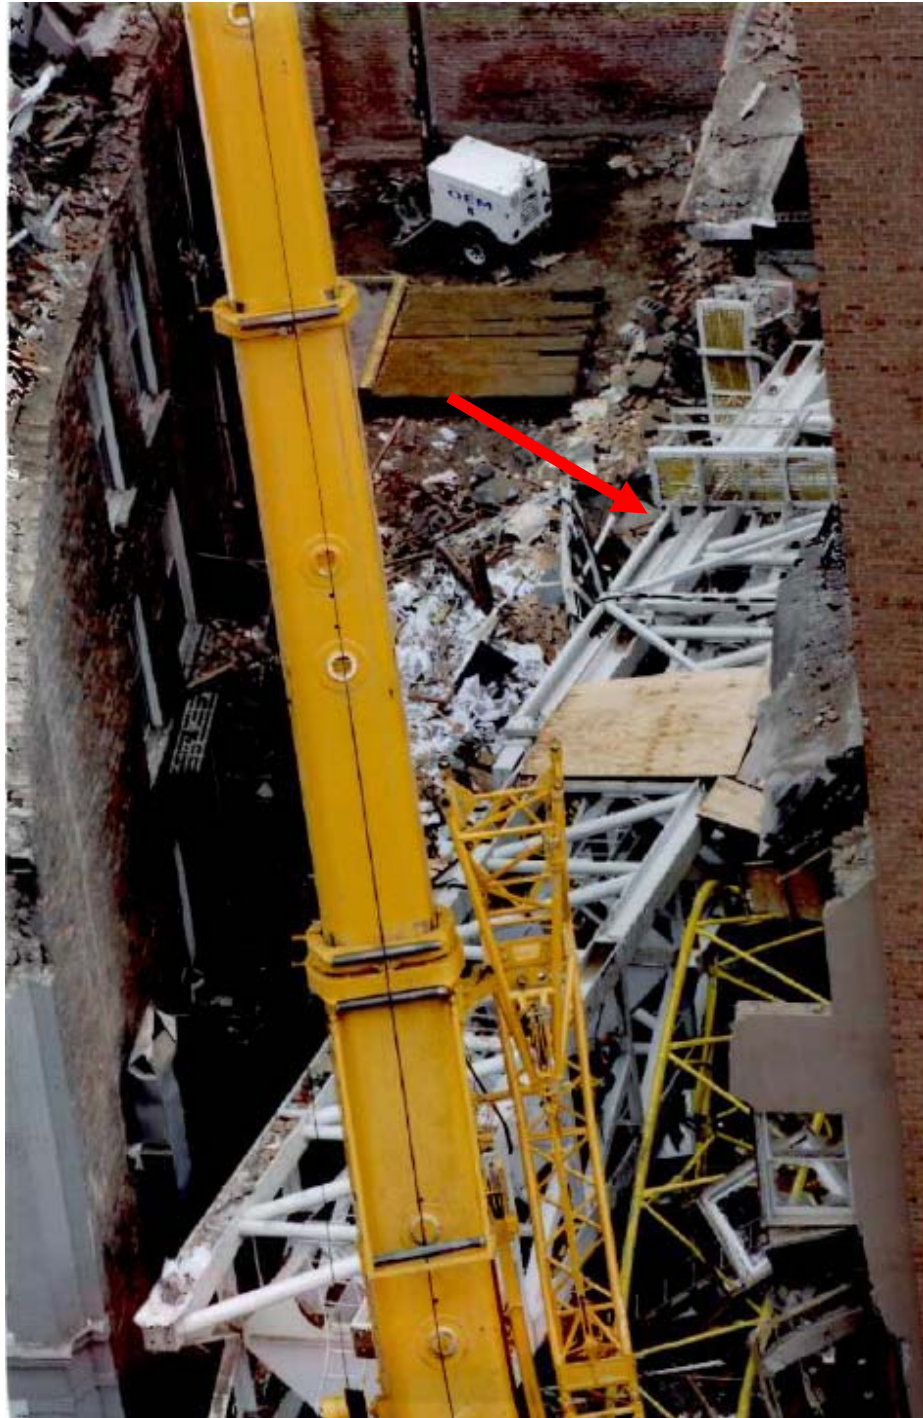
Photograph 1.6 – Photograph showing the external climbing frame attached to top of tower at the time of the collapse (source: Photos by the New York Police Department, Pictures 117-178, page 3 of 62).

Despite the dynamic loading, impact against the building and final positioning, the main tower sections did not fail with the exception of the point of impact to the building. Photograph 1.6 shows the top part of the tower after breaking from the lower section and falling to ground level, still intact.

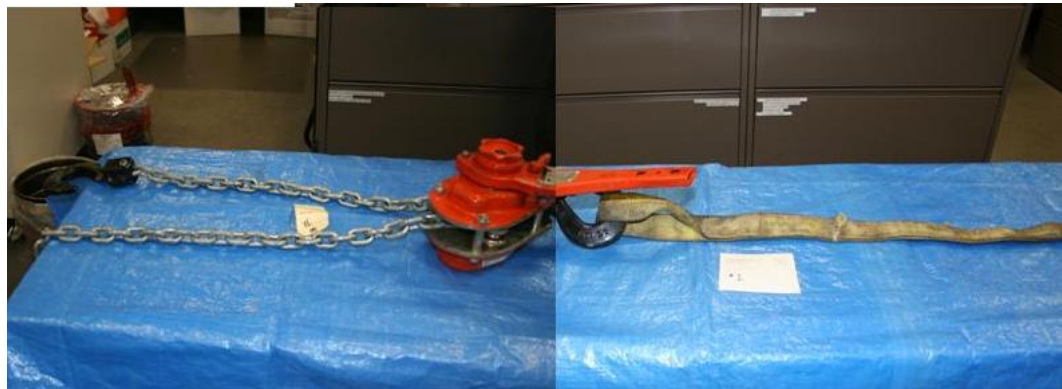
The collar/tie erection sequence describes five stages of work. Prior to the collapse, the erection of the collar had been completed through Stage 3 (see Figure 1.9 below, enlarged from Figure 1.13); i.e., the two collar halves had been bolted together and each half was being held in place vertically by two chain-falls. The chain-fall consisted of a hook, winch and chain. The chain-fall was attached to the collar by the hook via the lifting points. Each chain-fall was in turn supported by a polyester sling, attached via another hook, which was choked around a tower leg. A photograph of a recovered hook/winch/chain/hook/polyester sling assembly is provided in Photograph 1.8.

Photograph 1.8 – Chain-fall and polyester sling assembly recovered from collapse site by Arup.

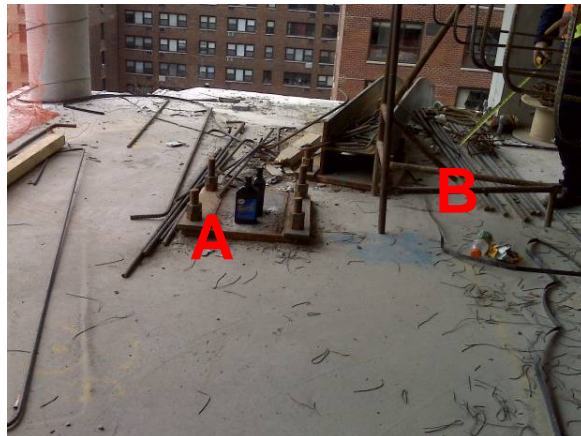
- Two (2) tie-beam to base plate welds (i.e., for base plates "9A" and "9C" as shown in Photographs 1.9 and 1.10);
- Two (2) tie-beam ends near the collar connection (i.e., at the other ends of Beams connected to base plates "B4" and "B5", as shown in Photographs 1.11 and 1.12); and
- One (1) failure of the tie-beam at the pin connection to the collar (i.e., Beam "9B", as shown in Photograph 1.13).

Photograph 1.9- Failed base plate 9A. Photo provided by the NYCDOB.

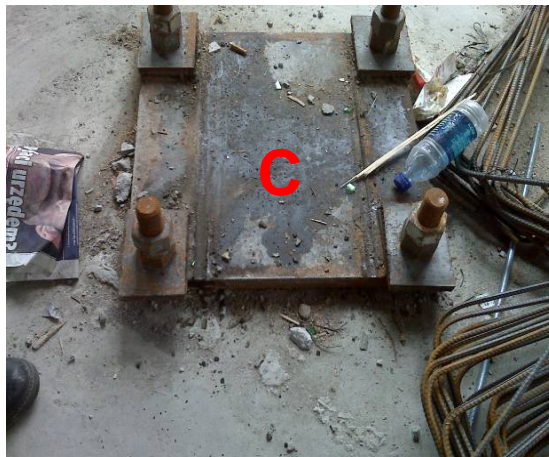
Photograph 1.10 – Conditions at 9th Floor: Failed base plate 9C for Beam B5 prior to its removal from the site (the bent beam in the photograph is Beam 9B). Photos provided by the NYCDOB.

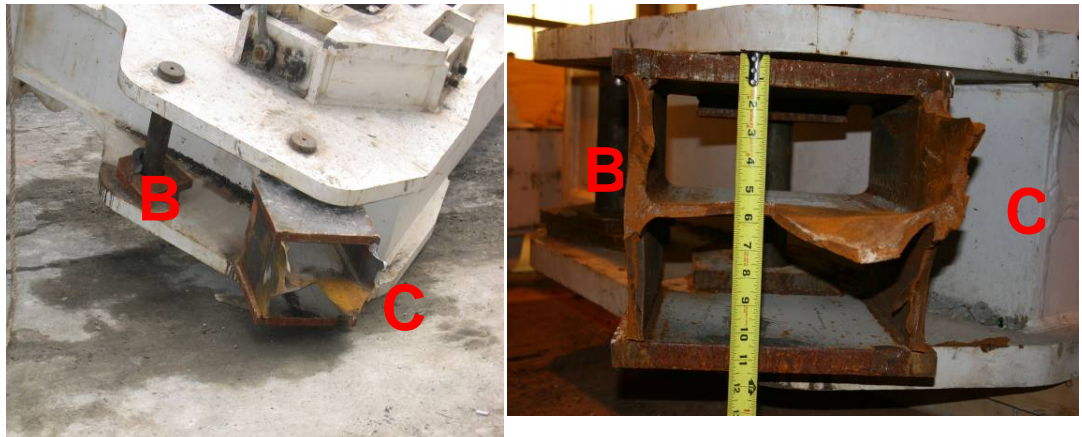
Photograph 1.11 – 9th Floor Collar: Top left corner shows the general layout of tie-beams to the collar. The lower left hand photograph shows the failed end for Beam B5 (labelled “B” in the photograph) prior to and after its removal from the site (the pin end of Beam 9B (labelled “C” in the photograph) sheared off). The lower right hand photograph is the same tie-beam end after removal to the NYCOEM warehouse. Photos by the crane engineer Peter Stroh IMG_0093.jpg and Arup.

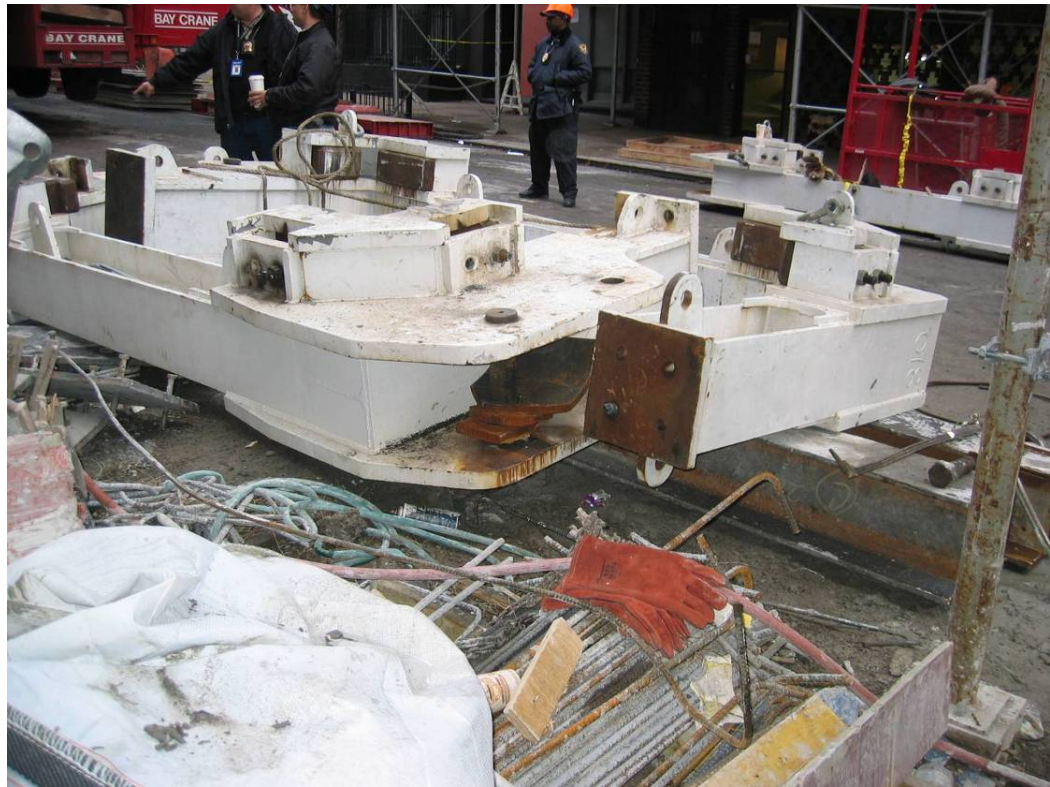
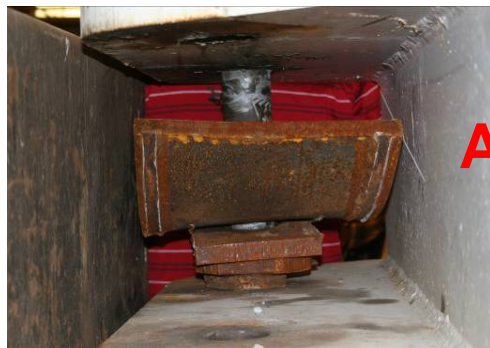
9th Floor Collar Assembly

Photograph 1.12 – The upper photograph shows the failed end of 9th floor tie-beam near collar connection (i.e., Beam B4 (“A”), at center of the photograph). The lower photograph is a close-up of the failed end of Beam B4 after removal to the NYCOEM warehouse. The top photo is by the crane engineer Peter Stroh IMG-0096.jpg. The bottom photo is provided by Arup.

Note that tie-beams B4 and B5 were welded to base plates 9A and 9C, respectively, in accordance with identification tags attached to these items by NYCDOB after recovery from the collapse site.

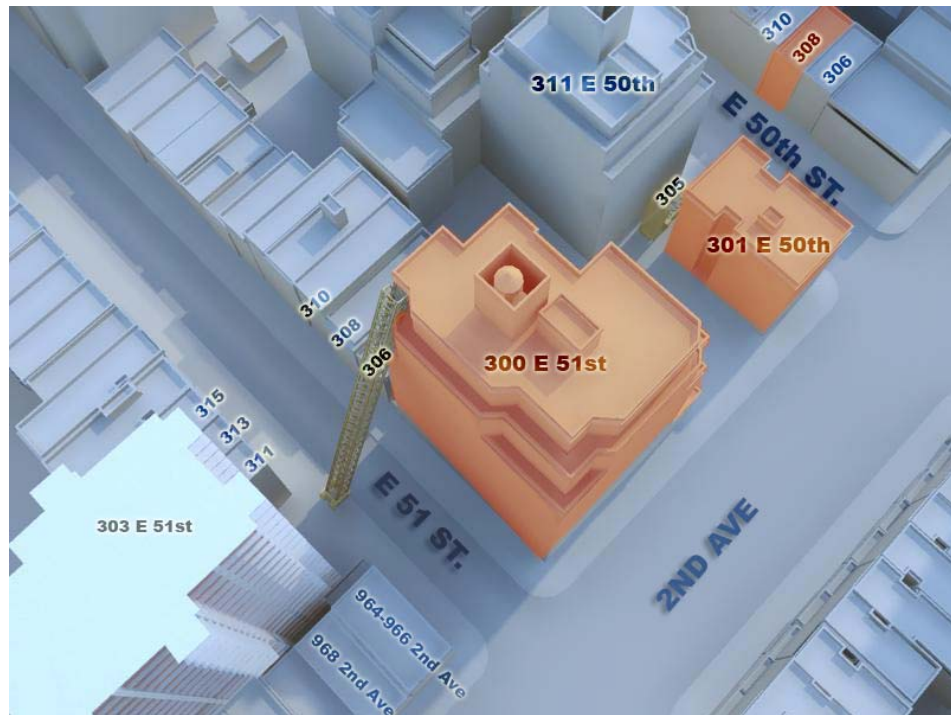
Figure 1.12 - Representation of the tower crane after collapse. Reference Photograph 1.6 with regard to the position of the crane within 305 E 50th St. Prepared by Arup.

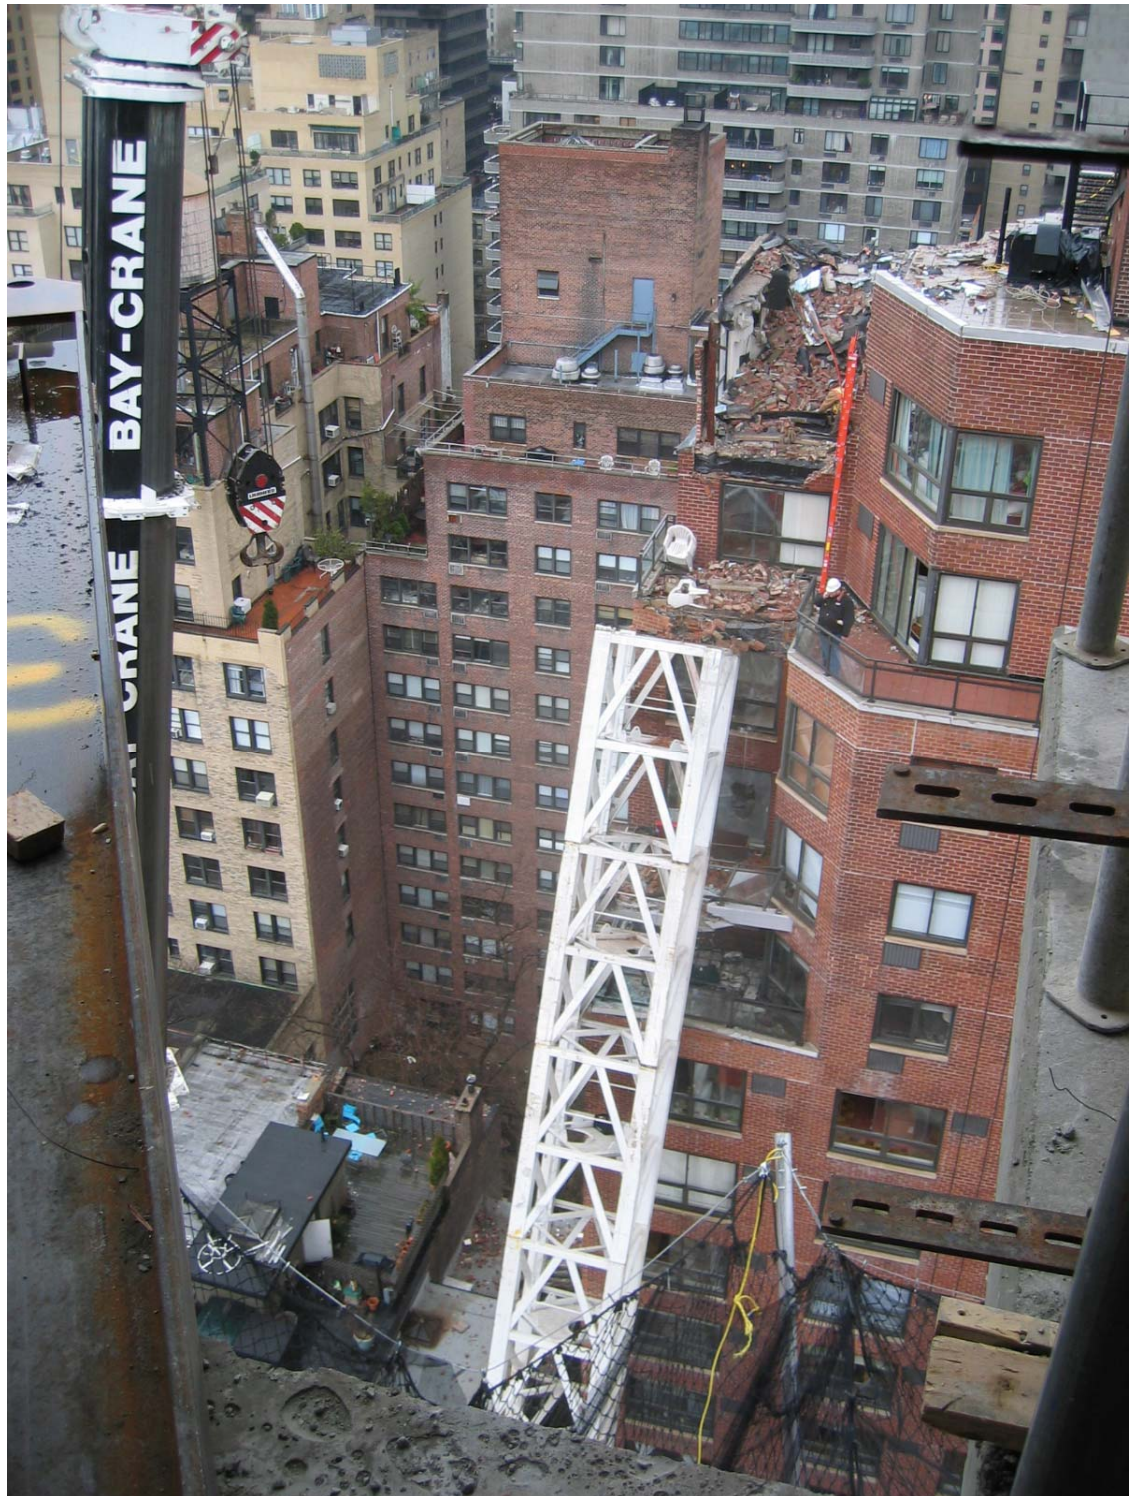
Of significant interest was the absence of failure of the tower crane sections themselves beyond that experienced by the impact of the upper sections with the building opposite (see Photographs 1.21 and 1.22 showing the lean of the tower across the street). The photographs also show the extent of the damage to the adjacent building caused by the crane collapse and the impact of the tower crane on these buildings. Figures 1.11 and 1.12 highlight the buildings affected by the collapse of the tower crane.

Photograph 1. 21 – View of the intact tower crane after collapse. Photograph by the crane engineer Peter Stroh, “After” photographs, IMG_066.jpg.

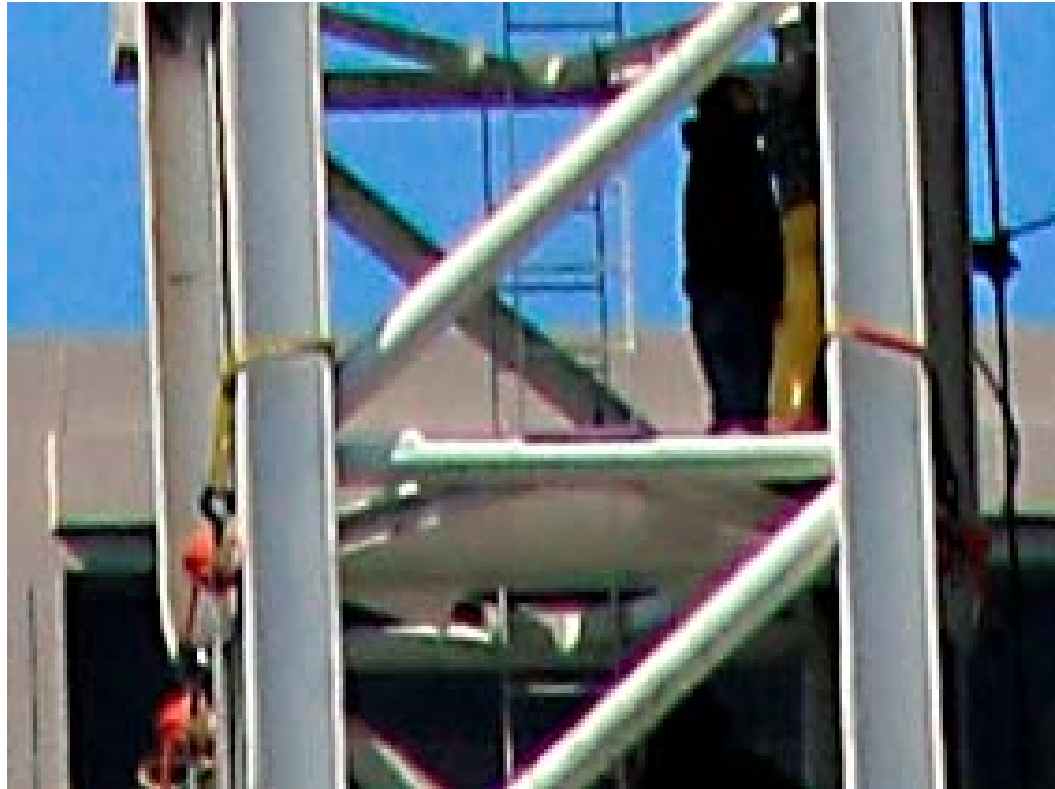
Polyester web slings were attached to the crane tower via a choker hitch. An extract from a photograph taken shortly before the collapse, shown in Photograph 3.1 below, clearly shows the choker hitch around the legs of the tower for two of the slings.

Photograph 3.1 - Close-up of crane tower shortly before collapse. Two polyester web slings are seen in a choker hitch around the legs of the tower. (Source: photograph by Gary Halby.

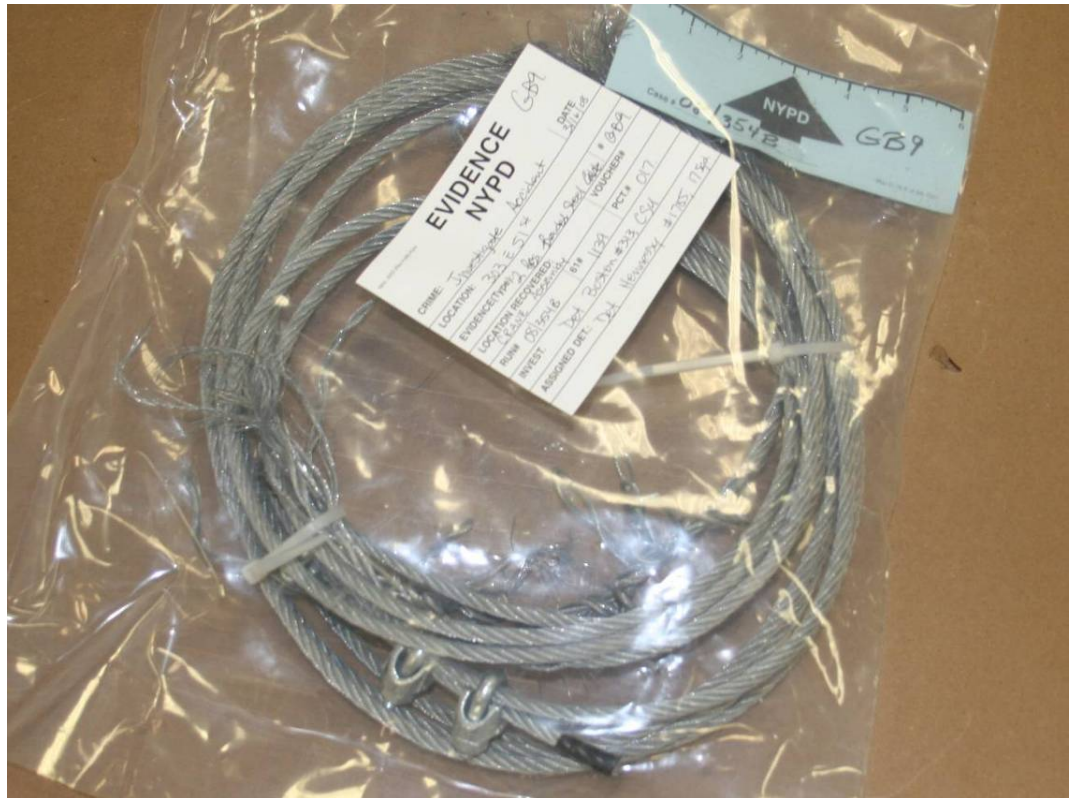
Wire rope U-bolt clip saddles were placed both on the live and dead ends of the wire ropes. An example can be seen in Photograph 3.2 taken of one of the wire ropes retained by OSHA.

Photograph 3.2 - OSHA retained evidence from NYPD GB9. Note the two clips only, with the saddle on the dead end of the wire rope. Photo by Arup.

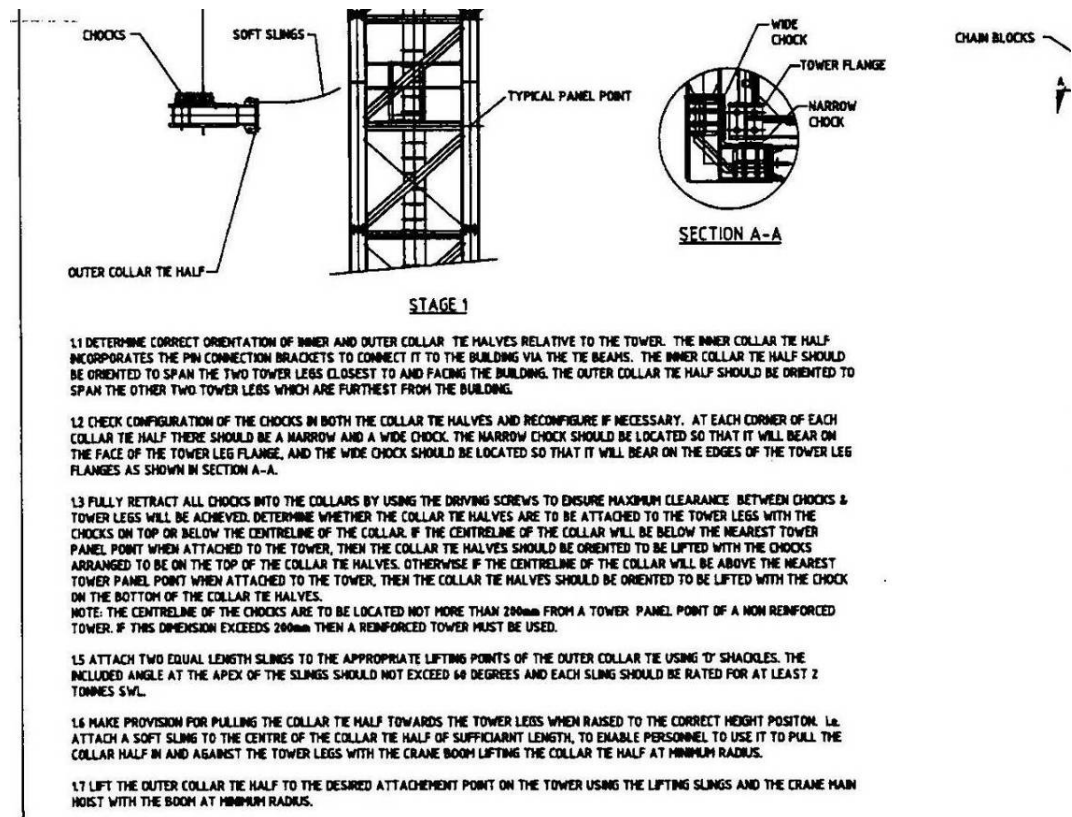
Design criteria for the selection of the attachment points could not be established. There are stated load ratings, including a 2 ton safe working load (SWL), given on the External Climbing Collar/Tie Erection Sequence drawing A1-1100.123, for the lifting slings (Stage 1, clause 1.5), and a 2 ton capacity for chain blocks (Stage 2, clause 2.2) on the same drawing. The latter value is not stated as a safe, rated, nominal or maximum capacity. There is no similar statement given regarding the use of wire rope, nor are wire ropes explicitly mentioned. See Figures 3.3, 3.4 and 3.5. Note also there is a reference to “soft sling” when pulling the half collar into position for the chain blocks (Stage 2, clause 1.6).

Figure 3.4 - Favelle Favco External Climbing Collar/Tie Erection Sequence Drawing A1-1100.123 Stage 1 details. Note clauses 1.5 and 1.6 references to 2 ton SWL for each lifting sling and a soft sling for pulling the half collar manually to the tower legs.

clamping force of the chock blocks to the tower legs is unknown; however, the installation drawing (see Figure 3.4) directs the installer to "Tighten chocks uniformly onto the tower legs using a rattle gun or similar." No information regarding the actual clamping force or treatment of the faying surfaces is provided.

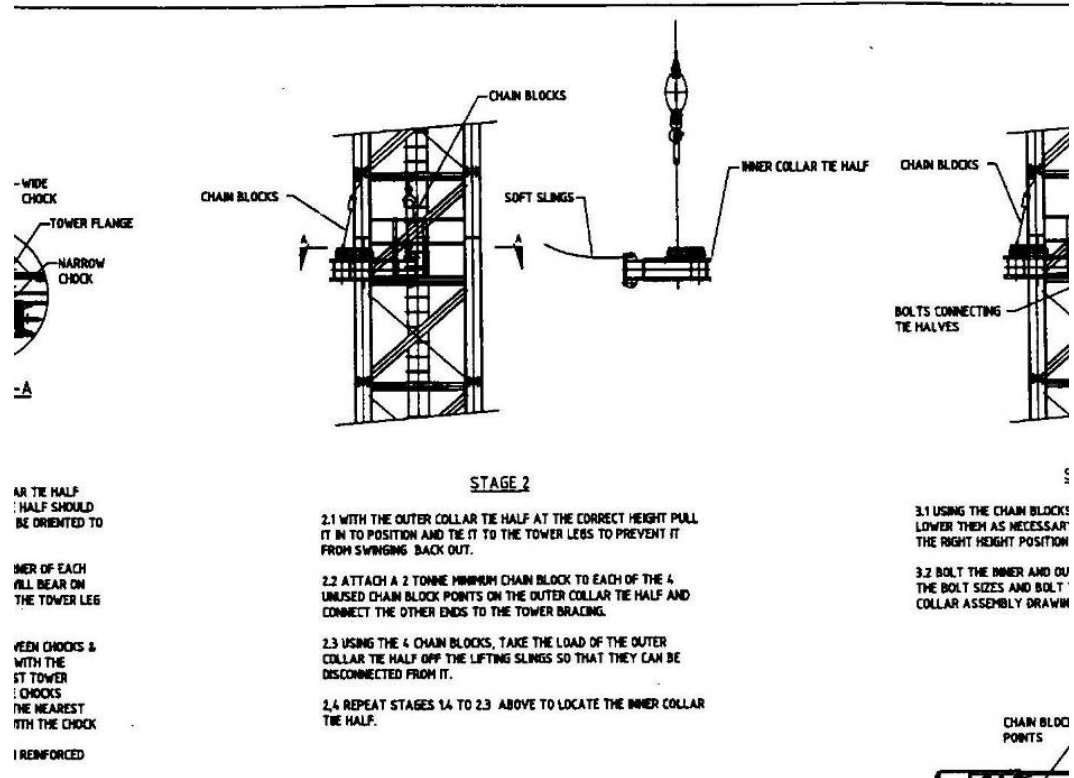
Figure 3.5 - Favelle Favco External Climbing Collar/Tie Erection Sequence Drawing A1-1100.123 Stage 2 details. Note clause 2.2 reference to a “2 ton minimum chain block.” There is no indication that this is a SWL, rated capacity or other.

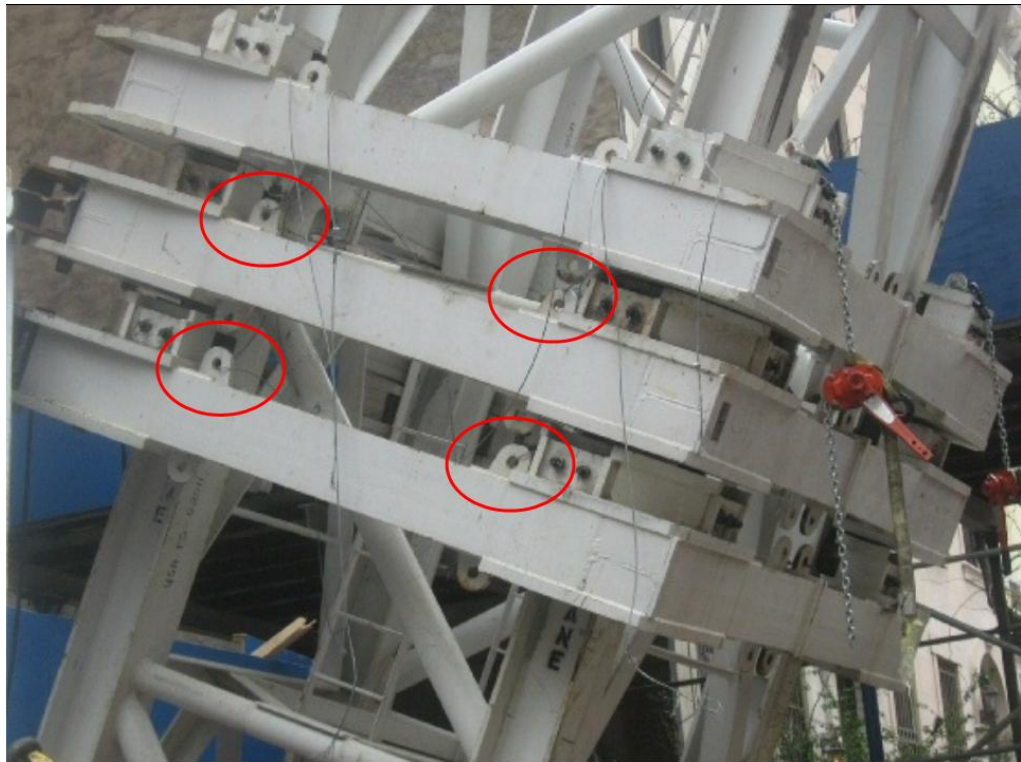
As part of the collar installation, wire ropes were implemented at completion of the tie-beam installation, as evidenced by post-collapse photographs as shown in Photographs 3.5 and 3.6.

Photograph 3.5 - View of the west elevation of the collapsed tower collars. The location of visible wire rope attachments to the collars are circled. Note the lack of thimbles in the formed sling. Photo from New York County District Attorney 328_58.jpg.

As can be seen in the photographs, the ropes were attached directly to the lugs on the collars. As previously mentioned, the specific lugs to which they were attached are not consistent with Favelle Favco's recommendations regarding the location of the four chain block attachment points which were to remain on the collars after completion of the collar / tie-beam installation. See Figure 3.2, 3.3, 3.4 and 3.5 for extracts from the Favelle Favco External Climbing Collar/Tie Erection Sequence Drawing A1-1100.123.

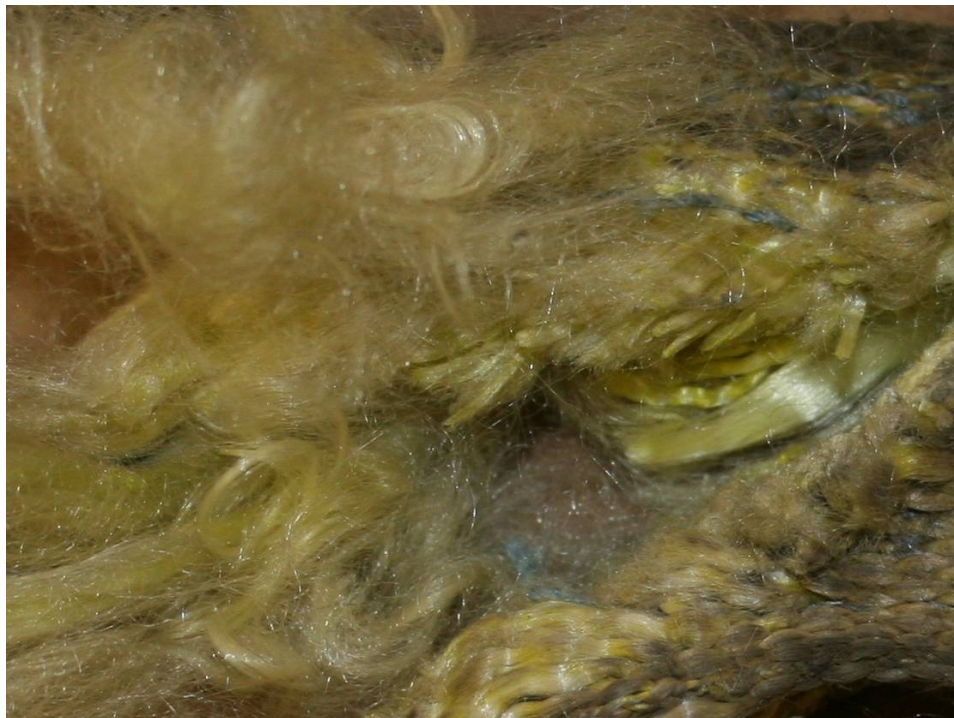
Photograph 3.9 - OSHA evidence item 1. Polyester web sling removed from the collapse site. This was taken from the southwest corner of the 9th floor collar. Note the varying degrees of fading of the webbing coinciding with the relative degree of potential exposure to ultraviolet rays. Magnification is approximately 2.5x. Photo by Arup.

As noted earlier, the Liftex Corporation was visibly bleached, indicating prolonged exposure to ultraviolet light. Close-up views and microphotographs also substantiate a range of color in fibers which would have had varying degrees of shielding due to overlying layers (see earlier Photographs 3.8, 3.9 AND 3.10).

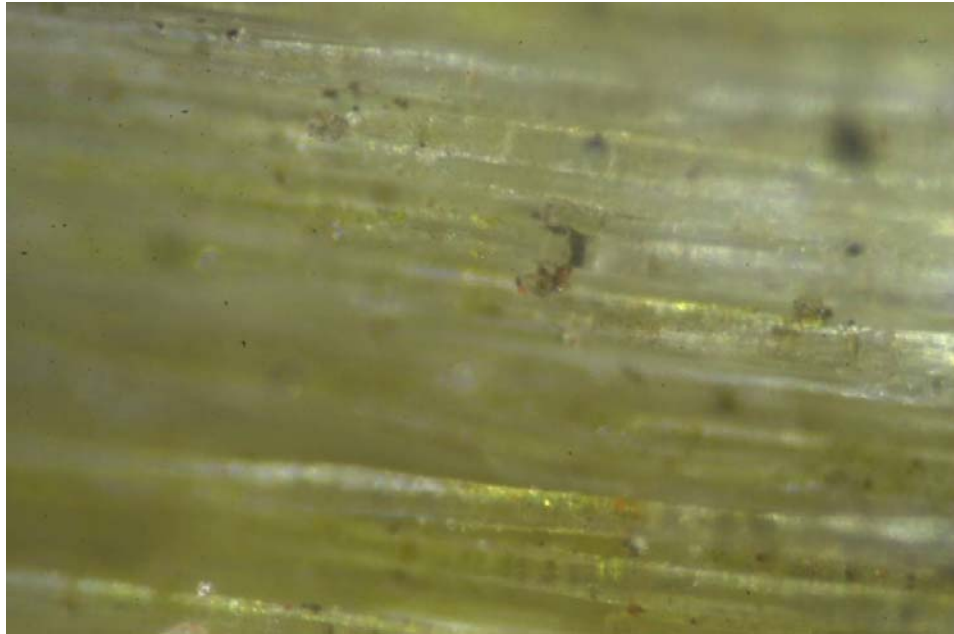
Photograph 3.10 - Microphotograph of OSHA evidence item 1, polyester web sling taken from the southwest corner lifting point of the 9th floor collar. Note the loss in color of many of the fibers. Magnification is approximately 200x. Photo by Arup.

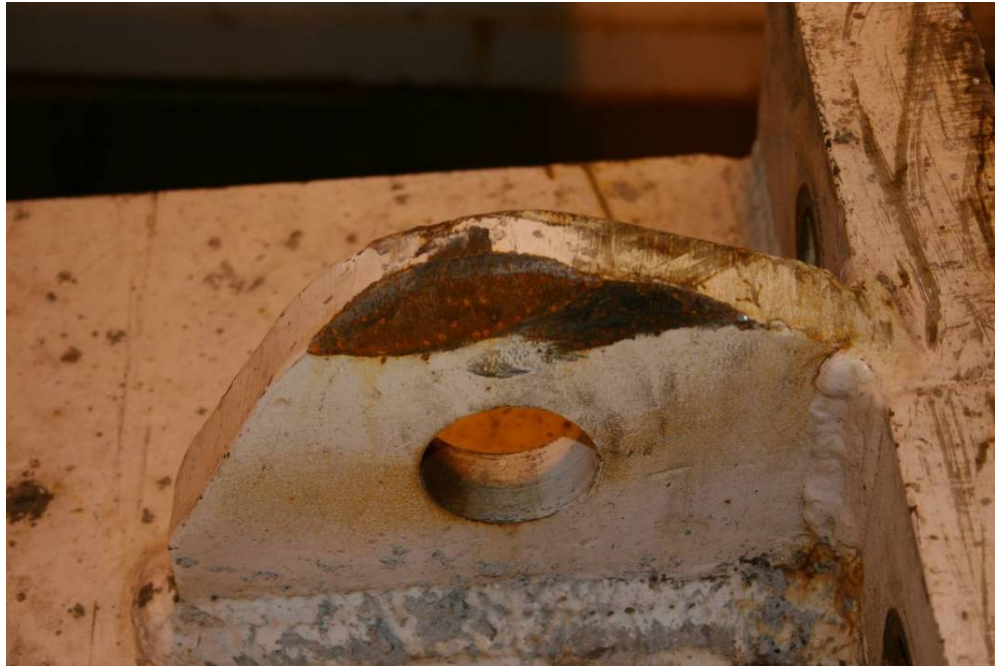
For a wire rope sling, this is normally controlled by use of a thimble inserted into the eye of the sling. As suggested by the lack of thimbles retrieved from the debris and photographs taken of the slings after the collapse, this was not done. As the wire rope needed to be threaded through the chain block attachment point, use of a thimble would have been impractical although it is possible that an open pattern thimble could also have been inserted around the chain block attachment, thereby creating an acceptable D/d ratio (where D is the minimum diameter of the sling formed by bending the wire rope and “d” is the diameter of the wire rope). A photo of the chain block attachment is given in Photograph 3.12 below. The unprotected/unpadded edge of the attachment is clearly visible. The chart which follows, Figure 3.6, taken from the Wire Rope Sling Users Manual published by the Wire Rope Technical Board provides information regarding the reduction in capacity arising from unacceptable D/d ratios.

Photograph 3.12 - Collar C2-A chain block attachment point. Note the unprotected edges on which the wire rope sling would have been bearing (typical for all chain block and lifting attachments for all collars).. Photo by Arup.

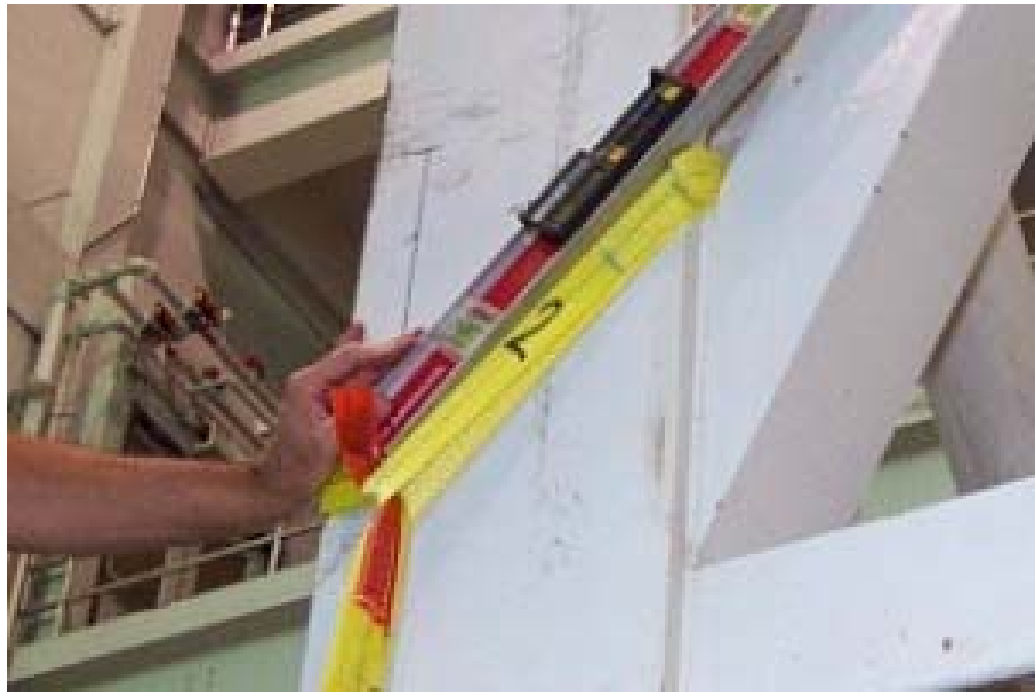
As the polyester web sling was choke hitched around the tower crane leg in the V-groove formed by the junction of the tower diagonal and leg, the sling, under load, would have necessarily been constricted, bunched and pinched. See Photograph 3.19 below.

Photograph 3.19 - ATLSS test setup prior to testing. Note that, as installed around the tower leg in the V-groove formed between the diagonal and the leg, the sling will necessarily be constricted, bunched and pinched by the load. Photo provided by OSHA.

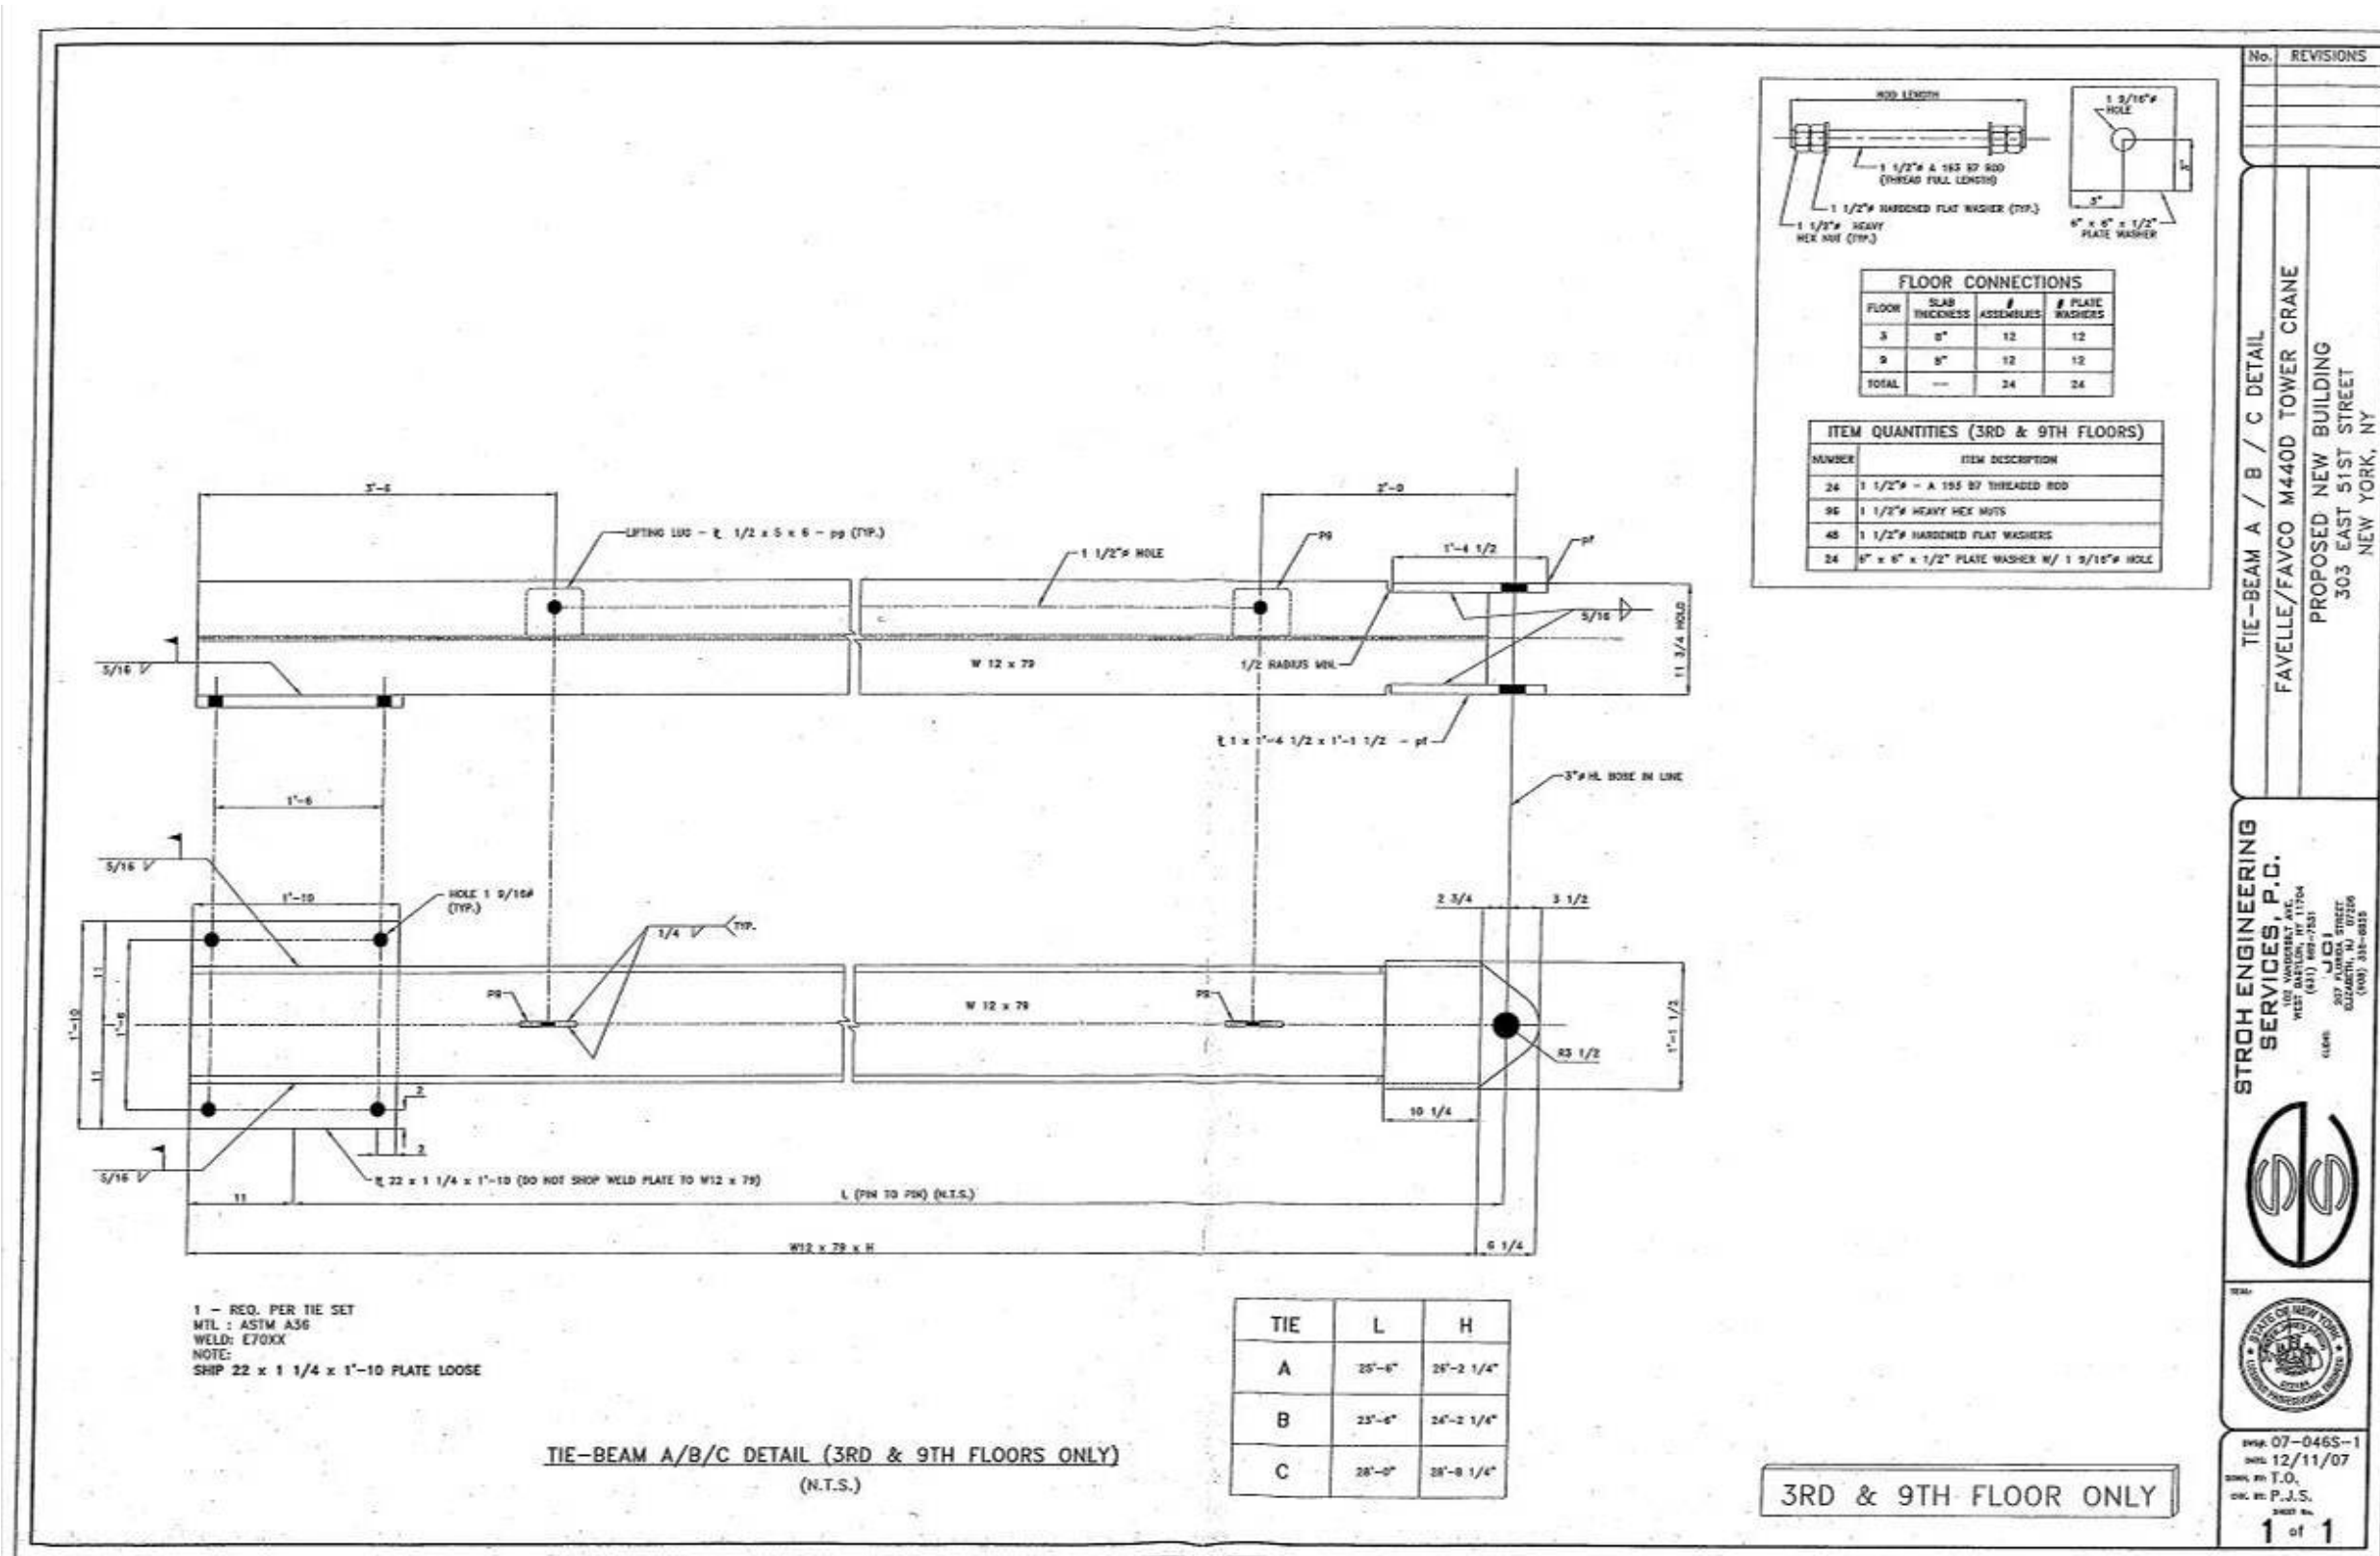
The fabrication drawings prepared by the crane engineer (Stroh Engineering) are given in the Figures 3.8 and 3.9 below. Minimal information is provided beyond the weld electrode, size and type of weld. NDT, verification inspection, weld acceptance criteria are all unspecified.

Figure 3.8 - Drawing 07-046S-1, Tie-Beam A/B/C Detail, prepared by the crane engineer Stroh Engineering Services, PC
