New York City
Department of Buildings

**51st Street Crane
Investigation**

March 2009

Ove Arup & Partners Consulting Engineers PC
155 Avenue of the Americas, New York NY 10013
Tel +1 212 229 2669 Fax +1 212 229 1056
www.arup.com

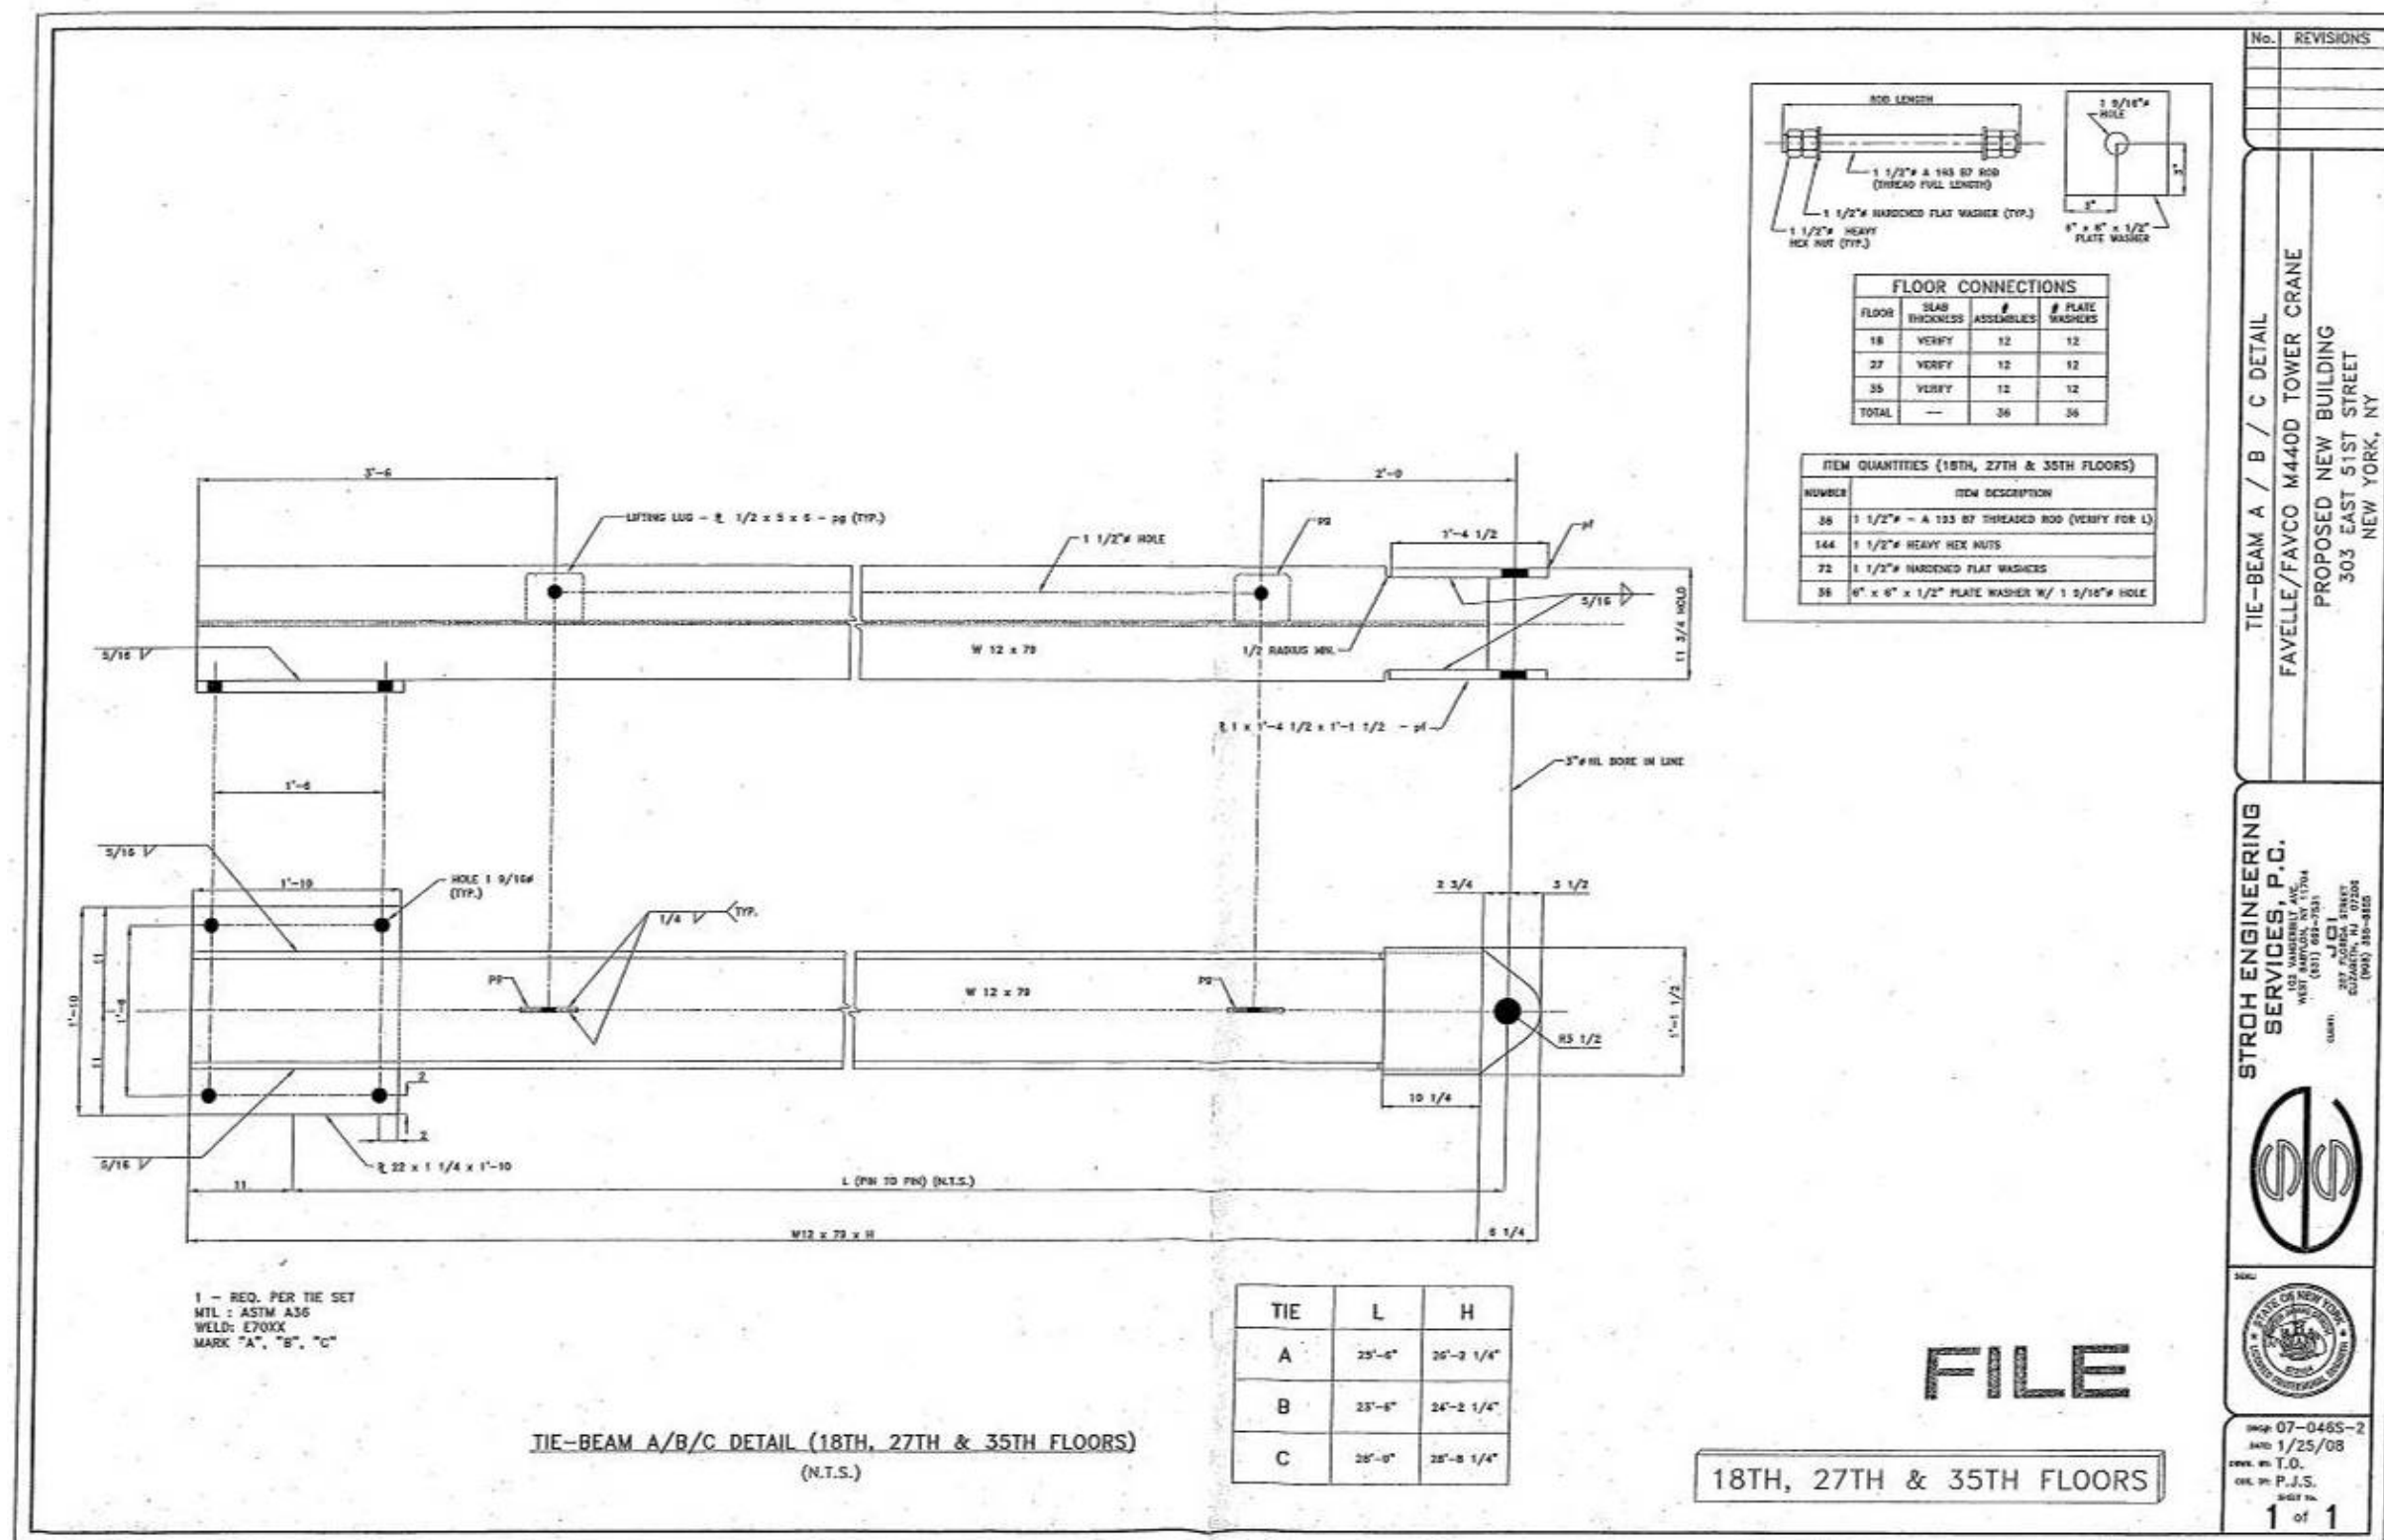
The fabrication drawings prepared by the crane engineer (Stroh Engineering) are given in the Figures 3.8 and 3.9 below. Minimal information is provided beyond the weld electrode, size and type of weld. NDT, verification inspection, weld acceptance criteria are all unspecified.

Figure 3.9 - Drawing 07-046S-2, Tie-Beam A/B/C Detail, prepared by the crane engineer Stroh Engineering Services, PC

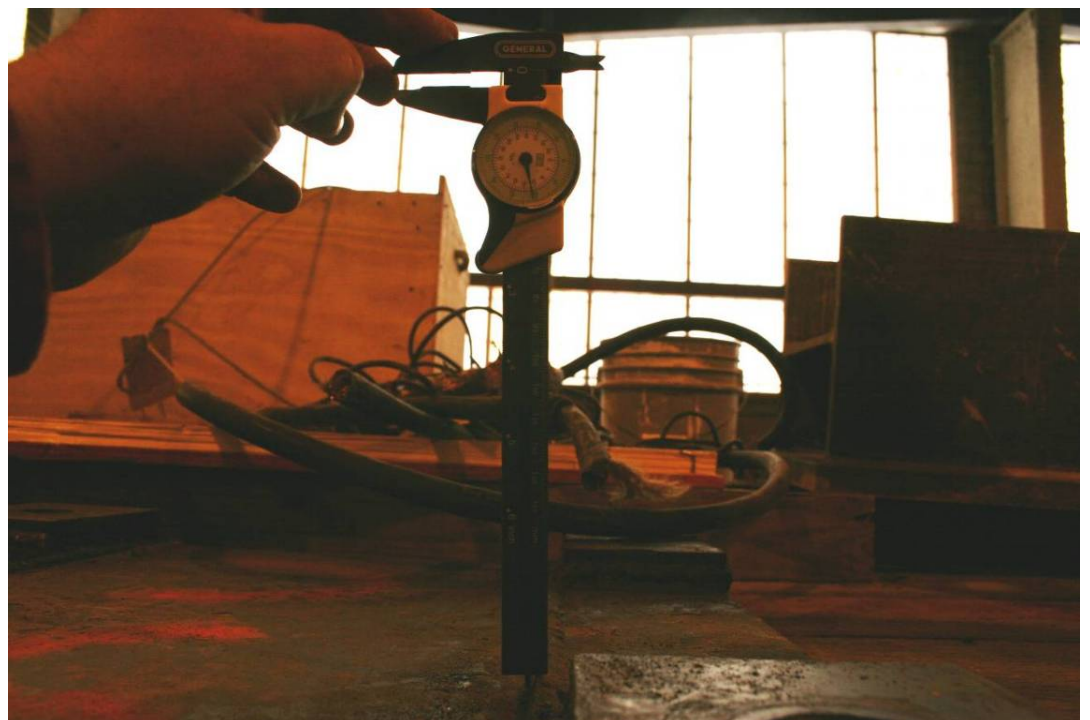
The fabrication drawings shown above reference 5/16 inch fillet welds connecting the base plates to the tie-beams at the building end of the tie-beams. It has been noted elsewhere that two of the base plates at the 9th floor level failed as a result of the impact of the 18th floor level collar. Photograph 3.22 below shows a typical measurement of the failed weld on the base plates. The measurement, taken on base plate 9C is 7 mm, or 0.275 inch. This is just under the specified 5/16 inch and represents approximately 11.8% less leg size than specified. Photograph 3.23, - which follows is a similar measurement on the same plate at another location. The latter fillet weld measured as 5 mm, or 0.197 inch. This is approximately 37.0% under the specified 5/16 inch weld. Note that both locations were randomly selected. Observations of base plates 9A and 9C indicated these would be typical measurements.

Photograph 3.23 - Fillet weld measurement of base plate 9C. Measurement is shown to be 5 mm, just over 3/16 inch, which is 37.0% under the specified 5/16 inch. Photo by Arup.

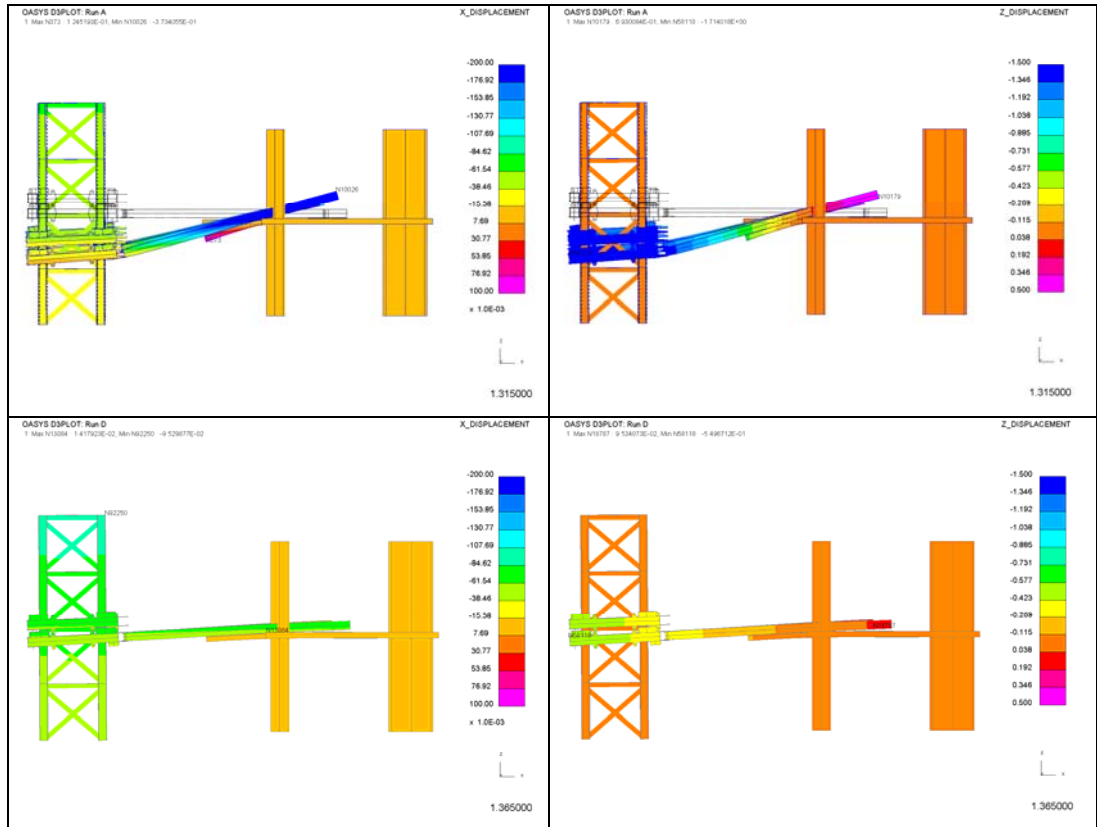
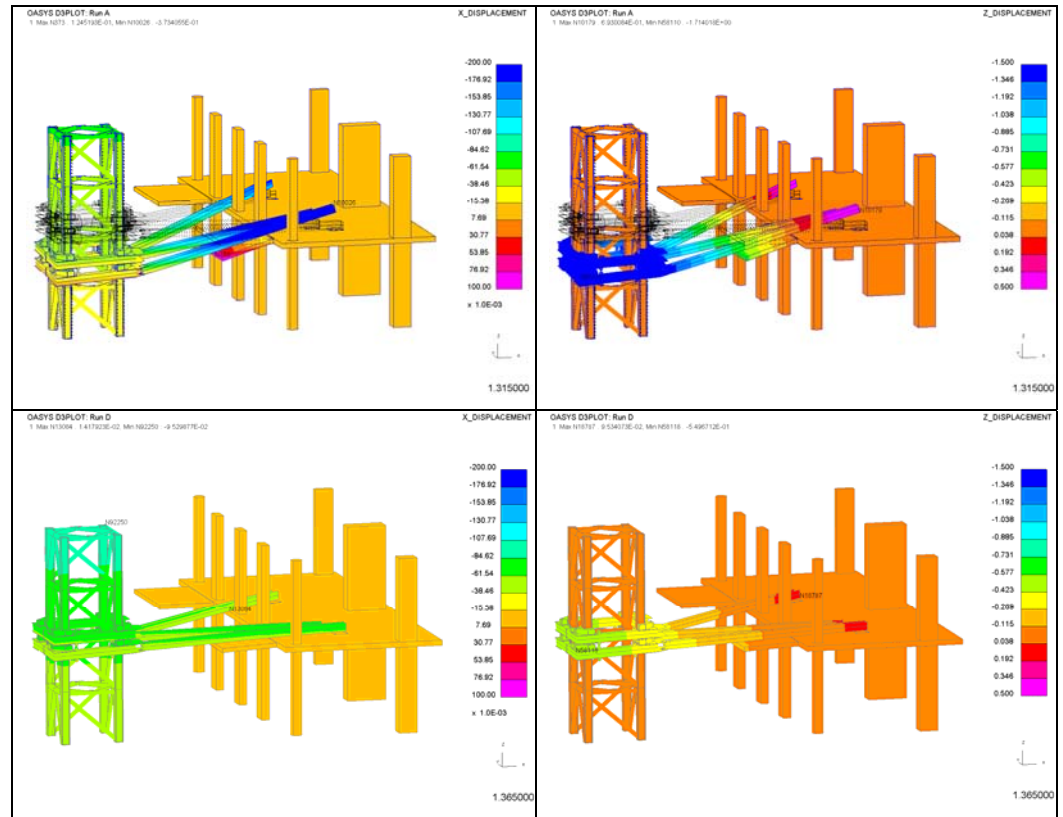
Figure 7.10 - Contours of X & Z Displacement (m) at end of analyses (x1 exaggeration). Prepared by Arup.

The 9th floor collar stops at a maximum vertical displacement of -5.6ft (-1.71m) in run A, and a minimum of -1.8ft (-0.55m) in run D.

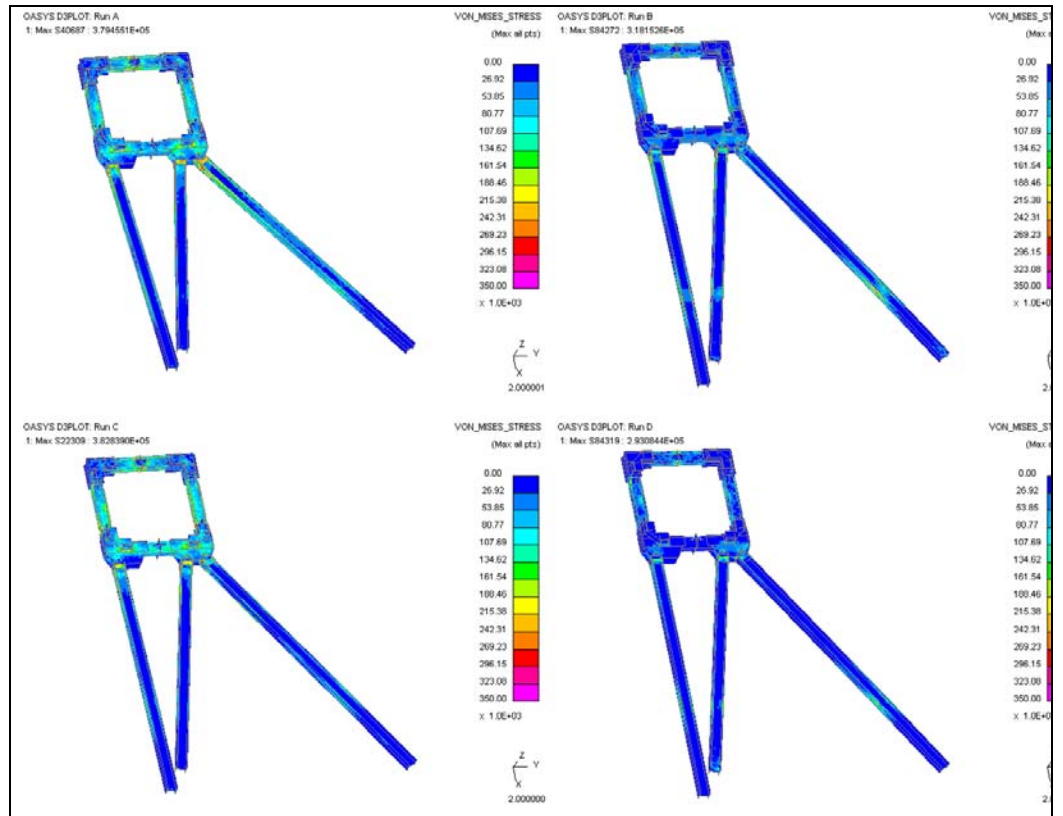
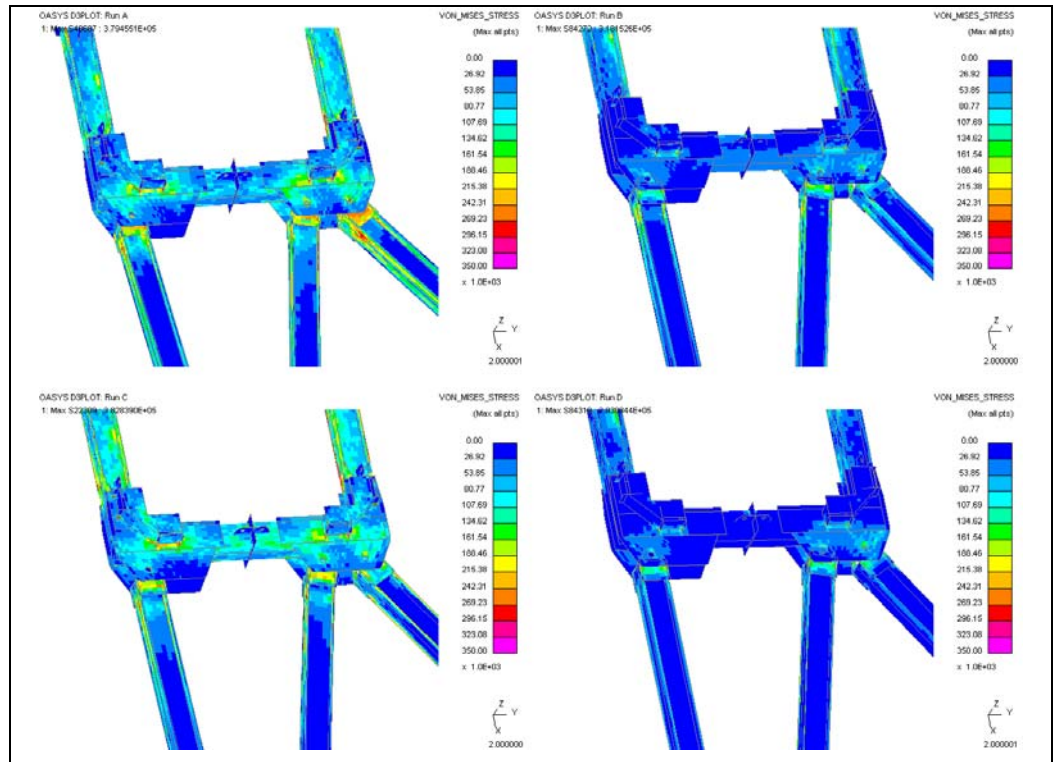
Figure 7.15 - Contours of von-Mises Stress (kPa) in Bottom Collar and Tie-Beams. Prepared by Arup.

The von-Mises stress in the tie-beam lugs local to the pinned connection are above the yield of 36.25ksi (250MPa), as can be seen in Figures 7.15 and 7.16.

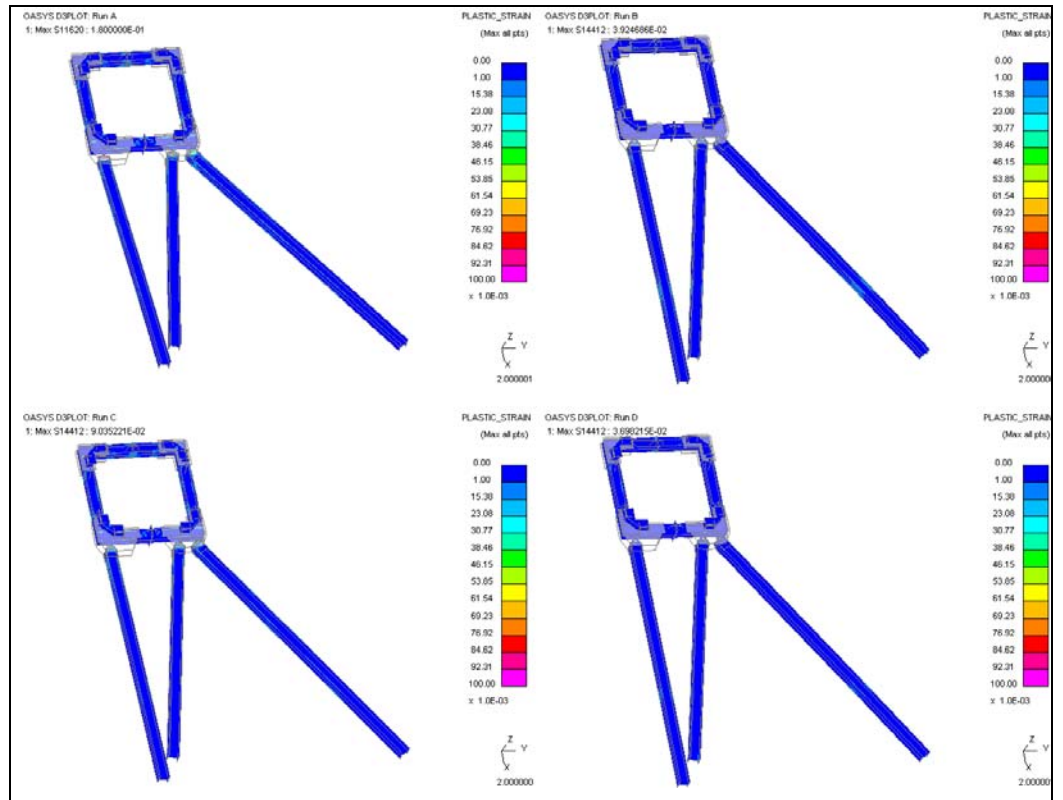
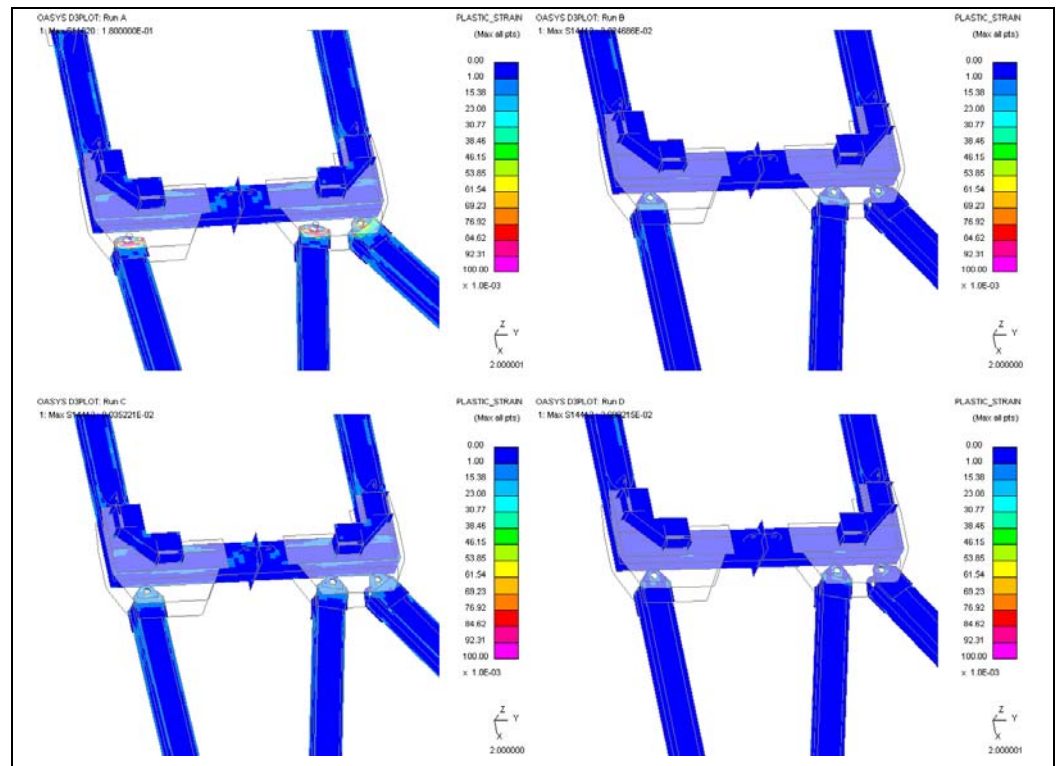
Figure 7.17 - Contours of Plastic Strain in Bottom Collar and Tie-Beam Lugs. Prepared by Arup.

Plastic strains of 18.0% are predicted around the lug holes for run A, see Figures 7.17 and 7.18. The collar lugs have been drawn translucent so as not to obscure the tie-beam lugs. This region is highly stressed but the modeling issues discussed in Section 7.4.1.5 suggest that the idealization of the pinned connection and welded beam connection are over strong.

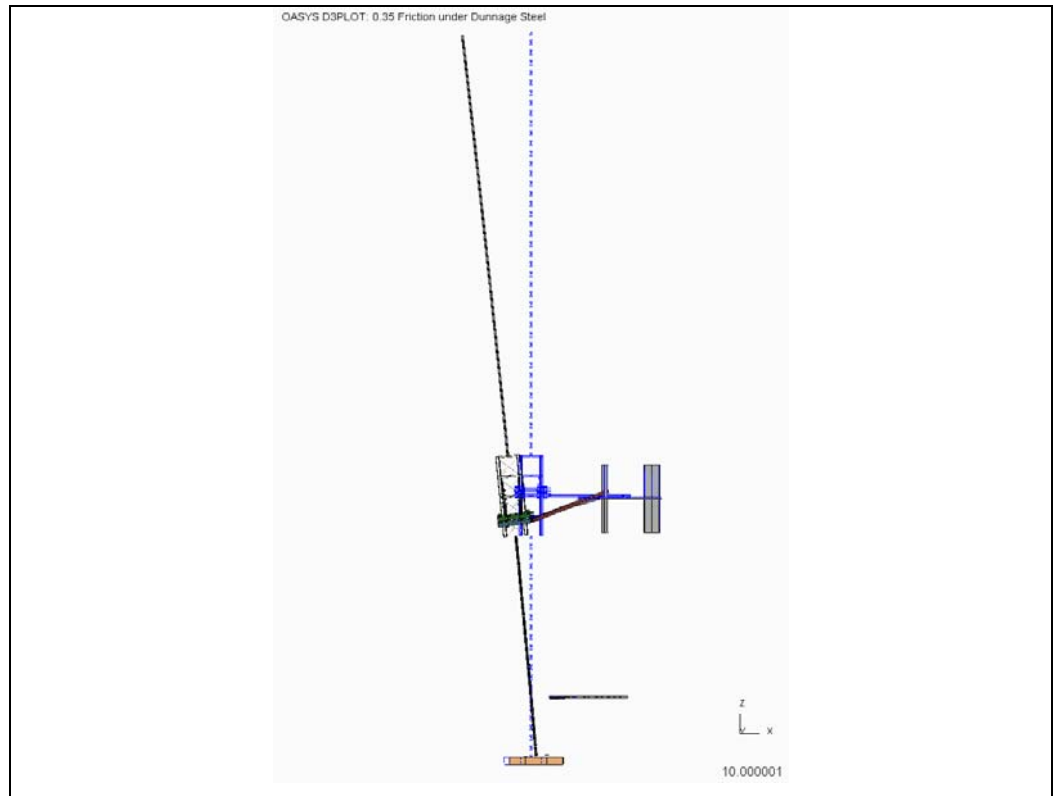
Figure 7.20 - Deformed shape plots. Prepared by Arup.

Analysis demonstrated that the horizontal force below the dunnage was great enough to overcome the frictional resistance due to the self-weight of the tower, hence the tower was predicted to fall, as can be seen in Figure 7.20. The dunnage movement can be seen in Figure 7.21. The tower tilts on top of the dunnage as there is no connection limiting this lift off.

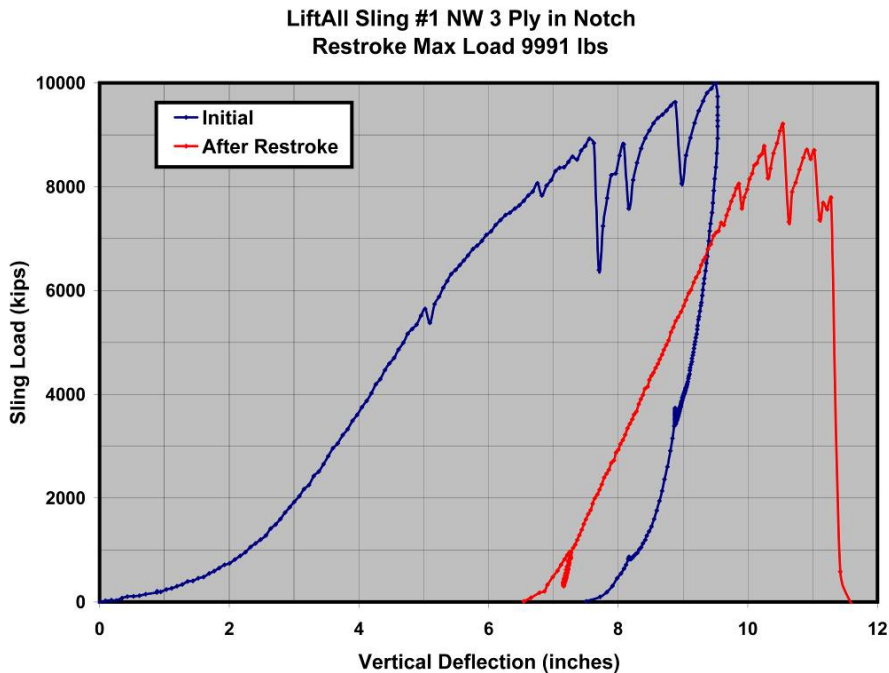
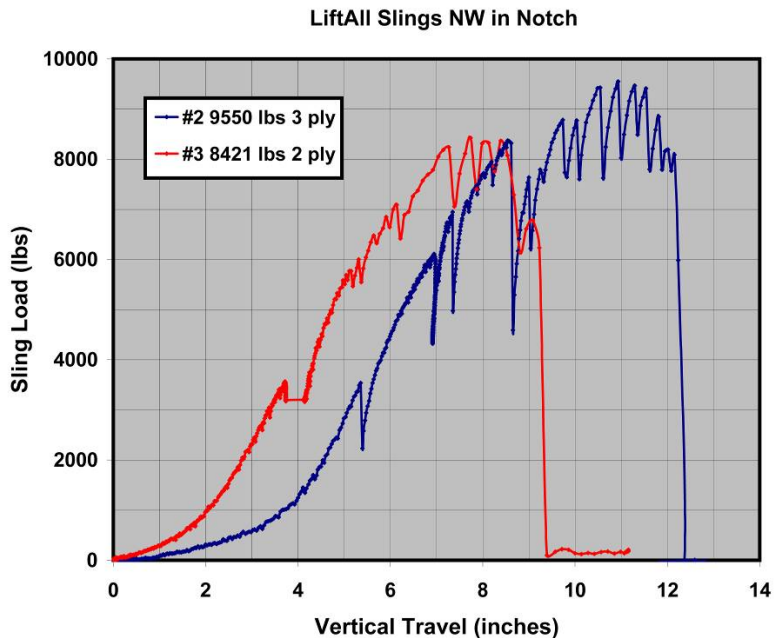
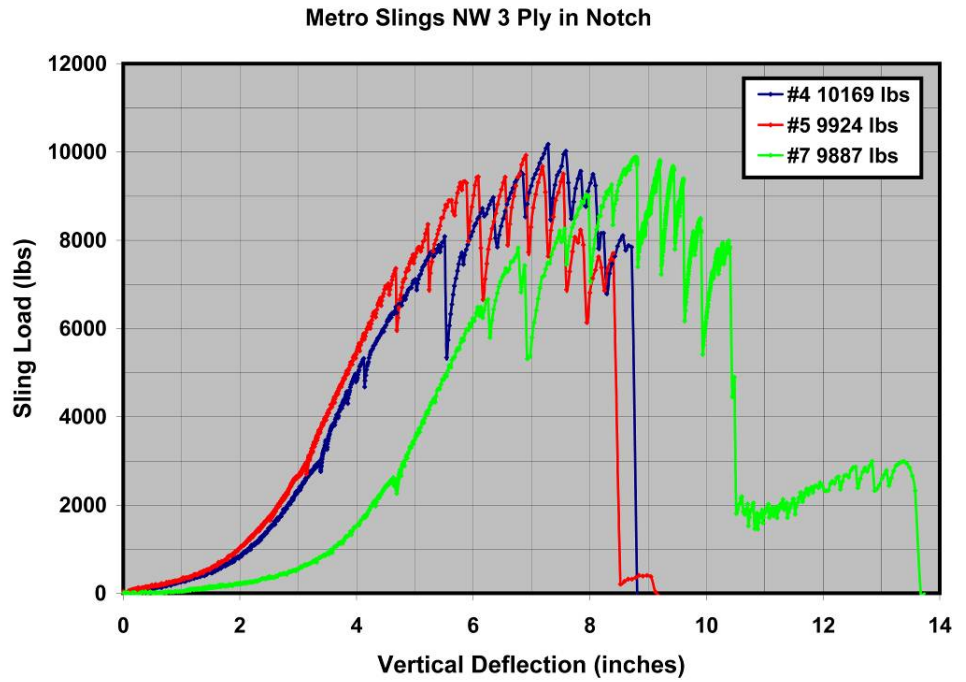
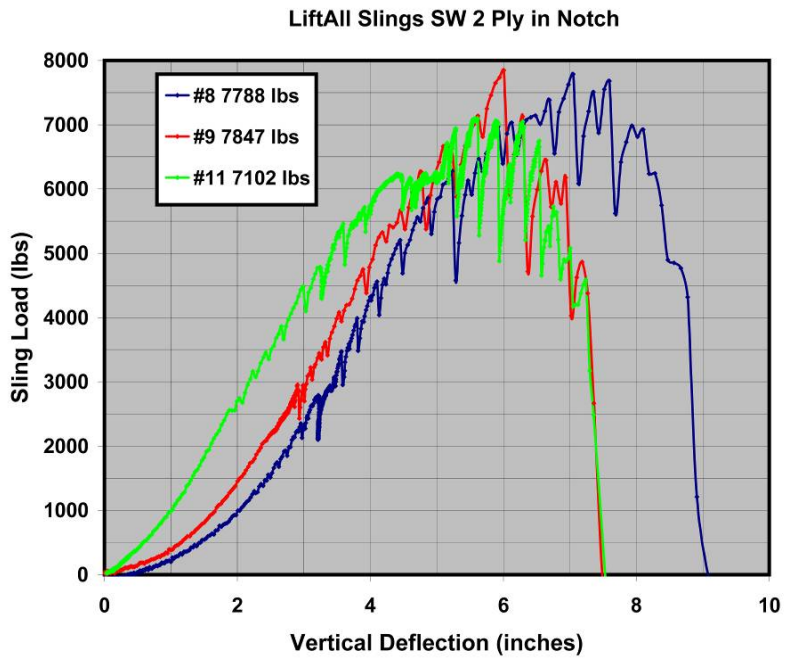
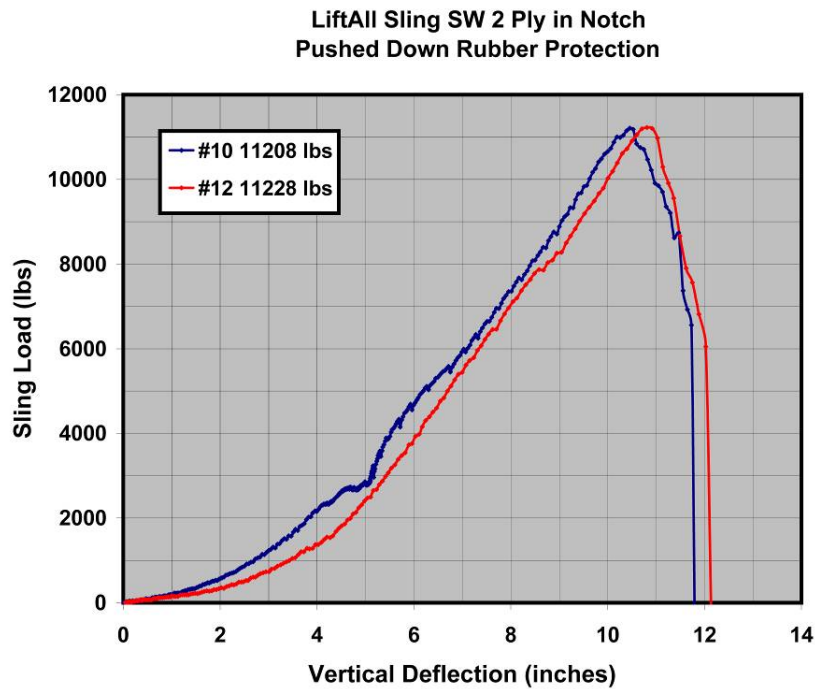
Test results are presented in Figures 8.4 through 8.8. A summary of the tests and maximum loads achieved in each test is given in Figure 8.9. As can be seen, the maximum load achieved by each sling was significantly below anticipated breaking strengths, although all tests failed above the rated capacity in a choker configuration.

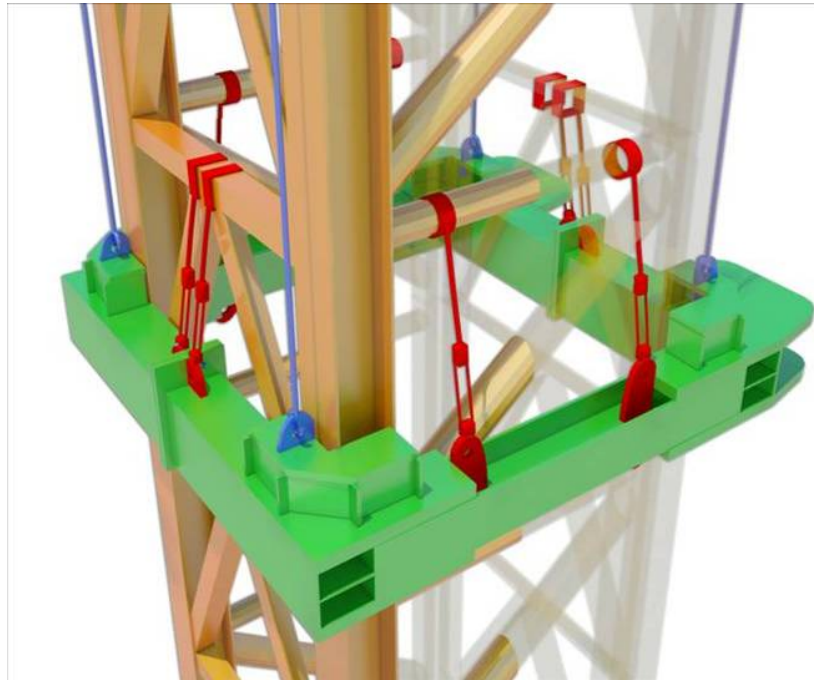
As previously noted in Section 1.2, the wrong lugs were used for the crane to lift the collar and for the slings to suspend the collar from the tower. The collar was actually lifted by the crane from lugs intended for the slings. With their point of attachment already in use, the slings were then attached to the lugs intended for lifting by the crane. This was quite significant as the points actually used for the slings aligned with the columns, which prevented a proper connection to the horizontal beams. Figure 8.10 illustrates the correct arrangement, including the use of the intended crane lifting points for the collar and the use of the intended sling attachments. This situation would have resulted in direct attachment of the slings to the horizontal steel as shown. Figure 8.11 shows actual points used to lift the collar and attach the slings.

Figure 8.10 - Elevation of the Collar Tie showing the specified/ideal crane lifting points (in blue) and the proposed sling attachment points (marked in red). Prepared by Arup.

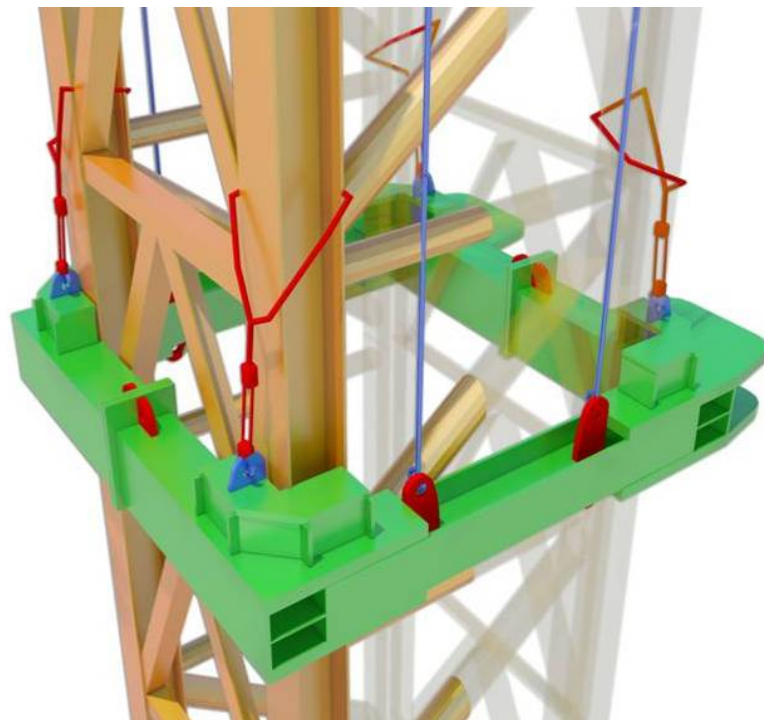
Due to the use of the incorrect lugs, the positioning of the slings as installed was inconsistent with the manufacturer's instructions. The slings were choke-hitched around the crane tower columns and drawn into the V-shaped grooves between the diagonal trussed members and the columns. None of the slings were protected against the edges by padding or other means which was required by the sling manufacturers as stated on labels affixed to the slings. See Photograph 8.4 below.

Figure 8.11 - Elevation of the Collar Tie showing the mix up in the use of the lifting points and the sling attachment- Result: choking the slings against unprotected edges. Prepared by Arup.

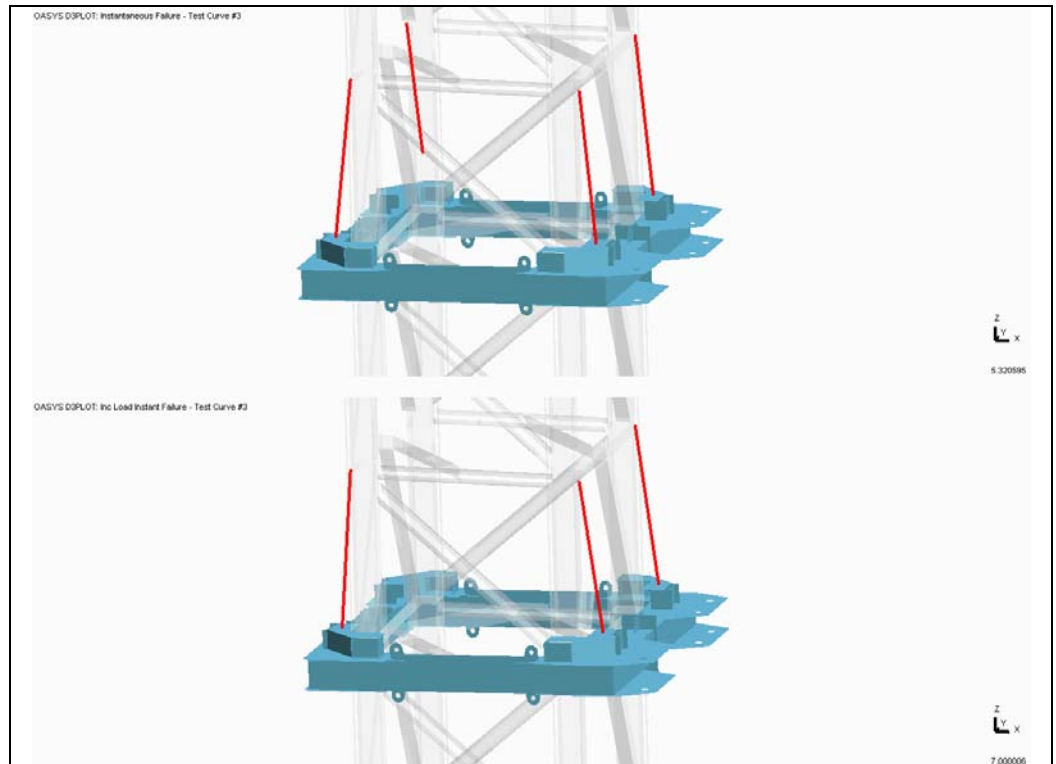
Figure 8.19 - Deformed Mesh at end of Curve #3 Analyses (uniform initial sling load top – non uniform initial sling loads bottom). Prepared by Arup.

Neither of the analyses in which the sling properties from curve #3 are used result in failure of the remaining slings, see Figure 8.19. Most of the load is initially transferred onto the NW sling for both analyses. The uniform initial sling load analysis is less severe, in which the NW sling reaches approximately 90% of its capacity; see the orange response in Figure 8.20. When the SW sling fails the load is lifted off the NE sling which is then intermittently loaded and unloaded.

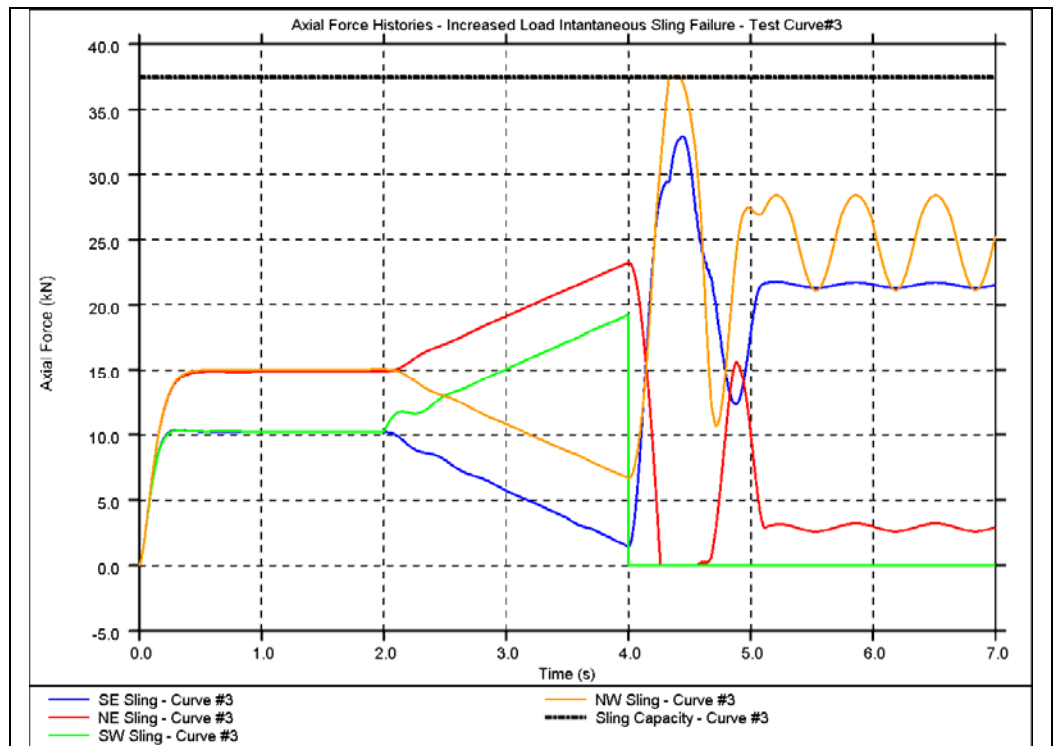
Figure 8.21 - Sling Force Time History –Non Uniform Initial Sling Loads – Test Curve #3. Prepared by Arup.

The non uniform initial sling load analysis causes some yielding in the NW sling, as can be seen by the plateau in the response at 4.4s, see Figure 8.21. The capacity of the sling, however, is enough to support the load it experiences.

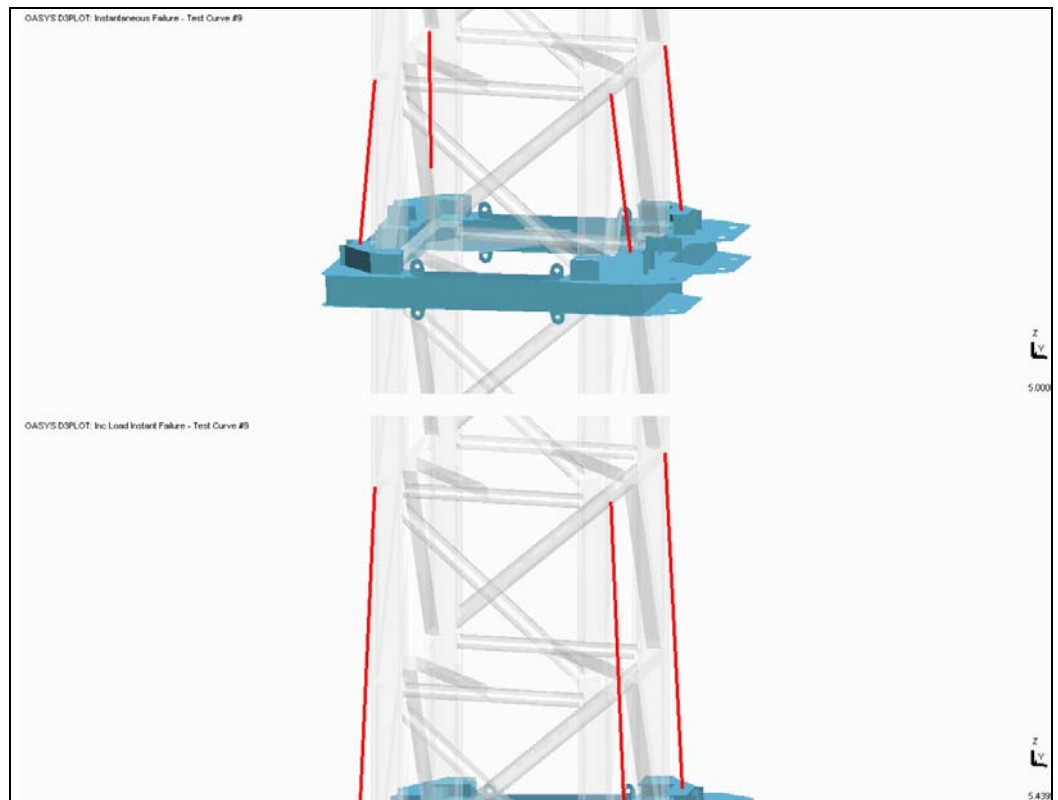
Figure 8.22 - Deformed Mesh at end of Curve #9 Analyses (uniform initial sling load top –non uniform initial sling load bottom). Prepared by Arup.

The uniform initial sling load analysis with curve #9 supports the collar after the initial sling failure, see Figure 8.22. Again, most of the load is initially transferred onto the NW sling, which reaches approximately 97% of its capacity; see the orange response in Figure 8.23. The remaining slings have sufficient capacity to support the collar.

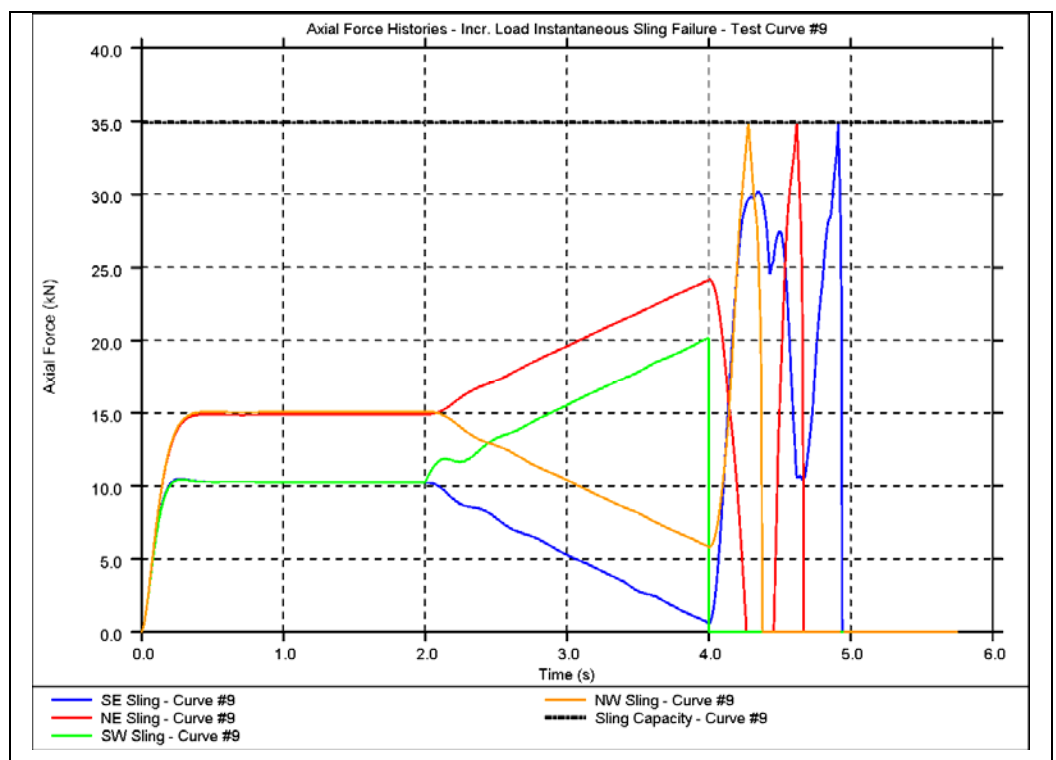
Figure 8.24 - Sling Force Time History – Non Uniform Initial Sling Loads– Test Curve #9.
Prepared by Arup.

The non uniform initial sling load analysis with curve #9 predicts that support for the collar will fail, as shown by the axial force in all slings reducing to zero in Figure 8.24. The subsequent failure of the NW sling causes the entire load to be transferred to the remaining NE and SE slings. Even though they still have sufficient static capacity, the dynamic amplification of this load transfer is large enough to cause further failure. The disappearing collar in Figure 8.22 indicates that the support system has failed. It should be noted that the NW, SE and NE slings have failed even though they are still drawn in the figure.

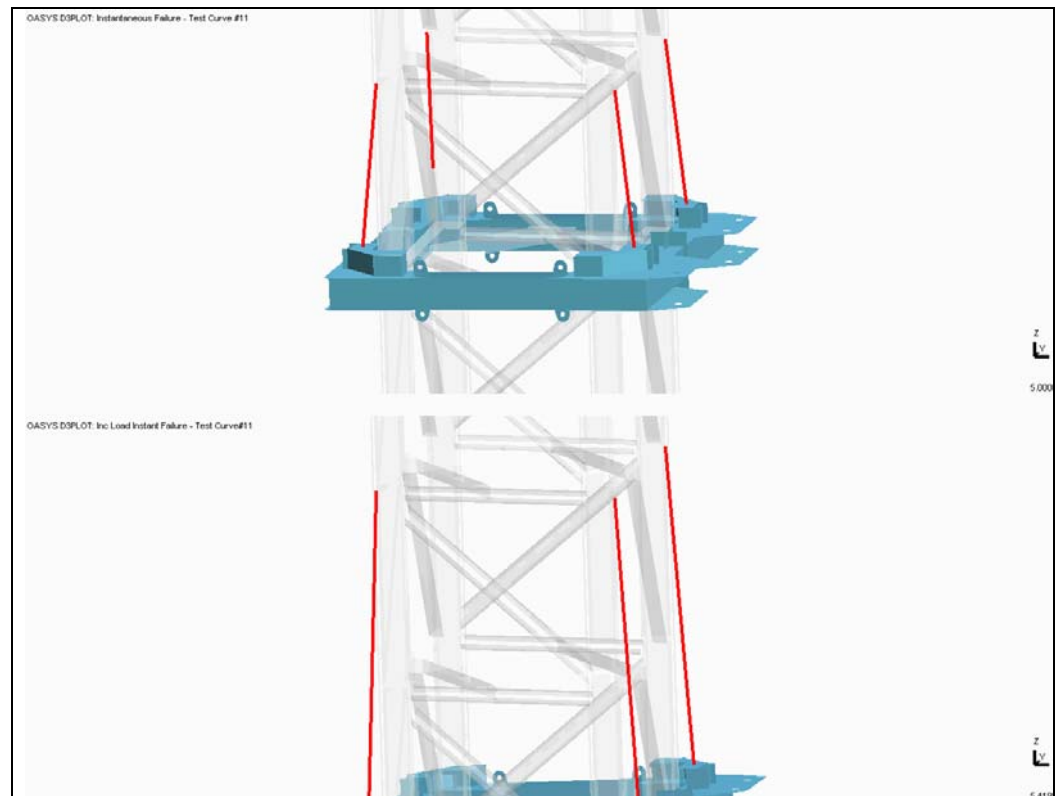
Figure 8.25 - Deformed Mesh at end of Curve #11 Analyses (Uniform initial slings loads top – non-uniform initial sling loads bottom). Prepared by Arup.

The uniform initial sling load analysis with curve #11 supports the collar after the initial sling failure, see Figure 8.25. Again, most of the load is initially transferred onto the NW sling, which causes some yielding, as can be seen by the plateau in the orange response at 2.4s (Figure 8.26). The sling yields again in subsequent load oscillations, but not enough to cause failure. The remaining slings have sufficient capacity to support the collar.

The non uniform initial sling load analysis with curve #11 predicts that support for the collar will fail, as shown by the axial force in all slings reducing to zero in Figure 8.27. The subsequent failure of the NW sling causes the entire load to be transferred to the remaining NE and SE slings, thus following the same failure mechanism described above for the curve #9 analysis. The disappearing collar in Figure 8.25 indicates that the support system has failed. It should be noted that the NW, SE and NE slings have failed even though they are still drawn in the figure.

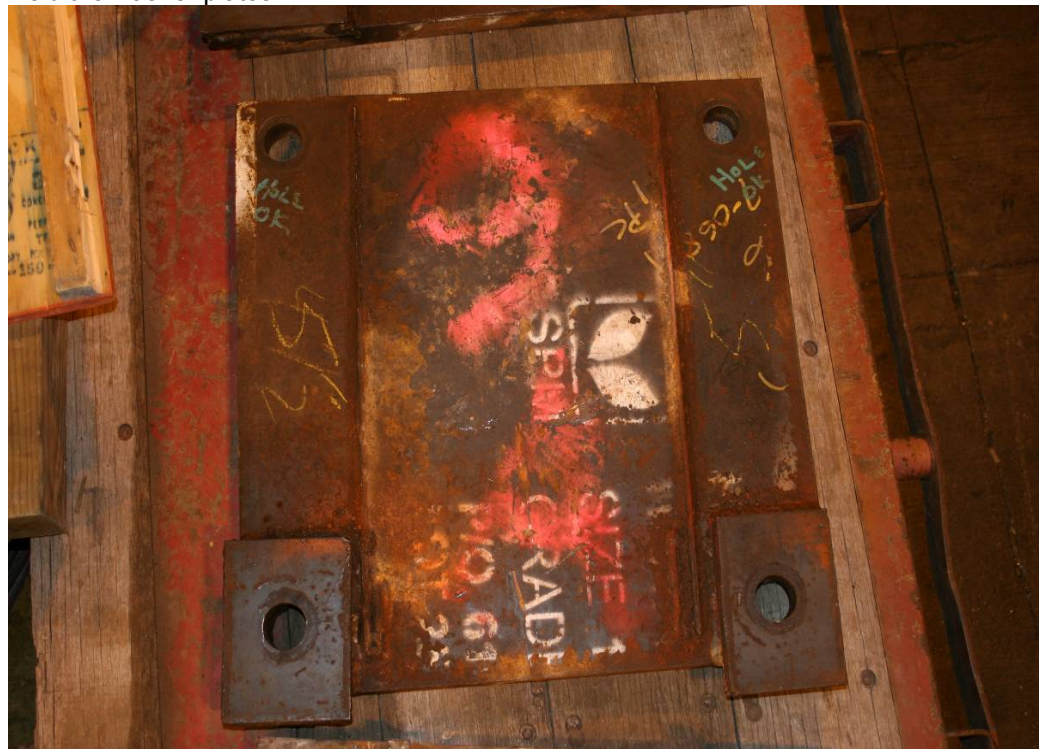
Photograph 9.1 – Base plate 9A from floor level 9. Photo by Arup.

The horizontal tie-beam/base plates consisted of a 1-1/4 in. thick steel plate with a W12x79 rolled shape fillet welded to the plate surface at the beam end. A pair of rectangular washer plates was used at each bolt location, where the base plates had been connected to the building floor slab, and tack welded to the base plate. The base plate components identified as 9A and 9C exhibited fully failed fillet welds between the tie-beam and base plate. The respective tie-beams, also exhibiting weld fracture at one end of the beam, were identified by ATLSS as B-4 and B-5. The third tie-beam/base plate component, identified as 9B, had intact welded connections.

The measured weld lengths varied and ranged from 20 inches to nearly the full length of the base plate. A short length of fillet weld of variable length was also deposited along the interior flange tips at the beam end ranging from 2-1/2 in. to 4-5/16 in. This compares with the fabrication drawings which specified a 22 in. length with no weld along the interior flange tip. See Figure 9.1 below.

Most bolt holes were drilled; a few holes appeared to be torch cut. Missing washer plates on base plates 9A and 9C were apparently not tack welded to the base plate. The section dimensions of the three W12x79 tie-beams were found to be within the permitted tolerances specified in ASTM A6. Note that in the drawing there is no requirement to tack weld the washer plates.

Tie-Beam B4 weld fractures showed similar fracture features but only a small amount of weld metal deposited on the tie-beam. The small amount of weld fracture observed on the tie-beam indicated an effective weld size much less than the deposited weld size previously measured on the base plate, arising from the tie-beam fit-up to the base plate. However, with the majority of weld having an effective weld size of 3/16", it is still sufficient to support the design loads (see Section 4 on Peer Review of Tower Crane On-Site Design) without failure, although not with the minimum required factor of safety. As for B-5, this is below the minimum specified by the American Welding Society.
