New York City
Department of Buildings

**51st Street Crane
Investigation**

March 2009

Ove Arup & Partners Consulting Engineers PC
155 Avenue of the Americas, New York NY 10013
Tel +1 212 229 2669 Fax +1 212 229 1056
www.arup.com

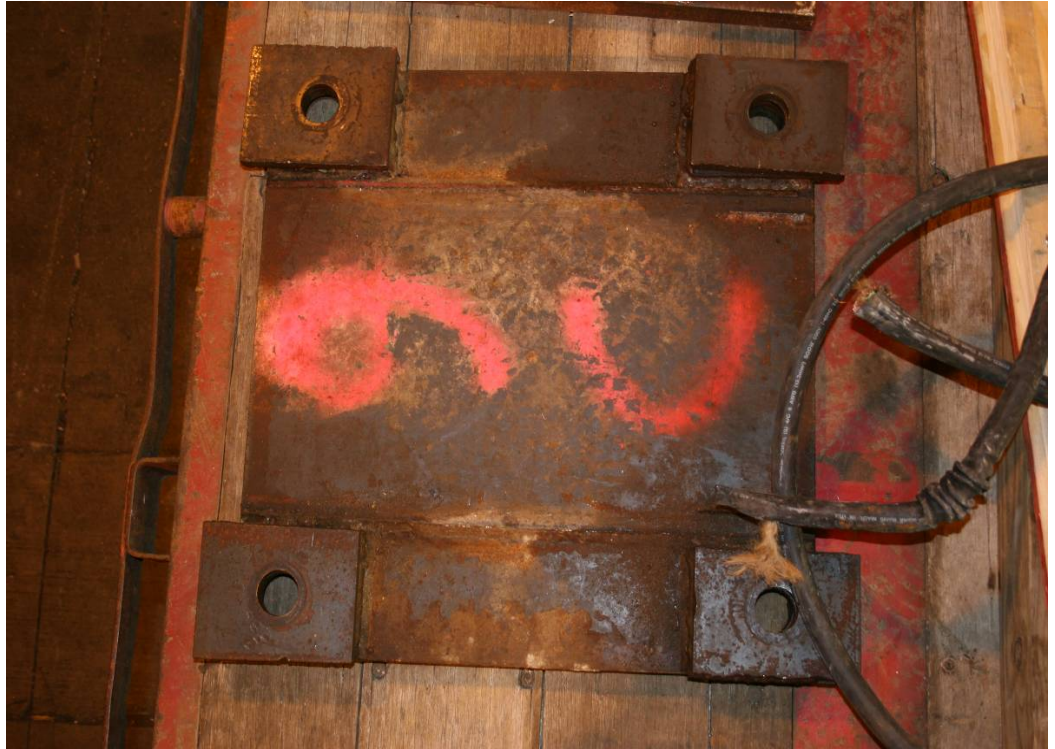
Photograph 9.2 – Base plate 9B from floor level 9. Photo by Arup.

With regard to the still intact assembly, Base Plate/Tie-Beam 9B, the welds appeared to be sound and free of fabrication defects. A weld toe crack on the tie-beam leg was observed in one fillet weld at the weld end, although separation of the components had not yet occurred.

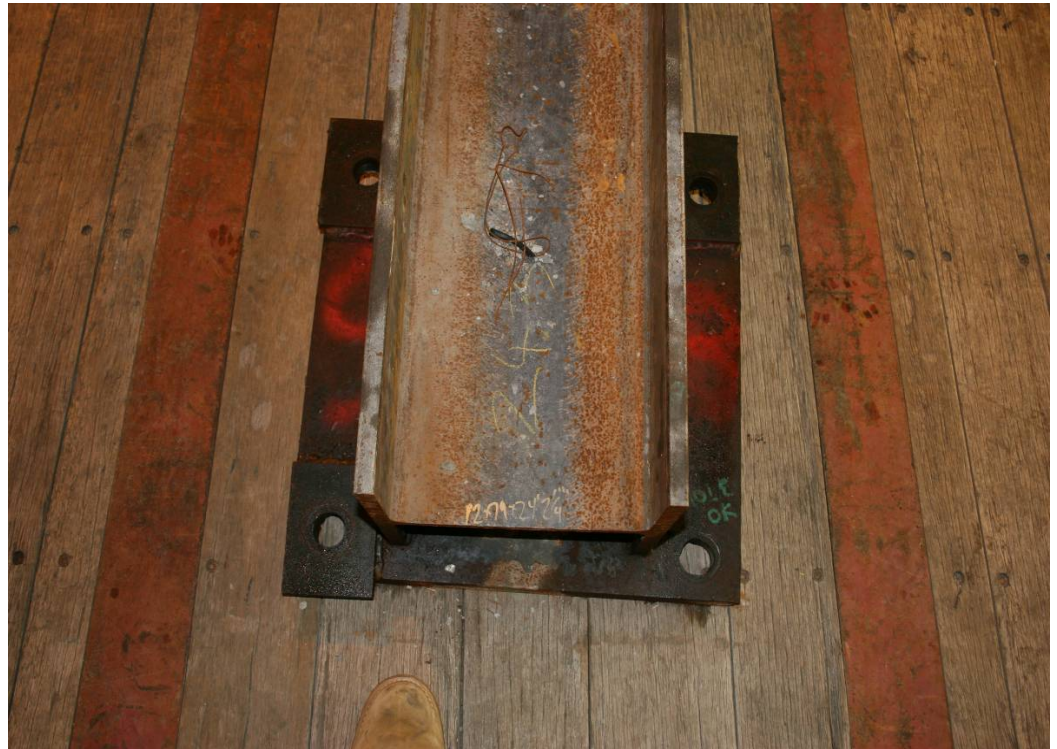
Photograph 9.3 – Base plate 9B from floor level 9. The tie-beam is still attached. Photo by Arup.

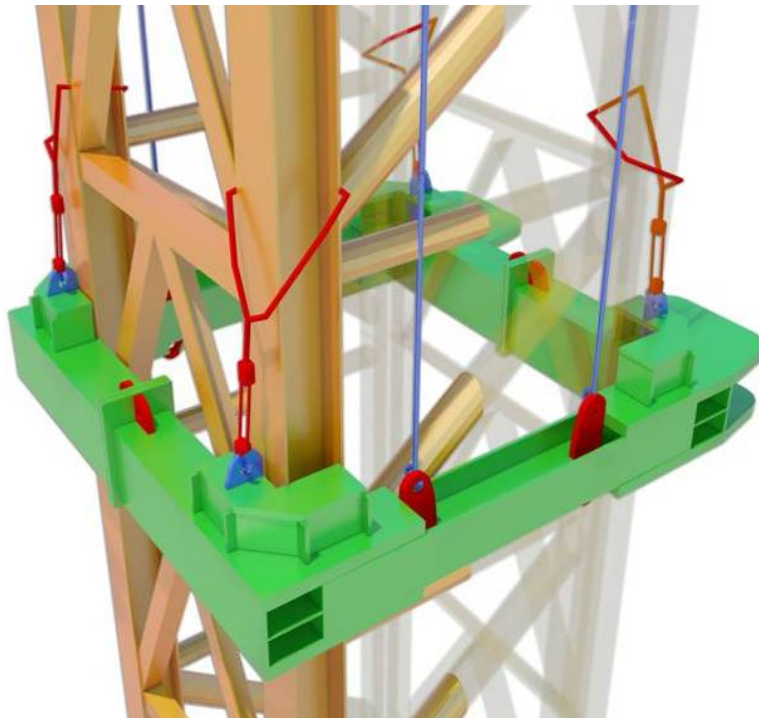
The lifting slings used to lift the collar halves into position should have been attached to the collar at locations designated by the tower manufacturer as lifting points. The lifting points are approximately located long the centroid of the collar mass. See Figure 3.2 showing these respective locations as well as the lugs to be used for later suspending the collar from the tower ("chain blocks"). The sling which had been used to lift the collar halves had been incorrectly attached to the collar using the chain block attachment points. This is evident in Photograph 11.1, which shows that during the lift, as a result of using the wrong lifting points, the collar half was unbalanced and was therefore significantly deviating from a horizontal orientation.

Figure 11.1 - Elevation of the Collar Tie showing the mix up in the use of the lifting points and the sling attachment- Result: choking the slings against unprotected edges. Prepared by Arup.

The two polyester web slings used to suspend the collar from the tower were attached to the lifting point lugs, rather than the designated chain block lugs. As a result, they were in the wrong location with regard to the tower face and had to be choked around the tower columns and diagonal bracing rather than the horizontal bracing. In that configuration, the polyester web slings were drawn into the "V" shaped groove between the bracing and the tower columns.

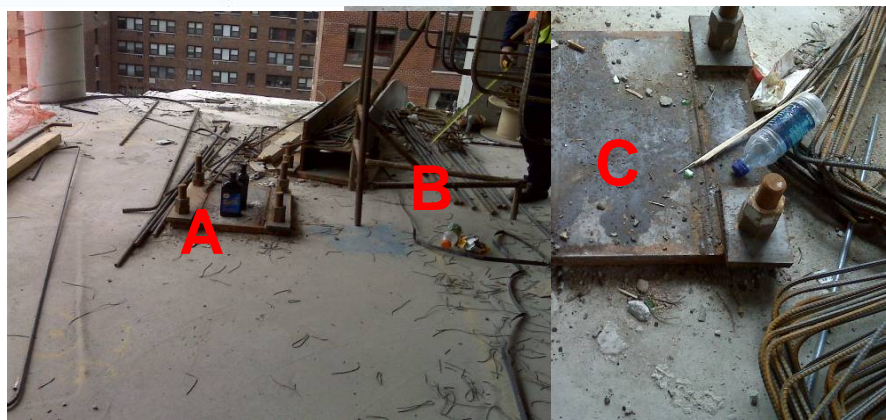
As demonstrated by structural analysis, the unanticipated loads arising from the dynamics of the collar falling from the 18th floor caused the failure of the collar connection at the 9th floor. The precise failure mode proved difficult to replicate analytically. However, even though the analysis over-estimated the strength of some components, it did demonstrate that the falling collar had ample energy to destroy the connection. Photographs 11.1 and 11.2 show the damaged end connections of the tie-beams at the tie-beams at the 9th floor. Photograph 11.1 shows the base plate connections after the incident. The tie-beams, marked 9A and 9C on the photograph, have completely separated from the base plates. Photograph 11.2 shows that all three tie-beams sheared off the collar near pins.

The tie-beam assembly at the 9th floor level was not welded as specified. However, this is not considered to have contributed to the tower collapse. Computer analysis indicates that the welds that connect the tie-in beams to the steel base plates would still have failed if the welds had been properly fabricated per the design. Further, site observations indicated that all three connections of the tie-beams to the collar also failed. Similar observations apply to the pin end fabrication; i.e., the pin end connections are also unable to withstand the impact loads.

Photograph 11.1 - 9th Floor: Failed base plate 9A for Beam B4 (labelled “A” in the photograph) and failed base plate 9C for Beam B5 (labelled “C” in the photograph) prior to its removal from the site (the bent beam in the photograph is Beam 9B). Photos provided by NYCD0B.

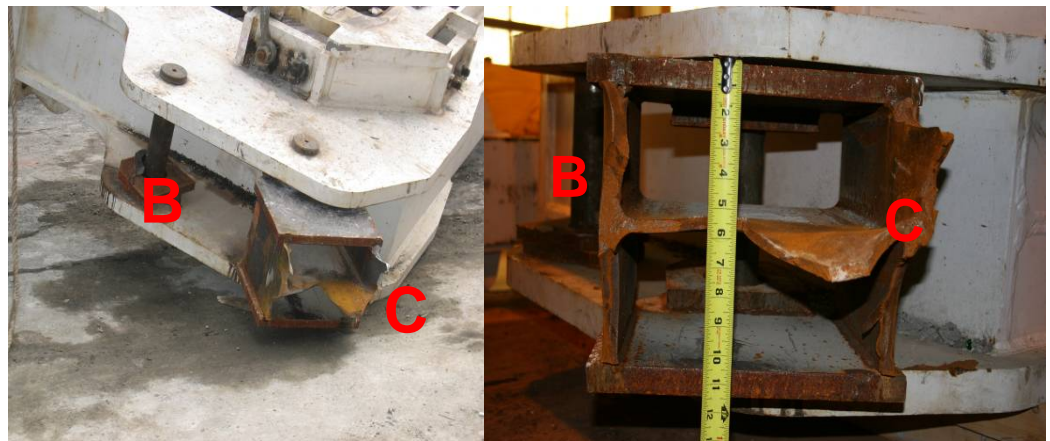
Photograph 11.2 - 9th Floor: Failed end for Beam B5 (labelled “C” in the photograph) prior to its removal from the site (the pin end of Beam B5 sheared off). Photos by Peter Stroh IMG 0093.jpg and Arup.

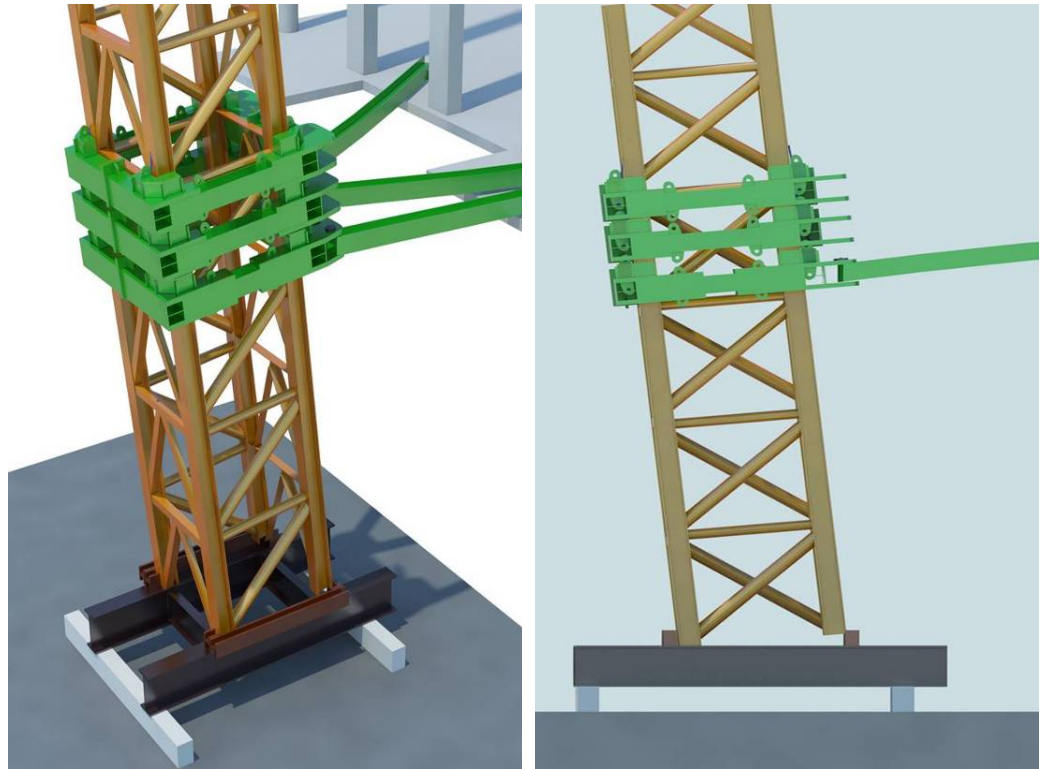
As demonstrated by structural analysis, the dunnage steel did slip across the foundations at the base of the crane and this resulted in the overturning of the tower. Figure 11.2

shows the slippage of the tower base towards the building and a rotation about the level 3 collar; resulting in the movement of the upper parts of the tower away from the building. As this movement continued, the tower legs at the base of the tower dislocated from the supporting pockets located on the dunnage beams; allowing another type of sliding as the tower legs slid along the dunnage. This is illustrated in Figure 11.3. The dunnage steel eventually slid completely off its foundation wall to the south. Photograph 11.3, taken after the collapse, clearly shows the movement of the dunnage beam and tower base.

Figure 11.2 - Elevation of the tower at the 3rd floor showing dunnage slippage at the supporting concrete walls and the uplift at the back legs of the tower (initiation of the tower rotation). Prepared by Arup.

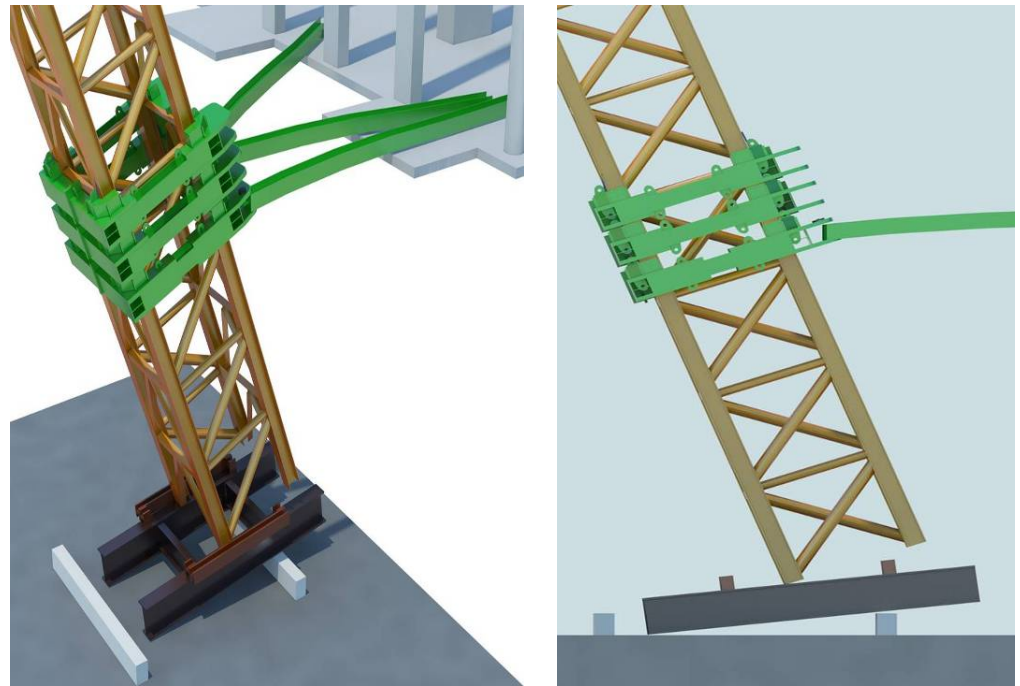
Figure 11.3 - Elevation of the tower at the 3rd floor showing dunnage slippage at the base and the uplift at the back legs of the tower and tower rotation. Prepared by Arup.

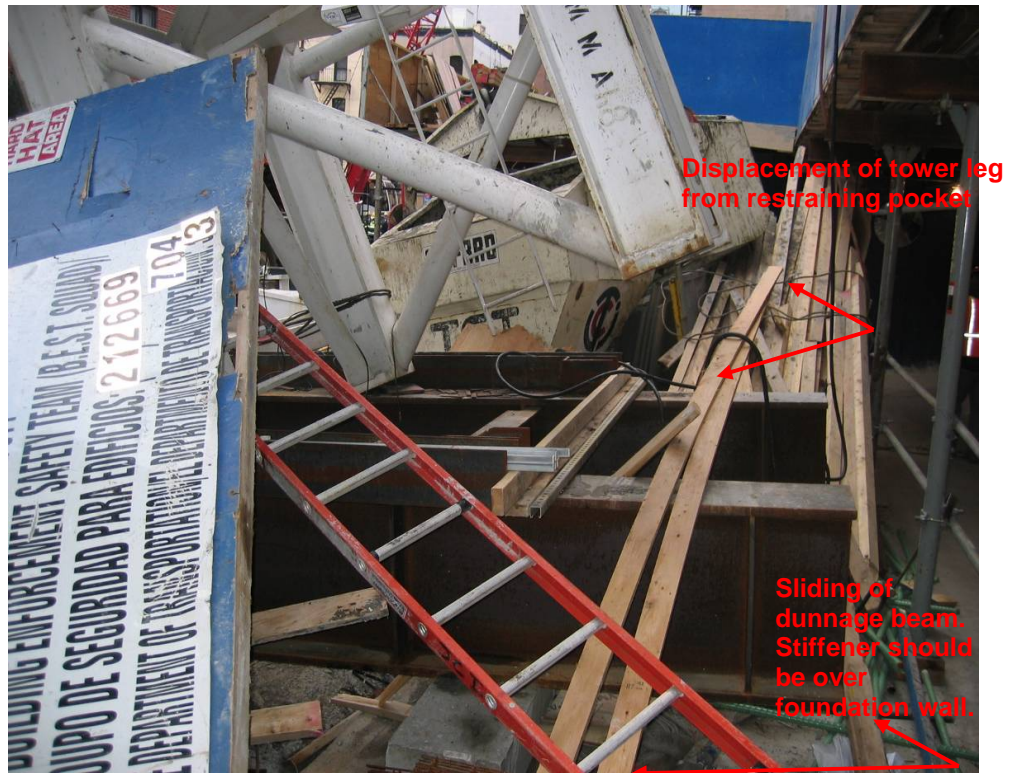
Photograph 11.3 - Base of tower crane after collapse. Note the movement of the dunnage beam and displacement of the tower legs from their restraining pockets. Photo from New York County District Attorney IMG_0379_109.jpg.

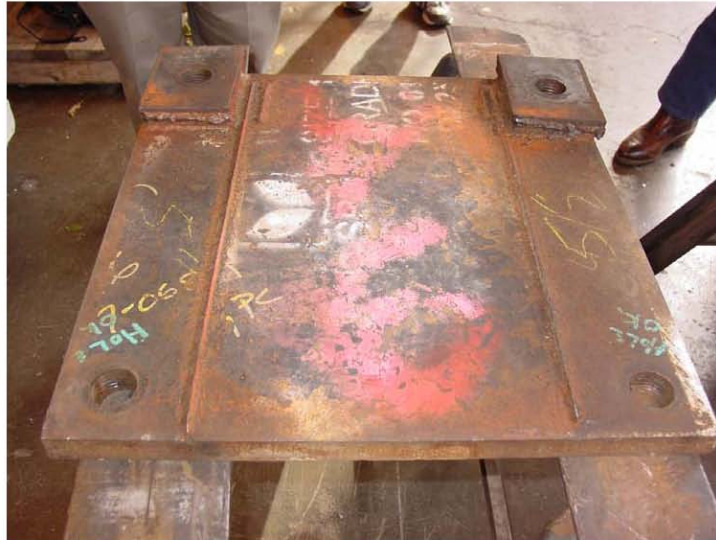
Tie-Beam B4 weld fractures showed similar fracture features but only a small amount of weld metal deposited on the tie-beam. The small amount of weld fracture observed on the tie-beam indicated an effective weld size much less than the deposited weld size previously measured on the base plate, arising from the tie-beam fit-up to the base plate. However, with the majority of weld having an effective weld size of 3/16", it is still sufficient to support the design loads (see Section 4 on Peer Review of Tower Crane On-Site Design) without failure, although not with the minimum required factor of safety. As for B-5, this is below the minimum specified by the American Welding Society.

Figure 1 Ninth Floor Horizontal Tie Beam Base Plate 9A With Weld Fractures.

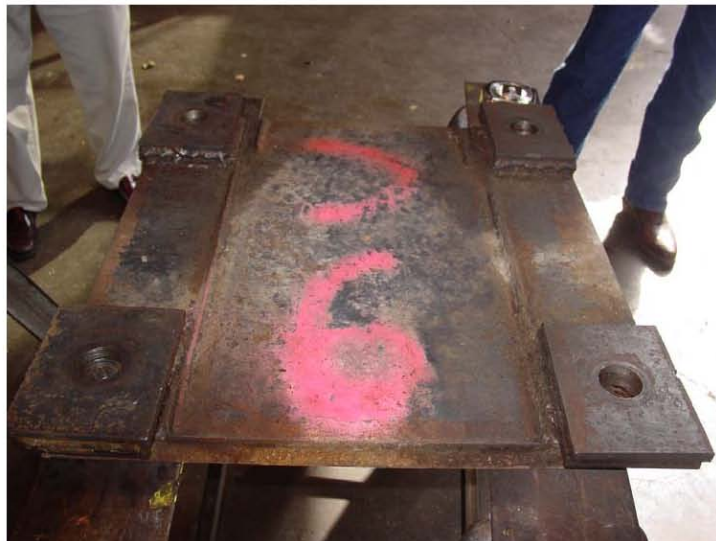
Similar fracture features as observed on Base Plate 9A and Tie-Beam B4 were also observed on Base Plate 9C and Tie-Beam B5. As with Base Plate B4 only a small amount of deposited weld metal was observed on Tie-Beam B5 again due to unequal weld legs and excessive root opening when the connection was welded.

Figure 2 Ninth Floor Horizontal Tie Beam Base Plate 9C With Weld Fractures.

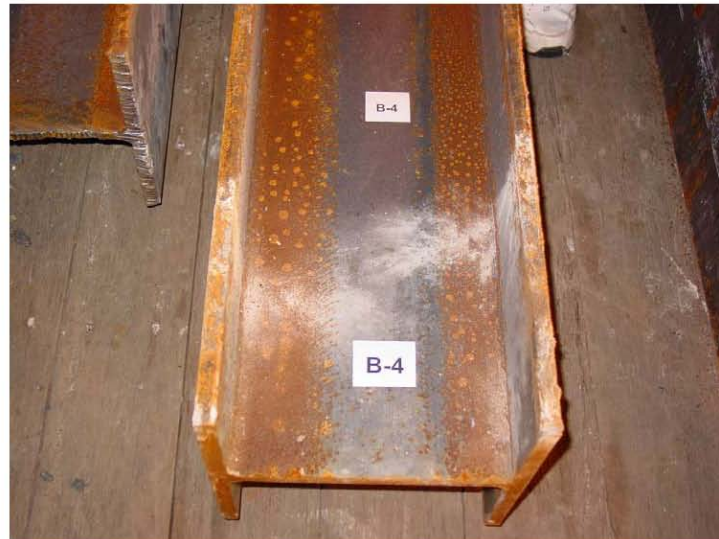
Figure 3 Ninth Floor Horizontal Tie Beam B4 End With Weld Fractures.
(Welded to Base Plate 9A).

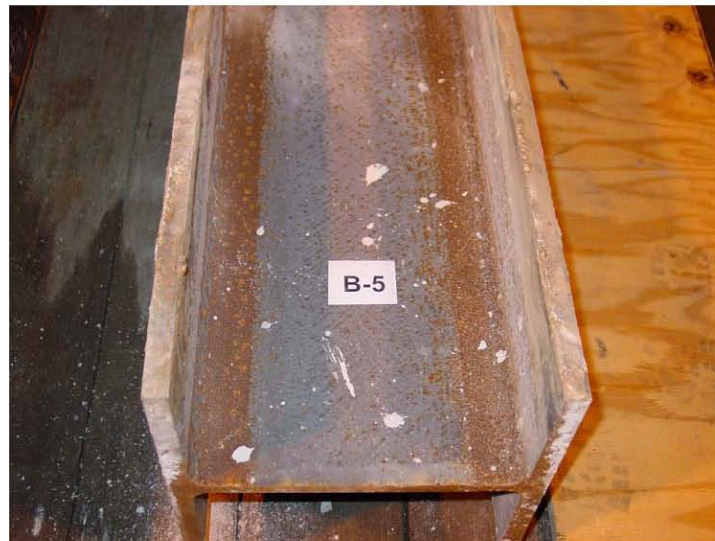
Figure 4 Ninth Floor Horizontal Tie Beam (B5) End With Weld Fractures.
(Welded to Base Plate 9C).

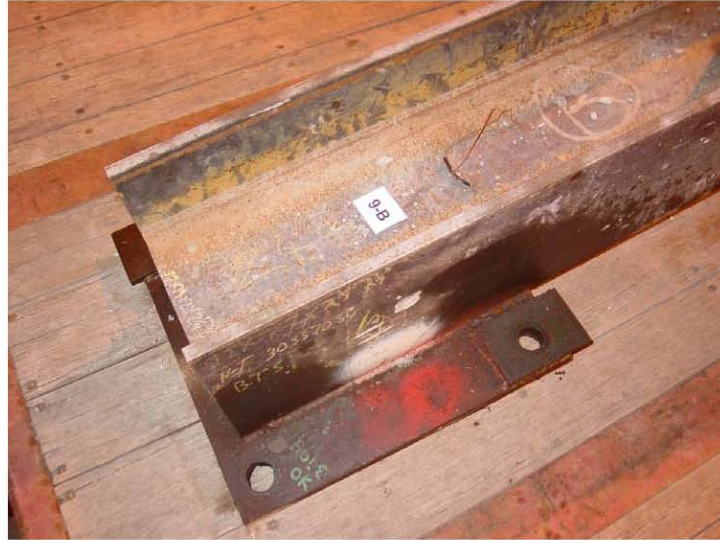
The horizontal tie-beam/base plate consisted of a 1-1/4 in. thick steel plate with a W12x79 rolled shape fillet welded to the plate surface at the beam end. The base plates were connected to the building floor slab by four bolts located at the base plate corners. A pair of rectangular washer plates were used at each bolt location and tack welded to the base plate. The base plate components identified as 9A and 9C exhibited fully failed fillet welds between the tie beam and base plate. The respective tie beams, also exhibiting weld fracture at one end of the beam, were identified as B-4 and B-5. As-found views of these components are shown in Figures 1 through 4. The third tie-beam/base plate component, identified as 9B, had intact welded connections (see Figure 5).

Figure 5 Intact Ninth Floor Horizontal Tie Beam and Base Plate 9B.

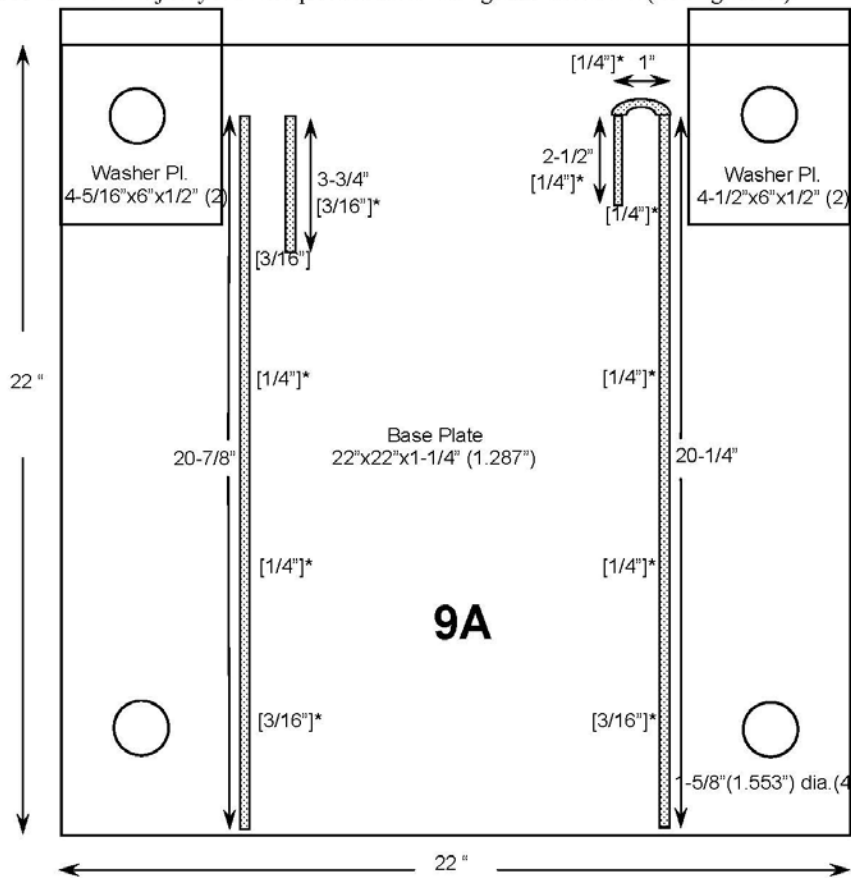
* Min. Weld Leg
Figure 6 Base Plate Dimensions and Weld Dimensions (Base Plate 9A).

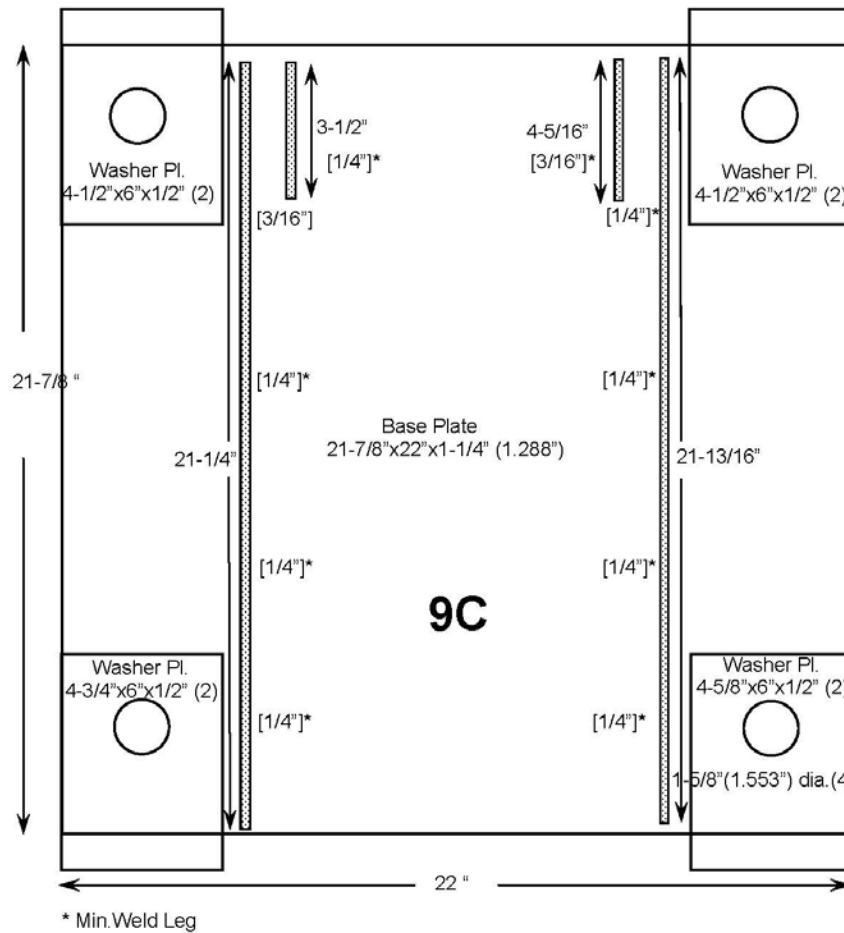
Figure 7 Base Plate Dimensions and Weld Dimensions (Base Plate 9C).

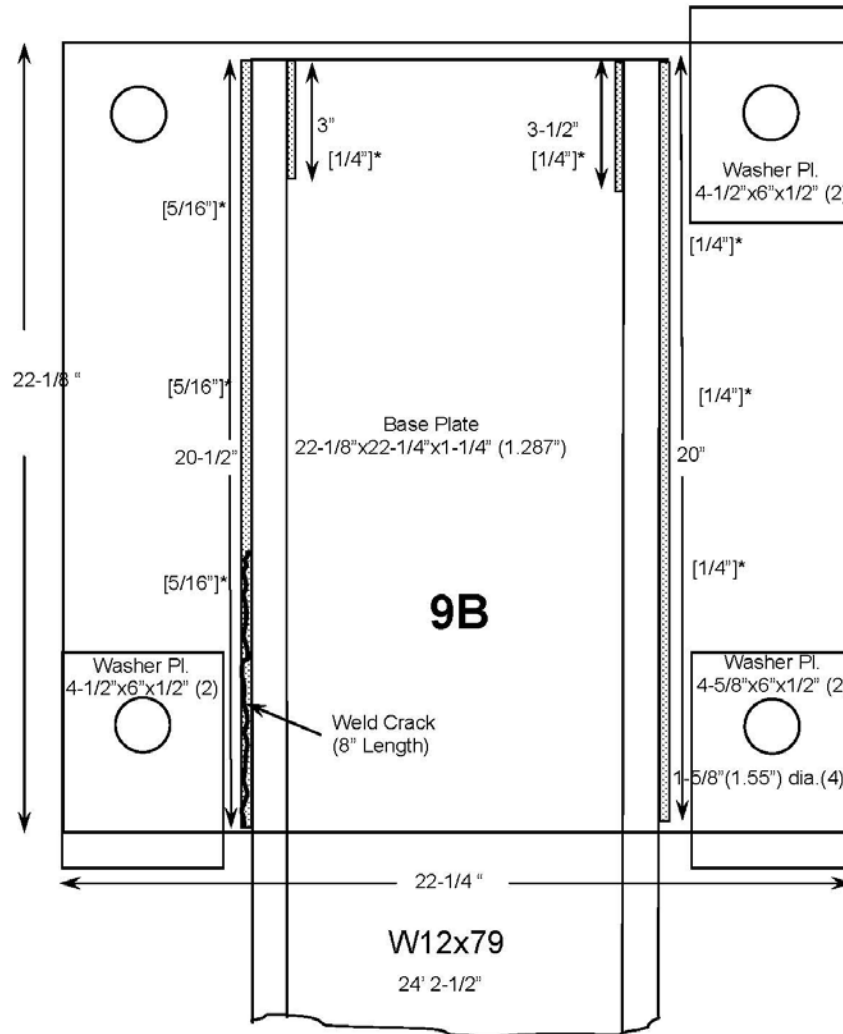
Figure 8 Base Plate Dimensions and Weld Dimensions (Base Plate 9B).

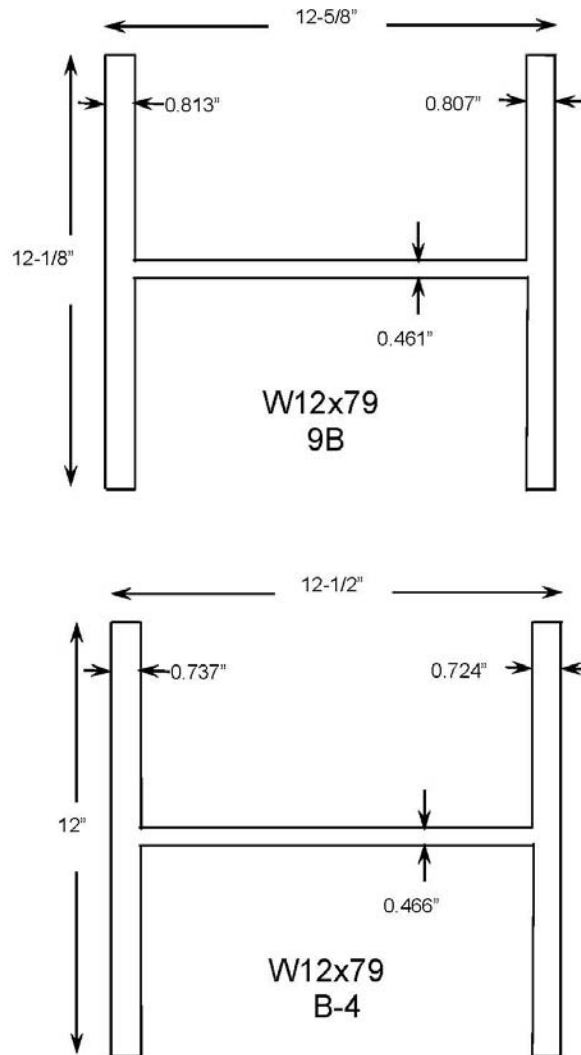
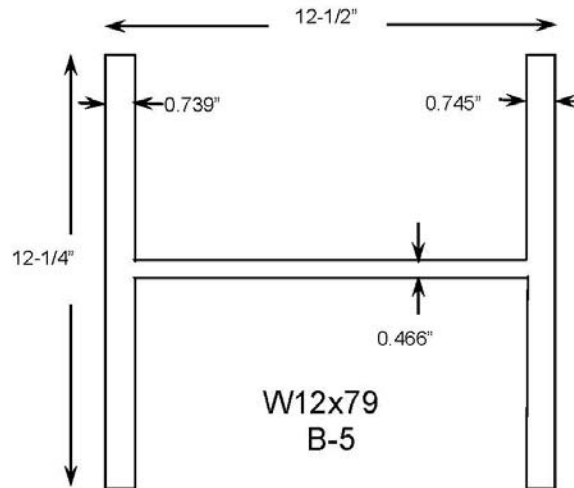
Figure 9 Tie Beam Dimensions.

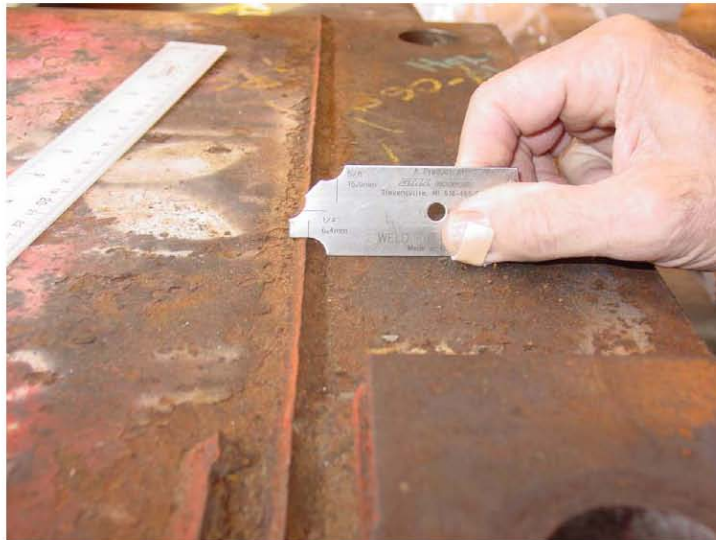
Examination of the weld fractures indicated that fracture occurred along the weld leg joining the tie beam and all or most of the deposited weld remained on the base plates. (Latter reassembly of the connections verified that the fractures occurred along the tie beam weld leg). Fillet welds generally exhibited unequal leg dimension with the shorter leg existing on the tie-beam. Fillet weld size measurements obtained on all three tie-beam/base plate components (see Figures 6-8) indicated a deposited weld size ranging from 3/16" to 5/16" with the majority of the deposited weld having a 1/4" weld size (see Figure 10).

Figure 10 Base Plate/Tie Beam Fillet Weld Size Measurement.

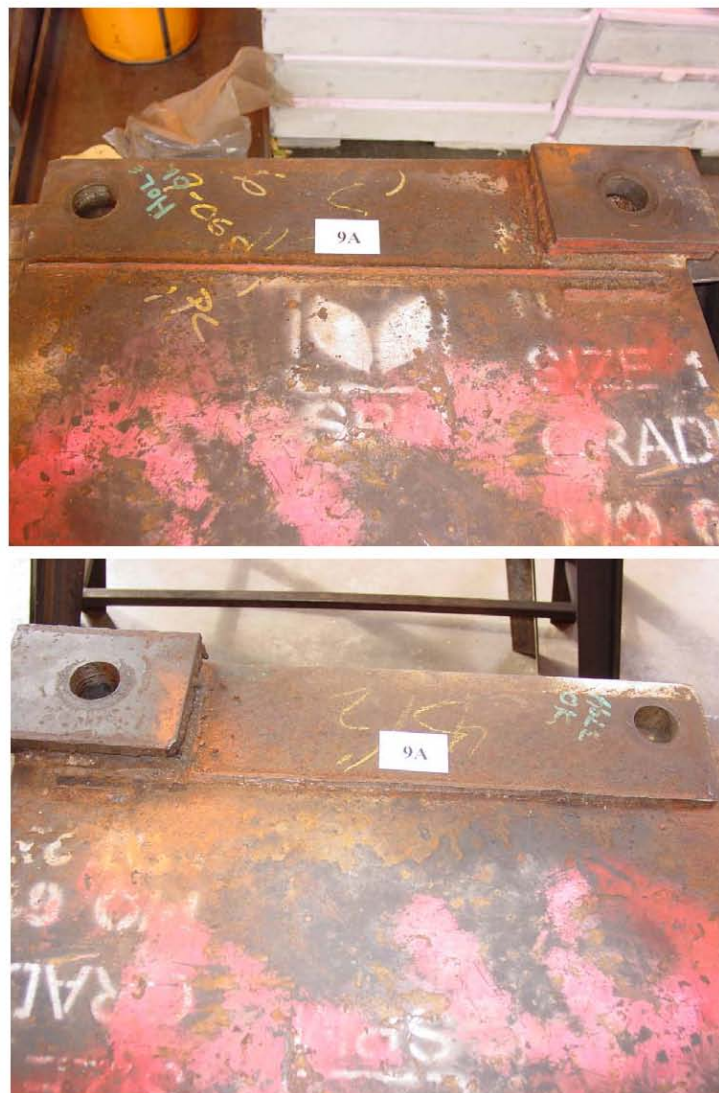
General views of the weld fractures on Base Plate 9A and the respective Tie Beam B4 are shown in Figures 11 and 12. Visual examination of the weld fractures indicated that the welds fractured by ductile shear along the weld leg of the tie beam. The welds were generally sound with acceptable weld quality. Only isolated occurrences of weld porosity was observed. Figure 13 shows the typical appearance of the weld fractures.

Figure 11 General Views of the Weld Fracture on Base Plate 9A.

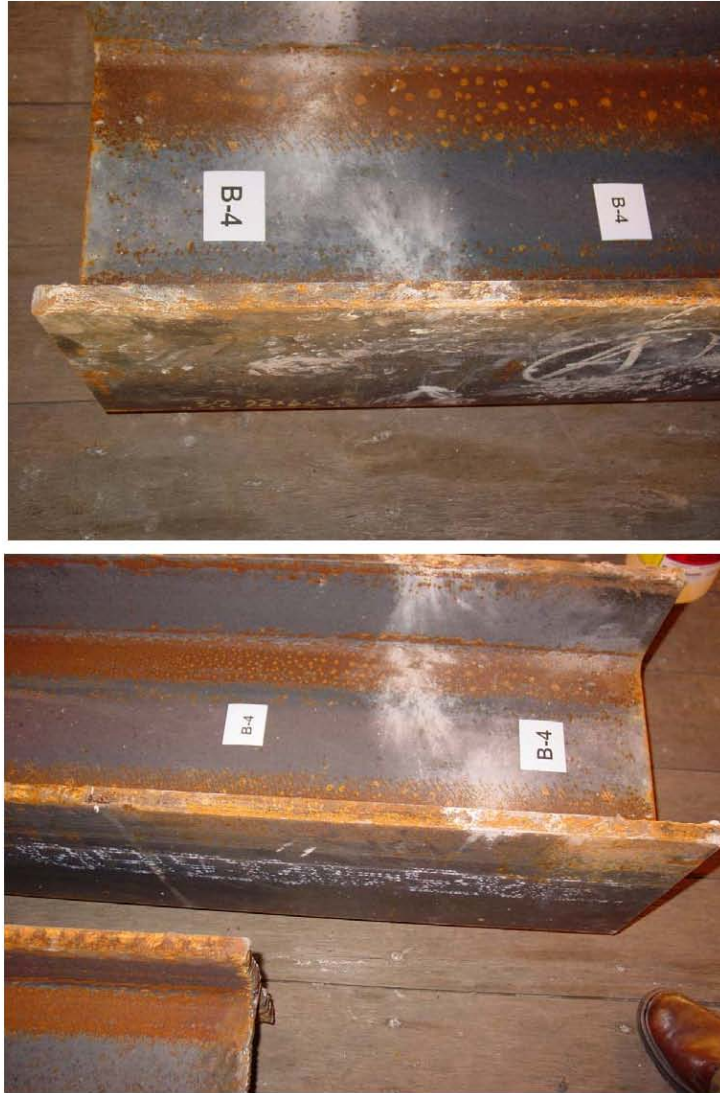
Figure 12 General Views of Weld Fracture on Tie Beam B4.

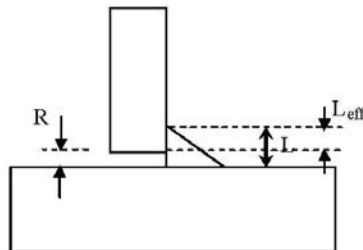
caused by root opening is shown schematically in Figure 15. Hence, because of the root opening the effective weld size of the base plate/tie beam connection was reduced to 1/8" to 1/4" with the majority of weld having an effective weld size of 3/16". Root openings of the size measured are not prohibited; the deposited weld size must be increased accordingly to result in the required weld size for the connection.

Figure 15 Fillet Weld Dimensions.

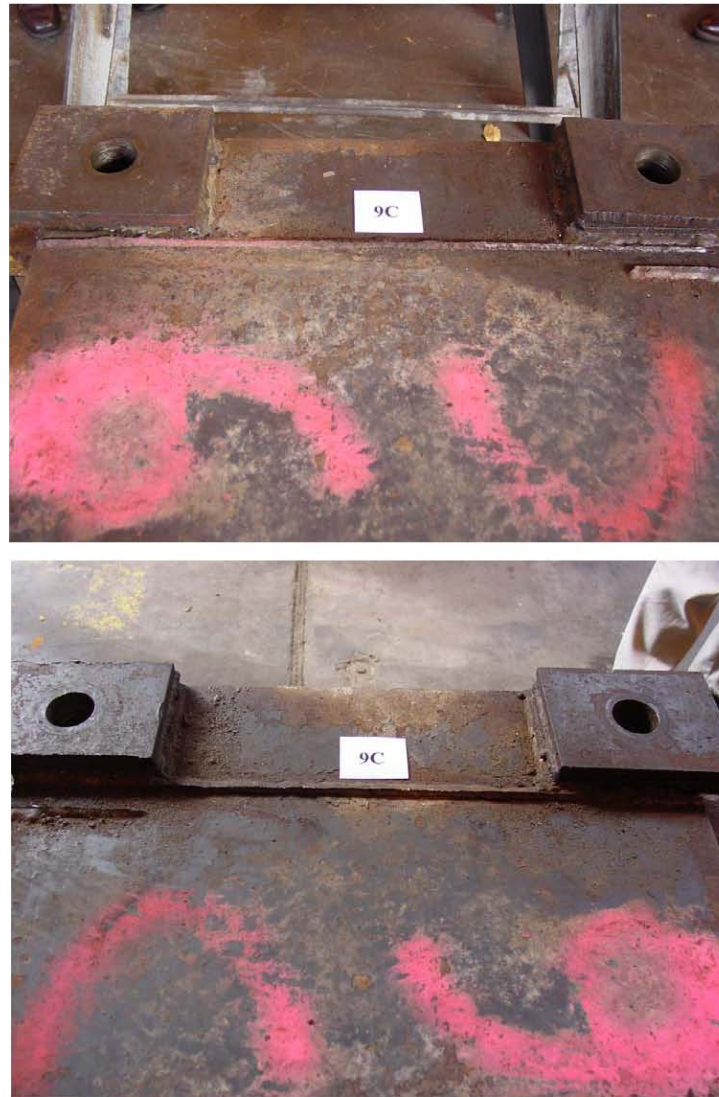
General views of the weld fractures on Base Plate 9C and the respective Tie Beam B5 are shown in Figures 16 and 17. Similar fracture features as observed on Base Plate 9A and Tie Beam B4 were also observed on Base Plate 9C and Tie Beam B5. Visual examination of the weld fractures indicated that the welds also fractured by ductile shear along the weld leg of the tie beam. The welds were generally sound and free of weld defects with only isolated weld porosity. No evidence of weld cracking or incomplete fusion was observed. Figure 18 and 19 shows the typical appearance of the weld fractures.

Figure 16 General Views of the Weld Fracture on Base Plate 9C.

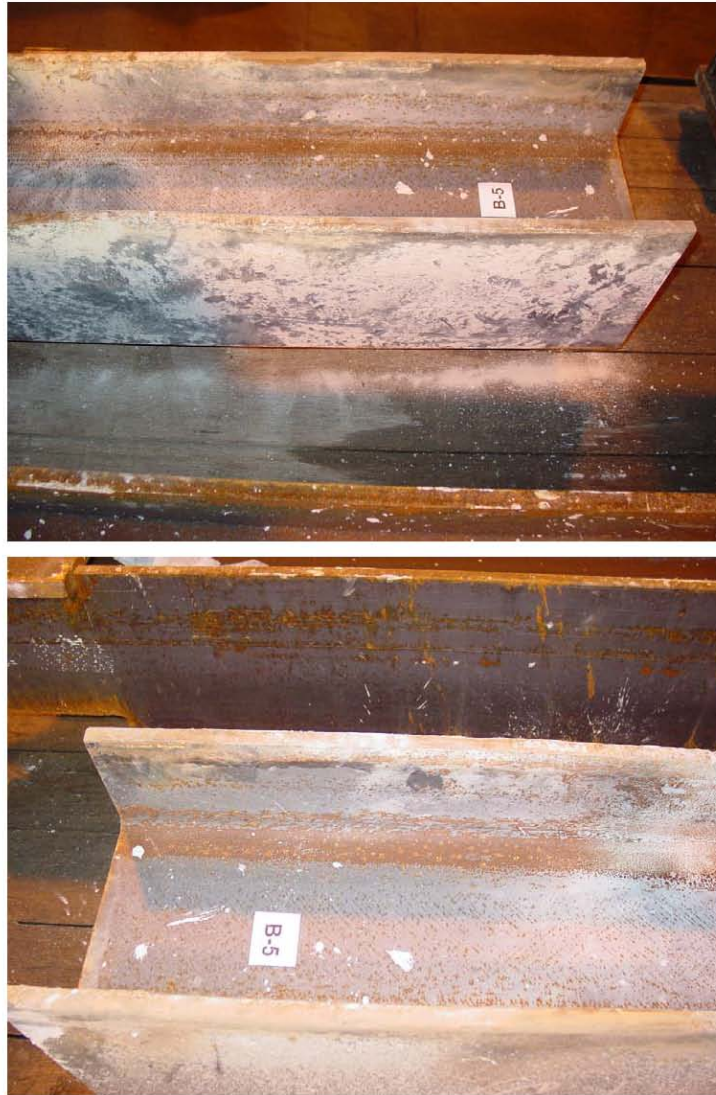
As with Base Plate B4 only a small amount of deposited weld metal was observed on Tie Beam B5 again due to unequal weld legs and weld root opening when the connection was welded. Evidence of root openings ranging from 0 to 1/16" was observed which reduced the effective weld leg size on the tie beam to 1/8" to 1/4" with the majority of weld having an effective weld size of 3/16".

Figure 17 General Views of Weld Fracture on Tie Beam B5.

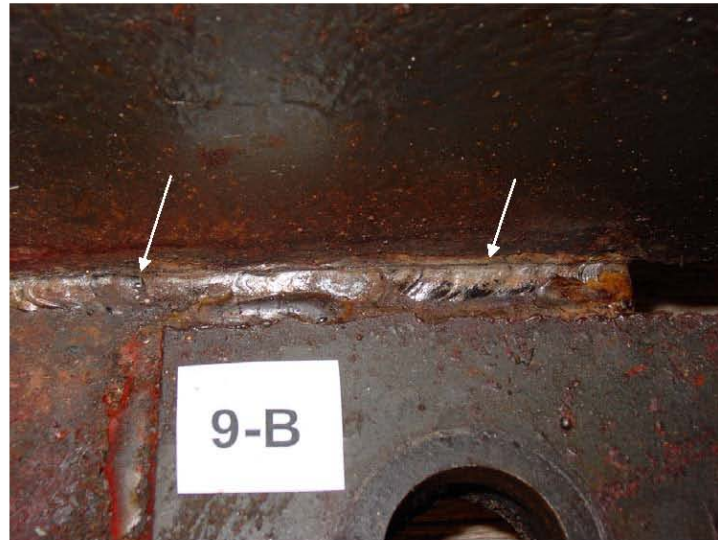
A visual examination of the intact base plate/tie beam welds was performed on Base Plate/Tie Beam 9B. General views of the welds are shown in Figure 20. Visual inspection of the welds indicated that they were generally sound and free of unacceptable defects. Deposited weld sizes ranged from 1/4" to 5/16". A crack was observed in one weld at the weld end that measured approximately 8 inches in length. The crack was located along the weld toe on the tie beam leg (See Figure 20 and Figure 21).

Figure 21 Enlarged View of Weld Toe Crack Observed in Base Plate 9B Weld. (see Arrows)

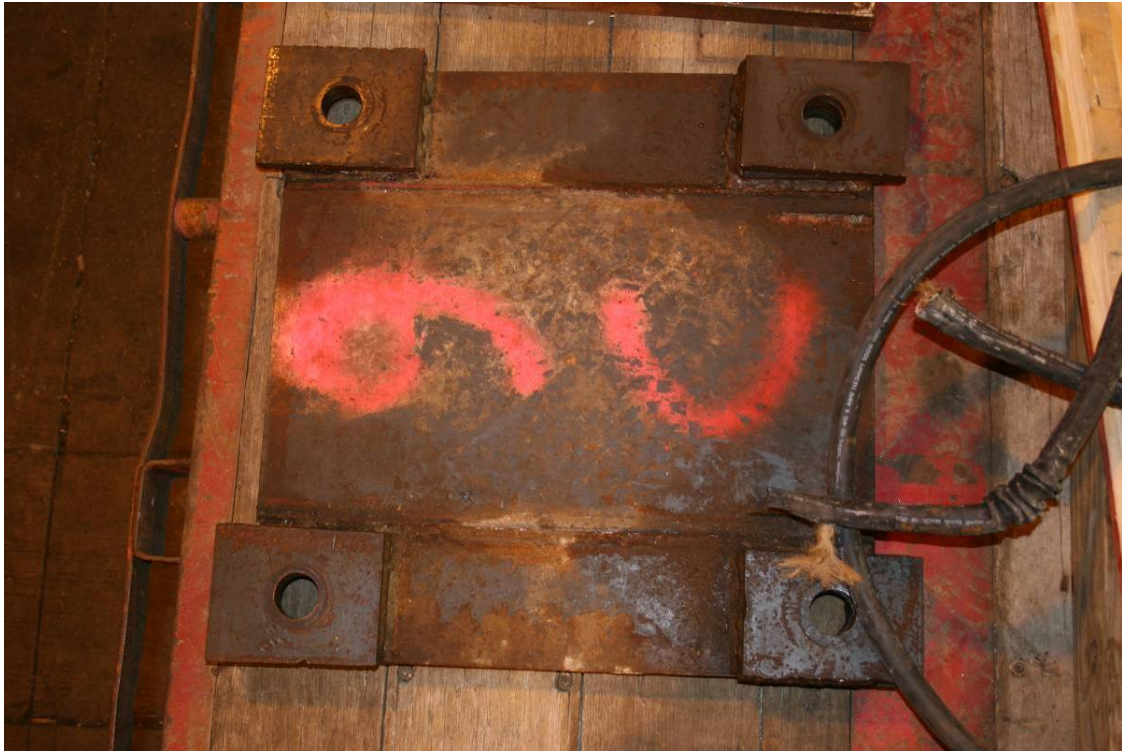
Photograph 3

- Movement of base plates 9A and 9C (e.g., item numbers 9A, shown in Photograph 1 and 9C, shown in Photograph 3) from ATLSS back to NYCDOB.
- Examination of failed and unfailed welded connections between horizontal tie-beams and their respective base plates for beams B4 and B5. The investigations shall equally include similar items for items B1, B2, B3, and B5 as well as the B9 plate and beam.

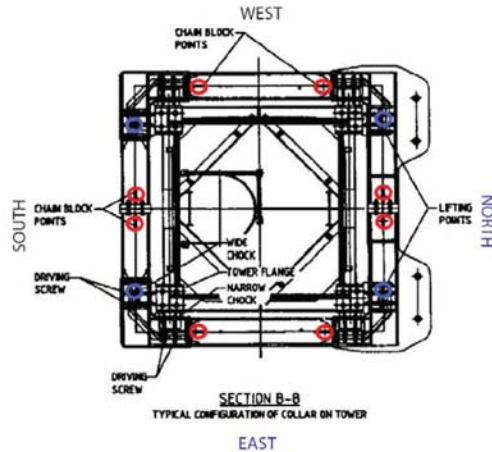
Figure 1. Positions of slings on the collar are shown by blue circles.

point of time when the sling failure occurred. The arrangement of the chain-falls and the slings on the assembled collar before the crash is shown by blue circles in Figure 1.

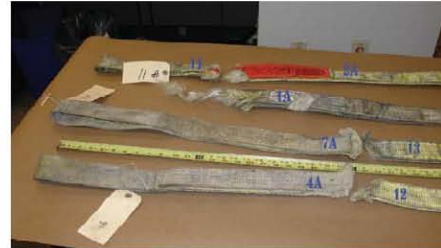
Pieces of the four slings involved in the incident are shown in Figure 2. Each piece is aligned with another, understood to possibly be the matching, missing part, to suggest the complete sling before failure. The numbers used in identifying are those assigned by OSHA. Note that one of the pieces that should be paired with piece 1A is missing and was reportedly not found.

Figure 2. Recovered pieces of slings involved in the crash.

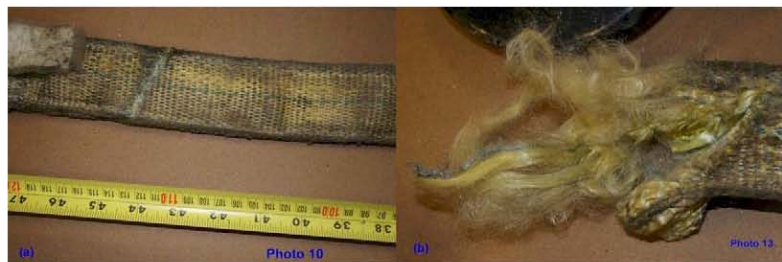
Sling Piece 1A: According to the label, the sling piece is made of polyester and manufactured by Metro Wire Rope Corporation. The piece, 57" in length, shows a number of high compressive stress and/or abrasion lines, approximately along the cross direction, see Figure 3a. In

Figure 3. (a) Sign of stress on sling piece 1A, (b) Fracture surface of sling piece 1A

some instances the fibers are broken (or cut) along the stress lines. Figure 3b shows a close up of the fractured end of the sling-piece 1A. The failure surface of the sling is along a diagonal line to the long direction of the sling. Visual examination of the fractured end clearly show two distinct areas. Almost ¾ of the sling failure surface seems to present a high-stress compression and/or abrasion failure from a sharp edge while the rest looks almost like slow-speed tensile failure. The slow-speed tensile failure is

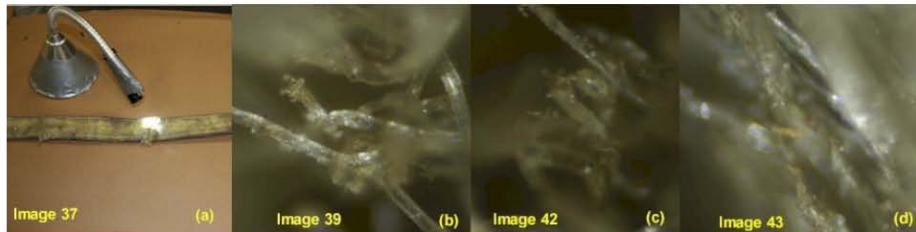
Figure 4. Micrographs (b-d) of fibers in sling 1A showing abrasion damage. Image (a) represents the position of the fibers presented in the micrographs.

characterized by fiber pull-out and thinning of fibers as seen in Figure 3b. The evidence of abrasion damage in sling-piece 1A is clearly evident in a few micrographs presented in Figure 4. The fibers in the vicinity of failure show mangled ends and fibrillation. In addition, the striations along the cross direction of the fibers, visible in Figure 4b and in others could be signs of initiation of cracks during this incident or due to prior use.

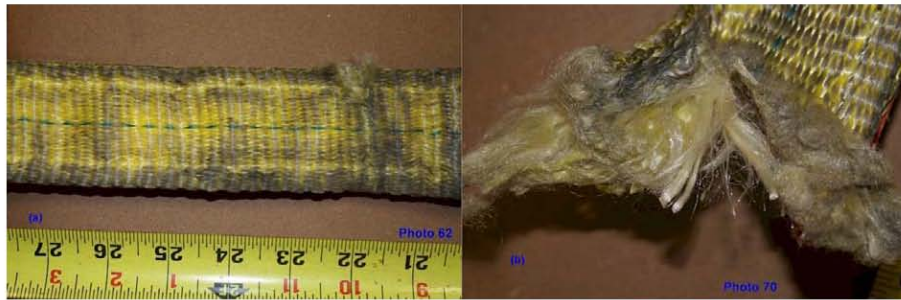
Figure 5. (a) Sign of stress on sling piece 2A, (b) Fracture surface of sling piece 2A

very high compressive stress, approximately along the cross direction as shown in Figure 5a. Some of the fibers along the stress line are broken.

The fracture surface is mostly at a diagonal to the axis of the sling, see Figure 5b. More than half of the failure surface seems to present a well-defined linear high-stress cut due to contact with a sharp edge. The evidence of abrasion melting is also present. The other part of the fracture surface presents a mix evidence of cutting, relatively slow tensile pull out, and high speed failure characterized by melting due to high-speed drawing. Limited evidence of mushroom-like fiber ends resulting from high speed failure are presented in Figure 6.

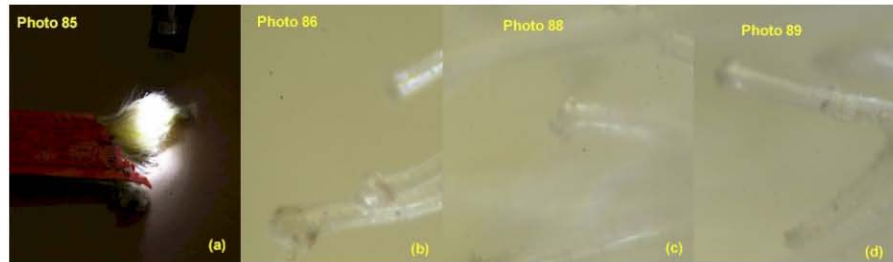
Figure 6. Micrographs (b-d) of fibers in sling 2A showing mushroom-like fracture ends . Image (a) represents the position of the fibers presented in the micrographs.

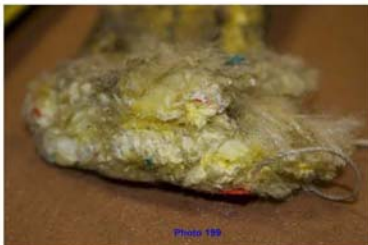
Figure 9. Fracture surface of sling piece 11.
