Report for
Buildings Commissioner Robert D. LiMandri

CTL, PC Project No. 500108

High Risk Construction Oversight Study

June 5, 2009

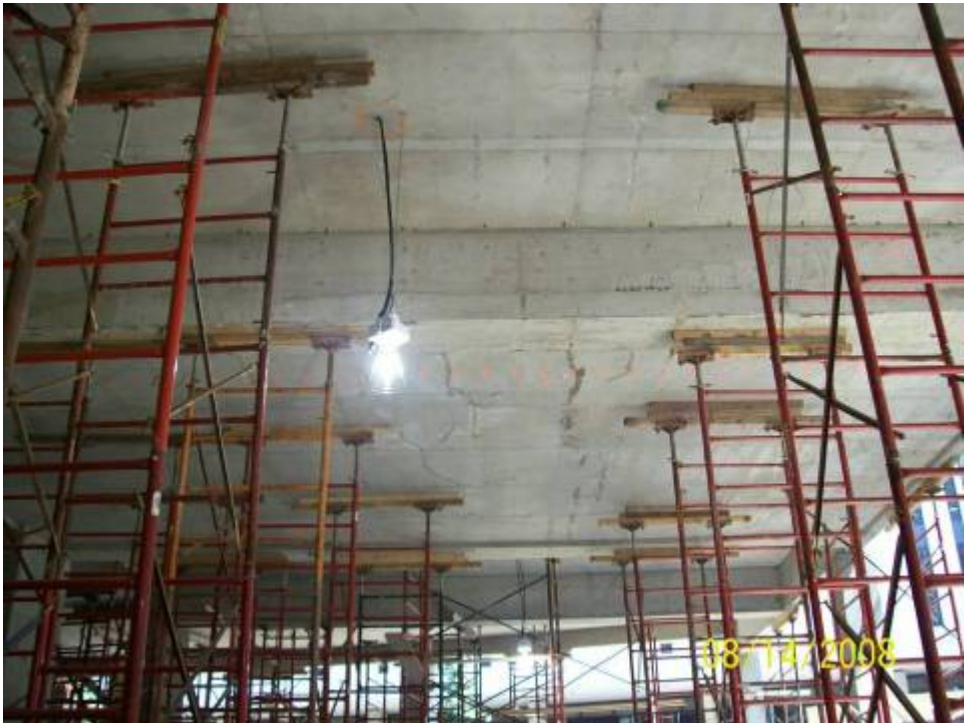
Figure B.6.3: Improved Filler Material Installation (Laid Horizontally) between Steel Shoring Tower and Concrete Soffit

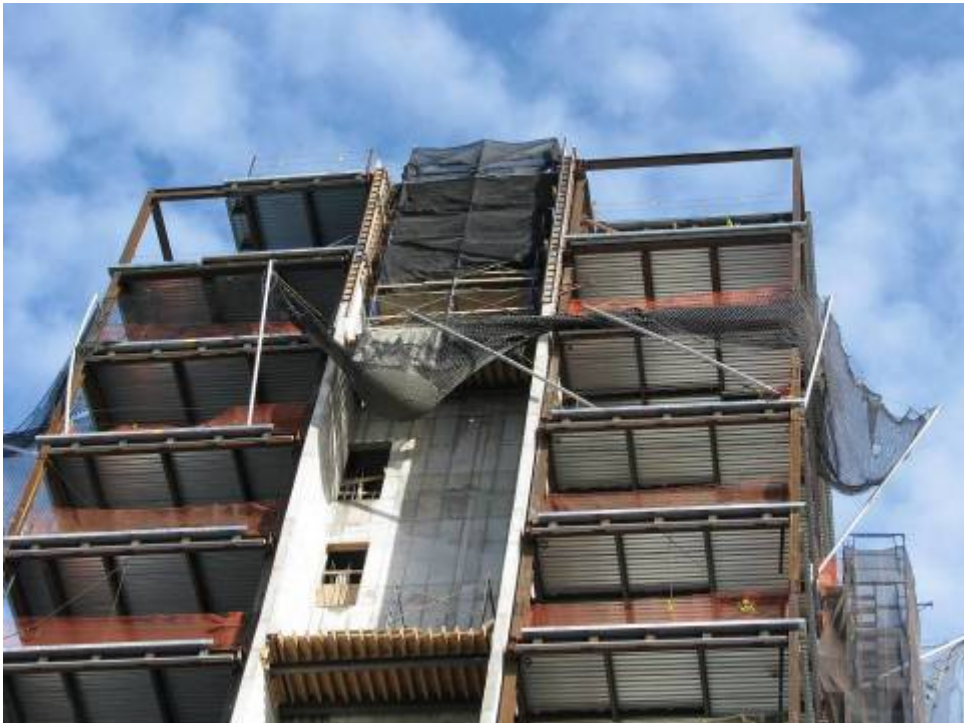
Figure B.6.14: Spilled Concrete after Form Blow-out Restrained by Horizontal Netting (Center)

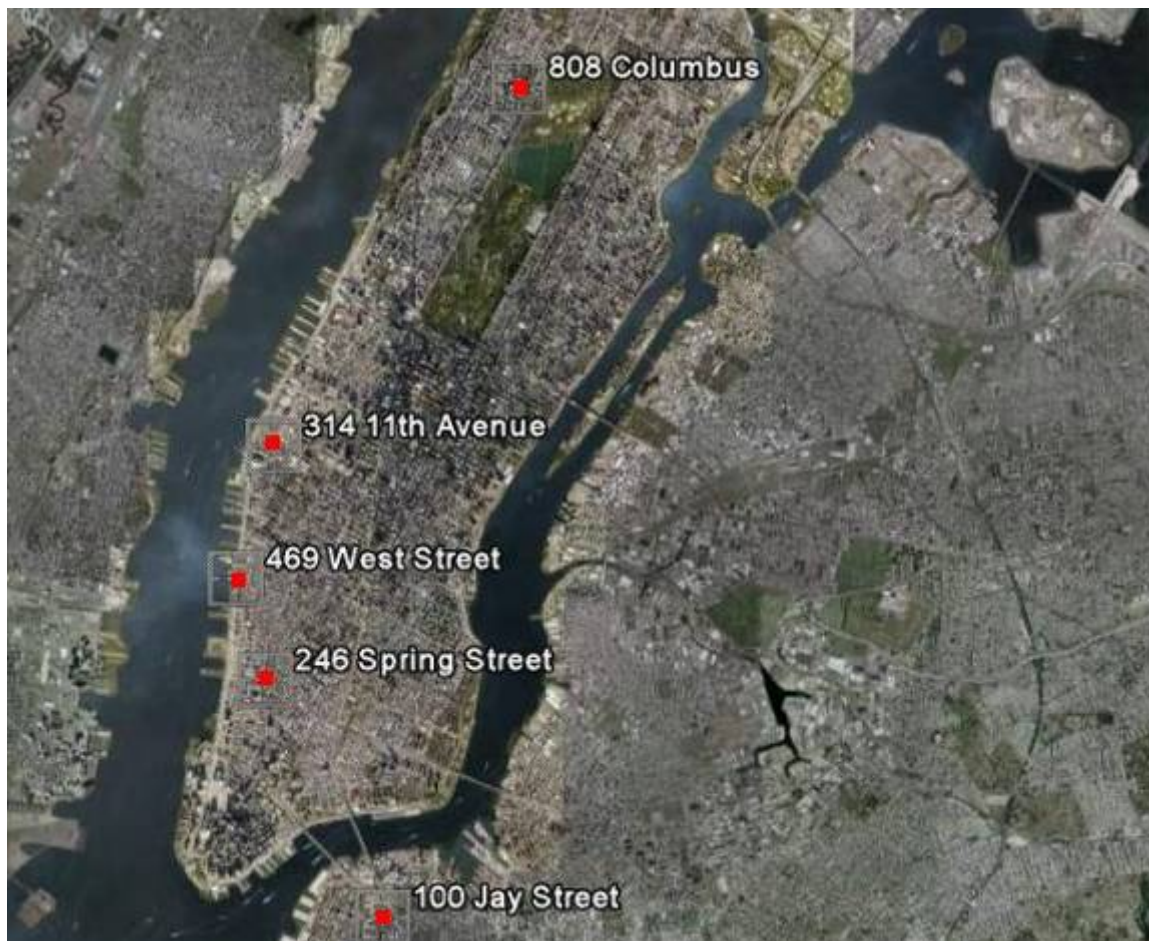
Address	Boro.	Incident Date	Description
100 Jay Street	Brooklyn	7/24/2006	Wind dislodged several formwork deck panels from 27th floor.
246 Spring St.	Manhattan	12/23/2007	Wind dislodged shoring element from the 39 th Floor
469 West St.	Manhattan	3/9/2008	Wind dislodged formwork from the 15 th floor
808 Columbus	Manhattan	6/11/2008	Wind dislodged formwork in reported winds of 30-40 mph
314 11 th Ave	Manhattan	10/22/2008	Wind dislodged (2) 3x4 timber posts from 16 th floor. Leading Edge deck lifted, removed voluntarily by contractor

Figure B.6.18: Historic Formwork Failures due to Wind Events

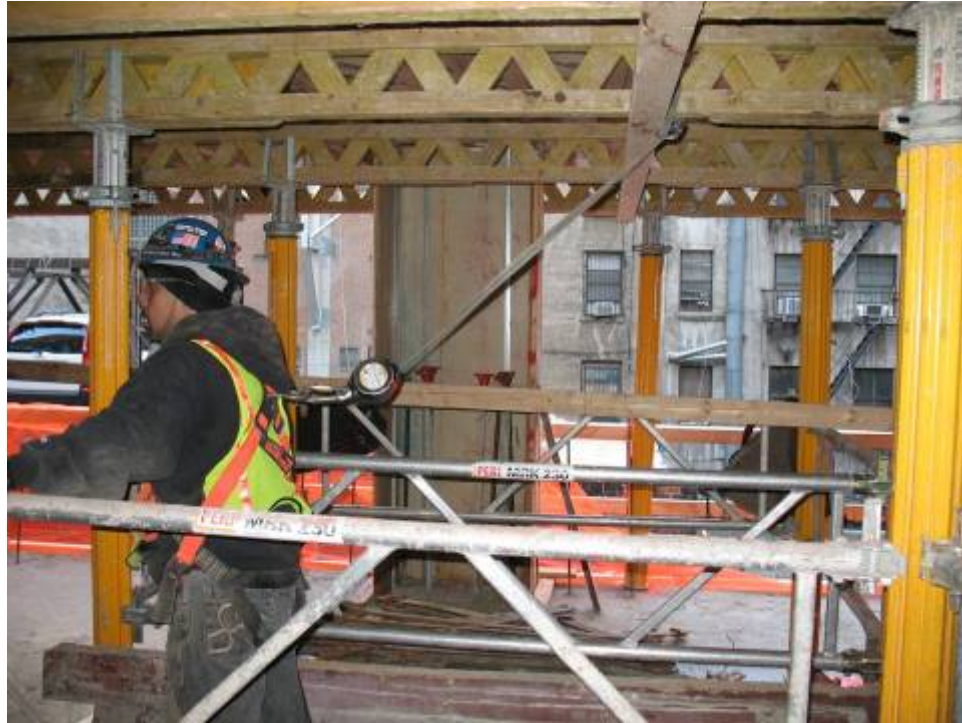
Figure B.8.4: Tie-off to Formwork Substructure Using Retractable Lanyard

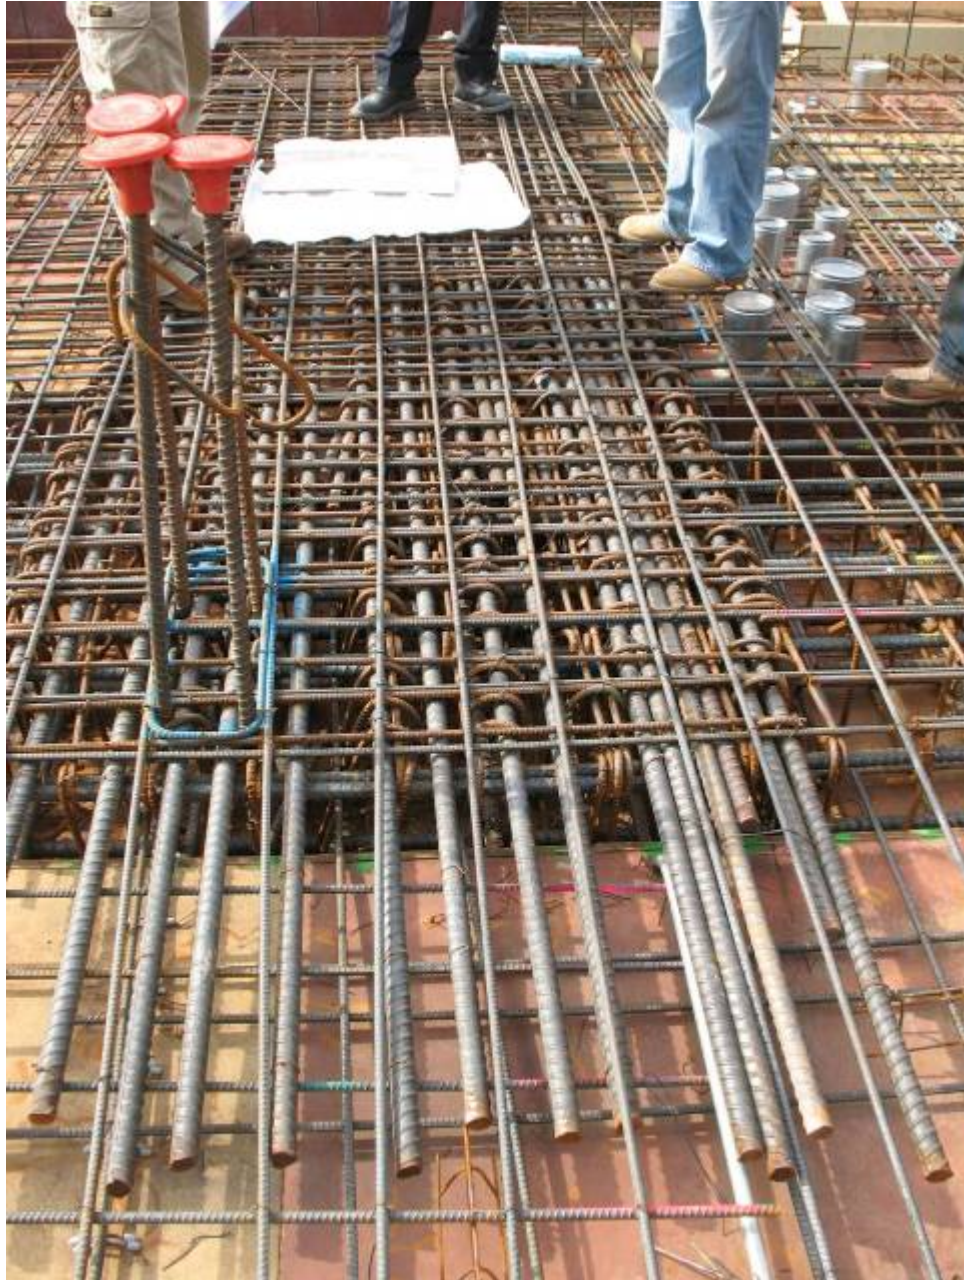
Figure B.9.13: First Floor Transfer Girder Bar Congestion. Site No. 47

HC-21	Reinforcing Placement Quality Assurance	
<p><i>Require documentation of proper bar placement procedures.</i></p> <p>Key Observation: Critical construction quality violations were observed at a quarter of all visited sites. Improper bar placement is a significant contributor to this defect rate.</p>

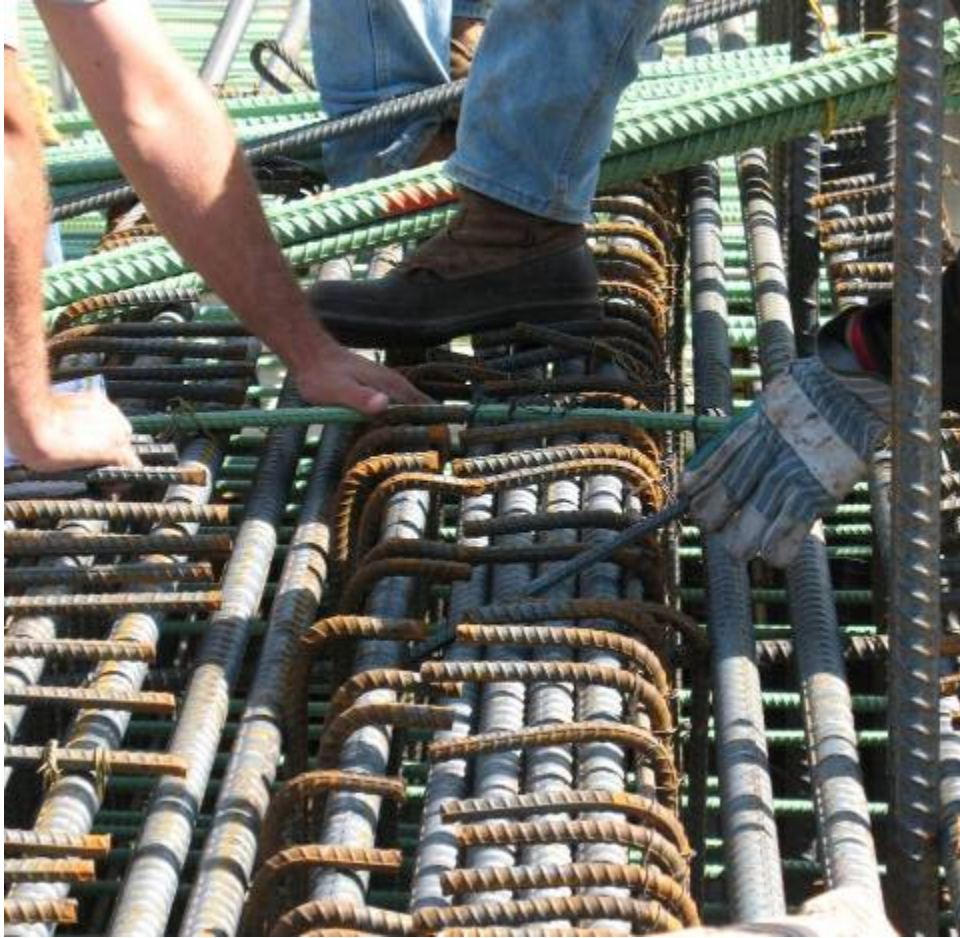
Figure B.10.3: Constructability Issues at Transfer Beam top bars

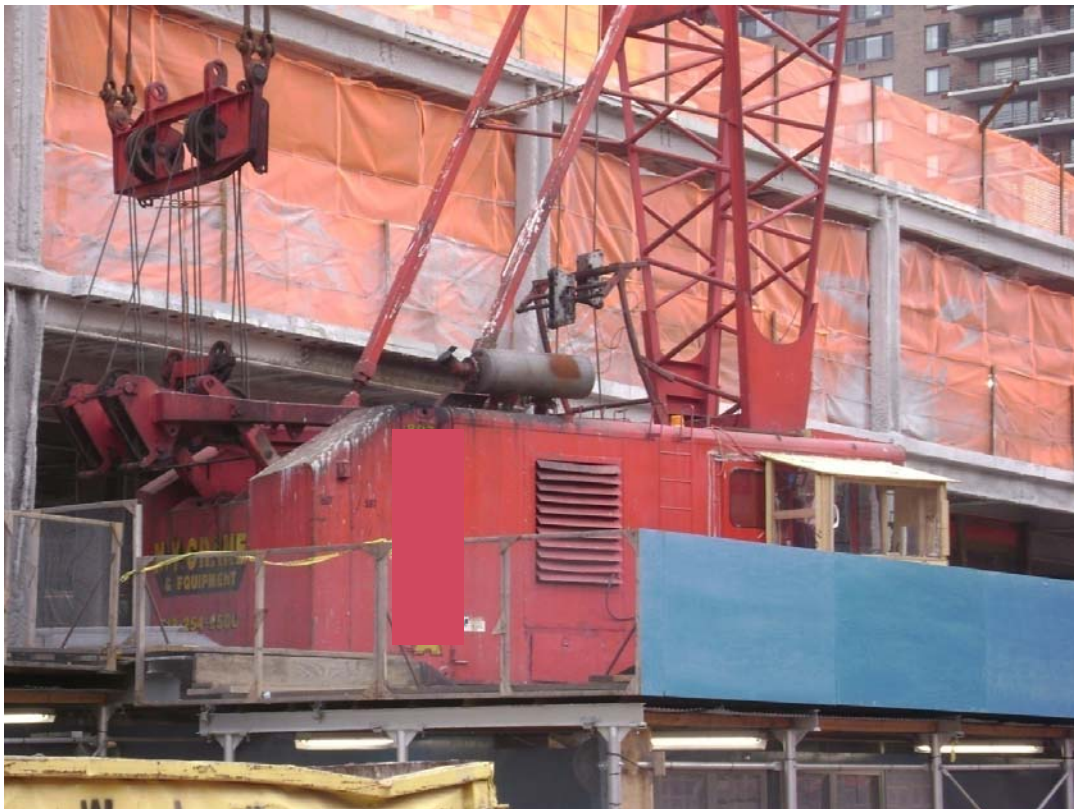
An age-survey of the active cranes in New York City indicates that 41% of tower and 10% of mobile cranes are older than 20 years and 23% of tower and 9% of mobile cranes are older than 30 years. This recommendation proposes heightened inspections and possible age limitations to address this concern.

Figure C.6.1: Example of Older Equipment (Site 48)

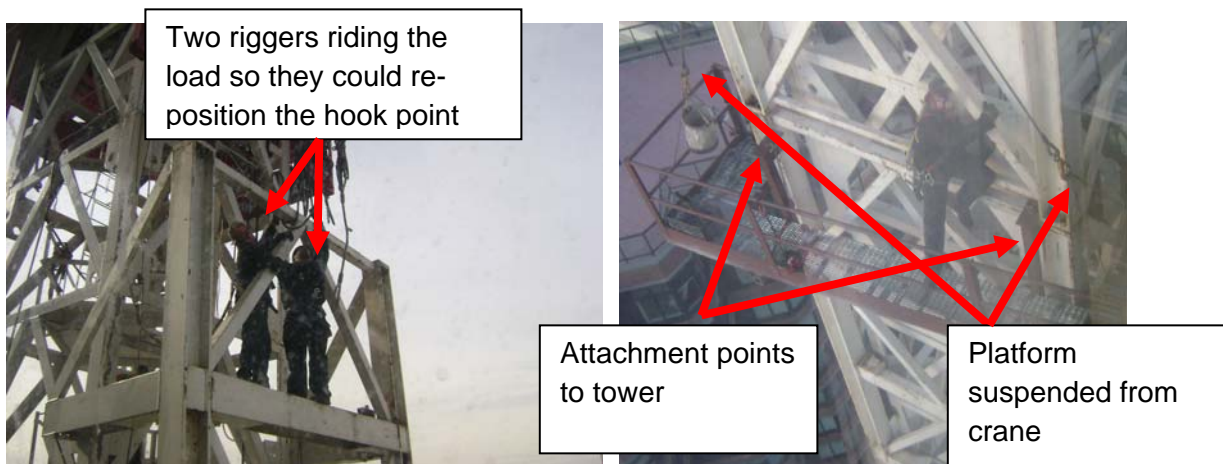
A common short-coming of older design is the limited access to the outermost tower bolts. In order to reach them, riggers must climb onto a platform that is attached to the outside of the tower. This platform is lifted into position on the outside of the tower using the crane and its position must be detached and reattached with each climbing section. In addition the tower crane rigger often has to change hook points for his safety harness. On 9/4/08 (Site C-94), an experienced tower crane rigger fell from a detachable, crane suspended work platform and died. A few weeks later on 11/12/08 (Site 49) the HRCO team witnessed a similar situation where a rigger climbed onto such a platform without a harness.

Figure C.6.5: Riggers “Riding the Load”

Figure C.6.6: Rigger Kicks Platform to Free It

Newer tower cranes utilize different tower designs. This design does not require the worker to ride the load, and he can remain on a platform to change pick points during assembly, climbing or dismantling process. Tower bolts can either be reached without the use of an outside platform or a platform which remains attached to the climbing frame. This minimizes the danger of a fall or of being crushed by suspended loads (figures C.6.5 and C.6.6).

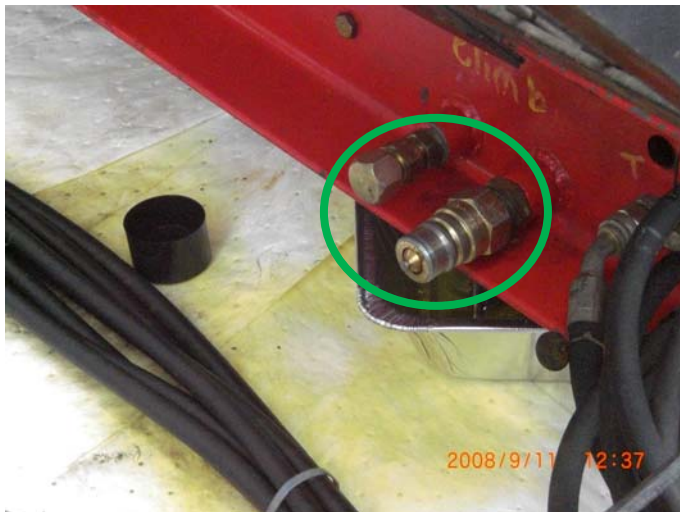
Figure C.6.9: Leaking Hydraulic Fitting

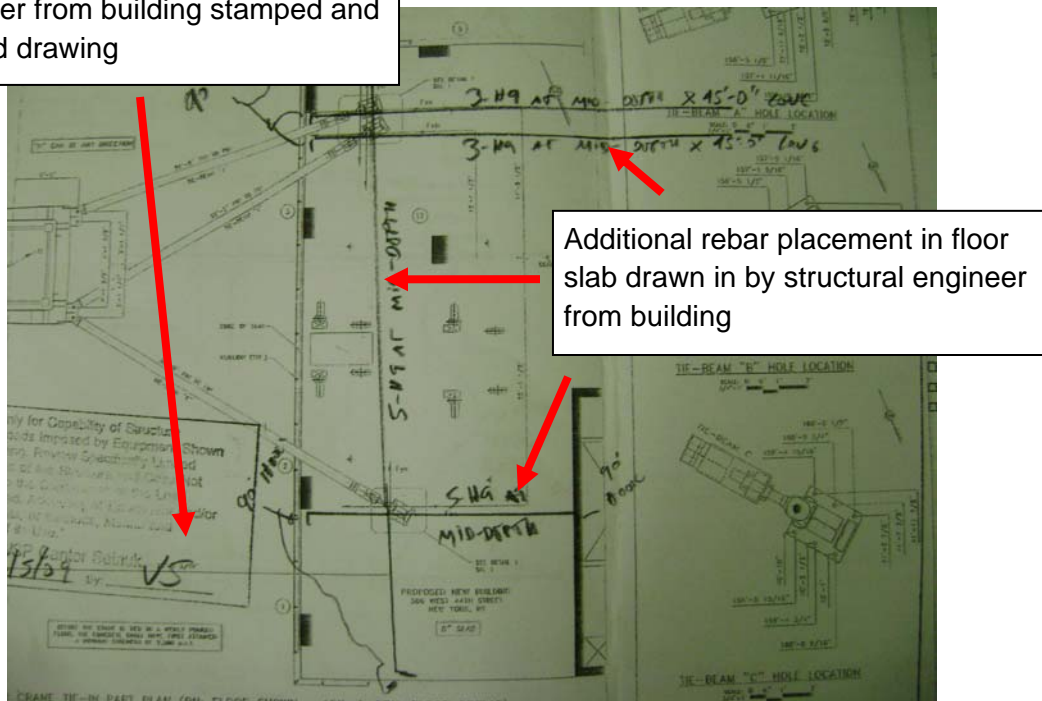
One occurrence was noted where the concrete design strength was higher than the installed strength. This was confirmed by the Crane EOR, and the EOR provided calculations that the lower installed strength was acceptable based upon the design criteria. If the original design was correct, the concrete may have failed. There was also an occurrence where the building EOR added rebar to the Crane EOR's design to overcome the bending moment on the concrete slab (site C-110 4/7/09). Figure C.7.2 shows the addition to the Crane's EOR drawings and the building EOR stamping the drawing.

Engineer from building stamped and initialed drawing

Additional rebar placement in floor slab drawn in by structural engineer from building

Figure C.7.2: Tie-in Slab Drawing Modifications (Site C-110)

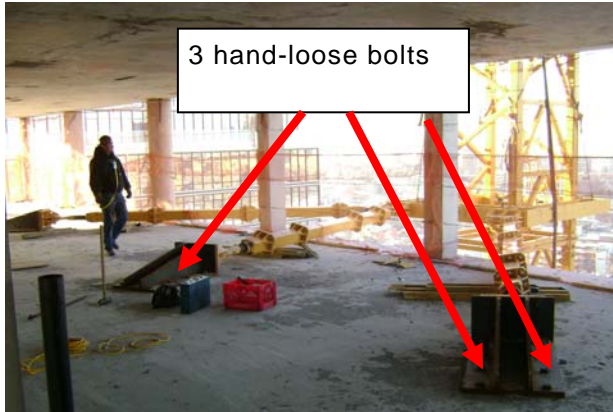
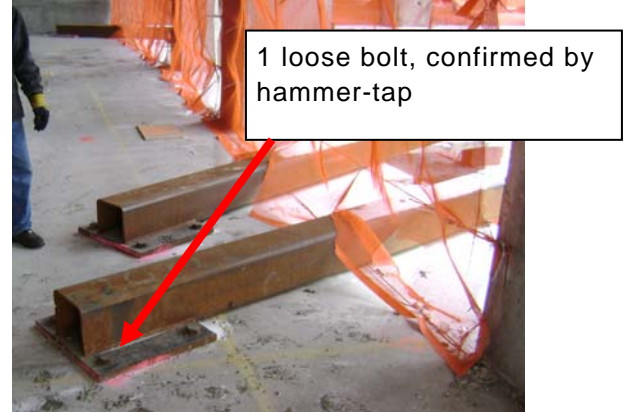
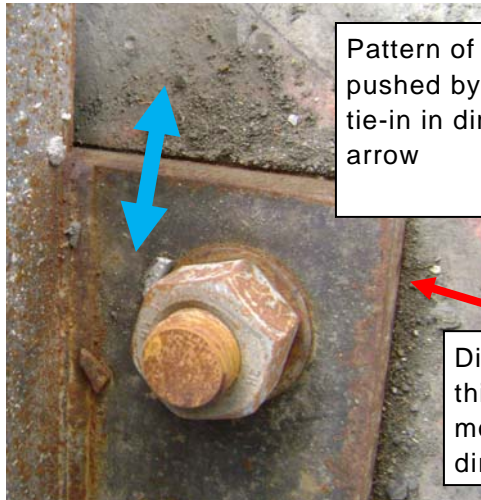
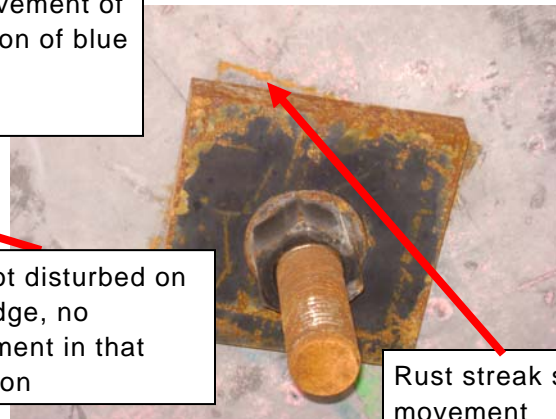
The HRCO crane team found four (4) instances where there were loose bolt(s) on 3 friction connections, and one of these showed signs of tie-in movement (see Table C.7.1).

Figure C.7.3: Examples of loose friction tie-in strut connections

The crane user must provide a means to assure that the bolt connections remain properly torqued (e.g. periodic re-torquing of bolts). Re-torquing may need to be conducted on a weekly, or even shorter, basis. Documentation of the minimum bolt torque and re-torquing procedure must be kept on site and accessible to DOB. The HRCO crane team recommends that the EOR insert such on the drawings provided with the Certificate of On-Site Inspection (CN).

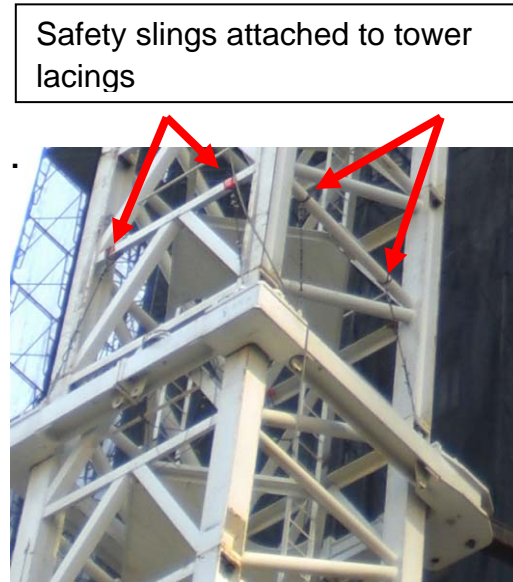
Figure C.7.5: Safety Slings at Site C-62.

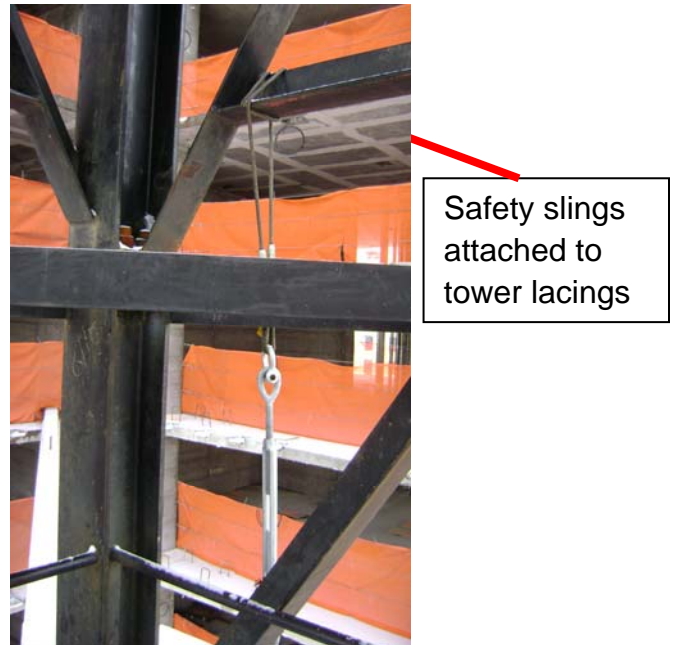
Figure C.7.6: Safety Slings at Site C-73.

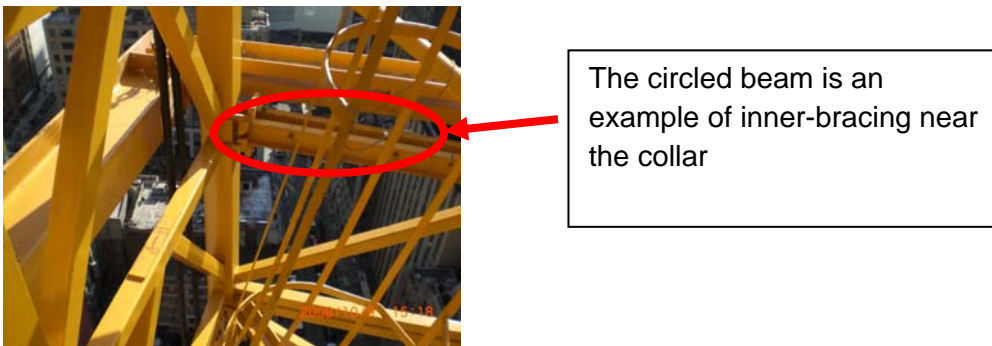
Figure C.7.7: Example of Tower Reinforcement at Tie-in (Site C-78, 10/9/08).

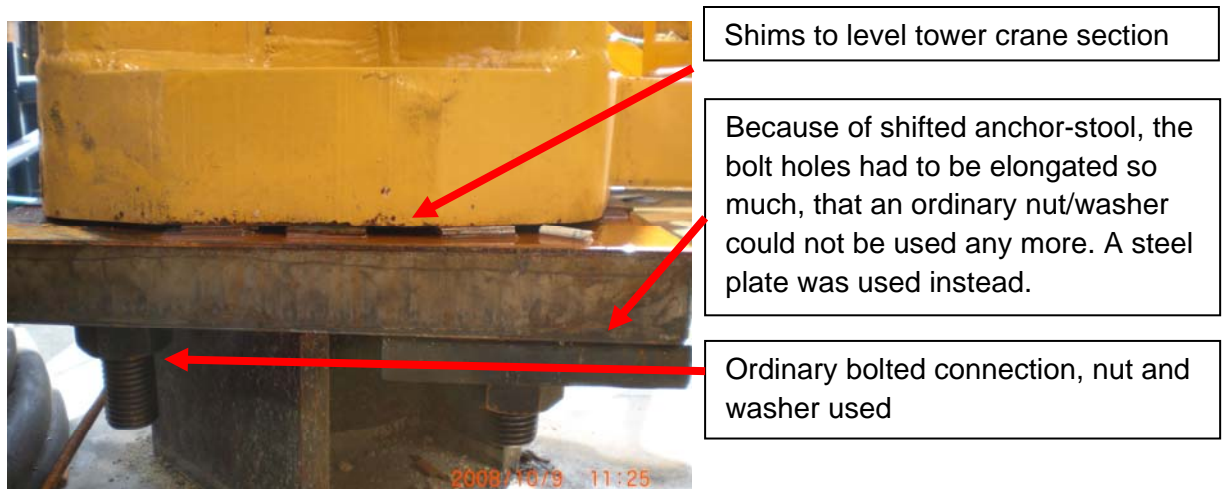
The HRCO team witnessed instances where the installation team had to use shims and/or enlarge the bolt holes to attach the first section to the anchor stools. This practice places an additional bending moment on the bolted connection. The use of the first section will allow the installation team to plumb the tower prior to pouring the foundation, which will minimize the need to shim and enlarge bolt holes. Figure C.7.10 shows an anchor stool and tower section that illustrates the need to shim the tower to achieve plumbness.

Shims to level tower crane section

Because of shifted anchor-stool, the bolt holes had to be elongated so much, that an ordinary nut/washer could not be used any more. A steel plate was used instead.

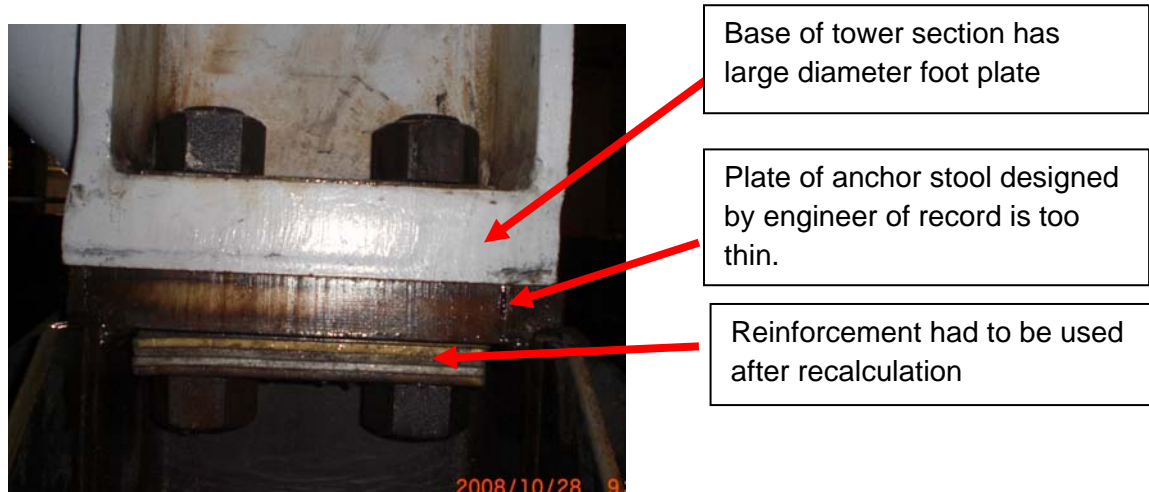
One custom (non-OEM) anchor stool was under-designed by the Crane Engineer of Record and required reinforcement prior to the crane being assembled.

Base of tower section has large diameter foot plate

Plate of anchor stool designed by engineer of record is too thin.

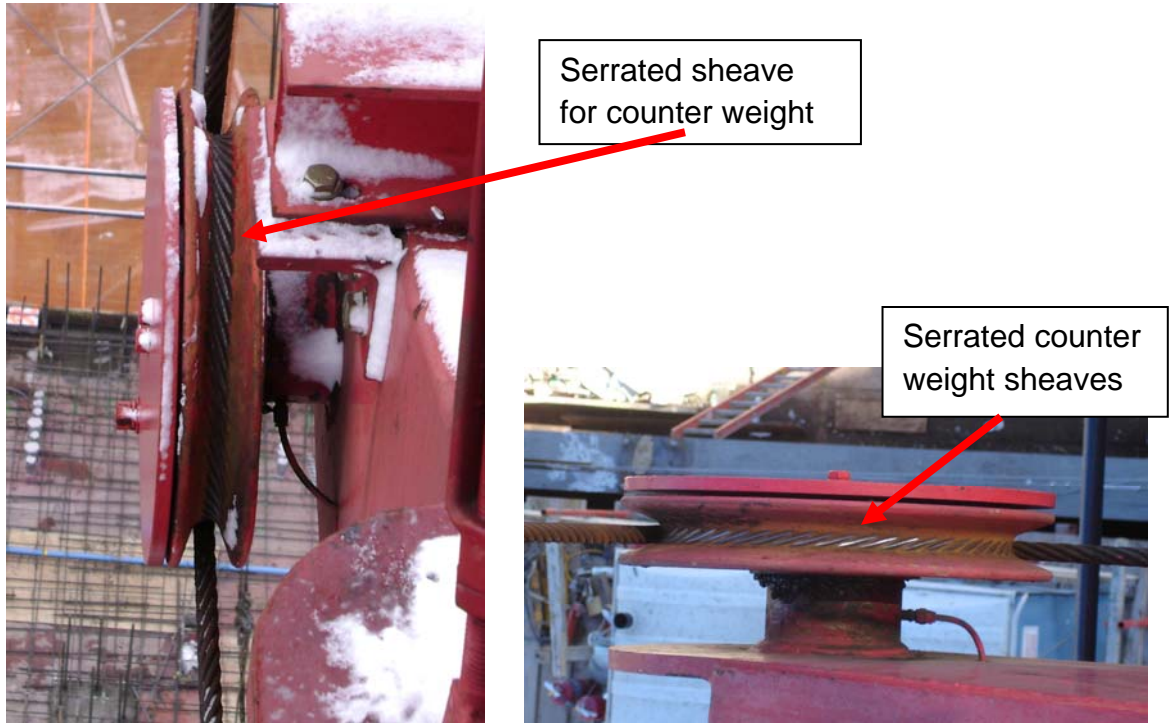
Figure C.7.17: Counter Weight Sheaves (Sites C-73 and C-76)

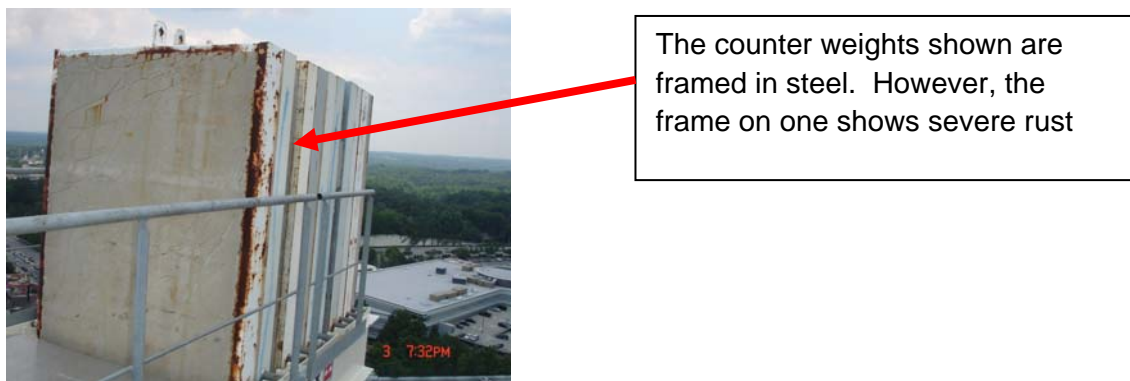
The use on non-framed hanging concrete counter weights is limited in New York City. Hanging concrete counterweights deteriorate over time, and become cracked and/or damaged during handling, which could result in failure or spalling (see Figure C.7.18 from site C-6 – 7/3/08).

Figure C.7.18: Encased Concrete Counterweights

Enclose concrete counterweights to protect against damage and spalling.
