The City of New York
Department of Investigation

**DOI REPORT ON THE FATALITY OF A NYCHA CARETAKER FOUND IN A GARBAGE HOIST
CALLS FOR NYCHA TO PERMANENTLY DECOMMISSION THESE UNITS**

Safety Issues Relating to Garbage Hoists Utilized at Certain NYCHA Facilities

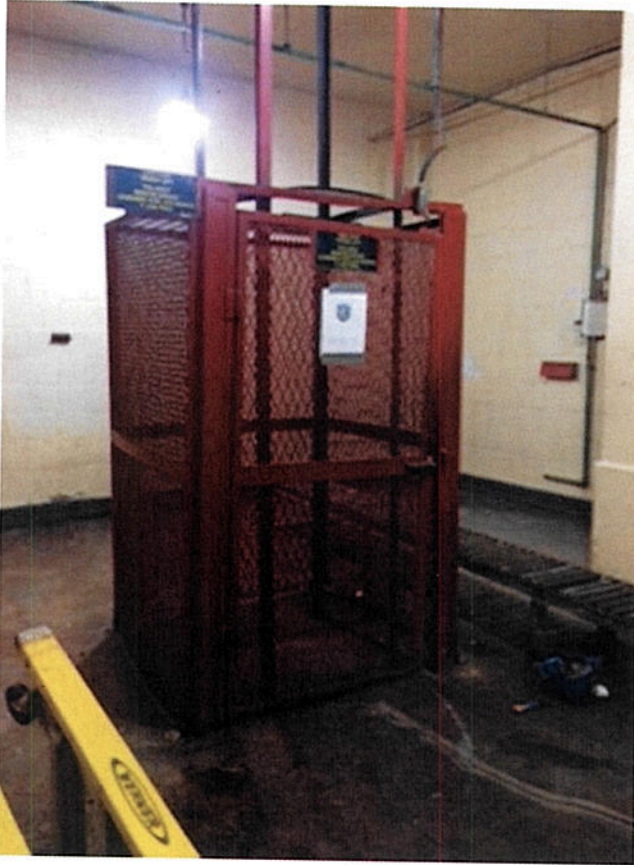
PHOTO #1

“PELIGRO - MONTACARGAS (CUIDADO CON LAS MANOS Y LOS PIES).”⁴ See Appendix A, Photos #1 and #2. The cage is equipped with a safety cage interlock switch that is designed to break the electrical circuit and prevent the hoist car from moving when the cage door is open. However, the cage door is damaged and bent so that it does not make contact with the safety cage switch. See Appendix A, Photos #3 and #4. The hoist car travels up from the basement level, through a hole in the basement ceiling/ground level floor. See Appendix A, Photo #5. DOI observed that there is no operating switch for the hoist at the basement level.

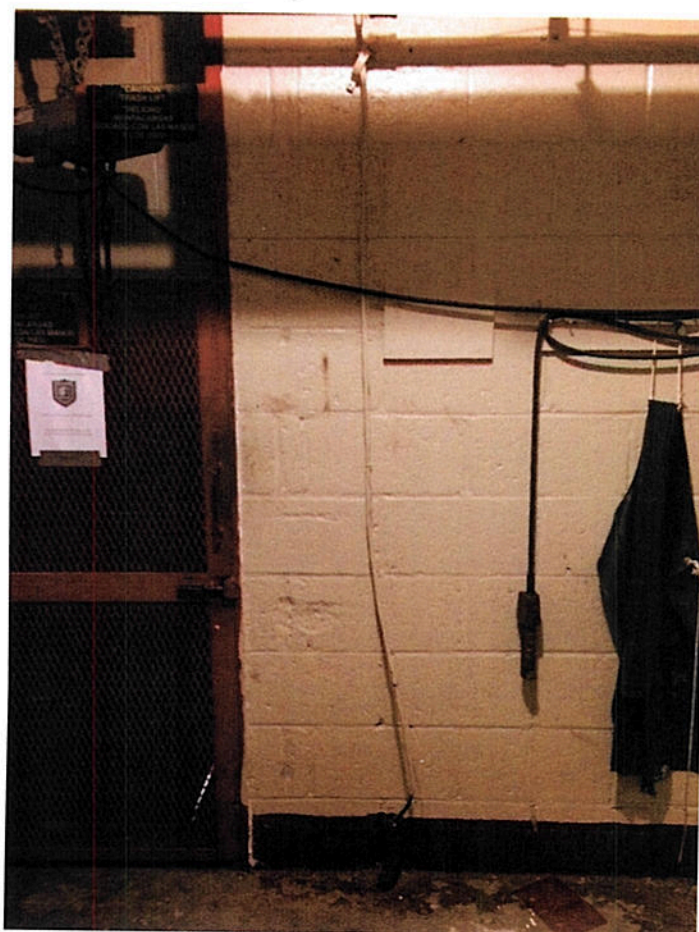
PHOTO #10

At the ground level, the hoistway⁵ terminus is located behind a locked red door marked with the same warning signs and equipped with the same safety cage interlock switch as on the basement level. See Appendix A, Photo #7. The hoist car travels up through the hole in the floor, which is enclosed on four sides by metal guardrails raised approximately one foot off the floor. The guardrails are bent and misaligned, such that the hoist car can easily slip off the track. See Appendix A, Photo #9. The hoist is operated by means of an electric switch on a cord outside of the hoistway door. See Appendix A, Photo #10.
