DEPARTMENT OF SANITATION - FY 2021

Asset Name : BRONX 12 GARAGE
Address : 1635 EAST 233RD ST. @ PROVOST AVE.
Borough : BRONX **Agency's Number** : N/A
Program / Asset # : DOS0037.000 / 4133 **Yr Built/Renovated** : 1992 /
Area Sq Ft : 115,996 **Project Type** : SANITATION
Date of Survey : 30-Apr-2019 **Landmark Status** : NONE
Areas Surveyed : Basement, Roof, Floors 1,2
Block : 4974 **Lot** : 28 **BIN** : 2090261

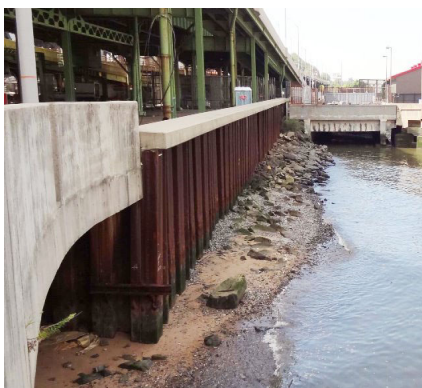
Bulkheads		Current Repair		Future Replacement		Maintenance			
System	Component Type	% of Total	Fail Date (Years)	Estimated Cost	Year FY	Estimated Cost	Cycle (Yrs)	Estimated Cost	Priority
Structural									
Gravity Wall	Concrete	5%			LIFE	* *	5		
		Cracking, Extent : Light, Area Affected : 25%							
		Location : Throughout Gravity Wall At South End							
	No Component	95%							
Revetment									
Stone		70%			LIFE	* *	5		\$900
	No Component	30%							
		Other Observation, Extent : Light, Area Affected : 0%							
		Location : North End							
		Explanation : Natural Shoreline

Sheet Piles									
Steel		65%			LIFE	* *			
	Steel	30%	4+	\$84,400	LIFE	* *			
		Corrosion, Extent : Moderate, Area Affected : 50%							
		Location : Tidal Zone							
		Missing Coating, Extent : Moderate, Area Affected : 50%							
		Location : Tidal Zone							
No Component		5%							
Pile Caps									
Concrete		100%			LIFE	* *	5		\$700
		Cracking, Extent : Light, Area Affected : 15%							
		Location : Throughout							
		Spalling, Extent : Light, Area Affected : 5%							
		Location : Isolated							
Backfill									
Fill	Not Accessible	100%							
Surface									
Brick Pavers		100%			2036	* *	5		\$2,500
		Other Observation, Extent : Light, Area Affected : 20%							
		Location : Behind Steel Sheet Pile Wall							
		Explanation : Settlement

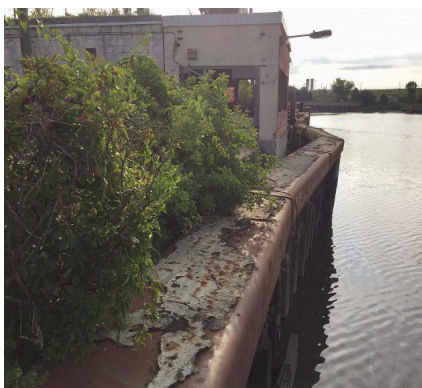
DEPARTMENT OF SANITATION - 827
FRESH KILLS, PLANT #2 MOORING DK STEEL SHEET PILE BULKHEAD
Asset # : 4155

Bulkheads		Current Repair		Future Replacement		Maintenance		Priority
System	Component Type	% of Total	Fail Date (Years)	Estimated Cost	Year FY	Estimated Cost	Cycle (Yrs)	
Structural	Coping/Curb							
	Steel	20%	4+	\$34,200	LIFE		* *	
		Corrosion, Extent : Moderate, Area Affected : 20%						
		Location : Throughout						
	Steel	60%			LIFE		* *	
	Steel	20%	Now	\$34,200	LIFE		* *	
		Other Observation, Extent : Severe, Area Affected : 100%						
		Location : Western 100 Feet						
		Explanation : Displaced Due To Impact

Sheet Piles							
	Steel	10%	Now	\$349,300	LIFE		* *	
		Excess Deflection, Extent : Severe, Area Affected : 100%						
		Location : Eastern 115 Feet						
	Steel	10%	4+	\$349,300	LIFE		* *	
		Corrosion, Extent : Moderate, Area Affected : 15%						
		Location : Tidal Zone						
	Not Accessible	80%						
		Other Observation, Extent : Light, Area Affected : 0%						
		Location :						
		Explanation : Behind Fender System						
Backfill	Fill							
	Topsoil	30%	Now	\$37,900	2068		* *	
		Sinkhole, Extent : Severe, Area Affected : 100%						
		Location : Eastern 80 Feet Behind Sheet Piles, 15 Feet Deep						
	Not Accessible	70%						
Surface	Asphalt	10%			2031	\$5,300	5	\$600
	Concrete	40%			2031	\$84,700	5	\$2,500
	Concrete	20%			2031	\$42,300	5	\$1,300
	Topsoil	30%	Now	\$9,500	2028	\$9,500	5	\$400
		Other Observation, Extent : Severe, Area Affected : 100%						
		Location : Eastern 80 Feet						
		Explanation : Sinkhole, 8 Feet Deep, Behind Sheeting

Fender	Facing							
	Timber	20%	Now	\$137,700	2043		* *	\$4,300
		Broken, Extent : Severe, Area Affected : 100%						
		Location : Western 50 Feet And Isolated Throughout						
	Timber	45%	2-4	\$309,900	2043		* *	\$9,700
		Rotting/Splitting, Extent : Moderate, Area Affected : 50%						
		Location : Throughout						
	No Component	10%						
	Not Accessible	25%						
	Wales and Chocks							
	Not Accessible	100%
