DEPT. OF SMALL BUSINESS SERV. - FY 2024

Asset Name : 125TH STREET PARKING GARAGE 5 LEVEL GARAGE
Address : 121 WEST 125TH STREET
Borough : MANHATTAN **Agency's Number** : N/A
Program / Asset # : DBS0028.000 / 4334 **Yr Built/Renovated** : 1972 / 2005
Area Sq Ft : 155,197 **Project Type** : ECONOMIC DEVELOPMENT
Date of Survey : 08-Feb-2019 **Landmark Status** : NONE
Areas Surveyed : Basement, Roof, Floors 1
Block : 1910 **Lot** : 1 **BIN** : 1081601

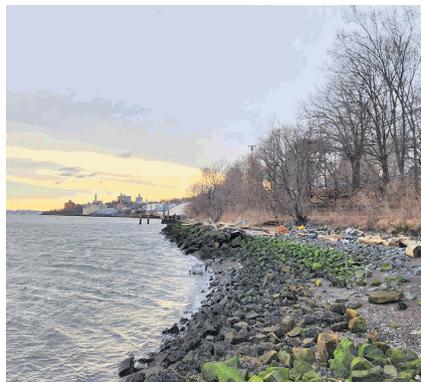
DEPT. OF SMALL BUSINESS SERV. - 801
REVETMENT
Asset # : 13931

Bulkheads		Current Repair		Future Replacement		Maintenance		Priority
System Component Type	% of Total	Fail Date (Years)	Estimated Cost	Year FY	Estimated Cost	Cycle (Yrs)	Estimated Cost	
Structural								
Revetment								
Stone	60%			LIFE	**	5	\$8,600	
	<i>Settlement, Extent : Light, Area Affected : 10%</i>							
	<i>Location : Near Western End Of Asset</i>							
	<i>Other Observation, Extent : Light, Area Affected : 100%</i>							
	<i>Location : Entire Length Of Asset</i>							
	<i>Explanation : Non-engineered Revetment</i>							
Stone	40%	4+	\$604,300	LIFE	**	5	\$2,900	
	<i>Missing Part, Extent : Moderate, Area Affected : 100%</i>							
	<i>Location : Missing Stone At Eastern Half</i>							
	<i>Other Observation, Extent : Light, Area Affected : 100%</i>							
	<i>Location : Entire Length Of Asset</i>							
	<i>Explanation : Non-engineered Revetment</i>							
Backfill								
Fill								
Not Accessible	100%

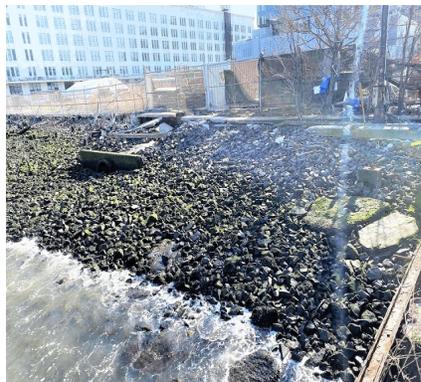
DEPT. OF SMALL BUSINESS SERV. - 801
REVTMENT
Asset # : 13951

Bulkheads		Current Repair		Future Replacement		Maintenance		Priority
System	Component Type	% of Total	Fail Date (Years)	Estimated Cost	Year FY	Estimated Cost	Cycle (Yrs)	Estimated Cost
Structural								
	Revetment							
	Stone	38%	4+	\$38,400	LIFE	**	5	\$200
		<i>Erosion, Extent : Severe, Area Affected : 100%</i>						
		<i>Location : Missing Stone From 47 Feet To 80 Feet From The Southern End Of Asset</i>						
	Stone	62%			LIFE	**	5	\$600
Backfill								
	Fill							
	Not Accessible	100%						
Surface								
	Concrete	35%	Now	\$31,400	2049	**	5	\$200
		<i>Broken, Extent : Severe, Area Affected : 100%</i>						
		<i>Location : Abandoned Sidewalk Collapsed From 47 Feet To 70 Feet From The Southern End Of Asset</i>						
		<i>Settlement, Extent : Severe, Area Affected : 100%</i>						
		<i>Location : Undermining Along Abandoned Sidewalk, Northern 40 Feet Of Asset</i>						
	Concrete	35%			2043	**	5	\$300

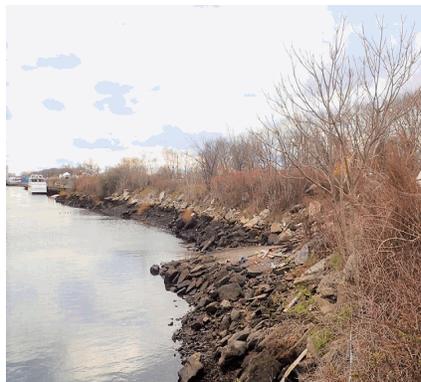
DEPT. OF SMALL BUSINESS SERV. - 801
REVTMENT
Asset # : 14013

Bulkheads		Current Repair		Future Replacement		Maintenance		Priority
System Component Type	% of Total	Fail Date (Years)	Estimated Cost	Year FY	Estimated Cost	Cycle (Yrs)	Estimated Cost	
Structural								
Revetment								
Stone	25%	Now	\$95,800	LIFE	**	5	\$800	
<i>Erosion, Extent : Severe, Area Affected : 80%</i>								
<i>Location : Loss Of Soil At Top Of Revetment 180 To 285 Feet From The North End</i>								
<i>Other Observation, Extent : Severe, Area Affected : 80%</i>								
<i>Location : 180 To 285 Feet From The North End</i>								
<i>Explanation : Missing Stone</i>								
Stone	70%	4+	\$268,100	LIFE	**	5	\$2,100	
<i>Other Observation, Extent : Light, Area Affected : 100%</i>								
<i>Location : Entire Length Of Asset</i>								
<i>Explanation : Improper Slope; Loss Of Topsoil</i>								
No Component	5%							
<i>Other Observation, Extent : Light, Area Affected : 0%</i>								
<i>Location :</i>

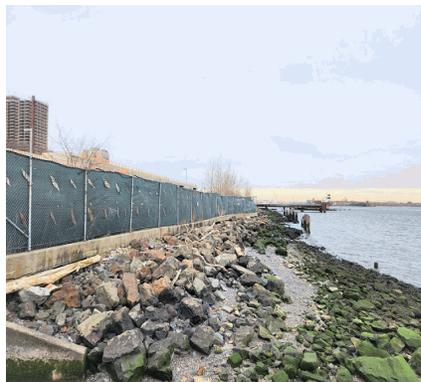
DEPT. OF SMALL BUSINESS SERV. - 801
REVTMENT /EAST AND WEST OF BALLPARK WHARF
Asset # : 13925

Bulkheads		Current Repair		Future Replacement		Maintenance		Priority
System Component Type	% of Total	Fail Date (Years)	Estimated Cost	Year FY	Estimated Cost	Cycle (Yrs)	Estimated Cost	
Structural								
Coping/Curb Concrete	70%	Now	\$215,100	LIFE	**	5	\$1,900	
<i>Broken, Extent : Severe, Area Affected : 4%</i>								
<i>Location : 1,376 Feet To 1,450 Feet From East End</i>								
<i>Excess Deflection, Extent : Moderate, Area Affected : 75%</i>								
<i>Location : 996 Feet To 1,376 Feet And 1,595 From East End To West End</i>								
<i>Other Observation, Extent : Severe, Area Affected : 100%</i>								
<i>Location : Undermined And Unsupported Starting 694 Feet From East End To West End</i>								
<i>Explanation : Undermined</i>								
No Component	30%							
Gravity Wall								
Concrete	30%			LIFE	**	5-10	\$7,100	
No Component	70%							
Revetment								
Stone	30%			LIFE	**	5	\$10,500	
Stone	70%	Now	\$1,550,400	LIFE	**	5	\$12,200

<i>Other Observation, Extent : Severe, Area Affected : 75%</i>								
<i>Location : Full Extent West Of Ballpark Wharf</i>								
<i>Explanation : Inadequate Armor Protection</i>								
Backfill								
Fill								
Gravel	15%	4+	\$33,300	2047	**	5	\$400	
<i>Sinkhole, Extent : Moderate, Area Affected : 5%</i>								
<i>Location : Beneath And Behind Concrete Surface West Of Ballpark Wharf</i>								
Not Accessible	30%							
Under Construction	55%							
Surface								
Concrete	5%			2043	**	5	\$1,700	
Topsoil	20%	Now	\$34,400	2032	\$57,400	5	\$1,400	
<i>Missing Part, Extent : Severe, Area Affected : 100%</i>								
<i>Location : At Sinkholes Inshore Of Concrete Surface West Of Ballpark Wharf</i>								
Topsoil	20%			2032	\$86,000	5	\$2,700	
Under Construction	55%

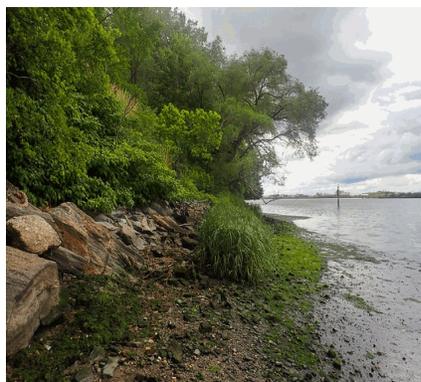
DEPT. OF SMALL BUSINESS SERV. - 801
REVETMENT EAST SIDE RIKERS ISLAND BRIDGE
Asset # : 14023

Bulkheads		Current Repair		Future Replacement		Maintenance		Priority
System Component Type	% of Total	Fail Date (Years)	Estimated Cost	Year FY	Estimated Cost	Cycle (Yrs)	Estimated Cost	
Structural Revetment Stone	100%			LIFE	**	5	\$12,600	
<i>Erosion, Extent : Moderate, Area Affected : 5%</i> <i>Location : Adjacent To Creek Near Bridge</i> <i>Other Observation, Extent : Light, Area Affected : 25%</i> <i>Location : Salt Marsh Offshore Of Revetment, Primarily On West Side And At North Point</i> <i>Explanation : Heavy Vegetation</i>								
Backfill Fill Not Accessible	100%							
Surface Topsoil	100%			2029	\$206,200	5	\$9,800	
<i>Erosion, Extent : Light, Area Affected : 5%</i> <i>Location : Isolated Areas</i> <i>Other Observation, Extent : Severe, Area Affected : 75%</i> <i>Location : Above Revetment</i> <i>Explanation : Heavy Vegetation</i>

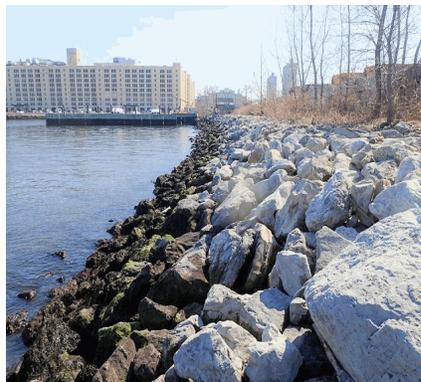
DEPT. OF SMALL BUSINESS SERV. - 801
REVTMENT HARBOR CHARLIE TO RAIL YARD

Bulkheads		Current Repair		Future Replacement		Maintenance		Priority
System Component Type	% of Total	Fail Date (Years)	Estimated Cost	Year FY	Estimated Cost	Cycle (Yrs)	Estimated Cost	
Structural								
Revetment								
Stone	85%			LIFE	**	5	\$2,800	
Stone	15%	4+	\$41,700	LIFE	**	5	\$500	
<i>Settlement, Extent : Moderate, Area Affected : 75%</i>								
<i>Location : West End Of Asset Consists Of Stone With Concrete And Asphalt Debris</i>								
<hr/>								
Backfill								
Fill								
Not Accessible	100%							
<hr/>								
Surface								
Gravel	8%			2041	**	2-5	\$100	
Topsoil	7%	4+	\$2,300	2032	\$3,800	5	\$100	
<i>Erosion, Extent : Moderate, Area Affected : 100%</i>								
<i>Location : West End Of Asset</i>								
<hr/>								
Topsoil	85%			2030	\$45,900	5	\$2,200	
<hr/>								
Deck Elements								
Railing								
Fencing	25%	Now	\$6,400	2037	**	3	\$100	
<i>Broken, Extent : Severe, Area Affected : 100%</i>

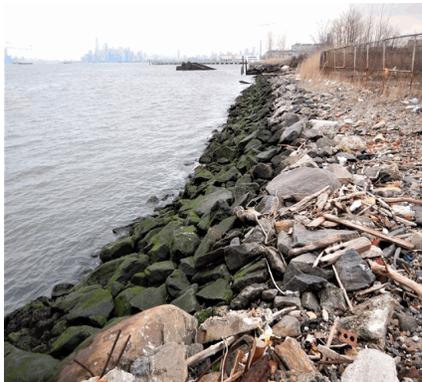
DEPT. OF SMALL BUSINESS SERV. - 801
REVTMENT NORTH SIDE OF 65TH ST. RAIL YARD
Asset # : 13969

Bulkheads		Current Repair		Future Replacement		Maintenance		Priority
System	Component Type	% of Total	Fail Date (Years)	Estimated Cost	Year FY	Estimated Cost	Cycle (Yrs)	Estimated Cost
Structural	Revetment Stone	100%			LIFE	**	5	\$2,400
		<i>Settlement, Extent : Light, Area Affected : 25%</i>						
		<i>Location : Sloughing At North And South Ends</i>						
Backfill	Fill	100%						
	Not Accessible	100%						
Surface	Gravel	100%			2043	**	2-5	\$600
		<i>Erosion, Extent : Moderate, Area Affected : 20%</i>						
		<i>Location : At North And South Ends In Natural Shoreline Above Revetment</i>

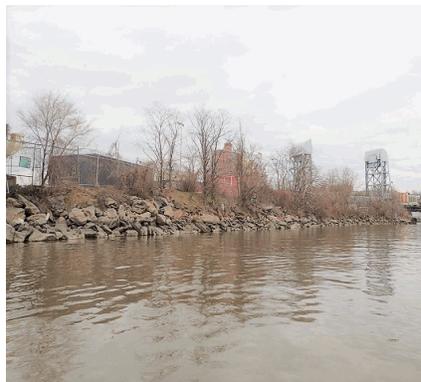
DEPT. OF SMALL BUSINESS SERV. - 801
REVTMENT - RIPRAP BULKHEAD
Asset # : 13793

Bulkheads		Current Repair		Future Replacement		Maintenance		Priority
System Component Type	% of Total	Fail Date (Years)	Estimated Cost	Year FY	Estimated Cost	Cycle (Yrs)	Estimated Cost	
Structural								
Revetment								
Stone	50%	4+	\$77,800	LIFE	**	5	\$1,800	
<i>Other Observation, Extent : Light, Area Affected : 20%</i>								
<i>Location : Across Entire Length</i>								
<i>Explanation : Non-engineered Shoreline Protection. Inadequate Placement. Evidence Of Material Loss</i>								
Stone	50%			LIFE	**	5	\$1,800	
<i>Other Observation, Extent : Light, Area Affected : 100%</i>								
<i>Location : Across Entire Length</i>								
<i>Explanation : Non-engineered Shoreline Protection</i>								
Backfill								
Fill								
Topsoil	25%	4+	\$9,900	2060	**			
<i>Erosion, Extent : Light, Area Affected : 20%</i>								
<i>Location : Above Revetment Across Entire Length</i>								
Not Accessible	75%

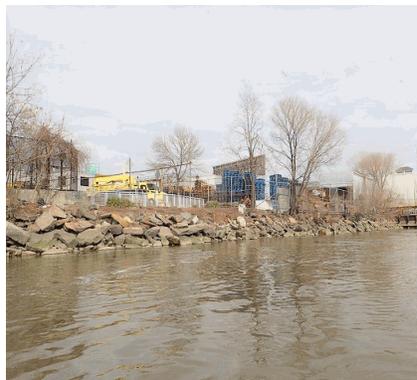
DEPT. OF SMALL BUSINESS SERV. - 801
REVTMENT - RIPRAP BULKHEAD
Asset # : 13797

Bulkheads		Current Repair		Future Replacement		Maintenance		Priority
System Component Type	% of Total	Fail Date (Years)	Estimated Cost	Year FY	Estimated Cost	Cycle (Yrs)	Estimated Cost	
Structural								
Revetment								
Stone	50%	4+	\$96,700	LIFE	**	5	\$800	
<i>Erosion, Extent : Moderate, Area Affected : 100%</i>								
<i>Location : Across Entire Length</i>								
<i>Other Observation, Extent : Moderate, Area Affected : 100%</i>								
<i>Location : South End Of Park And North Of Concrete Slab</i>								
<i>Explanation : Non-engineered, Inadequate Protection</i>								
Stone	50%	Now	\$96,700	LIFE	**	5	\$800	
<i>Erosion, Extent : Severe, Area Affected : 100%</i>								
<i>Location : 25 Feet To 150 Feet From Southern End</i>								
Backfill								
Fill								
Topsoil	50%	Now	\$27,500	2072	**			
<i>Erosion, Extent : Severe, Area Affected : 50%</i>								
<i>Location : 25 Feet From Southern End And Above Revetment Undermining Concrete Slab At Mid Asset</i>

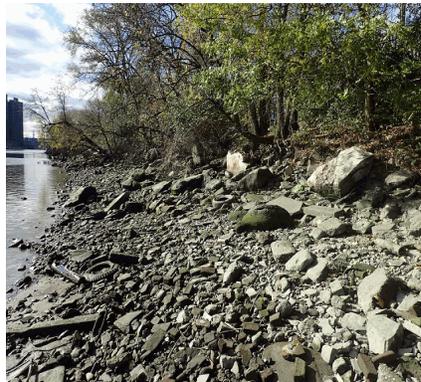
DEPT. OF SMALL BUSINESS SERV. - 801
REVTMENT - RIPRAP BULKHEAD
Asset # : 13799

Bulkheads		Current Repair		Future Replacement		Maintenance		Priority
System Component Type	% of Total	Fail Date (Years)	Estimated Cost	Year FY	Estimated Cost	Cycle (Yrs)	Estimated Cost	
Structural Revetment Stone	100%	4+	\$193,400	LIFE	**	5	\$1,500	
<i>Other Observation, Extent : Moderate, Area Affected : 100%</i>								
<i>Location : Entire Asset</i>								
<i>Explanation : Non-engineered, Inadequate Protection</i>								
Backfill Fill Topsoil	100%	4+	\$54,900	2072	**			
<i>Erosion, Extent : Moderate, Area Affected : 100%</i>								
<i>Location : Above Revetment</i>								
Surface Topsoil	100%	4+	\$15,000	2032	\$25,000	5	\$600	
<i>Erosion, Extent : Moderate, Area Affected : 30%</i>								
<i>Location : Above Revetment</i>

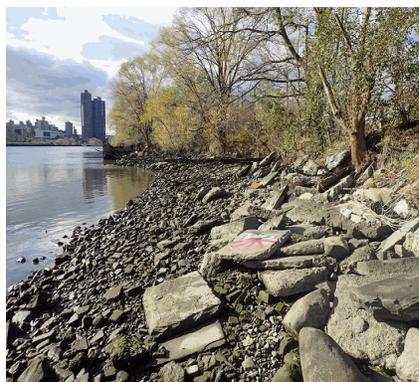
DEPT. OF SMALL BUSINESS SERV. - 801
REVTMENT - RIPRAP BULKHEAD
Asset # : 13800

Bulkheads		Current Repair		Future Replacement		Maintenance		Priority
System Component Type	% of Total	Fail Date (Years)	Estimated Cost	Year FY	Estimated Cost	Cycle (Yrs)	Estimated Cost	
Structural Revetment Stone	100%	Now	\$170,700	LIFE	**	5	\$1,300	
<i>Other Observation, Extent : Severe, Area Affected : 100%</i>								
<i>Location : Entire Revetment</i>								
<i>Explanation : Non-engineered, Inadequate Placement/ Protection, Concrete Debris</i>								
Backfill Fill Topsoil	70%	Now	\$33,900	2072	**			
<i>Erosion, Extent : Severe, Area Affected : 100%</i>								
<i>Location : Center Of Asset</i>								
<i>Other Observation, Extent : Severe, Area Affected : 100%</i>								
<i>Location : Center Of Asset</i>								
<i>Explanation : Slope Exposure And Instability</i>								
Not Accessible	30%							
Surface Asphalt	20%	Now	\$4,900	2047	**	5	\$300	
<i>Erosion, Extent : Severe, Area Affected : 100%</i>

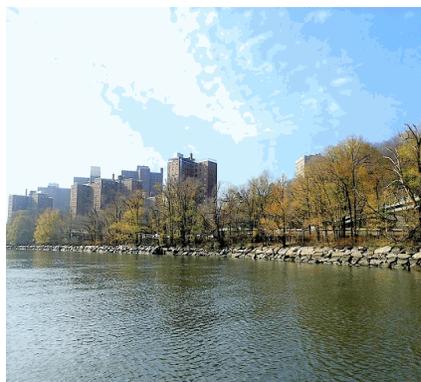
DEPT. OF SMALL BUSINESS SERV. - 801
REVTMENT - RIPRAP NO END OVER LAPS GRAVITY WALL
Asset # : 13820

Bulkheads		Current Repair		Future Replacement		Maintenance		Priority
System Component Type	% of Total	Fail Date (Years)	Estimated Cost	Year FY	Estimated Cost	Cycle (Yrs)	Estimated Cost	
Structural								
Revetment								
Stone	95%			LIFE	**	5	\$6,500	
	<i>Settlement, Extent : Light, Area Affected : 40%</i>							
	<i>Location : 360 Feet From South At Outfall And At North End</i>							
Stone	5%	4+	\$29,000	LIFE	**	5	\$300	
	<i>Other Observation, Extent : Light, Area Affected : 50%</i>							
	<i>Location : Inshore Of Outfalls And At 582 Feet, 600 Feet, And 788 Feet From South.</i>							
	<i>Sliding Of Revetment At 400 Feet And 850 Feet From South.</i>							
	<i>Explanation : Erosion With Inadequate Protection</i>							
Backfill								
Fill								
Topsoil	5%	Now	\$7,400	2060	**			
	<i>Erosion, Extent : Moderate, Area Affected : 100%</i>							
	<i>Location : Erosion Of Fill Inshore Of Outfalls</i>

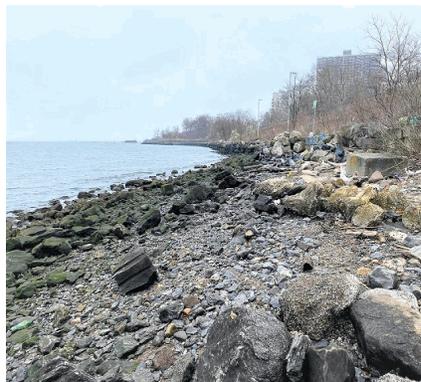
DEPT. OF SMALL BUSINESS SERV. - 801
REVTMENT #1
Asset # : 13927

Bulkheads		Current Repair		Future Replacement		Maintenance		Priority
System Component Type	% of Total	Fail Date (Years)	Estimated Cost	Year FY	Estimated Cost	Cycle (Yrs)	Estimated Cost	
Structural								
Revetment Stone	50%	2-4	\$198,700	LIFE	**	5	\$1,600	
<i>Other Observation, Extent : Severe, Area Affected : 100%</i>								
<i>Location : Along Entire Length Of Asset</i>								
<i>Explanation : Insufficient Armor</i>								
Stone	50%	Now	\$331,200	LIFE	**	5	\$1,600	
<i>Erosion, Extent : Severe, Area Affected : 100%</i>								
<i>Location : Revetment Failure At Intermittent Locations</i>								
Backfill								
Fill								
Topsoil	35%	Now	\$39,500	2074	**			
<i>Erosion, Extent : Severe, Area Affected : 70%</i>								
<i>Location : Sloughing At Areas Of Revetment Failure</i>								
Not Accessible	65%							
Surface								
Topsoil	65%	0-2	\$20,100	2034	\$33,500	5	\$800	
<i>Erosion, Extent : Moderate, Area Affected : 10%</i>

<i>Location : At Areas Of Insufficient Stone</i>								
Topsoil	35%	Now	\$18,000	2034	\$18,000	5	\$400	
<i>Erosion, Extent : Severe, Area Affected : 100%</i>								
<i>Location : Sloughing At Areas Of Revetment Failure, Up To Sidewalk</i>
