**DEPT. OF PARKS & RECREATION - FY 2018**

**Asset Name** : ABE STARK SKATING RINK INDOOR FACILITY  
**Address** : SURF AVE, W.19 ST AND BOARDWALK  
**Borough** : BROOKLYN **Agency's Number** : B336-01  
**Program / Asset #** : PAR0118.001 / 914 **Yr Built/Renovated** : 1969 / 2014  
**Area Sq Ft** : 43,873 **Project Type** : PARKS AND RECREATION  
**Date of Survey** : 17-Jul-2014 **Landmark Status** : NONE  
**Areas Surveyed** : Basement, Roof, Floors 1  
**Block** : 7072 **Lot** : 14 **BIN** :

**DEPT. OF PARKS & RECREATION - 846**  
**ABE STARK SKATING RINK INDOOR FACILITY**  
**Asset # : 914**

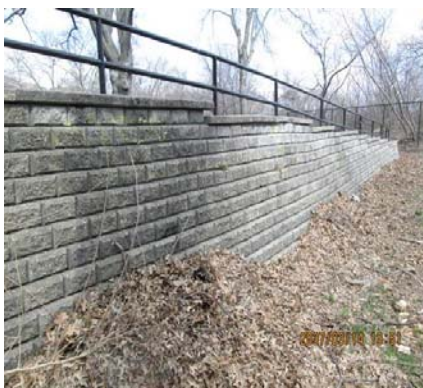
**DEPT. OF PARKS & RECREATION - 846**  
**HIGHBRIDGE PARK RETAINING WALL / CONCRETE RETAINING WALL**  
**Asset # : 14690**

Retaining Walls		Current Repair		Future Replacement		Maintenance			
System	Component Type	% of Total	Fail Date (Years)	Estimated Cost	Year FY	Estimated Cost	Cycle (Yrs)	Estimated Cost	Priority
Wall	Coping								
	Concrete	100%	2-4	\$300	LIFE	* *			
		Broken/Missing Elements, Extent : Light, Area Affected : 10%							
		Location : 50 Feet From North End							
		Other Observation, Extent : Light, Area Affected : 100%							
		Location : Throughout							
		Explanation : Material: Concrete Block							
Wall/Fence	Concrete	100%	4+	\$8,700	LIFE	* *	5	\$100	
		Broken/Missing Elements, Extent : Light, Area Affected : 2%							
		Location : 50 Feet From North End							
		Vegetation Growth, Extent : Light, Area Affected : 1%							
		Location : Throughout							
		Other Observation, Extent : Light, Area Affected : 100%							
		Location : Throughout							
		Explanation : Material: Concrete Block							
Base	Not Accessible	100%

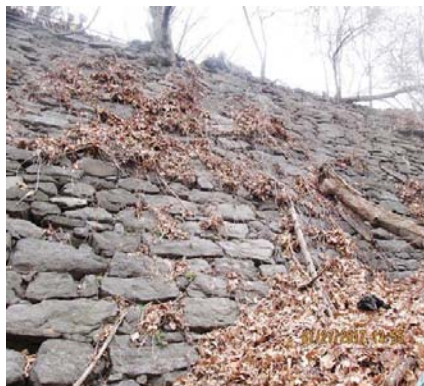
**DEPT. OF PARKS & RECREATION - 846**  
**HIGHBRIDGE PARK RETAINING WALL BETWEEN WALLS S & T**  
**Asset # : 14943**

Retaining Walls		Current Repair		Future Replacement		Maintenance		Priority
System Component Type	% of Total	Fail Date (Years)	Estimated Cost	Year FY	Estimated Cost	Cycle (Yrs)	Estimated Cost	
Wall								
Wall/Fence								
Rubble Stone	100%	4+	\$304,000	LIFE	* *	5	\$7,600	
<i>Broken/Missing Elements, Extent : Moderate, Area Affected : 5%</i>								
<i>Location : Random Locations Throughout</i>								
<i>Vegetation Growth, Extent : Moderate, Area Affected : 50%</i>								
<i>Location : Random Locations Throughout</i>								
<i>Other Observation, Extent : Moderate, Area Affected : 3%</i>								
<i>Location : Random Locations Throughout</i>								
<i>Explanation : 3 Inch Or More Diameter Tree Growth</i>								
Base								
Not Accessible	100%

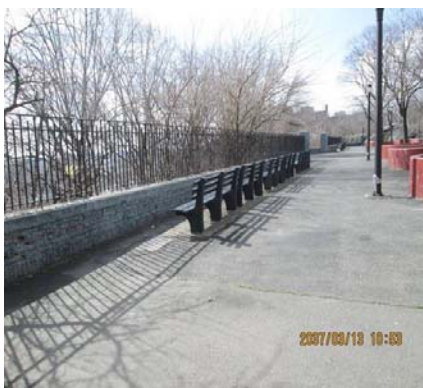
**DEPT. OF PARKS & RECREATION - 846**  
**HIGHBRIDGE PARK RETAINING WALL BRICK RETAINING / PERIMETER WALL**  
**Asset # : 14689**

Retaining Walls		Current Repair		Future Replacement		Maintenance		Priority
System	Component Type	% of Total	Fail Date (Years)	Estimated Cost	Year FY	Estimated Cost	Cycle (Yrs)	
Wall								
	Coping							
	Concrete	100%	4+	\$4,000	LIFE	* *		
		Cracks-Horizontal, Extent : Light, Area Affected : 5%						
		Location : Scattered Throughout						
		Jnt Mortar Miss/Erod, Extent : Moderate, Area Affected : 20%						
		Location : Scattered Throughout						
		Cracks-Vertical, Extent : Light, Area Affected : 5%						
		Location : Scattered Throughout						
Wall/Fence								
	Concrete	90%	2-4	\$471,200	LIFE	* *	5	\$1,200
		Broken/Missing Elements, Extent : Severe, Area Affected : 5%						
		Location : Random Locations Throughout						
		Jnt Mortar Miss/Erod, Extent : Moderate, Area Affected : 10%						
		Location : Random Locations Throughout						
		Loose Elements, Extent : Moderate, Area Affected : 5%						
		Location : At Center Of Wall Near Playground

Misaligned/Bulging, Extent : Severe, Area Affected : 5%						
		Location : North End, South End, And Center Of Wall						
		Vegetation Growth, Extent : Moderate, Area Affected : 10%						
		Location : Random Locations Throughout						
		Cracks-Vertical, Extent : Moderate, Area Affected : 5%						
		Location : Random Locations Throughout						
		Other Observation, Extent : Light, Area Affected : 100%						
		Location : East Face						
		Explanation : All Observations Were Made On Brick Fascia						
	Metal Fence	10%	4+	\$2,400	LIFE	* *	4-8	\$800
		Deteriorated Finish, Extent : Light, Area Affected : 10%						
		Location : Random Locations Throughout						
Base								
	Not Accessible	100%

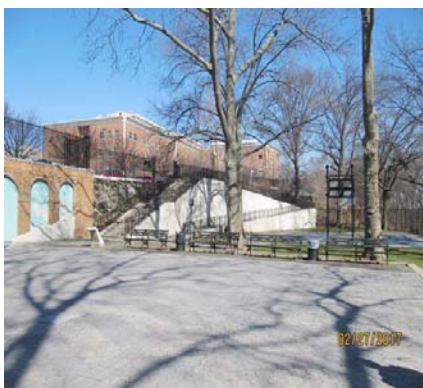
**DEPT. OF PARKS & RECREATION - 846**  
**HIGHBRIDGE PARK RETAINING WALL CONC. RETAINING / PERIMETER WALL**  
**Asset # : 14695**

Retaining Walls		Current Repair		Future Replacement		Maintenance		Priority
System	Component Type	% of Total	Fail Date (Years)	Estimated Cost	Year FY	Estimated Cost	Cycle (Yrs)	
Wall								
	Coping							
	Concrete	100%	4+	\$2,100	LIFE	* *		
		<i>Cracking/Crumbling, Extent : Light, Area Affected : 2%</i>						
		<i>Location : Random Locations Throughout</i>						
	Wall/Fence							
	Concrete	70%	4+	\$55,400	LIFE	* *	5	\$200
		<i>Broken/Missing Elements, Extent : Moderate, Area Affected : 2%</i>						
		<i>Location : At Center Of Wall</i>						
		<i>Spalling, Extent : Light, Area Affected : 5%</i>						
		<i>Location : 3 Rail Posts At South End And Center</i>						
		<i>Other Observation, Extent : Light, Area Affected : 10%</i>						
		<i>Location : At Random Locations Throughout</i>						
		<i>Explanation : Paint Peeling</i>						
	Metal Fence	30%	4+	\$1,900	LIFE	* *	4-8	\$600
		<i>Deteriorated Finish, Extent : Light, Area Affected : 10%</i>

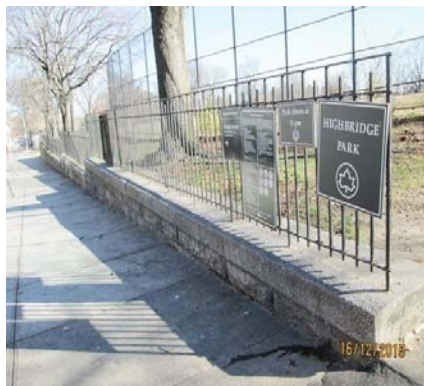
**DEPT. OF PARKS & RECREATION - 846**  
**HIGHBRIDGE PARK RETAINING WALL CURVING CUT STONE WALL**  
**Asset # : 14085**

Retaining Walls		Current Repair		Future Replacement		Maintenance		Priority
System	Component Type	% of Total	Fail Date (Years)	Estimated Cost	Year FY	Estimated Cost	Cycle (Yrs)	
Wall								
	Coping							
	Concrete	60%	4+	\$3,200	LIFE		* *	
		Cracking/Crumbling, Extent : Light, Area Affected : 2%						
		Location : North End Of Wall						
		Jnt Mortar Miss/Erod, Extent : Light, Area Affected : 2%						
		Location : Throughout, More Severe Towards The North End						
		Misaligned/Bulging, Extent : Light, Area Affected : 5%						
		Location : 110 Feet And 230 Feet North Of South End Of The World						
		Spalling, Extent : Light, Area Affected : 1%						
		Location : 45 Feet From North End Of The World						
	Concrete	40%			LIFE		* *	
Wall/Fence								
	Metal Fence	20%	4+	\$1,300	LIFE		* * 4-8	\$1,100
		Broken/Missing Elements, Extent : Light, Area Affected : 5%						
		Location : Random Locations Throughout

Deteriorated Finish, Extent : Light, Area Affected : 5%						
		Location : Random Locations Throughout						
		Other Observation, Extent : Light, Area Affected : 5%						
		Location : 110 Feet North Of South End Of Wall						
		Explanation : Displaced Section Of Metal Fence, Broken Connection						
	Metal Fence	15%			LIFE		* * 4-8	\$800
	Masonry:Granite	15%	4+	\$4,800	LIFE		* * 5	\$700
		Jnt Mortar Miss/Erod, Extent : Light, Area Affected : 5%						
		Location : Random Locations Throughout						
		Vegetation Growth, Extent : Light, Area Affected : 2%						
		Location : North Face Of Wall						
	Masonry:Granite	50%			LIFE		* * 5	\$2,300
Base								
	Not Accessible	100%

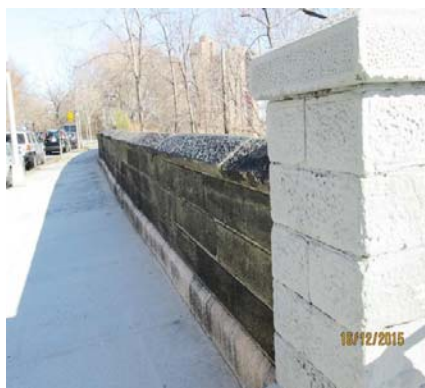
**DEPT. OF PARKS & RECREATION - 846**  
**HIGHBRIDGE PARK RETAINING WALL CUT STONE**

Retaining Walls		Current Repair			Future Replacement		Maintenance		Priority
System	Component Type	% of Total	Fail Date (Years)	Estimated Cost	Year FY	Estimated Cost	Cycle (Yrs)	Estimated Cost	
Wall									
	Coping								
	Masonry:Brownstone	85%	4+	\$3,100	LIFE	* *	5		
		Jnt Mortar Miss/Erod, Extent : Moderate, Area Affected : 5%							
		Location : Random Locations Throughout							
		Misaligned/Bulging, Extent : Moderate, Area Affected : 5%							
		Location : Within One Third Point From South End Of The Wall							
	Masonry:Brownstone	15%			LIFE	* *	5		
Wall/Fence									
	Masonry:Granite	10%	4+	\$1,000	LIFE	* *	5	\$100	
		Jnt Mortar Miss/Erod, Extent : Light, Area Affected : 5%							
		Location : Random Locations Throughout							
		Misaligned/Bulging, Extent : Moderate, Area Affected : 5%							
		Location : Within One Third Point From South End Of The Wall							
	Masonry:Sandstone	25%	4+	\$2,200	LIFE	* *

Jnt Mortar Miss/Erod, Extent : Light, Area Affected : 5%							
		Location : Random Locations Throughout							
		Misaligned/Bulging, Extent : Moderate, Area Affected : 5%							
		Location : Within One Third Point From South End Of The Wall							
		Vegetation Growth, Extent : Light, Area Affected : 2%							
		Location : Throughout The Areas Of Joint Openings							
	Masonry:Schist/Gneiss	50%	4+	\$4,500	LIFE	* *	5	\$600	
		Broken/Missing Elements, Extent : Light, Area Affected : 2%							
		Location : 35 Feet From The South End Of The Wall							
		Jnt Mortar Miss/Erod, Extent : Light, Area Affected : 5%							
		Location : Random Locations Throughout							
		Misaligned/Bulging, Extent : Moderate, Area Affected : 5%							
		Location : Within One Third Point From South End Of The Wall							
		Vegetation Growth, Extent : Light, Area Affected : 5%							
		Location : Random Locations Throughout

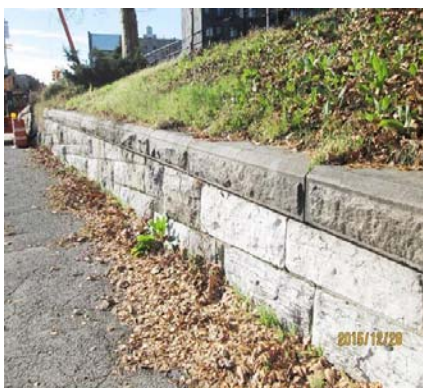
**DEPT. OF PARKS & RECREATION - 846**  
**HIGHBRIDGE PARK RETAINING WALL CUT STONE W/COPING**  
**Asset # : 14081**

Retaining Walls		Current Repair		Future Replacement		Maintenance		Priority
System Component Type	% of Total	Fail Date (Years)	Estimated Cost	Year FY	Estimated Cost	Cycle (Yrs)	Estimated Cost	
Wall								
Coping								
Masonry:Granite	100%	4+	\$700	LIFE		* *	5	
	<i>Jnt Mortar Miss/Erod, Extent : Light, Area Affected : 4%</i>							
	<i>Location : Random Locations Throughout</i>							
	<i>Vegetation Growth, Extent : Light, Area Affected : 2%</i>							
	<i>Location : Middle Of Wall</i>							
Wall/Fence								
Masonry:Sandstone	27%	4+	\$1,000	LIFE		* *		
	<i>Jnt Mortar Miss/Erod, Extent : Light, Area Affected : 4%</i>							
	<i>Location : Random Locations Throughout</i>							
	<i>Vegetation Growth, Extent : Light, Area Affected : 2%</i>							
	<i>Location : Random Locations Throughout</i>							
Masonry:Sandstone	73%			LIFE		* *		
Base								
Not Accessible	100%

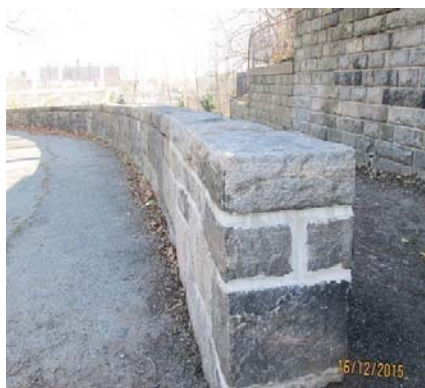
**DEPT. OF PARKS & RECREATION - 846**  
**HIGHBRIDGE PARK RETAINING WALL CUT STONE WALL**  
**Asset # : 14084**

Retaining Walls		Current Repair		Future Replacement		Maintenance		Priority
System Component Type	% of Total	Fail Date (Years)	Estimated Cost	Year FY	Estimated Cost	Cycle (Yrs)	Estimated Cost	
Wall								
Coping								
Masonry:Granite	100%	4+	\$1,100	LIFE	* *	5		
	<i>Jnt Mortar Miss/Erod, Extent : Light, Area Affected : 5%</i>							
	<i>Location : Random Locations Throughout</i>							
Wall/Fence								
Masonry:Granite	55%	4+	\$10,500	LIFE	* *	5	\$1,500	
	<i>Broken/Missing Elements, Extent : Light, Area Affected : 1%</i>							
	<i>Location : At 150 Feet And 215 Feet From South End Of The Wall</i>							
	<i>Jnt Mortar Miss/Erod, Extent : Light, Area Affected : 10%</i>							
	<i>Location : Random Locations Throughout</i>							
	<i>Vegetation Growth, Extent : Light, Area Affected : 5%</i>							
	<i>Location : Throughout The Areas Of Joint Openings</i>							
Masonry:Granite	45%			LIFE	* *	5	\$1,200

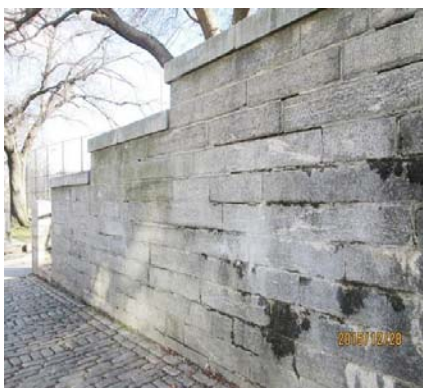
**DEPT. OF PARKS & RECREATION - 846**  
**HIGHBRIDGE PARK RETAINING WALL CUT STONE WALL**

Retaining Walls		Current Repair		Future Replacement		Maintenance		Priority
System Component Type	% of Total	Fail Date (Years)	Estimated Cost	Year FY	Estimated Cost	Cycle (Yrs)	Estimated Cost	
Wall								
Coping								
Masonry:Granite	100%	4+	\$900	LIFE	* *	5		
	<i>Jnt Mortar Miss/Erod, Extent : Light, Area Affected : 4%</i>							
	<i>Location : Random Locations Throughout</i>							
Wall/Fence								
Masonry:Granite	45%	4+	\$4,700	LIFE	* *	5	\$700	
	<i>Efflorescence, Extent : Light, Area Affected : 15%</i>							
	<i>Location : Random Locations Throughout</i>							
	<i>Jnt Mortar Miss/Erod, Extent : Light, Area Affected : 8%</i>							
	<i>Location : Random Locations Throughout</i>							
Masonry:Granite	55%			LIFE	* *	5	\$800	
Base								
Not Accessible	100%

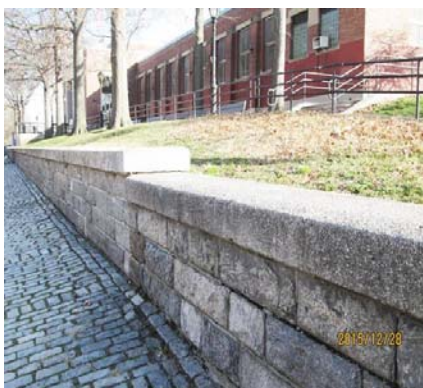
**DEPT. OF PARKS & RECREATION - 846**  
**HIGHBRIDGE PARK RETAINING WALL CUT STONE WALL**

Retaining Walls		Current Repair		Future Replacement		Maintenance		Priority
System	Component Type	% of Total	Fail Date (Years)	Estimated Cost	Year FY	Estimated Cost	Cycle (Yrs)	
Wall								
	Coping							
	Concrete	10%			LIFE	**		
	Masonry:Granite	90%	4+	\$900	LIFE	**	5	
	<i>Jnt Mortar Miss/Erod, Extent : Light, Area Affected : 3%</i>							
	<i>Location : Random Locations Throughout</i>							
	<i>Spalling, Extent : Light, Area Affected : 1%</i>							
	<i>Location : Random Locations Throughout</i>							
Wall/Fence								
	Masonry:Granite	37%	4+	\$1,500	LIFE	**	5	\$200
	<i>Jnt Mortar Miss/Erod, Extent : Light, Area Affected : 2%</i>							
	<i>Location : Random Locations Throughout</i>							
	<i>Spalling, Extent : Light, Area Affected : 1%</i>							
	<i>Location : Random Locations Throughout</i>							
	Masonry:Granite	63%			LIFE	**	5	\$400
Base								
	Not Accessible	100%

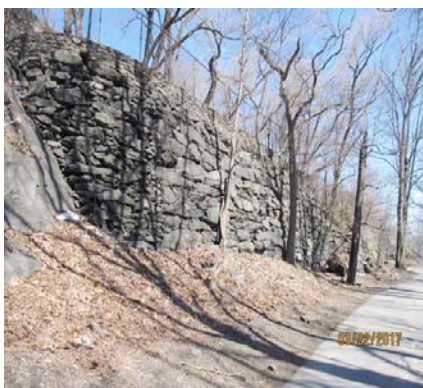
**DEPT. OF PARKS & RECREATION - 846**  
**HIGHBRIDGE PARK RETAINING WALL CUTSTONE PERIMETER WALL**  
**Asset # : 14699**

Retaining Walls		Current Repair		Future Replacement		Maintenance		Priority
System	Component Type	% of Total	Fail Date (Years)	Estimated Cost	Year FY	Estimated Cost	Cycle (Yrs)	
Wall								
	Wall/Fence							
	Metal Fence	10%	Now	\$2,400	LIFE	**	4-8	\$200 1
		<i>Broken/Missing Elements, Extent : Severe, Area Affected : 20%</i>						
		<i>Location : At North End</i>						
	Rubble Stone	90%	2-4	\$212,100	LIFE	**	5	\$1,300
		<i>Broken/Missing Elements, Extent : Moderate, Area Affected : 10%</i>						
		<i>Location : At North End Of Wall</i>						
		<i>Misaligned/Bulging, Extent : Moderate, Area Affected : 30%</i>						
		<i>Location : At North End Of Wall</i>						
		<i>Vegetation Growth, Extent : Light, Area Affected : 5%</i>						
		<i>Location : Scattered Throughout</i>						
Base								
	Not Accessible	100%

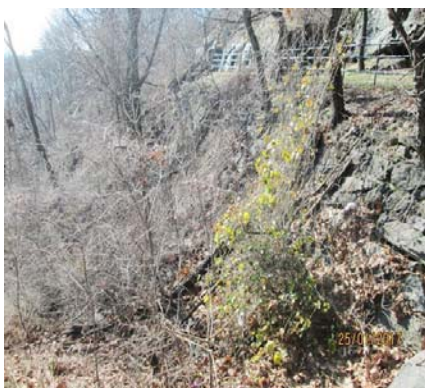
**DEPT. OF PARKS & RECREATION - 846**  
**HIGHBRIDGE PARK RETAINING WALL RETAINING / PERIMETER WALL**  
**Asset # : 14702**

Retaining Walls		Current Repair		Future Replacement		Maintenance		Priority
System Component Type	% of Total	Fail Date (Years)	Estimated Cost	Year FY	Estimated Cost	Cycle (Yrs)	Estimated Cost	
Wall								
Wall/Fence								
Rubble Stone	100%	Now	\$127,800	LIFE	* *	5	\$1,600	
Vegetation Growth, Extent : Severe, Area Affected : 60%								
Location : Throughout, 8+ Trees Over 3 Inch Diameter Throughout								
Other Observation, Extent : Light, Area Affected : 1%								
Location : North Side								
Explanation : 8-inch Steel Drainage Pipe Through Wall								
Base								
Not Accessible	100%

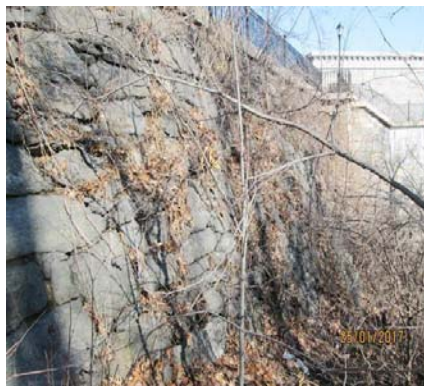
**DEPT. OF PARKS & RECREATION - 846**  
**HIGHBRIDGE PARK RETAINING WALL RETAINING / PERIMETER WALL**  
**Asset # : 14703**

Retaining Walls		Current Repair		Future Replacement		Maintenance			
System	Component Type	% of Total	Fail Date (Years)	Estimated Cost	Year FY	Estimated Cost	Cycle (Yrs)	Estimated Cost	Priority
Wall									
	Coping								
	Masonry:Limestone	100%			LIFE		* *		
		Spalling, Extent : Light, Area Affected : 2%							
		Location : Random Locations Throughout							
Wall/Fence									
	Metal Fence	20%	4+	\$900	LIFE		* *	4-8	\$700
		Broken/Missing Elements, Extent : Moderate, Area Affected : 1%							
		Location : Single Broken Post At South End							
		Impact Damage, Extent : Light, Area Affected : 2%							
		Location : Broken Spindles Southern End Of Fence							
		Loose Fastenings, Extent : Moderate, Area Affected : 2%							
		Location : Weld Failed At Bottom Of Posts Throughout							
	Rubble Stone	80%	2-4	\$16,900	LIFE		* *	5	\$2,100
		Jnt Mortar Miss/Erod, Extent : Moderate, Area Affected : 50%

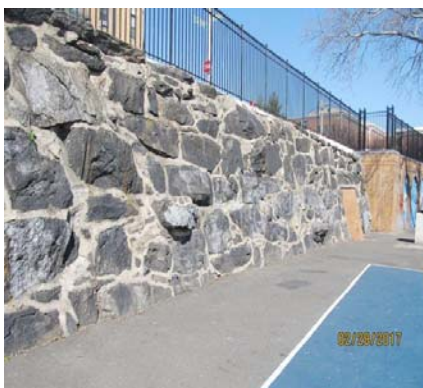
**DEPT. OF PARKS & RECREATION - 846**  
**HIGHBRIDGE PARK RETAINING WALL RUBBLE STONE PERIMETER WALL**  
**Asset # : 14693**

Retaining Walls		Current Repair		Future Replacement		Maintenance		Priority
System	Component Type	% of Total	Fail Date (Years)	Estimated Cost	Year FY	Estimated Cost	Cycle (Yrs)	
Wall								
	Coping							
	Masonry:Schist/Gneiss	80%	4+	\$5,000	LIFE	* *	5	
	<i>Cracking/Crumbling, Extent : Light, Area Affected : 5%</i>							
	<i>Location : At Random Locations</i>							
	<i>Vegetation Growth, Extent : Light, Area Affected : 5%</i>							
	<i>Location : Throughout</i>							
	<i>Other Observation, Extent : Light, Area Affected : 100%</i>							
	<i>Location : Throughout</i>							
	<i>Explanation : Schist With Concrete Parge</i>							
	Masonry:Schist/Gneiss	20%			LIFE	* *	5	
Wall/Fence								
	Rubble Stone	100%	4+	\$17,800	LIFE	* *	5	\$2,200
	<i>Broken/Missing Elements, Extent : Light, Area Affected : 2%</i>							
	<i>Location : At Random Locations</i>							
	<i>Jnt Mortar Miss/Erod, Extent : Light, Area Affected : 2%</i>

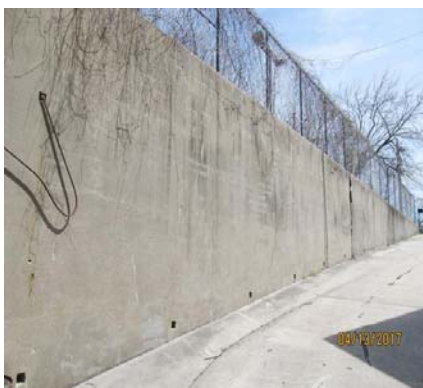
**DEPT. OF PARKS & RECREATION - 846**  
**HIGHBRIDGE PARK RETAINING WALL RUBBLE STONE RETAINING WALL**  
**Asset # : 14685**

Retaining Walls		Current Repair		Future Replacement		Maintenance		Priority
System	Component Type	% of Total	Fail Date (Years)	Estimated Cost	Year FY	Estimated Cost	Cycle (Yrs)	
Wall	Coping							
	Concrete	100%	4+	\$1,900	LIFE	* *		
		<i>Broken/Missing Elements, Extent : Light, Area Affected : 10%</i>						
		<i>Location : Throughout</i>						
		<i>Cracking/Crumbling, Extent : Light, Area Affected : 10%</i>						
		<i>Location : Throughout</i>						
Wall/Fence	Metal Fence	20%	4+	\$2,300	LIFE	* *	4-8	\$200
		<i>Deteriorated Finish, Extent : Light, Area Affected : 5%</i>						
		<i>Location : Random Locations Throughout</i>						
	Rubble Stone	80%	4+	\$4,500	LIFE	* *	5	\$600
		<i>Vegetation Growth, Extent : Light, Area Affected : 1%</i>						
		<i>Location : 10 Inch Diameter Tree Trunk 20 Feet From The South End</i>						
Base	Not Accessible	100%

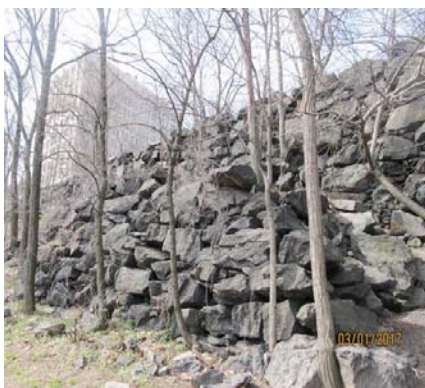
**DEPT. OF PARKS & RECREATION - 846**  
**HIGHBRIDGE PARK RETAINING WALL RUBBLE STONE RETAINING WALL**  
**Asset # : 14686**

Retaining Walls		Current Repair		Future Replacement		Maintenance		Priority
System Component Type	% of Total	Fail Date (Years)	Estimated Cost	Year FY	Estimated Cost	Cycle (Yrs)	Estimated Cost	
Wall								
Wall/Fence								
Rubble Stone	100%	2-4	\$326,600	LIFE	* *	5	\$8,100	
<i>Broken/Missing Elements, Extent : Light, Area Affected : 10%</i>								
<i>Location : At Random Locations</i>								
<i>Excess Worn/Erod Mat, Extent : Severe, Area Affected : 5%</i>								
<i>Location : Base Of Wall, 180 Feet From North End</i>								
<i>Vegetation Growth, Extent : Moderate, Area Affected : 5%</i>								
<i>Location : Random Locations Throughout Includes 6 Trees With Diameter of 3 Plus Inches</i>								
<i>Other Observation, Extent : Light, Area Affected : 1%</i>								
<i>Location : North End</i>								
<i>Explanation : North End Of Wall Collapsed</i>								
Base								
Not Accessible	100%

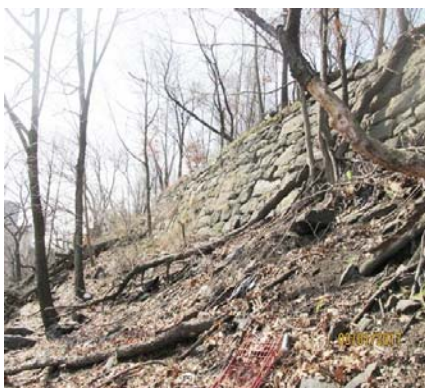
**DEPT. OF PARKS & RECREATION - 846**  
**HIGHBRIDGE PARK RETAINING WALL RUBBLE STONE RETAINING WALL**  
**Asset # : 14687**

Retaining Walls		Current Repair		Future Replacement		Maintenance		Priority
System Component Type	% of Total	Fail Date (Years)	Estimated Cost	Year FY	Estimated Cost	Cycle (Yrs)	Estimated Cost	
Wall								
Wall/Fence								
Rubble Stone	100%	4+	\$11,400	LIFE	* *	5	\$1,400	
<i>Vegetation Growth, Extent : Light, Area Affected : 5%</i>								
<i>Location : At Random Locations</i>								
<i>Other Observation, Extent : Light, Area Affected : 1%</i>								
<i>Location : 25 Feet From North End</i>								
<i>Explanation : Large Stump</i>								
Base								
Not Accessible	100%

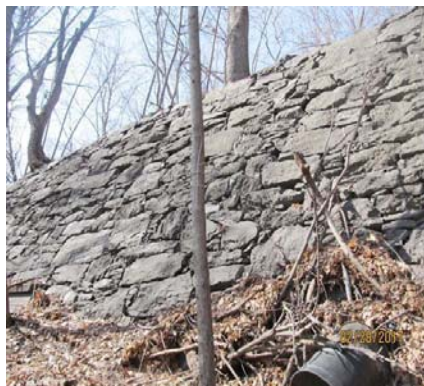
**DEPT. OF PARKS & RECREATION - 846**  
**HIGHBRIDGE PARK RETAINING WALL RUBBLE STONE RETAINING WALL**  
**Asset # : 14688**

Retaining Walls		Current Repair		Future Replacement		Maintenance		Priority
System Component Type	% of Total	Fail Date (Years)	Estimated Cost	Year FY	Estimated Cost	Cycle (Yrs)	Estimated Cost	
Wall								
Wall/Fence								
Rubble Stone	100%	4+	\$16,600	LIFE	* *	5	\$2,100	
Vegetation Growth, Extent : Light, Area Affected : 3%								
Location : 10 Plus Inch Tree Trunks From South End And At Random Locations Throughout								
Other Observation, Extent : Light, Area Affected : 2%								
Location : 60 Feet From North End								
Explanation : Drainage Structure Clogged								
Base								
Not Accessible	100%

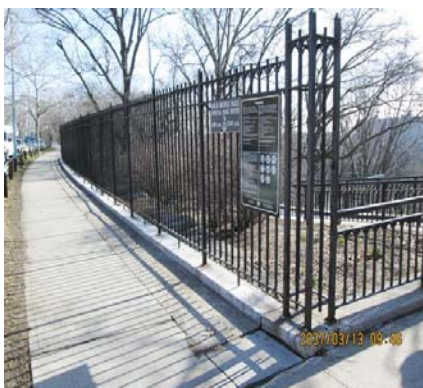
**DEPT. OF PARKS & RECREATION - 846**  
**HIGHBRIDGE PARK RETAINING WALL RUBBLESTONE RETAINING WALL**  
**Asset # : 14697**

Retaining Walls		Current Repair		Future Replacement		Maintenance		Priority
System Component Type	% of Total	Fail Date (Years)	Estimated Cost	Year FY	Estimated Cost	Cycle (Yrs)	Estimated Cost	
Wall								
Coping								
Masonry:Schist/Gneiss	85%	4+	\$2,600	LIFE	* *	5		
	<i>Cracking/Crumbling, Extent : Light, Area Affected : 2%</i>							
	<i>Location : Throughout</i>							
	<i>Vegetation Growth, Extent : Light, Area Affected : 20%</i>							
	<i>Location : Throughout</i>							
	<i>Other Observation, Extent : Light, Area Affected : 100%</i>							
	<i>Location : Throughout</i>							
	<i>Explanation : Schist Parged With Concrete</i>							
Masonry:Schist/Gneiss	15%			LIFE	* *	5		
Wall/Fence								
Rubble Stone	40%	4+	\$10,300	LIFE	* *	5	\$1,300	
	<i>Vegetation Growth, Extent : Moderate, Area Affected : 10%</i>							
	<i>Location : 5 Inch Tree Trunk At Center Of Wall; 6 Inch Tree Trunk At 9 Feet From North Wall; Throughout</i>

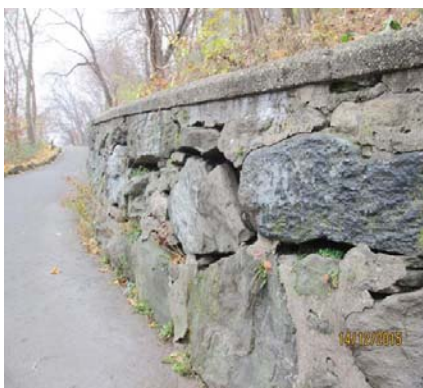
**DEPT. OF PARKS & RECREATION - 846**  
**HIGHBRIDGE PARK RETAINING WALL STACKED STONE W/MORTARED JOINTS**  
**Asset # : 14082**

Retaining Walls		Current Repair		Future Replacement		Maintenance		Priority
System	Component Type	% of Total	Fail Date (Years)	Estimated Cost	Year FY	Estimated Cost	Cycle (Yrs)	
Wall								
	Coping							
	Concrete	98%	4+	\$2,900	LIFE	* *		
		Cracking/Crumbling, Extent : Light, Area Affected : 8%						
		Location : Random Locations Throughout						
		Spalling, Extent : Light, Area Affected : 5%						
		Location : Random Locations Throughout						
		Vegetation Growth, Extent : Light, Area Affected : 15%						
		Location : Random Locations Throughout						
	Concrete	2%	Now	\$1,200	LIFE	* *		
		Broken/Missing Elements, Extent : Severe, Area Affected : 40%						
		Location : Localized Area At The North Part Of Wall						
Wall/Fence								
	Rubble Stone	48%	4+	\$84,500	LIFE	* *	5	\$4,200
		Broken/Missing Elements, Extent : Light, Area Affected : 8%						
		Location : Random Locations Throughout						
		Excess Worn/Erod Mat, Extent : Light, Area Affected : 7%

Location : Random Locations Throughout						
		Jnt Mortar Miss/Erod, Extent : Light, Area Affected : 7%						
		Location : Random Locations Throughout						
		Vegetation Growth, Extent : Light, Area Affected : 5%						
		Location : Random Locations Throughout						
	Rubble Stone	1%	Now	\$7,000	LIFE	* *	5	\$100
		Broken/Missing Elements, Extent : Severe, Area Affected : 20%						
		Location : Localized Area At The North Part Of Wall						
	Rubble Stone	51%			LIFE	* *	5	\$4,500
Base								
	Not Accessible	100%

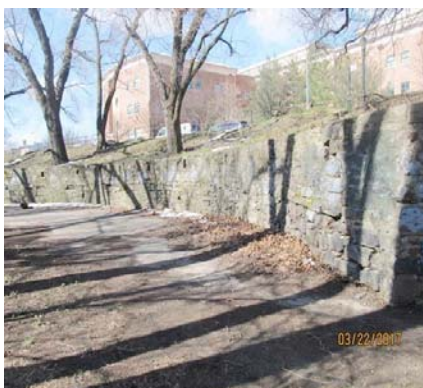
**DEPT. OF PARKS & RECREATION - 846**  
**HIGHBRIDGE PARK RETAINING WALL STONE RETAINING / PERIMETER WALL**  
**Asset # : 14698**

Retaining Walls		Current Repair		Future Replacement		Maintenance			
System	Component Type	% of Total	Fail Date (Years)	Estimated Cost	Year FY	Estimated Cost	Cycle (Yrs)	Estimated Cost	Priority
Wall	Coping								
	Concrete	100%			LIFE		* *		
		Other Observation, Extent : Light, Area Affected : 100%							
		Location : Top Of Wall							
		Explanation : Concrete Parge							
Wall/Fence	Masonry:Schist/Gneiss	100%	2-4	\$61,900	LIFE		* *	5	\$1,800
		Broken/Missing Elements, Extent : Light, Area Affected : 10%							
		Location : Scattered Throughout							
		Cracks-Horizontal, Extent : Moderate, Area Affected : 2%							
		Location : Scattered Throughout							
		Jnt Mortar Miss/Erod, Extent : Moderate, Area Affected : 10%							
		Location : Scattered Throughout							
		Misaligned/Bulging, Extent : Moderate, Area Affected : 5%							
		Location : 75 Feet From South End Of Wall							
		Vegetation Growth, Extent : Light, Area Affected : 5%

Location : Scattered Throughout							
		Cracks-Vertical, Extent : Moderate, Area Affected : 2%							
		Location : Scattered Throughout							
		Other Observation, Extent : Moderate, Area Affected : 1%							
		Location : 60 Feet From South End							
		Explanation : Wall Failure							
Base	Not Accessible	100%

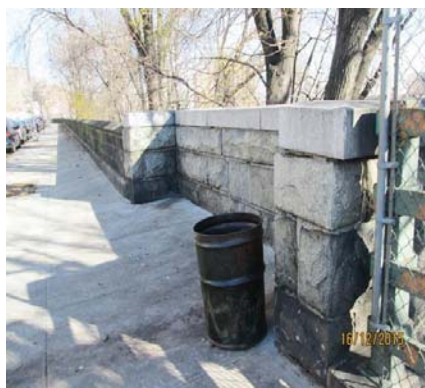
**DEPT. OF PARKS & RECREATION - 846**  
**HIGHBRIDGE PARK RETAINING WALL STONE TOPPED BY CUT STONE**  
**Asset # : 14088**

Retaining Walls		Current Repair		Future Replacement		Maintenance		Priority
System	Component Type	% of Total	Fail Date (Years)	Estimated Cost	Year FY	Estimated Cost	Cycle (Yrs)	
Wall								
	Coping							
	Masonry:Brownstone	80%	4+	\$4,300	LIFE	**	5	\$100
		Broken/Missing Elements, Extent : Light, Area Affected : 2%						
		Location : Random Locations Throughout						
		Jnt Mortar Miss/Erod, Extent : Moderate, Area Affected : 5%						
		Location : Random Locations Throughout						
		Spalling, Extent : Light, Area Affected : 2%						
		Location : 80 Feet From The South End Of The Wall						
	Masonry:Brownstone	20%			LIFE	**	5	
Wall/Fence								
	Masonry:Granite	5%	4+	\$4,600	LIFE	**	5	\$600
		Broken/Missing Elements, Extent : Light, Area Affected : 2%						
		Location : 410 Feet From South End Of The Wall						
		Jnt Mortar Miss/Erod, Extent : Light, Area Affected : 5%						
		Location : Random Locations Throughout

Masonry:Granite	5%			LIFE	**	5	\$600
	Masonry:Sandstone	7%	4+	\$5,600	LIFE	**		
		Broken/Missing Elements, Extent : Light, Area Affected : 2%						
		Location : Random Locations Throughout						
		Cracking/Crumbling, Extent : Light, Area Affected : 1%						
		Location : North Side Of The Wall						
		Jnt Mortar Miss/Erod, Extent : Light, Area Affected : 2%						
		Location : Random Locations Throughout						
		Vegetation Growth, Extent : Light, Area Affected : 2%						
		Location : Random Locations Throughout						
	Masonry:Sandstone	13%			LIFE	**		
	Masonry:Schist/Gneiss	20%	4+	\$15,900	LIFE	**	5	\$2,300
		Broken/Missing Elements, Extent : Light, Area Affected : 1%						
		Location : Random Locations Throughout						
		Jnt Mortar Miss/Erod, Extent : Light, Area Affected : 5%						
		Location : Random Locations Throughout						
		Vegetation Growth, Extent : Light, Area Affected : 5%						
		Location : Random Locations Throughout
