DEPT. OF PARKS & RECREATION - FY 2013

Asset Name : ABE STARK SKATING RINK INDOOR FACILITY
Address : SURF AVE, W. 19 ST. & BOARDWALK
Borough : BROOKLYN **Agency's Number** : B336-01
Program / Asset # : PAR0118.001 / 914 **Yr Built/Renovated** : 1969 / 2007
Area Sq Ft : 43,873 **Project Type** : PARKS AND RECREATION
Date of Survey : 20-Jul-2010 **Landmark Status** : NONE
Areas Surveyed : Basement, Roof, Floors 1
Block : 7072 **Lot** : 14 **BIN** :

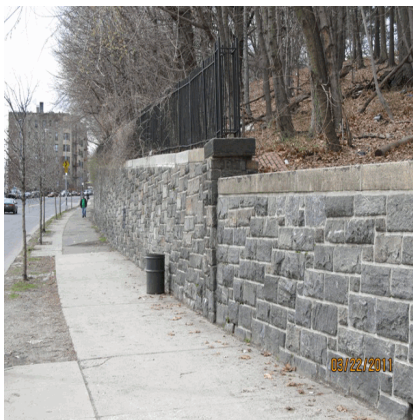
Retaining Walls		Current Repair		Future Replacement		Maintenance		Priority Code
System Component Type	% of Total	Fail Date (Years)	Estimated Cost	Year FY	Estimated Cost	Cycle (Yrs)	Estimated Cost	
Wall								
Coping								
Concrete	100%	2-4	\$5,900	LIFE	* *			A
Cracks-Horizontal, Extent : Moderate, Area Affected : 2%								
Location : Random Locations Throughout The Wall.								
Jnt Mortar Miss/Erod, Extent : Moderate, Area Affected : 5%								
Location : Random Locations Throughout The Wall.								
Recent Repair Evident, Extent : Moderate, Area Affected : 15%								
Location : Random Locations Throughout The Wall.								
Recent Replace Evident, Extent : Moderate, Area Affected : 25%								
Location : Random Locations Throughout The Wall.								
Spalling, Extent : Moderate, Area Affected : 2%								
Location : Random Locations Throughout The Wall.								
Vegetation Growth, Extent : Moderate, Area Affected : 20%

Location : Random Locations Throughout The Wall.								
Wall/Fence								
Metal Fence	18%	4+	\$7,800	LIFE	* *	4-8	\$3,900	B
Impact Damage, Extent : Light, Area Affected : 2%								
Location : Middle Portion Of The Wall.								
Vegetation Growth, Extent : Moderate, Area Affected : 10%								
Location : Random Locations Throughout The Wall.								
Masonry:Schist/Gnies	82%	2-4	\$291,300	LIFE	* *	5	\$14,900	B
Efflorescence, Extent : Moderate, Area Affected : 10%								
Location : Random Locations Throughout The Wall.								
Jnt Mortar Miss/Erod, Extent : Moderate, Area Affected : 5%								
Location : Random Locations Throughout The Wall.								
Misaligned/Bulging, Extent : Moderate, Area Affected : 8%								
Location : Near The South End Of The Wall.								
Recent Repair Evident, Extent : Moderate, Area Affected : 10%								
Location : Random Locations Throughout The Wall.								
Vegetation Growth, Extent : Light, Area Affected : 2%

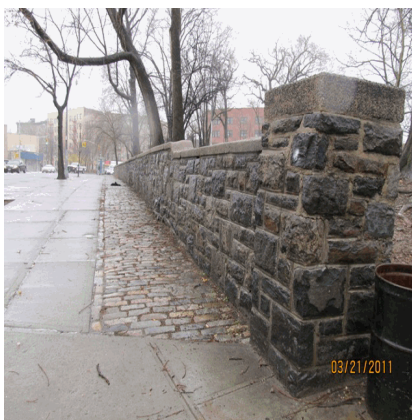
Retaining Walls		Current Repair		Future Replacement		Maintenance		Priority Code
System Component Type	% of Total	Fail Date (Years)	Estimated Cost	Year FY	Estimated Cost	Cycle (Yrs)	Estimated Cost	
Wall								
Coping								
Concrete	100%	2-4	\$300	LIFE	* *			A
	Broken/Missing Elem, Extent : Moderate, Area Affected : 5%							
	Location : Random Locations Throughout The Wall.							
	Cracks-Diagonal, Extent : Moderate, Area Affected : 2%							
	Location : Random Locations Throughout The Wall.							
	Jnt Mortar Miss/Erod, Extent : Moderate, Area Affected : 10%							
	Location : Random Locations Throughout The Wall.							
Wall/Fence								
Masonry:Schist/Gnies	100%	2-4	\$34,500	LIFE	* *	5	\$900	B
	Broken/Missing Elem, Extent : Moderate, Area Affected : 5%							
	Location : West End Portion Of The Wall.							
	Jnt Mortar Miss/Erod, Extent : Moderate, Area Affected : 15%							
	Location : Random Locations Throughout The South Face Of The Wall.

Loose Elements, Extent : Light, Area Affected : 1%							
	Location : South Face Middle Portion Of The Wall.							
	Recent Repair Evident, Extent : Moderate, Area Affected : 10%							
	Location : East End Portion Of The Wall.							
	Vegetation Growth, Extent : Light, Area Affected : 2%							
	Location : Random Locations Throughout The South Face Of The Wall.							
Base								
Not Accessible	100%							D

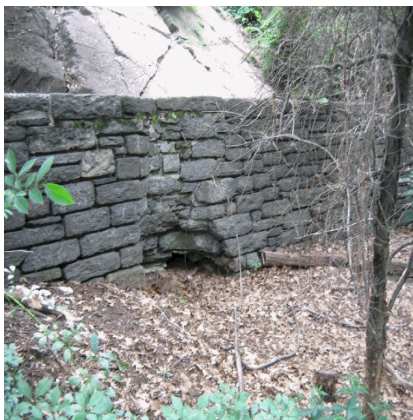
Retaining Walls		Current Repair		Future Replacement		Maintenance		Priority Code
System Component Type	% of Total	Fail Date (Years)	Estimated Cost	Year FY	Estimated Cost	Cycle (Yrs)	Estimated Cost	
Wall								
Coping								
Masonry:Schist/Gnies	100%	2-4	\$400	LIFE	* *	5		A
Broken/Missing Elem, Extent : Light, Area Affected : 1%								
Location : One Stone Missing At North End								
Vegetation Growth, Extent : Light, Area Affected : 5%								
Location : At Mid Length								
Wall/Fence								
Masonry:Schist/Gnies	1%	2-4	\$8,900	LIFE	* *	5		B
Broken/Missing Elem, Extent : Severe, Area Affected : 100%								
Location : One Stone Missing Approximately 30 Inches Long X 10 Inches High Two Feet								
Above Grade Undermining Stone Above It								
Masonry:Schist/Gnies	99%	4+	\$17,700	LIFE	* *	5	\$2,100	B
Broken/Missing Elem, Extent : Light, Area Affected : 5%								
Location : Random Location Throughout Wall

Cracking/Crumbling, Extent : Light, Area Affected : 5%								
Location : North End Of Wall								
Efflorescence, Extent : Light, Area Affected : 1%								
Location : South End								
Jnt Mortar Miss/Erod, Extent : Light, Area Affected : 20%								
Location : Random Location Throughout								
Vegetation Growth, Extent : Moderate, Area Affected : 50%								
Location : Northern Half Of Wall								
Other Observation, Extent : Light, Area Affected : 1%								
Location : Approximately One Third Point From South End								
Explanation : Large Tree Growing In Wall								
Base								
Not Accessible	100%							D

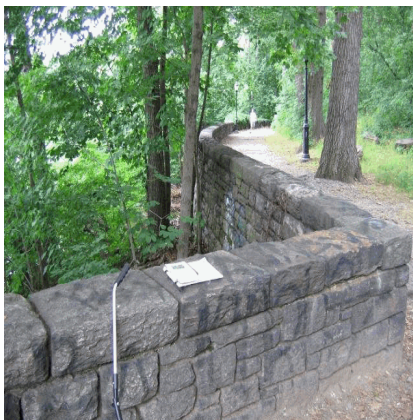
Retaining Walls		Current Repair		Future Replacement		Maintenance		Priority Code
System Component Type	% of Total	Fail Date (Years)	Estimated Cost	Year FY	Estimated Cost	Cycle (Yrs)	Estimated Cost	
Wall								
Coping								
Masonry:Schist/Gnies	100%	4+	\$800	LIFE	* *	5		A
<i>Broken/Missing Elem, Extent : Light, Area Affected : 1%</i> <i>Location : One Stone Missing At South End Staircase</i> <i>Vegetation Growth, Extent : Light, Area Affected : 20%</i> <i>Location : Southern Half Of Coping</i>								
Wall/Fence								
Masonry:Schist/Gnies	100%	2-4	\$32,600	LIFE	* *	5	\$3,900	B
<i>Efflorescence, Extent : Light, Area Affected : 2%</i> <i>Location : South End At Base Of Wall Below Weephole</i> <i>Vegetation Growth, Extent : Moderate, Area Affected : 30%</i> <i>Location : Within Southern Half Of Wall</i> <i>Other Observation, Extent : Light, Area Affected : 1%</i> <i>Location : Approximately At One Third Point From South End</i> <i>Explanation : 3-Inch Steel Utility Pipe Through Wall</i>

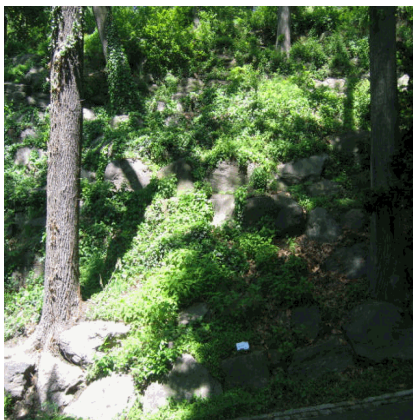
Retaining Walls		Current Repair		Future Replacement		Maintenance		Priority Code
System Component Type	% of Total	Fail Date (Years)	Estimated Cost	Year FY	Estimated Cost	Cycle (Yrs)	Estimated Cost	
Wall								
Wall/Fence								
Rubble Stone	80%			LIFE	* *	5	\$3,000	B
<i>Other Observation, Extent : Moderate, Area Affected : 100%</i>								
<i>Location : Steep Hillside</i>								
<i>Explanation : This Is A Revetment - Large Schist Stones Of Various Sizes Set Into An Earthern Embankment</i>								
Not Accessible	20%							D

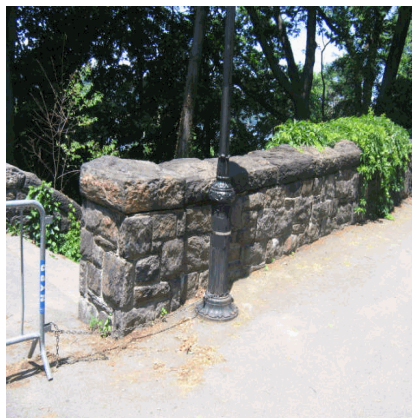
Retaining Walls		Current Repair		Future Replacement		Maintenance		Priority Code
System Component Type	% of Total	Fail Date (Years)	Estimated Cost	Year FY	Estimated Cost	Cycle (Yrs)	Estimated Cost	
Wall								
Coping								
Masonry:Schist/Gnies	100%	4+	\$2,200	LIFE	* *	5		A
	<i>Jnt Mortar Miss/Erod, Extent : Moderate, Area Affected : 30%</i>							
	<i>Location : Eroded Joints Below Coping</i>							
Wall/Fence								
Masonry:Schist/Gnies	60%	4+	\$56,800	LIFE	* *	5	\$2,700	B
	<i>Jnt Mortar Miss/Erod, Extent : Moderate, Area Affected : 30%</i>							
	<i>Location : Throughout</i>							
	<i>Vegetation Growth, Extent : Moderate, Area Affected : 20%</i>							
	<i>Location : Throughout</i>							
Not Accessible	40%							D
	<i>Other Observation, Extent : Light, Area Affected : 0%</i>							
	<i>Location : Throughout</i>							
	<i>Explanation : Covered With Vegetation</i>							
Base								
Not Accessible	100%							D

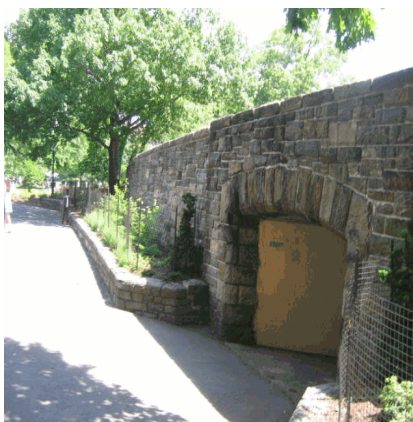
Retaining Walls		Current Repair		Future Replacement		Maintenance		
System Component Type	% of Total	Fail Date (Years)	Estimated Cost	Year FY	Estimated Cost	Cycle (Yrs)	Estimated Cost	Priority Code
Wall								
Coping								
Masonry:Schist/Gnies	100%			LIFE	* *	5		A
Wall/Fence								
Masonry:Schist/Gnies	100%			LIFE	* *	5	\$1,100	B
		Jnt Mortar Miss/Erod, Extent : Light, Area Affected : 10%						
		Location : Back Side Near Ends						
		Vegetation Growth, Extent : Severe, Area Affected : 20%						
		Location : Extensive Ivy And Vines Covering Back Of Wall						
Base								
Not Accessible	100%							D

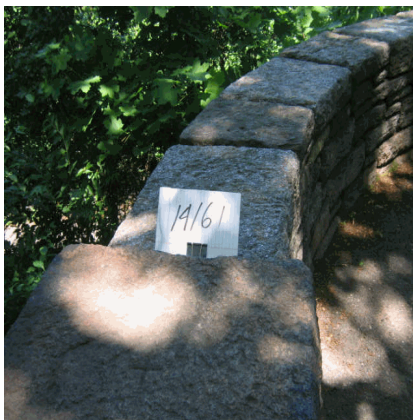
Retaining Walls		Current Repair		Future Replacement		Maintenance		Priority Code
System Component Type	% of Total	Fail Date (Years)	Estimated Cost	Year FY	Estimated Cost	Cycle (Yrs)	Estimated Cost	
Wall								
Coping								
Masonry:Schist/Gnies	100%	Now	\$1,700	LIFE	* *	5		A
<i>Other Observation, Extent : Moderate, Area Affected : 5%</i>								
<i>Location : Throughout</i>								
<i>Explanation : Missing Stones</i>								
Wall/Fence								
Masonry:Schist/Gnies	100%	Now	\$36,900	LIFE	* *	5	\$1,700	B
<i>Broken/Missing Elem, Extent : Light, Area Affected : 2%</i>								
<i>Location : Throughout</i>								
<i>Jnt Mortar Miss/Erod, Extent : Moderate, Area Affected : 30%</i>								
<i>Location : Throughout</i>								
<i>Other Observation, Extent : Moderate, Area Affected : 30%</i>								
<i>Location : Throughout</i>								
<i>Explanation : Vegetation And Efflorescence</i>								
Base								
Not Accessible	100%							D

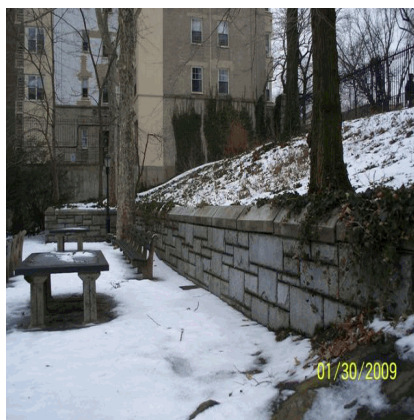
Retaining Walls		Current Repair		Future Replacement		Maintenance		Priority Code
System Component Type	% of Total	Fail Date (Years)	Estimated Cost	Year FY	Estimated Cost	Cycle (Yrs)	Estimated Cost	
Wall								
Coping								
Masonry:Granite	100%	4+	\$1,800	LIFE	* *	5		A
Jnt Mortar Miss/Erod, Extent : Moderate, Area Affected : 75%								
Location : Vertical And Horizontal Joints At Random Locations Throughout Wall.								
Vegetation Growth, Extent : Moderate, Area Affected : 50%								
Location : Random Locations Throughout Wall.								
Wall/Fence								
Masonry:Granite	100%	4+	\$20,300	LIFE	* *	5	\$400	B
Jnt Mortar Miss/Erod, Extent : Moderate, Area Affected : 60%								
Location : Vertical And Horizontal Joints At Random Locations Throughout Wall.								
Misaligned/Bulging, Extent : Moderate, Area Affected : 1%								
Location : Near The South End Of Wall.								
Vegetation Growth, Extent : Light, Area Affected : 20%

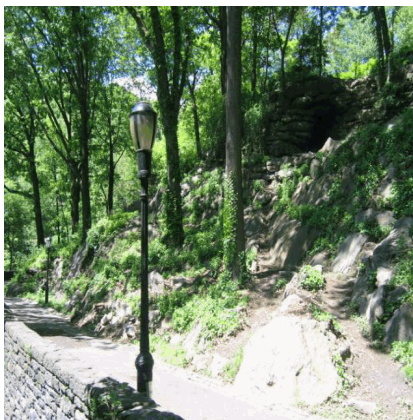
Retaining Walls		Current Repair		Future Replacement		Maintenance		
System Component Type	% of Total	Fail Date (Years)	Estimated Cost	Year FY	Estimated Cost	Cycle (Yrs)	Estimated Cost	Priority Code
Wall								
Wall/Fence								
Rubble Stone	80%			LIFE	* *	5	\$3,800	B
<i>Other Observation, Extent : Moderate, Area Affected : 100%</i>								
<i>Location : Steep Hillside</i>								
<i>Explanation : This Is A Revetment - Large Schist Stones Of Various Sizes Set Into An Earthen Embankment</i>								
No Component	20%							D

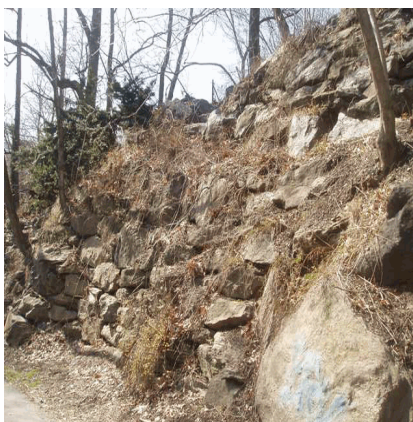
Retaining Walls		Current Repair		Future Replacement		Maintenance		
System Component Type	% of Total	Fail Date (Years)	Estimated Cost	Year FY	Estimated Cost	Cycle (Yrs)	Estimated Cost	Priority Code
Wall								
Wall/Fence								
Metal Fence	10%			LIFE	* *	4-8	\$700	B
Rubble Stone	90%	2-4	\$116,700	LIFE	* *	5	\$4,800	B
<i>Excess Worn/Erod Mat, Extent : Light, Area Affected : 40%</i>								
<i>Location : All Along East Face Of Wall</i>								
<i>Vegetation Growth, Extent : Moderate, Area Affected : 40%</i>								
<i>Location : From South End Up To 150 Ft, East Face</i>								
<i>Other Observation, Extent : Light, Area Affected : 100%</i>								
<i>Location : Along East Face Of Wall.</i>								
<i>Explanation : Slope Protection.</i>								
Base								
Not Accessible	100%							D

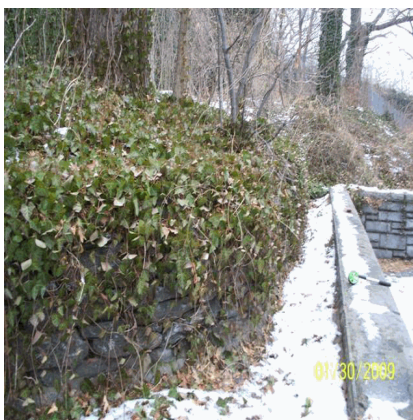
Retaining Walls		Current Repair		Future Replacement		Maintenance		
System Component Type	% of Total	Fail Date (Years)	Estimated Cost	Year FY	Estimated Cost	Cycle (Yrs)	Estimated Cost	Priority Code
Wall								
Wall/Fence								
Rubble Stone	100%	4+	\$8,200	LIFE	* *	5	\$100	B
<i>Broken/Missing Elem, Extent : Light, Area Affected : 2%</i>								
<i>Location : Random Locations Throughout Wall.</i>								
<i>Vegetation Growth, Extent : Moderate, Area Affected : 80%</i>								
<i>Location : Throughout Wall.</i>								
Base								
Not Accessible	100%							D

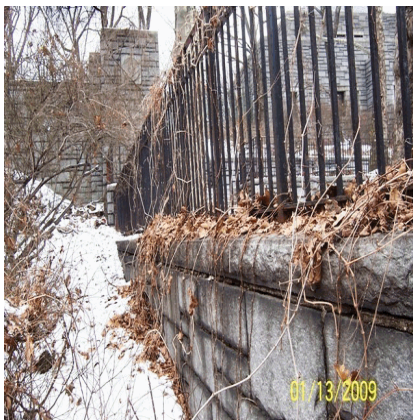
Retaining Walls		Current Repair		Future Replacement		Maintenance		Priority Code
System Component Type	% of Total	Fail Date (Years)	Estimated Cost	Year FY	Estimated Cost	Cycle (Yrs)	Estimated Cost	
Wall								
Coping								
Masonry:Schist/Gnies	100%	4+	\$6,700	LIFE	* *	5		A
<i>Jnt Mortar Miss/Erod, Extent : Severe, Area Affected : 75%</i>								
<i>Location : Throughout Length Of Wall</i>								
Wall/Fence								
Metal Fence	40%	4+	\$3,900	LIFE	* *	4-8	\$1,100	B
<i>Deteriorated Finish, Extent : Moderate, Area Affected : 50%</i>								
<i>Location : Bottom And Top Horizontal Rails; Base Of Vertical Posts</i>								
Masonry:Schist/Gnies	60%	4+	\$172,500	LIFE	* *	5	\$1,400	B
<i>Jnt Mortar Miss/Erod, Extent : Severe, Area Affected : 80%</i>								
<i>Location : Throughout Length Of Wall</i>								
<i>Misaligned/Bulging, Extent : Moderate, Area Affected : 5%</i>								
<i>Location : 23 ft From The Entrance(11 ft Long - 8" Bulge); 71 ft From The Entrance(11 ft Long - 4" Bulge); 32 ft From Opposite Side</i>

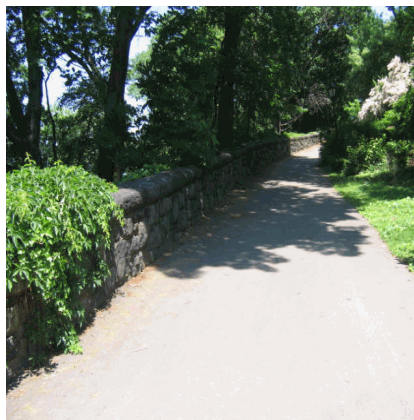
Retaining Walls		Current Repair		Future Replacement		Maintenance		Priority Code
System Component Type	% of Total	Fail Date (Years)	Estimated Cost	Year FY	Estimated Cost	Cycle (Yrs)	Estimated Cost	
Wall								
Coping								
Masonry:Schist/Gnies	100%			LIFE	* *	5		A
Wall/Fence								
Masonry:Schist/Gnies	50%			LIFE	* *	5	\$800	B
Not Accessible	50%							D
Other Observation, Extent : Light, Area Affected : 0%								
Location : Throughout								
Explanation : Covered With Vegetation								
Base								
Not Accessible	100%							D

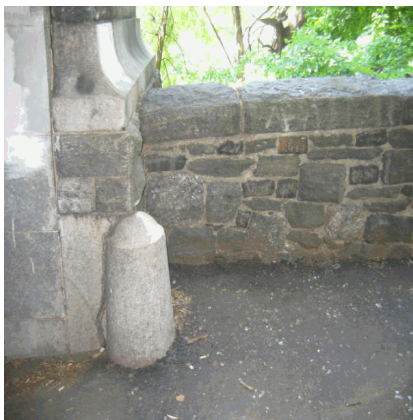
Retaining Walls		Current Repair		Future Replacement		Maintenance		Priority Code
System Component Type	% of Total	Fail Date (Years)	Estimated Cost	Year FY	Estimated Cost	Cycle (Yrs)	Estimated Cost	
Wall								
Coping								
Masonry:Schist/Gnies	100%	4+	\$2,700	LIFE	* *	5	\$100	A
<i>Other Observation, Extent : Light, Area Affected : 10%</i>								
<i>Location : At Beginning Of Wall</i>								
<i>Explanation : Displaced Stones</i>								
Wall/Fence								
Masonry:Schist/Gnies	100%	4+	\$117,100	LIFE	* *	5	\$13,800	B
<i>Jnt Mortar Miss/Erod, Extent : Moderate, Area Affected : 10%</i>								
<i>Location : Throughout</i>								
<i>Other Observation, Extent : Moderate, Area Affected : 30%</i>								
<i>Location : Throughout</i>								
<i>Explanation : Vegetation</i>								
Base								
Not Accessible	100%							D

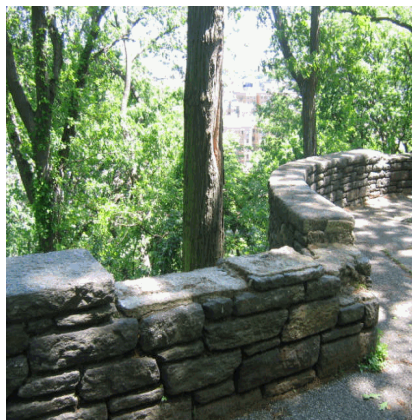
Retaining Walls		Current Repair		Future Replacement		Maintenance		Priority Code
System Component Type	% of Total	Fail Date (Years)	Estimated Cost	Year FY	Estimated Cost	Cycle (Yrs)	Estimated Cost	
Wall								
Coping								
Masonry:Schist/Gnies	100%	Now	\$6,100	LIFE	* *	5		A
<i>Other Observation, Extent : Light, Area Affected : 10%</i>								
<i>Location : Beginning Of Wall</i>								
<i>Explanation : Missing Stones</i>								
Wall/Fence								
Masonry:Schist/Gnies	100%	Now	\$26,500	LIFE	* *	5	\$3,100	B
<i>Broken/Missing Elem, Extent : Light, Area Affected : 2%</i>								
<i>Location : Beginning Of Wall</i>								
<i>Jnt Mortar Miss/Erod, Extent : Light, Area Affected : 2%</i>								
<i>Location : Throughout</i>								
<i>Other Observation, Extent : Moderate, Area Affected : 30%</i>								
<i>Location : Throughout</i>								
<i>Explanation : Vegetation</i>								
Base								
Not Accessible	100%							D

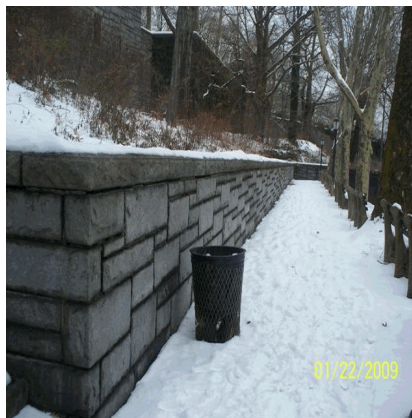
Retaining Walls		Current Repair		Future Replacement		Maintenance		Priority Code
System Component Type	% of Total	Fail Date (Years)	Estimated Cost	Year FY	Estimated Cost	Cycle (Yrs)	Estimated Cost	
Wall								
Coping								
Masonry:Granite	100%	4+	\$3,300	LIFE	* *	5		A
Jnt Mortar Miss/Erod, Extent : Severe, Area Affected : 80%								
Location : Vertical And Horizontal Joints Throughout.								
Vegetation Growth, Extent : Moderate, Area Affected : 5%								
Location : Scattered Throughout.								
Wall/Fence								
Masonry:Granite	100%	4+	\$18,300	LIFE	* *	5	\$800	B
Broken/Missing Elem, Extent : Moderate, Area Affected : 1%								
Location : North End Of Wall.								
Jnt Mortar Miss/Erod, Extent : Severe, Area Affected : 50%								
Location : Vertical And Horizontal Joints At Random Locations Throughout Wall.								
Vegetation Growth, Extent : Light, Area Affected : 5%								
Location : Scattered Throughout Wall.

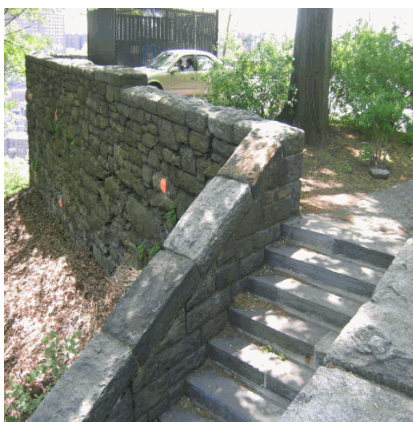
Retaining Walls		Current Repair		Future Replacement		Maintenance		
System Component Type	% of Total	Fail Date (Years)	Estimated Cost	Year FY	Estimated Cost	Cycle (Yrs)	Estimated Cost	Priority Code
Wall								
Coping								
Masonry:Schist/Gnies	100%			LIFE	* *	5		A
Wall/Fence								
Masonry:Schist/Gnies	80%	Now	\$165,100	LIFE	* *	5	\$3,900	B
			<i>Broken/Missing Elem, Extent : Moderate, Area Affected : 5%</i>					
			<i>Location : East Side</i>					
			<i>Cracking/Crumbling, Extent : Moderate, Area Affected : 20%</i>					
			<i>Location : At Beginning Face Of Wall</i>					
			<i>Loose Elements, Extent : Moderate, Area Affected : 20%</i>					
			<i>Location : At Beginning Face Of Wall</i>					
			<i>Vegetation Growth, Extent : Moderate, Area Affected : 30%</i>					
			<i>Location : Seasonal Vegetation Throughout East Face</i>					
			<i>Other Observation, Extent : Moderate, Area Affected : 3%</i>					
			<i>Location : East Side</i>

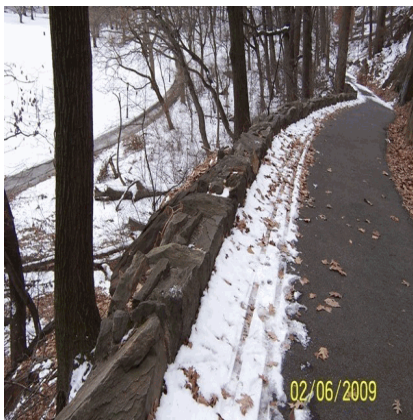
Retaining Walls		Current Repair		Future Replacement		Maintenance		
System Component Type	% of Total	Fail Date (Years)	Estimated Cost	Year FY	Estimated Cost	Cycle (Yrs)	Estimated Cost	Priority Code
Wall								
Wall/Fence								
Masonry:Schist/Gnies	100%	4+	\$12,200	LIFE	* *	5	\$600	B
<i>Broken/Missing Elem, Extent : Light, Area Affected : 2%</i> <i>Location : 77 Ft From The Left End Of The Wall Facing Towards The Hill.</i> <i>Vegetation Growth, Extent : Moderate, Area Affected : 90%</i> <i>Location : Throughout.</i> <i>Other Observation, Extent : Moderate, Area Affected : 2%</i> <i>Location : 7ft From The Right End Of The Wall Facing Towards The Hill.</i> <i>Explanation : 7 Ft Long Wall Section Is Leaning Approx. 12 In.</i>								
Base								
Not Accessible	100%							D

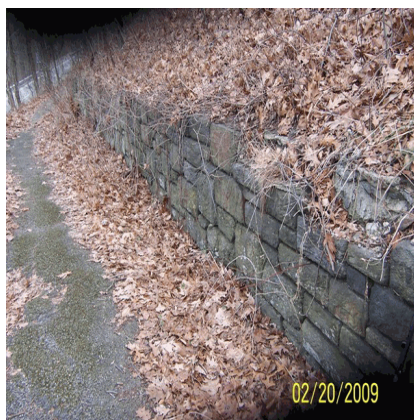
Retaining Walls		Current Repair		Future Replacement		Maintenance		Priority Code
System Component Type	% of Total	Fail Date (Years)	Estimated Cost	Year FY	Estimated Cost	Cycle (Yrs)	Estimated Cost	
Wall								
Wall/Fence								
Masonry:Schist/Gnies	100%	4+	\$21,000	LIFE	* *	5	\$500	B
<i>Broken/Missing Elem, Extent : Light, Area Affected : 2%</i> <i>Location : Approx. 10 Ft, 40 Ft And 50 Ft From The Upper End Of The Wall.</i> <i>Efflorescence, Extent : Light, Area Affected : 25%</i> <i>Location : Throughout.</i> <i>Jnt Mortar Miss/Erod, Extent : Moderate, Area Affected : 10%</i> <i>Location : Throughout.</i> <i>Vegetation Growth, Extent : Light, Area Affected : 25%</i> <i>Location : Throughout.</i>								
Base								
Not Accessible	100%							D

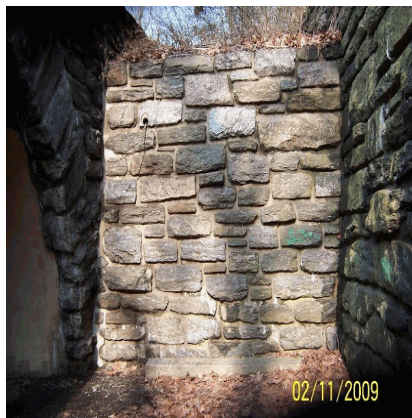
Retaining Walls		Current Repair		Future Replacement		Maintenance		Priority Code
System Component Type	% of Total	Fail Date (Years)	Estimated Cost	Year FY	Estimated Cost	Cycle (Yrs)	Estimated Cost	
Wall								
Wall/Fence								
Masonry:Schist/Gnies	100%	4+	\$8,800	LIFE	* *	5	\$1,100	B
<i>Efflorescence, Extent : Light, Area Affected : 2%</i>								
<i>Location : Throughout</i>								
<i>Staining/Scaling, Extent : Light, Area Affected : 60%</i>								
<i>Location : Throughout</i>								
<i>Vegetation Growth, Extent : Light, Area Affected : 10%</i>								
<i>Location : Throughout</i>								
Base								
Not Accessible	100%							D

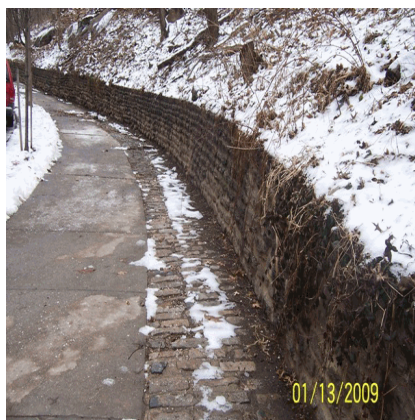
Retaining Walls		Current Repair		Future Replacement		Maintenance		Priority Code
System Component Type	% of Total	Fail Date (Years)	Estimated Cost	Year FY	Estimated Cost	Cycle (Yrs)	Estimated Cost	
Wall								
Coping								
Masonry:Schist/Gnies	100%	4+	\$5,400	LIFE	* *	5		A
<i>Vegetation Growth, Extent : Moderate, Area Affected : 15%</i>								
<i>Location : Middle Of Wall</i>								
Wall/Fence								
Masonry:Schist/Gnies	100%	4+	\$23,100	LIFE	* *	5	\$3,000	B
<i>Broken/Missing Elem, Extent : Light, Area Affected : 1%</i>								
<i>Location : Random Locations, Middle And South End Of Wall</i>								
<i>Jnt Mortar Miss/Erod, Extent : Light, Area Affected : 10%</i>								
<i>Location : Middle Of Wall Throughout</i>								
<i>Vegetation Growth, Extent : Light, Area Affected : 10%</i>								
<i>Location : Middle Of Wall</i>								
<i>Other Observation, Extent : Light, Area Affected : 1%</i>

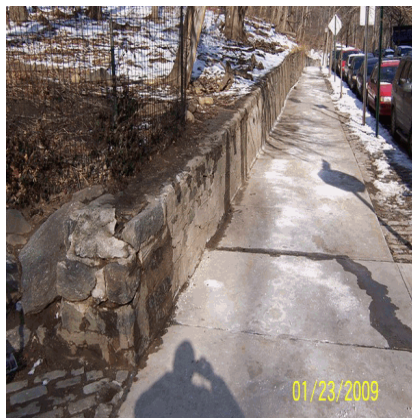
Retaining Walls		Current Repair		Future Replacement		Maintenance		
System Component Type	% of Total	Fail Date (Years)	Estimated Cost	Year FY	Estimated Cost	Cycle (Yrs)	Estimated Cost	Priority Code
Wall								
Wall/Fence								
Rubble Stone	100%	4+	\$15,200	LIFE	* *	5	\$700	B
<i>Broken/Missing Elem, Extent : Moderate, Area Affected : 5%</i>								
<i>Location : Throughout.</i>								
<i>Jnt Mortar Miss/Erod, Extent : Moderate, Area Affected : 10%</i>								
<i>Location : Throughout.</i>								
<i>Misaligned/Bulging, Extent : Moderate, Area Affected : 5%</i>								
<i>Location : 25ft Long 3" Bulging, 32ft From The Left End Of The Wall Facing From Payson Ave.</i>								
Base								
Not Accessible	100%							D

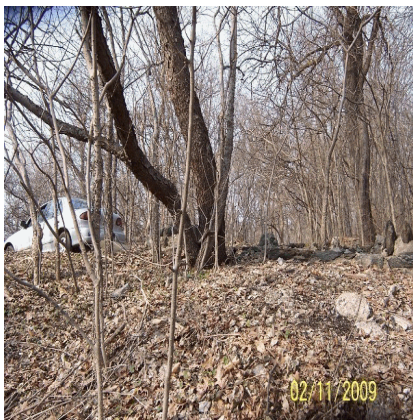
Retaining Walls		Current Repair		Future Replacement		Maintenance		Priority Code
System Component Type	% of Total	Fail Date (Years)	Estimated Cost	Year FY	Estimated Cost	Cycle (Yrs)	Estimated Cost	
Wall								
Wall/Fence								
Masonry:Schist/Gnies	5%	Now	\$7,800	LIFE	* *	5		B
<i>Other Observation, Extent : Severe, Area Affected : 80%</i> <i>Location : Approx. 48 Ft And 65 Ft From The Lower End Of The Wall.</i> <i>Explanation : Broken And Missing Elements With Exposed Earth.</i>								
Masonry:Schist/Gnies	95%	4+	\$12,400	LIFE	* *	5	\$600	B
<i>Broken/Missing Elem, Extent : Light, Area Affected : 5%</i> <i>Location : Throughout</i> <i>Recent Repair Evident, Extent : Light, Area Affected : 10%</i> <i>Location : Throughout</i> <i>Vegetation Growth, Extent : Moderate, Area Affected : 2%</i> <i>Location : Throughout.</i>								
Base								
Not Accessible	100%							D

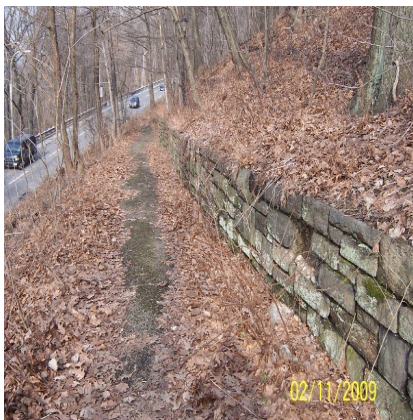
Retaining Walls		Current Repair		Future Replacement		Maintenance		
System Component Type	% of Total	Fail Date (Years)	Estimated Cost	Year FY	Estimated Cost	Cycle (Yrs)	Estimated Cost	Priority Code
Wall								
Coping								
Masonry:Schist/Gnies	5%	Now	\$500	LIFE	* *	5		A
Misaligned/Bulging, Extent : Severe, Area Affected : 80%								
Location : Approx. 180 Ft And 280 Ft From The Lower End Of The Wall.								
Masonry:Schist/Gnies	95%	4+	\$1,500	LIFE	* *	5		A
Broken/Missing Elem, Extent : Moderate, Area Affected : 20%								
Location : Throughout.								
Vegetation Growth, Extent : Light, Area Affected : 30%								
Location : Throughout								
Wall/Fence								
Masonry:Schist/Gnies	5%	Now	\$19,900	LIFE	* *	5	\$100	B
Other Observation, Extent : Severe, Area Affected : 80%								
Location : Approx. 180 Ft And 280 Ft From The Lower End Of The Wall. At 180 Ft, The Section Is 8 Ft Long And Has 8 In Bulge. At 280 Ft, The Section Is 10 Ft Long And Has 16 In Bulge.

Explanation : Bulging Section Has Failed Completely.								
Masonry:Schist/Gnies	95%	4+	\$62,900	LIFE	* *	5	\$1,600	B
Broken/Missing Elem, Extent : Moderate, Area Affected : 10%								
Location : Throughout								
Base								
Not Accessible	100%							D

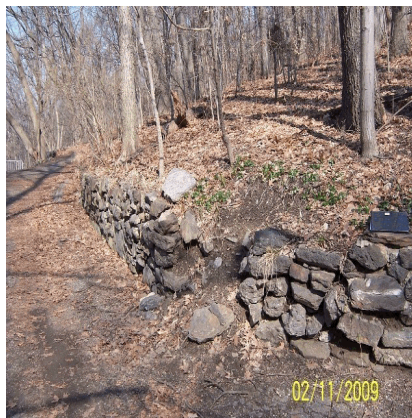
Retaining Walls		Current Repair		Future Replacement		Maintenance		Priority Code
System Component Type	% of Total	Fail Date (Years)	Estimated Cost	Year FY	Estimated Cost	Cycle (Yrs)	Estimated Cost	
Wall								
Wall/Fence								
Masonry:Schist/Gnies	2%	Now	\$3,800	LIFE	* *	5		B
<i>Broken/Missing Elem, Extent : Severe, Area Affected : 80%</i> <i>Location : Approx. 50 Ft And 150 Ft From The Lower End Of The Wall. At 50 Ft, 6 Ft Long Section Has Failed Completely. At 150 Ft, 30 Ft Long Partial Collapse Section Has Exposed Earth.</i>								
Masonry:Schist/Gnies	98%	4+	\$30,700	LIFE	* *	5	\$800	B
<i>Broken/Missing Elem, Extent : Moderate, Area Affected : 5%</i> <i>Location : Throughout.</i> <i>Misaligned/Bulging, Extent : Light, Area Affected : 5%</i> <i>Location : Throughout.</i> <i>Vegetation Growth, Extent : Light, Area Affected : 5%</i> <i>Location : Throughout.</i>								
Base								
Not Accessible	100%							D

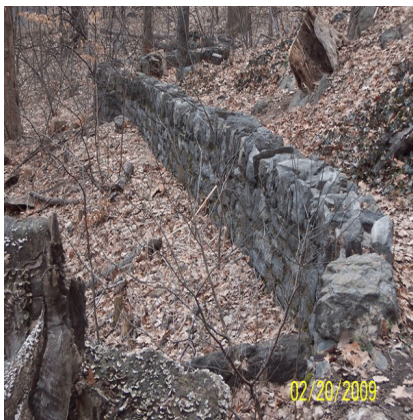
Retaining Walls		Current Repair		Future Replacement		Maintenance		Priority Code
System Component Type	% of Total	Fail Date (Years)	Estimated Cost	Year FY	Estimated Cost	Cycle (Yrs)	Estimated Cost	
Wall								
Coping								
Rubble Stone	100%	4+	\$200	LIFE	* *	5	\$100	A
<i>Broken/Missing Elem, Extent : Light, Area Affected : 2%</i>								
<i>Location : Approx. 30 Ft And 40 Ft From The Upper End Of The Wall.</i>								
Wall/Fence								
Rubble Stone	100%	4+	\$8,400	LIFE	* *	5	\$900	B
<i>Jnt Mortar Miss/Erod, Extent : Light, Area Affected : 5%</i>								
<i>Location : Throughout.</i>								
<i>Vegetation Growth, Extent : Moderate, Area Affected : 20%</i>								
<i>Location : Throughout.</i>								
Base								
Not Accessible	100%							D

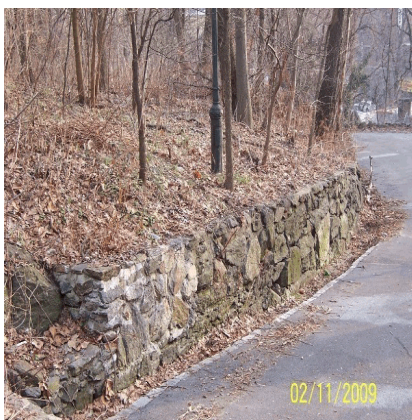
Retaining Walls		Current Repair		Future Replacement		Maintenance		Priority Code
System Component Type	% of Total	Fail Date (Years)	Estimated Cost	Year FY	Estimated Cost	Cycle (Yrs)	Estimated Cost	
Wall								
Coping								
Concrete	35%			LIFE	* *			A
<i>Other Observation, Extent : Light, Area Affected : 100%</i> <i>Location : Left End Of The Wall, Facing From Payson Ave.</i> <i>Explanation : 127 ft Long Concrete Coping Can Be Found At The Left End Of The Wall, Facing From Payson Ave.</i>								
No Component	65%							D
Wall/Fence								
Masonry:Schist/Gnies	65%	4+	\$56,600	LIFE	* *	5	\$1,500	B
<i>Broken/Missing Elem, Extent : Light, Area Affected : 5%</i> <i>Location : Throughout</i> <i>Vegetation Growth, Extent : Moderate, Area Affected : 10%</i> <i>Location : Throughout.</i>								
Rubble Stone	35%			LIFE	* *	5	\$700	B
<i>Other Observation, Extent : Light, Area Affected : 100%</i> <i>Location : Left End Of The Wall, Facing From Payson Ave.</i> <i>Explanation : 127 ft Long Rubble Wall Section Can Be Found At The Left End Of The Wall, Facing From Payson Ave.</i>

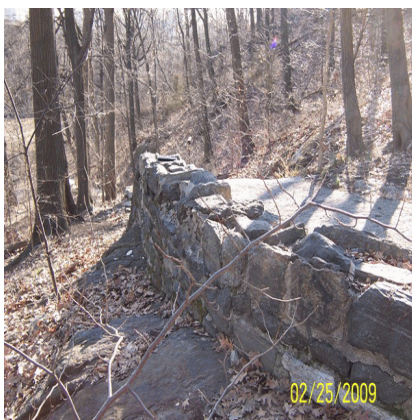
Retaining Walls		Current Repair		Future Replacement		Maintenance		Priority Code
System Component Type	% of Total	Fail Date (Years)	Estimated Cost	Year FY	Estimated Cost	Cycle (Yrs)	Estimated Cost	
Wall								
Coping								
Rubble Stone	100%	4+	\$200	LIFE	* *	5		A
Broken/Missing Elem, Extent : Moderate, Area Affected : 5%								
Location : 15 Ft, 45 Ft And 145 Ft From The Lower End Of The Wall.								
Vegetation Growth, Extent : Light, Area Affected : 2%								
Location : Throughout								
Wall/Fence								
Rubble Stone	100%	4+	\$2,100	LIFE	* *	5	\$200	B
Broken/Missing Elem, Extent : Light, Area Affected : 5%								
Location : Throughout.								
Vegetation Growth, Extent : Light, Area Affected : 5%								
Location : Throughout.								
Base								
Not Accessible	100%							D

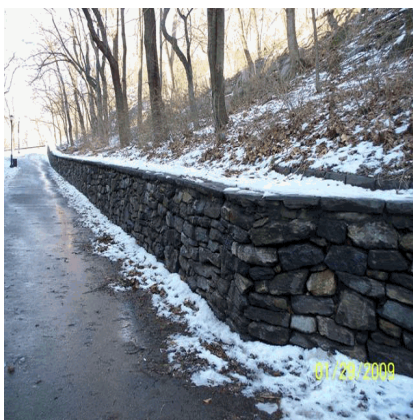
Retaining Walls		Current Repair		Future Replacement		Maintenance		Priority Code
System Component Type	% of Total	Fail Date (Years)	Estimated Cost	Year FY	Estimated Cost	Cycle (Yrs)	Estimated Cost	
Wall								
Coping								
Masonry:Schist/Gnies	100%	4+	\$2,500	LIFE	* *	5		A
<i>Broken/Missing Elem, Extent : Light, Area Affected : 2%</i>								
<i>Location : Random Locations Throughout Wall.</i>								
<i>Cracks-Diagonal, Extent : Light, Area Affected : 2%</i>								
<i>Location : Random Locations Throughout Wall.</i>								
<i>Jnt Mortar Miss/Erod, Extent : Moderate, Area Affected : 30%</i>								
<i>Location : Horizontal Joint At Random Locations Throughout Wall.</i>								
Wall/Fence								
Rubble Stone	100%	4+	\$18,000	LIFE	* *	5	\$800	B
<i>Broken/Missing Elem, Extent : Light, Area Affected : 10%</i>								
<i>Location : Random Locations Throughout Wall.</i>								
<i>Jnt Mortar Miss/Erod, Extent : Light, Area Affected : 5%</i>

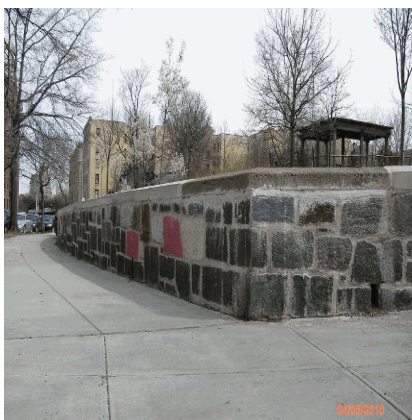
Retaining Walls		Current Repair		Future Replacement		Maintenance		Priority Code
System Component Type	% of Total	Fail Date (Years)	Estimated Cost	Year FY	Estimated Cost	Cycle (Yrs)	Estimated Cost	
Wall								
Coping								
Concrete	100%	4+	\$300	LIFE	* *			A
<i>Jnt Mortar Miss/Erod, Extent : Light, Area Affected : 10%</i> <i>Location : Close To The North End Of The Wall.</i> <i>Misaligned/Bulging, Extent : Light, Area Affected : 4%</i> <i>Location : Less Than 1/2" Bulge At The South Portion Of The Wall.</i> <i>Recent Replace Evident, Extent : Moderate, Area Affected : 80%</i> <i>Location : Throughout The Wall.</i> <i>Spalling, Extent : Light, Area Affected : 2%</i> <i>Location : South Portion Of The Wall.</i>								
Wall/Fence								
Masonry:Schist/Gnies	100%			LIFE	* *	5	\$900	B
<i>Jnt Mortar Miss/Erod, Extent : Light, Area Affected : 4%</i> <i>Location : Random Locations Throughout The Wall.</i> <i>Recent Repair Evident, Extent : Moderate, Area Affected : 30%</i> <i>Location : Joint Mortar At Random Locations Throughout The Wall.</i>

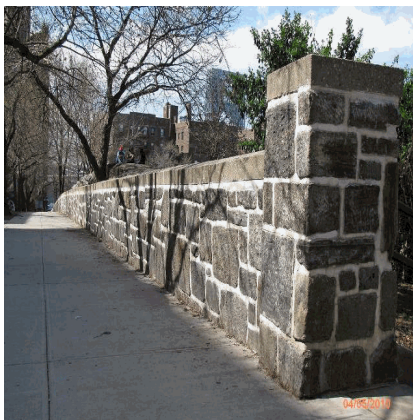
Retaining Walls		Current Repair		Future Replacement		Maintenance		Priority Code
System Component Type	% of Total	Fail Date (Years)	Estimated Cost	Year FY	Estimated Cost	Cycle (Yrs)	Estimated Cost	
Wall								
Coping								
Concrete	100%	4+	\$100	LIFE	* *			A
<i>Cracks-Horizontal, Extent : Light, Area Affected : 5%</i> <i>Location : Random Locations Throughout The Wall</i> <i>Jnt Mortar Miss/Erod, Extent : Light, Area Affected : 5%</i> <i>Location : Ramdon Locations Throughout The North Face Of The Wall.</i> <i>Spalling, Extent : Light, Area Affected : 2%</i> <i>Location : North Face Of The Wall.</i>								
Wall/Fence								
Masonry:Schist/Gnies	100%	4+	\$12,700	LIFE	* *	5	\$700	B
<i>Broken/Missing Elem, Extent : Light, Area Affected : 2%</i> <i>Location : South Face Of The Wall</i> <i>Recent Repair Evident, Extent : Light, Area Affected : 30%</i> <i>Location : Mortar Joints At Random Locations Throughout The Wall.</i> <i>Cracks-Vertical, Extent : Light, Area Affected : 2%</i> <i>Location : Random Locations Throughout The Wall.</i>

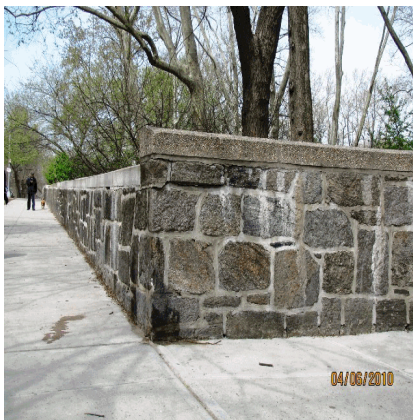
Retaining Walls		Current Repair		Future Replacement		Maintenance		Priority Code
System Component Type	% of Total	Fail Date (Years)	Estimated Cost	Year FY	Estimated Cost	Cycle (Yrs)	Estimated Cost	
Wall								
Coping								
Concrete	100%	4+	\$100	LIFE	* *			A
<i>Cracks-Horizontal, Extent : Light, Area Affected : 10%</i>								
<i>Location : Random Locations Throughout The Wall.</i>								
<i>Jnt Mortar Miss/Erod, Extent : Light, Area Affected : 10%</i>								
<i>Location : Random Locations Throughout The Wall.</i>								
<i>Recent Replace Evident, Extent : Moderate, Area Affected : 40%</i>								
<i>Location : Random Locations Throughout The Wall.</i>								
Wall/Fence								
Masonry:Schist/Gnies	100%	4+	\$7,700	LIFE	* *	5	\$1,000	B
<i>Jnt Mortar Miss/Erod, Extent : Light, Area Affected : 10%</i>								
<i>Location : Random Locations Throughout The Wall.</i>								
<i>Recent Repair Evident, Extent : Light, Area Affected : 30%</i>

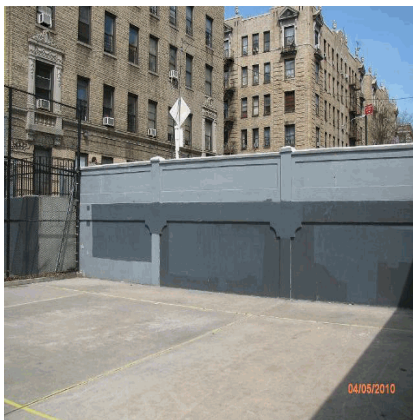
Retaining Walls		Current Repair		Future Replacement		Maintenance		Priority Code
System Component Type	% of Total	Fail Date (Years)	Estimated Cost	Year FY	Estimated Cost	Cycle (Yrs)	Estimated Cost	
Wall								
Coping								
Concrete	100%	4+	\$100	LIFE	* *			A
	<i>Cracks-Horizontal, Extent : Severe, Area Affected : 2%</i>							
	<i>Location : Middle Portion Of The Wall</i>							
	<i>Spalling, Extent : Light, Area Affected : 2%</i>							
	<i>Location : Random Locations Throughout The Wall.</i>							
Wall/Fence								
Concrete	90%	4+	\$19,900	LIFE	* *	5	\$100	B
	<i>Cracks-Horizontal, Extent : Light, Area Affected : 4%</i>							
	<i>Location : South Face Of The Wall.</i>							
	<i>Spalling, Extent : Moderate, Area Affected : 6%</i>							
	<i>Location : North Face Of The Wall</i>							
	<i>Cracks-Vertical, Extent : Severe, Area Affected : 8%</i>							
	<i>Location : North Face Of The Wall</i>

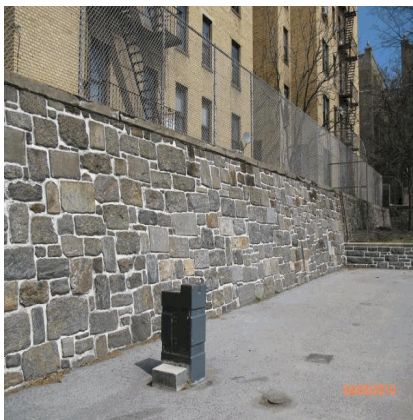
Retaining Walls		Current Repair		Future Replacement		Maintenance		Priority Code
System Component Type	% of Total	Fail Date (Years)	Estimated Cost	Year FY	Estimated Cost	Cycle (Yrs)	Estimated Cost	
Wall								
Coping								
Concrete	100%	4+	\$1,600	LIFE	* *			A
	<i>Jnt Mortar Miss/Erod, Extent : Moderate, Area Affected : 10%</i>							
	<i>Location : Random Locations Throughout The Wall.</i>							
	<i>Spalling, Extent : Moderate, Area Affected : 15%</i>							
	<i>Location : Random Locations Throughout The Wall.</i>							
Wall/Fence								
Metal Fence	45%			LIFE	* *	4-8	\$1,300	B
Masonry:Schist/Gnies	55%	4+	\$53,300	LIFE	* *	5	\$1,400	B
	<i>Jnt Mortar Miss/Erod, Extent : Light, Area Affected : 20%</i>							
	<i>Location : Random Locations Throughout The North And South Face Of The Wall.</i>							
	<i>Recent Repair Evident, Extent : Light, Area Affected : 30%</i>							
	<i>Location : Mortar Joints At The South Face Of The Wall.</i>

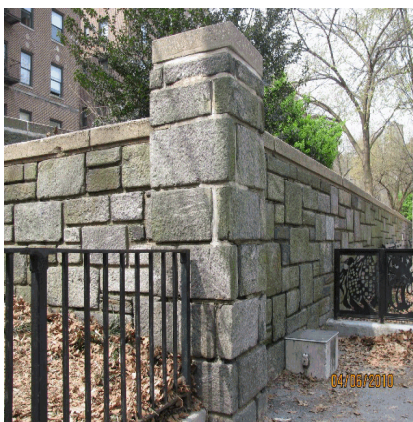
Retaining Walls		Current Repair		Future Replacement		Maintenance		Priority Code
System Component Type	% of Total	Fail Date (Years)	Estimated Cost	Year FY	Estimated Cost	Cycle (Yrs)	Estimated Cost	
Wall								
Coping								
Concrete	100%	4+	\$500	LIFE	* *			A
	<i>Cracks-Horizontal, Extent : Moderate, Area Affected : 30%</i>							
	<i>Location : Random Locations Throughout The Wall</i>							
	<i>Jnt Mortar Miss/Erod, Extent : Moderate, Area Affected : 20%</i>							
	<i>Location : Random Locations Throughout The Wall.</i>							
	<i>Misaligned/Bulging, Extent : Light, Area Affected : 2%</i>							
	<i>Location : 1" Bulge At The West Portion Of The Wall</i>							
Wall/Fence								
Masonry:Schist/Gnies	100%	4+	\$27,800	LIFE	* *	5	\$700	B
	<i>Jnt Mortar Miss/Erod, Extent : Moderate, Area Affected : 25%</i>							
	<i>Location : Random Locations Throughout The Wall.</i>							
Base								
Not Accessible	100%							D

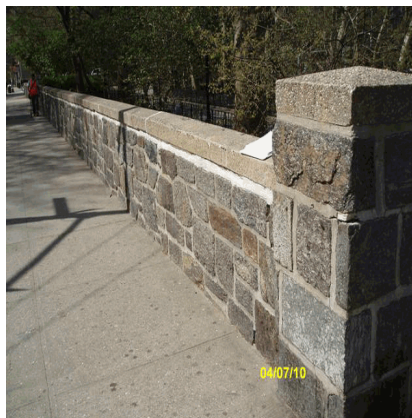
Retaining Walls		Current Repair		Future Replacement		Maintenance		Priority Code
System Component Type	% of Total	Fail Date (Years)	Estimated Cost	Year FY	Estimated Cost	Cycle (Yrs)	Estimated Cost	
Wall								
Coping								
Concrete	100%	4+	\$500	LIFE	* *			A
<i>Broken/Missing Elem, Extent : Light, Area Affected : 10%</i> <i>Location : 20ft. From South Of Ft. Washington Ave. Entrance.</i> <i>Excess Worn/Erod Mat, Extent : Moderate, Area Affected : 5%</i> <i>Location : Various Locations Throughout.</i> <i>Misaligned/Bulging, Extent : Light, Area Affected : 1%</i> <i>Location : Coping Misaligned 1" 173ft South Of Ft. Wasington Ave. Entrance.</i> <i>Recent Repair Evident, Extent : Moderate, Area Affected : 30%</i> <i>Location : Surface Mortor Replaced Under Coping At Various Locations.</i> <i>Other Observation, Extent : Moderate, Area Affected : 5%</i> <i>Location : Various Locations Throughout.</i> <i>Explanation : Surface Mortor Shrinkage And Separation Between Coping And Wall.</i>

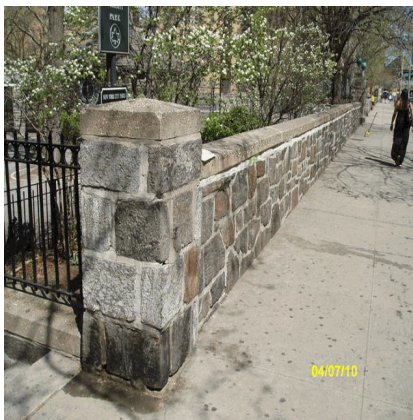
Retaining Walls		Current Repair		Future Replacement		Maintenance		Priority Code
System Component Type	% of Total	Fail Date (Years)	Estimated Cost	Year FY	Estimated Cost	Cycle (Yrs)	Estimated Cost	
Wall								
Coping								
Concrete	100%	4+	\$300	LIFE	* *			A
<i>Broken/Missing Elem, Extent : Light, Area Affected : 2%</i> <i>Location : 17ft. North Of Ft. Washington Ave. Entrance.</i> <i>Excess Worn/Erod Mat, Extent : Moderate, Area Affected : 8%</i> <i>Location : Various Locations Throughout.</i>								
Wall/Fence								
Masonry:Granite	100%	4+	\$19,500	LIFE	* *	5	\$500	B
<i>Efflorescence, Extent : Light, Area Affected : 2%</i> <i>Location : Starting At 40ft.; Ending At 50ft. North Of Ft. Washington Ave. Entrance.</i> <i>Jnt Mortar Miss/Erod, Extent : Light, Area Affected : 3%</i> <i>Location : Various Locations Throughout.</i> <i>Loose/Delam Surface, Extent : Light, Area Affected : 2%</i> <i>Location : 4ft. North Of Ft. Washington Ave. Entrance.</i> <i>Misaligned/Bulging, Extent : Light, Area Affected : 2%</i> <i>Location : 2" Out X 2ft. Wide; 62ft. North Of Ft. Washington Ave. Entrance.</i> <i>Staining/Scaling, Extent : Light, Area Affected : 1%</i> <i>Location : Moss And Rust Staining At Various Locations More Prominent On The Park Side.</i>

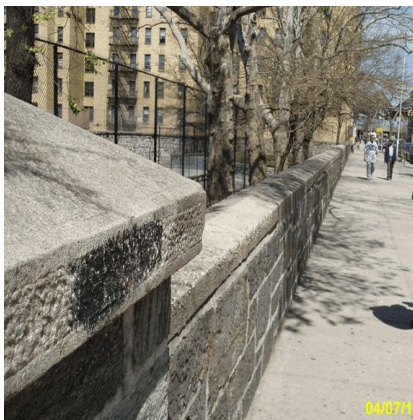
Retaining Walls		Current Repair		Future Replacement		Maintenance		Priority Code
System Component Type	% of Total	Fail Date (Years)	Estimated Cost	Year FY	Estimated Cost	Cycle (Yrs)	Estimated Cost	
Wall								
Coping								
Concrete	100%	4+	\$500	LIFE	* *			A
<i>Broken/Missing Elem, Extent : Light, Area Affected : 2%</i> <i>Location : 8ft South From North End Of Wall.</i> <i>Excess Worn/Erod Mat, Extent : Light, Area Affected : 2%</i> <i>Location : Various Locations Throughout.</i> <i>Jnt Mortar Miss/Erod, Extent : Light, Area Affected : 2%</i> <i>Location : Mortor Under And At Coping Joints Missing At Various Locations Throughout.</i> <i>Misaligned/Bulging, Extent : Light, Area Affected : 2%</i> <i>Location : Coping Shifted 2" From 84ft. To 104ft. South Of North End Of Wall.</i> <i>Other Observation, Extent : Light, Area Affected : 2%</i> <i>Location : Various Locations Throughout.</i> <i>Explanation : Spider Cracking Along Top Surface Of Coping.</i>

Wall/Fence								
Concrete	7%	4+	\$13,100	LIFE	* *	5		B
<i>Cracking/Crumbling, Extent : Light, Area Affected : 3%</i> <i>Location : Stair Side-various Locations</i> <i>Deteriorated Finish, Extent : Moderate, Area Affected : 24%</i> <i>Location : Stairside, Various Locations Throughout.</i> <i>Misaligned/Bulging, Extent : Light, Area Affected : 3%</i> <i>Location : Stair Side-228ft South Of North End Of Wall</i>								
Metal Fence	1%			LIFE	* *	4-8		B
Masonry:Granite	92%	4+	\$52,600	LIFE	* *	5	\$1,300	B
<i>Efflorescence, Extent : Light, Area Affected : 6%</i> <i>Location : Various Locations Throughout.</i> <i>Jnt Mortar Miss/Erod, Extent : Light, Area Affected : 5%</i> <i>Location : Various Locations Throughout.</i> <i>Loose/Delam Surface, Extent : Light, Area Affected : 2%</i> <i>Location : Park Side 85ft South Of North End Of Wall.</i> <i>Misaligned/Bulging, Extent : Light, Area Affected : 2%</i> <i>Location : Displacement 3 ft Wide X 1" Out-park Side 73 ft South Of The North End Of The Wall.</i> <i>Other Observation, Extent : Light, Area Affected : 5%</i> <i>Location : 6 ft Wide X 2" Out At 145 ft And 3 ft Wide X 3" Out At 184 ft Both Locations Are South From The North End Of The Wall.</i> <i>Explanation : Bulging (2) Places.</i>

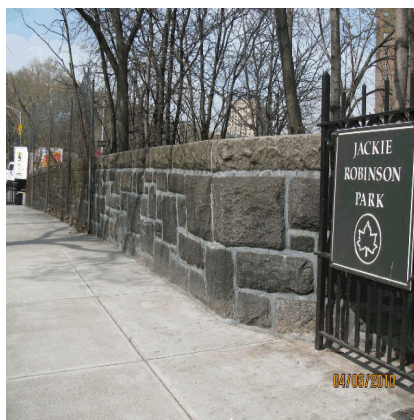
Retaining Walls		Current Repair		Future Replacement		Maintenance		Priority Code
System Component Type	% of Total	Fail Date (Years)	Estimated Cost	Year FY	Estimated Cost	Cycle (Yrs)	Estimated Cost	
Wall								
Coping								
Masonry:Granite	100%	4+	\$500	LIFE	* *	5		A
<i>Jnt Mortar Miss/Erod, Extent : Moderate, Area Affected : 40%</i>								
<i>Location : Random Locations Throughout The Wall.</i>								
<i>Misaligned/Bulging, Extent : Moderate, Area Affected : 2%</i>								
<i>Location : 2" To 3" Bulging At The Middle Portion Of The Wall.</i>								
Wall/Fence								
Metal Fence	48%			LIFE	* *	4-8	\$300	B
Masonry:Schist/Gnies	52%	4+	\$11,000	LIFE	* *	5	\$300	B
<i>Broken/Missing Elem, Extent : Moderate, Area Affected : 5%</i>								
<i>Location : Middle Portion Of The Wall (sidewalk Side).</i>								
<i>Jnt Mortar Miss/Erod, Extent : Moderate, Area Affected : 40%</i>								
<i>Location : Random Locations Throughout The Wall.</i>

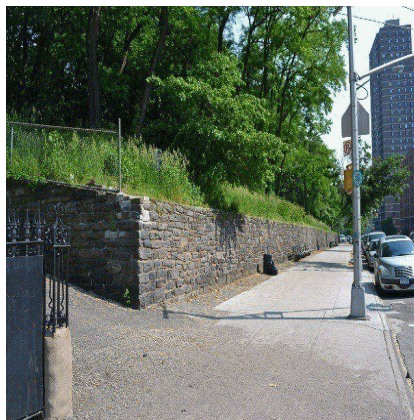
Retaining Walls		Current Repair		Future Replacement		Maintenance		
System Component Type	% of Total	Fail Date (Years)	Estimated Cost	Year FY	Estimated Cost	Cycle (Yrs)	Estimated Cost	Priority Code
Wall								
Wall/Fence								
Metal Fence	15%	4+	\$700	LIFE	* *	4-8	\$500	B
	<i>Other Observation, Extent : Light, Area Affected : 2%</i> <i>Location : At The Corner Of St. Nicholas Terrace And 128th St.</i> <i>Explanation : Loose Chain-link Fence Post.</i>							
Rubble Stone	85%	4+	\$19,600	LIFE	* *	5	\$2,200	B
	<i>Broken/Missing Elem, Extent : Moderate, Area Affected : 2%</i> <i>Location : 170 Ft, 190 Ft And 360 Ft From The Corner Of St. Nicholas Ave. And 128th Street.</i>							
Base								
Not Accessible	100%							D

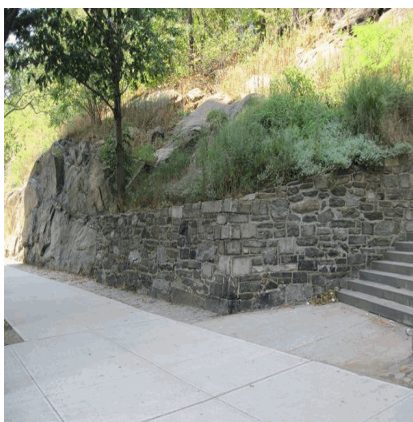
Retaining Walls		Current Repair		Future Replacement		Maintenance		
System Component Type	% of Total	Fail Date (Years)	Estimated Cost	Year FY	Estimated Cost	Cycle (Yrs)	Estimated Cost	Priority Code
Wall								
Wall/Fence								
Masonry:Schist/Gnies	100%	Now	\$23,200	LIFE	* *	5	\$600	B
<i>Broken/Missing Elem, Extent : Moderate, Area Affected : 10%</i>								
<i>Location : Along St. Nicholas</i>								
<i>Cracks-Diagonal, Extent : Moderate, Area Affected : 10%</i>								
<i>Location : Opposite Lionel Hampton Houses</i>								
<i>Jnt Mortar Miss/Erod, Extent : Moderate, Area Affected : 15%</i>								
<i>Location : Throughout</i>								
<i>Loose Elements, Extent : Moderate, Area Affected : 5%</i>								
<i>Location : St Nicholas Ave</i>								
Base								
Not Accessible	100%							D

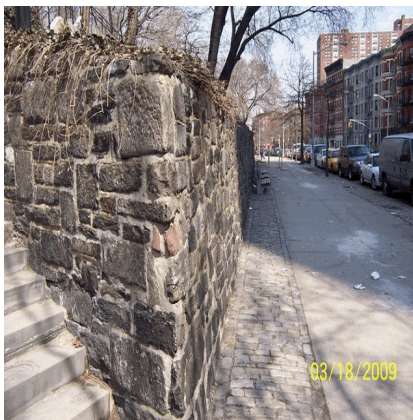
Retaining Walls		Current Repair		Future Replacement		Maintenance		
System Component Type	% of Total	Fail Date (Years)	Estimated Cost	Year FY	Estimated Cost	Cycle (Yrs)	Estimated Cost	Priority Code
Wall								
Wall/Fence								
Rubble Stone	100%	4+	\$5,400	LIFE	* *	5	\$600	B
<i>Broken/Missing Elem, Extent : Light, Area Affected : 2%</i>								
<i>Location : Throughout.</i>								
<i>Jnt Mortar Miss/Erod, Extent : Light, Area Affected : 2%</i>								
<i>Location : Throughout</i>								
<i>Vegetation Growth, Extent : Light, Area Affected : 2%</i>								
<i>Location : Throughout.</i>								
Base								
Not Accessible	100%							D

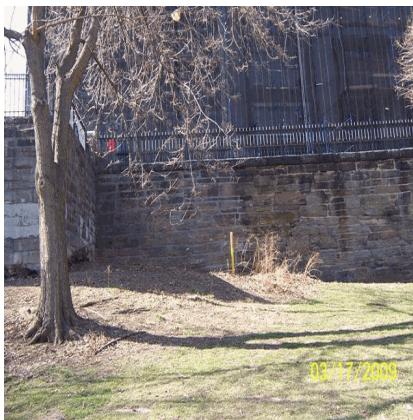
Retaining Walls		Current Repair		Future Replacement		Maintenance		Priority Code
System Component Type	% of Total	Fail Date (Years)	Estimated Cost	Year FY	Estimated Cost	Cycle (Yrs)	Estimated Cost	
Wall								
Coping								
Masonry:Schist/Gnies	100%	4+	\$1,900	LIFE	* *	5		A
<i>Jnt Mortar Miss/Erod, Extent : Moderate, Area Affected : 2%</i>								
<i>Location : Throughout.</i>								
<i>Misaligned/Bulging, Extent : Moderate, Area Affected : 2%</i>								
<i>Location : 2" Misaligned Towards Park Side Located 260 Ft From The South End Of The Wall.</i>								
Wall/Fence								
Metal Fence	4%			LIFE	* *	4-8	\$200	B
Rubble Stone	96%	4+	\$78,700	LIFE	* *	5	\$3,500	B
<i>Cracks-Diagonal, Extent : Light, Area Affected : 1%</i>								
<i>Location : 260 Ft From The South End Of The Wall.</i>								
<i>Jnt Mortar Miss/Erod, Extent : Light, Area Affected : 10%</i>								
<i>Location : Throughout.</i>

<i>Recent Repair Evident, Extent : Moderate, Area Affected : 5%</i>								
<i>Location : 70 Ft Long Section Starting From The North Side Of The Wall.</i>								
<i>Vegetation Growth, Extent : Light, Area Affected : 5%</i>								
<i>Location : Throughout.</i>								
Base								
Not Accessible	100%							D

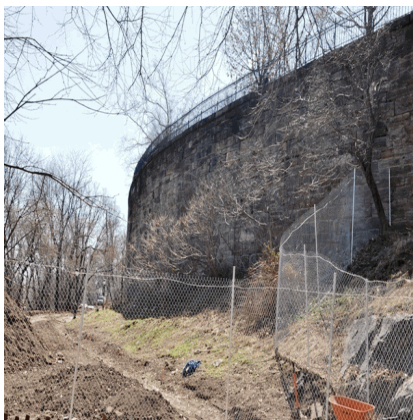
Retaining Walls		Current Repair		Future Replacement		Maintenance		
System Component Type	% of Total	Fail Date (Years)	Estimated Cost	Year FY	Estimated Cost	Cycle (Yrs)	Estimated Cost	Priority Code
Wall								
Coping								
Masonry:Schist/Gnies	10%	2-4	\$200	LIFE	* *	5		A
Other Observation, Extent : Moderate, Area Affected : 10%								
Location : Throughout.								
Explanation : Misaligned/shifted Coping Stones.								
Masonry:Schist/Gnies	90%	4+	\$1,700	LIFE	* *	5		A
Misaligned/Bulging, Extent : Moderate, Area Affected : 10%								
Location : Throughout								
Wall/Fence								
Metal Fence	5%	4+	\$400	LIFE	* *	4-8	\$100	B
Loose Fastenings, Extent : Moderate, Area Affected : 5%								
Location : Throughout.								
Under Construction	95%							D
Base								
Under Construction	100%							D

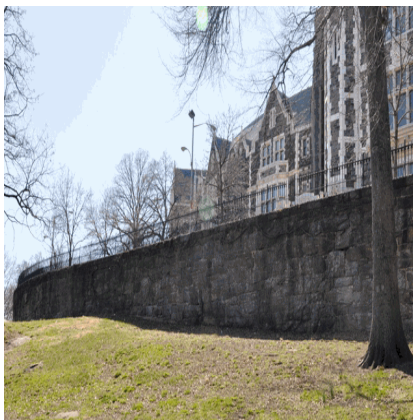
Retaining Walls		Current Repair		Future Replacement		Maintenance		
System Component Type	% of Total	Fail Date (Years)	Estimated Cost	Year FY	Estimated Cost	Cycle (Yrs)	Estimated Cost	Priority Code
Wall								
Coping								
Masonry:Schist/Gnies	100%	4+	\$2,100	LIFE	* *	5	\$100	A
<i>Jnt Mortar Miss/Erod, Extent : Light, Area Affected : 5%</i>								
<i>Location : Throughout.</i>								
<i>Misaligned/Bulging, Extent : Light, Area Affected : 1%</i>								
<i>Location : 5 Ft Long, 3 In Misaligned Section Located 140 Ft From The South End Of The Wall.</i>								
<i>Vegetation Growth, Extent : Moderate, Area Affected : 15%</i>								
<i>Location : Throughout.</i>								
Wall/Fence								
Metal Fence	30%			LIFE	* *	4-8	\$4,100	B
Rubble Stone	70%	4+	\$310,400	LIFE	* *	5	\$6,900	B
<i>Misaligned/Bulging, Extent : Moderate, Area Affected : 5%</i>								
<i>Location : 2 In Leaning Towards Park Side Located Approx. 400 Ft From The North End Of The Wall.</i>

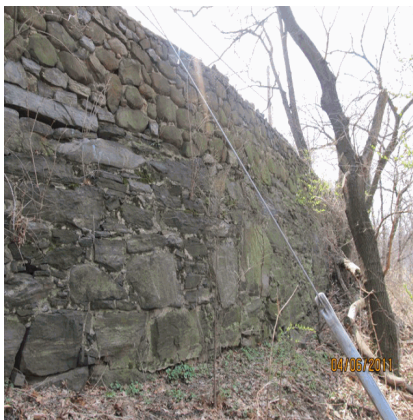
Retaining Walls		Current Repair		Future Replacement		Maintenance		Priority Code
System Component Type	% of Total	Fail Date (Years)	Estimated Cost	Year FY	Estimated Cost	Cycle (Yrs)	Estimated Cost	
Wall								
Coping								
Rubble Stone	100%	2-4	\$700	LIFE	* *	5	\$100	A
Broken/Missing Elem, Extent : Moderate, Area Affected : 10%								
Location : Random Locations Throughout The Wall.								
Vegetation Growth, Extent : Moderate, Area Affected : 15%								
Location : Random Locations Throughout The Wall.								
Wall/Fence								
Rubble Stone	100%	2-4	\$45,800	LIFE	* *	5	\$1,000	B
Broken/Missing Elem, Extent : Moderate, Area Affected : 10%								
Location : Random Locations Throughout The Wall.								
Jnt Mortar Miss/Erod, Extent : Moderate, Area Affected : 15%								
Location : Random Locations Throughout The Wall.								
Vegetation Growth, Extent : Moderate, Area Affected : 15%								
Location : Random Locations Throughout The Wall.

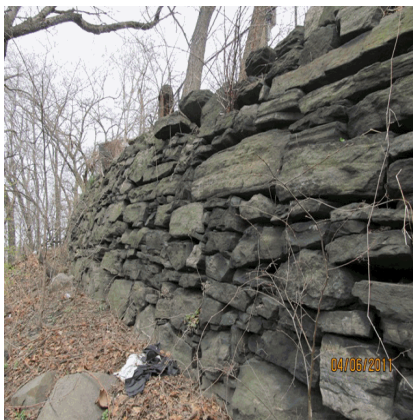
Retaining Walls		Current Repair		Future Replacement		Maintenance		
System Component Type	% of Total	Fail Date (Years)	Estimated Cost	Year FY	Estimated Cost	Cycle (Yrs)	Estimated Cost	Priority Code
Wall								
Wall/Fence								
Rubble Stone	100%	2-4	\$28,500	LIFE	* *	5	\$600	B
<i>Broken/Missing Elem, Extent : Moderate, Area Affected : 15%</i>								
<i>Location : Random Locations Throughout The Wall.</i>								
<i>Misaligned/Bulging, Extent : Moderate, Area Affected : 5%</i>								
<i>Location : Random Locations Throughout The Wall.</i>								
<i>Vegetation Growth, Extent : Moderate, Area Affected : 5%</i>								
<i>Location : Random Locations Throughout The Wall.</i>								
Base								
Not Accessible	100%							D

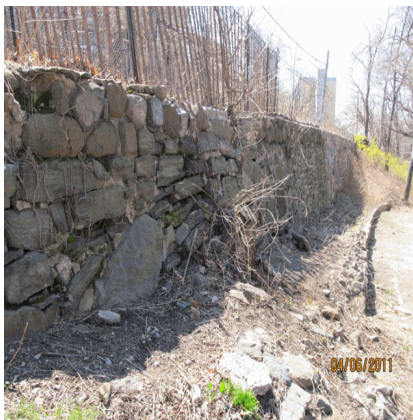
Retaining Walls		Current Repair		Future Replacement		Maintenance		Priority Code
System Component Type	% of Total	Fail Date (Years)	Estimated Cost	Year FY	Estimated Cost	Cycle (Yrs)	Estimated Cost	
Wall								
Coping								
Rubble Stone	100%	2-4	\$3,000	LIFE	* *	5	\$300	A
<i>Broken/Missing Elem, Extent : Moderate, Area Affected : 10%</i> <i>Location : Random Locations Throughout The Wall.</i> <i>Jnt Mortar Miss/Erod, Extent : Moderate, Area Affected : 5%</i> <i>Location : Random Locations Throughout The Wall.</i> <i>Recent Replace Evident, Extent : Moderate, Area Affected : 30%</i> <i>Location : Close To The North End Of The Wall.</i>								
Wall/Fence								
Metal Fence	20%	Now	\$17,300	LIFE	* *	4-8	\$600	B
<i>Broken/Missing Elem, Extent : Severe, Area Affected : 70%</i> <i>Location : Random Locations Throughout The Wall.</i> <i>Vegetation Growth, Extent : Severe, Area Affected : 10%</i> <i>Location : Middle Portion Of The Wall.</i> <i>Other Observation, Extent : Light, Area Affected : 20%</i> <i>Location : From The South End To The Middle Portion Of The Wall.</i> <i>Explanation : It Is Actually A Railing Not A Metal Fence But Railing Is Not Included In The Different Types Of Wall/fence</i>

Rubble Stone	80%	2-4	\$168,300	LIFE	* *	5	\$1,900	B
<i>Broken/Missing Elem, Extent : Moderate, Area Affected : 10%</i> <i>Location : Random Locations Throughout The Wall.</i> <i>Jnt Mortar Miss/Erod, Extent : Moderate, Area Affected : 20%</i> <i>Location : Random Locations Throughout The Wall.</i> <i>Recent Replace Evident, Extent : Moderate, Area Affected : 30%</i> <i>Location : Close To The North End Of The Wall.</i> <i>Vegetation Growth, Extent : Moderate, Area Affected : 2%</i> <i>Location : Random Locations Throughout The Wall.</i>								
Base								
Not Accessible	100%							D
