DEPT. OF PARKS & RECREATION - FY 2013

Asset Name : ABE STARK SKATING RINK INDOOR FACILITY
Address : SURF AVE, W. 19 ST. & BOARDWALK
Borough : BROOKLYN **Agency's Number** : B336-01
Program / Asset # : PAR0118.001 / 914 **Yr Built/Renovated** : 1969 / 2007
Area Sq Ft : 43,873 **Project Type** : PARKS AND RECREATION
Date of Survey : 20-Jul-2010 **Landmark Status** : NONE
Areas Surveyed : Basement, Roof, Floors 1
Block : 7072 **Lot** : 14 **BIN** :

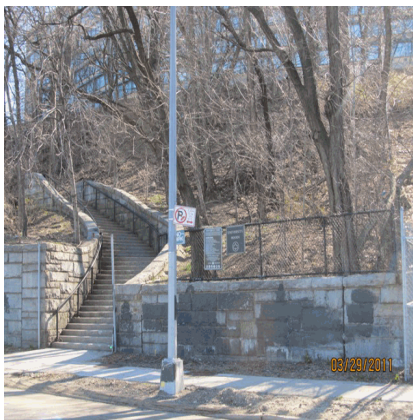
Retaining Walls		Current Repair		Future Replacement		Maintenance		Priority Code
System Component Type	% of Total	Fail Date (Years)	Estimated Cost	Year FY	Estimated Cost	Cycle (Yrs)	Estimated Cost	
Wall								
Coping								
Masonry:Granite	100%	4+	\$100	LIFE	* *	5		A
<i>Broken/Missing Elem, Extent : Light, Area Affected : 2%</i>								
<i>Location : Scattered Throughout</i>								
<i>Jnt Mortar Miss/Erod, Extent : Light, Area Affected : 2%</i>								
<i>Location : Scattered Throughout</i>								
<i>Loose Elements, Extent : Light, Area Affected : 2%</i>								
<i>Location : Scattered Throughout</i>								
<i>Loose/Delam Surface, Extent : Moderate, Area Affected : 1%</i>								
<i>Location : At South End Of Wall</i>								
Wall/Fence								
Masonry:Granite	100%	4+	\$2,900	LIFE	* *	5	\$400	B
<i>Efflorescence, Extent : Light, Area Affected : 1%</i>								
<i>Location : Scattered</i>								
<i>Jnt Mortar Miss/Erod, Extent : Light, Area Affected : 2%</i>

<i>Location : Throughout</i>								
<i>Loose Elements, Extent : Light, Area Affected : 2%</i>								
<i>Location : Scattered</i>								
<i>Loose/Delam Surface, Extent : Light, Area Affected : 1%</i>								
<i>Location : At North End Of Wall</i>								
Base								
Not Accessible	100%							D

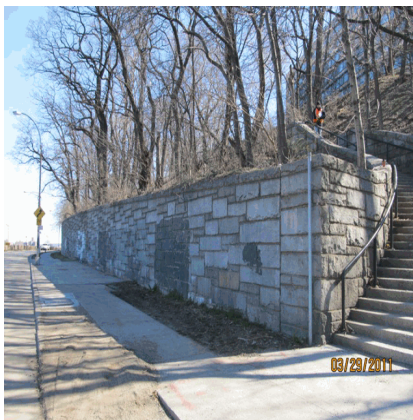
Retaining Walls		Current Repair		Future Replacement		Maintenance		Priority Code
System Component Type	% of Total	Fail Date (Years)	Estimated Cost	Year FY	Estimated Cost	Cycle (Yrs)	Estimated Cost	
Wall								
Coping								
Masonry:Granite	100%	4+	\$800	LIFE	* *	5	\$100	A
<i>Jnt Mortar Miss/Erod, Extent : Light, Area Affected : 2%</i>								
<i>Location : Scattered Throughout</i>								
<i>Loose Elements, Extent : Moderate, Area Affected : 1%</i>								
<i>Location : Scattered Throughout</i>								
Wall/Fence								
Masonry:Granite	100%	4+	\$36,400	LIFE	* *	5	\$4,700	B
<i>Jnt Mortar Miss/Erod, Extent : Light, Area Affected : 2%</i>								
<i>Location : Scattered Throughout</i>								
<i>Vegetation Growth, Extent : Light, Area Affected : 1%</i>								
<i>Location : At Middle Of Wall</i>								
Base								
Not Accessible	100%							D
