DEPT. OF SMALL BUSINESS SERV. - FY 2019

Asset Name : 125TH STREET PARKING GARAGE 5 LEVEL GARAGE
Address : 121 WEST 125TH STREET
Borough : MANHATTAN **Agency's Number** : N/A
Program / Asset # : DBS0028.000 / 4334 **Yr Built/Renovated** : 1972 / 2005
Area Sq Ft : 155,197 **Project Type** : ECONOMIC DEVELOPMENT
Date of Survey : 13-May-2015 **Landmark Status** : NONE
Areas Surveyed : Basement, Roof, Floors 1,2,3,4,5
Block : 1910 **Lot** : 1 **BIN** : 1081601

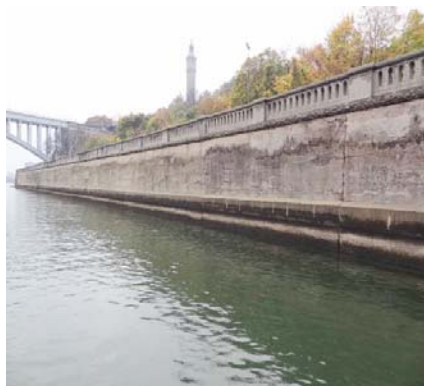
Asset Name : CONCRETE RETAINING WALL W/TIMBER CRIBBING FOUNDATION. BULKHEAD
Address : SO SIDE HAMILTON BRIDGE TO NO SIDE HIGH BRIDGE. SUB 3 OF BL
Borough : MANHATTAN **Agency's Number** : N/A
Program / Asset # : DBSR073.000 / 13817 **Yr Built/Renovated** :
Linear Ft : 1,170 **Project Type** : ECONOMIC DEVELOPMENT
Date of Survey : 16-Nov-2016 **Landmark Status** : NONE
Areas Surveyed :
Block : 2106 **Lot** : 997 **BIN** :

Bulkheads		Current Repair		Future Replacement		Maintenance		Priority
System	Component Type	% of Total	Fail Date (Years)	Estimated Cost	Year FY	Estimated Cost	Cycle (Yrs)	Estimated Cost
Structural								
	Coping/Curb							
	Stone	10%	4+	\$24,000	LIFE	**	5	\$200
		<i>Other Observation, Extent : Light, Area Affected : 30%</i>						
		<i>Location : Throughout</i>						
		<i>Explanation : Loose Or Missing Mortar Bedding</i>						
	Stone	90%			LIFE	**	5	\$1,800
Gravity Wall								
	Conc w/Stone Face	10%	4+	\$67,100	LIFE	**	5	\$10,500
		<i>Missing Block Seal, Extent : Light, Area Affected : 30%</i>						
		<i>Location : Bulkhead Face In Tidal Zone At South End Of Asset</i>						
	Concrete	67%	4+	\$129,100	LIFE	**	5	\$3,200
		<i>Cracking, Extent : Light, Area Affected : 5%</i>						
		<i>Location : Bulkhead Face Above Mhw</i>						
		<i>Exposed Reinforcement, Extent : Moderate, Area Affected : 5%</i>						
		<i>Location : At Spall 520 Feet From North</i>

<i>Spalling, Extent : Light, Area Affected : 25%</i>						
		<i>Location : From 600 Feet To 700 Feet From North, Above Mhw Line</i>						
	Concrete	3%	Now	\$173,400	LIFE	**	5	\$100
		<i>Not Plumb, Extent : Moderate, Area Affected : 100%</i>						
		<i>Location : Wall Is Leaning Between Construction Joints 995 Feet To 1030 Feet From North End</i>						
	Not Accessible	20%						
Backfill								
	Fill							
	Not Accessible	100%						
Surface								
	Asphalt	100%	4+	\$21,600	2037	**	5	\$6,700
		<i>Cracking, Extent : Light, Area Affected : 5%</i>						
		<i>Location : Throughout</i>						
		<i>Settlement, Extent : Light, Area Affected : 5%</i>						
		<i>Location : Isolated Throughout</i>						
		<i>Sinkhole, Extent : Moderate, Area Affected : 10%</i>						
		<i>Location : Between 1030 And 1123 Feet From North</i>						
Deck Elements								
	Parapet							
	Concrete	100%	4+	\$43,900	2029	\$878,400		
		<i>Spalling, Extent : Light, Area Affected : 25%</i>

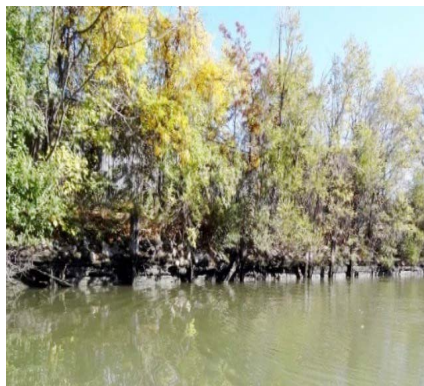
DEPT. OF SMALL BUSINESS SERV. - 801
CRIBBING BULKHEAD
Asset # : 13807

Bulkheads		Current Repair		Future Replacement		Maintenance		Priority
System Component Type	% of Total	Fail Date (Years)	Estimated Cost	Year FY	Estimated Cost	Cycle (Yrs)	Estimated Cost	
Structural								
Gravity Wall Timber Crib w/Stone	100%	Now	\$940,600	LIFE	**	4	\$9,200	1
<i>Broken, Extent : Severe, Area Affected : 50%</i>								
<i>Location : Isolated Members Throughout</i>								
<i>Missing Part, Extent : Severe, Area Affected : 15%</i>								
<i>Location : Collapsed At Eastern 47 Feet</i>								
<i>Rotting/Splitting, Extent : Severe, Area Affected : 10%</i>								
<i>Location : Horizontal Timbers And Timber Piles Throughout</i>								
<i>Tilting, Extent : Severe, Area Affected : 100%</i>								
<i>Location : Full Length</i>								
<i>Other Observation, Extent : Severe, Area Affected : 1%</i>								
<i>Location : West End Of Asset</i>								
<i>Explanation : Deterioration Of Concrete And Steel At Outfall</i>

<hr/>								
Backfill								
Fill								
Stone	20%	Now	\$17,500	LIFE	**	5	\$100	
<i>Erosion, Extent : Moderate, Area Affected : 50%</i>								
<i>Location : Isolated Throughout At Top Of Wall</i>								
Not Accessible	80%							
<hr/>								
Surface								
Concrete	10%	Now	\$11,600	2043	**	5	\$200	
<i>Broken, Extent : Severe, Area Affected : 100%</i>								
<i>Location : Eastern 30 Feet And Between 85 Feet And 110 Feet From East</i>								
<i>Other Observation, Extent : Moderate, Area Affected : 100%</i>								
<i>Location : Full Length Up To 3ft Deep</i>								
<i>Explanation : Undermining</i>								
Not Accessible	90%							
<i>Other Observation, Extent : Light, Area Affected : 0%</i>								
<i>Location :</i>								
<i>Explanation : Heavy Vegetation</i>

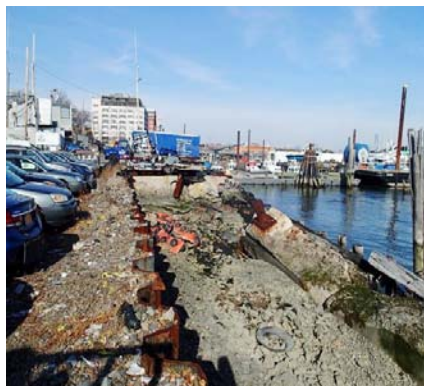
DEPT. OF SMALL BUSINESS SERV. - 801
FORMER PIER 7 - MILLERS LAUNCH STEEL SHEET PILE BULKHEAD
Asset # : 4261

Bulkheads		Current Repair		Future Replacement		Maintenance		Priority
System	Component Type	% of Total	Fail Date (Years)	Estimated Cost	Year FY	Estimated Cost	Cycle (Yrs)	Estimated Cost
Structural	Sheet Piles							
	Steel	60%	4+	\$361,200	LIFE	**		
		<i>Corrosion, Extent : Moderate, Area Affected : 70%</i>						
		<i>Location : Above Mudline</i>						
	No Component	15%						
		<i>Other Observation, Extent : Light, Area Affected : 0%</i>						
		<i>Location : At Foot Of Pier</i>						
		<i>Explanation : No Component</i>						
	Not Accessible	25%						
Backfill	Fill							
	Not Accessible	100%						
	Surface							
	Asphalt	70%			2029	\$31,900	5	\$4,000
		<i>Cracking, Extent : Light, Area Affected : 10%</i>						
		<i>Location : Throughout</i>						
	Concrete	10%	4+	\$18,200	2041	**	5	\$300
		<i>Broken, Extent : Moderate, Area Affected : 100%</i>						
		<i>Location : 250 Feet To 390 Feet From North (Collapsed Pier)</i>

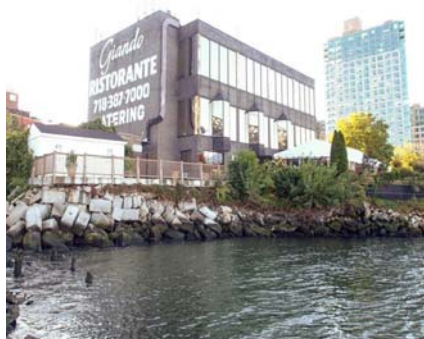
DEPT. OF SMALL BUSINESS SERV. - 801
GIANDO RESTAURANT REVETMENT/BULKHEAD

Bulkheads		Current Repair		Future Replacement		Maintenance		Priority
System	Component Type	% of Total	Fail Date (Years)	Estimated Cost	Year FY	Estimated Cost	Cycle (Yrs)	Estimated Cost
Structural								
	Gravity Wall							
	Concrete	15%	4+	\$302,600	LIFE	**	5	\$100
		<i>Displaced Elements, Extent : Moderate, Area Affected : 100%</i>						
		<i>Location : Midway Point Of Bulkhead</i>						
	Concrete	30%			LIFE	**	5	\$300
		<i>Displaced Elements, Extent : Light, Area Affected : 100%</i>						
		<i>Location : Southern Half</i>						
	No Component	55%						
Revetment								
	Stone	50%	2-4	\$92,000	LIFE	**	5	\$700
		<i>Other Observation, Extent : Severe, Area Affected : 100%</i>						
		<i>Location : Steep Slope, Exposed Fill, And Displaced Elements Throughout Northern Half</i>						
		<i>Explanation : Non-engineered Riprap</i>						
	Stone	25%			LIFE	**	5	\$400
	No Component	25%						
Backfill								
	Fill

Not Accessible	100%						
Surface								
	Concrete	85%			2036	**	5	\$2,400
		<i>Cracking, Extent : Light, Area Affected : 15%</i>						
		<i>Location : Isolated</i>						
	Topsoil	15%			2025	\$2,000	5	\$200
Fender								
	Facing							
	Timber	10%			2030	**	3	\$1,000
	No Component	90%						
Deck Elements								
	Railing							
	Plastic	20%			2021	\$7,700		
		<i>Worn, Extent : Moderate, Area Affected : 100%</i>						
		<i>Location : North End</i>						
	No Component	80%

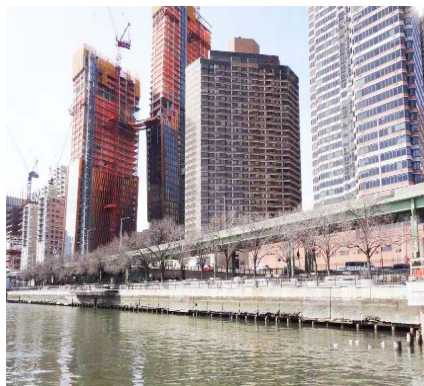
DEPT. OF SMALL BUSINESS SERV. - 801
GLICK PARK RELIEVING PLATFORM
Asset # : 4087

Bulkheads		Current Repair		Future Replacement		Maintenance		Priority
System	Component Type	% of Total	Fail Date (Years)	Estimated Cost	Year FY	Estimated Cost	Cycle (Yrs)	Estimated Cost
Structural	Coping/Curb							
	Concrete	45%			LIFE	**	5	\$200
				<i>Cracking, Extent : Light, Area Affected : 5%</i>				
				<i>Location : Isolated Throughout</i>				
				<i>Displaced Elements, Extent : Light, Area Affected : 10%</i>				
				<i>Location : Throughout</i>				
	Concrete	45%	2-4	\$80,000	LIFE	**	5	\$200
				<i>Broken, Extent : Moderate, Area Affected : 50%</i>				
				<i>Location : Isolated Throughout</i>				
				<i>Missing Part, Extent : Severe, Area Affected : 100%</i>				
				<i>Location : Isolated Throughout</i>				
				<i>Other Observation, Extent : Moderate, Area Affected : 20%</i>				
				<i>Location : Missing Grout Beneath Coping From 270 Ft To 460 Ft From North End</i>				
				<i>Explanation : Undermining</i>

Timber	5%			LIFE	**	5	
	Timber	5%	2-4	\$2,900	LIFE	**	5	
				<i>Missing Part, Extent : Severe, Area Affected : 100%</i>				
				<i>Location : At South End</i>				
				<i>Rotting/Splitting, Extent : Severe, Area Affected : 50%</i>				
				<i>Location : At South End</i>				
Pile Supported Wall	Conc w/Stone Face	25%	Now	\$185,300	LIFE	**	5	\$10,200
				<i>Other Observation, Extent : Severe, Area Affected : 50%</i>				
				<i>Location : Throughout</i>				
				<i>Explanation : Erosion Along Bottom Of Stone Face</i>				
	Conc w/Stone Face	75%			LIFE	**	5	\$30,500
				<i>Other Observation, Extent : Light, Area Affected : 50%</i>				
				<i>Location : Throughout</i>				
				<i>Explanation : Minor Erosion</i>				
Piles and Bracing	Timber	2%	Now	\$30,600	2042	**	4	\$1,500
				<i>Rotting/Splitting, Extent : Moderate, Area Affected : 30%</i>				
				<i>Location : At Tops Of Piles Along Bulkhead Face</i>				
	Not Accessible	98%

Lowlevel Pile Caps	Timber	5%	Now	\$11,500	LIFE	**		
				<i>Missing Part, Extent : Severe, Area Affected : 60%</i>				
				<i>Location : Along Bulkhead Face Throughout</i>				
				<i>Rotting/Splitting, Extent : Severe, Area Affected : 30%</i>				
				<i>Location : Along Bulkhead Face Throughout</i>				
	Not Accessible	95%						
Backfill	Fill							
	Not Accessible	100%
