DEPT. OF PARKS & RECREATION - FY 2015

Asset Name : ABE STARK SKATING RINK INDOOR FACILITY
Address : SURF AVE, W. 19 ST. & BOARDWALK
Borough : BROOKLYN **Agency's Number** : B336-01
Program / Asset # : PAR0118.001 / 914 **Yr Built/Renovated** : 1969 / 2014
Area Sq Ft : 43,873 **Project Type** : PARKS AND RECREATION
Date of Survey : 17-Jul-2014 **Landmark Status** : NONE
Areas Surveyed : Basement, Roof, Floors 1
Block : 7072 **Lot** : 14 **BIN** :

DEPT. OF PARKS & RECREATION - 846
ABE STARK SKATING RINK INDOOR FACILITY

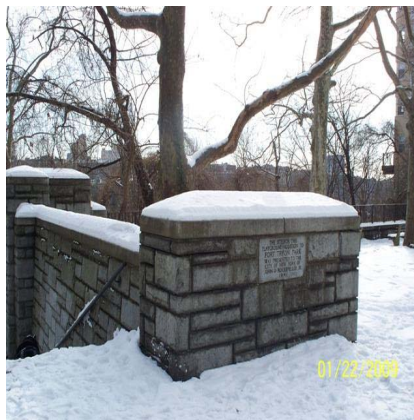
DEPT. OF PARKS & RECREATION - 846
FORT TRYON PARK RETAINING WALL EAST WALL OF SITTING AREA
Asset # : 14294

Retaining Walls		Current Repair		Future Replacement		Maintenance		Priority Code
System Component Type	% of Total	Fail Date (Years)	Estimated Cost	Year FY	Estimated Cost	Cycle (Yrs)	Estimated Cost	
Wall								
Coping								
Masonry:Granite	100%	Now	\$5,700	LIFE	**	5		A
<i>Jnt Mortar Miss/Erod, Extent : Moderate, Area Affected : 50%</i>								
<i>Location : Throughout</i>								
Wall/Fence								
Metal Fence	15%	Now	\$5,000	LIFE	**	4-8	\$300	B
<i>Deteriorated Finish, Extent : Moderate, Area Affected : 50%</i>								
<i>Location : Throughout</i>								
<i>Other Observation, Extent : Moderate, Area Affected : 50%</i>								
<i>Location : Throughout</i>								
<i>Explanation : Corroded</i>								
Masonry:Granite	85%	Now	\$107,000	LIFE	**	5	\$1,300	B
<i>Cracks-Diagonal, Extent : Moderate, Area Affected : 10%</i>								
<i>Location : At The Middle Of Western Face Of Wall - Sidewalk Side</i>								
<i>Jnt Mortar Miss/Erod, Extent : Moderate, Area Affected : 30%</i>

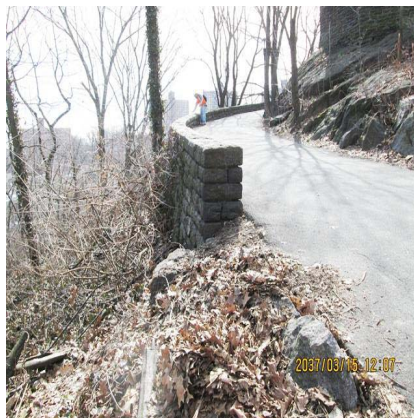
DEPT. OF PARKS & RECREATION - 846
FORT TRYON PARK RETAINING WALL GAZEBO OVERLOOK WALL
Asset # : 14174

Retaining Walls		Current Repair		Future Replacement		Maintenance		Priority Code
System Component Type	% of Total	Fail Date (Years)	Estimated Cost	Year FY	Estimated Cost	Cycle (Yrs)	Estimated Cost	Priority Code
Wall								
Coping								
Masonry: Schist/Gneiss	100%	4+	\$1,900	LIFE	**	5		A
<i>Jnt Mortar Miss/Erod, Extent : Light, Area Affected : 5%</i>								
<i>Location : Throughout</i>								
<i>Vegetation Growth, Extent : Light, Area Affected : 20%</i>								
<i>Location : Throughout</i>								
<hr/>								
Wall/Fence								
Masonry: Schist/Gneiss	80%	4+	\$10,600	LIFE	**	5	\$600	B
<i>Jnt Mortar Miss/Erod, Extent : Light, Area Affected : 10%</i>								
<i>Location : Throughout</i>								
<i>Misaligned/Bulging, Extent : Light, Area Affected : 1%</i>								
<i>Location : At Center Of Wall</i>								
<i>Vegetation Growth, Extent : Light, Area Affected : 40%</i>								
<i>Location : Throughout</i>

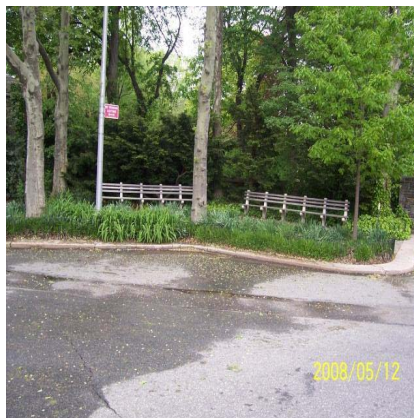
DEPT. OF PARKS & RECREATION - 846
FORT TRYON PARK RETAINING WALL MAIN ENTRANCE M. CORBIN CIRCLE
Asset # : 14183

Retaining Walls		Current Repair		Future Replacement		Maintenance		Priority Code
System Component Type	% of Total	Fail Date (Years)	Estimated Cost	Year FY	Estimated Cost	Cycle (Yrs)	Estimated Cost	Priority Code
Wall								
Coping								
Masonry: Granite	100%	Now	\$1,700	LIFE	**	5		A
<i>Jnt Mortar Miss/Erod, Extent : Moderate, Area Affected : 25%</i>								
<i>Location : Throughout</i>								
Wall/Fence								
Masonry: Schist/Gneiss	100%	Now	\$16,000	LIFE	**	5	\$400	B
<i>Jnt Mortar Miss/Erod, Extent : Moderate, Area Affected : 25%</i>								
<i>Location : Throughout North And South Faces And At The East Pylon At Top</i>								
<i>Misaligned/Bulging, Extent : Moderate, Area Affected : 5%</i>								
<i>Location : East Pylon Leaning Slightly Eastward At Top</i>								
<i>Spalling, Extent : Moderate, Area Affected : 10%</i>								
<i>Location : East Face</i>								
<i>Vegetation Growth, Extent : Severe, Area Affected : 25%</i>

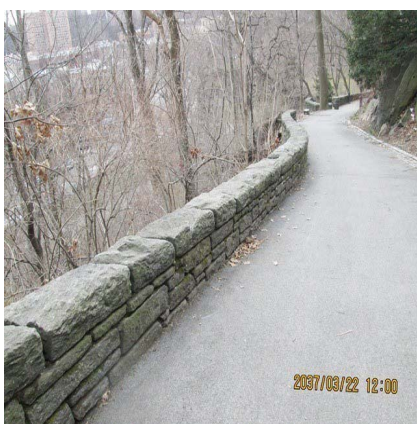
DEPT. OF PARKS & RECREATION - 846
FORT TRYON PARK RETAINING WALL NORTH OF DONGAN LAWN
Asset # : 14178

Retaining Walls		Current Repair		Future Replacement		Maintenance		Priority Code
System Component Type	% of Total	Fail Date (Years)	Estimated Cost	Year FY	Estimated Cost	Cycle (Yrs)	Estimated Cost	
Wall								
Coping								
Masonry: Schist/Gneiss	10%	4+	\$300	LIFE	**	5		A
<i>Jnt Mortar Miss/Erod, Extent : Light, Area Affected : 20%</i>								
<i>Location : Throughout</i>								
<i>Vegetation Growth, Extent : Light, Area Affected : 2%</i>								
<i>Location : Throughout</i>								
Masonry: Schist/Gneiss	90%			LIFE	**	5		A
Wall/Fence								
Masonry: Schist/Gneiss	10%	4+	\$9,000	LIFE	**	5	\$100	B
<i>Broken/Missing Elem, Extent : Light, Area Affected : 2%</i>								
<i>Location : At Random Locations Throughout</i>								
<i>Cracking/Crumbling, Extent : Light, Area Affected : 1%</i>								
<i>Location : South End Of The Wall</i>								
<i>Jnt Mortar Miss/Erod, Extent : Light, Area Affected : 15%</i>

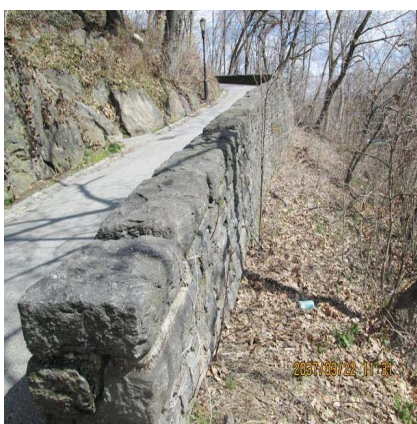
DEPT. OF PARKS & RECREATION - 846
FORT TRYON PARK RETAINING WALL NORTH OF DONGAN PL. ENTRANCE
Asset # : 14177

Retaining Walls		Current Repair		Future Replacement		Maintenance		Priority Code
System Component Type	% of Total	Fail Date (Years)	Estimated Cost	Year FY	Estimated Cost	Cycle (Yrs)	Estimated Cost	
Wall								
Coping								
Masonry: Schist/Gneiss	15%	4+	\$1,200	LIFE	**	5		A
<i>Cracking/Crumbling, Extent : Light, Area Affected : 1%</i>								
<i>Location : 200ft From North End</i>								
<i>Excess Worn/Erod Mat, Extent : Light, Area Affected : 4%</i>								
<i>Location : Throughout</i>								
<i>Jnt Mortar Miss/Erod, Extent : Light, Area Affected : 10%</i>								
<i>Location : Throughout</i>								
<i>Misaligned/Bulging, Extent : Light, Area Affected : 1%</i>								
<i>Location : At South End</i>								
<i>Spalling, Extent : Light, Area Affected : 1%</i>								
<i>Location : 60ft From South End</i>								
Masonry: Schist/Gneiss	85%			LIFE	**	5		A
Wall/Fence								
Masonry: Schist/Gneiss	2%	4+	\$13,800	LIFE	**	5		B

<i>Cracking/Crumbling, Extent : Light, Area Affected : 2%</i>								
<i>Location : At South End</i>								
<i>Jnt Mortar Miss/Erod, Extent : Light, Area Affected : 60%</i>								
<i>Location : Throughout</i>								
<i>Misaligned/Bulging, Extent : Light, Area Affected : 2%</i>								
<i>Location : At South End</i>								
<i>Spalling, Extent : Light, Area Affected : 1%</i>								
<i>Location : At North End</i>								
<i>Vegetation Growth, Extent : Light, Area Affected : 20%</i>								
<i>Location : At Center Of Wall</i>								
Masonry: Schist/Gneiss	15%			LIFE	**	5	\$300	B
Rubble Stone	18%	4+	\$12,300	LIFE	**	5	\$300	B
<i>Efflorescence, Extent : Light, Area Affected : 1%</i>								
<i>Location : At North End On East Face</i>								
<i>Jnt Mortar Miss/Erod, Extent : Light, Area Affected : 10%</i>								
<i>Location : Throughout</i>								
<i>Vegetation Growth, Extent : Light, Area Affected : 10%</i>

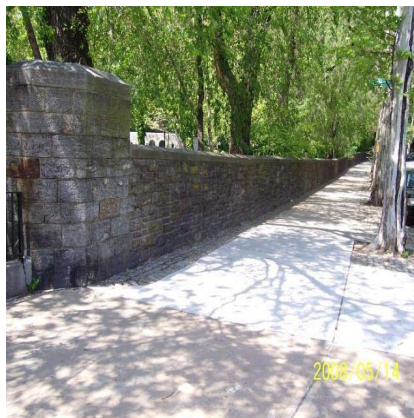
DEPT. OF PARKS & RECREATION - 846
FORT TRYON PARK RETAINING WALL NORTH SIDE PERIMETER WALL NO 1
Asset # : 14190

Retaining Walls		Current Repair		Future Replacement		Maintenance		Priority Code
System Component Type	% of Total	Fail Date (Years)	Estimated Cost	Year FY	Estimated Cost	Cycle (Yrs)	Estimated Cost	
Wall								
Coping								
Masonry: Granite	100%	Now	\$3,900	LIFE	**	5		A
<i>Jnt Mortar Miss/Erod, Extent : Moderate, Area Affected : 25%</i> <i>Location : Throughout</i> <i>Vegetation Growth, Extent : Moderate, Area Affected : 5%</i> <i>Location : At East End Park Entrance</i>								
Wall/Fence								
Masonry: Schist/Gneiss	100%	Now	\$112,100	LIFE	**	5	\$3,100	B
<i>Efflorescence, Extent : Moderate, Area Affected : 5%</i> <i>Location : In North And South Faces Of Wall</i> <i>Jnt Mortar Miss/Erod, Extent : Moderate, Area Affected : 25%</i> <i>Location : In North And South Faces Of Wall</i> <i>Misaligned/Bulging, Extent : Moderate, Area Affected : 5%</i> <i>Location : West End Pylon Leaning Slightly Westward</i> <i>Vegetation Growth, Extent : Moderate, Area Affected : 5%</i> <i>Location : At East End Near Park Entrance</i>

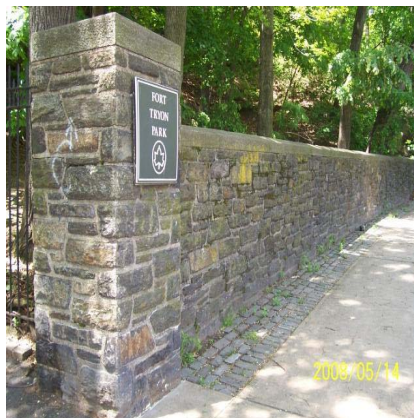
DEPT. OF PARKS & RECREATION - 846
FORT TRYON PARK RETAINING WALL NORTH SIDE PERIMETER WALL NO 2
Asset # : 14191

Retaining Walls		Current Repair		Future Replacement		Maintenance		Priority Code
System Component Type	% of Total	Fail Date (Years)	Estimated Cost	Year FY	Estimated Cost	Cycle (Yrs)	Estimated Cost	
Wall								
Coping								
Masonry: Granite	100%	Now	\$2,300	LIFE	**	5		A
<i>Jnt Mortar Miss/Erod, Extent : Moderate, Area Affected : 20%</i>								
<i>Location : Throughout</i>								
Wall/Fence								
Masonry: Schist/Gneiss	100%	Now	\$22,500	LIFE	**	5	\$600	B
<i>Efflorescence, Extent : Light, Area Affected : 5%</i>								
<i>Location : At Middle Of Wall On North Face</i>								
<i>Jnt Mortar Miss/Erod, Extent : Moderate, Area Affected : 25%</i>								
<i>Location : Throughout</i>								
Base								
Not Accessible	100%							D

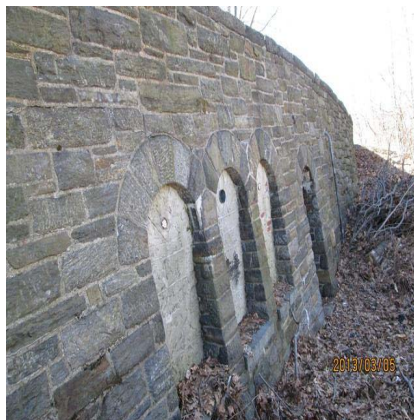
DEPT. OF PARKS & RECREATION - 846
FORT TRYON PARK RETAINING WALL NORTH WEST PARKING LOT
Asset # : 14162

Retaining Walls		Current Repair		Future Replacement		Maintenance		Priority Code
System Component Type	% of Total	Fail Date (Years)	Estimated Cost	Year FY	Estimated Cost	Cycle (Yrs)	Estimated Cost	
Wall								
Coping								
Masonry: Schist/Gneiss	100%			LIFE	* *	5	\$100	A
Wall/Fence								
Masonry: Schist/Gneiss	70%			LIFE	* *	5	\$4,800	B
			<i>Vegetation Growth, Extent : Light, Area Affected : 20%</i>					
			<i>Location : Throughout</i>					
			<i>Other Observation, Extent : Light, Area Affected : 2%</i>					
			<i>Location : 20 Feet From South End</i>					
			<i>Explanation : Door And Window Openings</i>					
Masonry: Schist/Gneiss	30%	4+	\$14,900	LIFE	* *	5	\$2,000	B
			<i>Other Observation, Extent : Light, Area Affected : 100%</i>					
			<i>Location : Throughout</i>					
			<i>Explanation : Repointing Is Not Performed</i>					
Base								
Not Accessible	100%							D

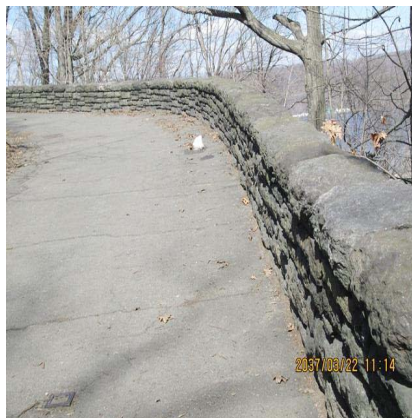
DEPT. OF PARKS & RECREATION - 846
FORT TRYON PARK RETAINING WALL NORTHERN MOST WALL
Asset # : 14181

Retaining Walls		Current Repair		Future Replacement		Maintenance		Priority Code
System Component Type	% of Total	Fail Date (Years)	Estimated Cost	Year FY	Estimated Cost	Cycle (Yrs)	Estimated Cost	
Wall								
Coping								
Masonry: Schist/Gneiss	10%	4+	\$600	LIFE	**	5		A
<i>Broken/Missing Elem, Extent : Light, Area Affected : 10%</i>								
<i>Location : At North And South Ends</i>								
<i>Jnt Mortar Miss/Erod, Extent : Light, Area Affected : 60%</i>								
<i>Location : Throughout</i>								
<i>Vegetation Growth, Extent : Light, Area Affected : 5%</i>								
<i>Location : Throughout</i>								
Masonry: Schist/Gneiss	90%			LIFE	**	5		A
Wall/Fence								
Masonry: Schist/Gneiss	10%	4+	\$10,000	LIFE	**	5	\$100	B
<i>Jnt Mortar Miss/Erod, Extent : Light, Area Affected : 65%</i>								
<i>Location : Throughout</i>								
<i>Staining/Scaling, Extent : Light, Area Affected : 2%</i>								
<i>Location : At Random Locations Throughout</i>

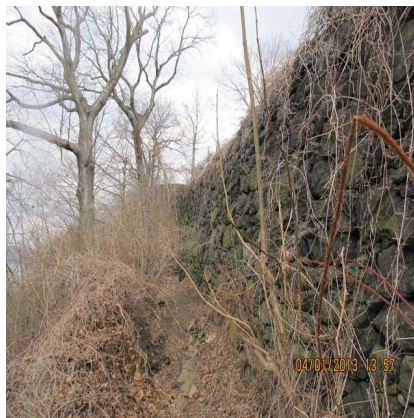
DEPT. OF PARKS & RECREATION - 846
FORT TRYON PARK RETAINING WALL PARALLEL TO WESTERN PROMENADE
Asset # : 14171

Retaining Walls		Current Repair		Future Replacement		Maintenance		Priority Code
System Component Type	% of Total	Fail Date (Years)	Estimated Cost	Year FY	Estimated Cost	Cycle (Yrs)	Estimated Cost	
Wall								
Coping								
Rubble Stone	100%	4+	\$4,100	LIFE	* *	5	\$500	A
<i>Other Observation, Extent : Moderate, Area Affected : 10%</i> <i>Location : Throughout Length Of Coping</i> <i>Explanation : Ivy Growth At Coping Is Causing Deterioration Of Joints</i>								
Wall/Fence								
Rubble Stone	100%	4+	\$29,000	LIFE	* *	5	\$3,500	B
<i>Broken/Missing Elem, Extent : Light, Area Affected : 10%</i> <i>Location : Throughout</i> <i>Other Observation, Extent : Severe, Area Affected : 30%</i> <i>Location : Throughout Length Of Wall</i> <i>Explanation : Ivy Growth At Coping Is Causing Deterioration Of Joints</i>								
Base								
Not Accessible	100%							D

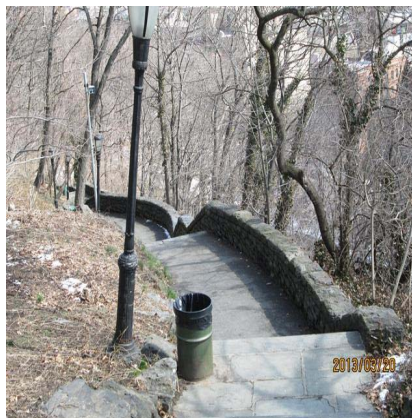
DEPT. OF PARKS & RECREATION - 846
FORT TRYON PARK RETAINING WALL PATH @HISTORIC MARKER CORBIN CIR
Asset # : 14172

Retaining Walls		Current Repair		Future Replacement		Maintenance		Priority Code
System Component Type	% of Total	Fail Date (Years)	Estimated Cost	Year FY	Estimated Cost	Cycle (Yrs)	Estimated Cost	Priority Code
Wall								
Coping								
Concrete	1%	4+	\$200	LIFE	**			A
<i>Cracking/Crumbling, Extent : Light, Area Affected : 100%</i>								
<i>Location : West Faces Of Stones</i>								
Masonry: Schist/Gneiss	99%	4+	\$8,400	LIFE	**	5		A
<i>Broken/Missing Elem, Extent : Severe, Area Affected : 40%</i>								
<i>Location : From The North End, Starting At 20ft Going To 281ft.</i>								
<i>Jnt Mortar Miss/Erod, Extent : Light, Area Affected : 5%</i>								
<i>Location : Throughout</i>								
<i>Spalling, Extent : Light, Area Affected : 1%</i>								
<i>Location : At Random Locations Throughout</i>								
<i>Vegetation Growth, Extent : Light, Area Affected : 7%</i>								
<i>Location : Throughout</i>

Wall/Fence								
Masonry: Schist/Gneiss	30%	4+	\$55,200	LIFE	**	5	\$1,500	B
<i>Cracking/Crumbling, Extent : Light, Area Affected : 2%</i>								
<i>Location : At Random Locations Throughout</i>								
<i>Efflorescence, Extent : Light, Area Affected : 2%</i>								
<i>Location : Throughout</i>								
<i>Jnt Mortar Miss/Erod, Extent : Light, Area Affected : 5%</i>								
<i>Location : Throughout</i>								
<i>Vegetation Growth, Extent : Light, Area Affected : 60%</i>								
<i>Location : Throughout</i>								
<i>Other Observation, Extent : Light, Area Affected : 1%</i>								
<i>Location : Near Center Of Wall</i>								
<i>Explanation : Larger Than 3 Inch Tree Trunk</i>								
Masonry: Schist/Gneiss	50%			LIFE	**	5	\$2,500	B
Not Accessible	20%							D
Base								
Not Accessible	100%							D

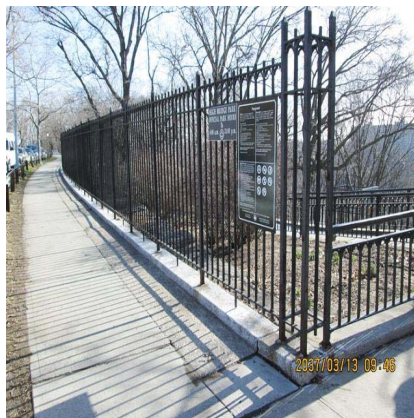
DEPT. OF PARKS & RECREATION - 846
HIGHBRIDGE PARK RETAINING WALL CUTSTONE W/ COPING RETAIN. WALL
Asset # : 14697

Retaining Walls		Current Repair		Future Replacement		Maintenance		Priority Code
System Component Type	% of Total	Fail Date (Years)	Estimated Cost	Year FY	Estimated Cost	Cycle (Yrs)	Estimated Cost	
Wall								
Coping								
Concrete	30%	2-4	\$3,700	LIFE	**			A
<i>Cracking/Crumbling, Extent : Light, Area Affected : 2%</i>								
<i>Location : At Random Locations</i>								
<i>Other Observation, Extent : Light, Area Affected : 100%</i>								
<i>Location : Throughout</i>								
<i>Explanation : Visible Wall Adjustment Made On Coping</i>								
No Component	70%							D
Wall/Fence								
Metal Fence	20%			LIFE	**	4-8	\$900	B
Rubble Stone	78%			LIFE	**	5	\$2,500	B
<i>Recent Repair Evident, Extent : Light, Area Affected : 10%</i>								
<i>Location : Repointing Within The Playground</i>								
Rubble Stone	2%	4+	\$24,500	LIFE	**	5	\$100	B
<i>Broken/Missing Elem, Extent : Light, Area Affected : 50%</i>

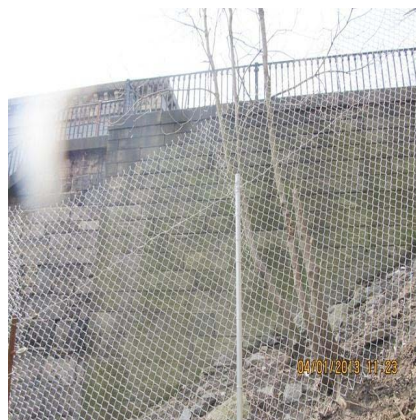
DEPT. OF PARKS & RECREATION - 846
HIGHBRIDGE PARK RETAINING WALL CUTSTONE W/ COPING RETAIN. WALL
Asset # : 14704

Retaining Walls	Current Repair		Future Replacement		Maintenance		Priority Code	
System Component Type	% of Total	Fail Date (Years)	Estimated Cost	Year FY	Estimated Cost	Cycle (Yrs)	Estimated Cost	Priority Code
Wall								
Coping								
Masonry:Granite	100%	4+	\$6,600	LIFE	**	5		A
	<i>Jnt Mortar Miss/Erod, Extent : Moderate, Area Affected : 40%</i>							
	<i>Location : Scattered Throughout</i>							
	<i>Other Observation, Extent : Severe, Area Affected : 80%</i>							
	<i>Location : Throughout Length Of Wall</i>							
	<i>Explanation : Vegetation Growth Through Joints Is Lifting Coping Stones</i>							
Wall/Fence								
Metal Fence	10%			LIFE	**	4-8	\$100	B
Masonry:Granite	90%	4+	\$5,100	LIFE	**	5	\$800	B
	<i>Jnt Mortar Miss/Erod, Extent : Light, Area Affected : 20%</i>							
	<i>Location : Scattered Throughout</i>							
Base								
Not Accessible	100%							D

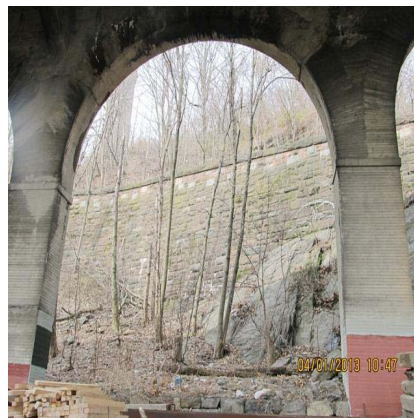
DEPT. OF PARKS & RECREATION - 846
HIGHBRIDGE PARK RETAINING WALL CUTSTONE W/ COPING RETAIN. WALL
Asset # : 14705

Retaining Walls		Current Repair		Future Replacement		Maintenance		Priority Code
System Component Type	% of Total	Fail Date (Years)	Estimated Cost	Year FY	Estimated Cost	Cycle (Yrs)	Estimated Cost	Priority Code
Wall								
Coping								
Masonry: Schist/Gneiss	91%			LIFE	**	5		A
Masonry: Schist/Gneiss	6%	4+	\$1,400	LIFE	**	5		A
<i>Spalling, Extent : Moderate, Area Affected : 80%</i>								
<i>Location : At South End Of Wall</i>								
<i>Vegetation Growth, Extent : Moderate, Area Affected : 40%</i>								
<i>Location : At South End Of Wall</i>								
Masonry: Schist/Gneiss	3%	Now	\$1,400	LIFE	**	5		A
<i>Misaligned/Bulging, Extent : Severe, Area Affected : 100%</i>								
<i>Location : At South End Of Wall</i>								
Wall/Fence								
Masonry: Granite	5%			LIFE	**	5	\$300	B
Masonry: Sandstone	40%	4+	\$40,500	LIFE	**			B
<i>Efflorescence, Extent : Light, Area Affected : 10%</i>								
<i>Location : Scattered Throughout</i>

<i>Vegetation Growth, Extent : Light, Area Affected : 10%</i>								
<i>Location : Scattered Throughout</i>								
<i>Other Observation, Extent : Moderate, Area Affected : 5%</i>								
<i>Location : At Center Of Wall</i>								
<i>Explanation : Water Infiltration</i>								
Masonry: Schist/Gneiss	55%			LIFE	**	5	\$3,400	B
Base								
Not Accessible	100%							D

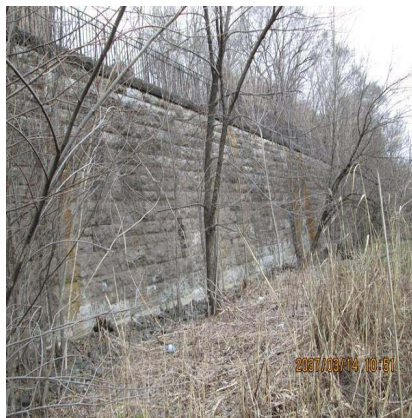
DEPT. OF PARKS & RECREATION - 846
HIGHBRIDGE PARK RETAINING WALL CUTSTONE W/ COPING RETAIN. WALL
Asset # : 14707

Retaining Walls		Current Repair		Future Replacement		Maintenance		Priority Code
System Component Type	% of Total	Fail Date (Years)	Estimated Cost	Year FY	Estimated Cost	Cycle (Yrs)	Estimated Cost	Priority Code
Wall								
Coping								
Concrete	1%			LIFE	**			A
<i>Other Observation, Extent : Light, Area Affected : 100%</i> <i>Location : 30ft From North End</i> <i>Explanation : Material: Concrete Block</i>								
Masonry:Brownstone	1%			LIFE	**	5		A
<i>Other Observation, Extent : Light, Area Affected : 100%</i> <i>Location : 1151 Feet From South End</i> <i>Explanation : Material: Cut Quarry Stone</i>								
Masonry:Granite	87%	4+	\$14,200	LIFE	**	5	\$300	A
<i>Cracking/Crumbling, Extent : Light, Area Affected : 1%</i> <i>Location : 1200 Feet From South End</i> <i>Jnt Mortar Miss/Erod, Extent : Light, Area Affected : 4%</i> <i>Location : Throughout</i> <i>Misaligned/Bulging, Extent : Light, Area Affected : 2%</i> <i>Location : A Length Of 32 Feet At 1232 Feet From South End</i> <i>Vegetation Growth, Extent : Light, Area Affected : 5%</i> <i>Location : 5 Inch Minimum Diameter Tree Trunks At 548 And 588 Feet From South End; 10 And 20 Feet From North End; At Random Locations</i>

Masonry:Granite	11%	Now	\$21,500	LIFE	**	5		A
<i>Broken/Missing Elem, Extent : Light, Area Affected : 100%</i> <i>Location : Broken Elements At Random Locations And Missing Elements At A Length Of 67 Feet At 1306 Feet From South End; Temp. Concrete Barriers Were Installed</i>								
Wall/Fence								
Metal Fence	20%	4+	\$38,000	LIFE	**	4-8	\$6,700	B
<i>Vegetation Growth, Extent : Light, Area Affected : 10%</i> <i>Location : At Random Locations Throughout</i> <i>Other Observation, Extent : Light, Area Affected : 5%</i> <i>Location : At Random Locations</i> <i>Explanation : Rusted</i>								
Metal Fence	2%	Now	\$38,000	LIFE	**	4-8	\$700	B
<i>Broken/Missing Elem, Extent : Light, Area Affected : 5%</i> <i>Location : At The Same Locations Of Impact Damage</i> <i>Impact Damage, Extent : Moderate, Area Affected : 5%</i> <i>Location : At 192, 212, 779, 819, 891, 914, 1059, 1154, 1187 And 1198 From South End</i>
