**DEPT. OF PARKS & RECREATION - FY 2019**

**Asset Name** : ABE STARK SKATING RINK INDOOR FACILITY  
**Address** : SURF AVE, W.19 ST AND BOARDWALK  
**Borough** : BROOKLYN **Agency's Number** : B336-01  
**Program / Asset #** : PAR0118.001 / 914 **Yr Built/Renovated** : 1969 / 2014  
**Area Sq Ft** : 43,873 **Project Type** : PARKS AND RECREATION  
**Date of Survey** : 09-May-2018 **Landmark Status** : NONE  
**Areas Surveyed** : Roof, Floors 1,Att  
**Block** : 7072 **Lot** : 14 **BIN** :

**DEPT. OF PARKS & RECREATION - 846**  
**ABE STARK SKATING RINK INDOOR FACILITY**

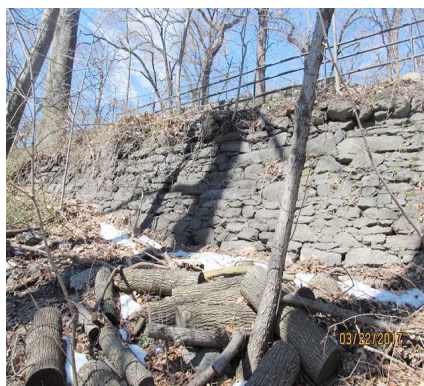
**DEPT. OF PARKS & RECREATION - 846**  
**HIGHBRIDGE PARK RETAINING WALL CUTSTONE RETAINING WALL**  
**Asset # : 14700**

Retaining Walls		Current Repair		Future Replacement		Maintenance		Priority
System Component Type	% of Total	Fail Date (Years)	Estimated Cost	Year FY	Estimated Cost	Cycle (Yrs)	Estimated Cost	
Wall								
Wall/Fence								
Rubble Stone	85%	2-4	\$51,900	LIFE	**	5	\$1,300	
			<i>Broken/Missing Elements, Extent : Light, Area Affected : 20%</i>					
			<i>Location : North End</i>					
			<i>Misaligned/Bulging, Extent : Light, Area Affected : 10%</i>					
			<i>Location : Throughout</i>					
			<i>Vegetation Growth, Extent : Moderate, Area Affected : 40%</i>					
			<i>Location : Scattered Throughout, And Large Diameter Trees Growing Out Of Top Of The Wall Throughout</i>					
			<i>Other Observation, Extent : Moderate, Area Affected : 10%</i>					
			<i>Location : Full Length Of Wall</i>					
			<i>Explanation : Washout At Top Of Wall</i>					
Rubble Stone	15%			LIFE	**	5	\$200	
Base								
Not Accessible	100%

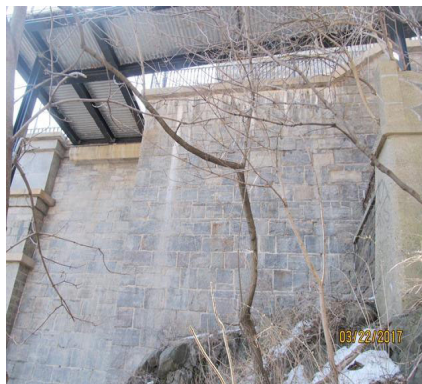
**DEPT. OF PARKS & RECREATION - 846**  
**HIGHBRIDGE PARK RETAINING WALL CUTSTONE W/ COPING RETAIN. WALL**  
**Asset # : 14704**

Retaining Walls		Current Repair		Future Replacement		Maintenance		Priority
System Component Type	% of Total	Fail Date (Years)	Estimated Cost	Year FY	Estimated Cost	Cycle (Yrs)	Estimated Cost	
Wall								
Coping								
Masonry:Granite	100%	4+	\$100	LIFE	**	5		
<i>Jnt Mortar Miss/Erod, Extent : Light, Area Affected : 5%</i>								
<i>Location : Scattered Throughout</i>								
Wall/Fence								
Metal Fence	10%			LIFE	**	4-8	\$100	
Masonry:Granite	90%	4+	\$5,400	LIFE	**	5	\$800	
<i>Jnt Mortar Miss/Erod, Extent : Light, Area Affected : 2%</i>								
<i>Location : Scattered Throughout</i>								
Base								
Not Accessible	100%

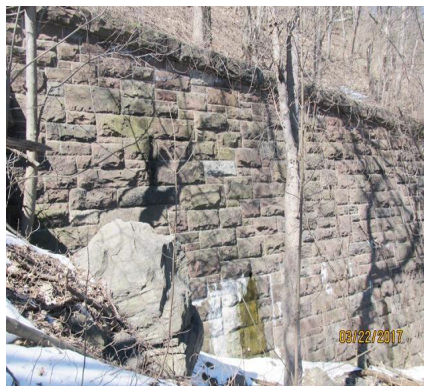
**DEPT. OF PARKS & RECREATION - 846**  
**HIGHBRIDGE PARK RETAINING WALL CUTSTONE W/ COPING RETAIN. WALL**

Retaining Walls		Current Repair		Future Replacement		Maintenance		Priority
System Component Type	% of Total	Fail Date (Years)	Estimated Cost	Year FY	Estimated Cost	Cycle (Yrs)	Estimated Cost	Priority
Wall								
Coping								
Masonry:Schist/Gneiss	100%	4+	\$2,500	LIFE		**	5	
<i>Spalling, Extent : Light, Area Affected : 1%</i>								
<i>Location : Throughout</i>								
<i>Vegetation Growth, Extent : Light, Area Affected : 2%</i>								
<i>Location : Throughout</i>								
Wall/Fence								
Masonry:Sandstone	100%	4+	\$109,000	LIFE		**		
<i>Efflorescence, Extent : Light, Area Affected : 2%</i>								
<i>Location : Scattered Throughout</i>								
<i>Vegetation Growth, Extent : Light, Area Affected : 5%</i>								
<i>Location : Scattered Throughout</i>								
<i>Other Observation, Extent : Moderate, Area Affected : 5%</i>								
<i>Location : Scattered Throughout</i>								
<i>Explanation : Water Infiltration</i>

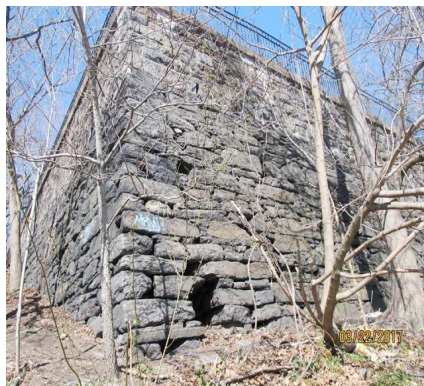
**DEPT. OF PARKS & RECREATION - 846**  
**HIGHBRIDGE PARK RETAINING WALL CUTSTONE W/ COPING RETAIN. WALL**

Retaining Walls		Current Repair		Future Replacement		Maintenance		Priority
System Component Type	% of Total	Fail Date (Years)	Estimated Cost	Year FY	Estimated Cost	Cycle (Yrs)	Estimated Cost	Priority
Wall								
Coping								
Concrete	94%	2-4	\$51,900	LIFE		**		
			<i>Spalling, Extent : Moderate, Area Affected : 20%</i>					
			<i>Location : Scattered Throughout, With Concentration On North End</i>					
			<i>Vegetation Growth, Extent : Light, Area Affected : 20%</i>					
			<i>Location : Scattered Throughout</i>					
Concrete	6%			LIFE		**		
Wall/Fence								
Metal Fence	15%	2-4	\$40,200	LIFE		**	4-8	\$1,600
			<i>Deteriorated Finish, Extent : Severe, Area Affected : 5%</i>					
			<i>Location : At Base Of Rail, Throughout</i>					
			<i>Misaligned/Bulging, Extent : Light, Area Affected : 20%</i>					
			<i>Location : Scattered Throughout</i>					
			<i>Other Observation, Extent : Severe, Area Affected : 10%</i>

<i>Location : At North End Of Wall</i>					
			<i>Explanation : Loose Guardrail Supports, Area Fenced Off</i>					
Masonry:Schist/Gneiss	85%	4+	\$56,200	LIFE		**	5	\$7,900
			<i>Broken/Missing Elements, Extent : Severe, Area Affected : 1%</i>					
			<i>Location : At South End Of Wall</i>					
			<i>Efflorescence, Extent : Moderate, Area Affected : 5%</i>					
			<i>Location : Scattered Throughout</i>					
			<i>Jnt Mortar Miss/Erod, Extent : Moderate, Area Affected : 5%</i>					
			<i>Location : Scattered Throughout</i>					
			<i>Misaligned/Bulging, Extent : Moderate, Area Affected : 5%</i>					
			<i>Location : At North End And South End Of Wall</i>					
			<i>Vegetation Growth, Extent : Moderate, Area Affected : 10%</i>					
			<i>Location : Scattered Throughout</i>					
			<i>Weepholes Not Funct, Extent : Moderate, Area Affected : 5%</i>					
			<i>Location : At Center Of Wall</i>					
Base

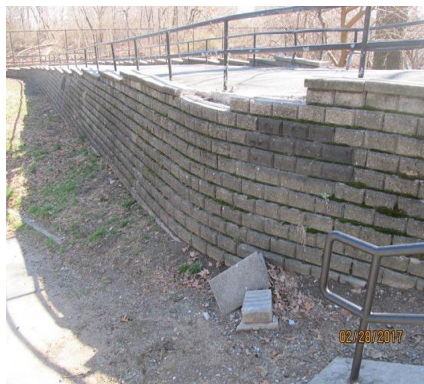
**DEPT. OF PARKS & RECREATION - 846**  
**HIGHBRIDGE PARK RETAINING WALL GRANITE BRICK RETAINING WALL**

Retaining Walls		Current Repair		Future Replacement		Maintenance		Priority
System Component Type	% of Total	Fail Date (Years)	Estimated Cost	Year FY	Estimated Cost	Cycle (Yrs)	Estimated Cost	Priority
Wall								
Coping								
Concrete	100%	2-4	\$2,400	LIFE		**		
			<i>Broken/Missing Elements, Extent : Moderate, Area Affected : 10%</i>					
			<i>Location : At Center Of Wall</i>					
			<i>Other Observation, Extent : Light, Area Affected : 100%</i>					
			<i>Location : Throughout</i>					
			<i>Explanation : Material: Concrete Block</i>					
Wall/Fence								
Concrete	100%	4+	\$7,900	LIFE		**	5	\$100
			<i>Broken/Missing Elements, Extent : Light, Area Affected : 5%</i>					
			<i>Location : 20 Feet From North End</i>					
			<i>Vegetation Growth, Extent : Light, Area Affected : 1%</i>					
			<i>Location : At Random Locations</i>					
			<i>Other Observation, Extent : Light, Area Affected : 100%</i>

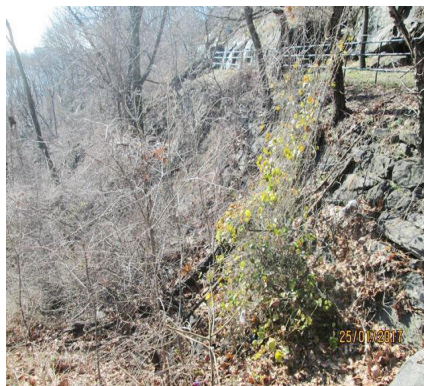
**DEPT. OF PARKS & RECREATION - 846  
HIGHBRIDGE PARK RETAINING WALL RETAINING / PERIMETER WALL**

Retaining Walls		Current Repair		Future Replacement		Maintenance		Priority
System Component Type	% of Total	Fail Date (Years)	Estimated Cost	Year FY	Estimated Cost	Cycle (Yrs)	Estimated Cost	
Wall								
Wall/Fence								
Rubble Stone	100%	Now	\$130,700	LIFE	**	5	\$1,600	
<i>Vegetation Growth, Extent : Severe, Area Affected : 60%</i> <i>Location : Throughout, 8+ Trees Over 3 Inch Diameter Throughout</i> <i>Other Observation, Extent : Light, Area Affected : 1%</i> <i>Location : North Side</i> <i>Explanation : 8-inch Steel Drainage Pipe Through Wall</i>								
Base								
Not Accessible	100%

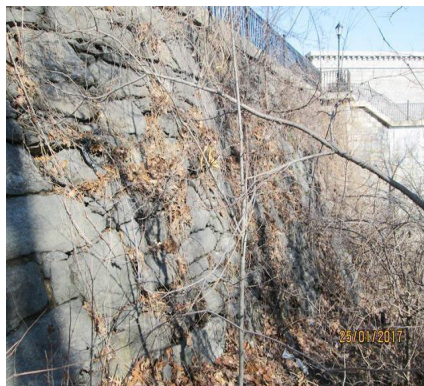
**DEPT. OF PARKS & RECREATION - 846**  
**HIGHBRIDGE PARK RETAINING WALL RETAINING / PERIMETER WALL**  
**Asset # : 14703**

Retaining Walls		Current Repair		Future Replacement		Maintenance		Priority
System Component Type	% of Total	Fail Date (Years)	Estimated Cost	Year FY	Estimated Cost	Cycle (Yrs)	Estimated Cost	
Wall								
Coping								
Masonry:Limestone	100%			LIFE	**			
<i>Spalling, Extent : Light, Area Affected : 2%</i>								
<i>Location : Random Locations Throughout</i>								
Wall/Fence								
Metal Fence	20%	4+	\$900	LIFE	**	4-8	\$700	
<i>Broken/Missing Elements, Extent : Moderate, Area Affected : 1%</i>								
<i>Location : Single Broken Post At South End</i>								
<i>Impact Damage, Extent : Light, Area Affected : 2%</i>								
<i>Location : Broken Spindles Southern End Of Fence</i>								
<i>Loose Fastenings, Extent : Moderate, Area Affected : 2%</i>								
<i>Location : Weld Failed At Bottom Of Posts Throughout</i>								
Rubble Stone	80%	2-4	\$17,200	LIFE	**	5	\$2,100	
<i>Jnt Mortar Miss/Erod, Extent : Moderate, Area Affected : 50%</i>

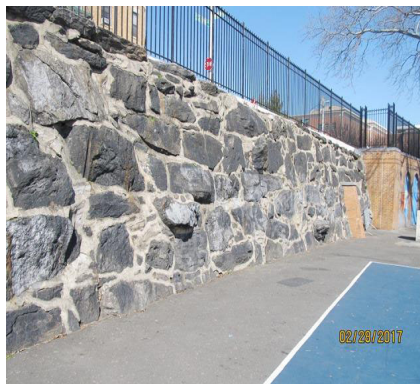
**DEPT. OF PARKS & RECREATION - 846**  
**HIGHBRIDGE PARK RETAINING WALL RUBBLE STONE PERIMETER WALL**  
**Asset # : 14693**

Retaining Walls		Current Repair		Future Replacement		Maintenance		Priority
System Component Type	% of Total	Fail Date (Years)	Estimated Cost	Year FY	Estimated Cost	Cycle (Yrs)	Estimated Cost	Priority
Wall								
Coping								
Masonry:Schist/Gneiss	80%	4+	\$5,100	LIFE	**	5		
<i>Cracking/Crumbling, Extent : Light, Area Affected : 5%</i>								
<i>Location : At Random Locations</i>								
<i>Vegetation Growth, Extent : Light, Area Affected : 5%</i>								
<i>Location : Throughout</i>								
<i>Other Observation, Extent : Light, Area Affected : 100%</i>								
<i>Location : Throughout</i>								
<i>Explanation : Schist With Concrete Parge</i>								
Masonry:Schist/Gneiss	20%			LIFE	**	5		
Wall/Fence								
Rubble Stone	100%	4+	\$18,100	LIFE	**	5	\$2,200	
<i>Broken/Missing Elements, Extent : Light, Area Affected : 2%</i>								
<i>Location : At Random Locations</i>								
<i>Jnt Mortar Miss/Erod, Extent : Light, Area Affected : 2%</i>

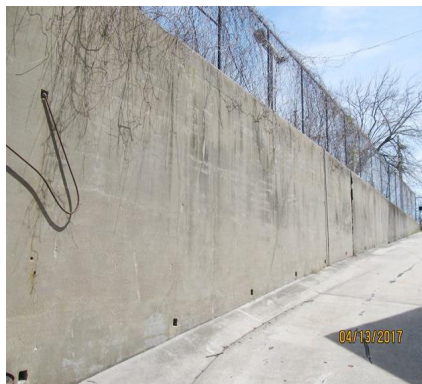
**DEPT. OF PARKS & RECREATION - 846**  
**HIGHBRIDGE PARK RETAINING WALL RUBBLE STONE RETAINING WALL**  
**Asset # : 14685**

Retaining Walls		Current Repair		Future Replacement		Maintenance		Priority
System Component Type	% of Total	Fail Date (Years)	Estimated Cost	Year FY	Estimated Cost	Cycle (Yrs)	Estimated Cost	
Wall								
Coping Concrete	100%	4+	\$2,000	LIFE			**	
<i>Broken/Missing Elements, Extent : Light, Area Affected : 10%</i>								
<i>Location : Throughout</i>								
<i>Cracking/Crumbling, Extent : Light, Area Affected : 10%</i>								
<i>Location : Throughout</i>								
Wall/Fence								
Metal Fence	20%	4+	\$2,400	LIFE		**	4-8	\$200
<i>Deteriorated Finish, Extent : Light, Area Affected : 5%</i>								
<i>Location : Random Locations Throughout</i>								
Rubble Stone	80%	4+	\$4,600	LIFE		**	5	\$600
<i>Vegetation Growth, Extent : Light, Area Affected : 1%</i>								
<i>Location : 10 Inch Diameter Tree Trunk 20 Feet From The South End</i>								
Base								
Not Accessible	100%

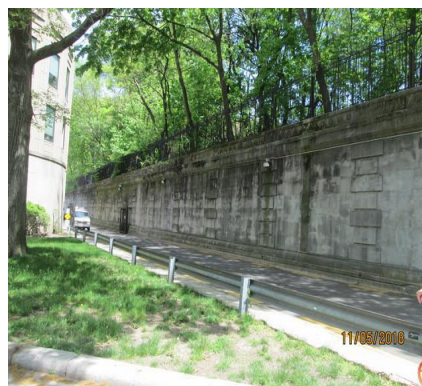
**DEPT. OF PARKS & RECREATION - 846**  
**MT. PROSPECT PARK RETAINING WALL**  
**Asset # : 14962**

Retaining Walls		Current Repair		Future Replacement		Maintenance		Priority
System	Component Type	% of Total	Fail Date (Years)	Estimated Cost	Year FY	Estimated Cost	Cycle (Yrs)	Estimated Cost
Wall								
	Coping							
	Concrete	75%	4+	\$2,900	LIFE	**		
				<i>Cracks-Vertical, Extent : Light, Area Affected : 2%</i>				
				<i>Location : Random Locations Throughout</i>				
	Concrete	25%			LIFE	**		
Wall/Fence								
	Concrete	75%	4+	\$76,400	LIFE	**	5	\$1,900
				<i>Spalling, Extent : Light, Area Affected : 1%</i>				
				<i>Location : Random Locations Throughout</i>				
				<i>Cracks-Vertical, Extent : Light, Area Affected : 1%</i>				
				<i>Location : Random Locations Throughout</i>				
	Metal Fence	15%	4+	\$7,100	LIFE	**	4-8	\$2,300
				<i>Deteriorated Finish, Extent : Moderate, Area Affected : 20%</i>				
				<i>Location : Random Locations Throughout</i>				
				<i>Vegetation Growth, Extent : Light, Area Affected : 1%</i>

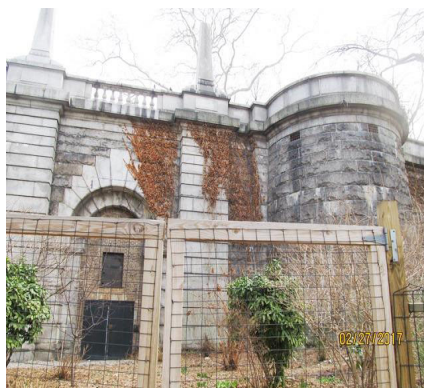
**DEPT. OF PARKS & RECREATION - 846**  
**RIVERSIDE PARK RETAINING WALL**  
**Asset # : 14247**

Retaining Walls		Current Repair		Future Replacement		Maintenance		Priority
System Component Type	% of Total	Fail Date (Years)	Estimated Cost	Year FY	Estimated Cost	Cycle (Yrs)	Estimated Cost	Priority
Wall								
Coping								
Masonry:Granite	100%	4+	\$6,100	LIFE	**	5		
<i>Cracking/Crumbling, Extent : Light, Area Affected : 10%</i>								
<i>Location : East Face</i>								
<i>Jnt Mortar Miss/Erod, Extent : Moderate, Area Affected : 50%</i>								
<i>Location : Throughout</i>								
<i>Vegetation Growth, Extent : Light, Area Affected : 2%</i>								
<i>Location : At Seating Area North End Top Face</i>								
Wall/Fence								
Masonry:Granite	15%	4+	\$45,600	LIFE	**	5	\$500	
<i>Cracks-Diagonal, Extent : Moderate, Area Affected : 10%</i>								
<i>Location : At Seating Area East Face North End</i>								
<i>Efflorescence, Extent : Moderate, Area Affected : 10%</i>								
<i>Location : Random Locations Throughout</i>

<i>Jnt Mortar Miss/Erod, Extent : Moderate, Area Affected : 20%</i>								
<i>Location : Throughout</i>								
<i>Spalling, Extent : Moderate, Area Affected : 10%</i>								
<i>Location : West Face</i>								
<i>Vegetation Growth, Extent : Light, Area Affected : 20%</i>								
<i>Location : West Face</i>								
Masonry:Granite	84%	4+	\$55,500	LIFE	**	5	\$2,800	
<i>Efflorescence, Extent : Moderate, Area Affected : 10%</i>								
<i>Location : Random Locations Throughout</i>								
<i>Jnt Mortar Miss/Erod, Extent : Moderate, Area Affected : 5%</i>								
<i>Location : Throughout</i>								
<i>Other Observation, Extent : Light, Area Affected : 5%</i>								
<i>Location : West Face</i>								
<i>Explanation : Clay Brick With No Defects</i>								
Steel Grating	1%	4+	\$100	2048	**			
<i>Deteriorated Finish, Extent : Light, Area Affected : 100%</i>								
<i>Location : Throughout</i>								
Base

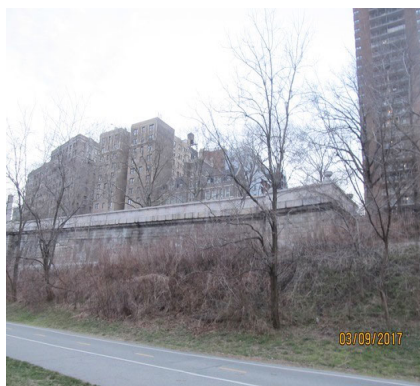
**DEPT. OF PARKS & RECREATION - 846**  
**RIVERSIDE PARK RETAINING WALL**  
**Asset # : 14249**

Retaining Walls		Current Repair		Future Replacement		Maintenance		Priority
System Component Type	% of Total	Fail Date (Years)	Estimated Cost	Year FY	Estimated Cost	Cycle (Yrs)	Estimated Cost	
<b>Wall</b>								
<b>Coping</b>								
Masonry:Granite	100%	2-4	\$46,700	LIFE	**	5	\$400	
<i>Jnt Mortar Miss/Erod, Extent : Moderate, Area Affected : 10%</i>								
<i>Location : Throughout</i>								
<i>Misaligned/Bulging, Extent : Moderate, Area Affected : 10%</i>								
<i>Location : Throughout</i>								
<i>Spalling, Extent : Moderate, Area Affected : 10%</i>								
<i>Location : At North End</i>								
<hr/>								
<b>Wall/Fence</b>								
Masonry:Granite	85%	2-4	\$570,600	LIFE	**	5	\$29,300	
<i>Jnt Mortar Miss/Erod, Extent : Moderate, Area Affected : 5%</i>								
<i>Location : Throughout</i>								
<i>Staining/Scaling, Extent : Moderate, Area Affected : 50%</i>								
<i>Location : West Face Throughout</i>

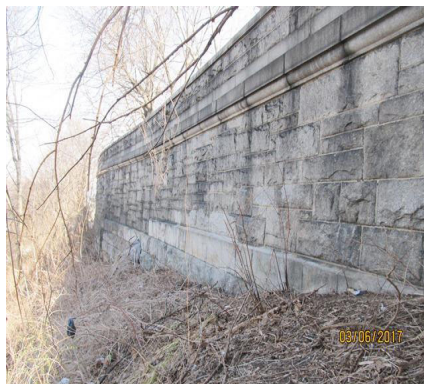
**DEPT. OF PARKS & RECREATION - 846  
RIVERSIDE PARK RETAINING WALL  
Asset # : 14252**

Retaining Walls		Current Repair		Future Replacement		Maintenance		Priority
System Component Type	% of Total	Fail Date (Years)	Estimated Cost	Year FY	Estimated Cost	Cycle (Yrs)	Estimated Cost	
Wall								
Coping								
Masonry:Granite	100%	4+	\$11,600	LIFE	**	5	\$200	
			<i>Jnt Mortar Miss/Erod, Extent : Light, Area Affected : 10%</i>					
			<i>Location : Random Locations Throughout</i>					
			<i>Vegetation Growth, Extent : Light, Area Affected : 15%</i>					
			<i>Location : Random Locations Throughout</i>					
Wall/Fence								
Masonry:Granite	47%	Now	\$180,400	LIFE	**	5	\$8,000	
			<i>Cracking/Crumbling, Extent : Moderate, Area Affected : 10%</i>					
			<i>Location : West Face</i>					
			<i>Efflorescence, Extent : Moderate, Area Affected : 10%</i>					
			<i>Location : Scattered Throughout Western Face Of Wall</i>					
			<i>Jnt Mortar Miss/Erod, Extent : Moderate, Area Affected : 20%</i>					
			<i>Location : Throughout Wall Mostly On Western Face</i>

<i>Staining/Scaling, Extent : Moderate, Area Affected : 20%</i>					
			<i>Location : Scattered Throughout Western Face Of Wall</i>					
			<i>Vegetation Growth, Extent : Moderate, Area Affected : 10%</i>					
			<i>Location : Random Locations Throughout Western Face Of Wall</i>					
			<i>Other Observation, Extent : Light, Area Affected : 75%</i>					
			<i>Location : West Face</i>					
			<i>Explanation : 75 Percent Of West Face Inaccessible</i>					
Masonry:Granite	53%			LIFE	**	5	\$9,100	
Base								
Not Accessible	100%

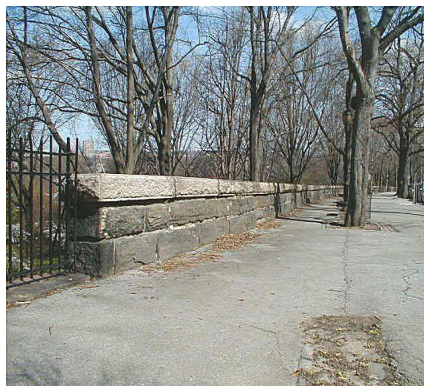
**DEPT. OF PARKS & RECREATION - 846**  
**RIVERSIDE PARK RETAINING WALL**  
**Asset # : 215**

Retaining Walls		Current Repair		Future Replacement		Maintenance		Priority
System Component Type	% of Total	Fail Date (Years)	Estimated Cost	Year FY	Estimated Cost	Cycle (Yrs)	Estimated Cost	
Wall								
Coping								
Masonry:Granite	100%	4+	\$10,400	LIFE	**	5	\$700	
			<i>Jnt Mortar Miss/Erod, Extent : Severe, Area Affected : 10%</i>					
			<i>Location : Random Locations Throughout</i>					
Wall/Fence								
Masonry:Schist/Gneiss	5%	0-2	\$670,700	LIFE	**	5	\$2,900	
			<i>Broken/Missing Elements, Extent : Moderate, Area Affected : 50%</i>					
			<i>Location : Random Locations Throughout</i>					
			<i>Jnt Mortar Miss/Erod, Extent : Severe, Area Affected : 100%</i>					
			<i>Location : Random Locations Throughout</i>					
			<i>Misaligned/Bulging, Extent : Severe, Area Affected : 50%</i>					
			<i>Location : Random Locations Throughout.</i>					
			<i>Vegetation Growth, Extent : Moderate, Area Affected : 80%</i>

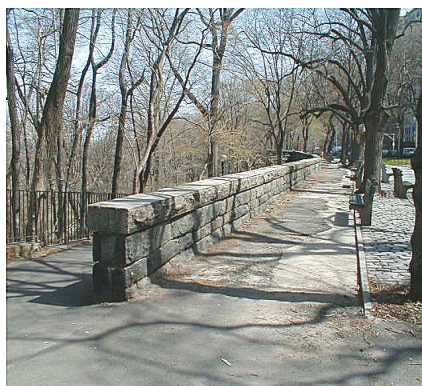
**DEPT. OF PARKS & RECREATION - 846**  
**RIVERSIDE PARK RETAINING WALL**  
**Asset # : 217**

Retaining Walls		Current Repair		Future Replacement		Maintenance		Priority
System Component Type	% of Total	Fail Date (Years)	Estimated Cost	Year FY	Estimated Cost	Cycle (Yrs)	Estimated Cost	
Wall								
Coping								
Masonry:Granite	5%	4+	\$28,400	LIFE	**	5		
			<i>Jnt Mortar Miss/Erod, Extent : Severe, Area Affected : 80%</i>					
			<i>Location : Random Locations Throughout</i>					
			<i>Vegetation Growth, Extent : Moderate, Area Affected : 40%</i>					
			<i>Location : Random Locations Throughout</i>					
Masonry:Granite	95%			LIFE	**	5	\$800	
Wall/Fence								
Masonry:Schist/Gneiss	100%	4+	\$1,224,300	LIFE	**	5	\$62,800	
			<i>Broken/Missing Elements, Extent : Severe, Area Affected : 5%</i>					
			<i>Location : Random Locations Throughout</i>					
			<i>Jnt Mortar Miss/Erod, Extent : Severe, Area Affected : 10%</i>					
			<i>Location : Random Locations Throughout</i>					
			<i>Vegetation Growth, Extent : Moderate, Area Affected : 50%</i>

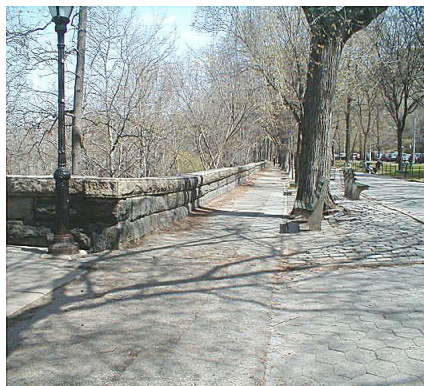
**DEPT. OF PARKS & RECREATION - 846**  
**RIVERSIDE PARK RETAINING WALL**  
**Asset # : 218**

Retaining Walls		Current Repair		Future Replacement		Maintenance		Priority
System Component Type	% of Total	Fail Date (Years)	Estimated Cost	Year FY	Estimated Cost	Cycle (Yrs)	Estimated Cost	
Wall								
Coping								
Masonry:Granite	5%	4+	\$3,000	LIFE	**	5		
<i>Jnt Mortar Miss/Erod, Extent : Severe, Area Affected : 100%</i>								
<i>Location : Random Locations Throughout</i>								
Masonry:Granite	95%			LIFE	**	5	\$800	
Wall/Fence								
Masonry:Schist/Gneiss	100%	Now	\$1,277,600	LIFE	**	5	\$65,500	
<i>Broken/Missing Elements, Extent : Moderate, Area Affected : 2%</i>								
<i>Location : Various Areas Between 108th And 109th Streets</i>								
<i>Jnt Mortar Miss/Erod, Extent : Light, Area Affected : 15%</i>								
<i>Location : Random Locations Throughout</i>								
<i>Vegetation Growth, Extent : Light, Area Affected : 20%</i>								
<i>Location : Park Side Wall</i>								
Base								
Not Accessible	100%

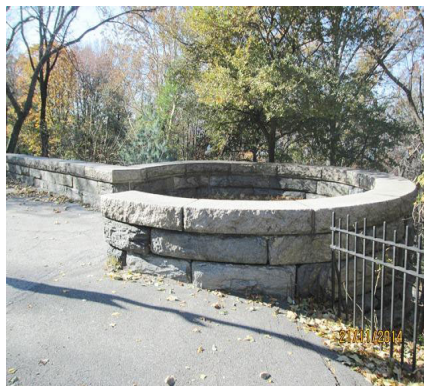
**DEPT. OF PARKS & RECREATION - 846**  
**RIVERSIDE PARK RETAINING WALL**  
**Asset # : 219**

Retaining Walls		Current Repair		Future Replacement		Maintenance		Priority
System Component Type	% of Total	Fail Date (Years)	Estimated Cost	Year FY	Estimated Cost	Cycle (Yrs)	Estimated Cost	
Wall								
Coping								
Masonry:Granite	100%	4+	\$11,400	LIFE	**	5	\$800	
			<i>Jnt Mortar Miss/Erod, Extent : Light, Area Affected : 10%</i>					
			<i>Location : Throughout</i>					
			<i>Misaligned/Bulging, Extent : Moderate, Area Affected : 1%</i>					
			<i>Location : Between 116th And 119th Streets</i>					
			<i>Vegetation Growth, Extent : Light, Area Affected : 1%</i>					
			<i>Location : Throughout</i>					
Wall/Fence								
Masonry:Schist/Gneiss	100%	4+	\$1,224,300	LIFE	**	5	\$62,800	
			<i>Broken/Missing Elements, Extent : Light, Area Affected : 1%</i>					
			<i>Location : Park Side, Stones Below Coping</i>					
			<i>Jnt Mortar Miss/Erod, Extent : Light, Area Affected : 10%</i>					
			<i>Location : Throughout</i>

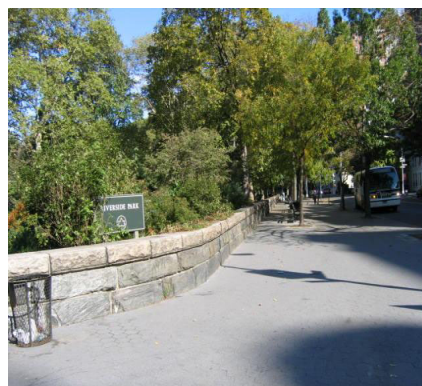
**DEPT. OF PARKS & RECREATION - 846**  
**RIVERSIDE PARK RETAINING WALL**  
**Asset # : 13722**

Retaining Walls		Current Repair		Future Replacement		Maintenance		Priority
System	Component Type	% of Total	Fail Date (Years)	Estimated Cost	Year FY	Estimated Cost	Cycle (Yrs)	Estimated Cost
Wall	Coping							
	Masonry:Granite	100%	4+	\$8,900	LIFE	**	5	\$600
				<i>Jnt Mortar Miss/Erod, Extent : Light, Area Affected : 5%</i>				
				<i>Location : Throughout</i>				
				<i>Misaligned/Bulging, Extent : Light, Area Affected : 1%</i>				
				<i>Location : South End Of Wall</i>				
Wall/Fence	Masonry:Schist/Gneiss	100%	Now	\$385,900	LIFE	**	5	\$49,500
				<i>Broken/Missing Elements, Extent : Severe, Area Affected : 1%</i>				
				<i>Location : Three Failed Areas On Park Side Of Wall</i>				
				<i>Jnt Mortar Miss/Erod, Extent : Moderate, Area Affected : 5%</i>				
				<i>Location : Throughout</i>				
				<i>Vegetation Growth, Extent : Moderate, Area Affected : 10%</i>				
				<i>Location : Throughout</i>
