DEPT. OF SMALL BUSINESS SERV. - FY 2014

Asset Name : 125TH STREET PARKING GARAGE 5 LEVEL GARAGE
Address : 121 WEST 125TH STREET
Borough : MANHATTAN **Agency's Number** : N/A
Program / Asset # : DBS0028.000 / 4334 **Yr Built/Renovated** : 1972 / 2005
Area Sq Ft : 155,197 **Project Type** : ECONOMIC DEVELOPMENT
Date of Survey : 06-Dec-2010 **Landmark Status** : NONE
Areas Surveyed : Basement, Roof, Floors 1,2,3,4,5
Block : 1910 **Lot** : 1 **BIN** : 1081601

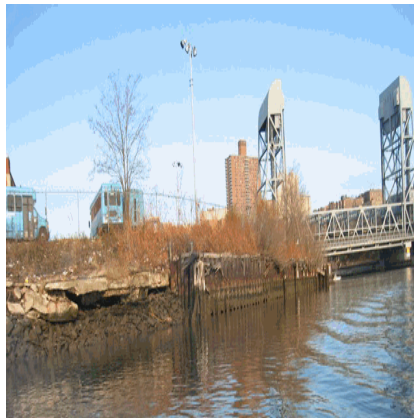
DEPT. OF SMALL BUSINESS SERV. - 801
STEEL SHEETPILE BULKHEAD
Asset # : 13792

Bulkheads		Current Repair		Future Replacement		Maintenance		Priority Code
System Component Type	% of Total	Fail Date (Years)	Estimated Cost	Year FY	Estimated Cost	Cycle (Yrs)	Estimated Cost	
Structural								
Gravity Wall								
Timber Crib w/Stone	20%	Now	\$135,800	LIFE	**	4	\$1,200	A
			<i>Other Observation, Extent : Severe, Area Affected : 100%</i>					
			<i>Location : Station 2+10 To 2+50 From North</i>					
			<i>Explanation : Collapsed/ Failed</i>					
No Component	80%							D
Piles and Bracing								
Steel	1%	4+	\$2,200	LIFE	**	5	\$300	A
			<i>Corrosion, Extent : Light, Area Affected : 10%</i>					
			<i>Location : Single Pipe Pile At South End Of Asset</i>					
No Component	99%							D

Sheet Piles								
Steel	70%	Now	\$967,700	LIFE	**			A
			<i>Other Observation, Extent : Severe, Area Affected : 30%</i>					
			<i>Location : Throughout At Waterline</i>					
			<i>Explanation : Dent, Holes</i>					
No Component	20%							D
Not Accessible	10%							D
Pile Caps								
Timber	80%	Now	\$9,400	LIFE	**	4	\$1,300	A
			<i>Broken, Extent : Severe, Area Affected : 100%</i>					
			<i>Location : Throughout</i>					
No Component	20%							D
Backfill								
Fill								
Topsoil	70%	Now	\$35,000	2064	**			B
			<i>Sinkhole, Extent : Severe, Area Affected : 100%</i>					
			<i>Location : Inshore Of Sheet Pile Bulkhead</i>					
			<i>Other Observation, Extent : Severe, Area Affected : 100%</i>					
			<i>Location : Inshore Of Sheet Pile Bulkhead</i>					
			<i>Explanation : Significant Fill Loss</i>					
Not Accessible	30%							D

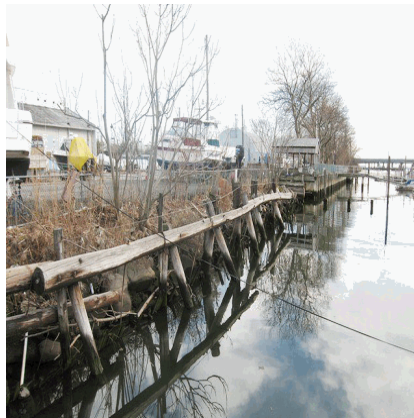
DEPT. OF SMALL BUSINESS SERV. - 801
TIMBER BULKHEAD PAERDERGAT BASIN
Asset # : 13480

Bulkheads		Current Repair		Future Replacement		Maintenance		Priority Code
System Component Type	% of Total	Fail Date (Years)	Estimated Cost	Year FY	Estimated Cost	Cycle (Yrs)	Estimated Cost	
Structural								
Piles and Bracing								
Timber	5%			2033	**	4	\$5,300	A
Timber	85%	Now	\$801,800	2039	**	4	\$89,700	A
<i>Other Observation, Extent : Severe, Area Affected : 100%</i>								
<i>Location : Throughout</i>								
<i>Explanation : Failed And/ Or Severe Deterioration</i>								
No Component	7%							D
Not Accessible	3%							D
Revetment								
Concrete	3%	Now	\$16,200	LIFE	**			C
<i>Other Observation, Extent : Severe, Area Affected : 100%</i>								
<i>Location : Between Sta. 0+21 And 0+91 (From West)</i>								
<i>Explanation : Minimal To No Shoreline Protection</i>								
Concrete	4%	4+	\$6,500	LIFE	**			C
<i>Other Observation, Extent : Moderate, Area Affected : 20%</i>								
<i>Location : Along Top Of Revetment From Sta. 0+00 To 0+21 And 0+91 To 1+70</i>

<i>Explanation : Non-engineered Slope; Inadequate Protection</i>								
No Component	93%							D
Sheet Piles								
Timber	5%			LIFE	**	4	\$1,000	A
Timber	20%	0-2	\$184,200	LIFE	**	4	\$2,600	A
<i>Rotting/Splitting, Extent : Severe, Area Affected : 100%</i>								
<i>Location : Typical Throughout</i>								
<i>Other Observation, Extent : Severe, Area Affected : 100%</i>								
<i>Location : Typical Throughout</i>								
<i>Explanation : Severely Deteriorated / Failed Above Lower Wale</i>								
Timber	60%	Now	\$552,500	LIFE	**	4	\$7,900	A
<i>Other Observation, Extent : Severe, Area Affected : 100%</i>								
<i>Location : Throughout</i>								
<i>Explanation : Collapsed/ Failed Above Mlw</i>								
No Component	7%							D
Not Accessible	8%							D
Wales								
Timber	5%			LIFE	**	4	\$800	A
Timber	40%	0-2	\$48,500	LIFE	**	4	\$4,200	A
<i>Rotting/Splitting, Extent : Severe, Area Affected : 100%</i>

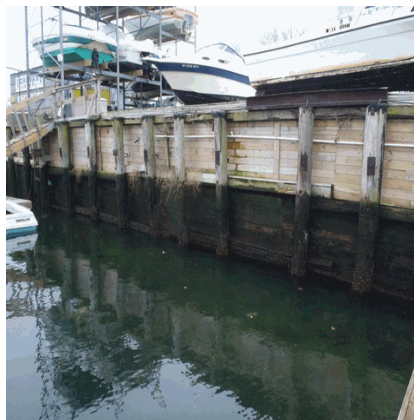
DEPT. OF SMALL BUSINESS SERV. - 801
TIMBER BULKHEAD YANKEE SKIPPER
Asset # : 20

Bulkheads		Current Repair		Future Replacement		Maintenance		Priority Code
System Component Type	% of Total	Fail Date (Years)	Estimated Cost	Year FY	Estimated Cost	Cycle (Yrs)	Estimated Cost	
Structural								
Piles and Bracing								
Timber	70%	4+	\$46,000	2038	**	4	\$10,300	A
<i>Rotting/Splitting, Extent : Moderate, Area Affected : 40%</i>								
<i>Location : Throughout Bulkhead</i>								
Timber	25%	0-2	\$16,400	2038	**	4	\$3,700	A
<i>Rotting/Splitting, Extent : Severe, Area Affected : 50%</i>								
<i>Location : Isolated Throughout Bulkhead</i>								
Timber	5%			2038	**	4	\$700	A
<i>Recent Replace Evident, Extent : Light, Area Affected : 100%</i>								
<i>Location : Near South End Of Bulkhead</i>

Sheet Piles								
Timber, 10' Water	60%	4+	\$123,800	LIFE	**	4	\$1,100	A
<i>Worn, Extent : Light, Area Affected : 100%</i>								
<i>Location : Above Mlw Elevation</i>								
Timber, 10' Water	40%			LIFE	**	4	\$700	A
<i>Recent Replace Evident, Extent : Light, Area Affected : 100%</i>								
<i>Location : Above Mhw Elevation</i>								
Wales								
Timber	75%	4+	\$12,700	LIFE	**	4	\$1,100	A
<i>Rotting/Splitting, Extent : Light, Area Affected : 50%</i>								
<i>Location : Throughout</i>								
Timber	25%	0-2	\$4,200	LIFE	**	4	\$400	A
<i>Rotting/Splitting, Extent : Severe, Area Affected : 50%</i>								
<i>Location : Lower Wale</i>								
Backfill								
Fill								
Not Accessible	100%							D
Surface								
Gravel	40%			2032	**	2-5	\$100	B
Topsoil	40%			2021	\$2,400	5	\$200	B
Not Accessible	20%							D

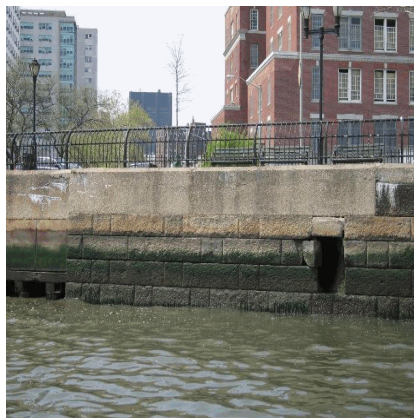
DEPT. OF SMALL BUSINESS SERV. - 801
TIMBER PILE SUPPORTED BULKHEAD
Asset # : 13843

Bulkheads		Current Repair		Future Replacement		Maintenance		Priority Code
System Component Type	% of Total	Fail Date (Years)	Estimated Cost	Year FY	Estimated Cost	Cycle (Yrs)	Estimated Cost	
Structural								
Gravity Wall								
Conc w/Stone Face	100%	4+	\$54,200	LIFE	**	5	\$3,800	A
<i>Cracking, Extent : Light, Area Affected : 20%</i>								
<i>Location : Above Mhw In Outboard Face</i>								
<i>Missing Block Seal, Extent : Severe, Area Affected : 30%</i>								
<i>Location : Between Stones In Tidal Zone</i>								
<i>Spalling, Extent : Moderate, Area Affected : 20%</i>								
<i>Location : Top Corner Sta 0+49 (from North)</i>								
Piles and Bracing								
Not Accessible	100%							D
Backfill								
Fill								
Not Accessible	100%							D
Surface								
Asphalt Pavers	100%	4+	\$5,000	2030	**	5	\$200	B
<i>Settlement, Extent : Light, Area Affected : 100%</i>								
<i>Location : Throughout Offset 3ft From Outboard Bulkhead Face</i>

<i>Other Observation, Extent : Severe, Area Affected : 2%</i>								
<i>Location : Along Settlement Joint</i>								
<i>Explanation : Broken Pavers</i>								
Deck Elements								
Railing								
Steel	100%	4+	\$2,300	2019	\$46,200			B
<i>Other Observation, Extent : Light, Area Affected : 15%</i>								
<i>Location : Isolated Throughout</i>								
<i>Explanation : Coating Loss</i>

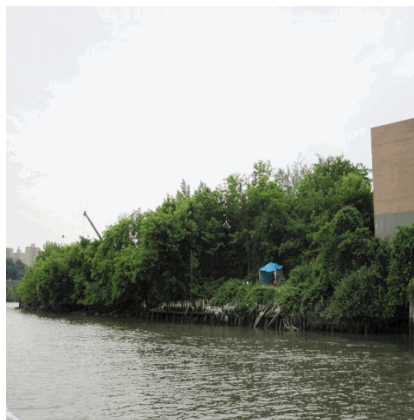
**DEPT. OF SMALL BUSINESS SERV. - 801
TIMBER SHEETPILE/RIPRAP BULKHEAD
Asset # : 13791**

Bulkheads		Current Repair		Future Replacement		Maintenance		Priority Code
System Component Type	% of Total	Fail Date (Years)	Estimated Cost	Year FY	Estimated Cost	Cycle (Yrs)	Estimated Cost	
Structural								
Piles and Bracing								
Timber	100%	Now	\$1,452,600	2037	* *	4	\$65,000	A
<i>Broken, Extent : Severe, Area Affected : 100%</i>								
<i>Location : Throughout</i>								
<hr/>								
Backfill								
Fill								
Topsoil	100%	Now	\$106,100	2062	* *			B
<i>Erosion, Extent : Severe, Area Affected : 100%</i>								
<i>Location : Throughout</i>								
<hr/>								
Surface								
Topsoil	100%	Now	\$26,600	2022	\$26,600	5	\$1,000	B
<i>Erosion, Extent : Severe, Area Affected : 100%</i>								
<i>Location : Throughout</i>								
<hr/>

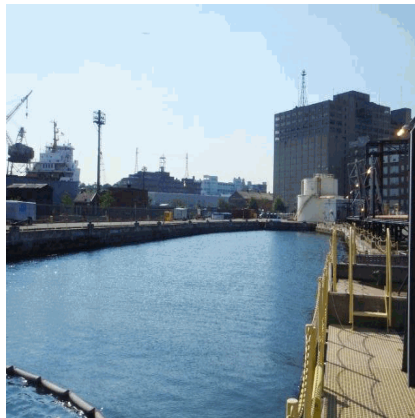
DEPT. OF SMALL BUSINESS SERV. - 801
WET BERTH 2 BULKHEAD
Asset # : 13533

Bulkheads		Current Repair		Future Replacement		Maintenance		Priority Code
System Component Type	% of Total	Fail Date (Years)	Estimated Cost	Year FY	Estimated Cost	Cycle (Yrs)	Estimated Cost	Priority Code
Structural								
Gravity Wall								
Conc w/Stone Face	5%	4+	\$57,700	LIFE	**	5	\$4,100	A
<i>Displaced Elements, Extent : Severe, Area Affected : 10%</i>								
<i>Location : 1090 Ft From Asset 13532</i>								
<i>Erosion, Extent : Moderate, Area Affected : 25%</i>								
<i>Location : In Tidal Zone</i>								
<i>Missing Block Seal, Extent : Moderate, Area Affected : 100%</i>								
<i>Location : Throughout</i>								
<i>Spalling, Extent : Moderate, Area Affected : 25%</i>								
<i>Location : Isolated Throughout Concrete At Top Of Wall</i>								
Concrete	10%	4+	\$165,600	LIFE	**	5	\$400	A
<i>Cracking, Extent : Moderate, Area Affected : 15%</i>								
<i>Location : Throughout Above Mlw</i>

<i>Spalling, Extent : Moderate, Area Affected : 25%</i>								
<i>Location : At Top Of Wall 261 ft,365 ft To 382 ft,398 ft To 429 ft,462 ft To 465 ft, And 803 ft To 810 ft From Asset 13532</i>								
<i>Other Observation, Extent : Moderate, Area Affected : 15%</i>								
<i>Location : Throughout Above Mlw</i>								
<i>Explanation : Efflorescence</i>								
Concrete	10%			LIFE	**	5-10	\$700	A
<i>Cracking, Extent : Light, Area Affected : 15%</i>								
<i>Location : Cracking With Efflorescence Throughout</i>								
Not Accessible	75%							D
Backfill								
Fill								
Not Accessible	100%							D
Surface								
Asphalt	93%	4+	\$17,200	2033	**	5	\$4,800	B
<i>Cracking, Extent : Severe, Area Affected : 30%</i>								
<i>Location : Multiple Large Cracks Throughout</i>								
Concrete	5%	4+	\$3,700	2033	**	5	\$300	B
<i>Cracking, Extent : Light, Area Affected : 5%</i>								
<i>Location : Adjacent To Asset 13532</i>

<i>Spalling, Extent : Moderate, Area Affected : 10%</i>								
<i>Location : Adjacent To Asset 13532</i>								
Not Accessible	2%							D
<i>Other Observation, Extent : Light, Area Affected : 0%</i>								
<i>Location : Under Pipe Rack</i>								
<i>Explanation : Concrete Catch Basin</i>								
Deck Elements								
Railing								
Steel	90%			2022	\$884,400			B
Steel	10%	Now	\$9,800	2022	\$98,300			B
<i>Loose Connections, Extent : Severe, Area Affected : 100%</i>								
<i>Location : Broken Railing Connections 91 ft,378 ft,515 ft To 525 ft, And 565 ft To 575 ft From Asset 13532</i>
