NEW YORK CITY DEPARTMENT OF TRANSPORTATION

SAFE STREETS NYC

SAFE STREETS NYC:

Traffic Safety Improvements In New York City

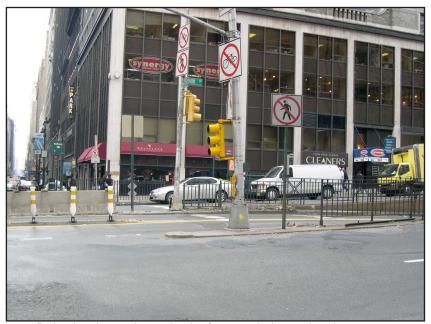
Pedestrian signage, iron pedestrian fences and other roadway improvements discourage pedestrians to cross at this location and provide for safer vehicular movements

- A Jersey barrier separating the southbound tunnel exit from southbound Park Avenue surface traffic.
- Flexible delineators along the centerline of Park Avenue between the mouth of the tunnel and the south leg crosswalk.
- Signs prohibiting through traffic on westbound East 33rd Street and requiring all traffic to turn right to proceed northbound on Park Avenue surface road or into the tunnel (except trucks, which are prohibited in the tunnel).
- Wayfinding signs to direct motorists primarily to East 31st Street to access East 33rd Street west of Park Avenue and points west.

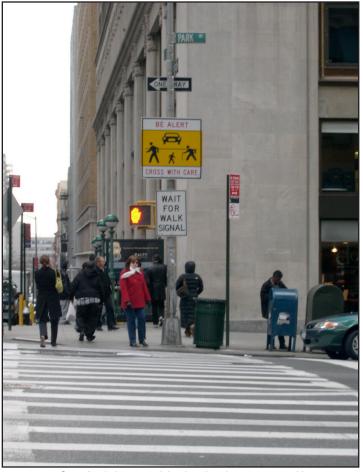
Oversized signage advised pedestrians to cross with care and wait for the walk signal

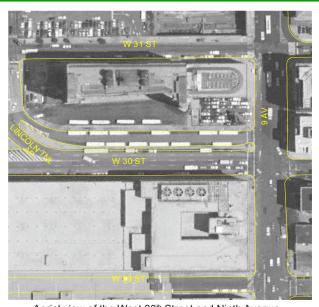
Aerial view of the West 30th Street and Ninth Avenue

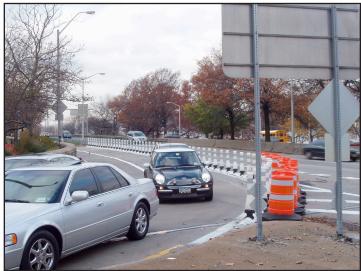
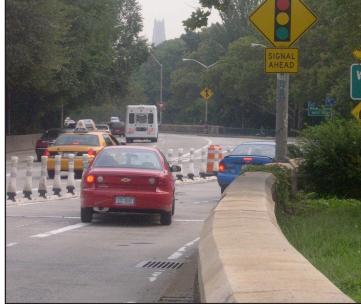
Clockwise from above: The operation of the Henry Hudson Parkway/West 95th/96th Street Interchange under the new configuration. Flexible delineators, traffic barrels and improved markings for southbound vehicles exiting at West 95th Street. Advanced signage advises motorists of approaching signal. Oversized gantry mounted signage advises motorists of approaching exit ramp.

These treatments were implemented through the use of new markings on the roadway, advance signage, and the use of flexible bollards and delineators on all approaches and ramps. This represented a highly effective, low cost mitigation strategy that effectively improved vehicular safety at the interchange. A comparison using NYPD data for the nine months prior to implementation

The improvements and resulting changes in traffic flow are shown on the following two pages.
