DEPT. OF SMALL BUSINESS SERV. - FY 2020

Asset Name : 125TH STREET PARKING GARAGE 5 LEVEL GARAGE
Address : 121 WEST 125TH STREET
Borough : MANHATTAN **Agency's Number** : N/A
Program / Asset # : DBS0028.000 / 4334 **Yr Built/Renovated** : 1972 / 2005
Area Sq Ft : 155,197 **Project Type** : ECONOMIC DEVELOPMENT
Date of Survey : 08-Feb-2019 **Landmark Status** : NONE
Areas Surveyed : Basement, Roof, Floors 1
Block : 1910 **Lot** : 1 **BIN** : 1081601

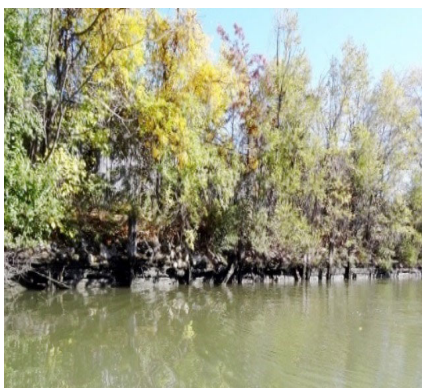
DEPT. OF SMALL BUSINESS SERV. - 801
CRIBBING BULKHEAD
Asset # : 13807

Bulkheads		Current Repair		Future Replacement		Maintenance			
System	Component Type	% of Total	Fail Date (Years)	Estimated Cost	Year FY	Estimated Cost	Cycle (Yrs)	Estimated Cost	Priority
Structural									
	Gravity Wall								
	Timber Crib w/Stone	100%	Now	\$960,800	LIFE	* *	4	\$9,200	1
		Broken, Extent : Severe, Area Affected : 50%							
		Location : Isolated Members Throughout							
		Missing Part, Extent : Severe, Area Affected : 15%							
		Location : Collapsed At Eastern 47 Feet							
		Rotting/Splitting, Extent : Severe, Area Affected : 10%							
		Location : Horizontal Timbers And Timber Piles Throughout							
		Tilting, Extent : Severe, Area Affected : 100%							
		Location : Full Length							
		Other Observation, Extent : Severe, Area Affected : 1%							
		Location : West End Of Asset							
		Explanation : Deterioration Of Concrete And Steel At Outfall							
Backfill									
	Fill

Stone	20%	Now	\$17,800	LIFE	* *	5	\$100	
		Erosion, Extent : Moderate, Area Affected : 50%							
		Location : Isolated Throughout At Top Of Wall							
	Not Accessible	80%							
Surface									
	Concrete	10%	Now	\$11,900	2043	* *	5	\$200	
		Broken, Extent : Severe, Area Affected : 100%							
		Location : Eastern 30 Feet And Between 85 Feet And 110 Feet From East							
		Other Observation, Extent : Moderate, Area Affected : 100%							
		Location : Full Length Up To 3ft Deep							
		Explanation : Undermining							
	Not Accessible	90%							
		Other Observation, Extent : Light, Area Affected : 0%							
		Location :							
		Explanation : Heavy Vegetation

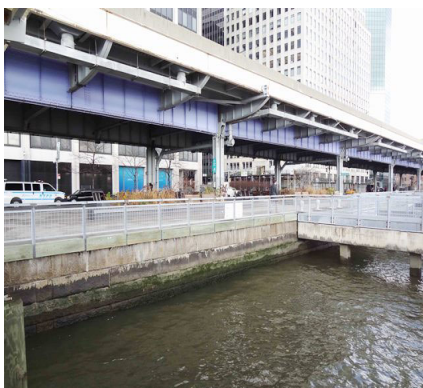
DEPT. OF SMALL BUSINESS SERV. - 801
EAST RIVER ESPLANADE BULKHEAD
Asset # : 2581

Bulkheads		Current Repair		Future Replacement		Maintenance			
System	Component Type	% of Total	Fail Date (Years)	Estimated Cost	Year FY	Estimated Cost	Cycle (Yrs)	Estimated Cost	Priority
Structural									
	Coping/Curb								
	Concrete	20%			LIFE	* *	5	\$200	
	No Component	80%							
Gravity Wall									
	Stone	25%			LIFE	* *	5	\$18,900	
	Not Accessible	75%							
Sheet Piles									
	Steel	2%			LIFE	* *			
	No Component	95%							
	Not Accessible	3%							
Backfill									
	Fill								
	Not Accessible	100%							
Surface									
	Asphalt	5%			2036	* *	5	\$500	
	Asphalt Pavers	60%			2036	* *	5	\$6,100	
				Settlement, Extent : Light, Area Affected : 10%					
				Location : Isolated Locations Throughout					
	Topsoil	35%			2025	\$17,600	5	\$1,500	
Deck Elements									
	Railing								
	Steel	20%			2026	\$178,200			
	No Component	80%

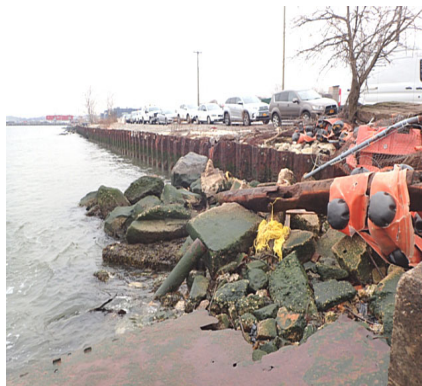
DEPT. OF SMALL BUSINESS SERV. - 801
FORMER PIER 7 - MILLERS LAUNCH STEEL SHEET PILE BULKHEAD
Asset # : 4261

Bulkheads		Current Repair			Future Replacement		Maintenance		
System	Component Type	% of Total	Fail Date (Years)	Estimated Cost	Year FY	Estimated Cost	Cycle (Yrs)	Estimated Cost	Priority
Structural									
	Sheet Piles								
	Steel	85%	4+	\$261,400	LIFE	* *			
		Corrosion, Extent : Moderate, Area Affected : 70%							
		Location : Above Mudline							
	No Component	15%							
		Other Observation, Extent : Light, Area Affected : 0%							
		Location : At North Foot Of Pier							
		Explanation : No Component							
Backfill									
	Fill								
	Not Accessible	100%							
Surface									
	Concrete	15%	4+	\$28,000	2045	* *	5	\$400	
		Broken, Extent : Moderate, Area Affected : 100%							
		Location : At North End							
	Gravel	85%			2039	* *	2-5	\$1,300	
		Erosion, Extent : Moderate, Area Affected : 100%							
		Location : Along Upper Edge Of Bulkhead

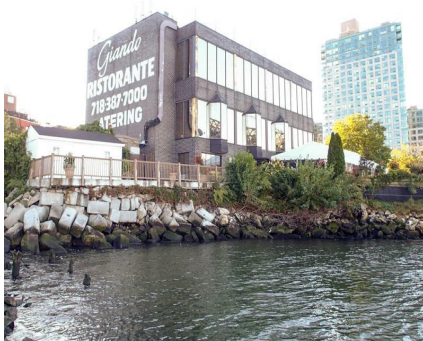
DEPT. OF SMALL BUSINESS SERV. - 801
GIANDO RESTAURANT REVETMENT/BULKHEAD
Asset # : 13506

Bulkheads		Current Repair		Future Replacement		Maintenance		Priority
System Component Type	% of Total	Fail Date (Years)	Estimated Cost	Year FY	Estimated Cost	Cycle (Yrs)	Estimated Cost	
Structural								
Gravity Wall								
Concrete	15%	4+	\$309,100	LIFE	* *	5	\$100	
	<i>Displaced Elements, Extent : Moderate, Area Affected : 100%</i>							
	<i>Location : Midway Point Of Bulkhead</i>							
Concrete	30%			LIFE	* *	5	\$300	
	<i>Displaced Elements, Extent : Light, Area Affected : 100%</i>							
	<i>Location : Southern Half</i>							
No Component	55%							
Revetment								
Stone	50%	2-4	\$94,000	LIFE	* *	5	\$700	
	<i>Other Observation, Extent : Severe, Area Affected : 100%</i>							
	<i>Location : Steep Slope, Exposed Fill, And Displaced Elements Throughout Northern Half</i>							
	<i>Explanation : Non-engineered Riprap</i>							
Stone	25%			LIFE	* *	5	\$400	
No Component	25%							
Backfill								
Fill

Not Accessible	100%							
Surface								
Concrete	85%			2036	* *	5	\$2,400	
	<i>Cracking, Extent : Light, Area Affected : 15%</i>							
	<i>Location : Isolated</i>							
Topsoil	15%			2025	\$2,100	5	\$200	
Fender								
Facing								
Timber	10%			2030	\$30,000	3	\$1,300	
No Component	90%							
Deck Elements								
Railing								
Plastic	20%			2021	\$7,800			
	<i>Worn, Extent : Moderate, Area Affected : 100%</i>							
	<i>Location : North End</i>							
No Component	80%

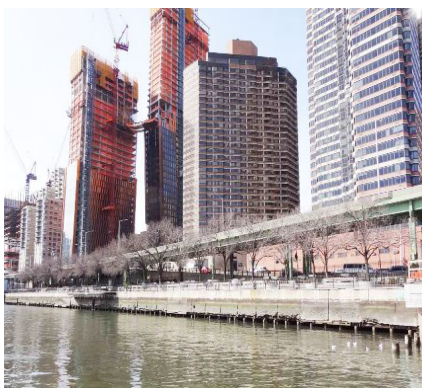
DEPT. OF SMALL BUSINESS SERV. - 801
GLICK PARK RELIEVING PLATFORM
Asset # : 4087

Bulkheads		Current Repair		Future Replacement		Maintenance			
System	Component Type	% of Total	Fail Date (Years)	Estimated Cost	Year FY	Estimated Cost	Cycle (Yrs)	Estimated Cost	Priority
Structural	Coping/Curb Concrete	45%			LIFE	**	5	\$200	
		Cracking, Extent : Light, Area Affected : 5% Location : Isolated Throughout Displaced Elements, Extent : Light, Area Affected : 10% Location : Throughout							
	Concrete	45%	2-4	\$81,800	LIFE	**	5	\$200	
		Broken, Extent : Moderate, Area Affected : 50% Location : Isolated Throughout Missing Part, Extent : Severe, Area Affected : 100% Location : Isolated Throughout Other Observation, Extent : Moderate, Area Affected : 20% Location : Missing Grout Beneath Coping From 270 Ft To 460 Ft From North End Explanation : Undermining							
	Timber	5%			LIFE	**	5		
	Timber	5%	2-4	\$3,000	LIFE	**	5		
		Missing Part, Extent : Severe, Area Affected : 100% Location : At South End Rotting/Splitting, Extent : Severe, Area Affected : 50% Location : At South End

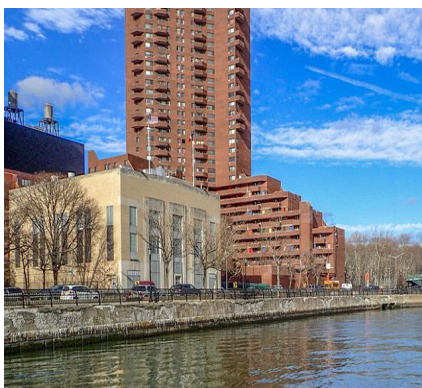
DEPT. OF SMALL BUSINESS SERV. - 801
GRAVITY RETAINING WALL / BULKHEAD
Asset # : 13832

Bulkheads		Current Repair		Future Replacement		Maintenance			
System	Component Type	% of Total	Fail Date (Years)	Estimated Cost	Year FY	Estimated Cost	Cycle (Yrs)	Estimated Cost	Priority
Structural									
	Gravity Wall								
	Conc w/Stone Face	75%			LIFE	* *	5	\$17,600	
		Cracking, Extent : Light, Area Affected : 20%							
		Location : Outboard Face Above Mean High Water							
		Erosion, Extent : Moderate, Area Affected : 5%							
		Location : Adjacent To Culvert							
		Missing Block Seal, Extent : Moderate, Area Affected : 30%							
		Location : Between Stone Facing In Tidal Zone							
	Conc w/Stone Face	25%	2-4	\$152,300	LIFE	* *	5	\$5,900	
		Spalling, Extent : Moderate, Area Affected : 30%							
		Location : Top Edge Of Concrete, In Some Locations Undermining Railing							
		Other Observation, Extent : Moderate, Area Affected : 100%							
		Location : Concrete Above Stone Face							
		Explanation : Chemical Deterioration Of Concrete

Backfill									
	Fill								
	Not Accessible	100%							
	Surface								
	Asphalt Pavers	98%			2038	* *	5	\$2,900	
		Settlement, Extent : Light, Area Affected : 5%							
		Location : Near Tree Planter							
	Topsoil	2%			2027	\$300	5		
Deck Elements									
	Railing								
	Steel	100%			2027	\$259,500			
		Missing Coating, Extent : Light, Area Affected : 5%							
		Location : Throughout							
Electrical									
	Lighting Fixture								
	Incandescent	100%			2024				
		Other Observation, Extent : Light, Area Affected : 100%							
		Location : 4 Light Poles							
		Explanation : Lighting

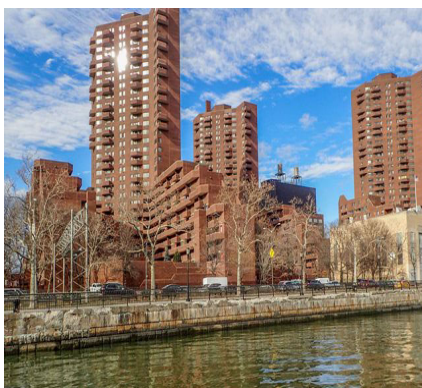
DEPT. OF SMALL BUSINESS SERV. - 801
GRAVITY RETAINING WALL / BULKHEAD
Asset # : 13833

Bulkheads		Current Repair			Future Replacement		Maintenance		
System	Component Type	% of Total	Fail Date (Years)	Estimated Cost	Year FY	Estimated Cost	Cycle (Yrs)	Estimated Cost	Priority
Structural									
	Gravity Wall								
	Conc w/Stone Face	75%			LIFE	* *	5	\$18,200	
		Cracking, Extent : Moderate, Area Affected : 30%							
		Location : Outboard Face Above Mean High Water Elevation							
		Efflorescence, Extent : Moderate, Area Affected : 30%							
		Location : Concrete Above Stone Facing							
		Missing Block Seal, Extent : Moderate, Area Affected : 50%							
		Location : Between Stone Facing In Tidal Zone							
	Conc w/Stone Face	25%	2-4	\$158,200	LIFE	* *	5	\$6,100	
		Spalling, Extent : Moderate, Area Affected : 50%							
		Location : Throughout Concrete Above Stone Face And At Top Surface Of Wall Below Railing							
		Other Observation, Extent : Moderate, Area Affected : 100%							
		Location : Throughout Concrete Above Stone Face And At Top Surface Of Wall Below Railing

Explanation : Chemical Deterioration Of Concrete							
Backfill									
	Fill								
	Not Accessible	100%							
	Surface								
	Asphalt Pavers	94%			2038	* *	5	\$2,900	
	Asphalt Pavers	4%	4+	\$5,800	2042	* *	5	\$100	
		Other Observation, Extent : Moderate, Area Affected : 50%							
		Location : Near North End Of Asset Adjacent To Planter							
		Explanation : Uplift Of Pavers							
	Topsoil	2%			2027	\$300	5		
Deck Elements									
	Railing								
	Steel	100%			2027	\$269,500			
		Missing Coating, Extent : Light, Area Affected : 5%							
		Location : Throughout							
Electrical									
	Lighting Fixture								
	Incandescent	100%			2024				
		Other Observation, Extent : Light, Area Affected : 100%							
		Location : 4 Light Poles							
		Explanation : Lighting
