**New York City Department of Environmental Protection  
Bureau of Water Supply**

**Report on Stormwater Remediation Projects for the  
East of Hudson (EOH) Nonpoint Source Pollution Control Program**

**September 2020**

### Maple Avenue, Town of Bedford, Westchester County

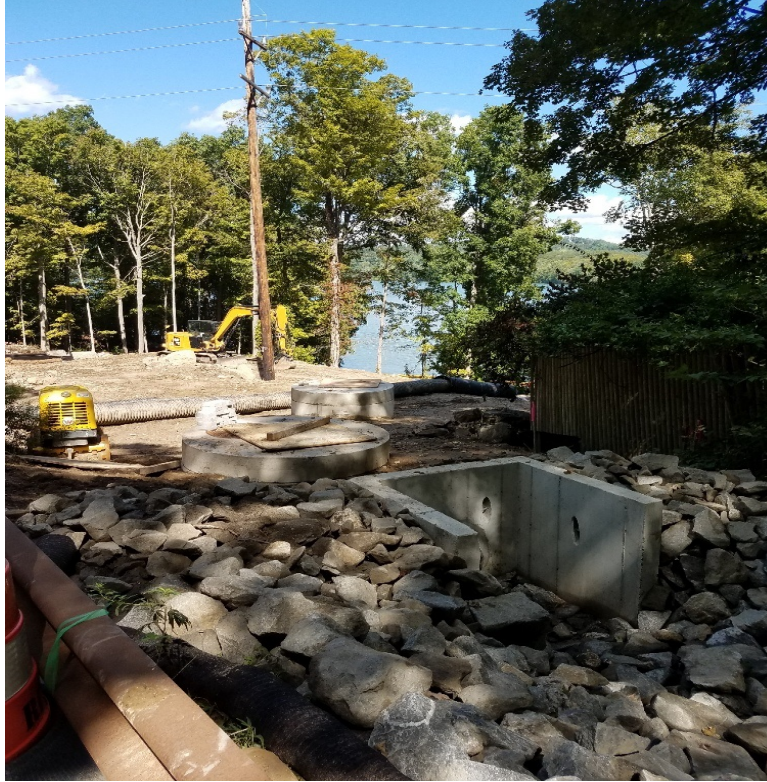
Figure 1: Partial view of inlet swale along Maple Avenue  
Showing headwall and diversion manhole

During the reporting period, the contractor worked at the Maple Avenue site to install site swales, headwalls, discharge head, the diversion portion of the project, and the hydrodynamic separator. The detention piping is on-site and the contractor is preparing for installation. The contractor will install the filters and complete backfilling, grading, and planting following pipe installation. The current contractor schedule shows project completion in October 2020, one month after the September 30, 2020 FAD construction deadline, in part due to COVID-19 related delays. Figures 1 and 2 show portions of the Maple Avenue site in September 2020.

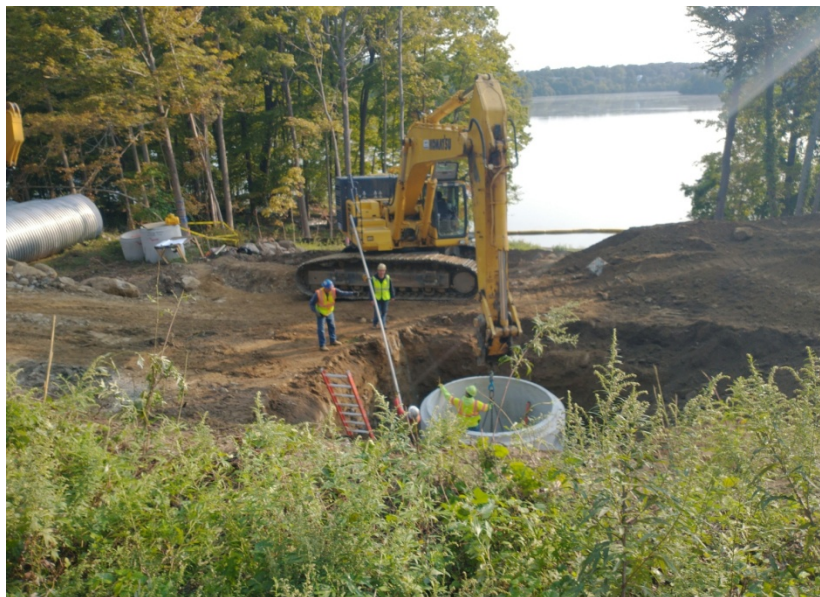
Figure 2: View of the site looking from Maple Avenue toward  
the Cross River Reservoir showing precast structures  
and detention piping.
