The Roosevelt Building

Designation List 512

LP-2620

Architect: Stephen Decatur Hatch

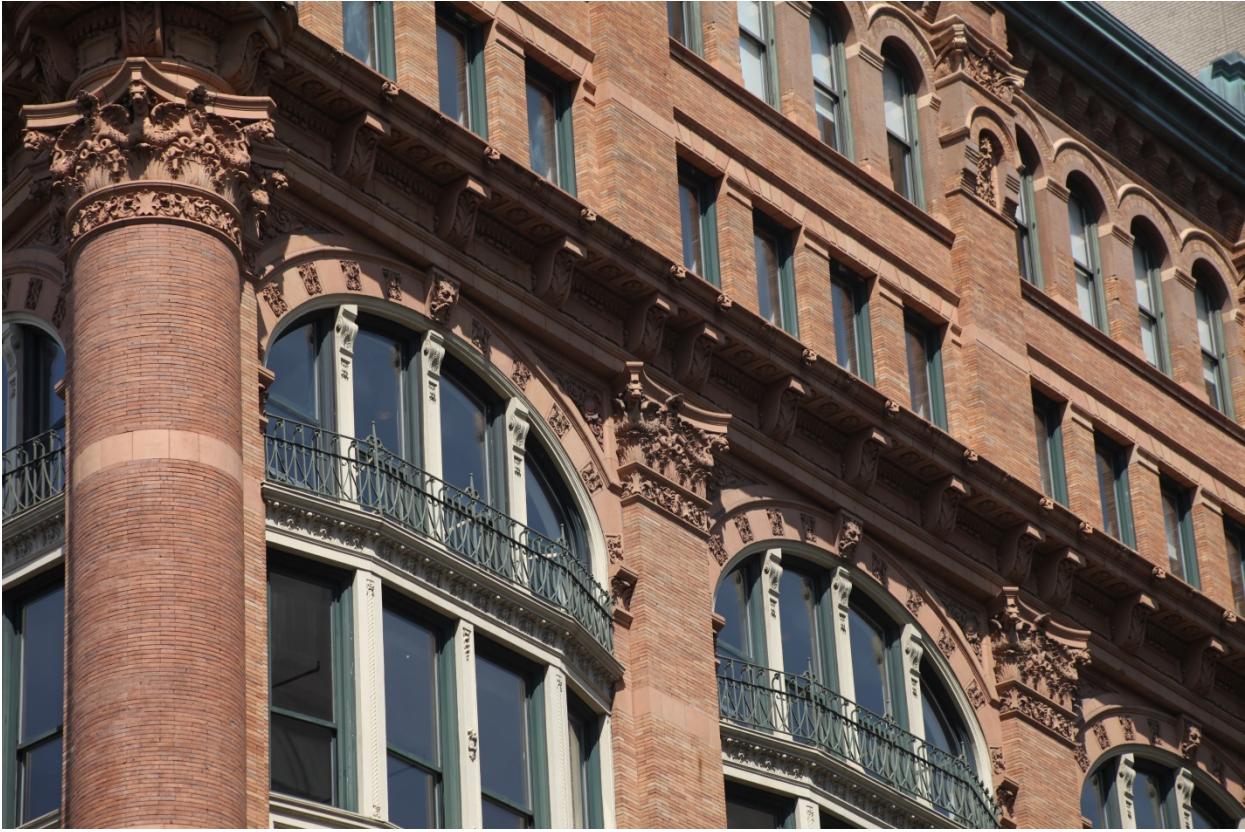
**Detail of Broadway Facade,
The Roosevelt Building**
Jessica Baldwin, August, 2018

Multi-story classical pilasters separate the bays on the symmetrical, five-bay, east facade facing Broadway, with arcaded windows topping the building's shaft and crown. The center of the two-story granite base includes a coffered, terra-cotta arch marking the location of the former entrance, which is now infilled with modern alterations. A face ornaments the keystone, and the spandrels feature leaf scrollwork framing the building's monogram

The four-story shaft includes six, four-story Roman brick pilasters with terra cotta Corinthian capitals separating the bays. Each bay is topped with an arch and encompasses the third- to sixth-story windows. The volutes on the capitals are half beast, half sea creature, arching over a bed of acanthus leaves with tails bound together in the center. Attached to the pilasters on the third story are terra-cotta panels with classical pediments containing a festoon. The central two panels feature two mermaids with foliated tails, facing each other and conjointly holding a torch with an arrangement of leaves and vines; a face is centered on the panels on the outer pilasters. Four double-hung sash windows are located within each bay on the third story, and are separated by narrow spiral, engaged terra-cotta columns.

The fourth- to sixth-story windows have cast iron surrounds with a subtly projecting bay on the fifth story. Three angled sides form the projecting bay: two windows in the center and one window on each angled side. The fourth-story windows are separated by iron pilasters topped with brackets cast with human faces wearing a lion’s head that support the overhang of the projecting bay above. Low iron

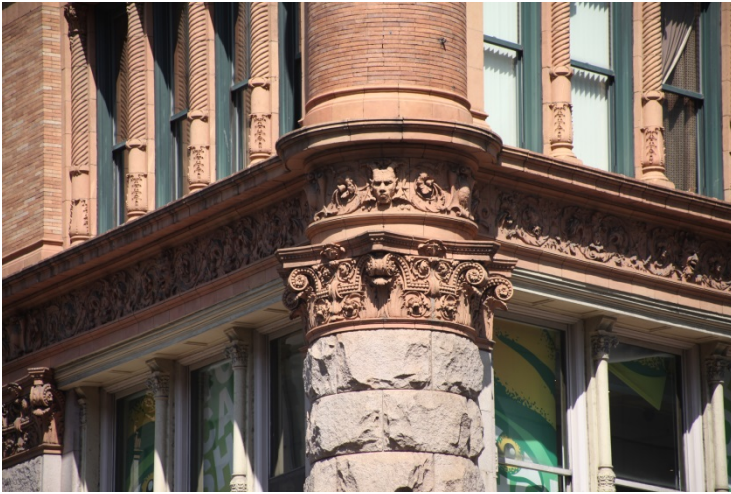
Corner Detail, The Roosevelt Building
Jessica Baldwin, August, 2018

At the building’s southeast corner, starting at the second story and rising above the roof-top cornice, is a rounded, engaged column. Like the primary facades, the column is divided into a tripartite configuration with a rusticated stone base and Roman brick shaft and crown. Intermediate cornices from the Broadway facade wrap around the column to extend along the East 13th Street facade. Below

Along the shaft, at the top of the third story, the column features a decorative terra-cotta shield ornament enriched with scrolls, festoons, and leaf motifs. Smooth bands of terra-cotta tiles mark the column at the fourth, fifth, seventh and eighth stories. At the top of the column is a domed “bee-hive” copper cupola with a fish scale pattern. A copper orb rises from the center of the dome, and forms the building’s pinnacle.

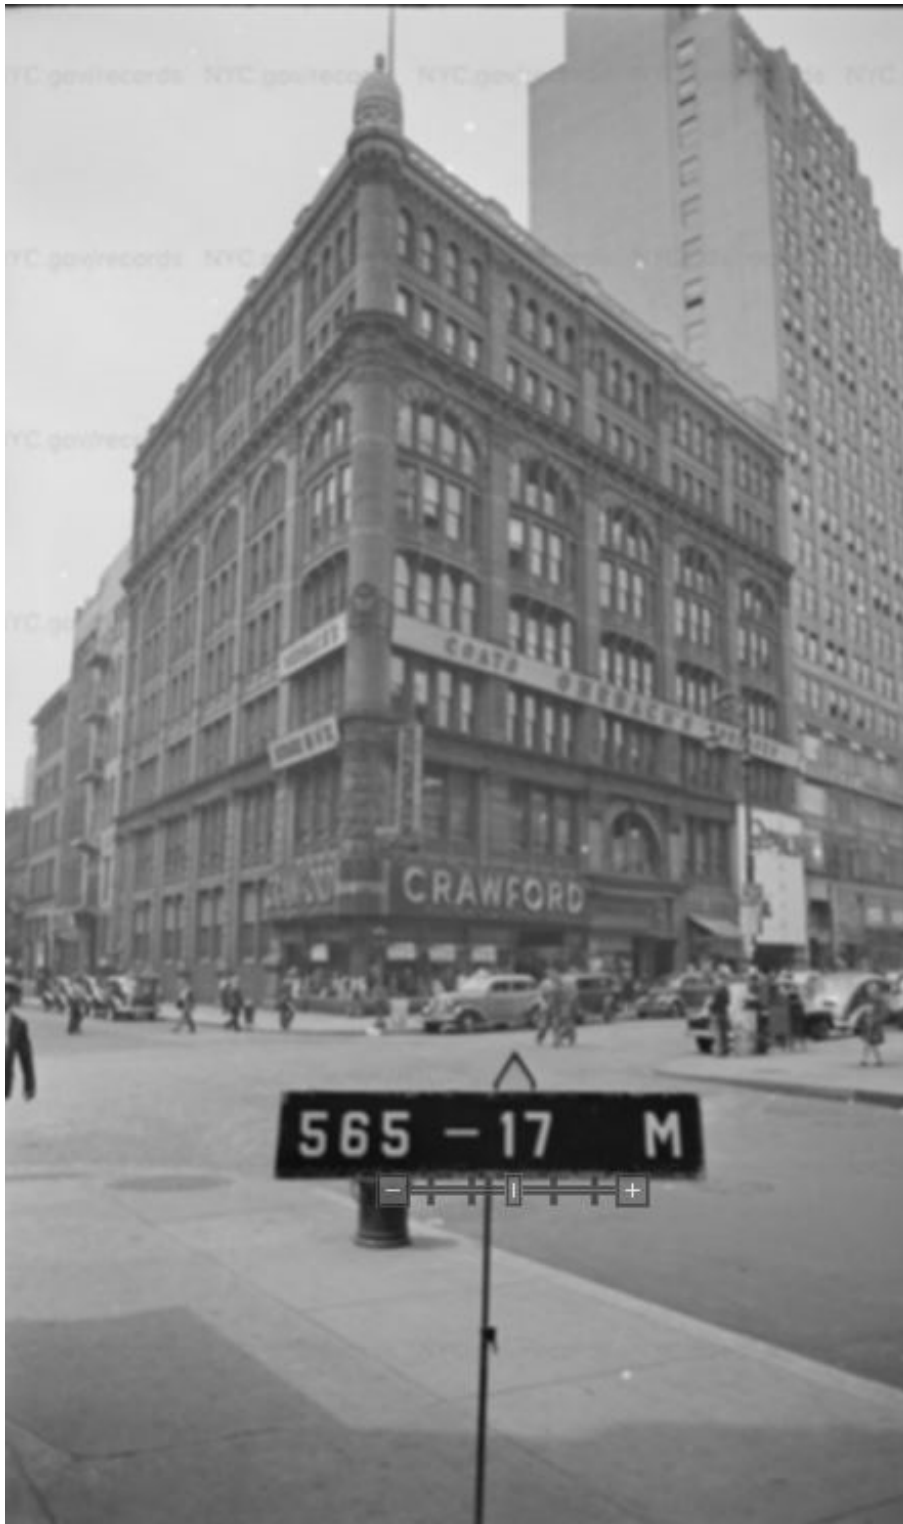
The Roosevelt Building, 841 Broadway

New York City Department of Taxes Photograph (c. 1938-1943), Courtesy NYC Municipal Archives

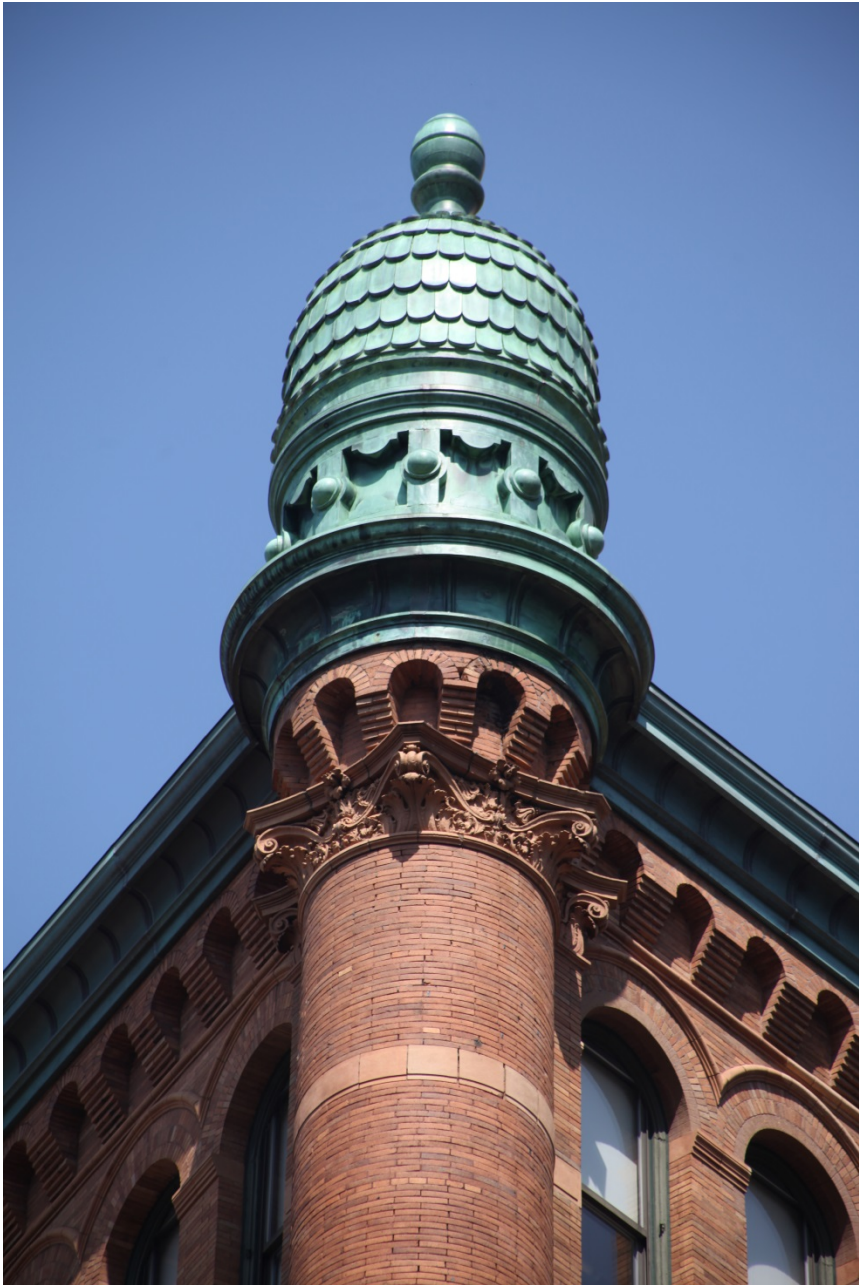
Cupola, The Roosevelt Building
Jessica Baldwin, August, 2018

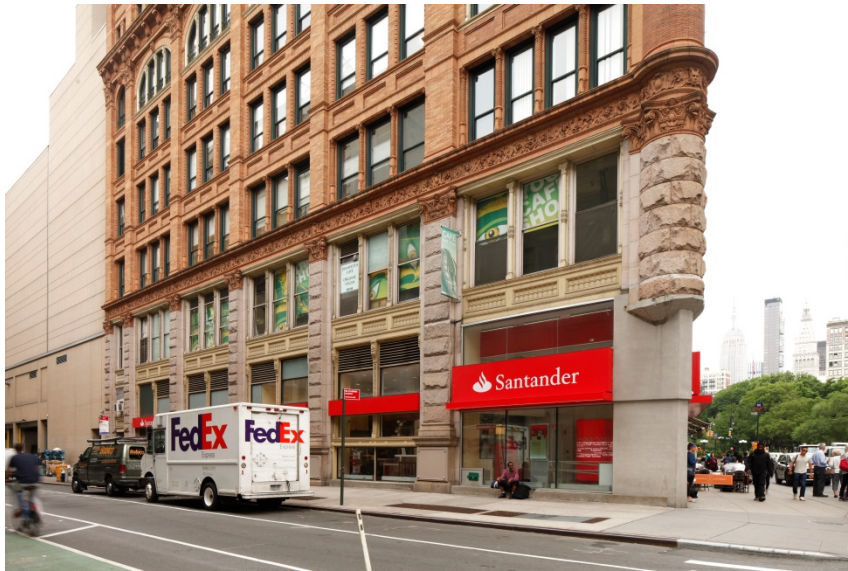
**13th Street Facade,
The Roosevelt Building**
Sarah Moses, June, 2019

The primary south facade facing East 13th Street, which contains five full bays and a narrow partial bay on the far west end, is a simplified version of the Broadway facade. The overall tripartite configuration of the two facades is nearly identical and the projecting intermediate cornices feature the same terra-cotta ornamentation previously described for the Broadway facade.

A few differences between the facades are apparent. The base of the south facade has been less altered by commercial modifications than the Broadway facade. The stone pilasters extend all the way to the ground and the original window openings remain largely intact; narrow pilasters separate the paired first-story commercial windows and feature vertical foliated ornamentation and brackets with shields and small delicate faces.

Above the base in the **shaft**, four of the five full bays on the south facade do not feature the projecting iron bays found on the Broadway facade. The far east bay located on East 13th Street at Broadway is identical to the bays on the Broadway facade, with an iron bay projecting at the fifth story.
