**DOI INVESTIGATION REVEALS COMMUNICATION FAILURES AND A BROKEN SAFETY DEVICE  
IN FATAL 2015 NYCHA ELEVATOR ACCIDENT**

**New York City Department of Investigation**

**Elevator-Related Accidents and Fatality at NYCHA Public Housing**

**March 2016**

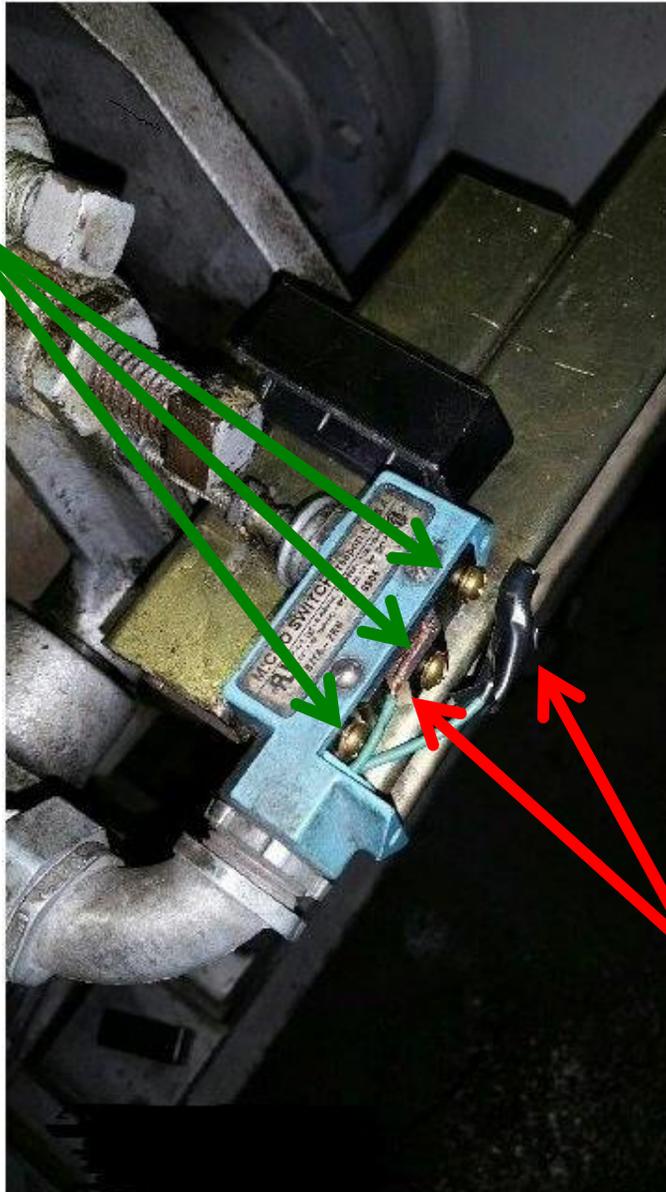
## **Boston Road Plaza, Elevator Motor Room, Elevator A brake monitor microswitch with disconnected wires**

Wires should have been connected to two of these three screws in order to activate the brake monitor

but instead, the wires were not connected to the screws, and both stripped wire tips were covered in black electrical tape.

- Disconnected brake monitor (Boston Road): At Boston Road, a NYCHA Special Teams mechanic removed the cover from the brake monitor and observed that the brake monitor wiring had been disconnected and covered in black electrical tape.<sup>17</sup> See photograph, Appendix A. During interviews with DOI, multiple elevator staff stated variously that brake monitors “definitely can cause issues” by shutting down elevators, because the devices are “very sensitive.” Based on these consistent statements by multiple NYCHA mechanics and supervisors, and because the Boston Road brake monitor wire tips had been deliberately covered in black tape, DOI determined that it is possible that at some point before the accident, one of the several elevator mechanics who worked on the Boston Road elevator intentionally disconnected the brake monitor in an effort to prevent shutdowns.<sup>18</sup> Because NYCHA protocols did not require regular brake monitor inspections, this condition could have gone undetected indefinitely.

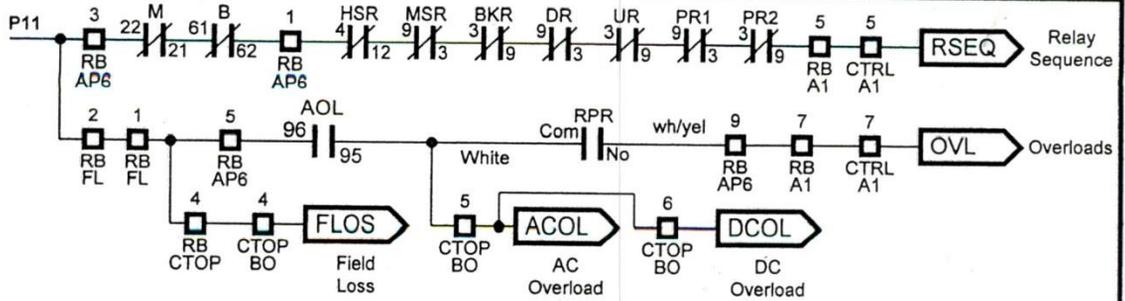
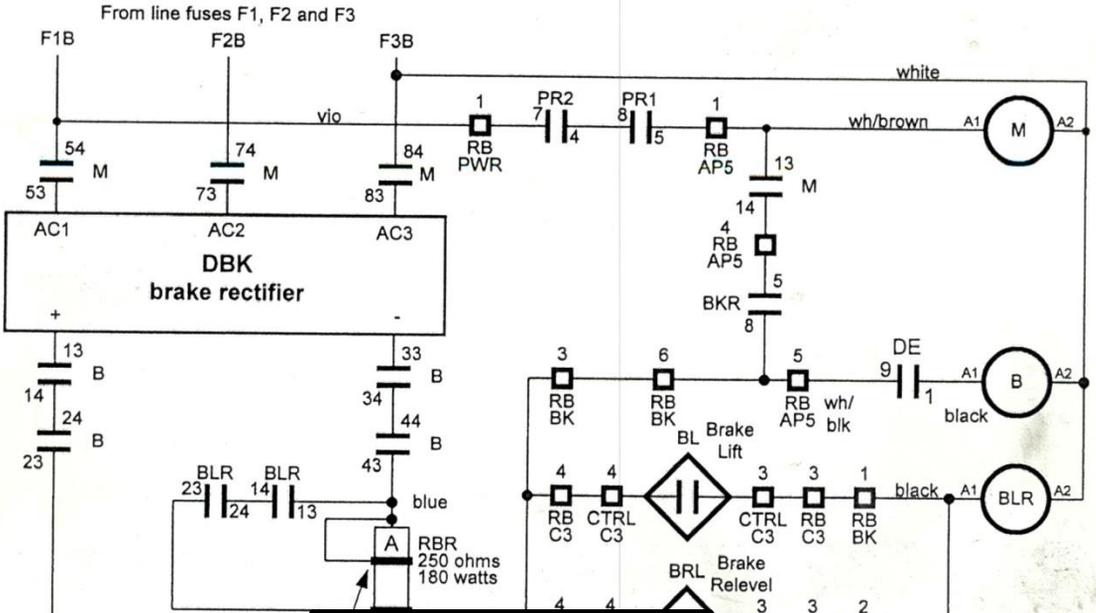
**Morris Houses, 1373 Washington Avenue, Bronx  
Tricon Prints: Brake Circuit and Machine Room Wiring  
Diagram**

**This print indicates that the brake switch should be wired "normally open":**

**matched by the textual note:**

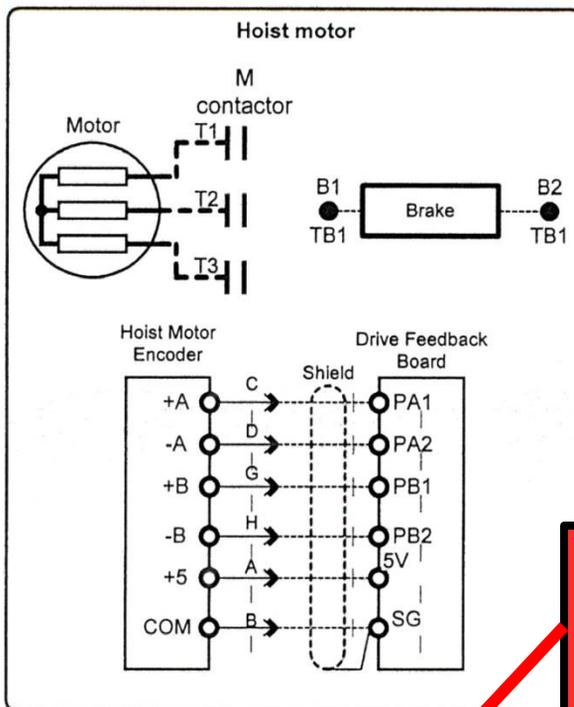
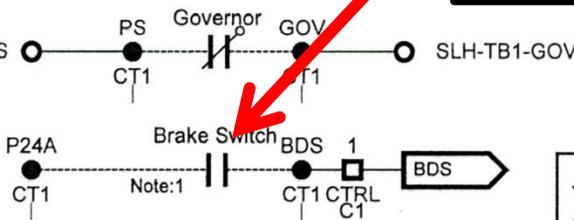
**This print indicates that the brake switch should be wired "normally open":**

**matched by the textual note:**

Note:1 Brake switch input used where monitoring is provided. Switch closes when brake lifts.

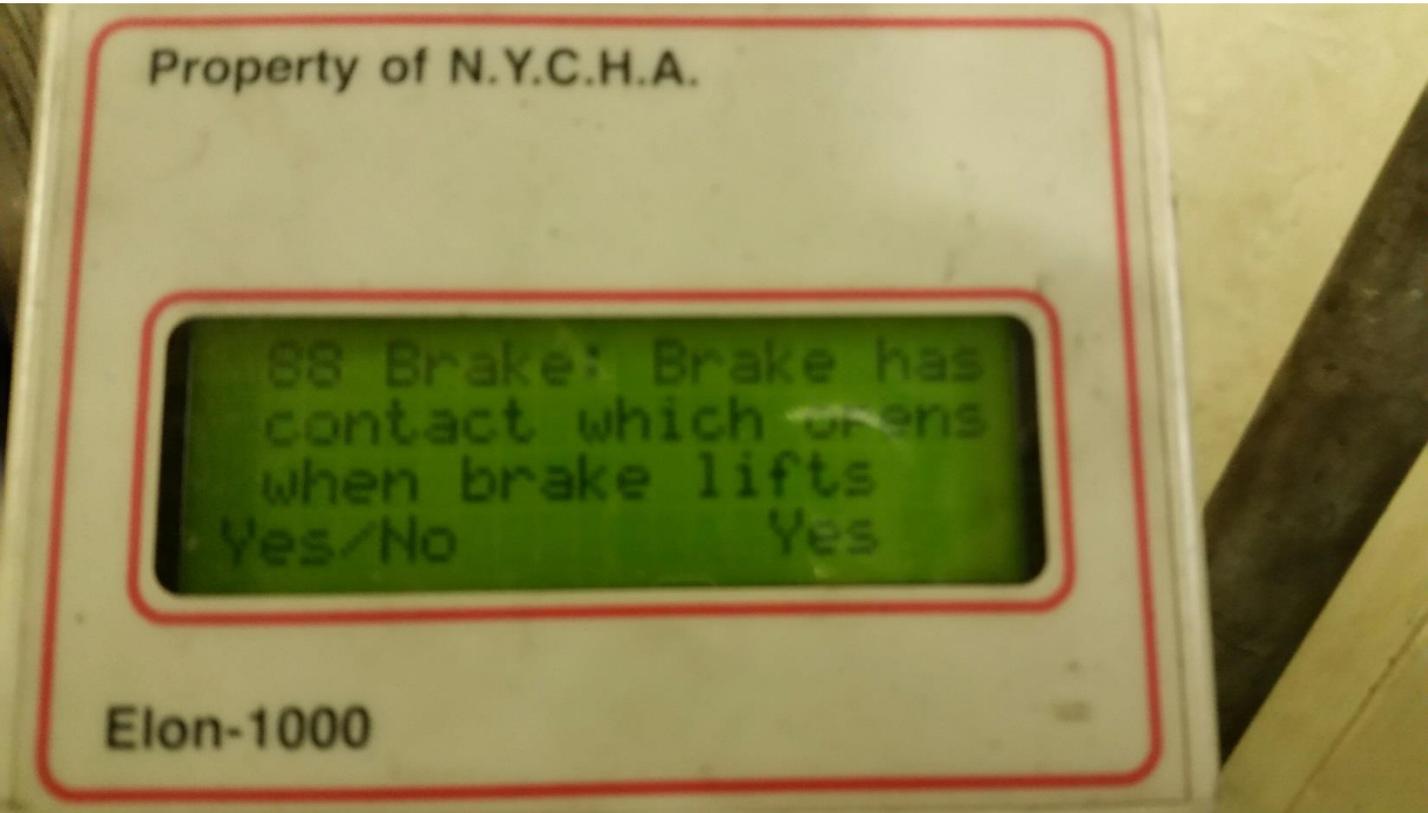
**Tricon Handheld Device, Setup Parameter 88**

**“Brake has contact which opens when brake lifts: Yes/No”**

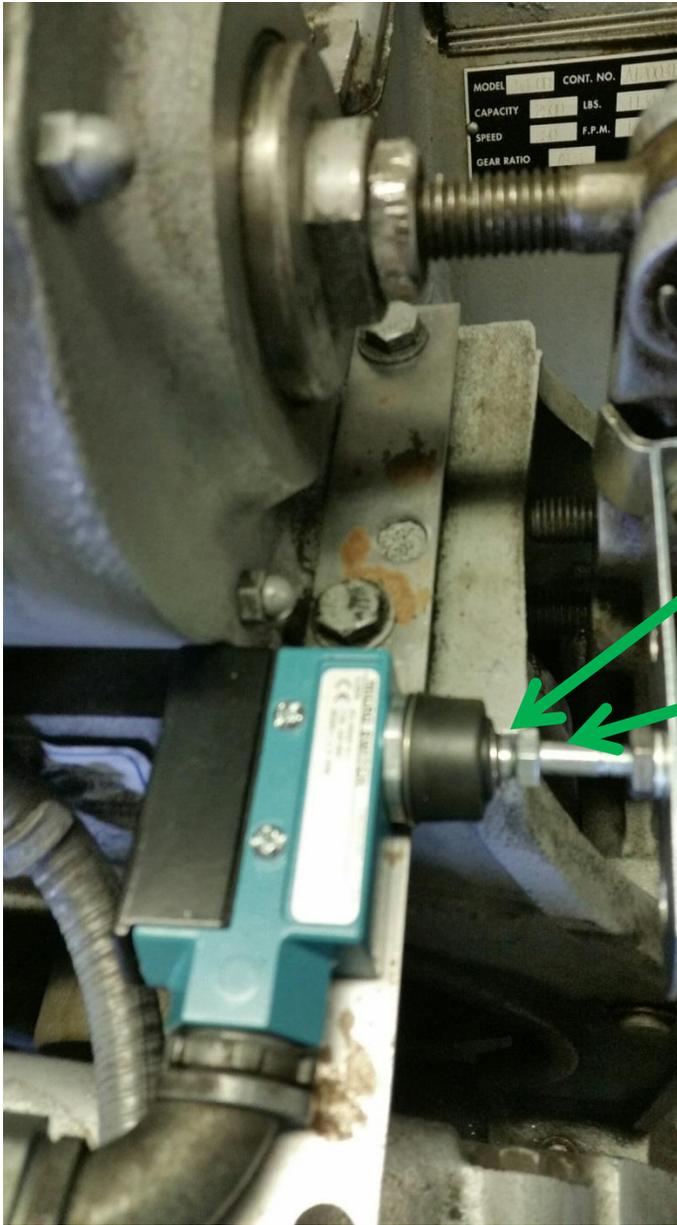
**Brake monitor, with linkage bolt fabricated by NYCHA**

To function, the brake monitor microswitch must make contact with the linkage bolt.

- Missing linkage bolts (Morris Houses): After the Morris Houses accident, NYCHA conducted inspections and discovered that a bolt needed to link up and activate the brake monitors was missing on 33 out of 34 brake monitors at that development.<sup>21</sup> NYCHA subsequently fabricated bolts to activate these brake monitors. See photograph, Appendix E. This issue also went undetected because NYCHA did not routinely inspect its brake monitors until after the subject accidents.
