**New York City Department of Environmental Protection
Bureau of Water Supply**

**Stream Management Program
Request for Approval for the Final Ashokan Basin Stream Project:
Woodland Creek at Woodland Valley Park Association**

March 2017

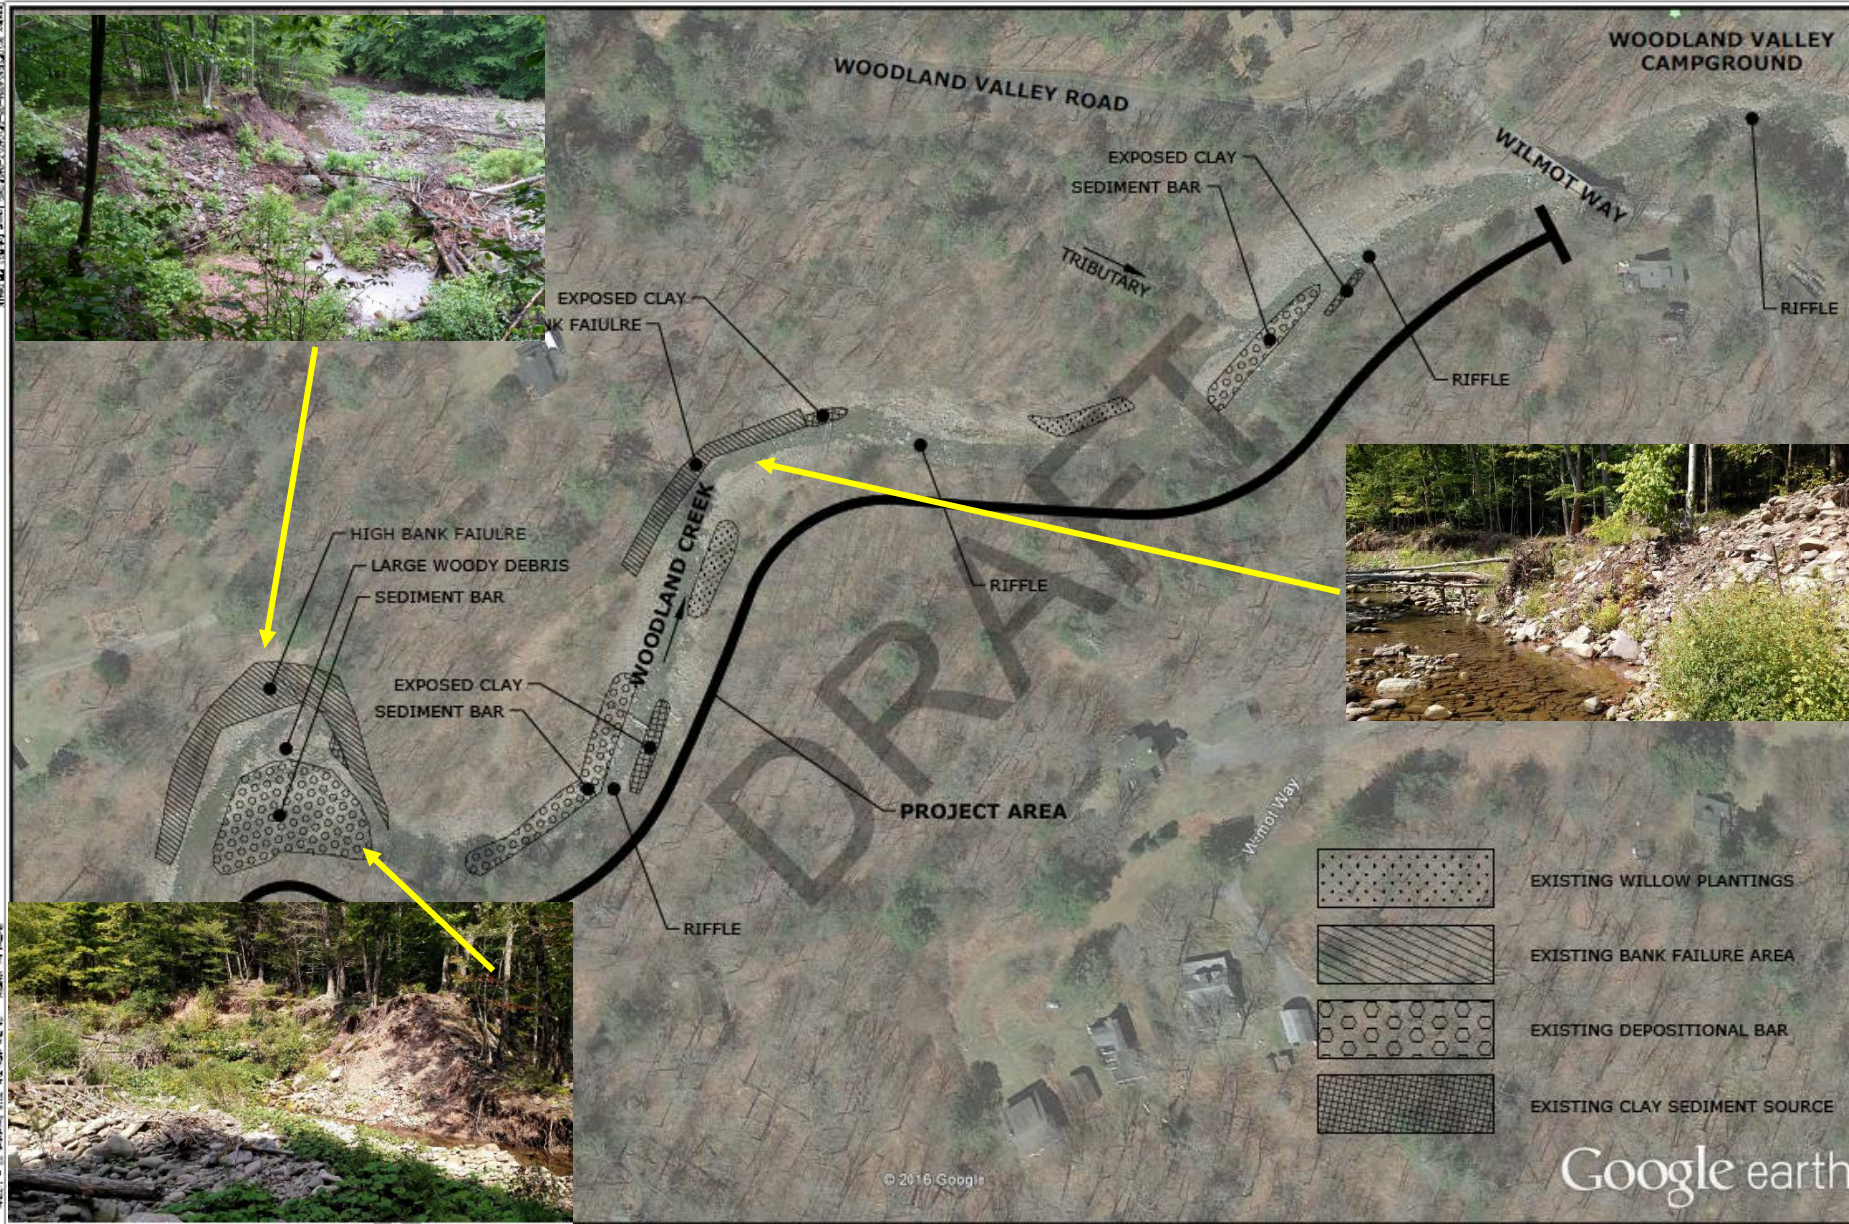
FIG 2-1

PROJECT SITE
 WOODLAND CREEK
 STREAM RESTORATION PROJECT
 WOODLAND VALLEY ROAD
 TOWN OF PHOENICIA, ULSTER COUNTY, NEW YORK

meander bends. The accumulation of these coarse sediment deposits is further contributing to erosion by forcing flow laterally into the banks. The largest bank failure within this project reach is located at the upstream end, measuring approximately 160 feet in length and 30 feet in height, and consisting of both clay and coarse sediment.

The stream restoration design for this project is currently at the 60% stage, and uses hydraulic modeling to identify the cause of instability in the channel bed and banks. Existing bank erosion, including the high bank failure in the upstream section of the project reach, are currently proposed to be stabilized through the creation of bankfull benches wherever feasible in order to allow the channel to dissipate energy during moderate flood flows by accessing a floodplain. These benches will likely be protected with a combination of rock and bioengineering structures to maximize stability. Realignment of the stream channel through this reach to a geometry appropriate for the valley setting, and more in line with historical channel alignment, will be used to assist in taking the pressure off of eroding banks. The grade and slope of the channel will be controlled through the construction of hardened riffles so that the stream cannot form headcuts and further threaten bank and channel stability.
