Local Law 117 Report

This report outlines the efforts of the New York City Fire Department (FDNY) to enhance firehouse facilities to accommodate a more diverse workforce. Prompted by Local Law 117 of 2022, authored by Council Member Joann Ariola and enacted by Mayor Eric Adams, the Fire Department is tasked with assessing each firehouse to identify necessary permanent upgrades for the inclusion of all firefighters. The FDNY's ongoing efforts on this front have taken five forms:

Bureau of Facilities Management FIRE AND EMS STATION DESIGN STANDARDS

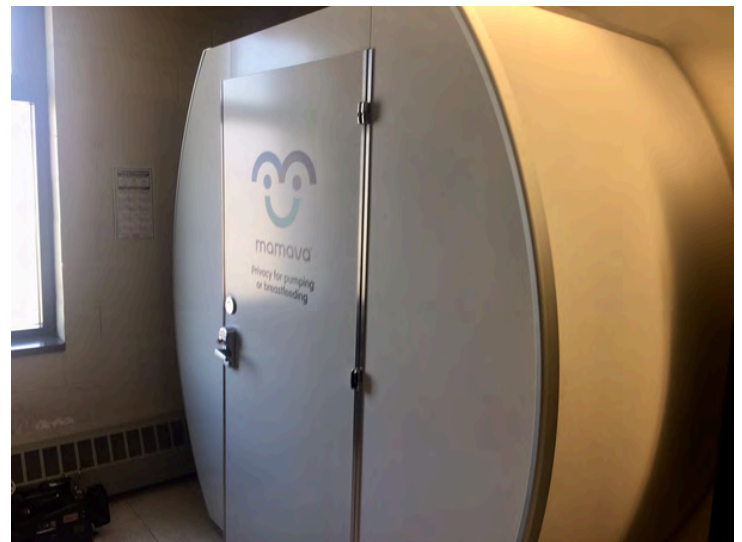
Pictured to the right is a nursing pod in Station 47, Engine 265, Ladder 121, and Battalion 47 in Queens. The 4 foot by 8 foot pod is a self-contained mobile unit equipped with comfortable benches, a table, an electrical outlet for plugging in a breast pump and a door that can be locked for privacy.

Additionally, permanent nursing pods and nursing rooms continue to be installed on an as-needed basis. As of this writing, 17 fire facilities are currently equipped with a nursing space.

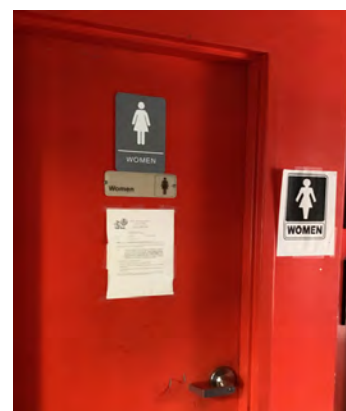
Example of proper signage for female restroom.

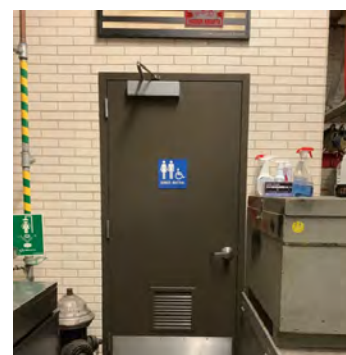
Example of proper signage for gender-neutral restroom.

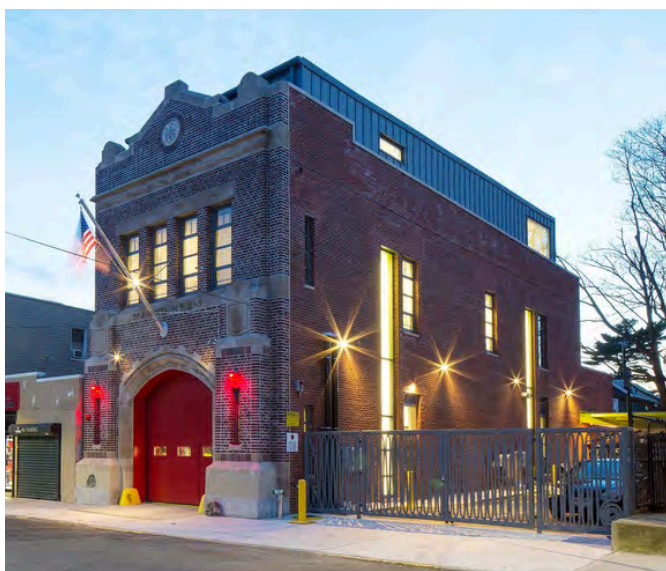
The photo above is of Engine 293 in Queens which recently renovated to include an additional floor.
