**New York City Department of Environmental Protection
Bureau of Water Supply**

**Report on Stormwater Remediation Projects for the
East of Hudson (EOH) Nonpoint Source Pollution Control Program**

June 2019

Report on Stormwater Remediation Projects for the East of Hudson Nonpoint Source Pollution Control Program

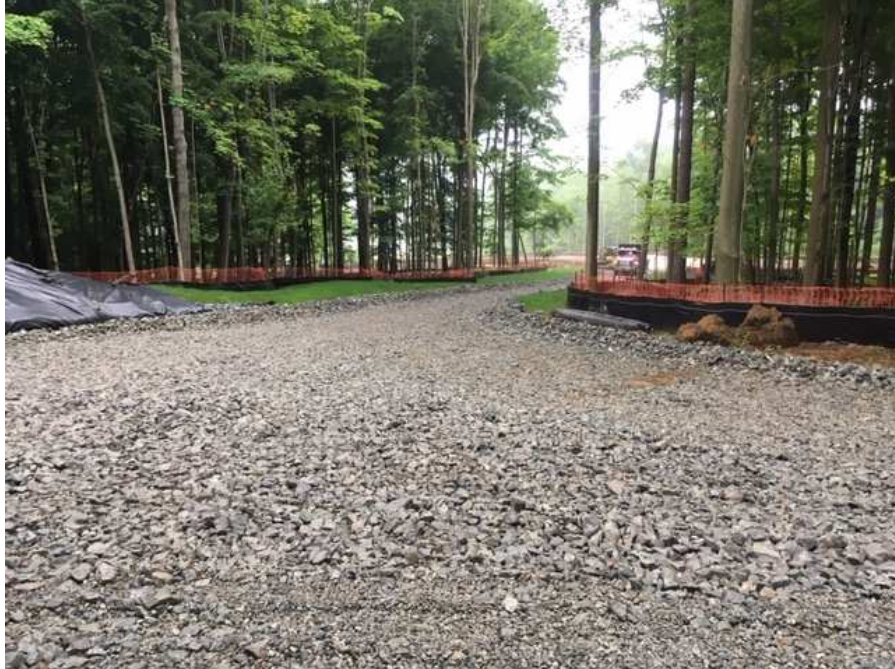
Figure 1: Construction Driveway at Drewville Road

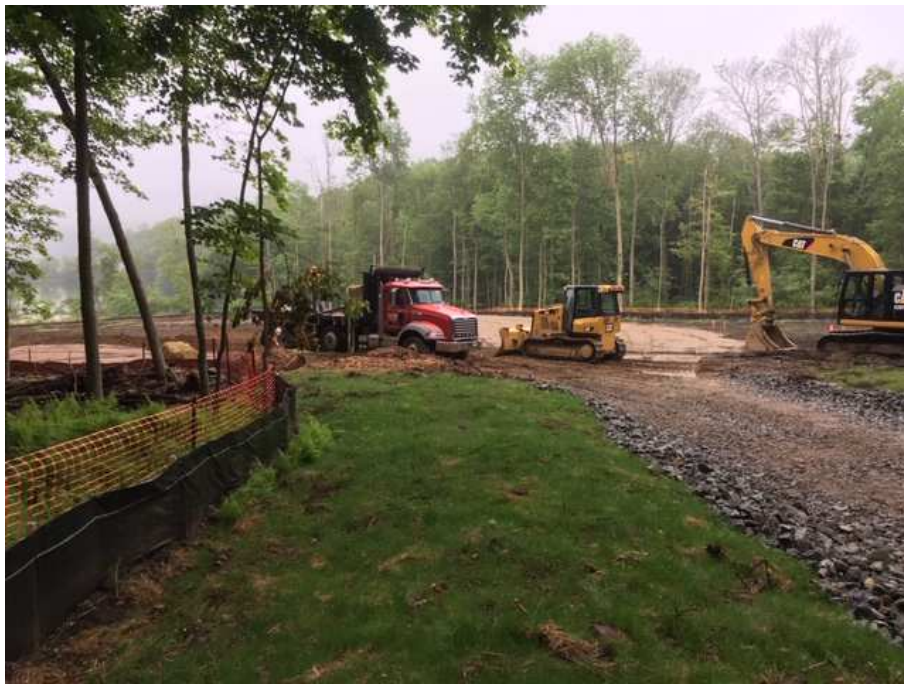
Figure 2: Location of Proposed Pond at Drewville Road

The drainage area for the project includes asphalt paving on Drewville Road and Drew Lane, impervious rooftops, asphalt-paved parking lots, and wooded and grassy areas. Runoff from the drainage area is collected in a roadside drainage ditch on Drewville Road and drains to Croton Falls Reservoir. The primary objectives of the project are to repair the drainage ditch to prevent erosion within the ditch, prevent undermining of the rock wall adjacent to the ditch, and reduce the amount of sediment deposition in the woods and along the shoreline of the Croton Falls Reservoir. The stormwater measures consist of a forebay and a micropool, which will extend the detention time of the stormwater, allowing solid material to settle.
