INVESTIGATION REPORT:

JANUARY 14, 2008 SHORING COLLAPSE AT 9 DOMINICK ST. (AKA 246 SPRING ST.) MANHATTAN

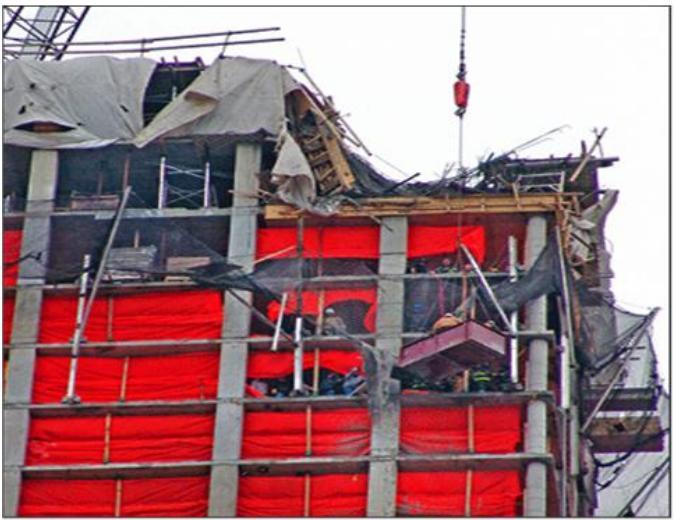
Photo 1 Collapse Area - Looking West

Investigation around the boundaries of the debris field allowed a better understanding of the general construction layout. Observations in that area revealed instances of improper installation that are described in the report. The investigators strongly believe that such improprieties also existed in the area that completely collapsed. One of the main observations based on the layout of the debris, was that whatever the initiating cause, the extent of the total failure was limited to the two-level of shores installation. Clearly, the failure did not progress in any manner past the edge of the already poured 41^{st} floor (see Photo 1).

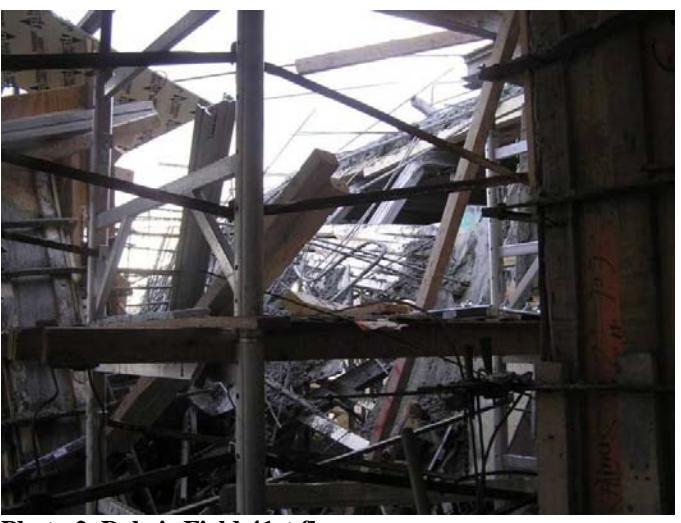
Photo 2 Debris Field 41st fl.

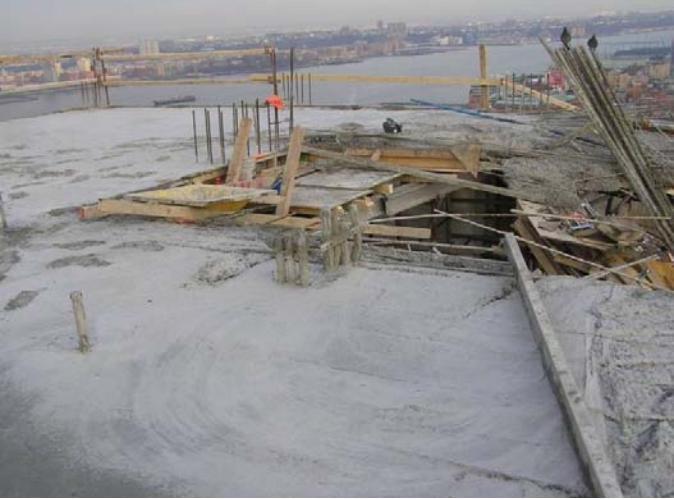
Photo 3 42nd Fl. Debris - Looking North East

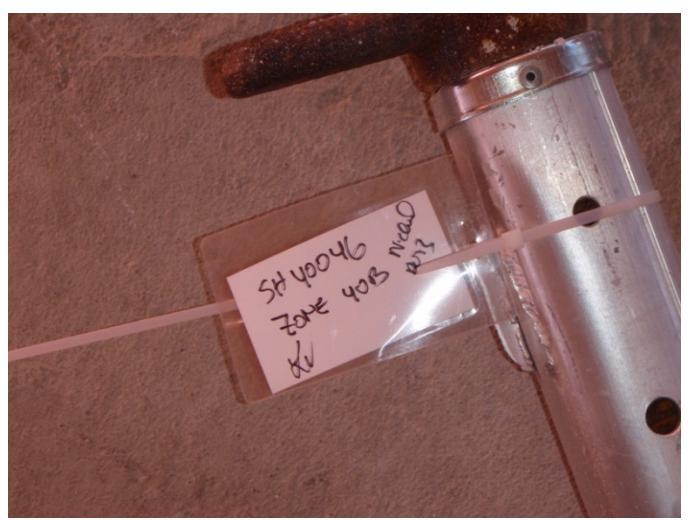
Photo 4 Typical Tag and Failure at Connection Note Name, Zone and Signature

• Failure of the tube next to the weld connecting the horizontal or diagonal elements to the vertical legs. While a special failure analysis of the weld was not performed, it appears that in most cases the tube walls sheared at the weld. In one or two cases there might

have been separation of the weld from the tube material (see Photo 4 Typical Tag and Photo 10 Fracture Near Weld).

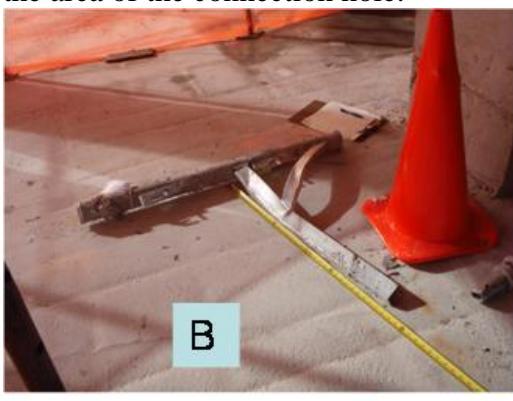
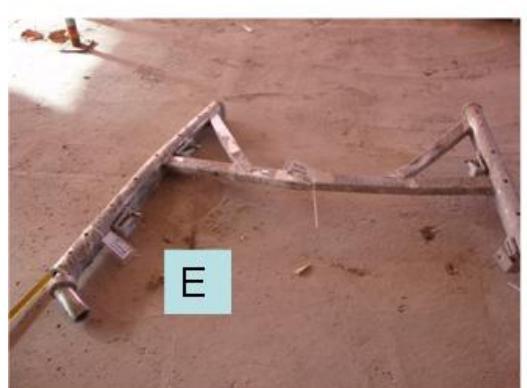
• Failure of the tubes (diagonal or horizontal). This might have occurred at connections of horizontals with diagonals or in the aluminum tube at the weld line to the vertical leg (see Photo 8 – Failure Modes).

Photo 8 Failure Modes

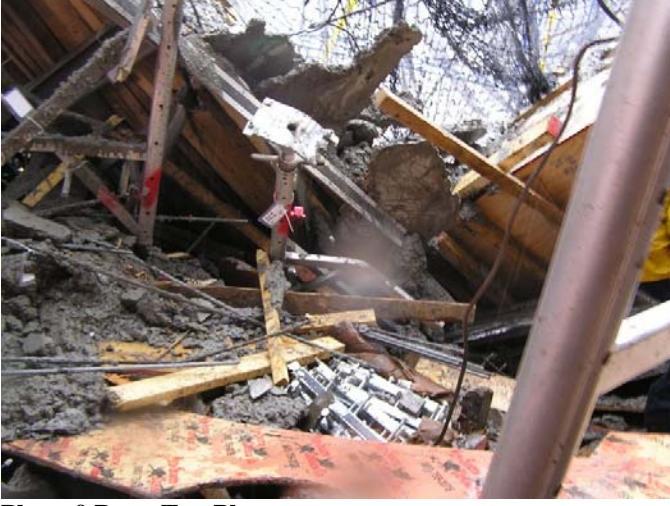
Several top plates were found bent (see Photo 9 Bent Top Plate). Also, two or three locking cams were found broken.

Photo 9 Bent Top Plate

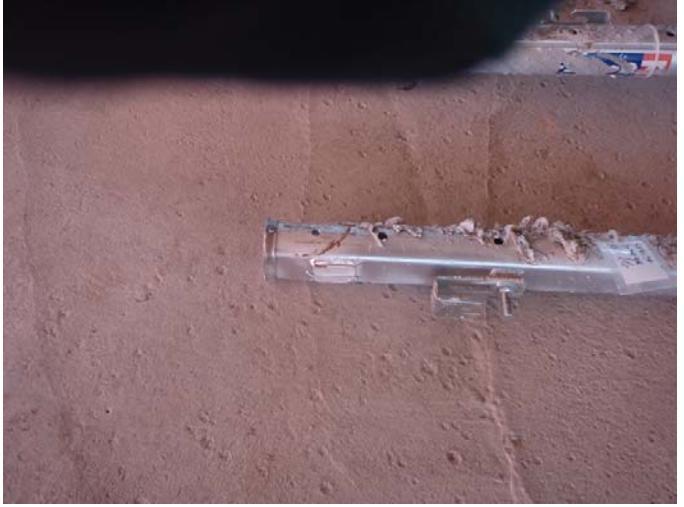
Photo 10 Fracture near Weld

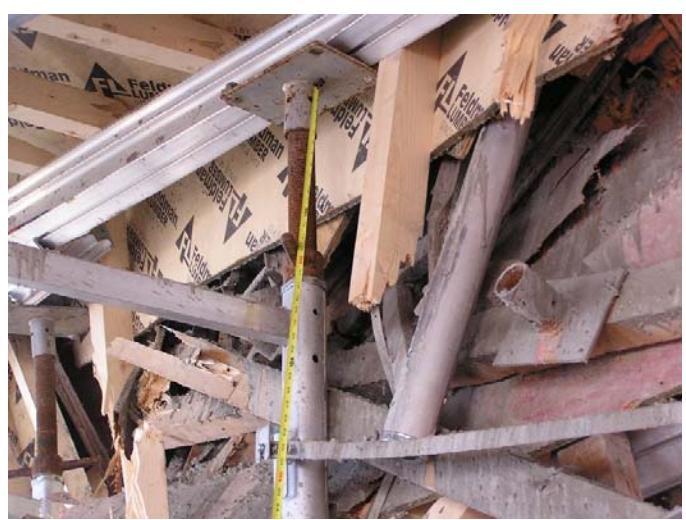
The investigation did not identify any major issues with regard to the assemblage of the tube frame into a tower. The extension of the leg adjusting fillet tube reached in some cases 20 in. when measured from the top of the aluminum tube to the top of the plate.

Photo 11 Adjustment Screw with Extension Over 12"

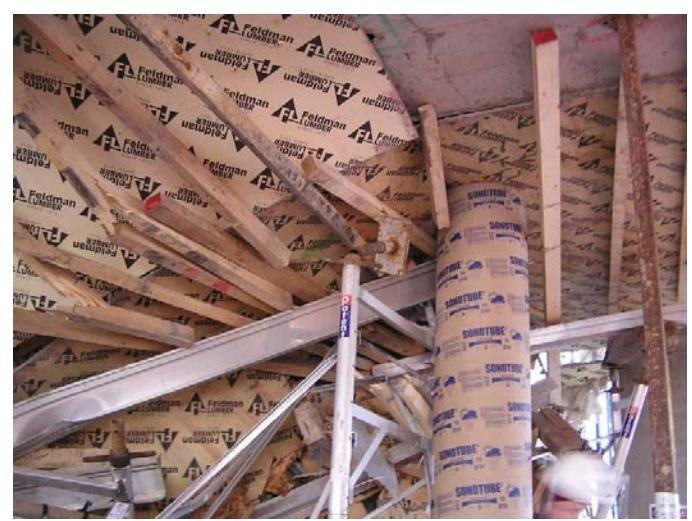
The investigation noted several cases where the extension legs fractured at the line of insertion to the vertical aluminum leg (see Photo 12 Fractured Adjustment Screw Failed extension leg. Note lack of attachment of wood joists to stringer).

Photo 12 Fractured Adjustment Screw

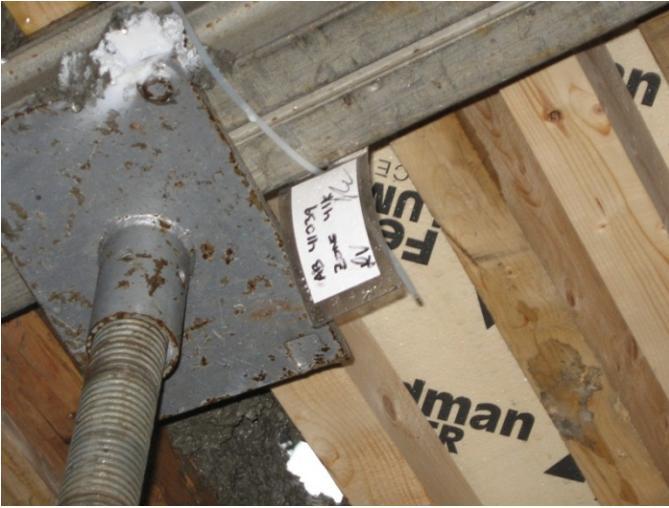
Photo 13 Stringer Set Eccentric on Head Does Not Follow Patent Instructions

In some cases it was observed that the stringers had not been fastened with clamps at the plate support. The layout and splicing of stringers on the shoring plate is discussed at 4.2 and verified in calculations at Appendix A 3.2.2 and 3.3.2. See also Photo 13. The stringers on the east side of the area had been attached with perforated metal bands to the 4x4 wood underneath.

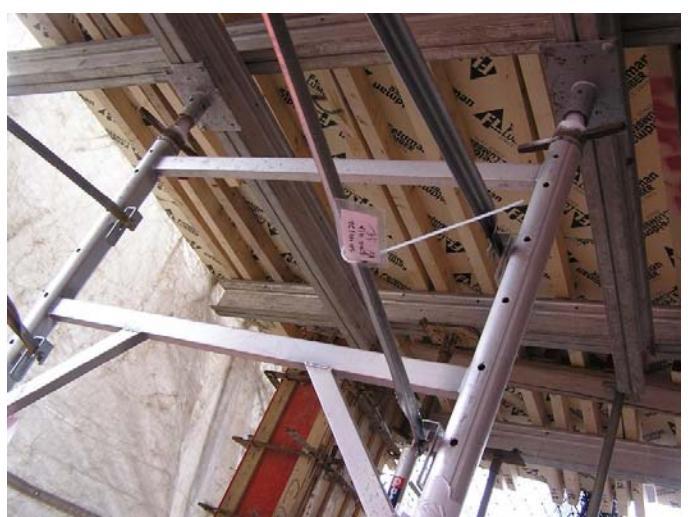
Photo 14 Stringer Supporting Stringer

We observed in the vicinity of the collapse zone stringers supported by other stringers. In fact, the position of the tower based on our layout would not work without some stringers supporting other stringers. Such layout is not necessarily wrong, but the stringers need to be calculated for the loads. Also, at each of the observed stringer support on stringer we could not observe any positive connection. Several of such stacked beams observed in the vicinity of the collapse were twisted.

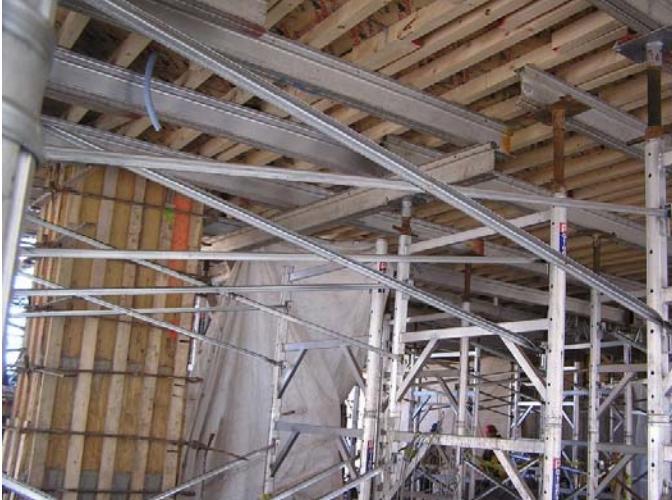
Photo 15 Improper Stringer Setting

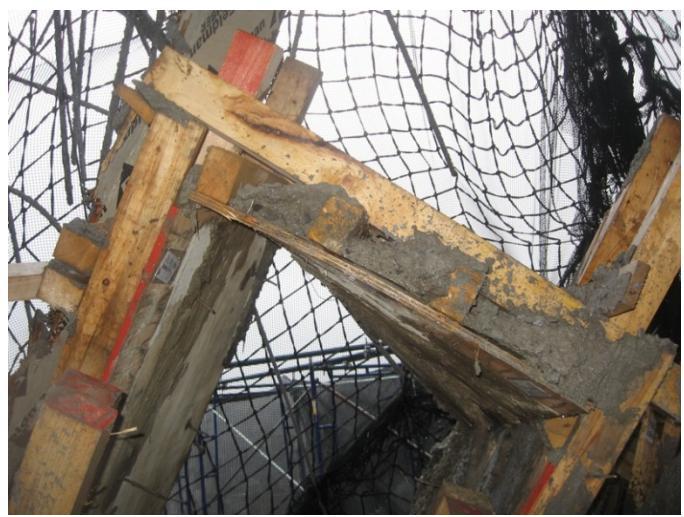
The beam formwork was composed of plywood reinforced with 3x4 wood ribs and kept together with Meadow-Burke ties set at 30". Some of the forms (the 3 sides) were found in the debris. The investigation was not able to recover intact formwork in significant amounts (see Photo 17). The investigation also could not reconstitute the means of support (if any) of the top of the beam side formwork (where it meets the horizontal forms). The snap tie hardware is from Meadow Burke, with the ties having a diameter of .22". The ties are attached via wedges to pairs of 3x4 joists (see Photo 18 –Beam Formwork –Ties and Ribs).

Photo 17 Beam Form (Upside-down)

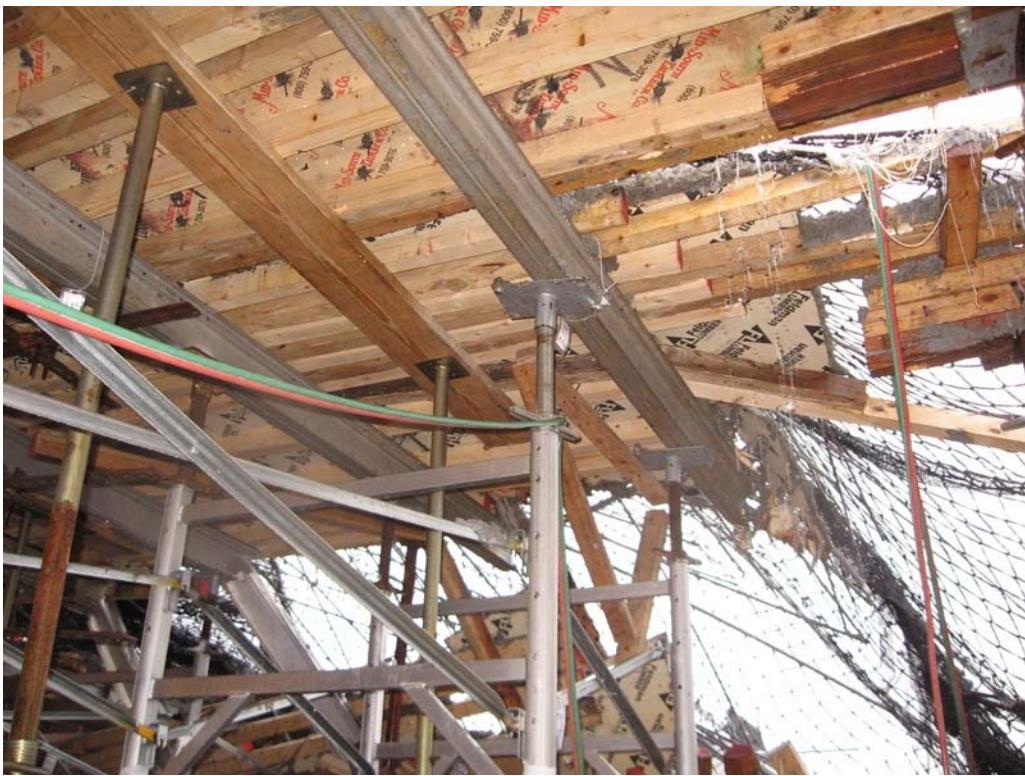
Patent's instructions require the stringer to be set in a manner to ensure a centered load on the head plate (Figure 8 Lapping of Stringers – from Patent Instructions). In fact, this layout is shown on each of the drawings, underscoring the importance of the requirement. The extent of the damage in the collapsed zone prevented the investigators from ascertaining whether the stringers were properly installed in the portion that collapsed, but proper installation (as shown in Patent's sketch) was not found anywhere else (i.e., in areas immediately adjoining the collapse or in areas to the south of the building that used the same tower configuration) (see Photo 20 Eccentric Stringer Position). It is thus a reasonable inference that the collapsed portion was similarly improperly installed.

When the stringers are laid using the improper method described above, there will be a 2 inch eccentricity in the application of the stringer reaction to the leg support. The resulting moment will reduce the carrying capacity of the leg, hence the manufacturer interdiction for such a layout.

Photo 20 Eccentric Stringer Position on Head

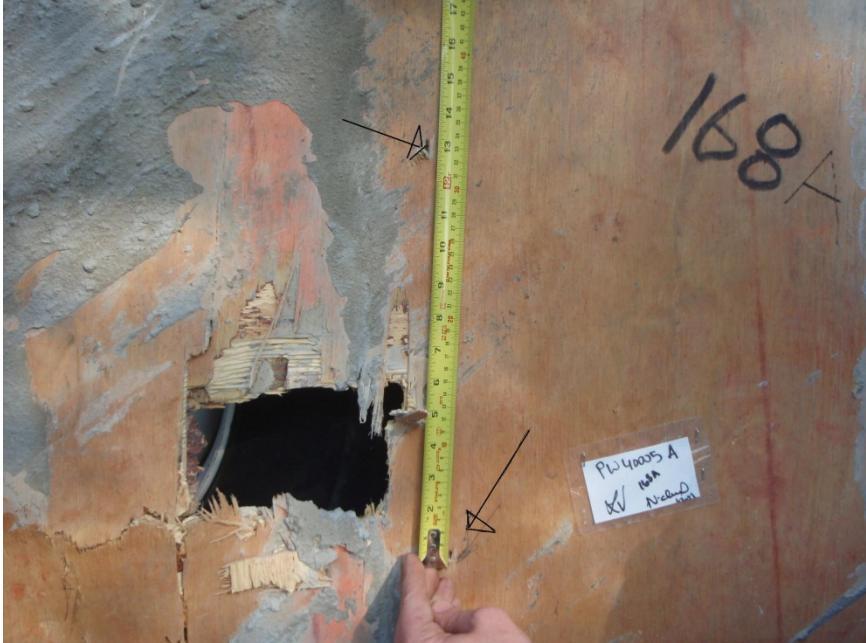
performed directly from the top leg to the bottom or via a system capable of sustaining the forces. In our case, the plywood and joists were interposed between the legs (see Figures 6 and 7 and Photo 21). Note in Photo 21 the almost precise contour of the base plate defined by the punch hole and the relative position of the nails. The alignment of nails indicates the position of the joists. Clearly the plate was set between the joists and not on top of them. Several punchholes like this were found in the debris.

Photo 21 Plywood Penetrated by Leg Base

Our calculations show that the shoring towers were likely to fail when the punching of the plywood occurred at the 41st floor, which corresponds with the punched plywood observed in the debris (Photo 25 and Appendix B). Engineering calculations (see discussion at 7.2.4) prove that the load on the leg far exceeded the capacity of the plywood to resist punching. The intensity of loads that were capable of punching the plywood was determined by Wood Advisory, which performed tests on plywood found at the site. Photo 21 is a clear example of punched plywood. It also demonstrates that the leg was not atop a joist.

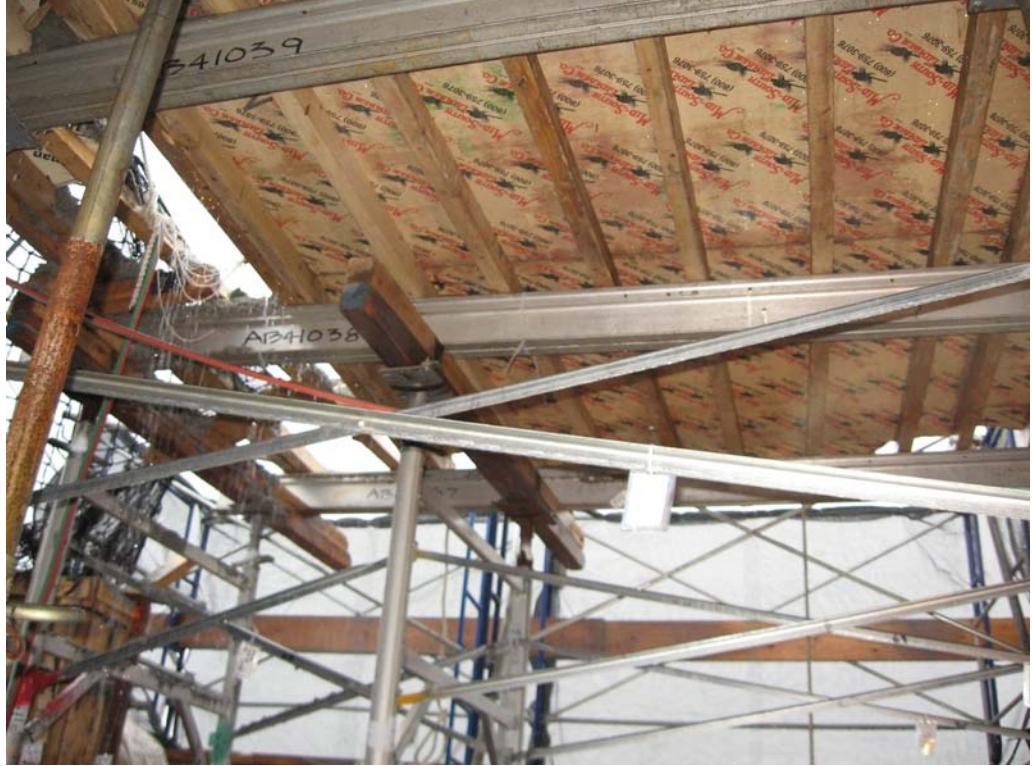
As installed, the two floor stack had no positive attachment to the 41st floor, and as a result, it amounted to an independent two story structure that should have had additional specific provisions for stability. To transfer lateral loads as those indicated in the Building Code 27-1035 (c) (3) one would need to nail or fasten each stacked element to the one below (i.e. plywood to joists, joists to stringers, stringers to towers, tower legs to mud slab and so on). Chapter 3, Examination of Debris, documents a number of cases where no connection existed. The installation lacked a systematic concern for transfer of horizontal loads.

A proper installation would have transferred the lateral forces developed at each individual shore tower. Nailing, which would have assured such transfer of lateral forces, was not always present at the site, especially at shore legs. Only a few leg bases were nailed into the 41st wood floor. The legs at the 40th floor that could not have been nailed into the concrete should have been placed on and nailed to sills. What resulted was a gravity system that relied on friction to transfer horizontal loads (friction develops in the presence of vertical (gravity) forces and is directly proportional with vertical forces). At some phases during the concrete pour process some bays were not loaded, and, as a result of continuity effects, some portions of girders or posts might even have experienced a tendency to uplift. Consequently, at some locations there might have been no friction to transfer the loads.

Photo 22 Shoring at the East Side. Note absence of ties

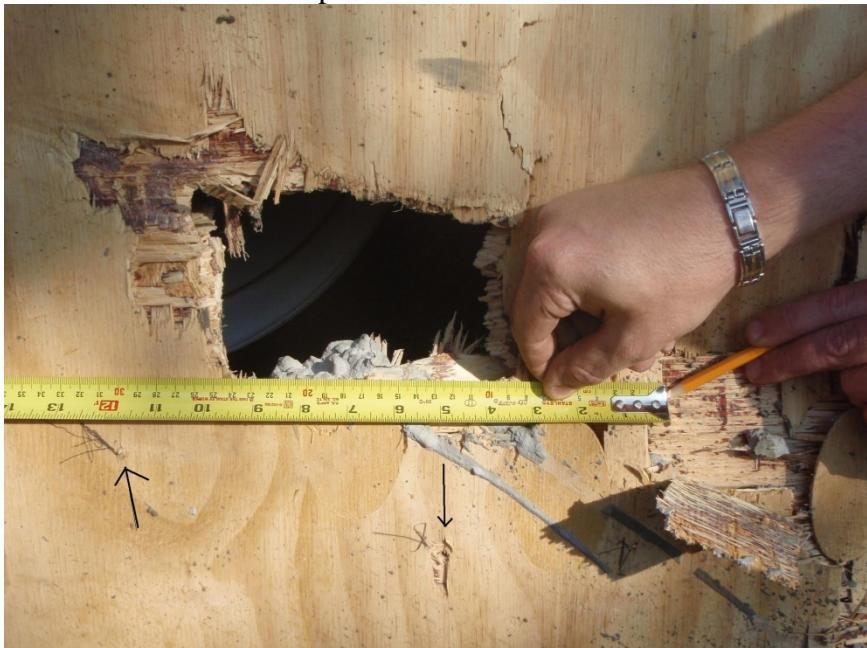
In the investigators' opinion punching of the plywood was most likely the initial failure that started the chain of collapse.

Photo 25 Punched Plywood

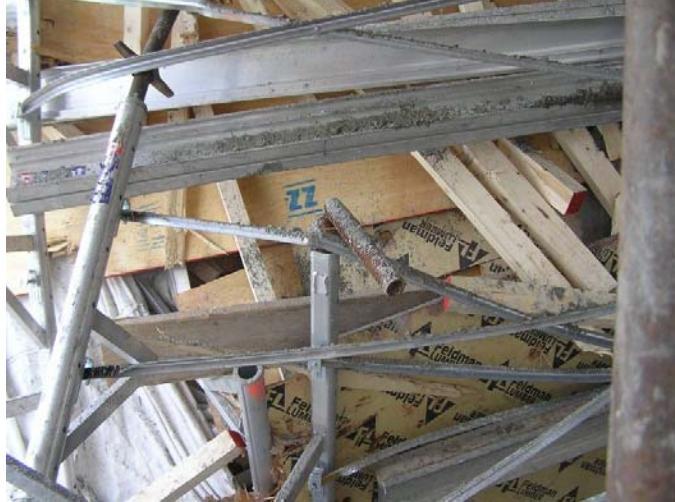
Photo 26 Broken Adjustment Screw Extension

This scenario (Figures 10 and 11) clearly explains the global failure of the entire stacked system and is supported by calculations, lab testing and numerous pieces of broken adjustment screws found in the debris. The scenario follows naturally from the mode of failure on the floor above (see 8.1.1). Since such failure would have occurred in any tower under the central beam (where the loads are maximum) the resulting general collapse would be consistent with the layout of the debris existing at the site.

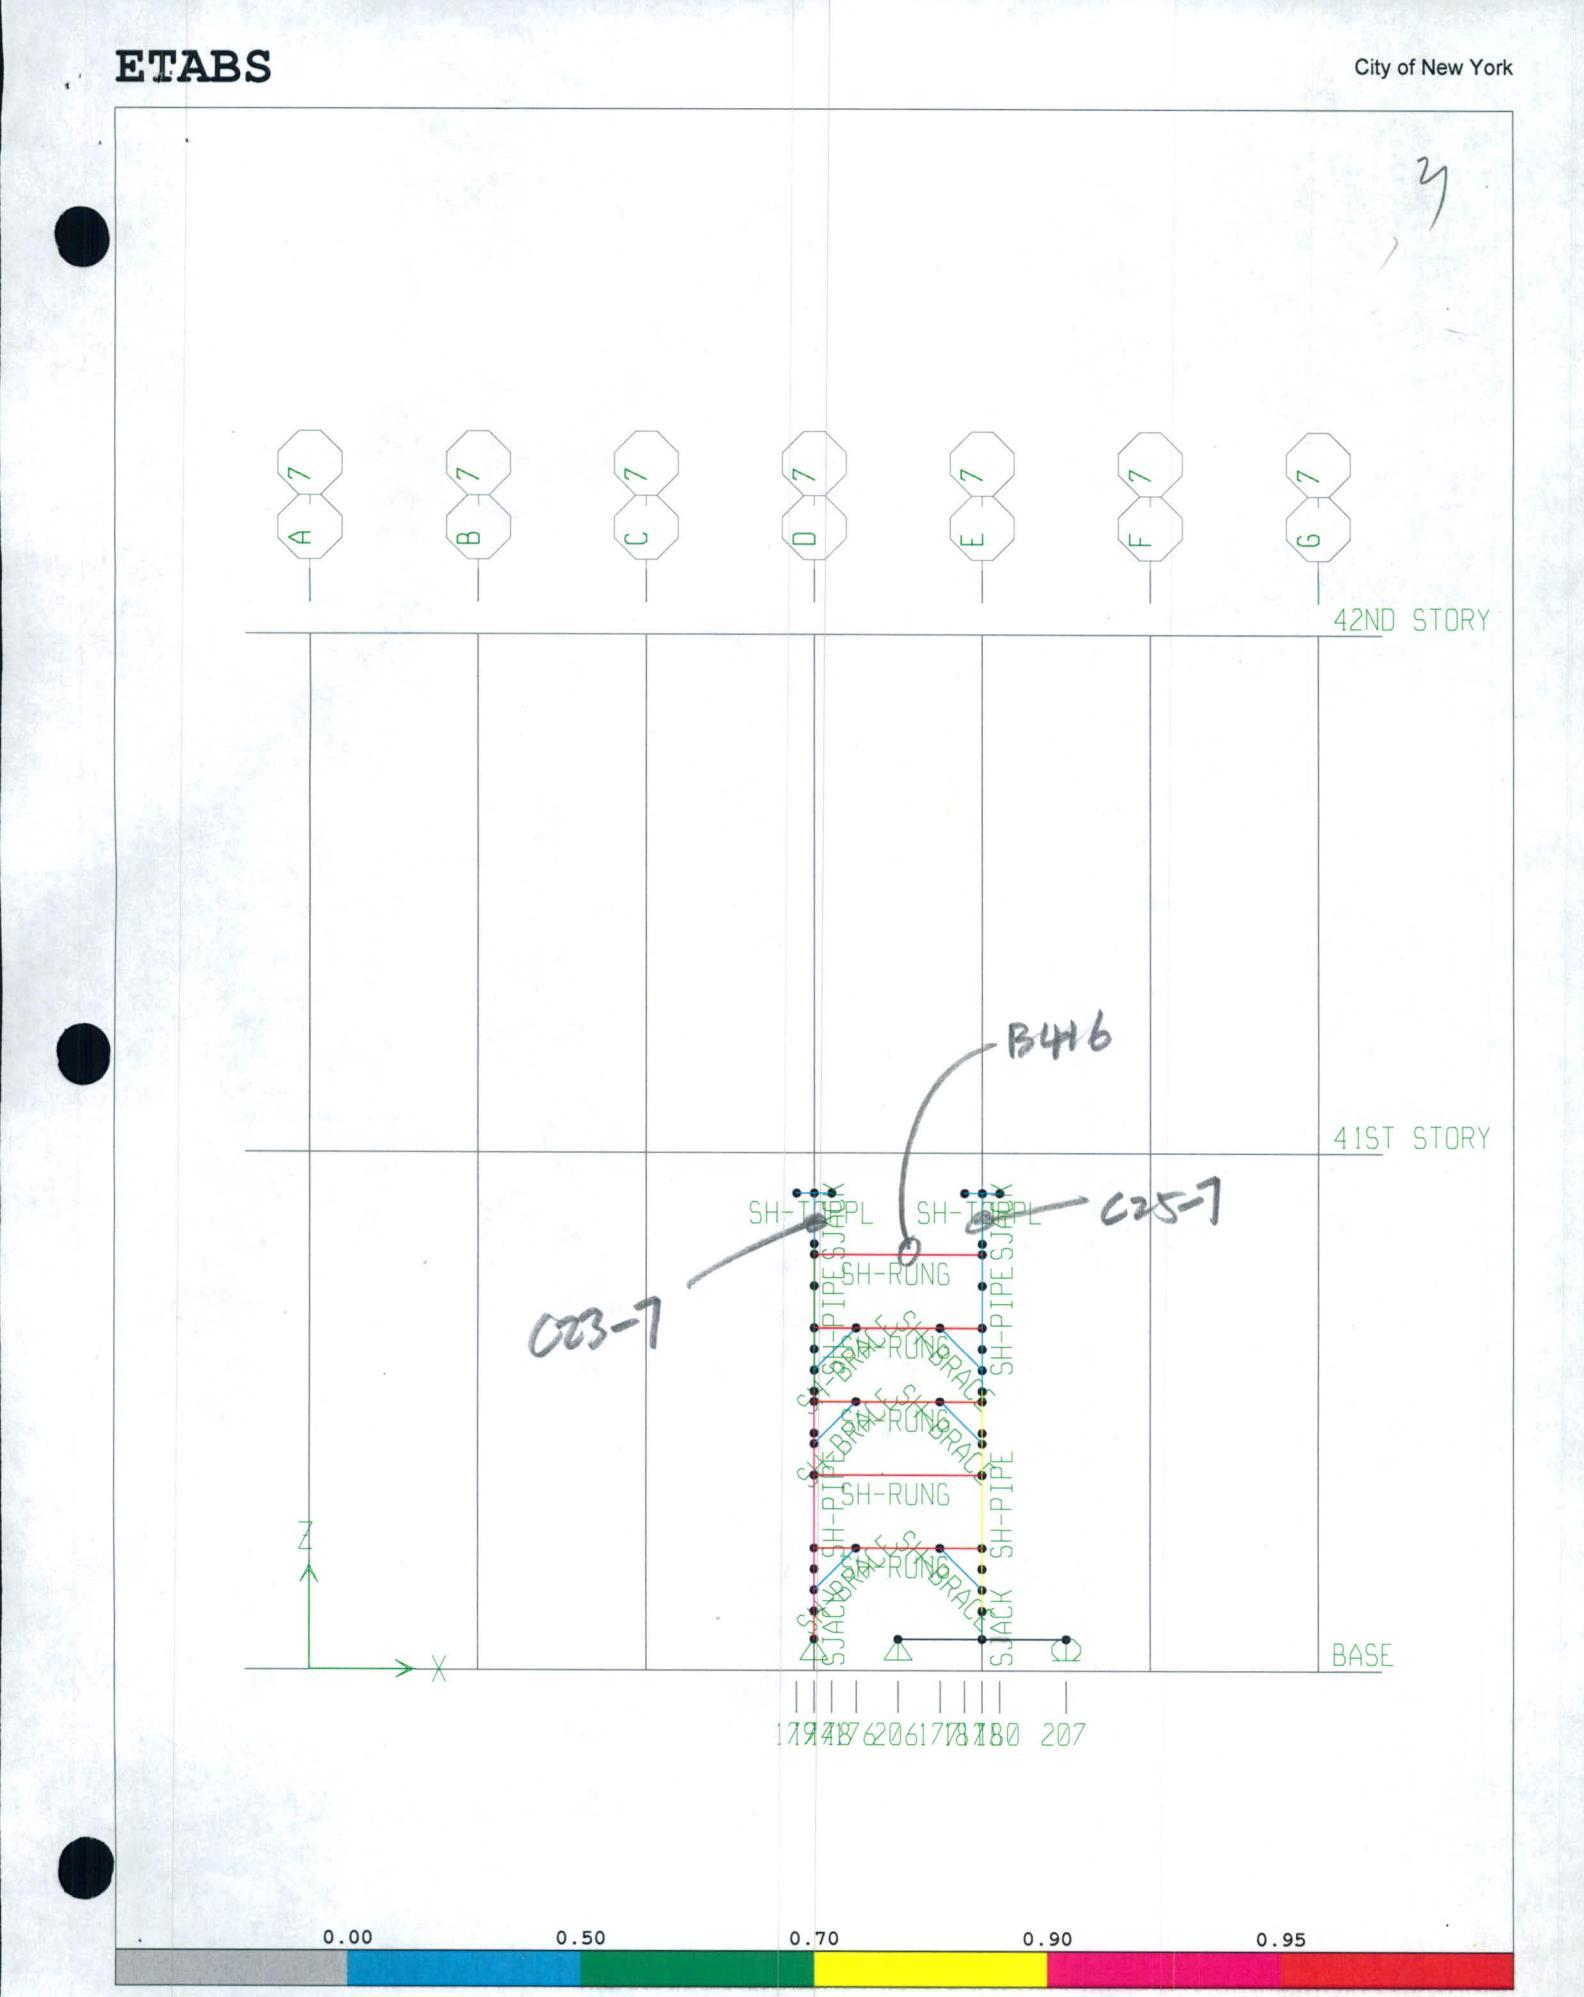
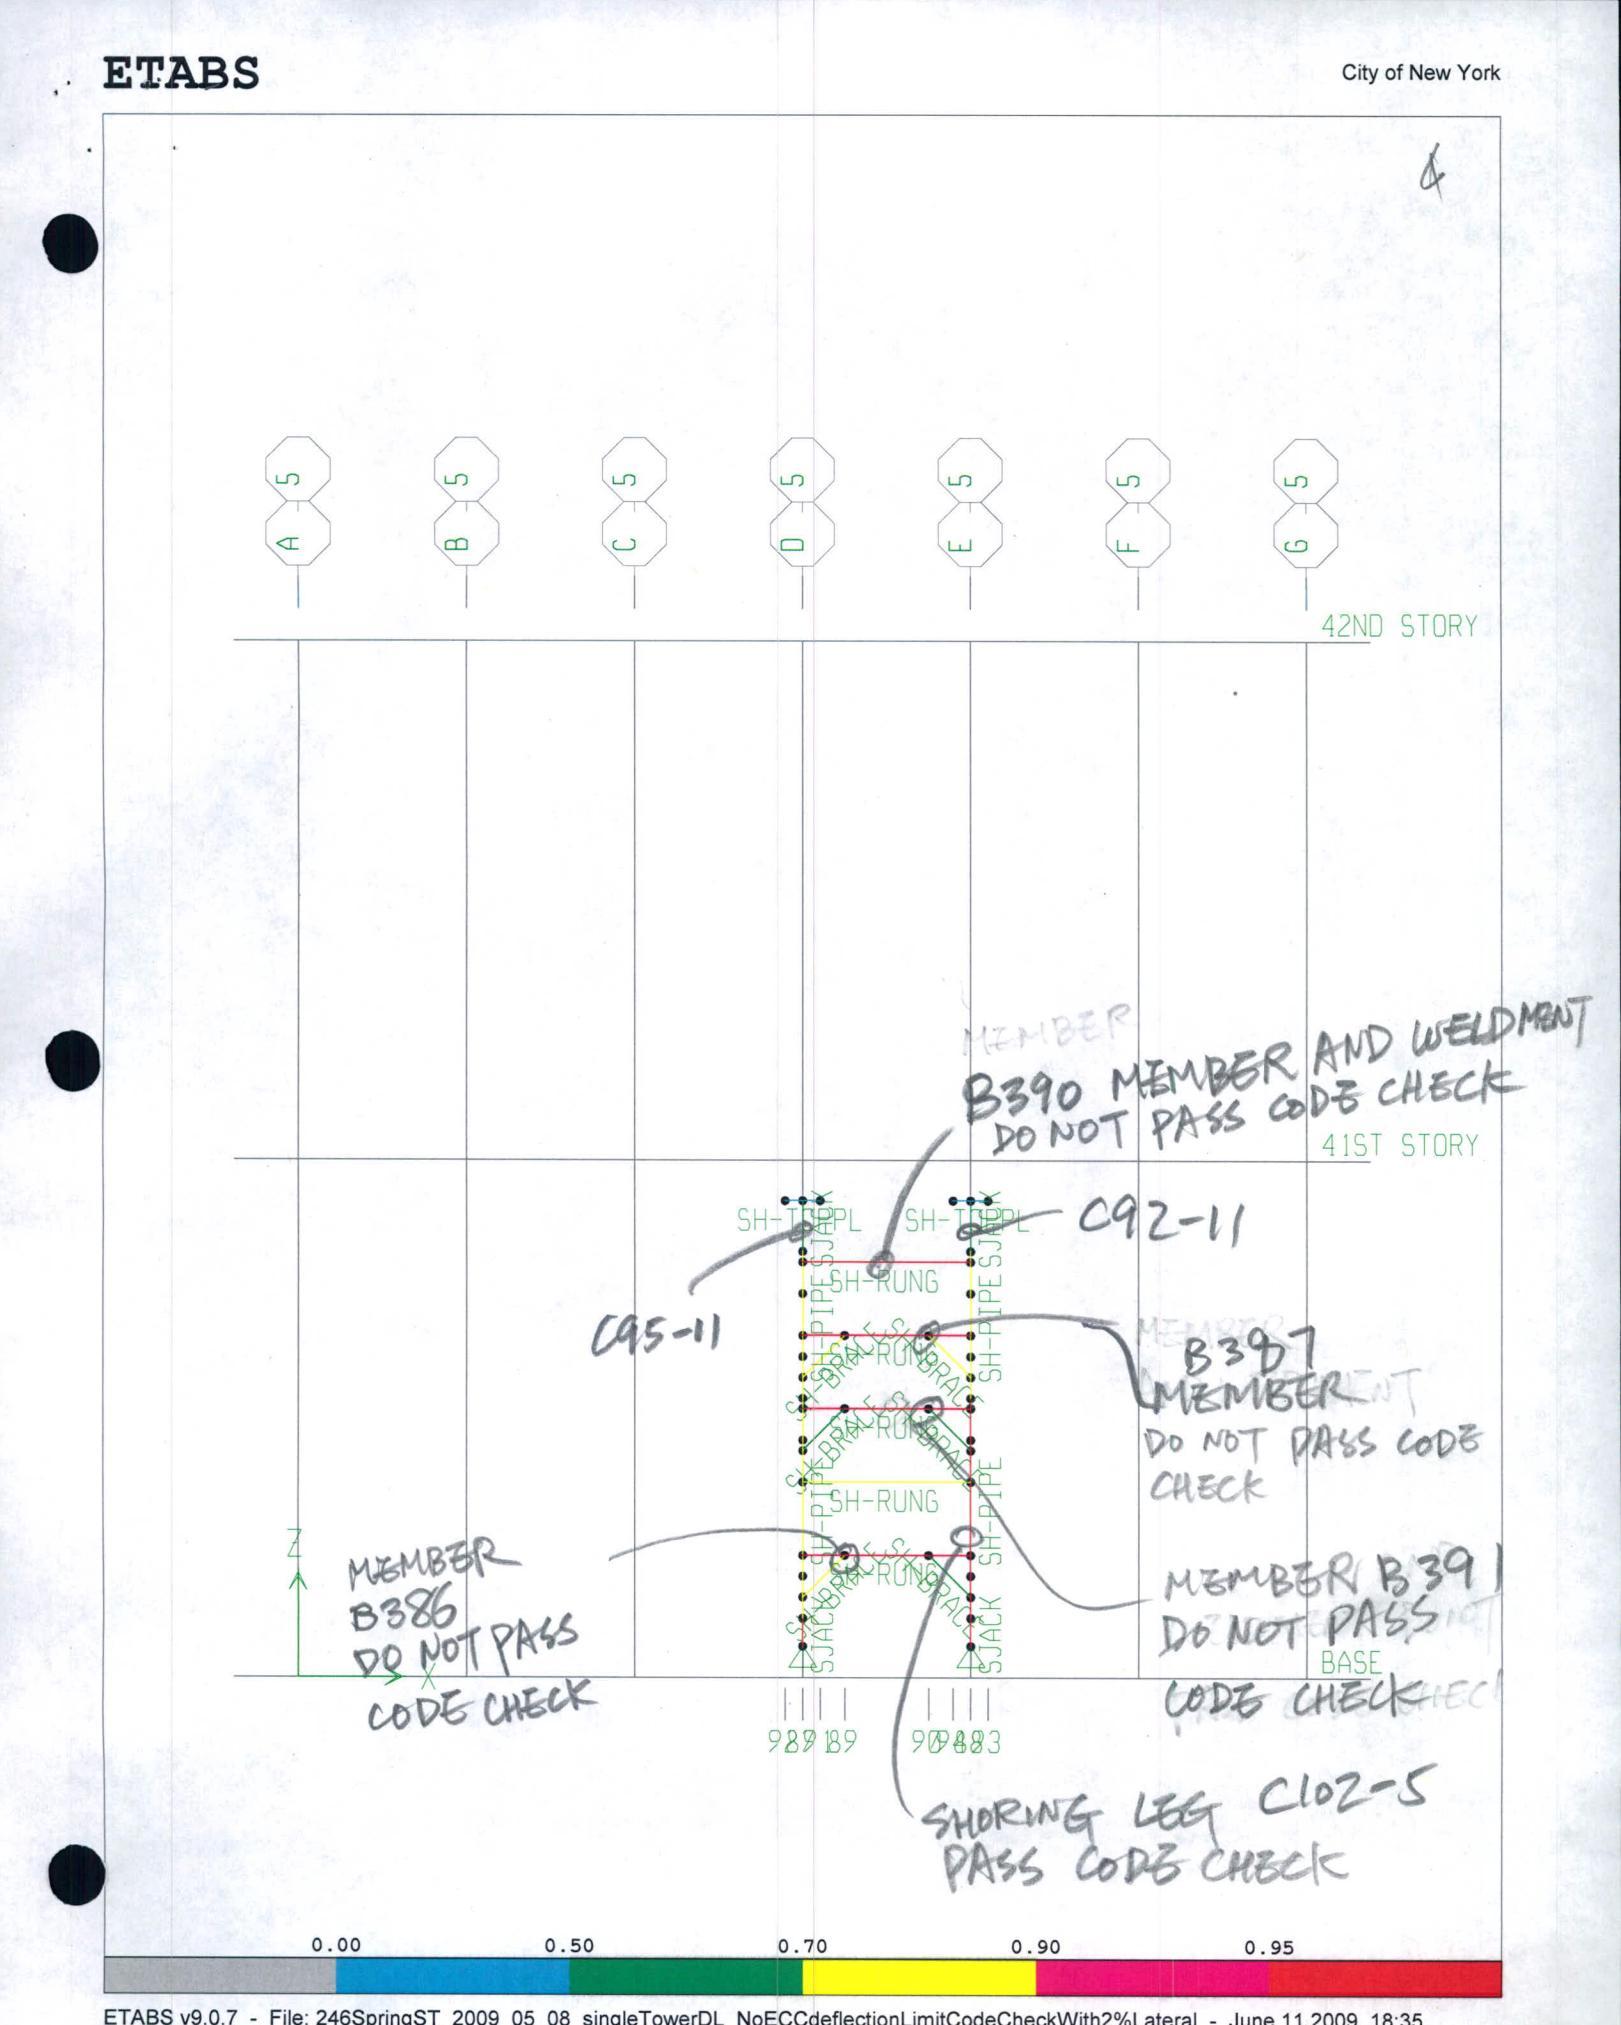
Result: shore failure

- Screw jack allowable stresses produced by bending and compression are about 60% of the allowable.
- Aluminum shoring leg under bending and compression was stressed at about 90% of allowable.
- Horizontal members and connections from horizontal members to shoring legs do not meet allowable stress ratio combination. The ratio actual versus allowable is 2.

Stress ratio in knee brace is insignificant.

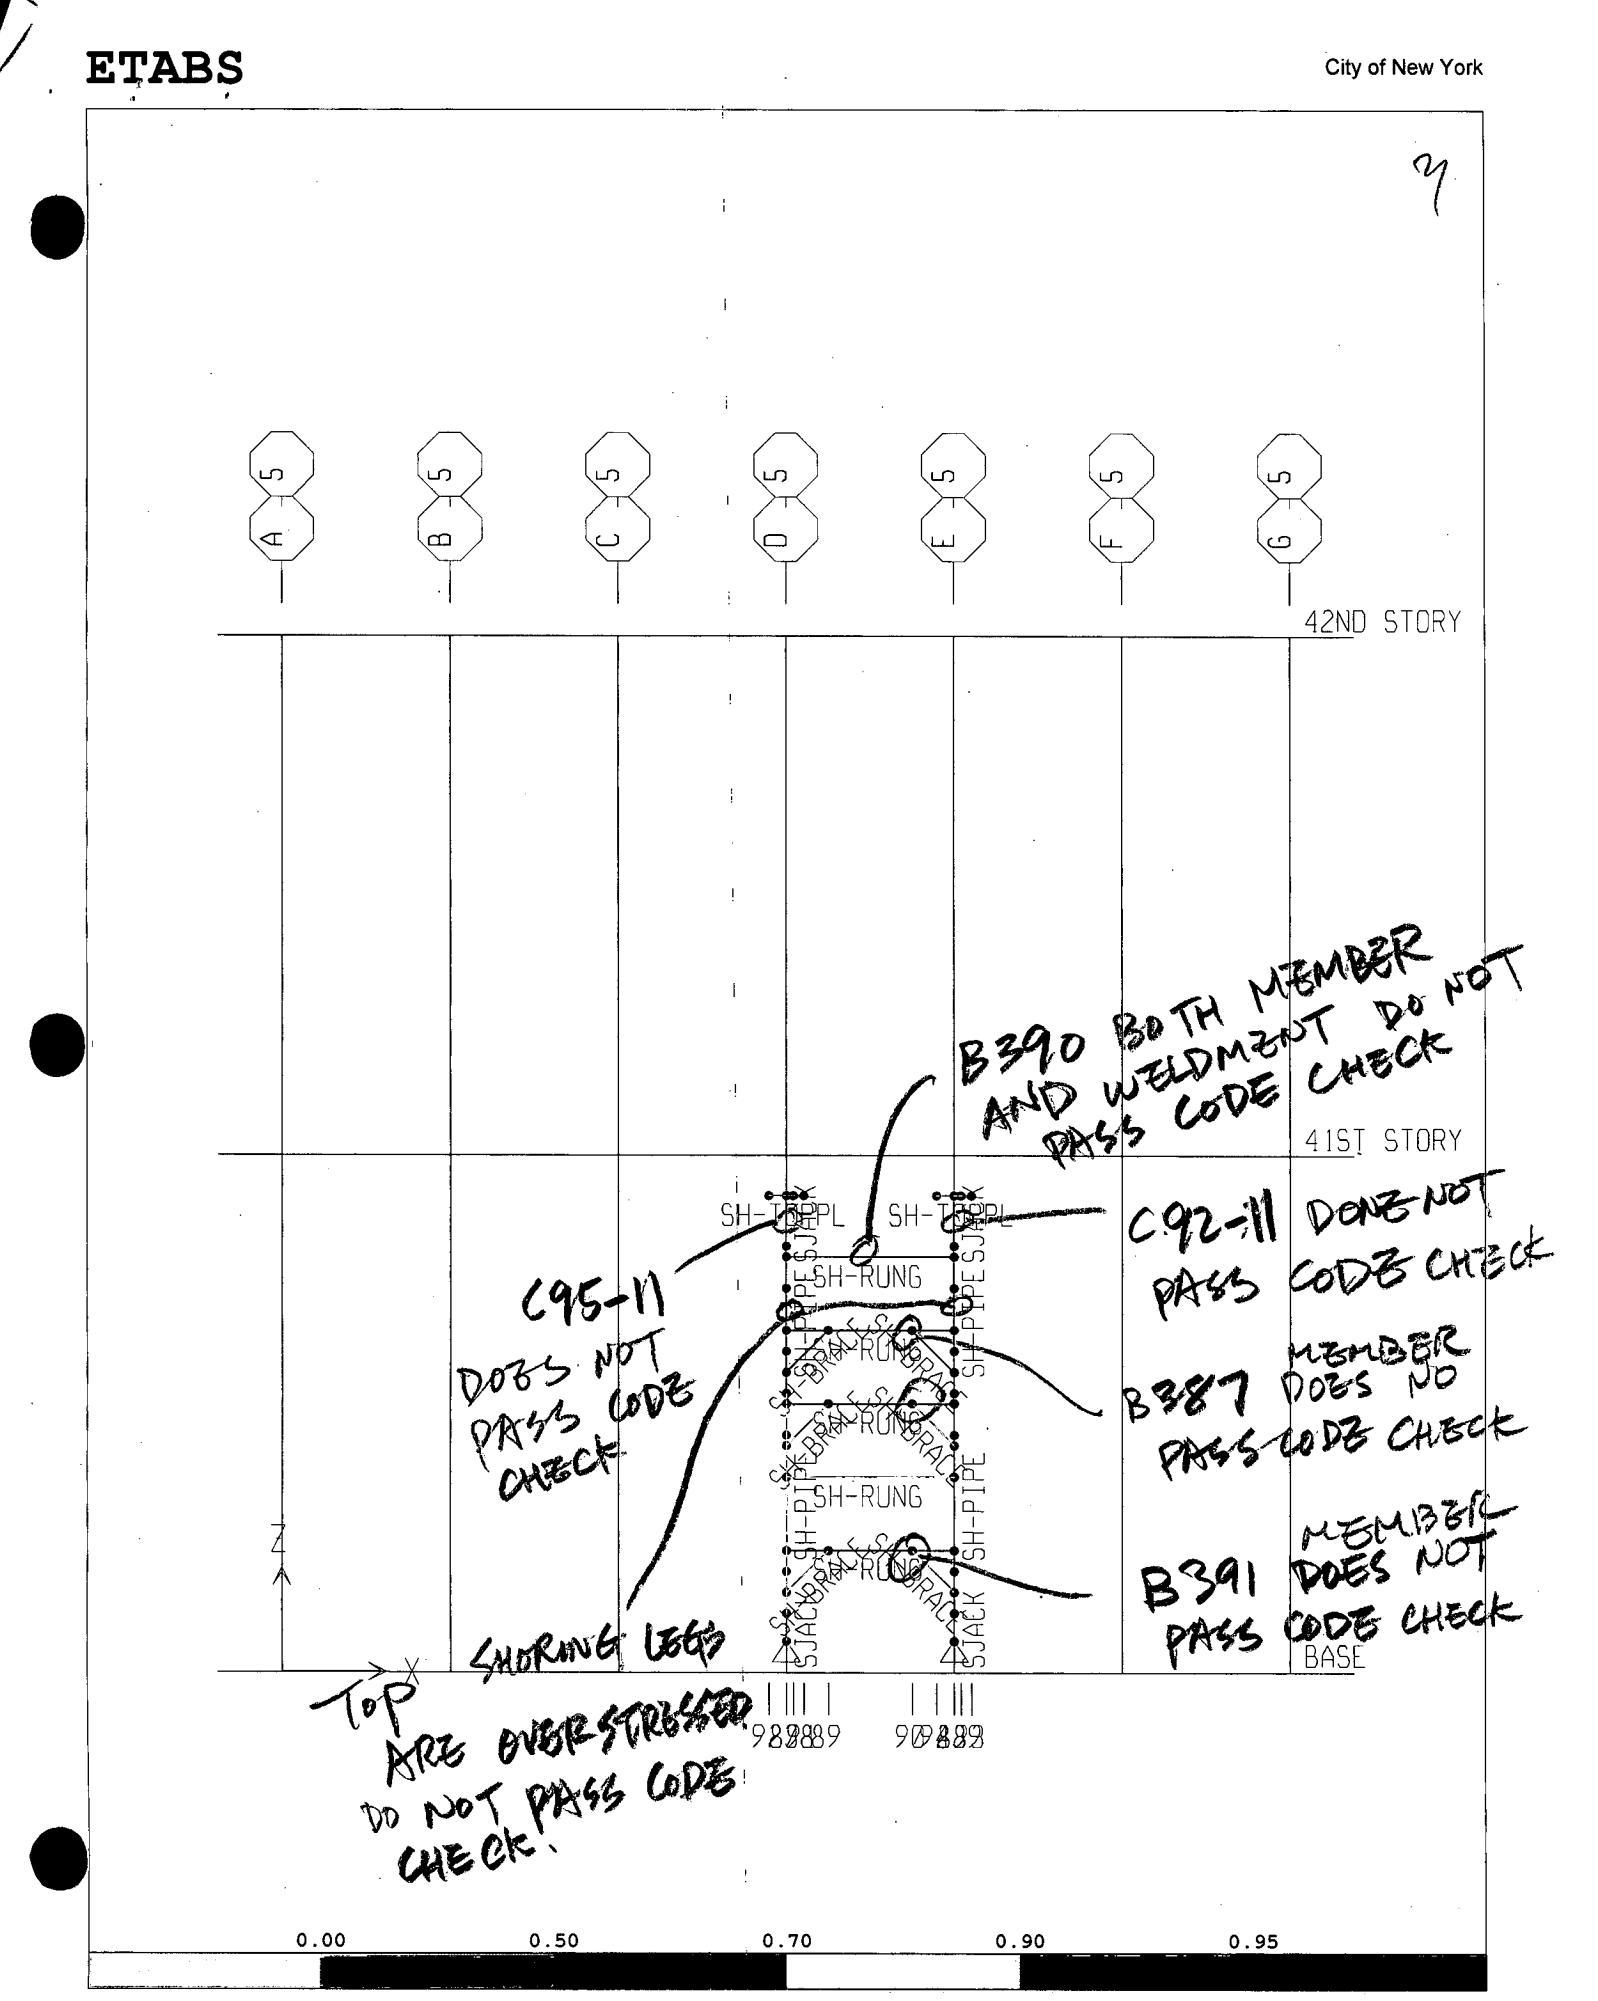
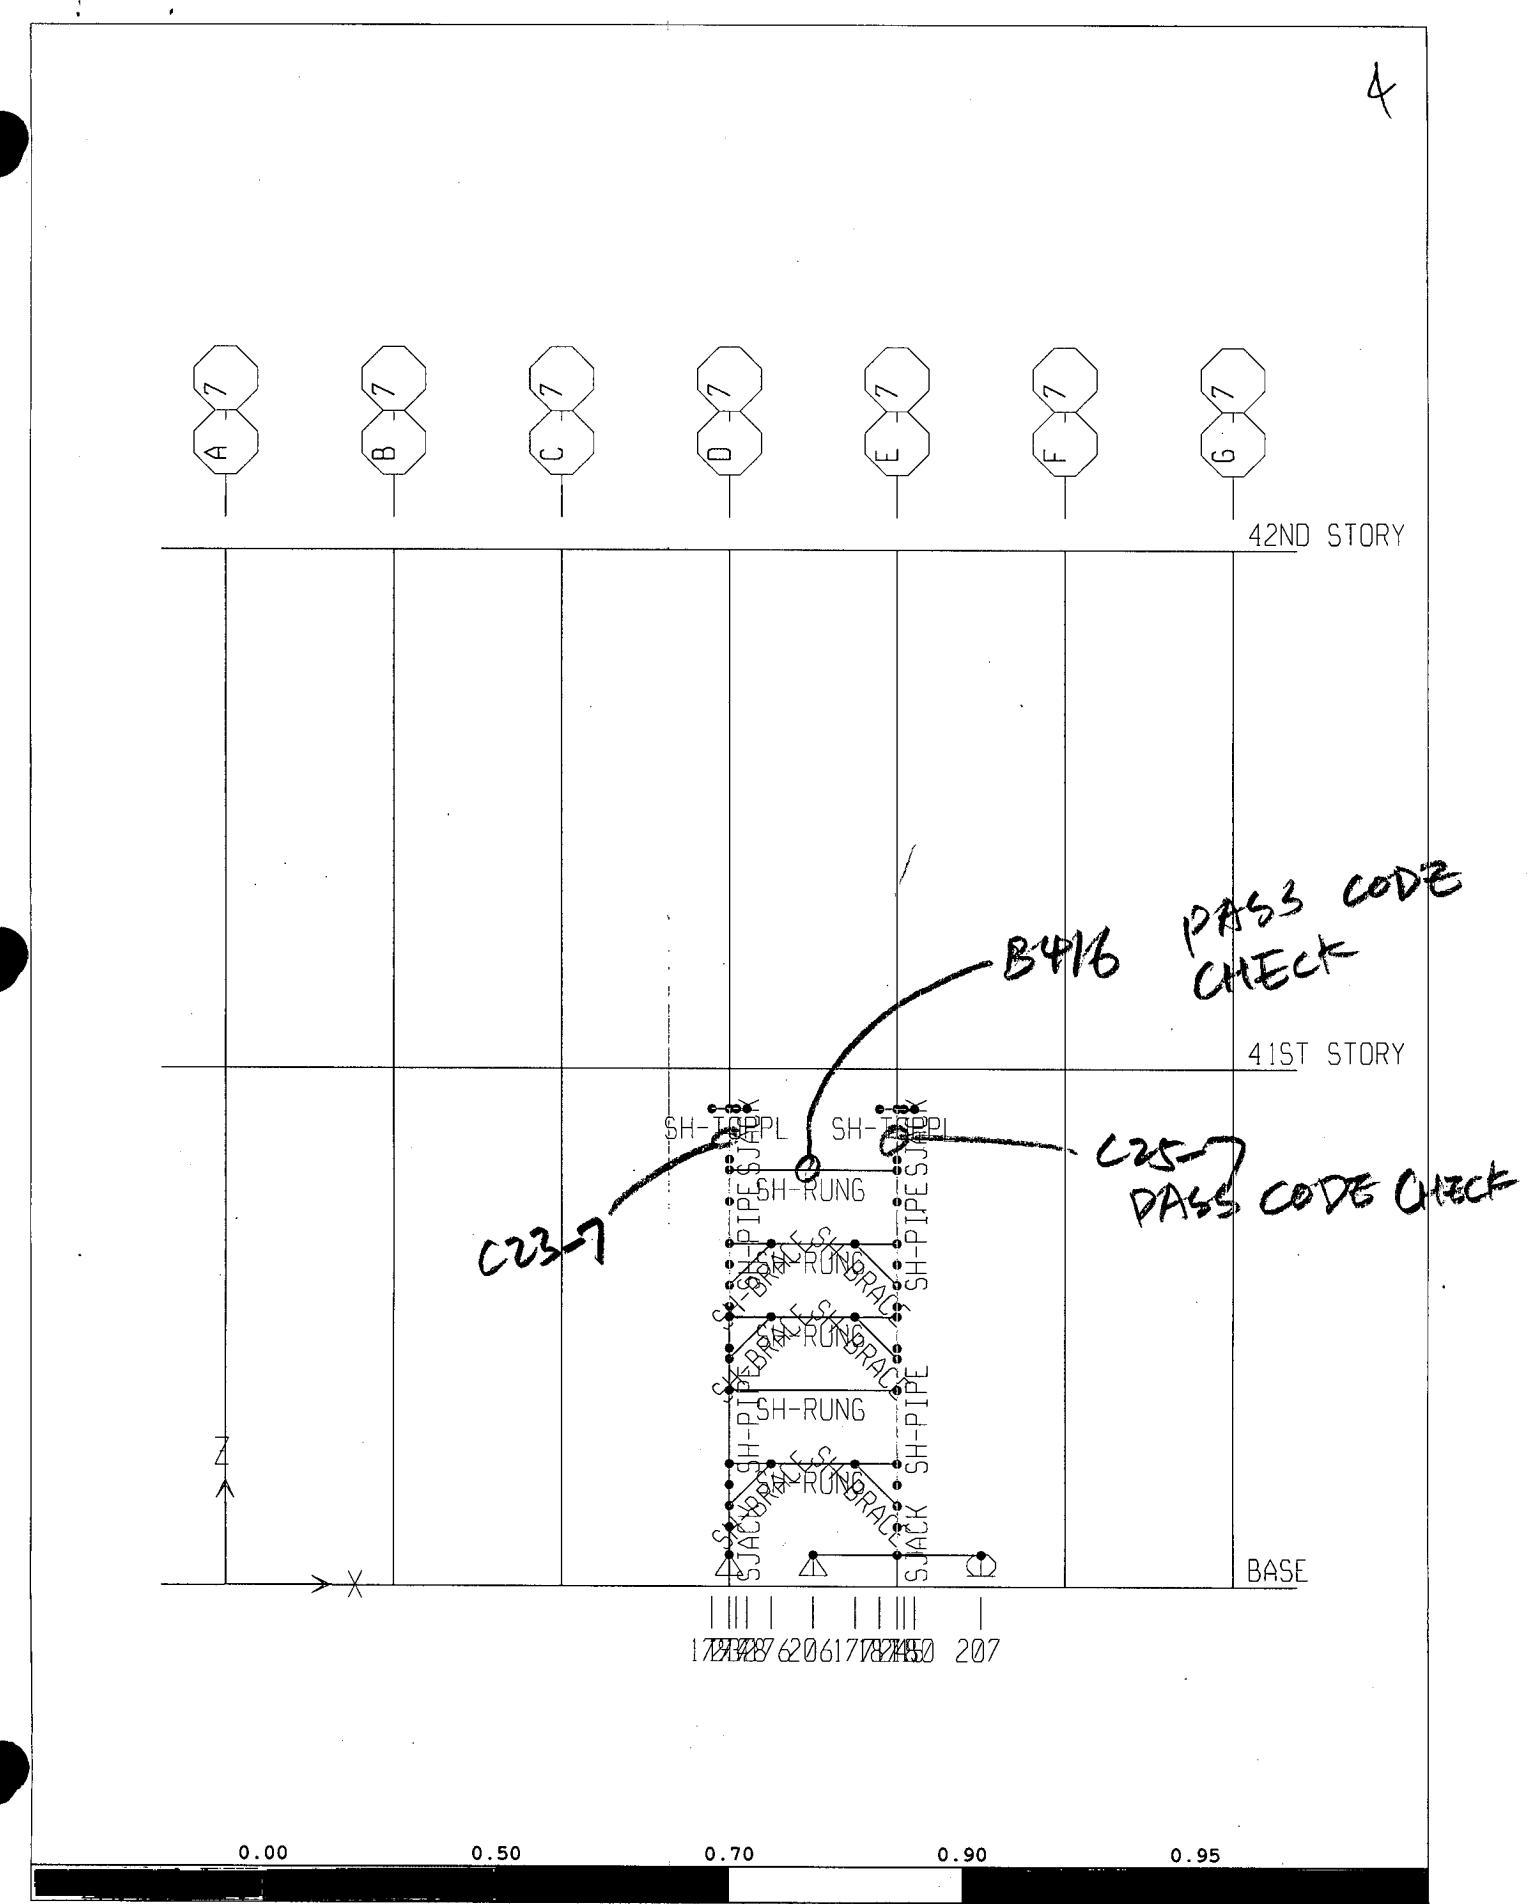
Result: screw jack and shore failure

- Screw jack allowable stresses produced by bending and compression are about 140% of the allowable. Overstress condition.
- Aluminum shoring leg under bending and compression was stressed at about 140 % of allowable. Overstress condition.
- Horizontal members and connections from horizontal members to shoring legs do not meet allowable stress ratio combination. The ratio actual versus allowable is 2.62 Overstress condition.
