INVESTIGATION REPORT:

JANUARY 14, 2008 SHORING COLLAPSE AT 9 DOMINICK ST. (AKA 246 SPRING ST.) MANHATTAN

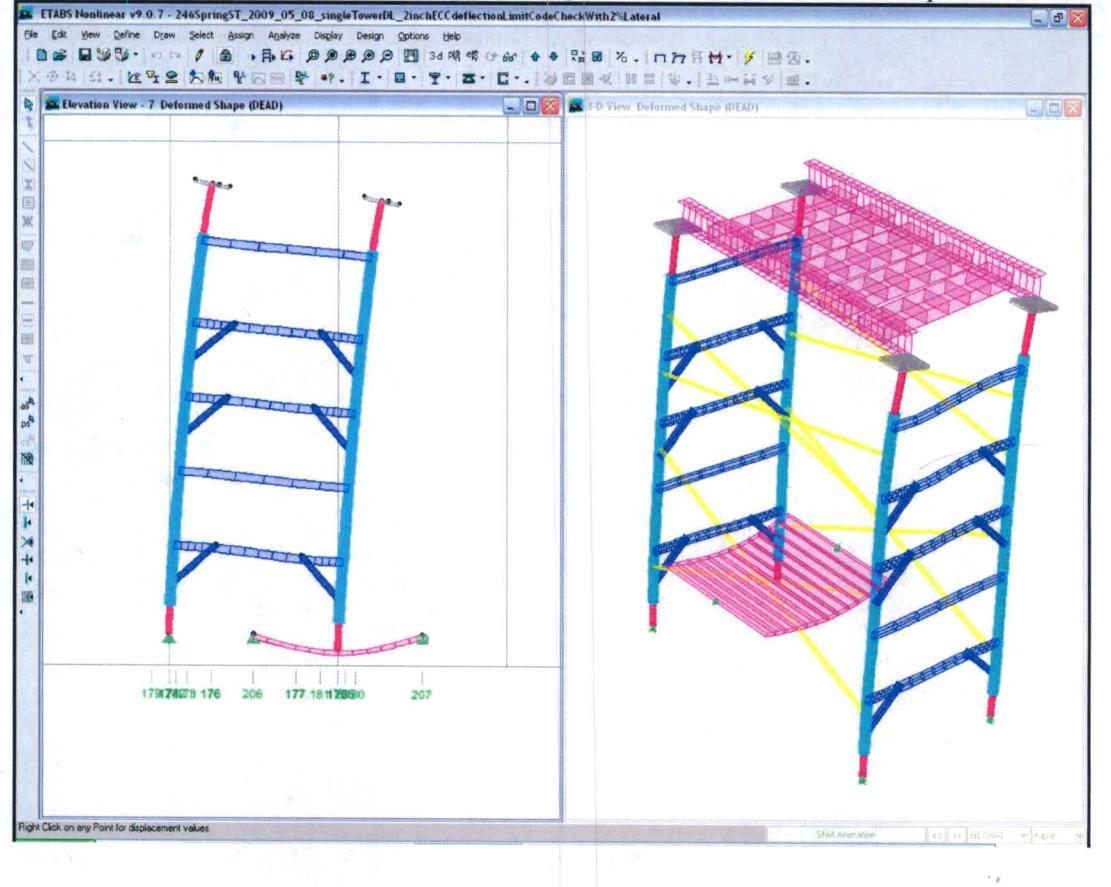
Below is the general deflected shape of single tower with likelihood of punch:

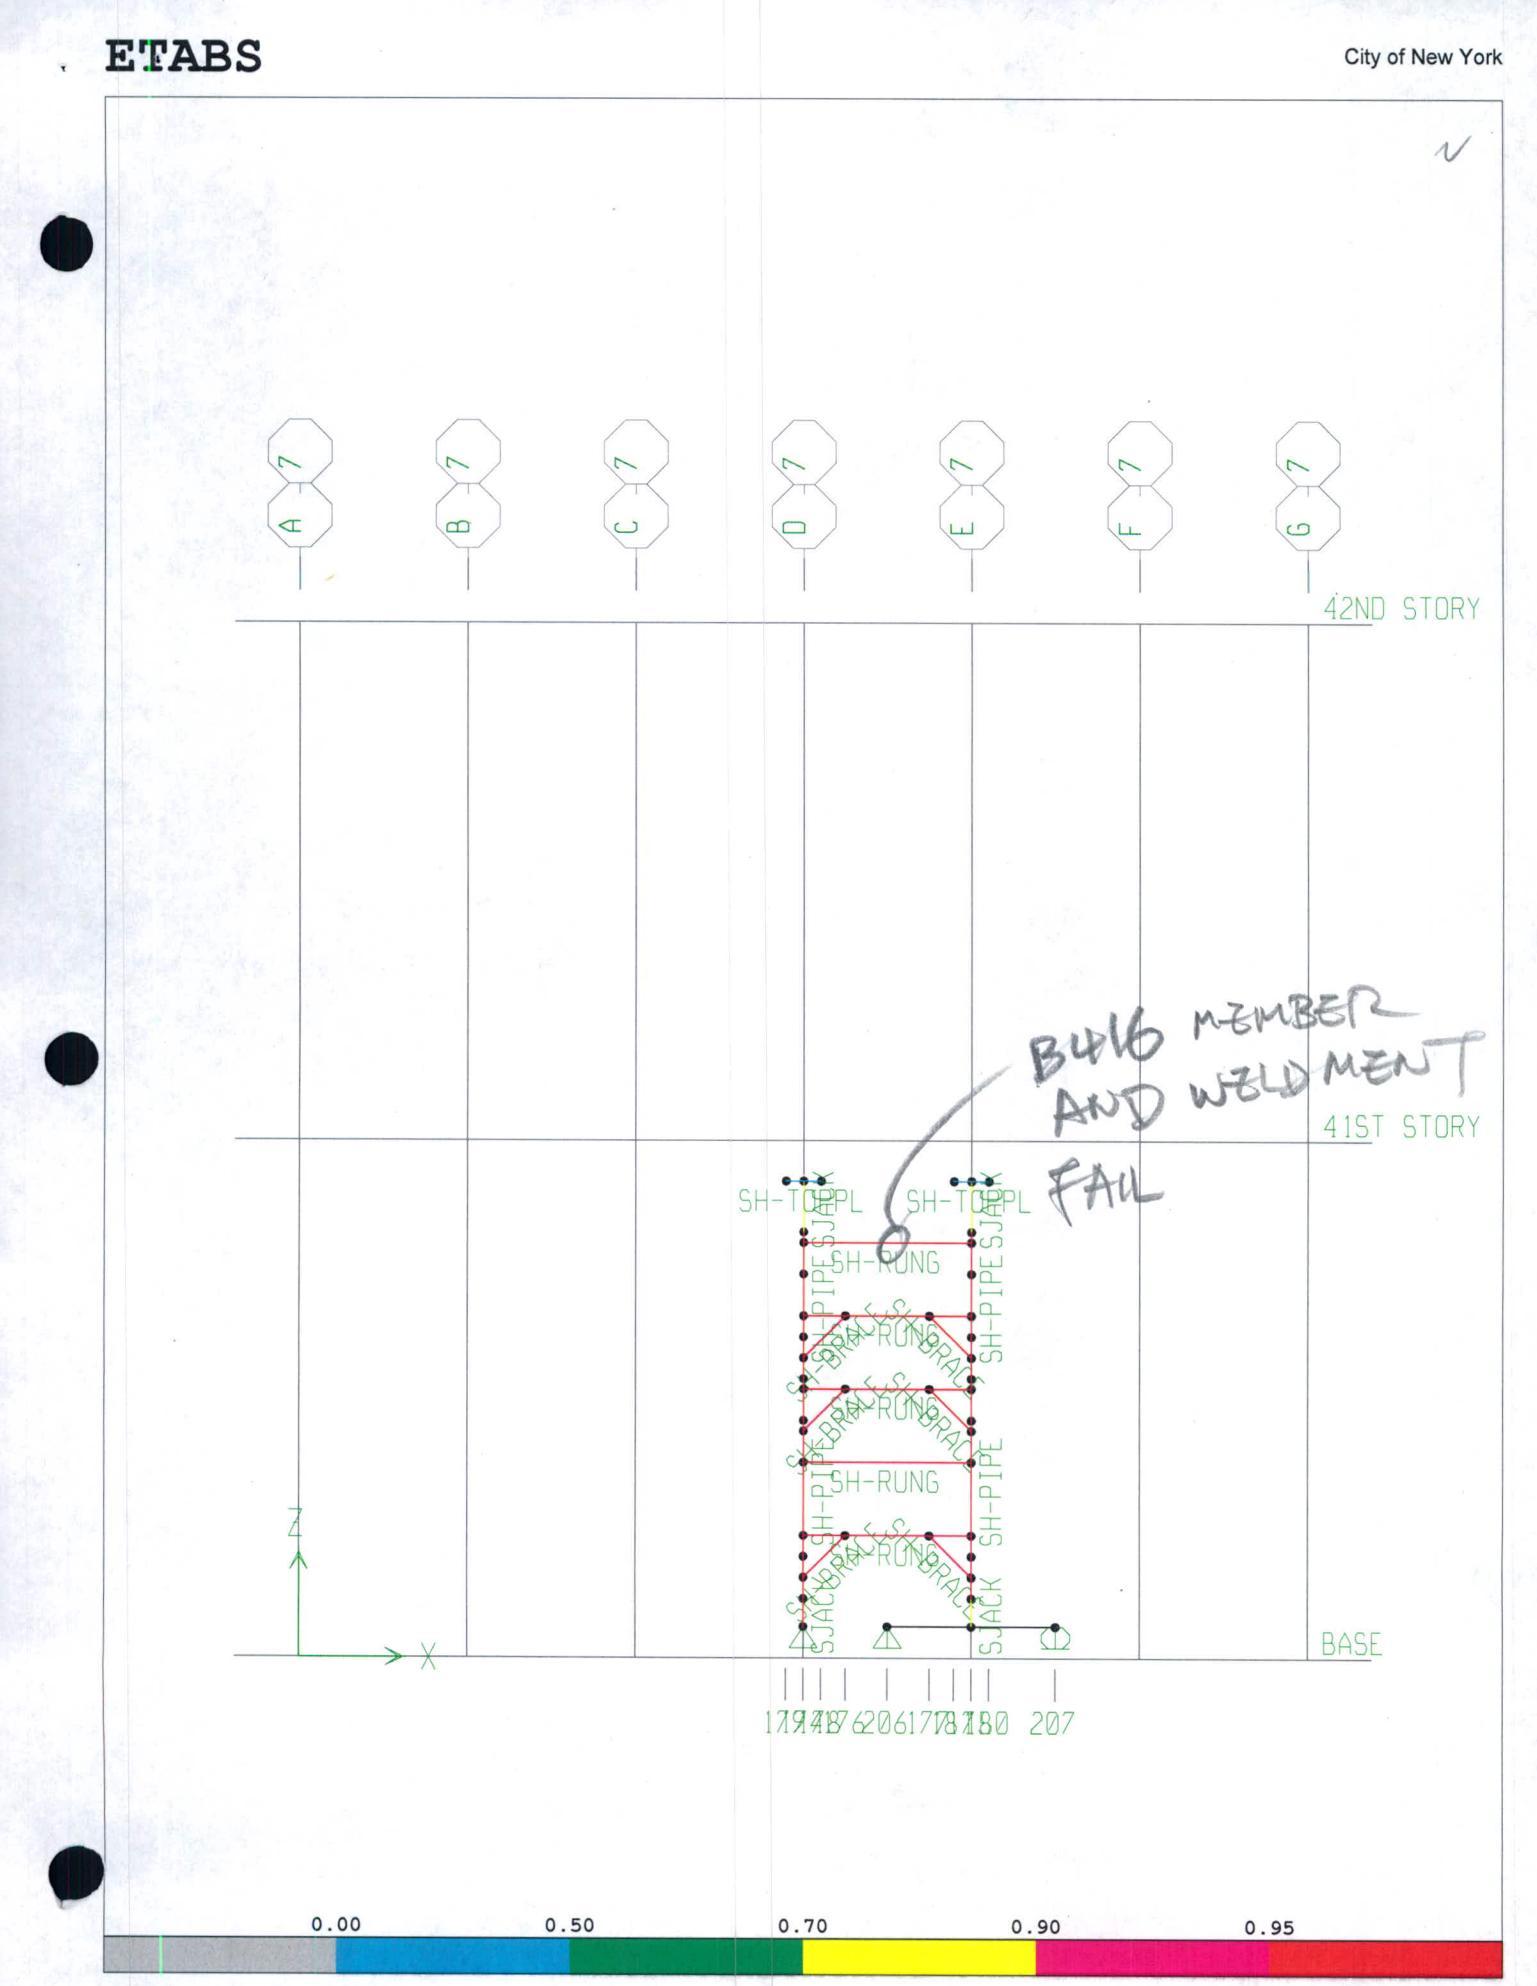
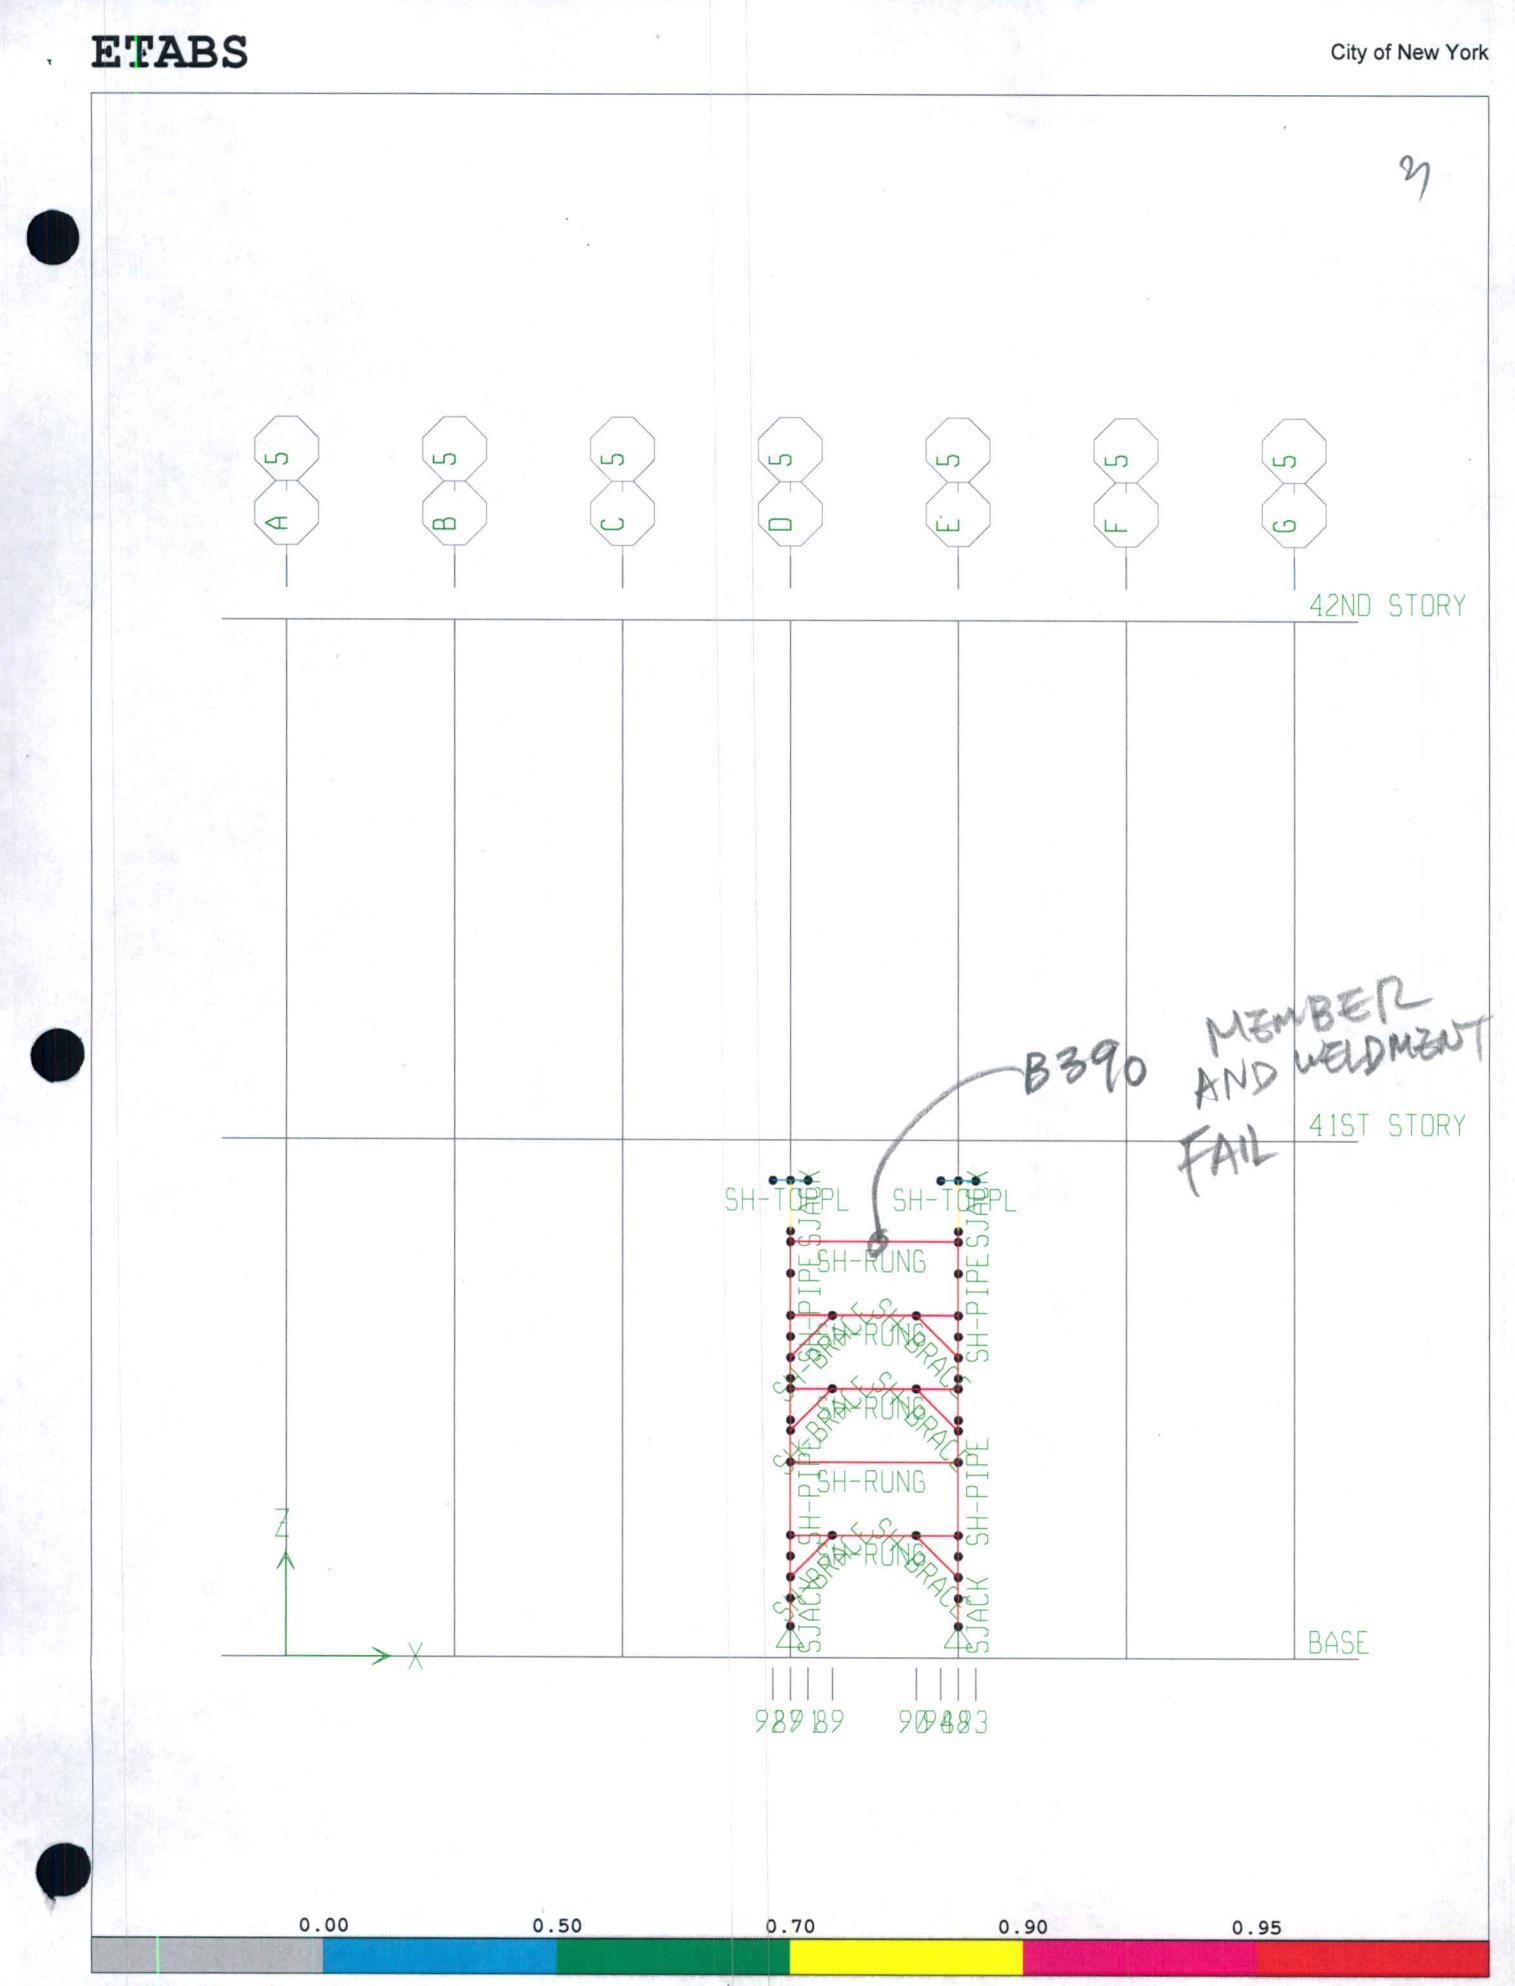
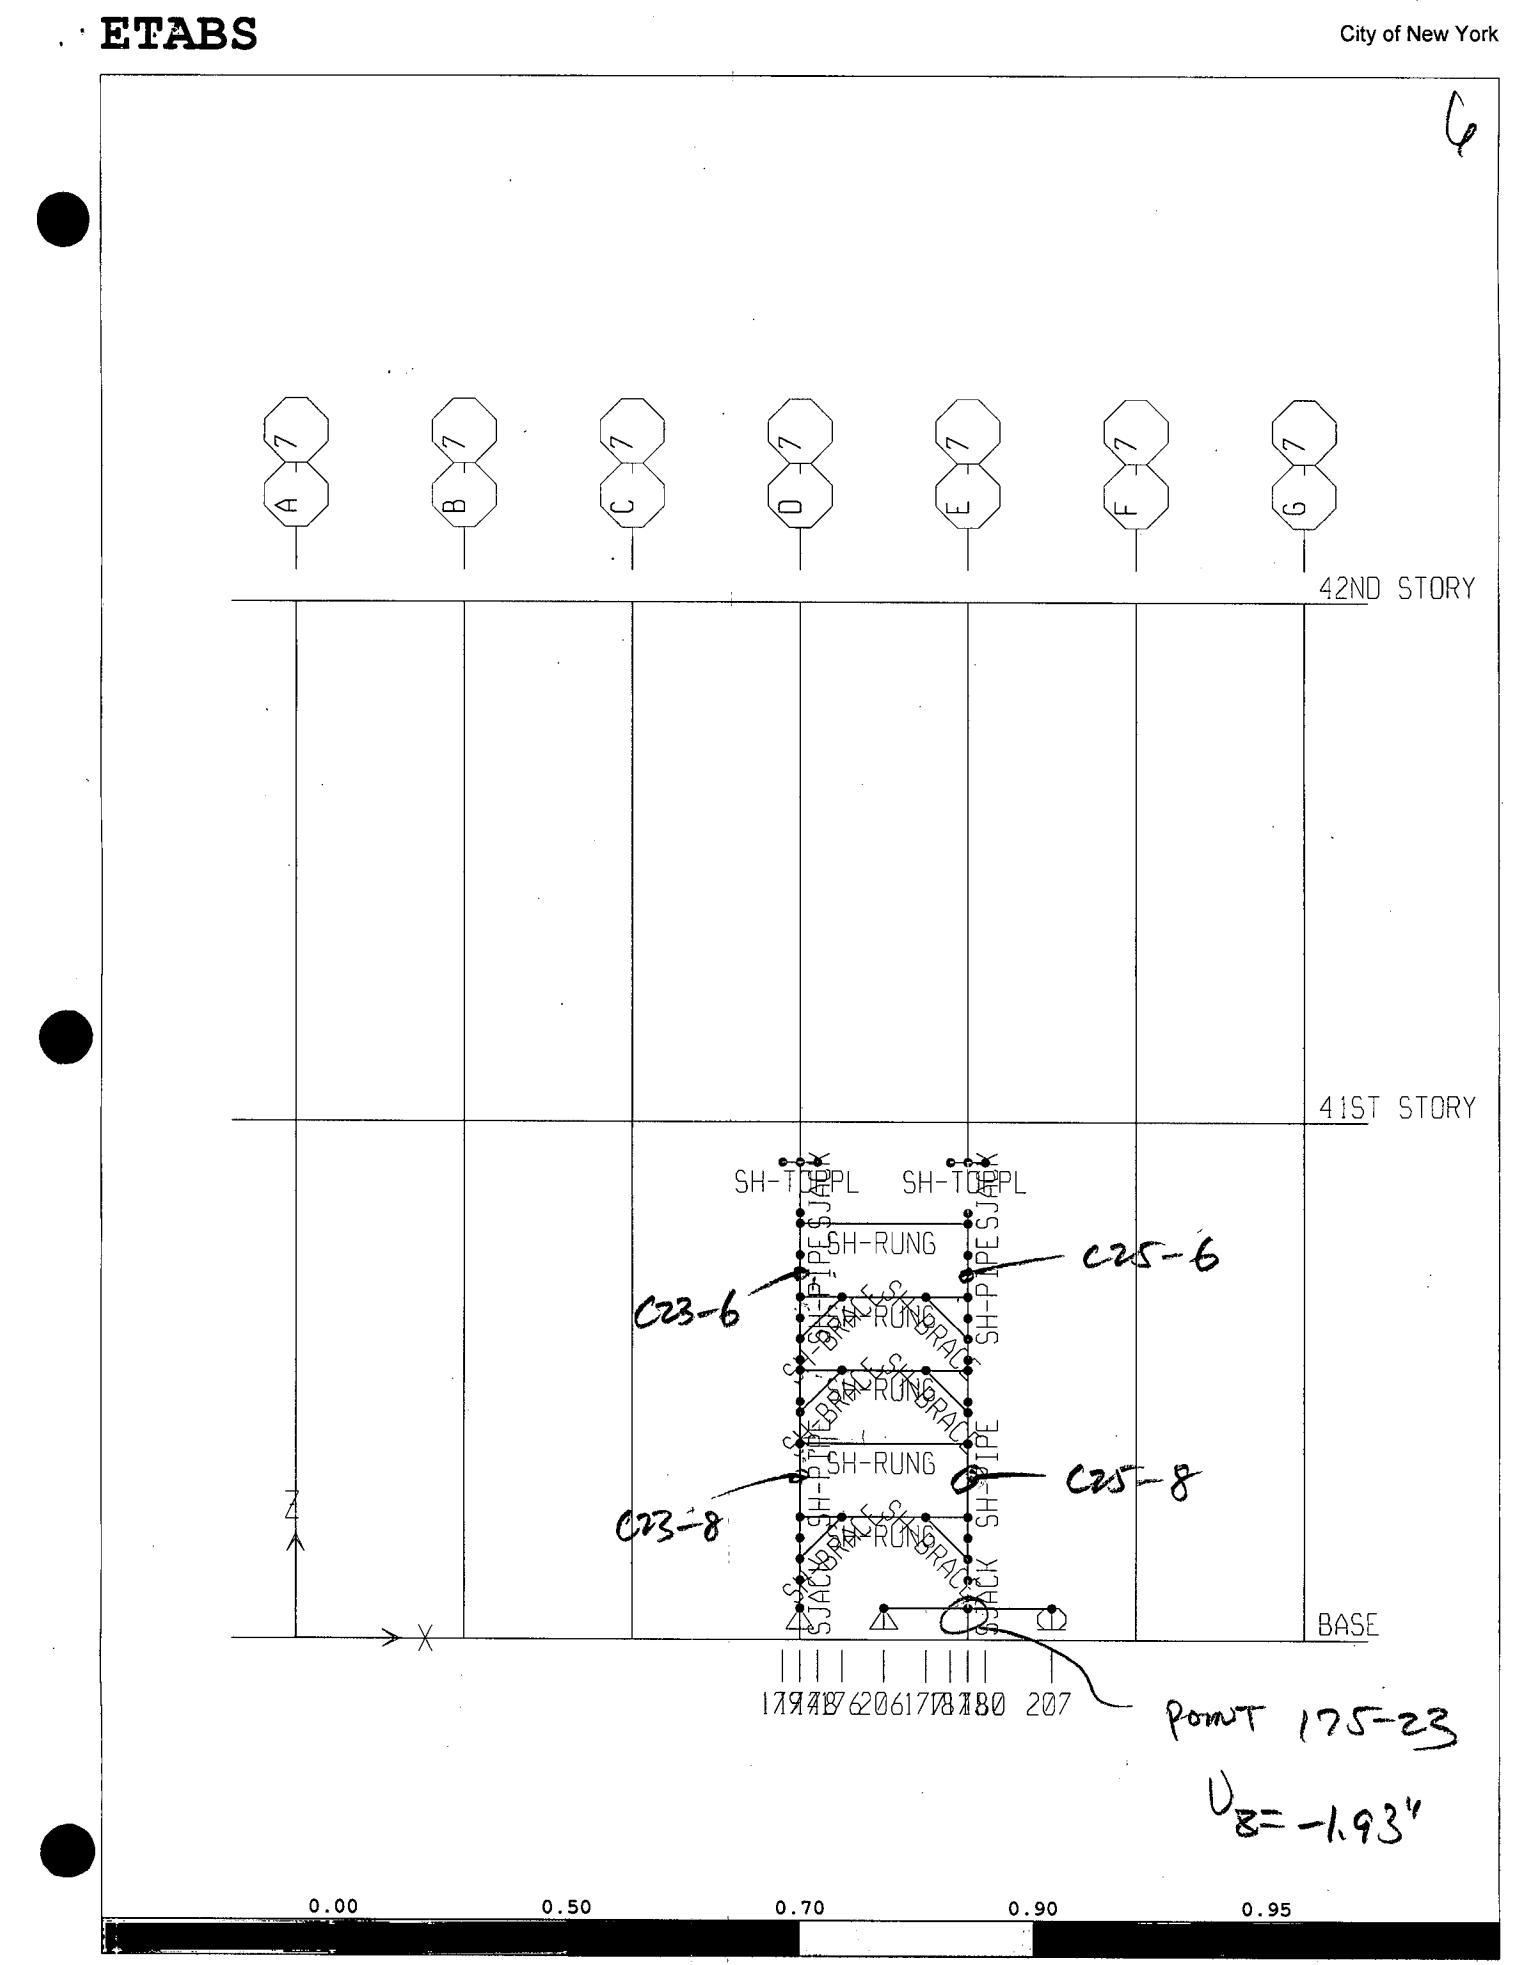
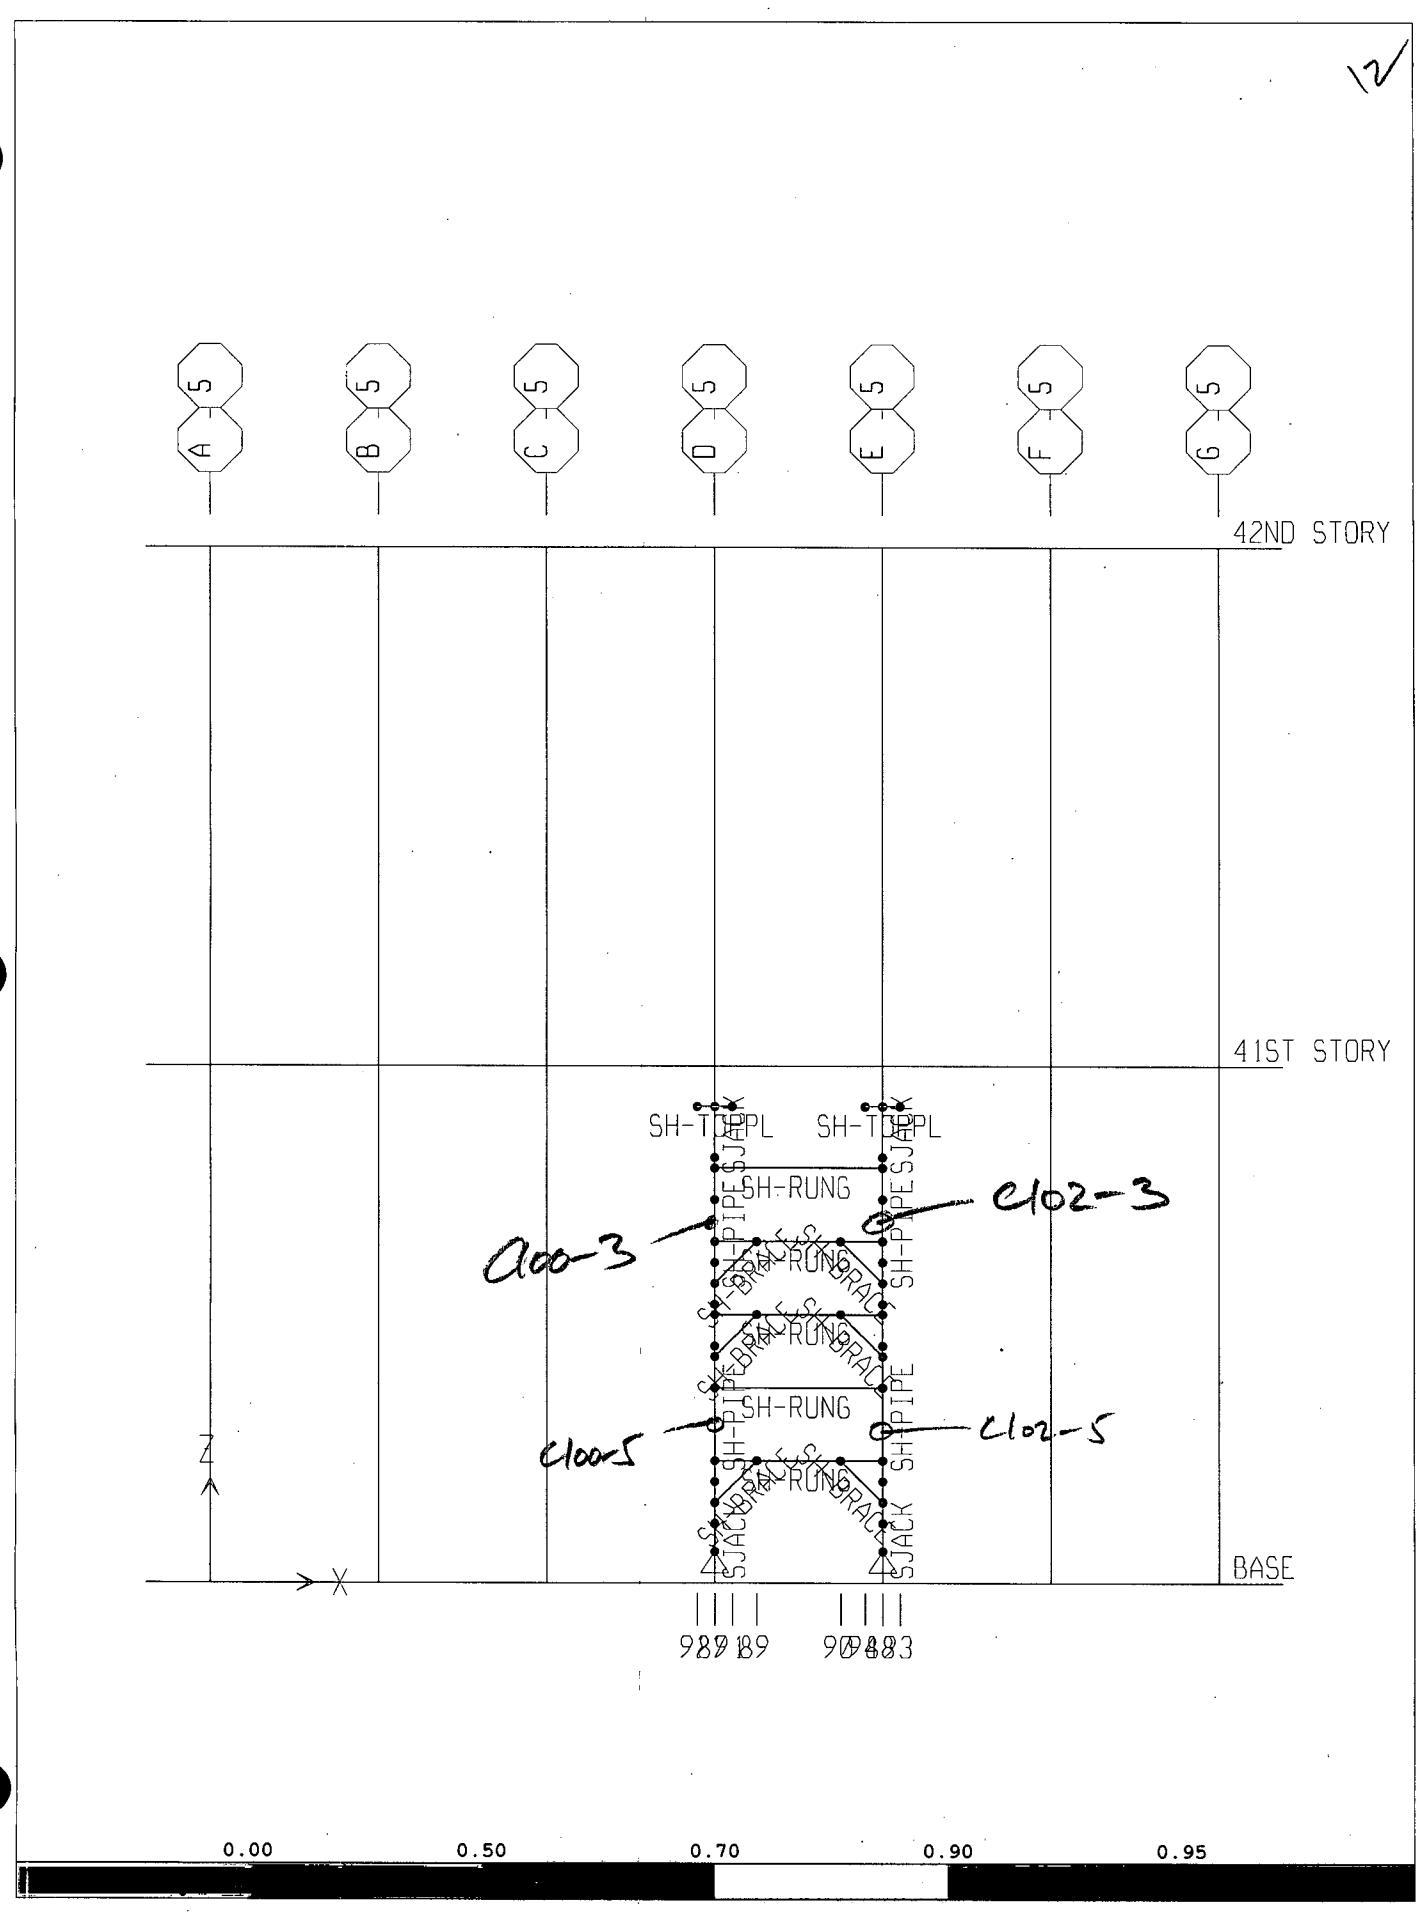
Result: shore failure

- Screw jacks do not fail.
- Shoring leg across from the flexible support leg may or may not fail in combination of axial compression and bending. Other 3 legs do not fail in buckle or bending.

- Horizontal members fail in bending, and connections from horizontal members to shoring leg fail in weldment.
- Knee brace does not fail.
- The downward deflection at the flexible support is 1.93".

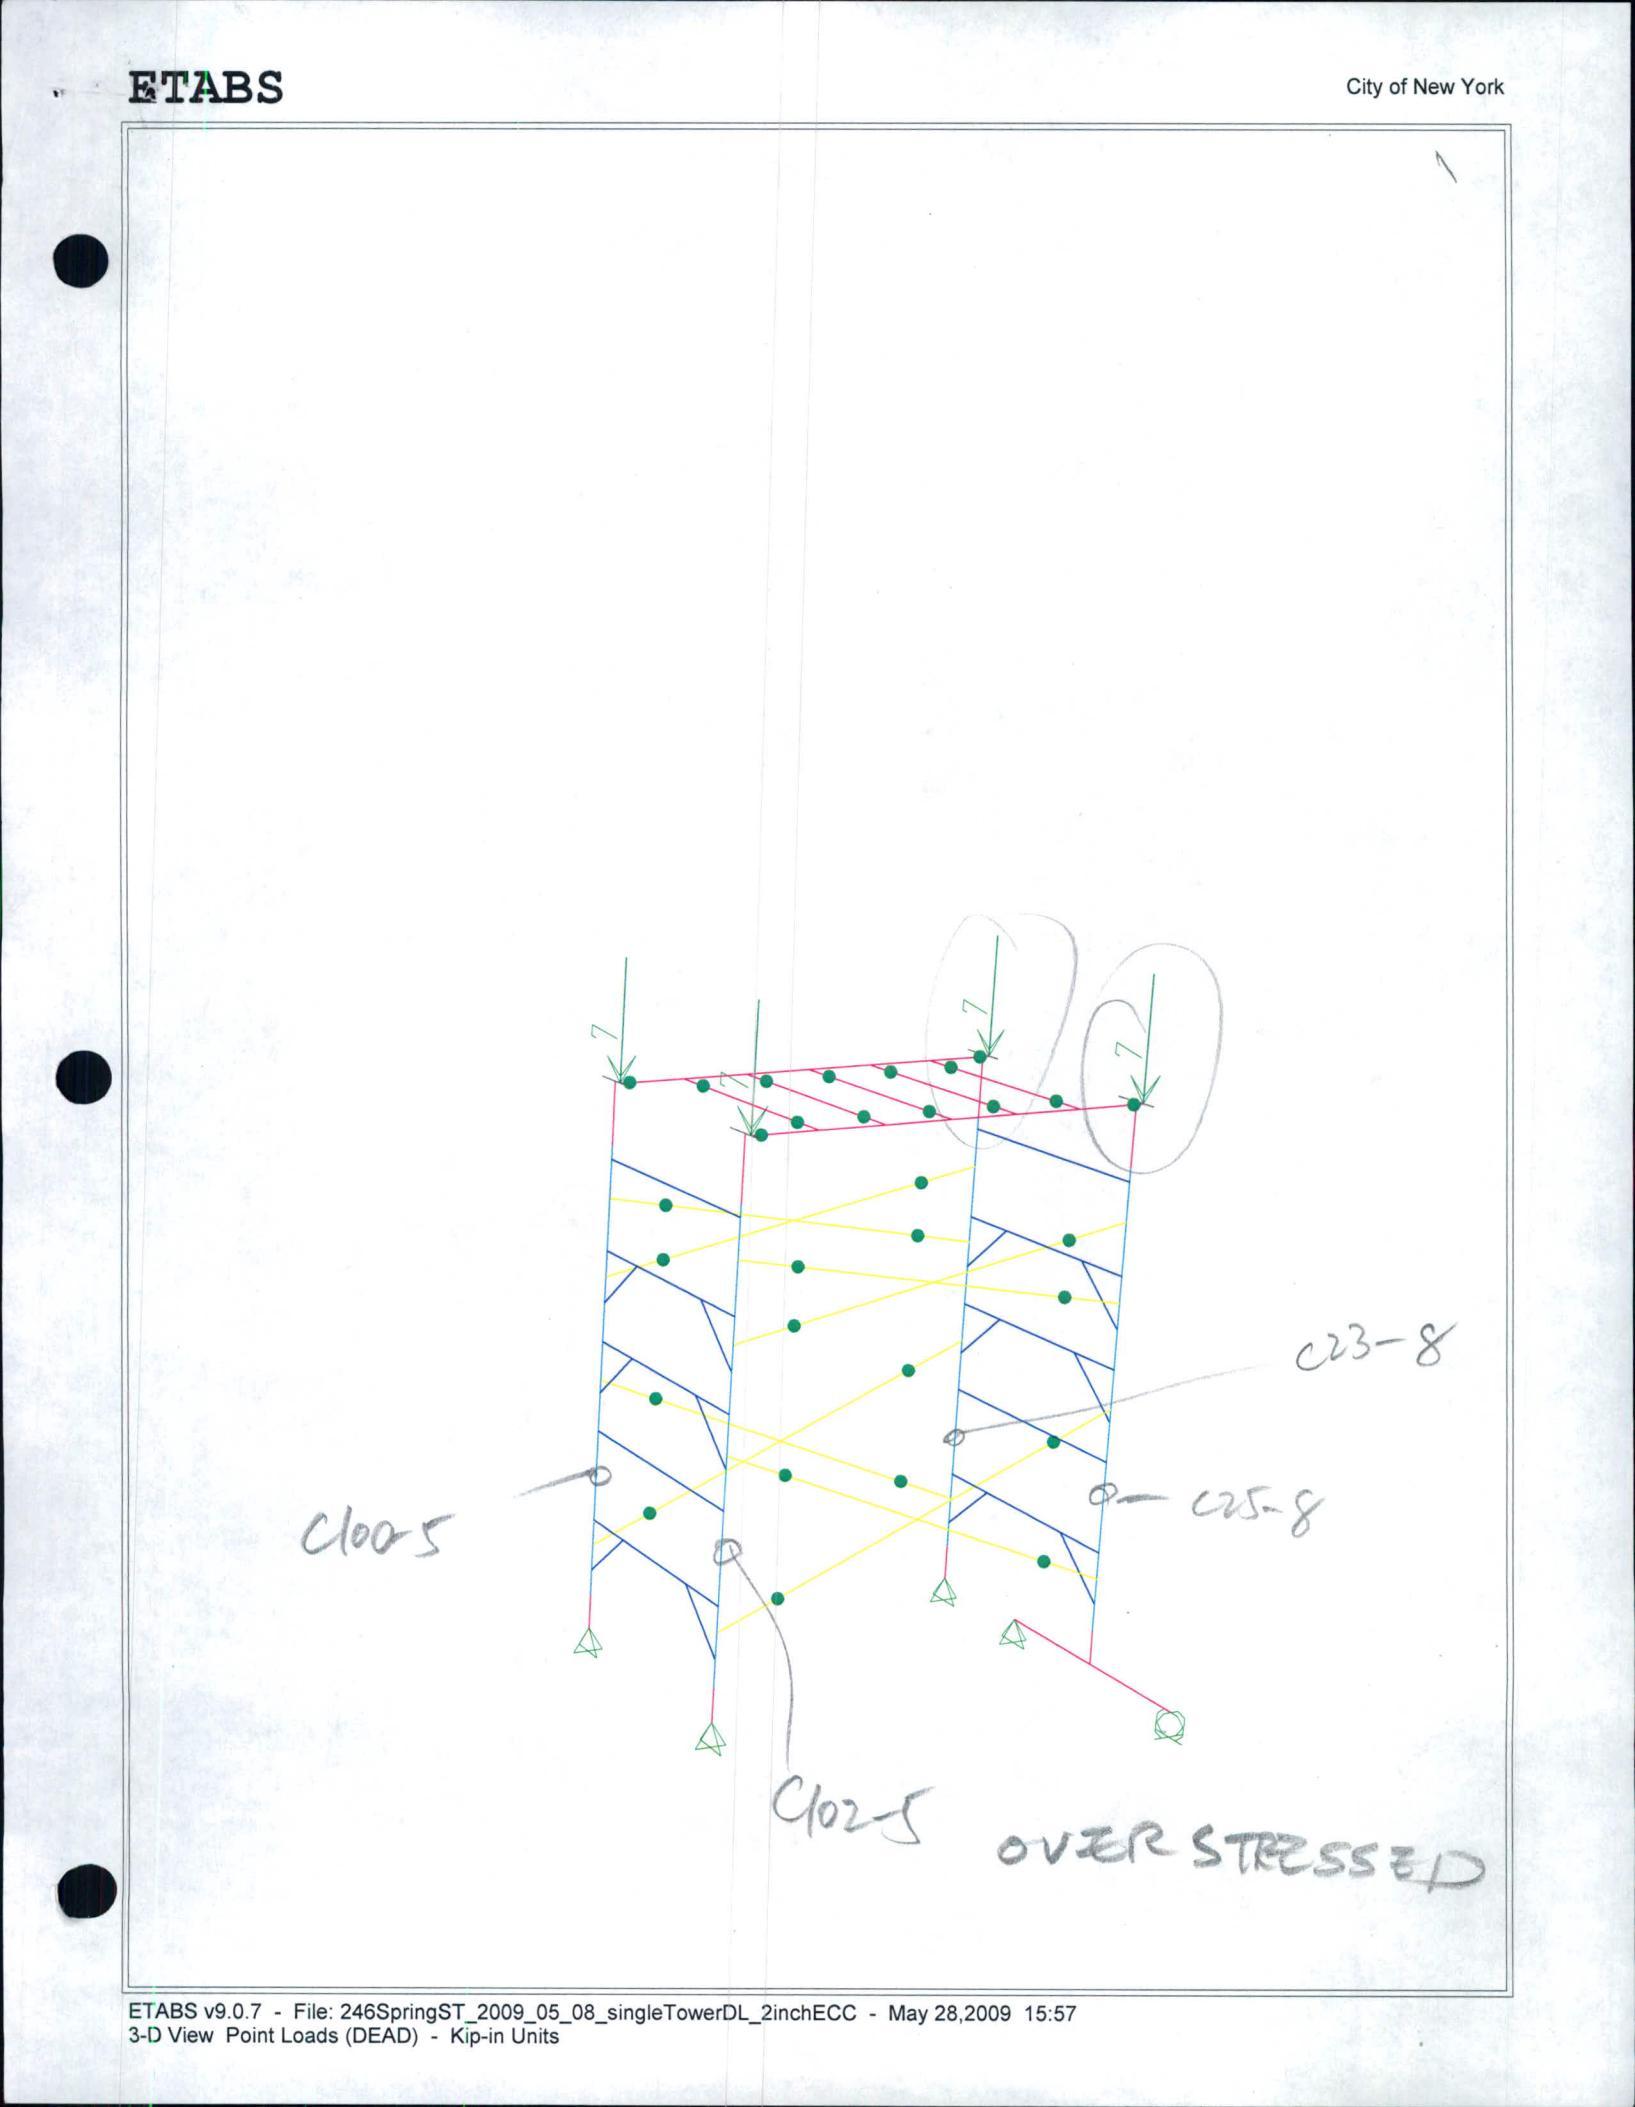
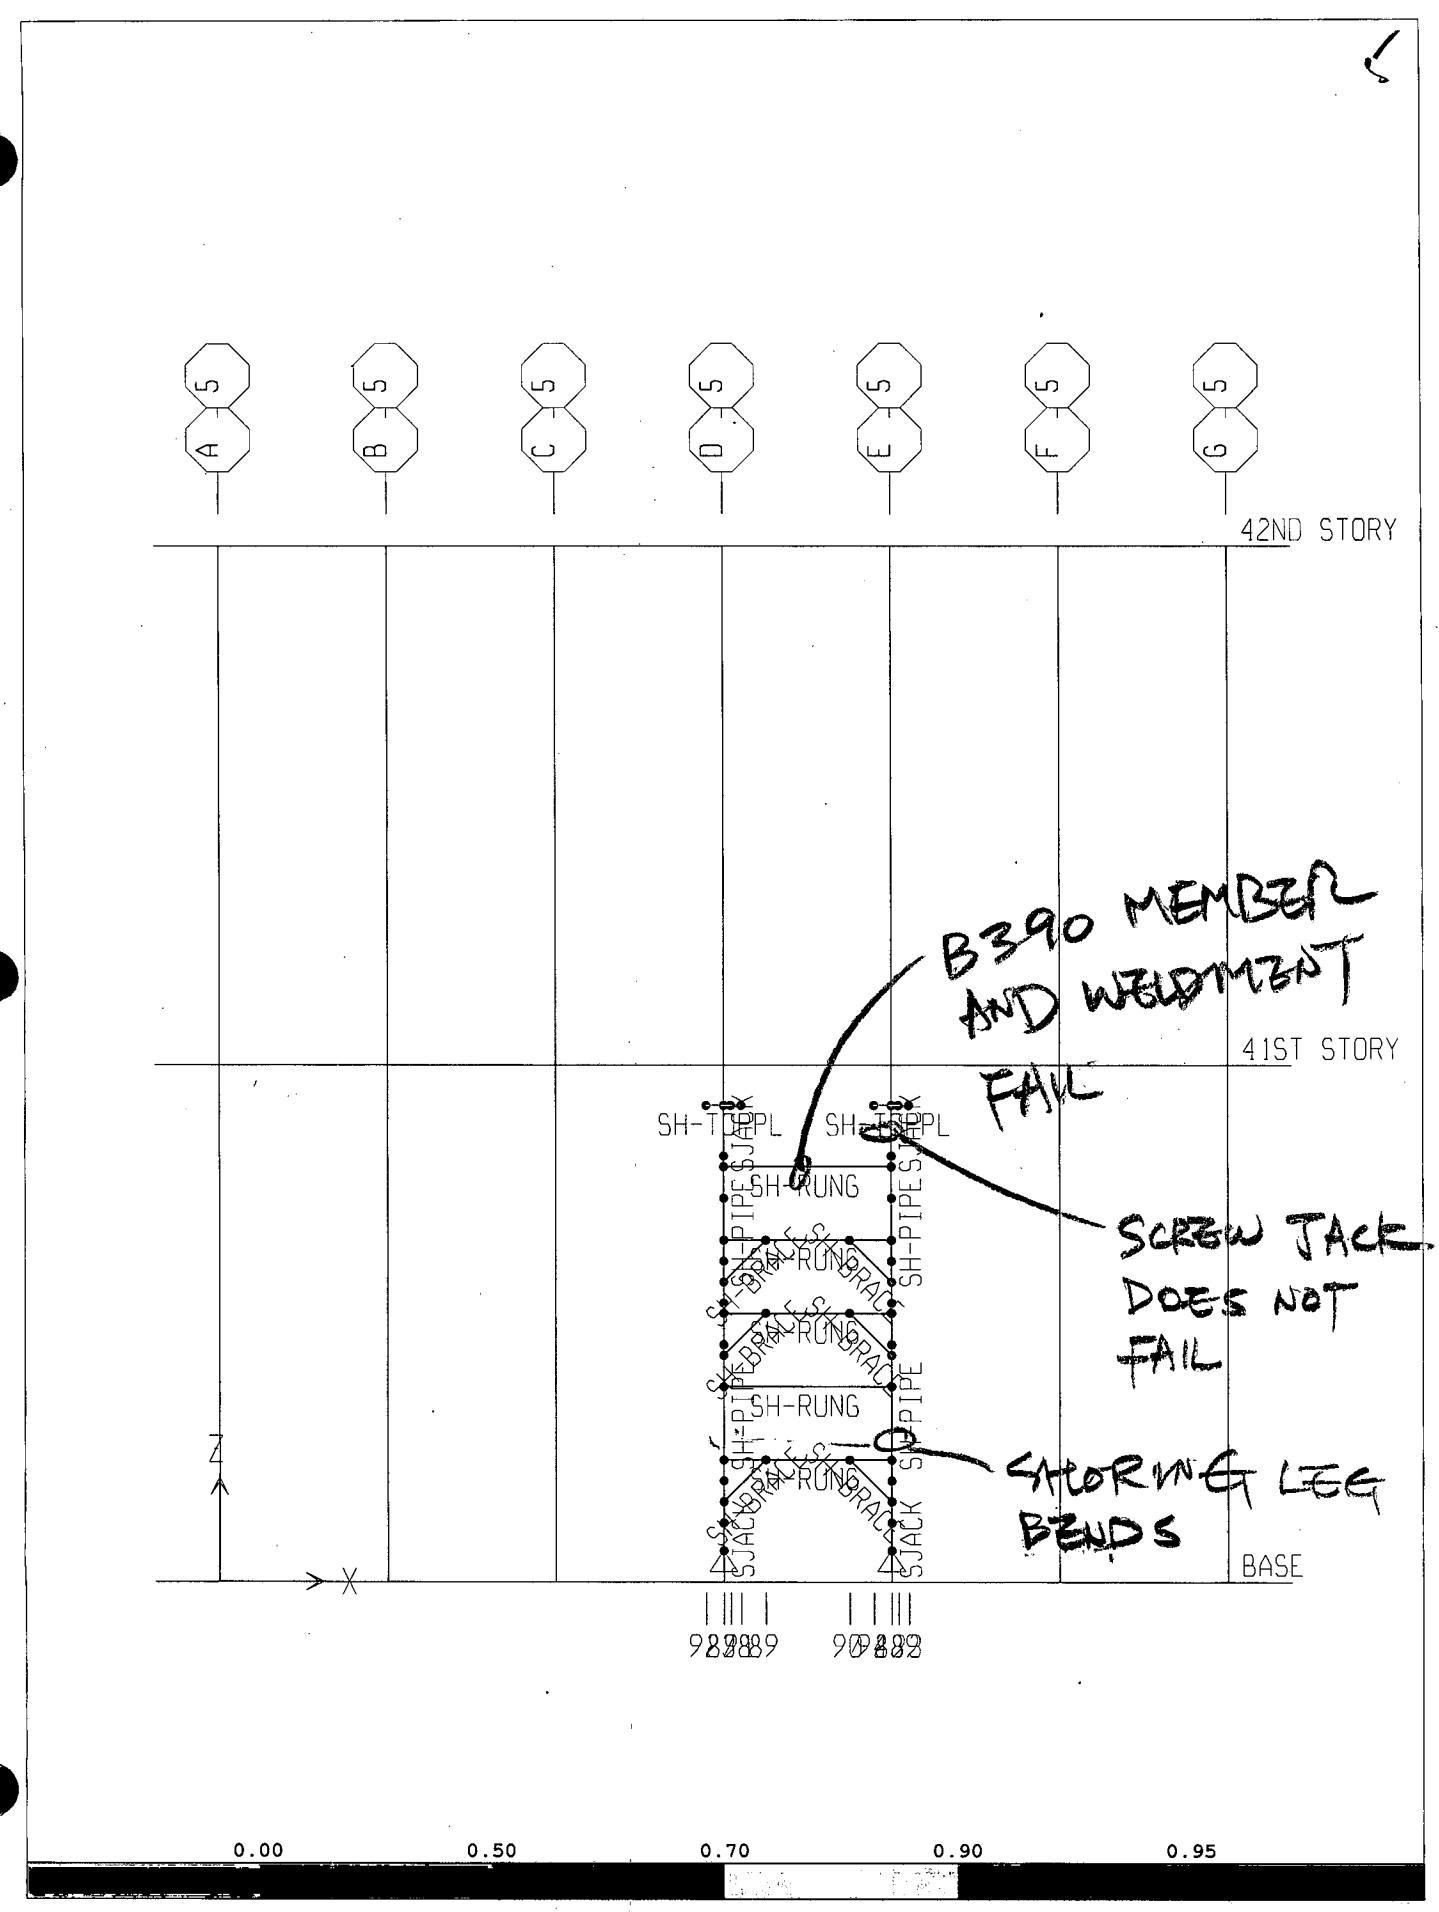
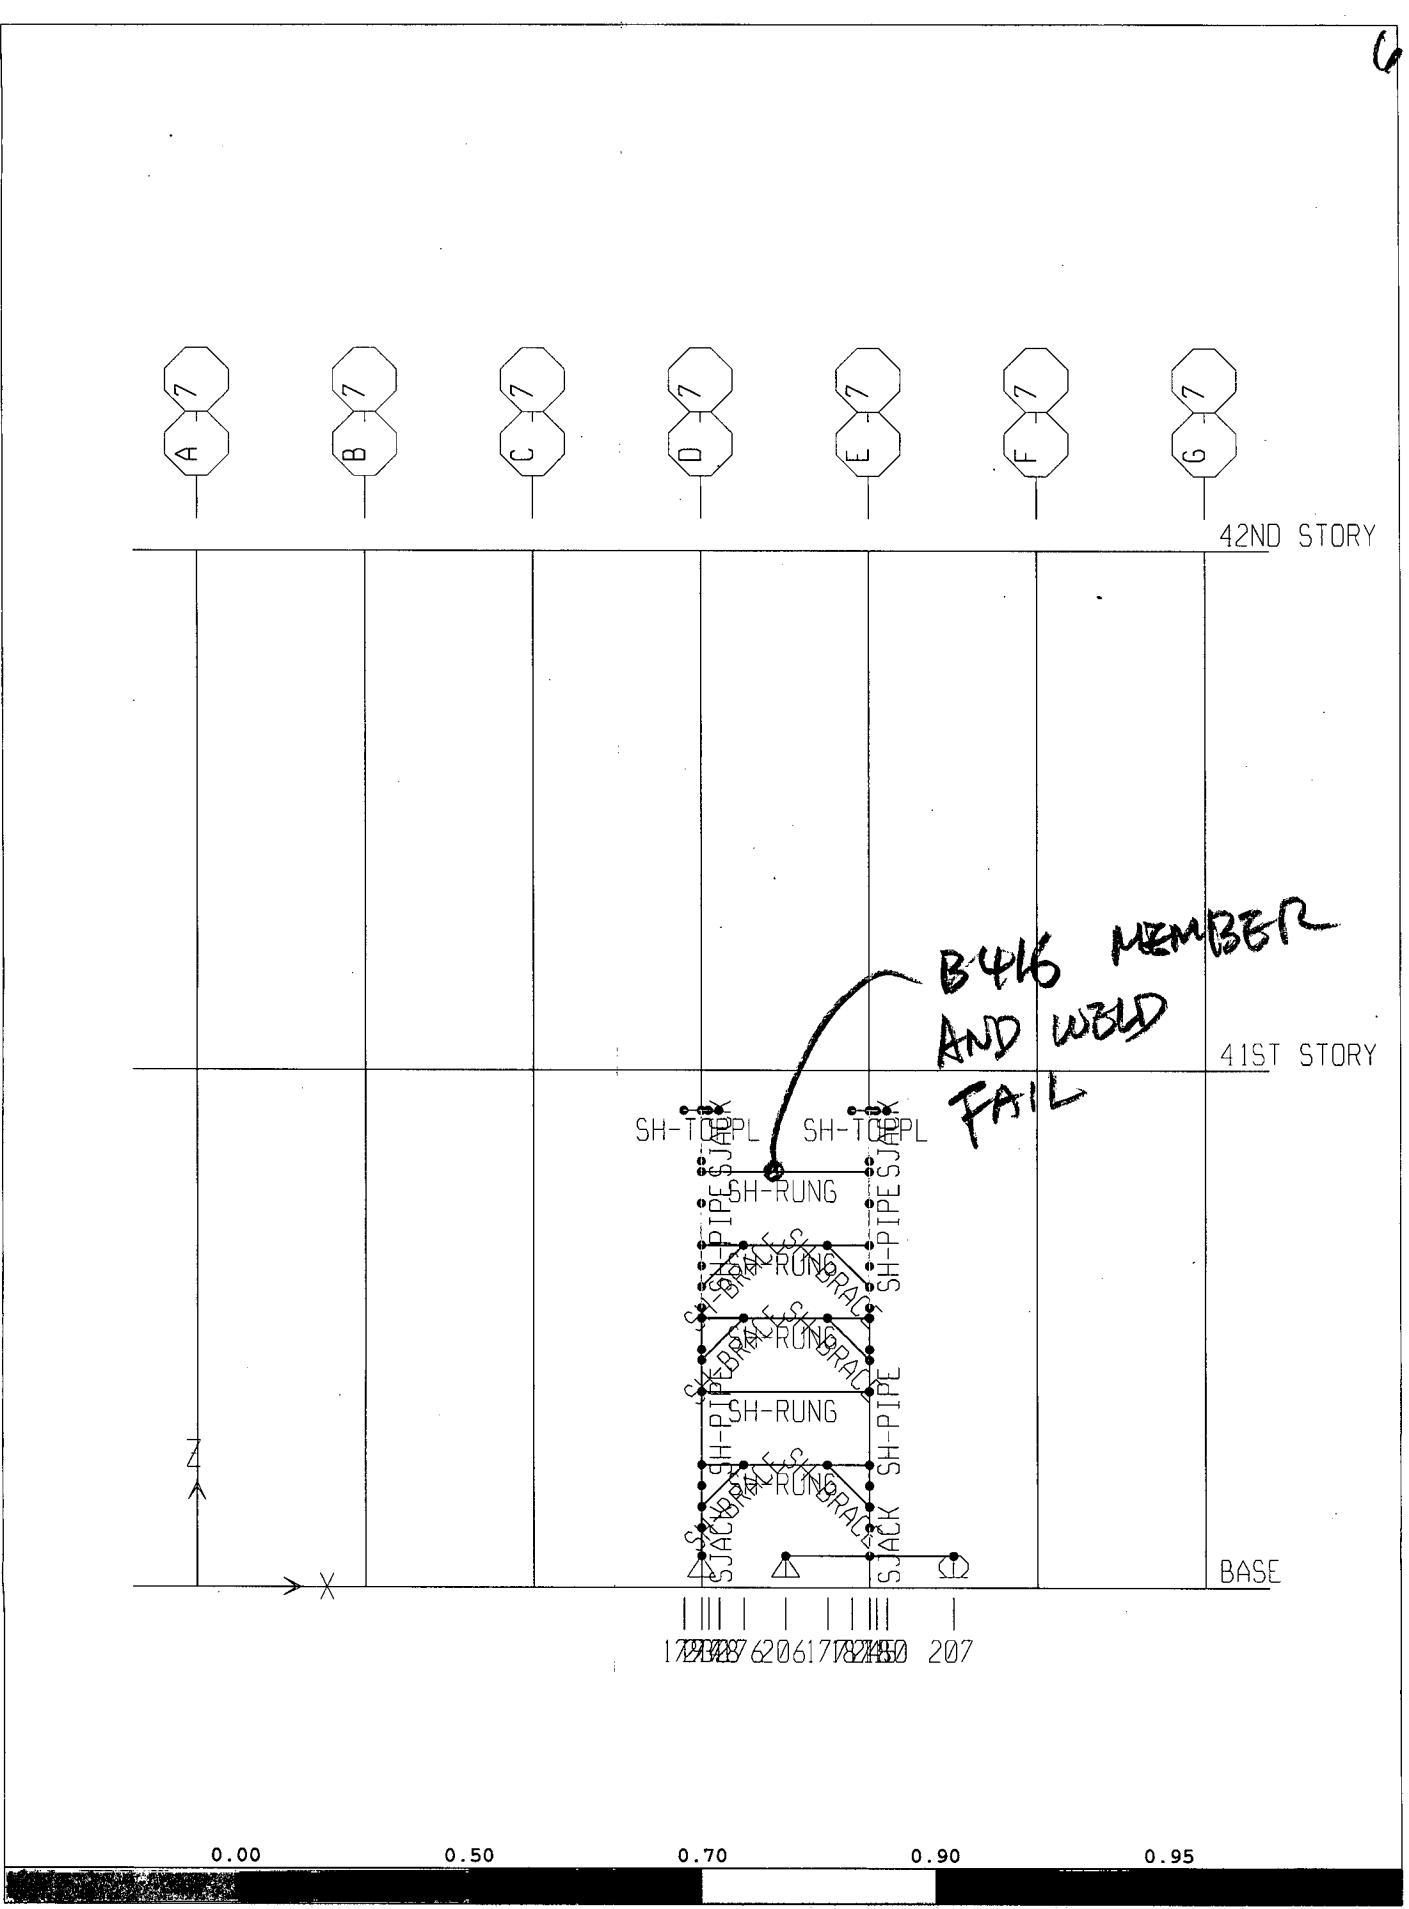
Result: shore failure

- Screw jacks do not fail.
- Shoring leg across from the flexible support leg may or may not fail in combination of axial compression and bending. Other 3 legs do not fail.
- Horizontal members fail in bending, and connections from horizontal members to shoring leg fail in weldment.
- Knee brace does not fail.
- The downward deflection at the flexible support is 2.092".
