INVESTIGATION REPORT:

JANUARY 14, 2008 SHORING COLLAPSE AT 9 DOMINICK ST. (AKA 246 SPRING ST.) MANHATTAN

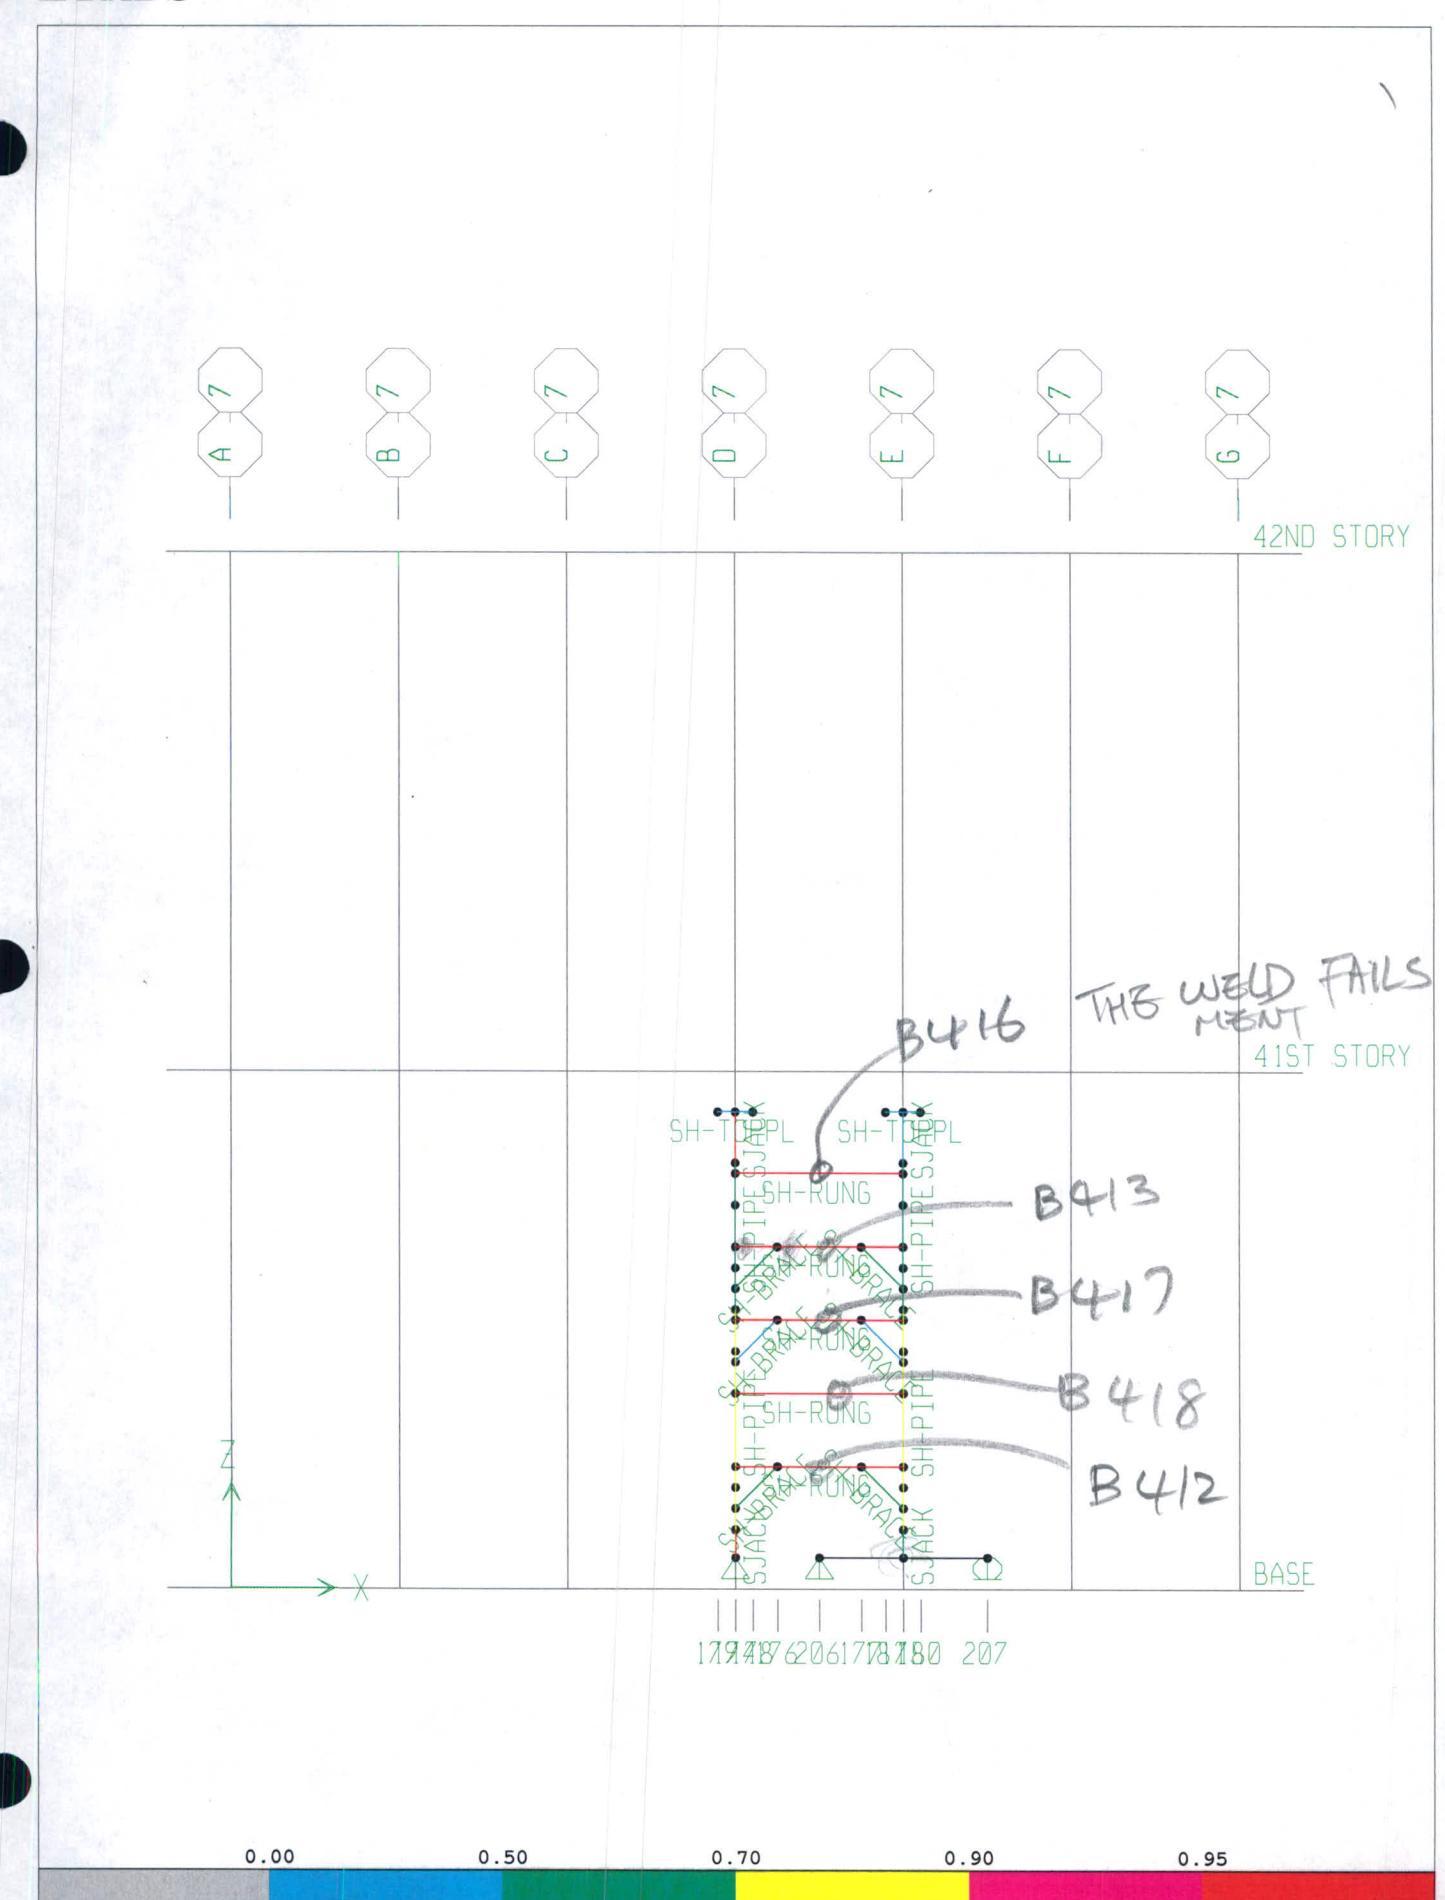
Result: shore failure

- Screw jacks do not fail.
- All 4 Shoring legs do not fail in buckle or bending.
- The connections from the top horizontal members to the leg fail in weldment. The bottom horizontal members fail in bending, and the connections from the bottom horizontal members to the leg fail in weldment. The other horizontal members and connections are still ok.
- Knee brace does not fail in compression, tension or bending.

ETABS v9.0.7 - File: 246SpringST_2009_05_08_singleTowerDL_NoECCdeflectionLimit - May 29,2009 19:24 Elevation View - 7 Steel Design Sections (AISC-ASD89) - Kip-in Units

MEMBER FAILURE STRENGTH Muttmate = 10.4 kin > M33 = 4.7 kin (ok)

WELD FAILURE STRENGEN Multimate = 3.6 K-in < M33 = 4.7 k-in (FAIL)

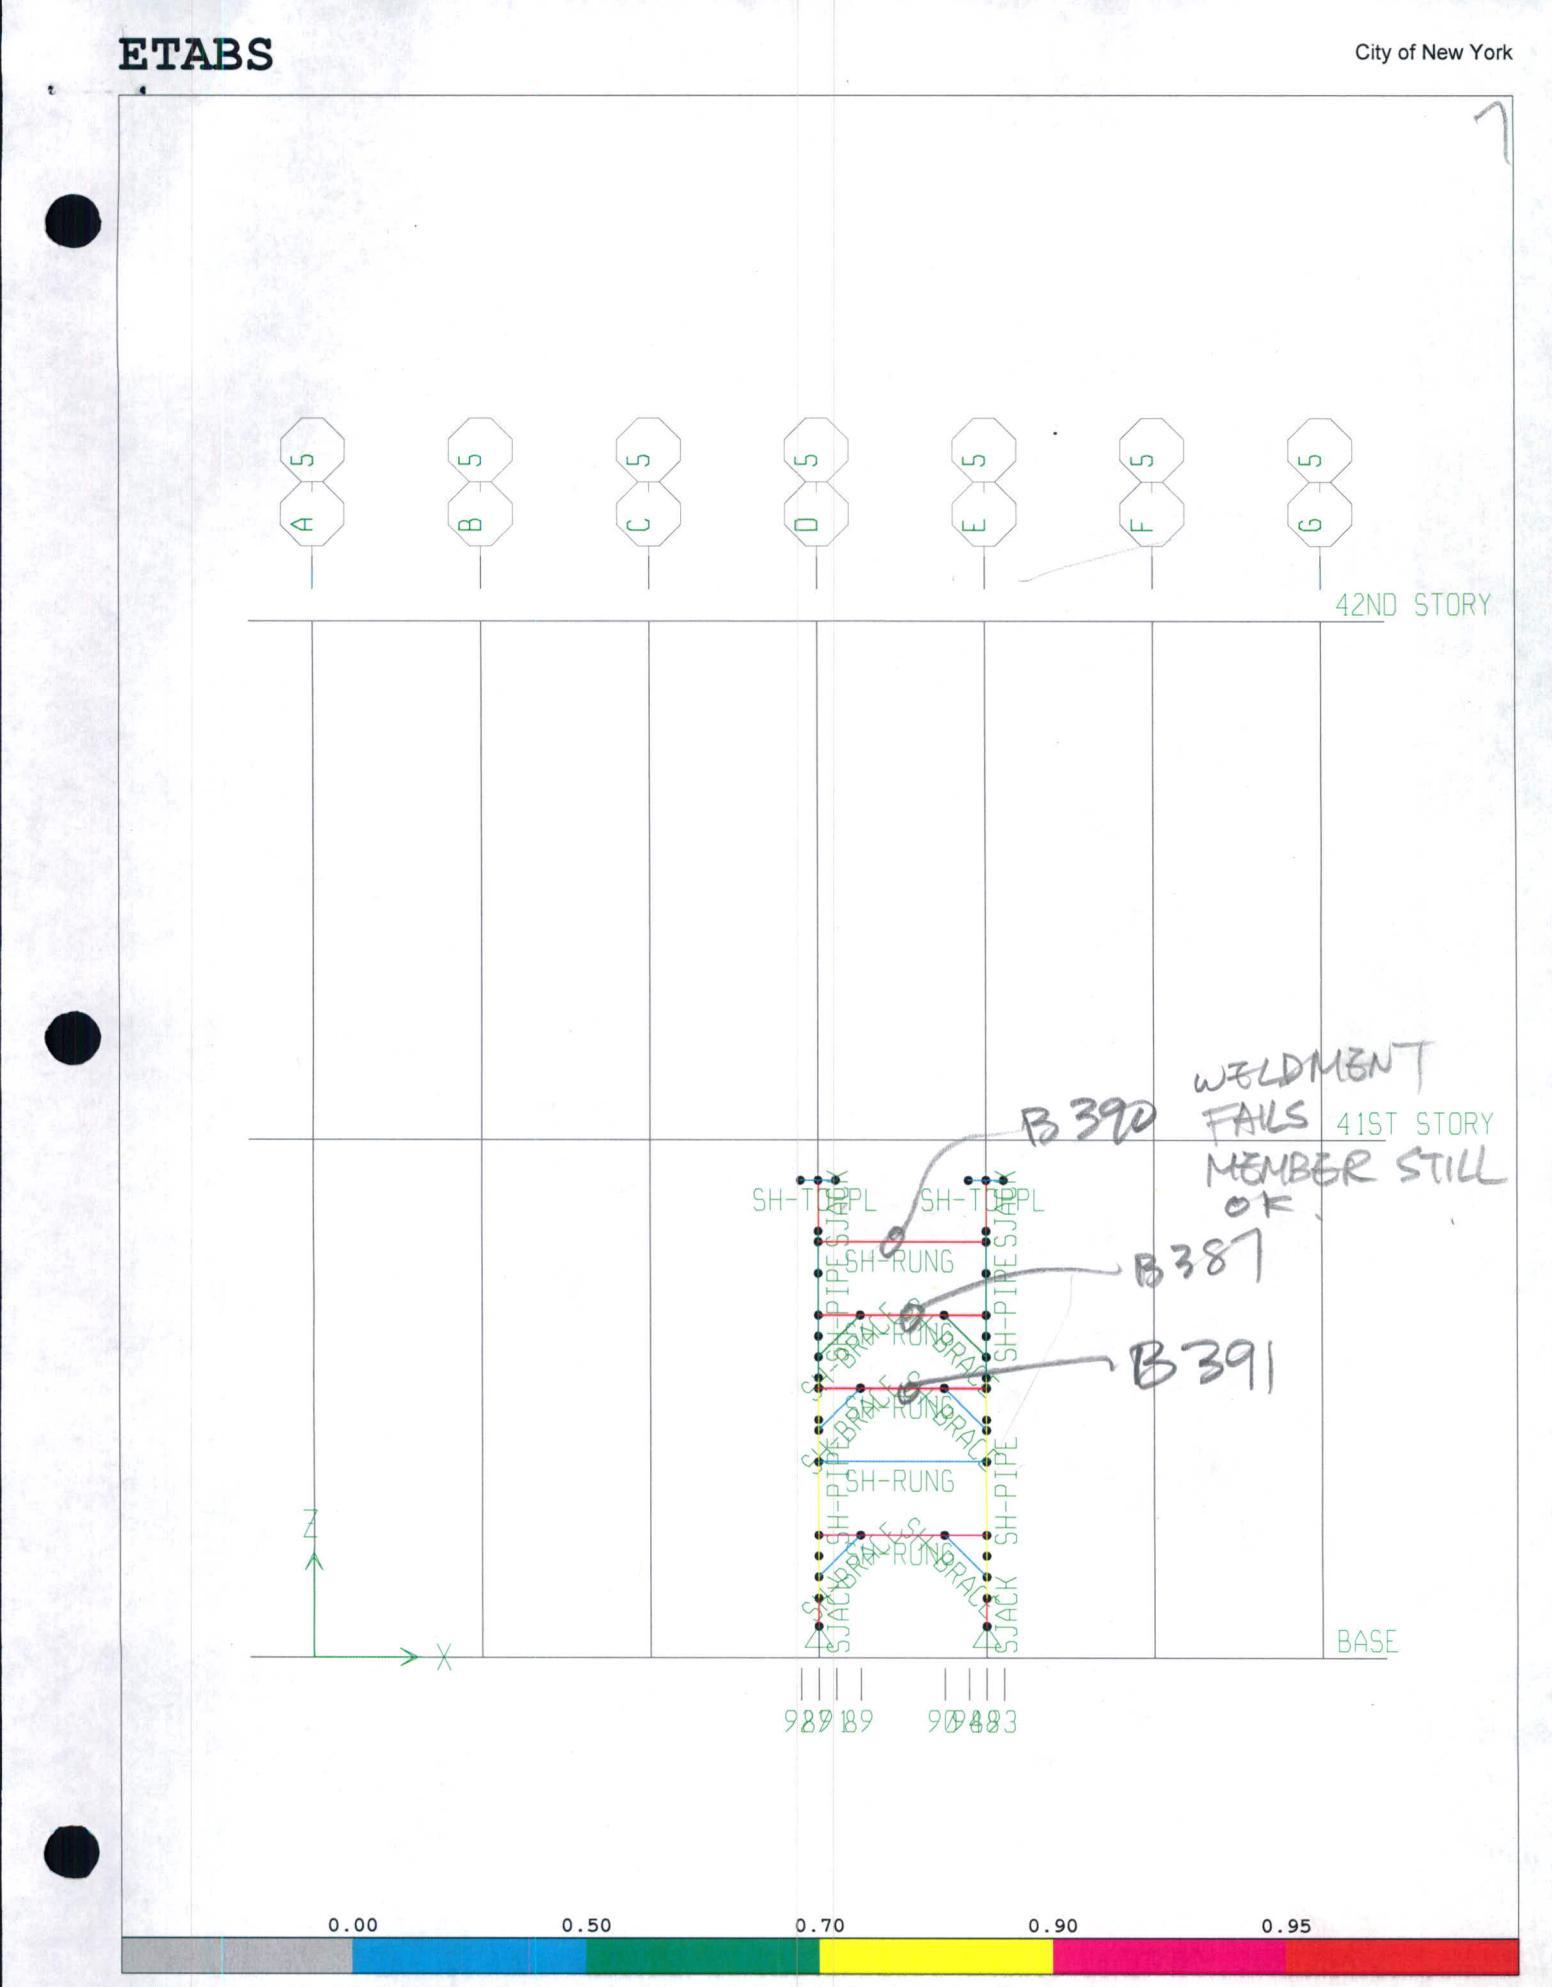
ETABS v9.0.7 - File: 246SpringST_2009_05_08_singleTowerDL_NoECCdeflectionLimit - May 29,2009 19:24 Elevation View - 5 Steel Design Sections (AISC-ASD89) - Kip-in Units

AISC-ASD89 STEEL SECTION CHECK Units: Kip-in (Summary for Combo and Station) Level: 41ST STORY Element: B390 Station Loc: 48.000 Section ID: SH-RUNG Element Type: Moment Resisting Frame Classification: Compact L=48.000 A=0.503 i22=0.133 i33=0.338 s22=0.213 s33=0.300 r22=0.515 r33=0.820 NGLDMENT FAILS E=10100.000 fy=35.000 RLLF=1.000 1.121 0.002 + 0.745 + 0.374P-M33-M22 Demand/Capacity Ratio is STRESS CHECK FORCES & MOMENTS M33 M22 ٧2 V3 Combo DSTLS2 0.024 -0.070 -4.692 1.676 0.196 (H2-1) AXIAL FORCE & BIAXIAL MOMENT DESIGN fa Fa Ft Stress Allowable Allowable 0.048 Axial 5.987 21.000 fb Fb Fe Cm Κ Cb L Allowable Stress Allowable Factor Factor Factor Factor Major Bending 15.635 21.000 15.165 1.000 1.000 1.000 2.300 Minor Bending 21.000 7.860 5.987 1.000 1.000 1.000 SHEAR DESIGN fv FV Stress Allowable Stress Ratio Major Shear 0.580 14.000 0.041 loc: 48 Minor Shear 0.373 14.000 0.027 WELD FAIL STREWGTH Multimate = 3.6 E-in CM33 = 4.7 E-in (FAIL)

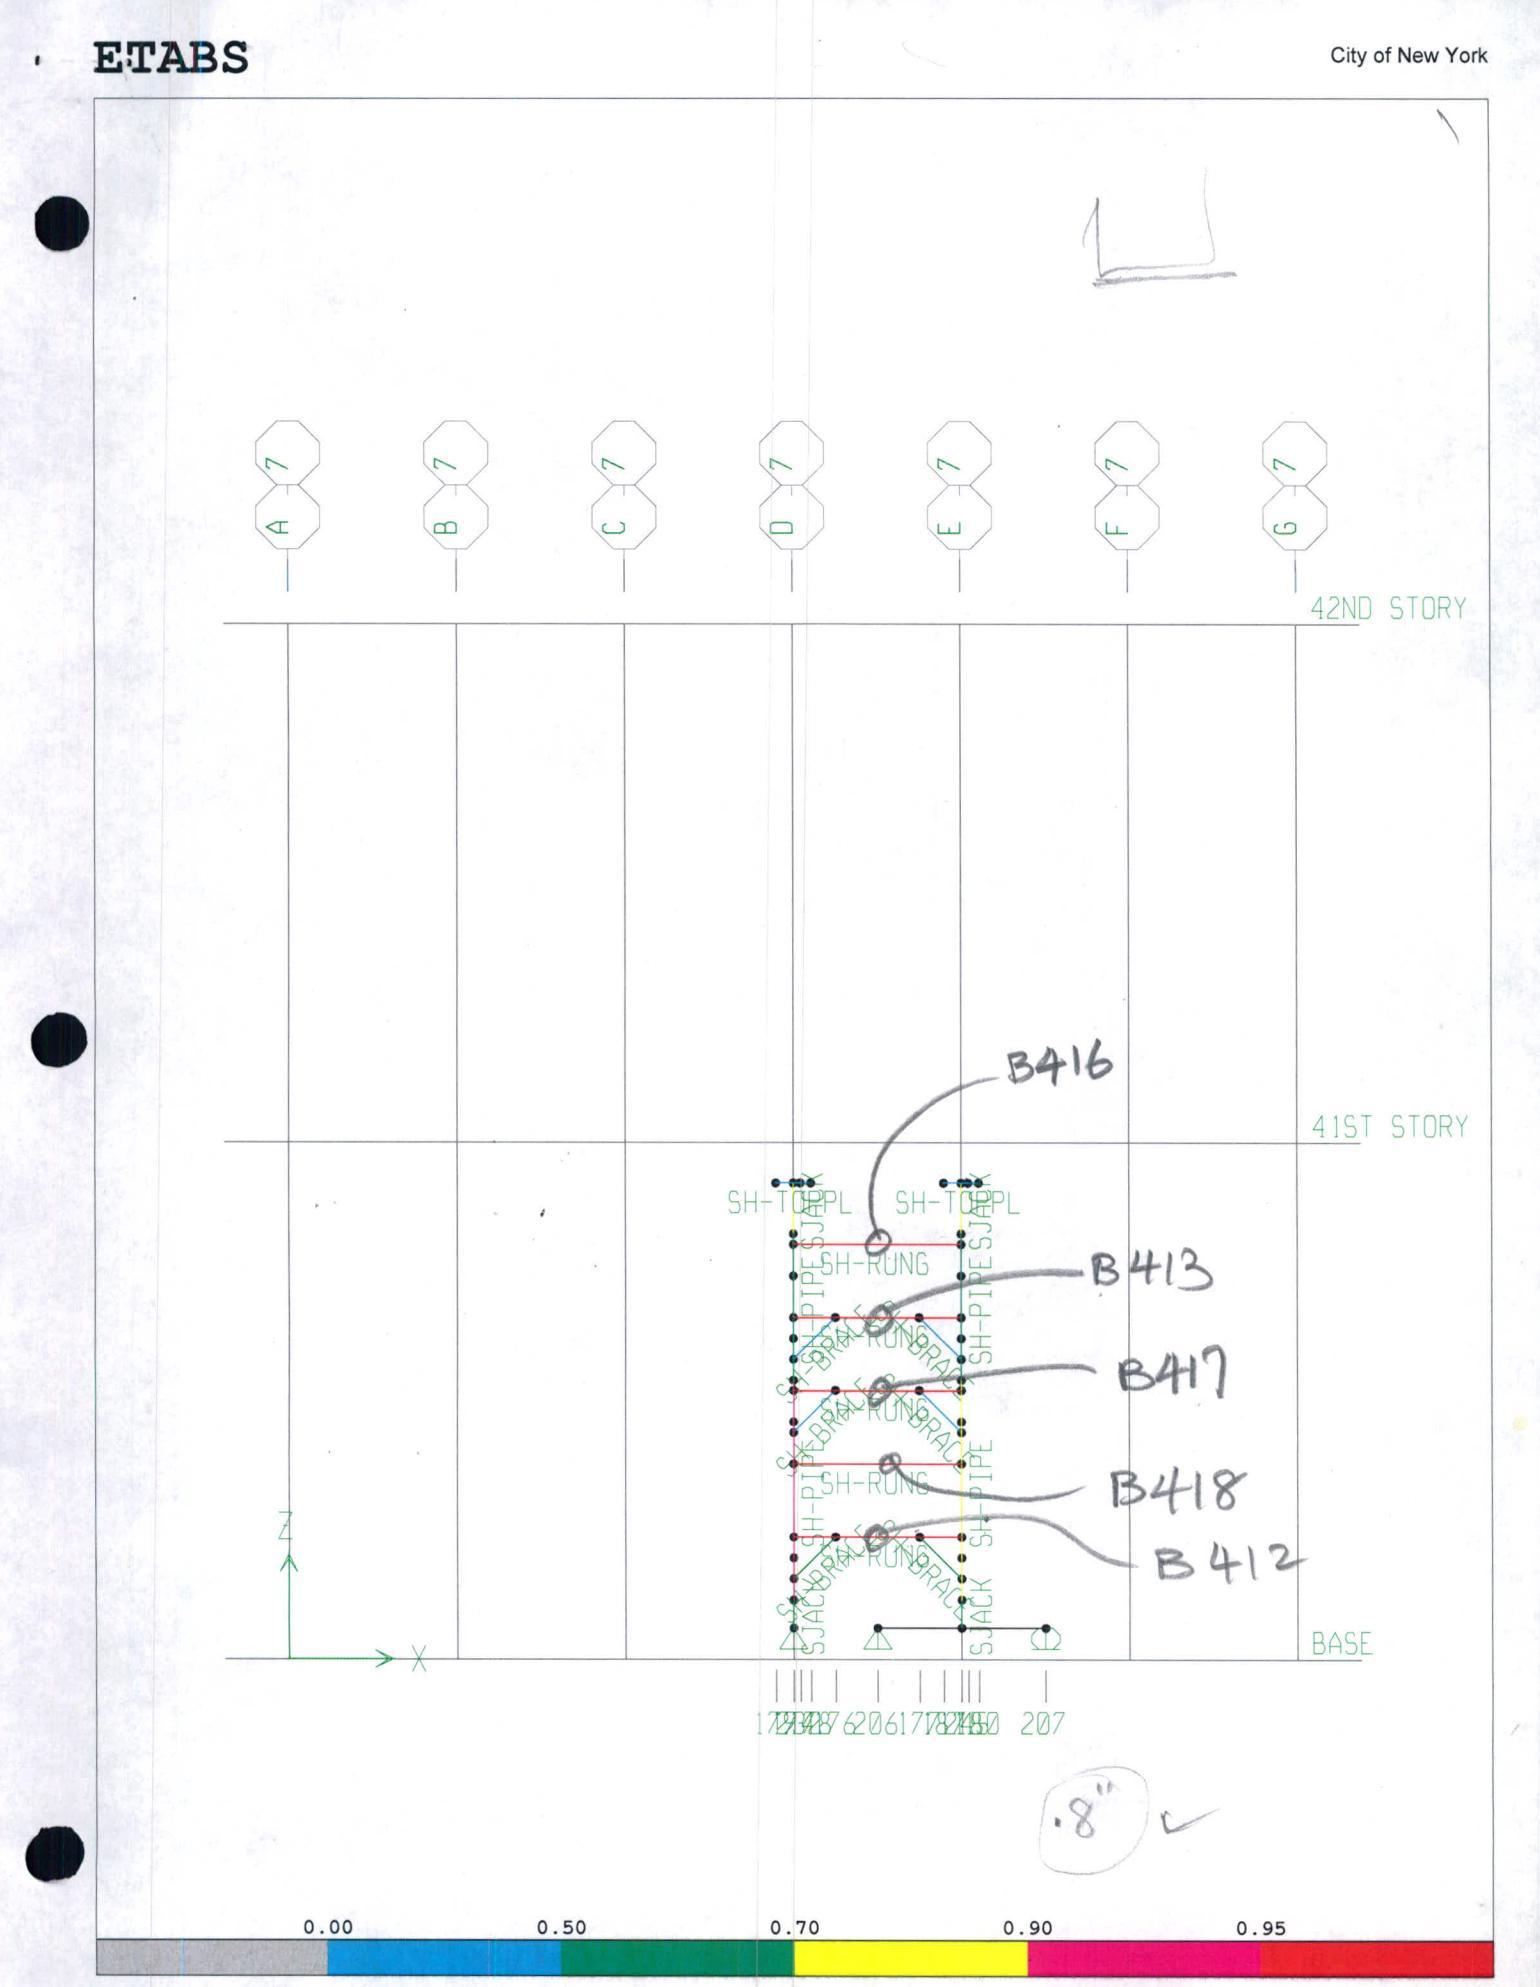
Result: shore failure

- Screw jacks do not fail.
- All 4 Shoring legs do not fail.
- The horizontal members fail in bending, connections from the top horizontal members to the leg fail in weldment.

• Knee brace does not fail

ETABS v9.0.7 - File: 246SpringST_2009_05_08_singleTowerDL_2inchECCdeflectionLimit - May 29,2009 19:12 Elevation View - 7 Steel Design Sections (AISC-ASD89) - Kip-in Units

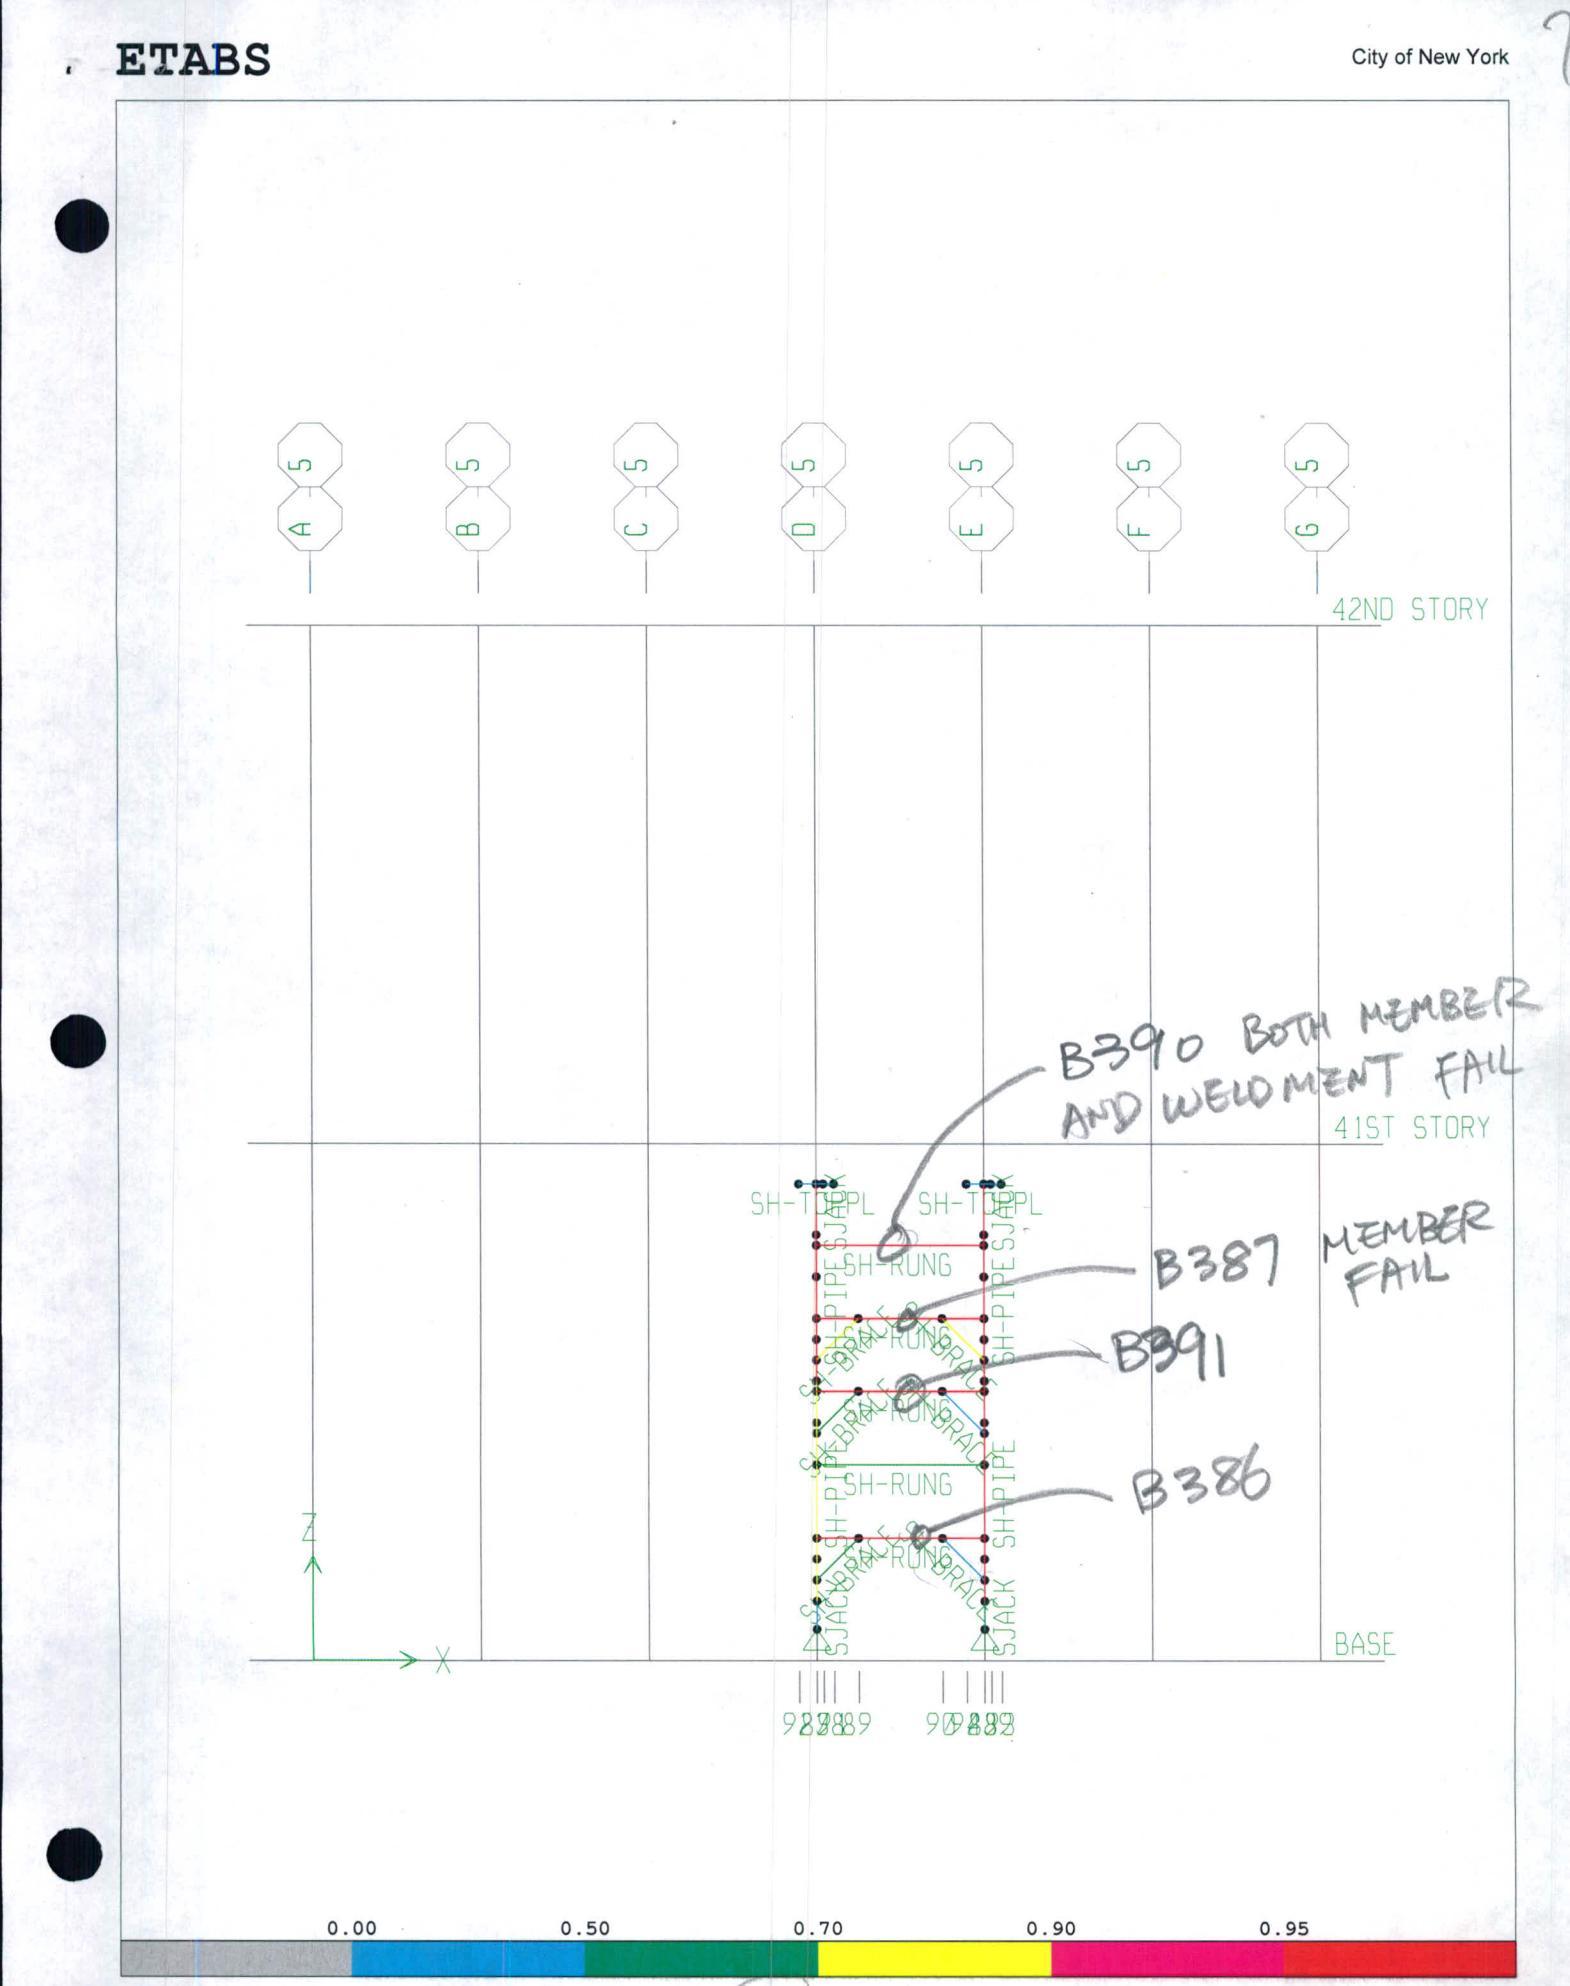
AISC-ASD89 STEEL SECTION CHECK- Units: Kip-in (Summary for Combo and Station) Level: 41ST STORY Element: B412 Station Loc: 12.000 Section ID: SH-RUNG Element Type: Moment Resisting-Frame Classification: Compact L=48.000 A=0.503 i22=0.133 i33=0.338 s22=0.213 s33=0.300 r22=0.515 r33=0.820 E=10100.000 fy=35.000 RLLF=1.000 P-M33-M22 Demand/Capacity Ratio is 1.329 0.076 040 0.214 STRESS CHECK FORCES &_MOMENTS, -M33-M22 v2 ívз Ρ -0_227 Combo DSTLS2 0.530 0.080 6.552 0.960 AXIAL FORCE & BIAXIAL MOMENT DESTEN (H1-3) fa Fa Ft Allowable Stress Allowable Axial 0.452 5.987 21.000 Fe fb Fb Cm Κ L Cb Allowable Stress Allowable Factor Factor Factor Factor Major Bending 21.833 21.000 60.662 0.850 1.000 0.500 1.000 Minor Bending 4.500 21.000 5.987 0.850 1.000 1.000 SHEAR DESIGN fv FV. Stress Stress llowable Ratio Major Shear 571 14.000 0.112 0.426 Minor Shear 14.000 0.030

ETABS v9.0.7 - File: 246SpringST_2009_05_08_singleTowerDL_2inchECCdeflectionLimit - May 29,2009 18:55 Elevation View - 5 Steel Design Sections (AISC-ASD89) - Kip-in Units

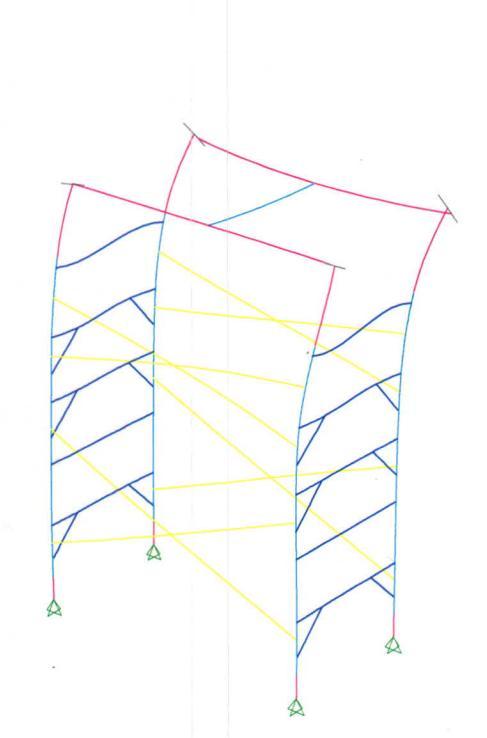
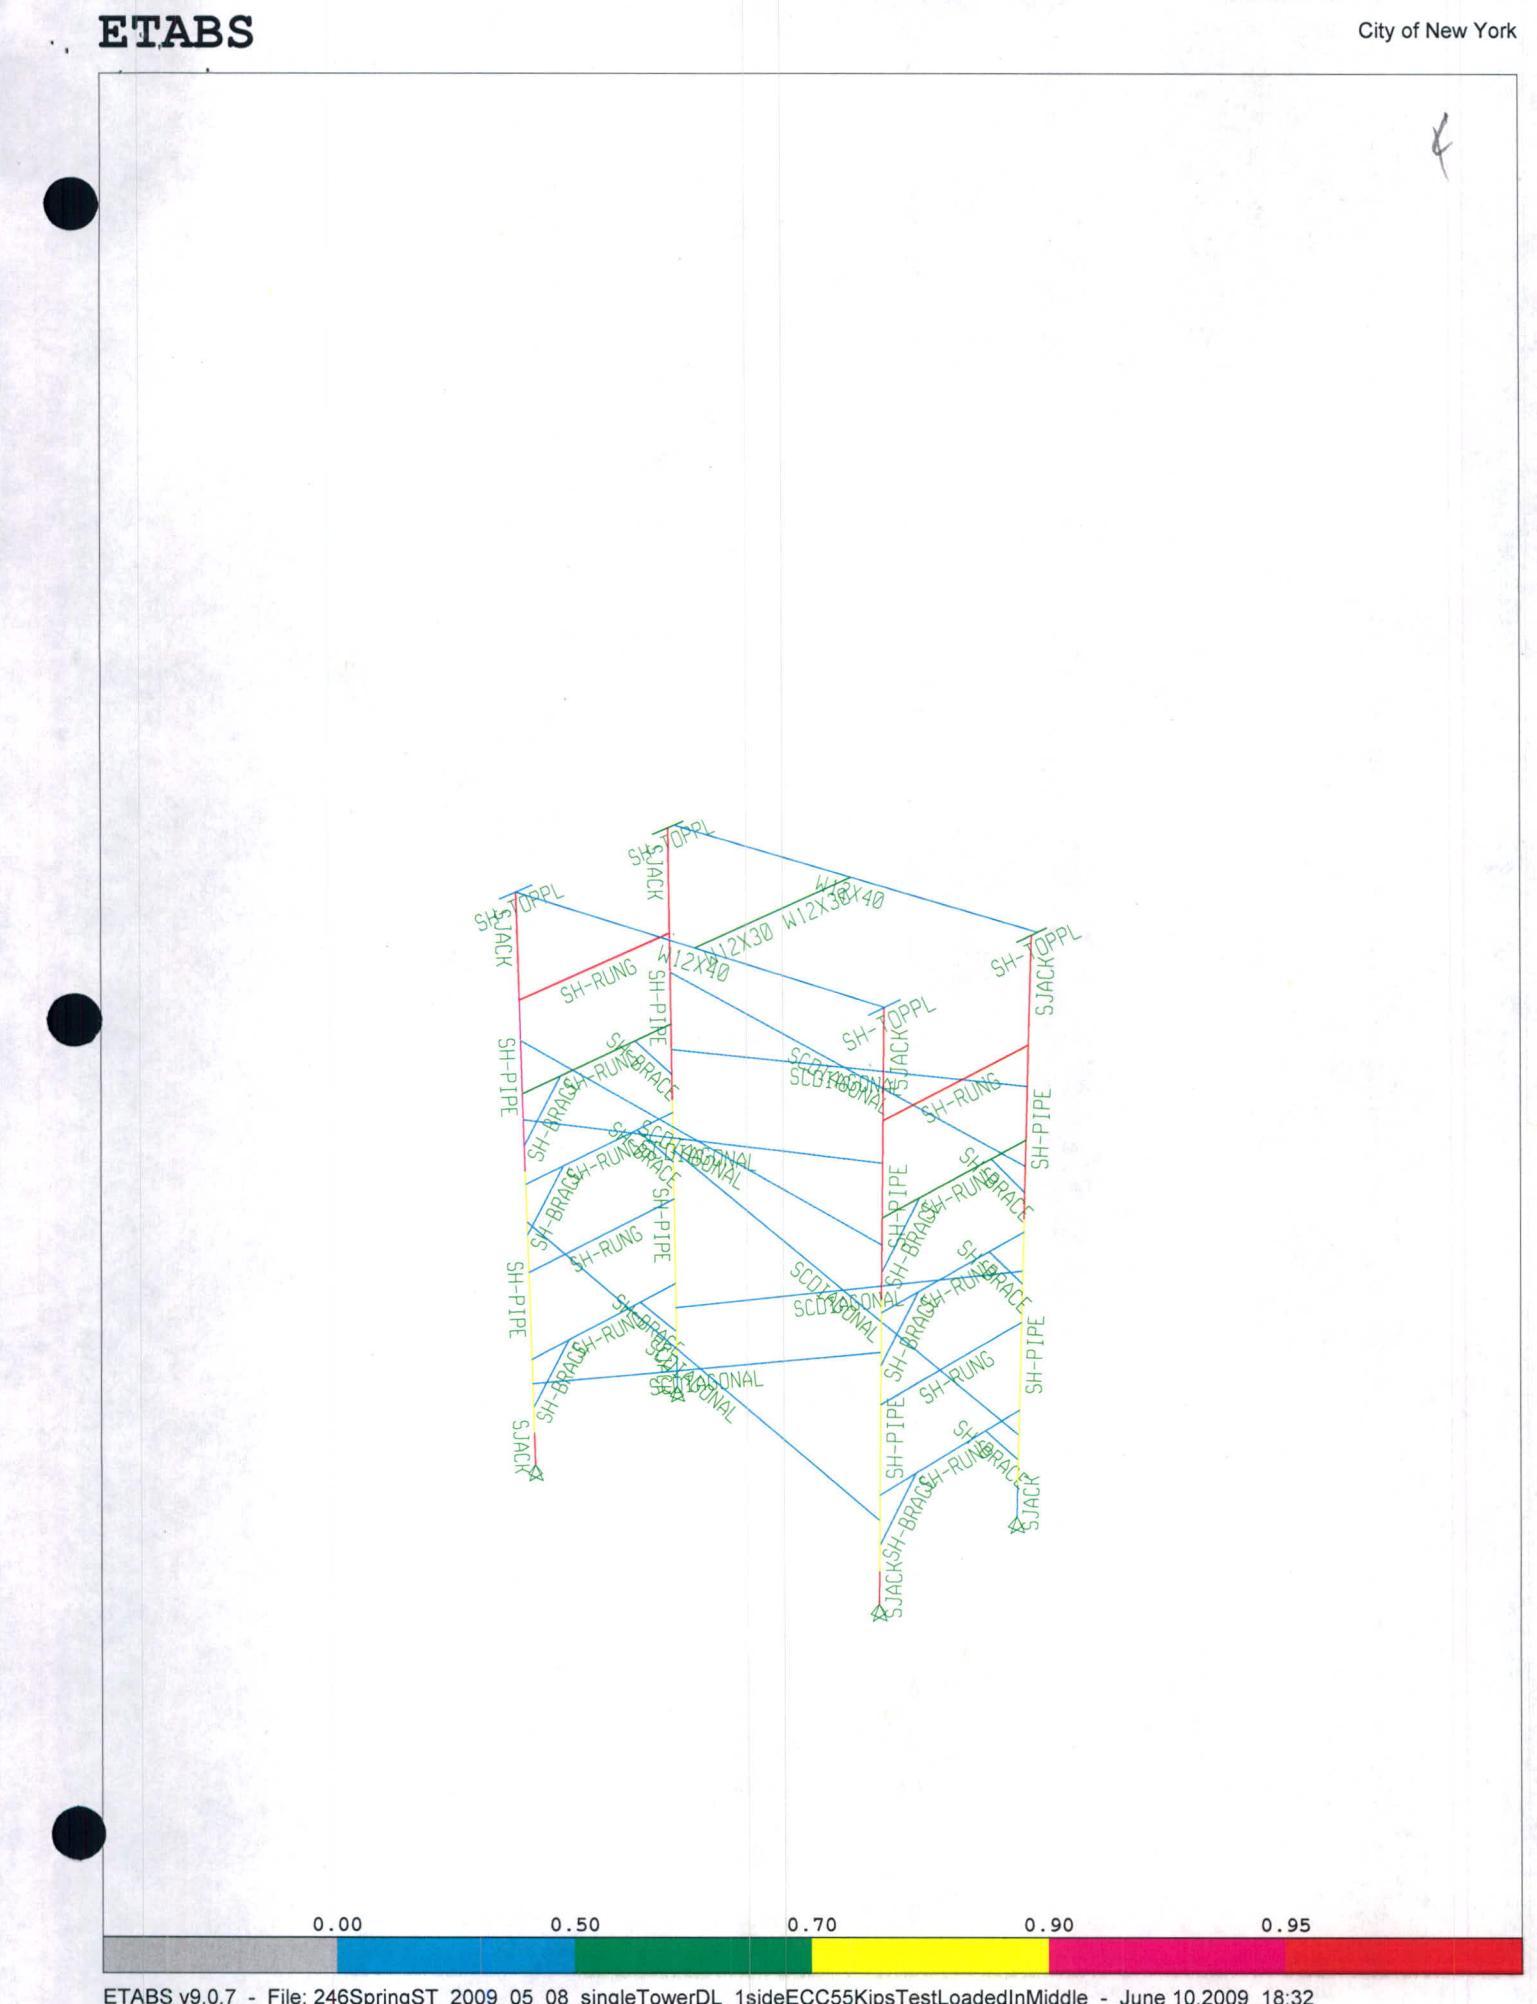
Result: shore failure

- Screw jacks on the 2" loaded sides buckles and has large deflection.
- All 4 Shoring legs do not fail in buckle or bending.
- The connection from the top horizontal members to the legs fail in weldment.
- Knee brace does not fail in compression, tension or bending.
- The horizontal top deflection is in the order of .8", and the deflection from Lehigh Testing Lab for the similar condition is in order of .6". The results are comparable.

ETABS v9.0.7 - File: 246SpringST_2009_05_08_singleTowerDL_1sideECC55KipsTestLoadedInMiddle - June 10,2009 18:16 3-D View Deformed Shape (DEAD) - Kip-in Units

ETABS v9.0.7 - File: 246SpringST_2009_05_08_singleTowerDL_1sideECC55KipsTestLoadedInMiddle - June 10,2009 18:32 3-D View Steel Design Sections (AISC-ASD89) - Kip-in Units

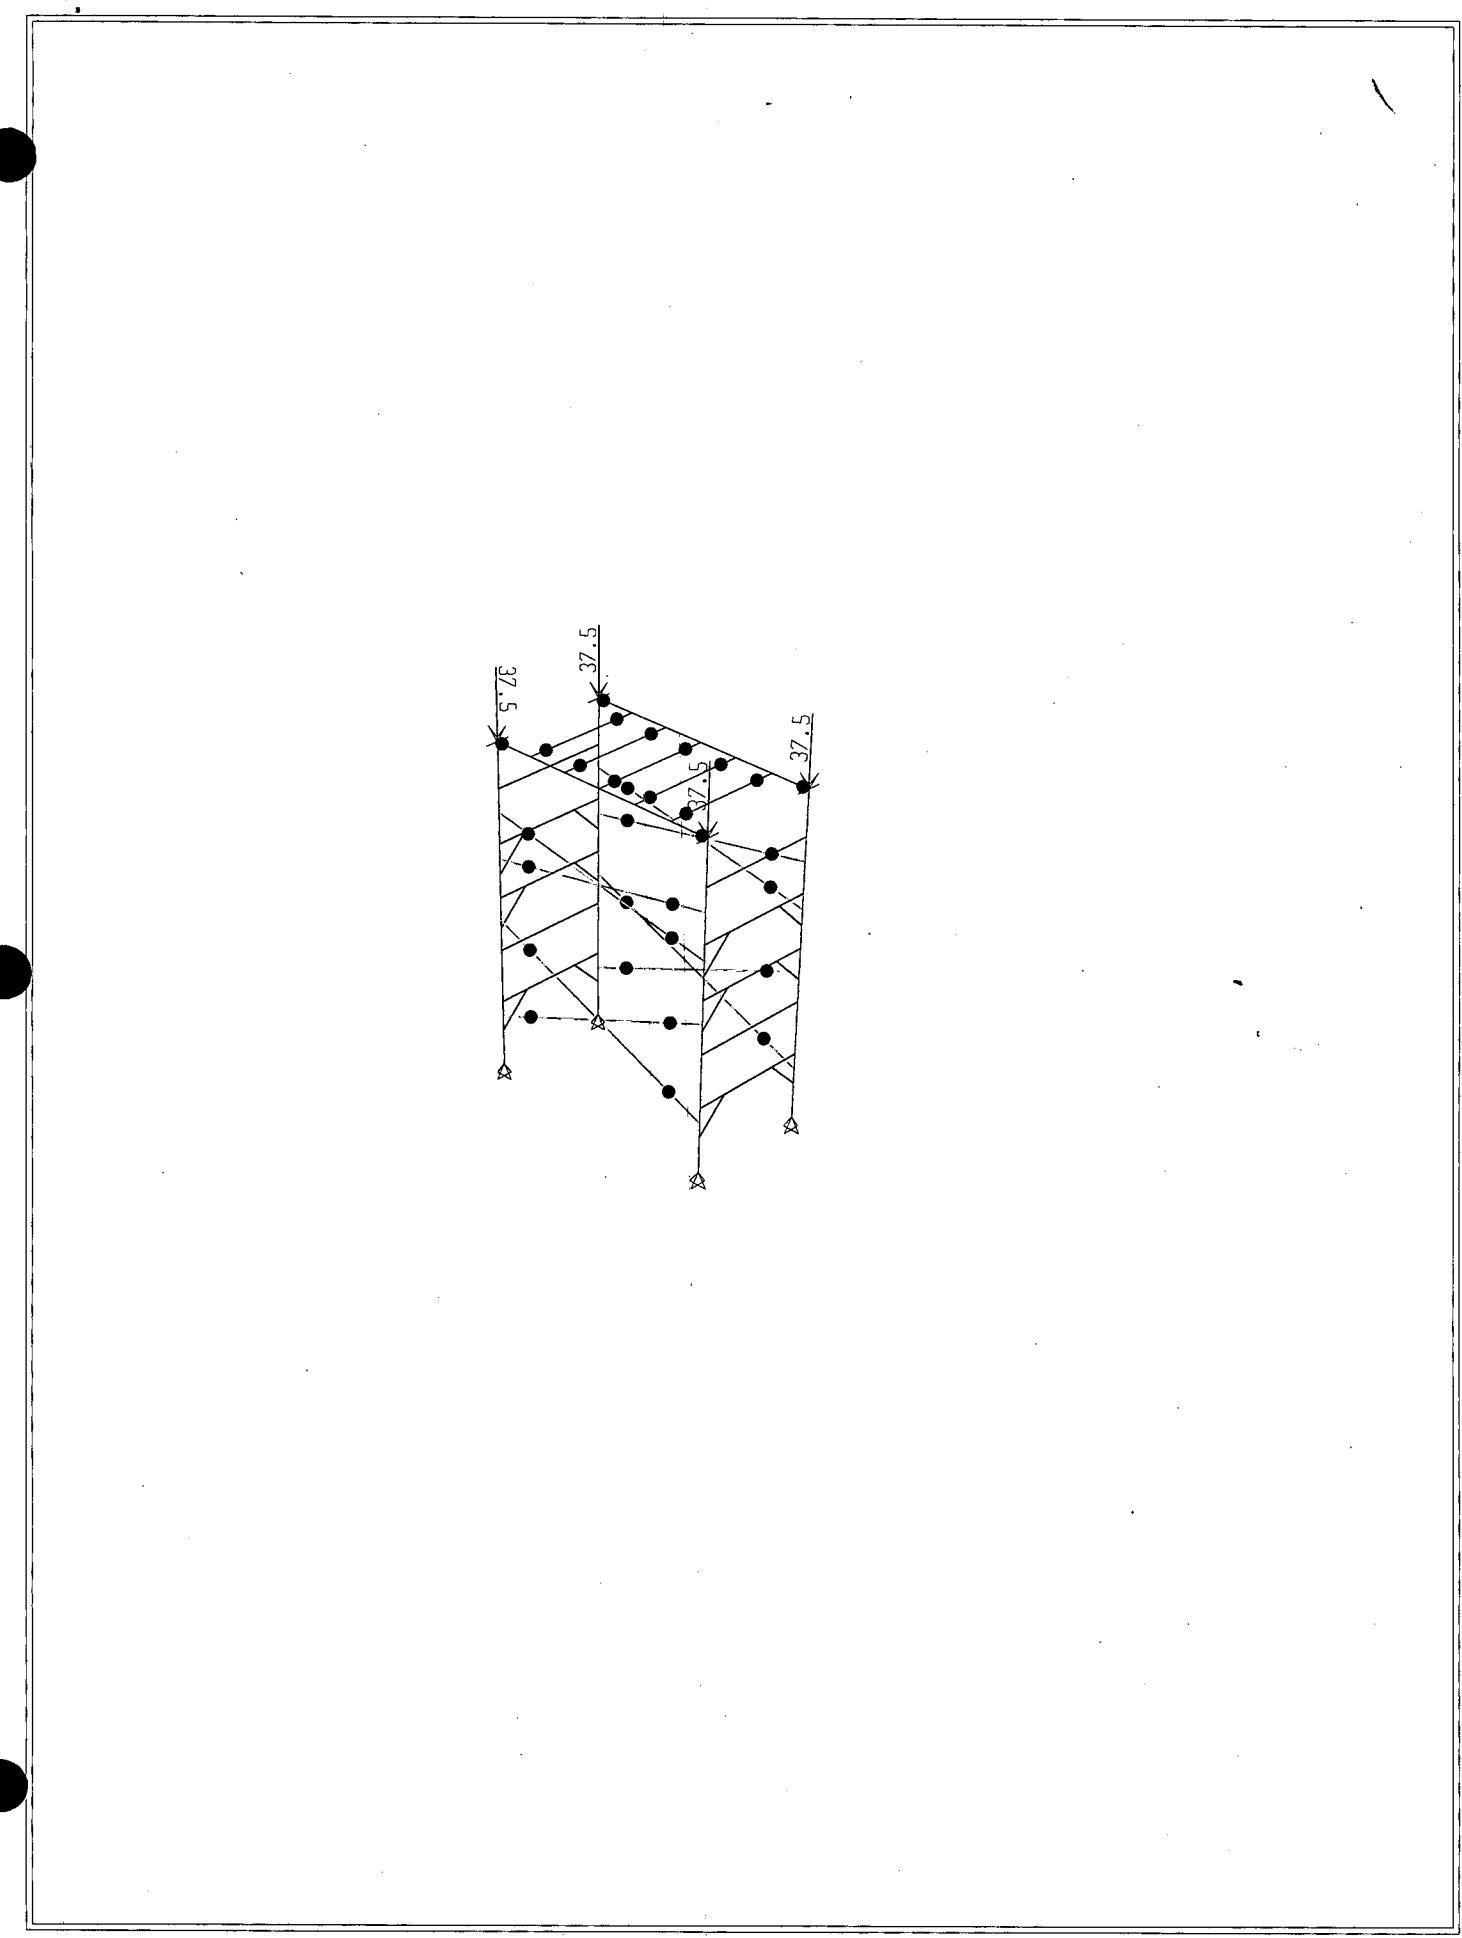
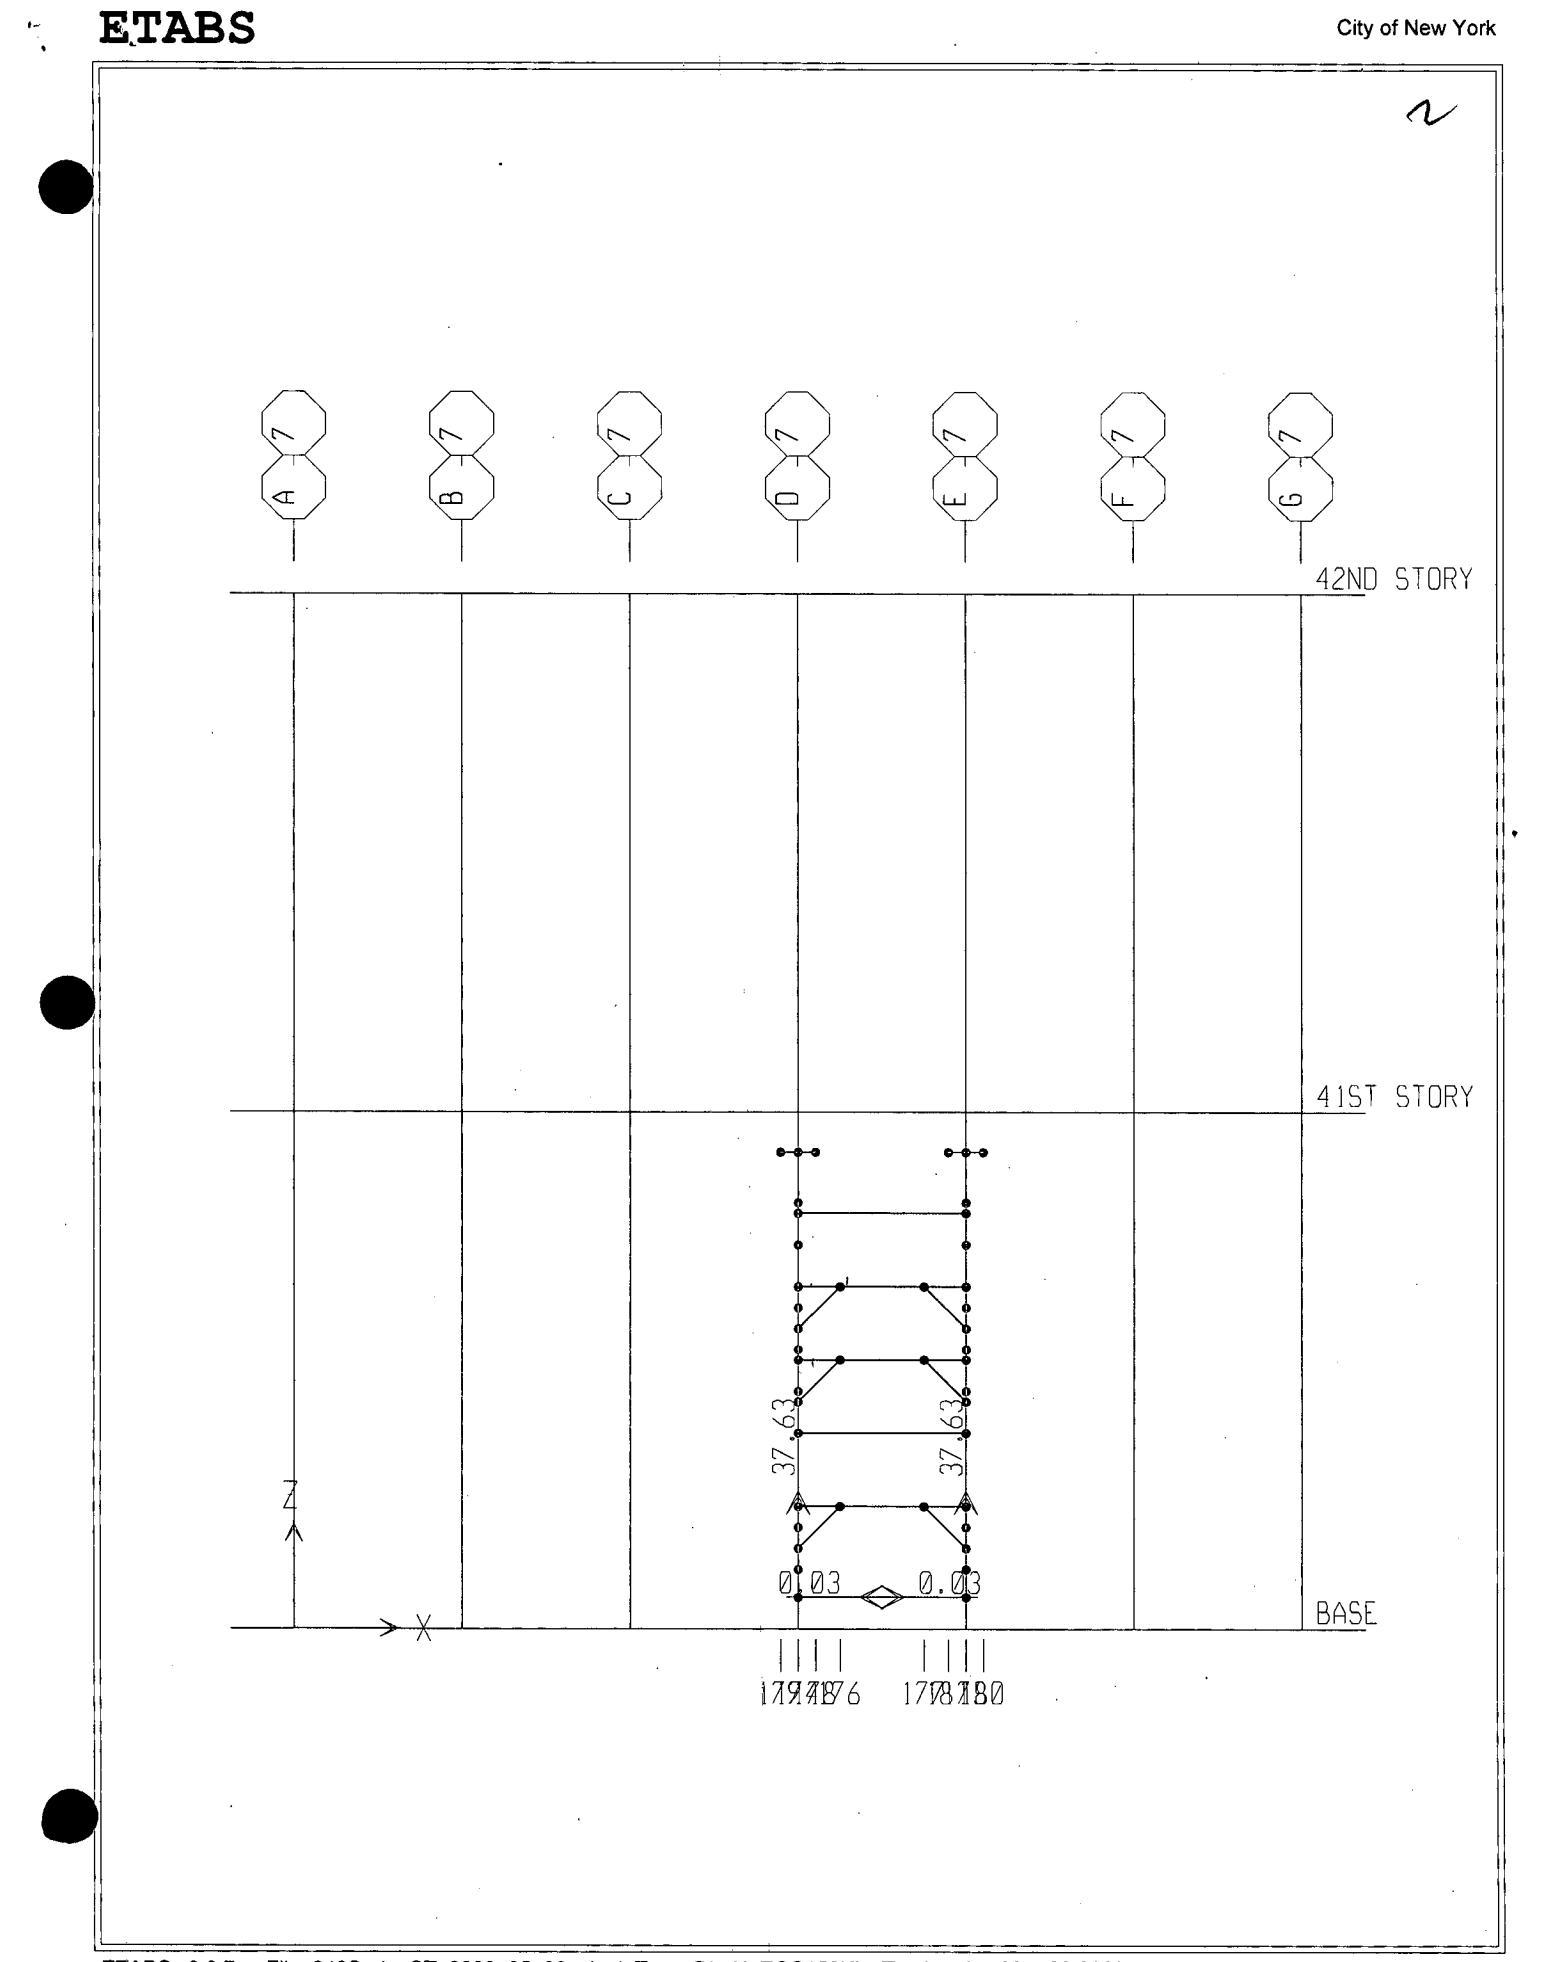
Result: shore failure

- Screw jacks do not fail in combination of compression and bending.
- All 4 Shoring legs fail in combination of compression and bending.
- All horizontal members and connections do not fail.
- Knee brace does not fail in compression, tension or bending.
- Test and computer analysis are comparable

ETABS v9.0.7 - File: 246SpringST_2009_05_08_singleTowerDL_NoECC150KipsTestLoad - May 28,2009 15:46 3-D View Point Loads (DEAD) - Kip-in Units

ETABS v9.0.7 - File: 246SpringST_2009_05_08_singleTowerDL_NoECC150KipsTestLoad - May 28,2009 15:45 Elevation View - 7 Restraint Reactions (DEAD) - Kip-in Units
