INVESTIGATION REPORT:

JANUARY 14, 2008 SHORING COLLAPSE AT 9 DOMINICK ST. (AKA 246 SPRING ST.) MANHATTAN

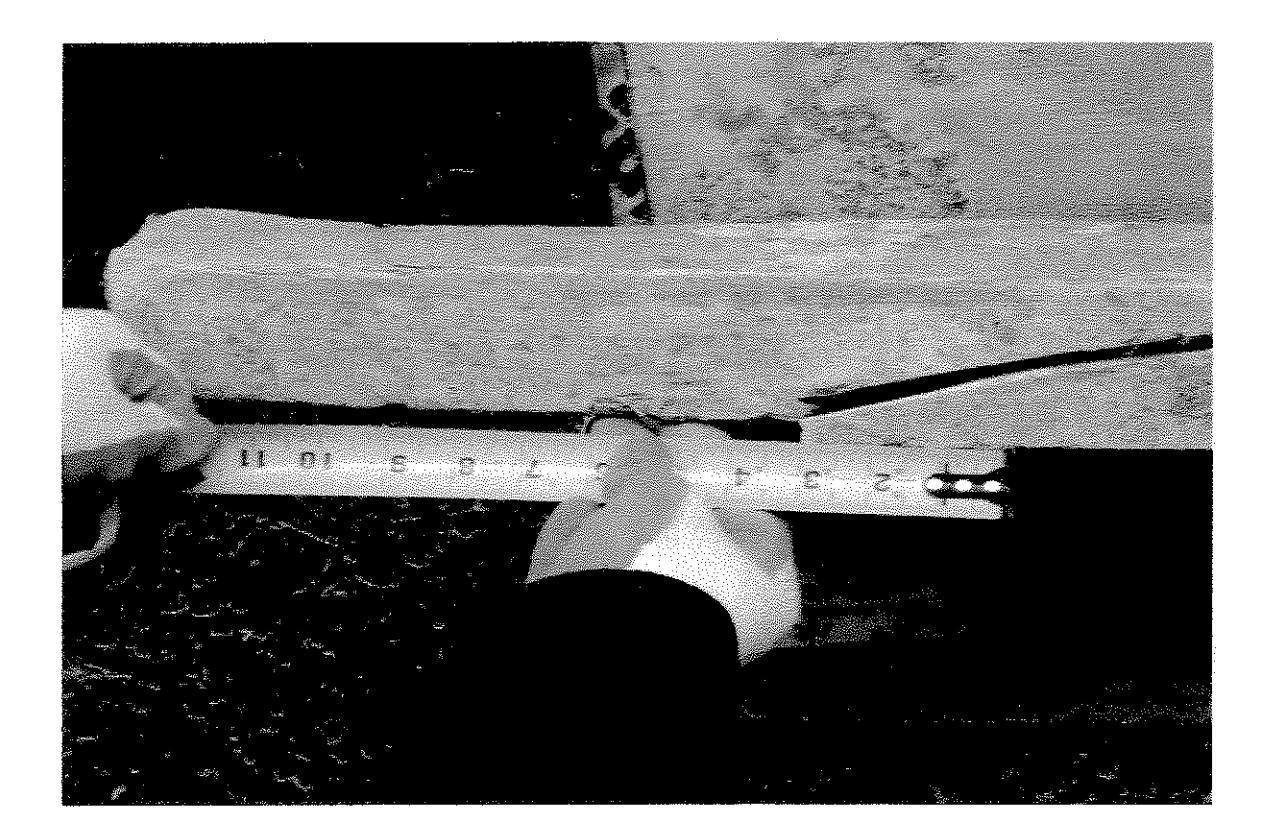
Dimension lumber which does not meet the minium requirements for either No. 3 (Structural Light Framing) or Utility (Light Framing) were classified as Economy grade, and have no published design values. One of the most distinct grade controlling characteristics documented during our inspections was slope-of-grain (SOG). We observed severe SOG in numerous pieces (photos 4 - 6) which resulted in down grading the lumber to either a No. 3 or Economy grade.

Photo 6 - Slope-of-grain of 1:3 on lumber attached to sample with DOB #PW40007.

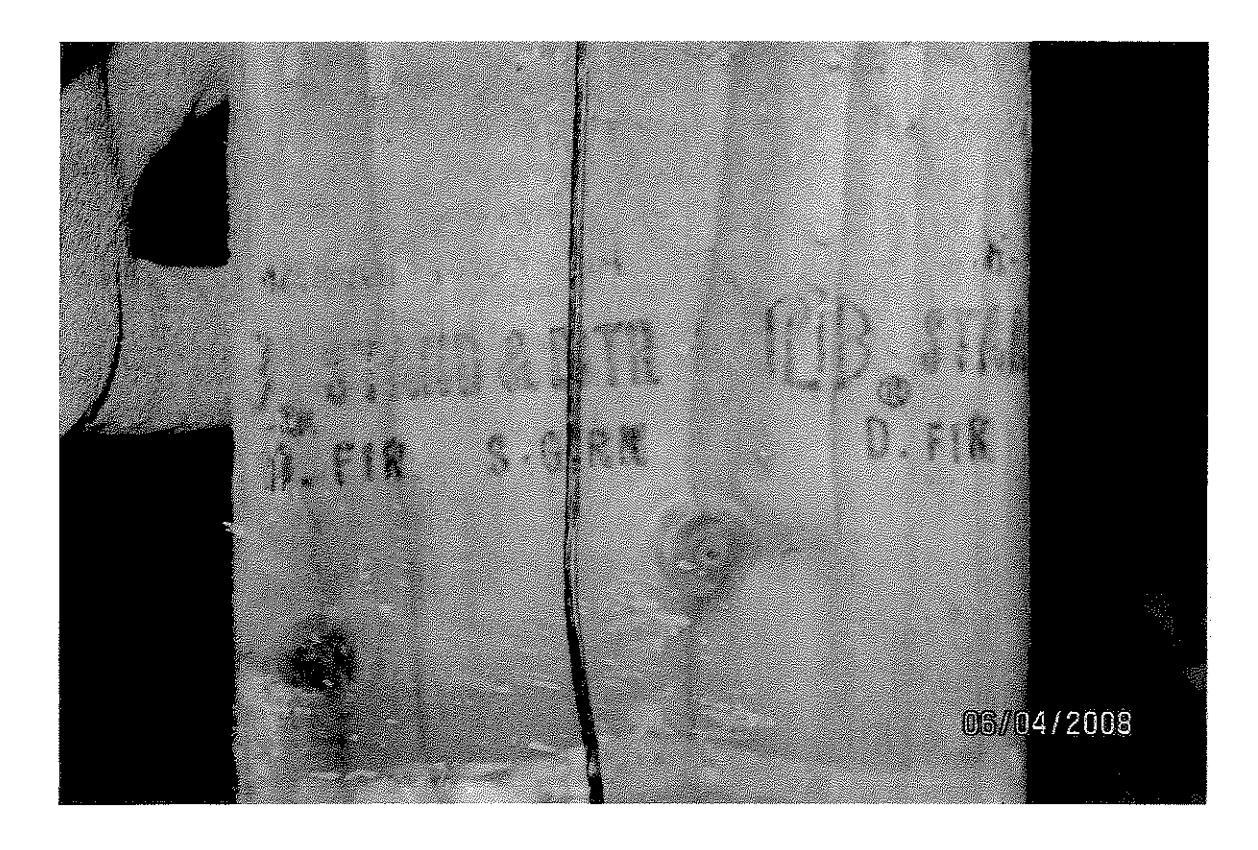
1. STAND&BTR, D-FIR, S-GRN, PLIB (photo 10), and

Photo 10 - Standard and Better (STAND&BTR) lumber stamp on 4x4, sample with DOB #41035C.

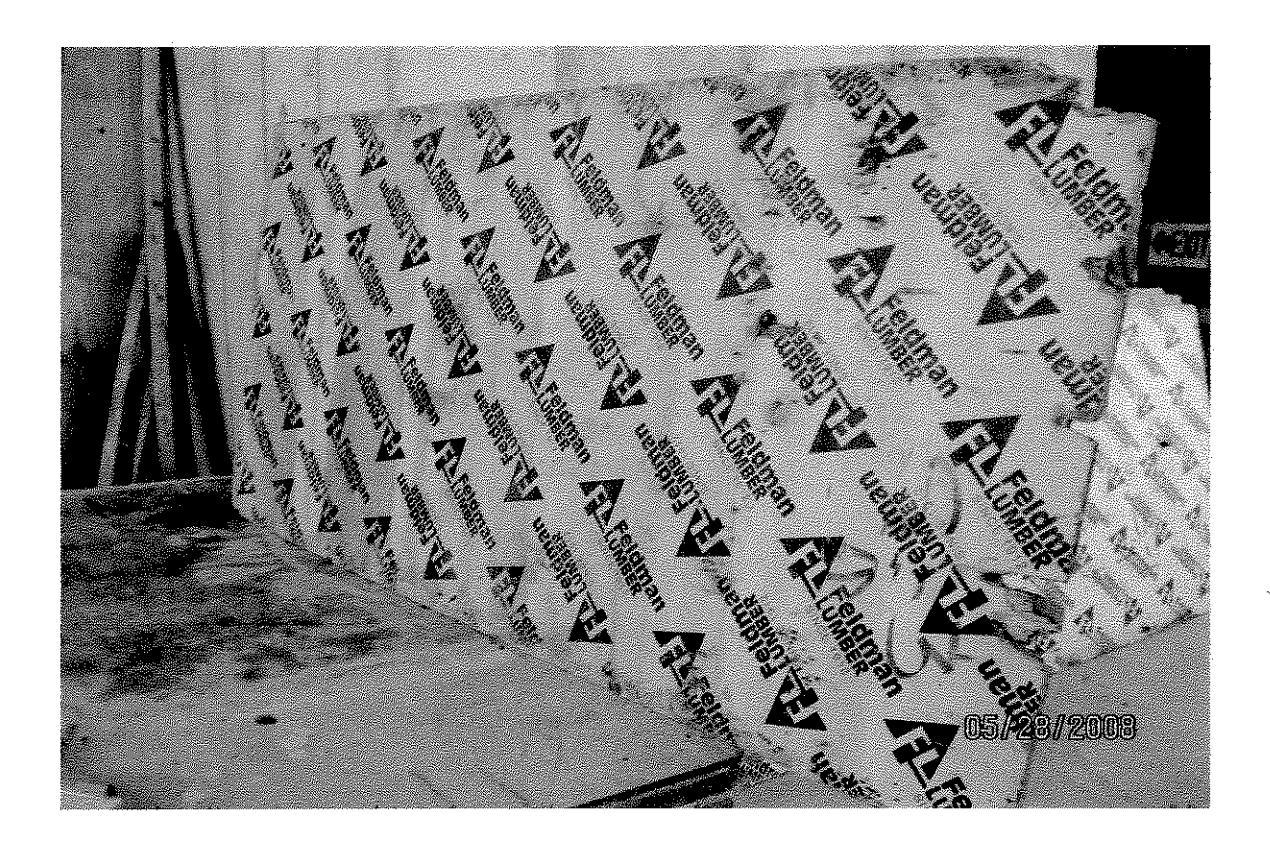
During our three day inspection, we inspected over 100 broken pieces of plywood of varying sizes. All of the concrete formwork was 5-ply plywood with melamine overlays on both faces which were marked either "Feldman Lumber" (photo 14), or "Mid-South Lumber Company" (photo 15). No visible grade stamps could be documented for this material since both faces were covered with a melamine overlay. One grade stamp was documented on several panels which did not have melamine overlays. The stamp read; Futter, Mill 332, Uni-Form, B-B Class (photo 16). Several of the broken formwork panels had consistent linear failures which appeared to be punch-through failures (photos 17 - 19). Based on this consistent pattern, it appeared that these failures were caused by the steel column base plates (6" x 8") which had punched through the plywood panels. As a result of this observation, the NYCDOB requested that a concentrated load test be performed on the plywood to examine the load carrying capacity of the plywood formwork using a 6" x 8" steel column base plate retained from the site, and 3x4 framing at 16" on-center spacing.

Photo 14 - 4'x8' plywood sheet with "Feldman Lumber" melamine overlay.

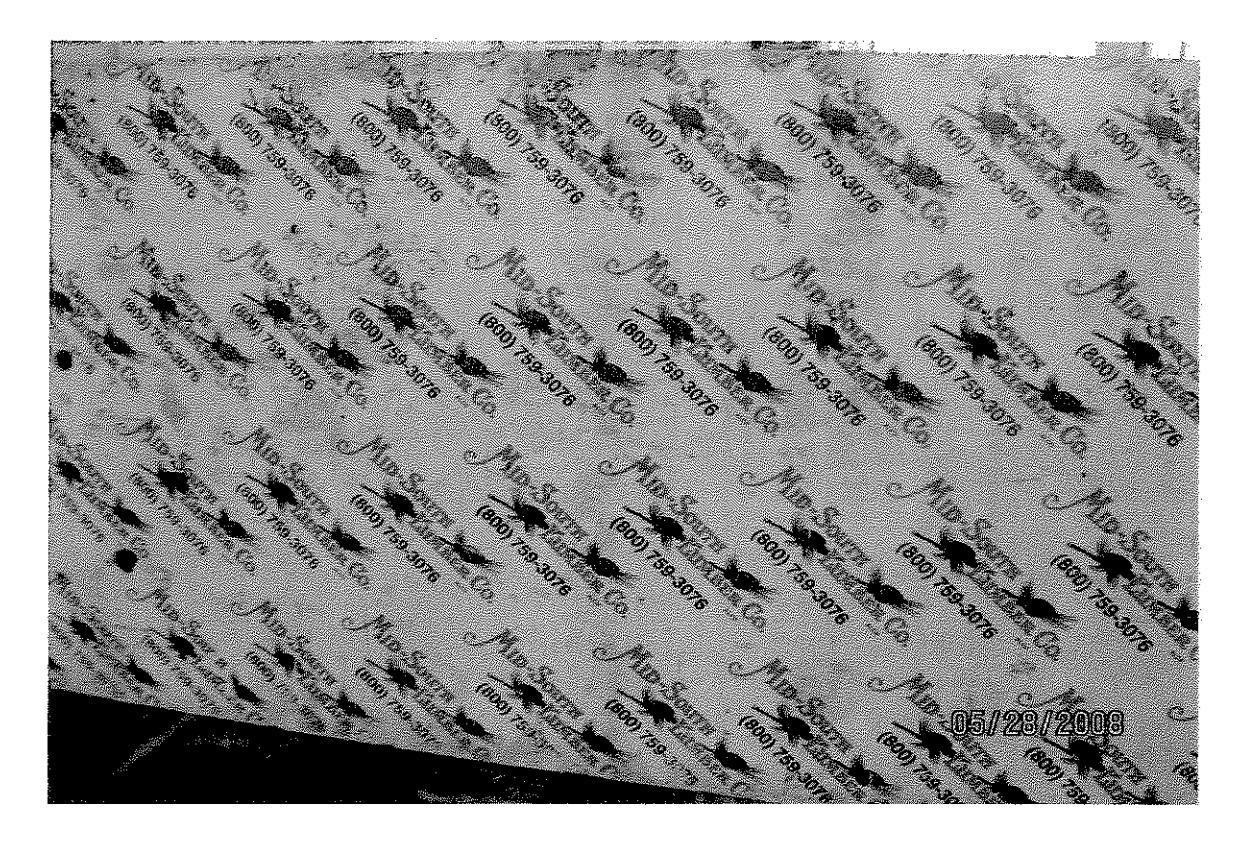
Photo 15 - 4'x8' plywood sheet with "Mid-South Lumber Company" melamine overlay.

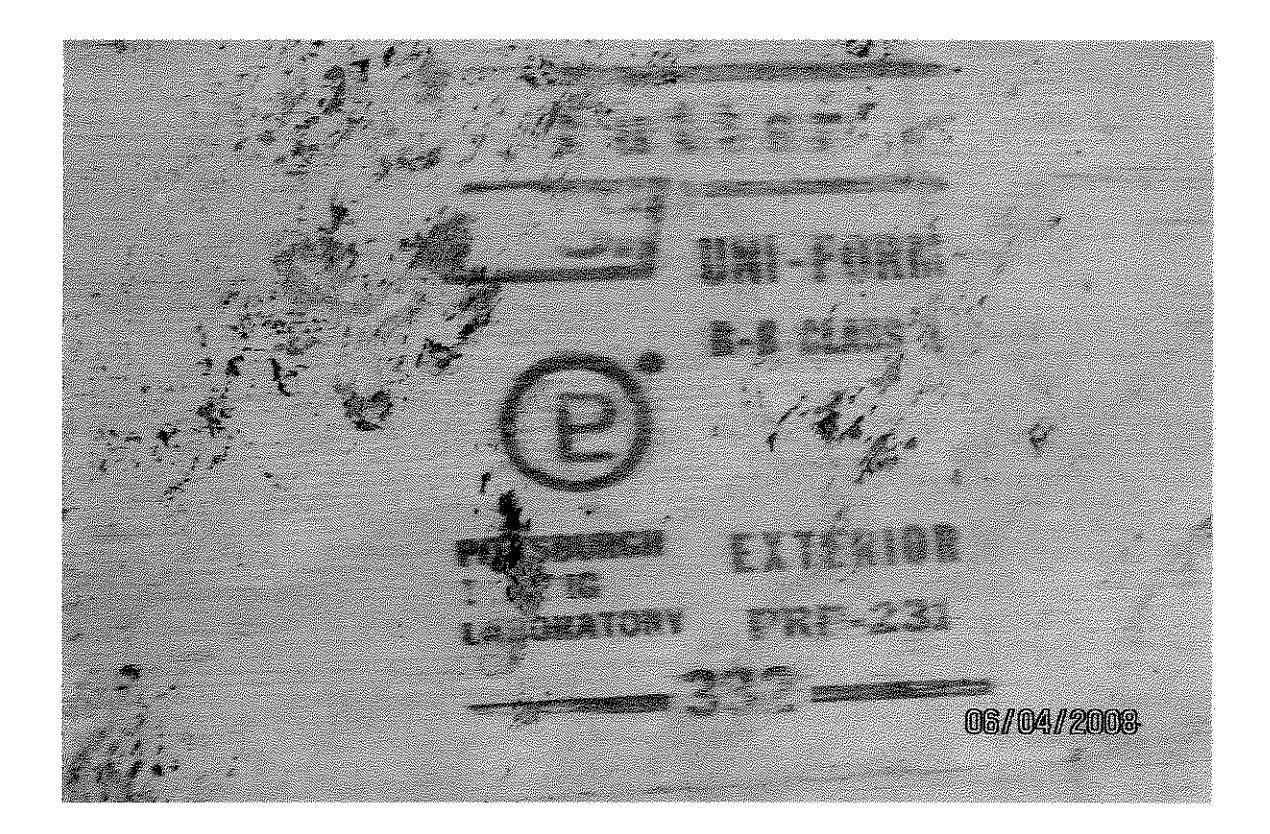
Photo 16 - 4'x8' plywood sheet with a Futter Lumber Company grade stamp.

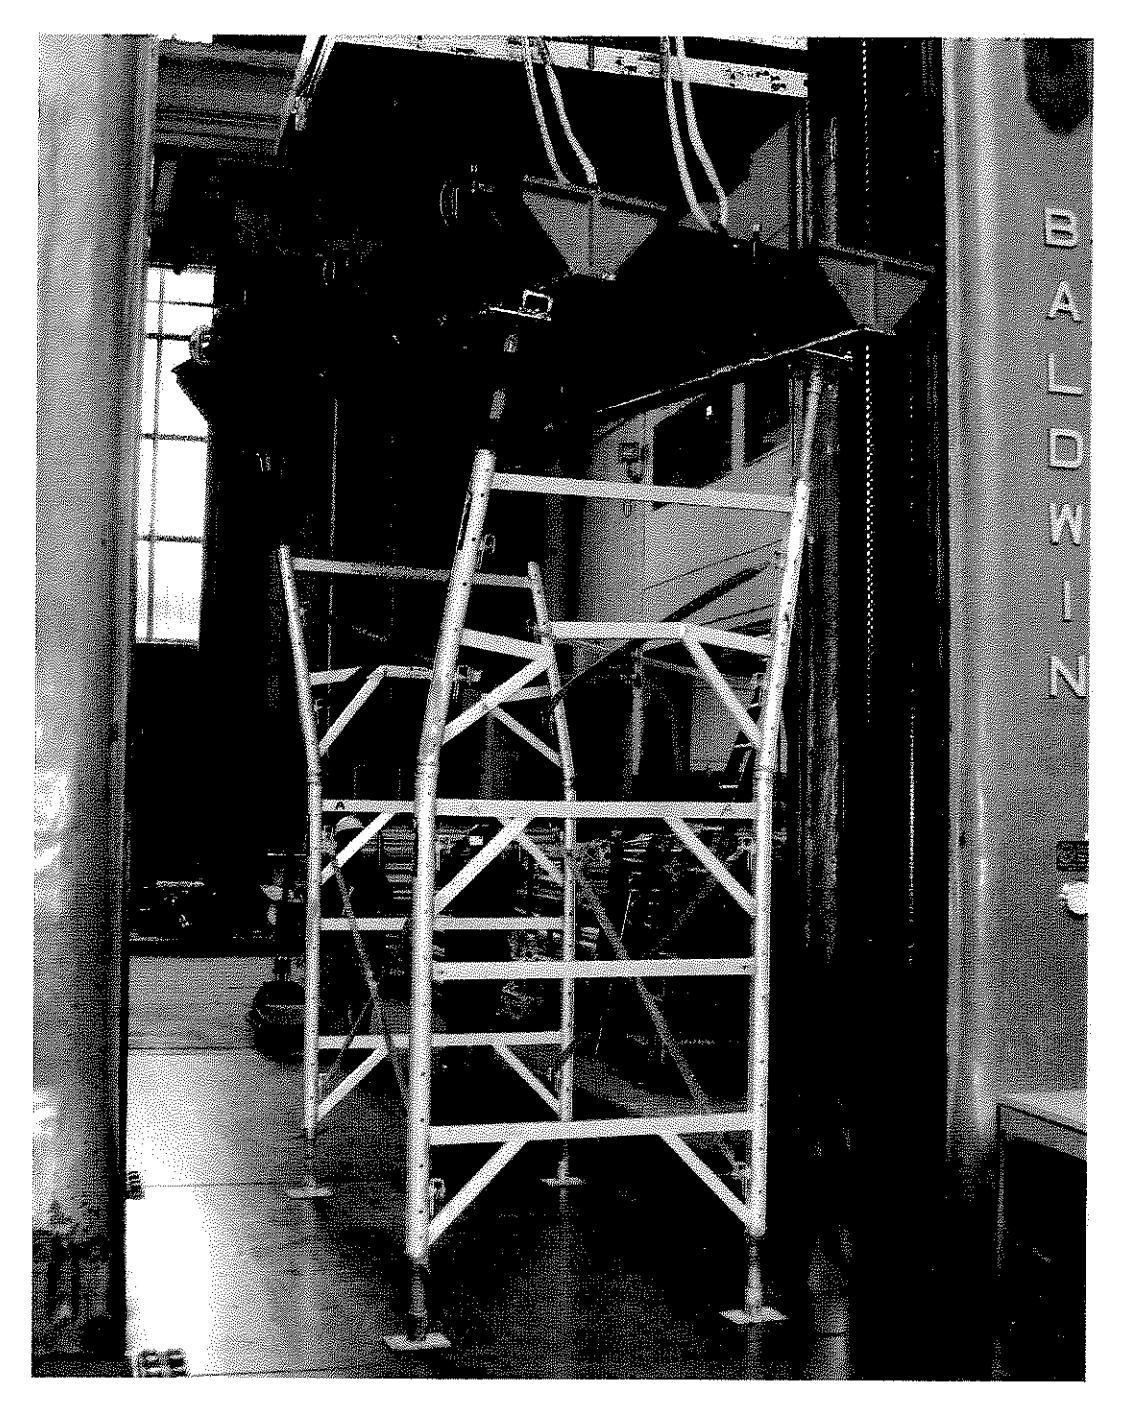
Figure 2: Tower 1 Post Test

Test	Test Type	Btm SJ [in]	Top SJ [in]	Total Height [in]	Max Load [lbs]	Failure mode		
1	Concentric Load Tower "A"	12	18	136	159,000	Racking		
2	Concentric Load Tower "C"	12	18	136	154,500	Racking		
3	Concentric Load Tower "B"	None	18	130	152,100	Racking		
4	Eccentric Load (Various Components)	12	18	136	61,300	Screw jack buckling		
5	Eccentric Load (Various Components)	None	21	133	52,100	Screw jack buckling		
6	Eccentric Load (Various Components)	12	21	139	56,400	Top plate fractured

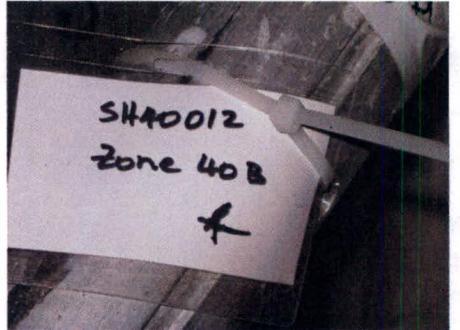
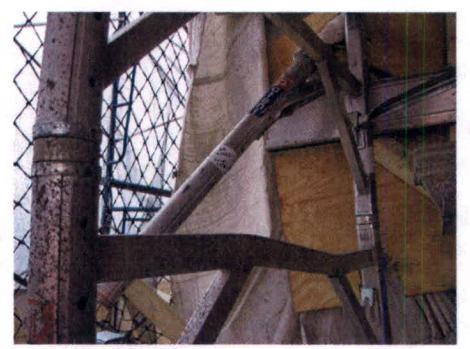
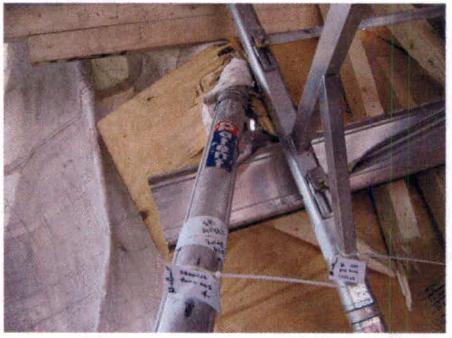
SH 40012 (on 41st floor) Broken Bottom frame with SH 40019 (3'-6") Zone 40B

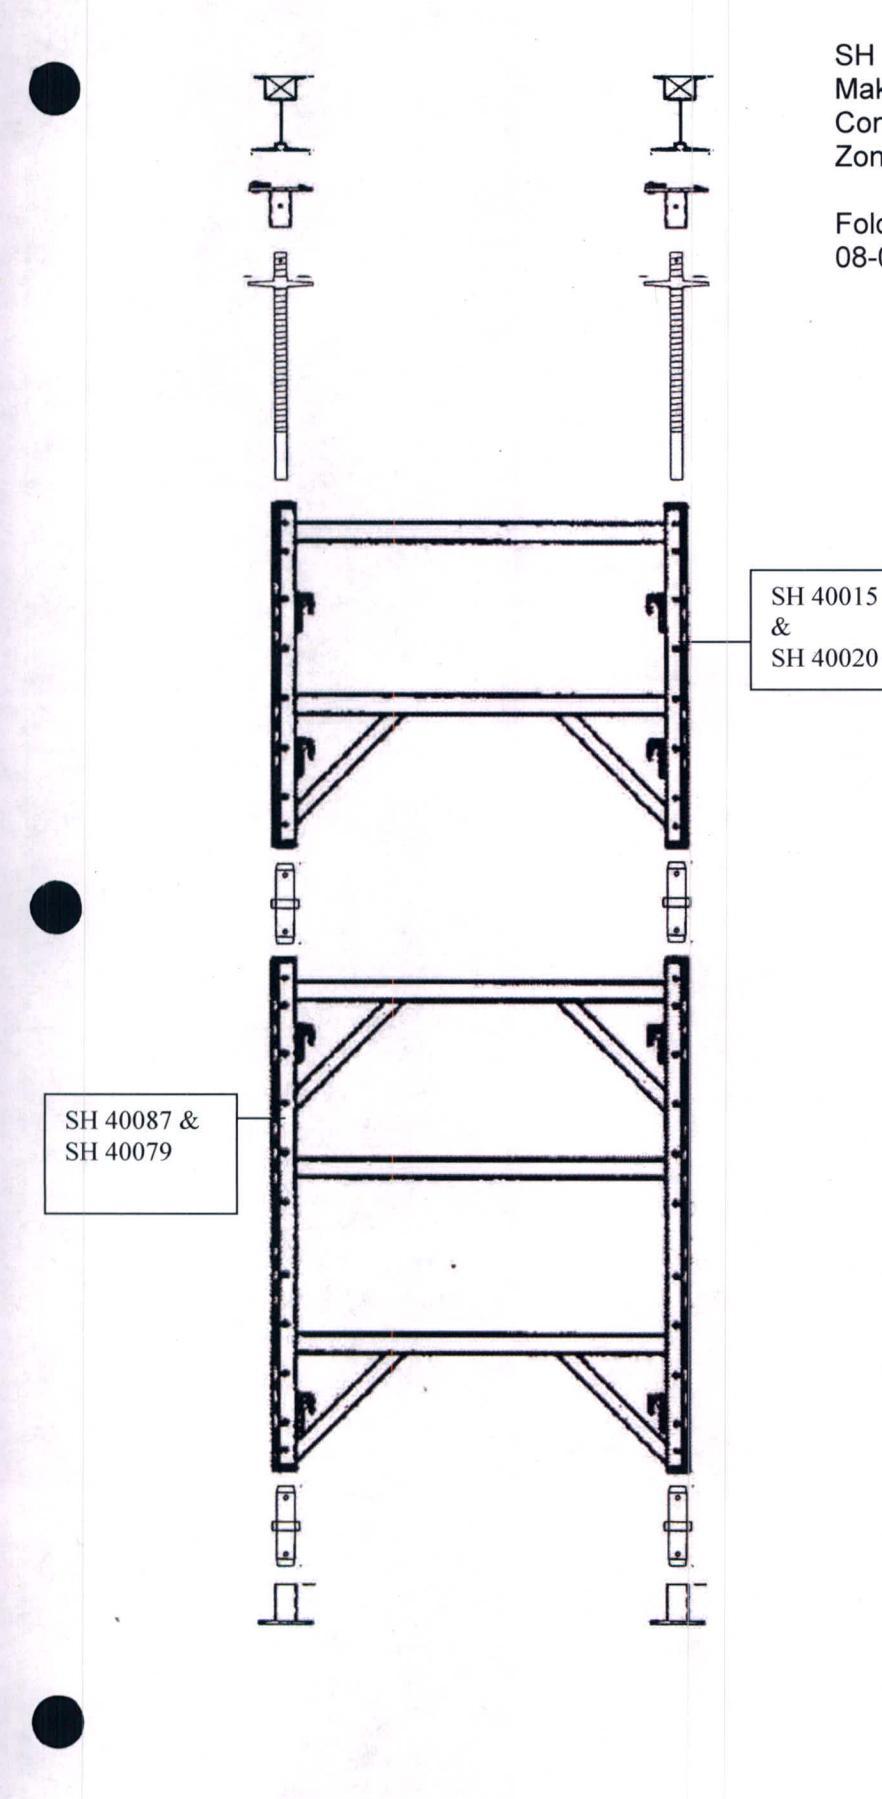
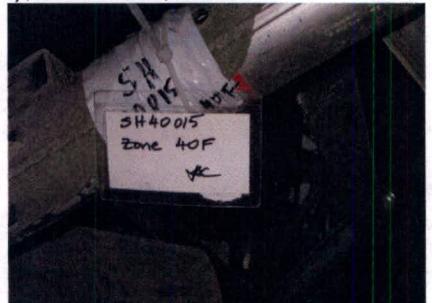
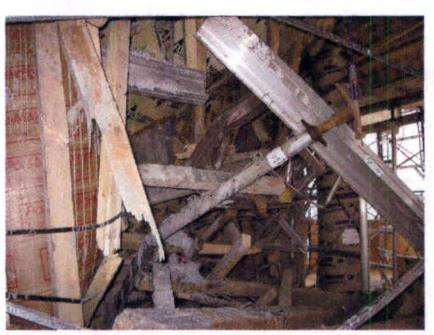
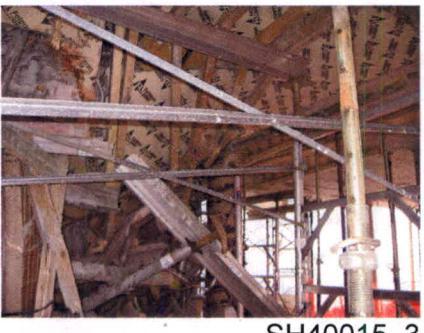
SH 40015

Makes a frame with SH 40020 Connects to SH 40005(Tower) Zone 40F

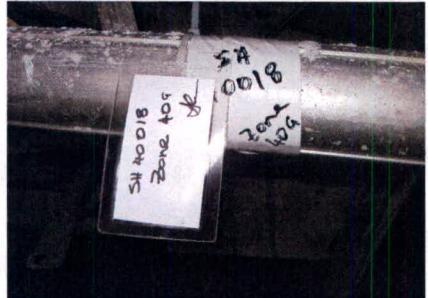
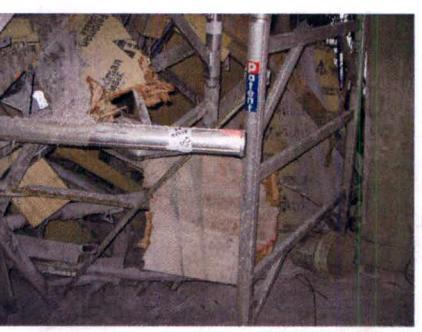
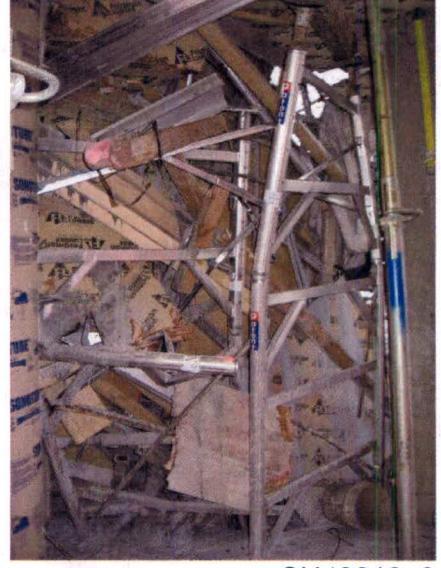
SH40018_1

SH 40018 Broken Bottom Frame on 41st floor Zone 40G

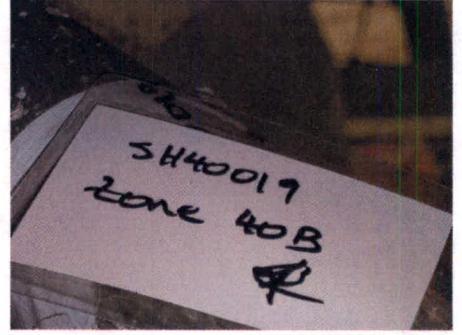
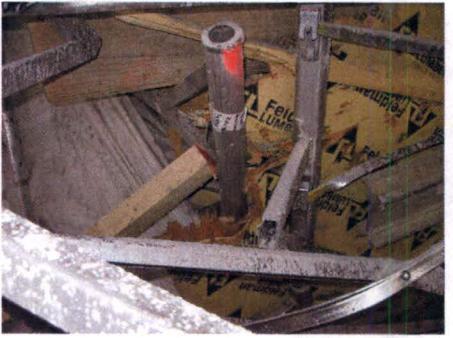
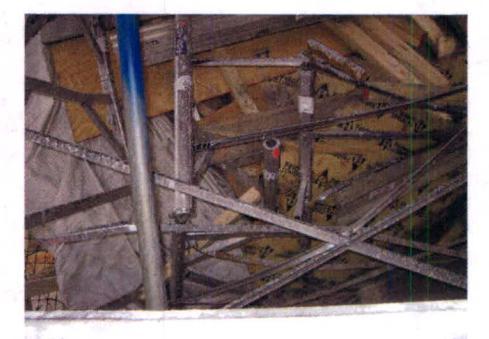
SH40019_1

SH 40019 41St Floor Bottom Frame Broken with SH 40012

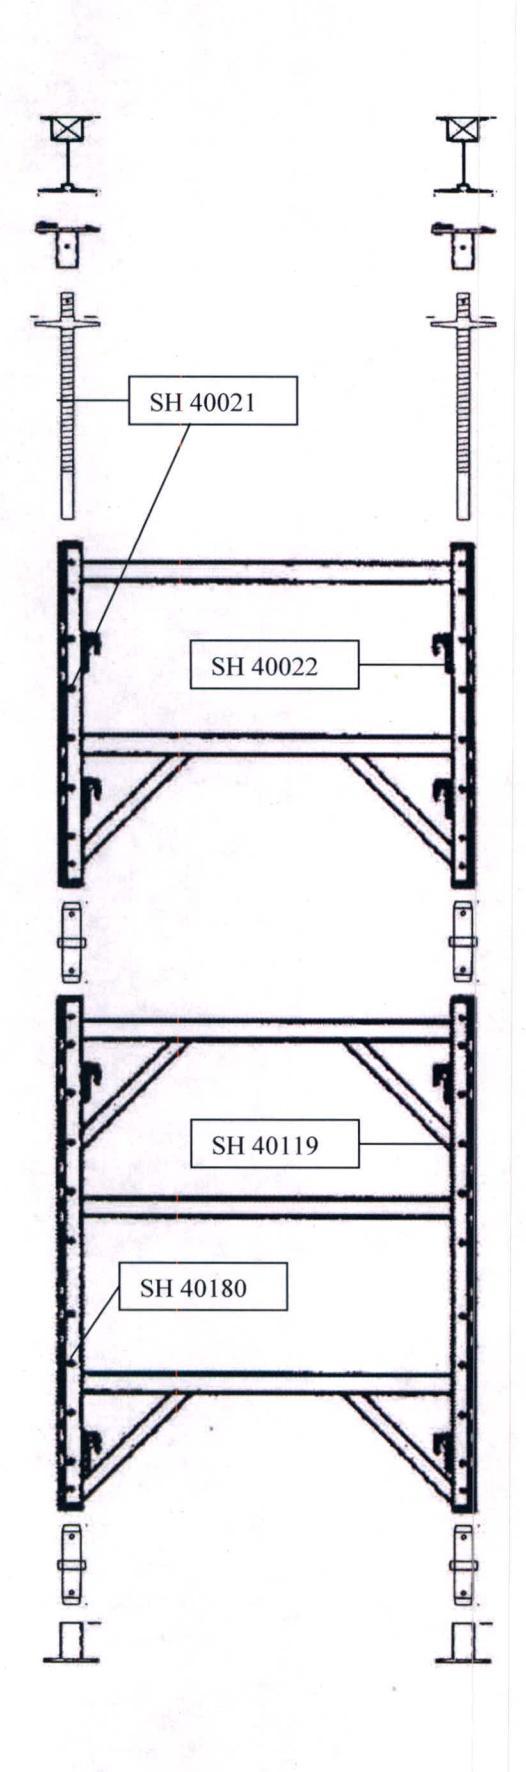
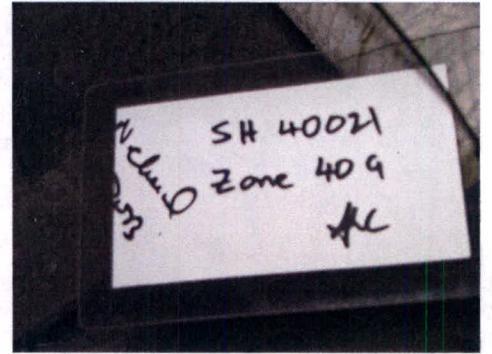
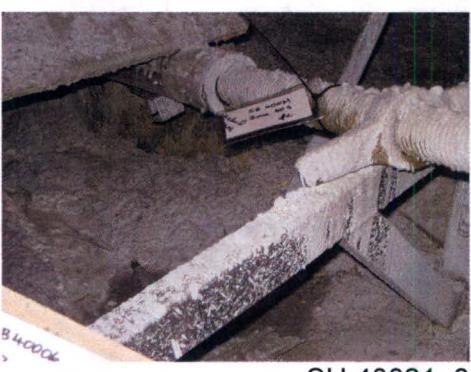
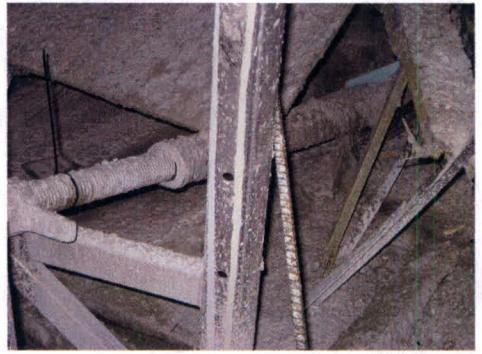
SH 40021_1

SH 40021 Zone 40G Found on Floor Collapse Zone Screw Jack and top shore broken

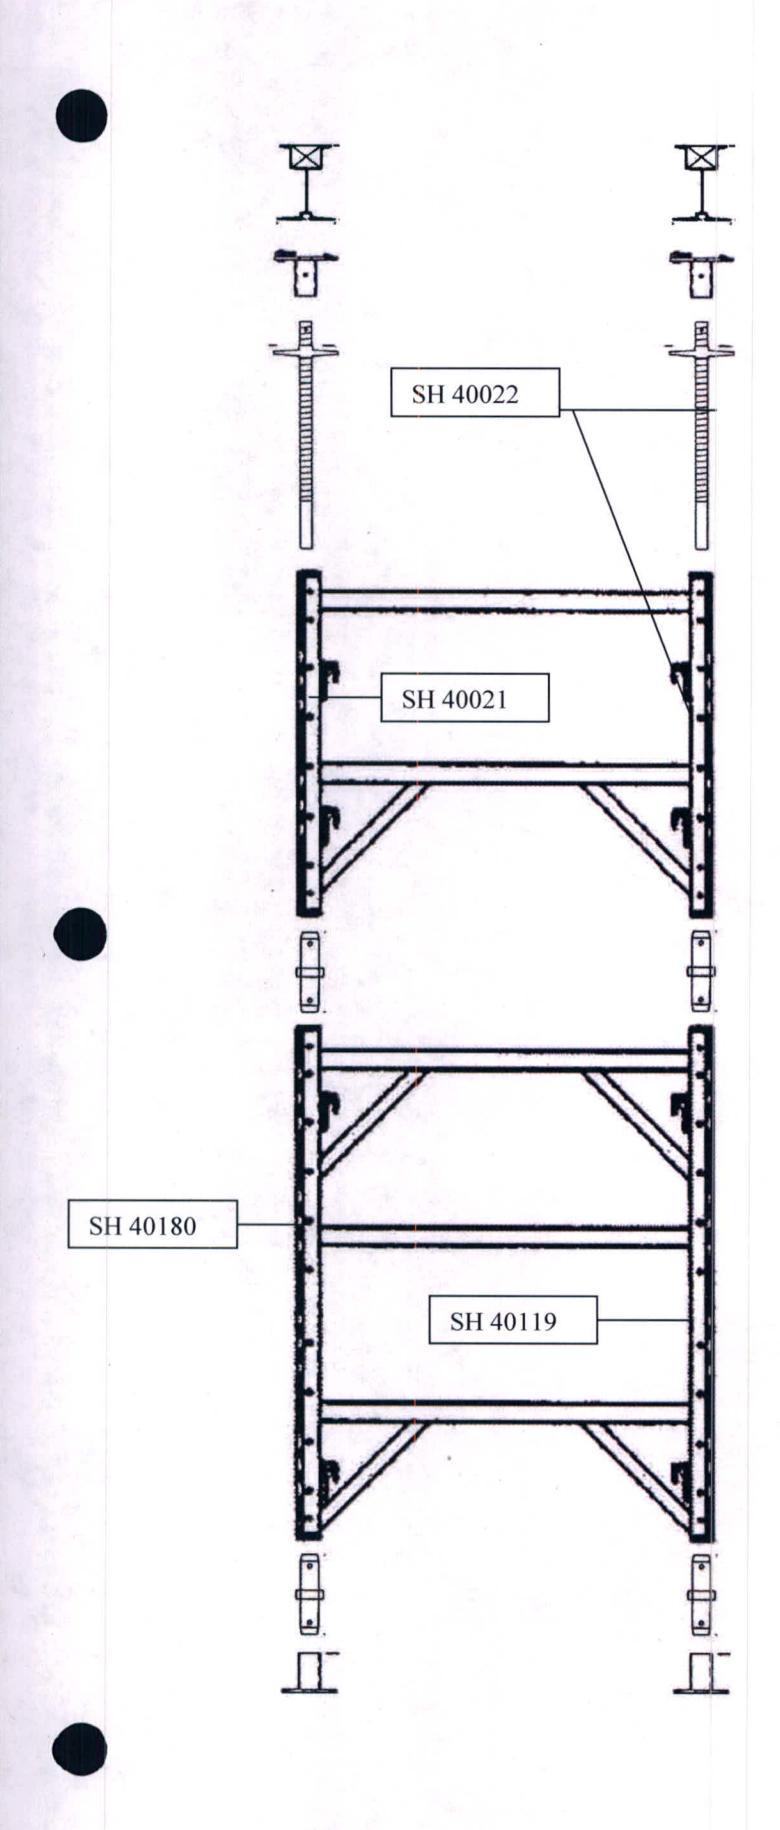
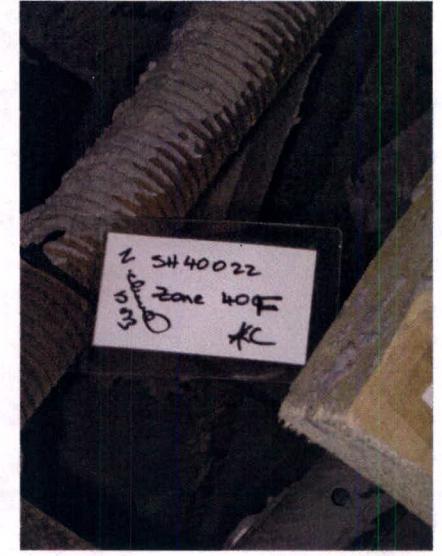
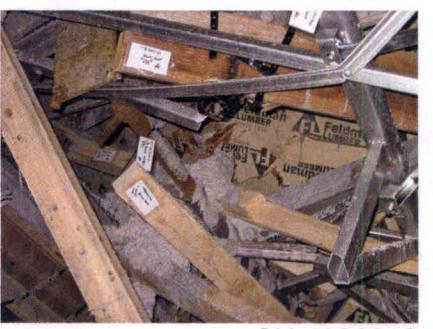
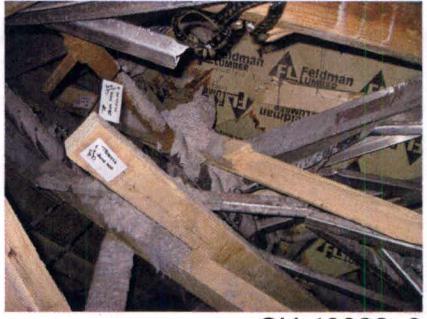
SH 40022_1

SH 40022 Screw Jack and Shore Zone 40F Connection to other shore leg

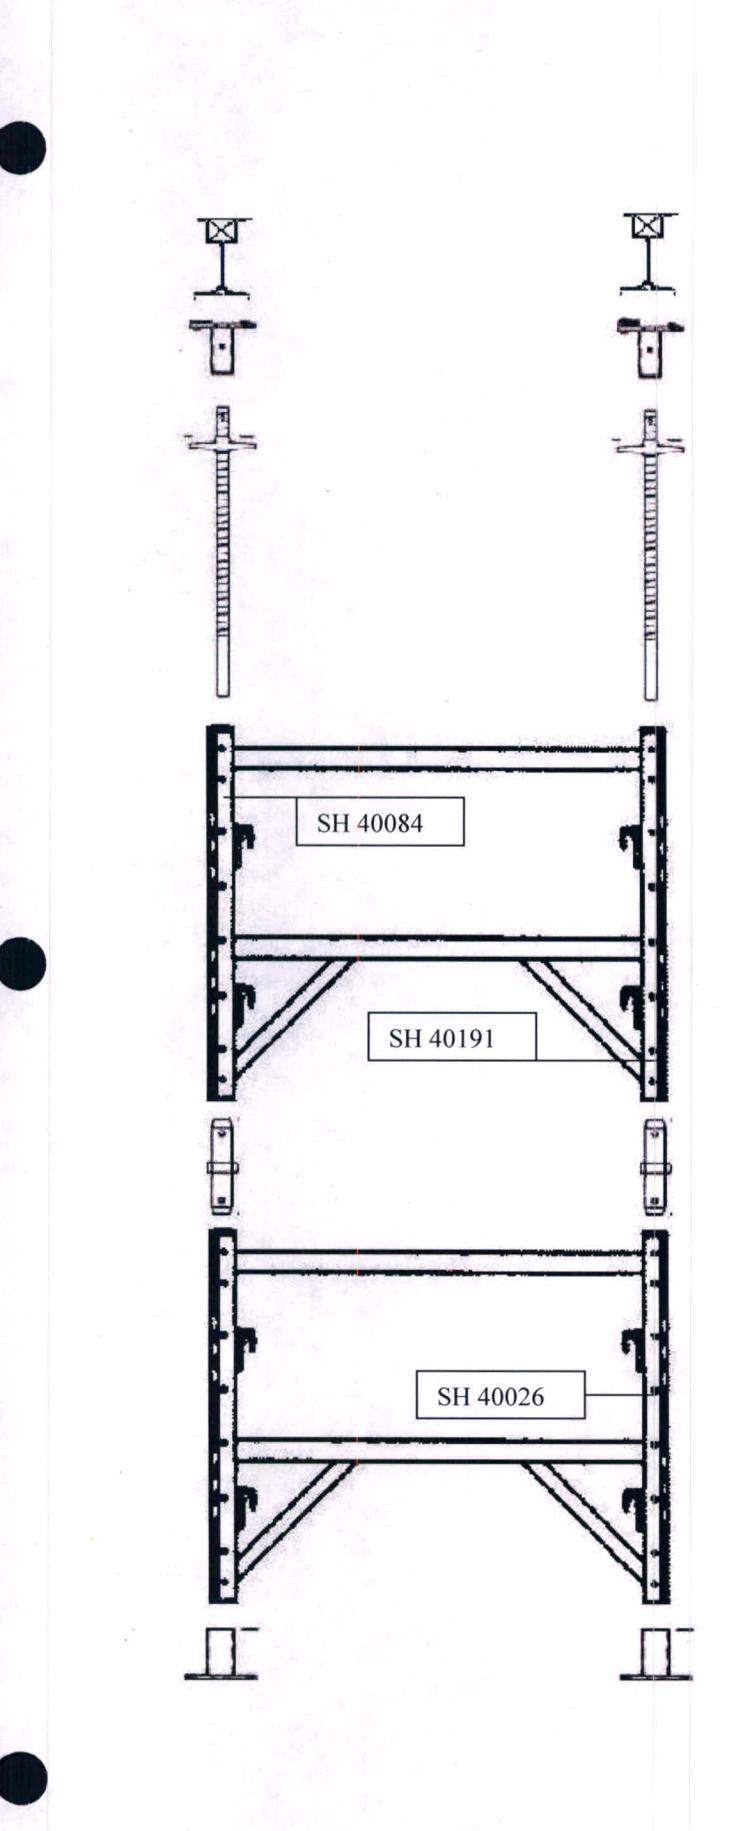
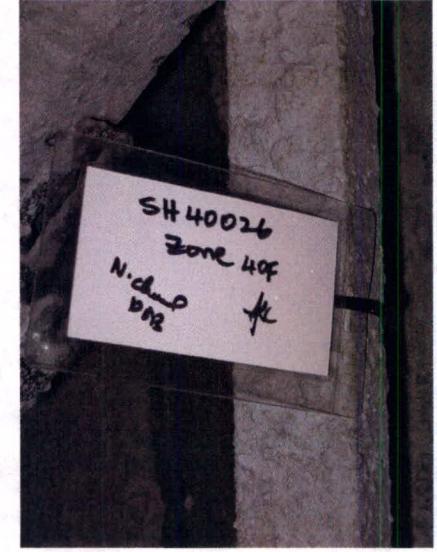
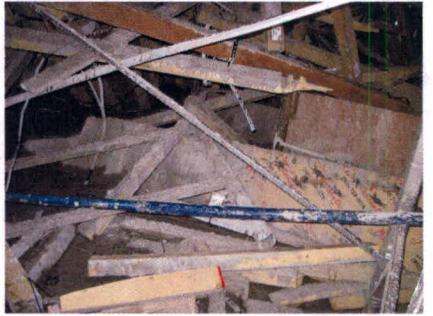
SH 40026_1

SH 40026 (41st floor bottom frame 3'-6") Found on floor Bott Frame Zone 40F

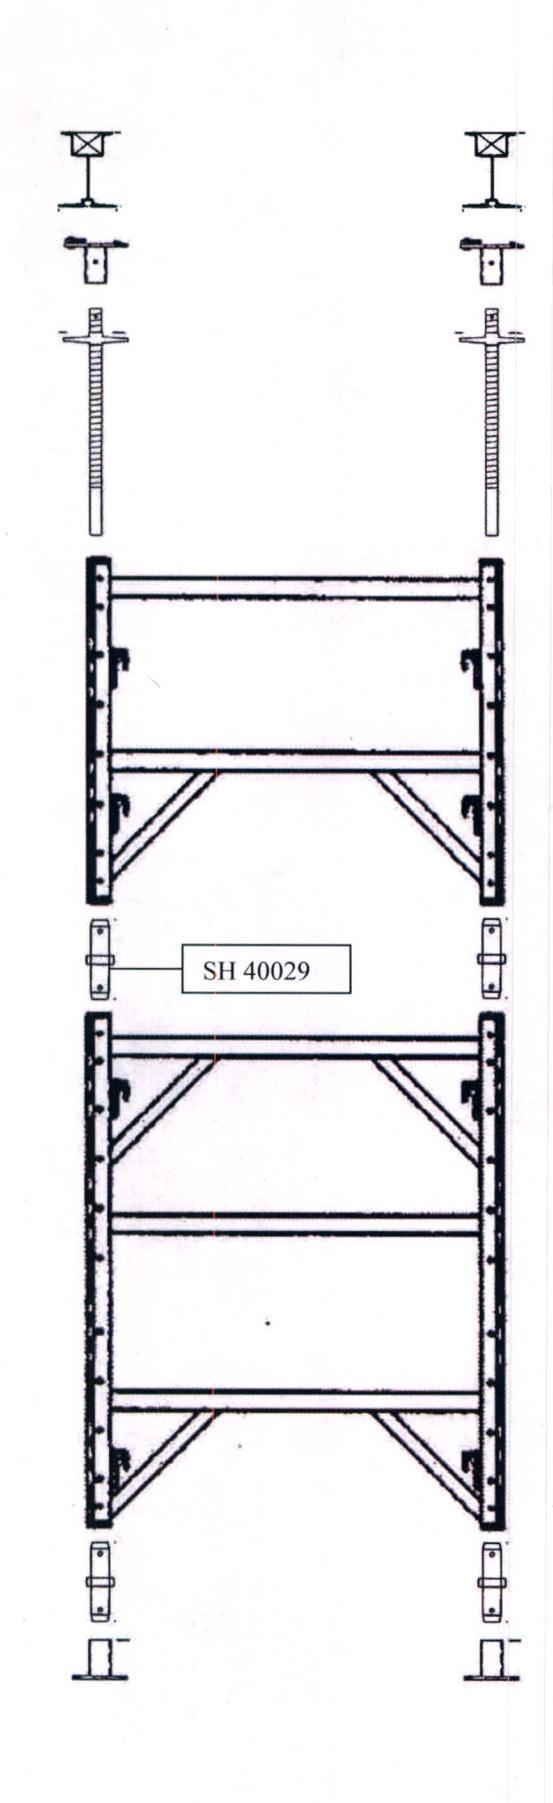
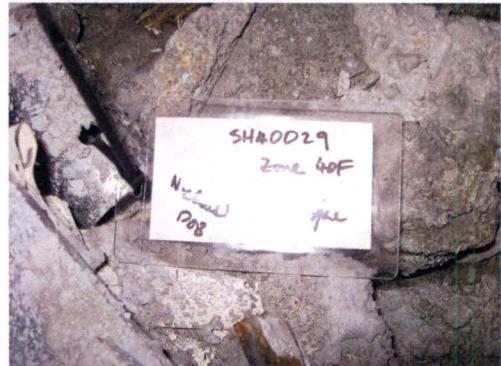
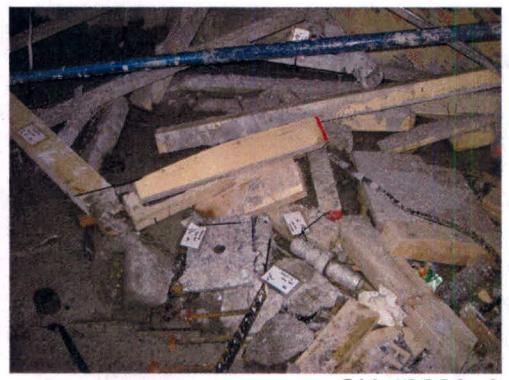
SH 40029_1

SH 40029 Coupler Zone 40F

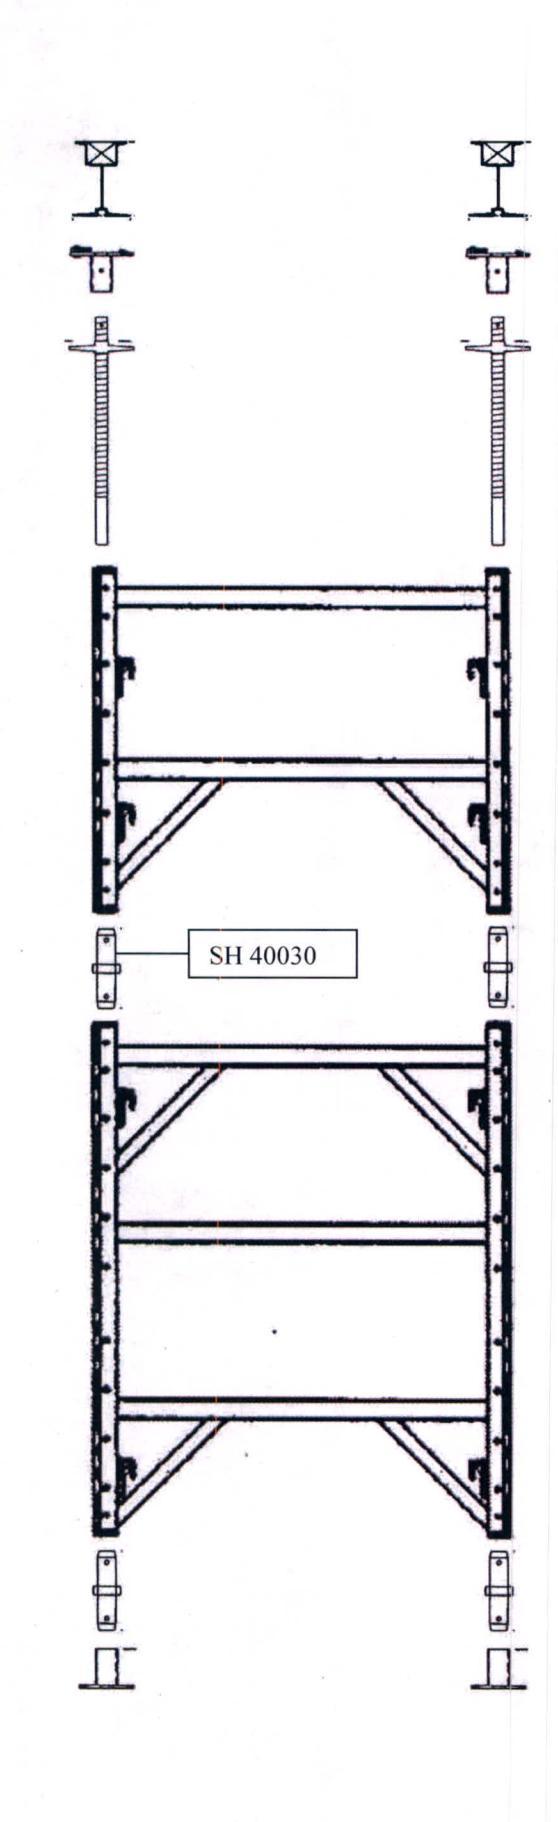
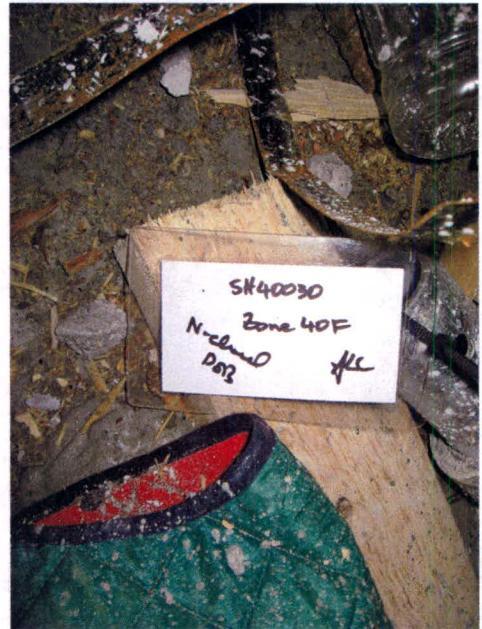
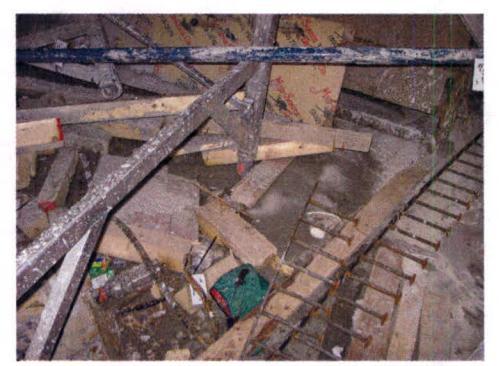
SH 40030_1

SH 40030 Coupler 40F

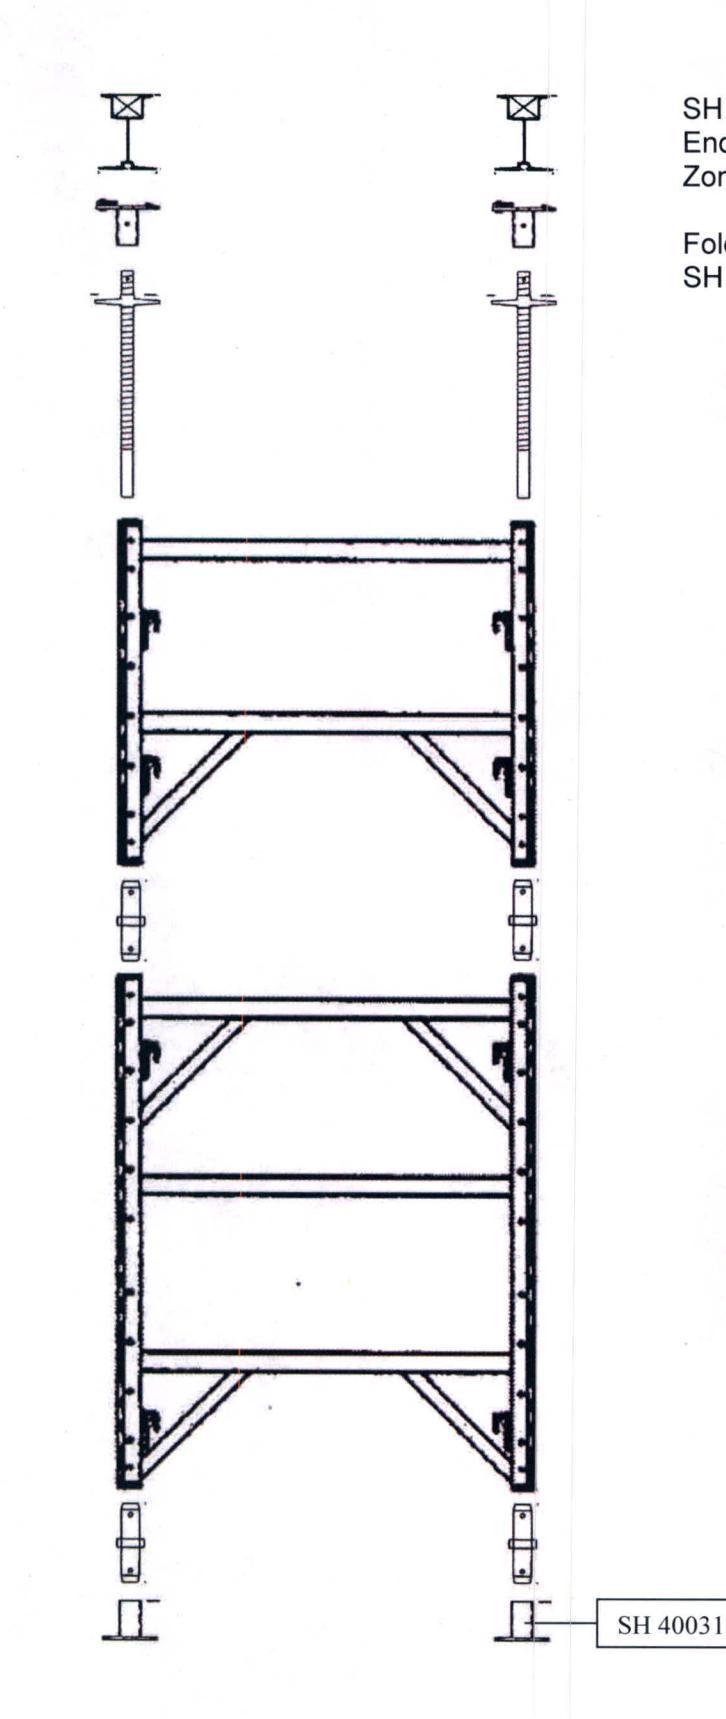
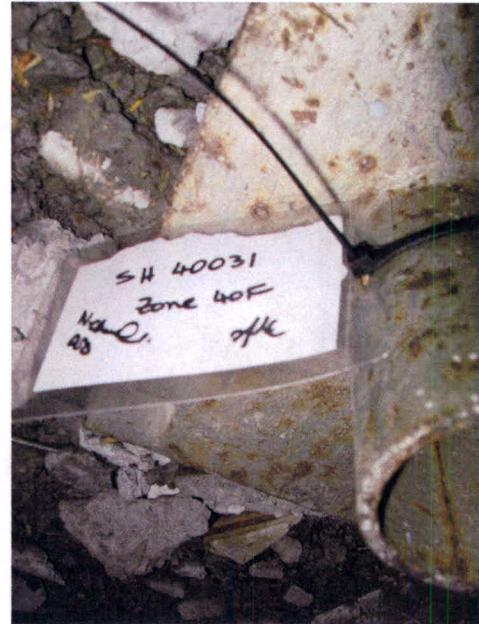
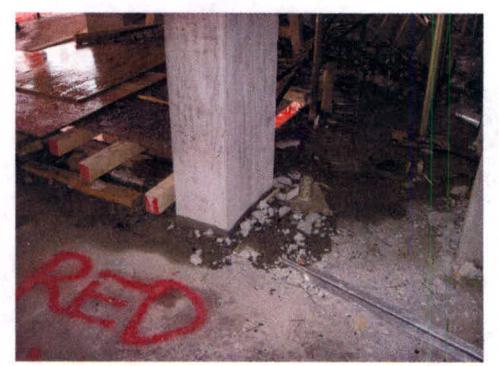
SH 40031_1

SH 40031 End Plate Zone 40F

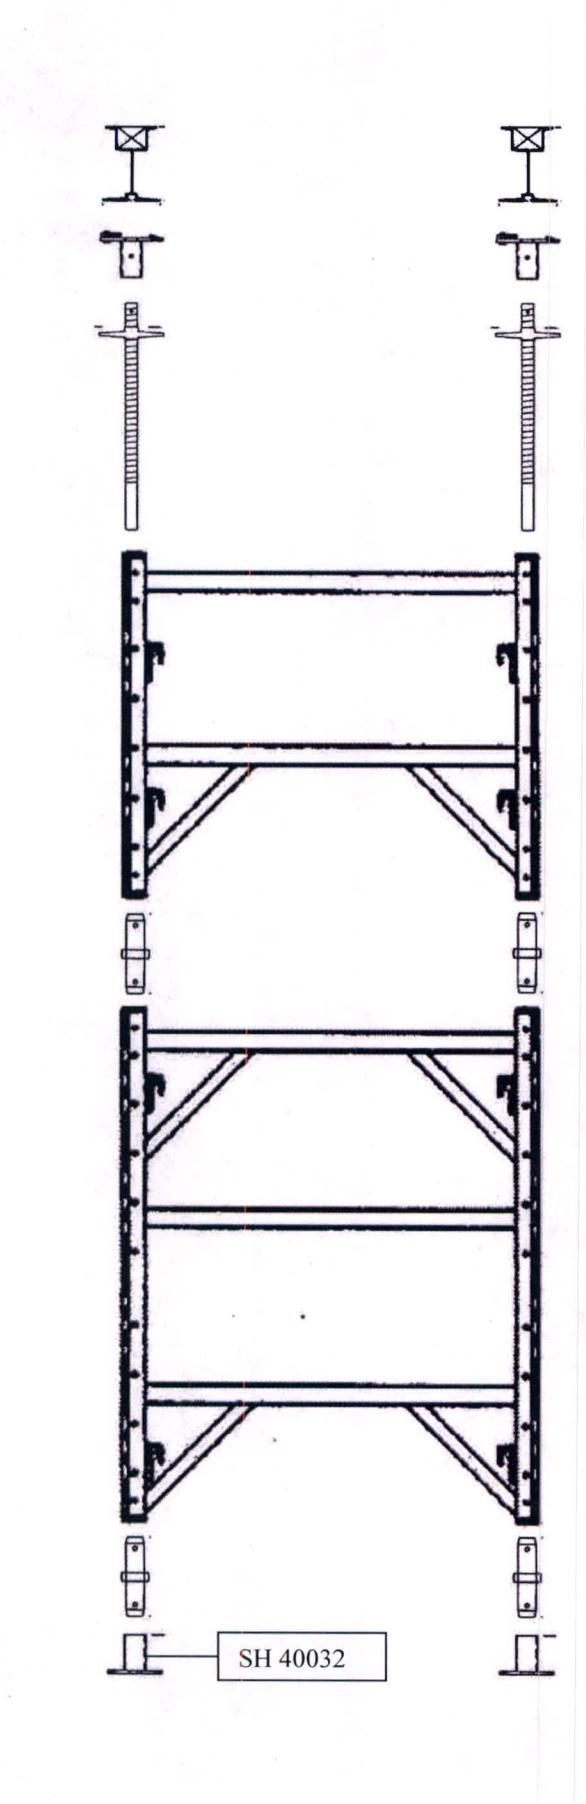
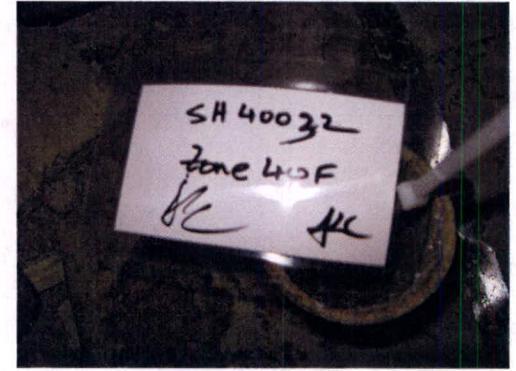
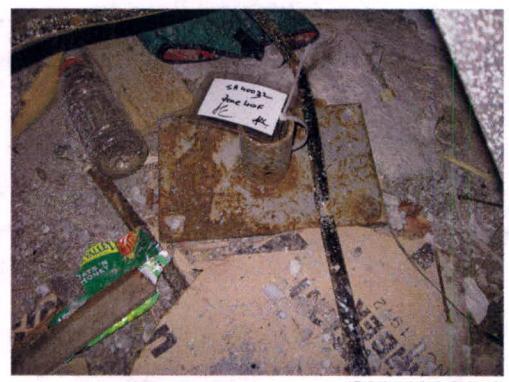
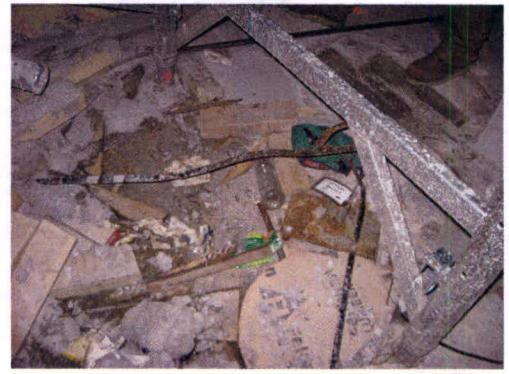
SH 40032 1

SH 40032 End Plate Zone 40F
