INVESTIGATION REPORT:

JANUARY 14, 2008 SHORING COLLAPSE AT 9 DOMINICK ST. (AKA 246 SPRING ST.) MANHATTAN

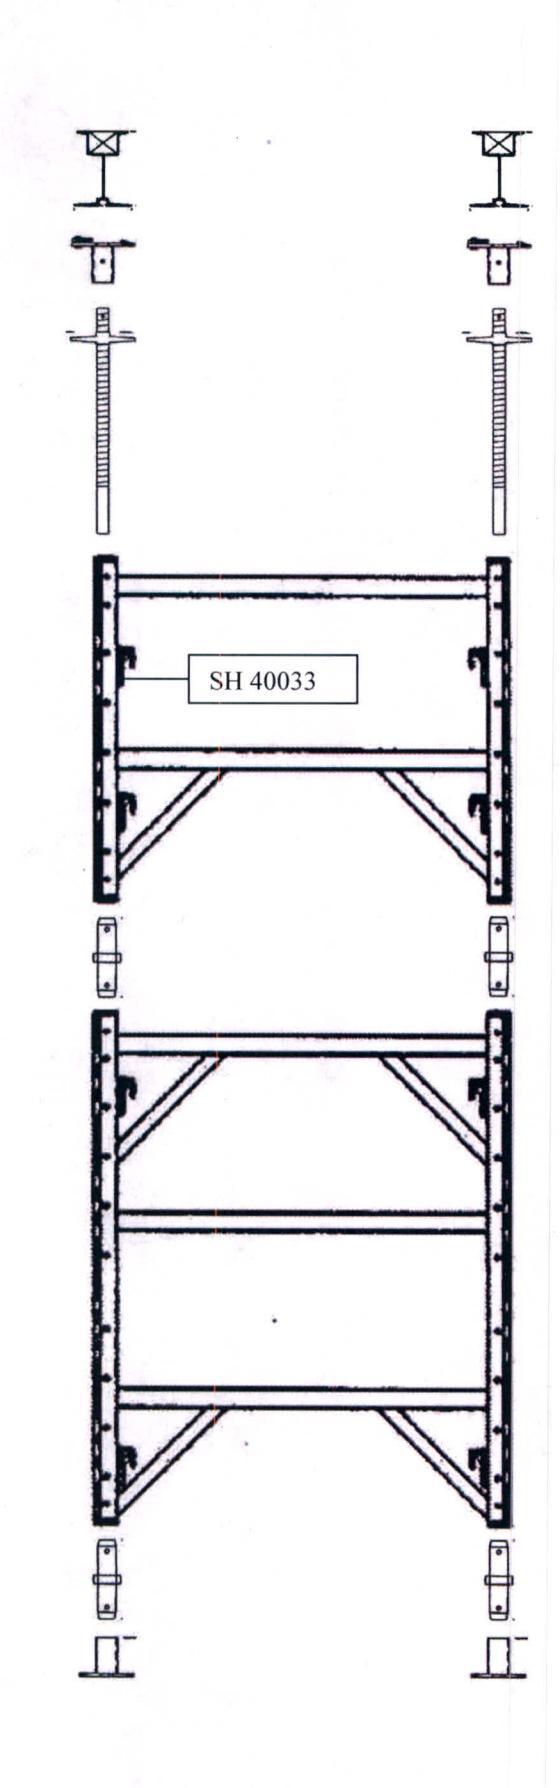
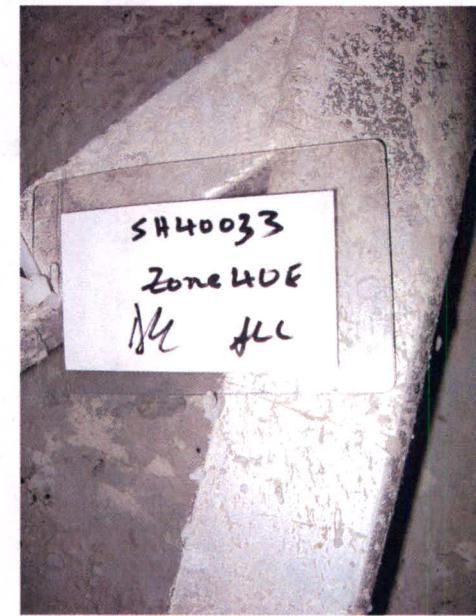
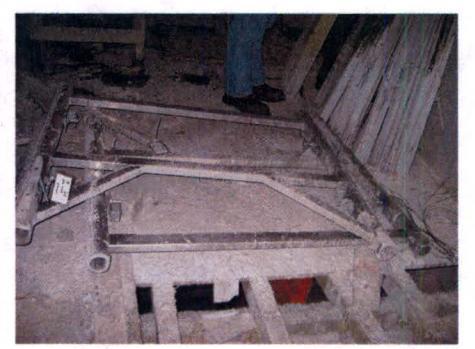
SH 40033 1

SH 40033 Zone 40E Top Frame neat at Col. 101 Moved from Original Position-Unknown

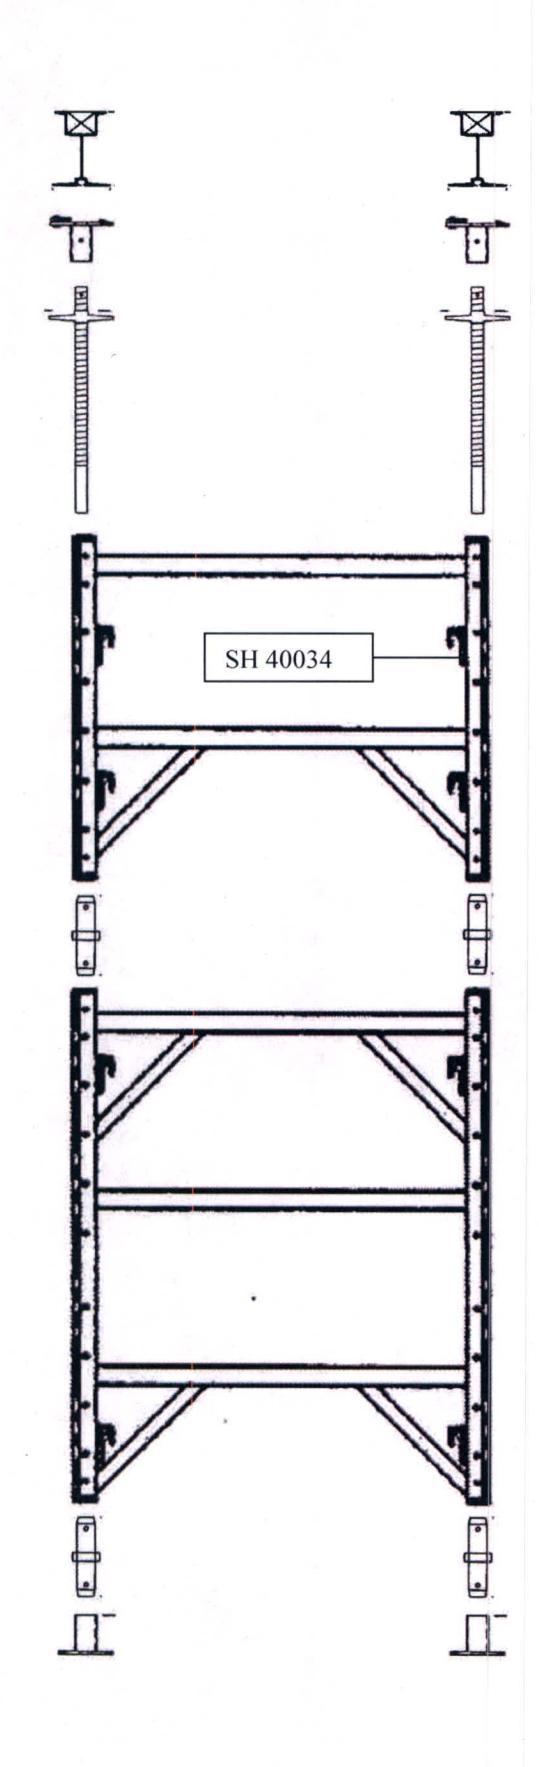
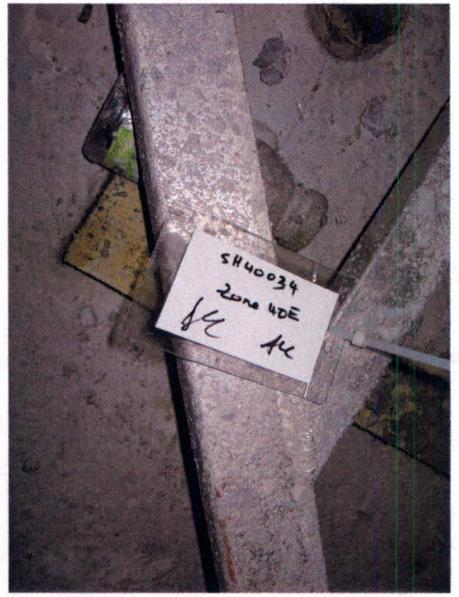
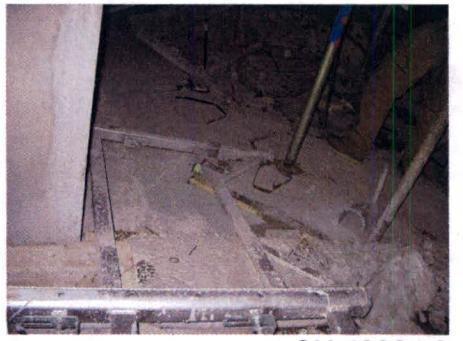
SH 40034 1

SH 40034 Zone 40E At location of Column 101 Top Frame Move from Original Location-Unknown

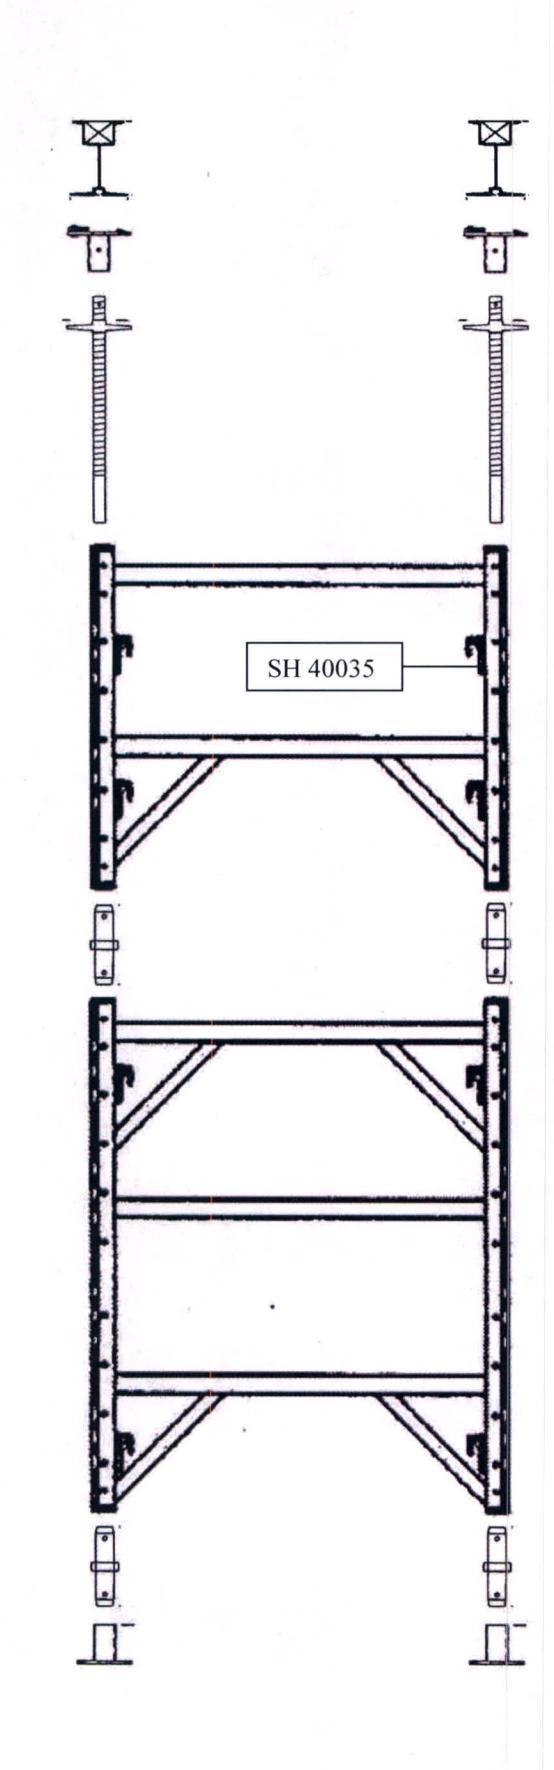
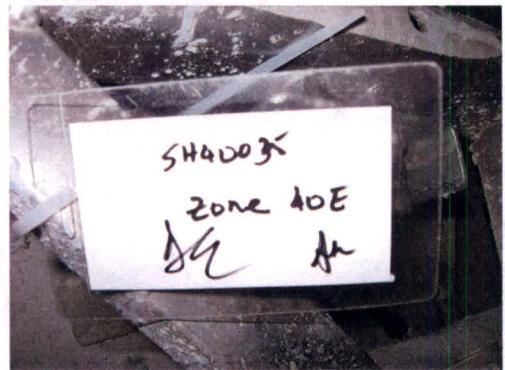
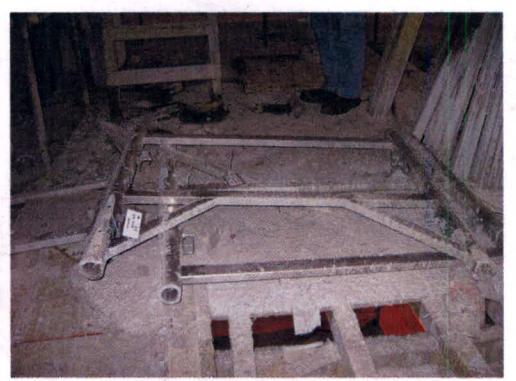
SH 40035 1

SH 40035 Top Frame near Col. 101 Zone 40E Move from original location-Unknown

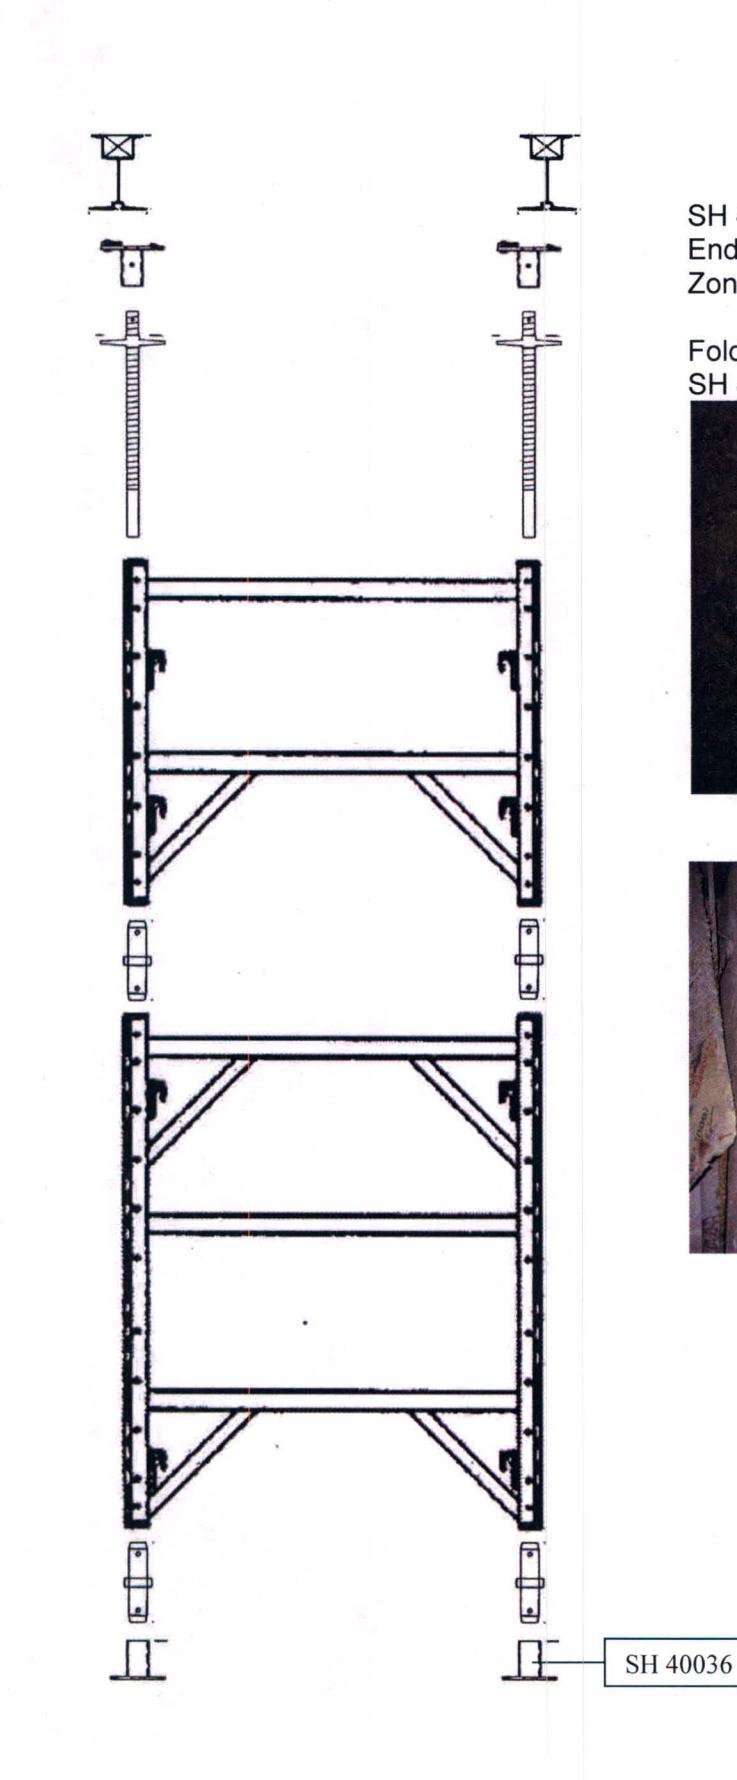
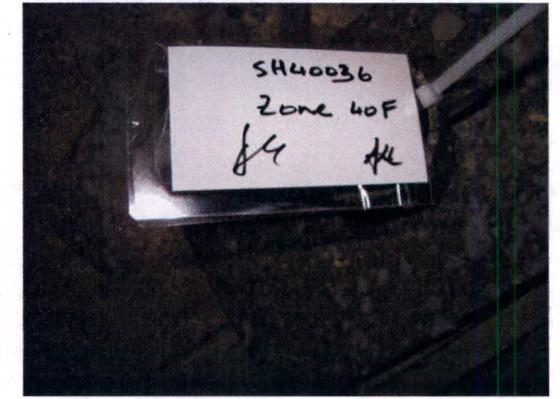
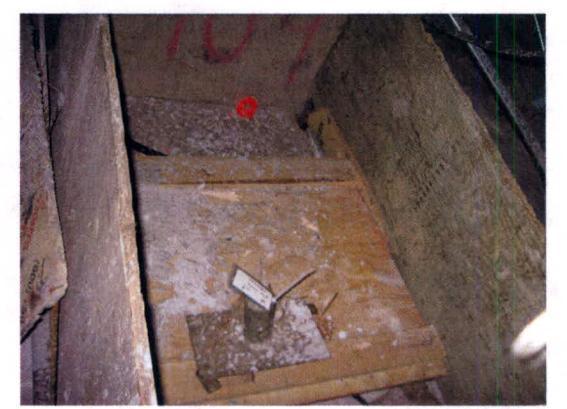
SH 40036 1

SH 40036 End plate Zone 40F

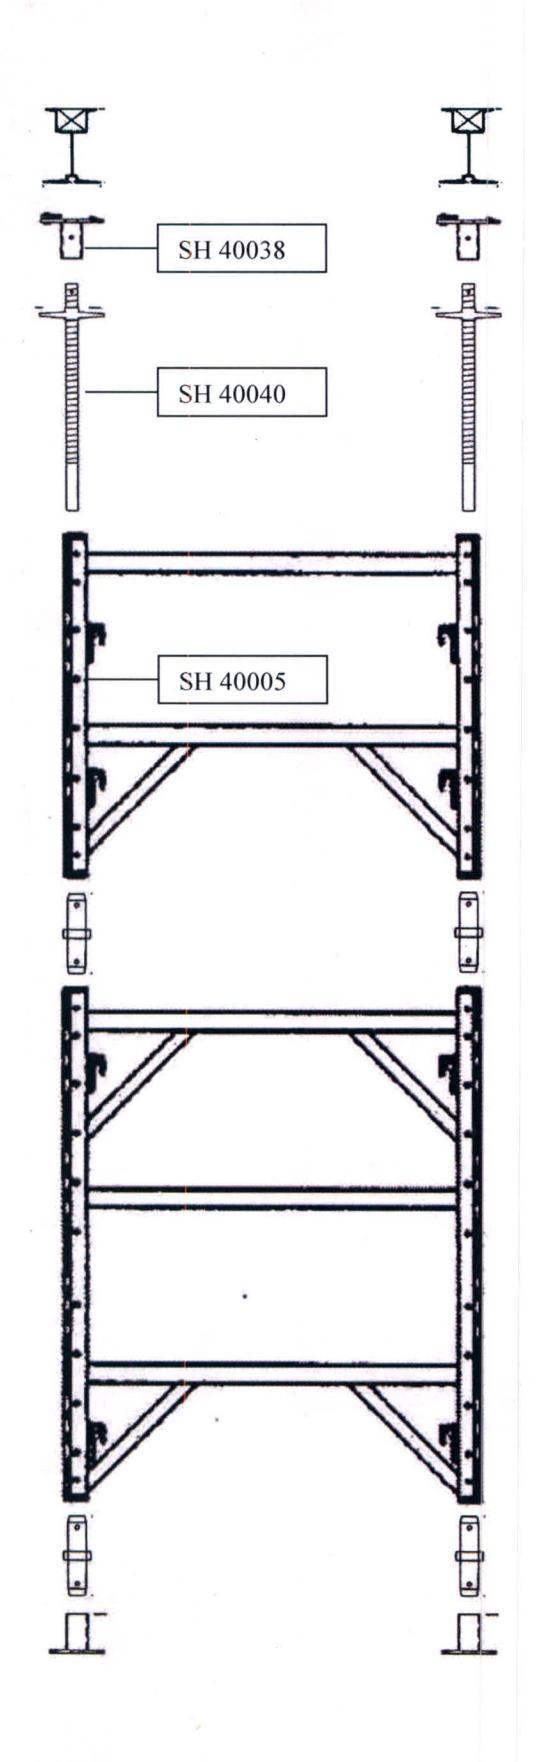
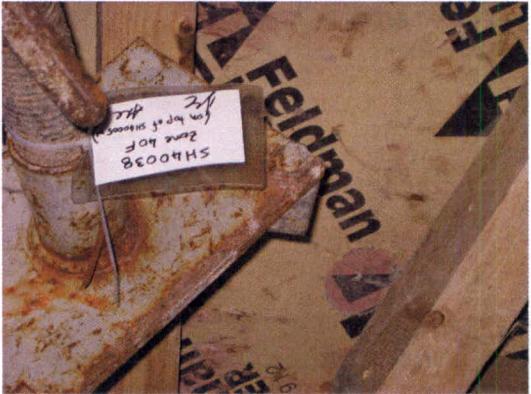
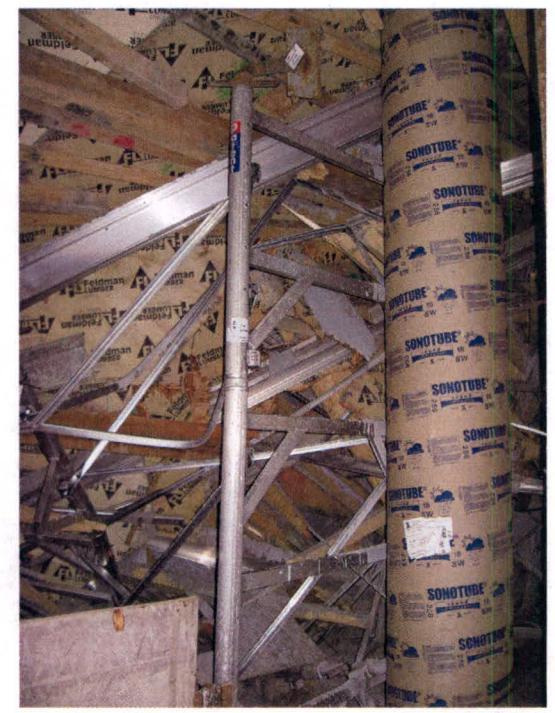
SH 40038 1

SH 40038 Top Plate Zone 40F Attached to SH 40005

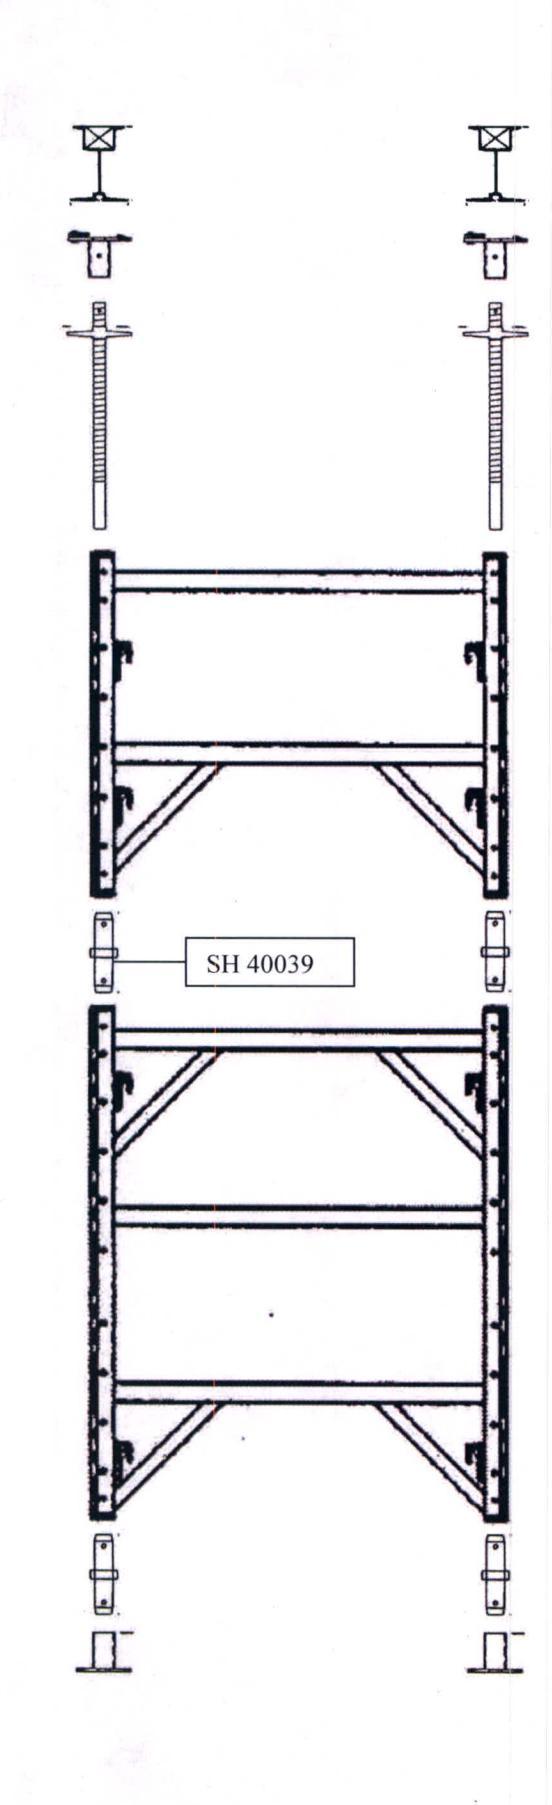
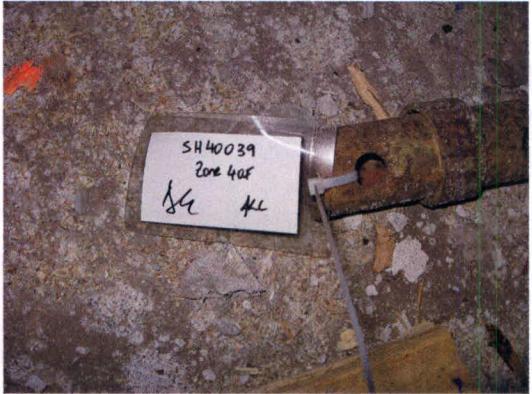
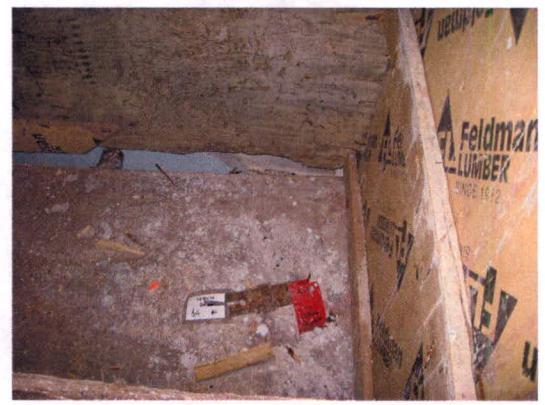
SH 40039 1

SH 40039 Coupler Zone 40F

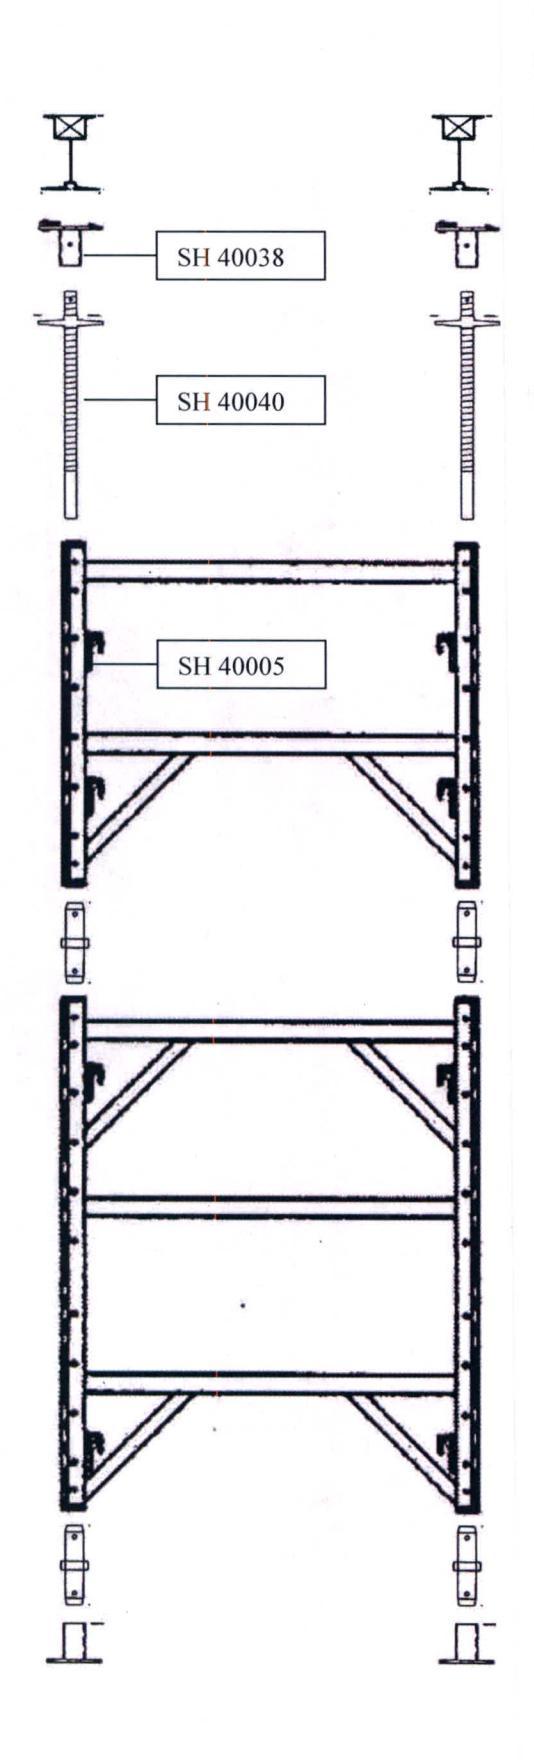
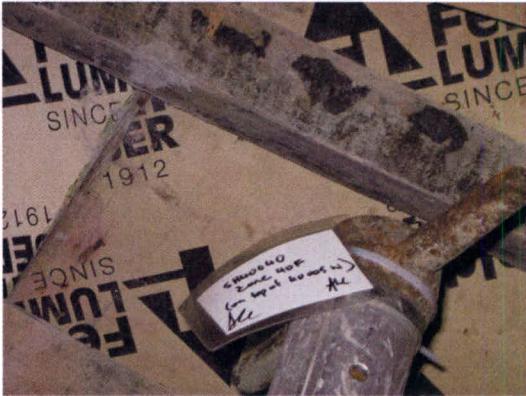
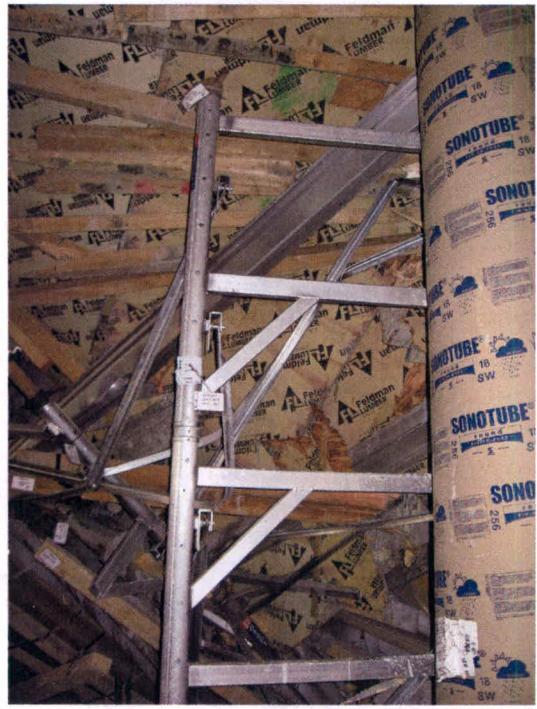
SH 40040 1

SH 40040 Screw Jack Zone 40F

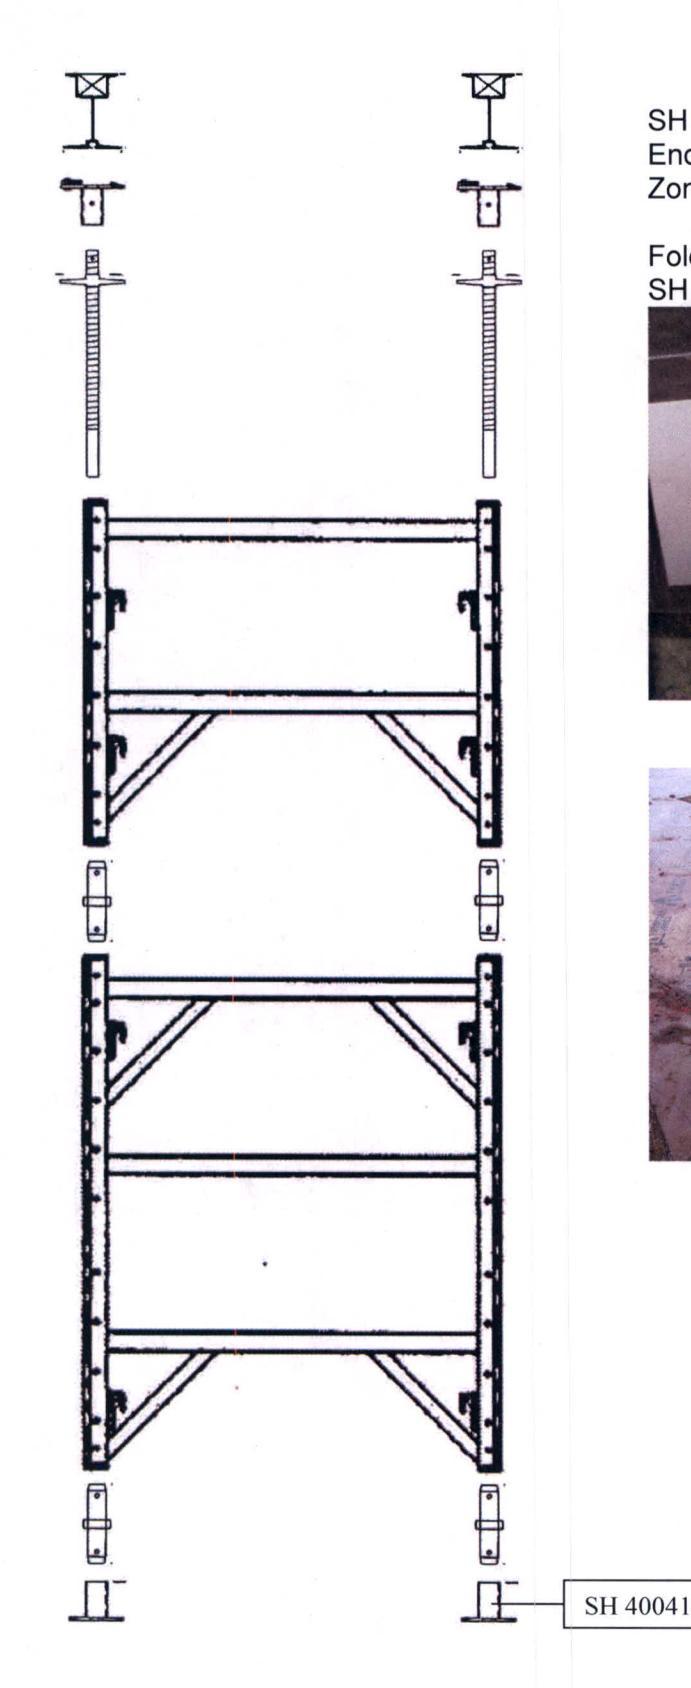
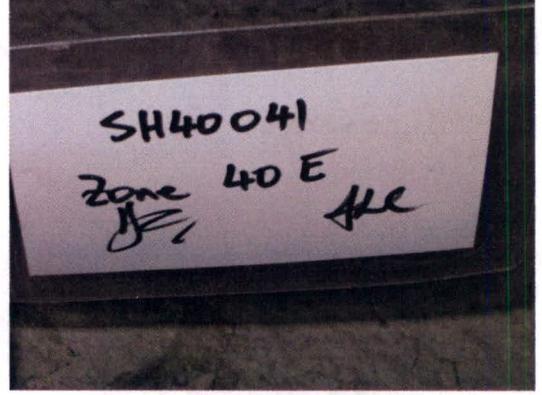
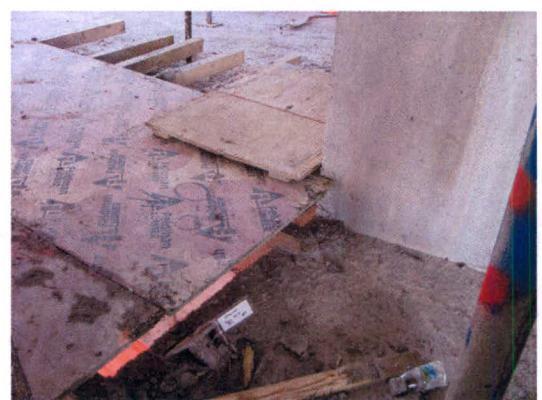
SH 40041 1

SH 40041 End Plate Zone 40F

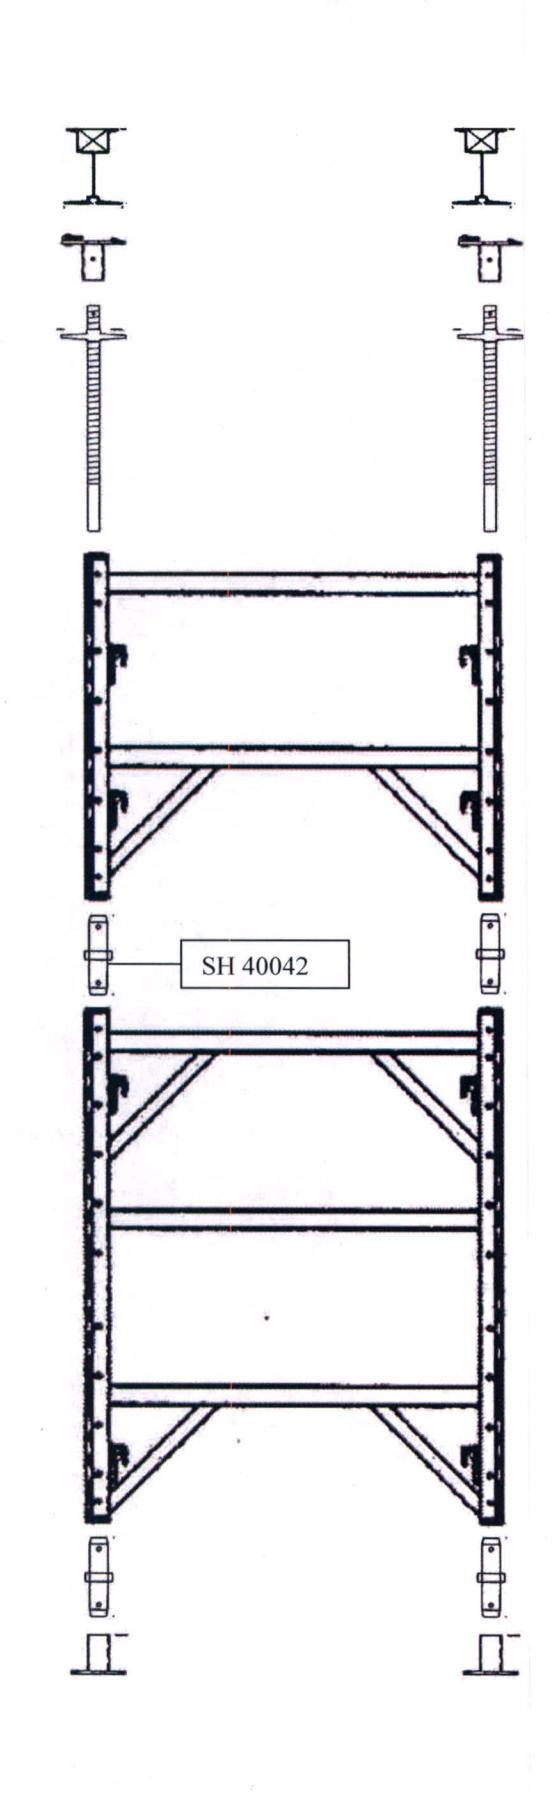
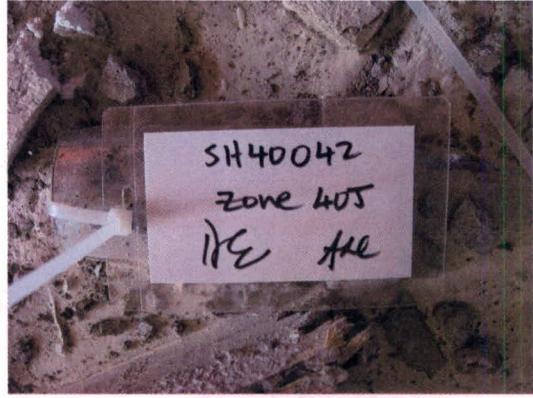
SH 40042 1

SH 40042 Coupler Zone 40E

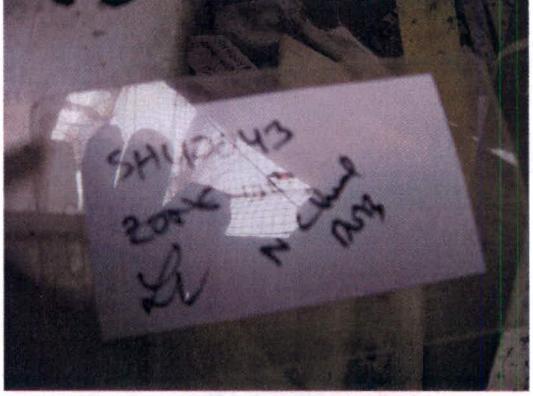
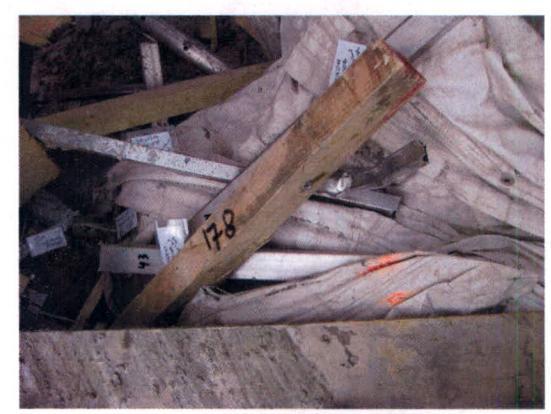
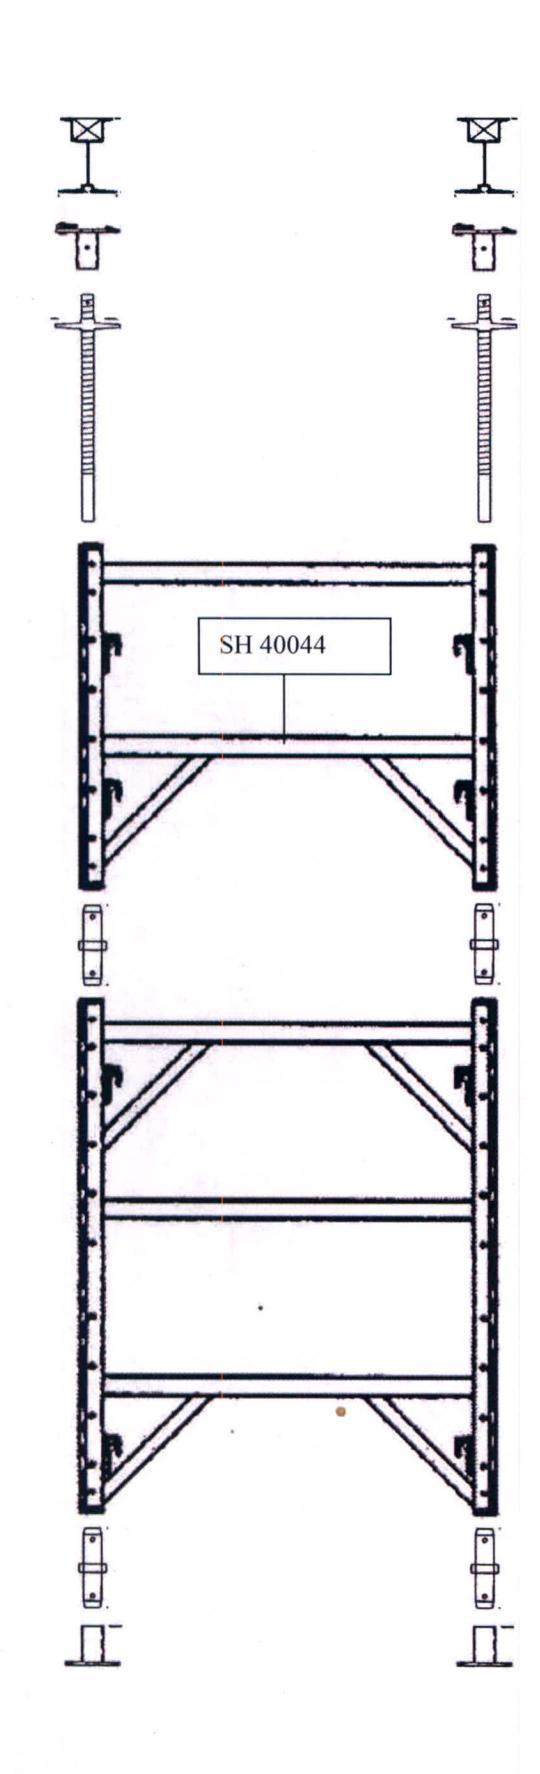
Folder: 08-02-15; SH 40043

SH 40043 Piece of Shore Zone 40B

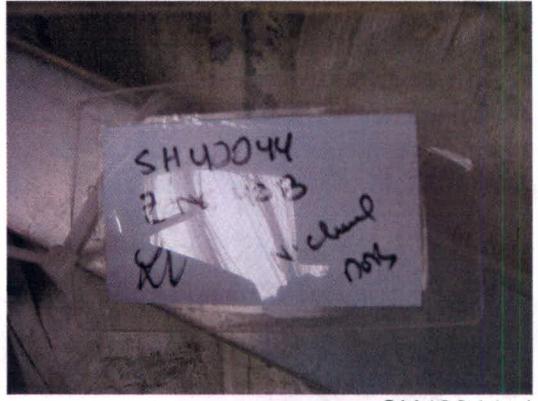
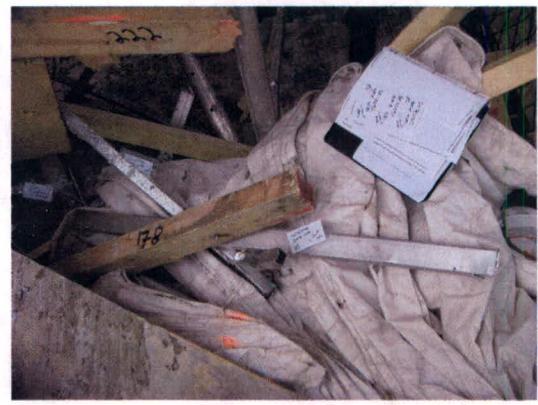
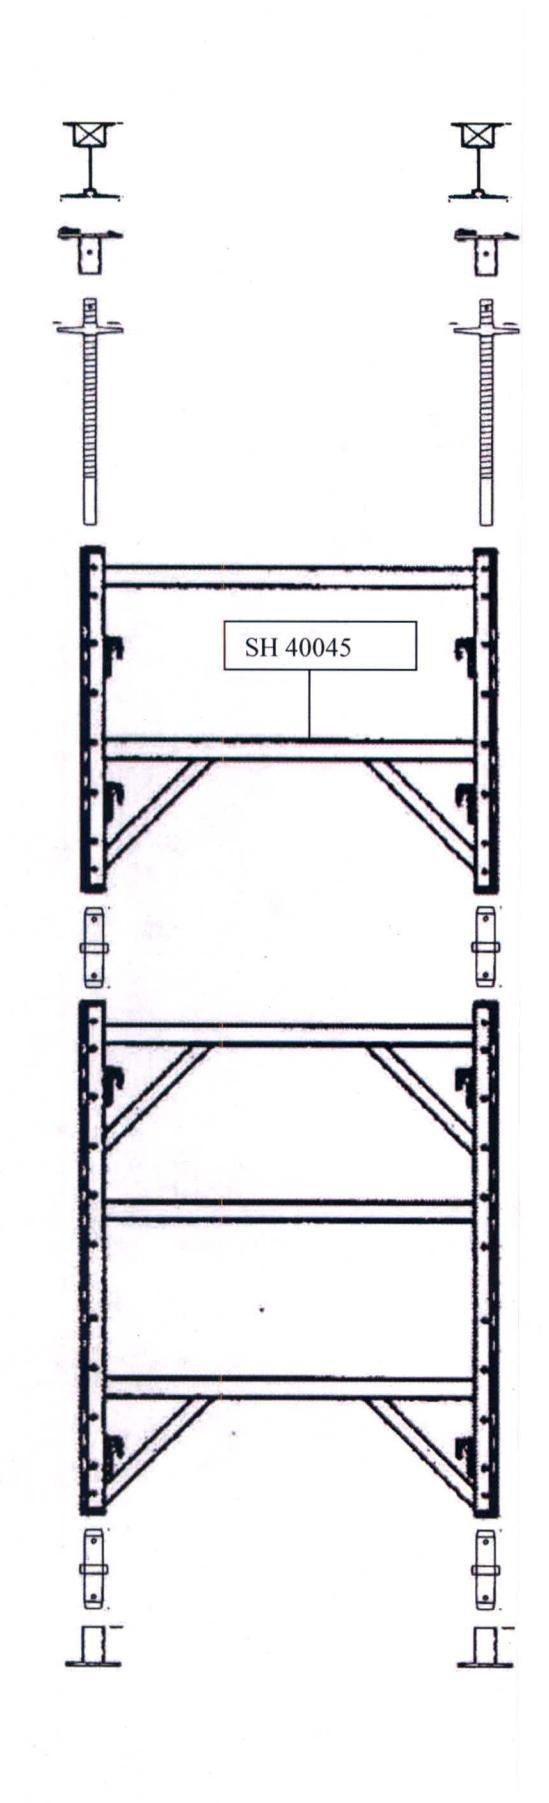
Folder: 08-02-15; SH 40044

SH 40044 Piece of Shore Zone 40B

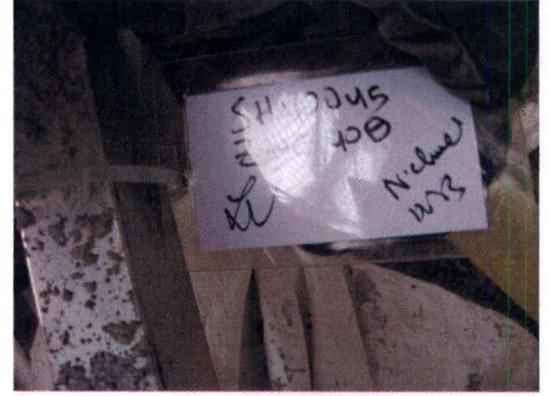
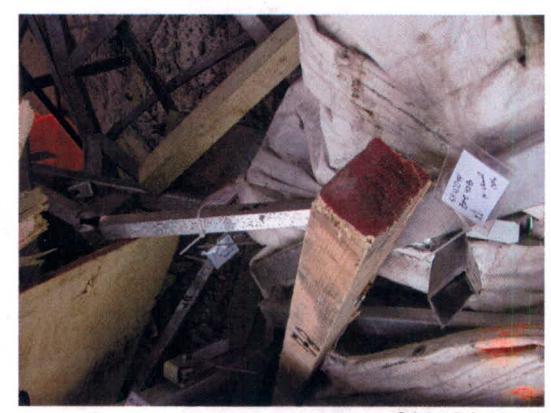
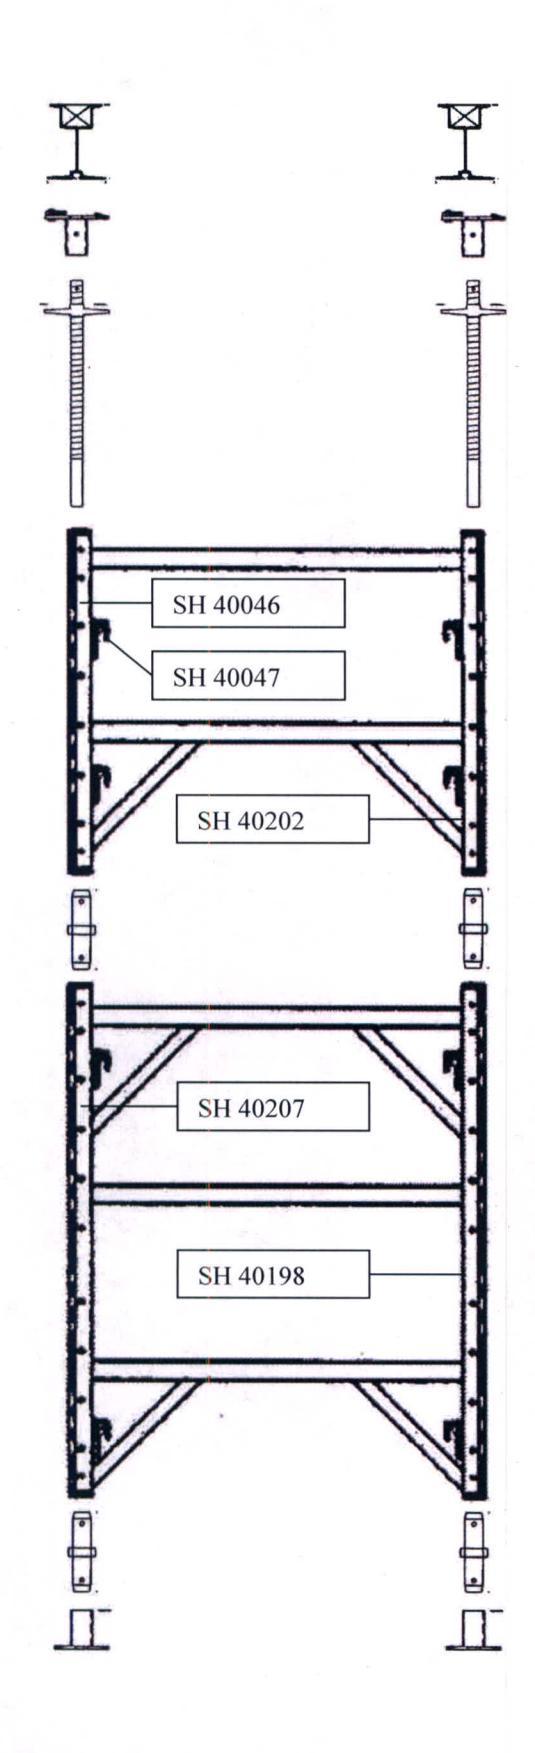
Folder: 08-02-15; SH 40045

SH 40045 Piece of Shore Zone 40B

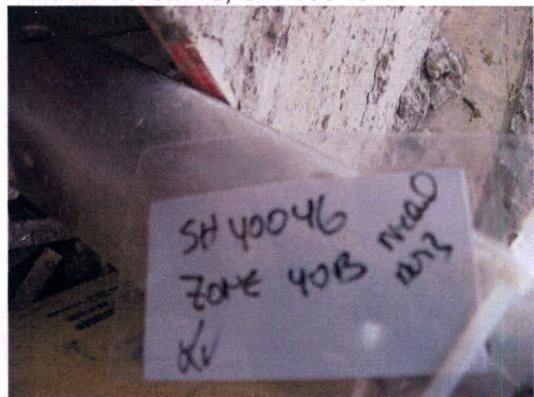
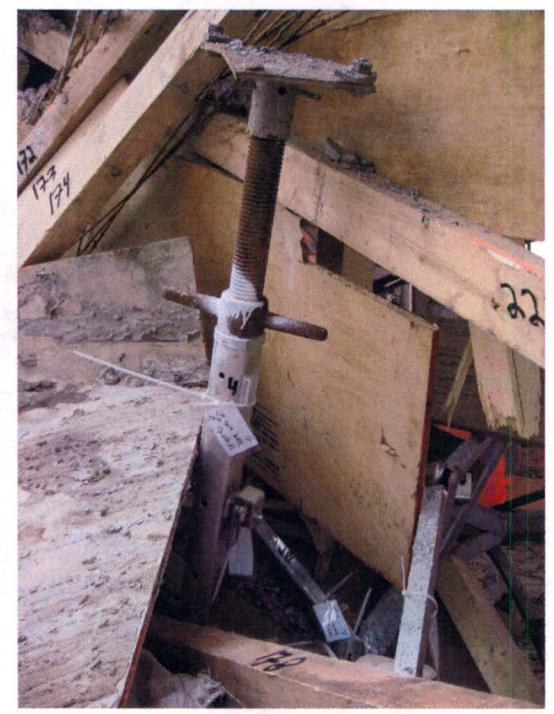
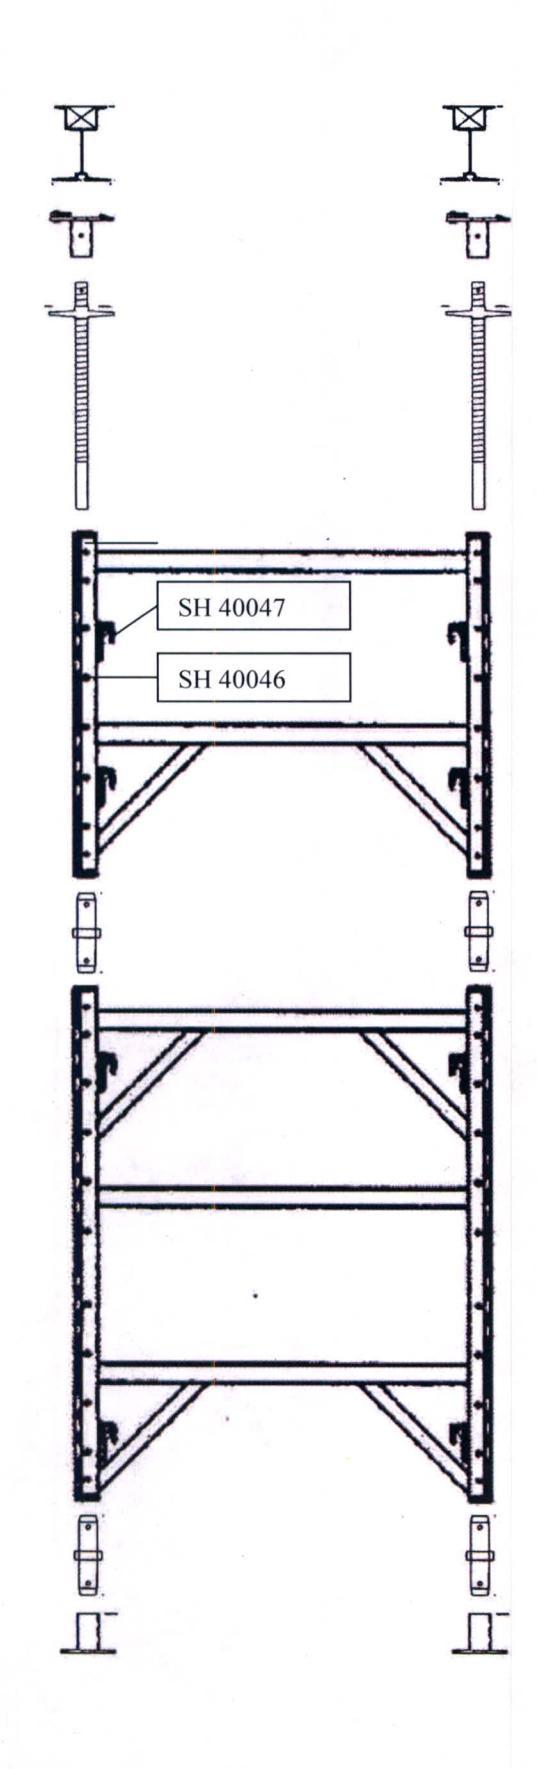
Folder: 08-02-15; SH 40046

SH 40046 Top Shore Attached Screw Jack and Top Plate Attached to X Brace SH 40047 Zone 40B

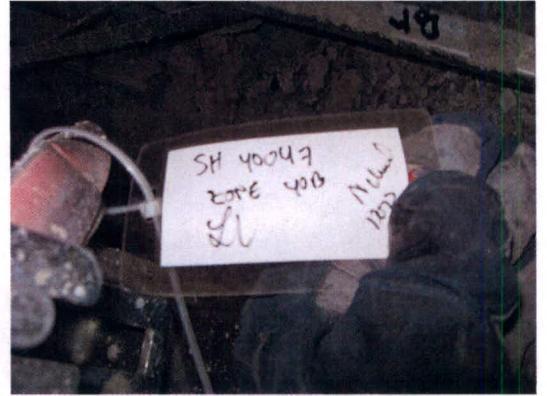
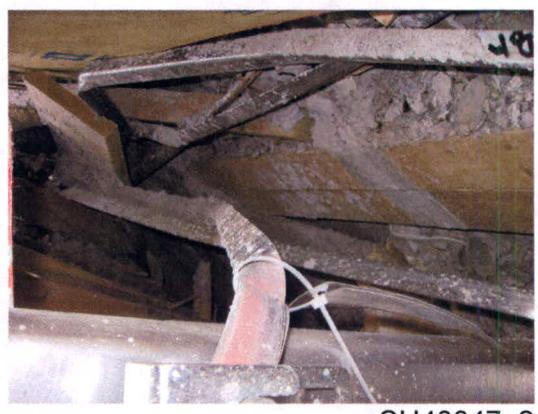
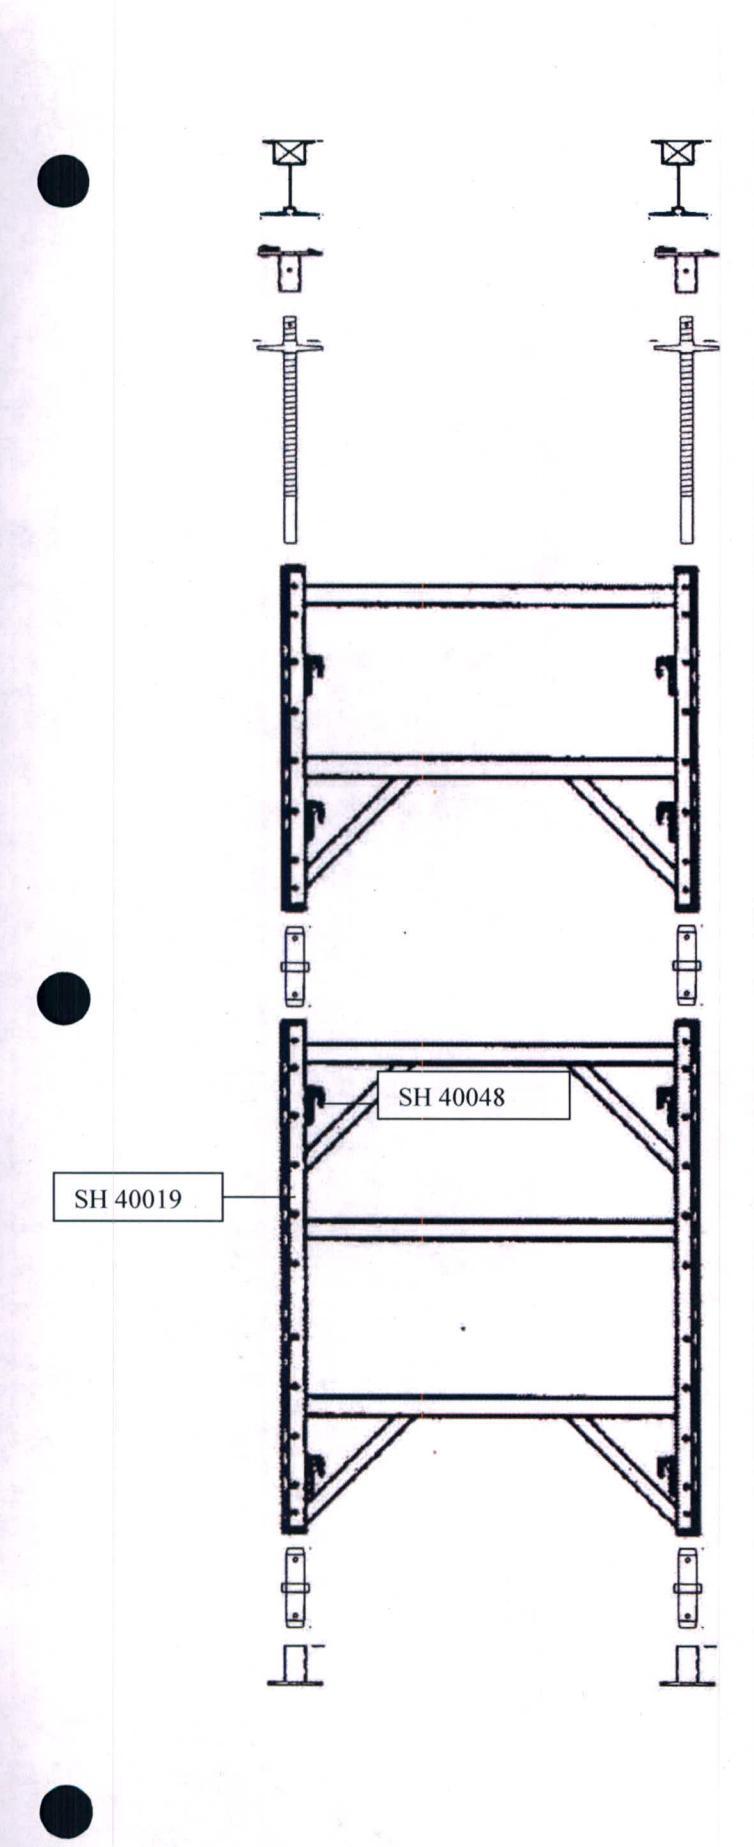
Folder: 08-02-15; SH 40047

SH 40047 X Brace Attached to SH 40046
