INVESTIGATION REPORT:

JANUARY 14, 2008 SHORING COLLAPSE AT 9 DOMINICK ST. (AKA 246 SPRING ST.) MANHATTAN

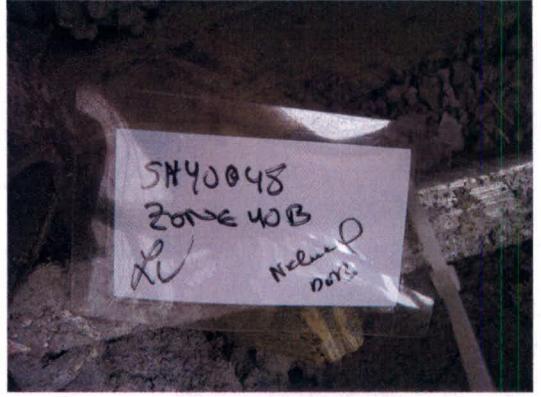
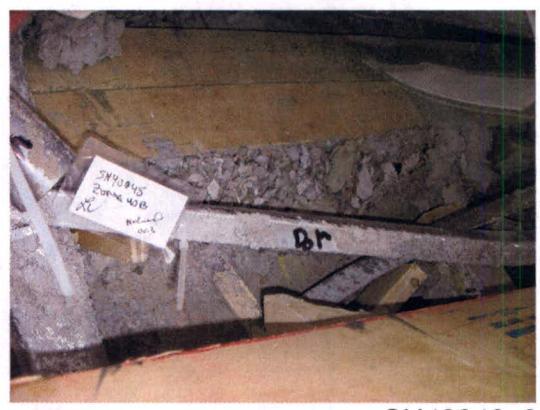
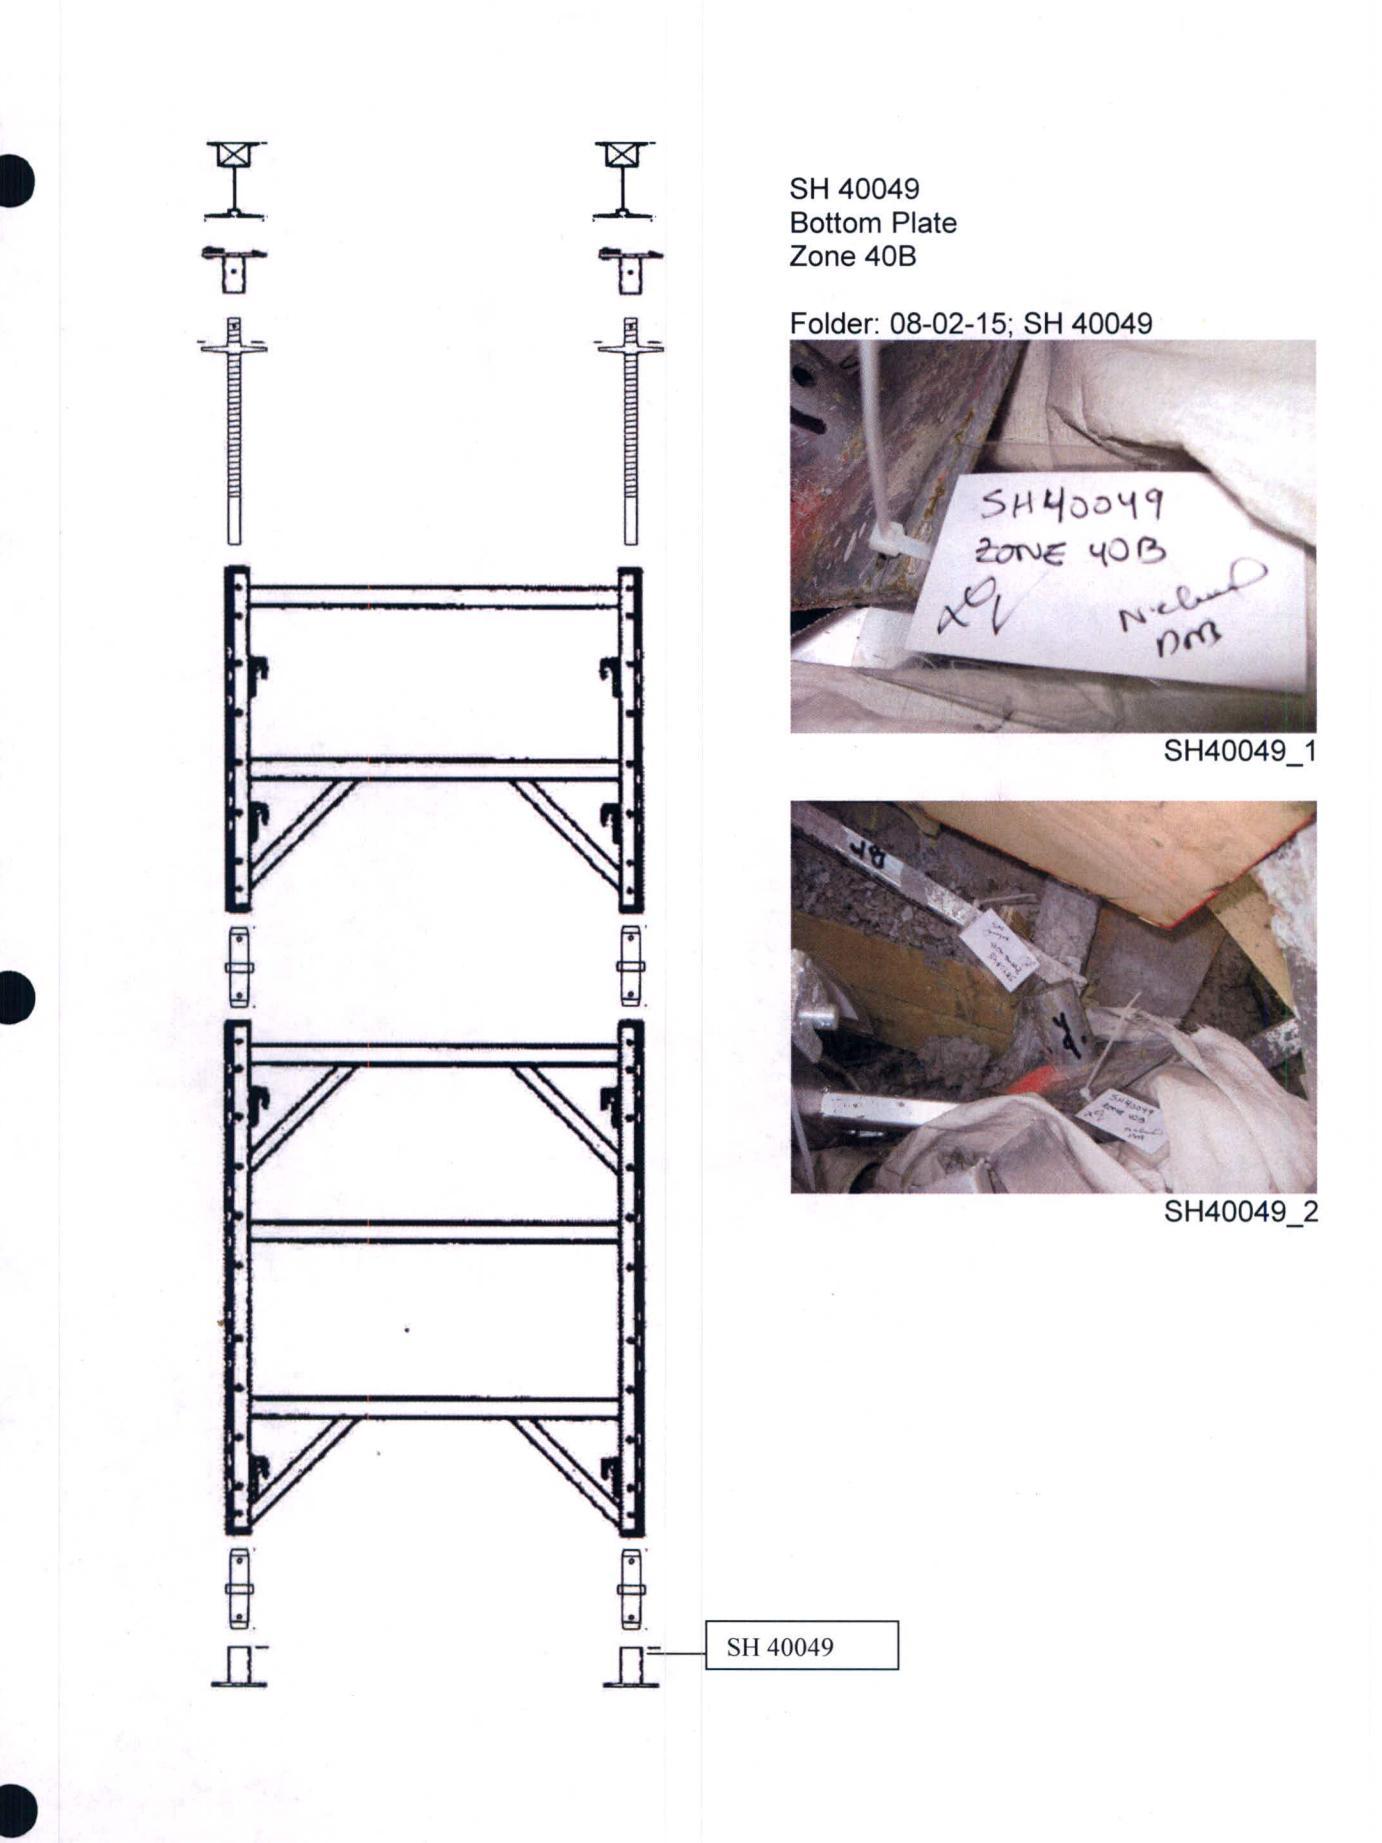
Folder: 08-02-15; SH 40048

SH 40048 X Brace Attached to bottom frame SH 40019

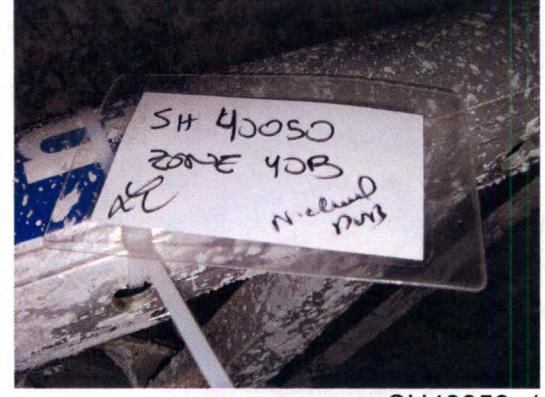
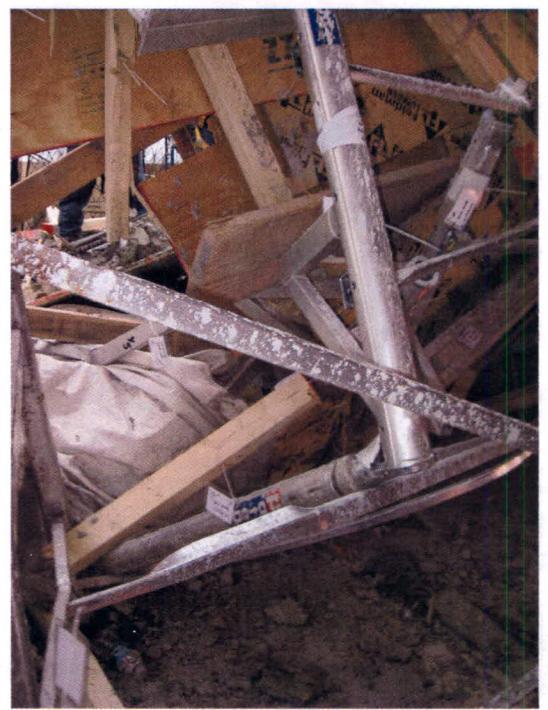
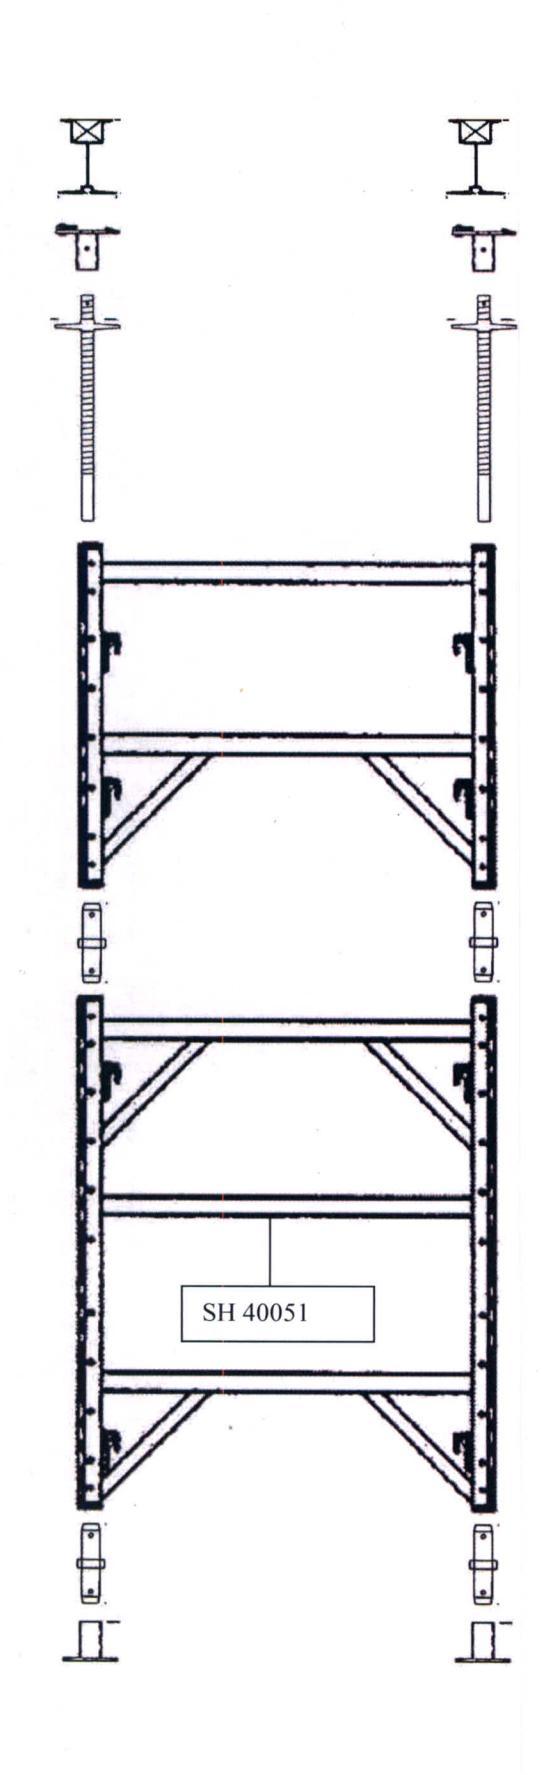
Folder: 08-02-15; SH 40050

SH 40050 Bottom shore broken connect SH 40072 to make full frame Shore Connect to SH 40010 with brace to make tower Zone 40B

SH 40072 Bottom Frame of SH 40017 Broken Zone 40B

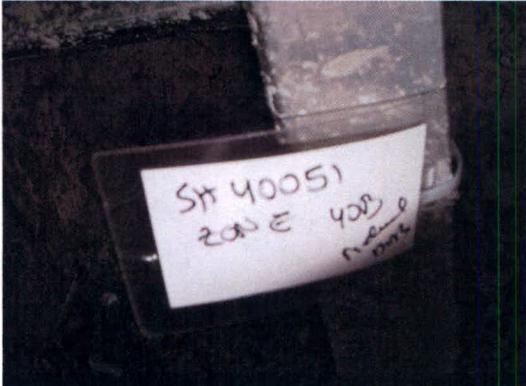
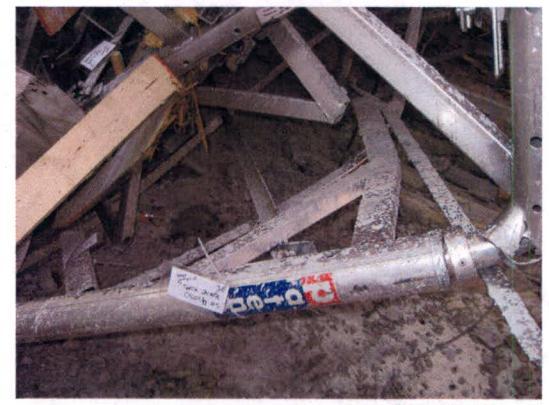
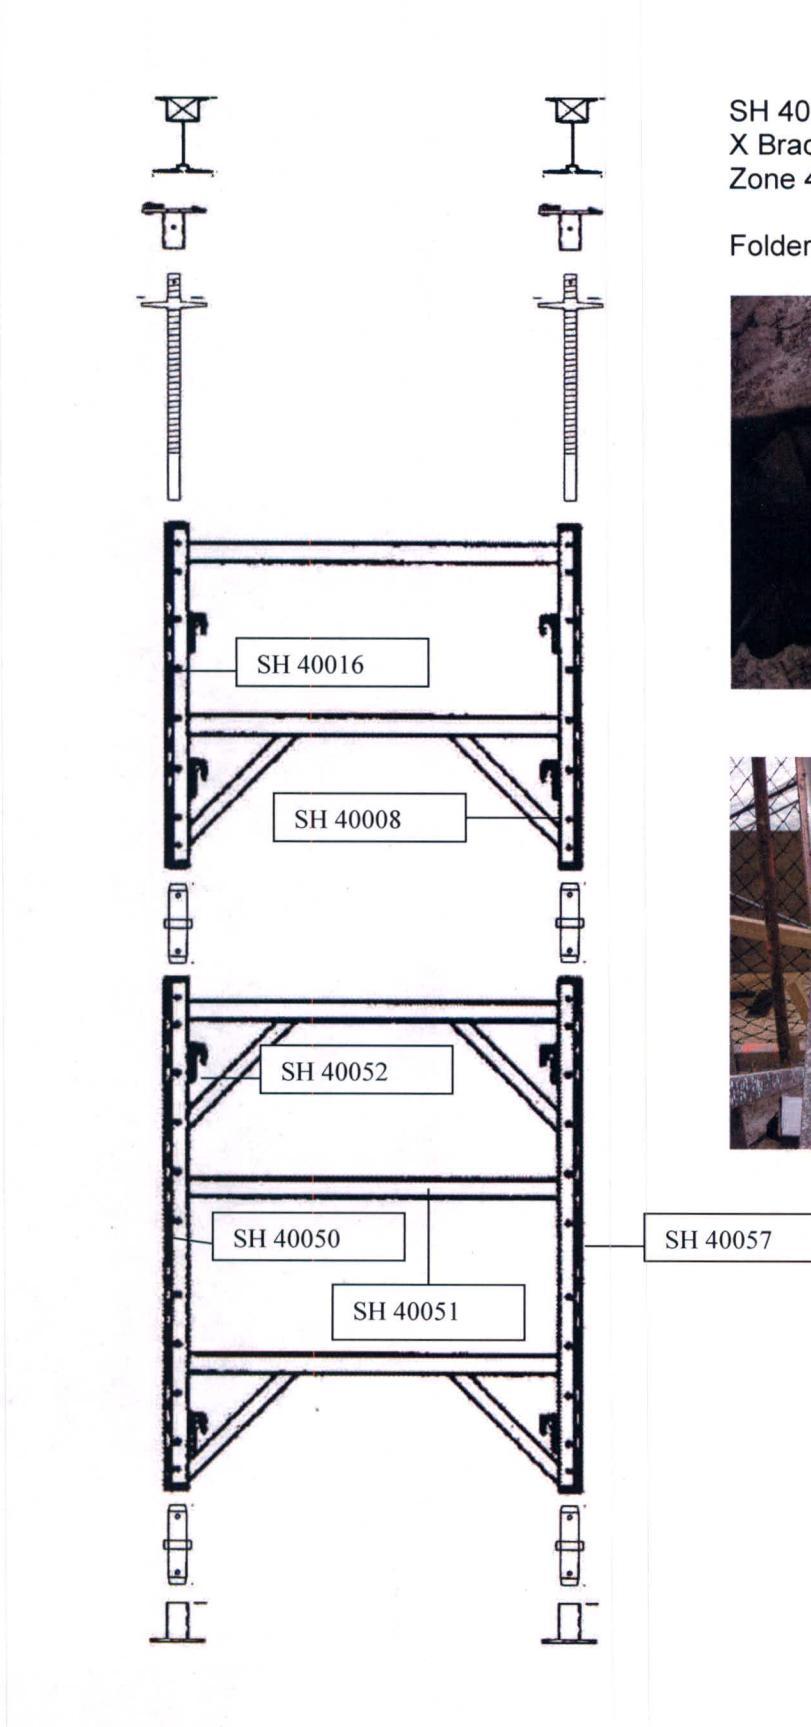
Folder: 08-02-15; SH 40051

SH 40051 Piece of frame that is part of SH 40050 Zone 40B

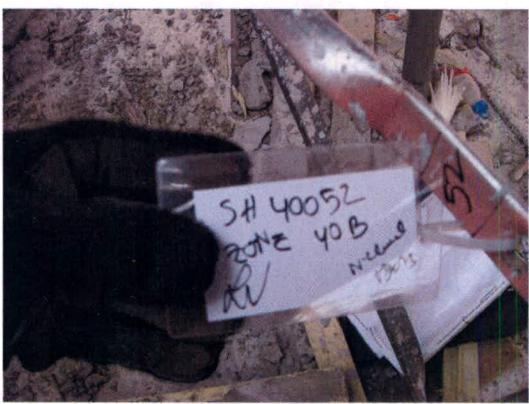
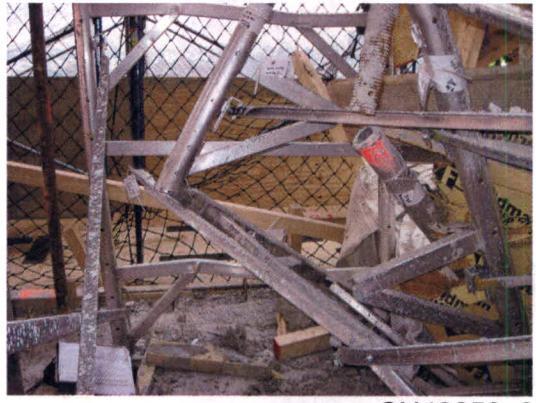
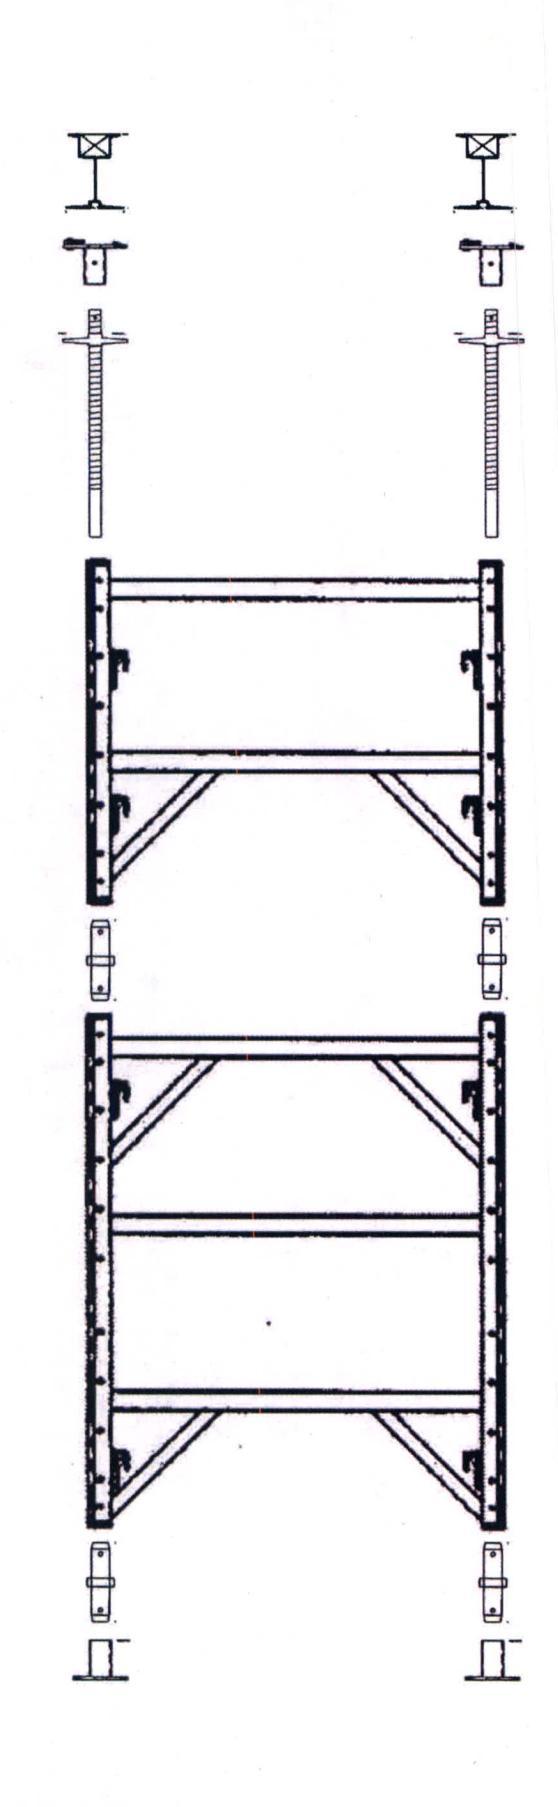
Folder: 08-02-15; SH 40052

SH 40052 X Brace Zone 40B

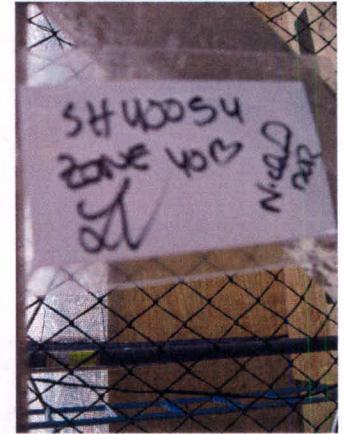
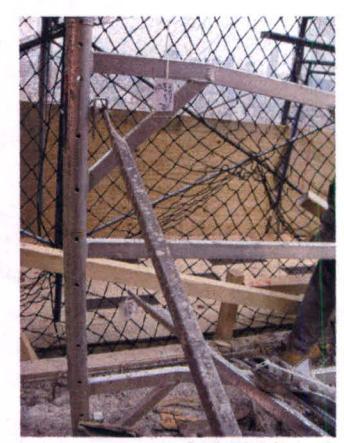
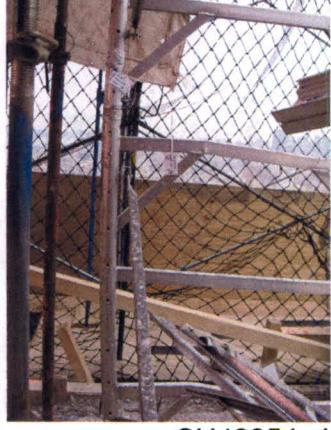
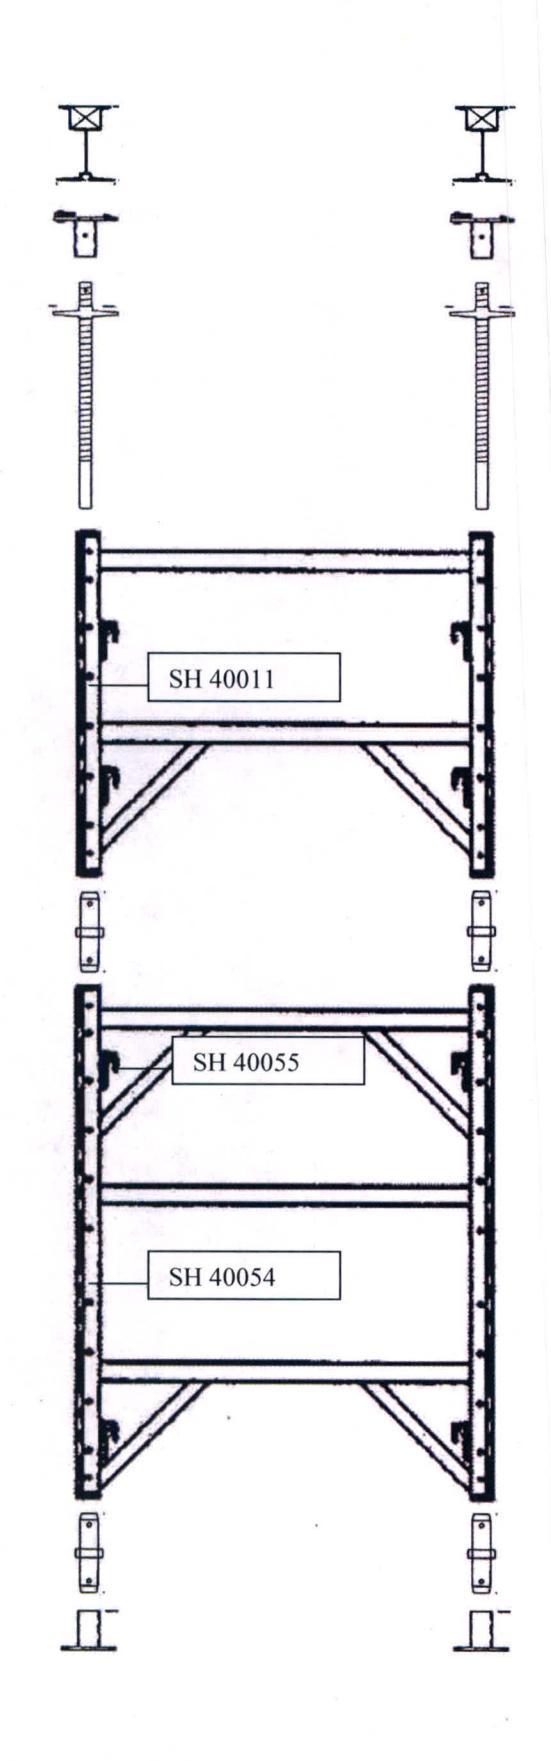
Folder: 08-02-15; SH 40054

SH 40054 Bottom Frame of SH 40011

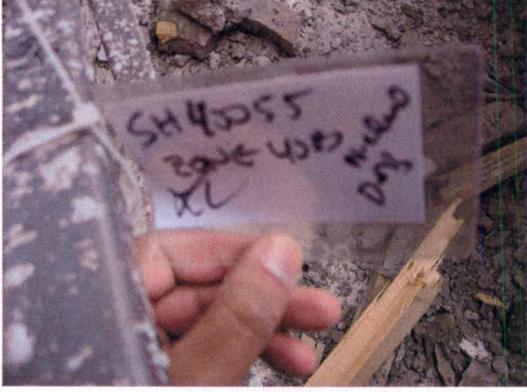
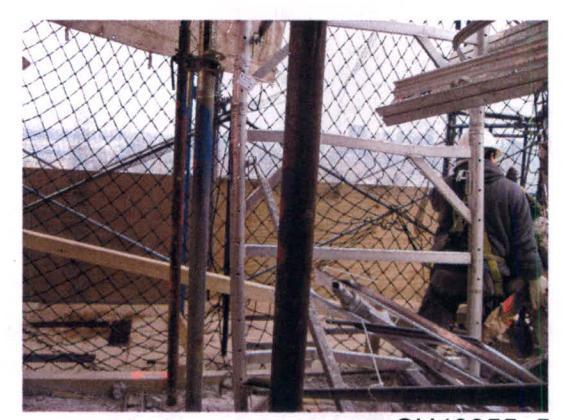
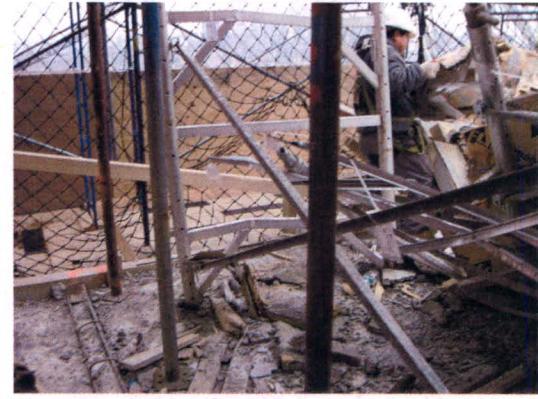
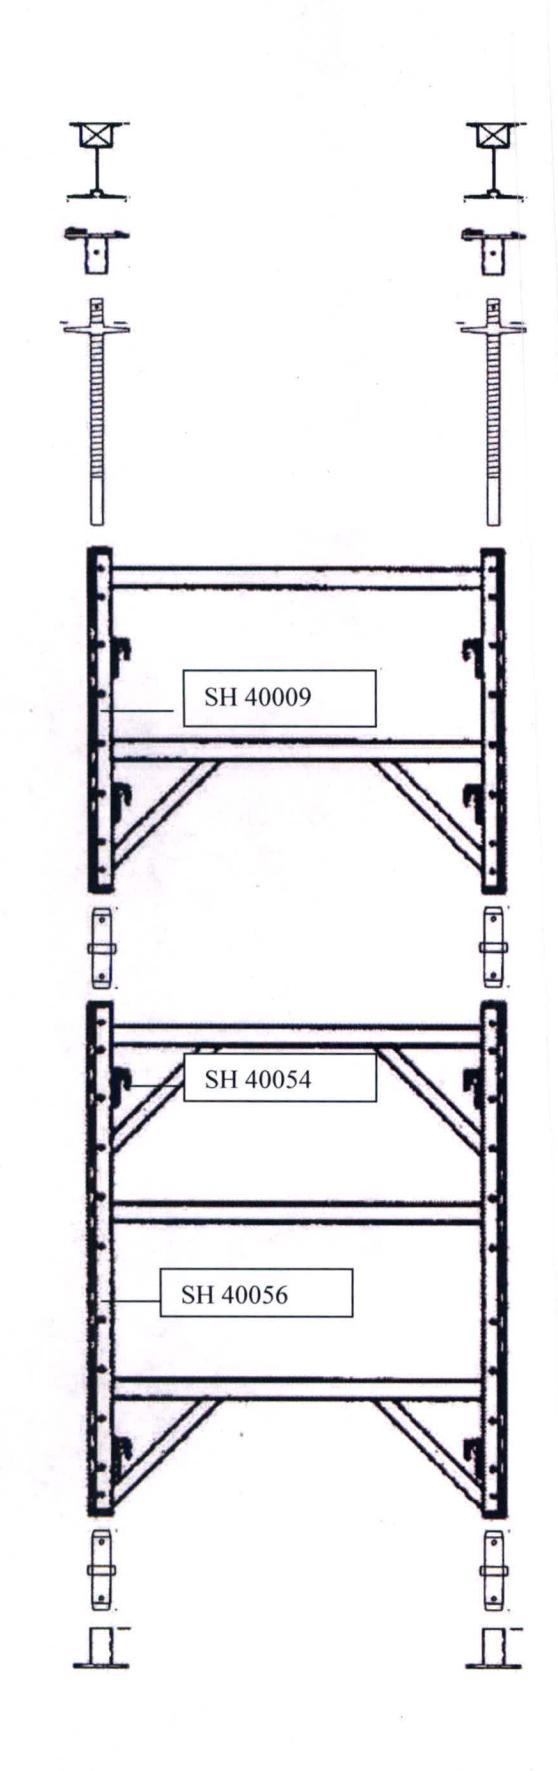
SH 40055

X Brace Connect with SH 40054 for Bottom Shore and Top Shore SH 40011 Zone 40B

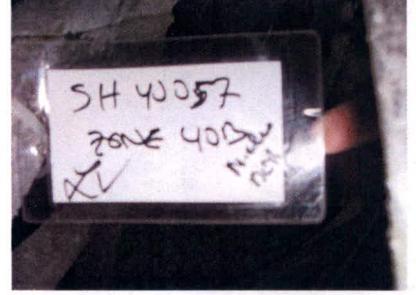
SH40057_1

SH 40057 Broken Bottom Frame of SH 40008 Connected to Bottom Brace of SH 40058 Zone 40B Folder: 08-02-15; SH 40057

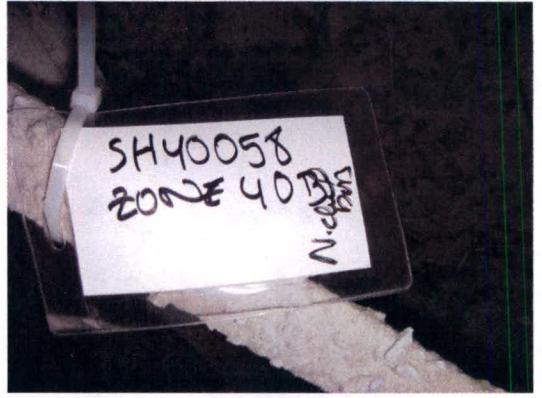
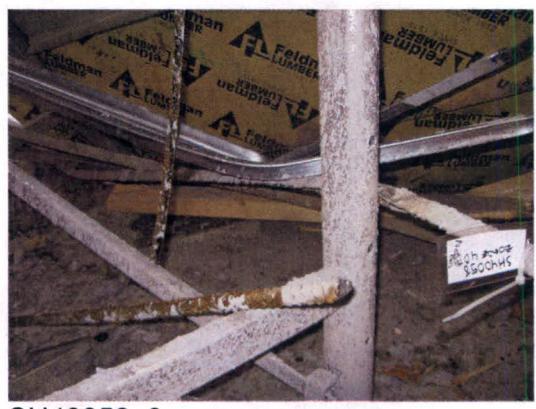
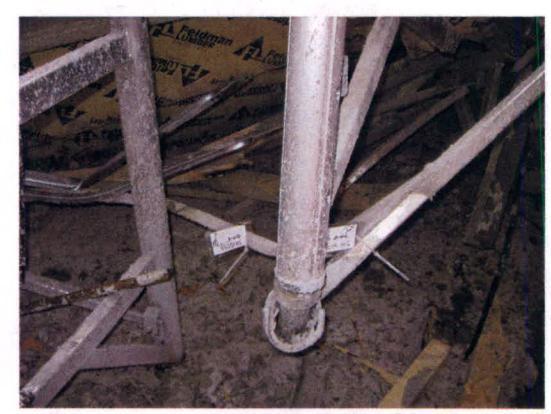
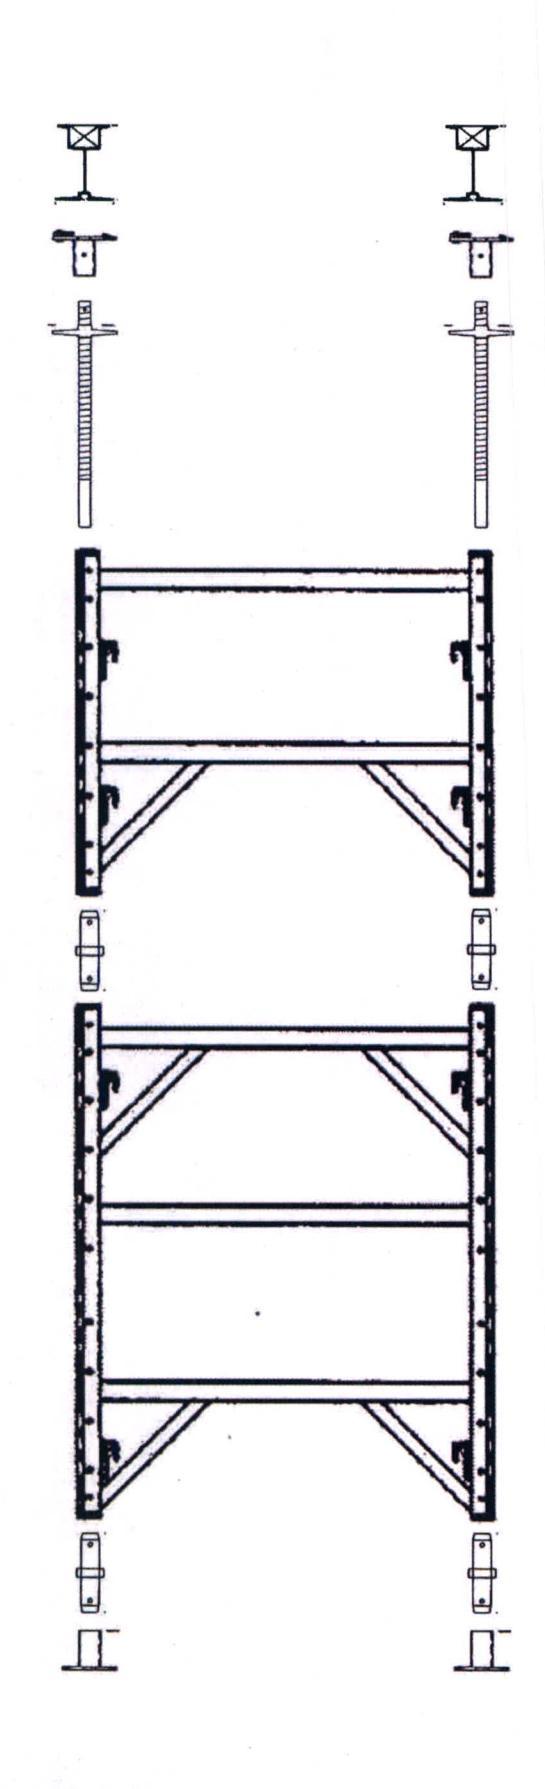
Folder: 08-02-15; SH 40058

SH 40058 Bottom Brace connected to Bottom Frame SH 40057 Zone 40B

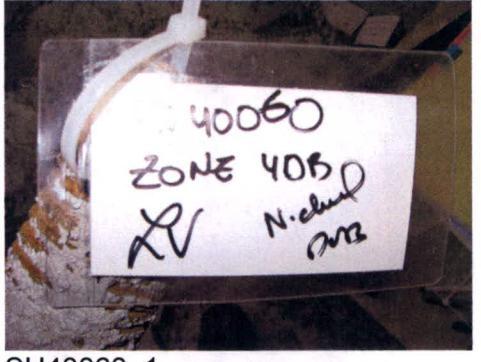
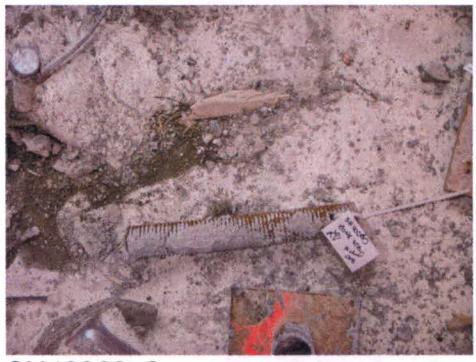
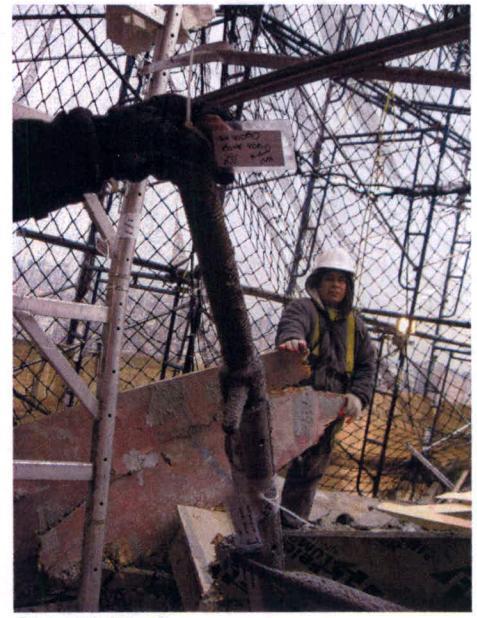
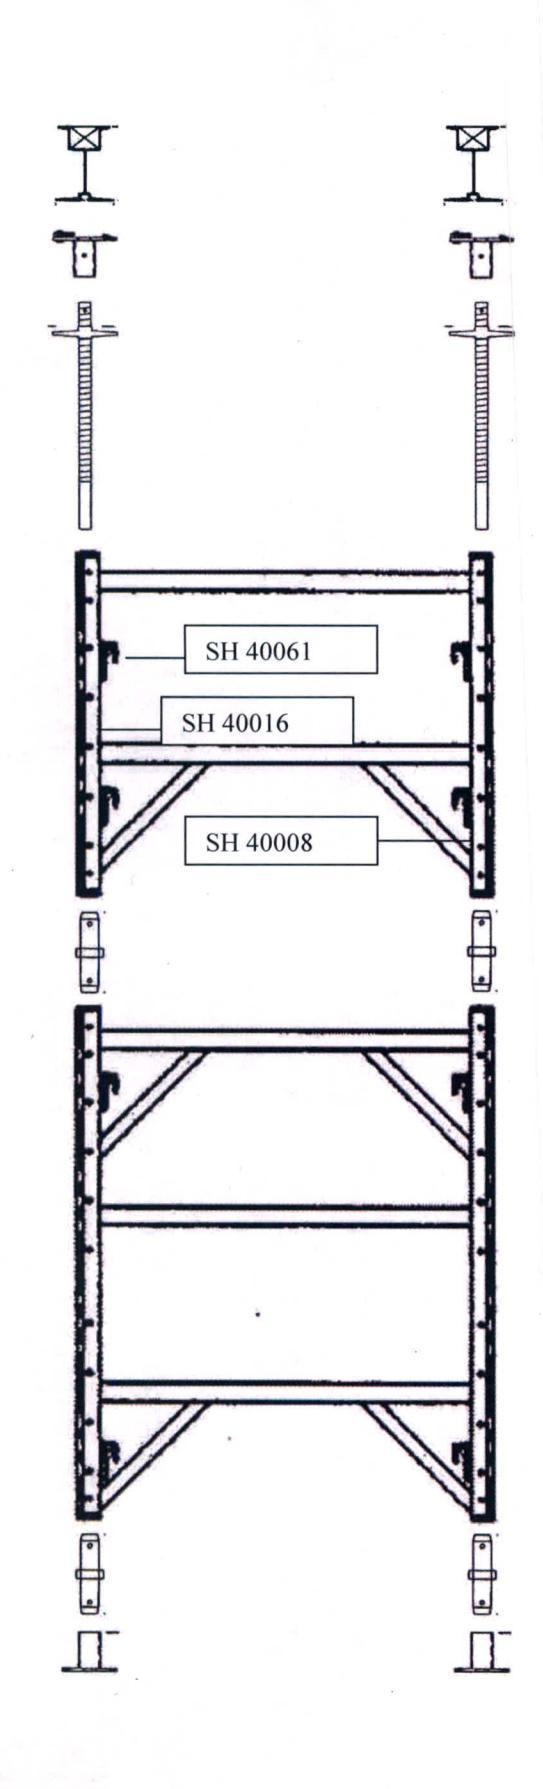
Folder: 08-02-15; SH 40060

SH 40060 Screw Jack Zone 40B

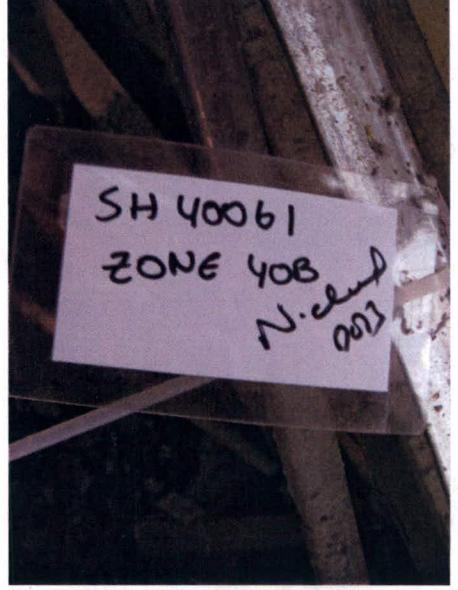
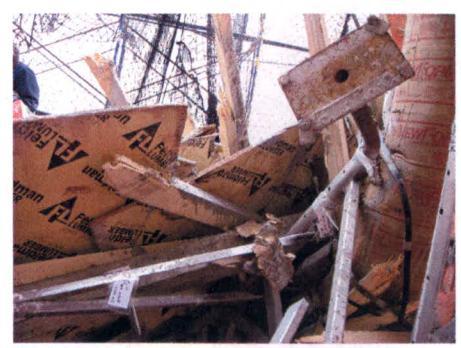
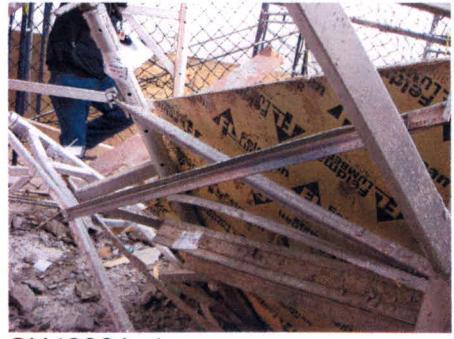
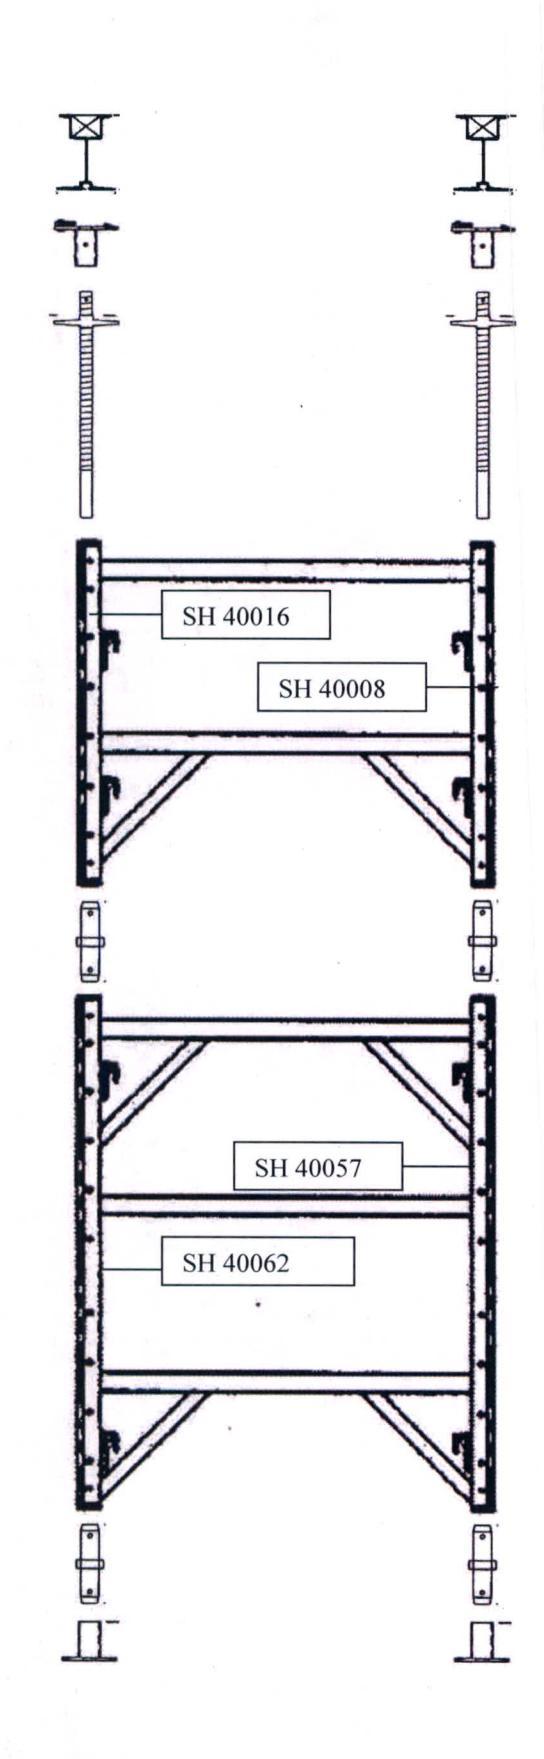
Folder: 08-02-15; SH 40061

SH 40061 X Brace Connects to SH 40016 and SH 40017 Zone 40B

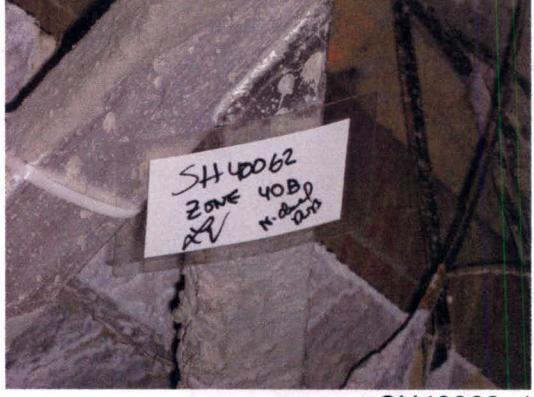
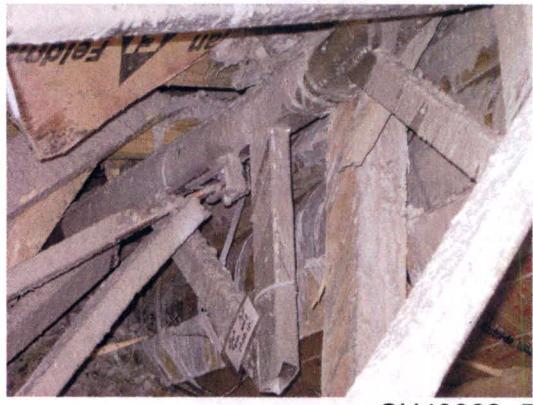
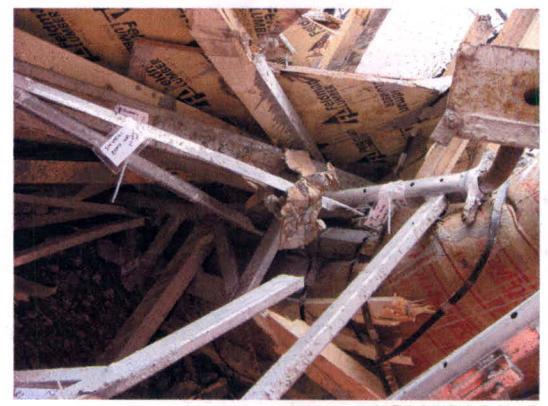
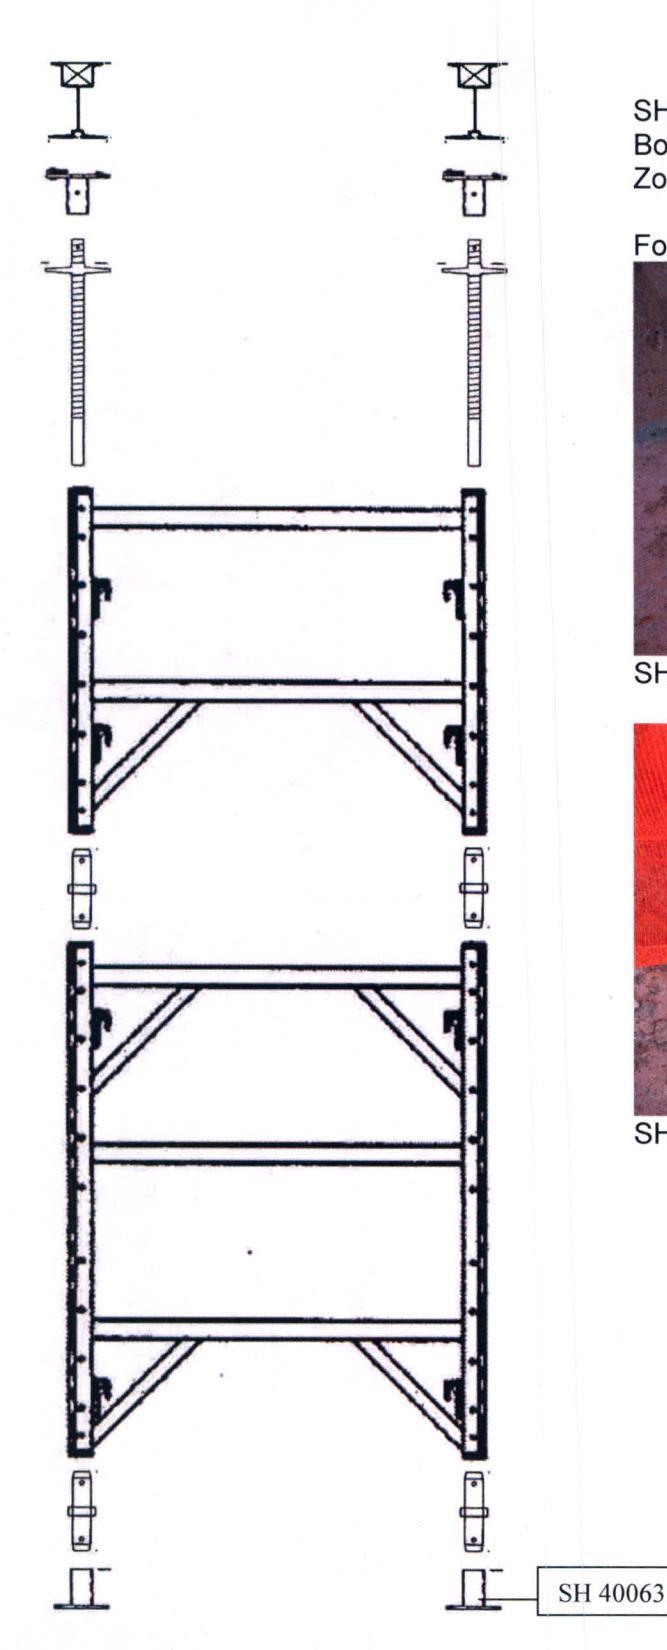
Folder: 08-02-15; SH 40062

SH 40062 Bottom Frame of SH 40016 Zone 40B

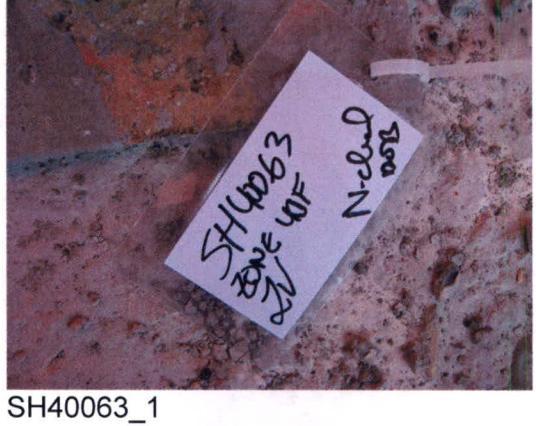
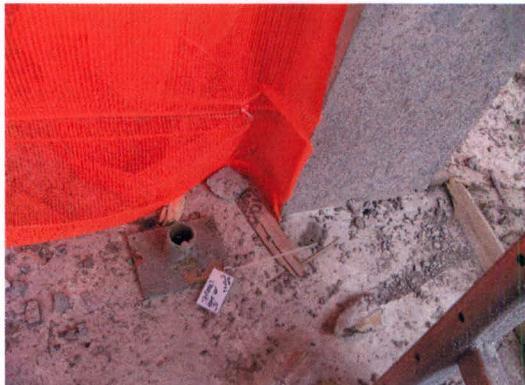
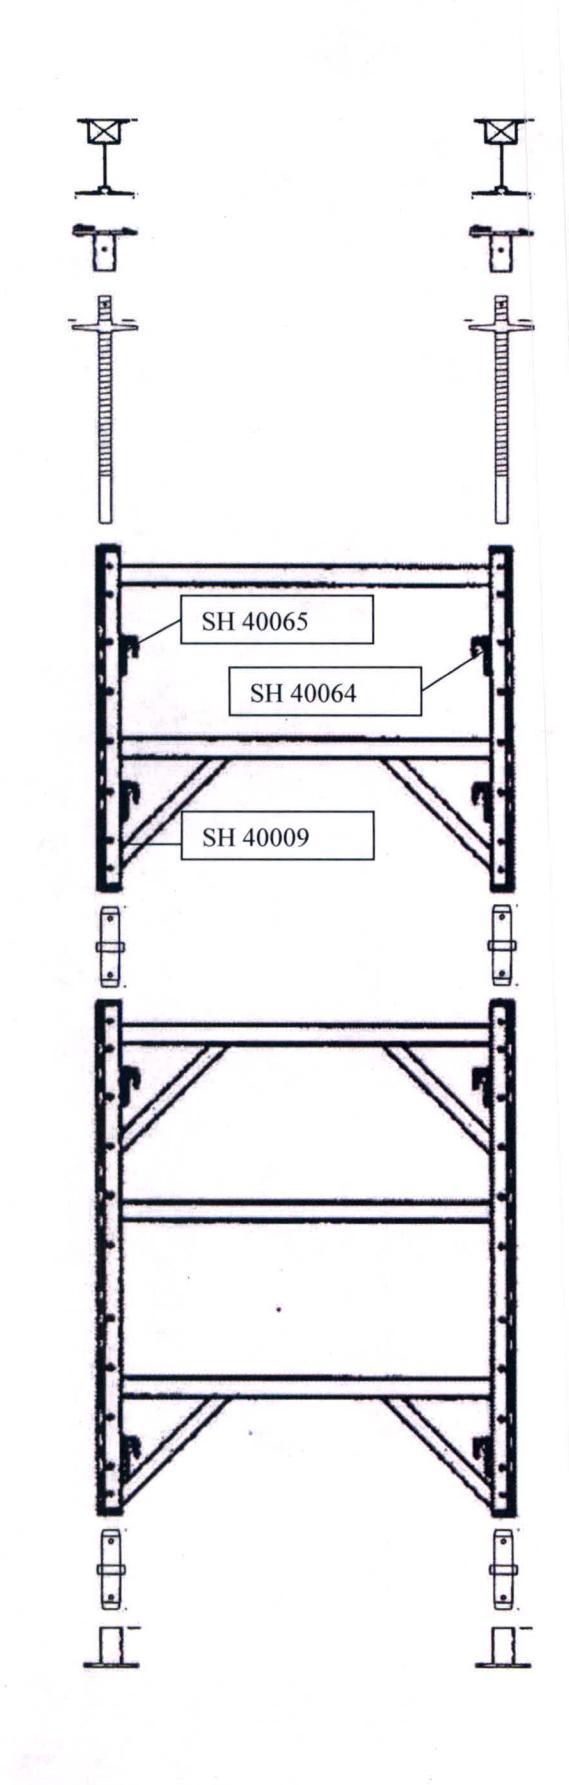
Folder: 08-02-15; SH 40063

SH 40063 Bottom Plate Zone 40F

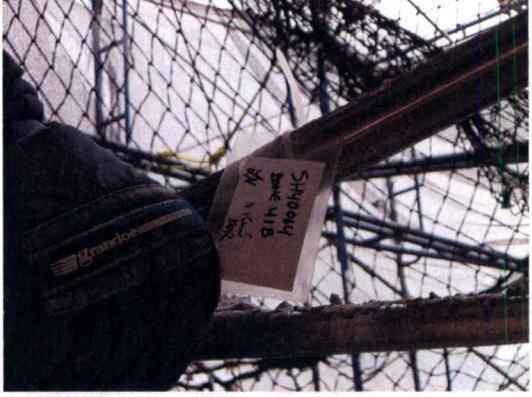
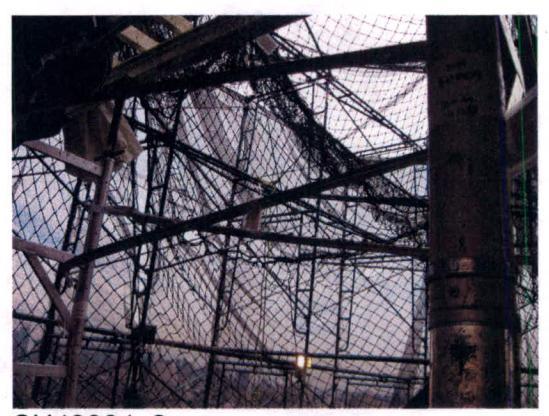
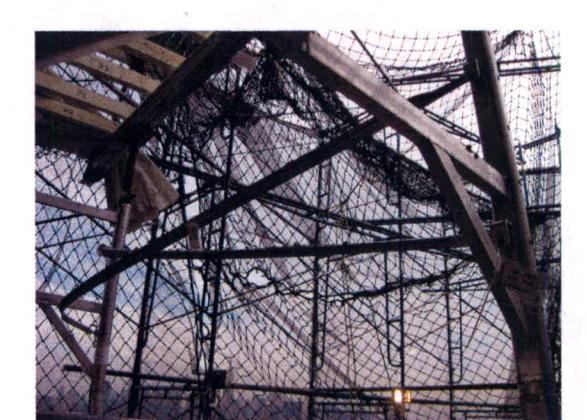
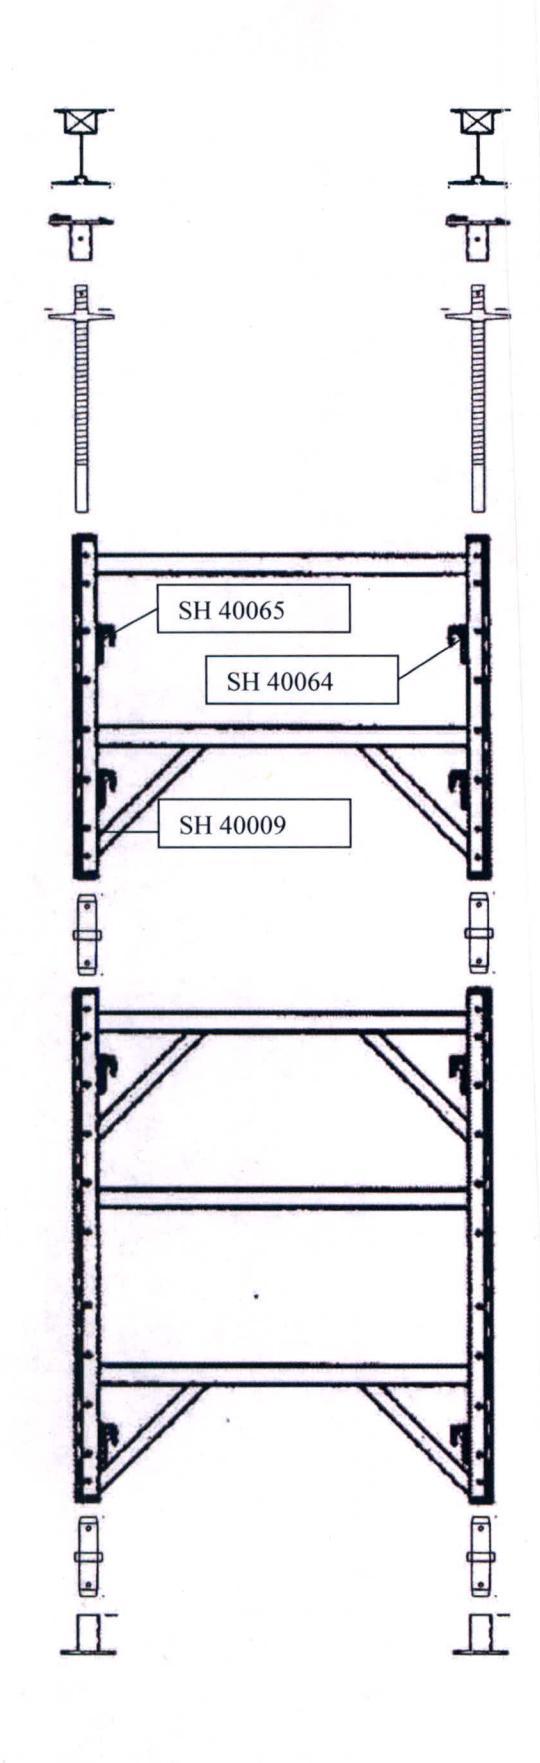
Folder: 08-02-15; SH 40064

SH 40064 Top X Brace Connects SH 40009 to SH 40011 Zone 40B

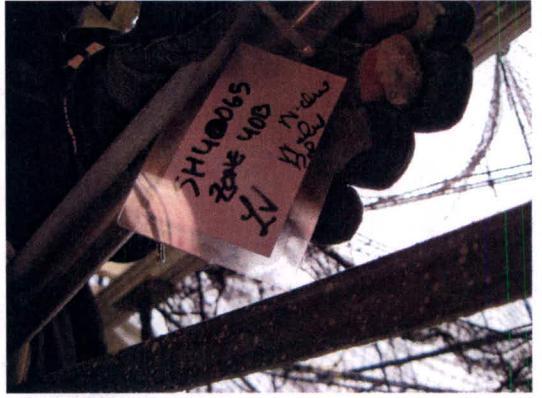
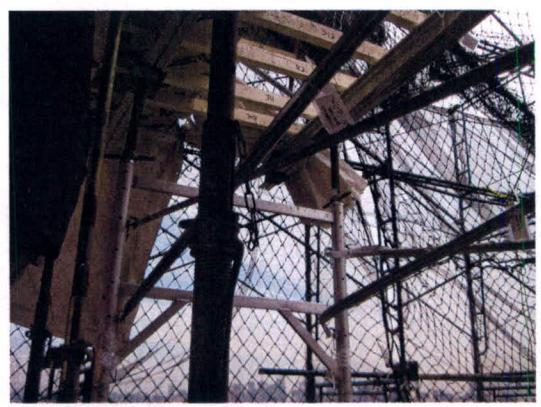
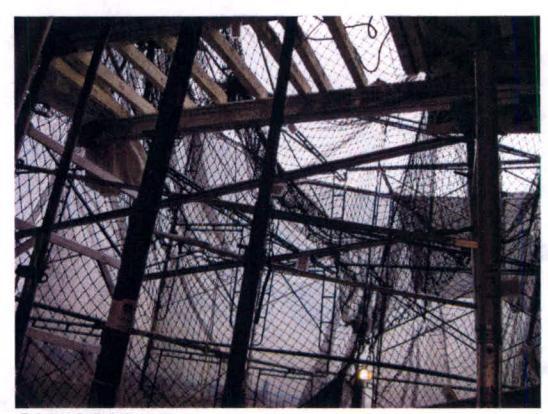
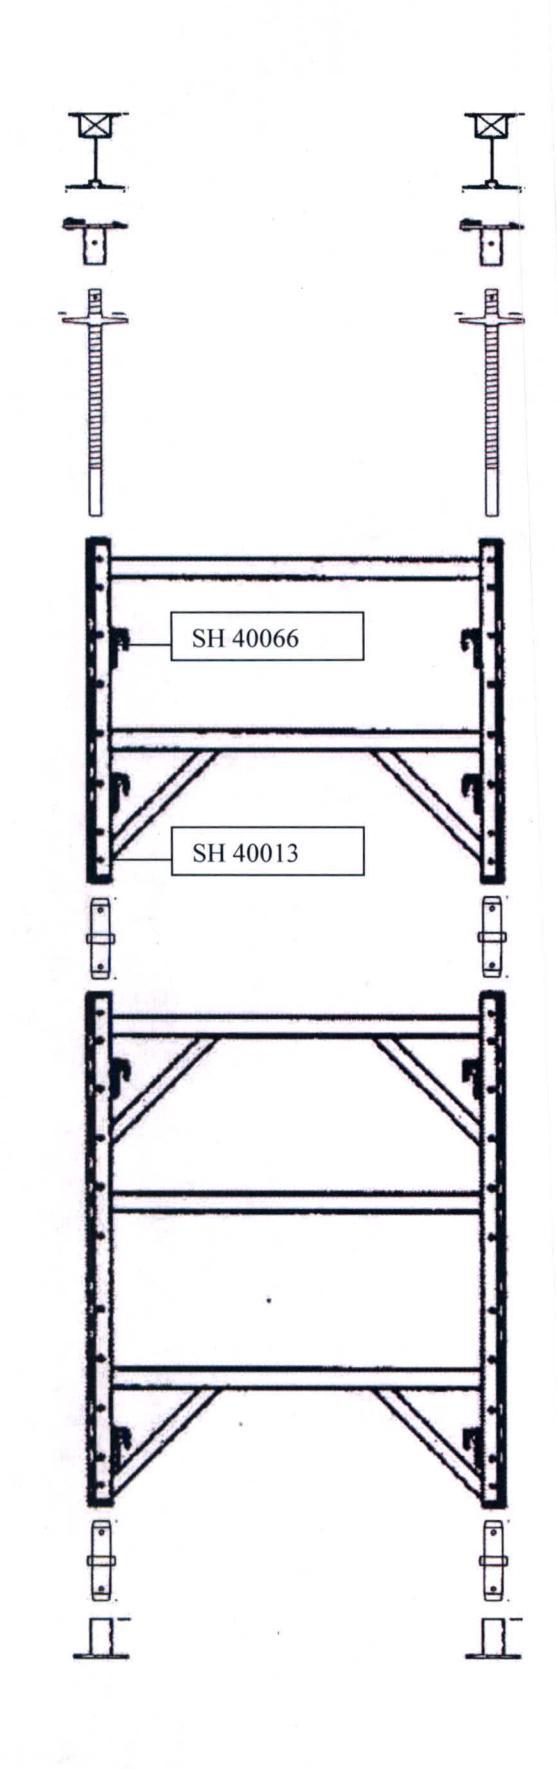
Folder: 08-02-15; SH 40065

SH 40065 X Brace Connect SH 40009 to SH 40011 Zone 40B
