INVESTIGATION REPORT:

JANUARY 14, 2008 SHORING COLLAPSE AT 9 DOMINICK ST. (AKA 246 SPRING ST.) MANHATTAN

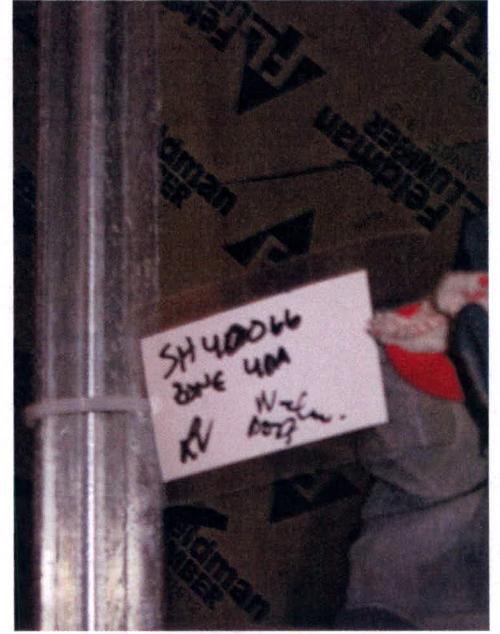
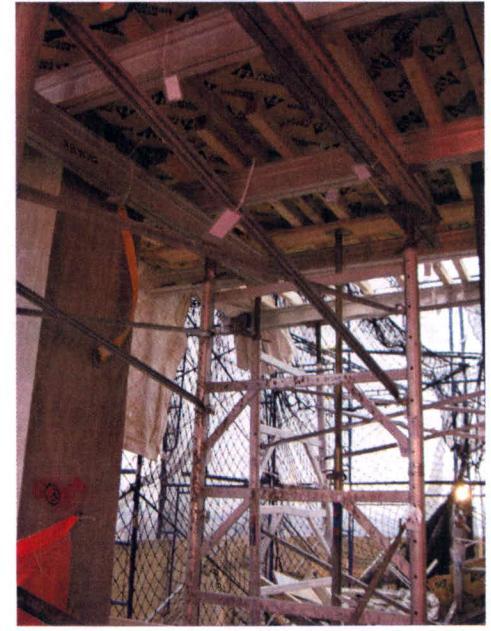
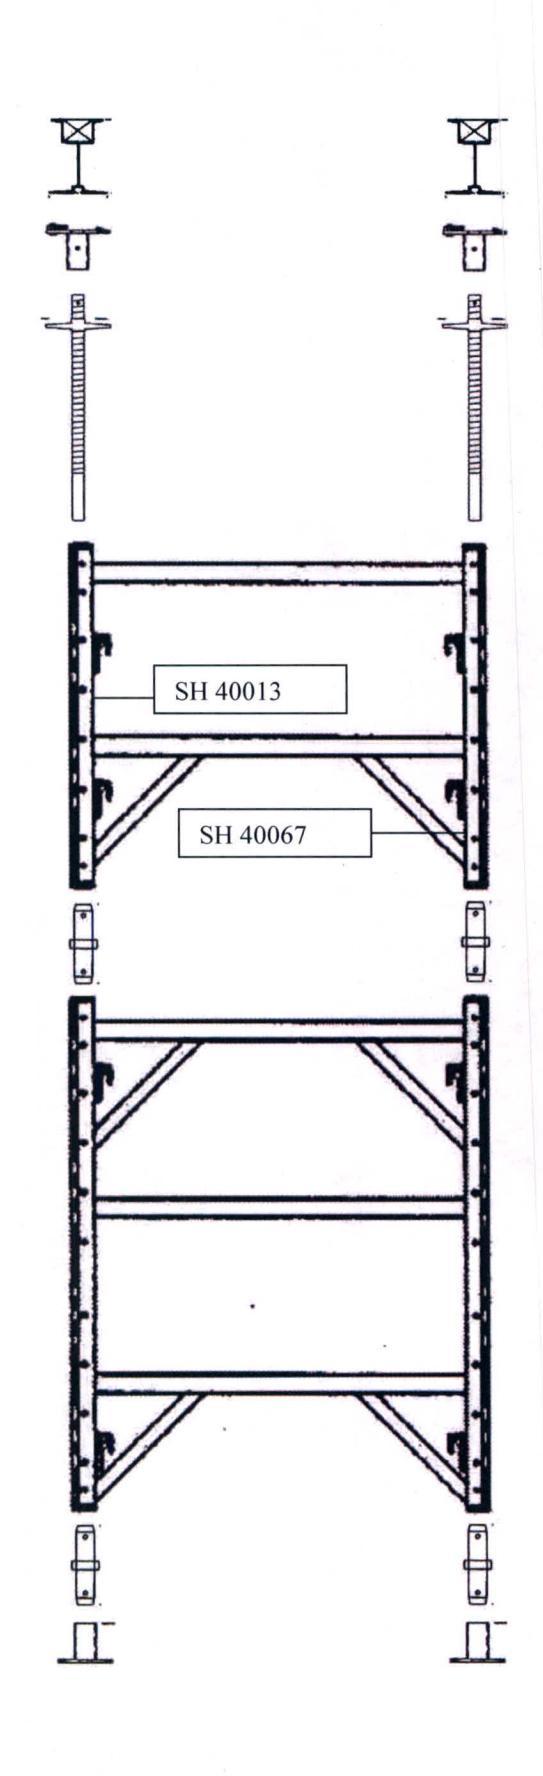
Folder: 08-02-15; SH 40066

SH 40066 X Brace Connect SH 40013 to SH 40014 Zone 40A

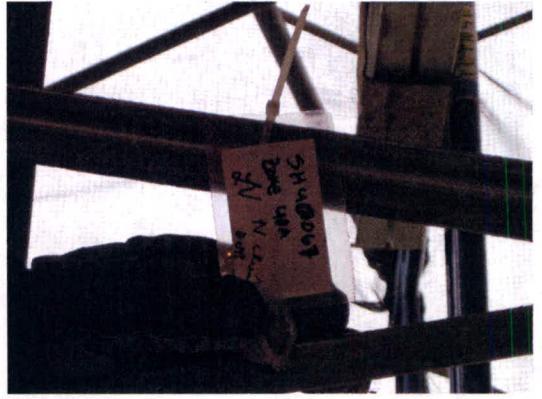
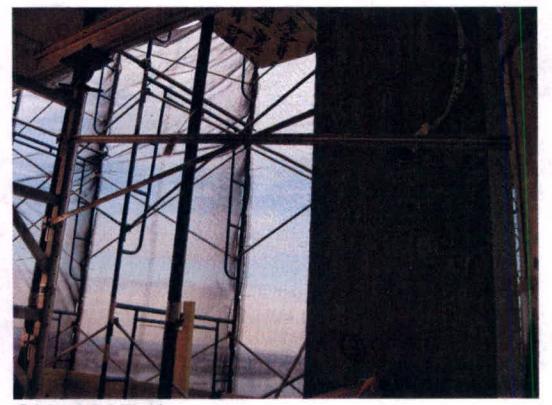
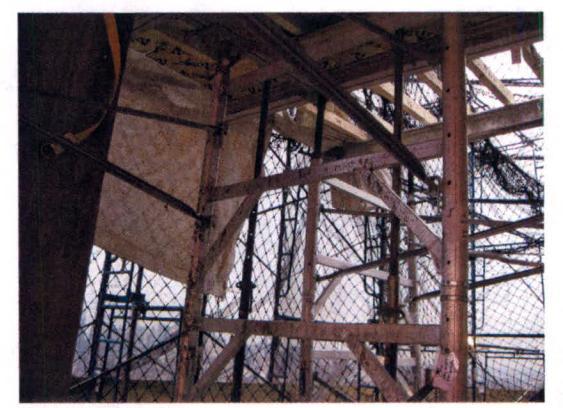
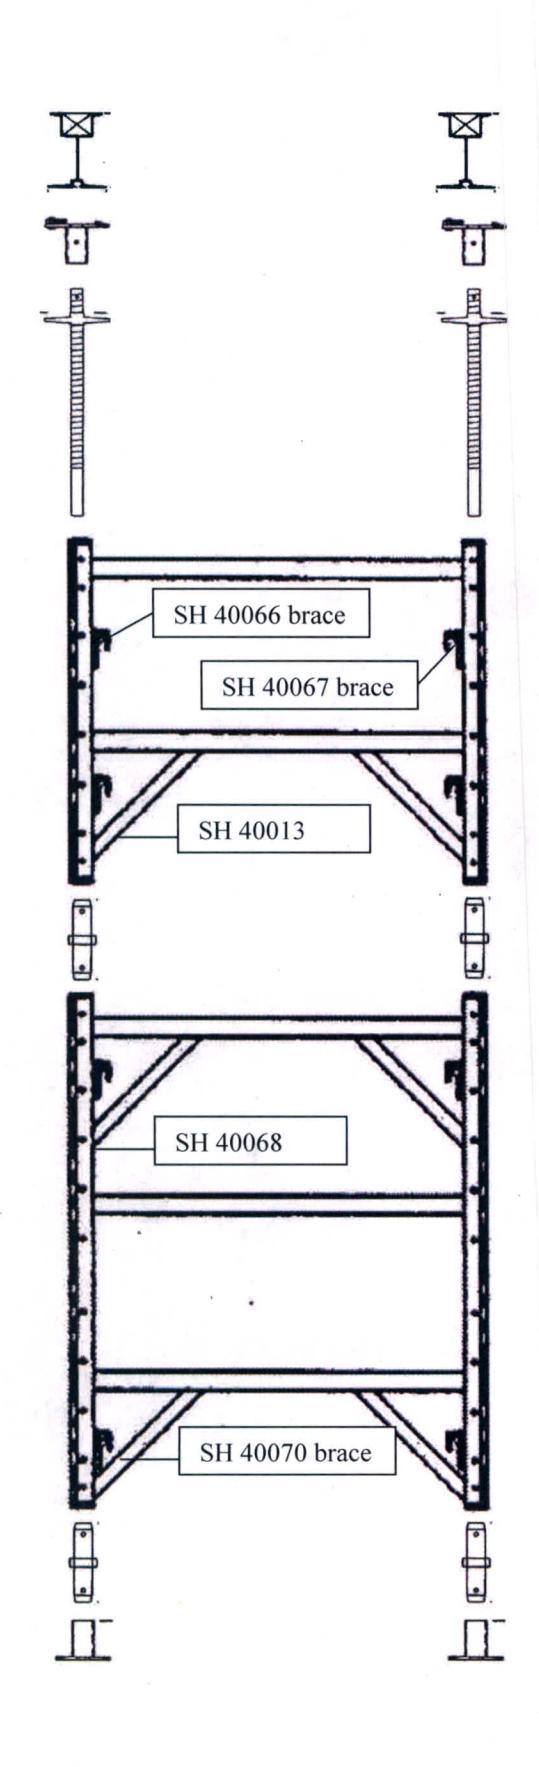
Folder: 08-02-15; SH 40067

SH 40067 X Brace Connect SH 40013 to SH 40014 Zone 40A

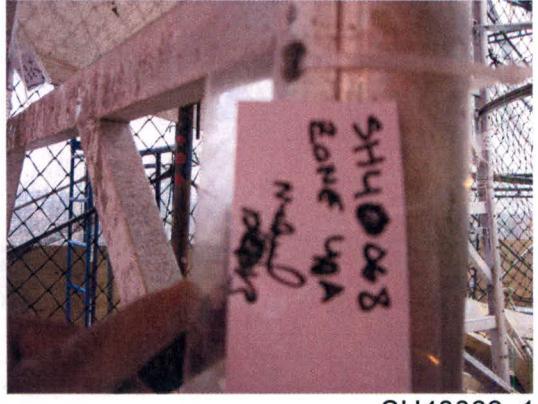
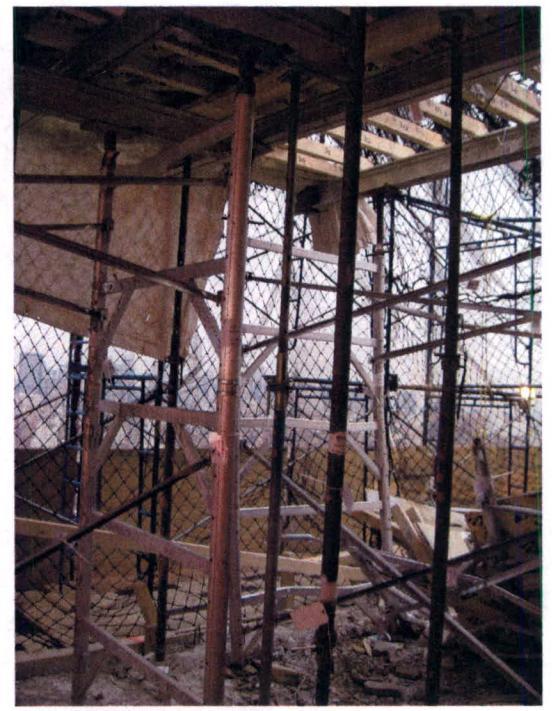
Folder: 08-02-15; SH 40068

SH 40068 Bottom Frame of SH 40013 Zone 40A

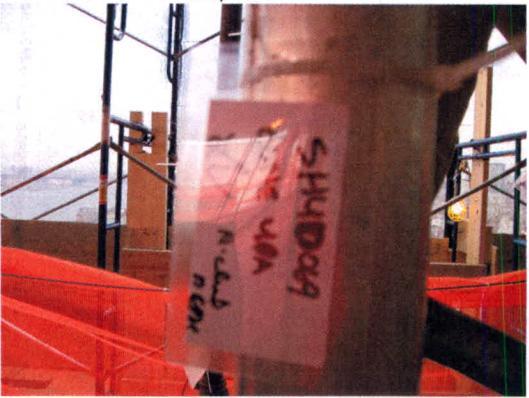
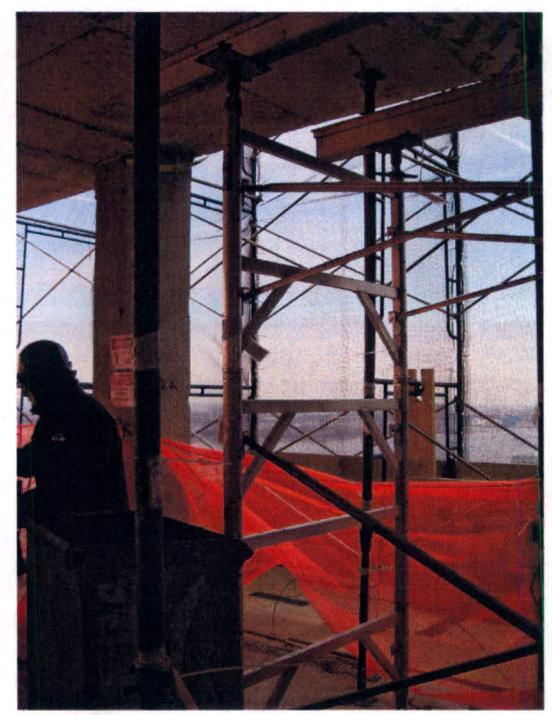
Folder: 08-02-15; SH

SH 40069 Bottom Frame of SH 40014 Zone 40A

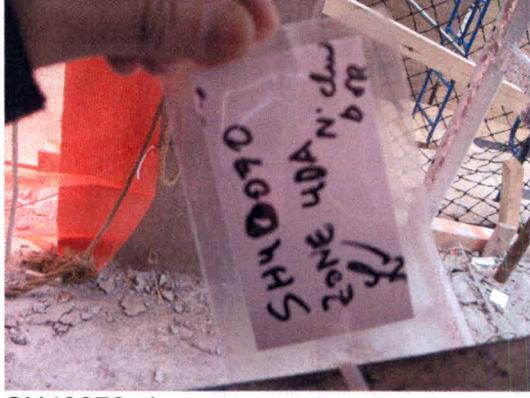
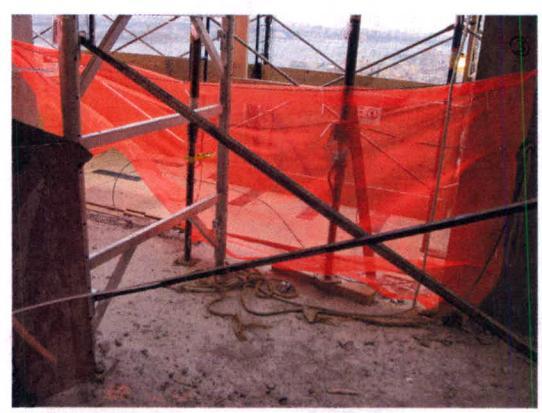
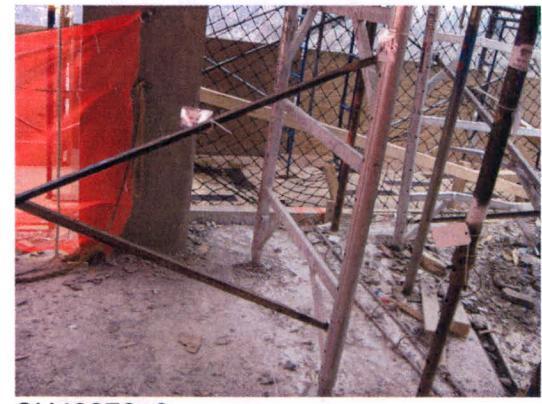
Folder: 08-02-15; SH 40070

SH 40070 Bottom X Brace Connects SH 40068 to SH 40069

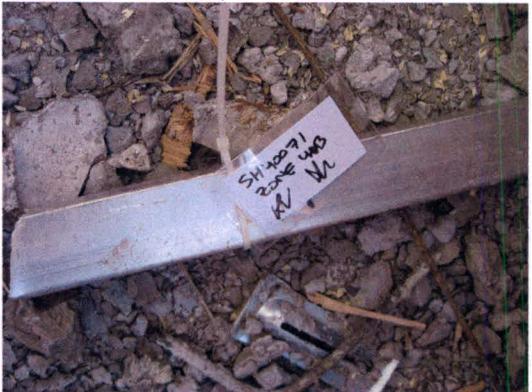
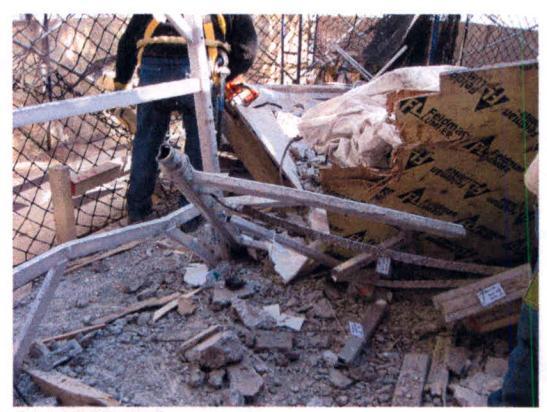
Folder: 08-02-16; SH

SH 40071 Broken Piece of Frame Might Connect to SH 40072 Zone 40B

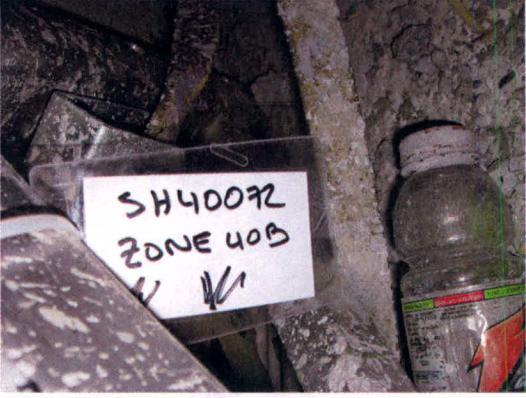
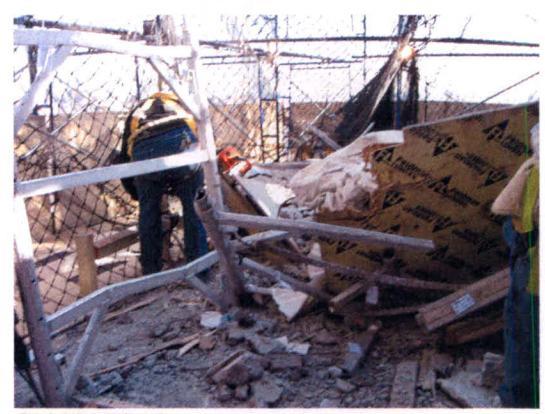
Folder: 08-02-16; SH 470072

SH 40072 Bottom Frame of SH 40017 Broken Zone 40B

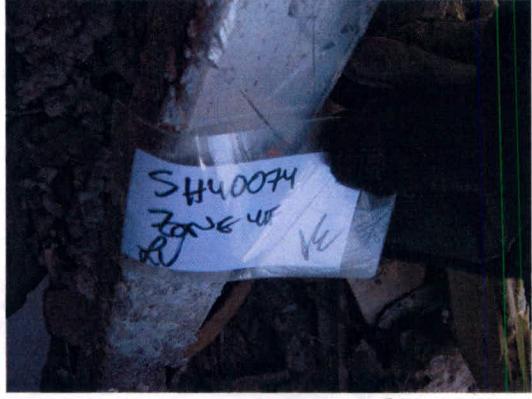
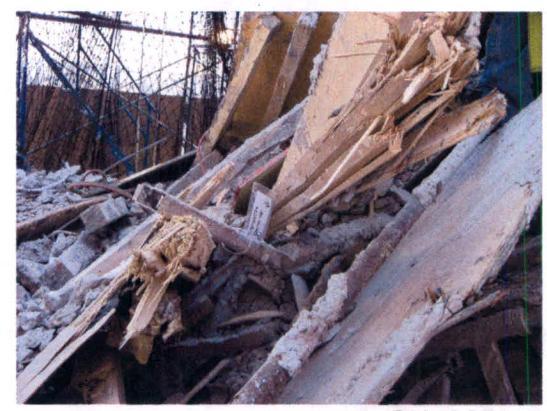
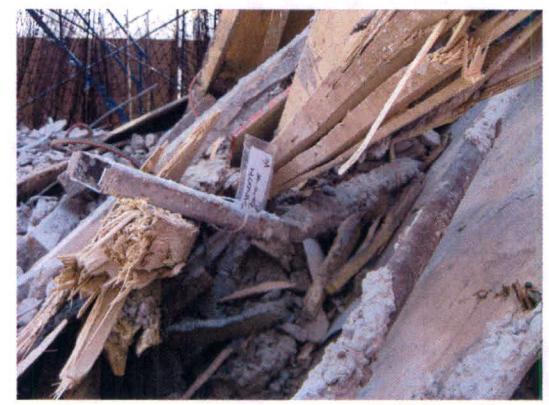
Folder: 08-02-16; SH 40074

SH 40074 Piece of Frame SH 40013 Zone 40F

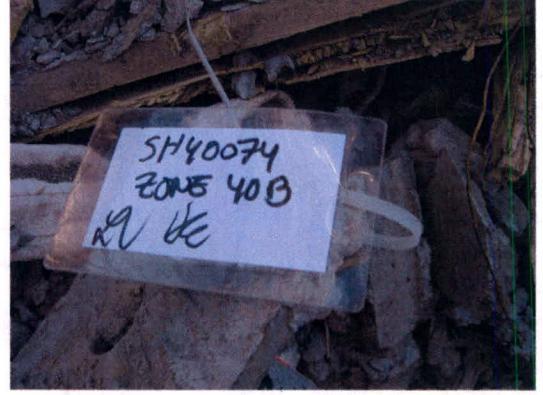
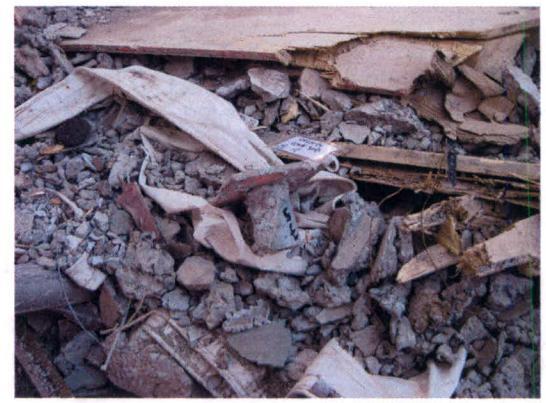
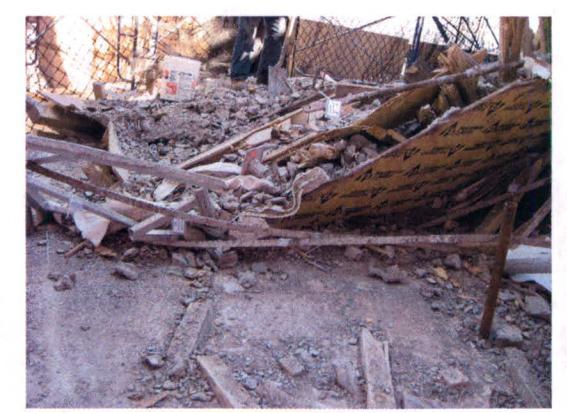
Folder: 08-02-16; SH 40074 Dup

SH 40074 Dup Component should have been labeled as SH 40075 Plate Zone 40B

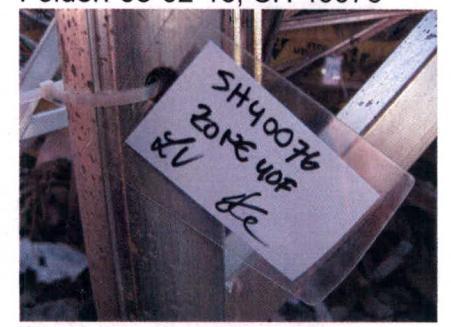
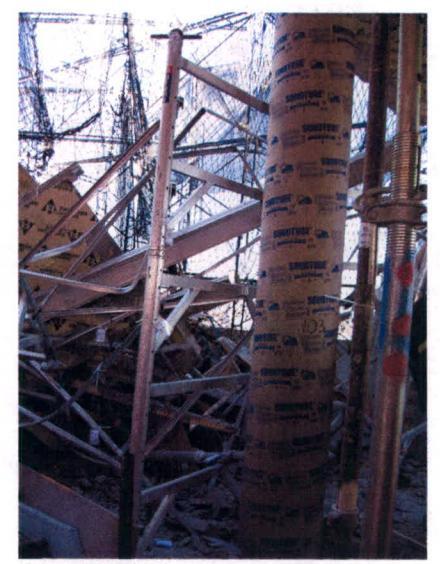
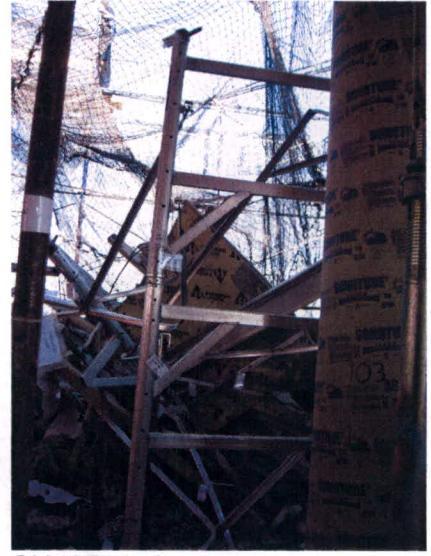
SH 40076 Bottom Frame of SH 40005 Zone 40F Folder: 08-02-16; SH 40076

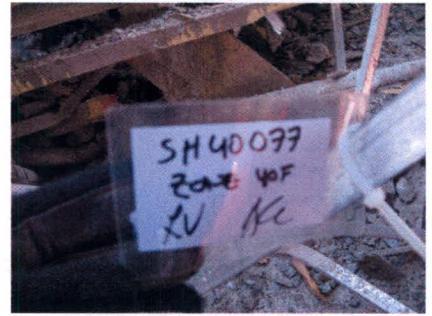
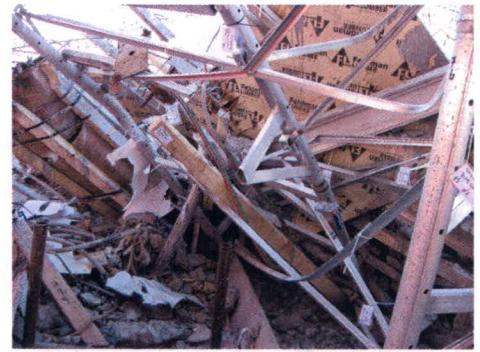
SH 40077 Brace conn to SH 40076 Zone 40F Folder: 08-02-16; SH 40077

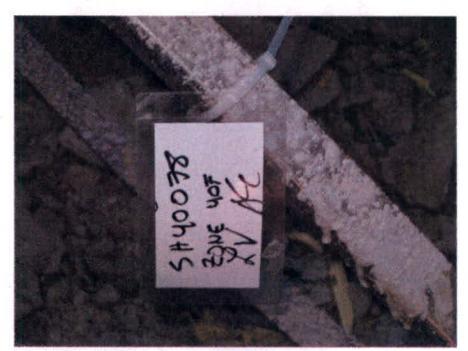
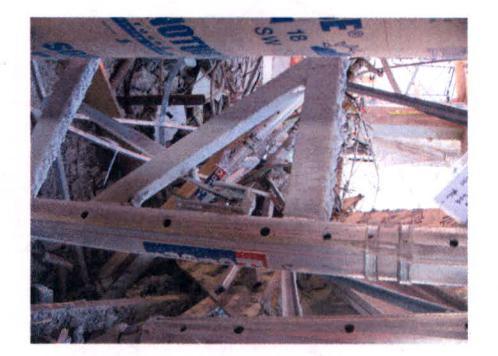
SH 40078 Brace conn to SH 40076 Zone 40F Folder: 08-02-16; SH 40078

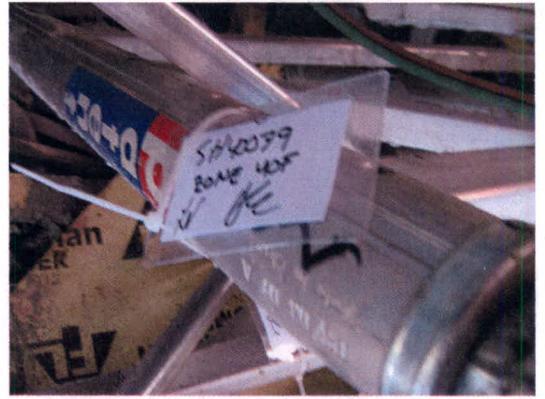
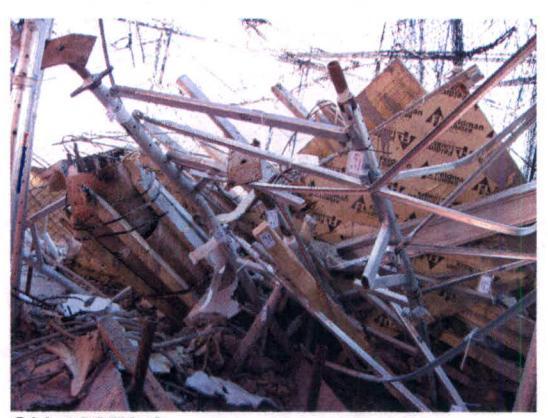
Folder: 08-02-16; SH 40079

SH 40079 Bottom Frame of SH 40020 Zone 40F

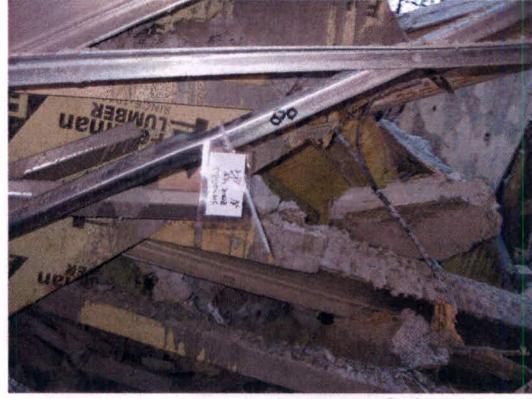
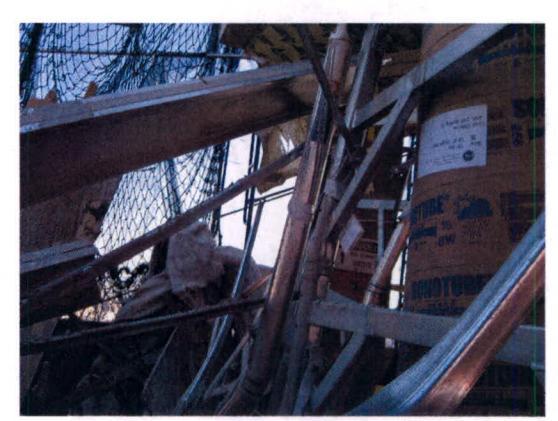
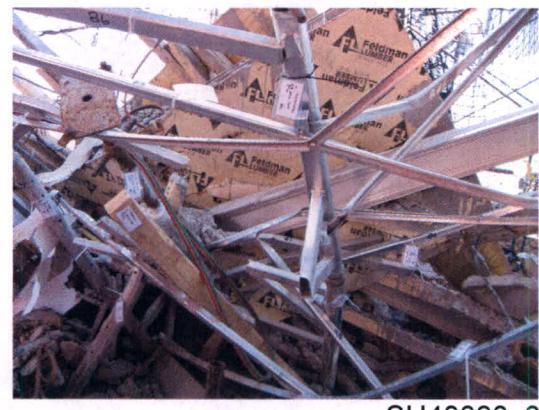
Folder: 08-02-16; SH 40080

SH 40080 X Brace Zone 40F

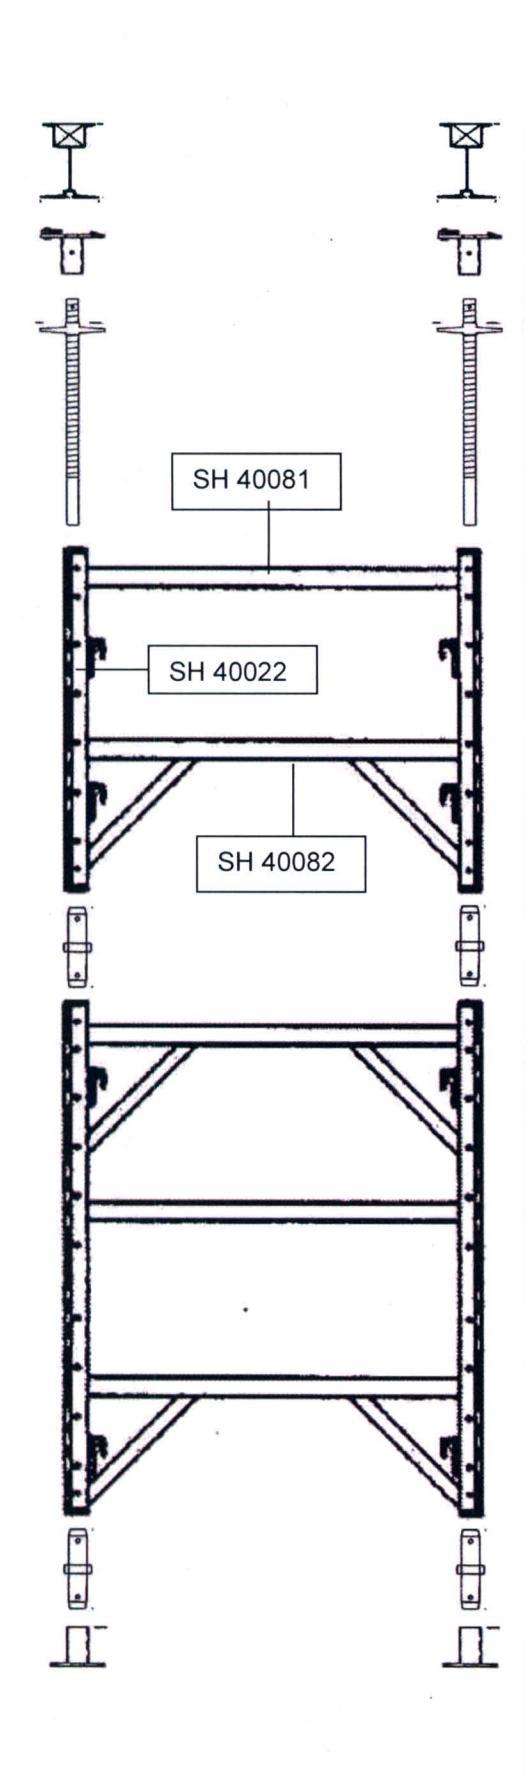
SH 40081 Broken piece of frame Might Connect to SH 40022 Zone 40F

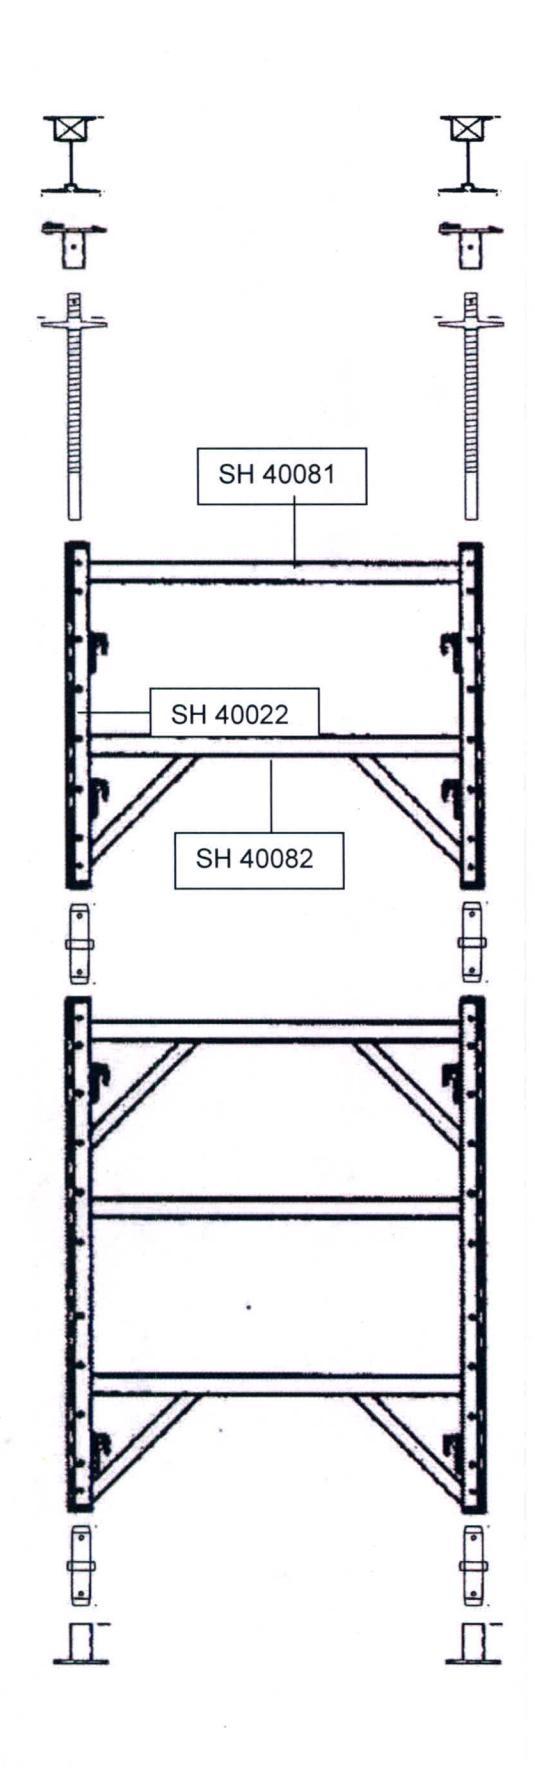
SH 40082 Broken piece of Frame Might connect to SH 40022 Zone 40F

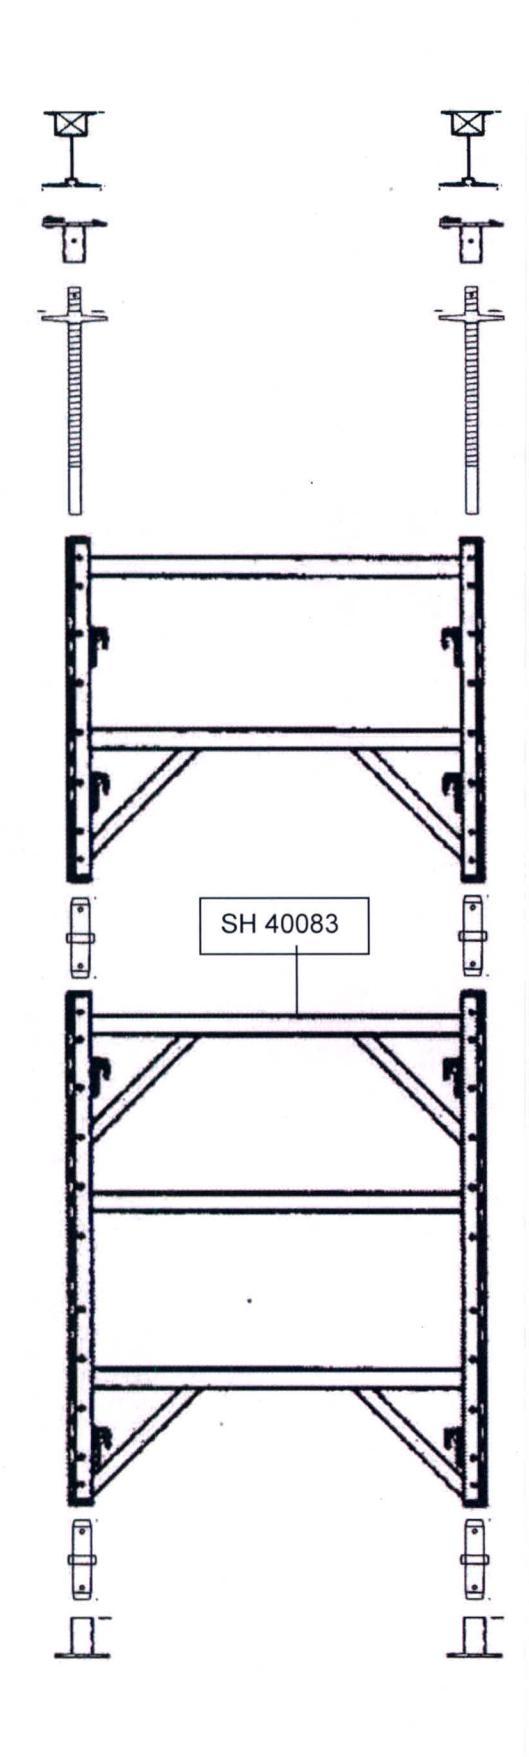
SH 40083 Broken Piece Zone 40F

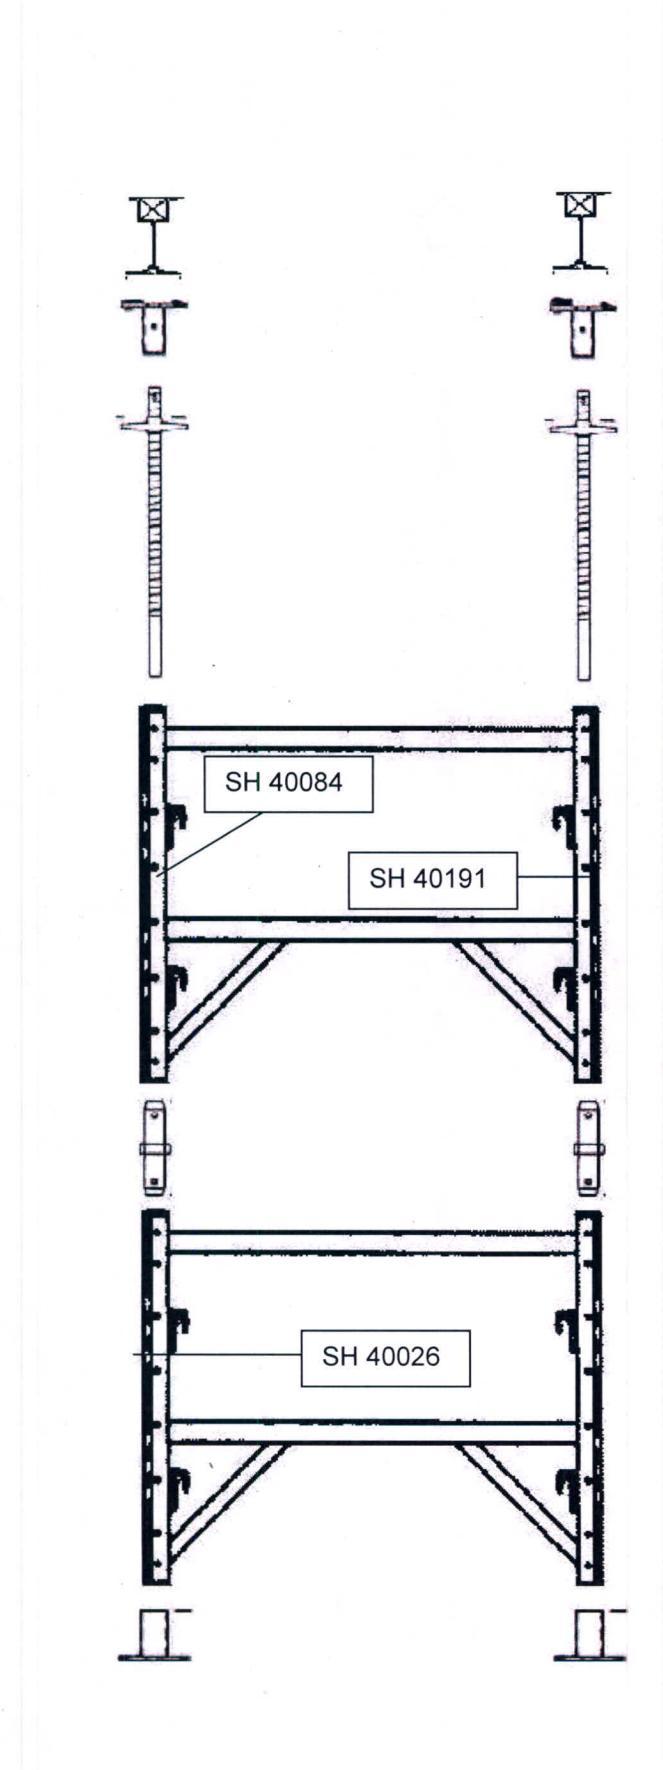
SH 40084 on 41st floor Top Shore near SH 40015 & SH 40087 Zone 40F (3'-6")

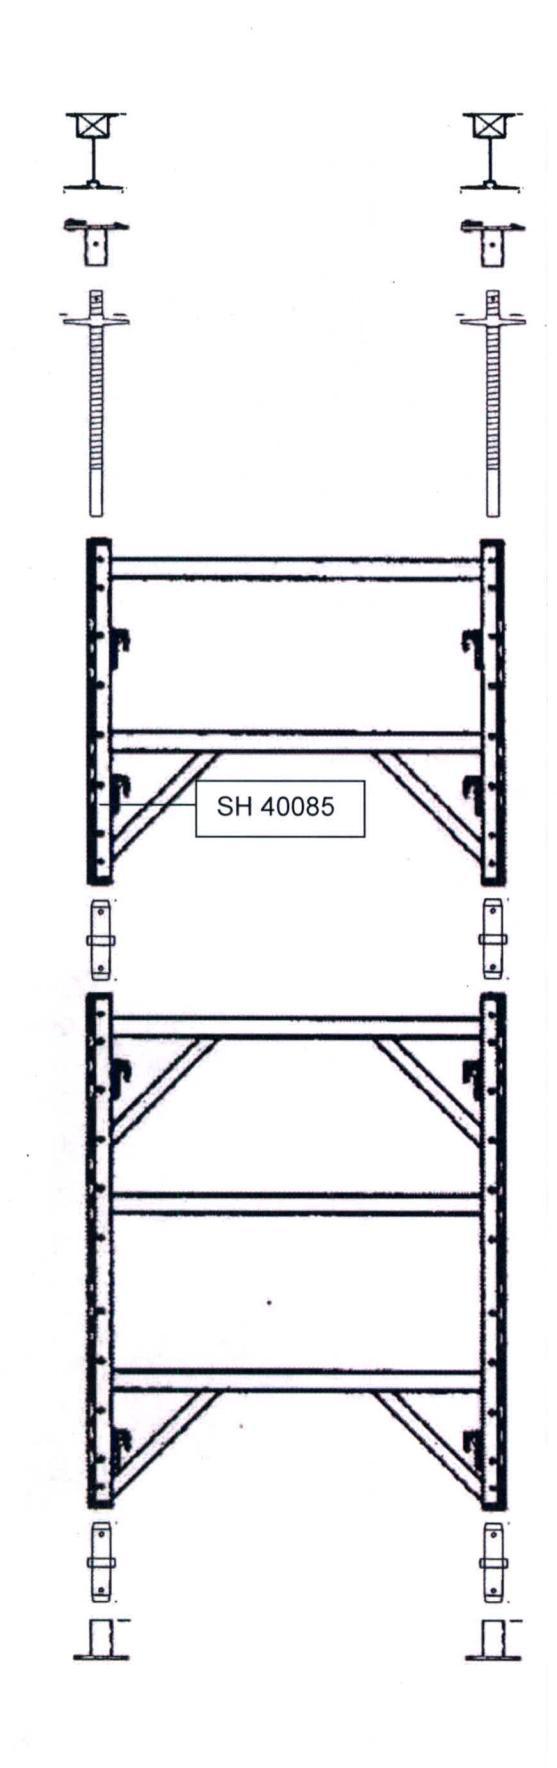
SH 40085 Top X Brace Attached to SH 40015 Zone 40F

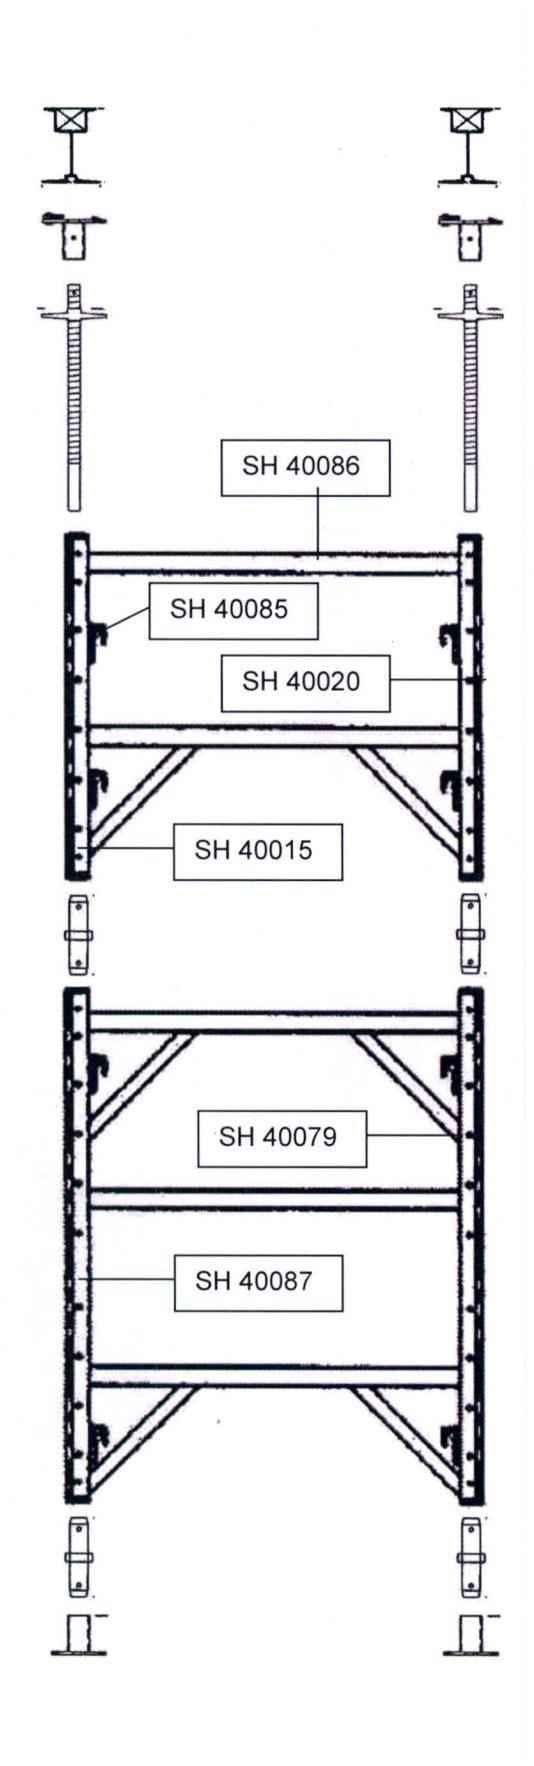
SH 40086 Piece of Frame SH 40020

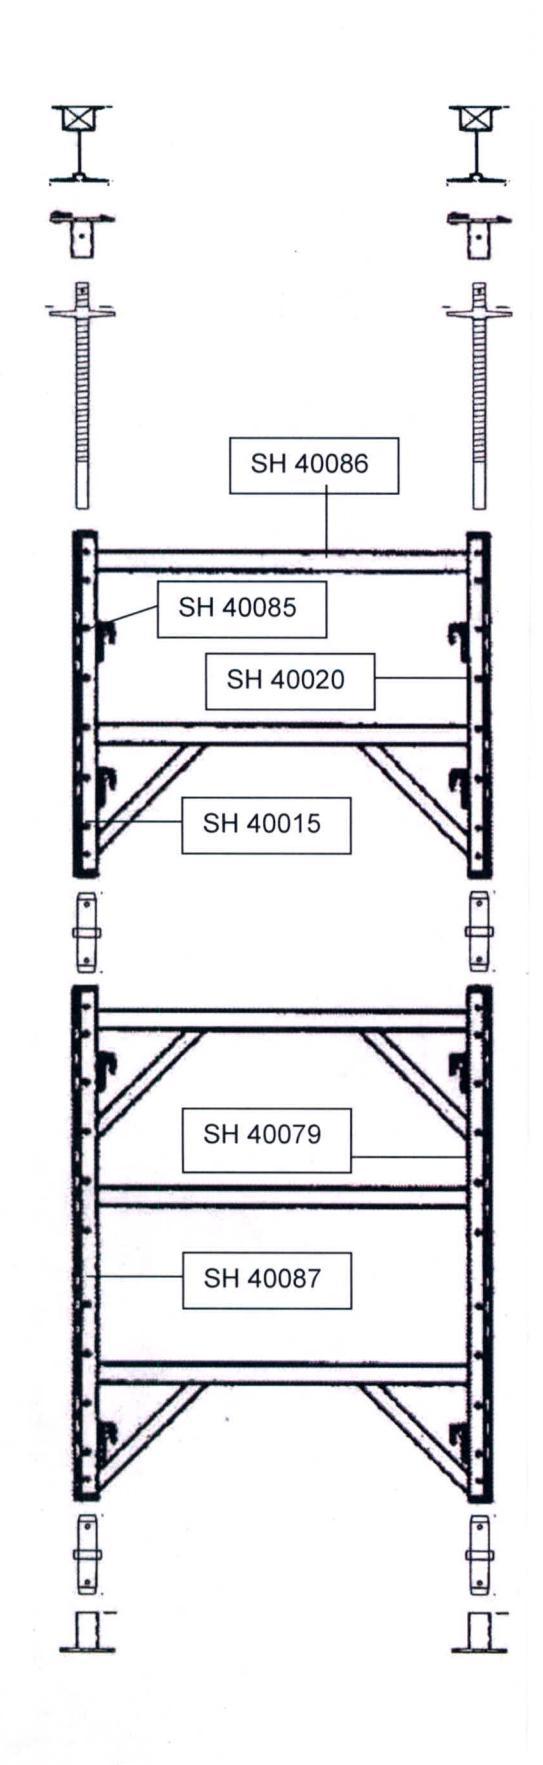
SH 40087 Bottom Frame of SH 40015 Makes a bottom frame with SH 40079 Zone 40F

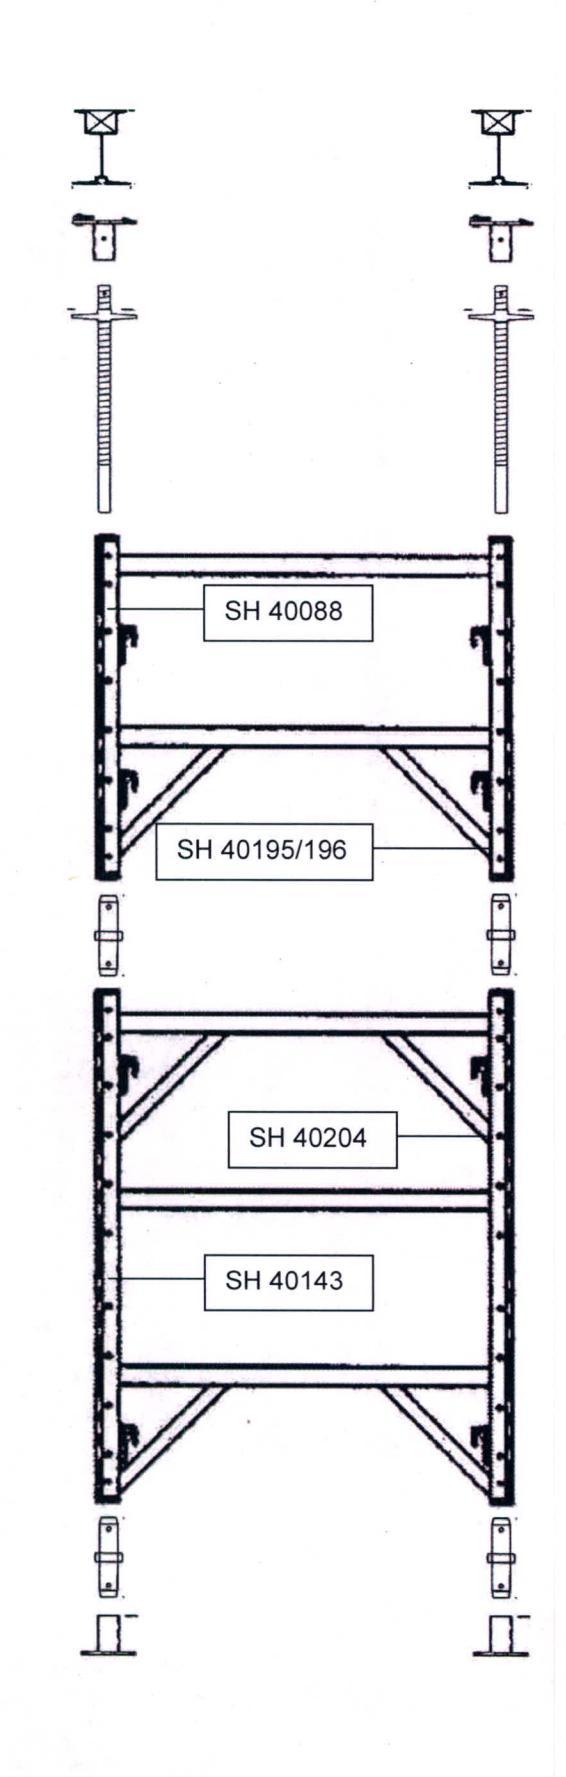
SH 40088 Top Frame (Shore and Screw jack) Zone 40F

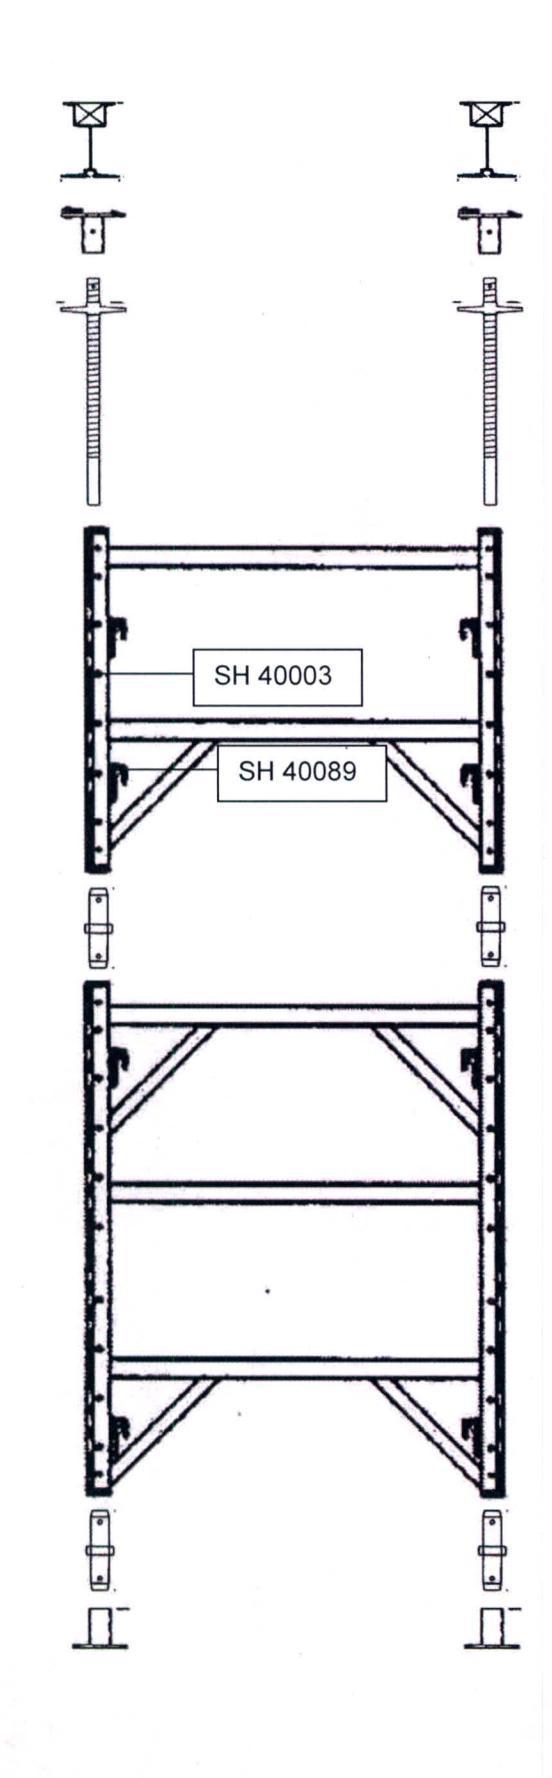
SH 40089 X Brace Connects SH 40003 to SH 40004

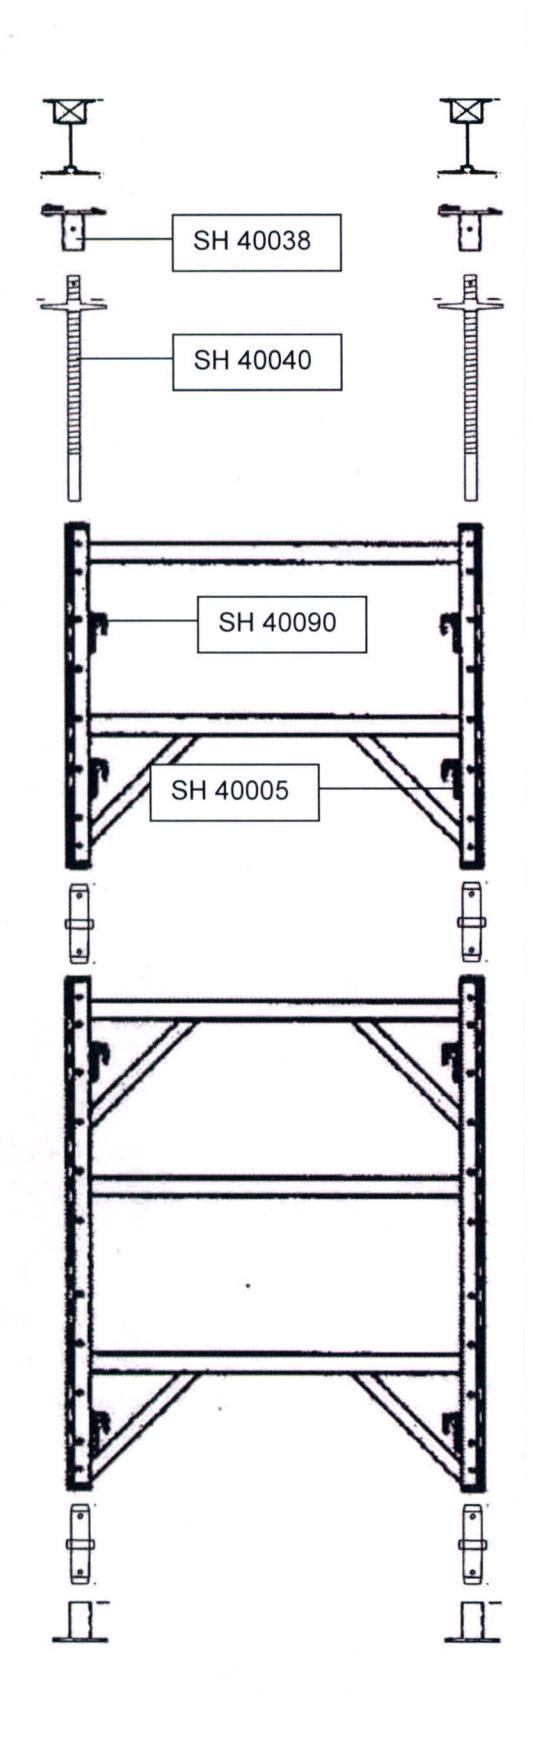
SH 40090 X Brace Connects SH 40005 to SH 40020 Zone 40F

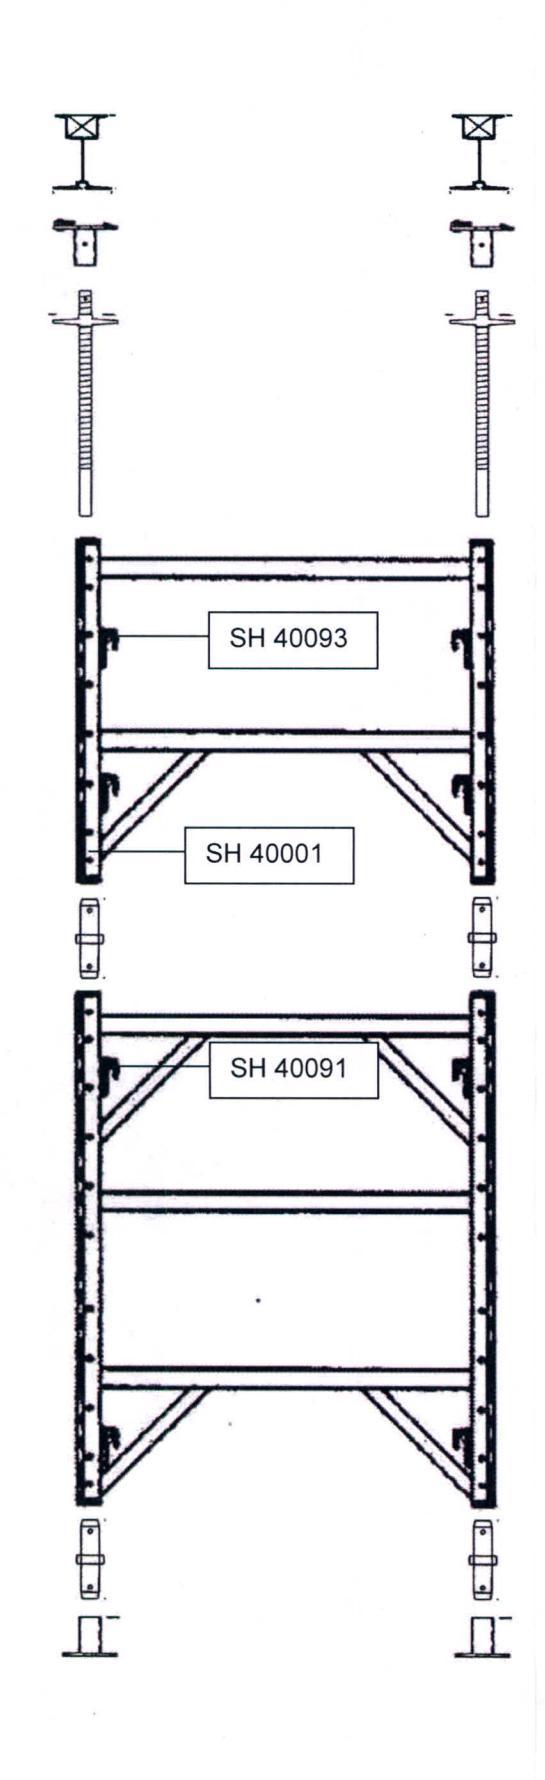
SH 40091 Bottom X Brace Top Brace is SH 40093 (Connects SH 40001 and SH 40002) Zone 40K

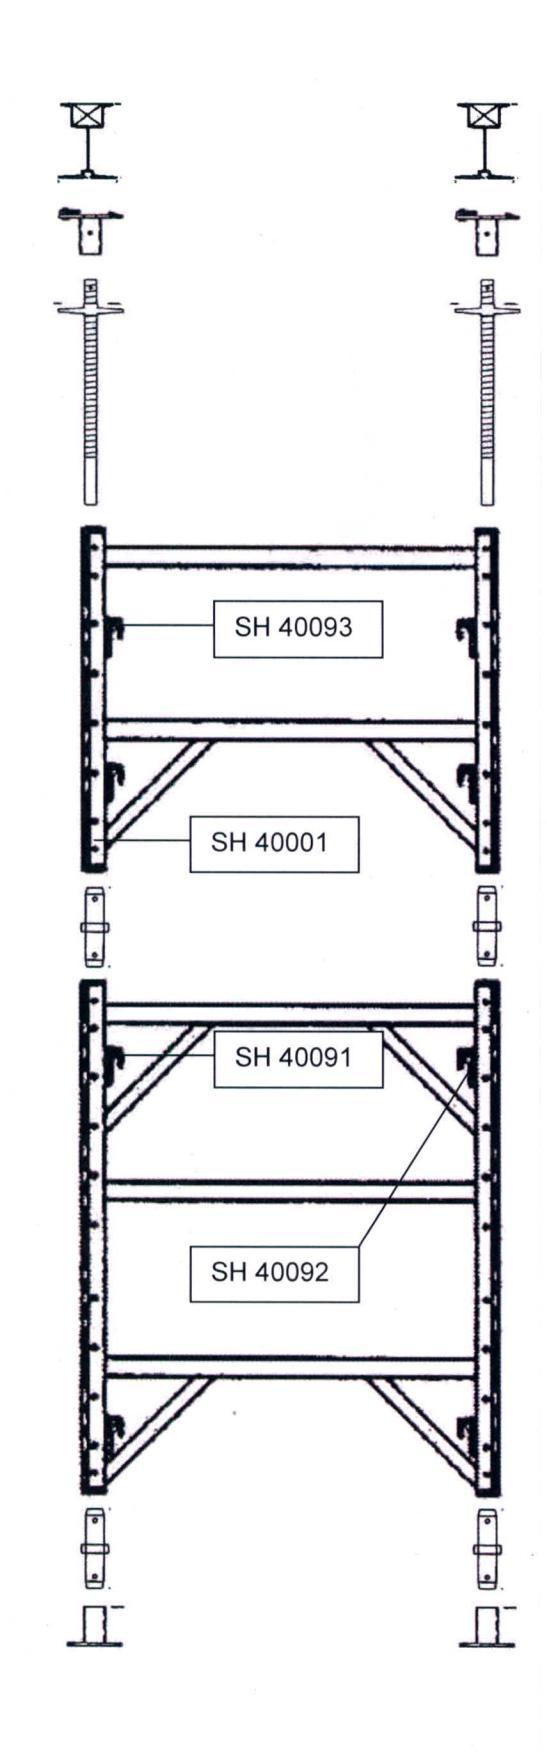
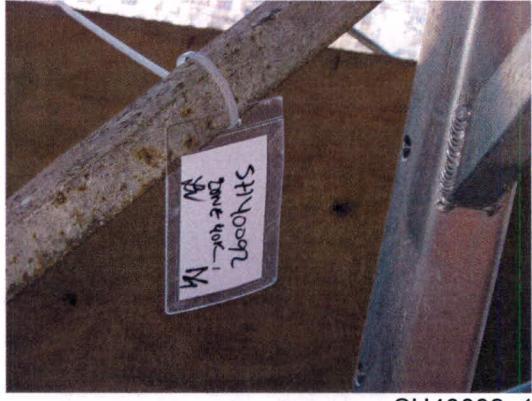
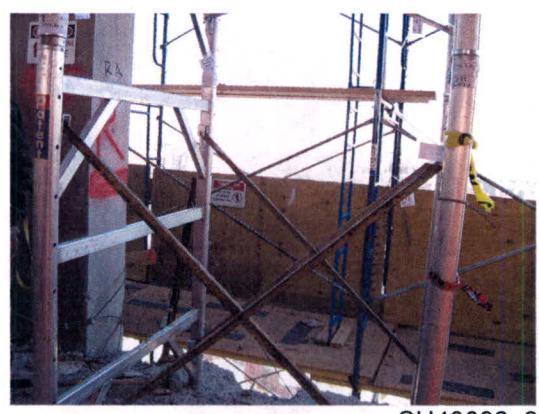
Folder: 08-02-16; SH 40092

SH 40092 Bottom X Brace parallel to SH 40091 Zone 40K
