INVESTIGATION REPORT:

JANUARY 14, 2008 SHORING COLLAPSE AT 9 DOMINICK ST. (AKA 246 SPRING ST.) MANHATTAN

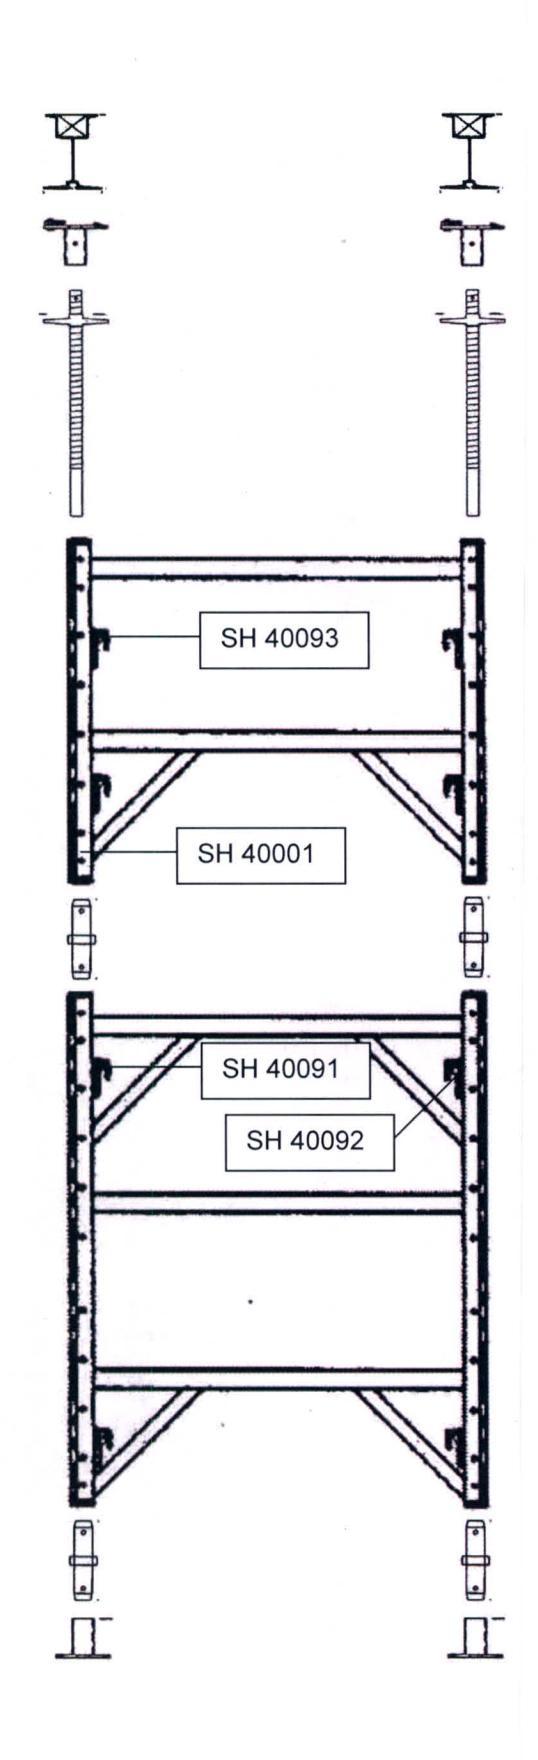
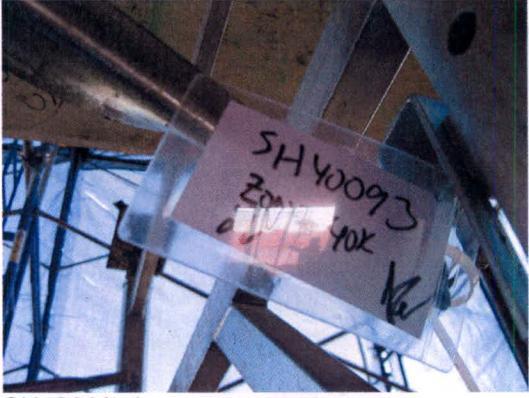
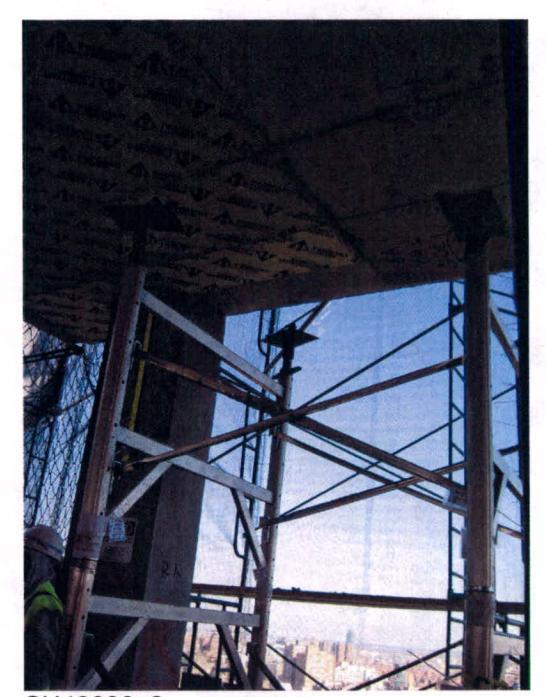
Folder: 08-02-16; SH 40093

SH 40093 Top X Brace connects SH 40001 & SH 40002 Zone 40K

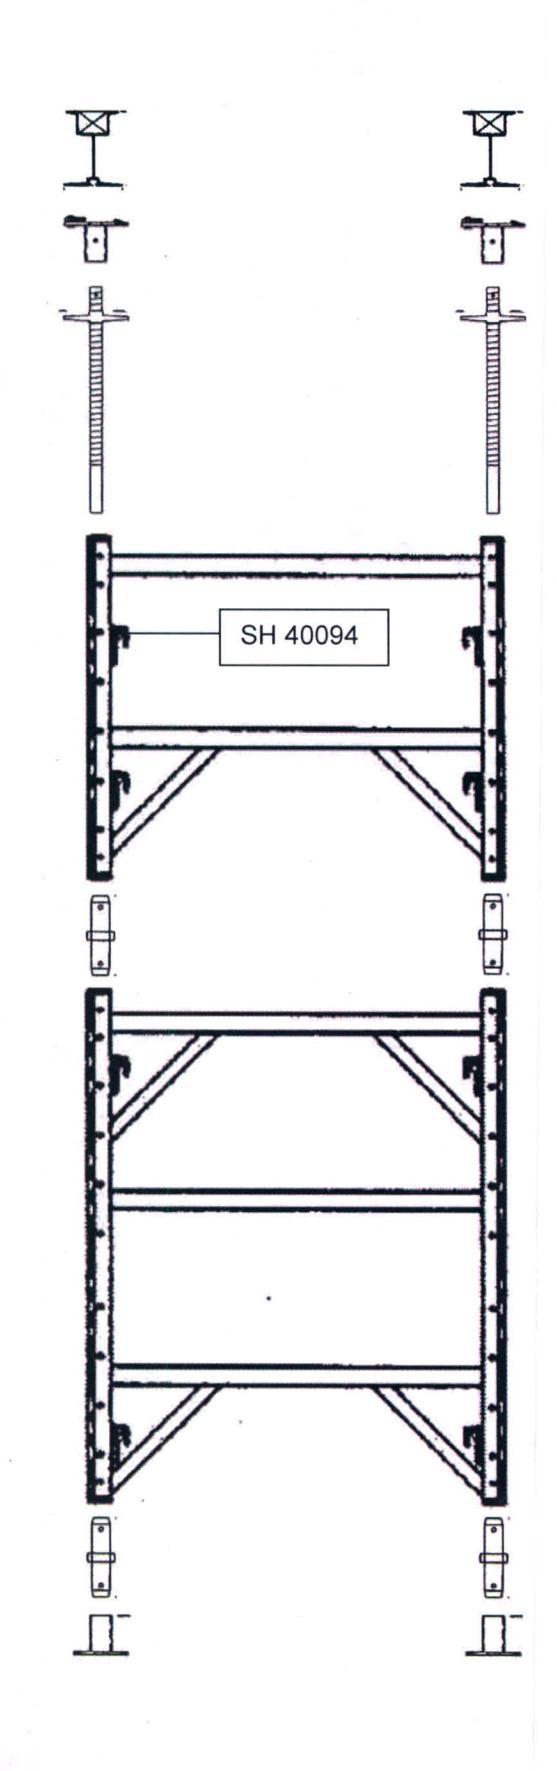
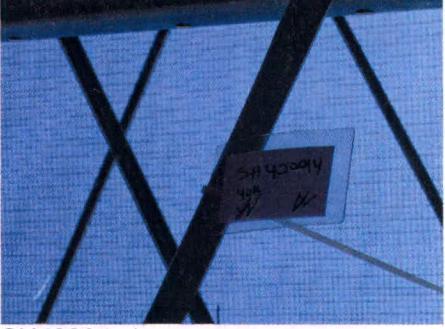
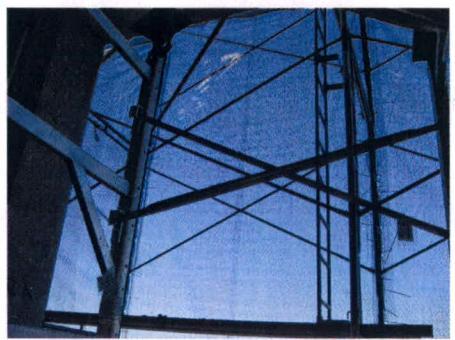
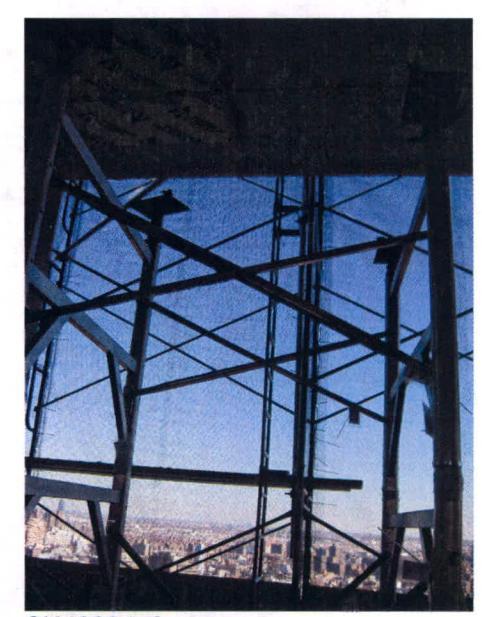
Folder: 08-02-16; SH 40094

SH 40094 X Brace Zone 40K

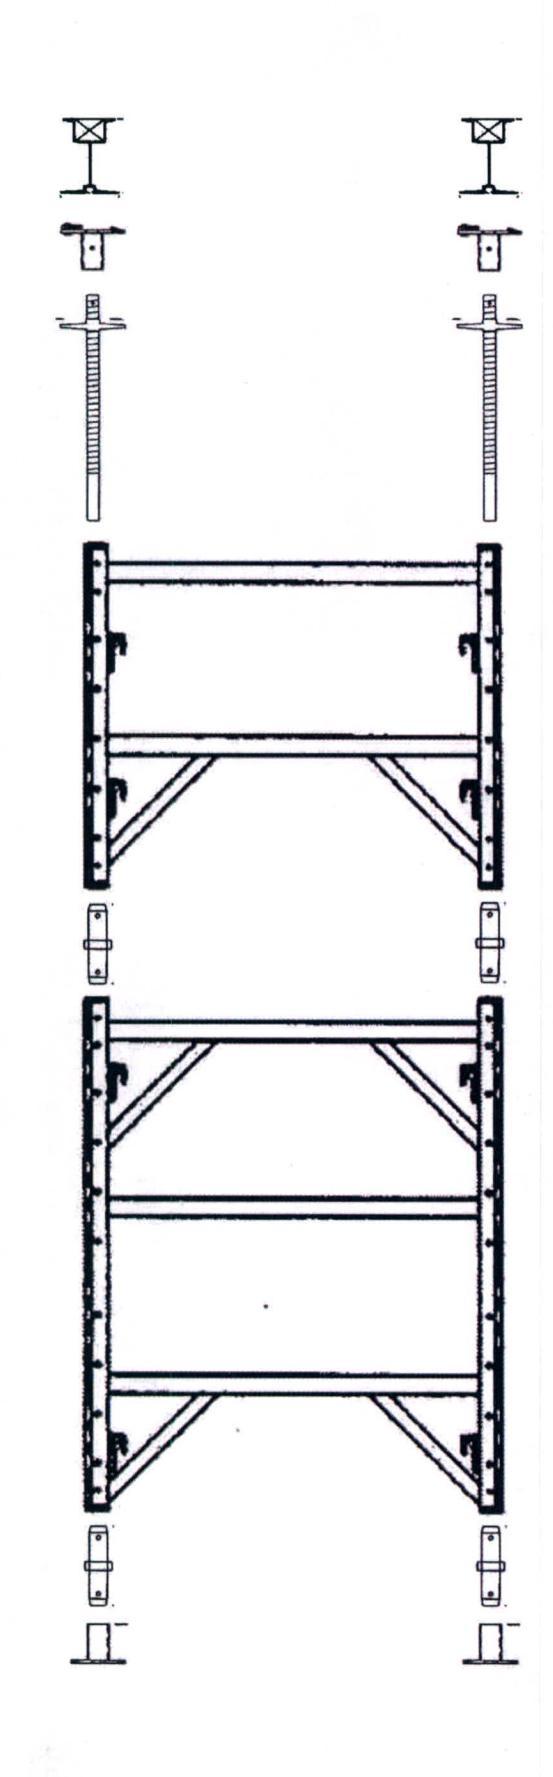
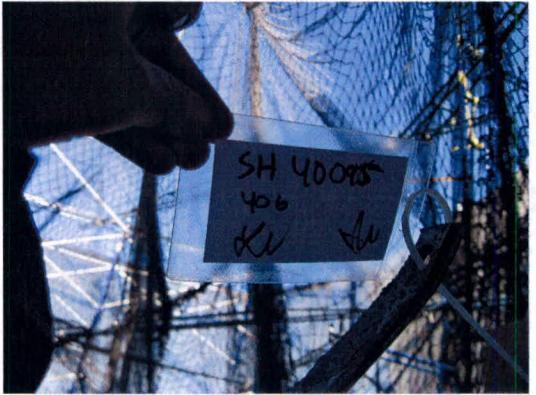
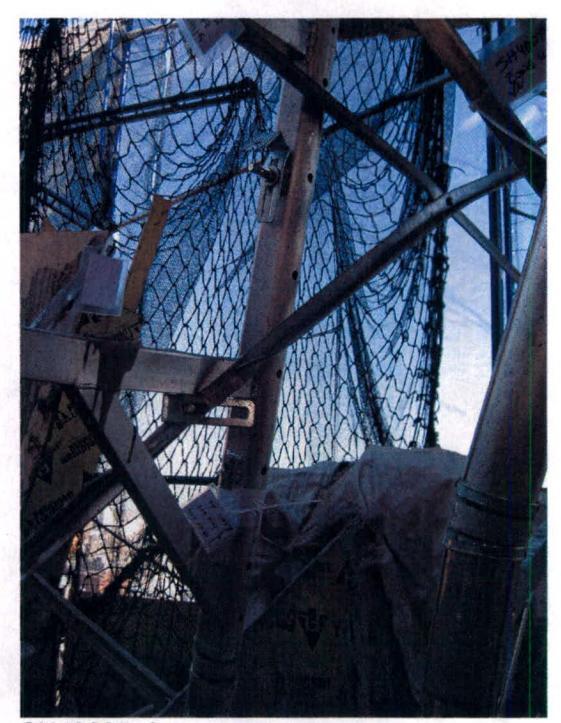
Folder: 08-02-16; SH 40095

SH 40095 X Brace Leaning on SH 40004 Zone 40K

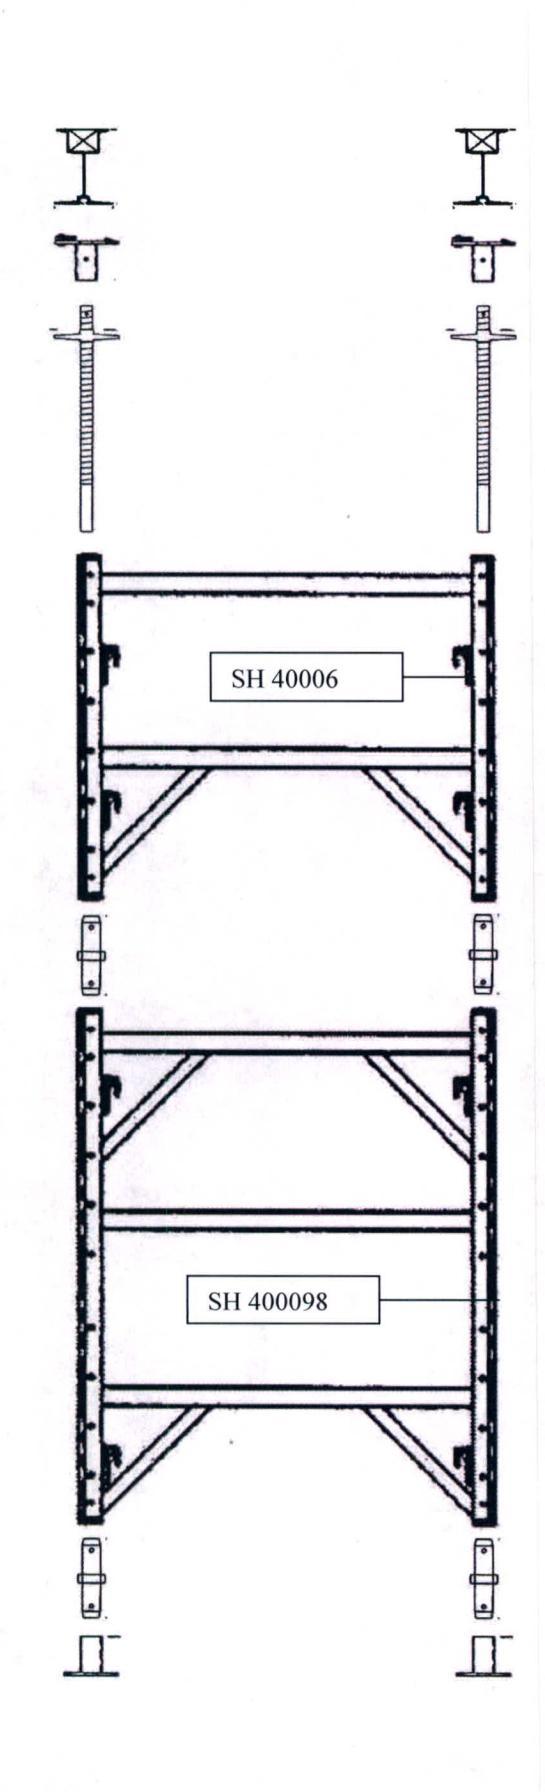
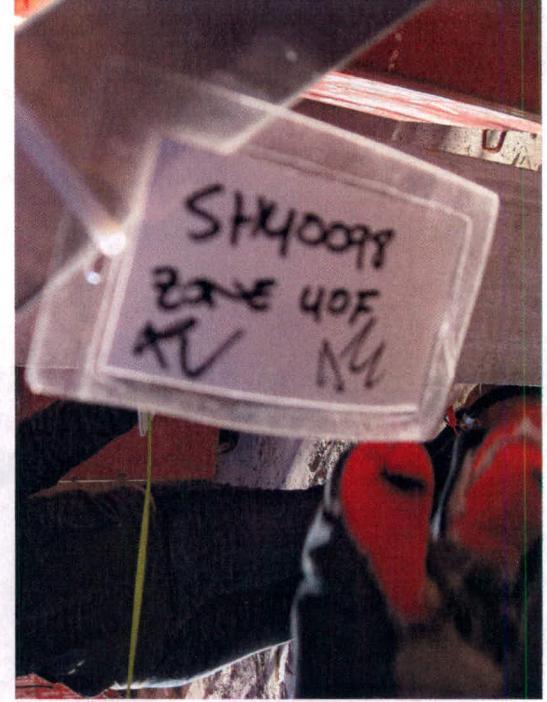
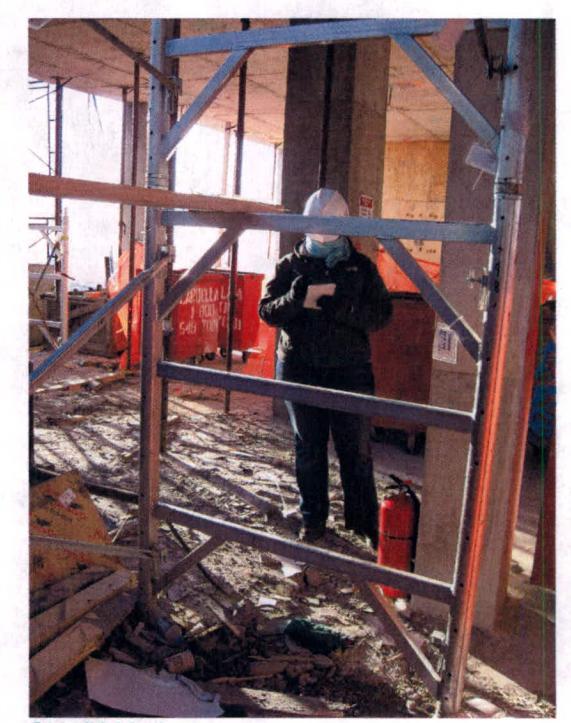
Folder: 08-02-19; 08-02-19; SH 40098

SH 40098 Bottom Frame of SH 40006 Zone 40F

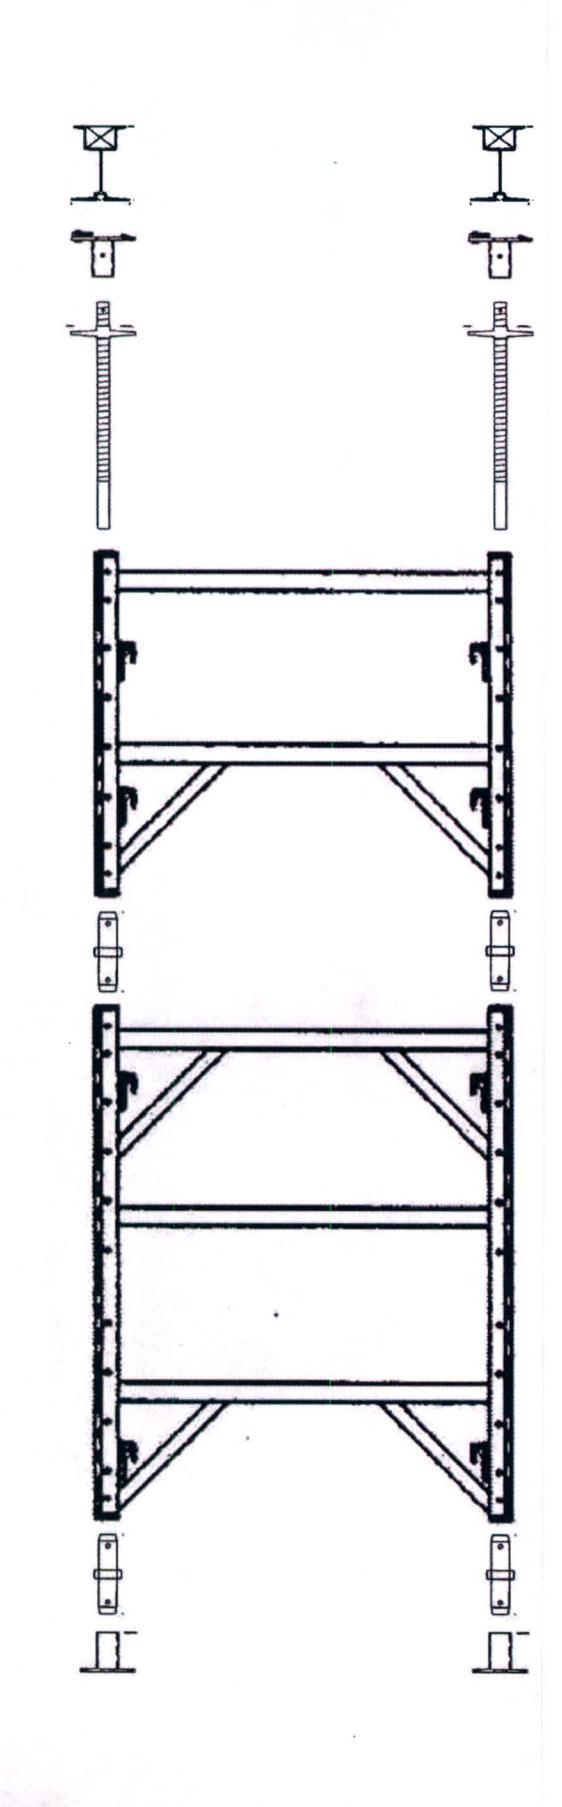
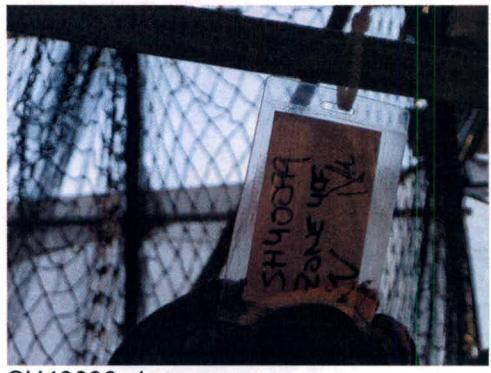
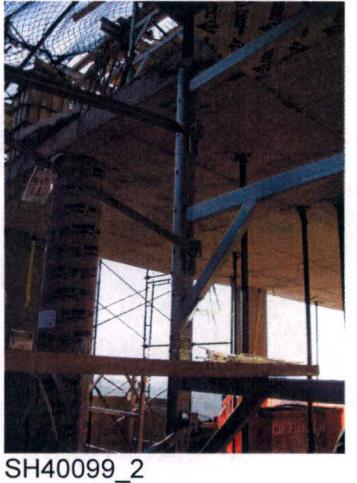
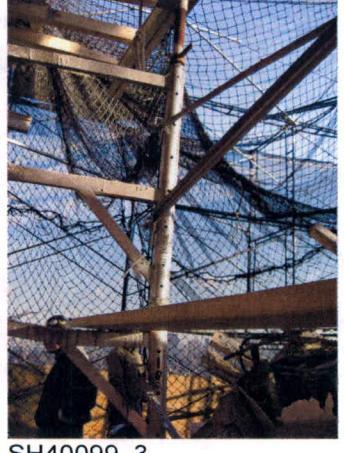
Folder: 08-02-19; 08-02-19; SH 40099

SH 40099 Top East Brace Attached to SH 40007 Relocated from original position See SH 40007 Zone 40F

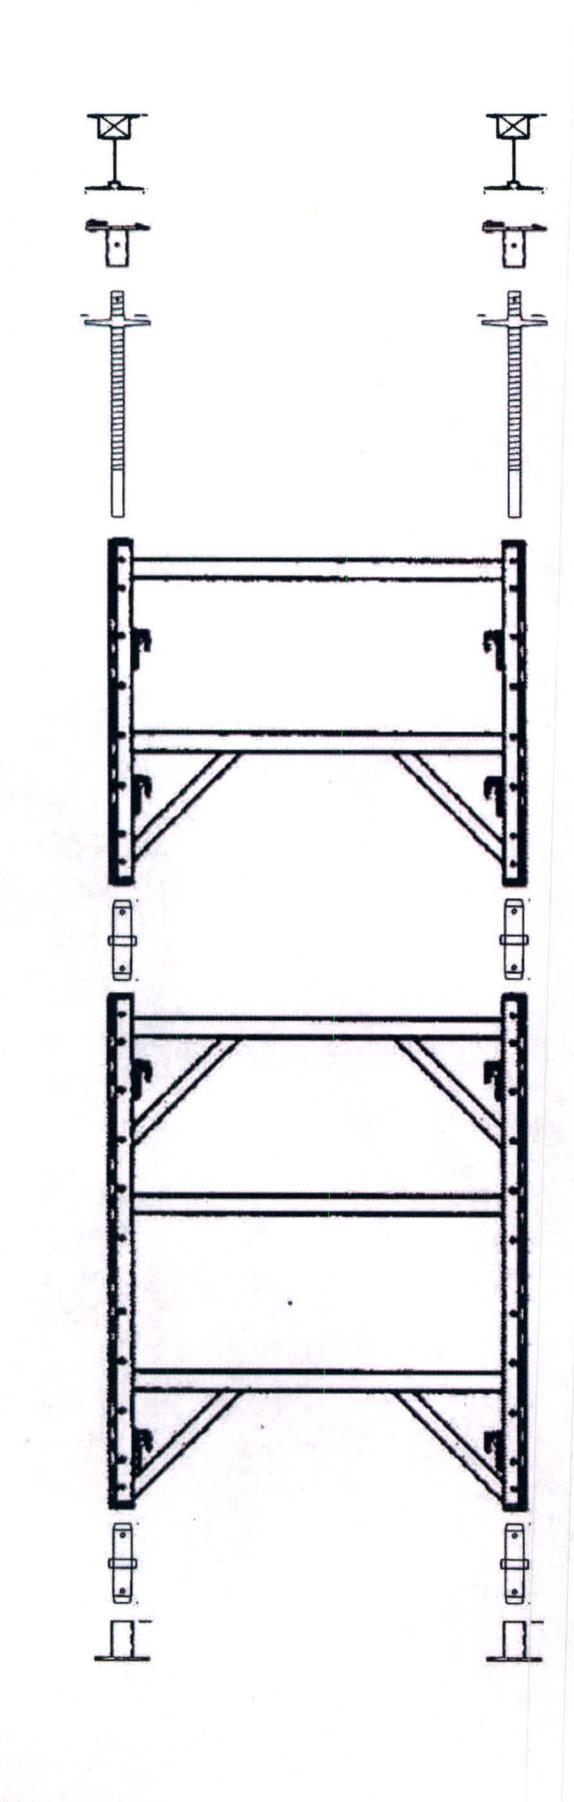
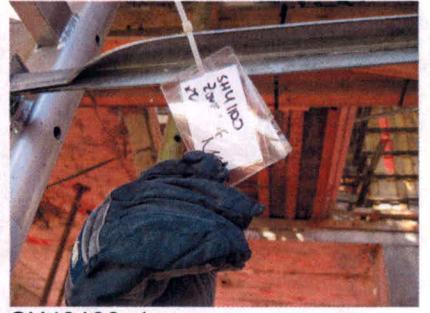
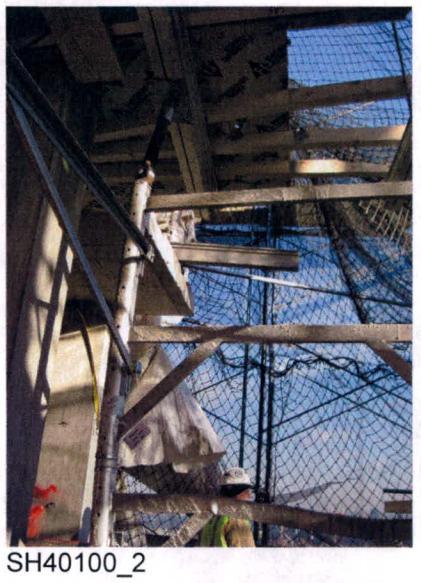
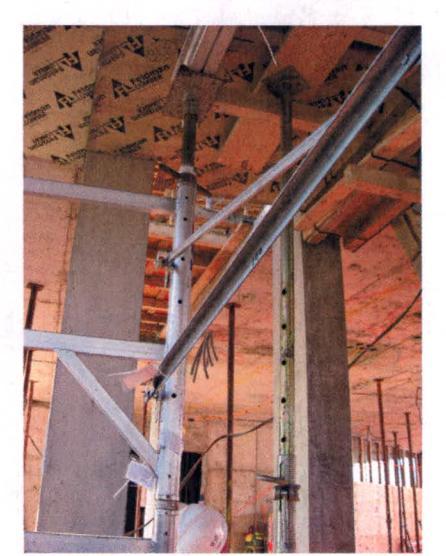
Folder: 08-02-19; 08-02-19; SH 40100

SH 40100 Top X Brace of SH 40007 Zone 40F

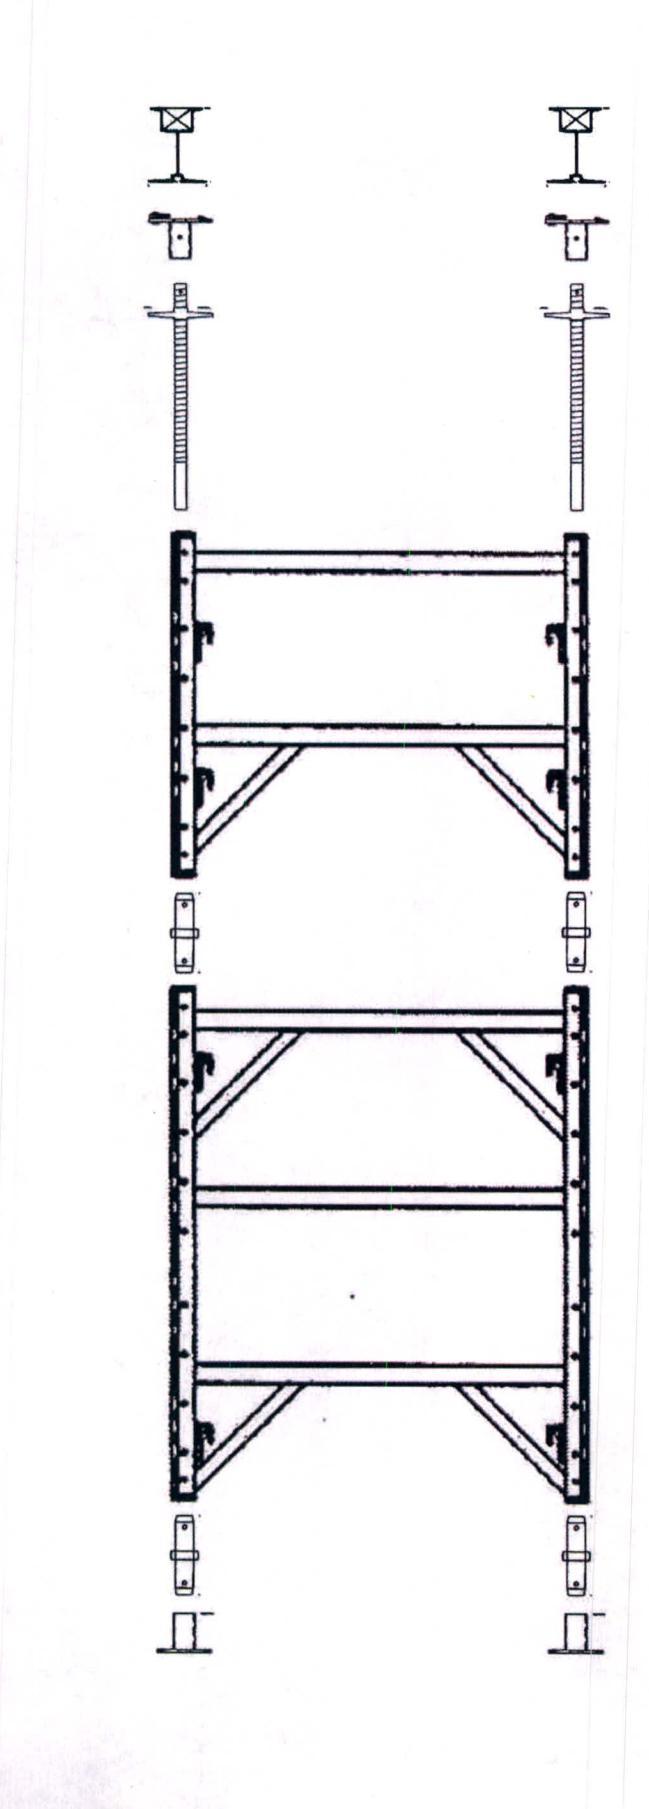
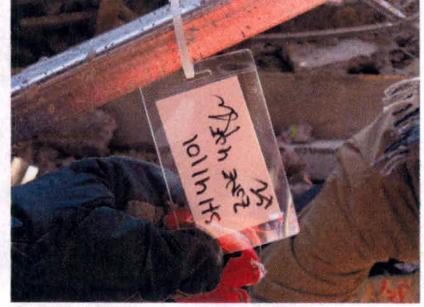
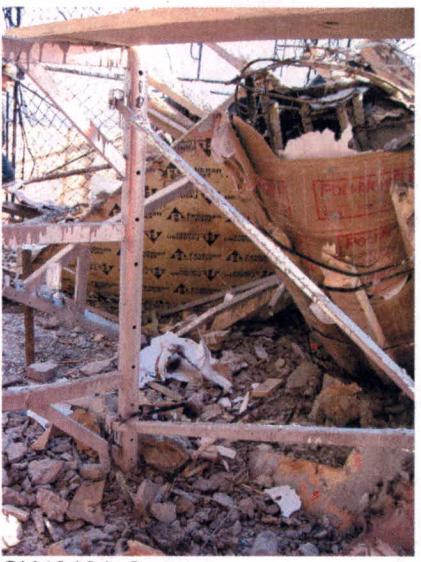
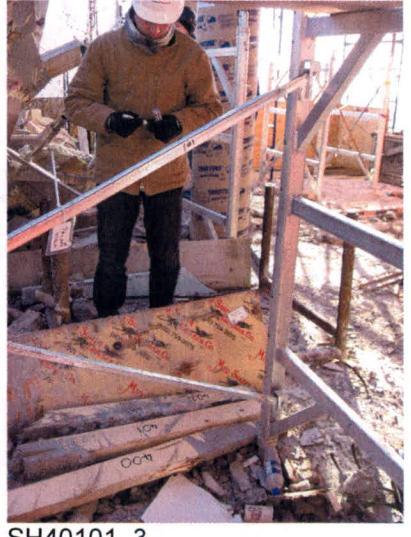
Folder: 08-02-19; 08-02-19; SH 40101

SH 40101 Bottom X Brace for Bottom Frame SH 40102 Zone 40F

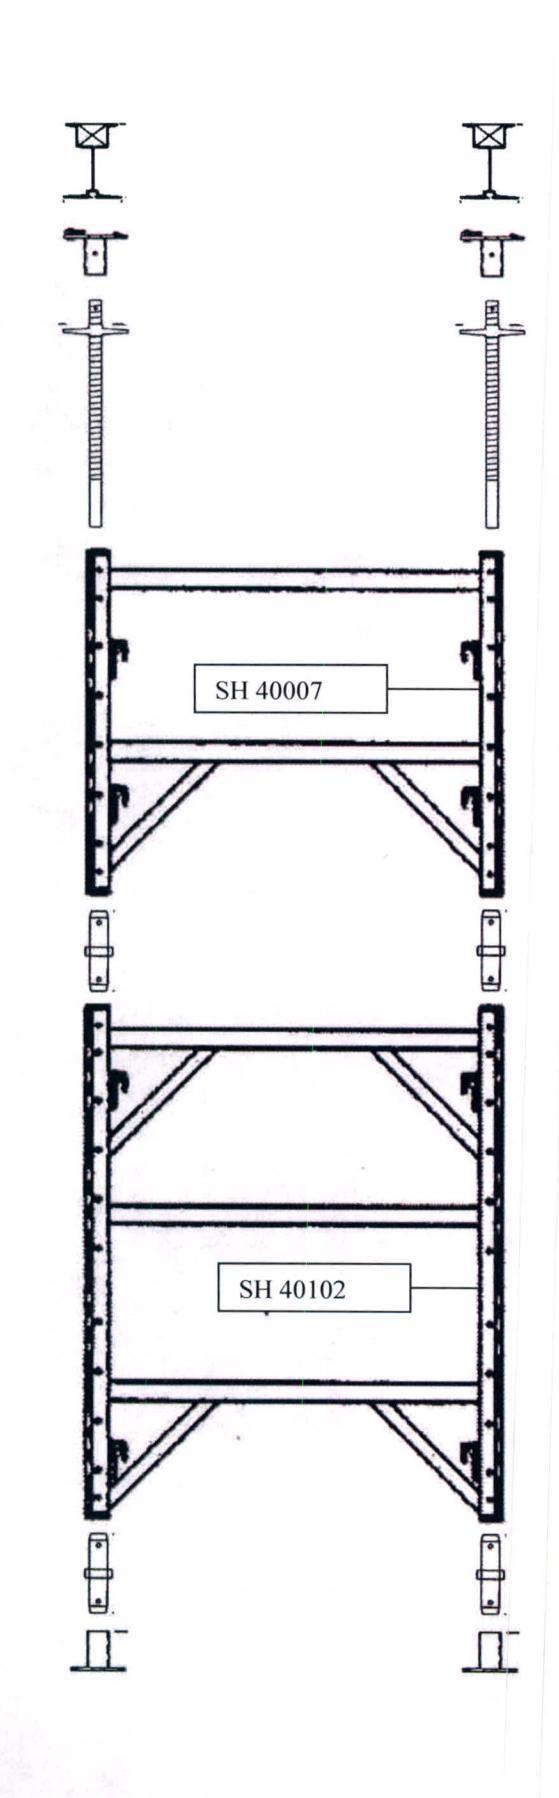
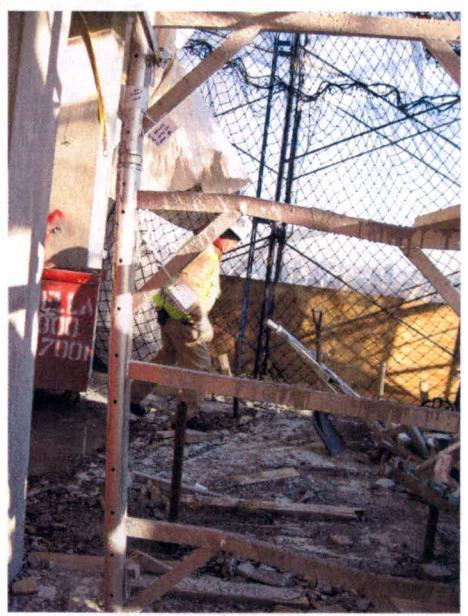
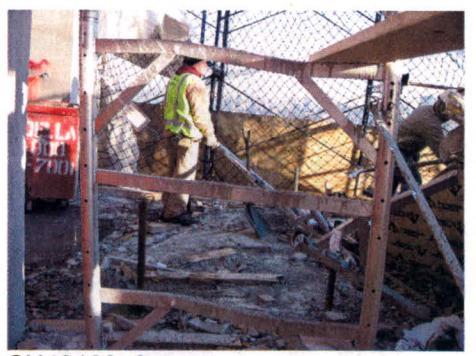
Folder: 08-02-19; 08-02-19; SH 40102

SH 40102 Bottom Frame of SH 40007 Connected to Brace SH 40101 Zone 40F

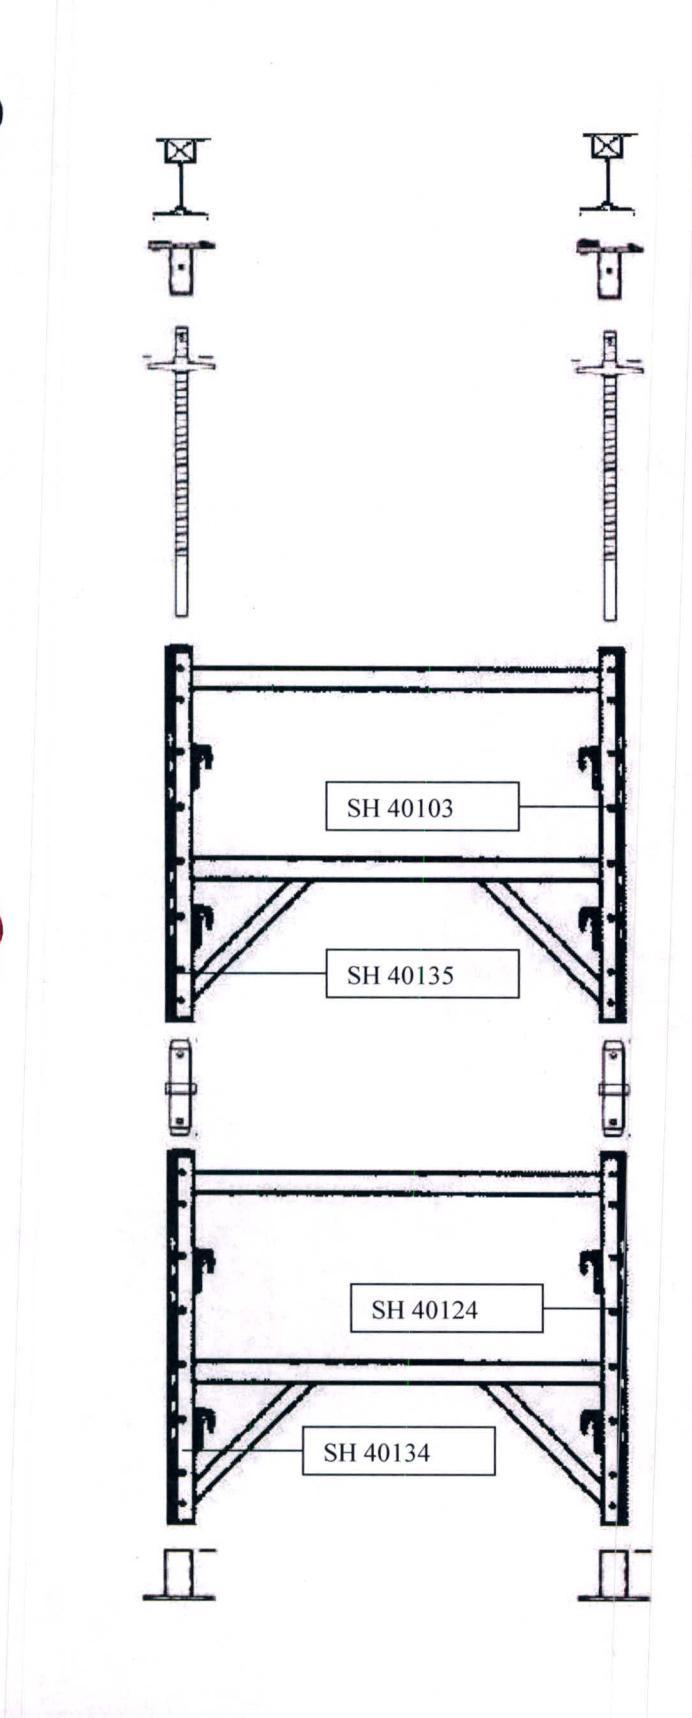
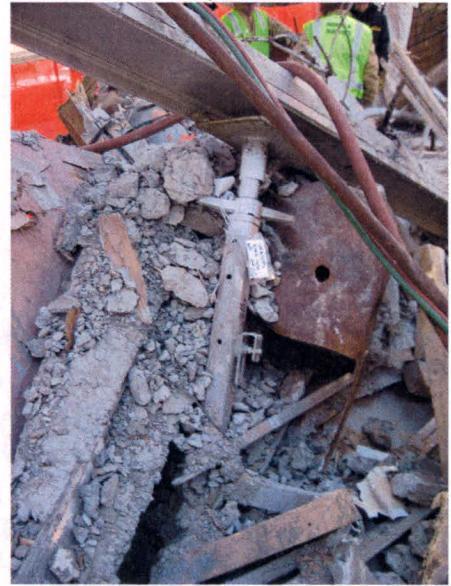
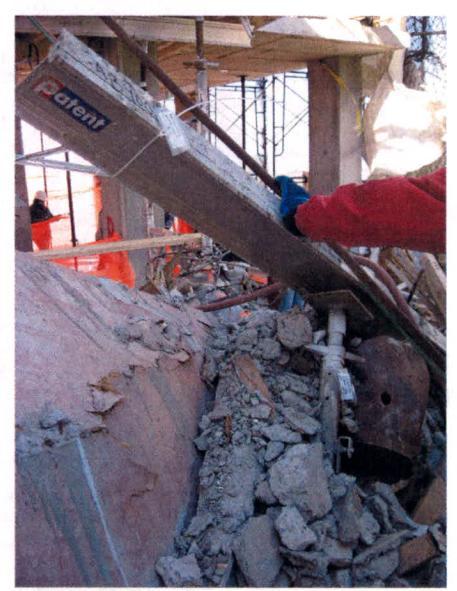
Folder: 08-02-19; SH 40103

SH 40103 on 41st floor Top Shore of SH 40124 Support AB 40014 Zone 40F

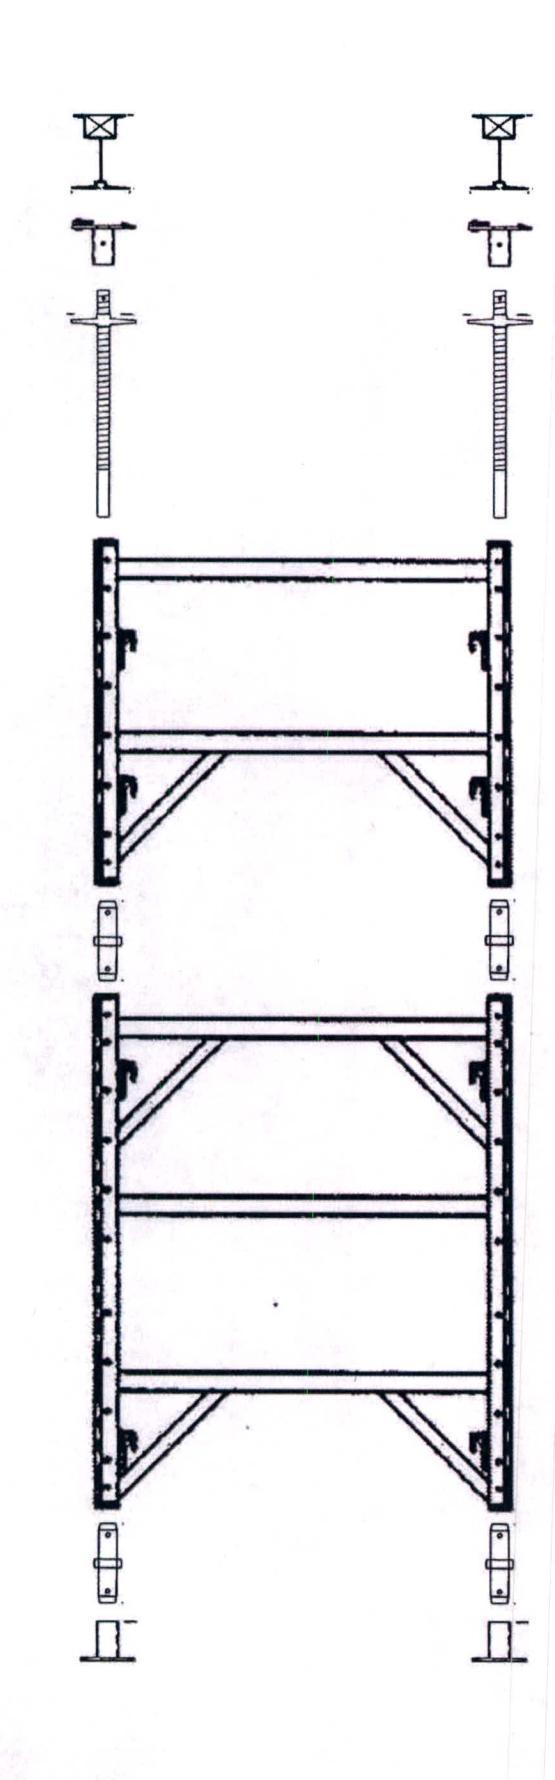
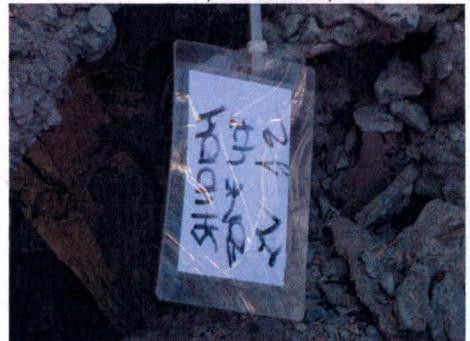
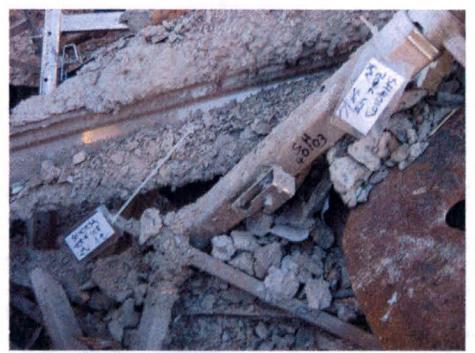
Folder: 08-02-19; 08-02-19; SH 40104

SH 40104 X Brace collapsed near SH 40103 Zone 40F

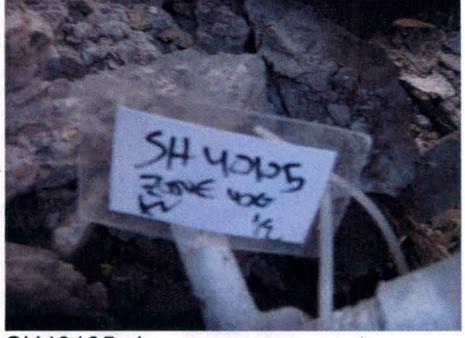
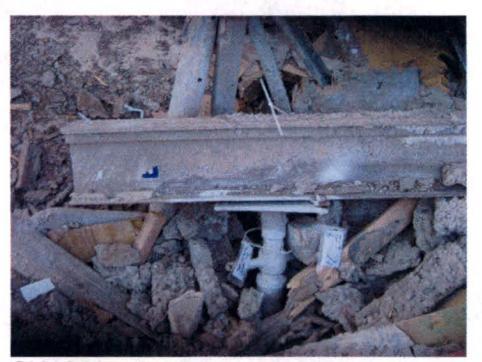
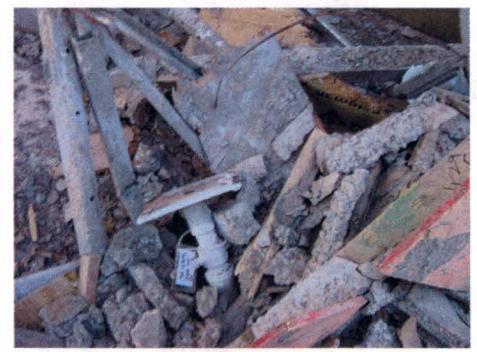
SH40105_1

SH 40105 Attached to Screw Jack & Top plate Supports AB 40042 Zone 40F

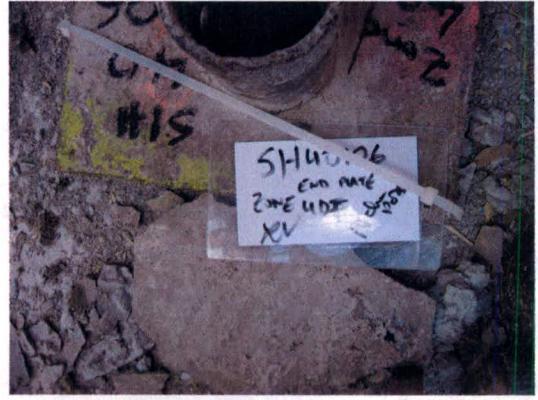
SH40106_1

SH 40106 Bottom Plate Zone 40F Folder: 08-02-19; SH 40106

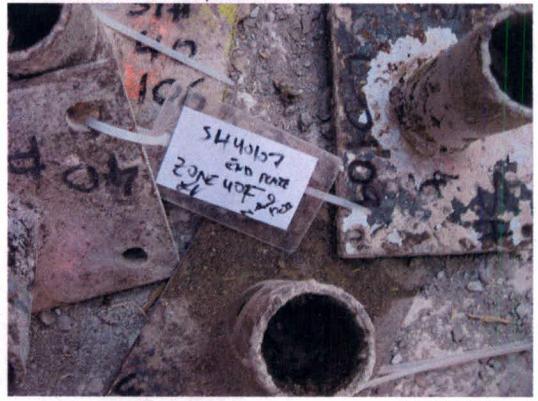
SH40107_1

SH 40107 Bottom Plate Zone 40F Folder: 08-02-19; SH 40107

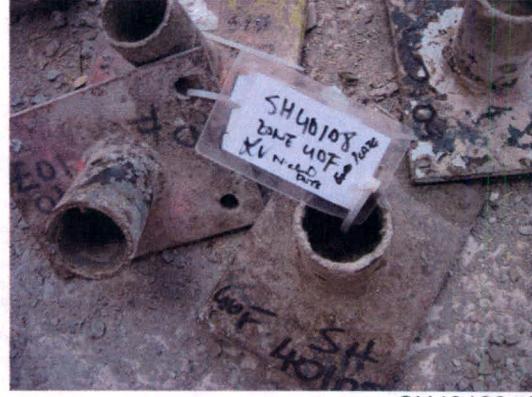
SH40108_1

SH 40108 Bottom Plate Zone 40F Folder: 08-02-19; SH 40108

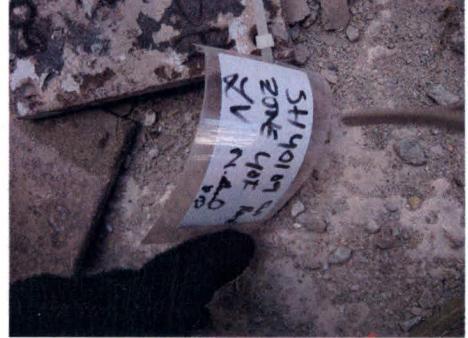
SH40109_1

SH 40109 Bottom Plate Zone 40F Folder: 08-02-19; 08-02-19; SH

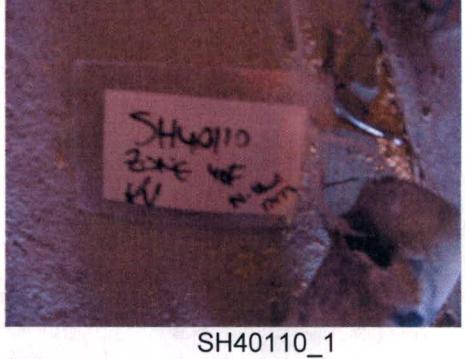
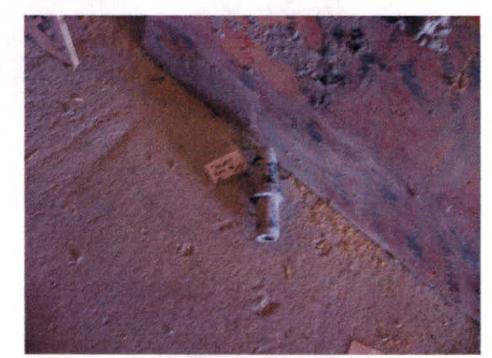
SH40110_2

SH 40110 Coupler Moved from original position Zone 40F Folder: 08-02-19; 08-02-19; SH

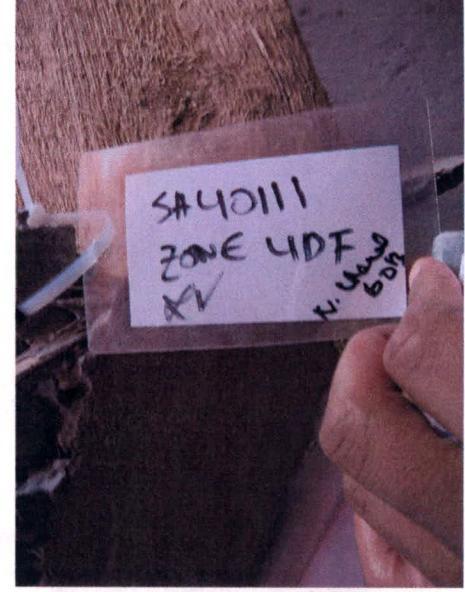
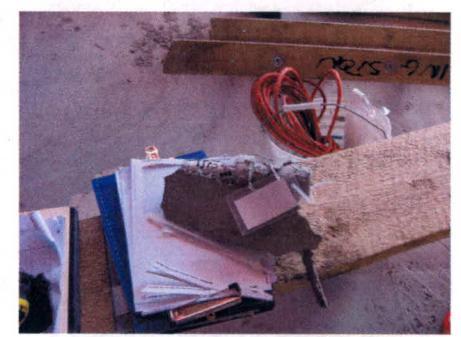
SH40111_1

SH 40111 Coupler Moved from original position Zone 40F

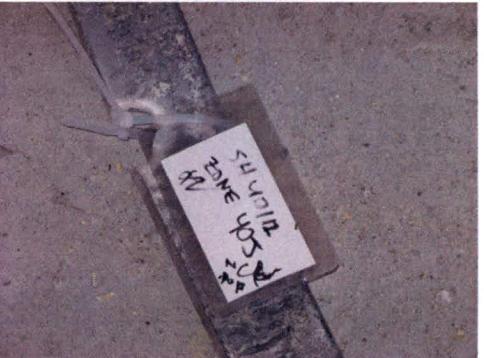
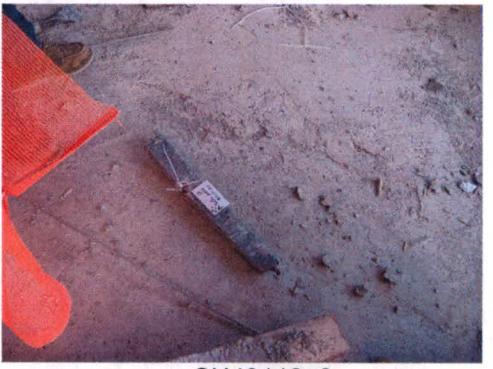
SH40112_1

SH 40112 Broken piece of frame Moved from original position Zone 40J

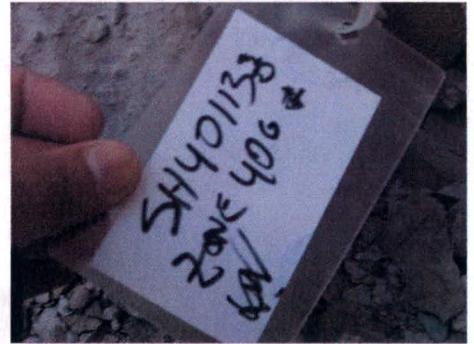
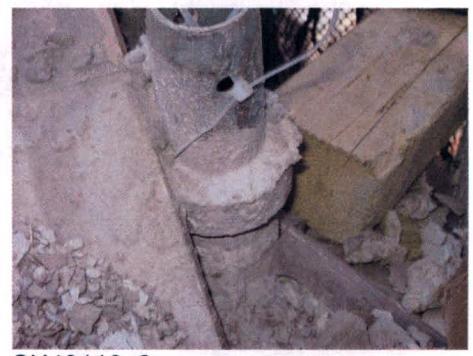
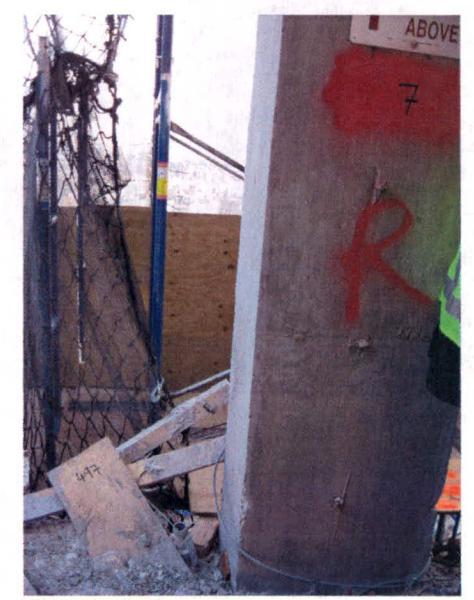
SH40113_1

SH 40113 Coupler Zone 40G

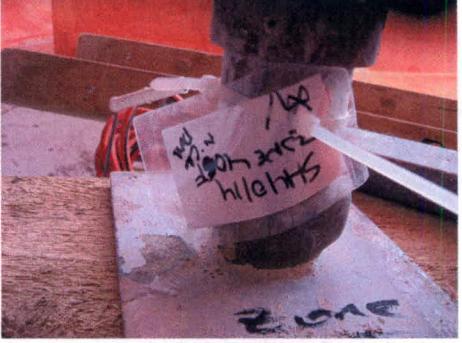
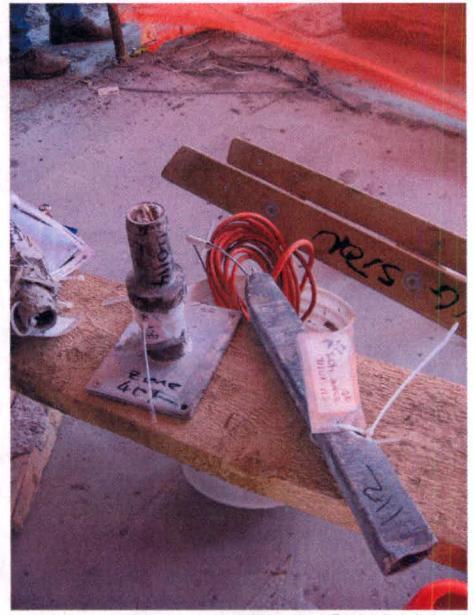
SH40114_1

SH 40114 Coupler with Bottom Plate Zone 40F

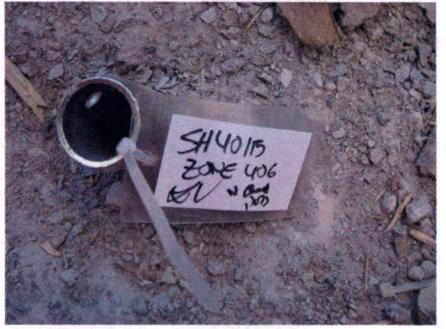
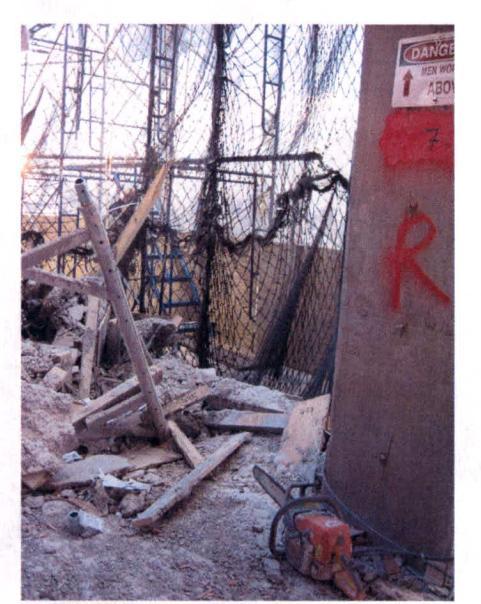
SH40115_1

SH 40115 Coupler Zone 40G

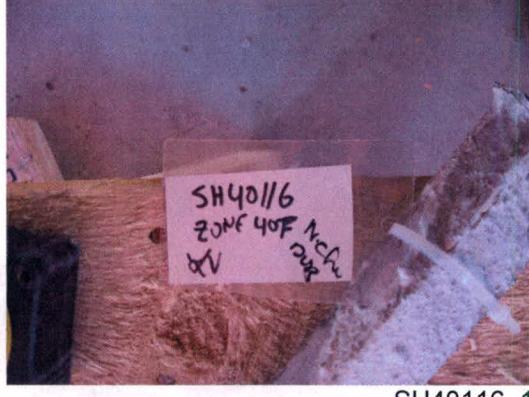
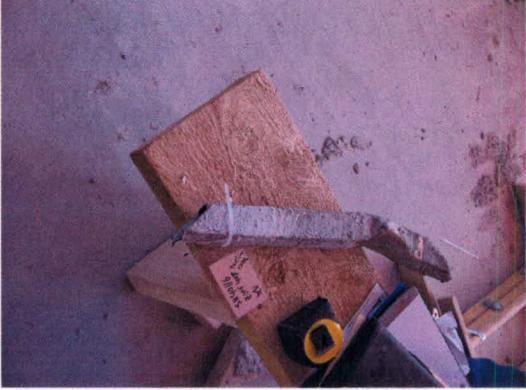
SH40116_1

SH 40116 Piece of frame Moved from original position Zone 40F

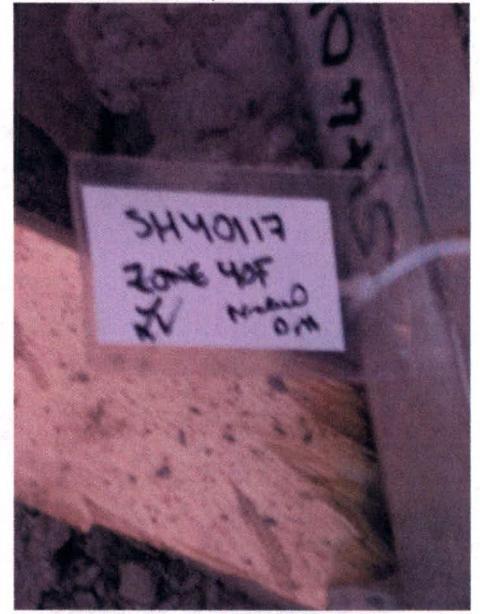
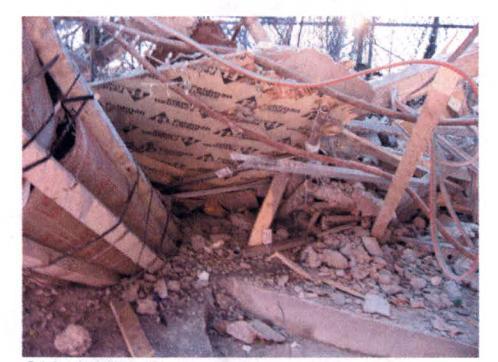
SH40117_1

SH 40117 Broken piece of frame found under SH 40088 (retagged) Zone 40F

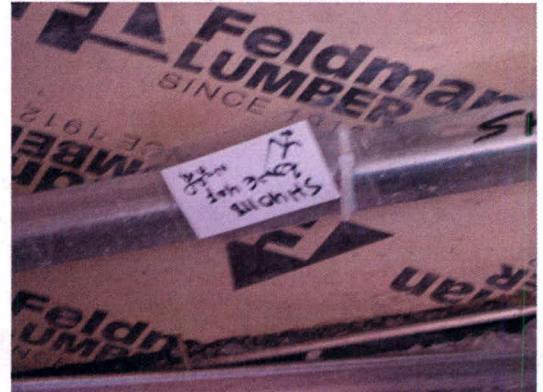
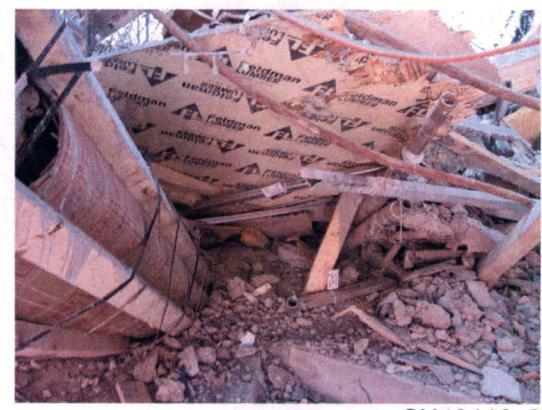
SH40118_1

SH 40118 Brace Connected to SH 40088 Zone 40F

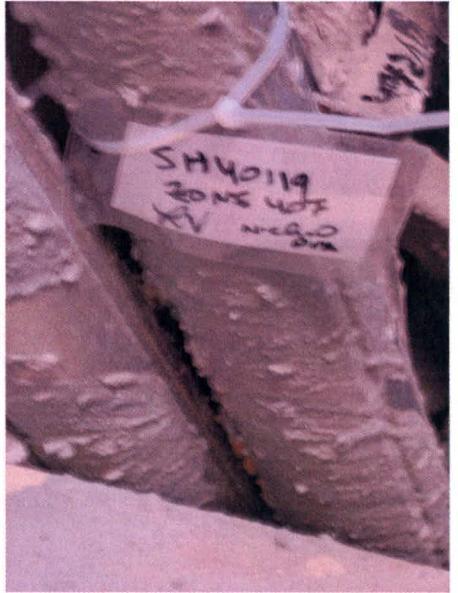
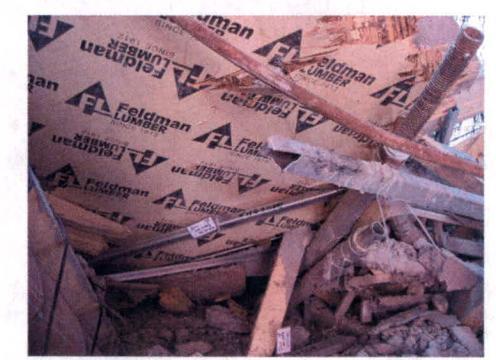
SH40119_1

SH 40119 Bottom Shore Broken with SH 40180 Zone 40F

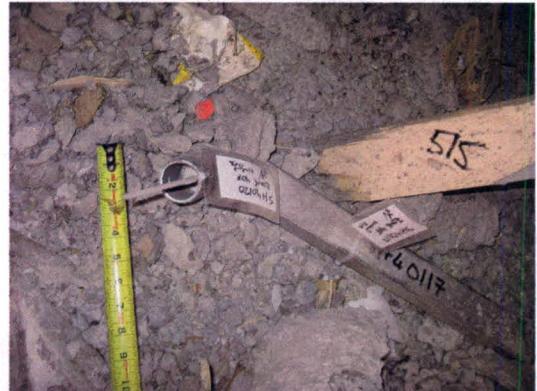
SH40120_1

SH 40120 Coupler Zone 40F

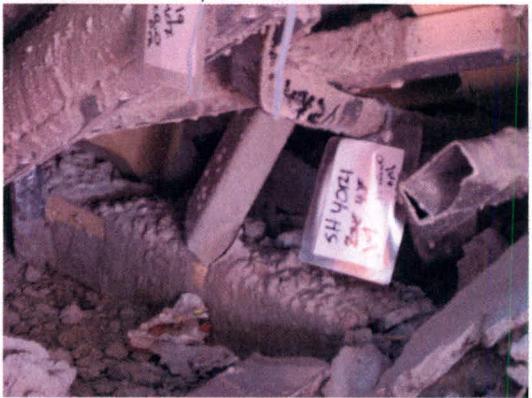
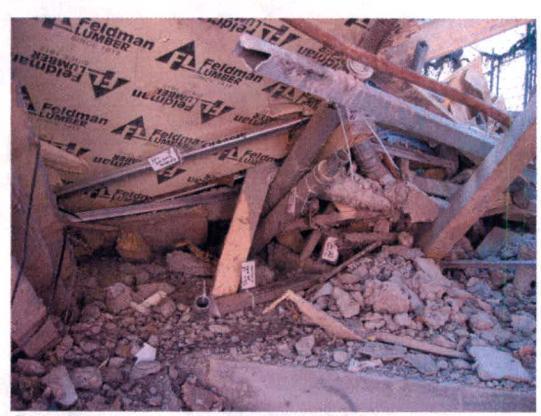
SH 40121 X Brace connect to SH 40119 Zone 40F

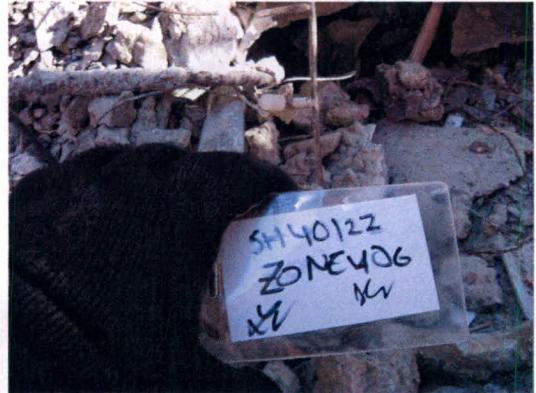
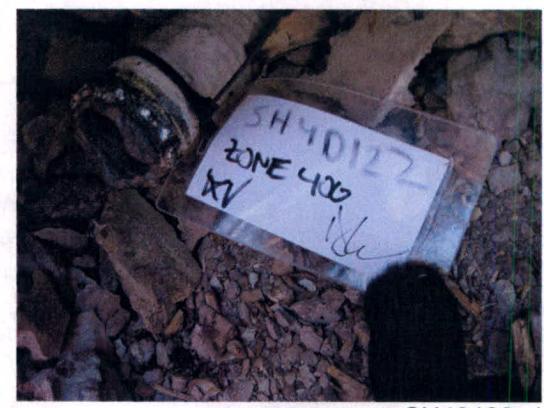
SH 40122 Screw Jack cut Zone 40G
