INVESTIGATION REPORT:

JANUARY 14, 2008 SHORING COLLAPSE AT 9 DOMINICK ST. (AKA 246 SPRING ST.) MANHATTAN

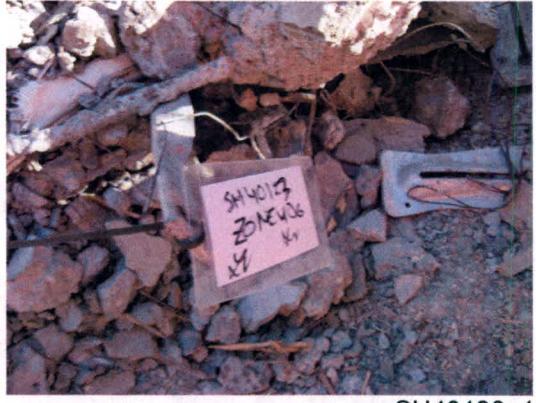
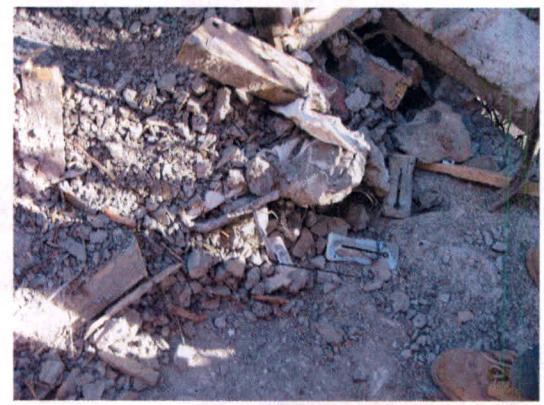
SH 40123 X Brace Zone 40G

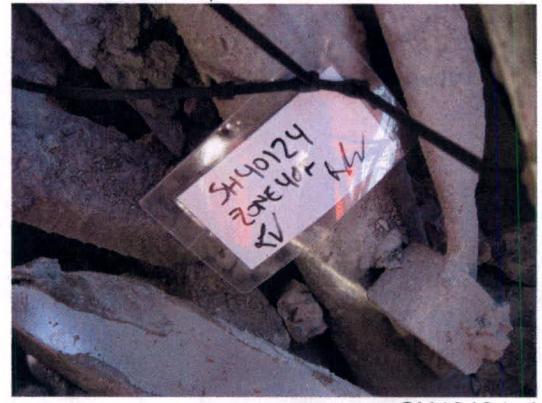
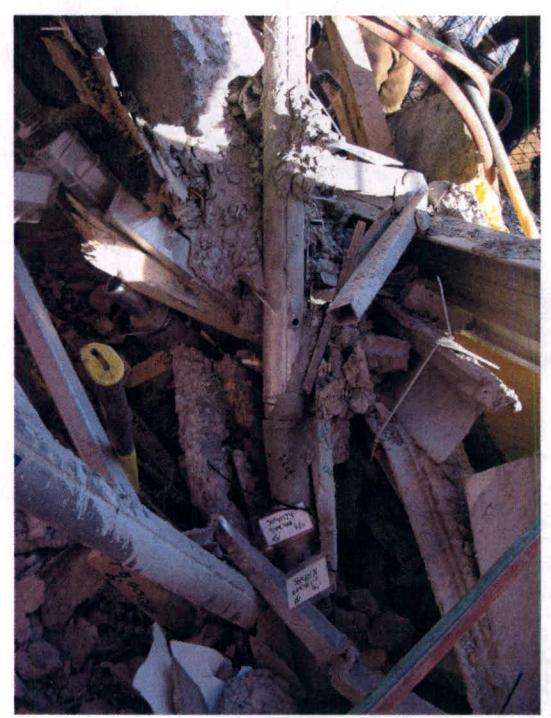
SH 40124 on 41st floor Bottom frame of SH 40103 Attached to bottom brace SH 40126 Zone 40F

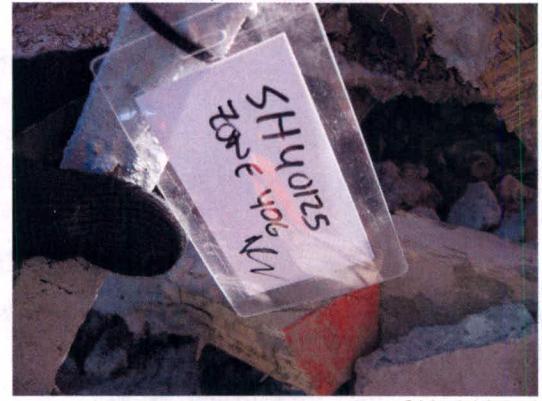
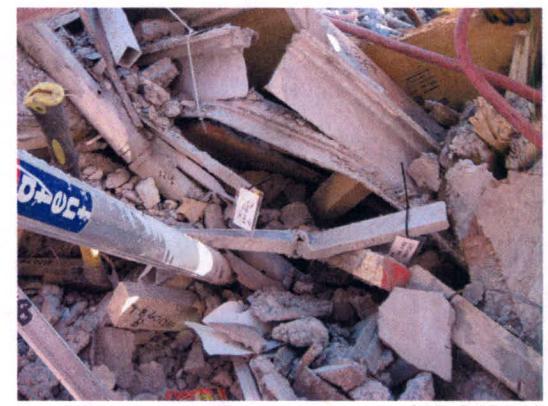
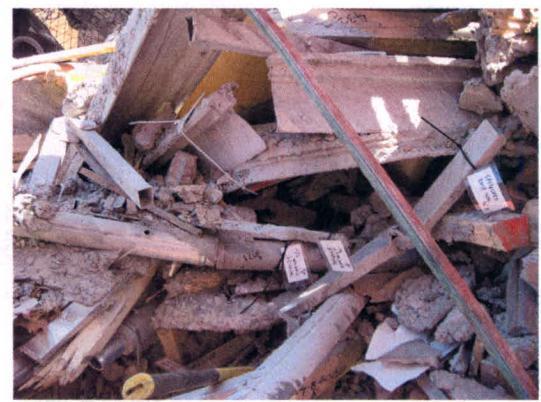
SH 40125 Broken piece near SH 40124 Zone 40G

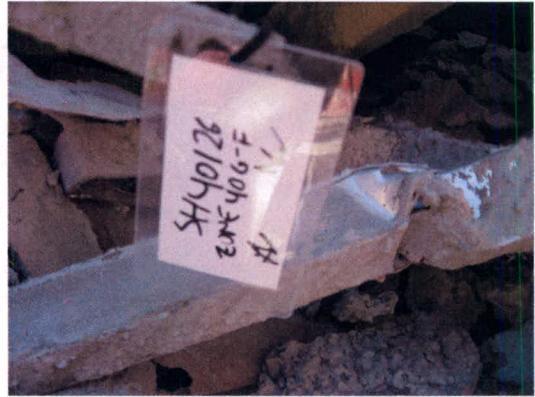
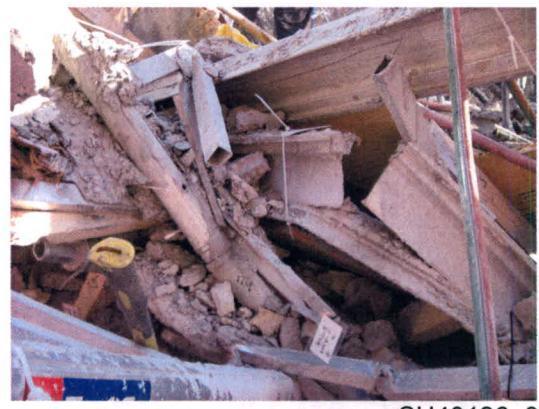
SH 40126 Brace Zone 40G-F

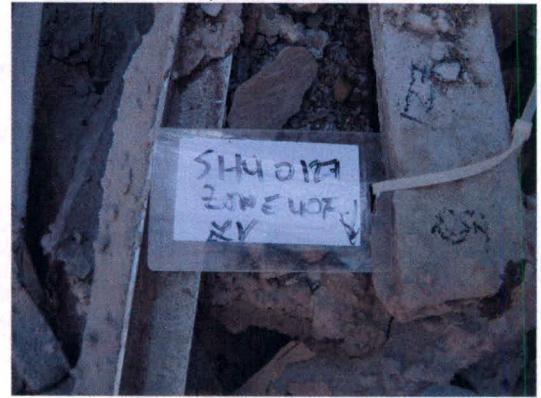
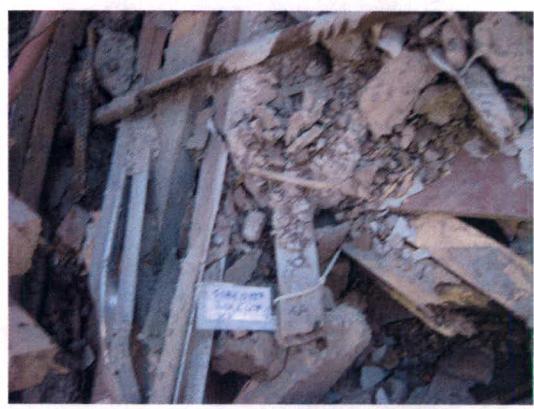
SH 40127 Broken piece Zone 40F

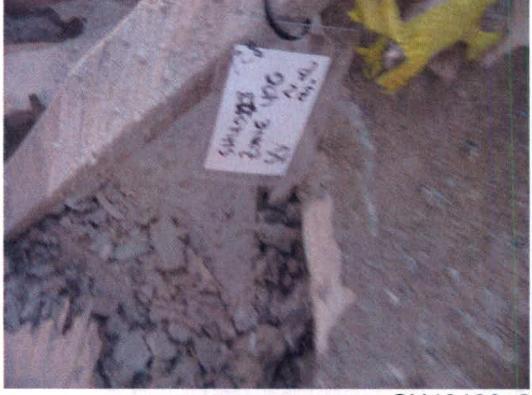
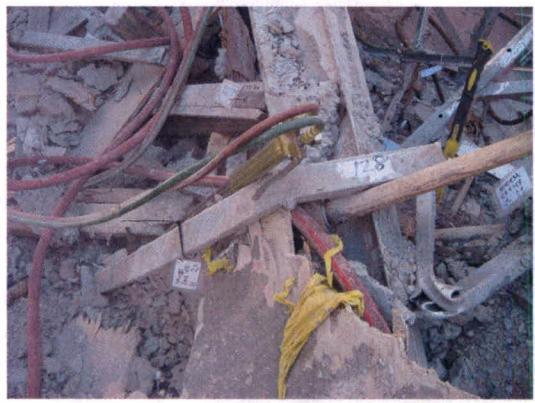
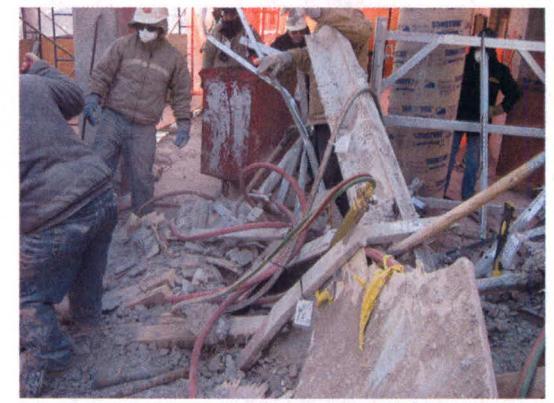
SH 40128 Broken Piece Zone 40G

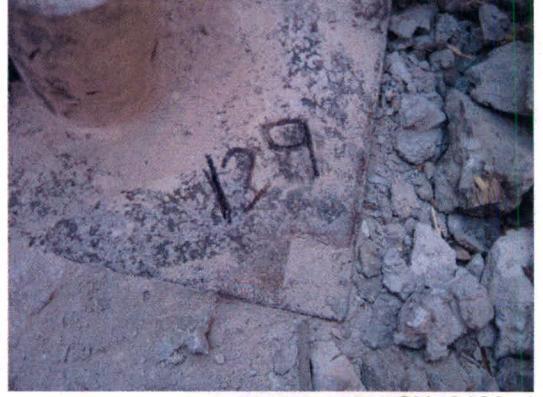
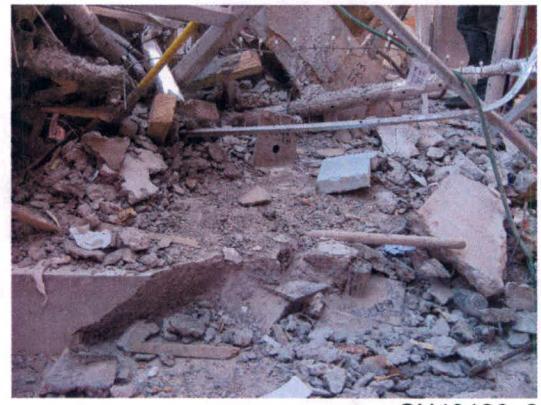
SH 40129 Top plate Zone 40F

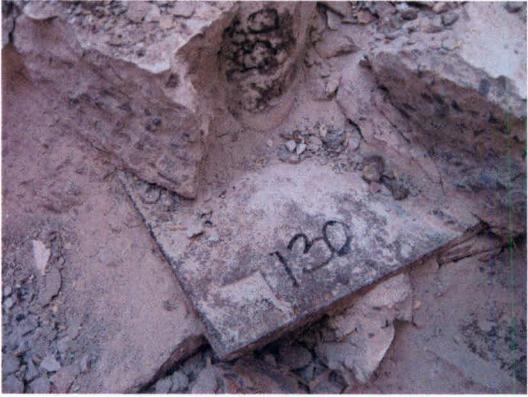
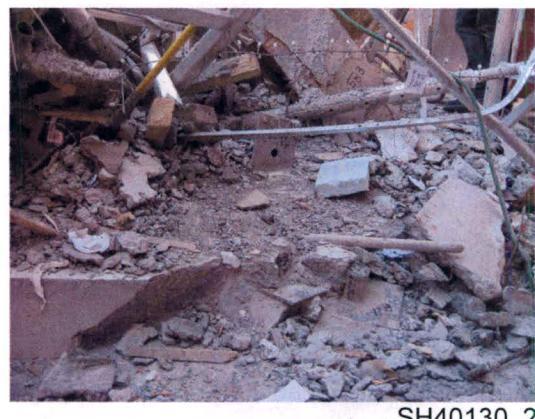
SH 40130 Top plate Zone 40F

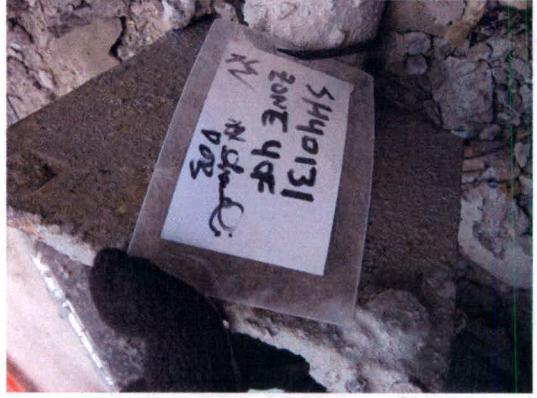
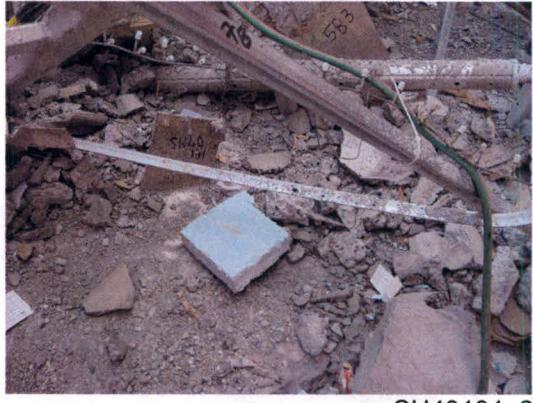
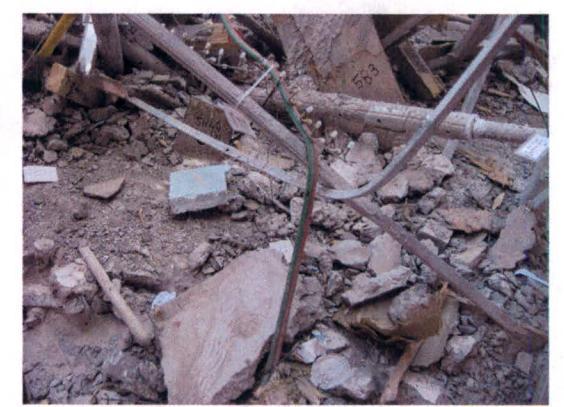
SH 40131 Top plate Zone 40F

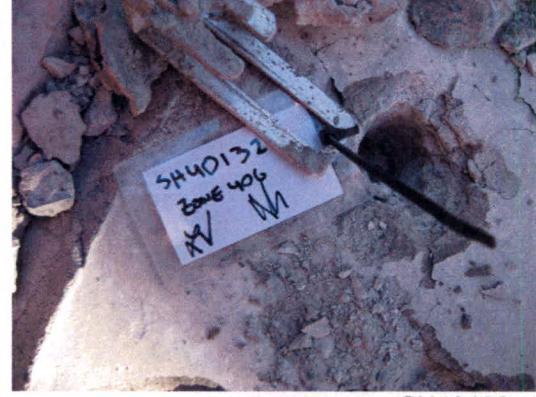
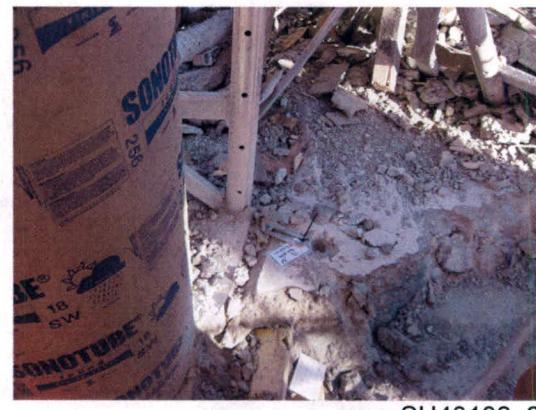
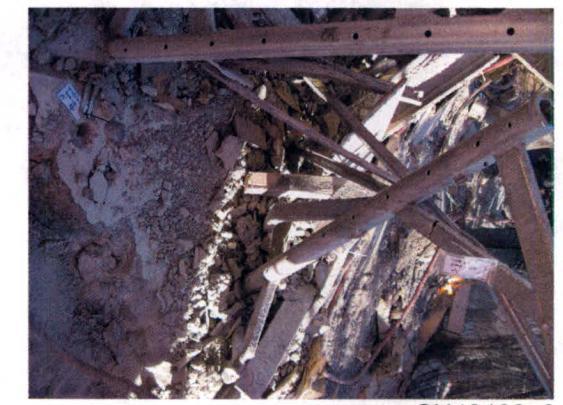
SH 40132 Clip Zone 40G

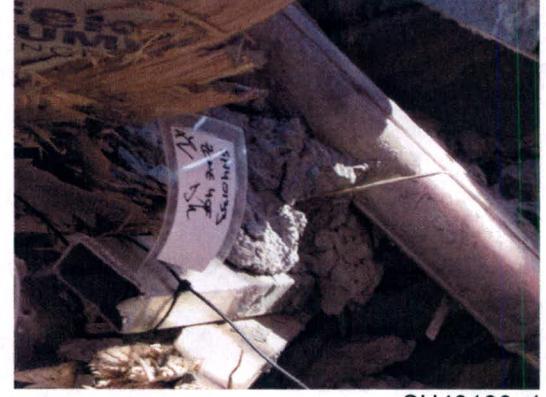
SH40133_1

SH 40133 Frame Piece Near SH 40124

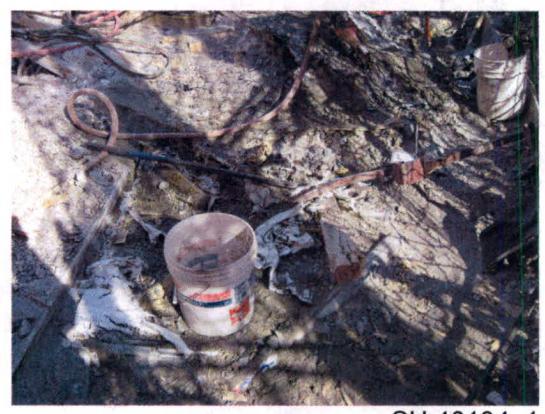
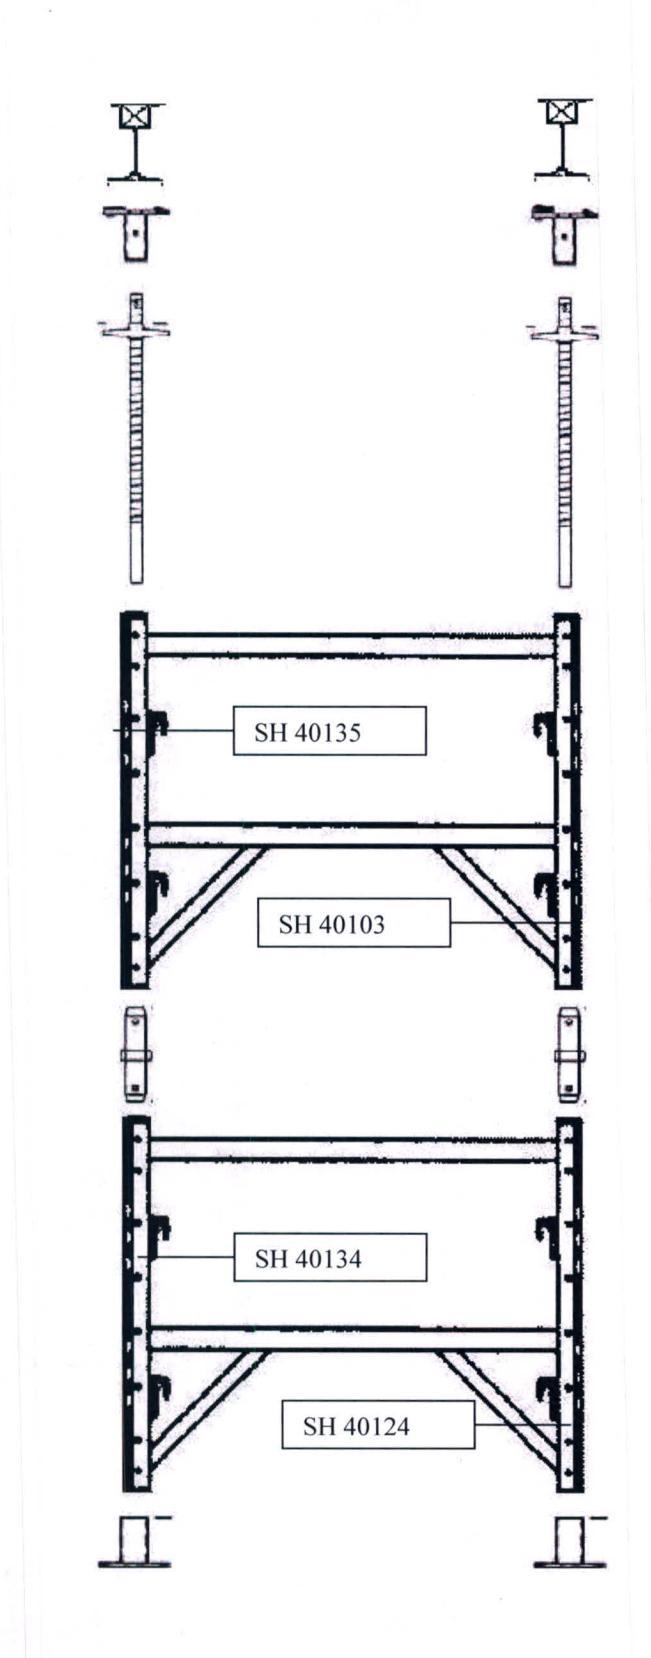
SH 40134_1

SH 40134 Frame buried in Concrete Bottom Frame of SH 135 Zone 40G

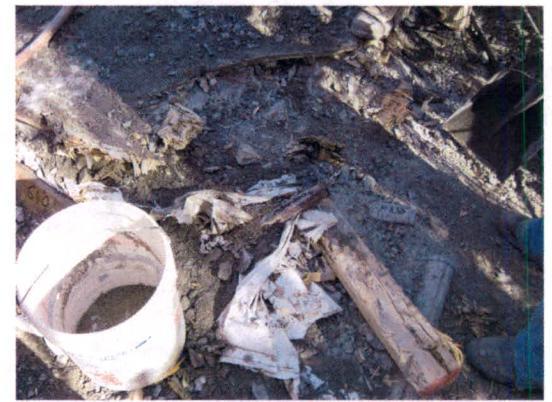
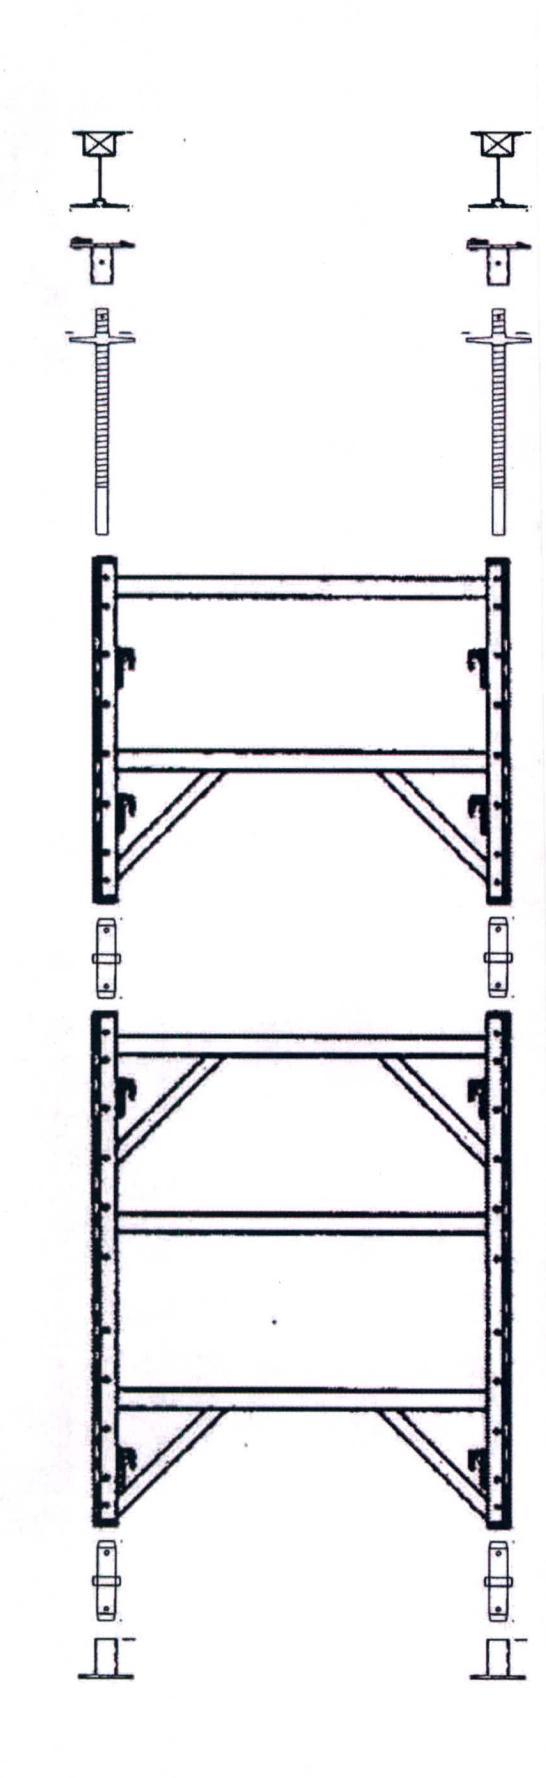
SH 40135_1

SH 40135 Frame buried in Concrete Zone 40G

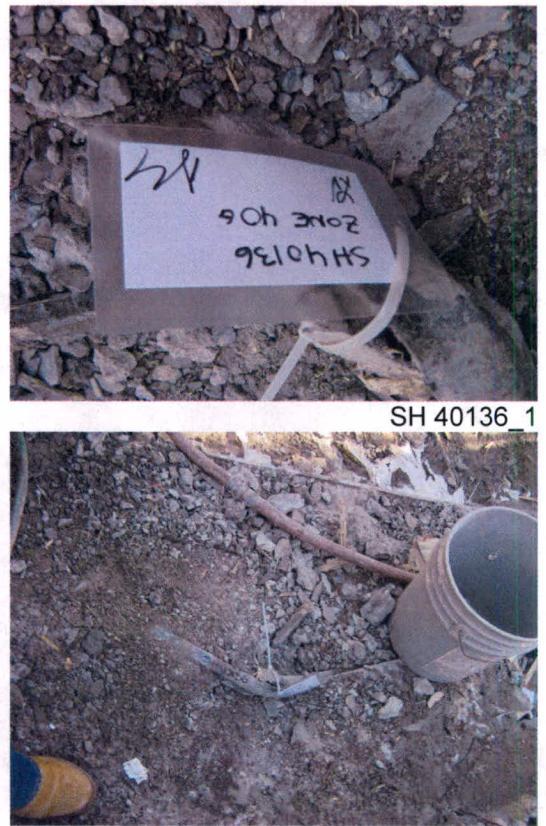
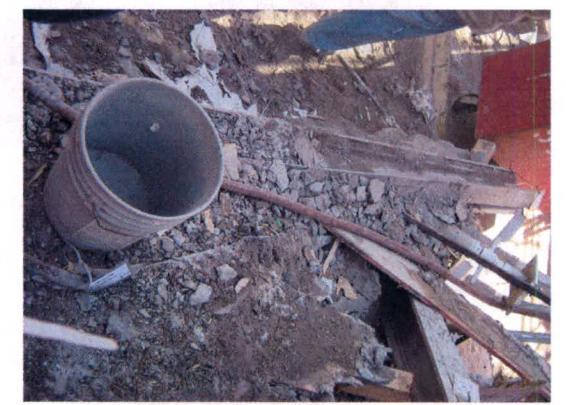
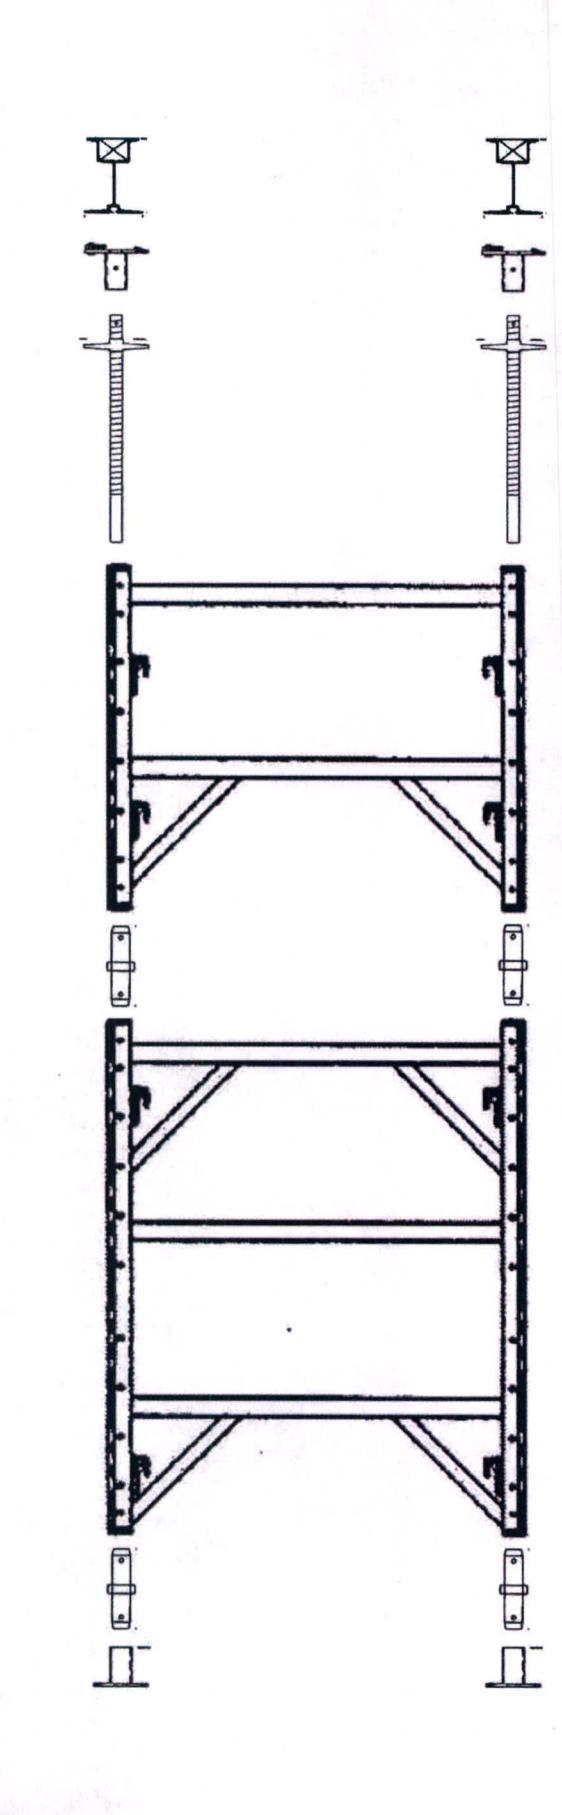
SH 40136_2

SH 40136 Brace Zone 40G

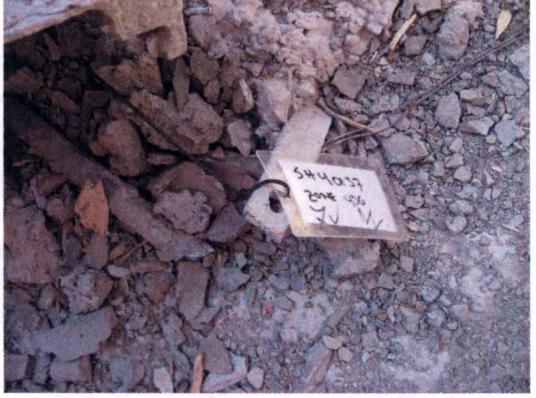
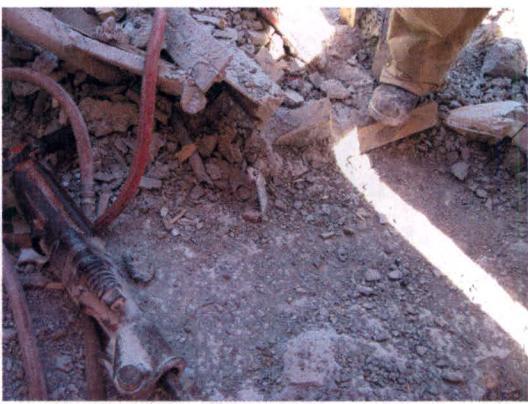
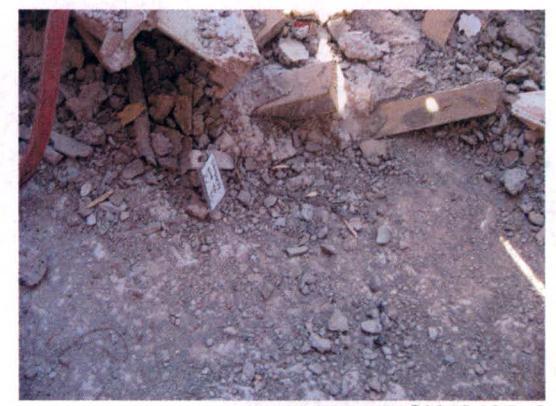
SH40137_1

SH 40137 X Brace Zone 40G

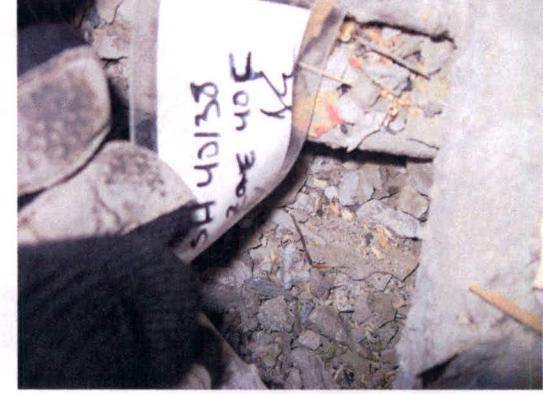
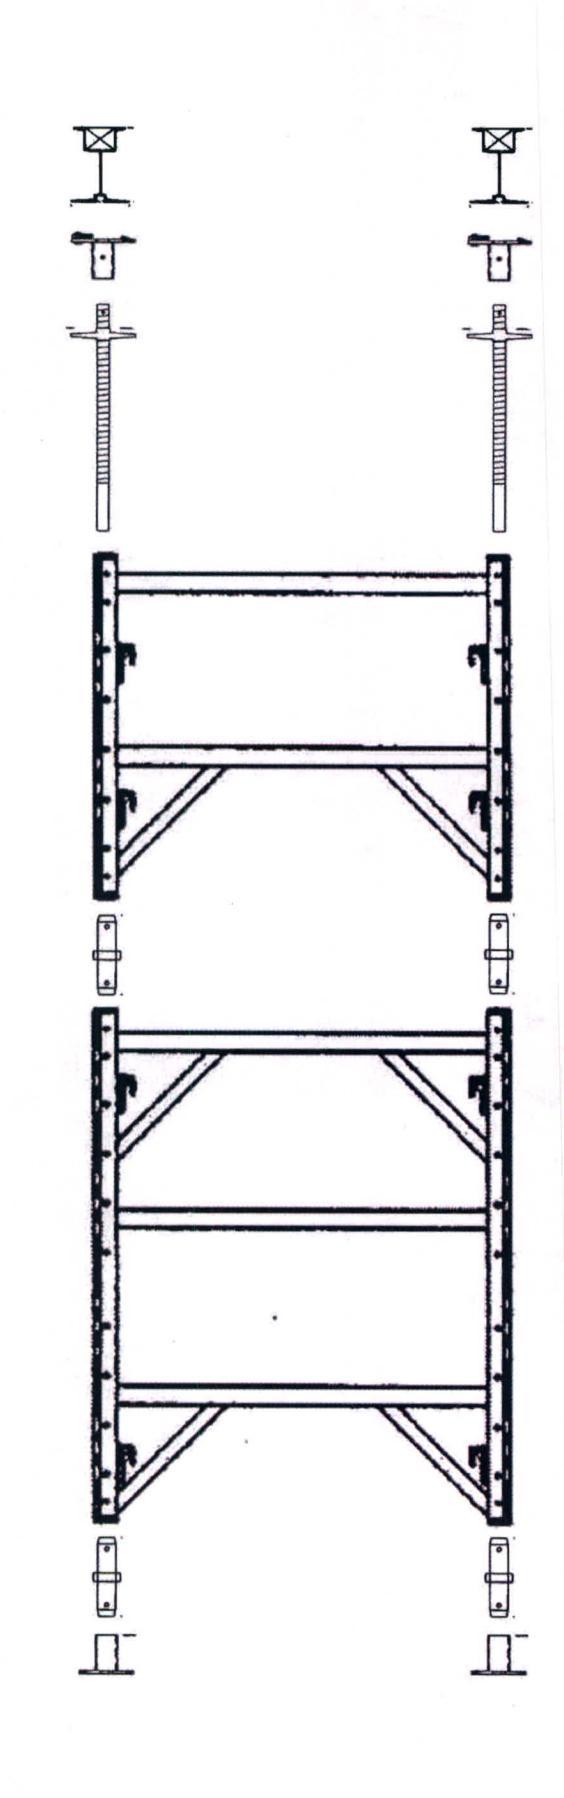
SH40138_1

SH 40138 on 41st floor Broken top frame of SH 40166 Zone 40F

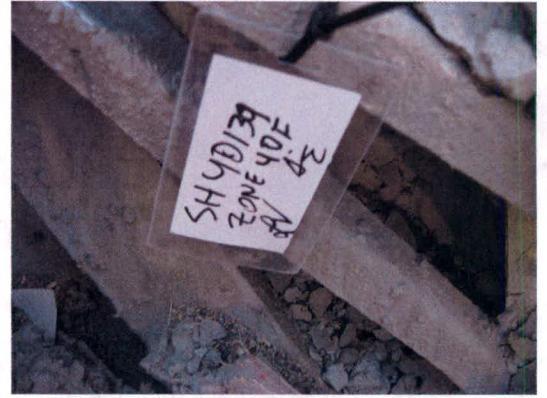
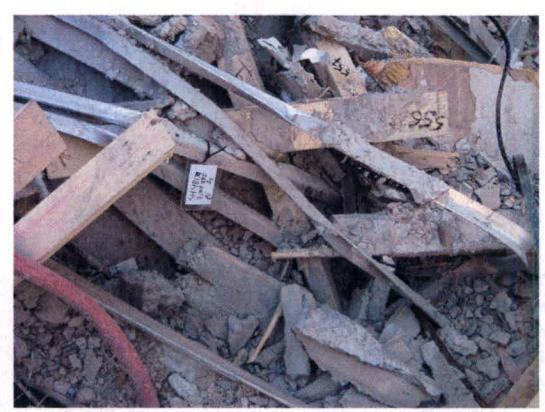
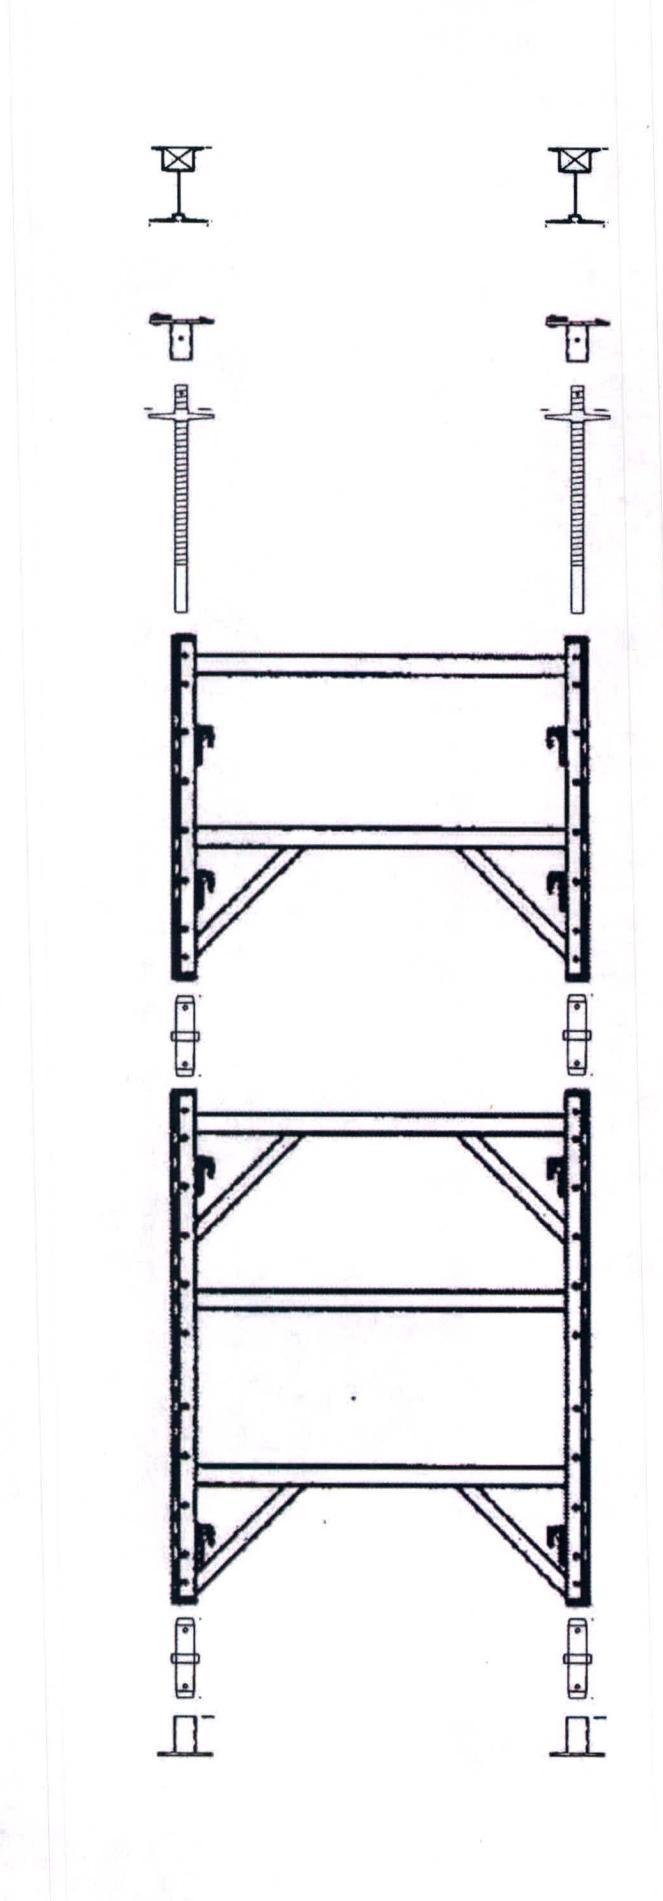
SH40139_1

SH 40139 X Brace Zone 40F

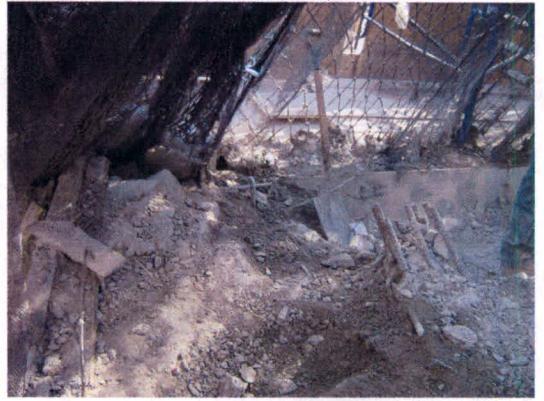
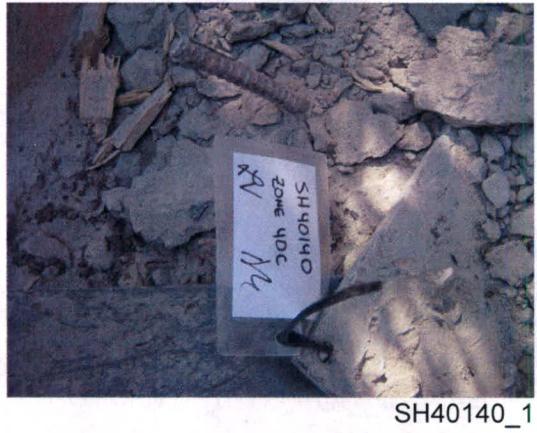
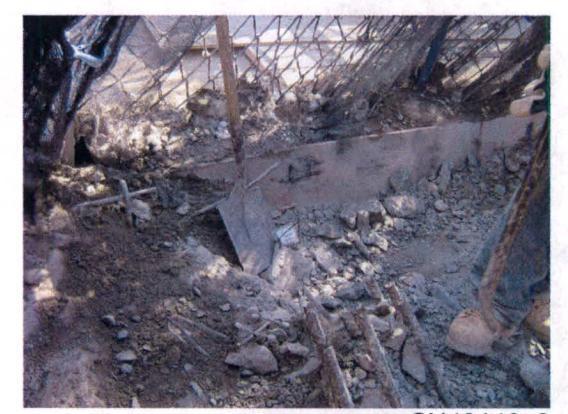
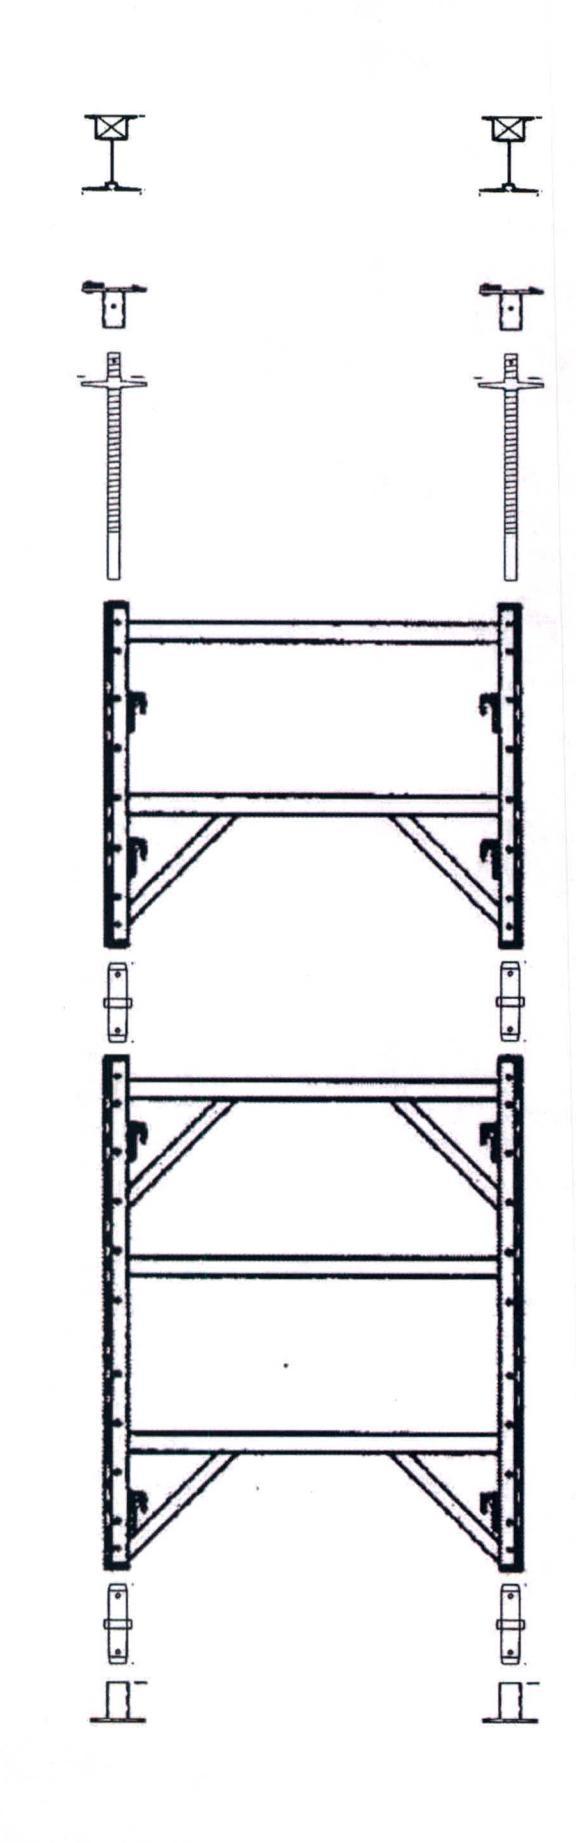
SH40140_3

SH 40140 Top plate Zone 40C

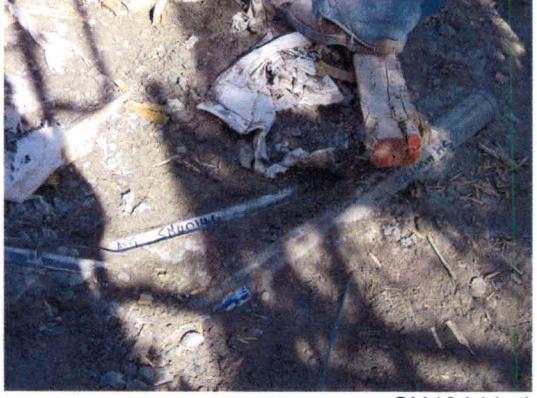
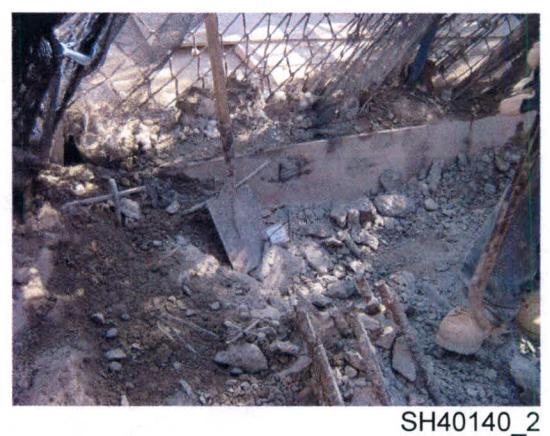
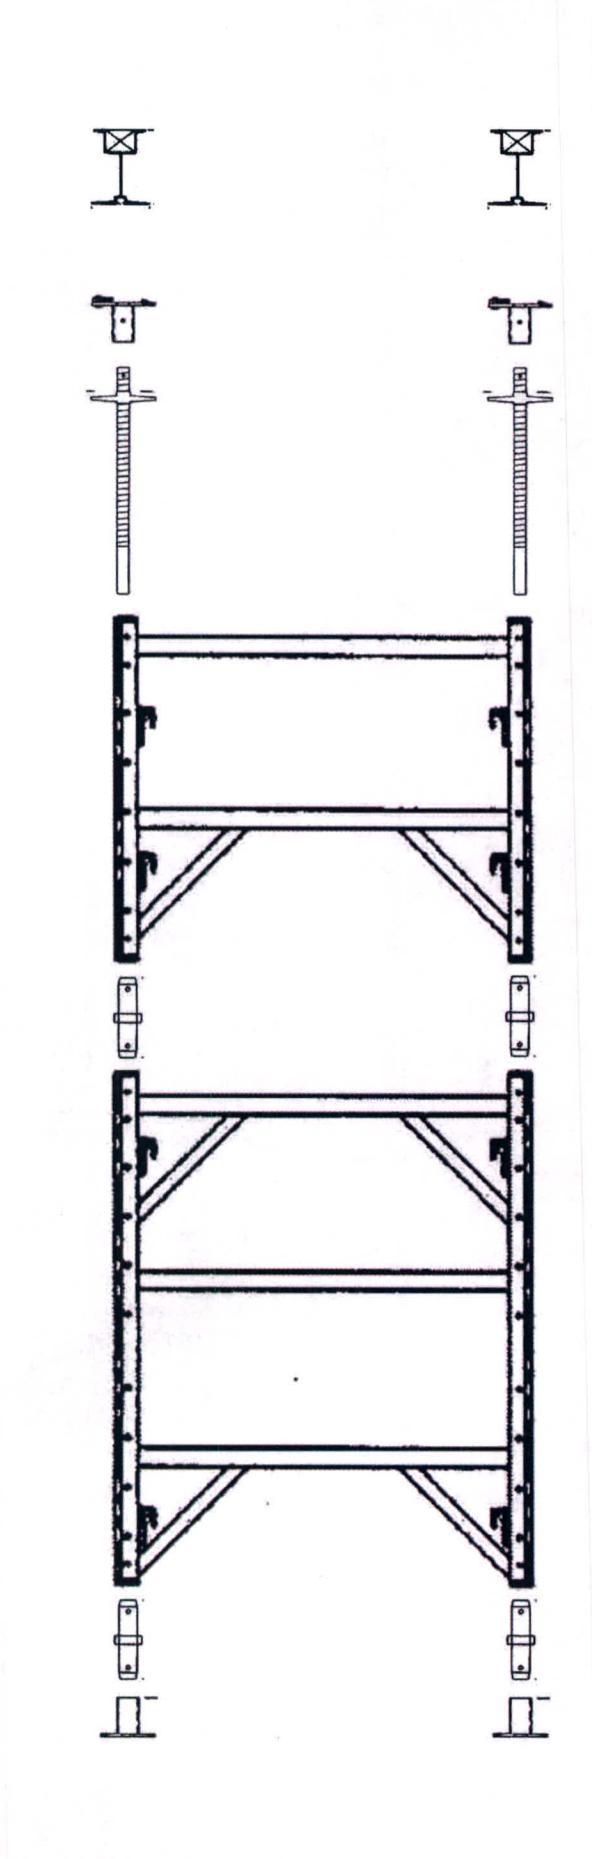
SH40141_1

SH 40141 Brace Zone 40G

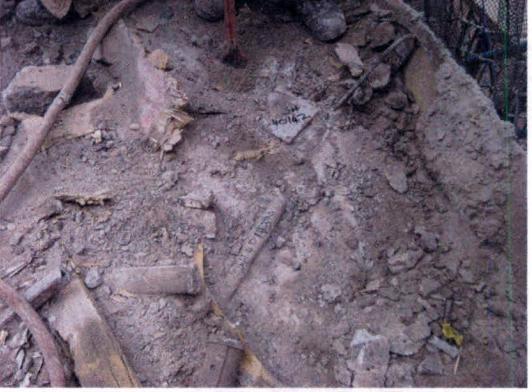
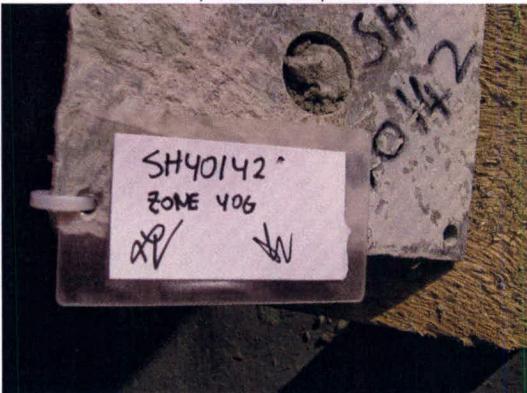
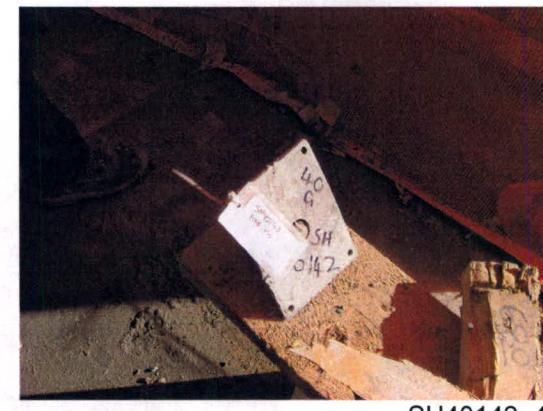
SH40142_1

SH 40142 Bottom Plate Moved from original position Zone 40G-C

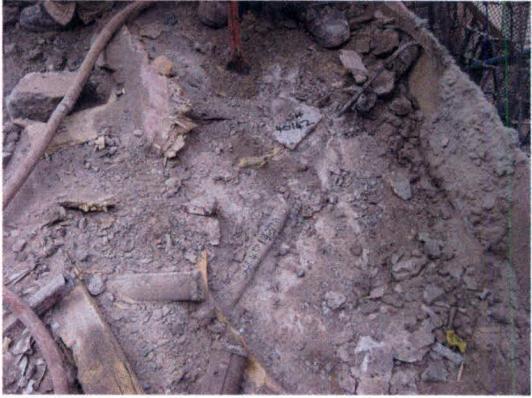
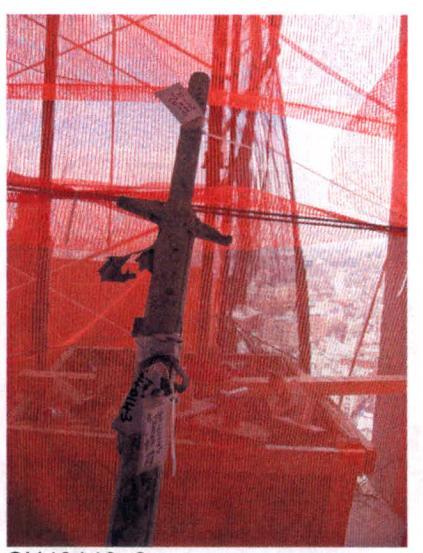
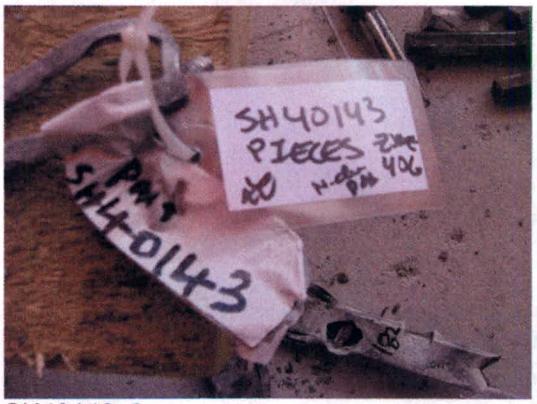
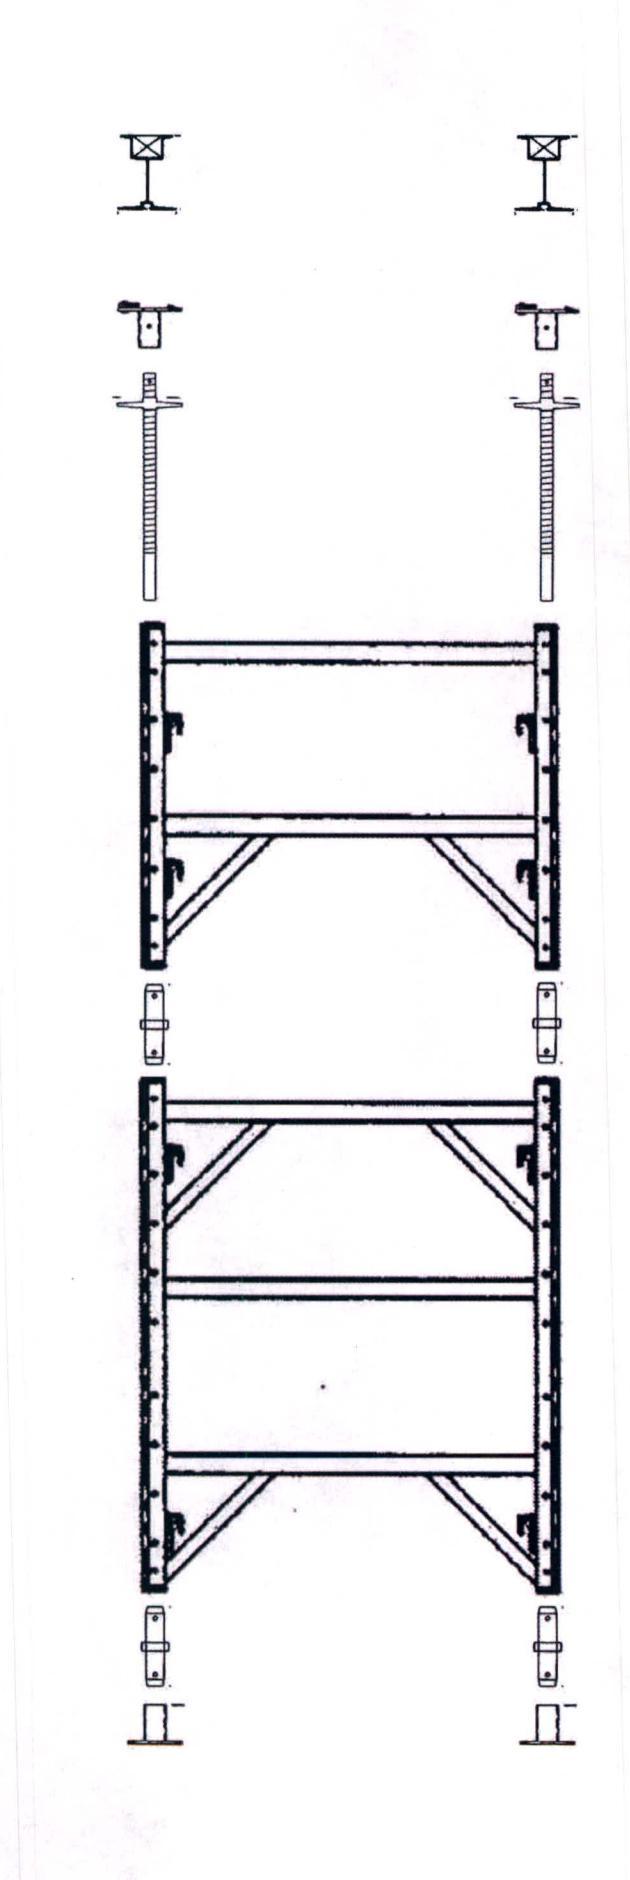
SH 40143_1

SH 40143 Screw jack and Broken Bottom Frame Zone 40G-C

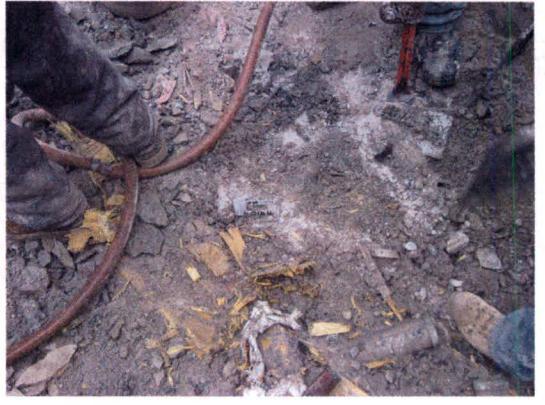
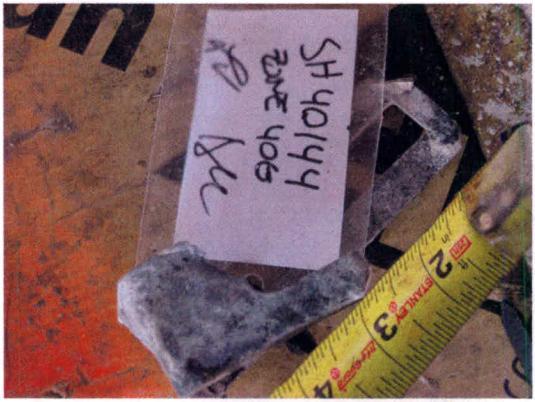
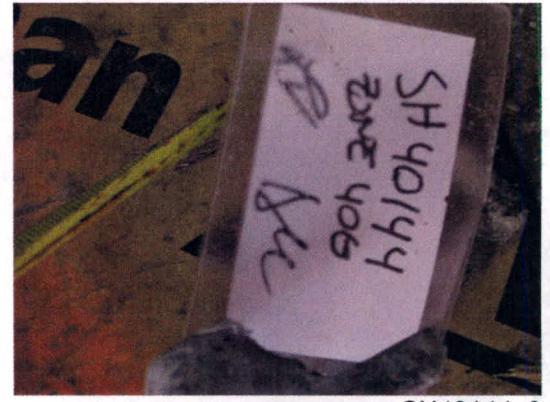
SH40144_2

SH 40144 Clip Zone 40G-C

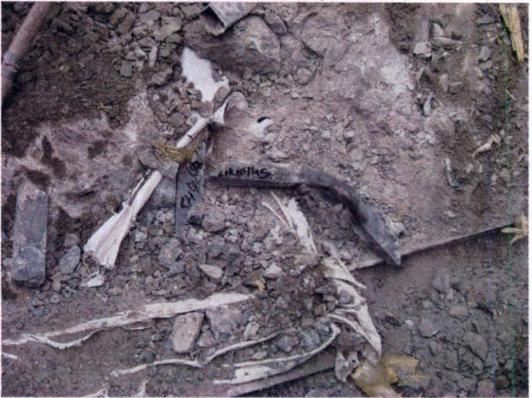
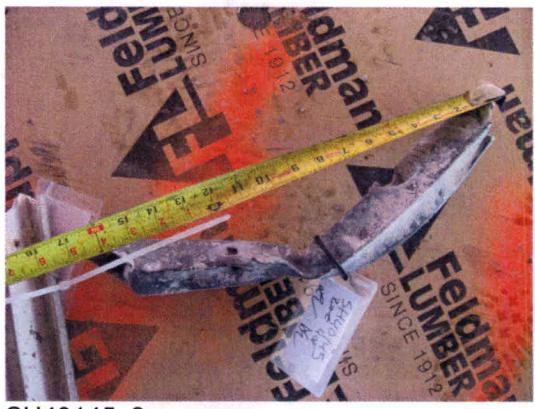
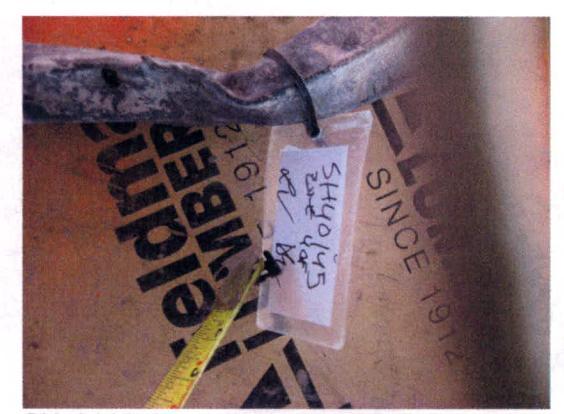
SH 40145_1

SH 40145 Broken piece of frame Zone 40F

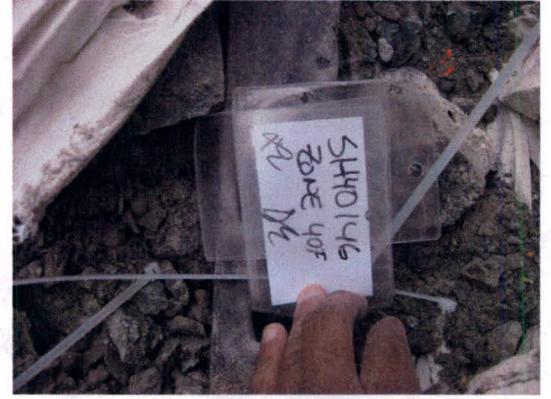
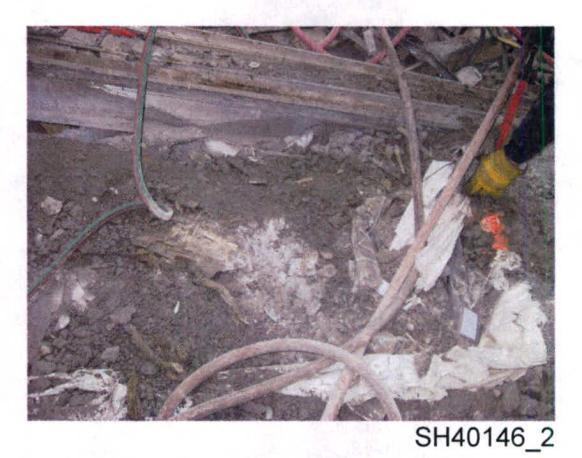
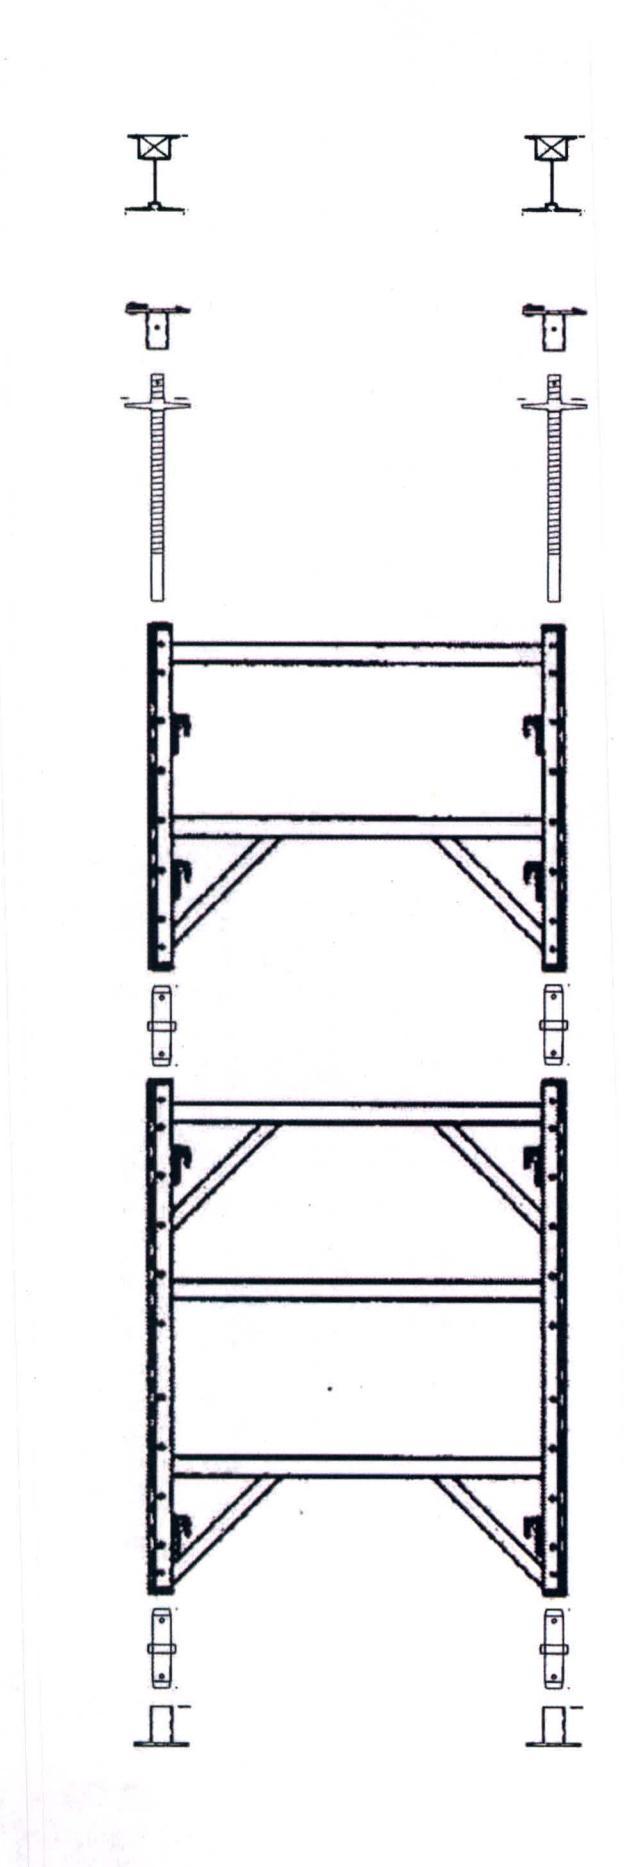
SH40146_1

SH 40146 Broken piece of frame Zone 40F

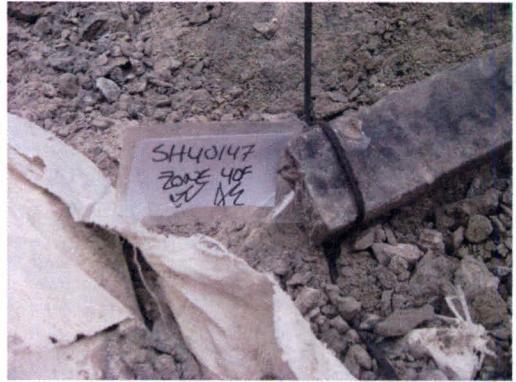
SH40147_1

SH 40147 Piece of frame Zone 40F

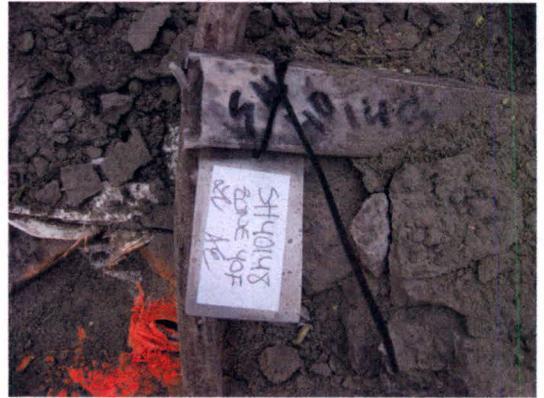
SH40148_2

SH 40148 Piece of Frame Zone 40F

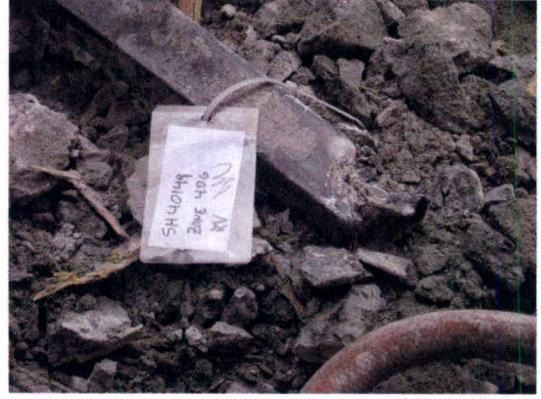
SH40149_1

SH 40149 Broken piece of frame Zone 40G

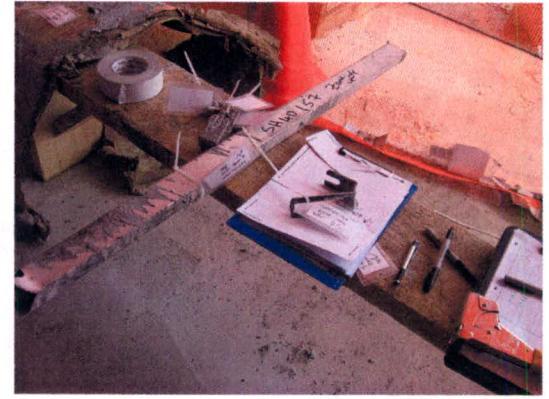
SH40157_1

SH 40157 Broken piece of Frame Zone 40G
