INVESTIGATION REPORT:

JANUARY 14, 2008 SHORING COLLAPSE AT 9 DOMINICK ST. (AKA 246 SPRING ST.) MANHATTAN

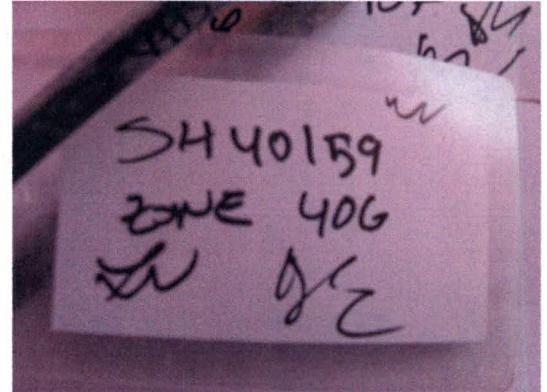
SH40159_1

SH 40159 Bracket Zone 40G

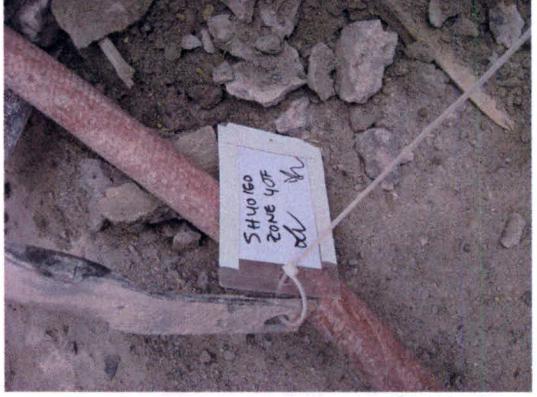
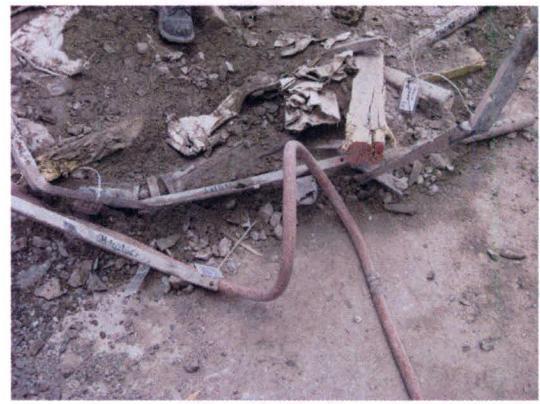
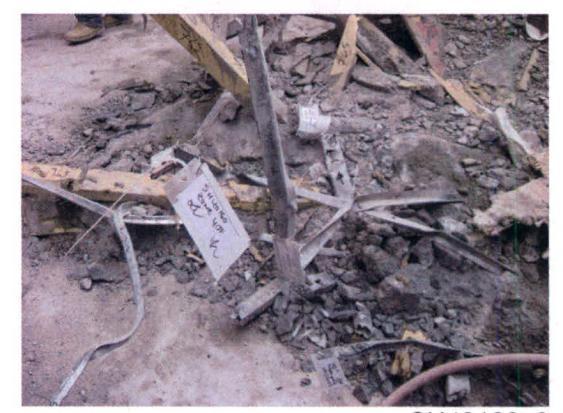
SH 40160 Brace Zone 40G

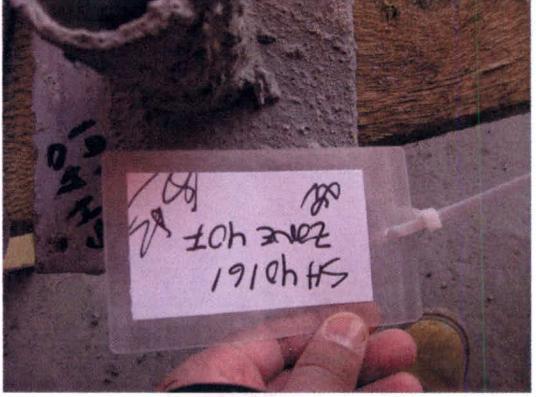
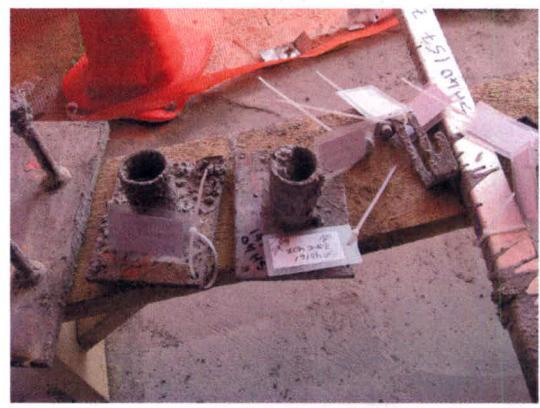
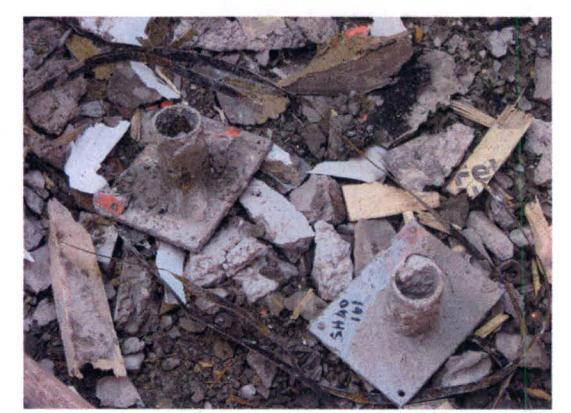
SH 40161 Top plate Zone 40F

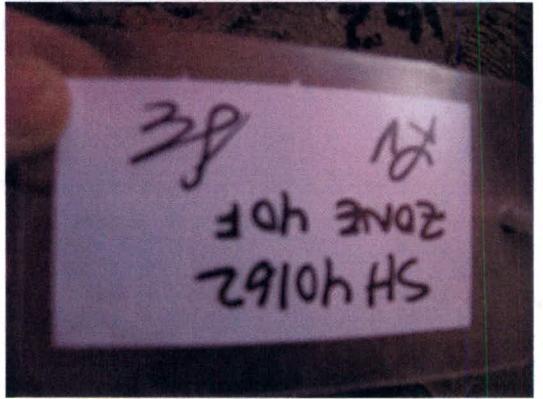
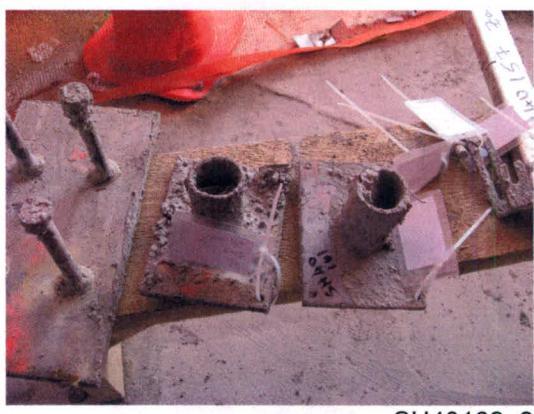
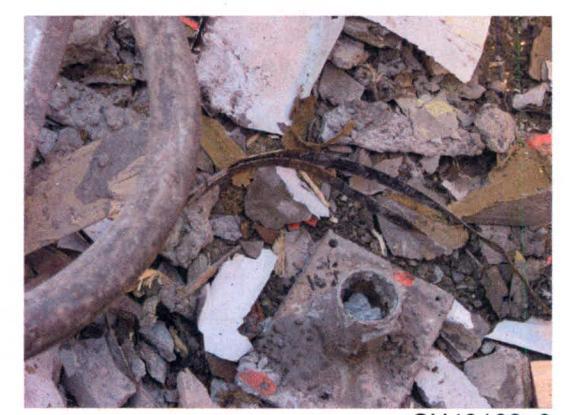
SH 40162 Top plate Zone 40F

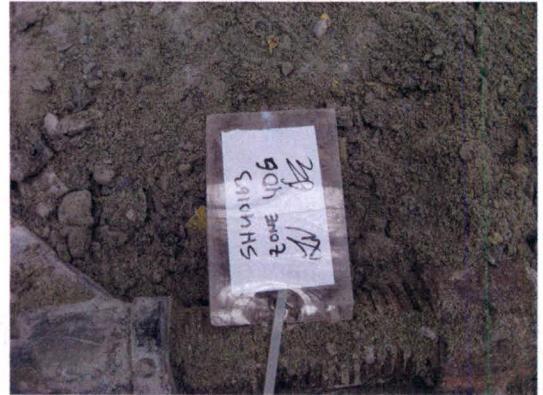
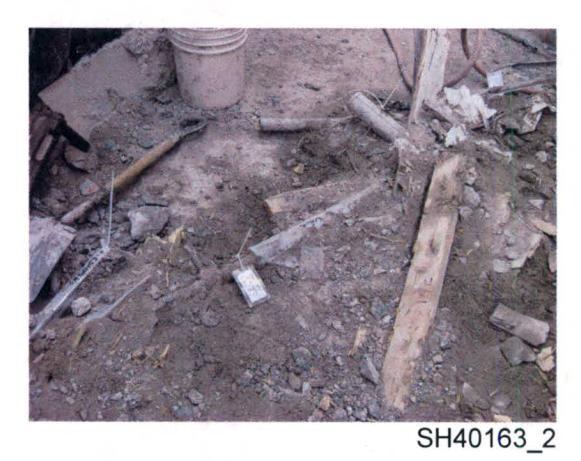
SH 40163 on 41st Floor Bott Frame of SH 40165 Frame lying on Slab Zone 40G-C

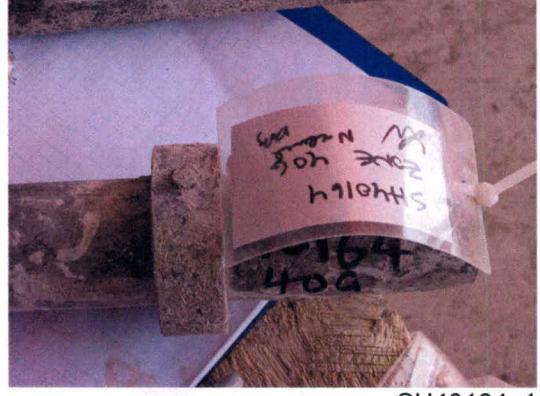
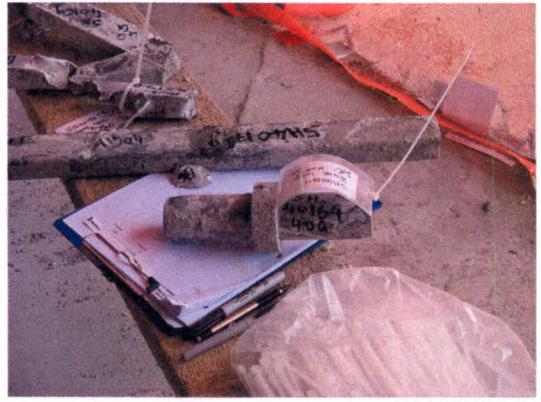
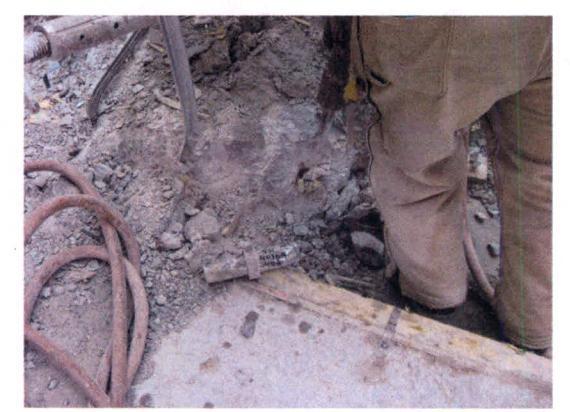
SH 40164 Coupler Zone 40G

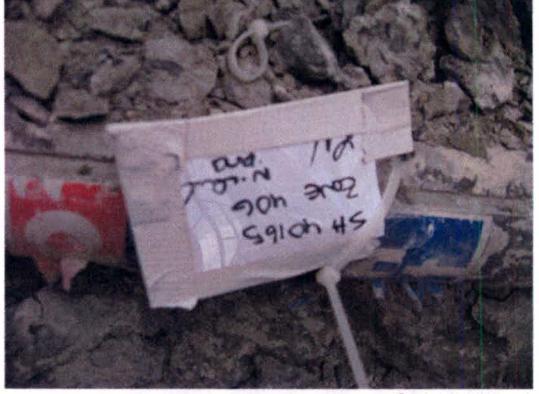
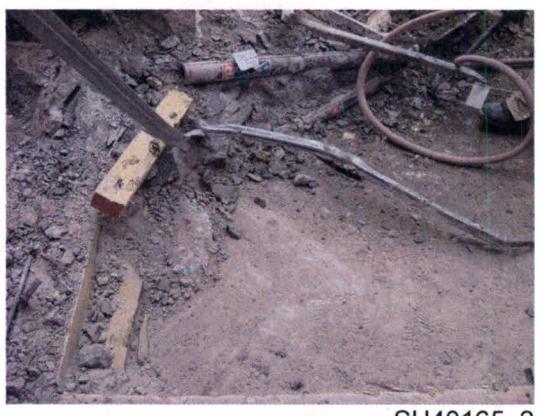
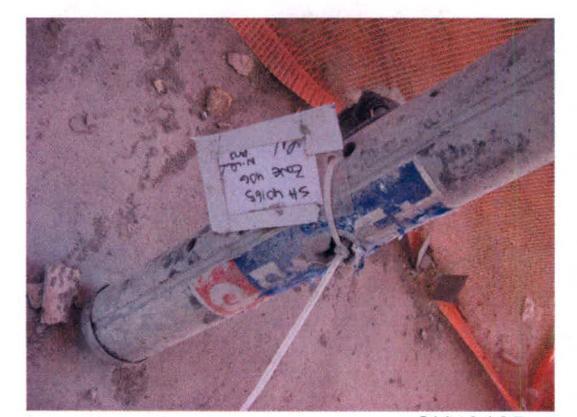
SH 40165 on 41st floor Top Frame 3'-6" Shoring tower frame is buried Zone 40G

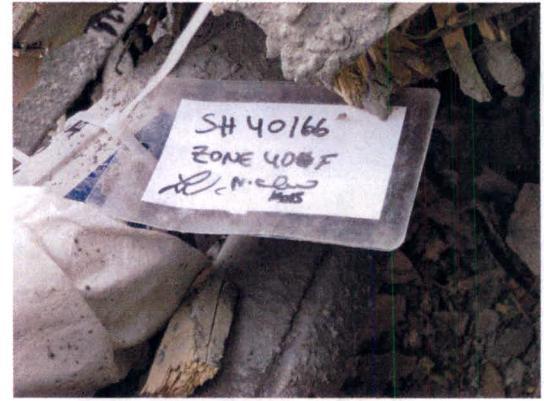
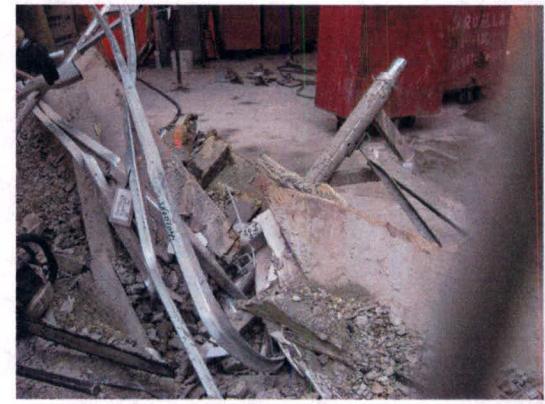
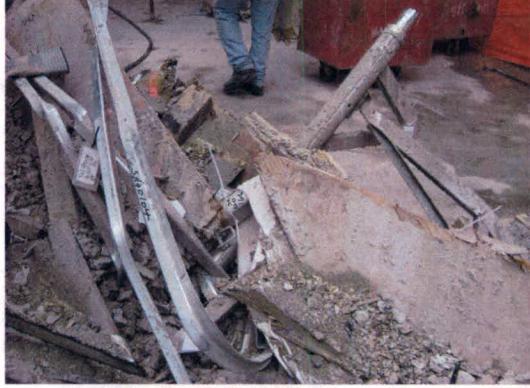
SH 40166 Bottom Frame lying on SH 40062 Zone 40F

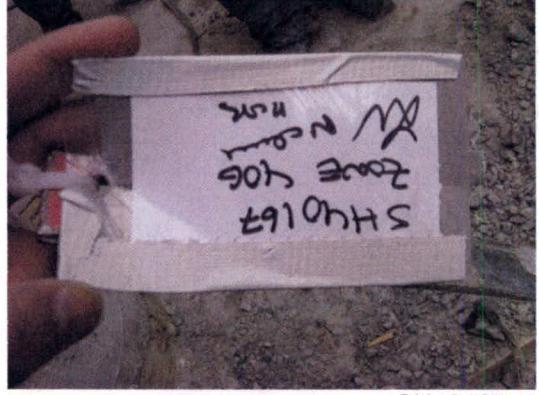
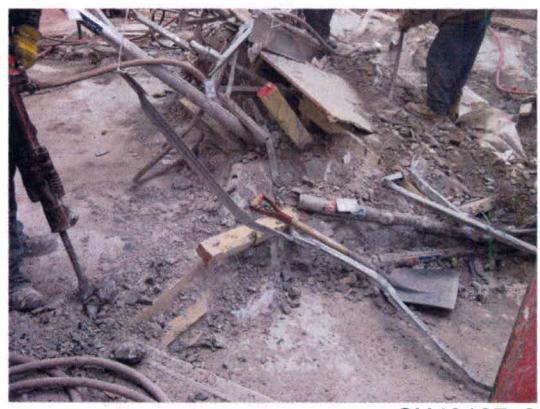
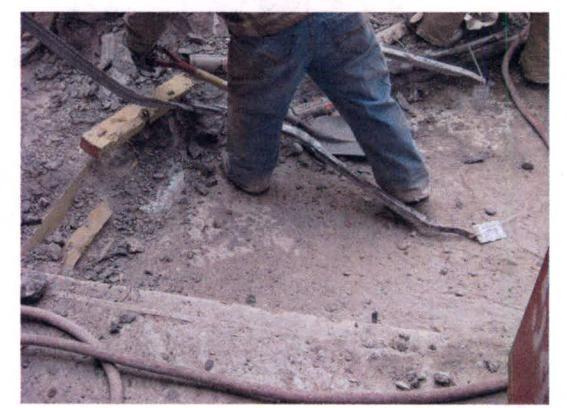
SH 40167 Brace Zone 40G

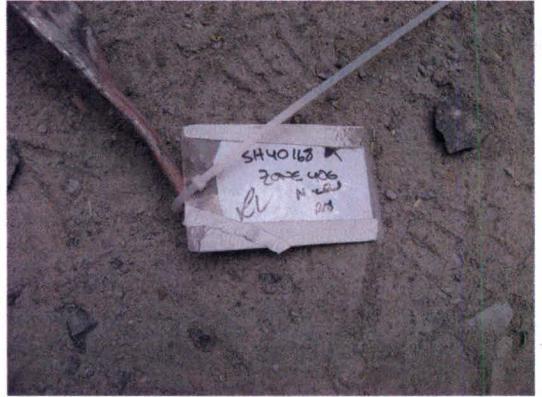
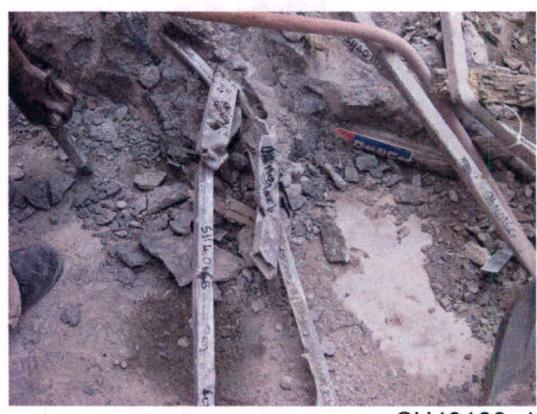
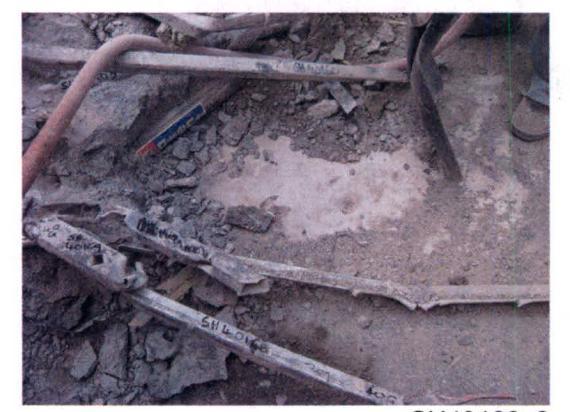
SH 40168 Brace Zone 40G

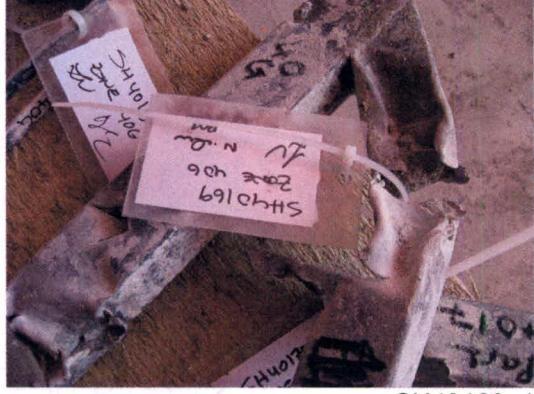
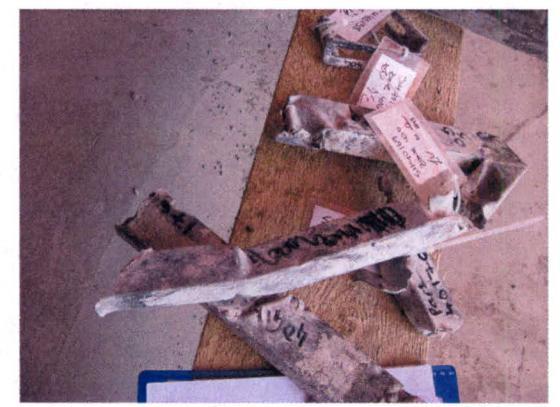
SH 40169 Broken frame part of SH 40165 Zone 40G

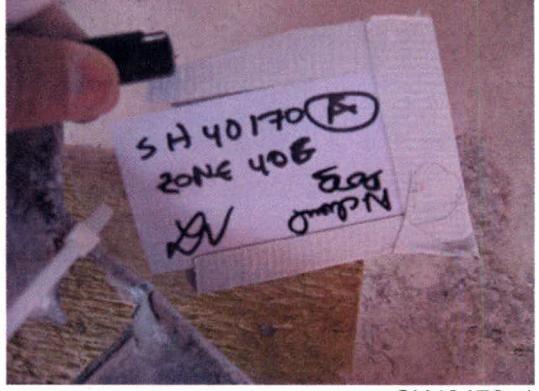
SH40170_1

SH 40170 Piece of frame Part of SH 40163 Zone 40G

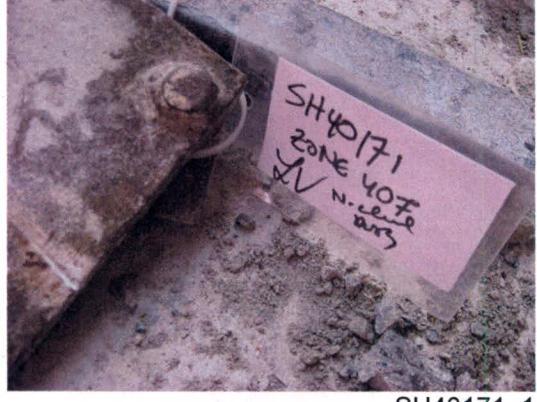
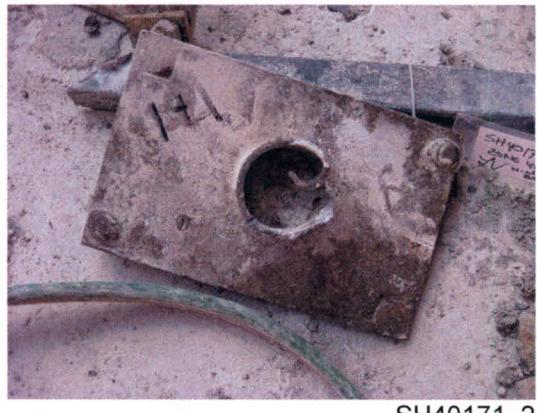
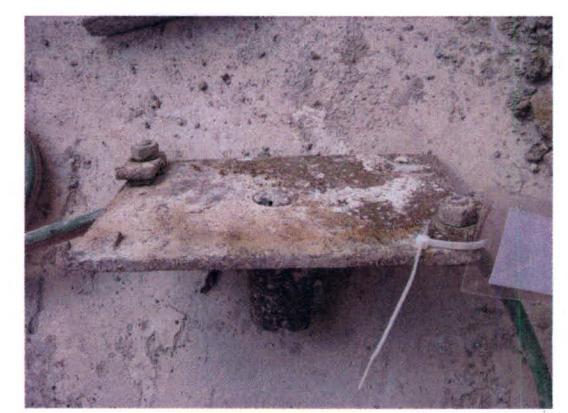
Folder: 08-02-27; 08-02-27; SH 40171

SH 40171 Top plate Zone 40F

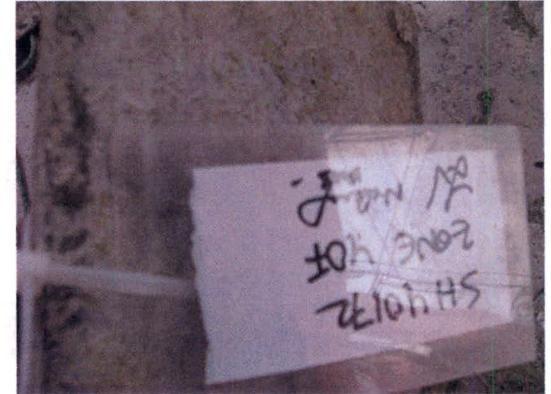
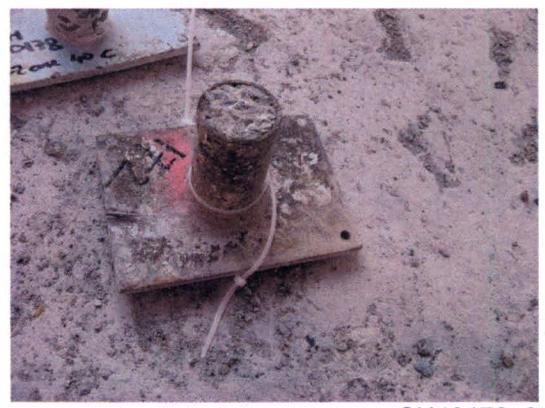
Folder: 08-02-27; SH

SH 40172 Top plate Zone 40F

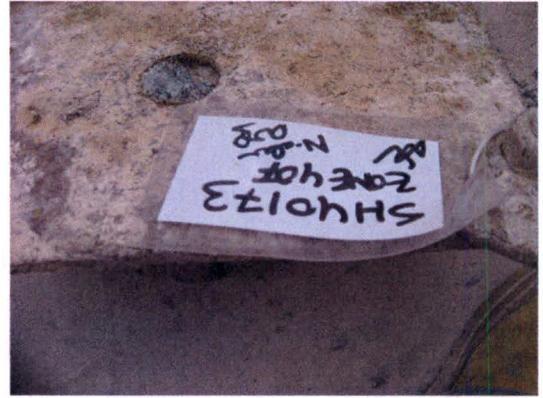
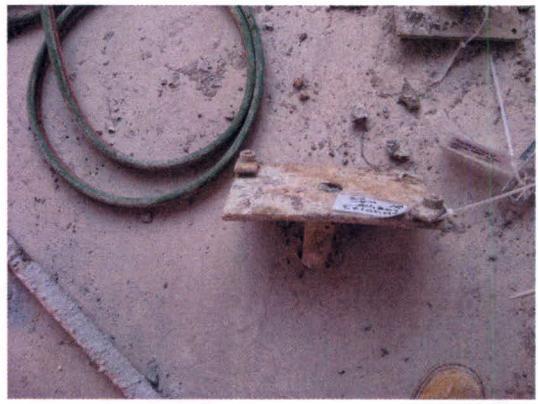
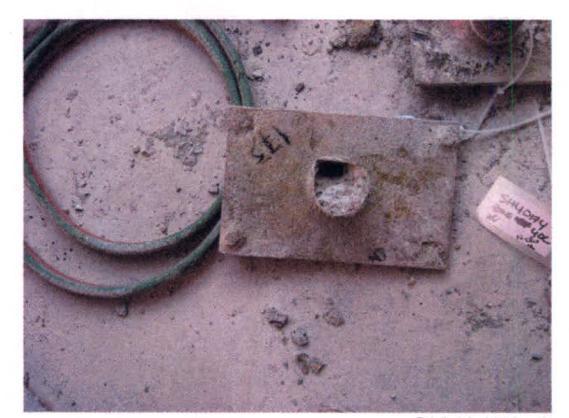
Folder: 08-02-27; 08-02-27; SH

SH 40173 Top plate Zone 40F

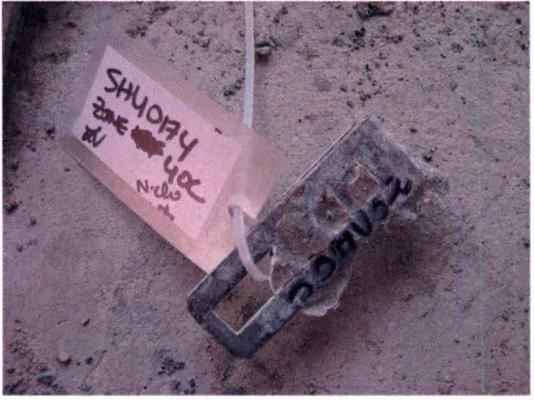
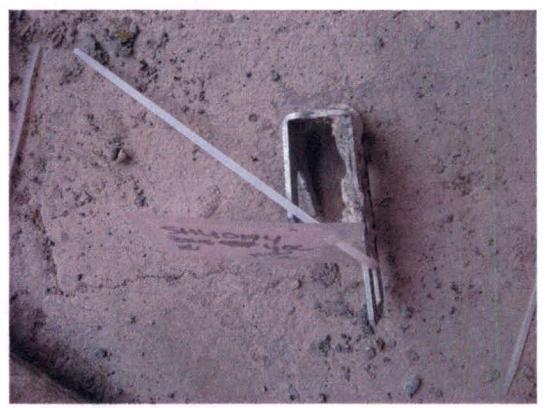
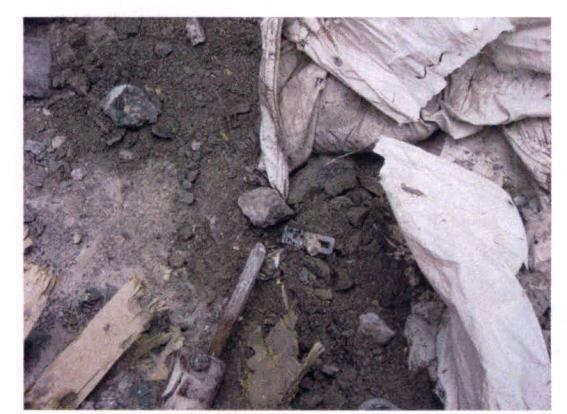
Folder: 08-02-27; 08-02-27; SH 40174

SH 40174 Bracket Zone 40C

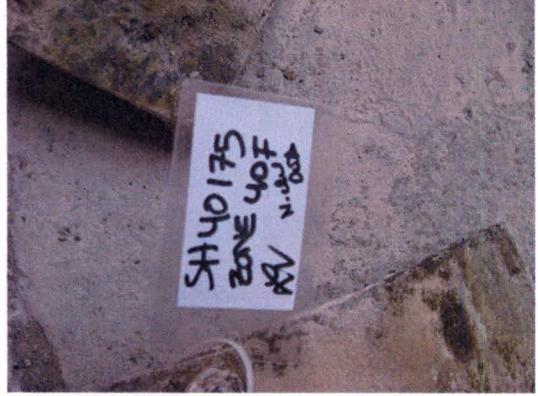
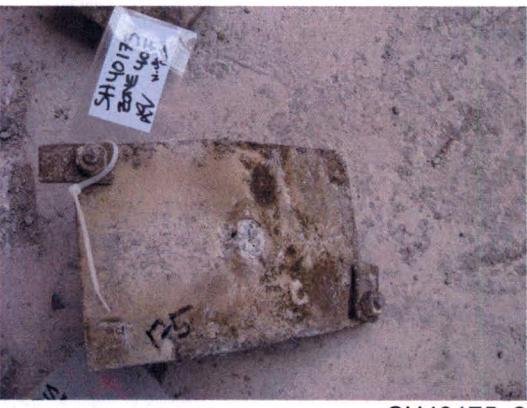
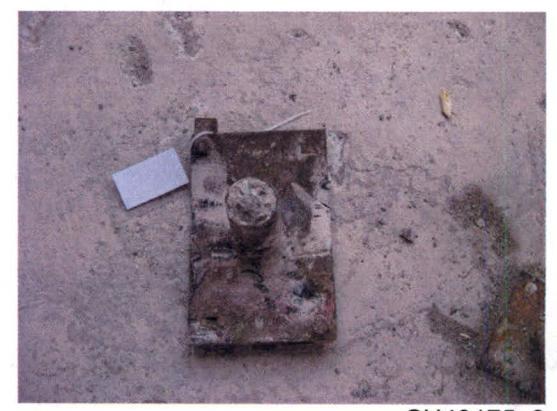
Folder: 08-02-27; 08-02-27; SH 40175

SH 40175 Top plate Zone 40F

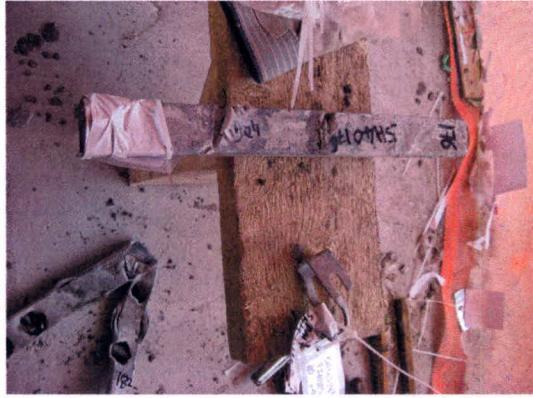
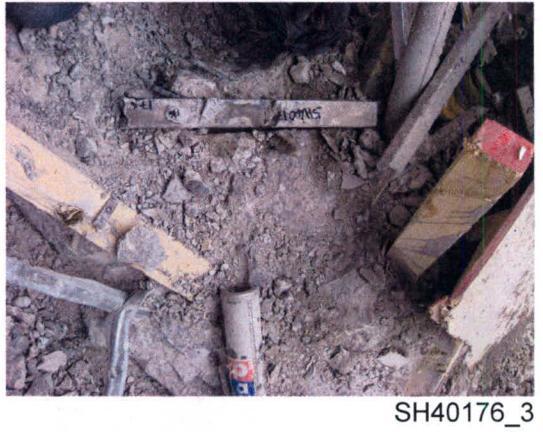
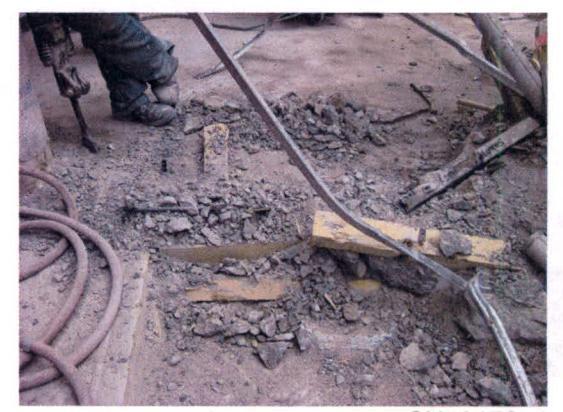
Folder: 08-02-27; 08-02-27; SH

SH 40176 Piece of frame, part of frame SH 40180 Zone 40G

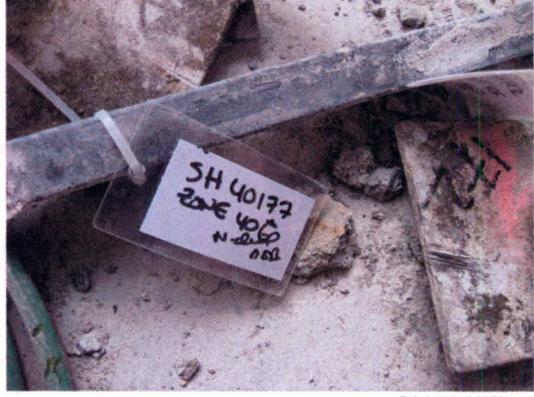
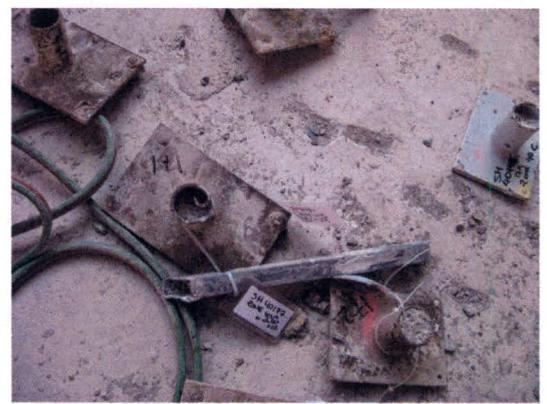
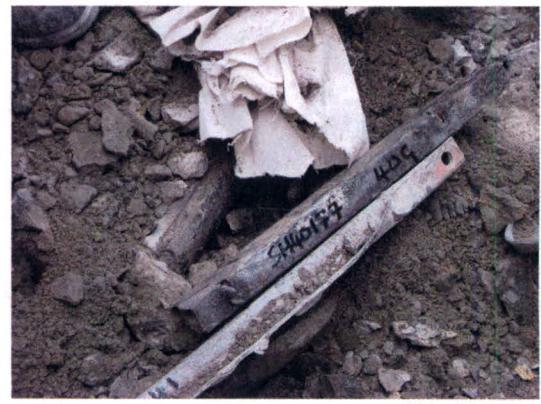
Folder: 08-02-27; 08-02-27; SH 40177

SH 40177 Piece of frame Part of SH 40180 Zone 40G

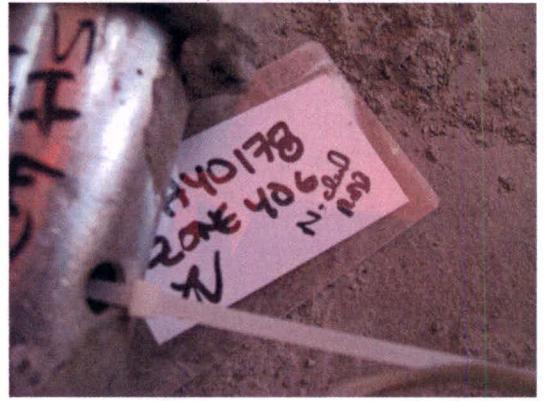
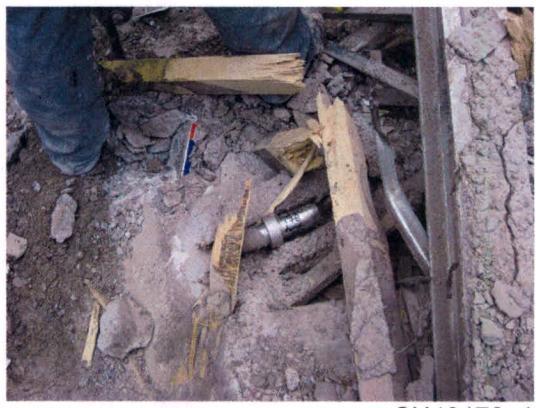
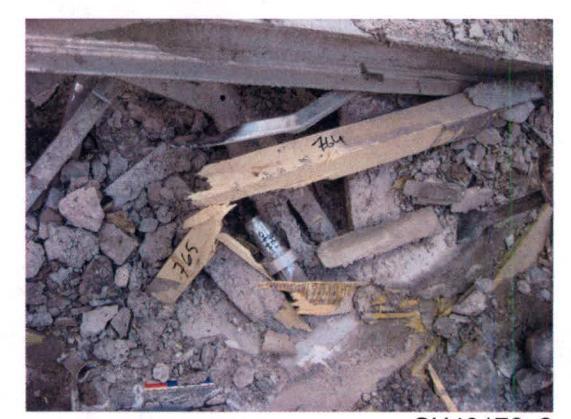
Folder: 08-02-27; 08-02-27; SH 40178

SH 40178 Coupler Zone 40G

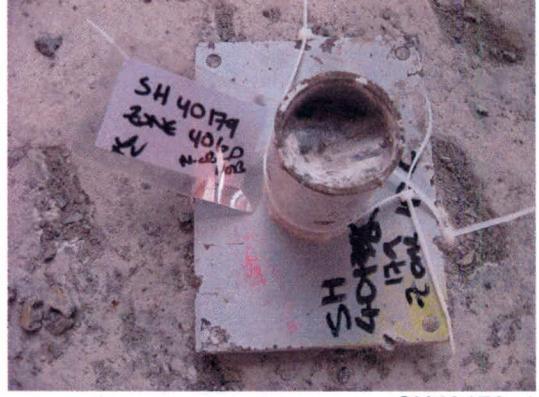
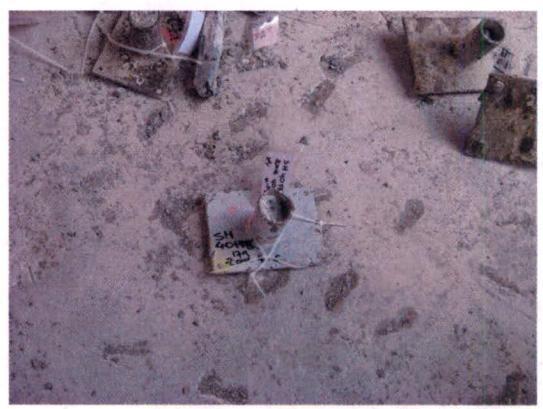
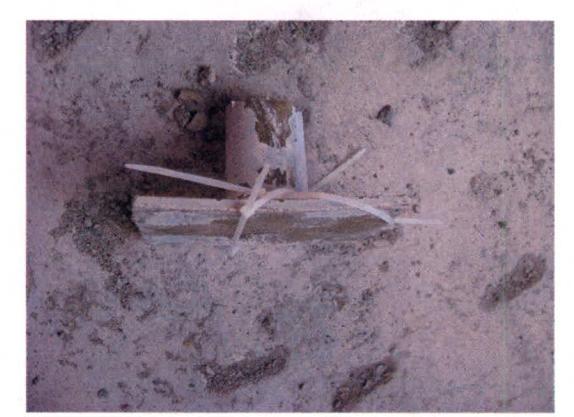
Folder: 08-02-27; 08-02-27; SH 40179

SH 40179 Bottom plate Zone 40G

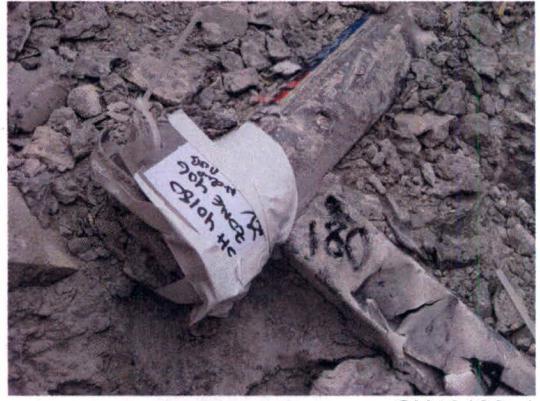
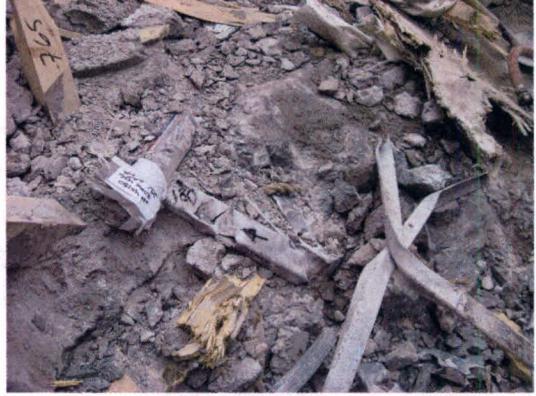
Folder: 08-02-27; 08-02-27; SH 40180

SH 40119 Bottom Shore Broken with SH 40180 Zone 40F

SH 40180 Bottom Frame (5'-3") bottom screw jack located near SH 40195/196 Zone 40G

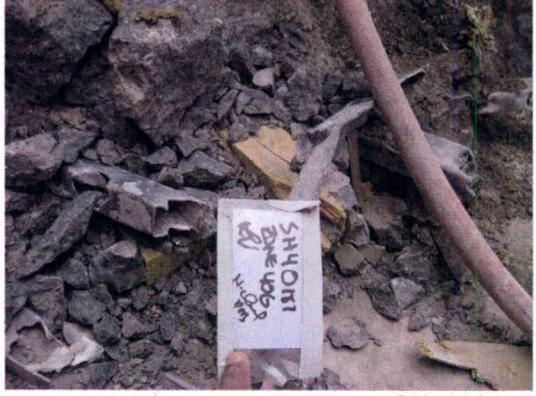
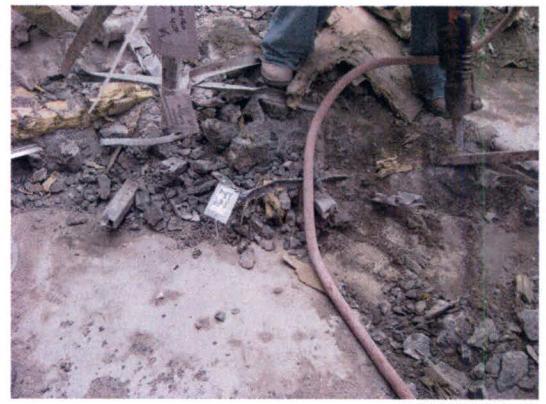
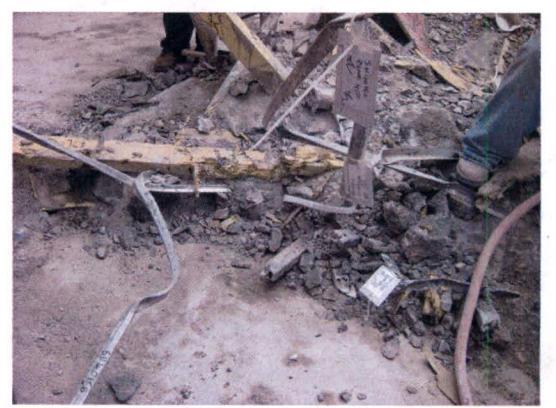
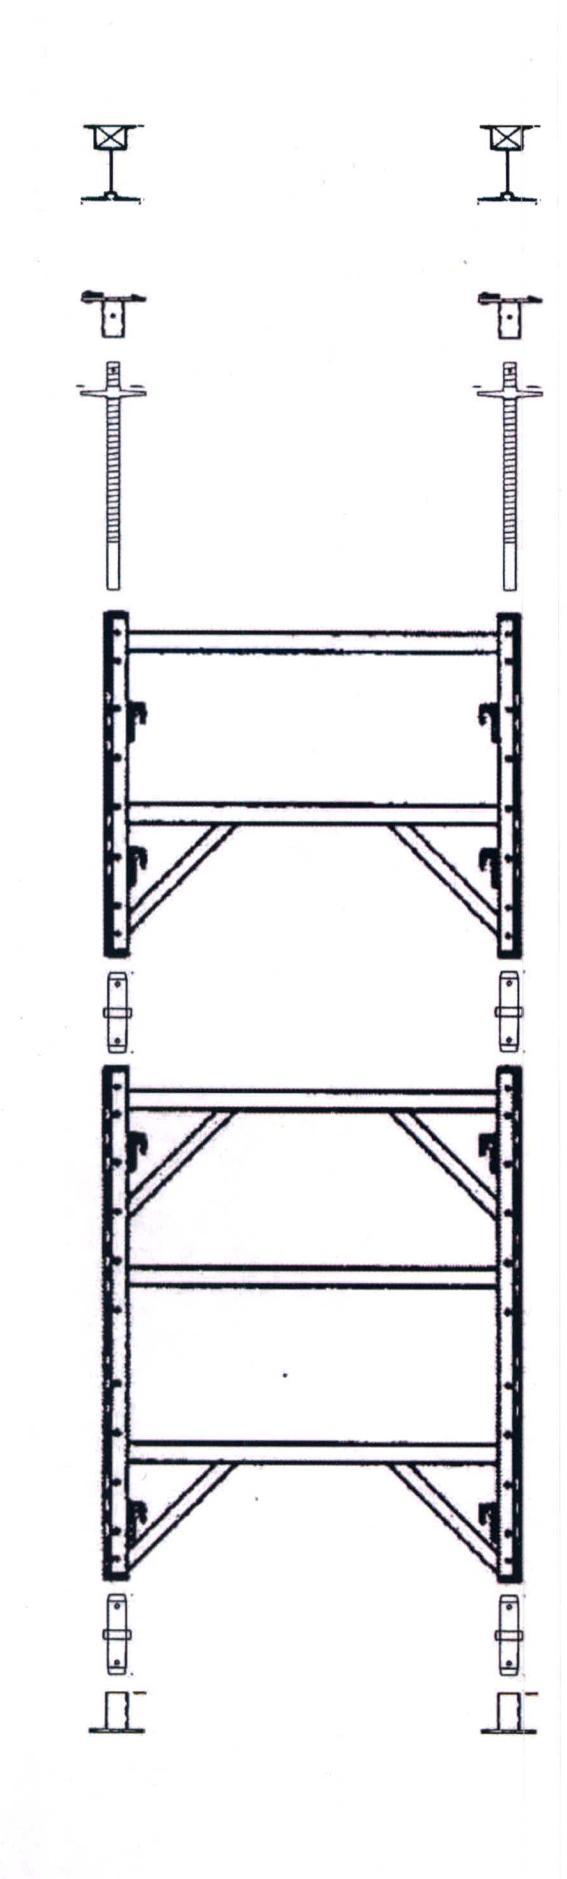
SH 40181 Brace Zone 40G

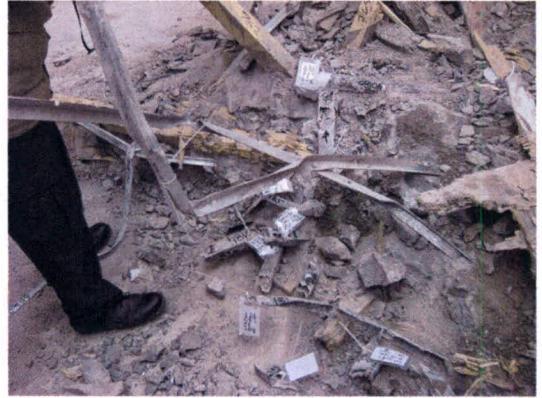
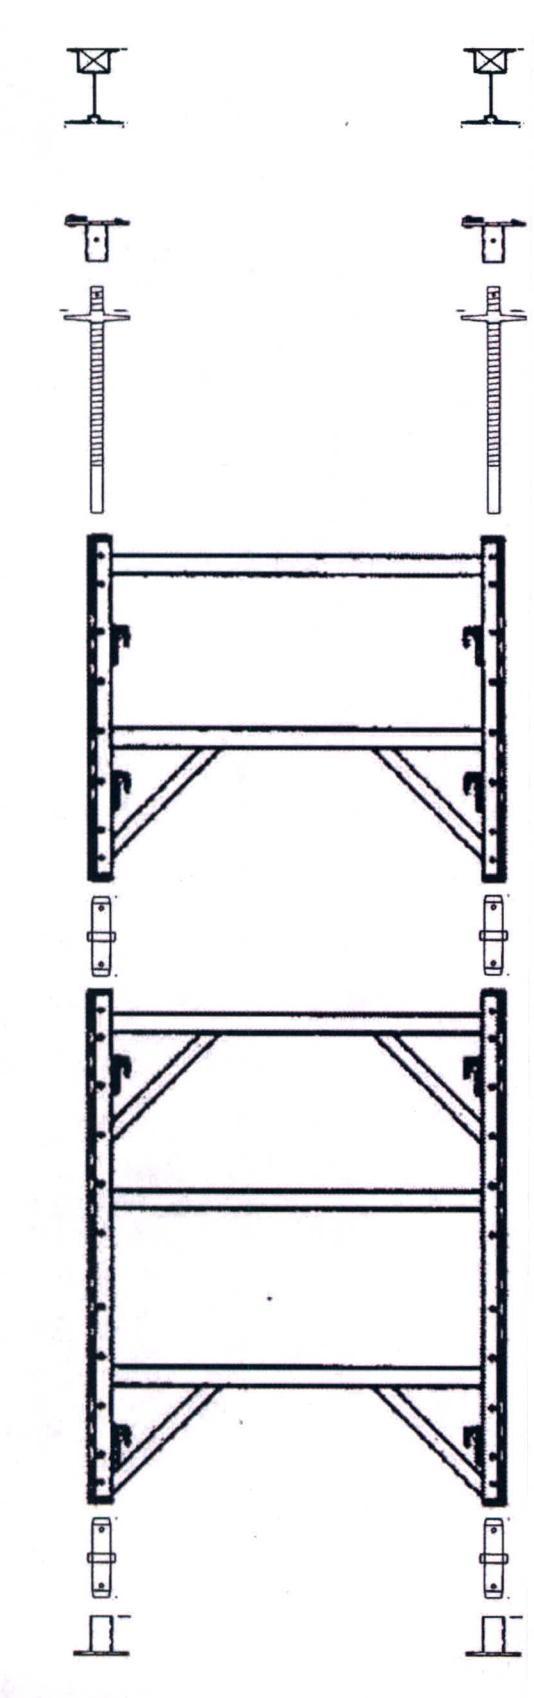
SH 40182 Piece of SH 40163 Bottom diagonal Zone 40G

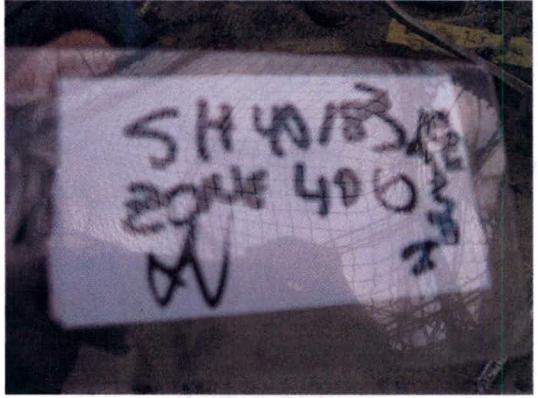
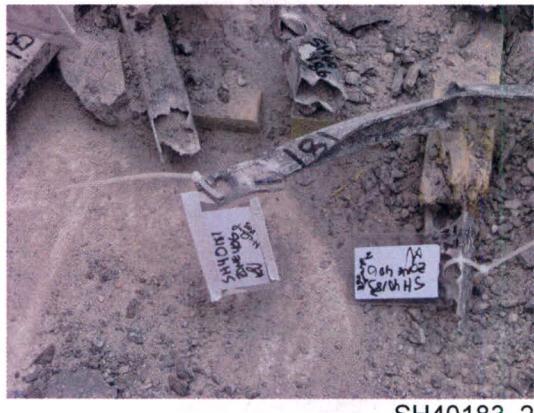
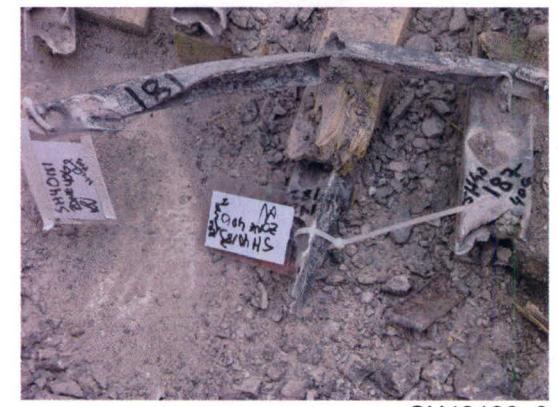
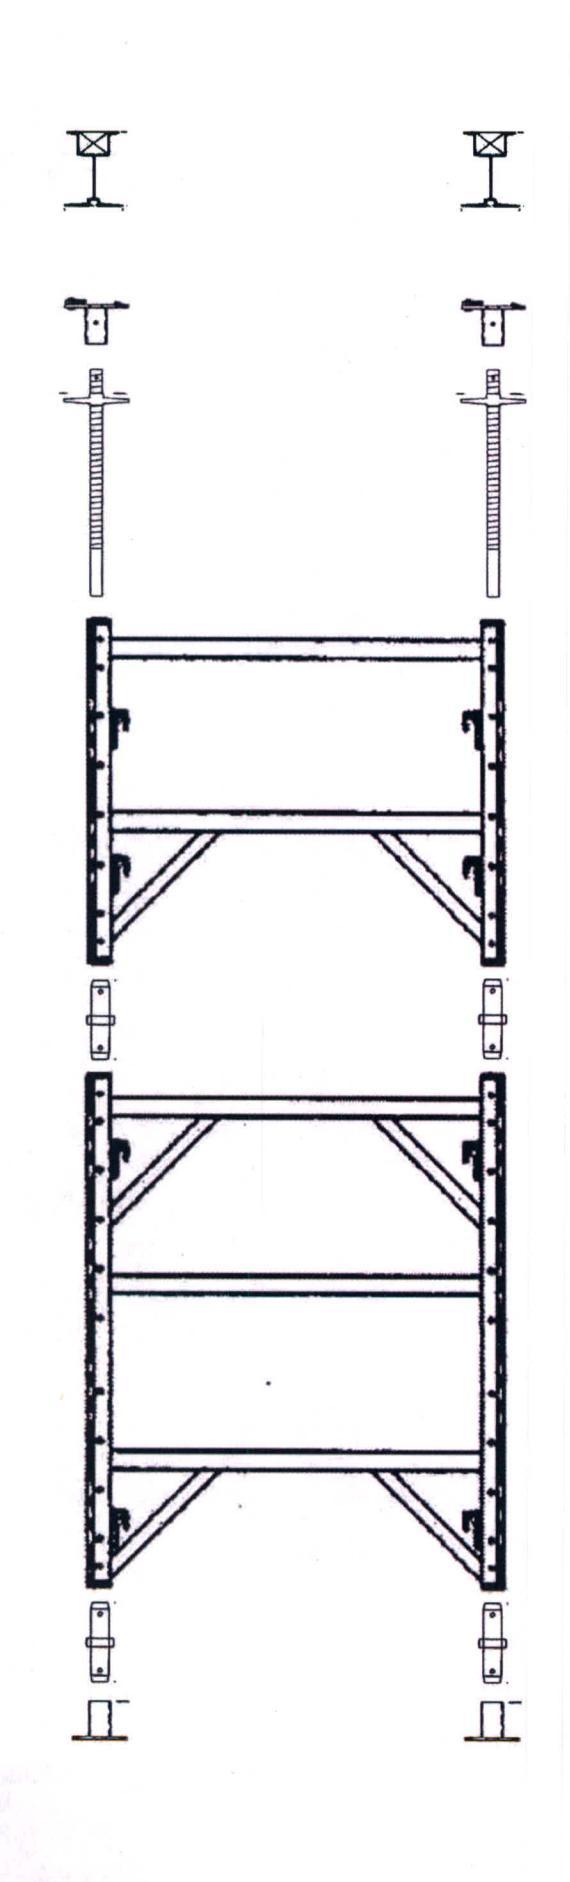
SH 40183 Piece of diagonal Zone 40G

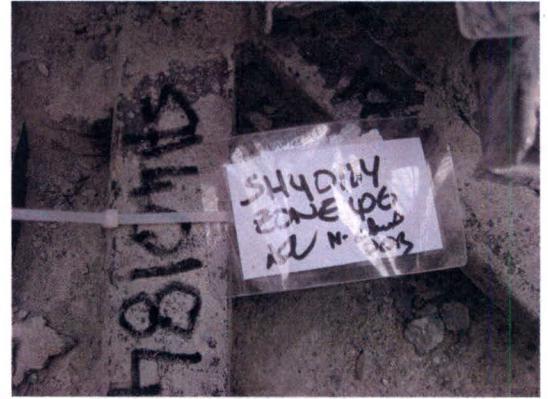
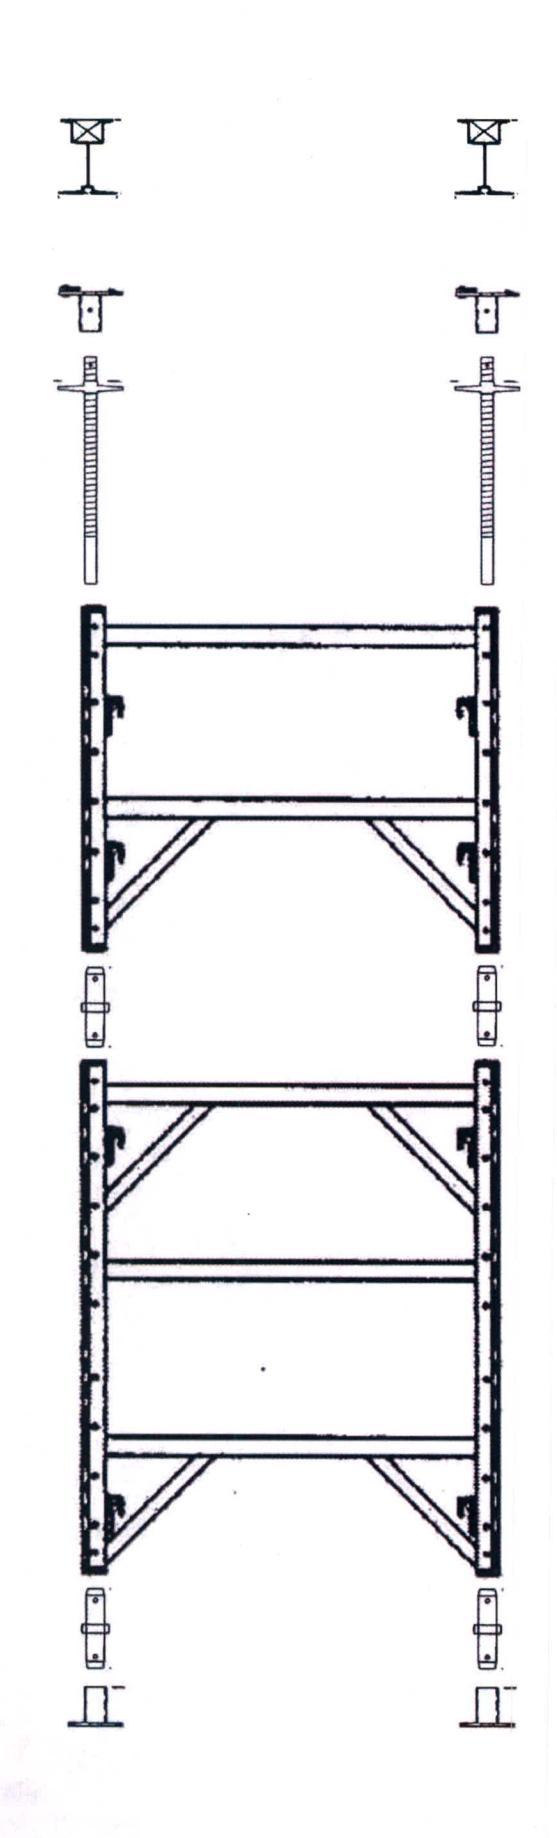
SH 40184 Horizontal and diagonal section of Tower part of Frame SH 40180 Zone 40G

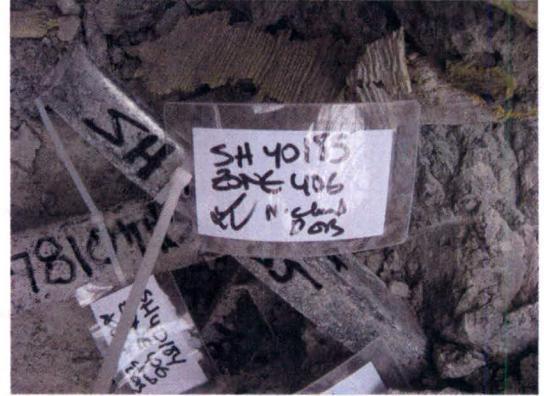
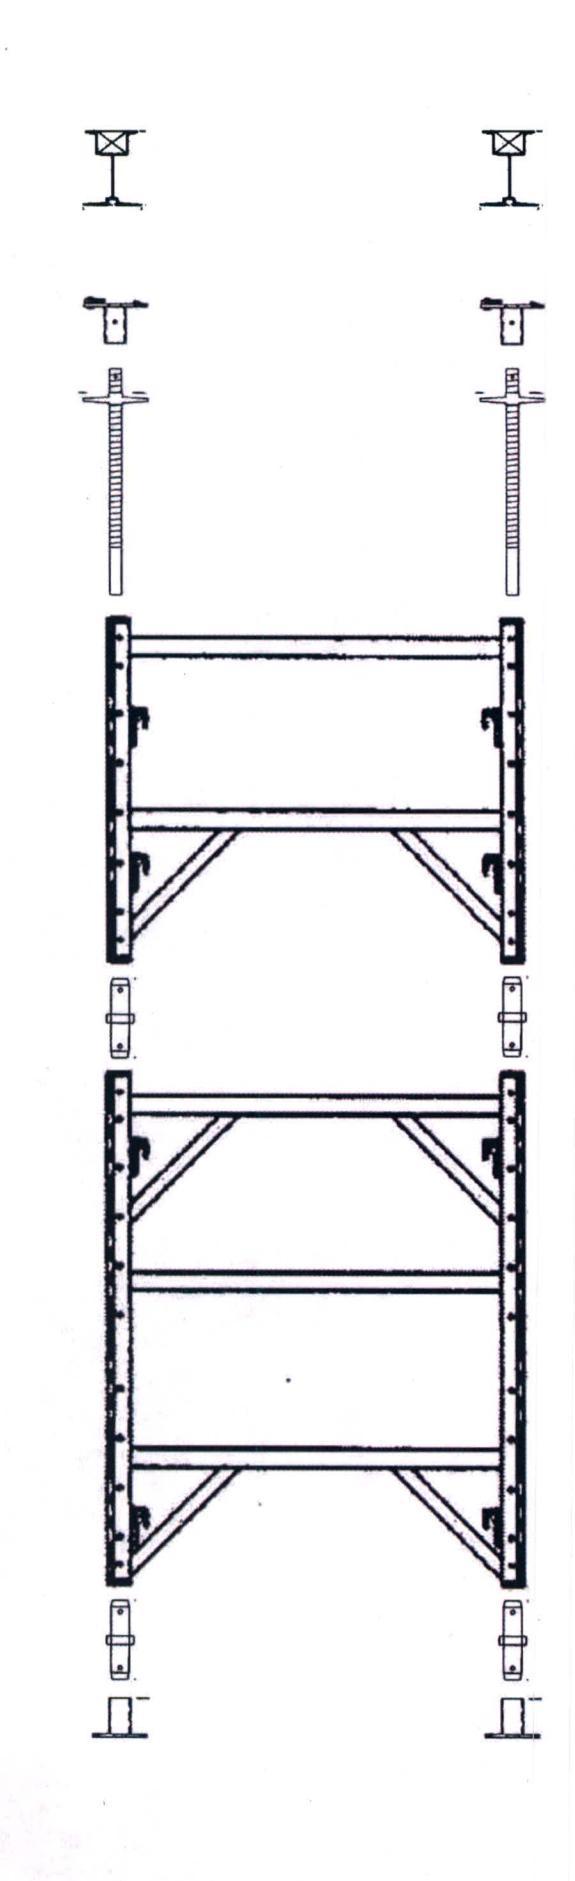
SH 40185 Brace Zone 40G

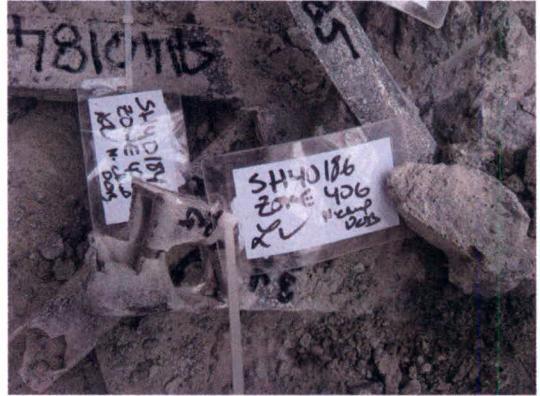
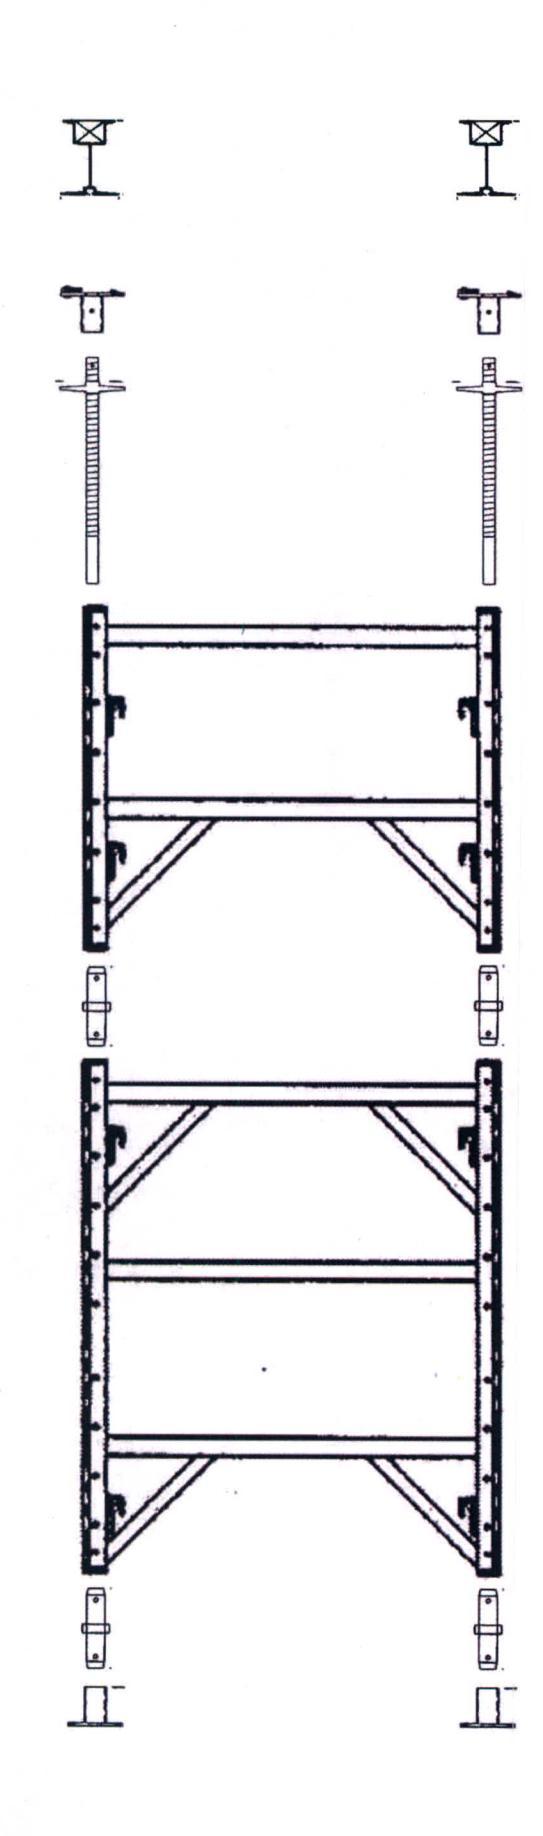
SH 40186

Horizontal and Diagonal section of Tower Part of SH 40180 Zone 40G

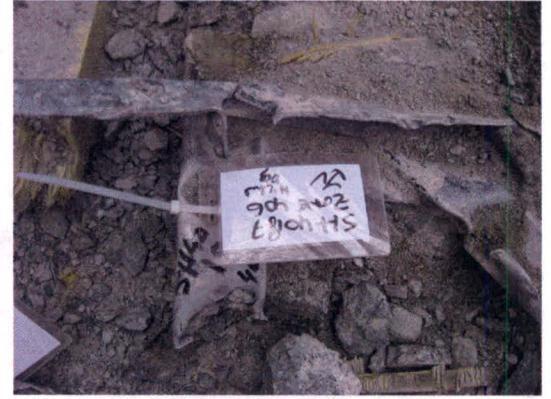
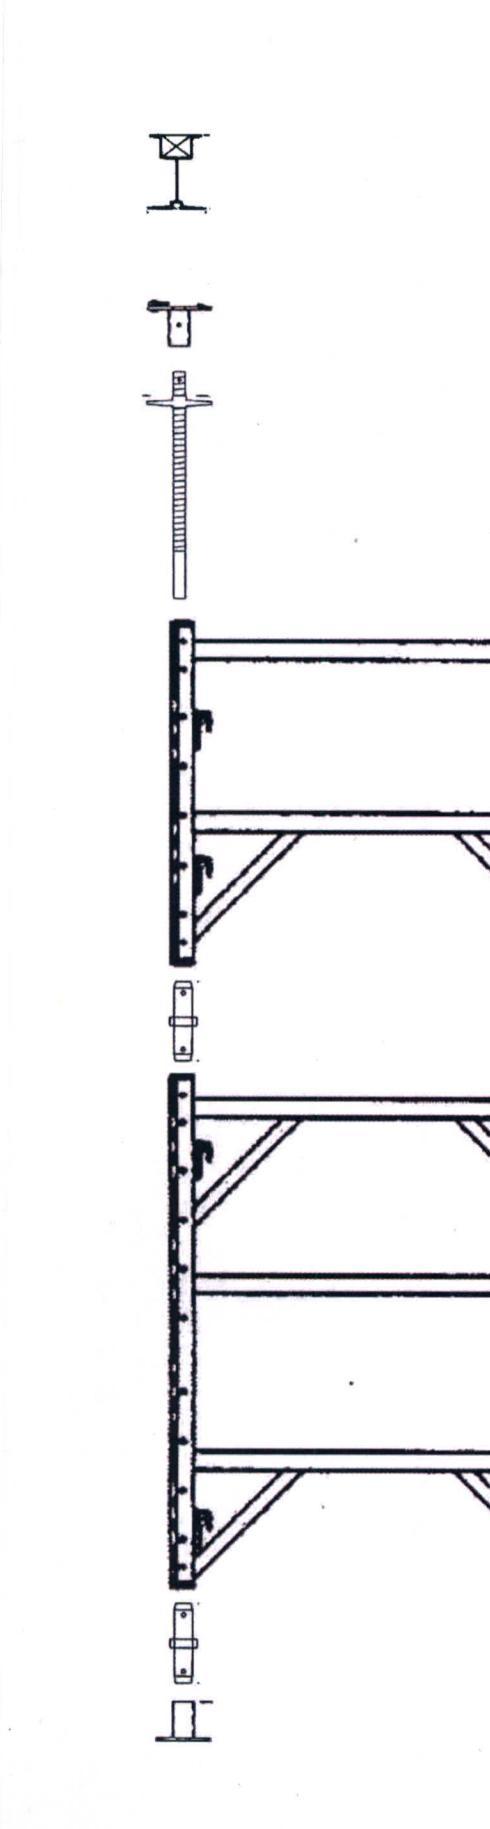
SH 40187 Horizontal and Diagonal section of tower Part of SH 40135 Zone 40G
