INVESTIGATION REPORT:

JANUARY 14, 2008 SHORING COLLAPSE AT 9 DOMINICK ST. (AKA 246 SPRING ST.) MANHATTAN

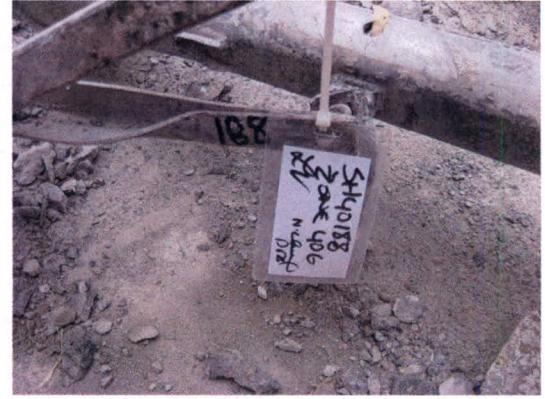
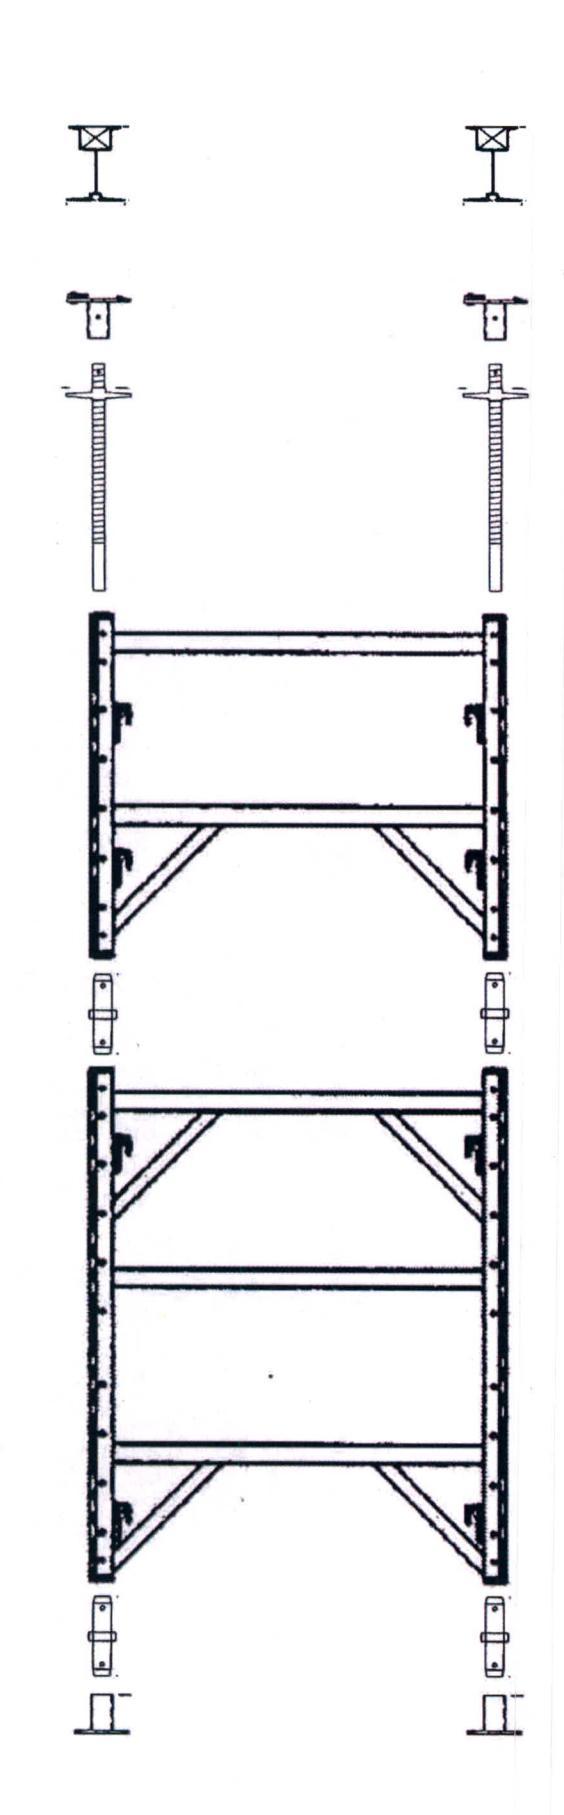
SH 40188 Brace connect to SH 40135 Zone 40G

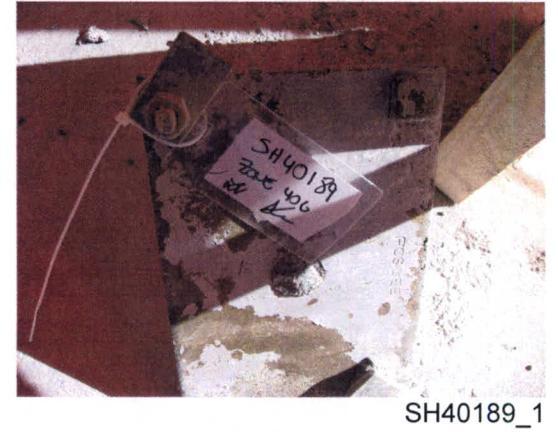
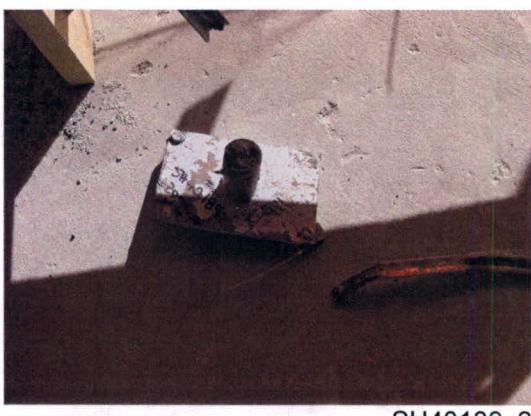
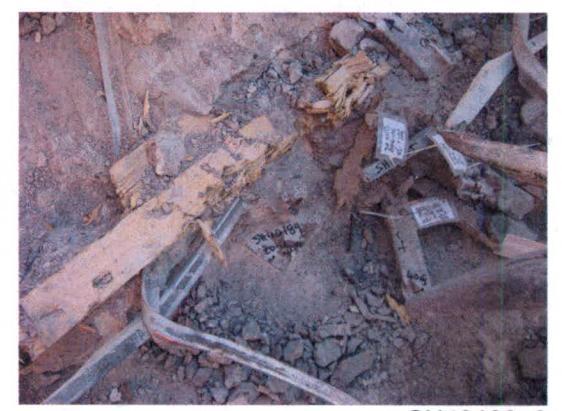
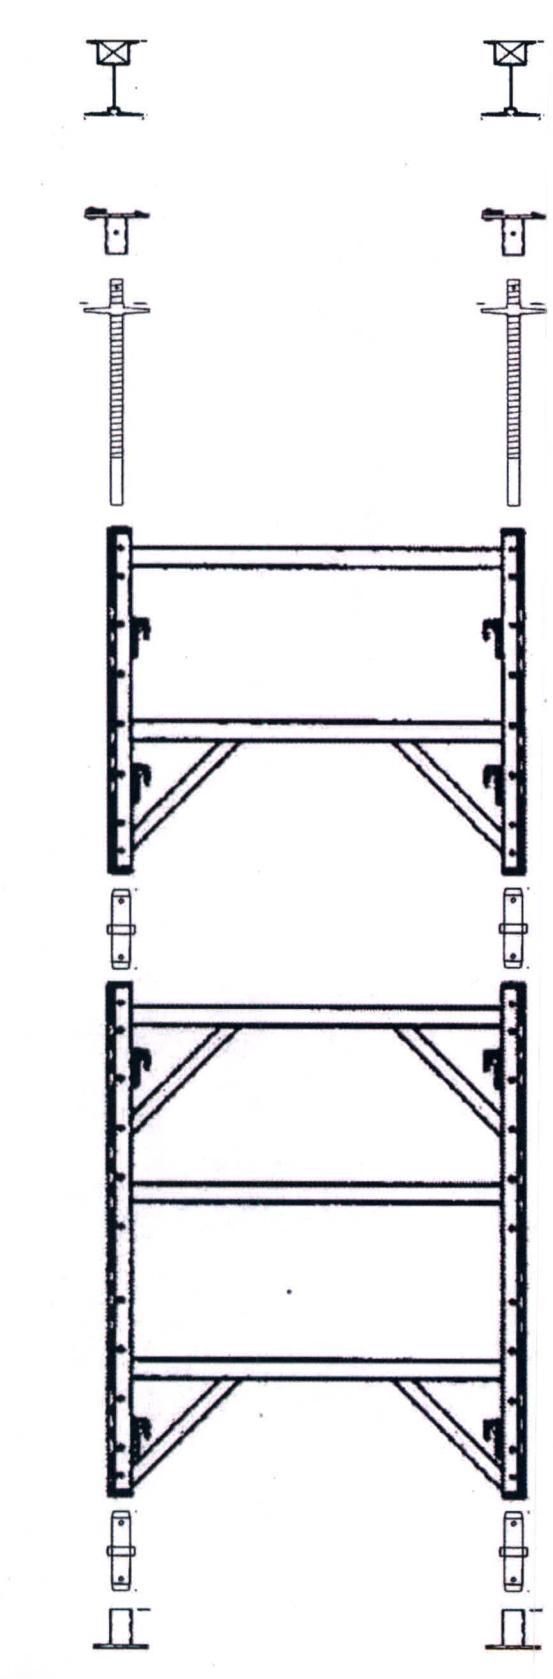
SH 40189 Bottom plate Zone 40G

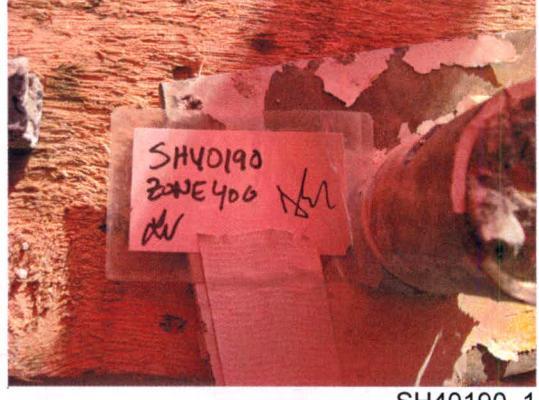
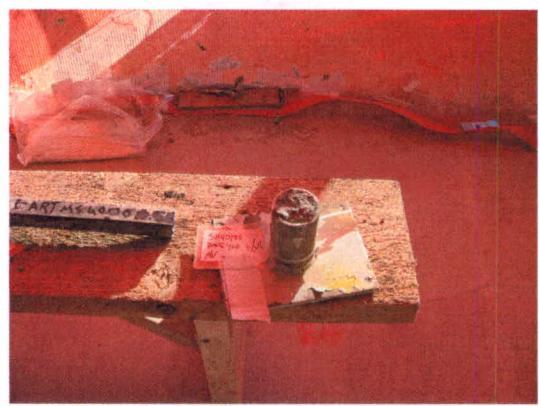
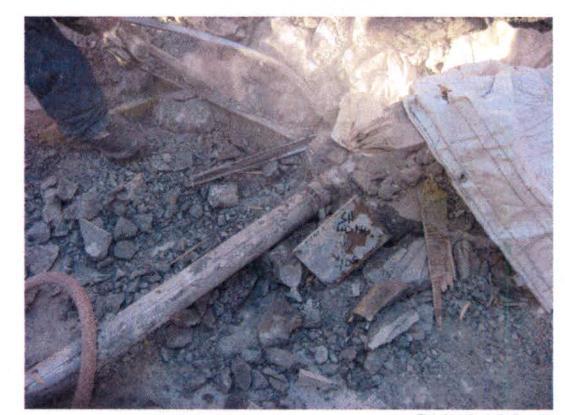
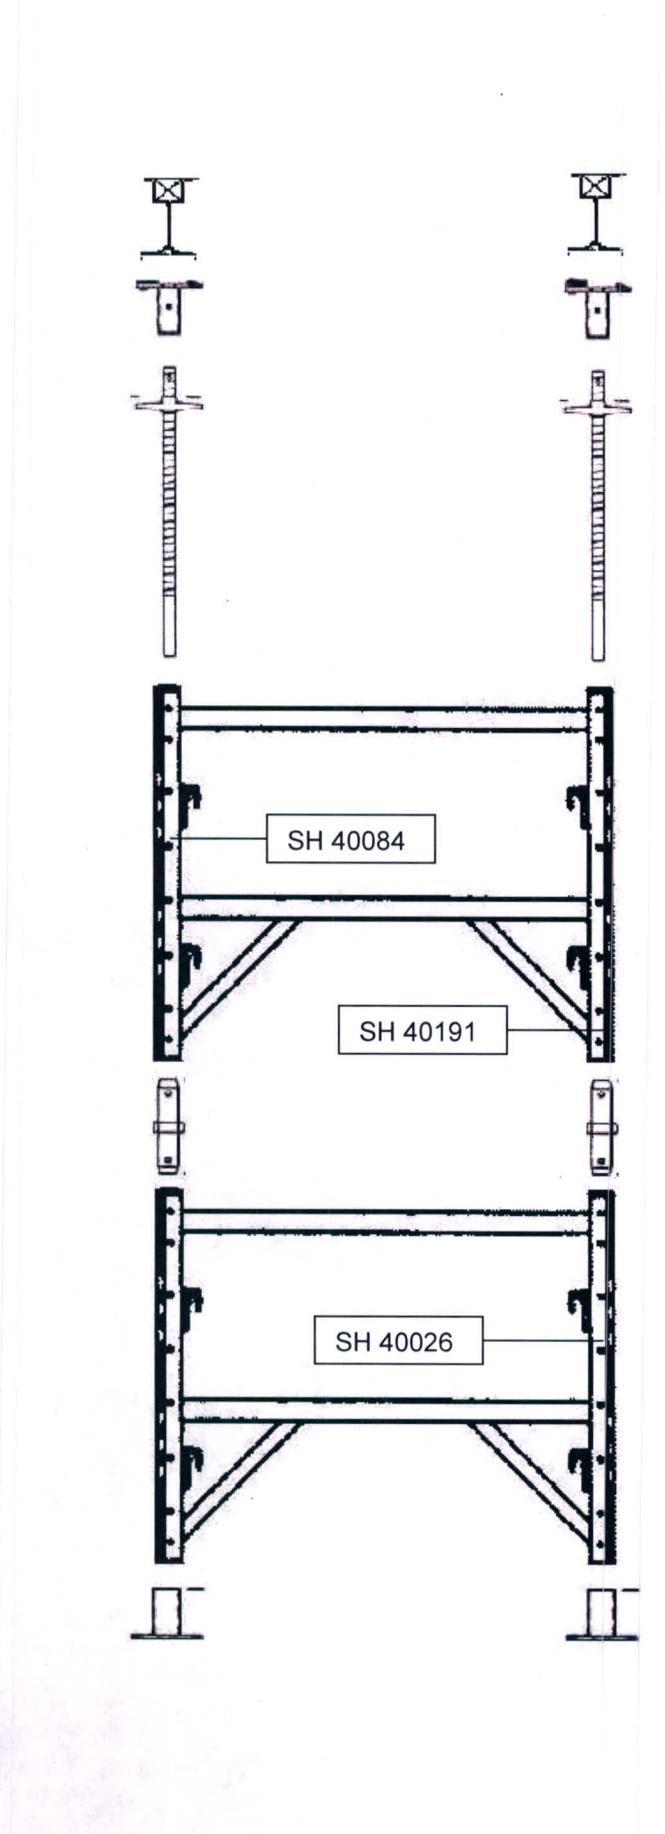
SH 40190 Bottom plate Zone 40G

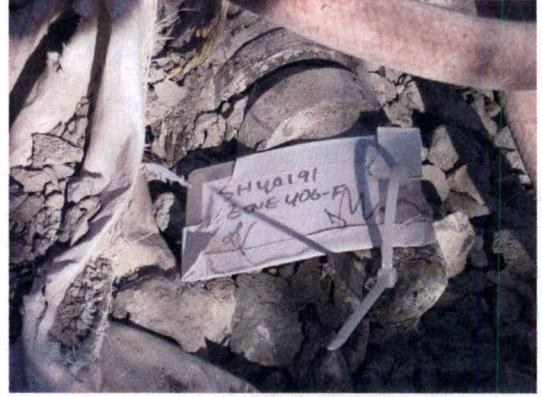
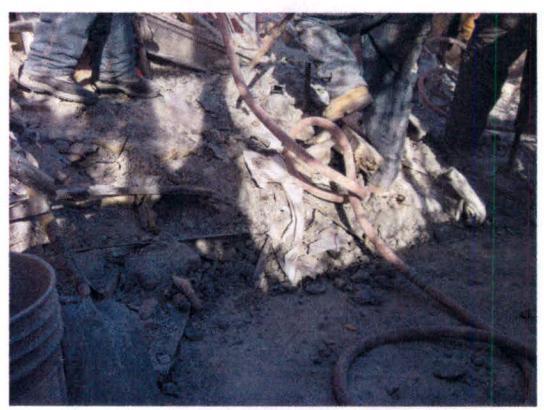
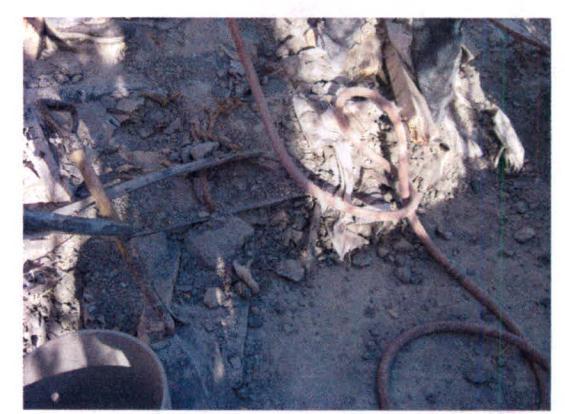
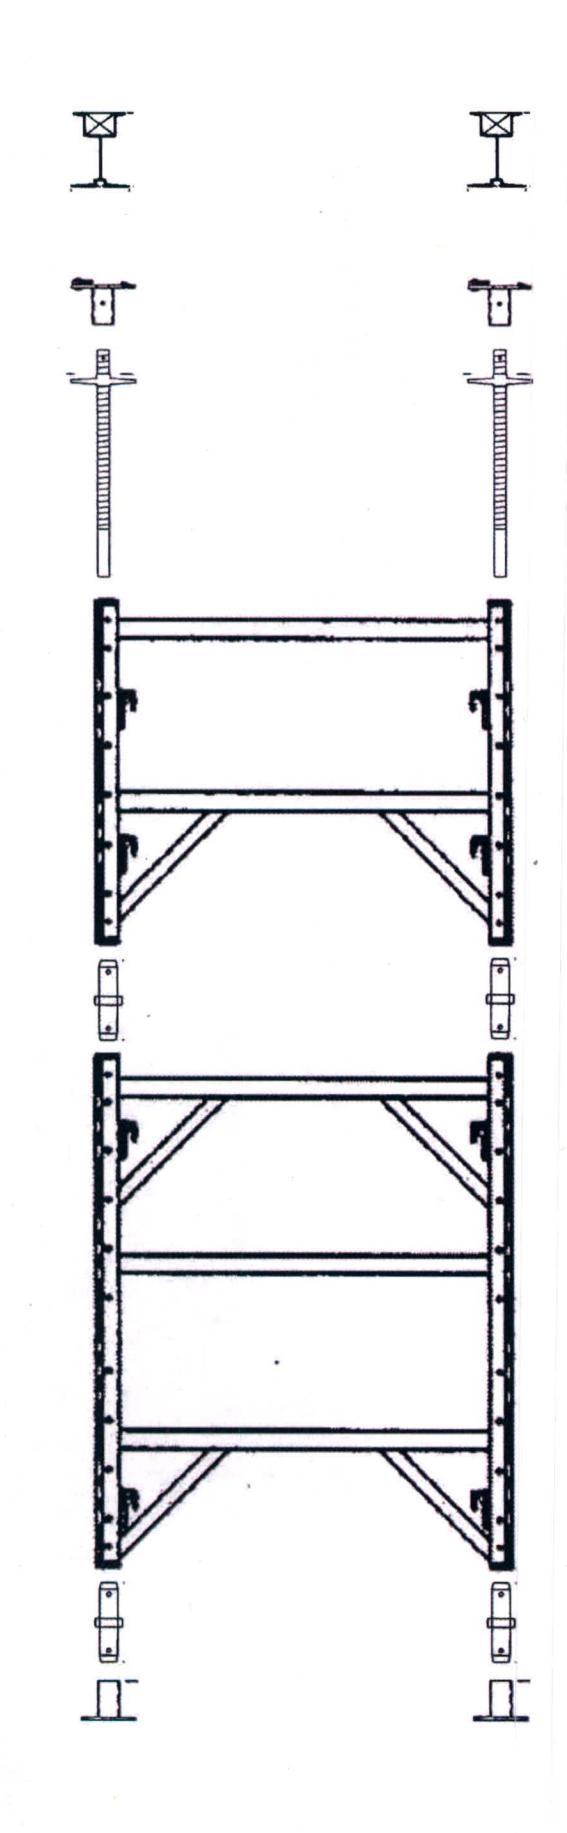
SH 40191 Top Frame connected to SH 40135 on 41st floor Zone 40G-F

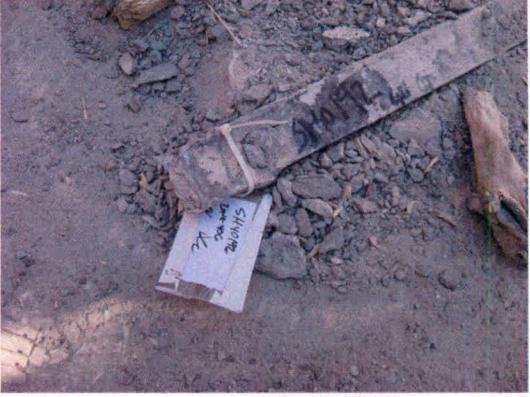
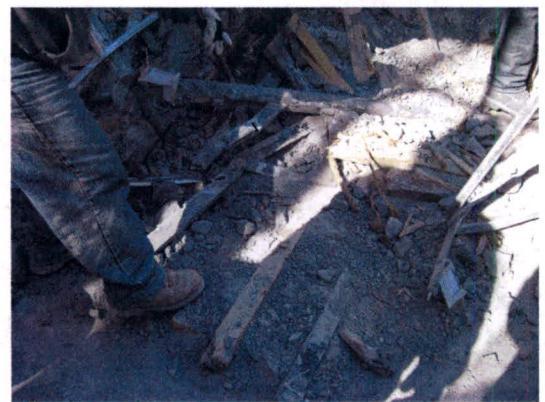
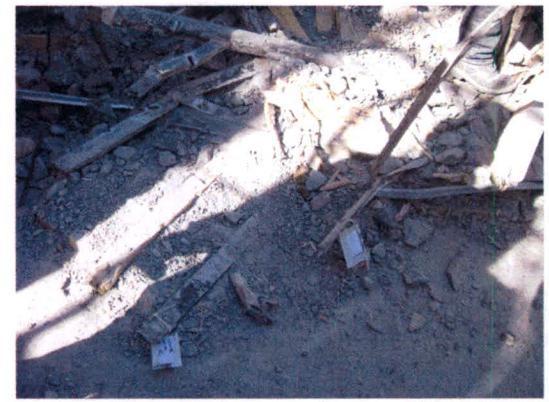
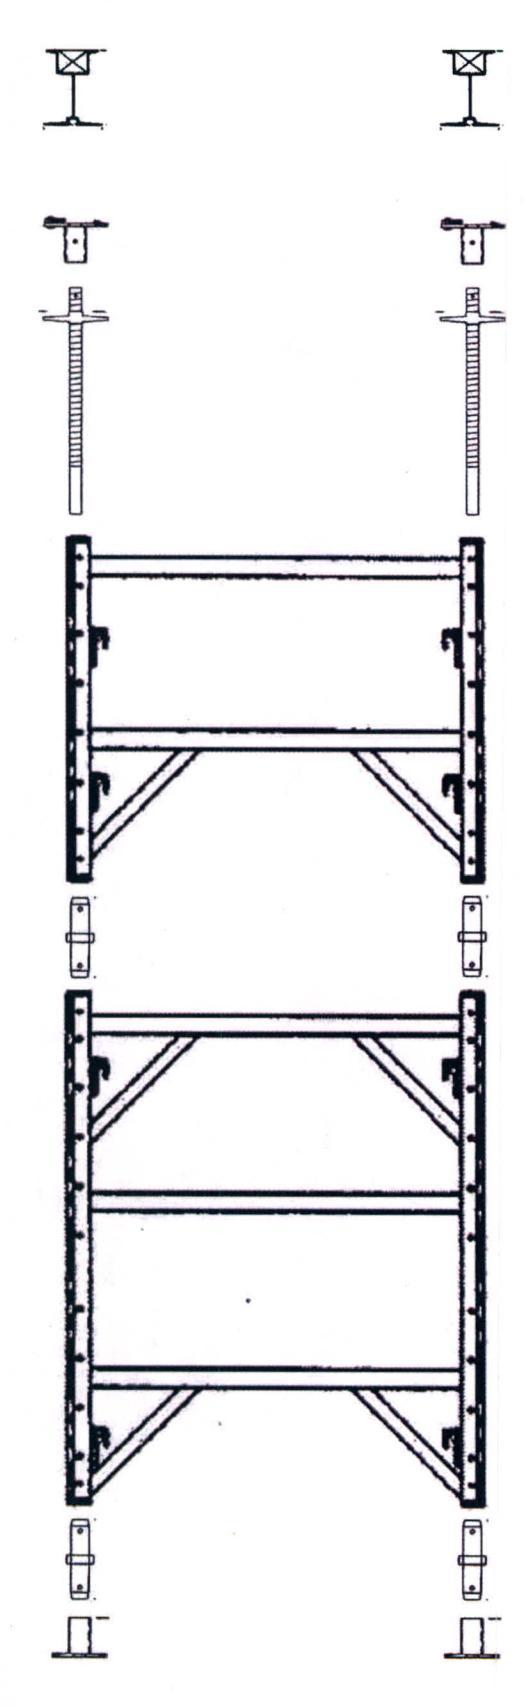
SH 40192 Piece of frame Part of SH 40180 Zone 40G

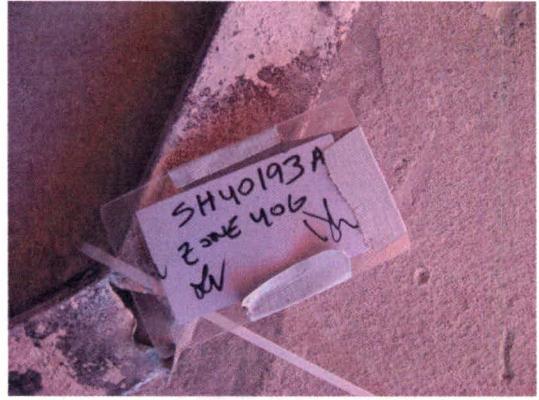
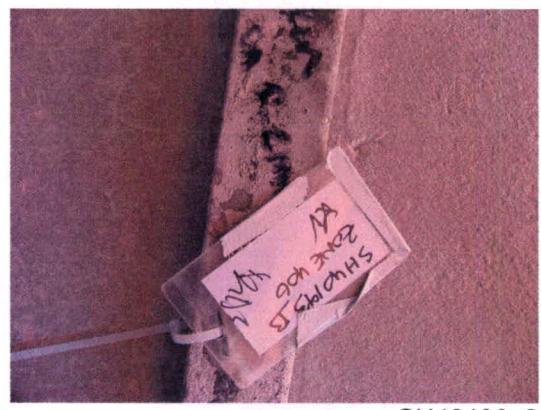
SH 40193 Piece of frame Zone 40G

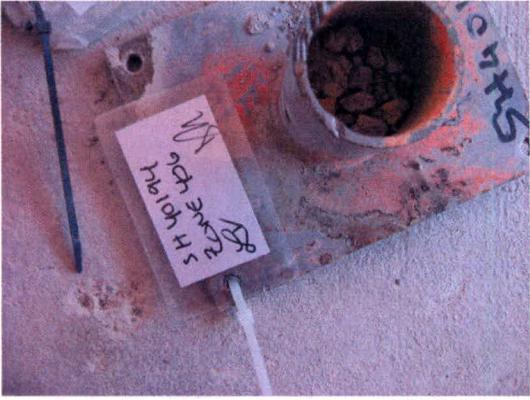
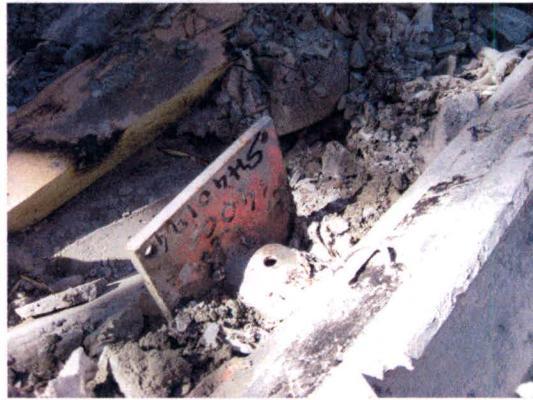
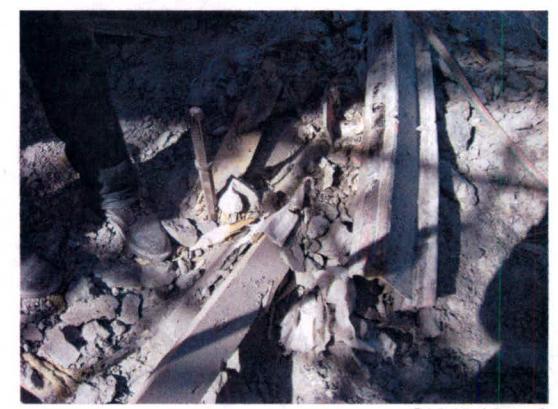
SH 40194 Bottom plate Zone 40G

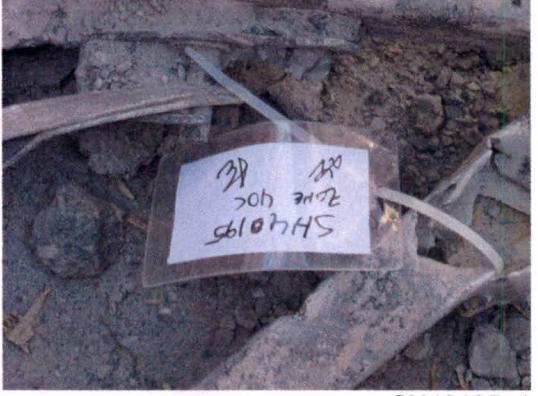
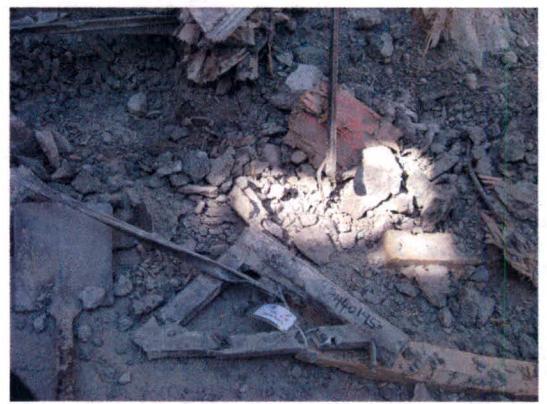
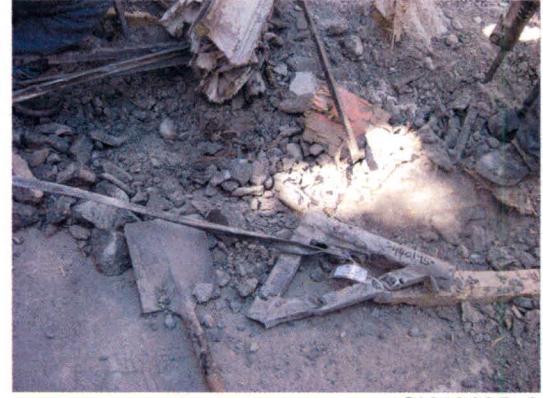
Top frame fractured off from SH 40196 SH 40185 and SH 40195 were connected Zone 40C

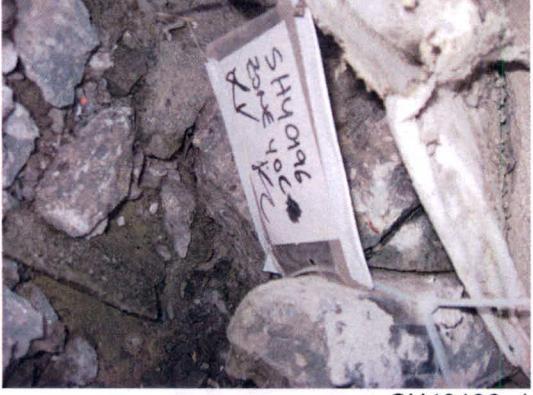
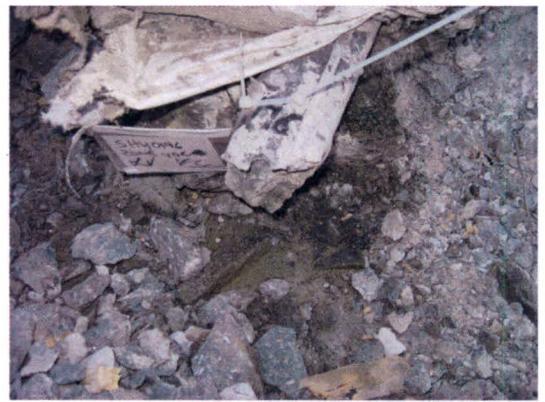
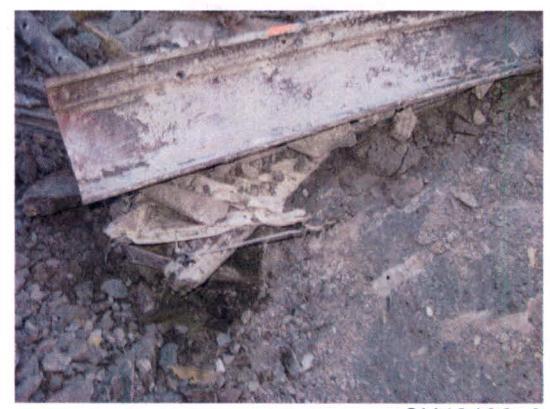
Remaining fractured part of SH 40195 frame buried in concrete Zone 40C

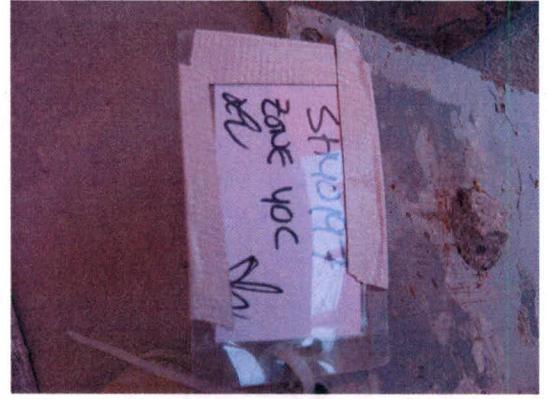
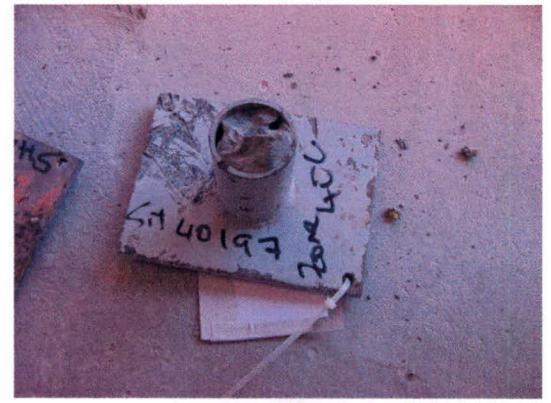
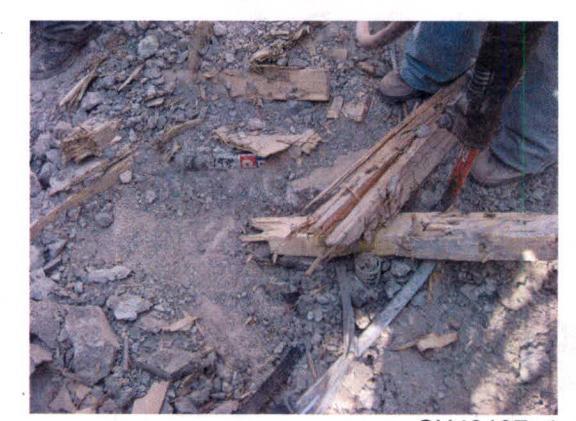
SH 40197 Bottom plate Zone 40C

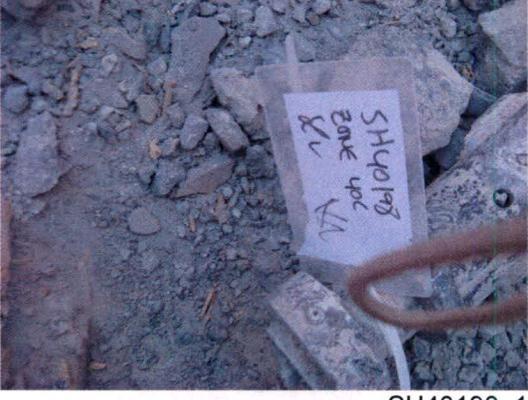
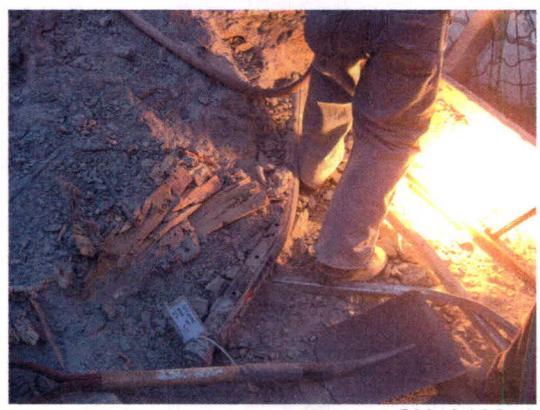
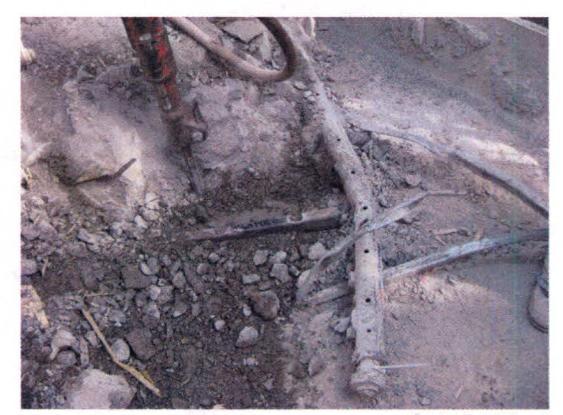
SH 40198 Frame buried in concrete Zone 40C

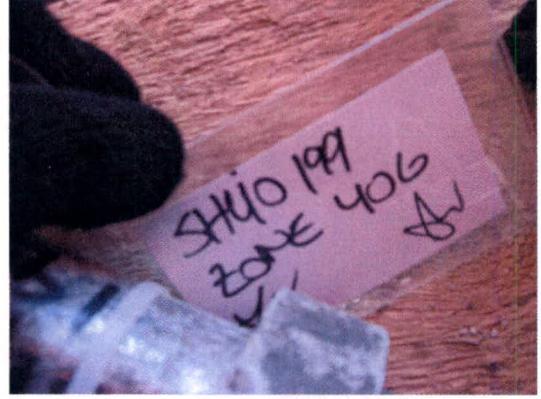
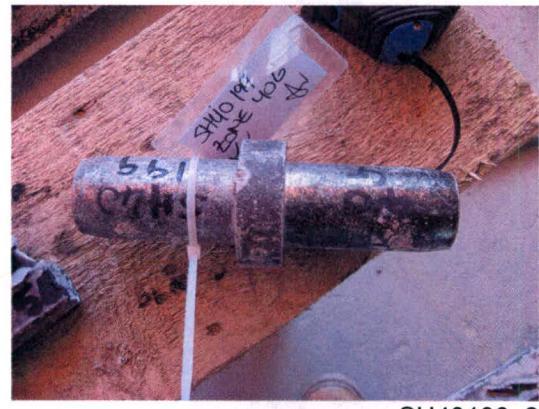
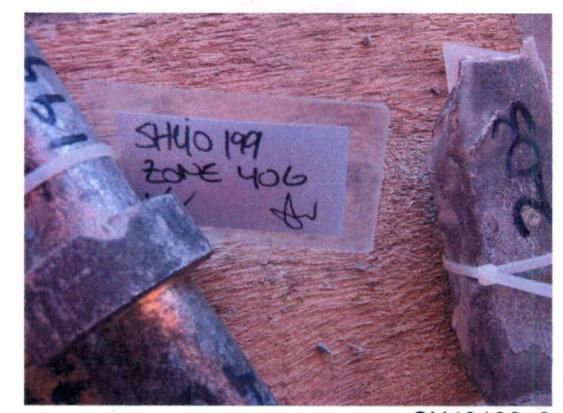
SH 40199 Coupler buried in Concrete Zone 40C

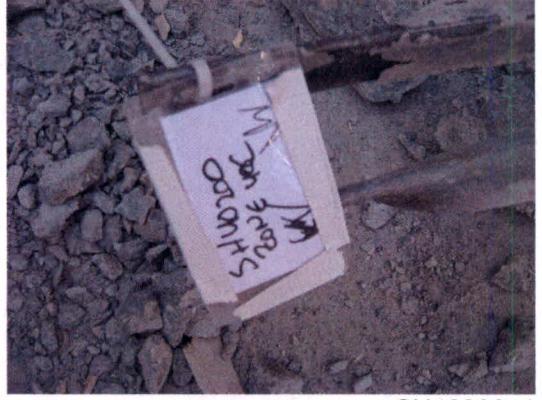
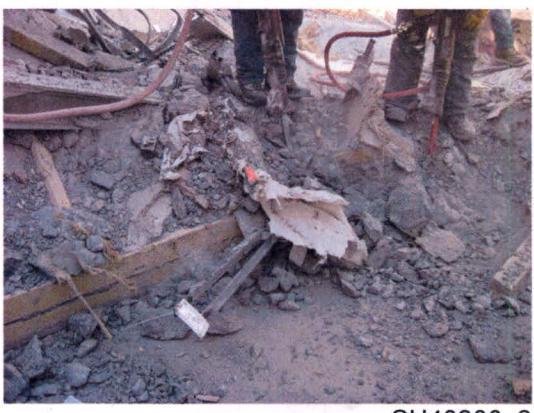
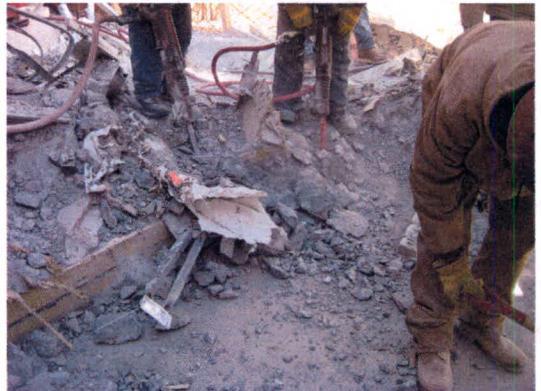
SH 40200 Brace buried in concrete Zone 40C

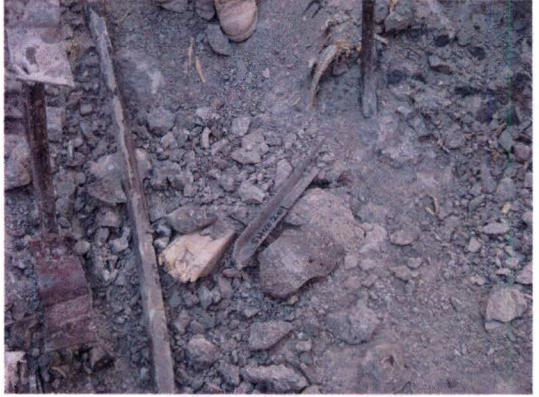
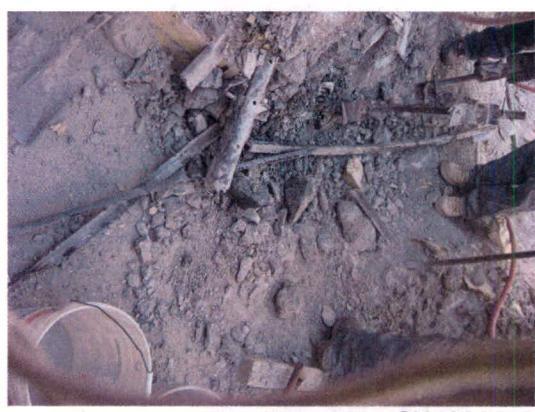
SH 40201 Brace Zone 40C

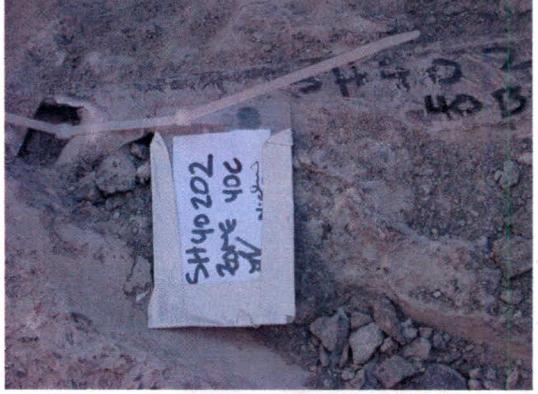
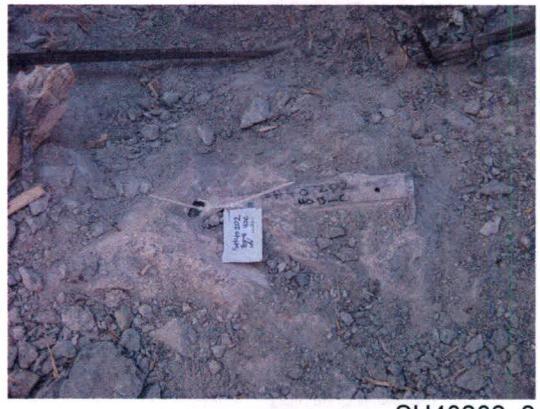
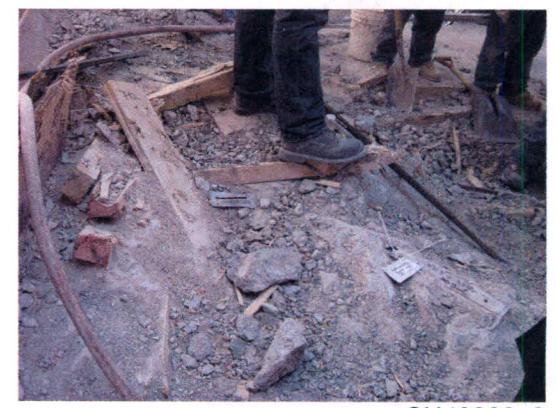
SH 40202 Shoring tower Zone 40C

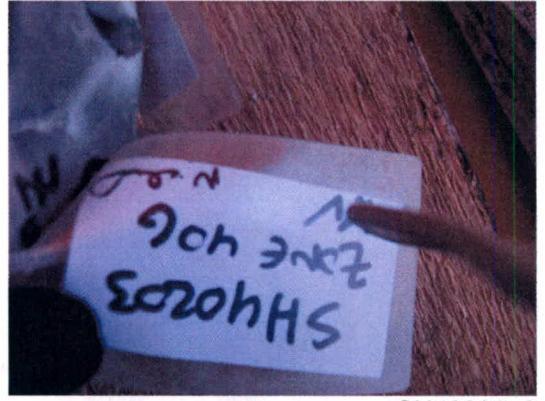
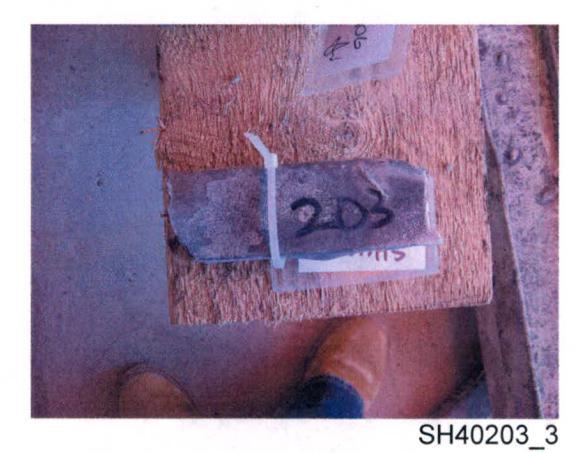
SH 40203 Piece of Frame Zone 40G

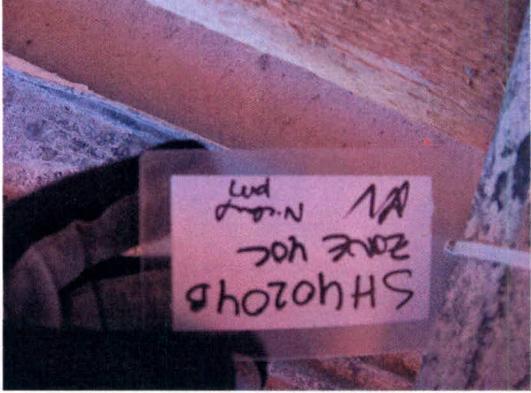
SH 40204 Bottom Frame buried Zone 40C

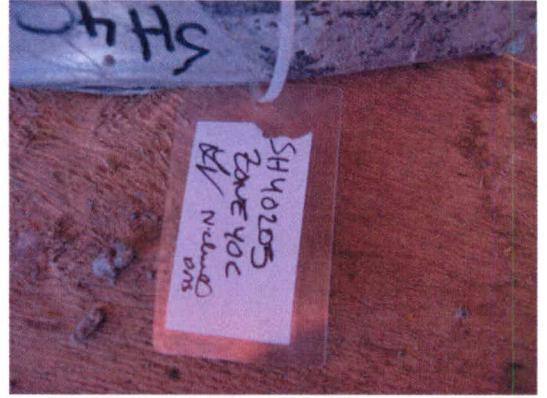
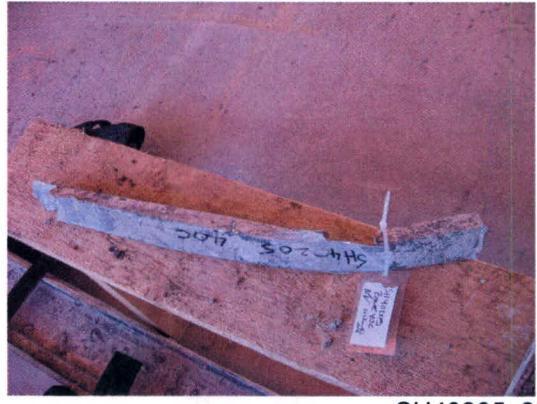
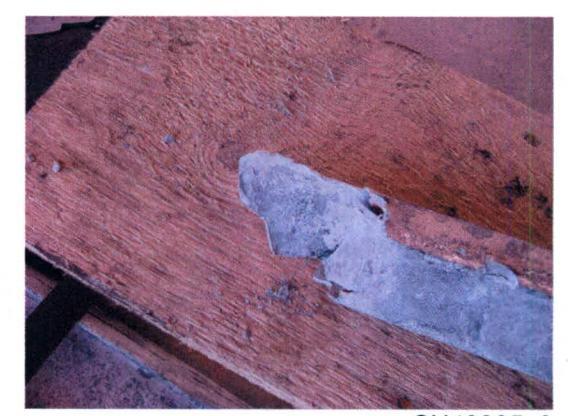
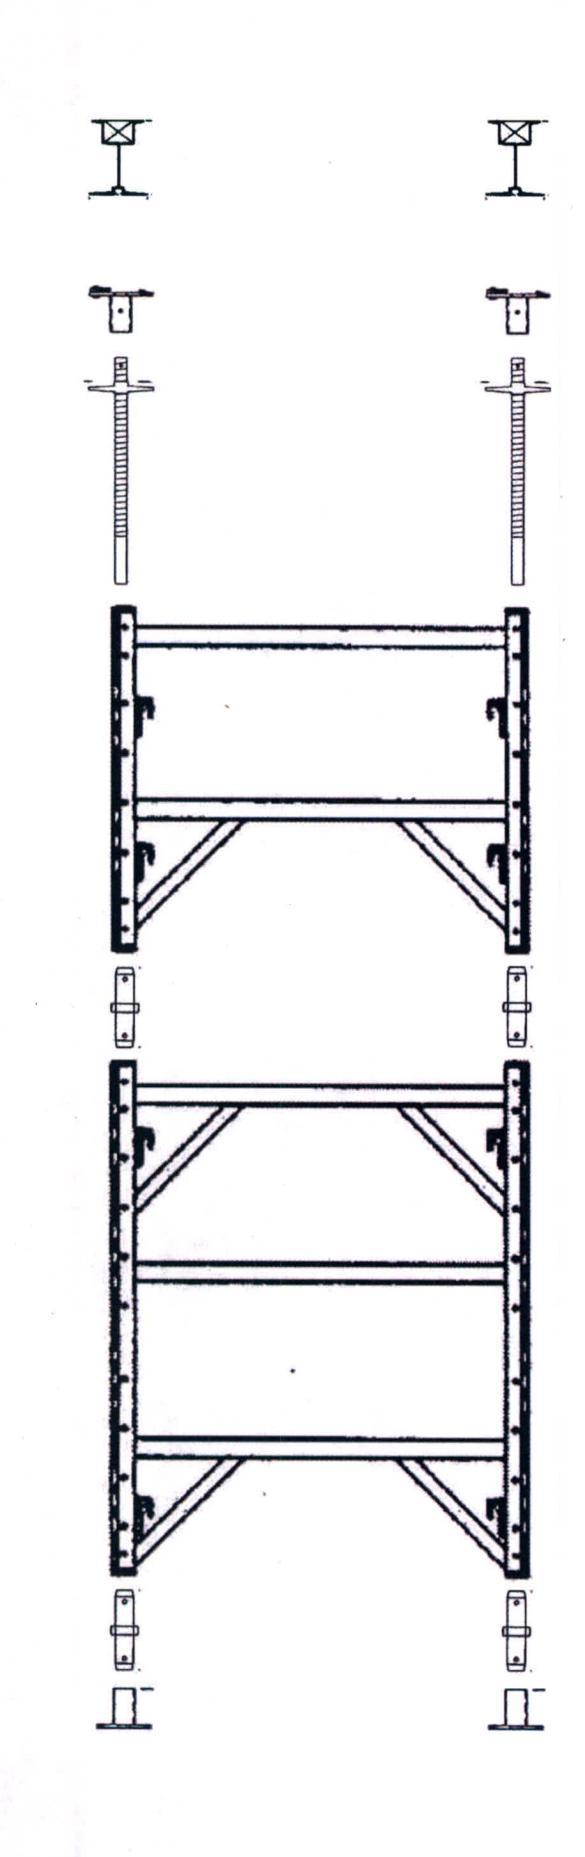
Folder: 08-02-28; 08-02-28; SH 40205

SH 40205 Piece of frame Zone 40C

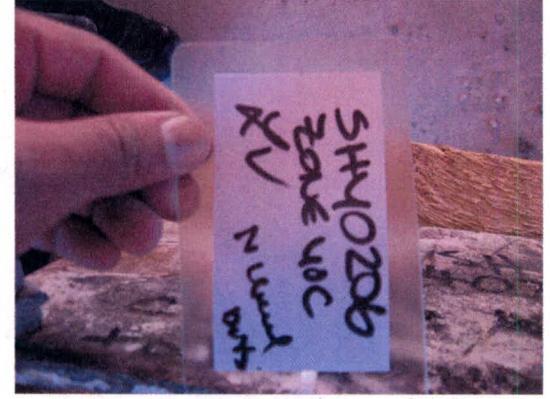
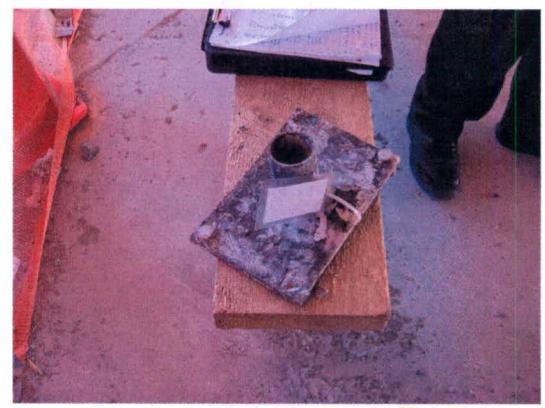
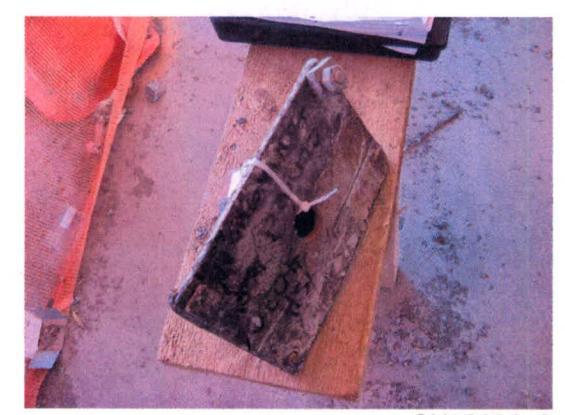
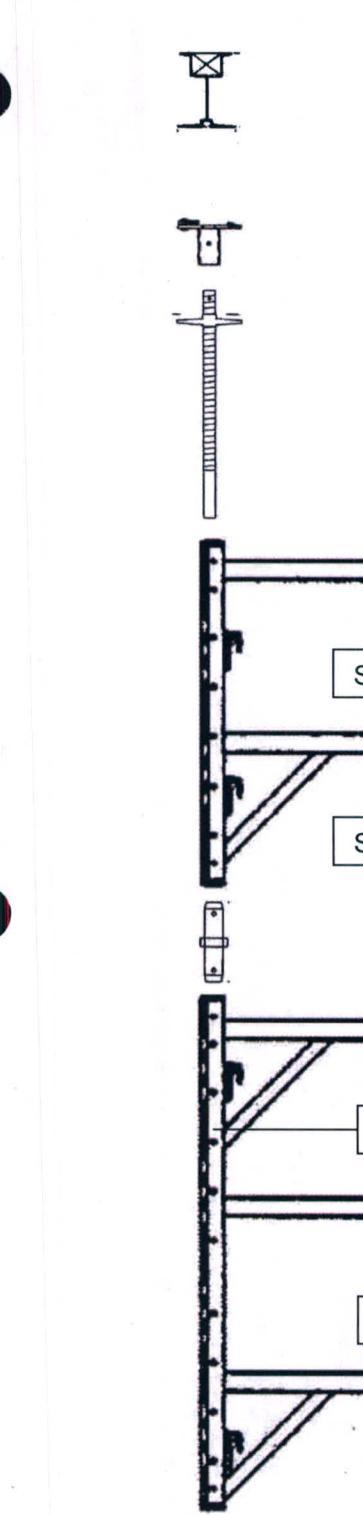
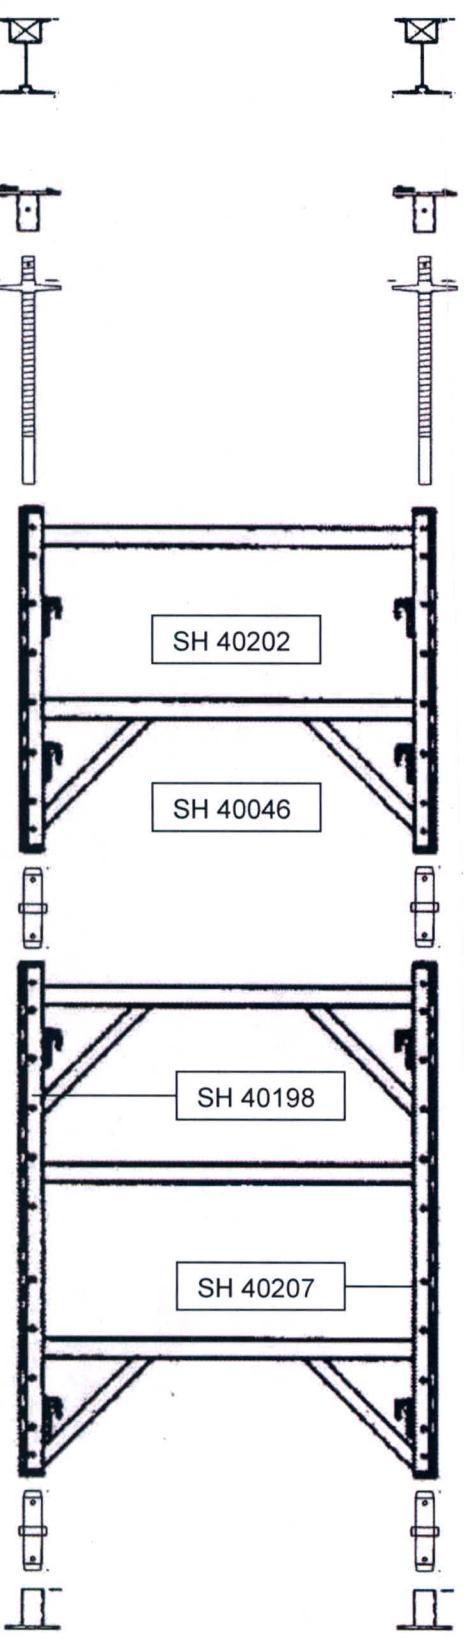
Folder: 08-02-28; 08-02-28; SH 40206

SH 40206 Top piece connect to SH 40196(Top plate) Zone 40C

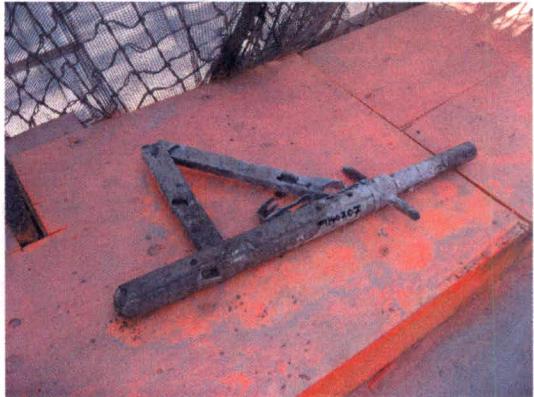
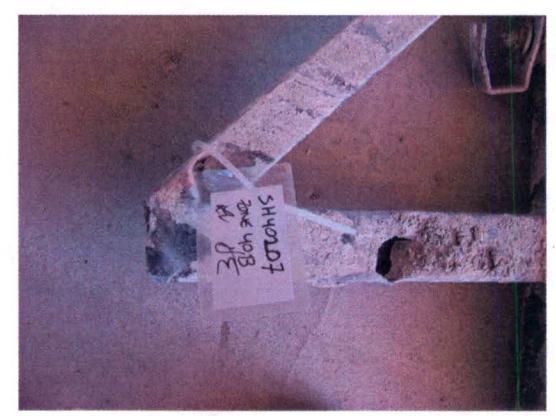
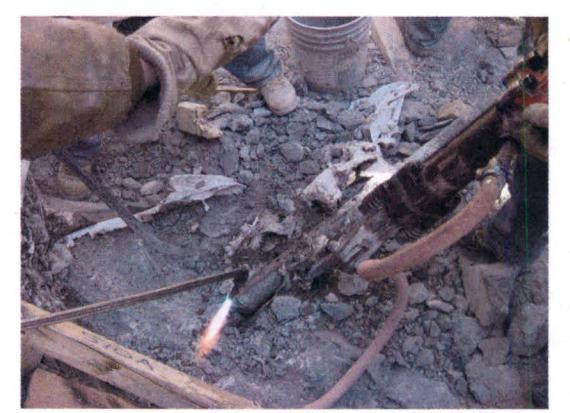
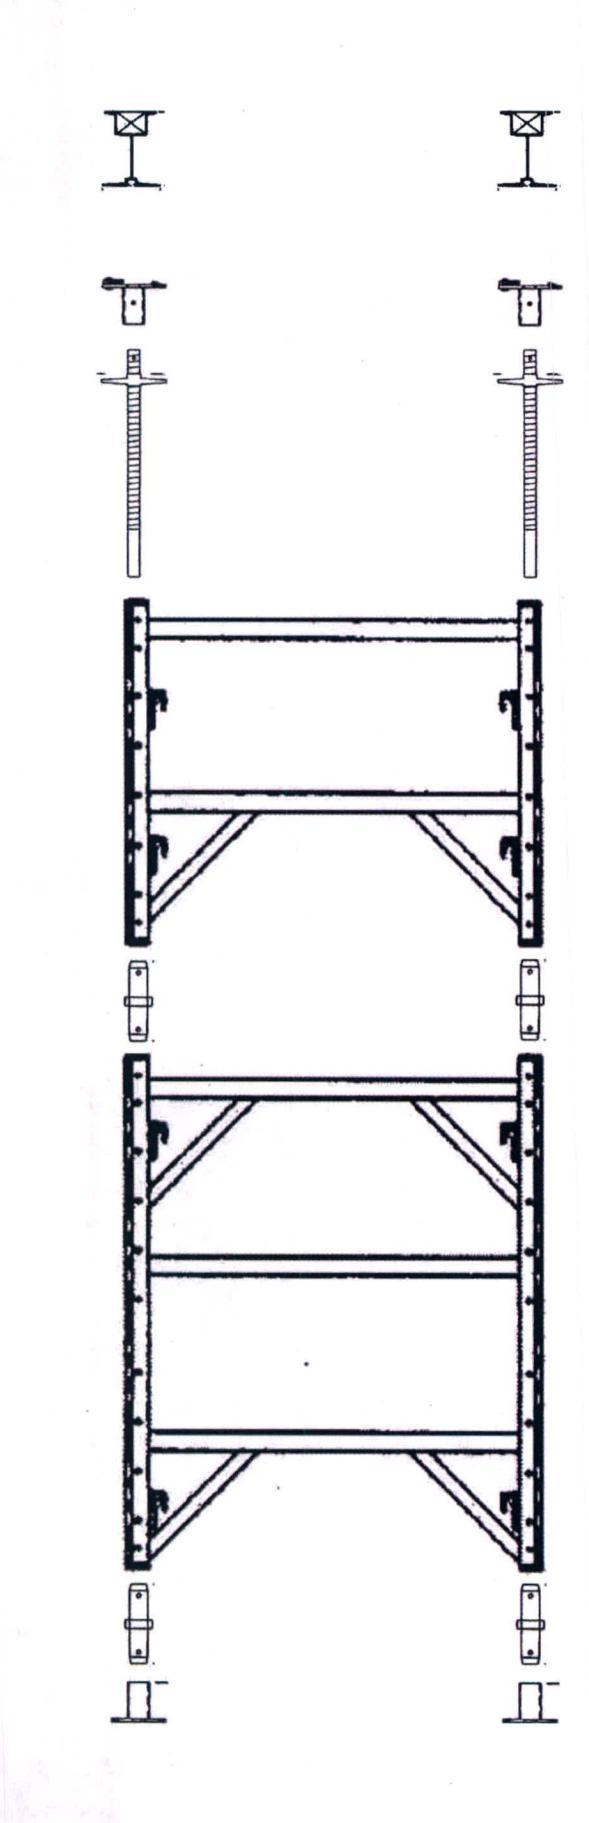
Folder: 08-02-29; SH 40207

SH 40207 Bottom Frame Broken (torched) Zone 40C

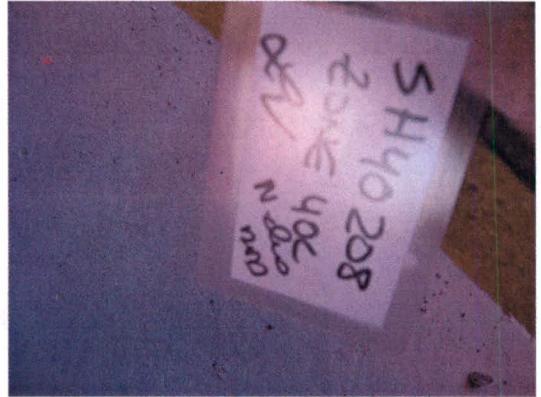
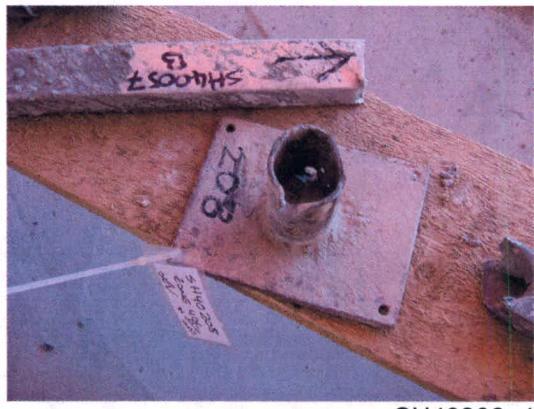
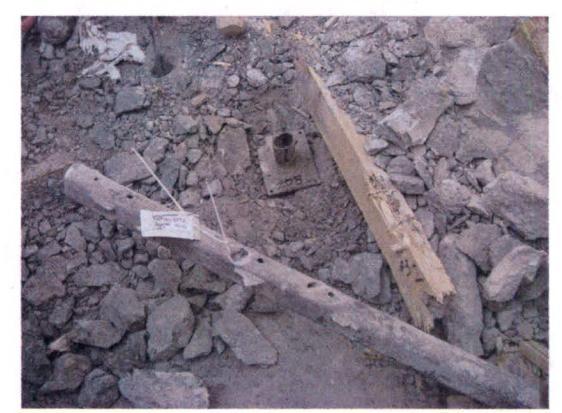
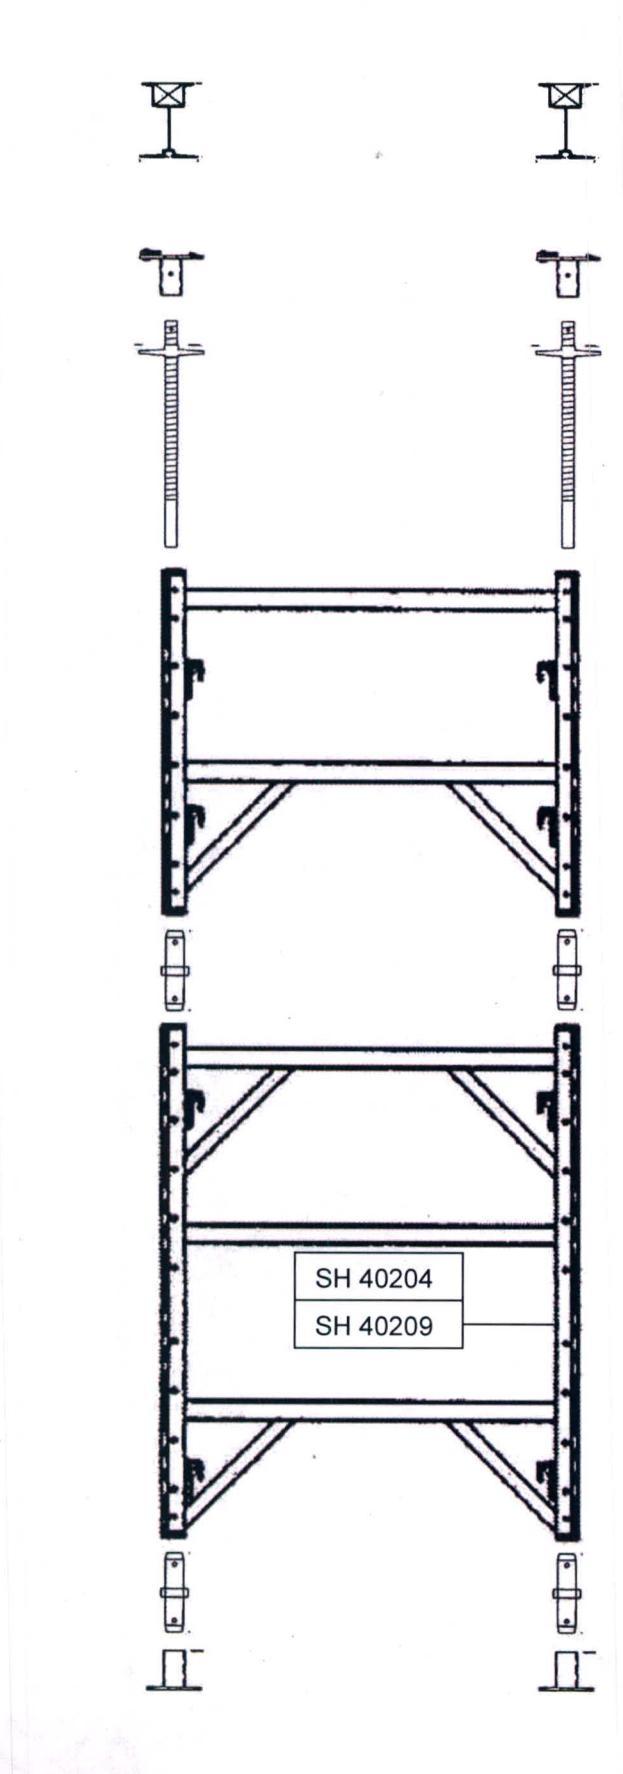
Folder: 08-02-29; SH 40208

SH 40208 Top plate Zone 40C
