INVESTIGATION REPORT:

JANUARY 14, 2008 SHORING COLLAPSE AT 9 DOMINICK ST. (AKA 246 SPRING ST.) MANHATTAN

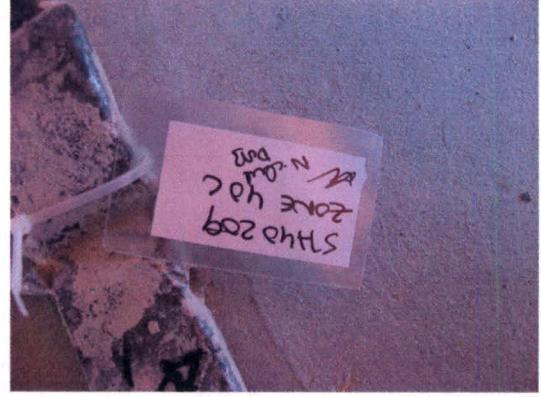
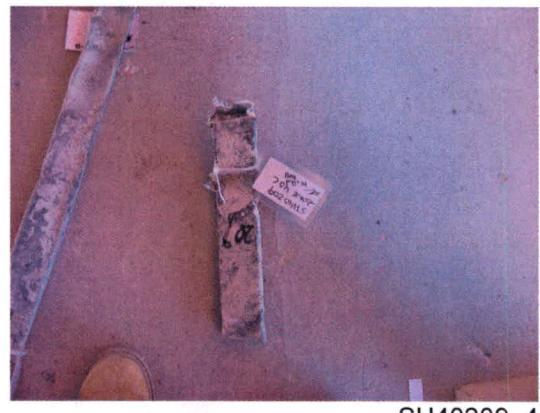
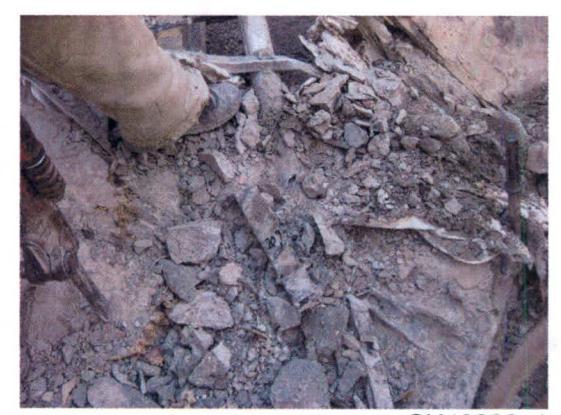
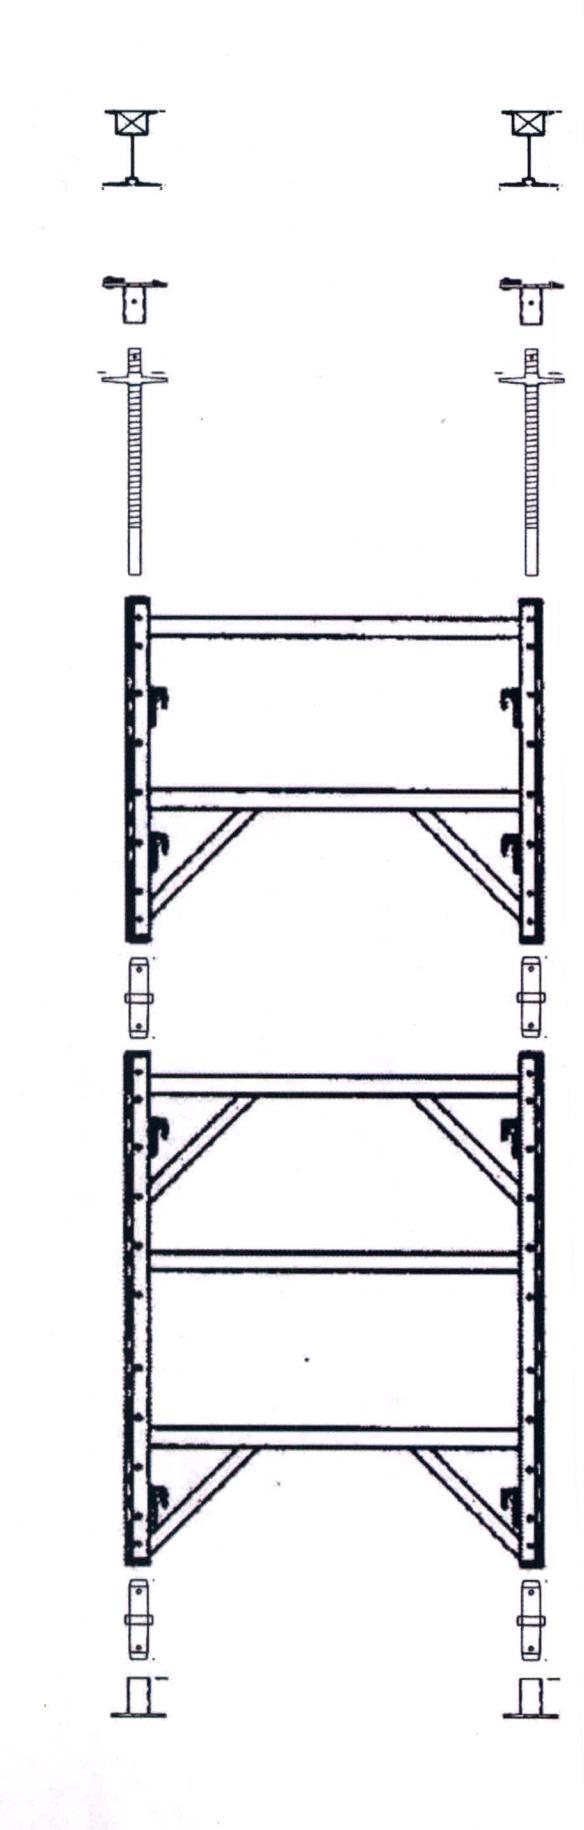
Folder: 08-02-29; SH 40209

SH 40209 Piece of frame part of SH 40204 Zone 40C

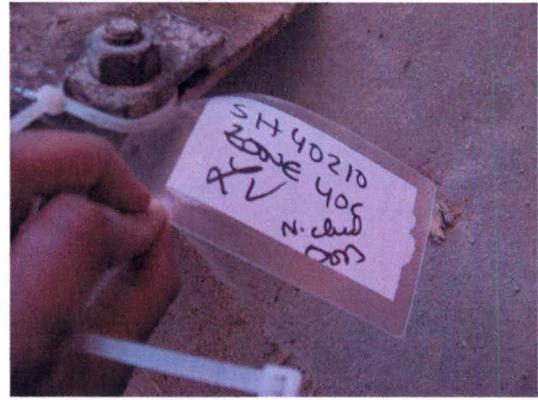
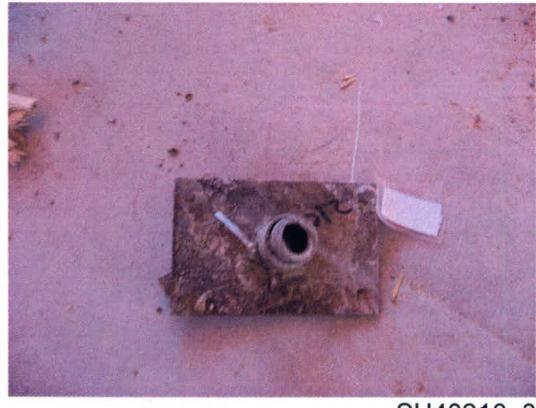
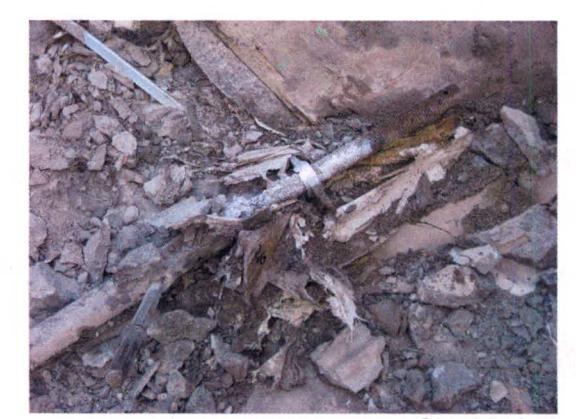
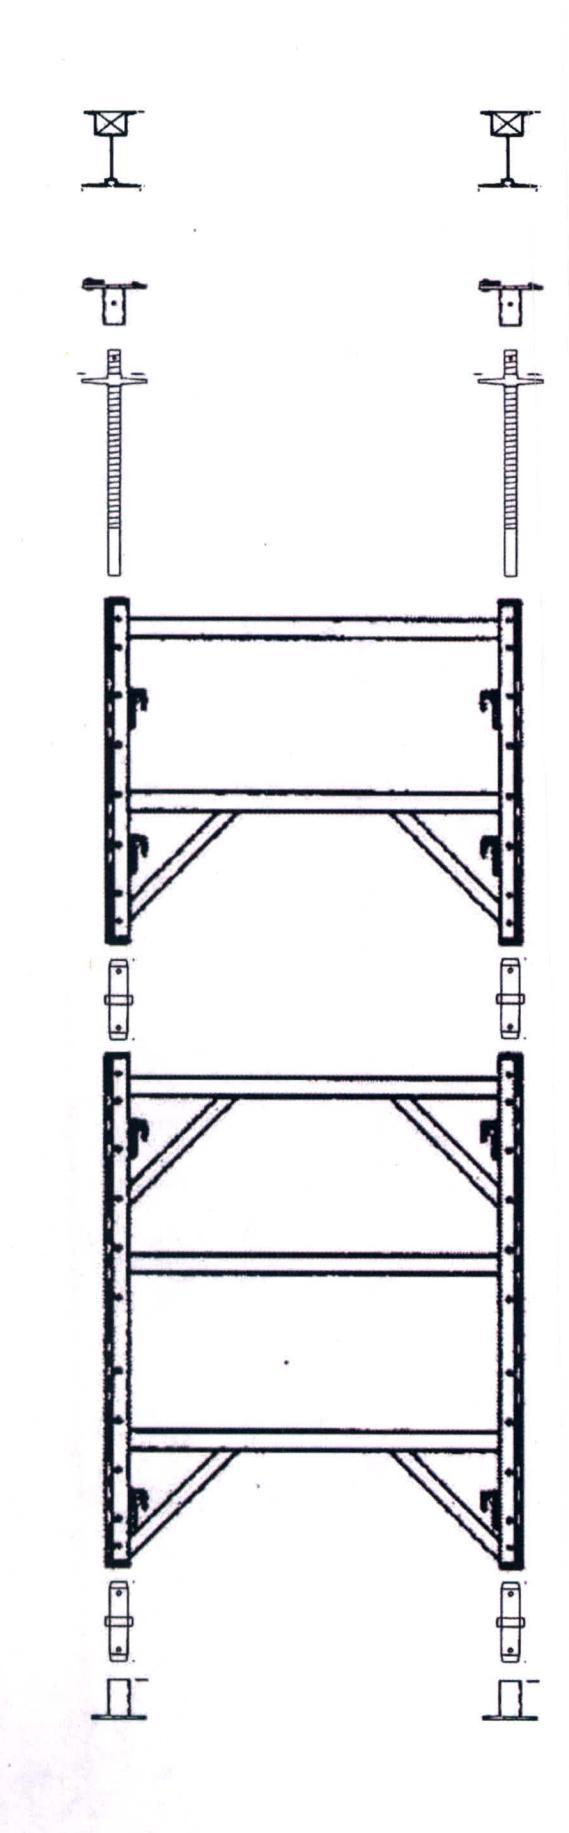
Folder: 08-02-29; SH 40210

SH 40210 Top plate Zone 40B

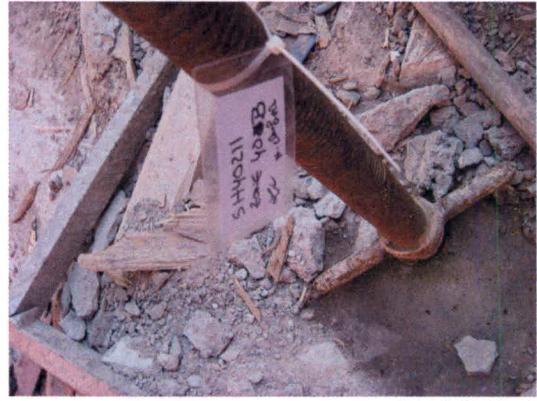
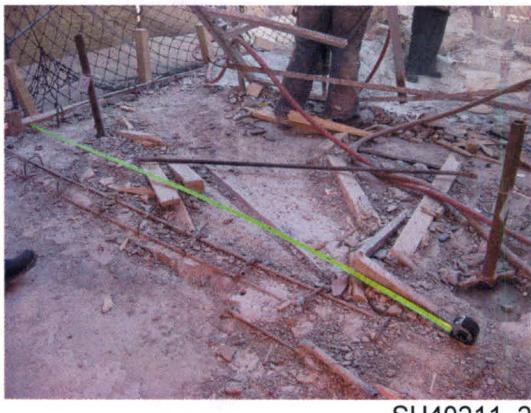
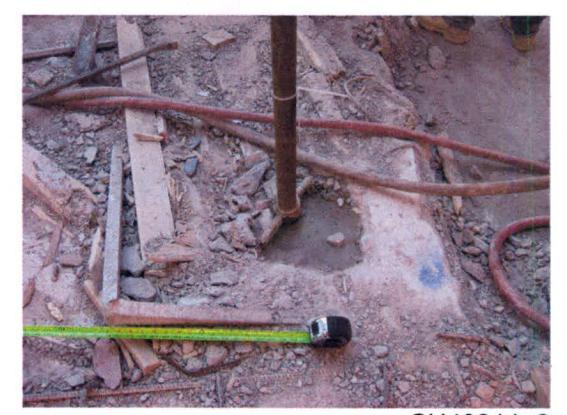
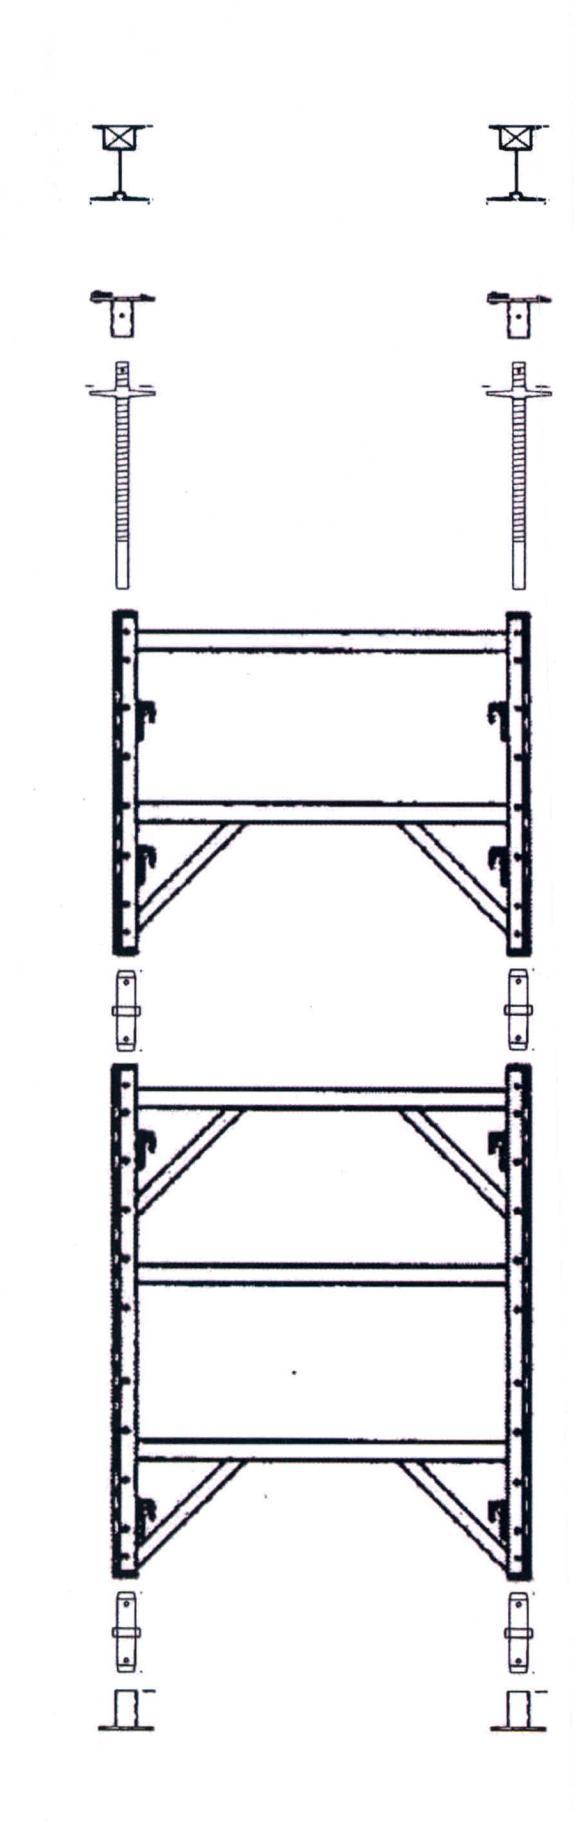
Folder: 08-02-29; SH 40211

SH 40211 Screw Jack and Bottom plates for SH 40056 Zone 40B

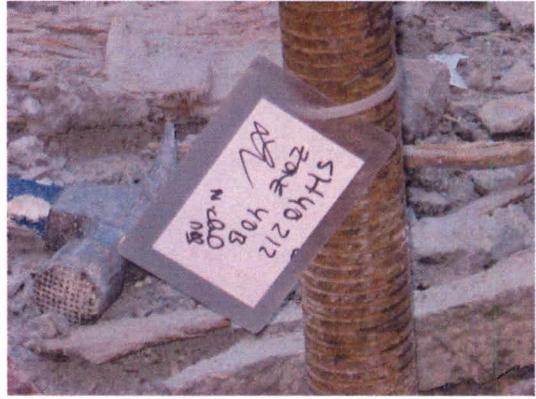
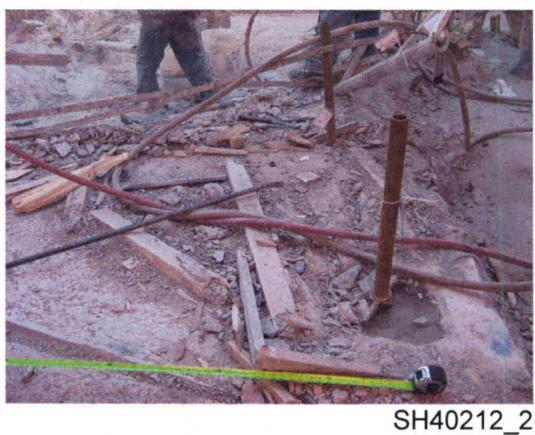
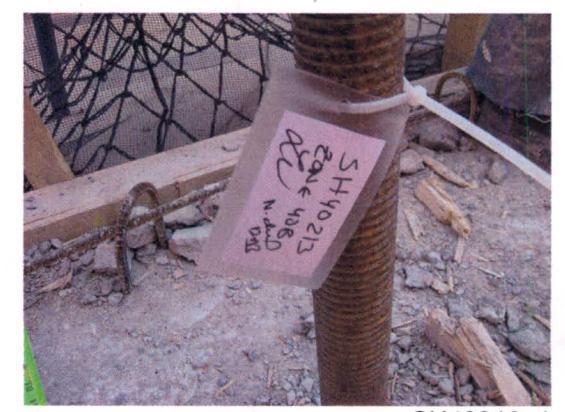
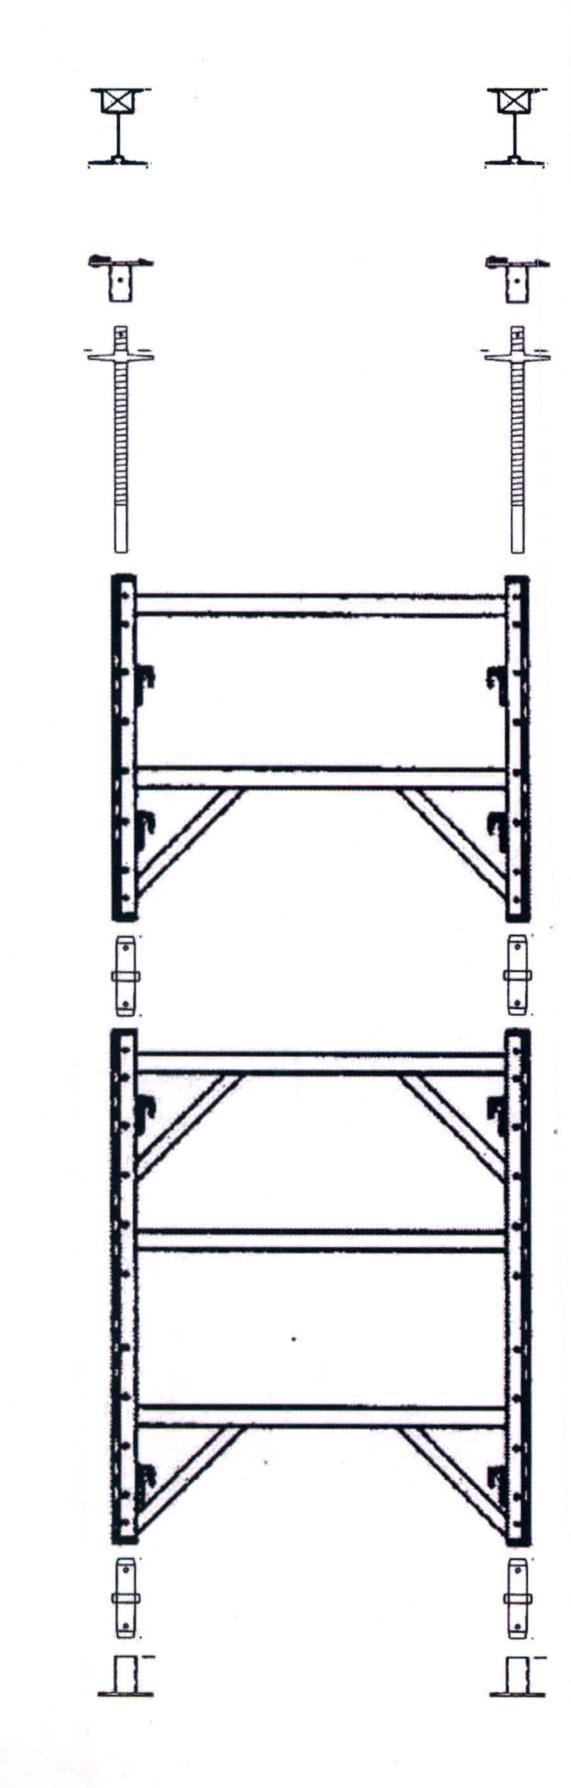
Folder: 08-02-29; SH 40212

SH 40212 Screw Jack and Bottom plates of SH 40056 Zone 40B

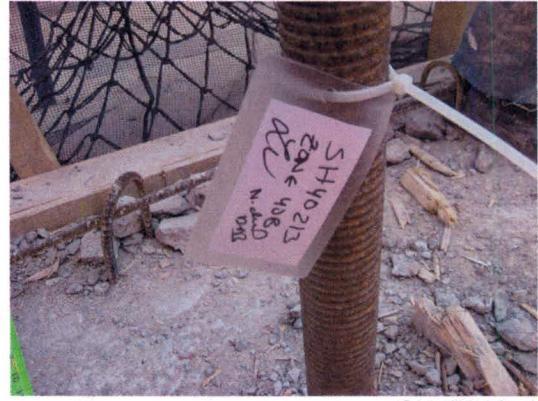
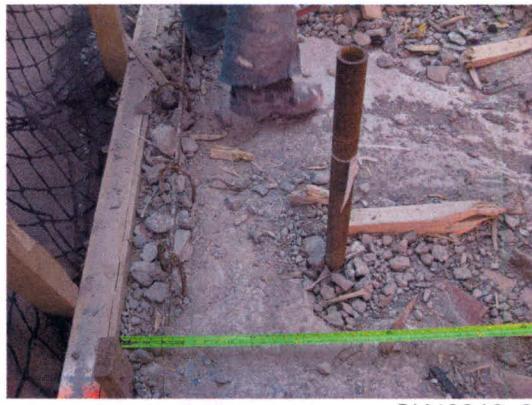
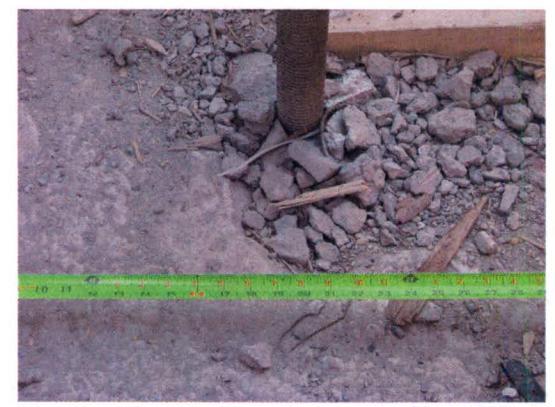
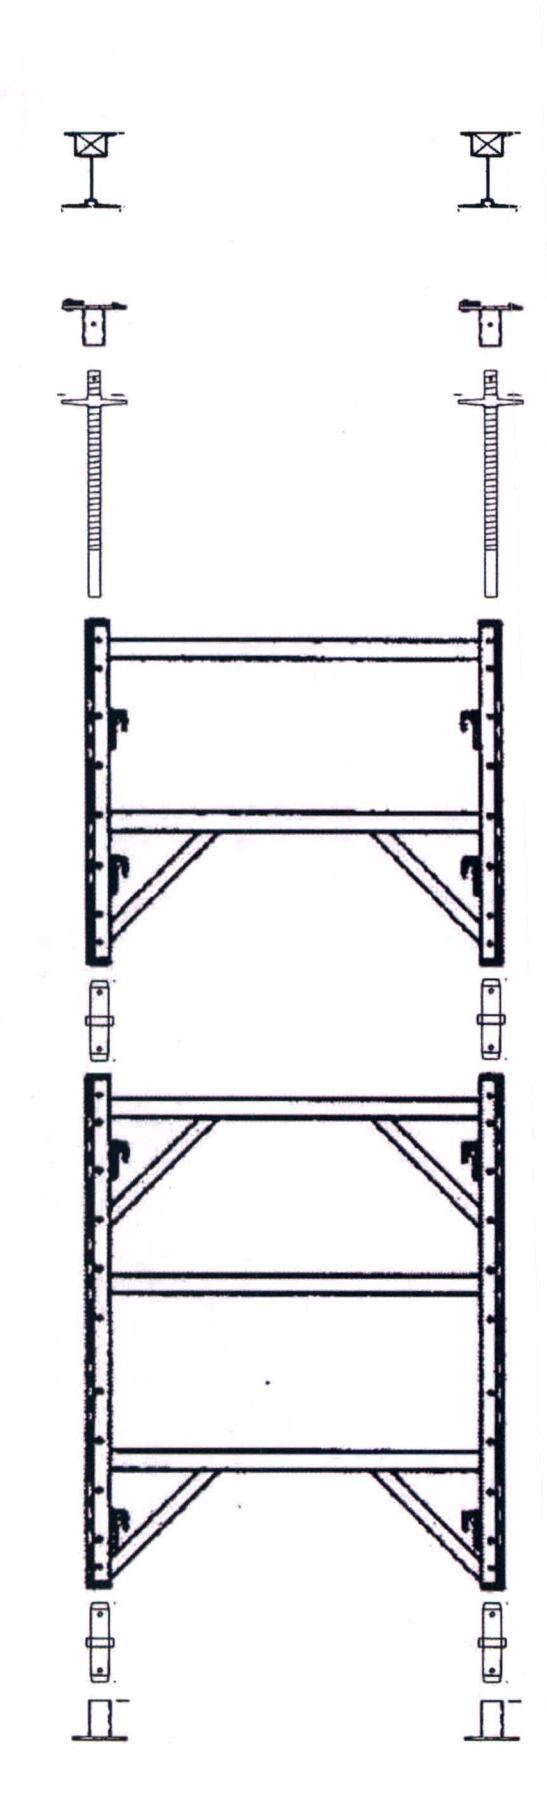
Folder: 08-02-29; SH 40213

SH 40213 Screw jack and Bottoms Zone 40B

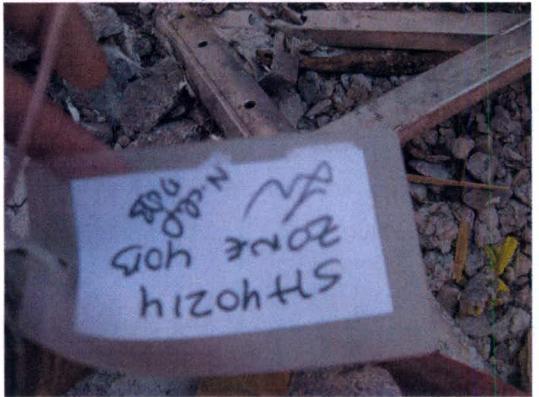
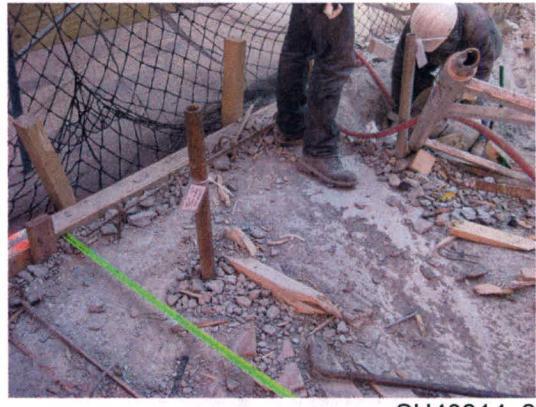
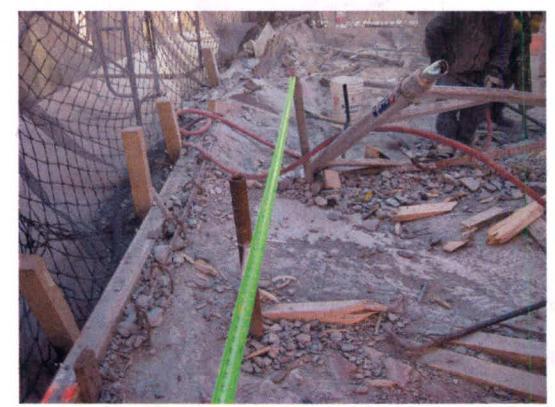
Folder: 08-02-29; SH 40214

SH 40214 Screw jack and Bottom plates Zone 40B

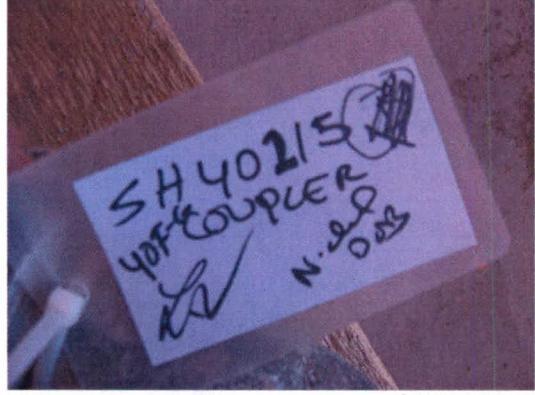
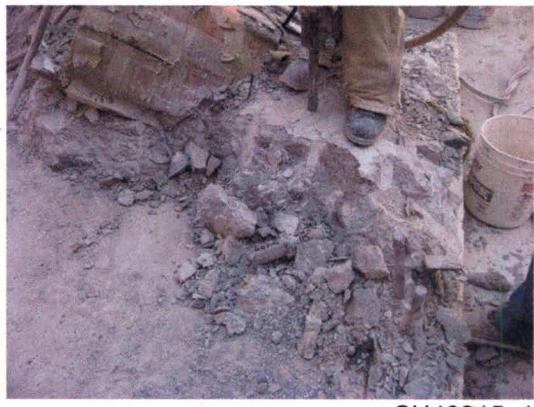
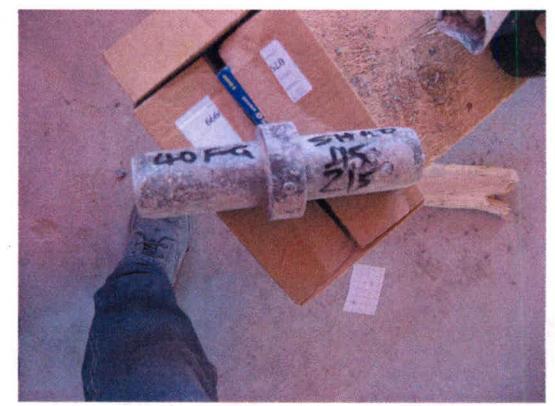
Folder: 08-02-29; SH 40215

SH 40215 Coupler Zone 40F-G

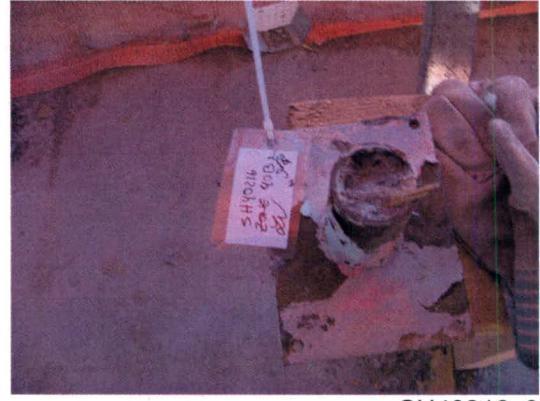
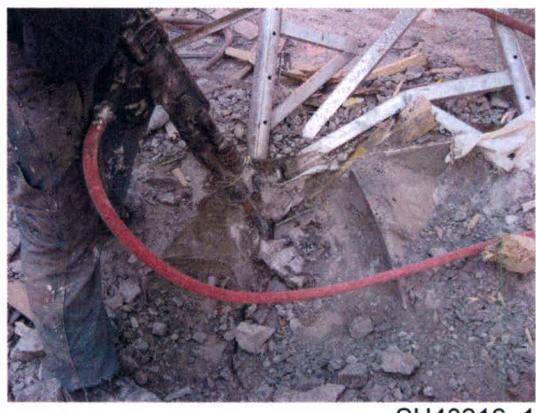
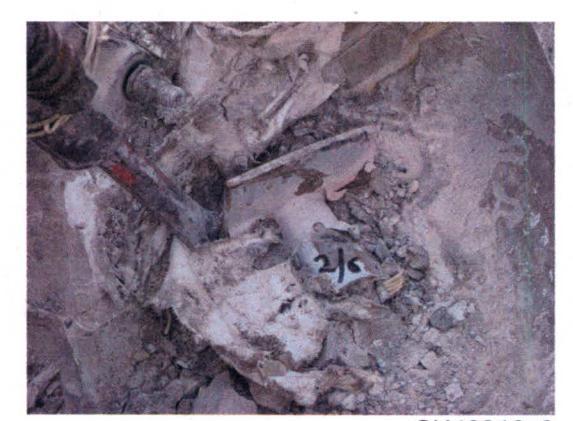
Folder: 08-02-29; SH 40216

SH 40216 Bottom plate Zone 40B

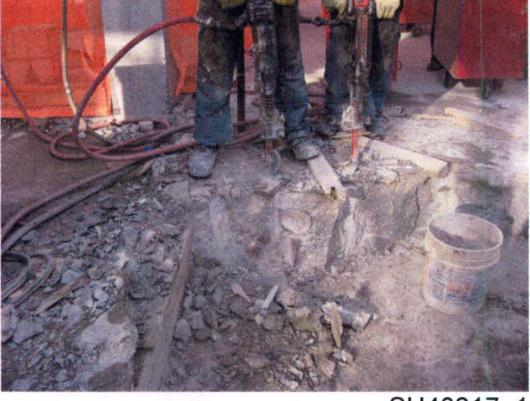
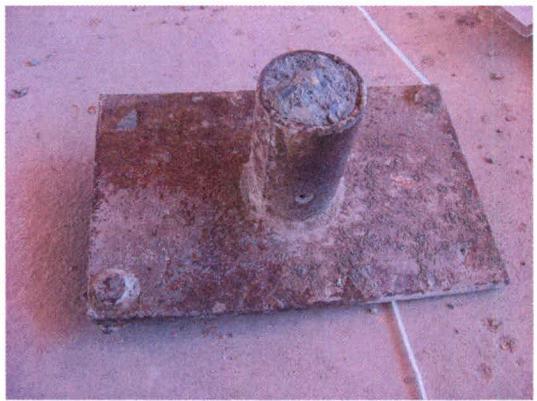
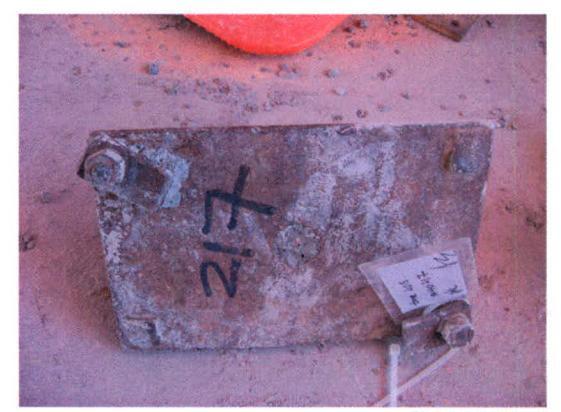
Folder: 08-03-03; SH 40217

SH 40217 Top plate Zone 40B

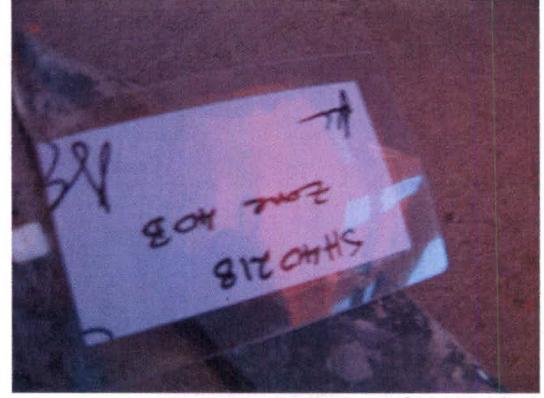
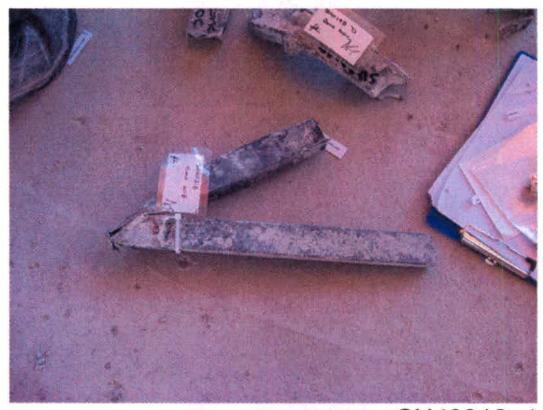
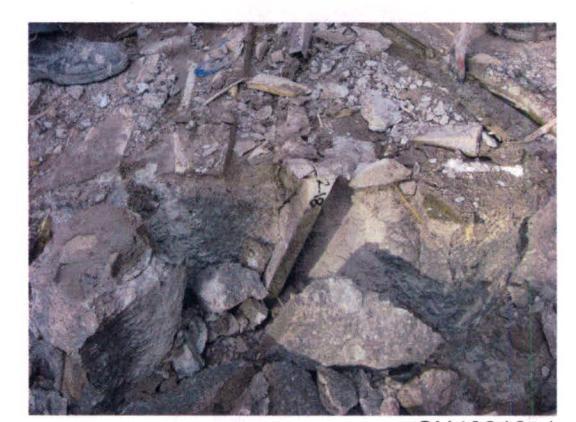
Folder: 08-03-03; SH 40218

SH 40218 Piece of frame SH 40198 Zone 40B

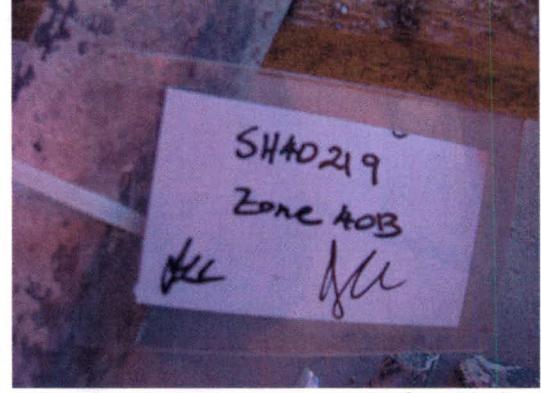
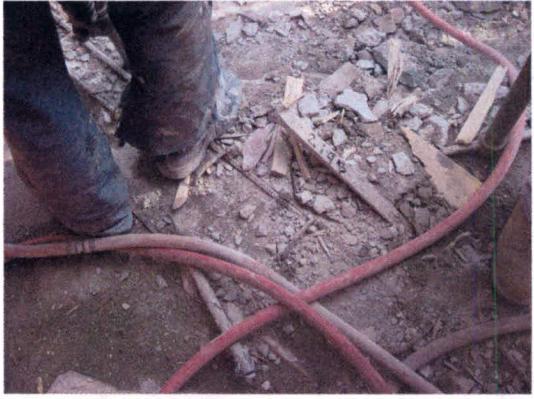
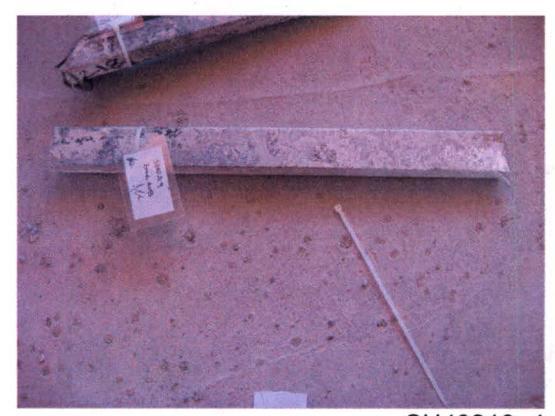
Folder: 08-03-03; SH 40219

SH 40219 Piece of frame Zone 40B

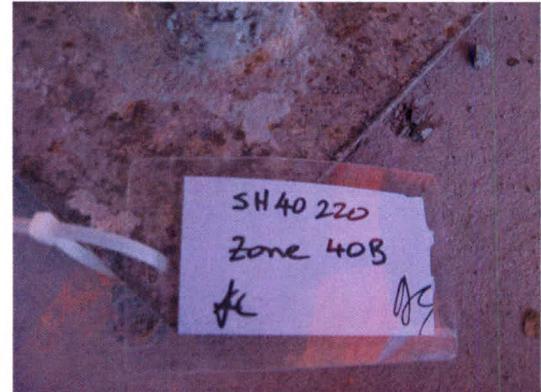
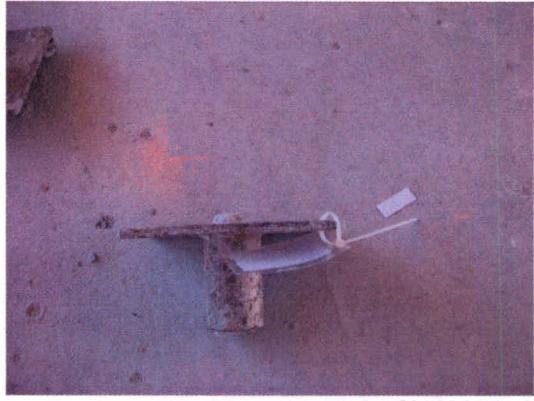
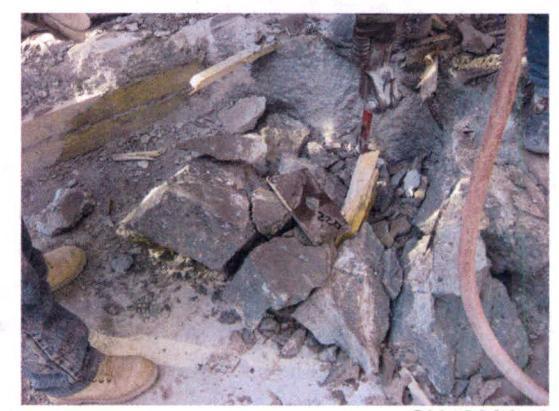
Folder: 08-03-03; SH 40220

SH 40220 Bottom plate Zone 40B

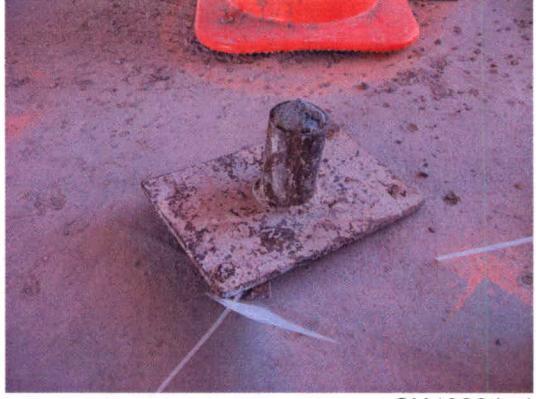
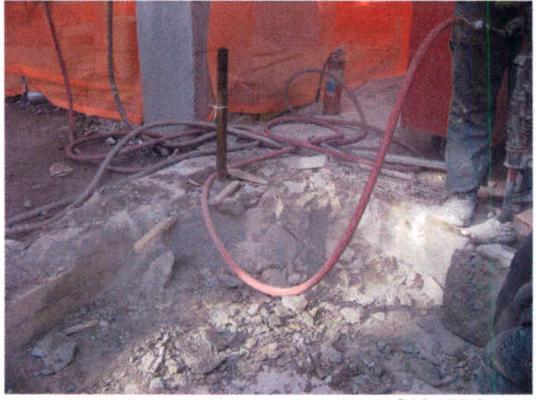
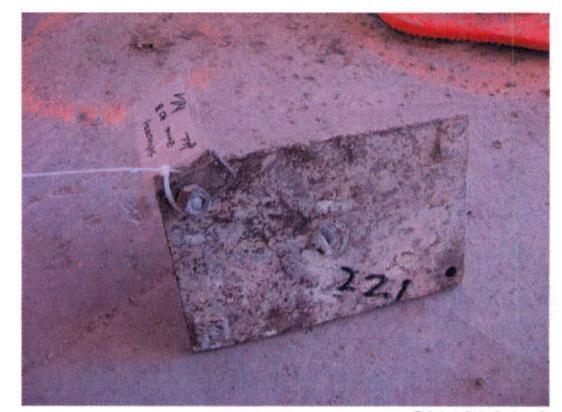
Folder: 08-03-03; SH 40221

SH 40221 To plate Zone 40B

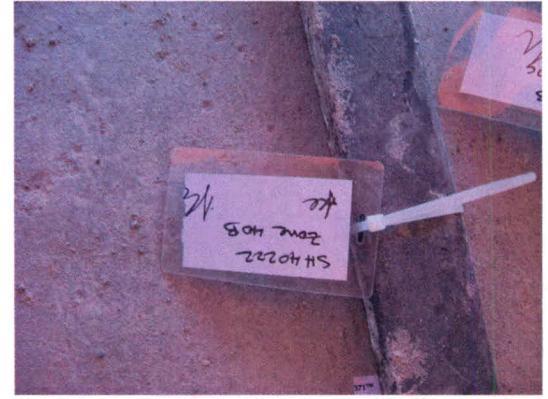
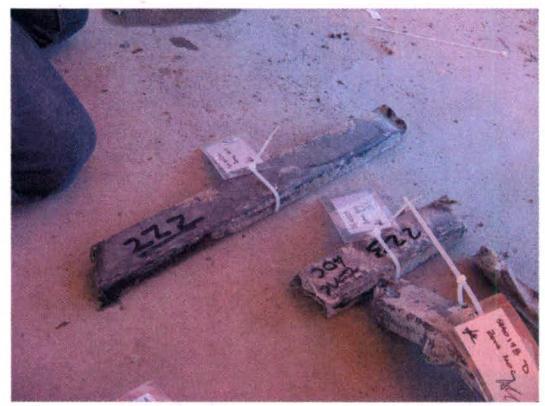
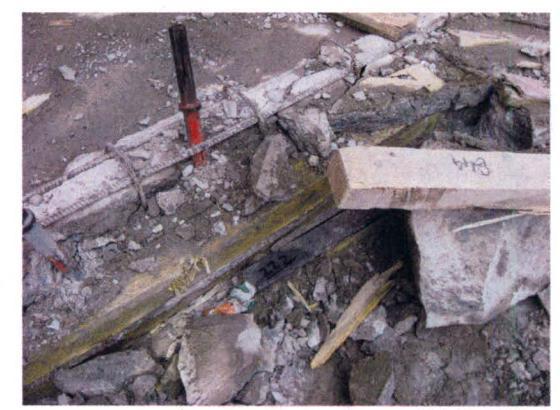
Folder: 08-03-03; SH 20222

SH 40222 Piece of frame Zone 40B

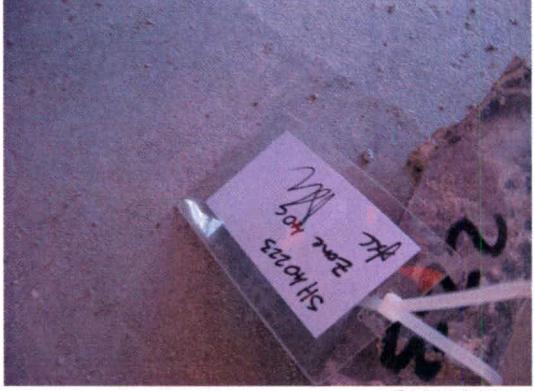
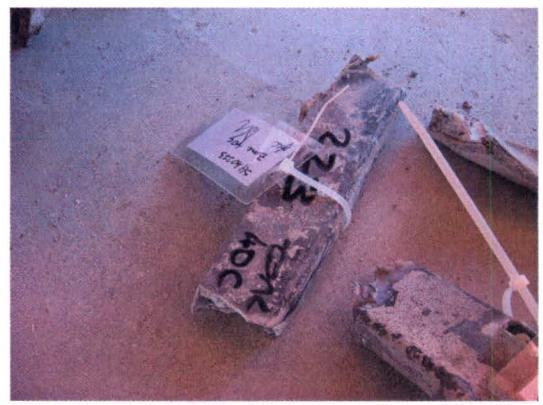
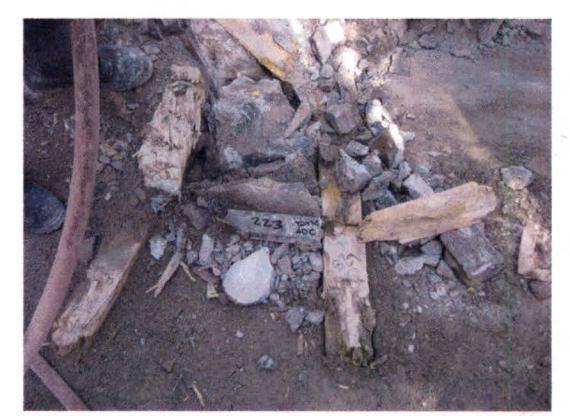
Folder: 08-03-03; SH 40223

SH 40223 Piece of frame Zone 40C

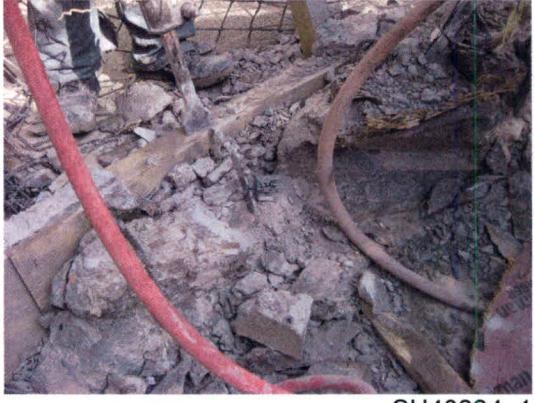
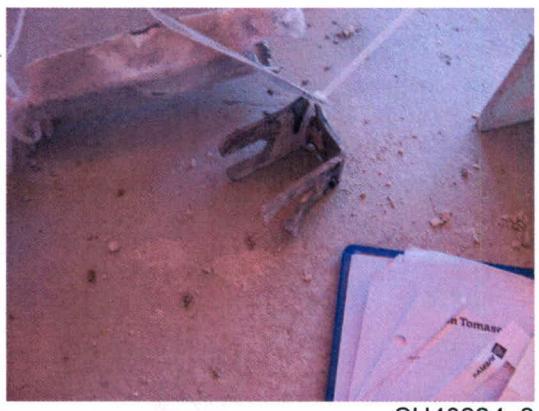
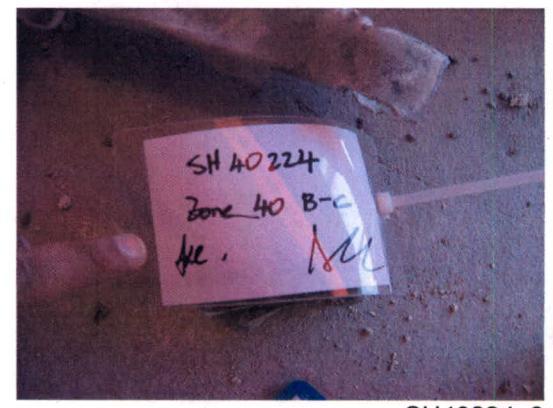
SH 40224 Piece of frame Zone 40B

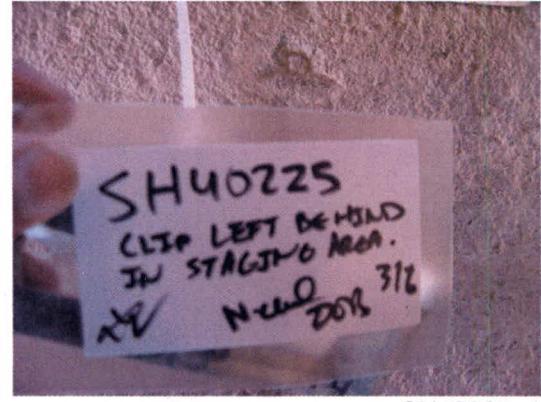
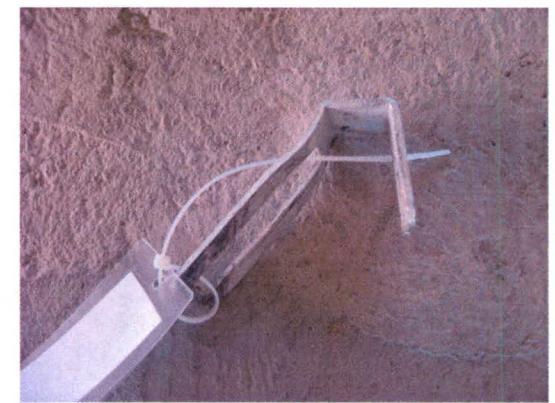
SH 40225 Clip left behind in staging area

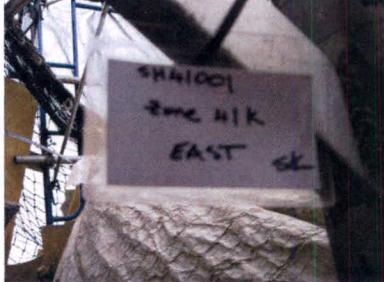
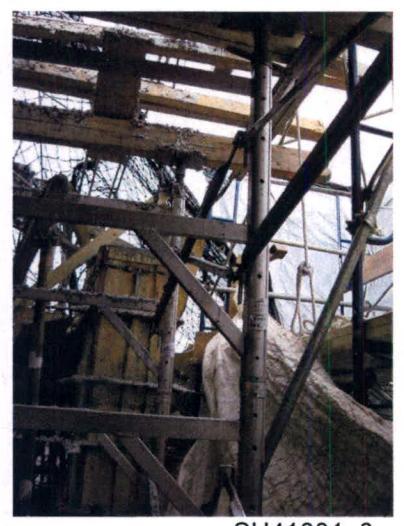
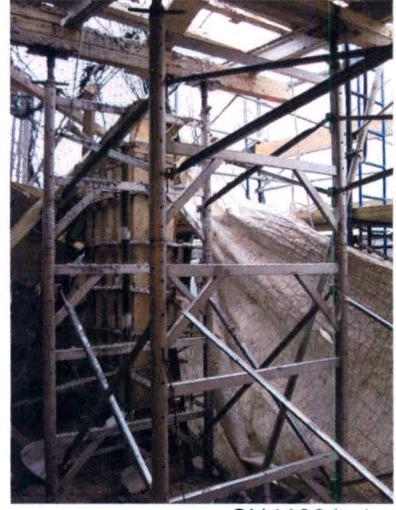
SH 41001 Top Frame Bottom Frame SH 41062 Connect to SH 41002 Zone 41K

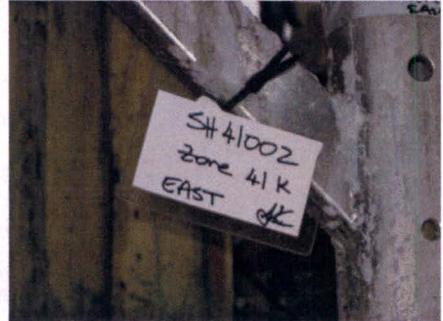
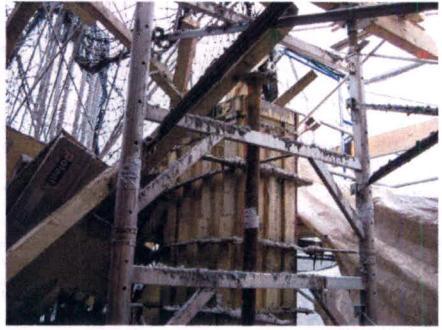
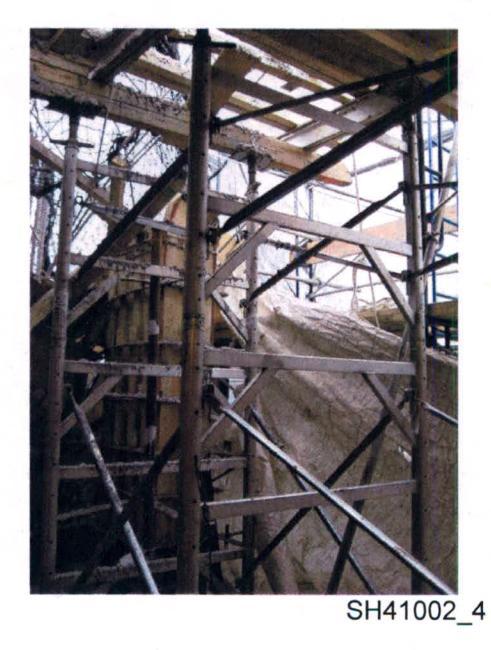
SH 41002 Top Frame Bottom Frame SH 41061 Connect to SH 41001(Tower) Zone 41K

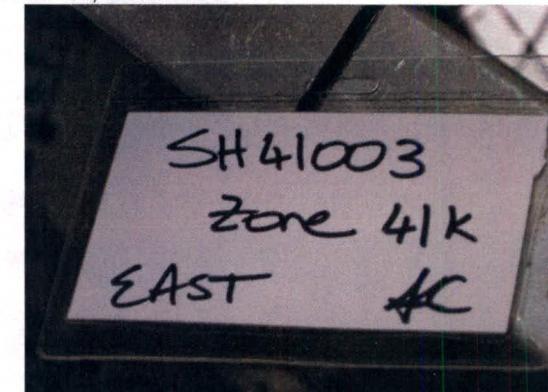
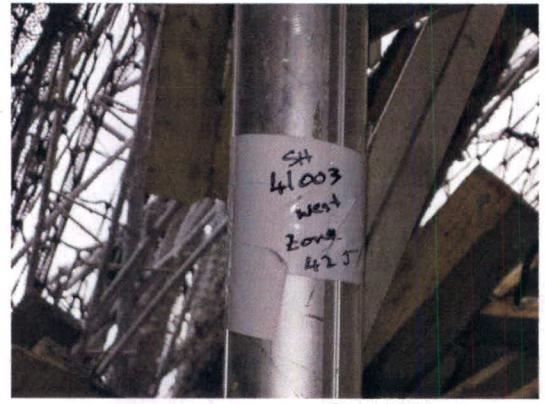
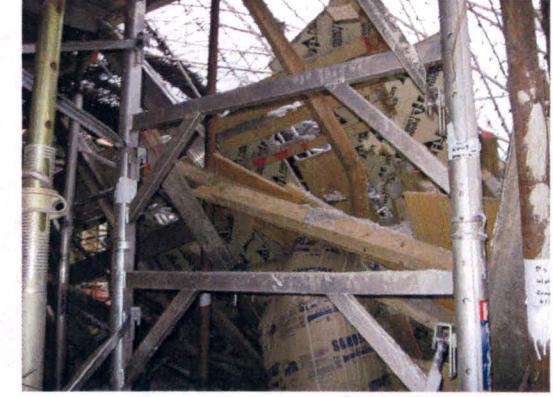
SH 41003 Top Frame Bottom Frame SH 41026 Connect to top SH 41004(Tower) Zone 41K-J

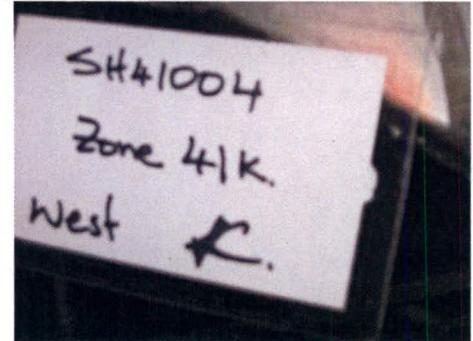
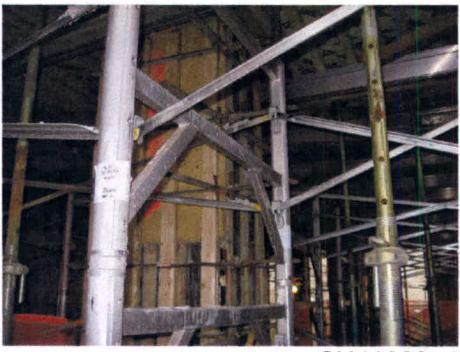
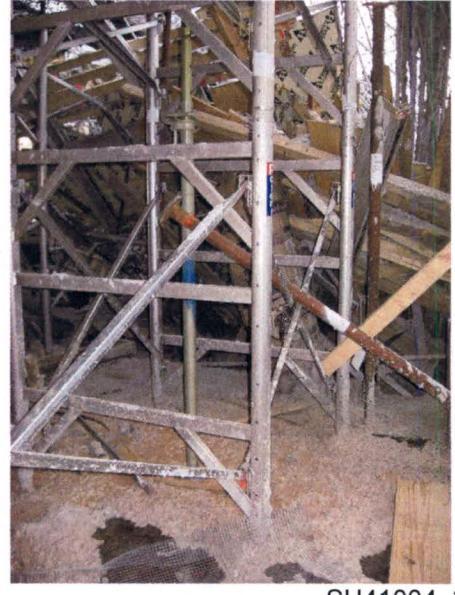
SH 41004 Top Frame Bottom Frame SH 41075 Connect to top SH 41003 Zone 41K

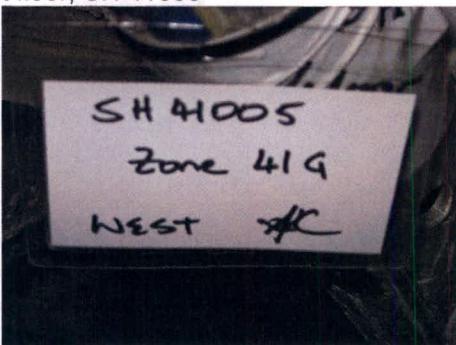
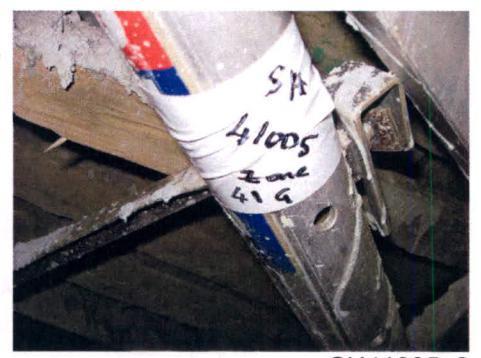
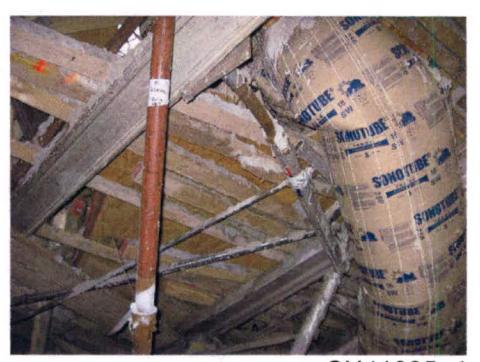
SH 41005 Broken Top Frame Bottom Frame SH 41027 and SH 41028 Supports AB 41004 Zone 41G

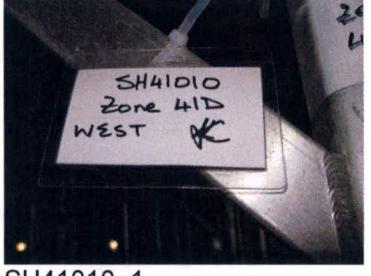
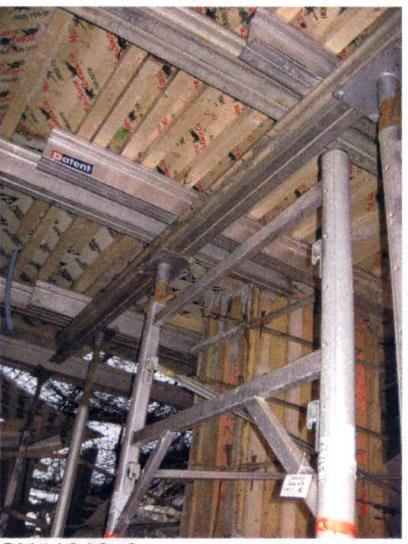
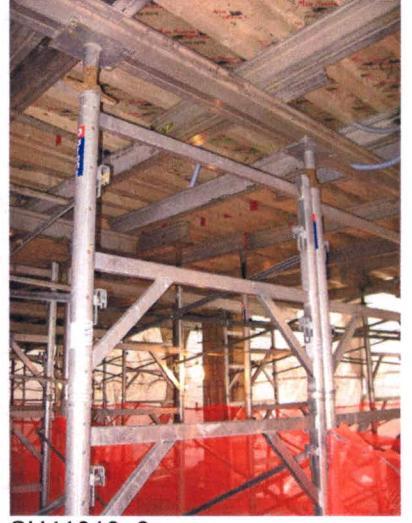
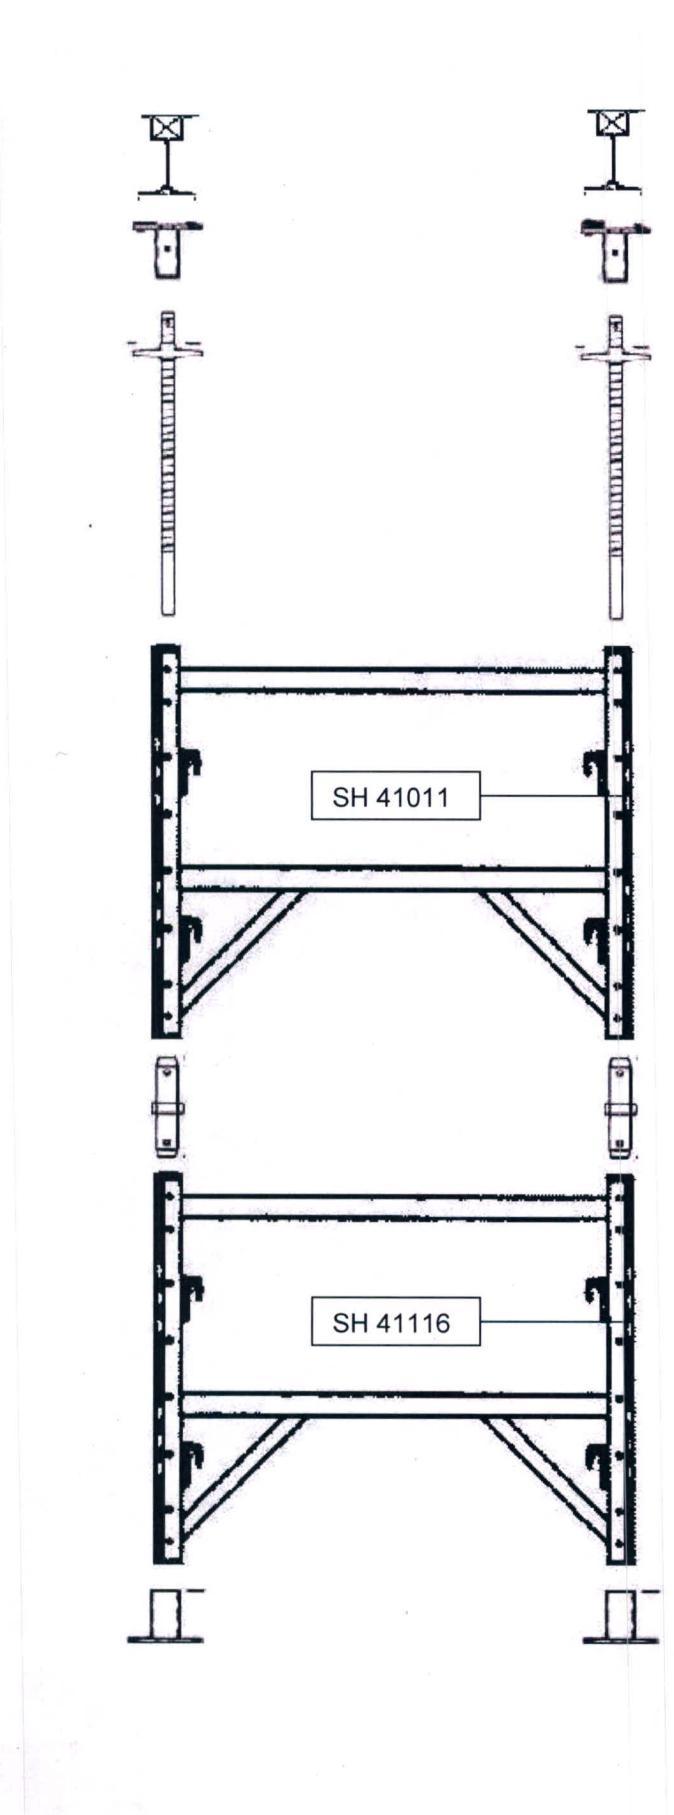
Folder: 08-01-29 (updated 08-02-04 & 08-02-05); 41st floor; SH 41010

SH 41010 Top Frame Bottom Frame SH 41115 Connect to Top SH 41009(Tower) Zone 41D

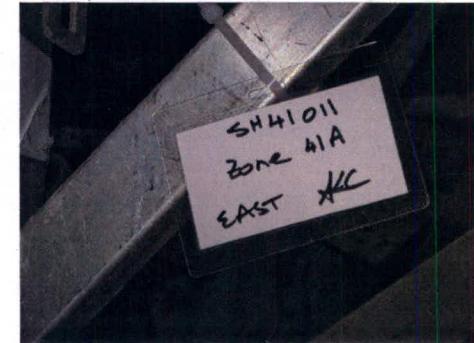
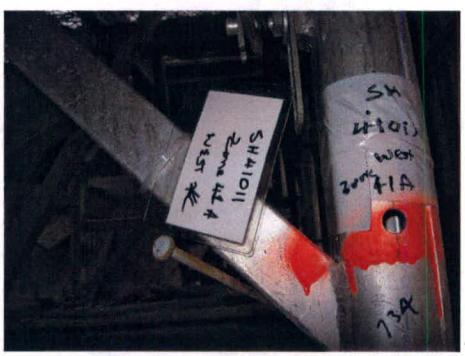
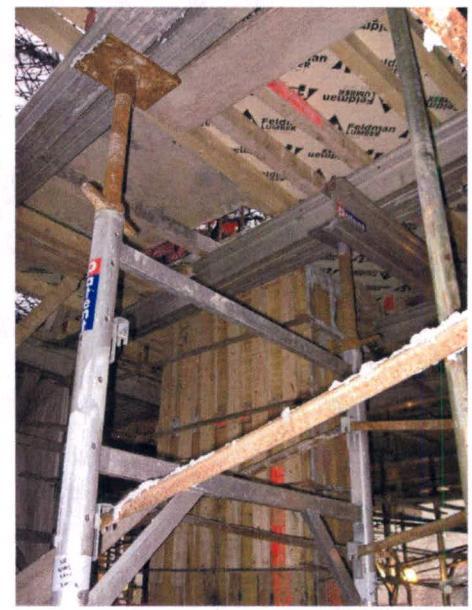
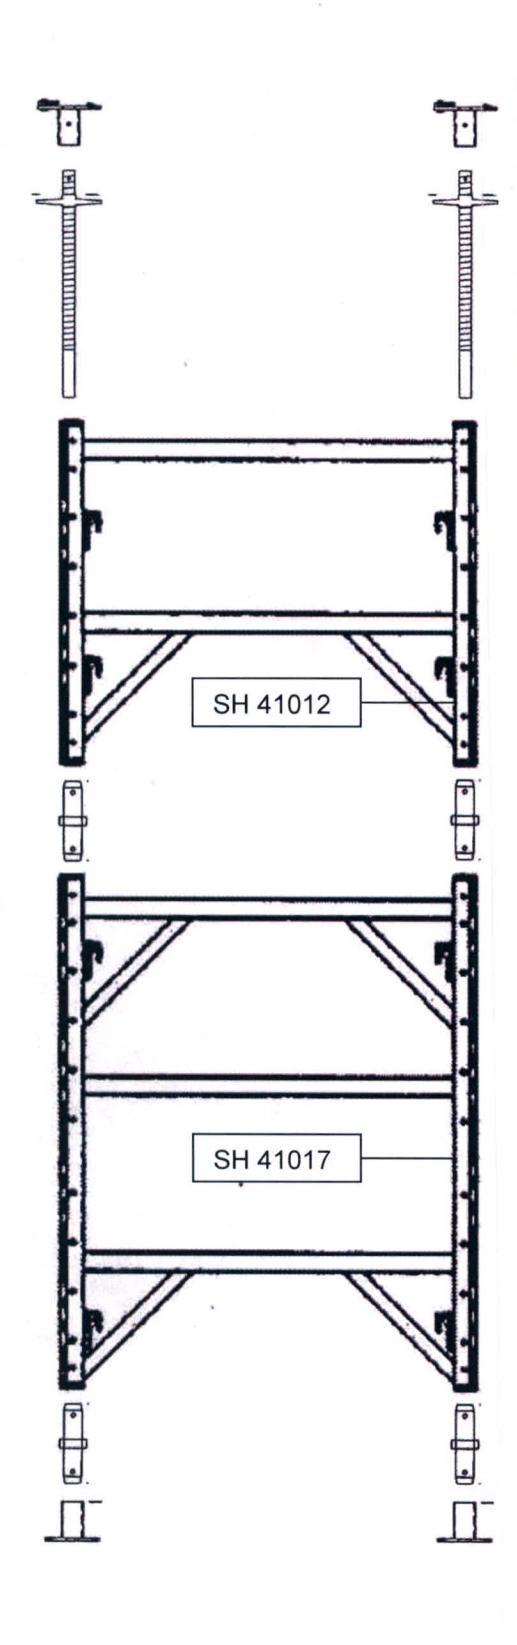
SH 41011 Top Frame Bottom Frame SH 41116 Zone 41A Folder: 08-01-29 (updated 08-02-04 & 08-02-05); 41st floor; SH
