INVESTIGATION REPORT:

JANUARY 14, 2008 SHORING COLLAPSE AT 9 DOMINICK ST. (AKA 246 SPRING ST.) MANHATTAN

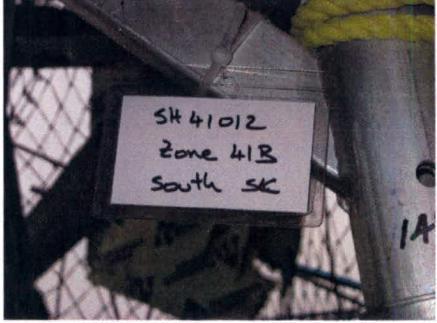
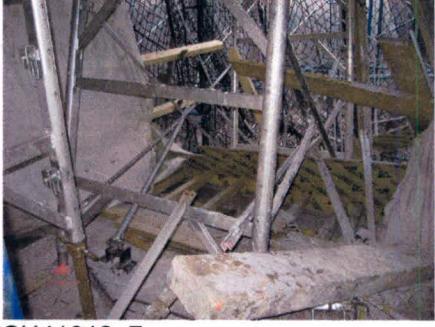
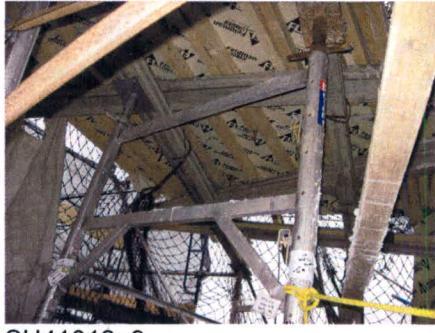
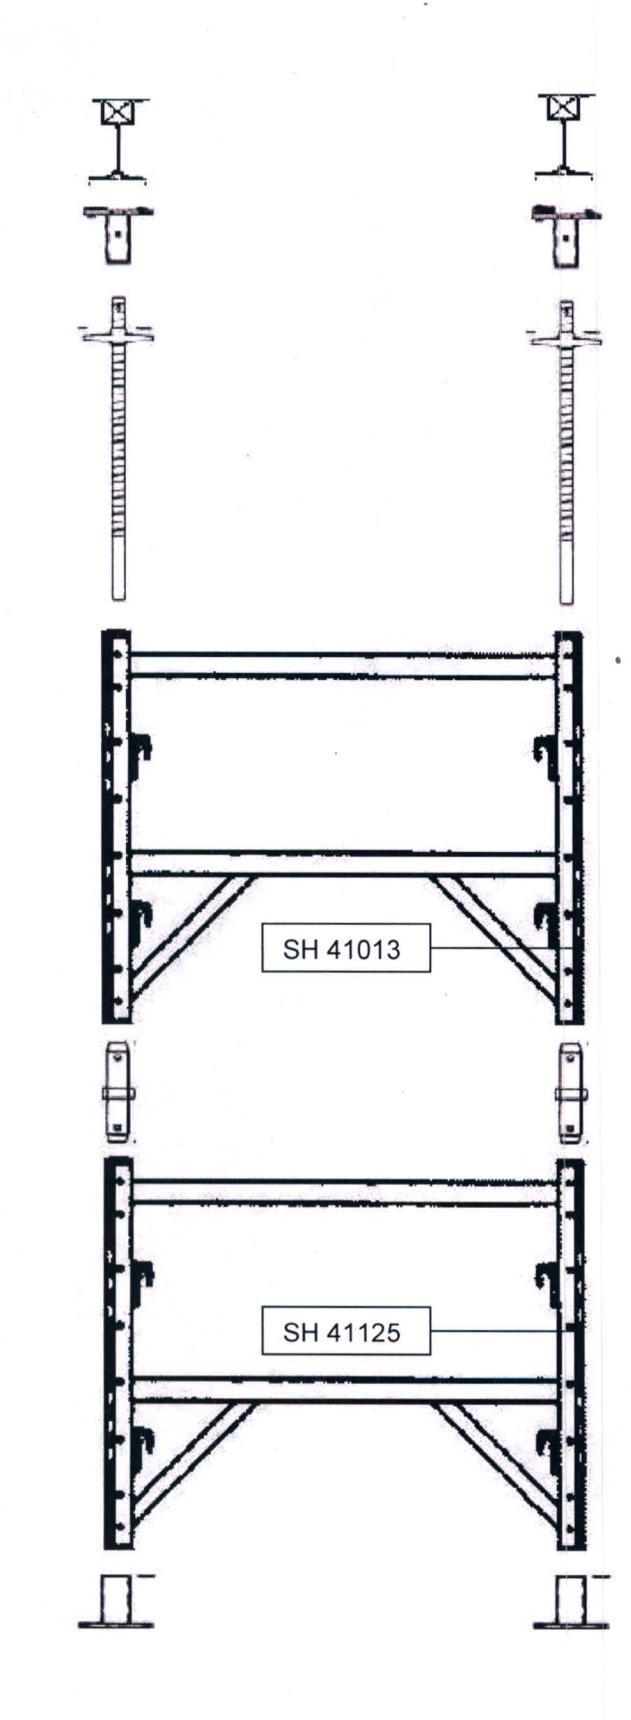
Folder: 08-01-29 (updated 08-02-04 & 08-02-05); 41st floor; SH 41012

SH 41012 Top Frame Bottom Frame SH 41017 Zone 41B

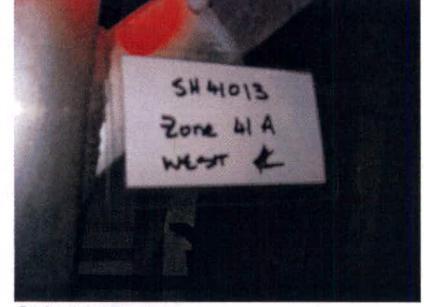
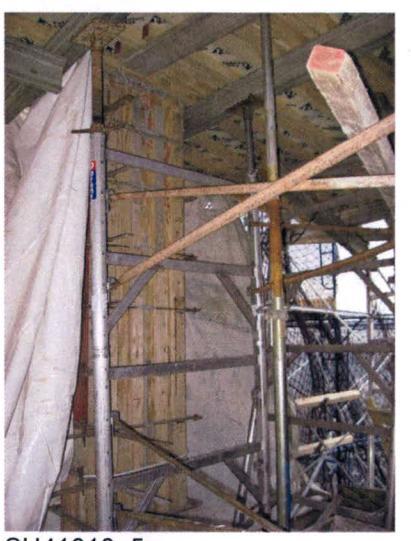
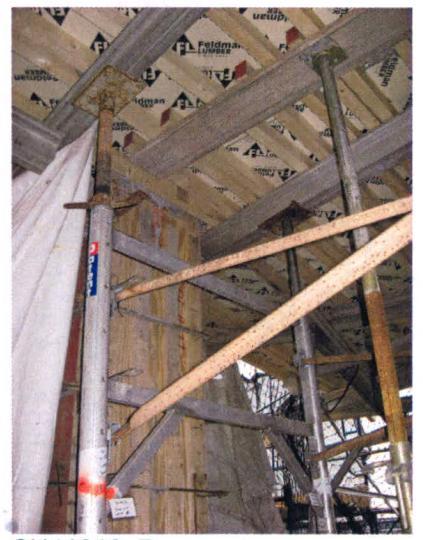
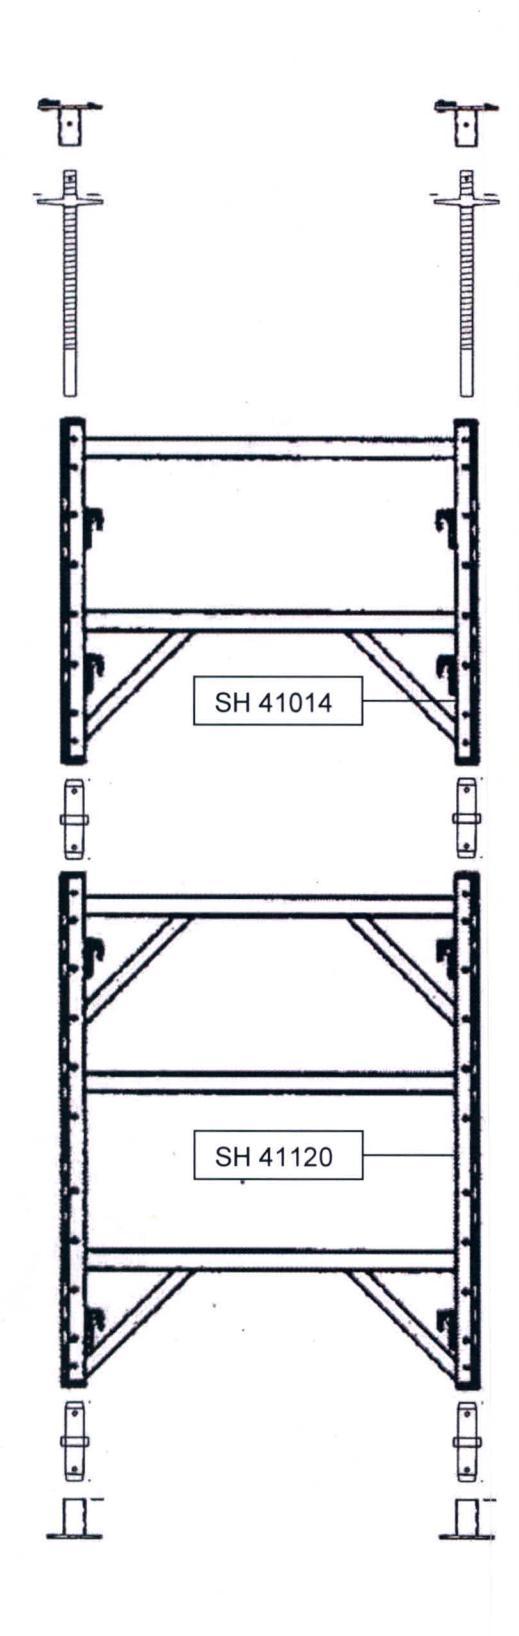
Folder: 08-01-29 (updated 08-02-04 & 08-02-05); 41st floor; SH 41013

SH 41013 Top Frame Bottom Frame SH 41125 Zone 41A-B

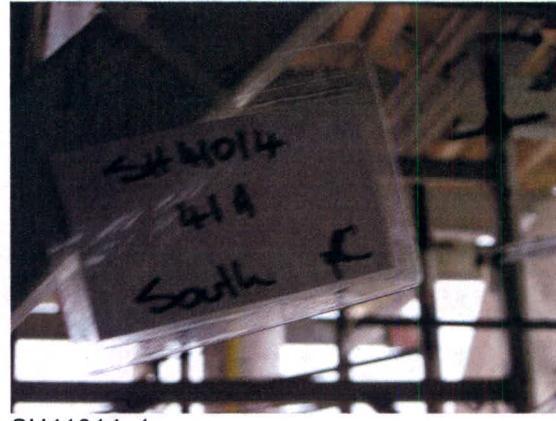
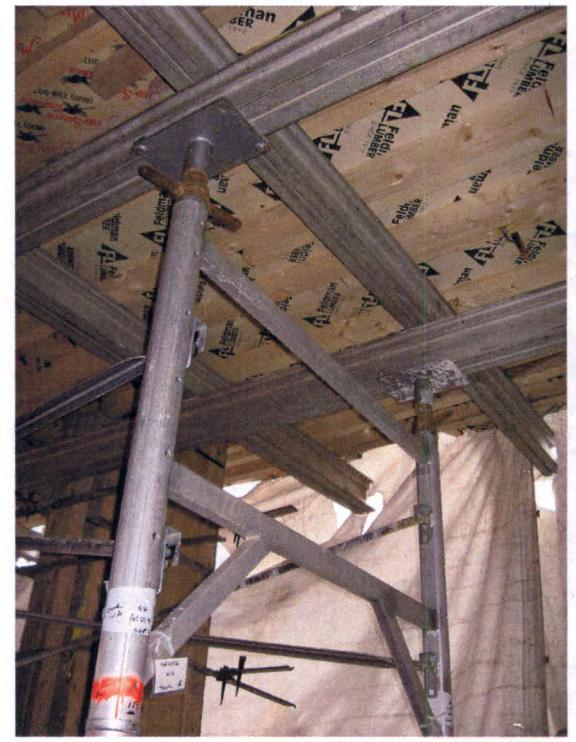
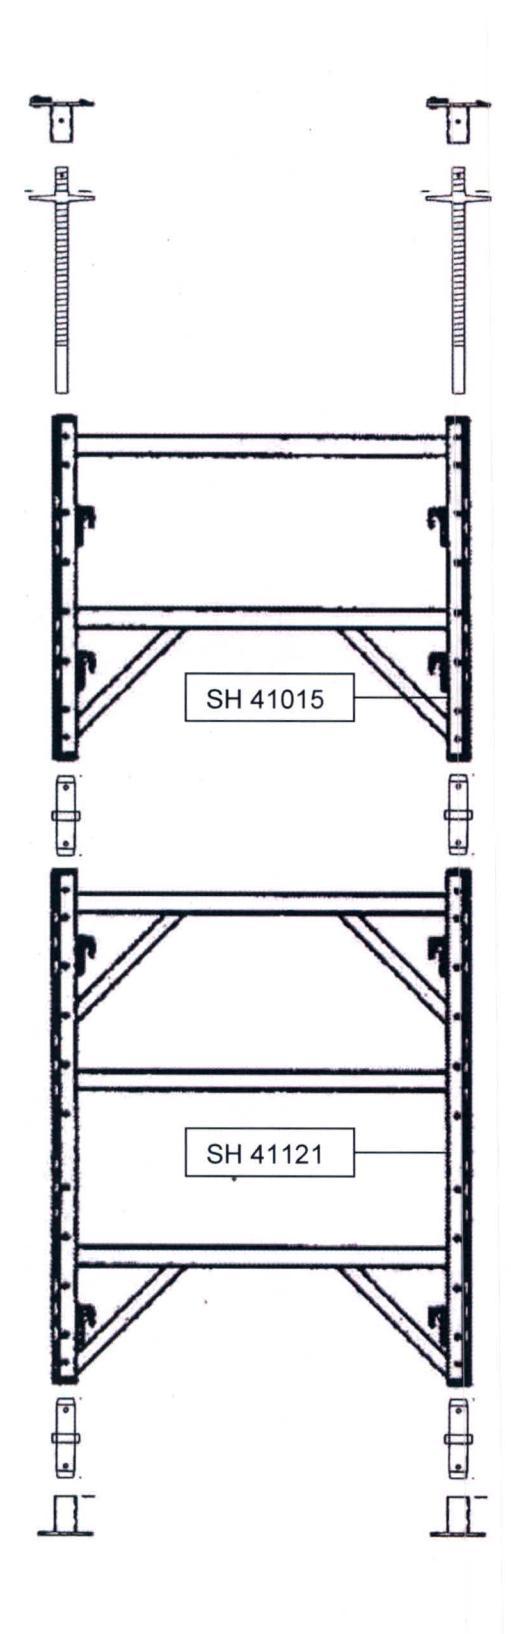
Folder: 08-01-29 (updated 08-02-04 & 08-02-05); 41st floor; SH 41014

SH 41014 Top Frame Bottom Frame SH 41120 Zone 41A

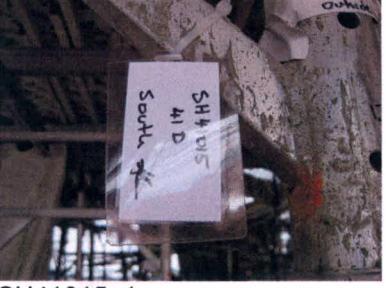
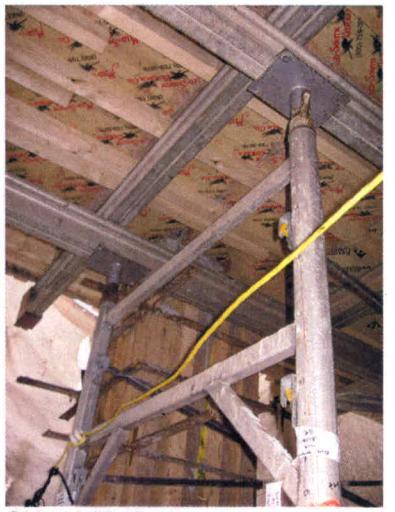
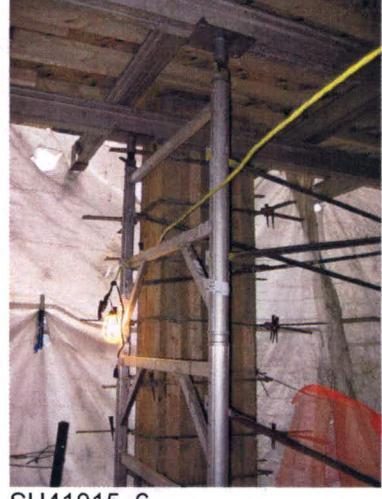
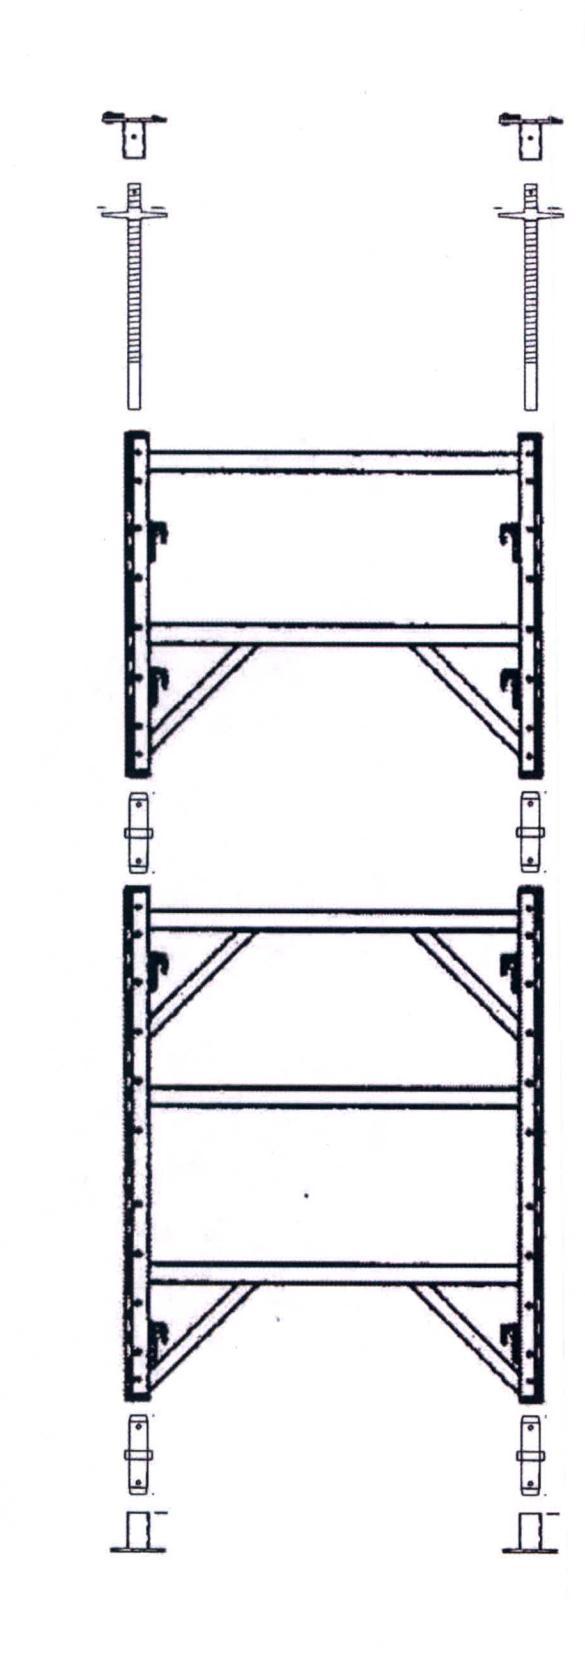
Folder: 08-01-29 (updated 08-02-04 & 08-02-05); 41st floor; SH 41015

SH 41015 Top Frame Bottom Frame SH 41121 Zone 41D

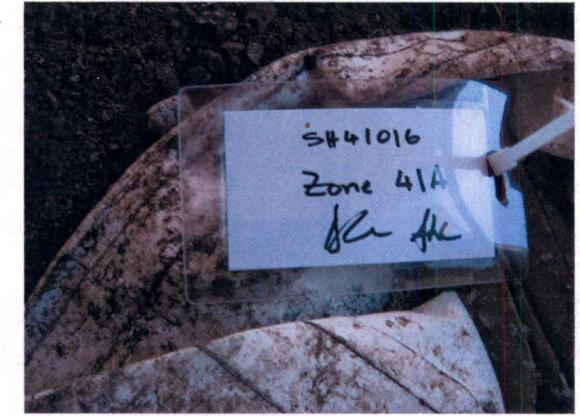
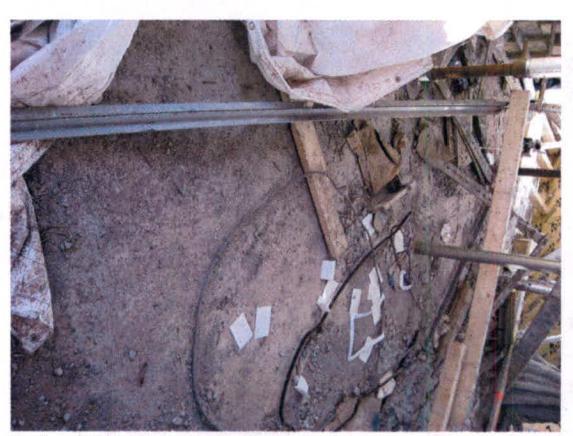
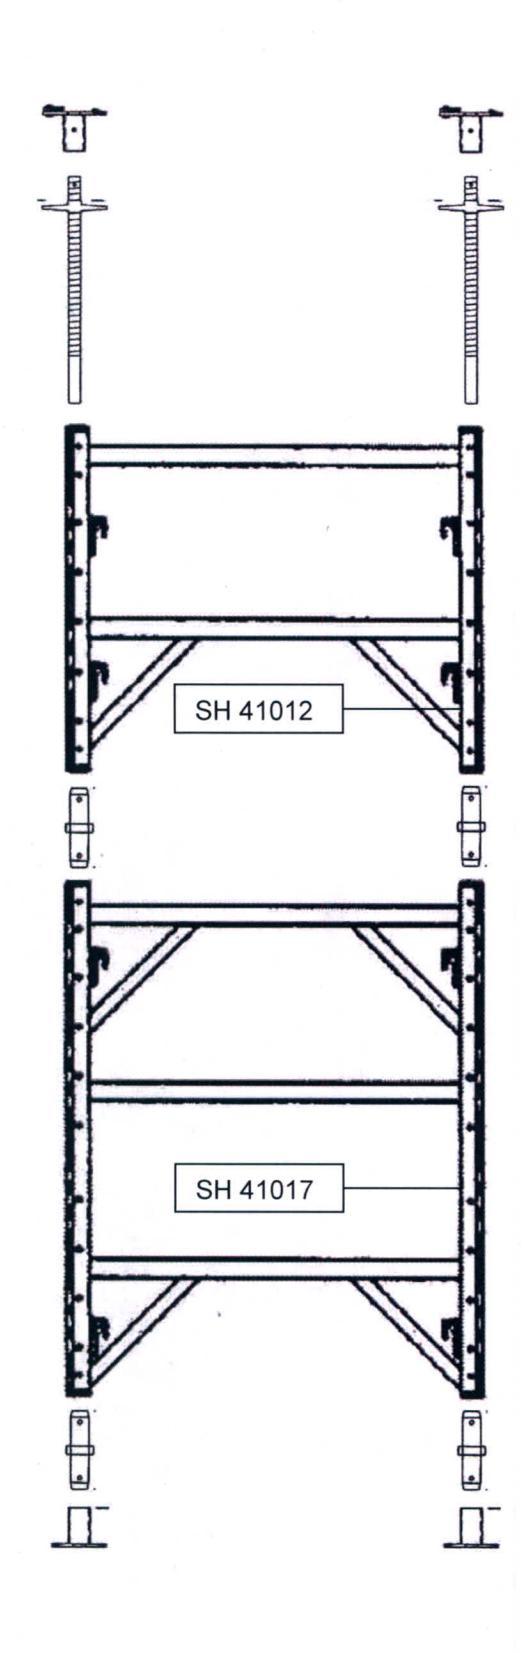
Folder: 08-02-06 to 08-02-08; SH 41016

SH 41016 X Brace Zone 41A

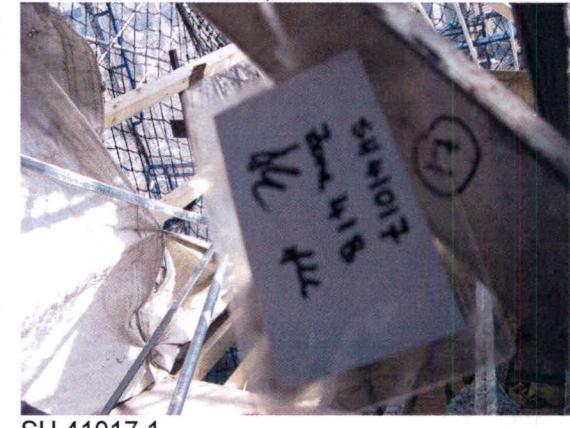
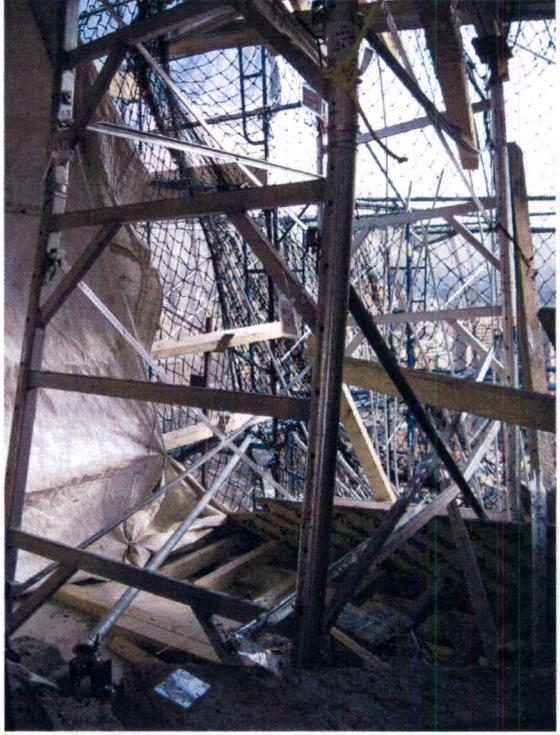
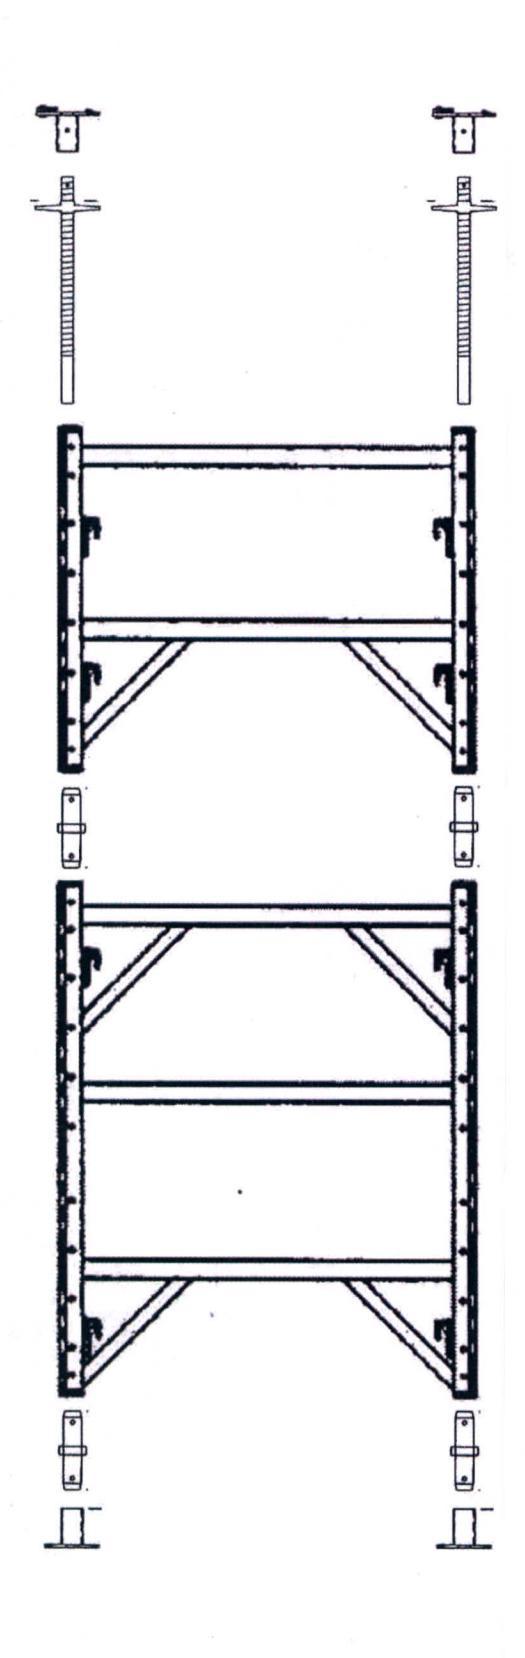
Folder: 08-02-06 to 08-02-08; SH 41017

SH 41017 Bottom of SH 41012 Zone 41B

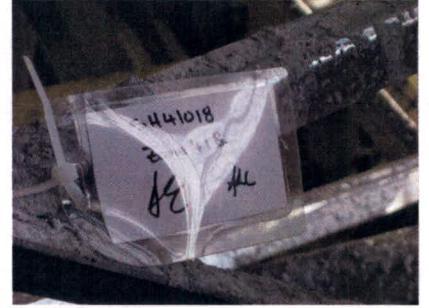
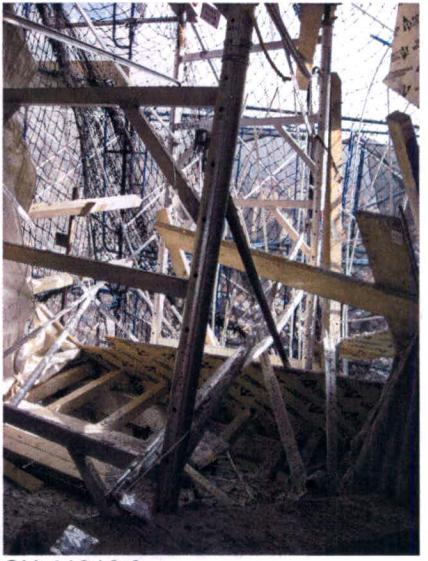
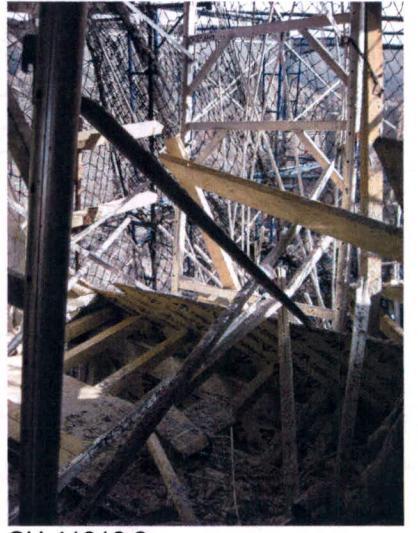
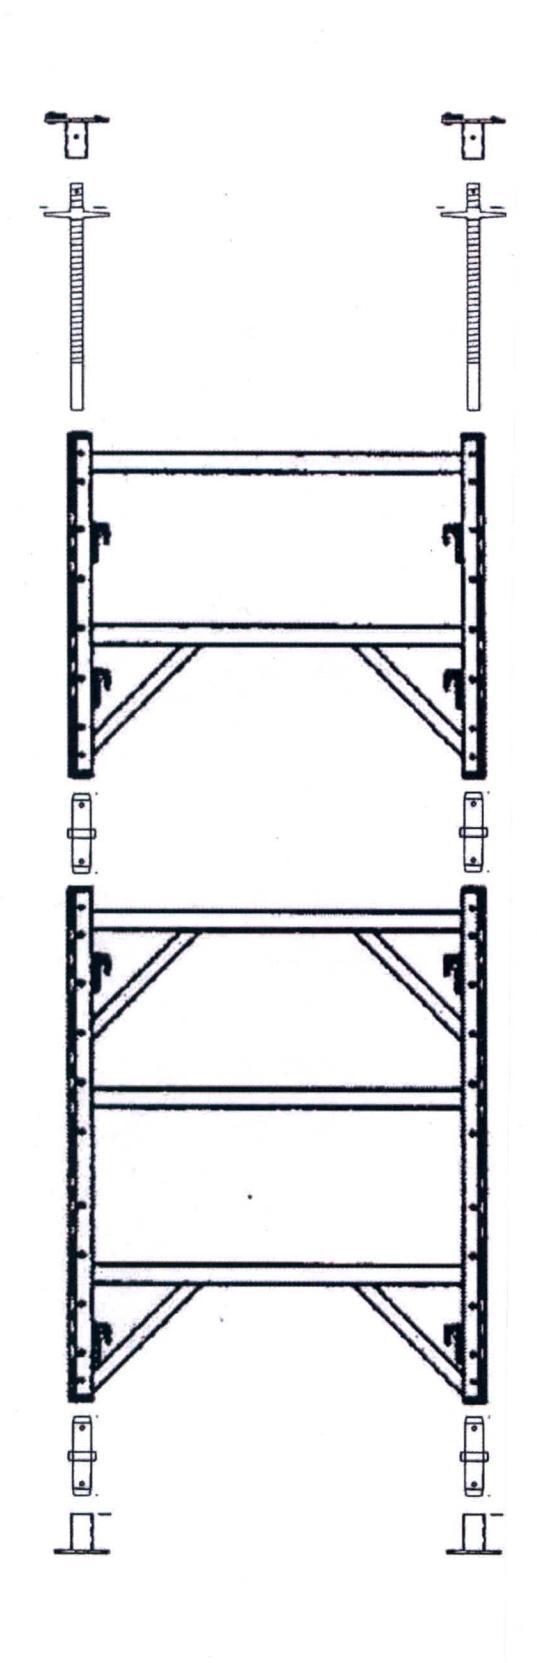
Folder: 08-02-06 to 08-02-08; SH 41018

SH 41018 Brace for SH 41017 Zone 41B

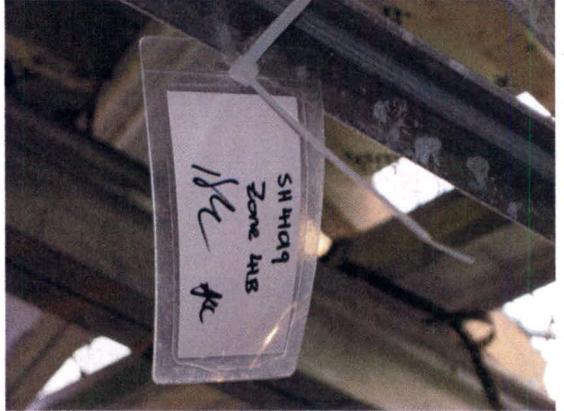
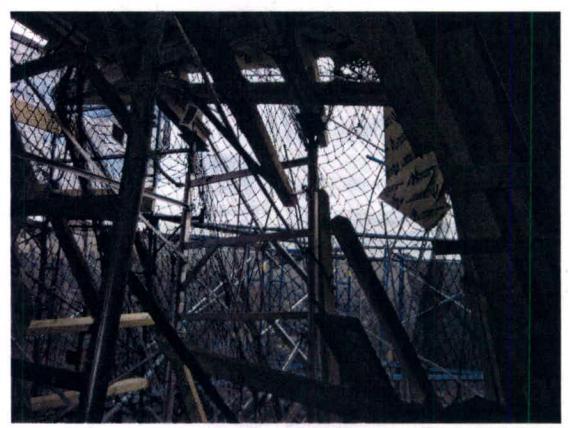
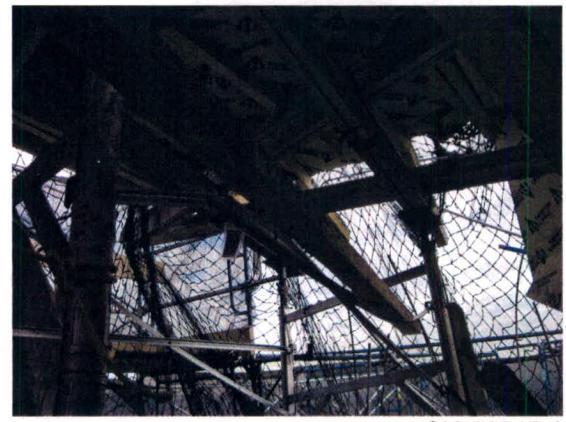
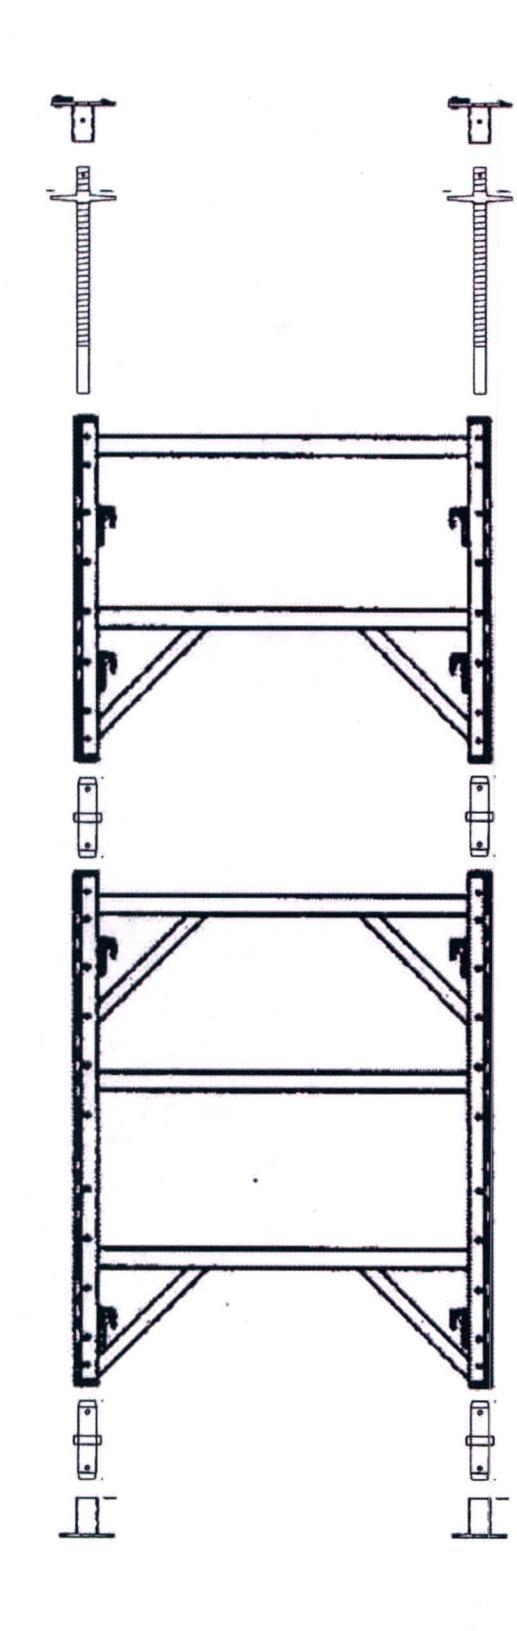
Folder: 08-02-06 to 08-02-08; SH 41019

SH 41019 Top brace Connect to SH 41012 Zone 41B

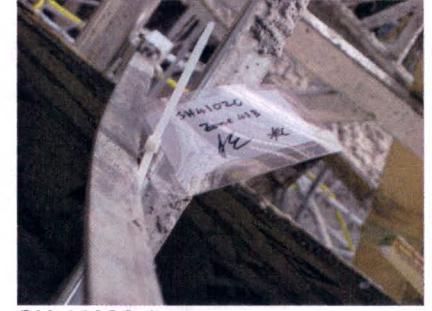
Folder: 08-02-06 to 08-02-08; SH 41020

SH 41020 Bottom Brace Attached to SH 41017 & SH 41039 Zone 41B

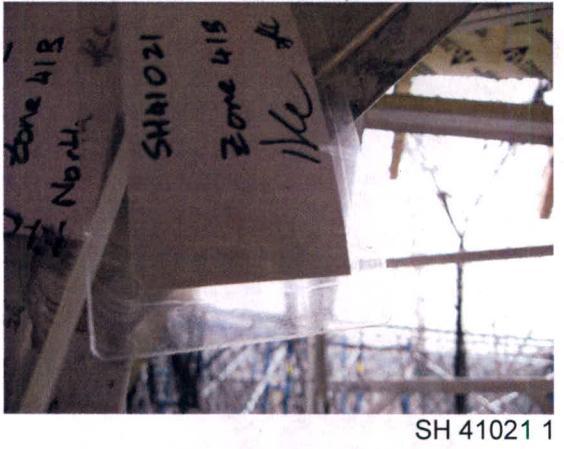
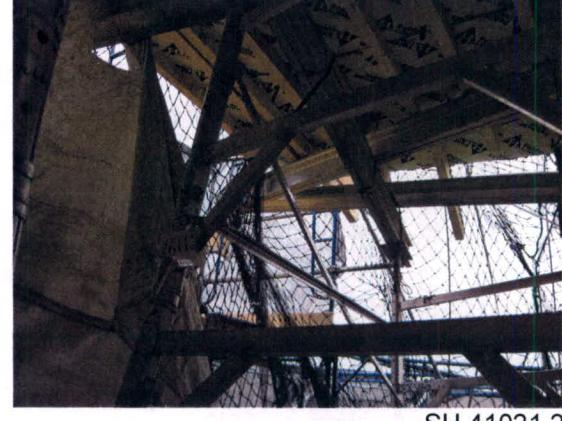
SH 41021 2

SH 41021 Top brace Attached to SH 41012 Zone 41B

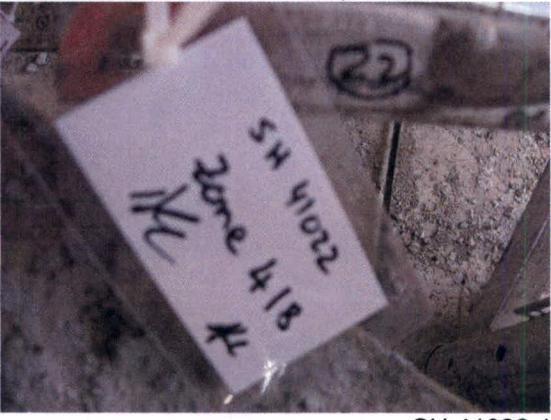
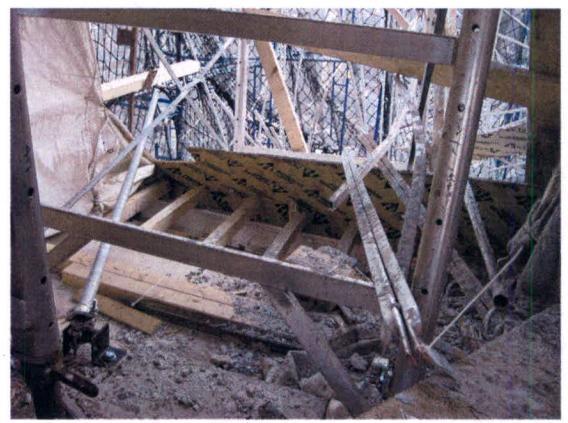
SH 41022 1

SH 41022 Brace Zone 41B

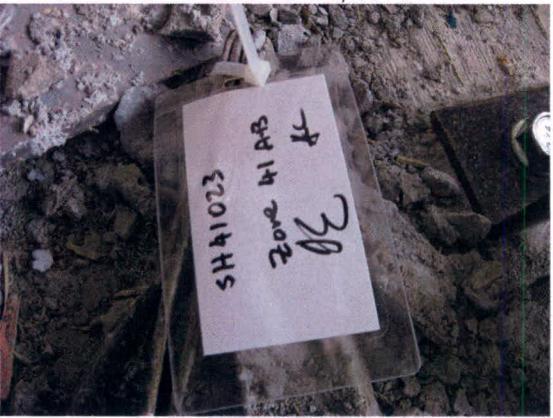
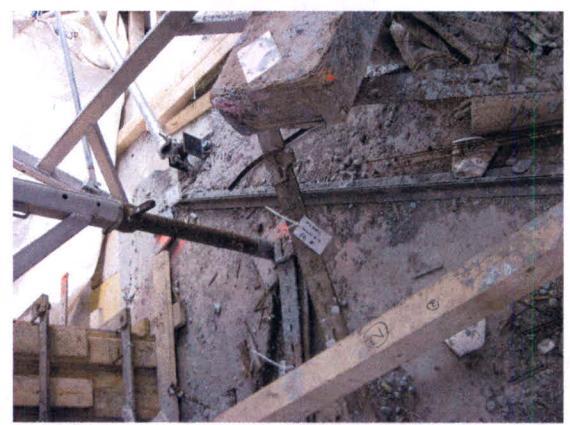
SH 41023 1

SH 41023 Brace Zone 41B

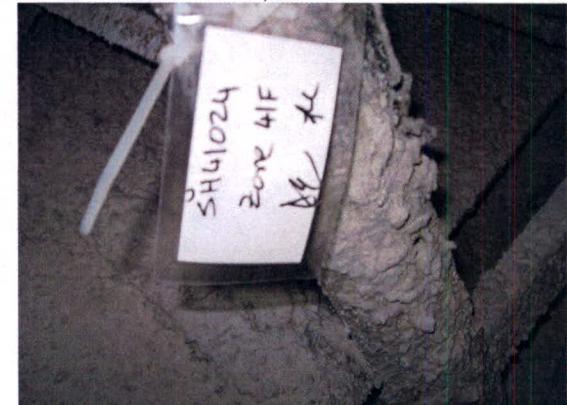
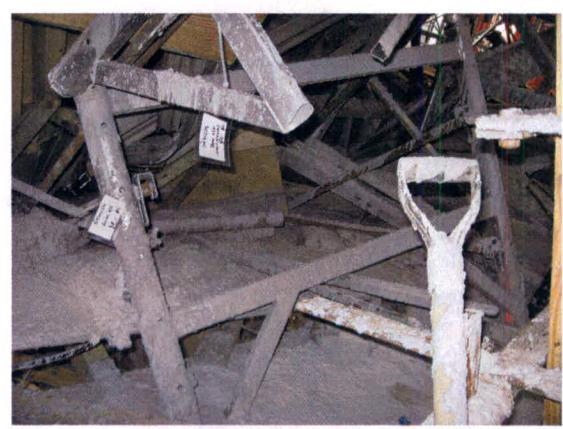
SH 41024 1

SH 41024 Bottom Shore of SH 41025 and SH 41048 Zone 41F

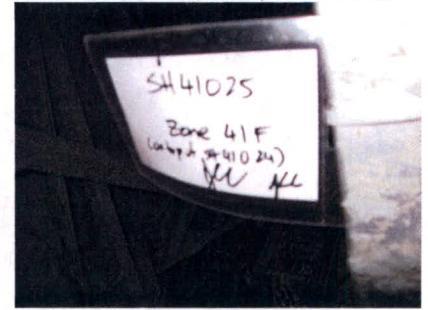
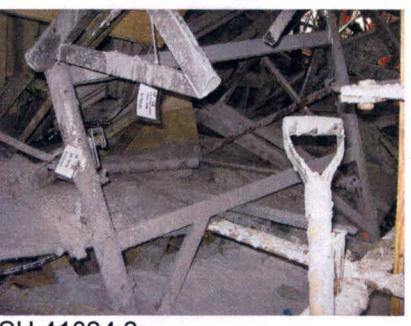
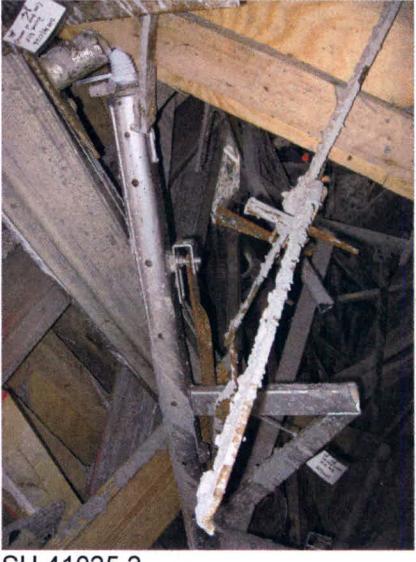
SH 41025 1

SH 41025 Broken Top Shore of SH 41024 Connect to top plate SH 41026 Zone 41F

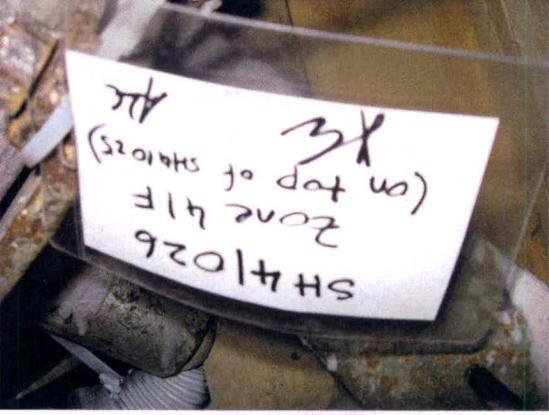
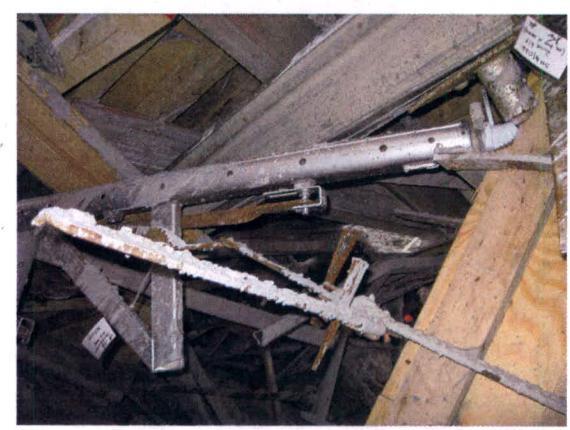
SH 41026 1

SH 41026 Top plate of SH 41025 Zone 41F

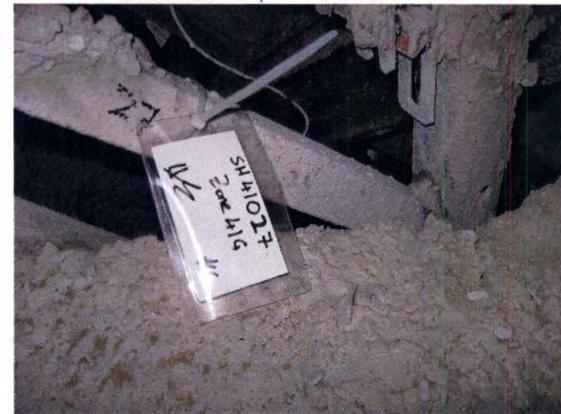
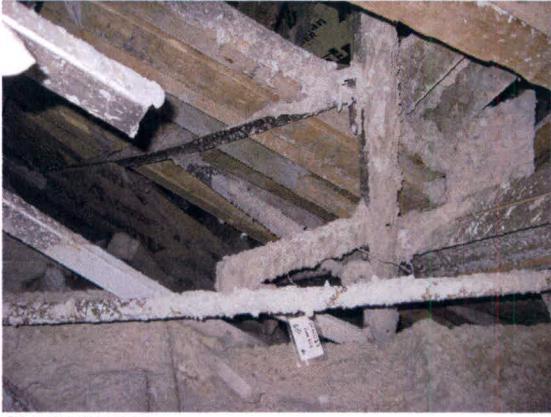
SH 41027 1

SH 41027 Broken Bottom Frame of SH 41005 Zone 41G

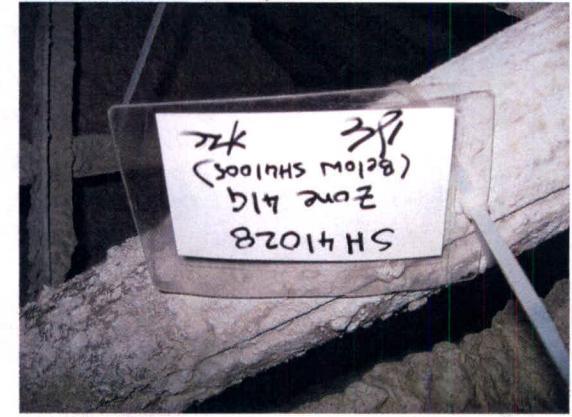
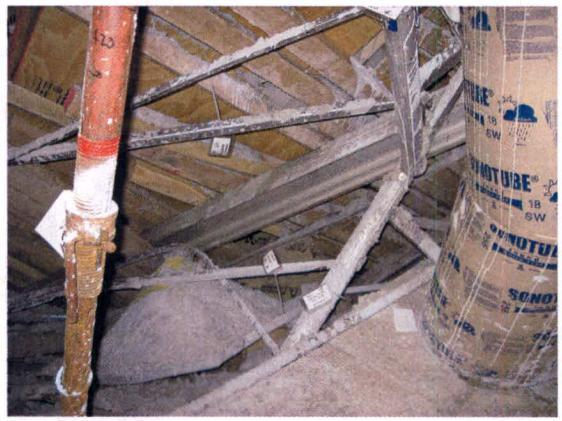
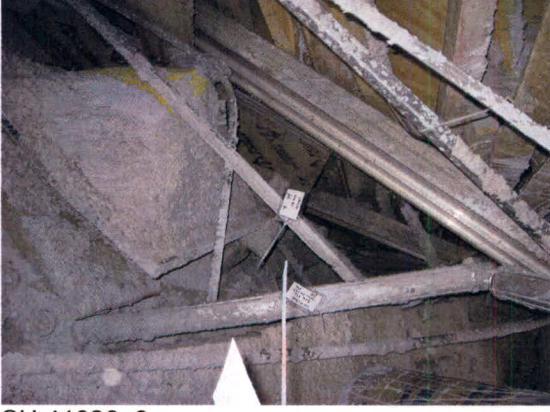
SH 41028 1

Broken Bottom Frame 3'6" Bottom Shore of SH 41005 Connected to brace SH 41030 Zone 41G

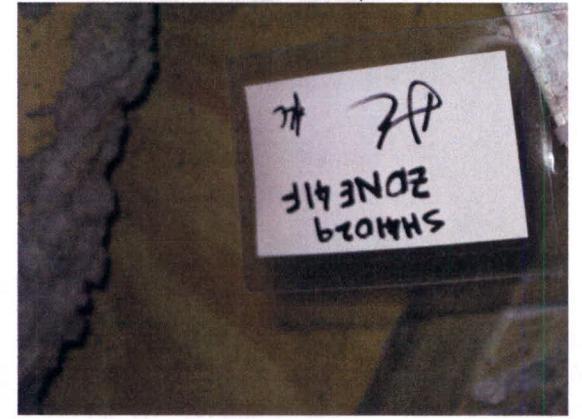
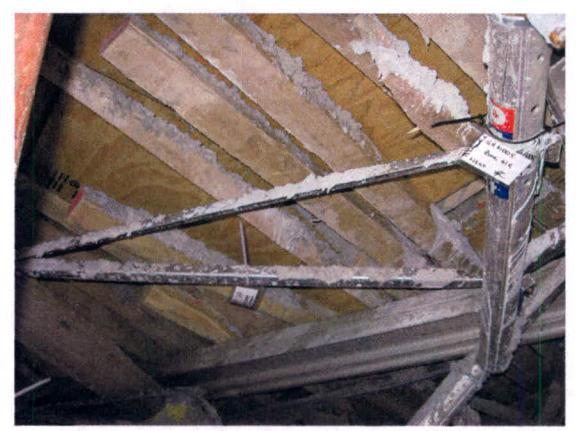
SH 41029 1

SH 41029 Top brace Attached to SH 410005 Zone 41F

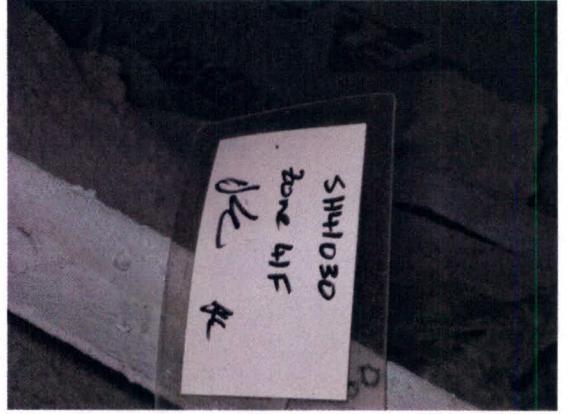
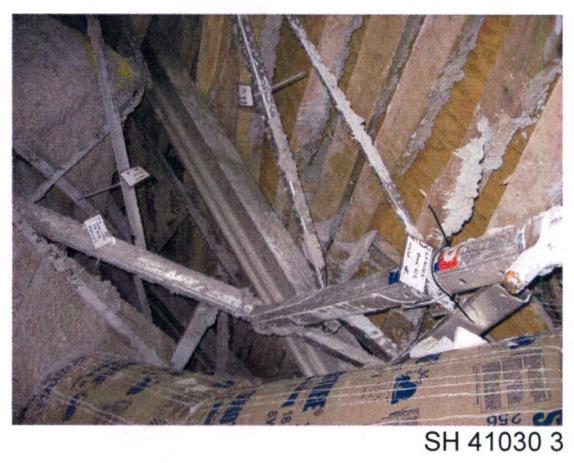
SH 41030 1

SH 41030 Bottom Brace Attached to SH 41028 Zone 41F

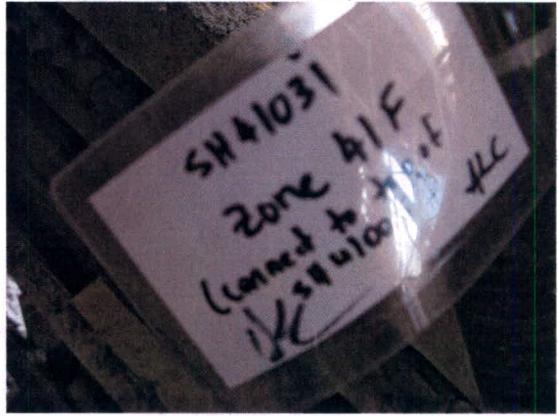
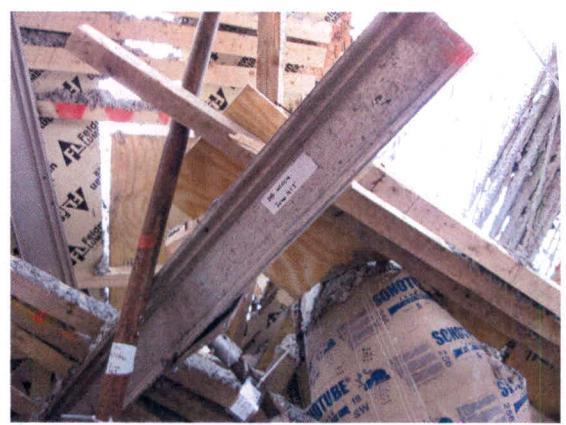
SH 41031 1

SH 41031 Top plate of SH 41005 and AB 41004 Zone 41F

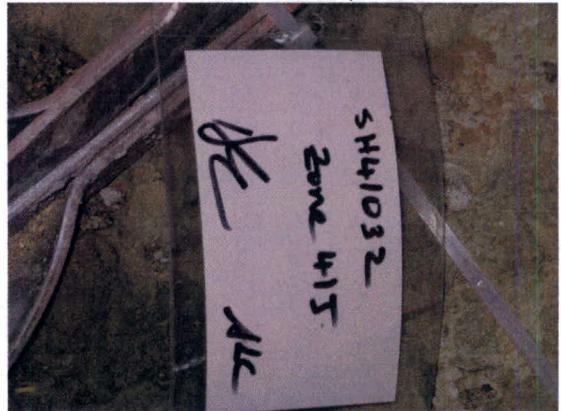
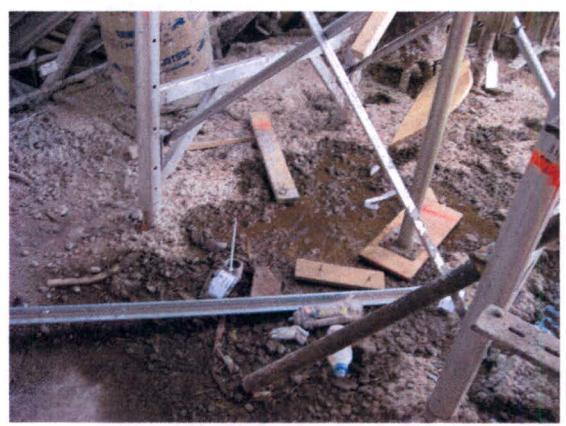
SH 41032 1

SH 41032 Brace Zone 41J

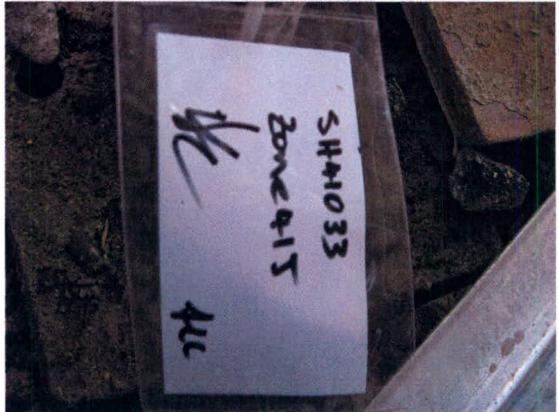
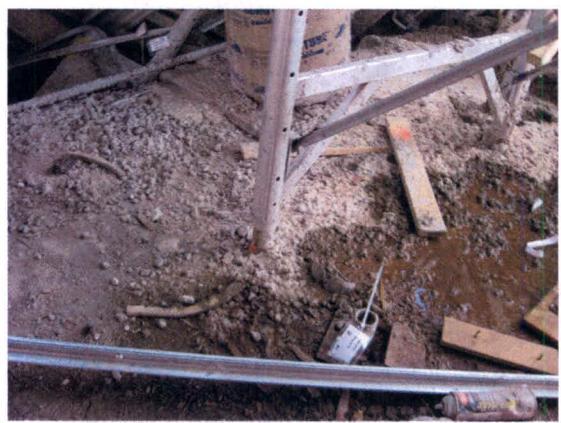
SH 41033 1

SH 41033 End plate Zone 41J

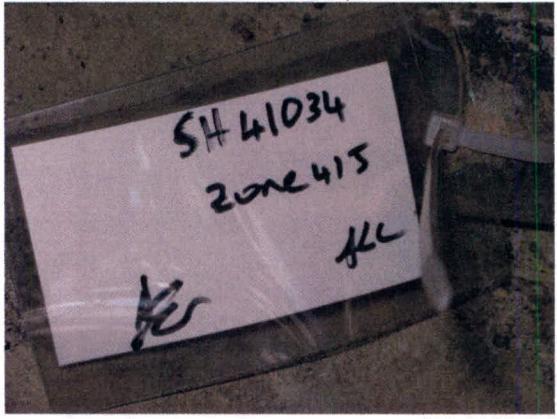
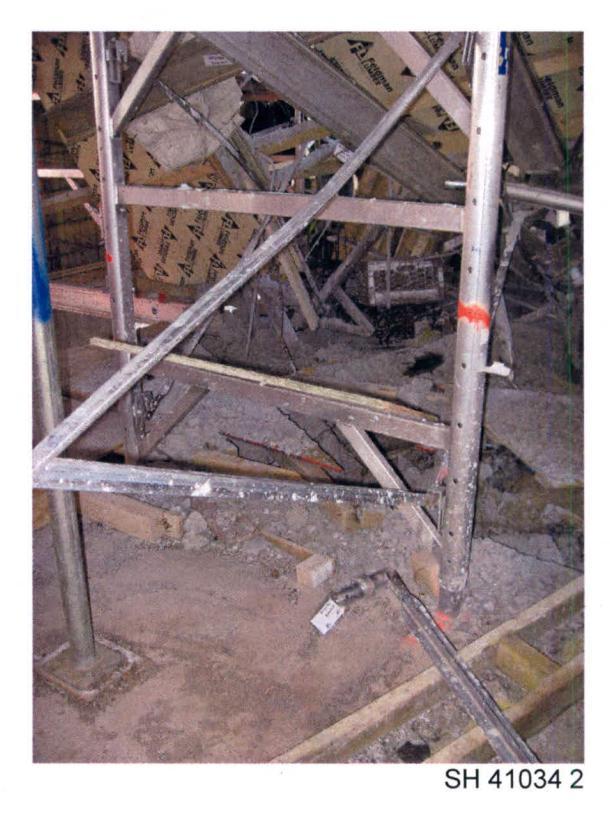
SH 41034 1

SH 41034 Coupler Zone 41J

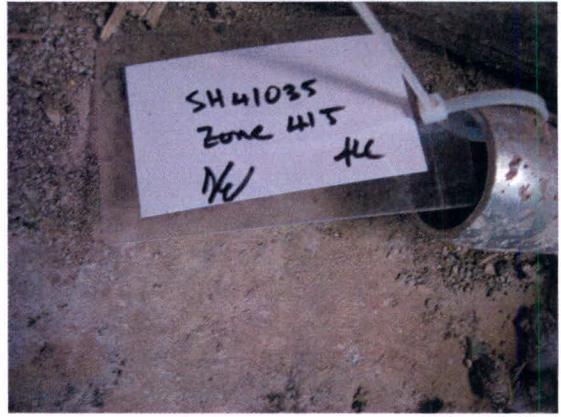
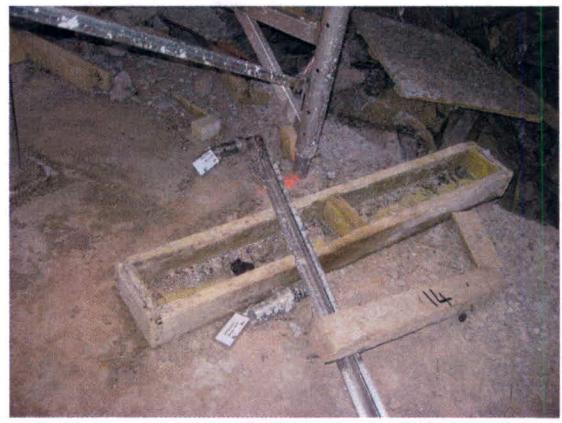
SH 41035 1

SH 41035 Coupler

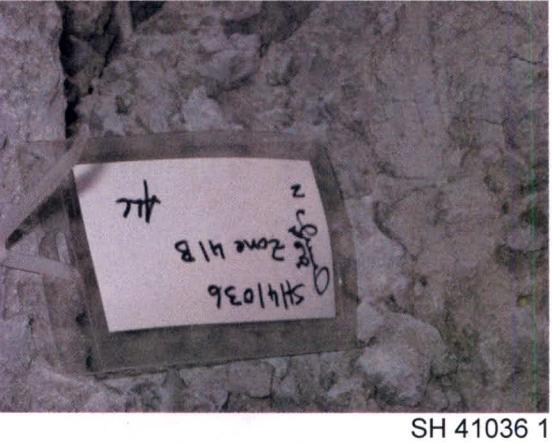
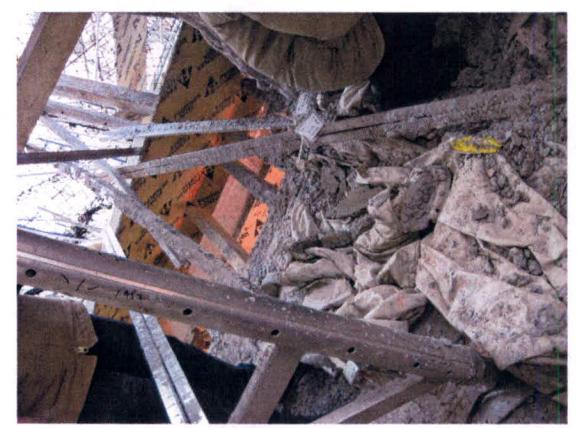
SH 41036 2

SH 41036 Brace Zone 41B

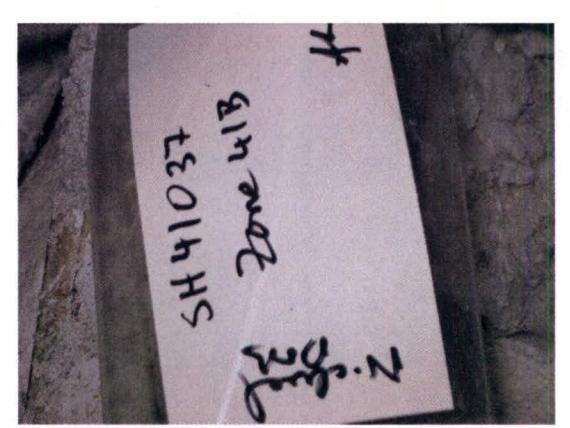
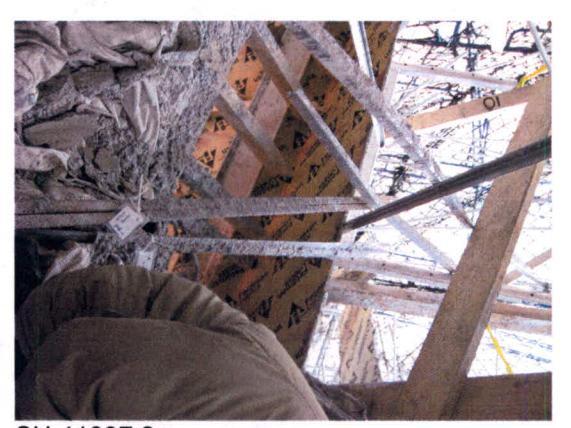
SH 41037 1

SH 41037 Brace Zone 41B

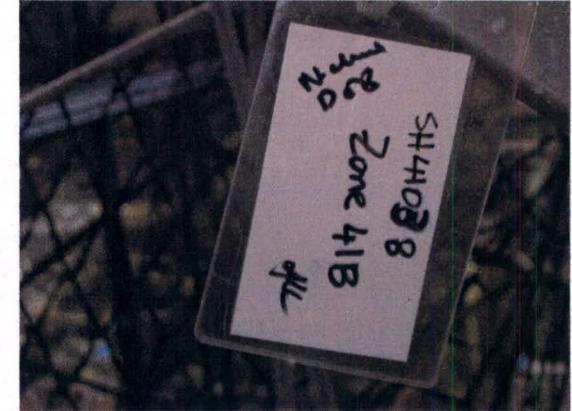
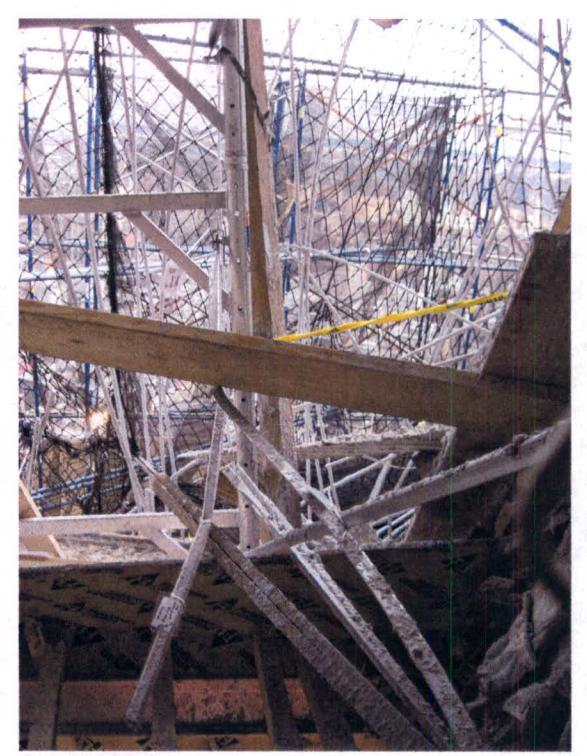
SH 41038 1

SH 41038 Bottom Piece of Shoring frame Attached to SH 41060 Zone 41B

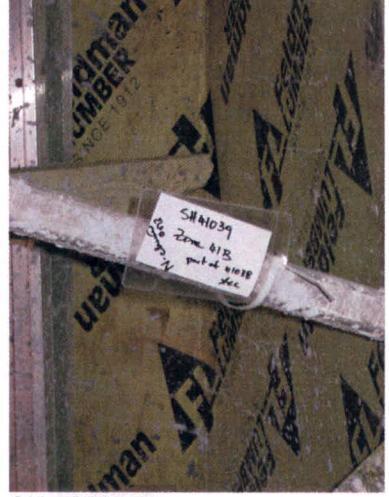
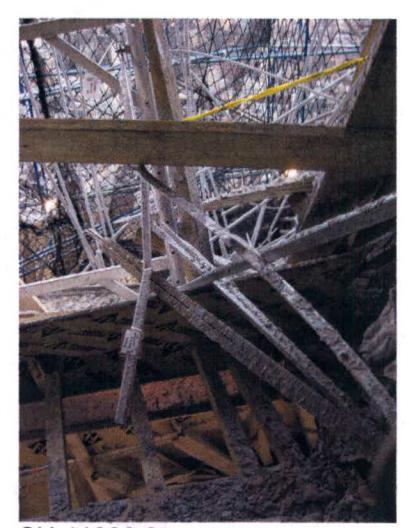
SH 41039 1

SH 41039 Bottom Frame of SH 41060 Part of SH 41038 Zone 41B

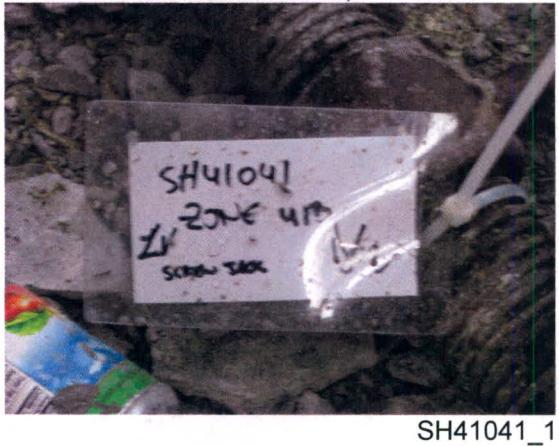
SH41041_2

SH 41041 Screw Jack Zone 41B

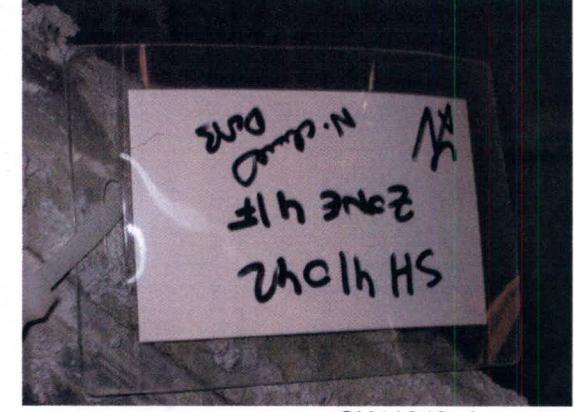
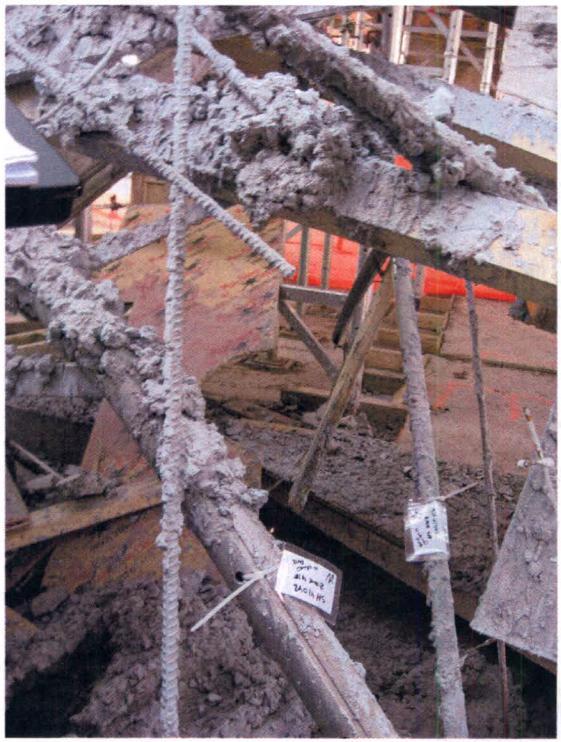
SH41042_1

SH 41042 Bottom frame of SH 41091 & SH 41090 Attached to SH 41043 Zone 41F
