INVESTIGATION REPORT:

JANUARY 14, 2008 SHORING COLLAPSE AT 9 DOMINICK ST. (AKA 246 SPRING ST.) MANHATTAN

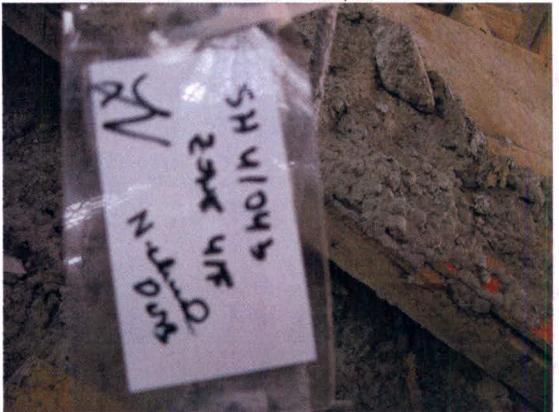
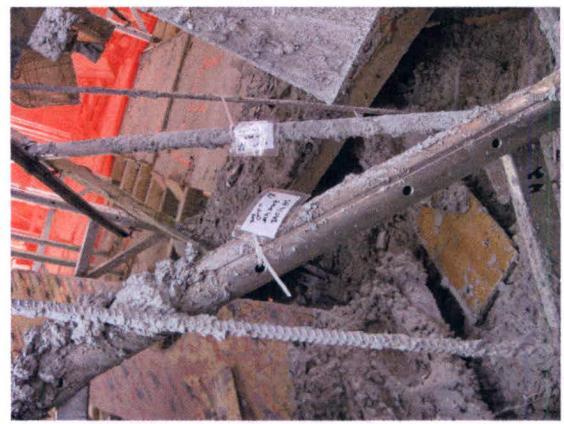
SH41043_1

SH 41043 Brace Attached to SH 41042 Zone 41F

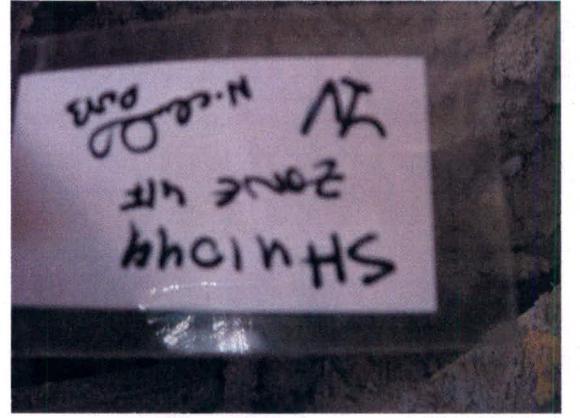
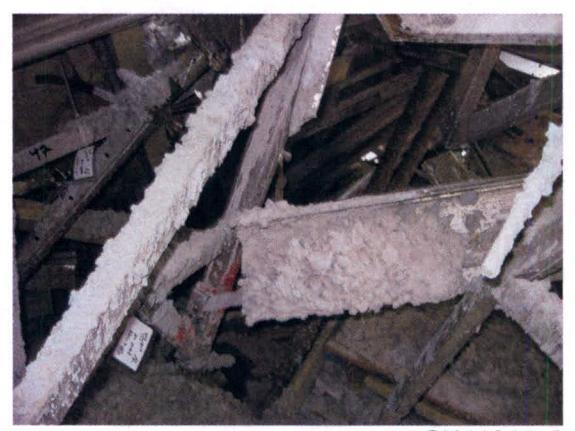
SH41044_1

SH 41044 Broken With SH 41042 Bottom Shore of SH 41090 & SH 41091 Attached to SH 41042 Zone 41F

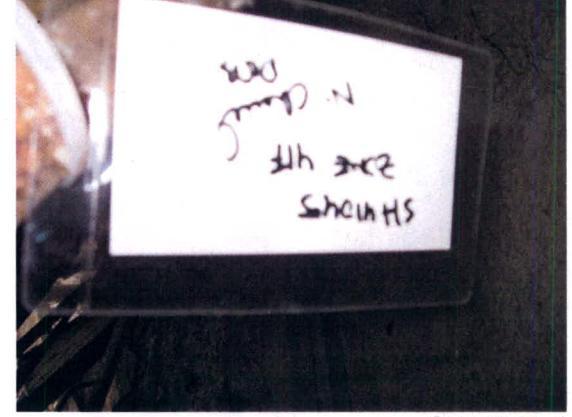
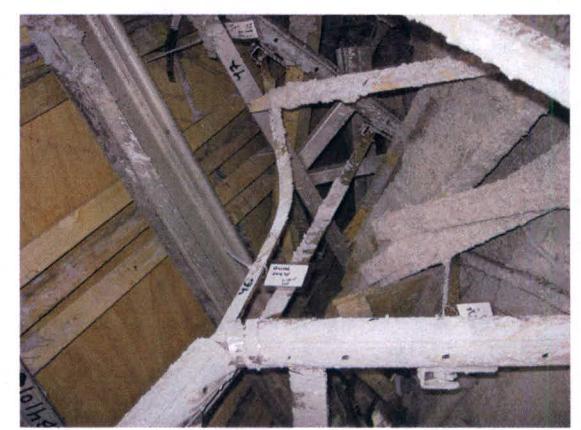
SH41045_1

SH 41045 Bottom Brace of SH 41024 Zone 41F

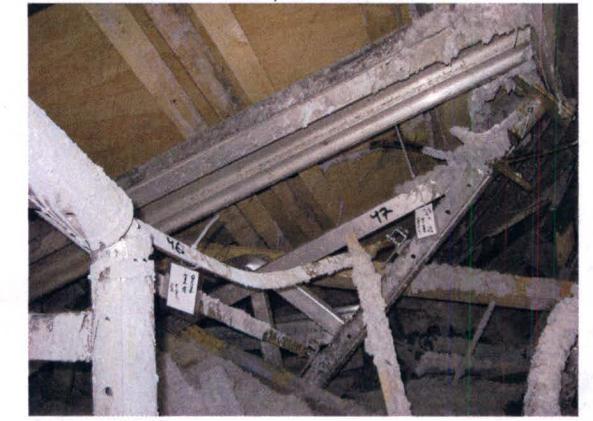
SH 41046 Brace Connected to SH 41047 Zone 41F

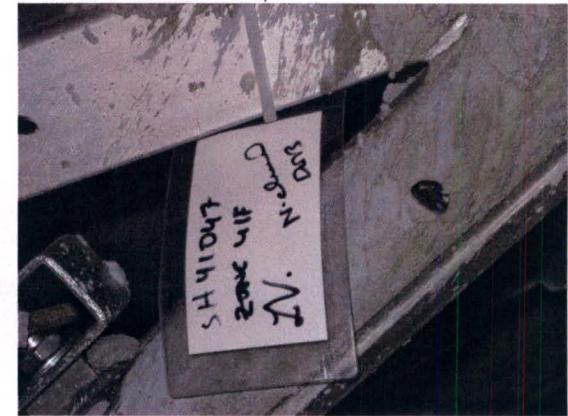
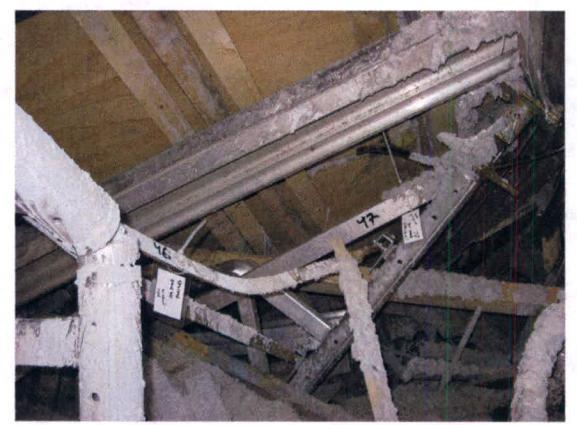
SH41047_1

SH 41047 Broken With SH 41179 Top Shore of SH 41186 & SH 41190 Attached to brace SH 41046 Zone 41F

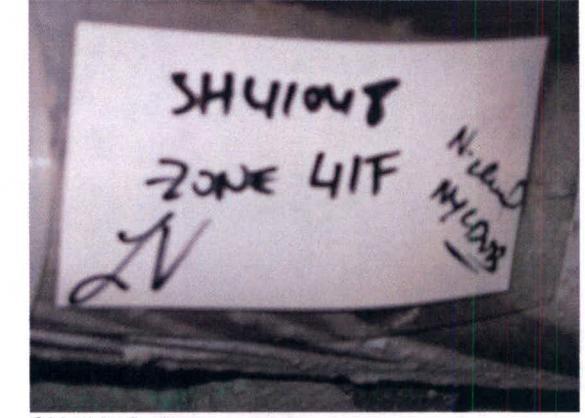
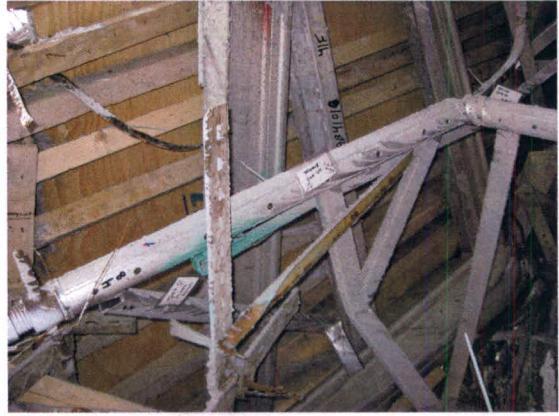
SH41048_1

SH 41048 Broken Top Shore Attached to SH 41046 on top SH 41024 Piece of Frame SH 41049 Zone 41F

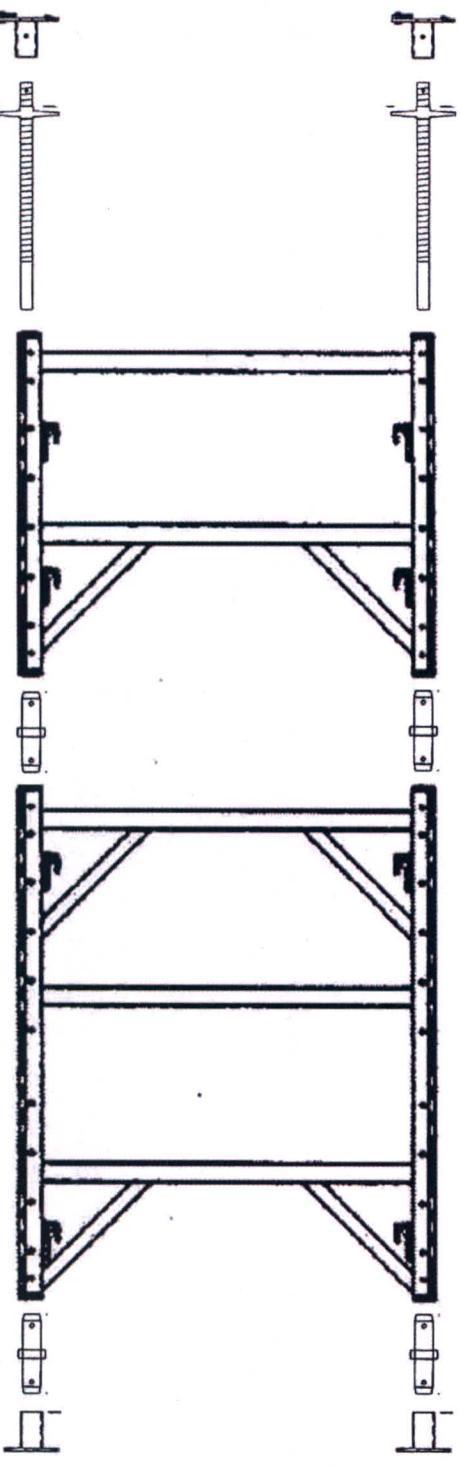
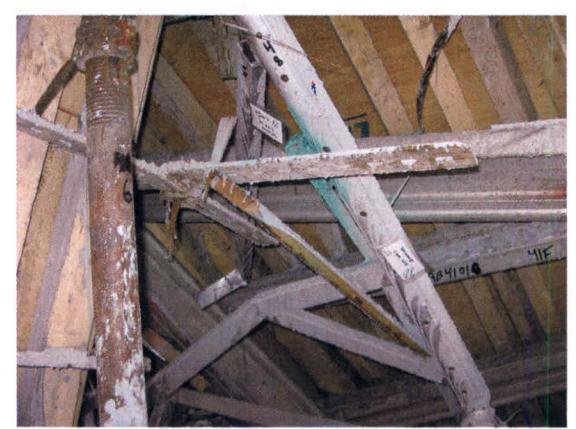
SH41049_1

SH 41049 Broken piece from SH 41048 Zone 41 F

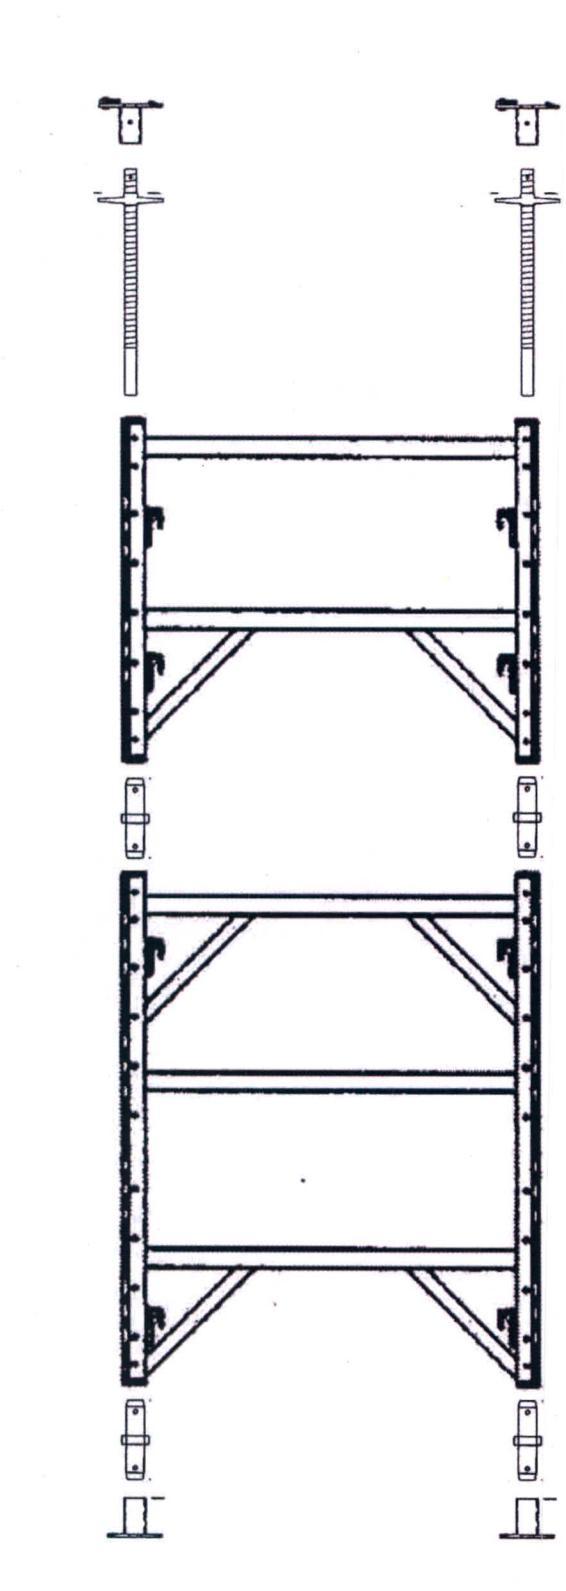
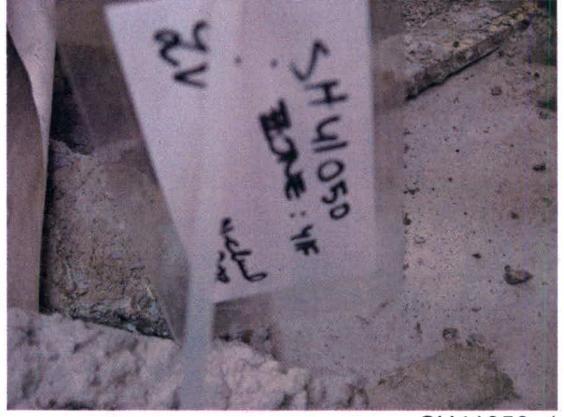
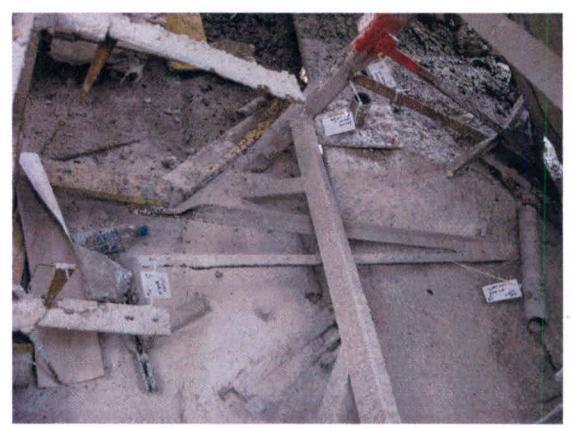
SH41050_1

SH 41050 Brace Zone 41F

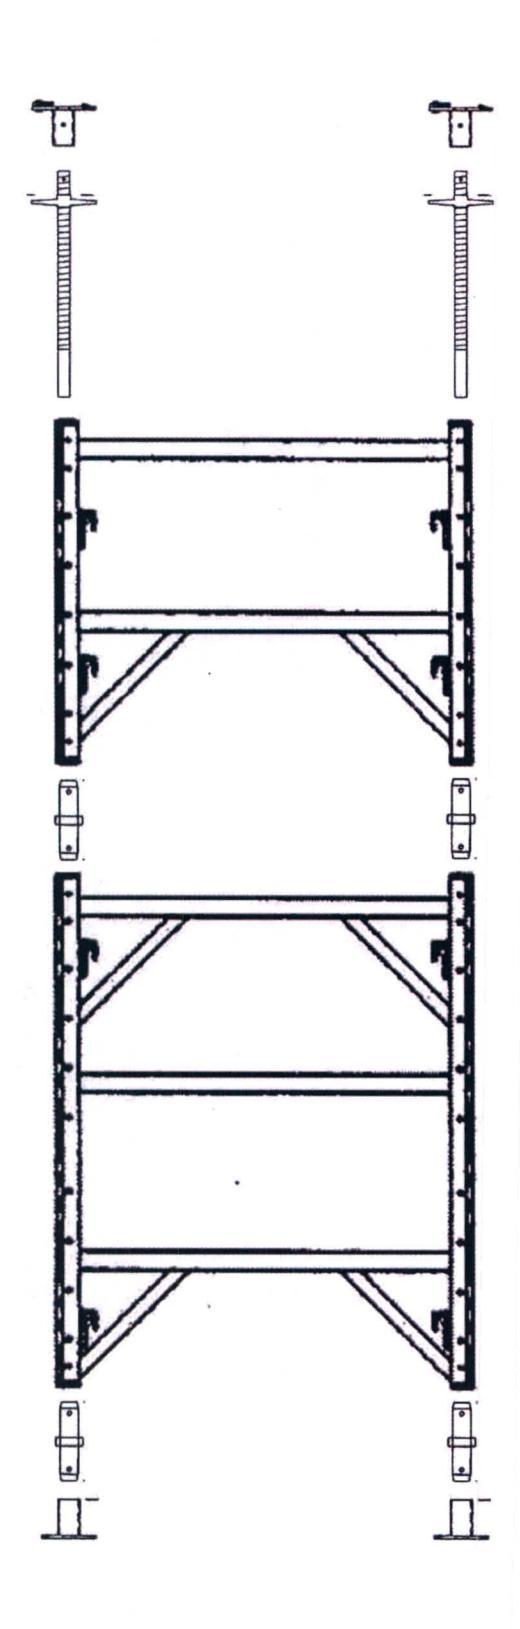
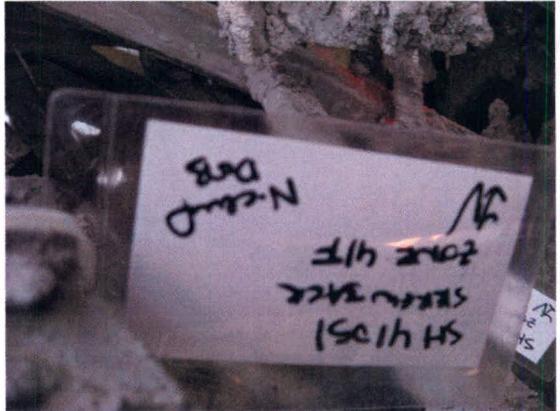
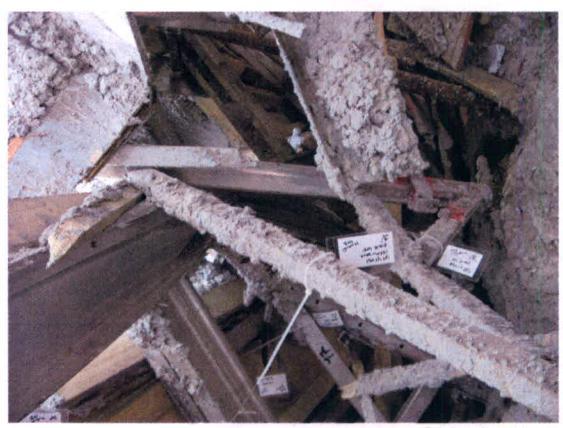
SH41051_1

SH 41051 Broken piece of frame Attached to bottom SH 41044 Zone 41F

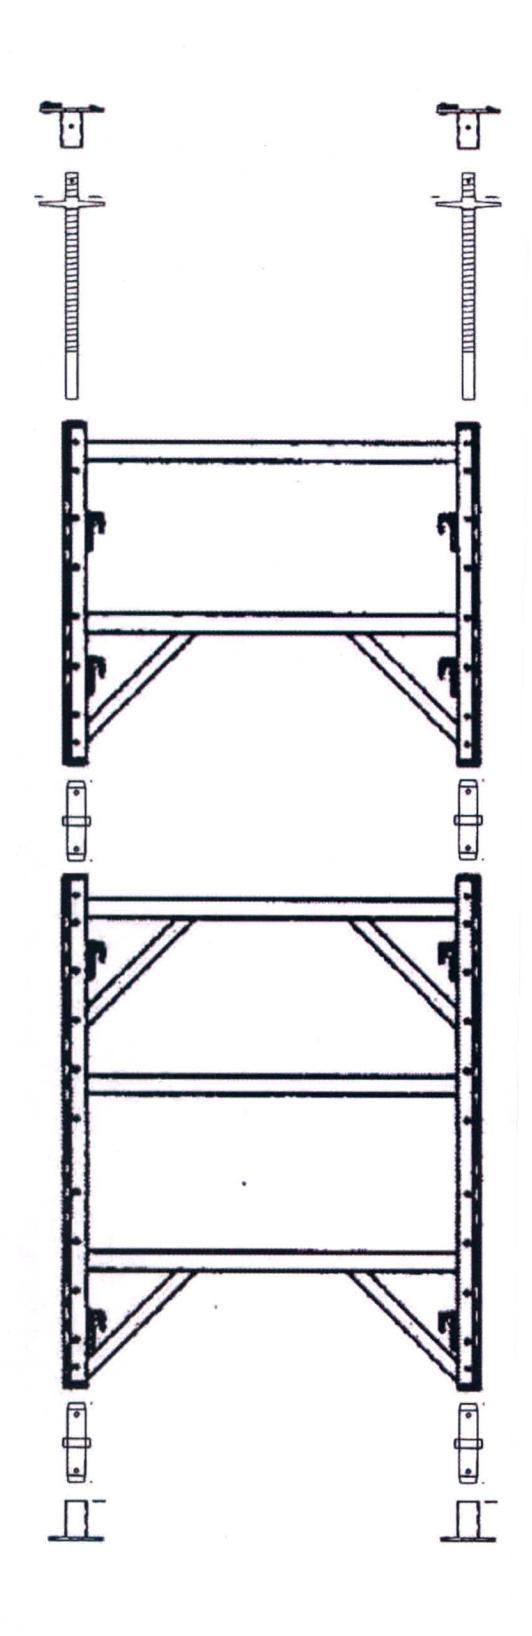
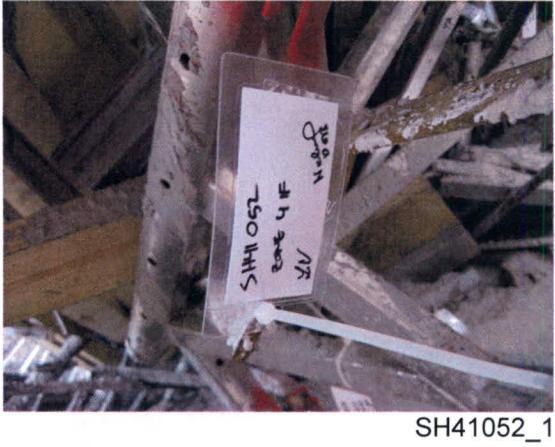
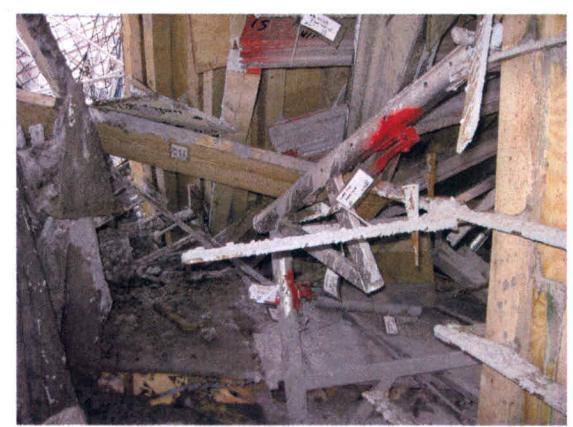
SH41052_2

SH 41052 Brace Zone 41F

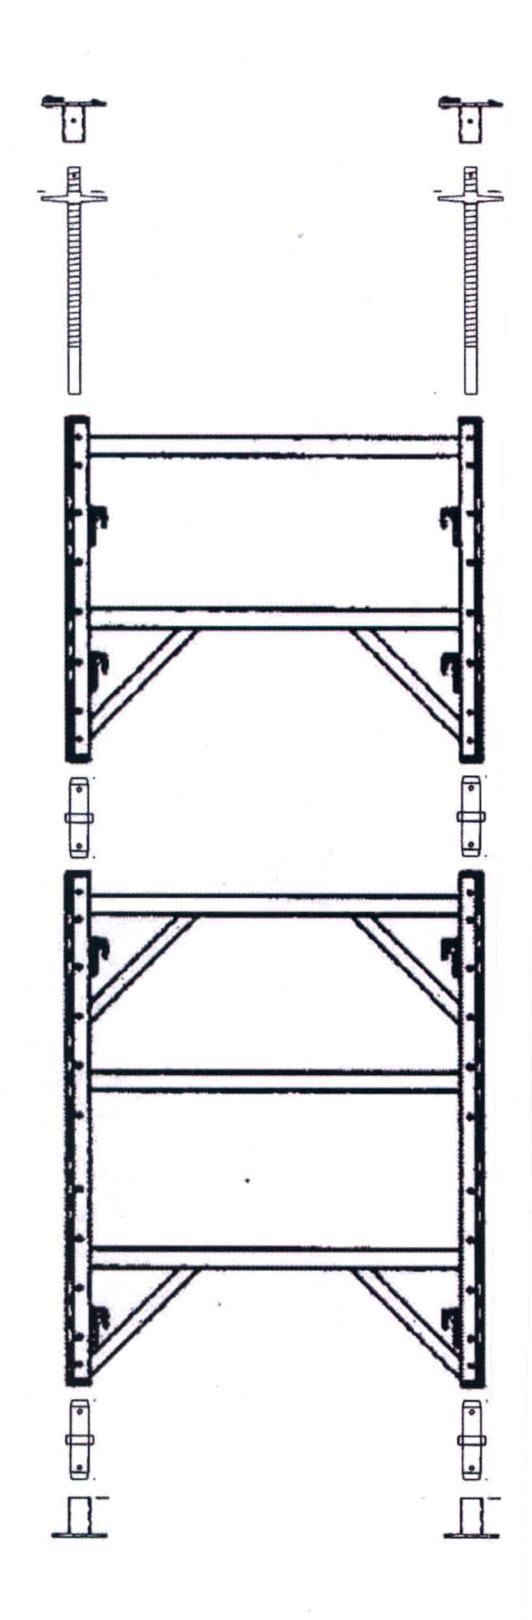
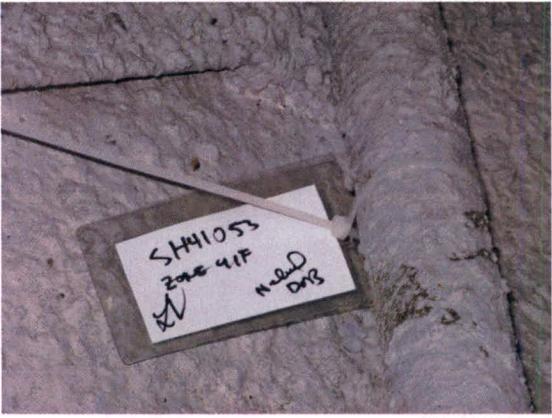
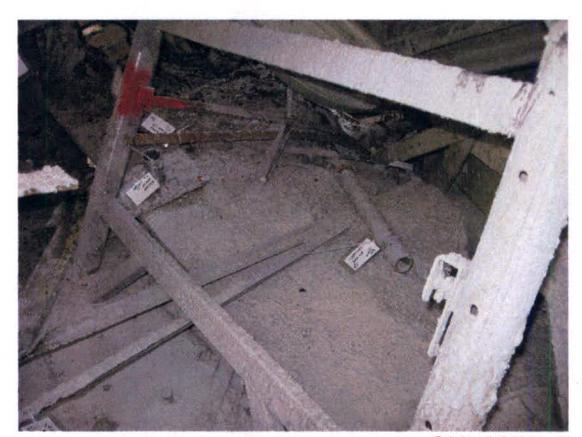
SH41053_1

SH 41053 Screw Jack Zone 41F

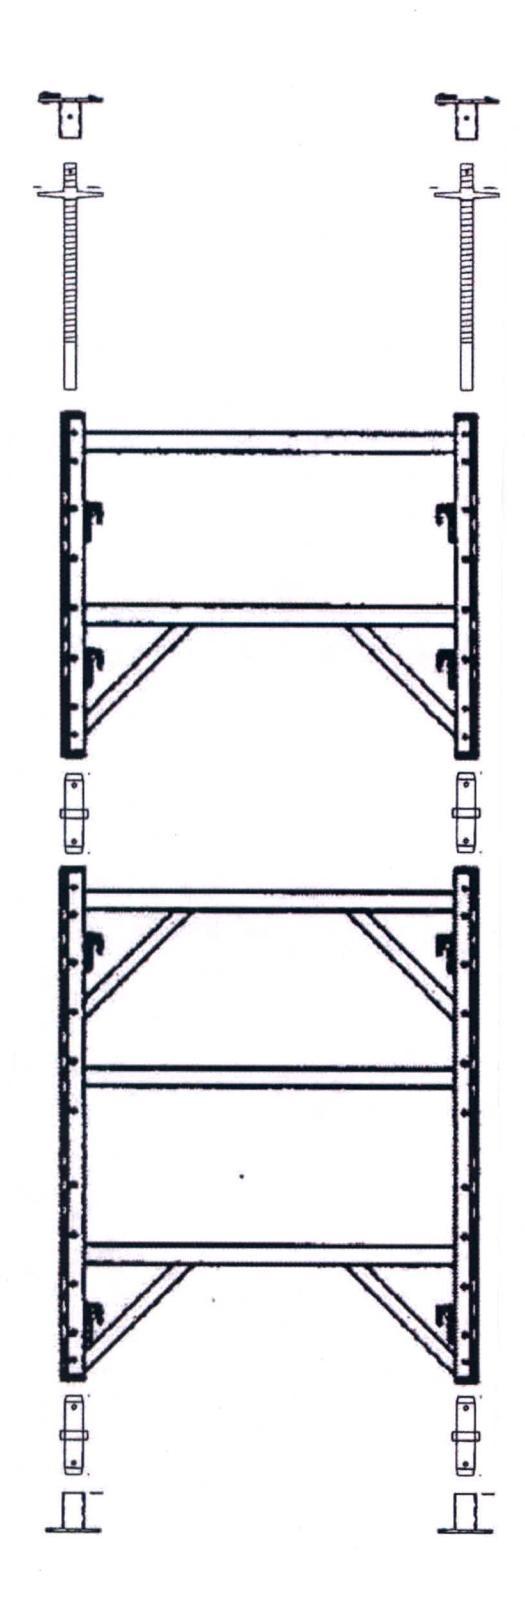
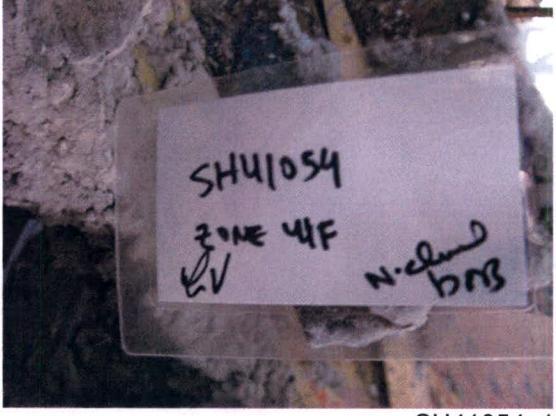
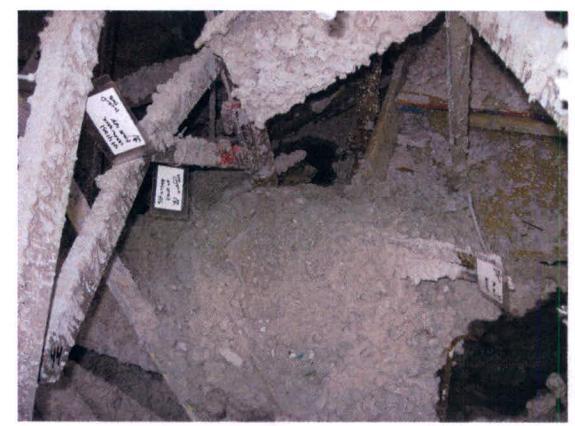
SH41054_1

SH 41054 Brace Zone 41F

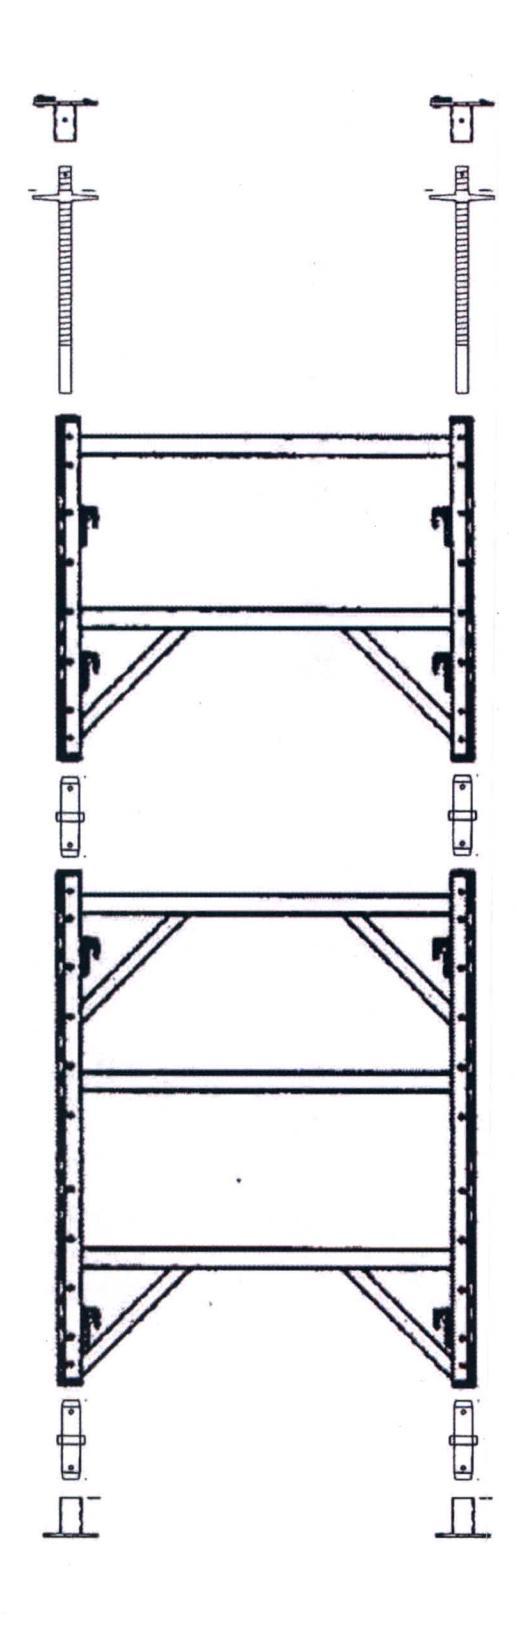
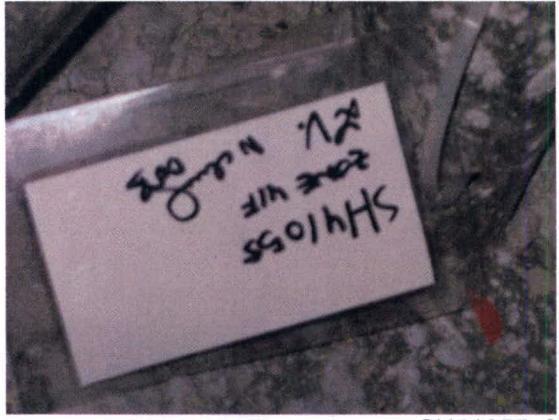
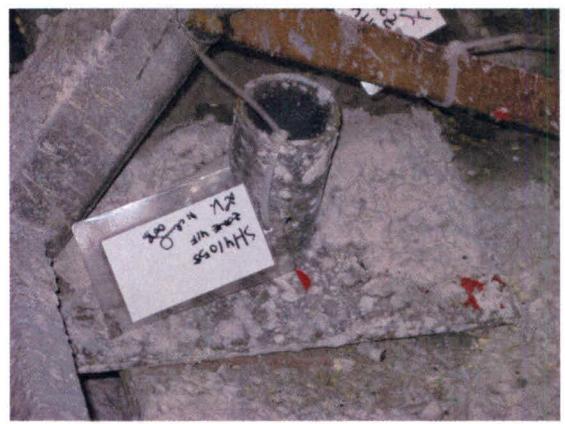
SH41055_2

SH 41055 Bottom Plate Zone 41F

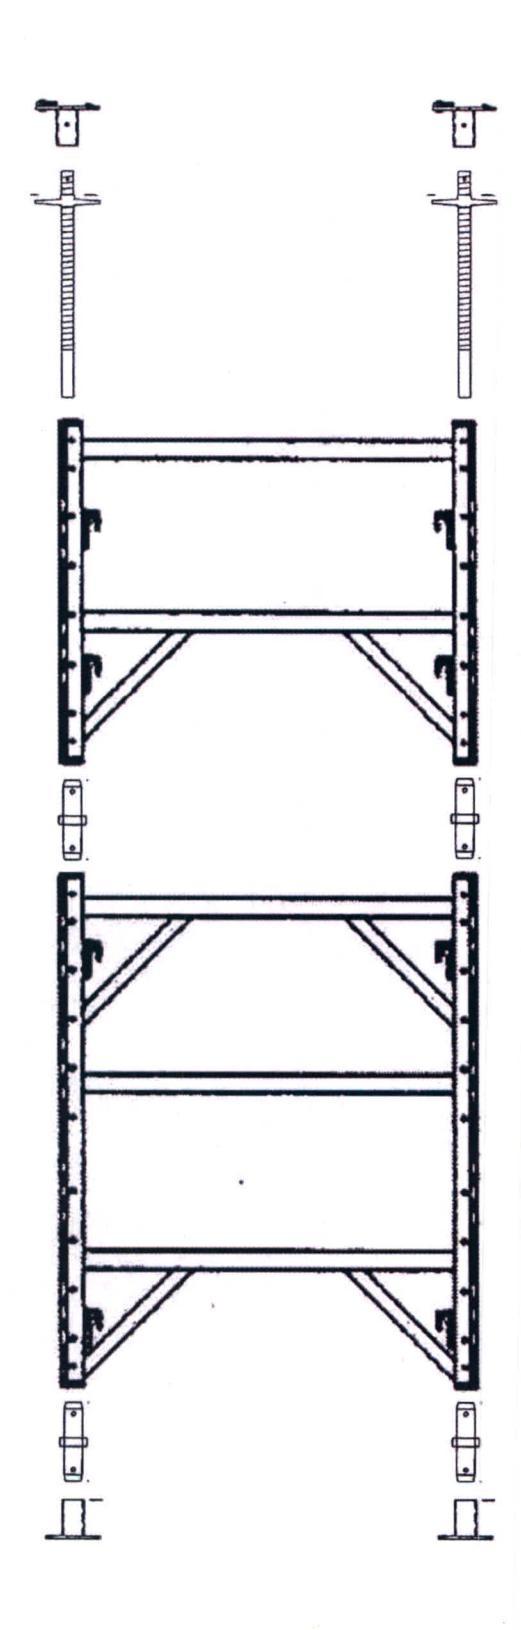
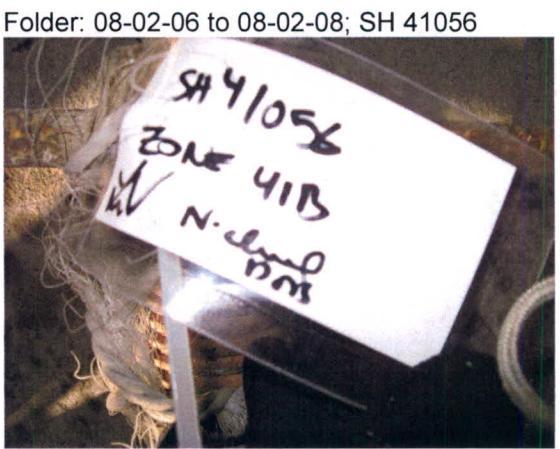
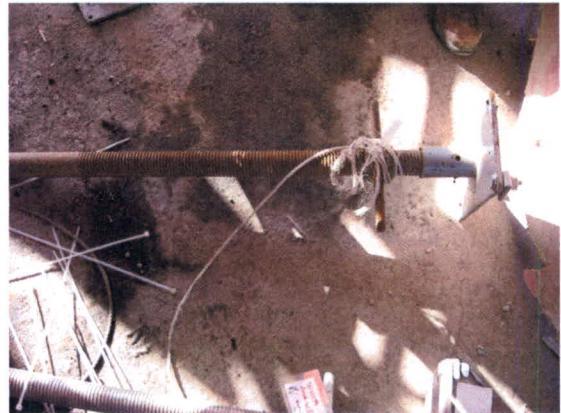
SH41056_1

SH 41056 Top plate and Screw Jack Zone 41B

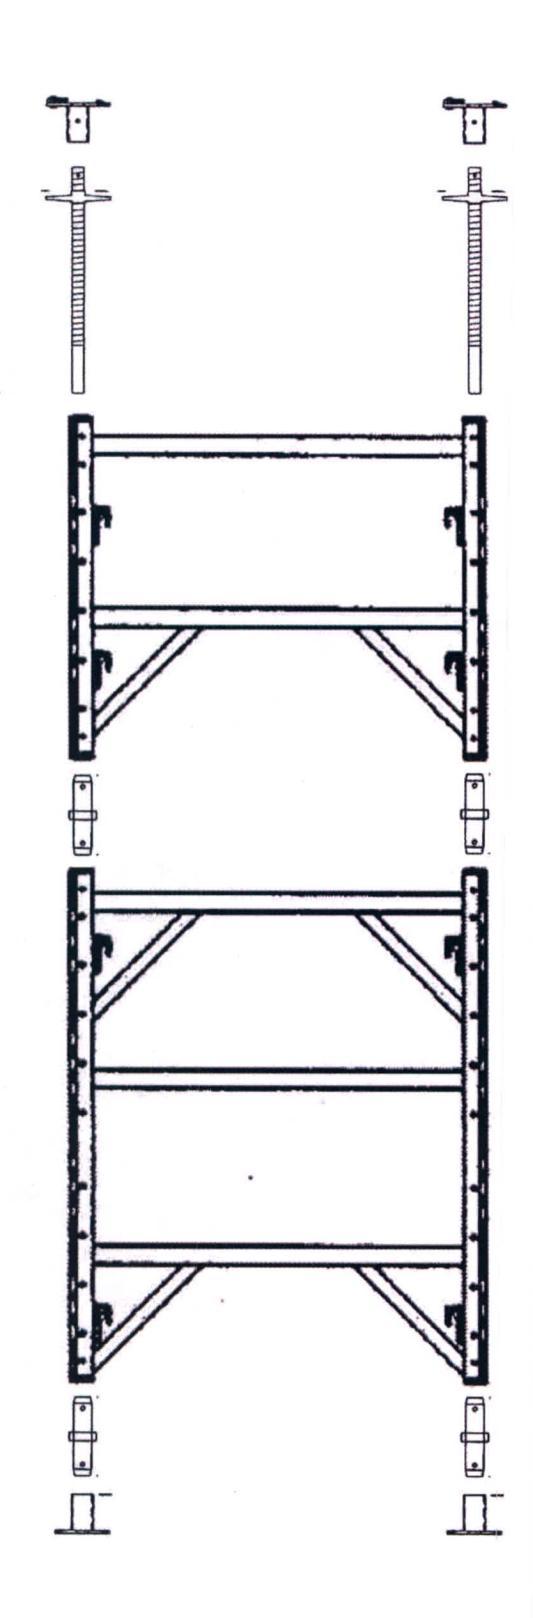
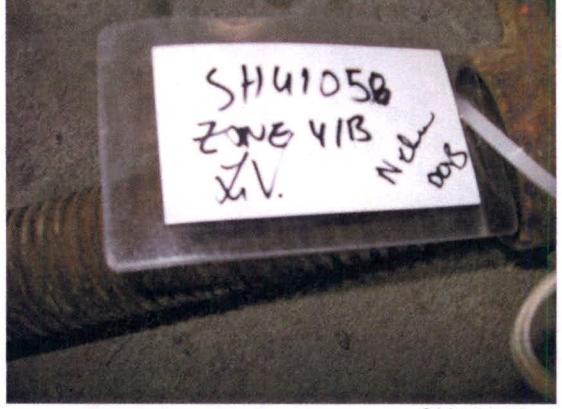
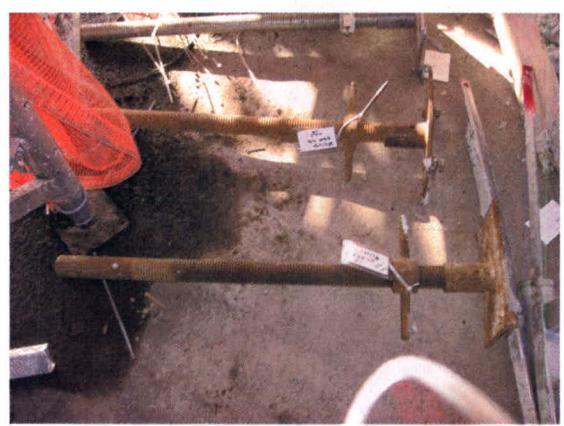
SH41058_1

SH 41058 Top plate and Screw Jack Zone 41B

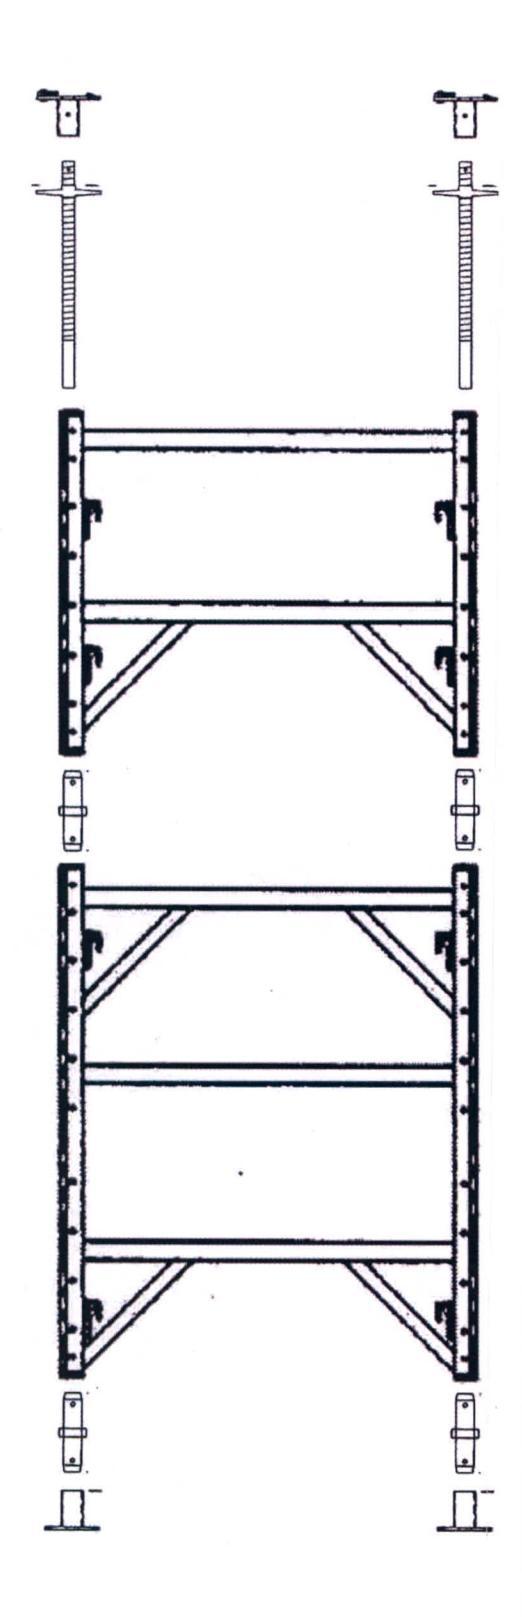
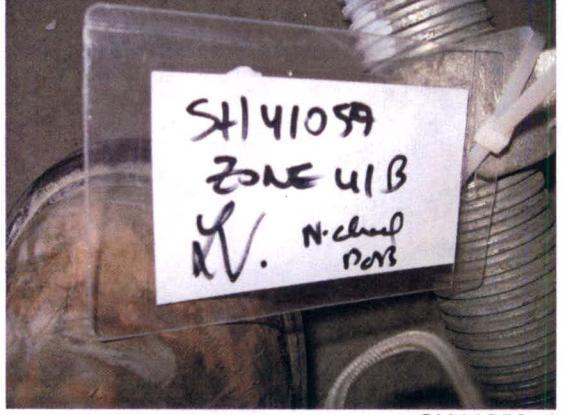
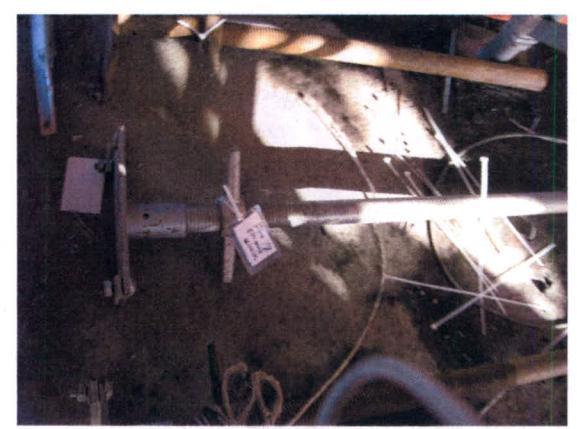
SH41059_1

SH 41059 Top Plate and Screw Jack Zone 41B

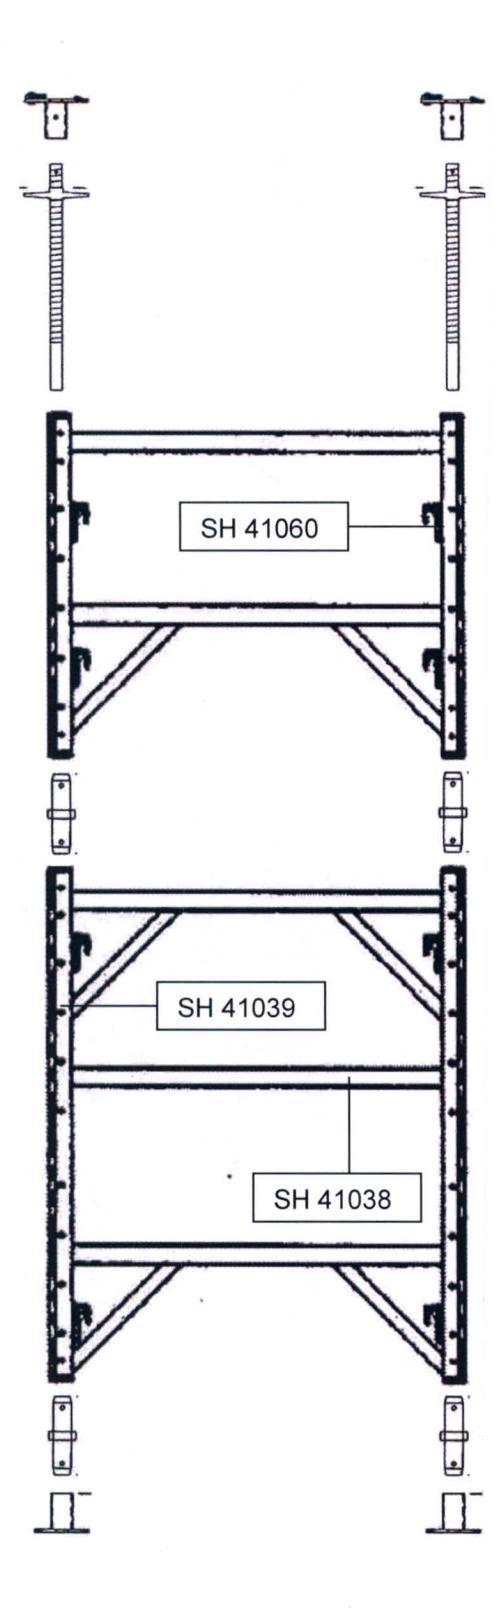
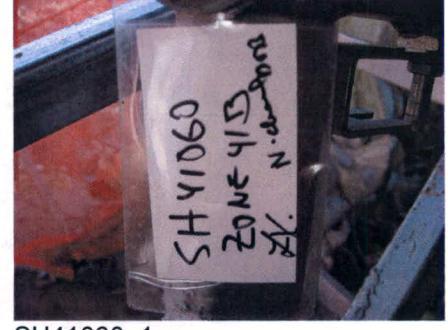
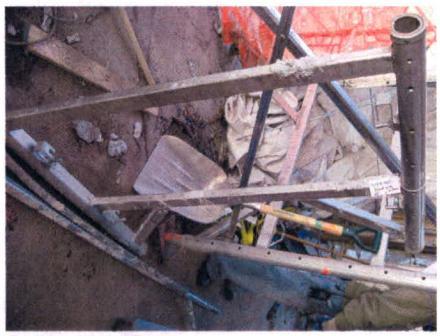
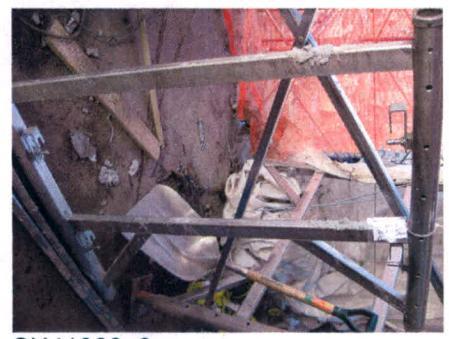
SH41060_1

SH 41060 Top frame of SH 41038 Zone 41B

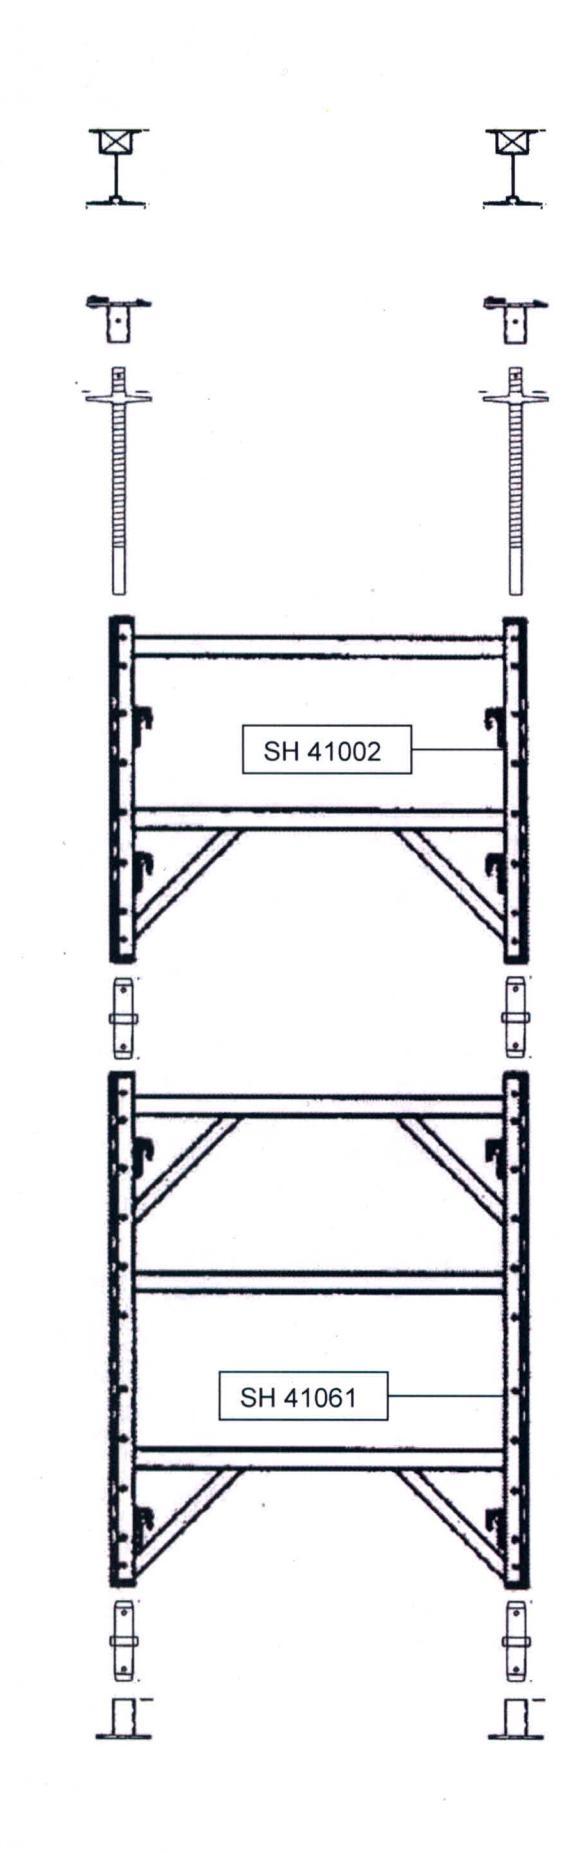
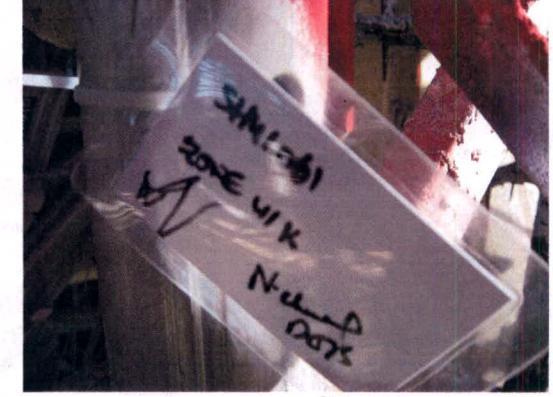
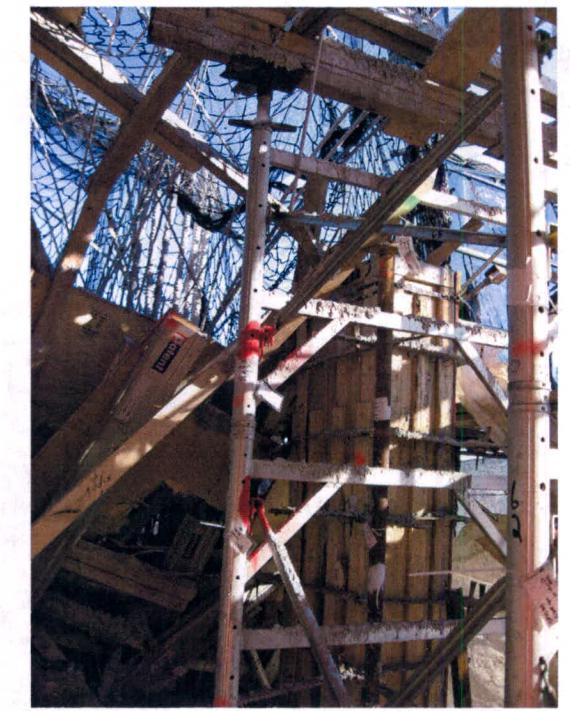
SH41061_1

SH 41061 Bottom of SH 41002 Zone 41K

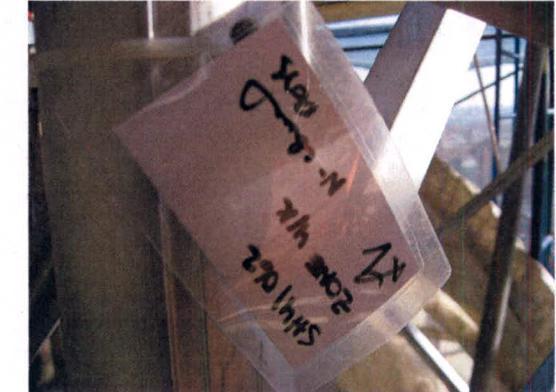
SH41062_2

SH 41062 Bottom of SH 41001 Zone 41K

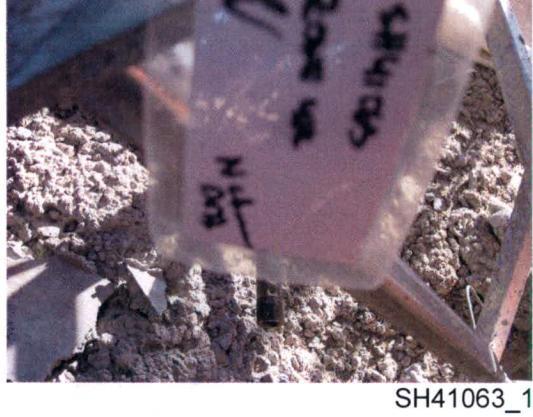
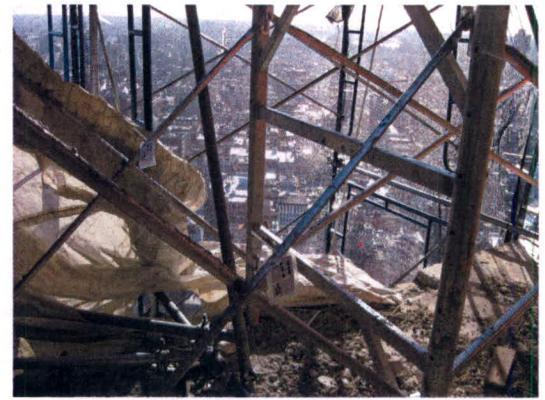
SH41063_2

SH 41063 Brace Connects SH 41062 to SH 41061 Zone 41K

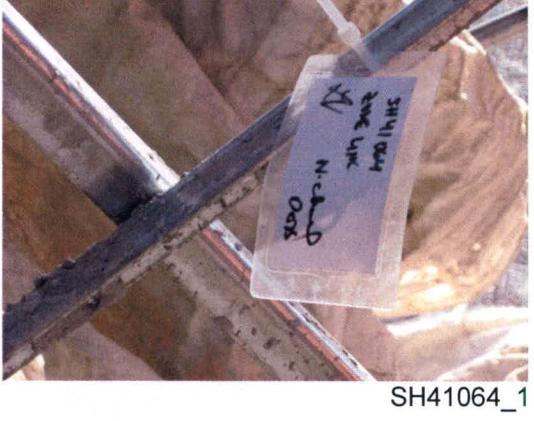
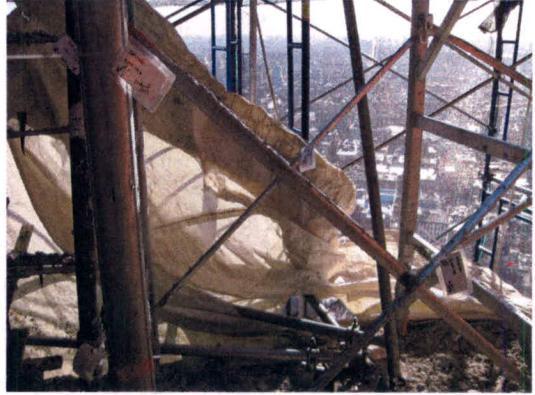
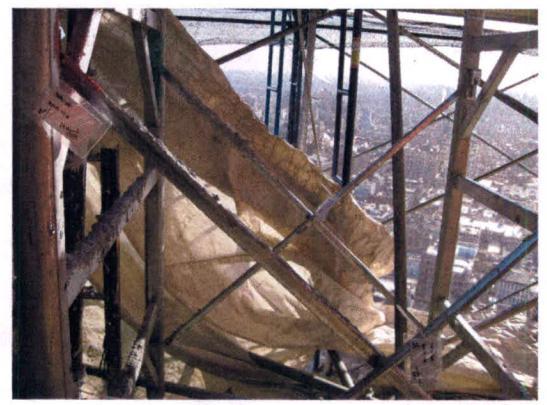
SH41064_2

SH 41064 Brace Connects SH 41062 to SH 41061 Zone 41K

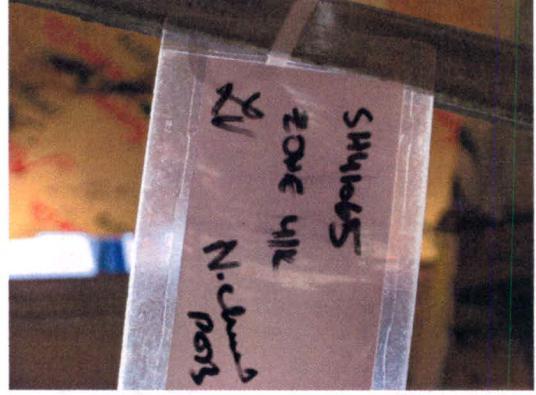
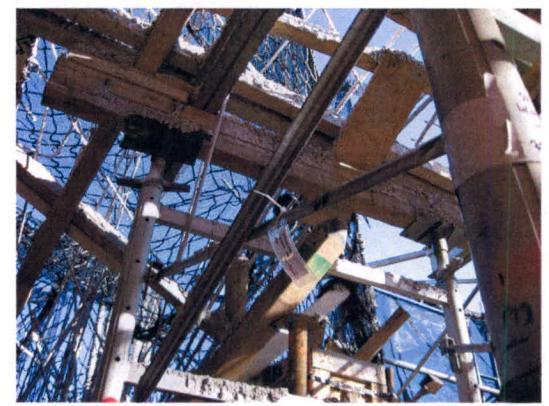
SH41065_1

SH 41065 Brace Connects SH 41001 to SH 41002 Zone 41K

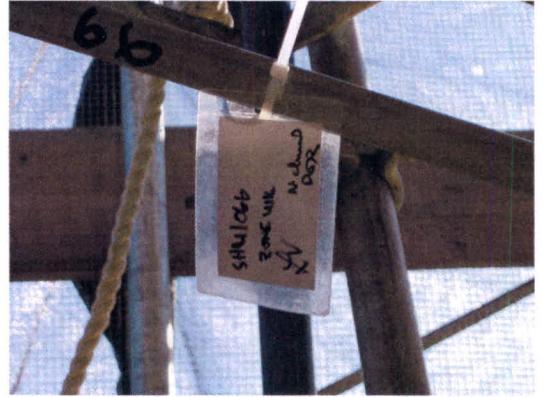
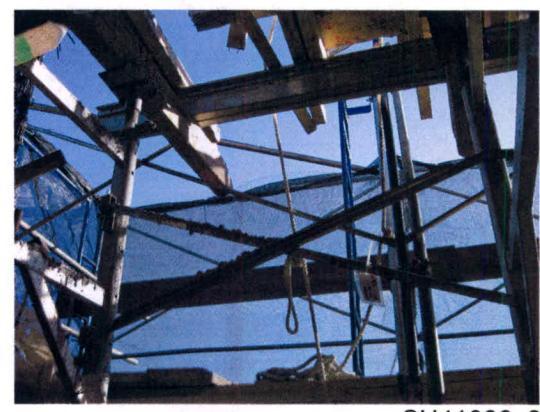
SH41066_1

SH 41066 Brace Connects SH 41001 to SH 41002 Zone 41K

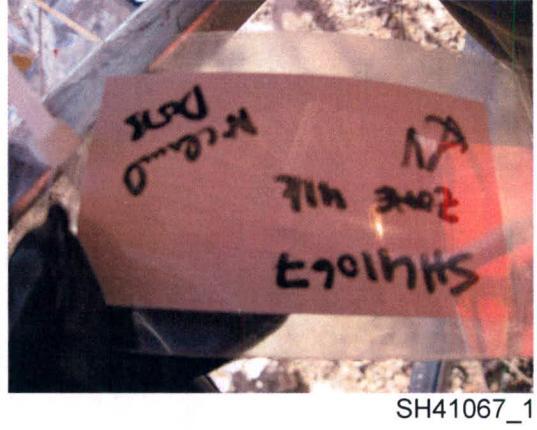
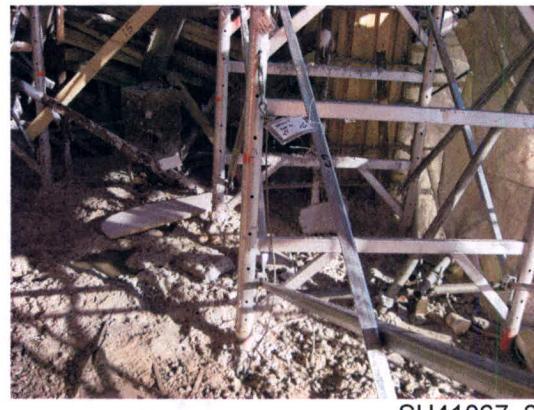
SH41067_2

Brace connect to bottom SH 41062 Zone 41K

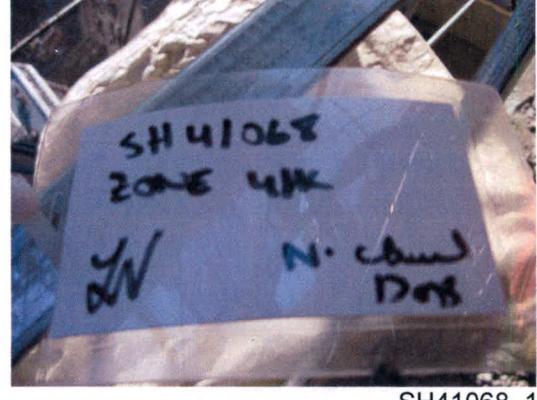
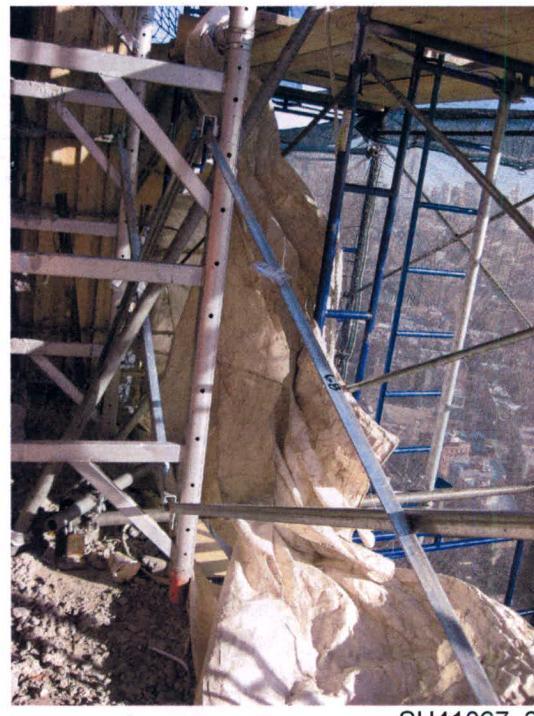
SH41068_1

SH 41068 Brace connecting SH 41062 to SH 41083

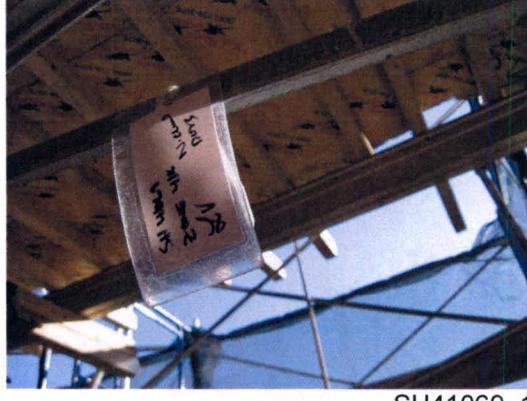
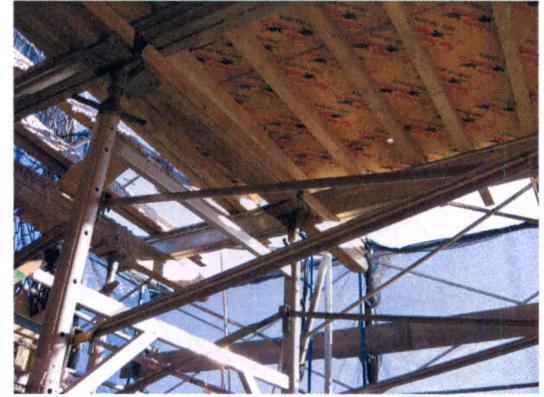
SH41069_1

SH 41069 Top Brace Connect SH 41001 to SH 41084 Zone 41K

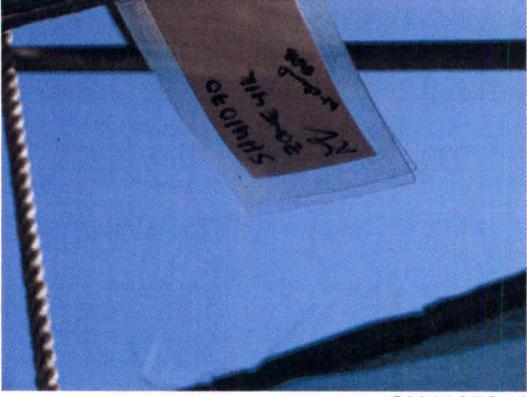
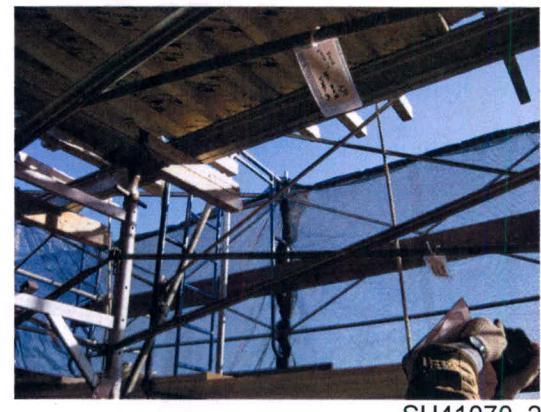
SH41070_1

SH 41070 Brace Connect SH 41001 to SH 41084 Zone 41K
