INVESTIGATION REPORT:

JANUARY 14, 2008 SHORING COLLAPSE AT 9 DOMINICK ST. (AKA 246 SPRING ST.) MANHATTAN

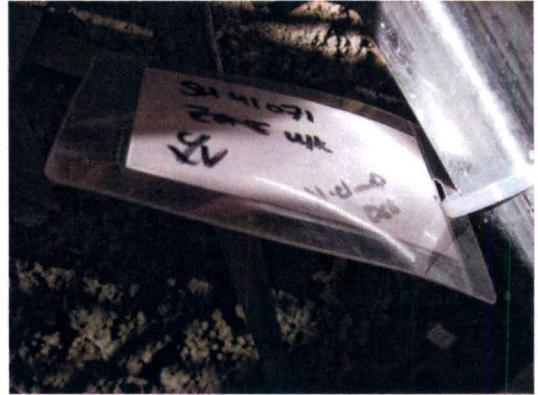
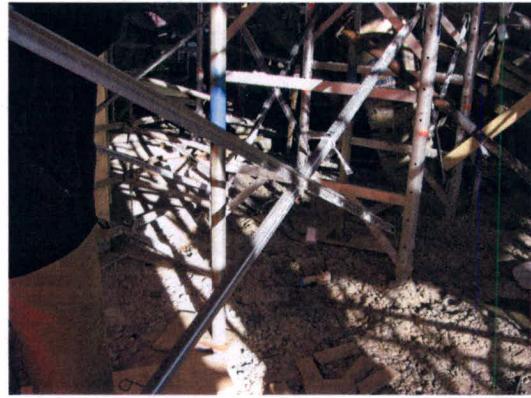
SH41071_1

SH 41071 Brace Connect SH 41074 to SH 41075 Zone 41K

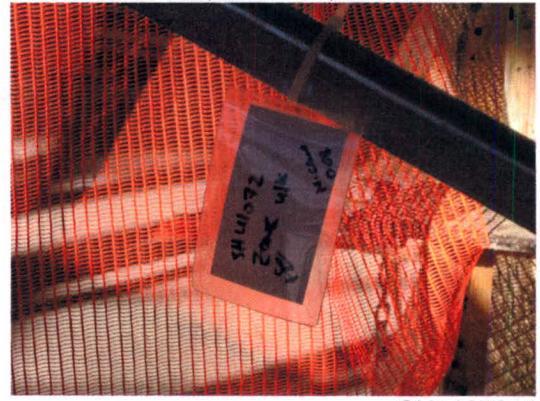
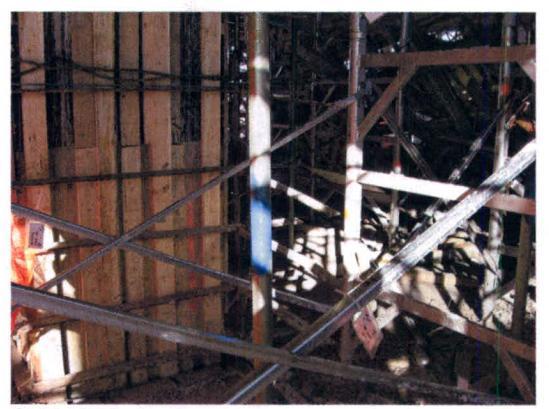
SH41072_1

SH 41072 Brace connects SH 41075 Zone 41K

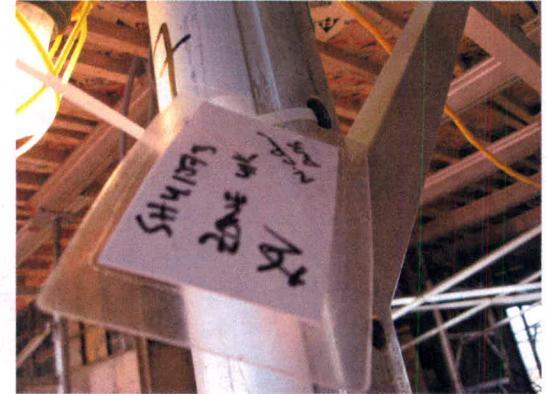
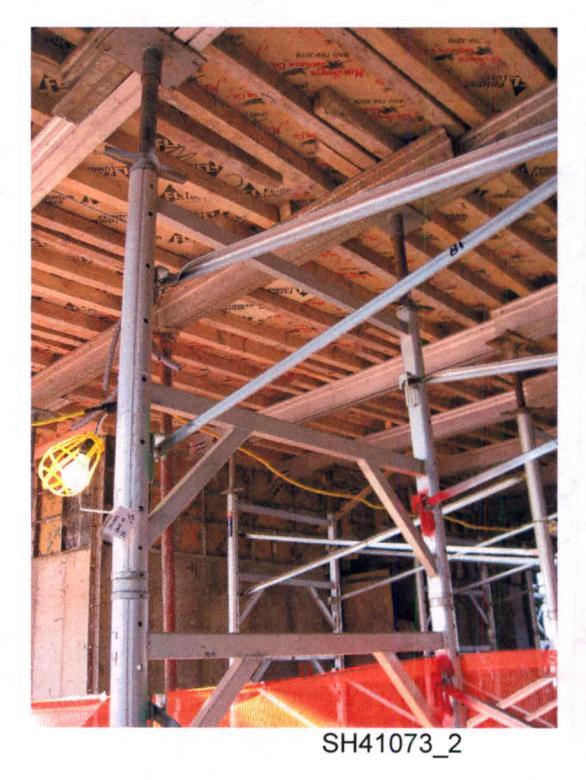
SH41073_1

SH 41073 Top of SH 41074 Connects to top brace SH 41081 Connects to bottom brace SH 41071 Zone 41K

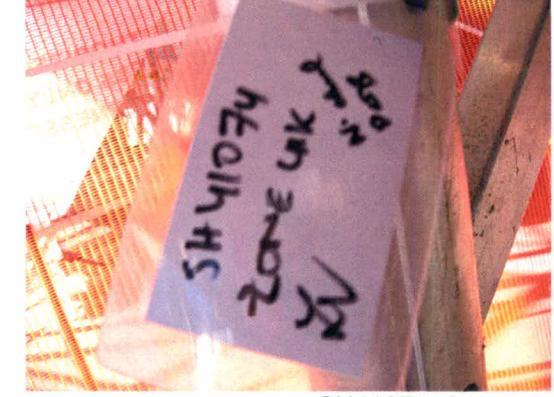
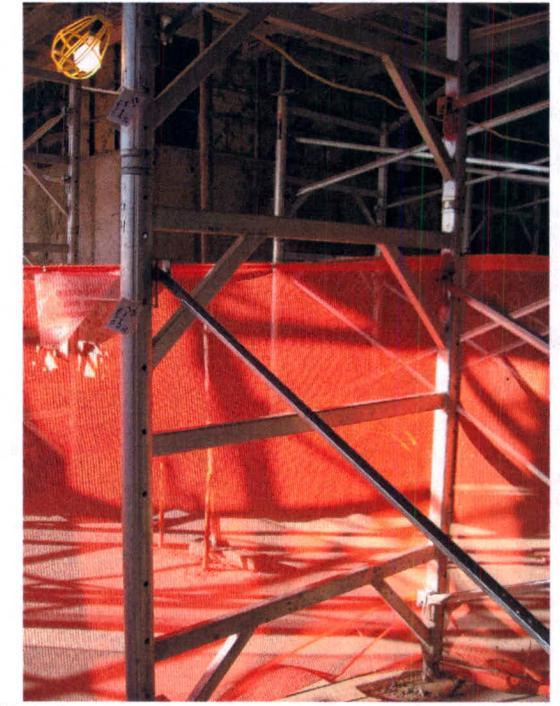
SH41074_1

Bottom Frame of SH 41073 Connects to SH 41071 and SH 41072 Zone 41K

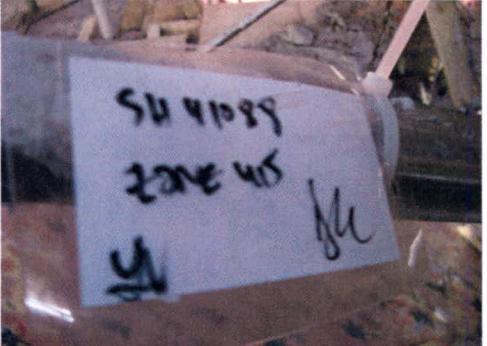
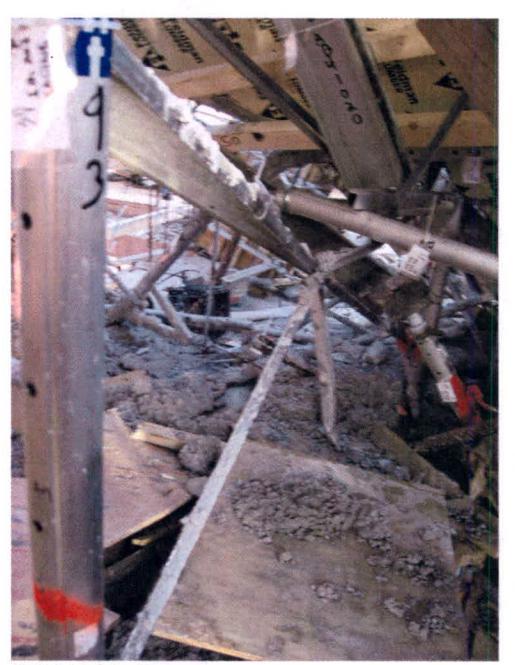
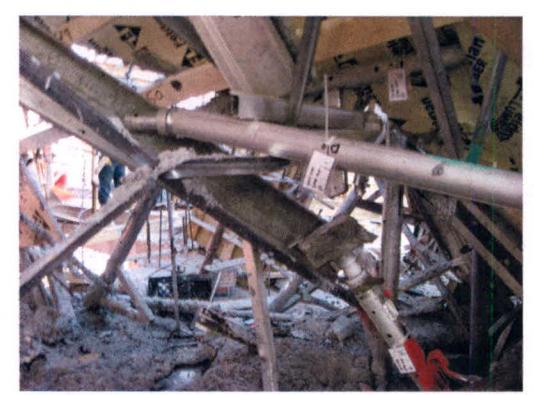
Folder: 08-02-12; 08-02-12; SH 41088

Brace connects SH 41093 to SH 41044 Zone 41F

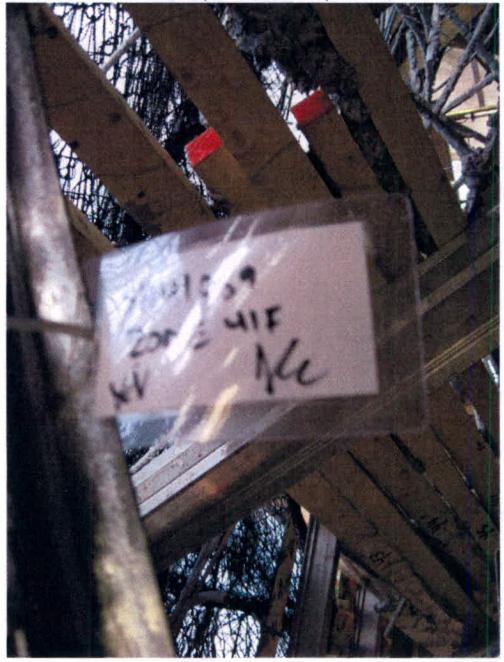
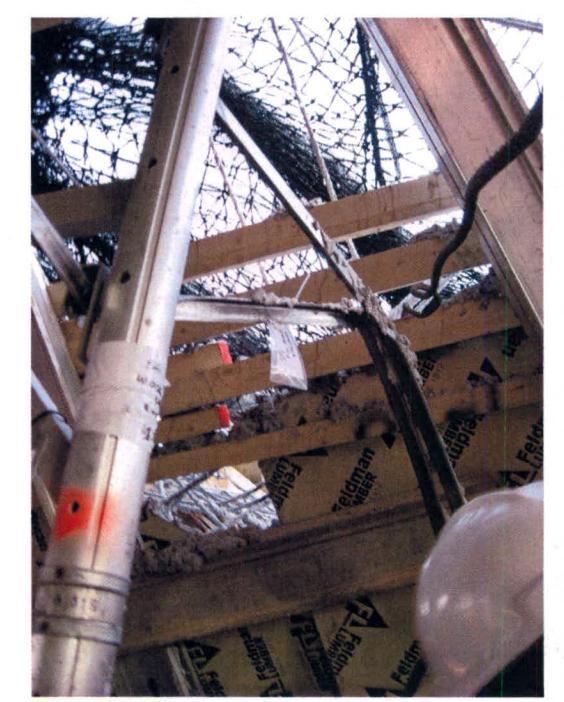
Brace connects SH 41090 and SH 41006 Zone 41F

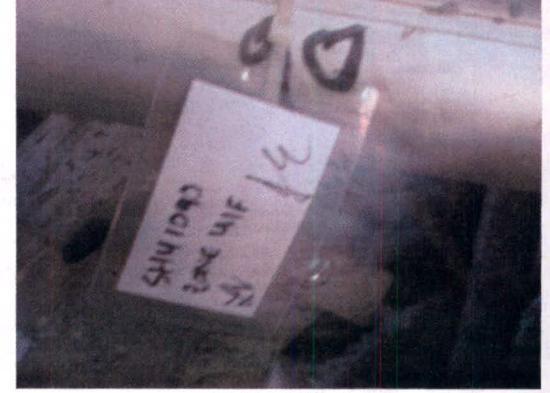
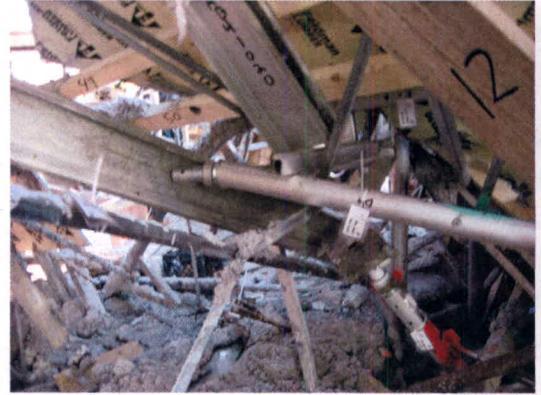
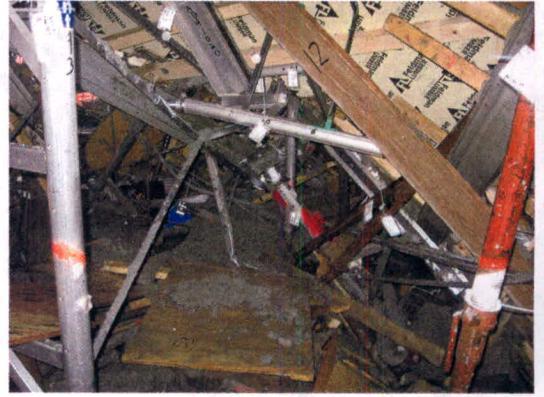
Folder: 08-02-12; 08-02-12; SH 41090

SH 41090 Top Frame with SH 41091 Top Frame of SH 41042 & SH 41044

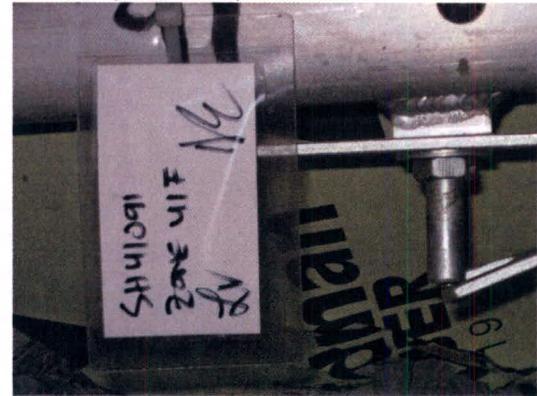
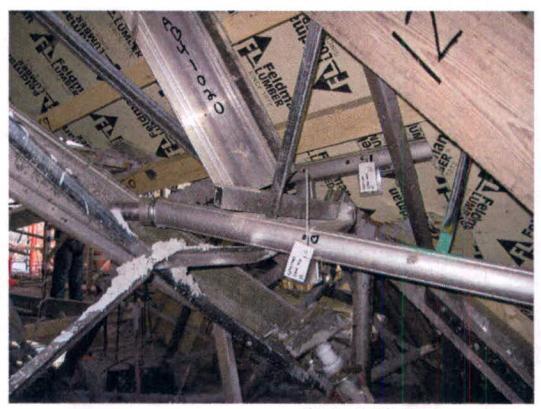
Folder: 08-02-12; 08-02-12; SH 41091

SH 41091 Broken with SH 41090 Top Frame of SH 41042 & SH 41044 Half piece of SH 41092 Zone 41F

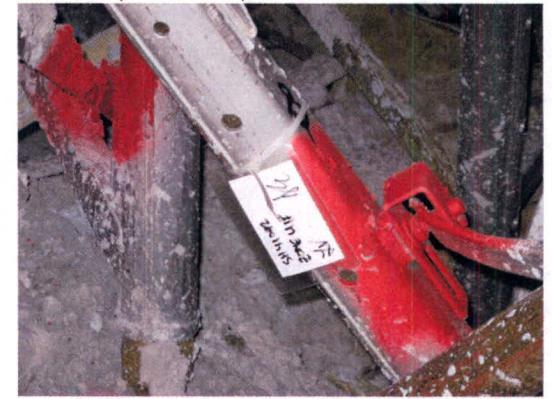
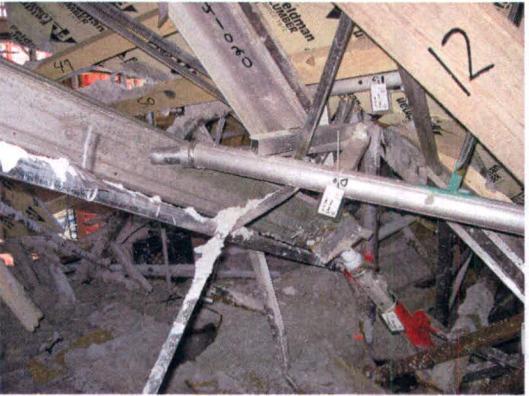
Folder: 08-02-12; 08-02-12; SH 41092

SH 41092 Broken with SH 41185 Top Frame of SH 41183 Connects to SH 41029 and SH 41005 Zone 41F-G

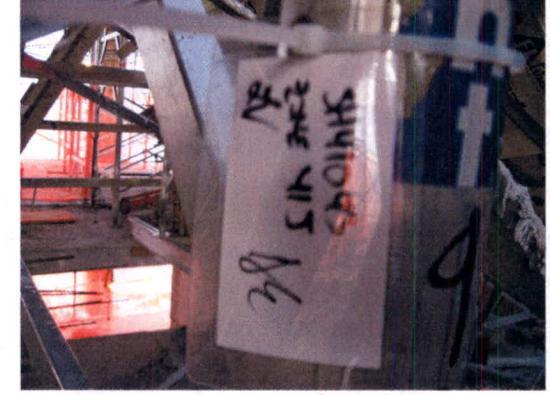
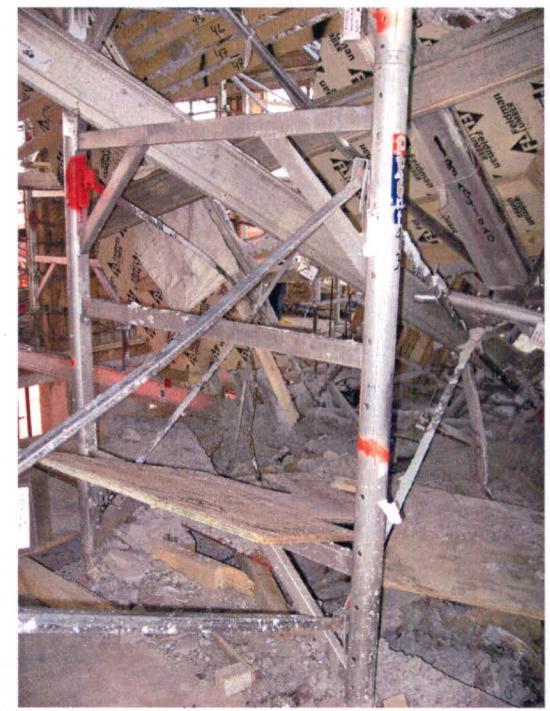
Folder: 08-02-12; 08-02-12; SH 41093

SH 41093 Bottom Frame of SH 41006 Connect to SH 41029 Zone 41J

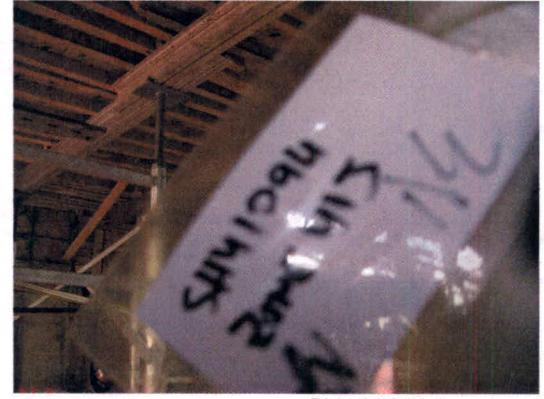
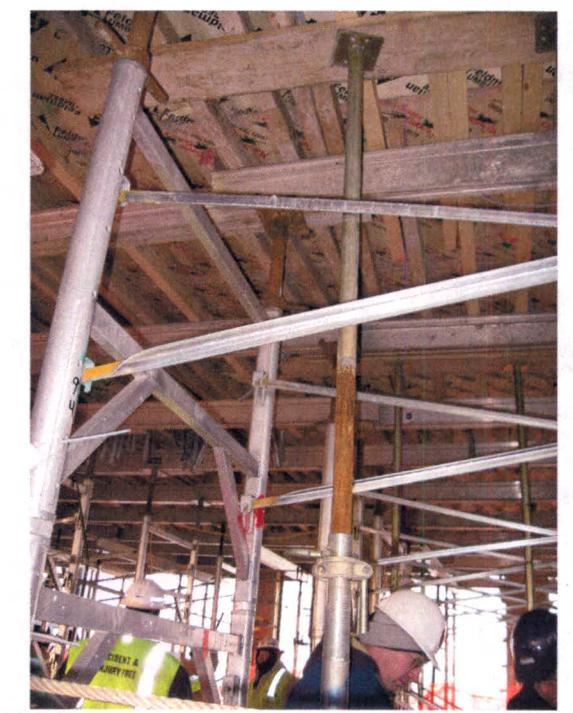
Folder: 08-02-12; 08-02-12; SH 41094

SH 41094 Top frame of SH 41095 Zone 41J

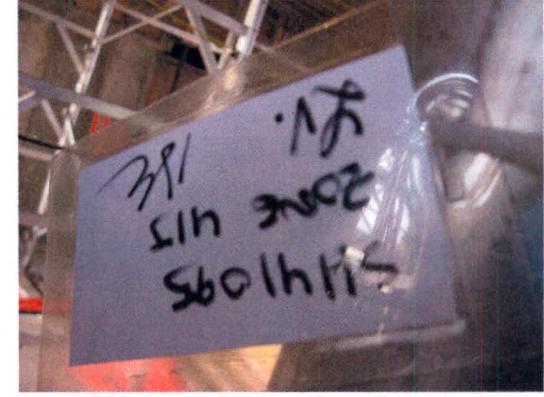
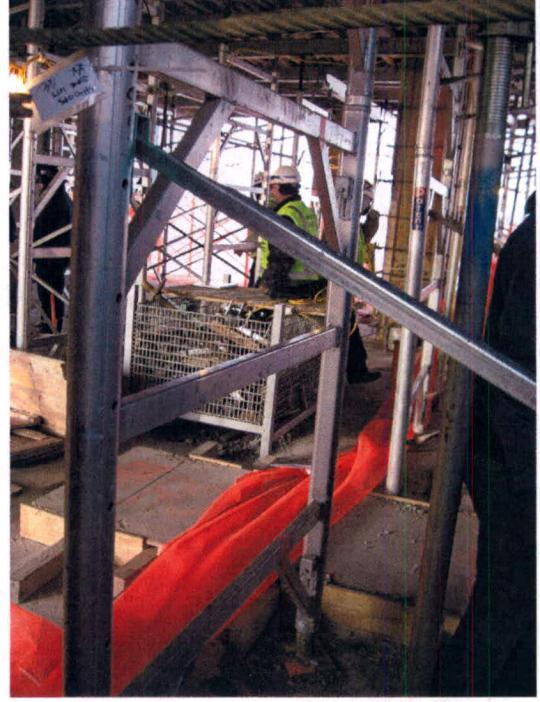
Folder: 08-02-12; 08-02-12; SH 41095

Bottom Frame of SH 41094 Connects to SH 41087 and SH 41086 Zone 41J

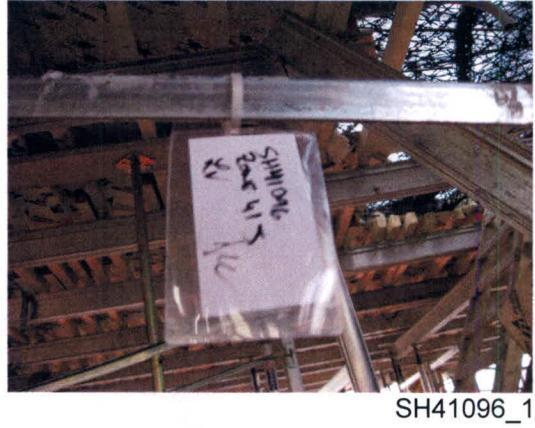
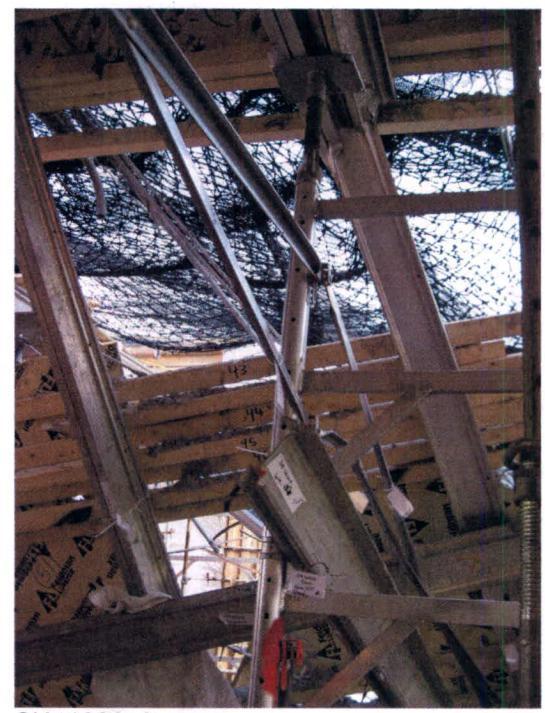
Folder: 08-02-12; 08-02-12; SH 41096

Brace connects SH 41094 and SH 41006 Zone 41F

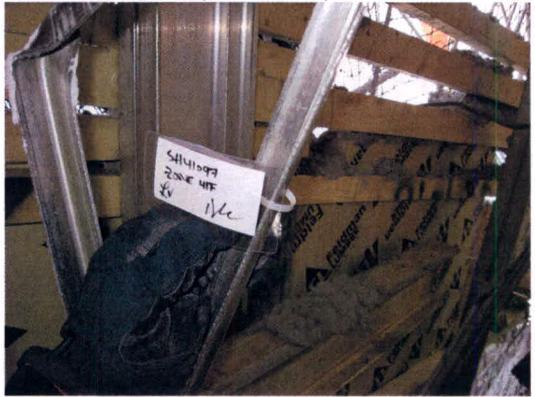
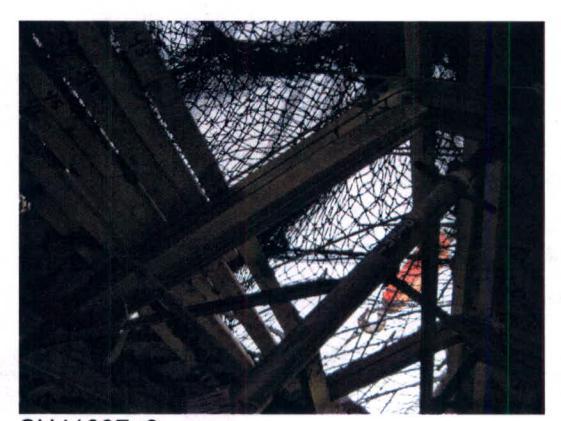
Folder: 08-02-12; 08-02-12; SH 41097

SH 41097 Top Brace connects SH 41091 Zone 41F

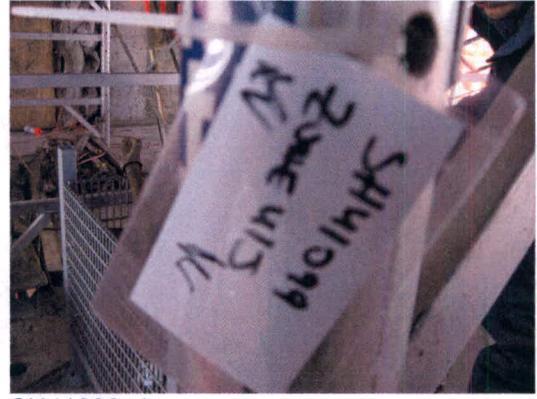
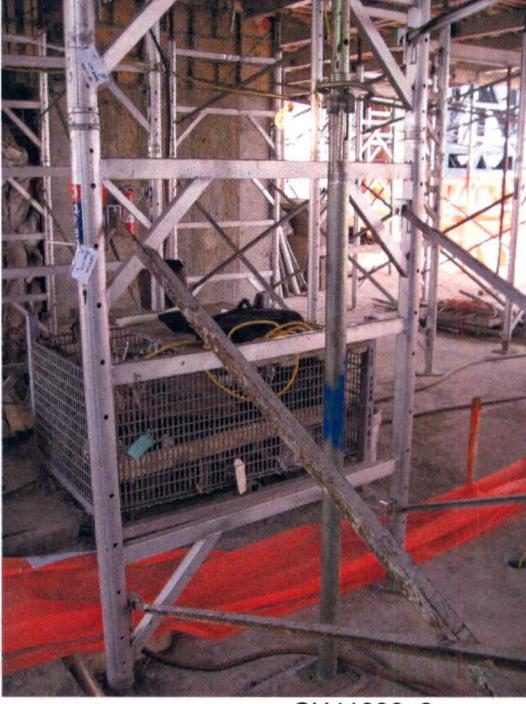
Folder: 08-02-12; 08-02-12; SH 41099

SH 41099 Bottom Frame of SH 41100 Connect to brace SH 41101 Zone 41J

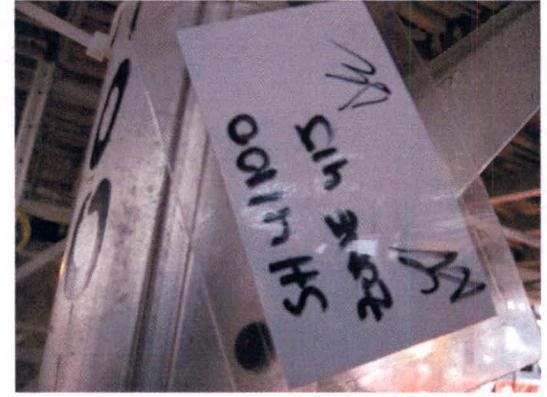
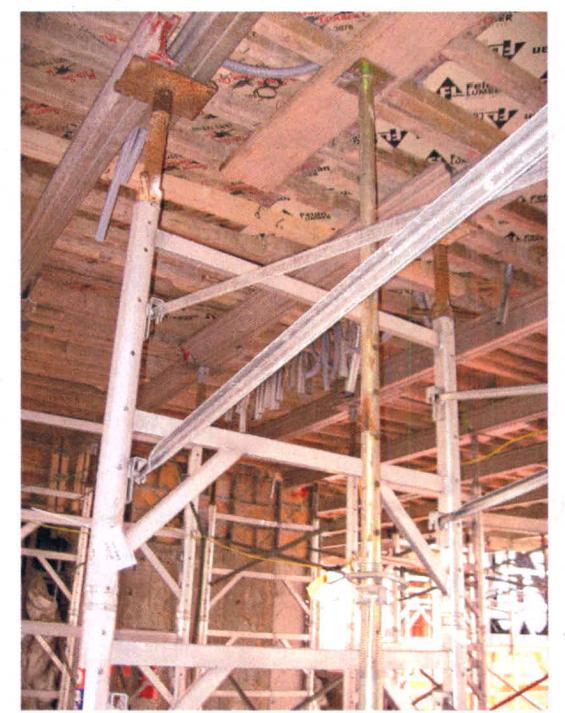
Folder: 08-02-12; 08-02-12; SH 41100

SH 41100 Top frame of SH 41099 Zone 41J

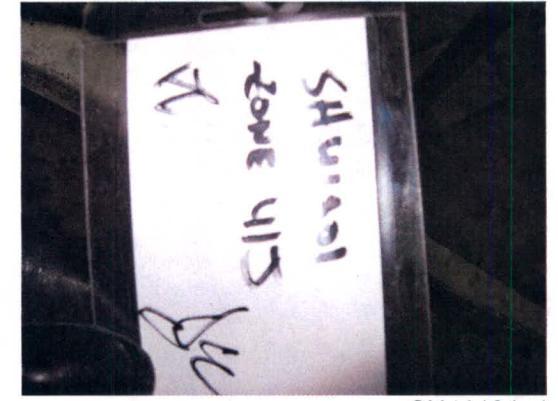
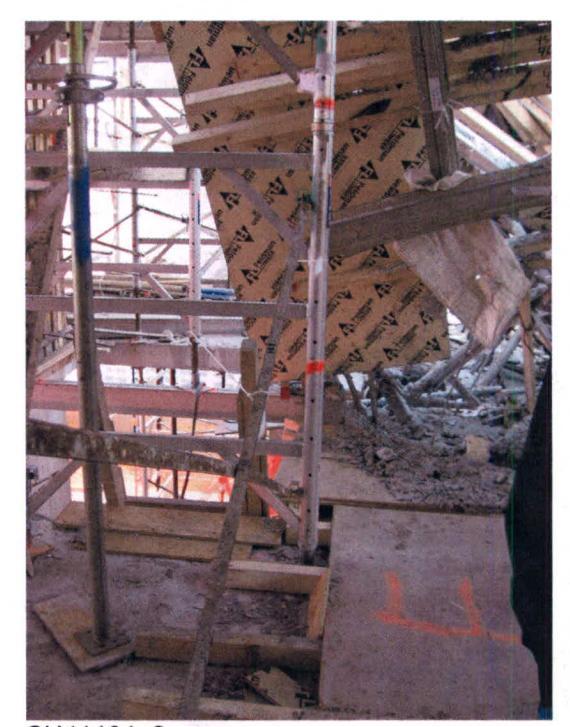
Folder: 08-02-12; 08-02-12; SH 41101

SH 41101 Brace of SH 41099 Zone 41J

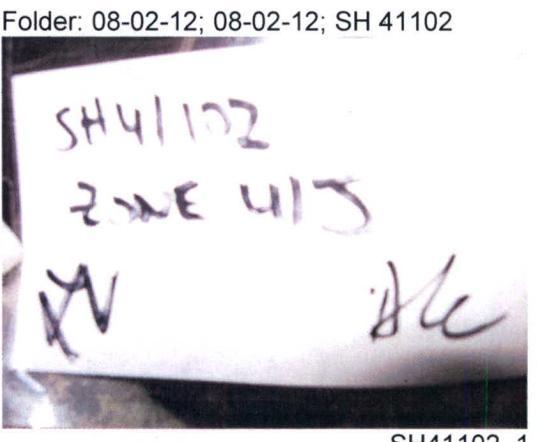
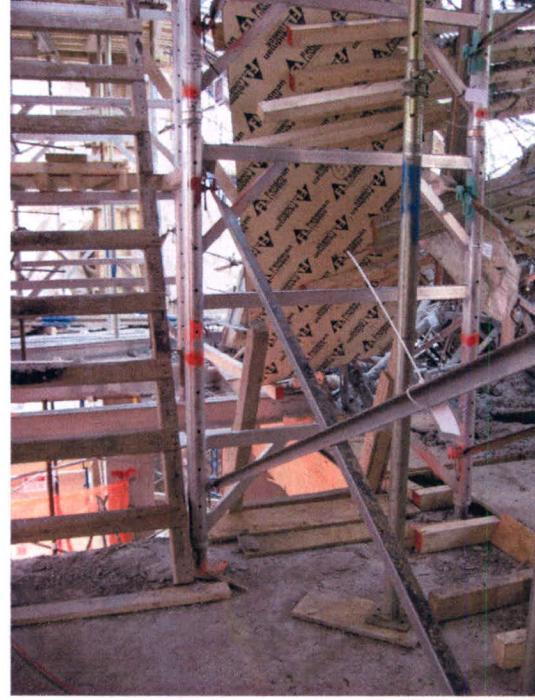
SH41102_1

SH 41102 Bottom Brace for SH 41099 Top Shore is SH 41007 Zone 41J

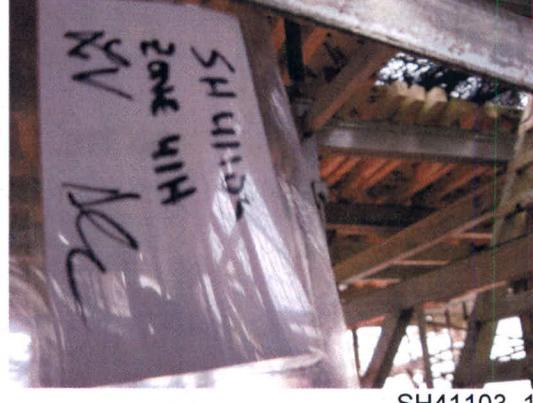
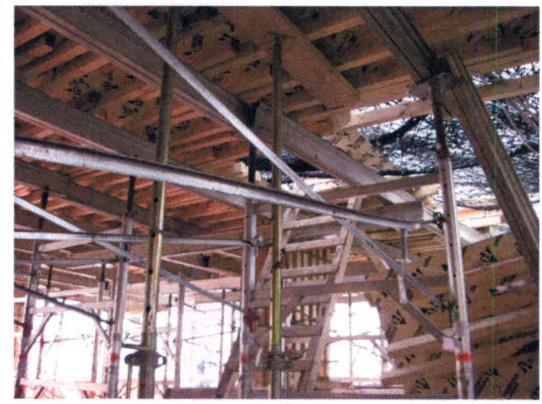
SH41103_1

SH 41103 Top brace Brace connects SH 41007 and SH 41100 Zone 41J

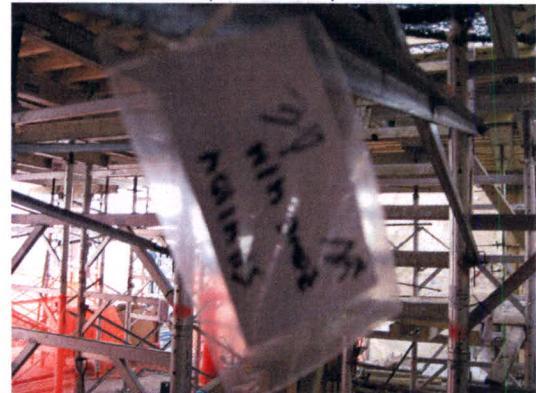
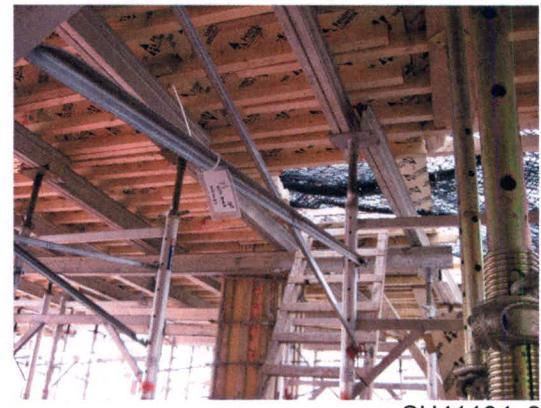
SH41104_1

SH 41104 Top brace Brace Connects to SH 41007 and SH 41100 Zone 41H

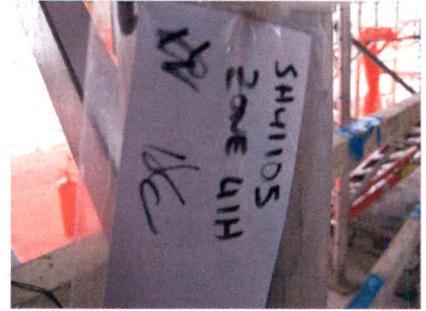
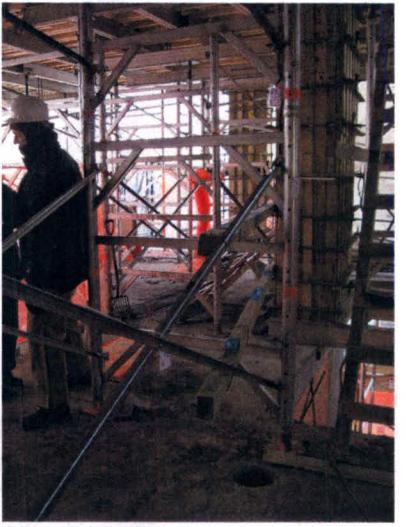
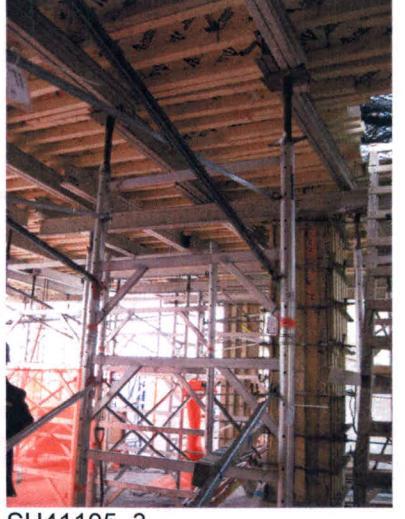
SH41105_1

Bottom Frame of SH 41008 Connects to brace SH 41108 and SH 41109 Zone 41H

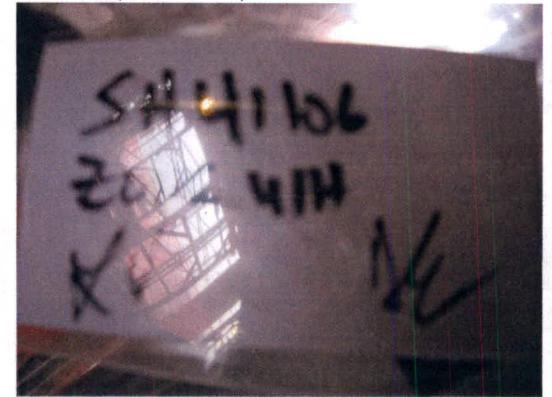
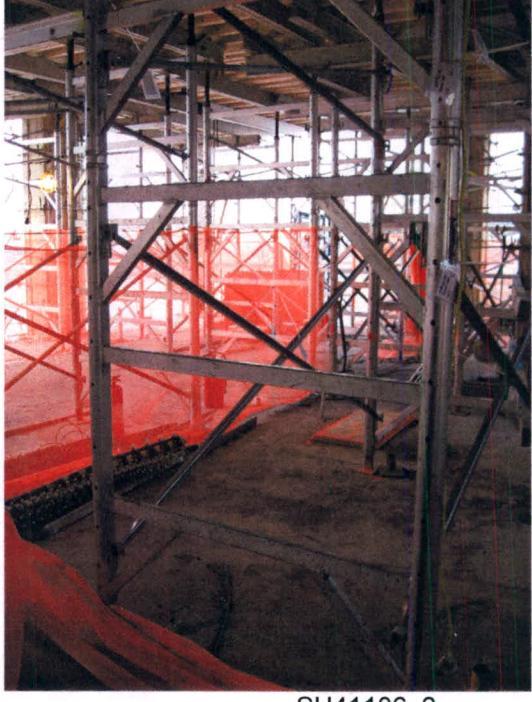
SH41106_1

Bottom Frame of SH 41107 Connects to brace SH 41108 and SH 41109 Zone 41H

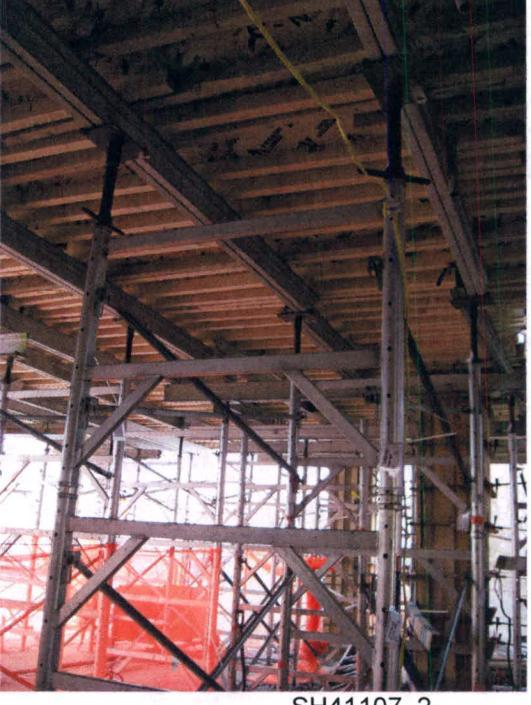
SH41107_1

Top frame of SH 41106 Connects to SH 4110 and SH 41111 Zone 41H

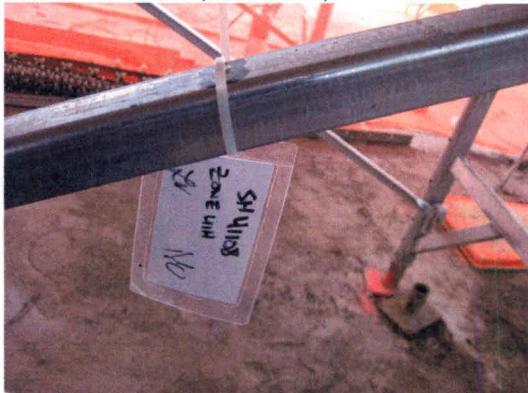
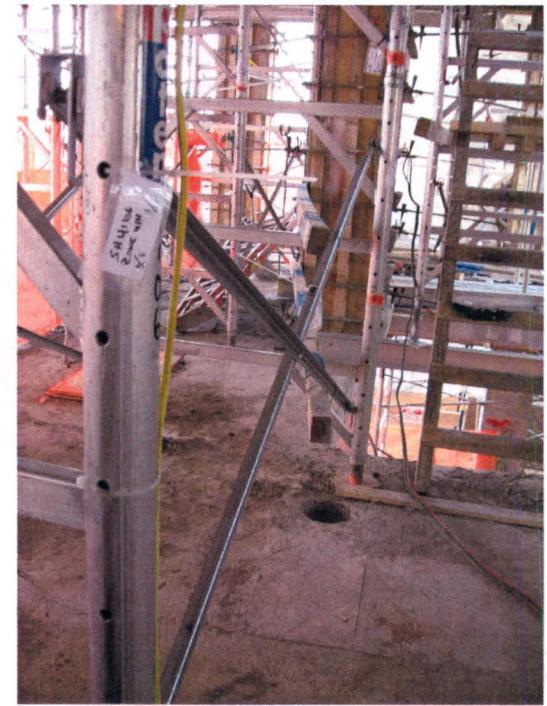
SH41108_1

SH 41108 Bottom Brace Brace of SH 41105 and SH 41106 Zone 41H

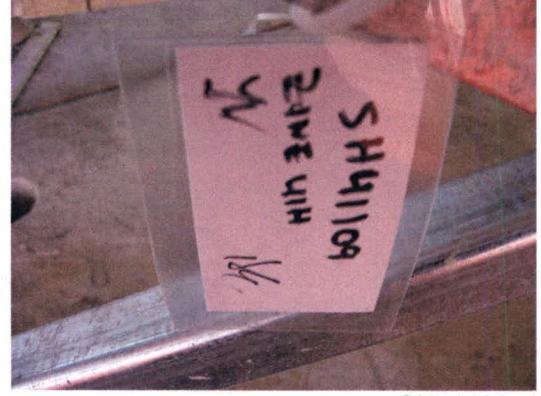
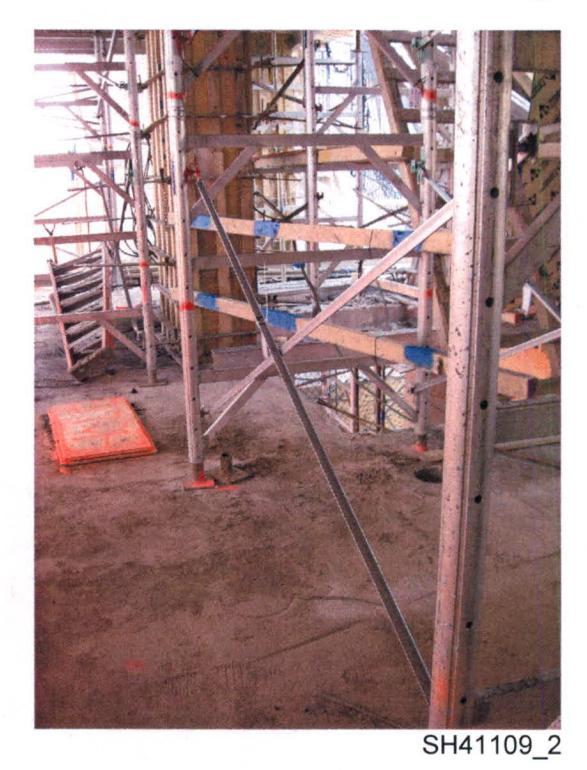
SH41109_1

SH 41109 Brace Connects SH 41105 and SH 41106 Zone 41H

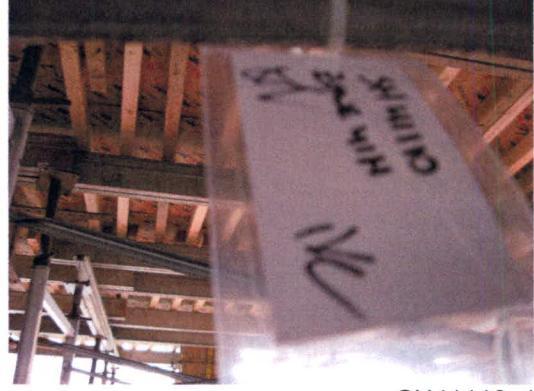
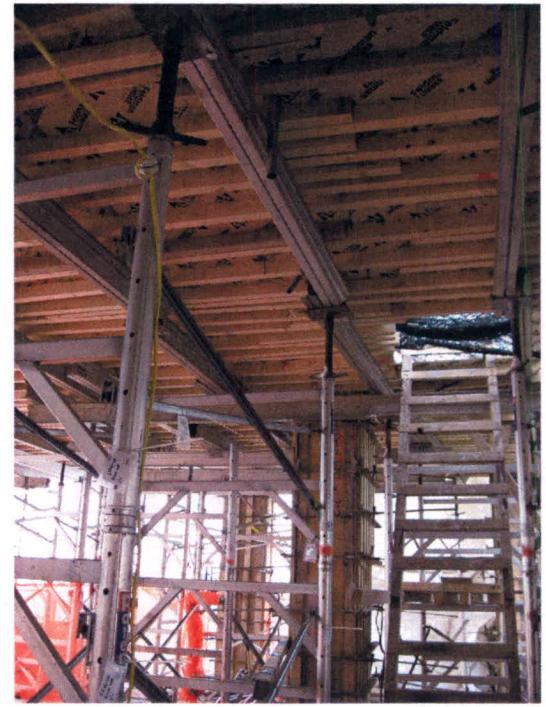
SH41110_1

SH 41110 Brace Connects SH 41108 and SH 41107 Zone 41H

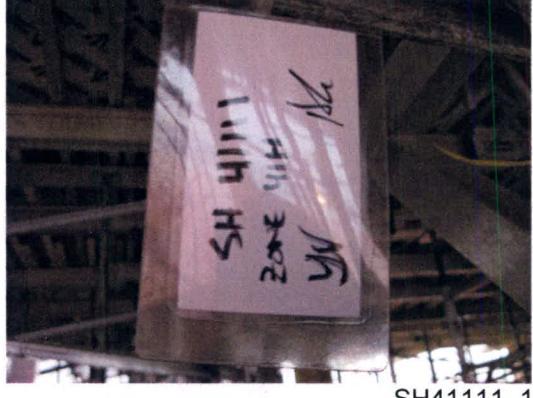
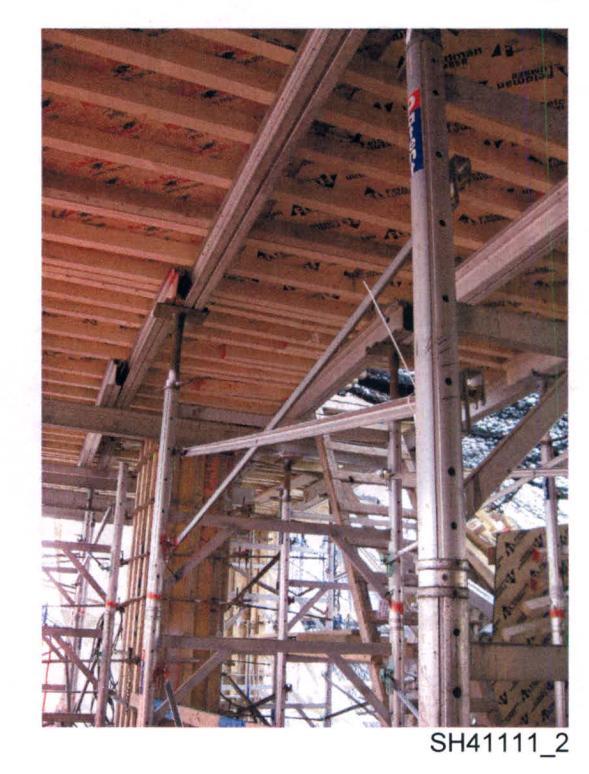
SH41111_1

SH 41111 Brace Connects to SH 41008 and SH 41107 Zone 41H

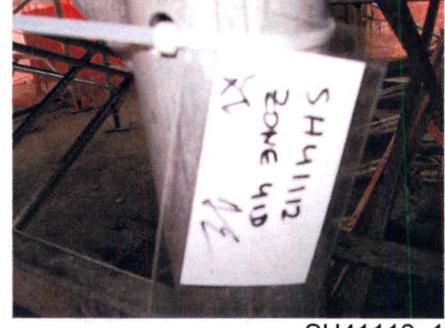
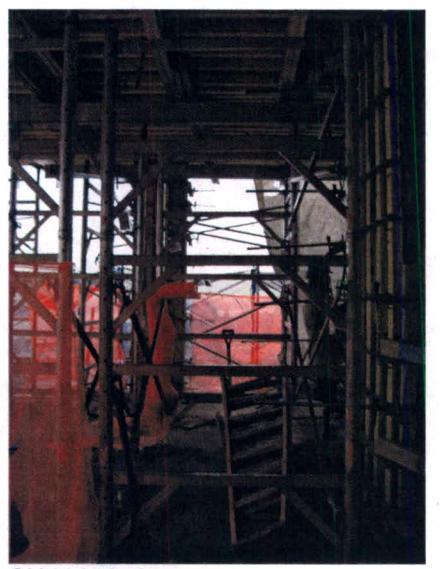
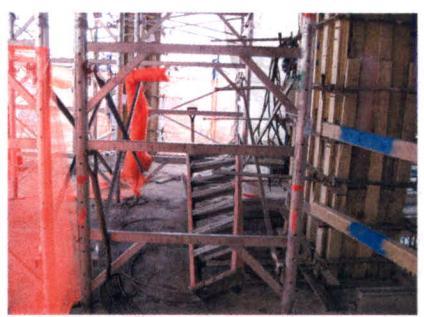
SH41112_1

SH 41112 Bottom Frame of SH 41009 Zone 41D

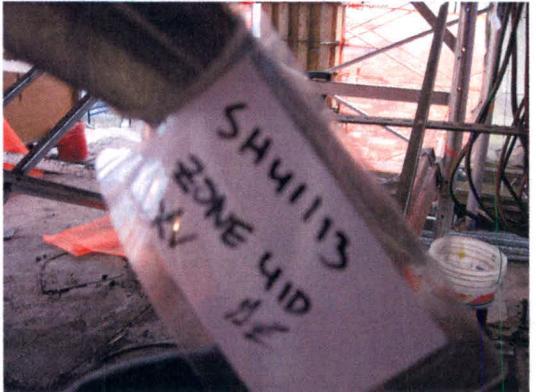
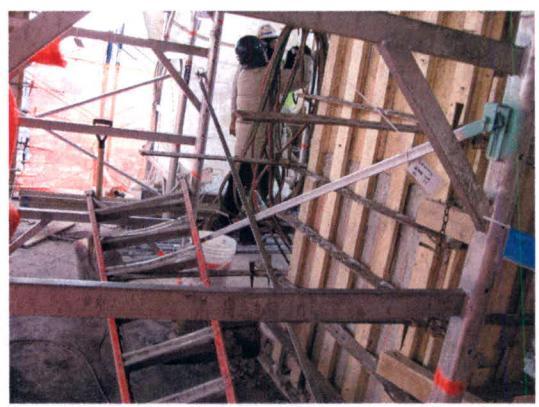
SH41113_1

SH 41113 Brace Connect SH 41115 and SH 41112 Zone 41D

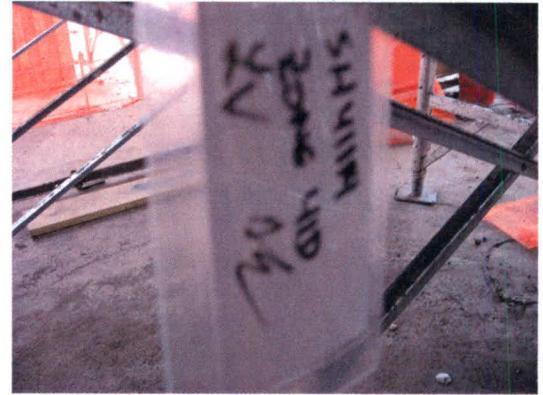
SH41114_1

SH 41114 Brace Connect to SH 41115 and SH 41112 Zone 41D

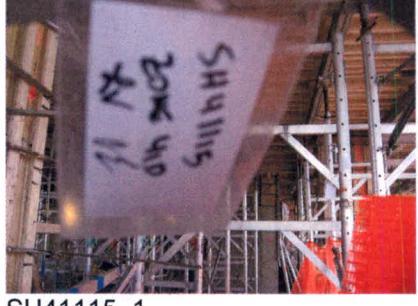
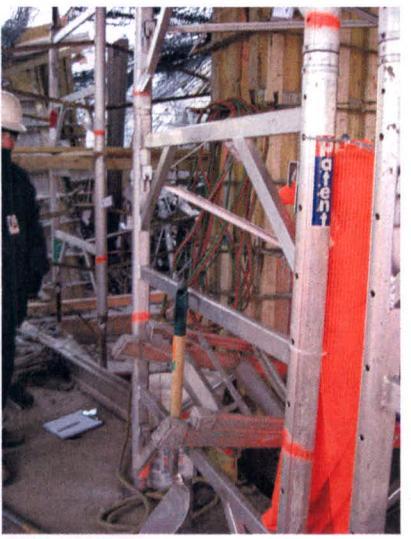
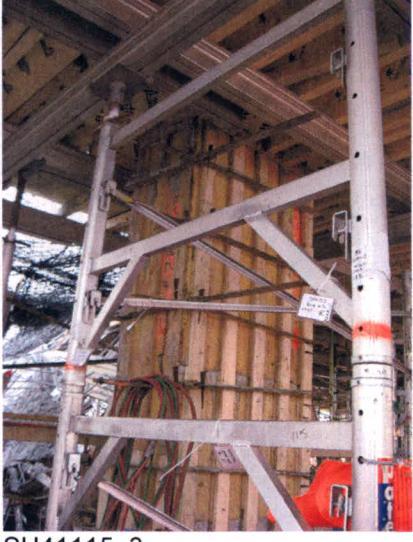
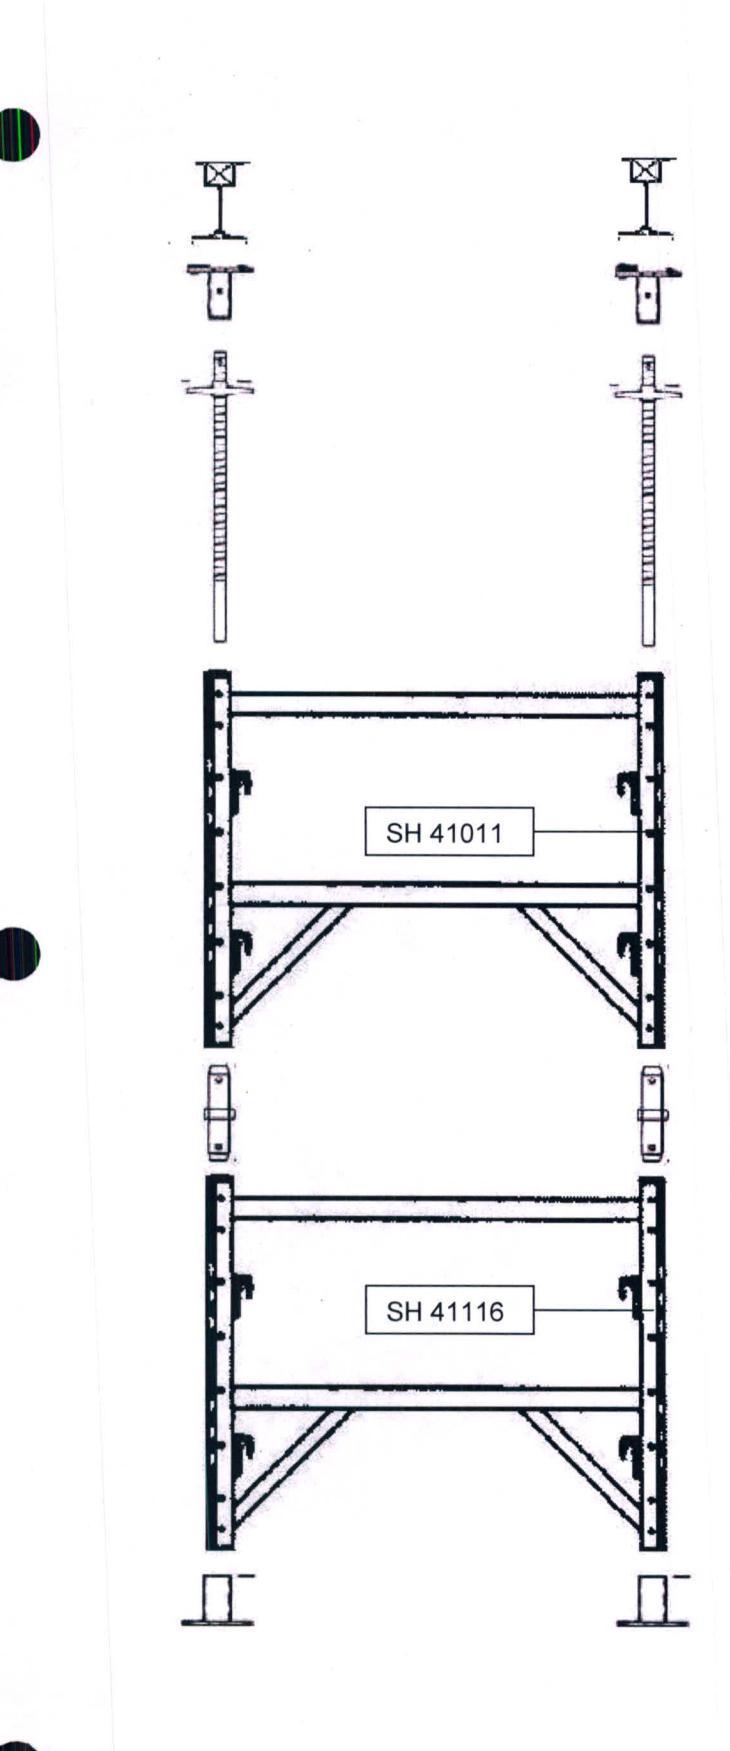
SH 41115 Bottom Frame of SH 41010 Zone 41D Folder: 08-02-12; 08-02-12; SH 41115

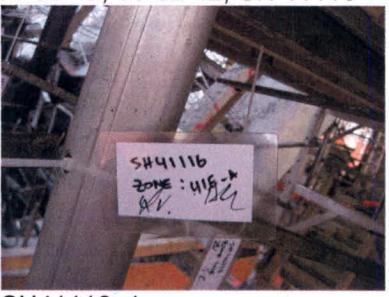
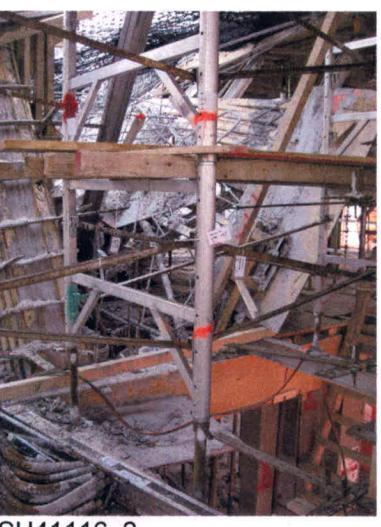
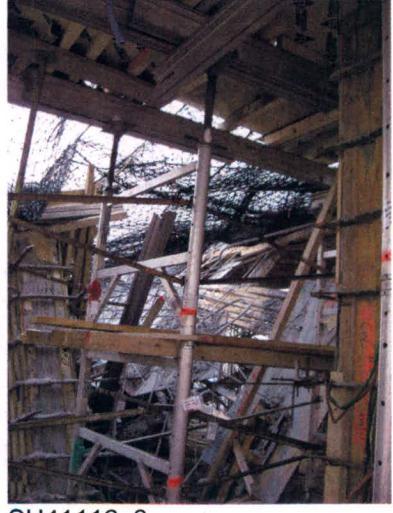
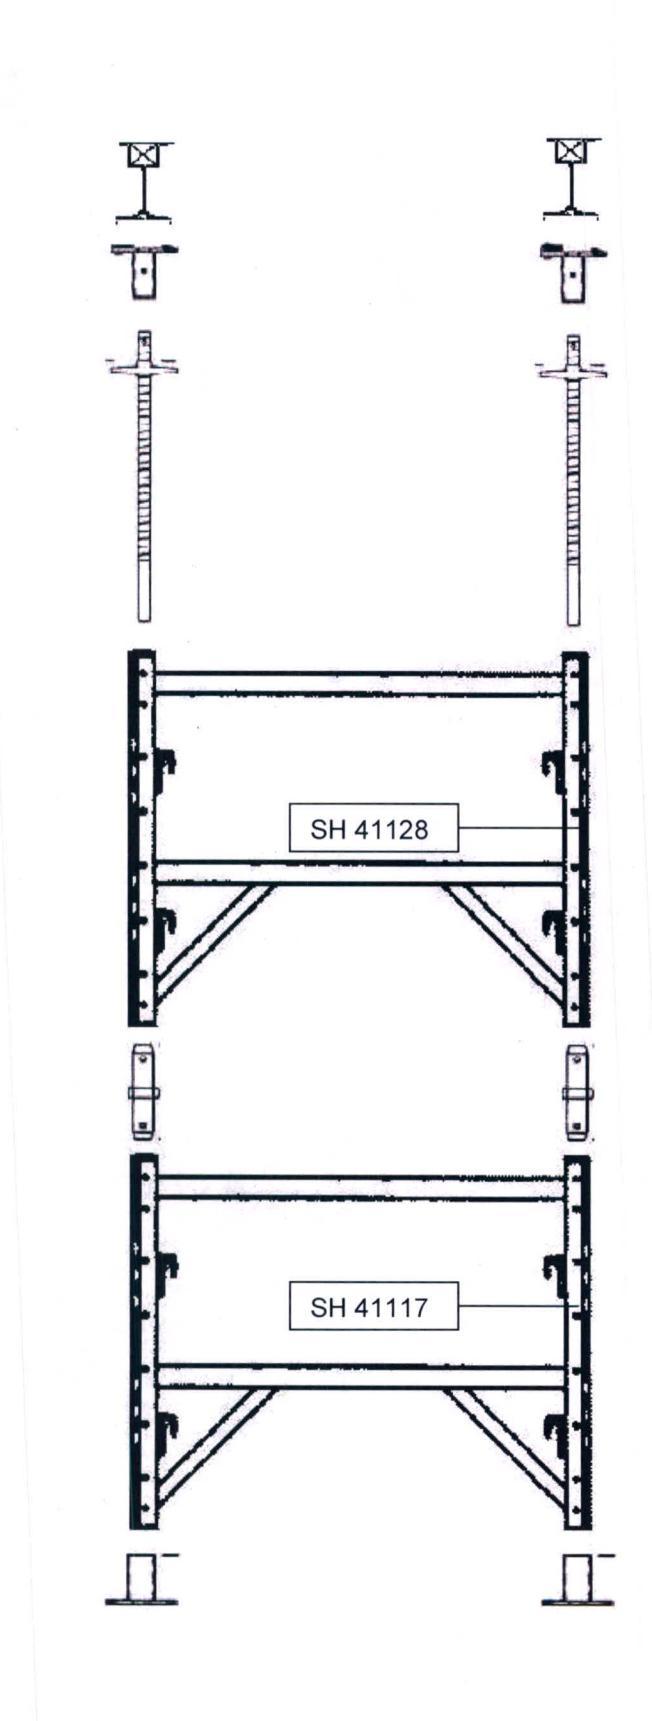
SH 41116 Bottom Frame of SH 41011 Connected to Brace SH 41118 Zone 41E-A

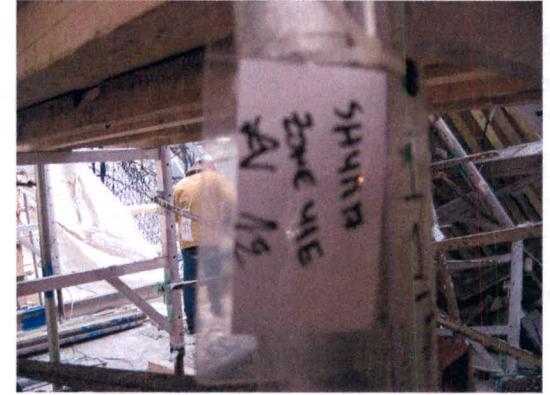
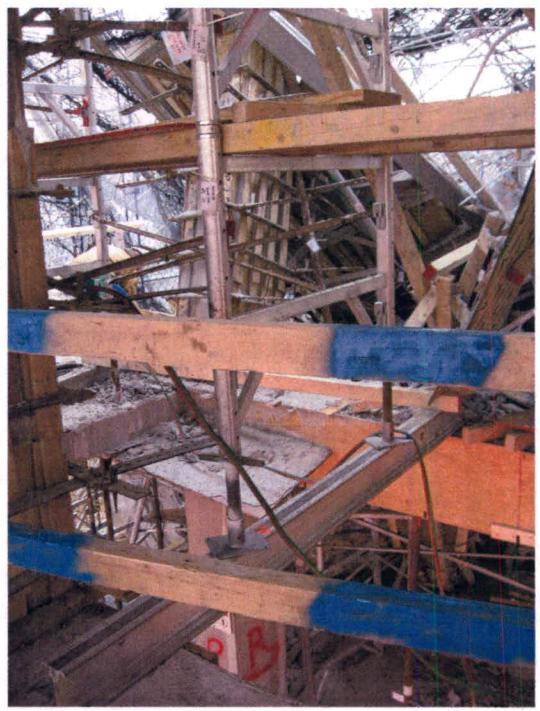
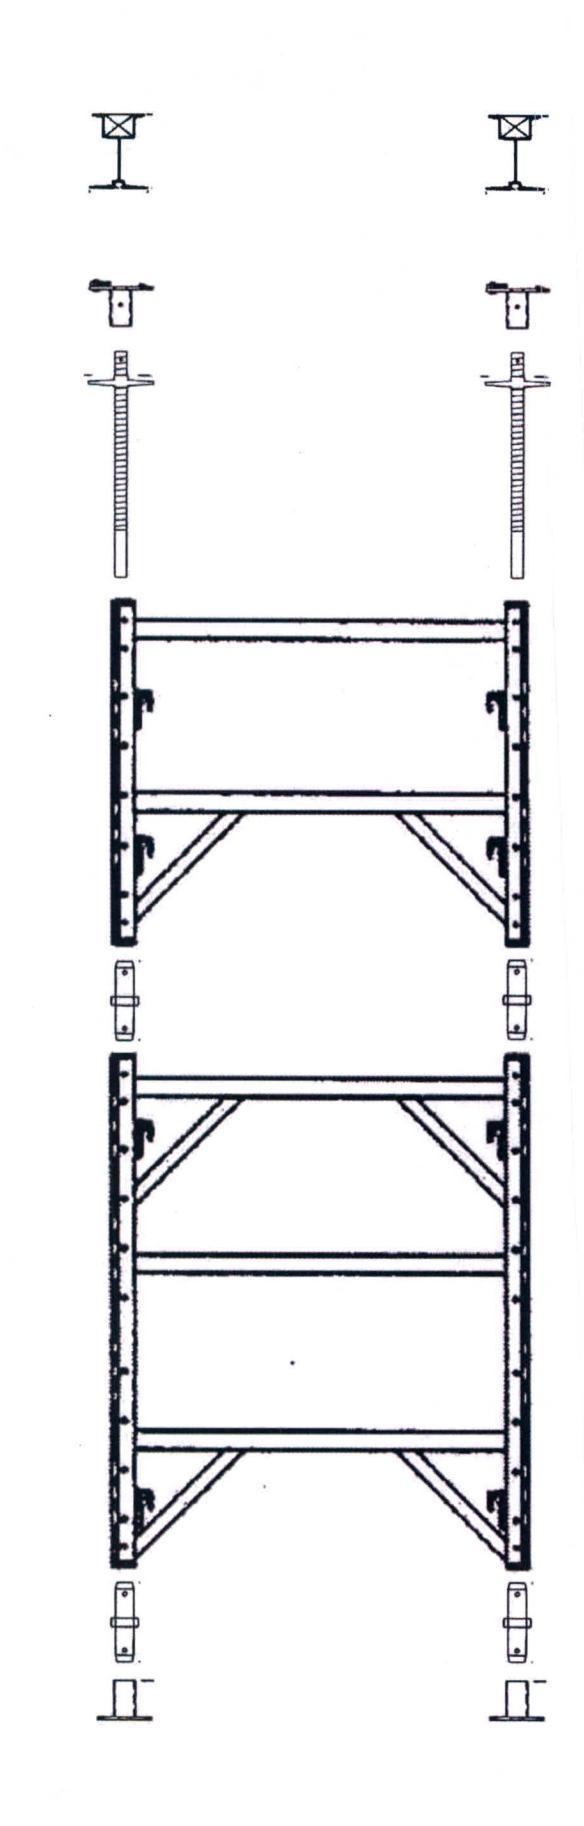
SH 41117 Bottom Frame of SH 41128 Zone 41E
