INVESTIGATION REPORT:

JANUARY 14, 2008 SHORING COLLAPSE AT 9 DOMINICK ST. (AKA 246 SPRING ST.) MANHATTAN

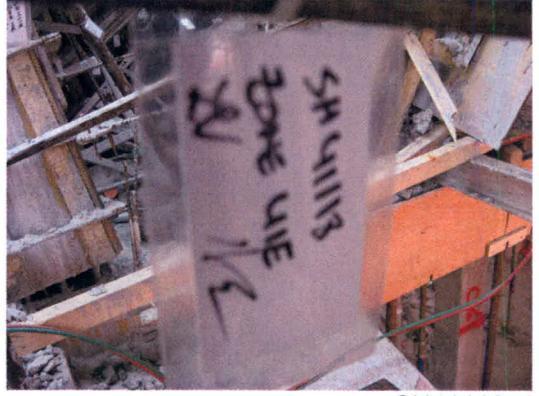
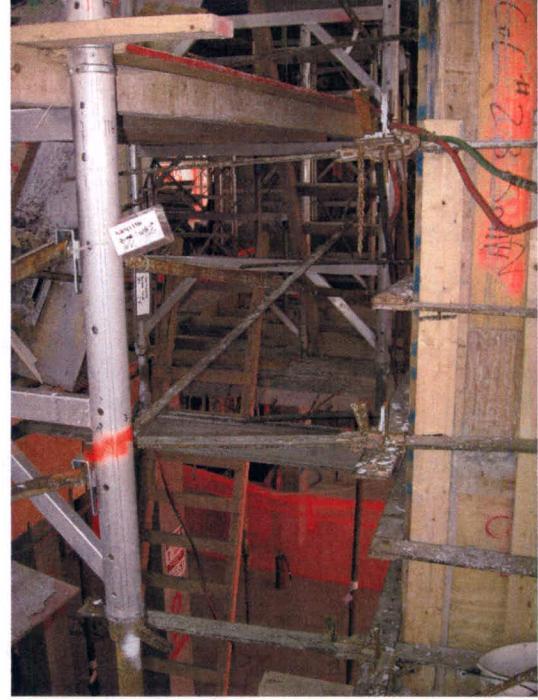
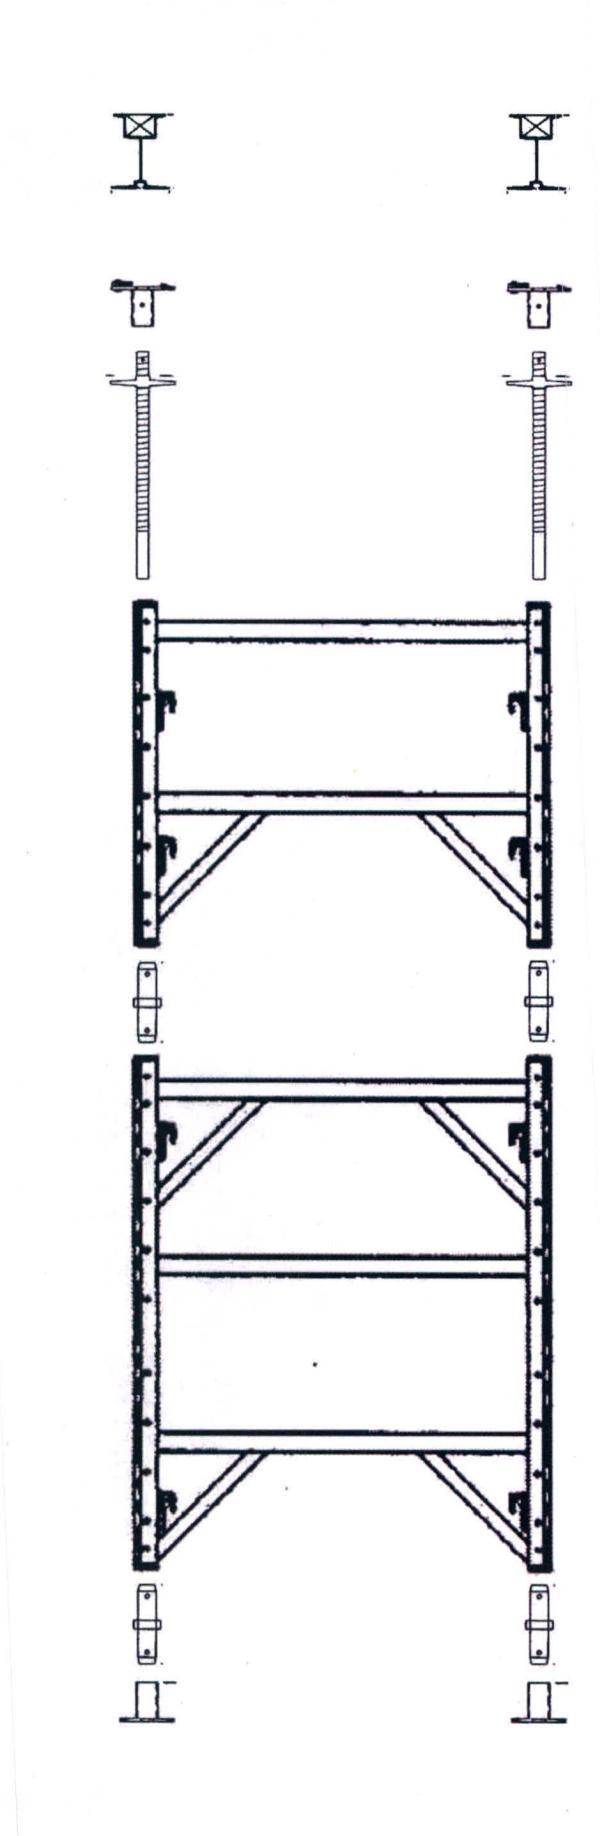
SH 41118 Bottom Brace Connecting SH 41119 and SH 41116 Zone 41E-A

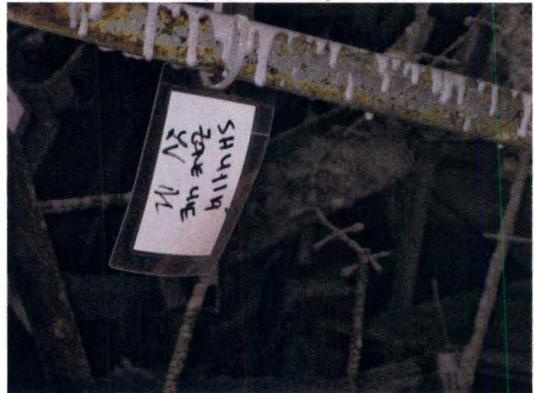
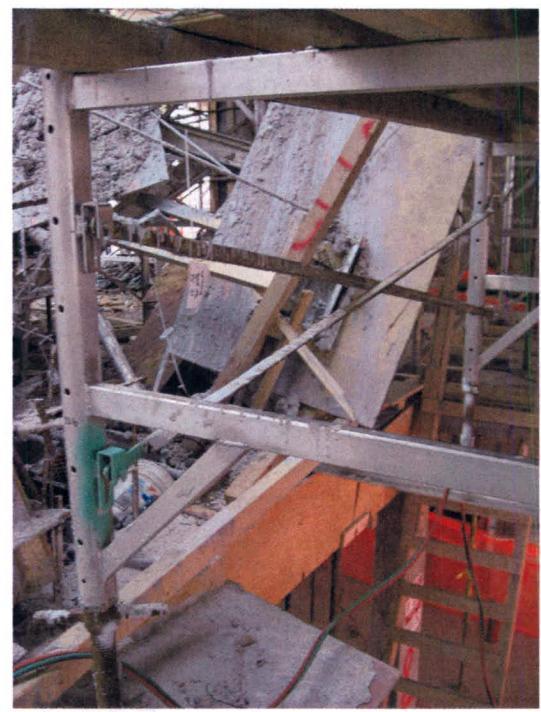
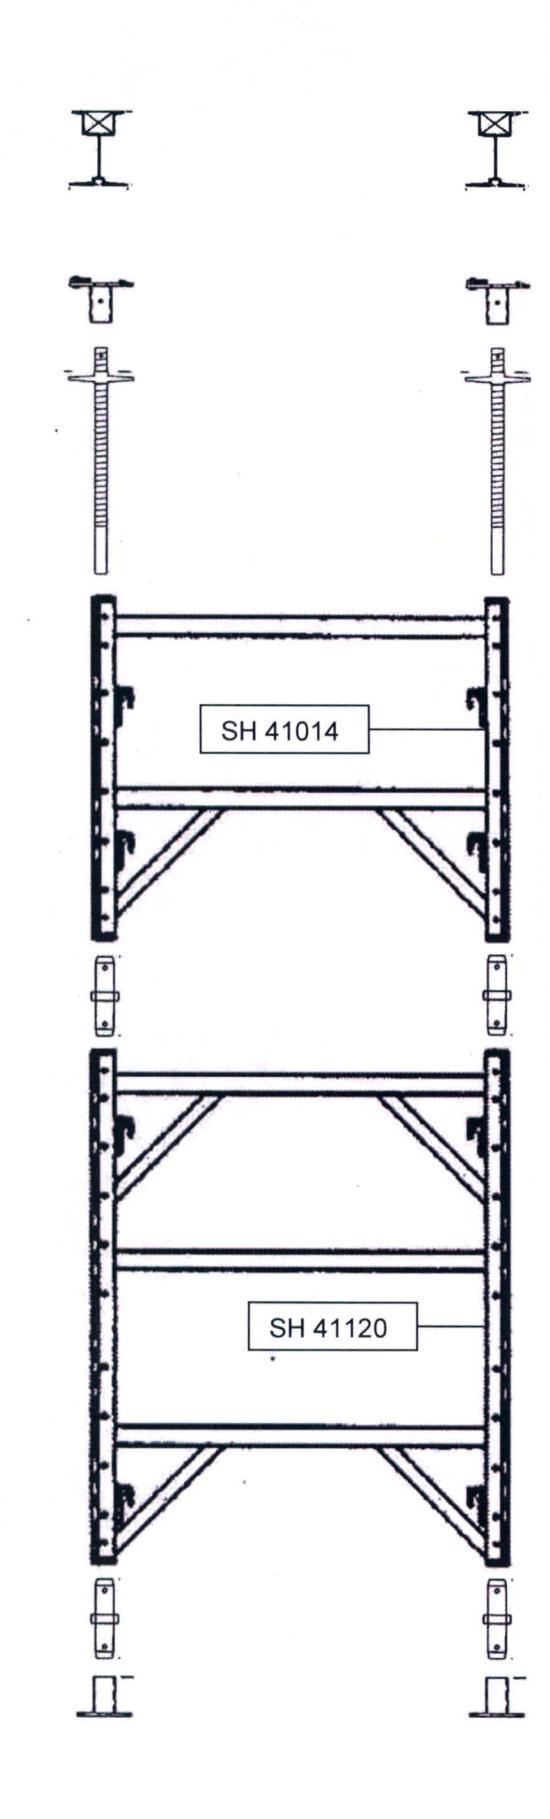
SH 41119 Bottom Brace Connecting SH 41117 and SH 41116 Zone 41E-A

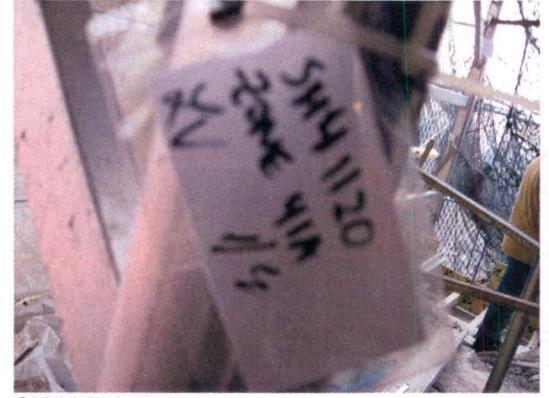
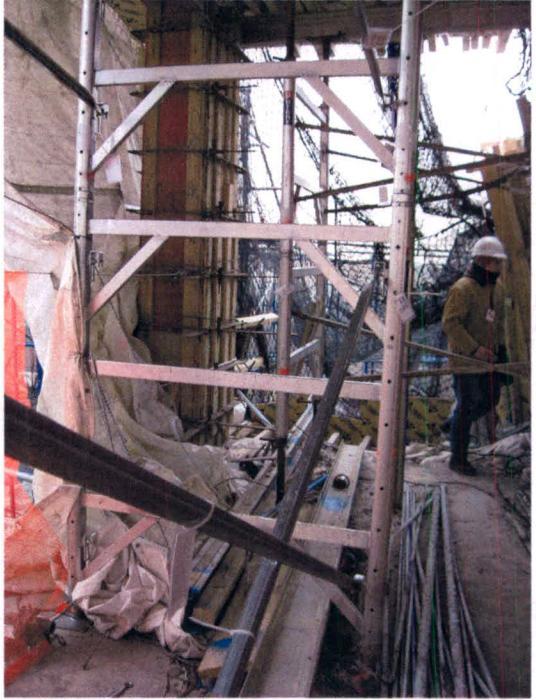
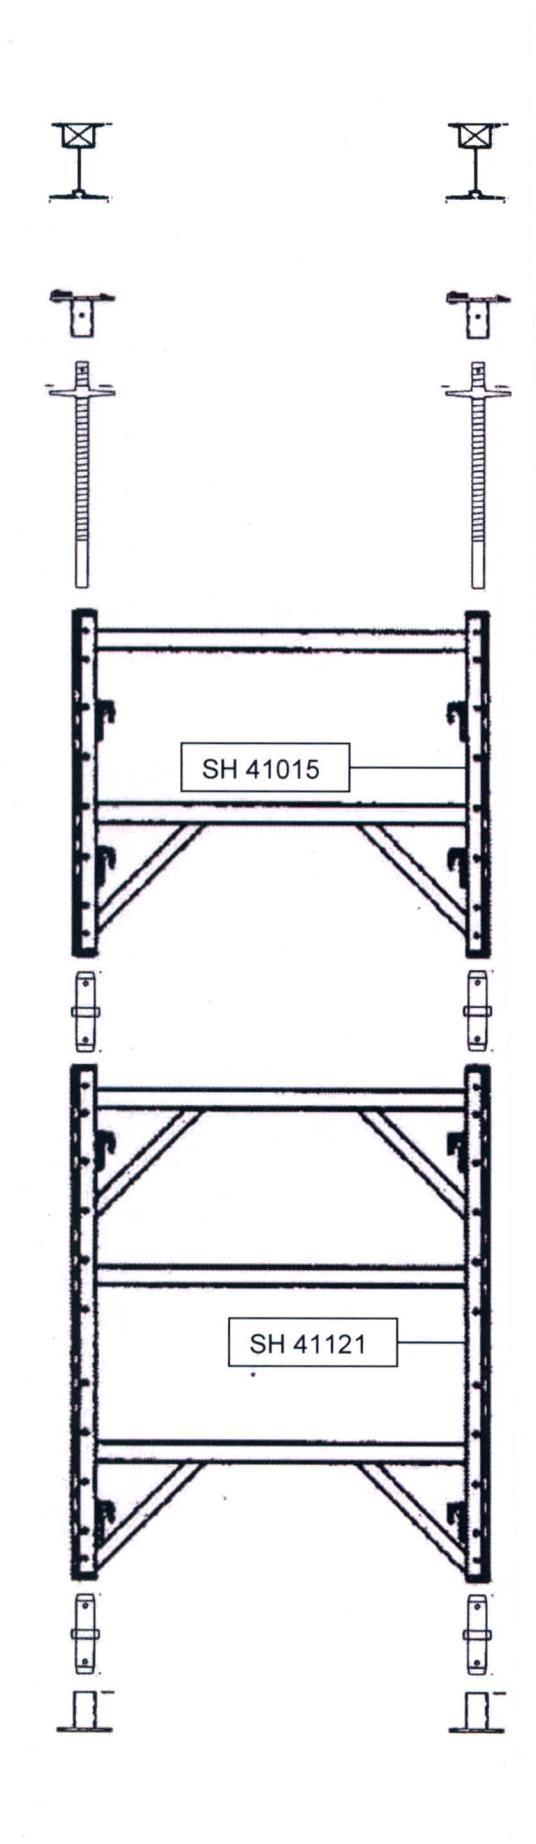
SH 41120 Bottom Frame of SH 41014 Connects to brace SH 41122 Zone 41A

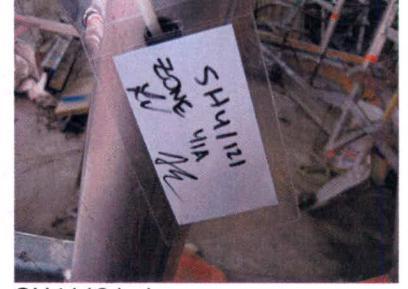
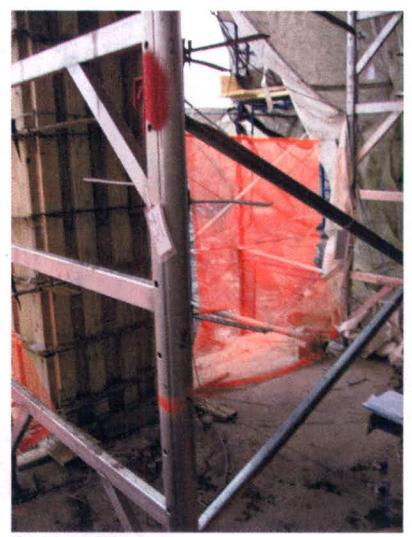
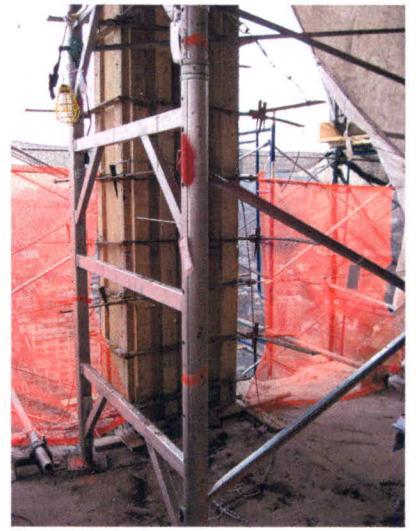
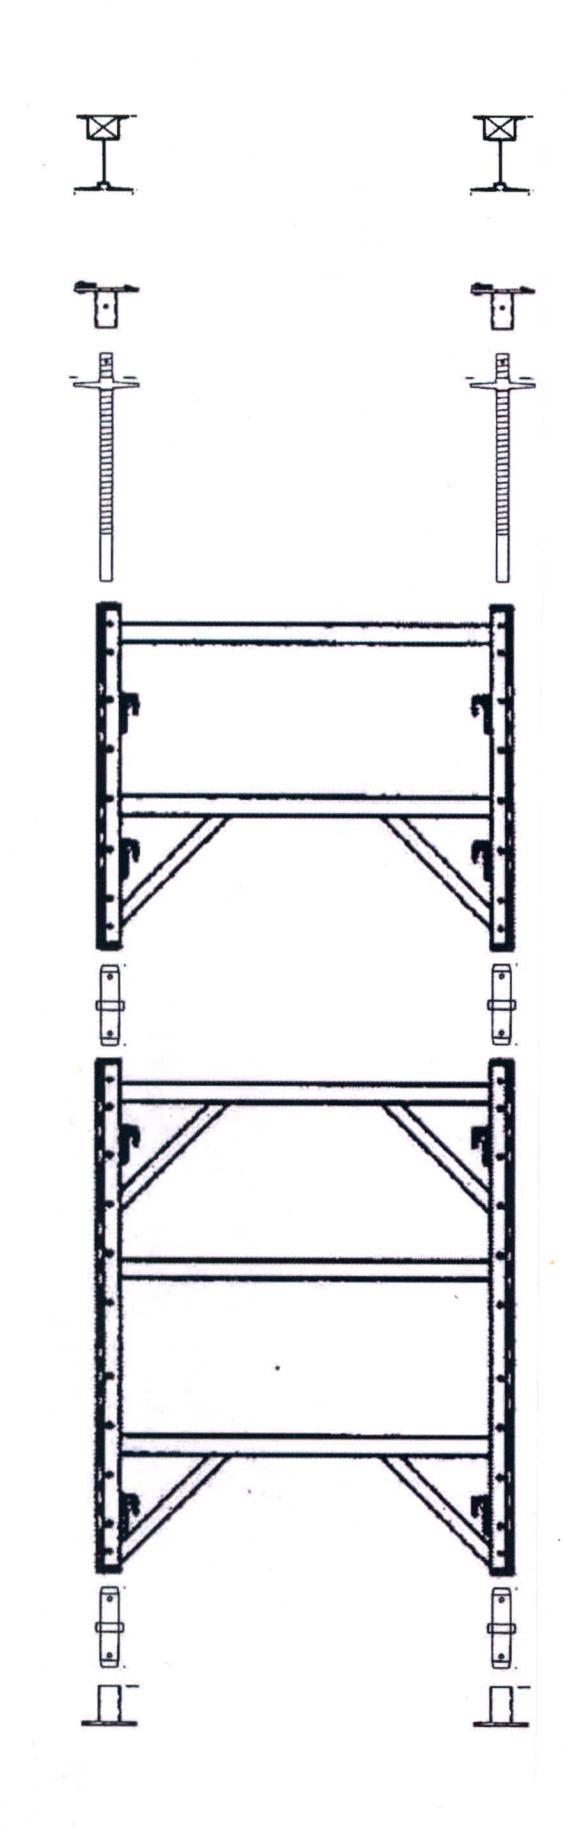
SH 41121 Bottom Shore of SH 41015 Connects by SH Zone 41A

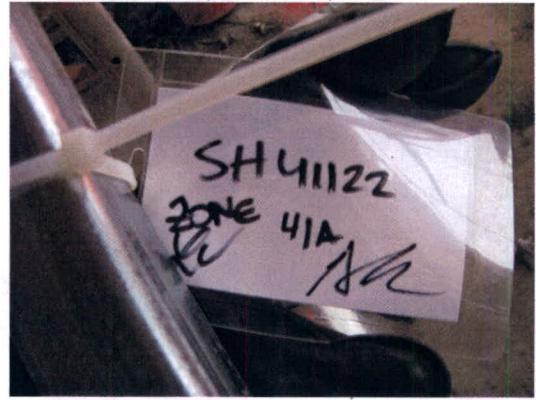
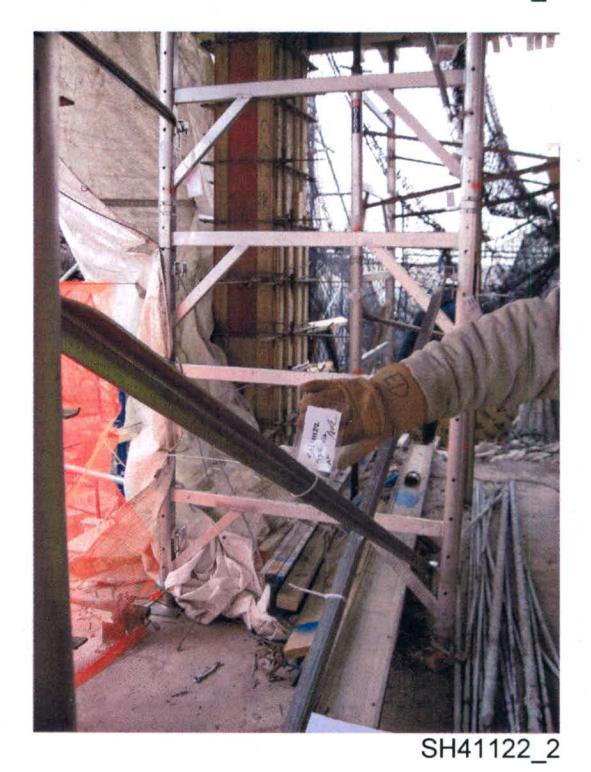
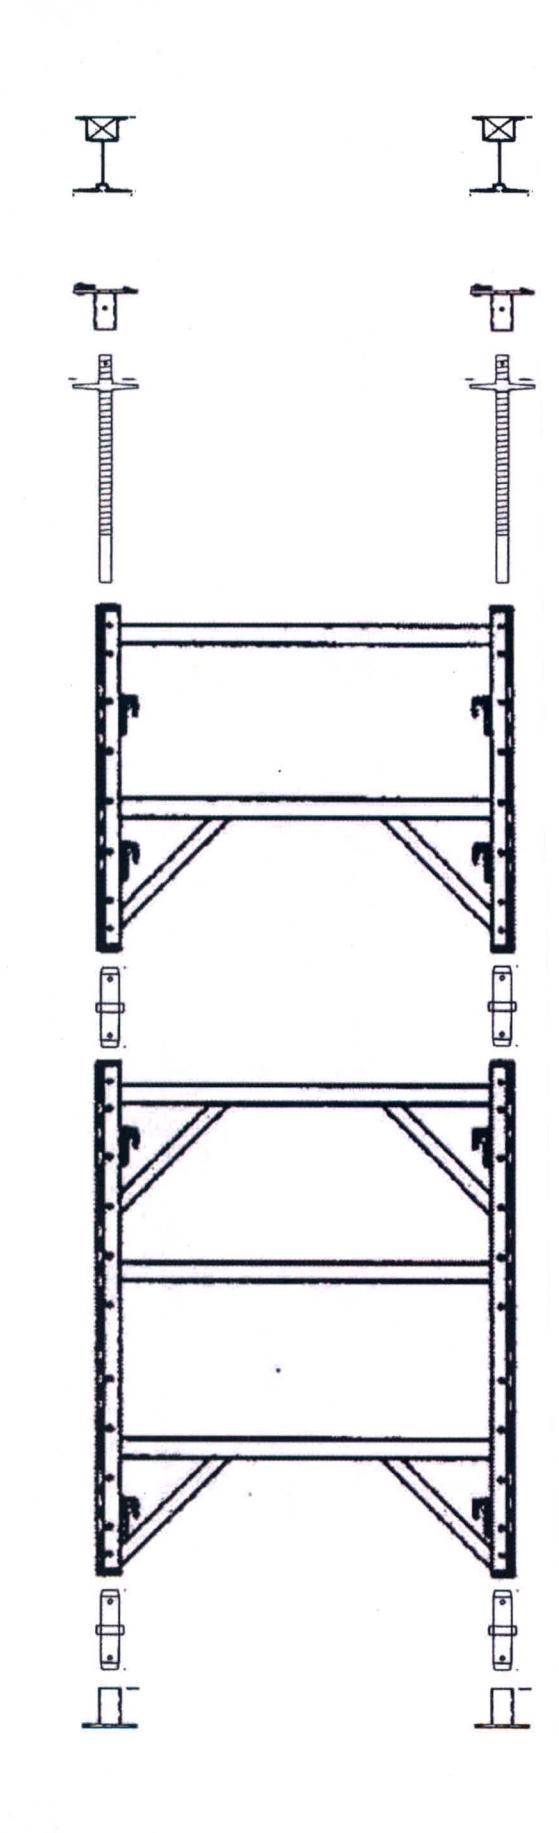
SH 41122 Bottom Brace Connects SH 41121 & SH 41120 Zone 41A

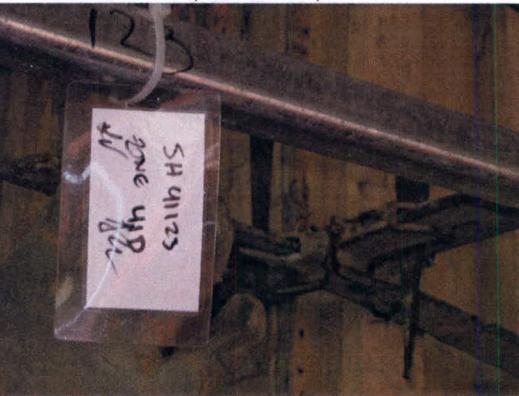
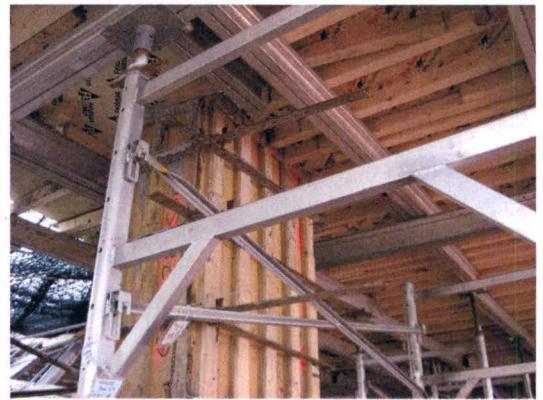
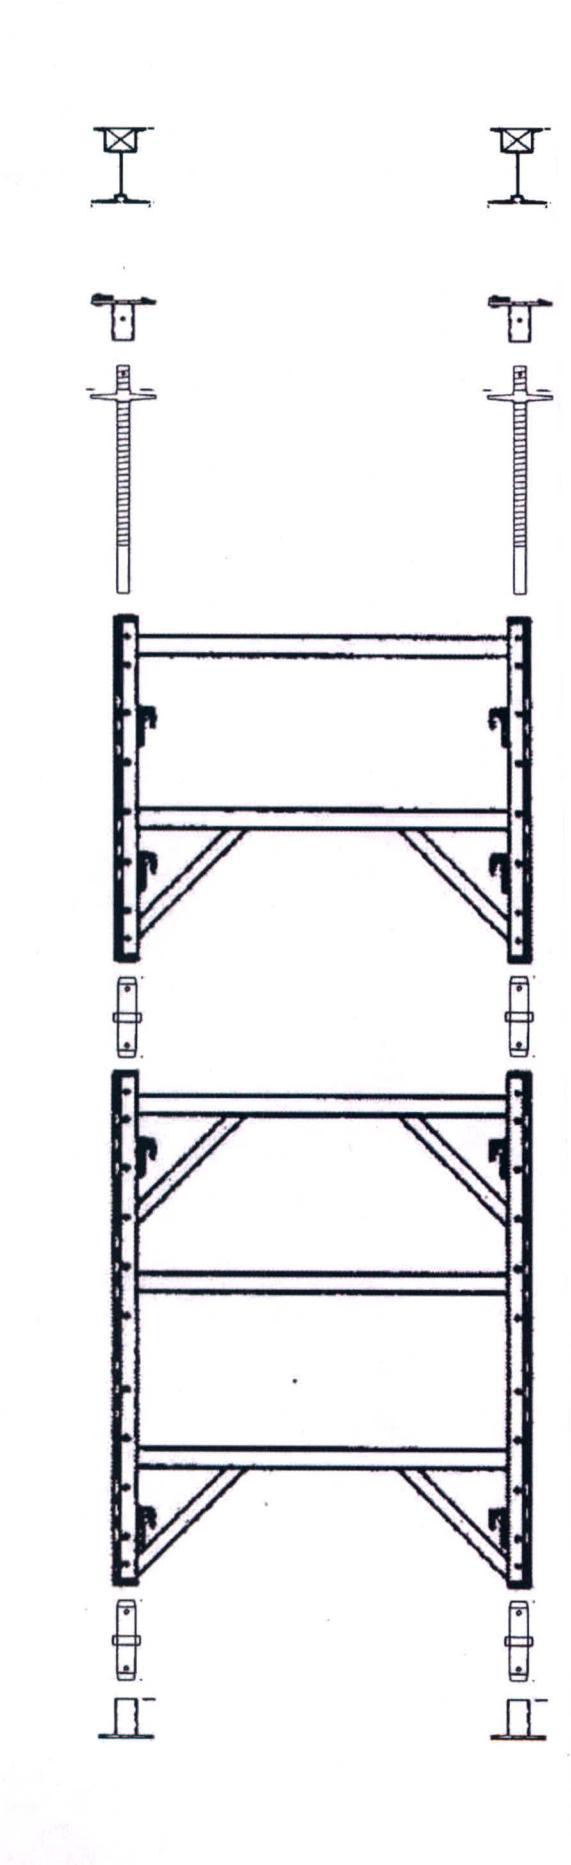
SH 41123 Top Brace Connects SH 41110 to SH 41112 Zone 41D

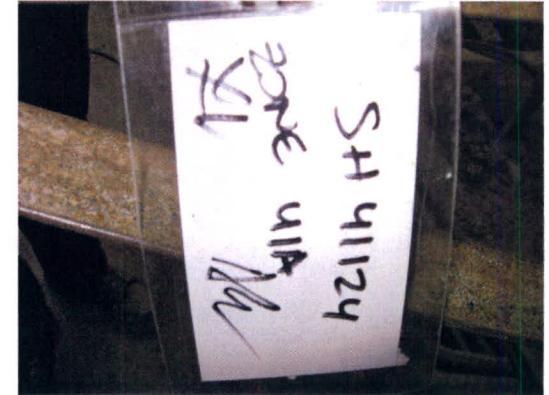
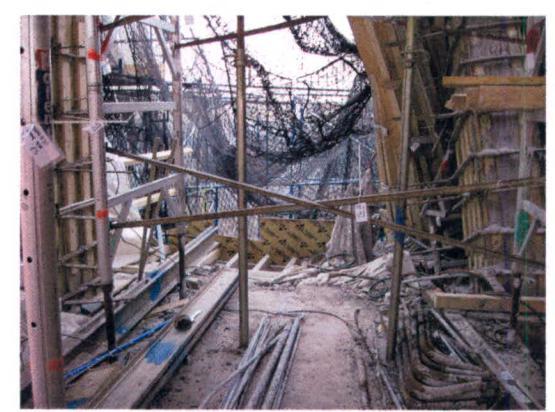
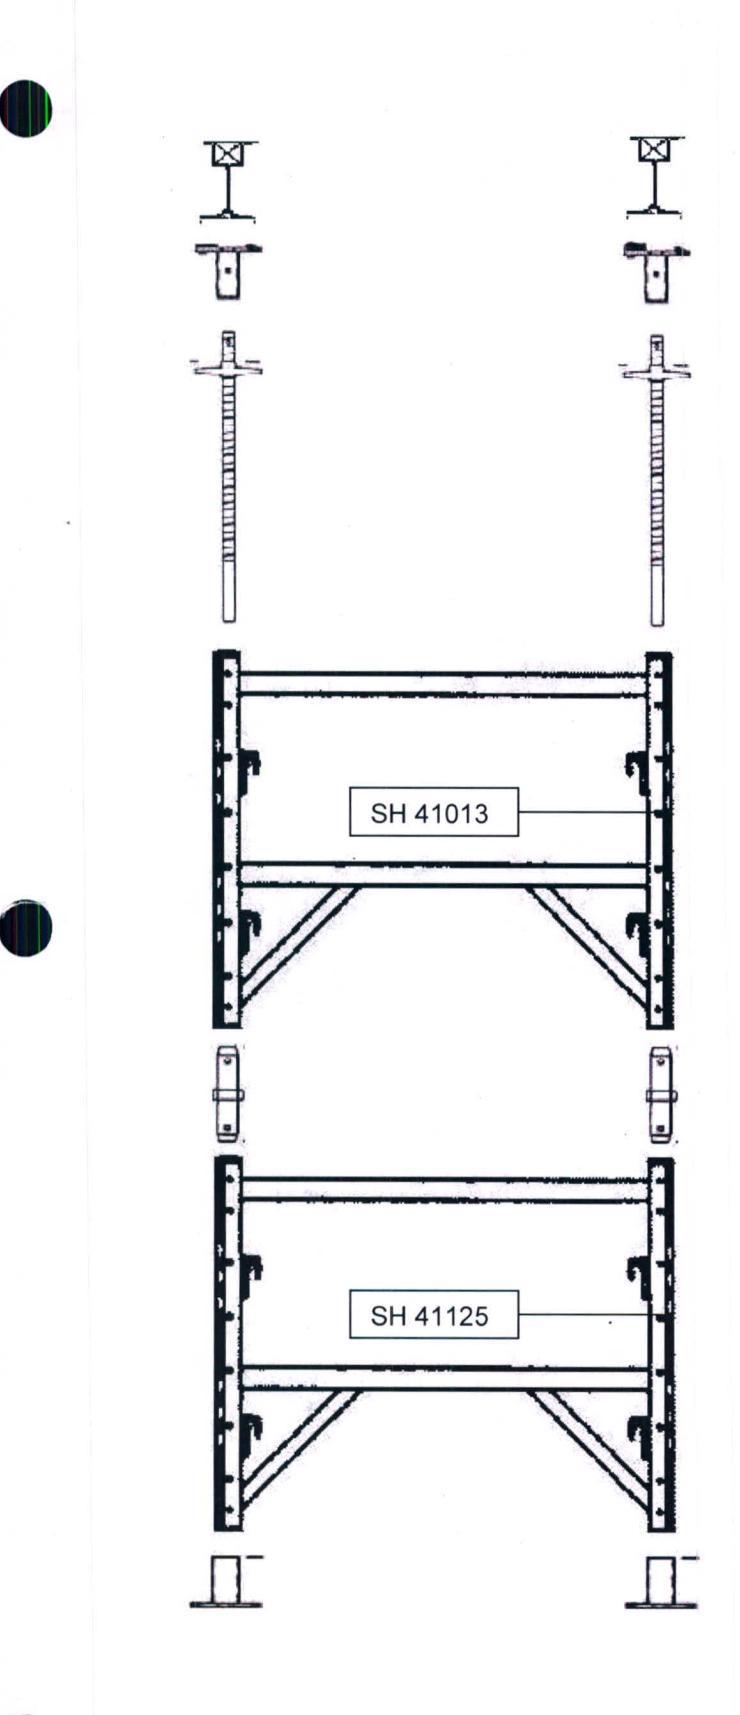
SH 41124 Bottom Brace Connects SH 41125 & SH 41116 Zone 41A

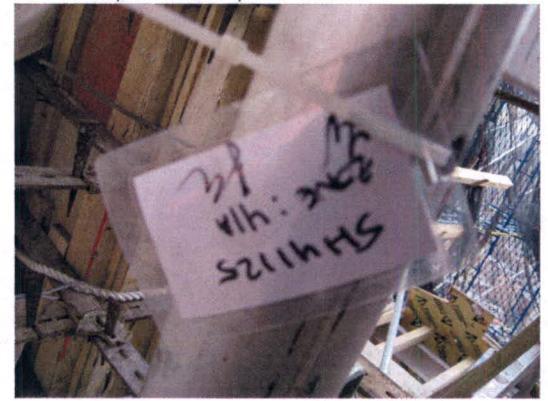
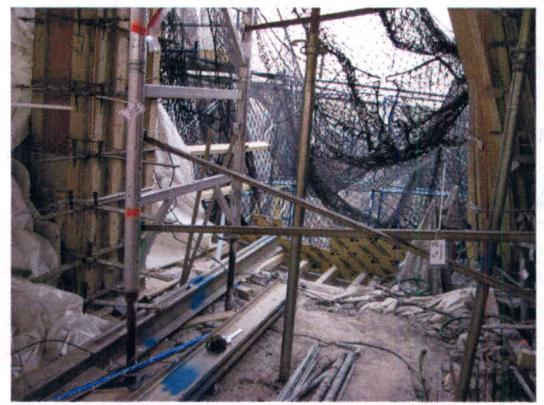
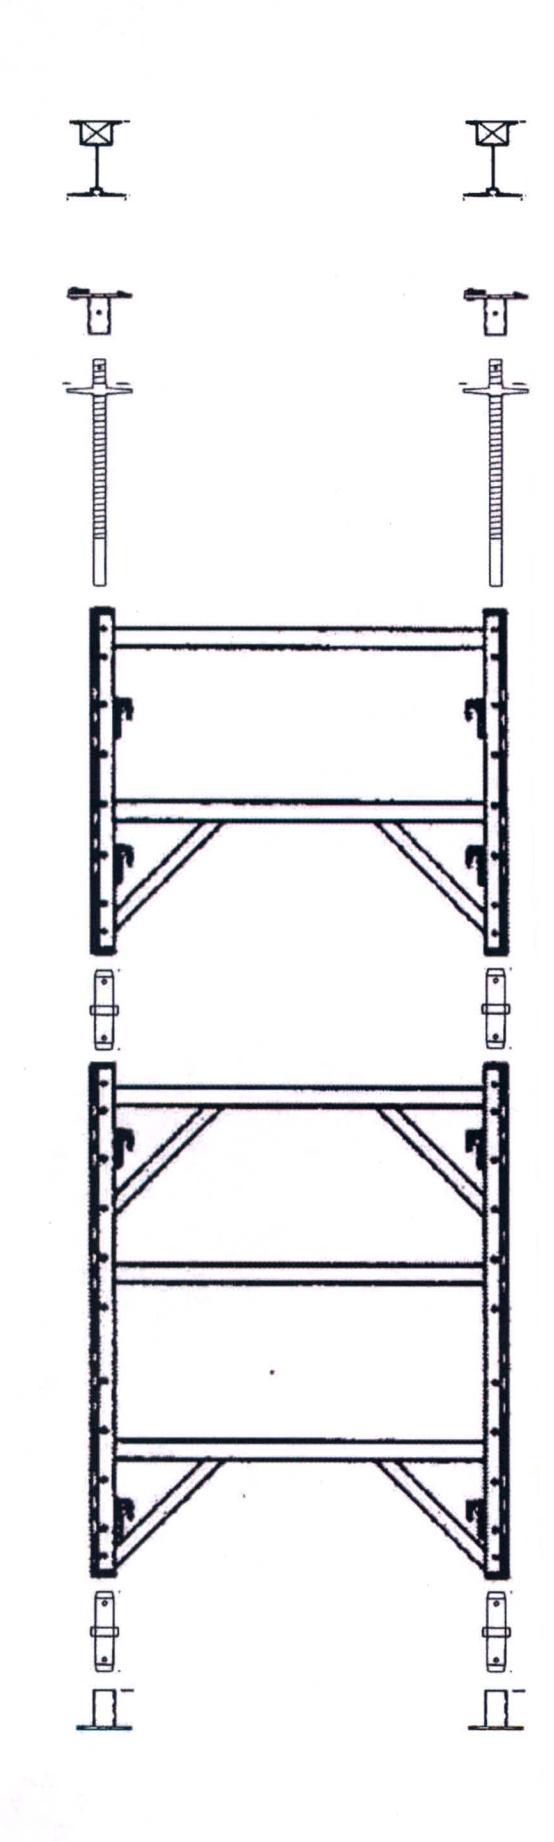
SH 41125 Bottom Shore of SH 41013 Connect to Brace SH 41124 Zone 41A

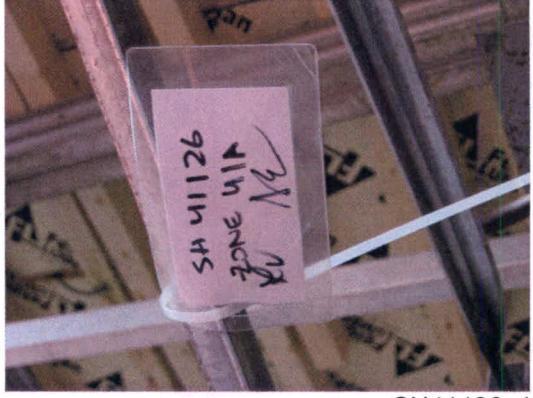
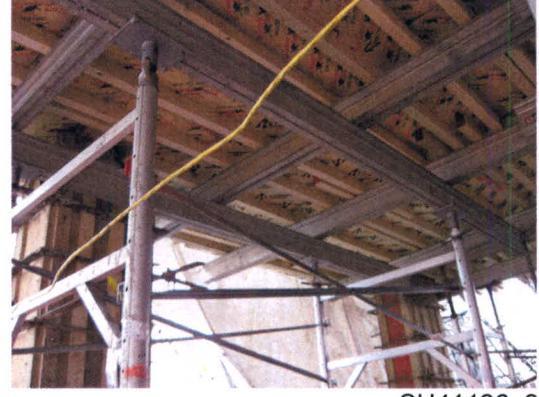
SH 41126 Brace Connects SH 41014 and SH 41012 Zone 41A

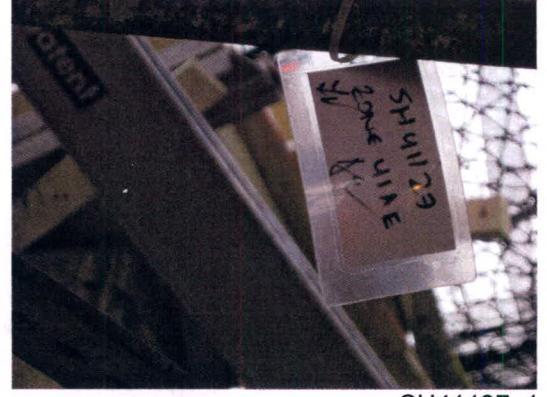
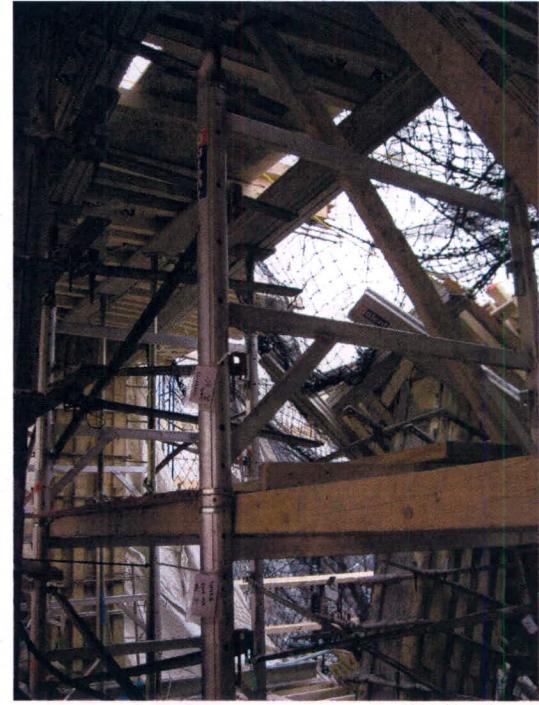
SH41127_1

SH 41127 Top Brace Top Shore SH 41128 Bottom Shore SH 41117 Connecting SH 41011 Zone 41E-A

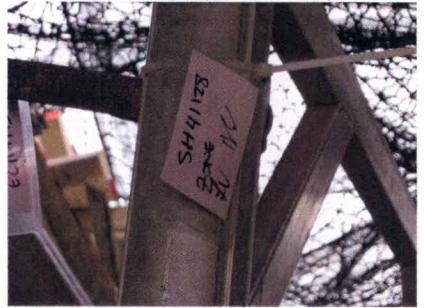
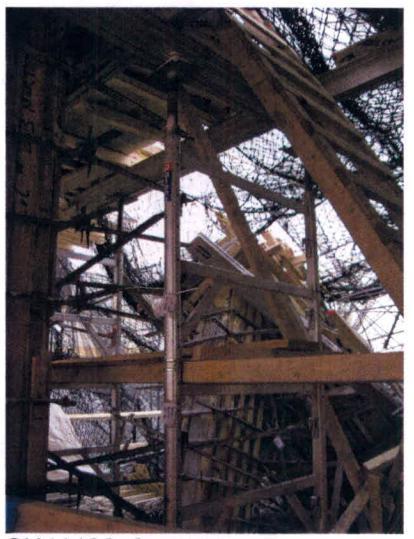
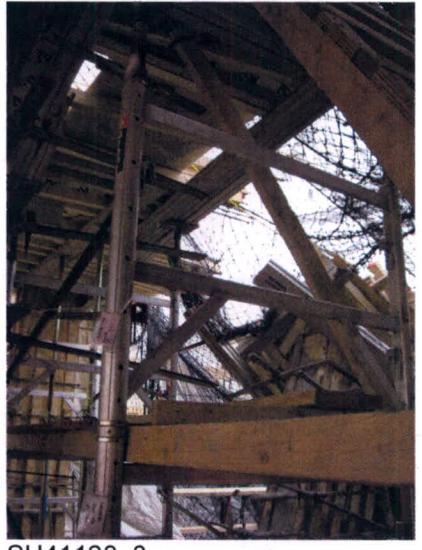
SH41128_1

SH 41128 Top Shore of SH 41117 Zone 41B

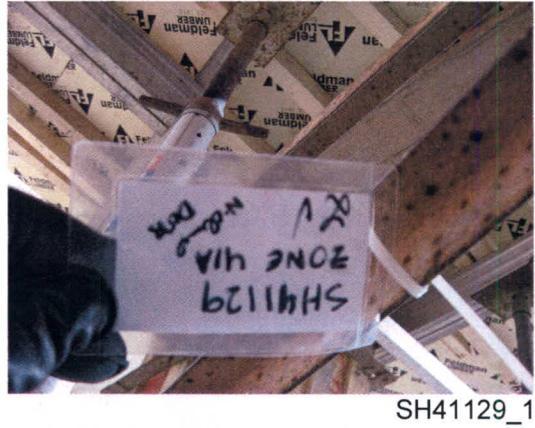
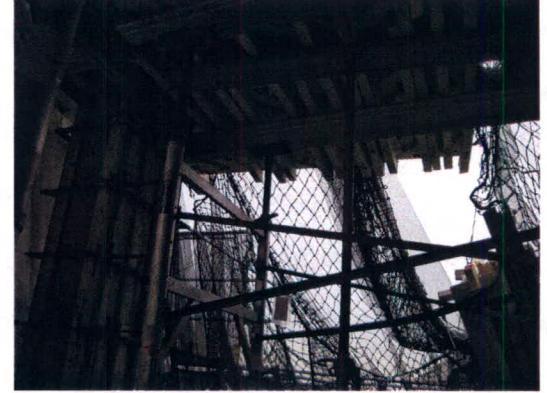
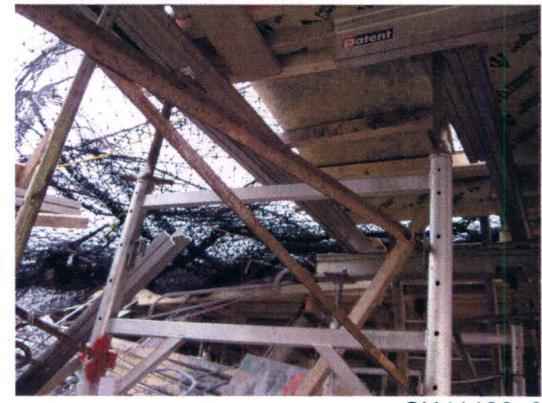
SH41129 2

SH 41129 Top Brace Connect to SH 41128 Zone 41

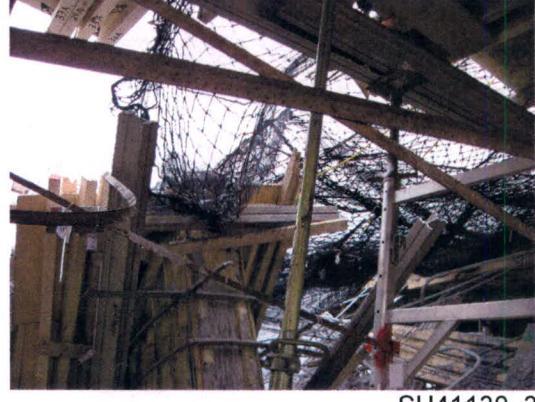
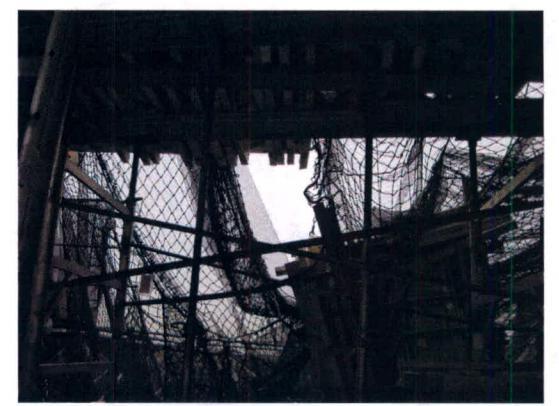
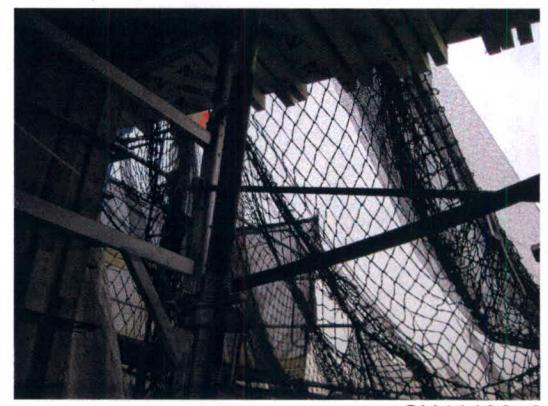
SH41130_3

SH 41130 Brace Connect to SH 41128 Zone 41B

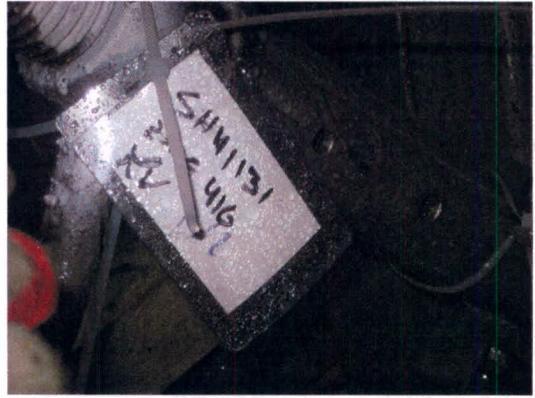
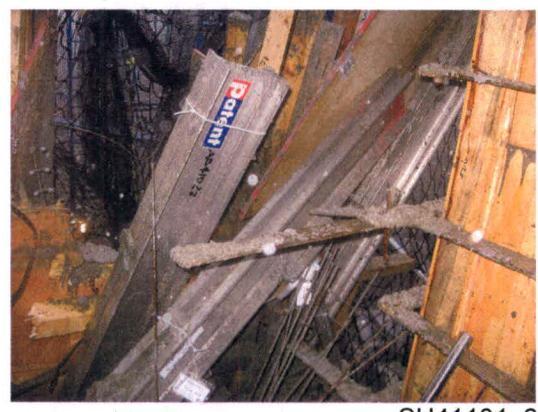
SH41131_1

SH 41131 Top plate Zone 41G

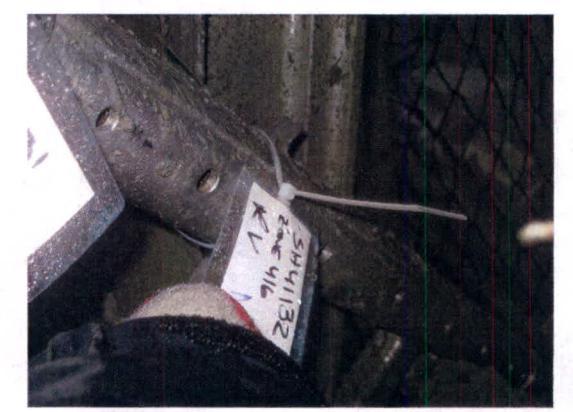
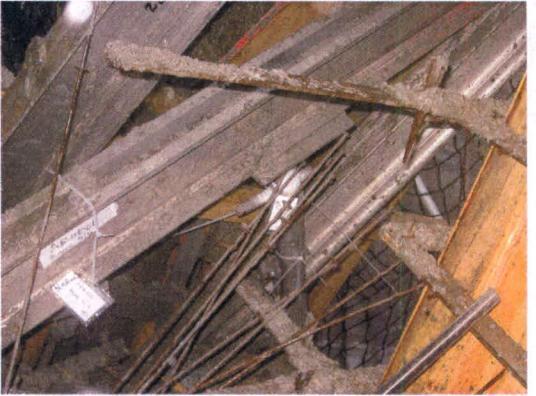
SH41132_1

SH 41132 Top Frame of SH 41152 and SH 41149 Frame Connects to SH 41135 Zone 41G

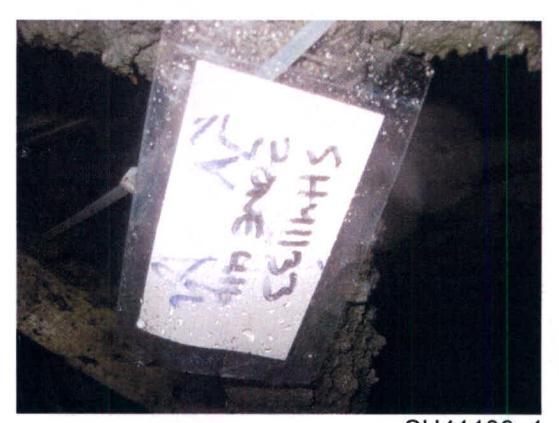
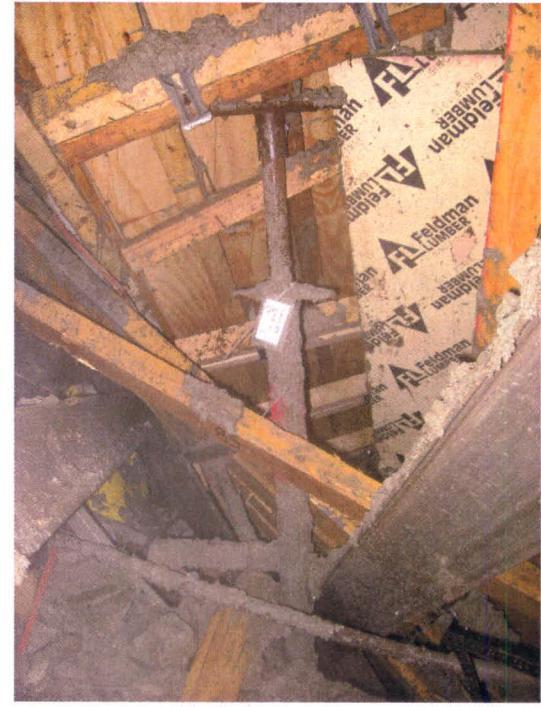
SH41133_1

SH 41133 Top Frame Frame connecting SH 41026 and AB 41001 Zone 41G

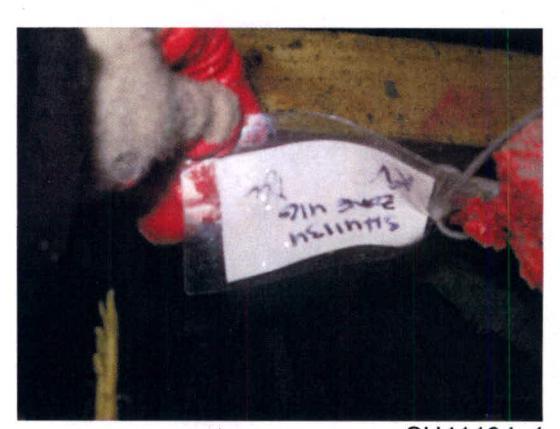
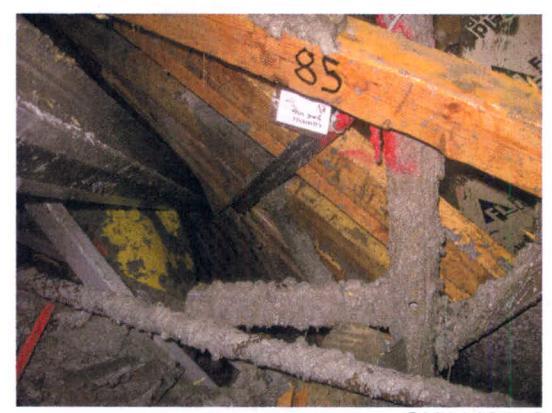
SH41134_1

SH 41134 Brace Connects SH 41133 Zone 41G

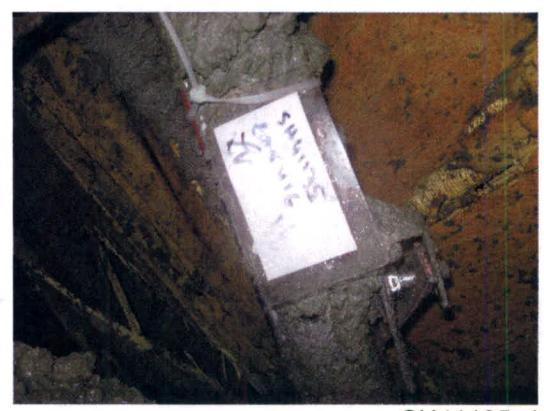
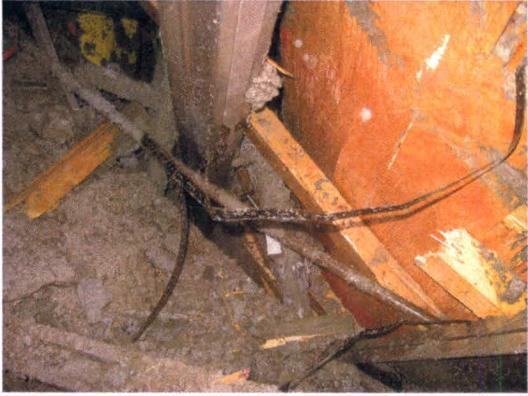
SH41135_1

SH 41135 Frame Connects to AB 41002 Zone 41G

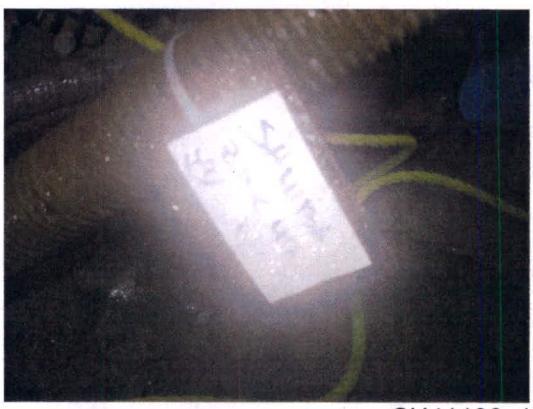
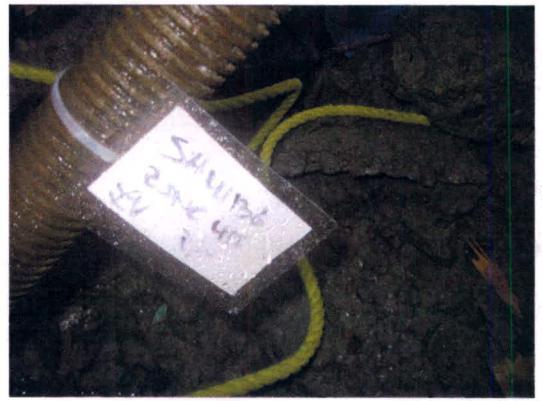
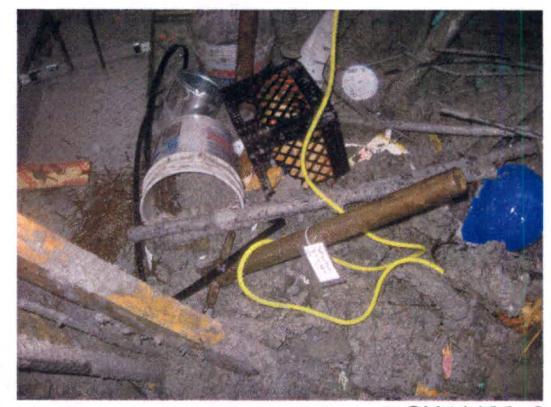
SH41136_1

SH 41136 Screw Jack Leg SH 41042 Zone 41G

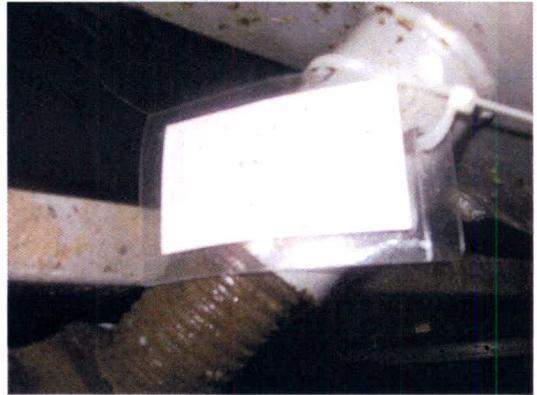
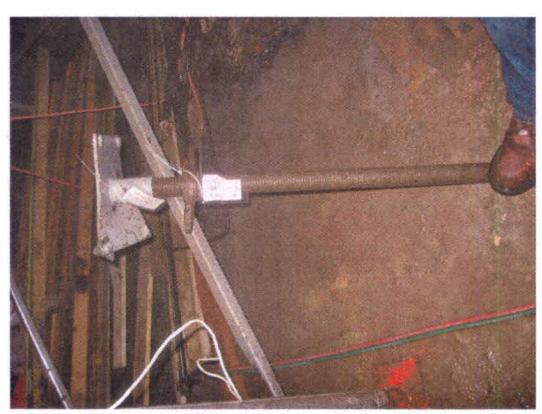
SH41137_1

SH 41137 Top plate attached to PW 41006 Zone 41F

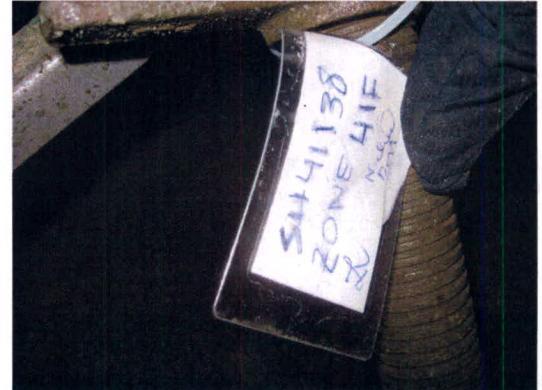
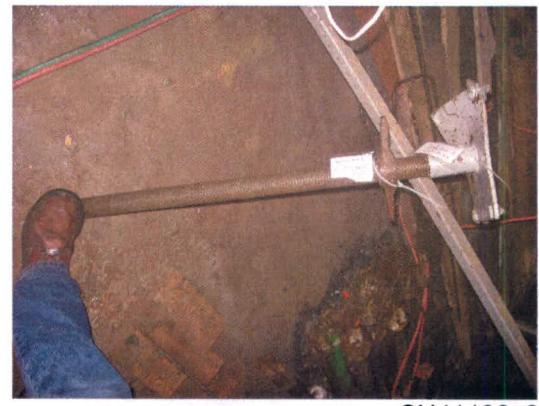
SH41138_1

SH 41138 Screw Jack Leg Zone 41F

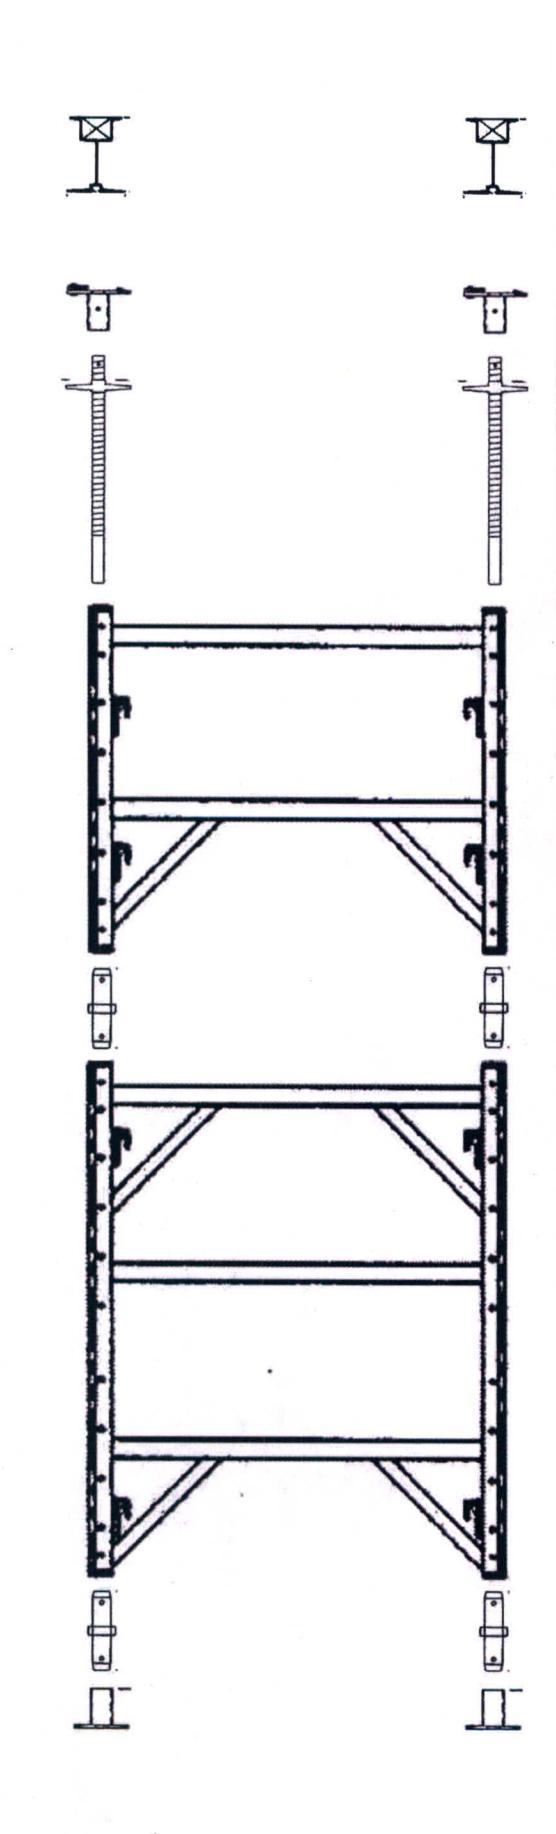
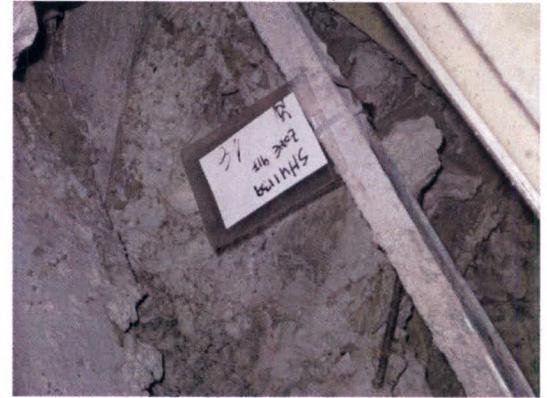
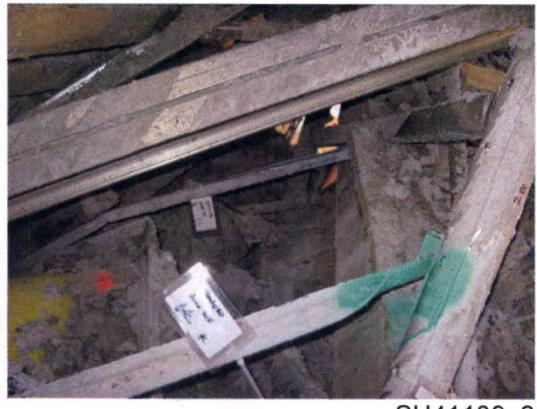
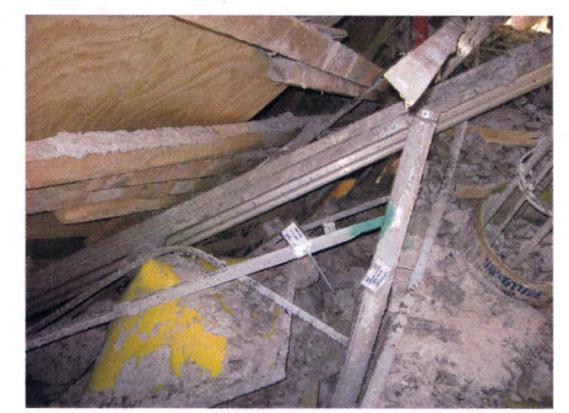
Folder: 08-02-14; 08-02-14; SH 41139

SH 41139 Brace Zone 41F

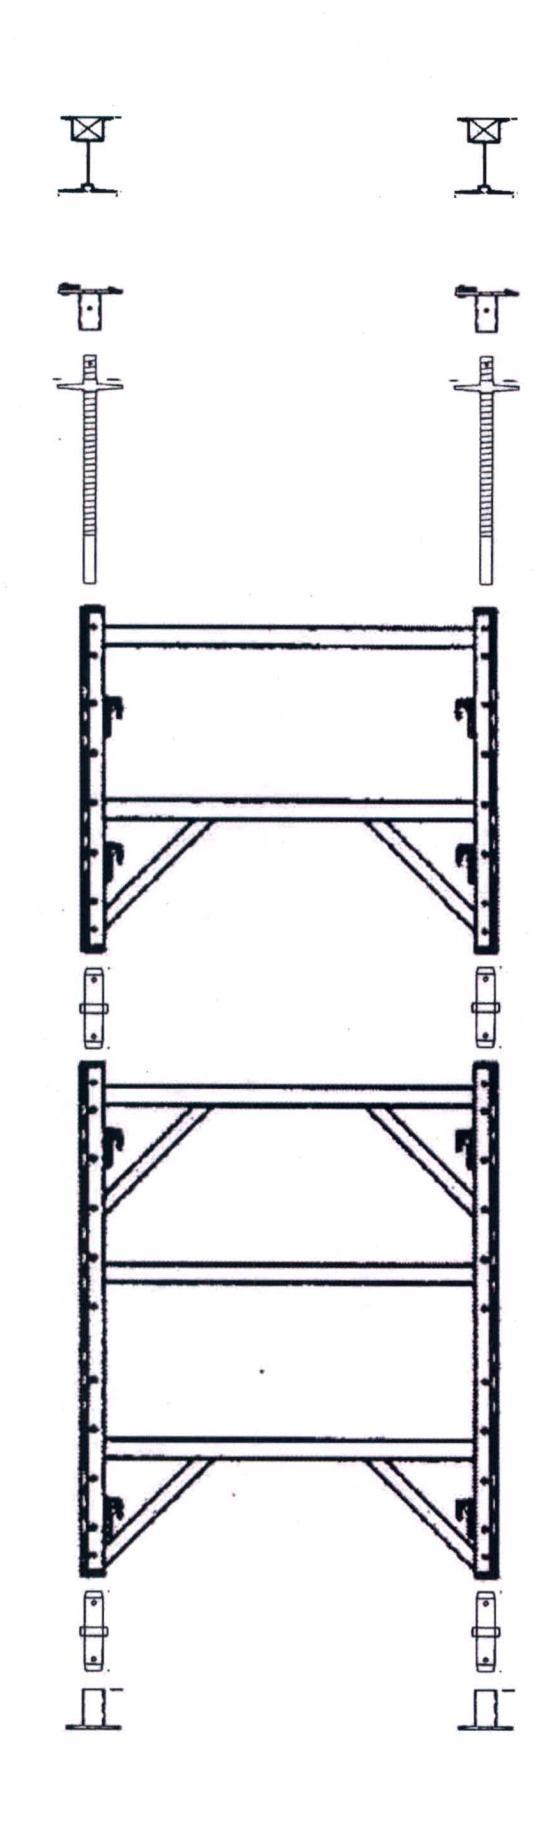
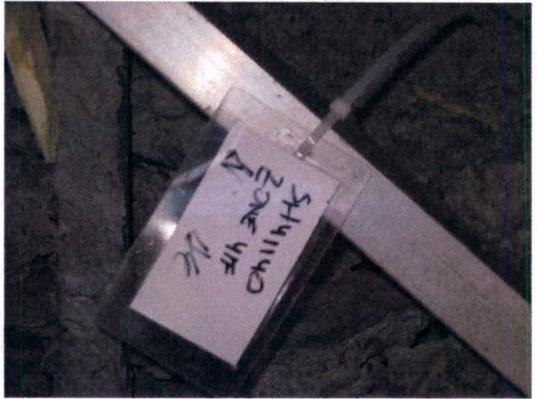
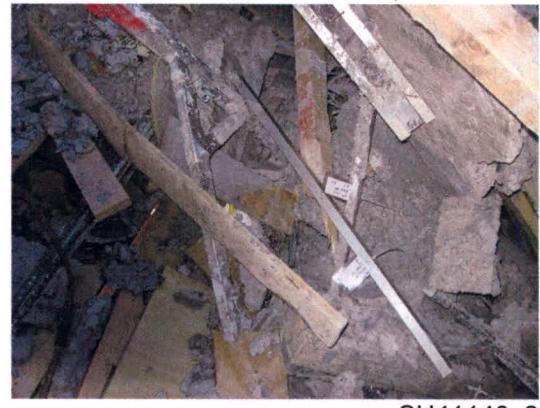
Folder: 08-02-14; 08-02-14; SH 41140

SH 41140 Piece of Frame Zone 41F
