INVESTIGATION REPORT:

JANUARY 14, 2008 SHORING COLLAPSE AT 9 DOMINICK ST. (AKA 246 SPRING ST.) MANHATTAN

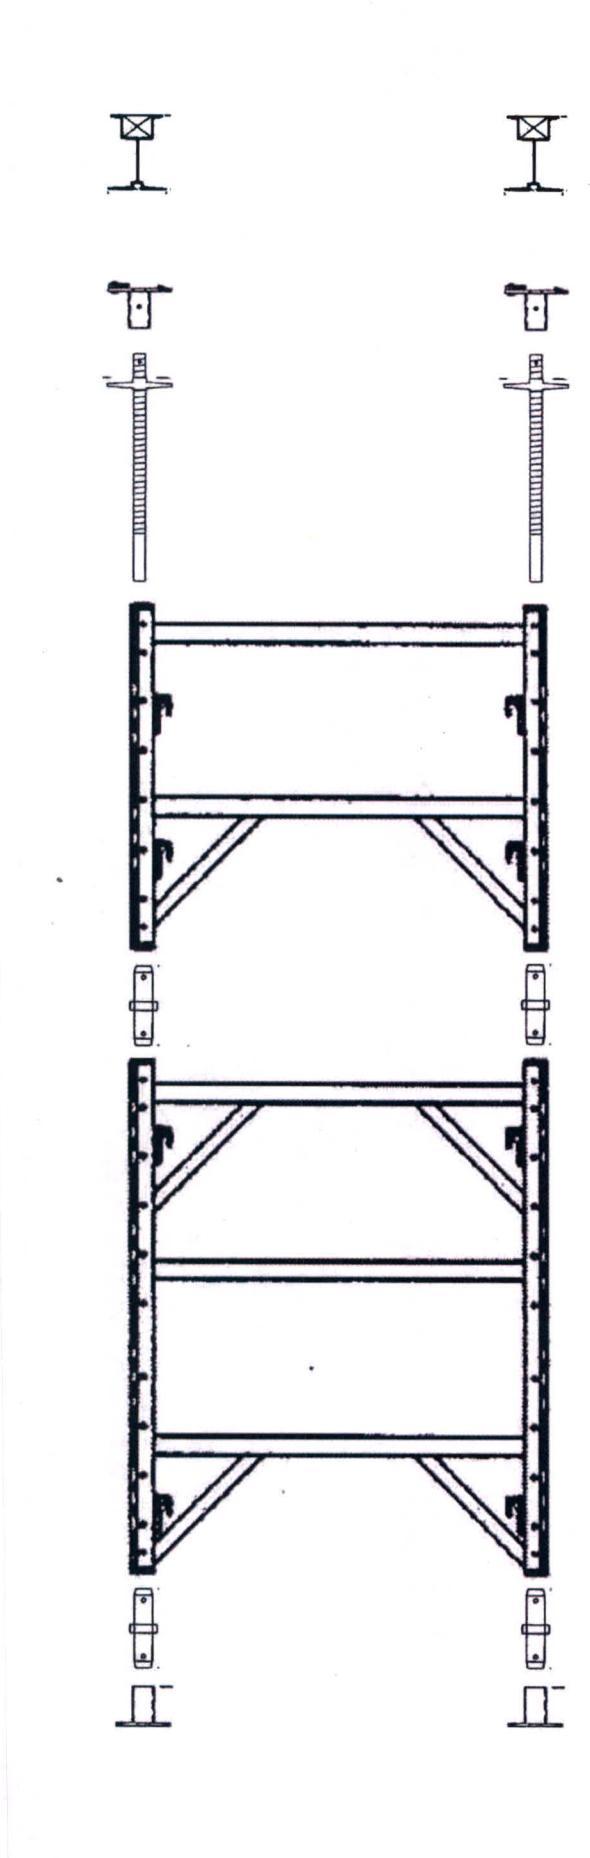
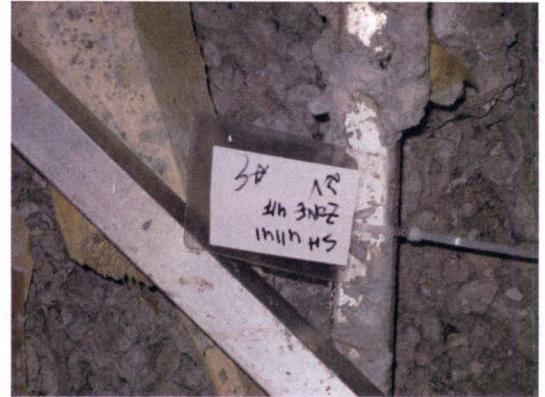
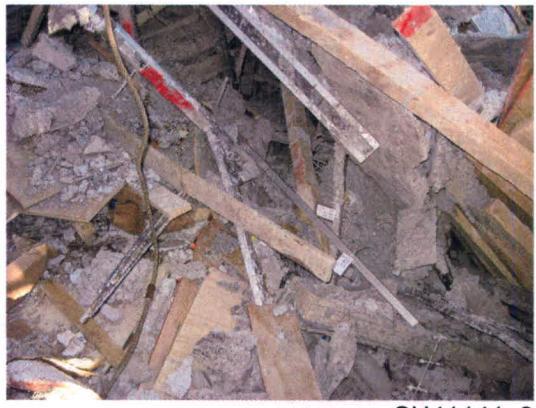
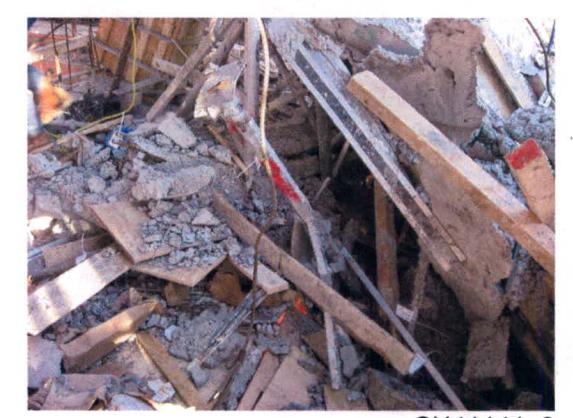
Folder: 08-02-14; 08-02-14; SH 41141

SH 41141 Brace Zone 41F

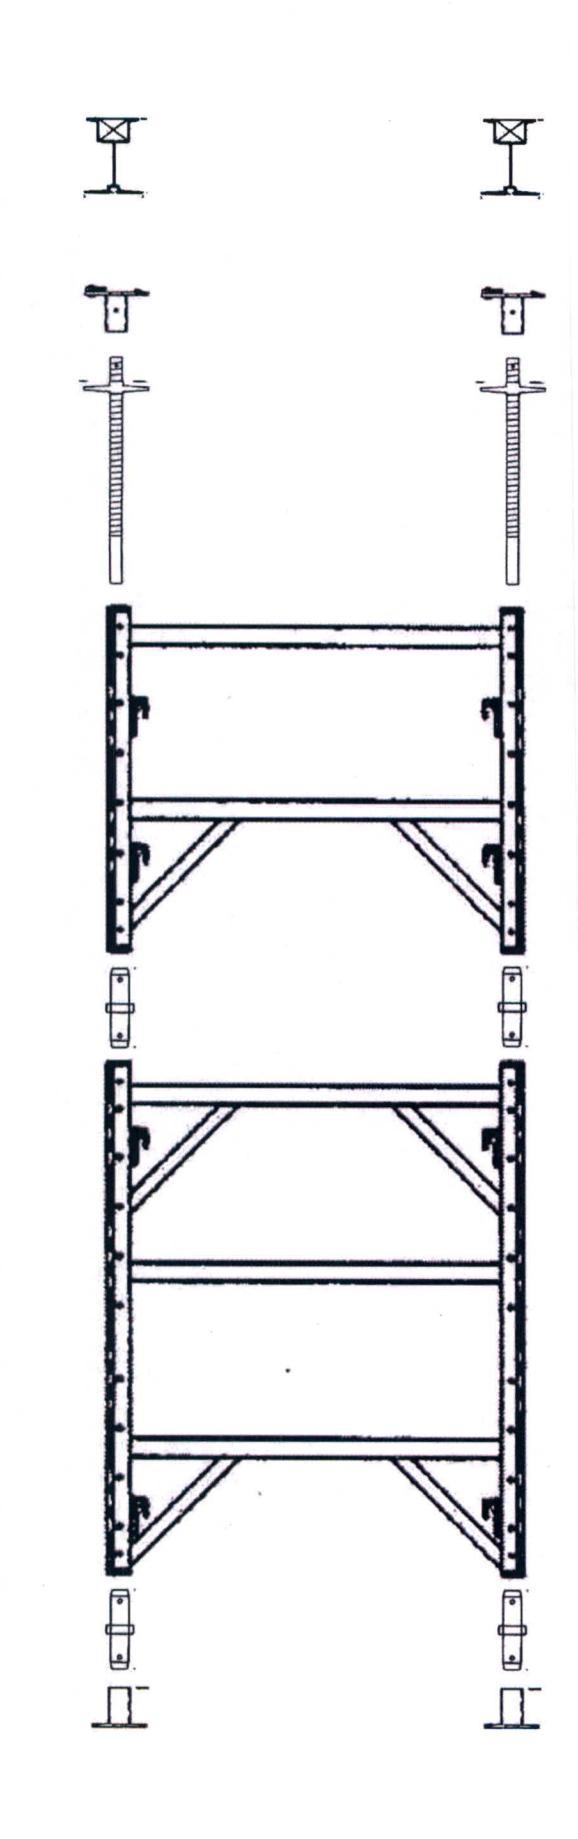
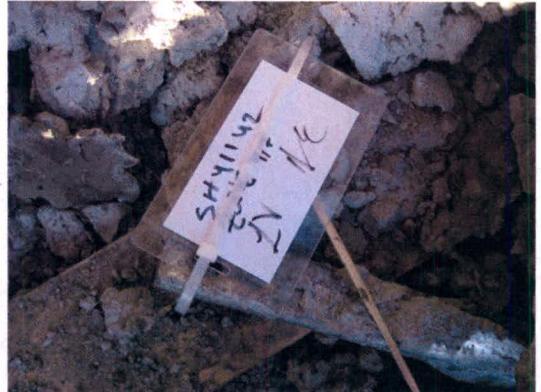
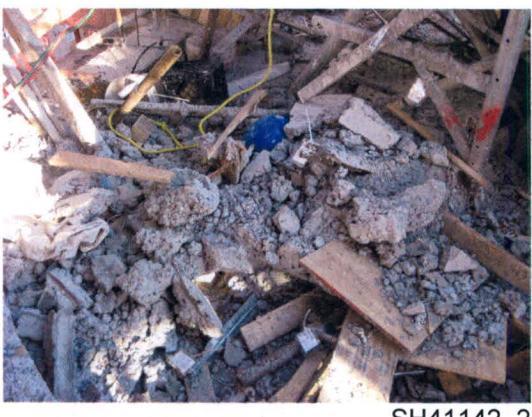
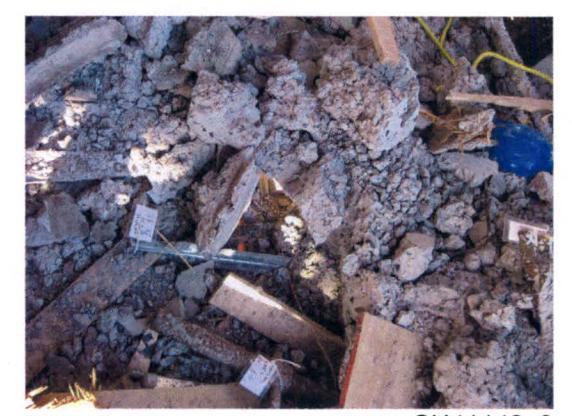
SH 41142

Frame connects to SH 41029 and SH 41039 Zone 41F

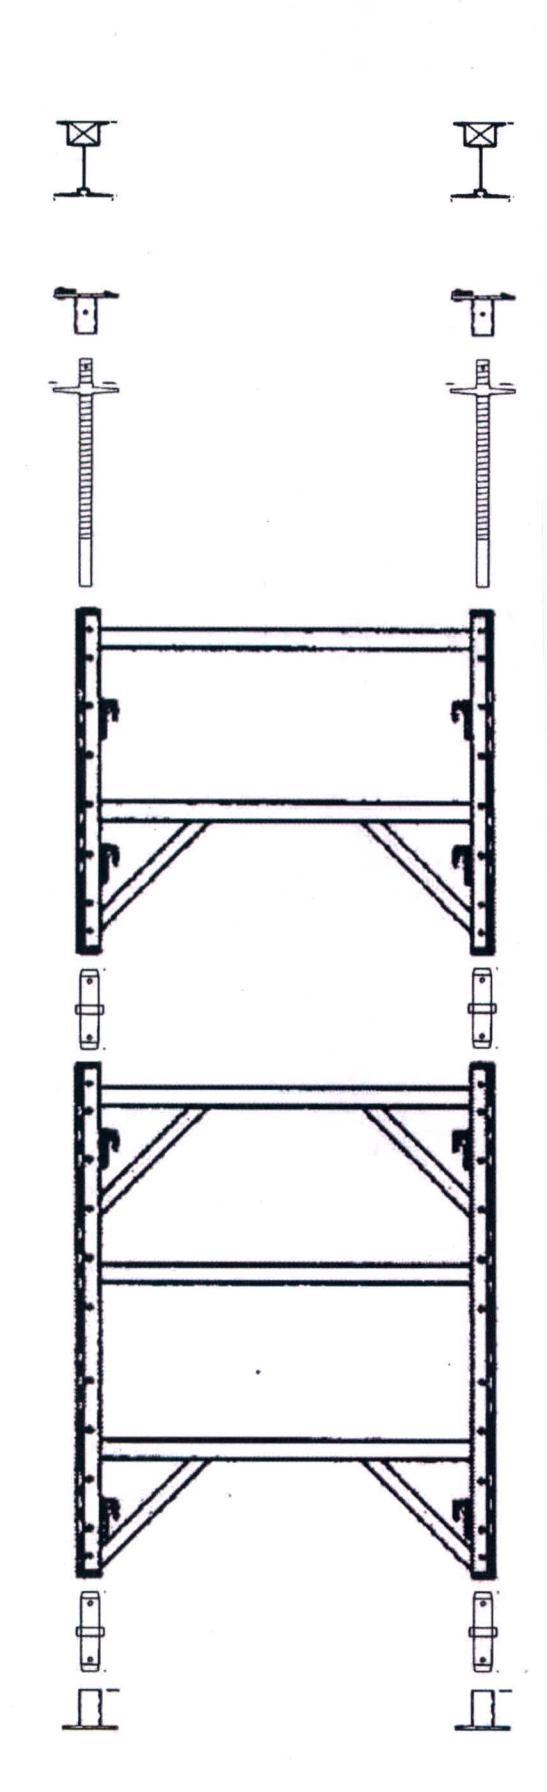
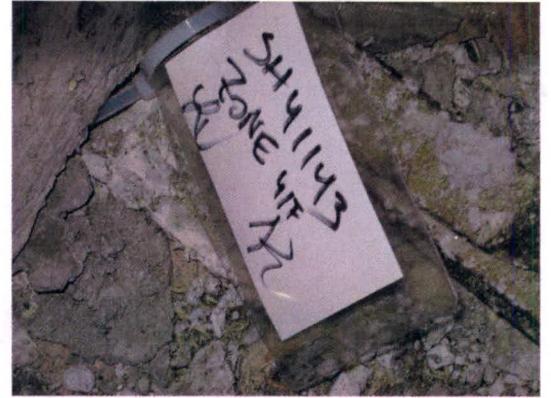
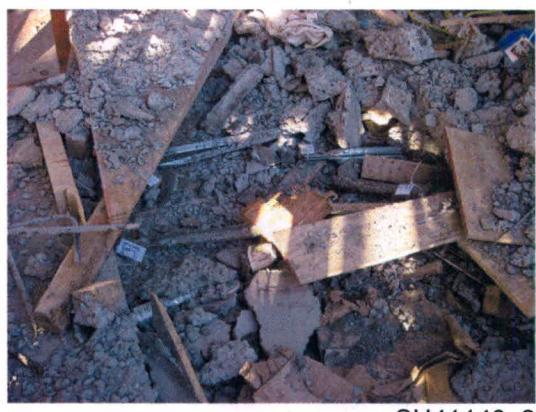
Folder: 08-02-14; 08-02-14; SH 41143

SH 41143 Brace Zone 41F

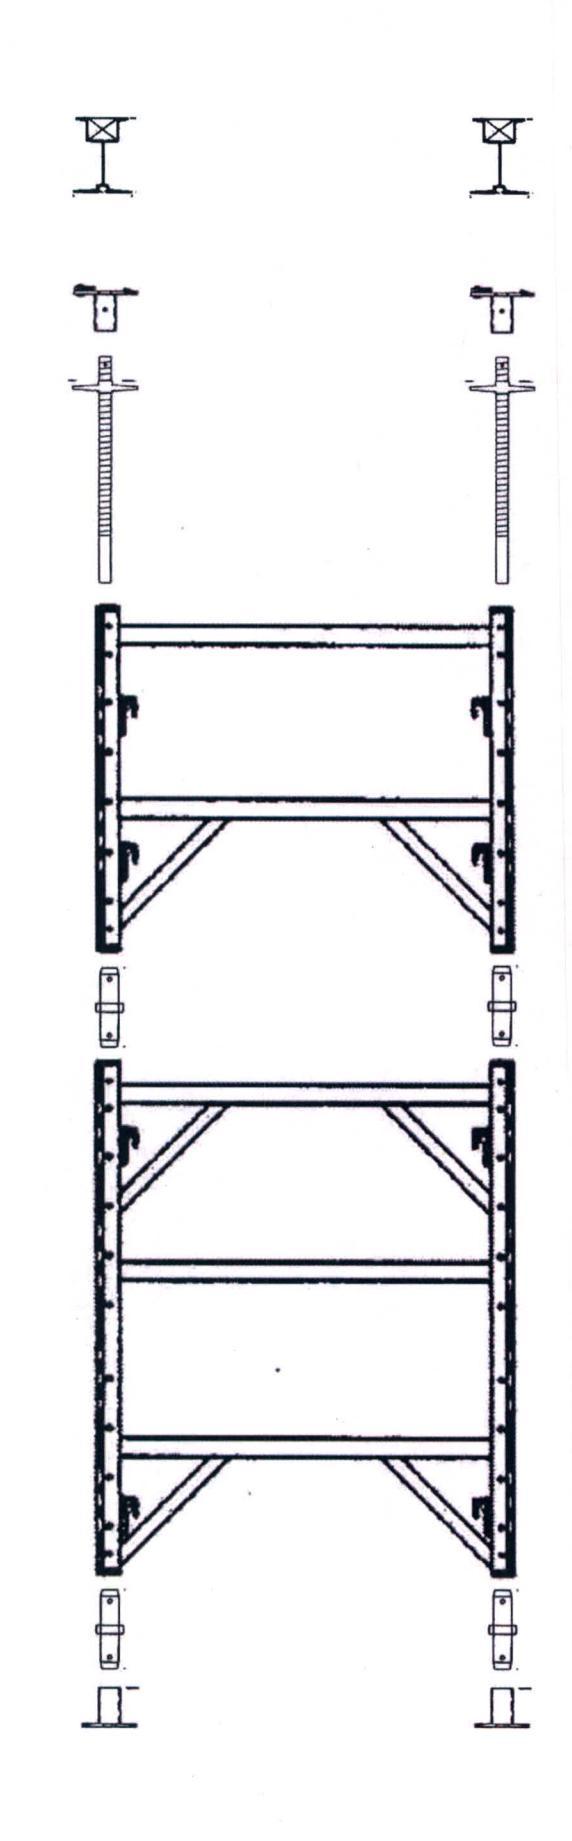
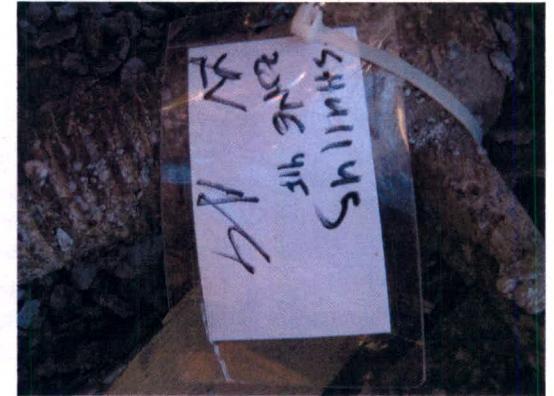
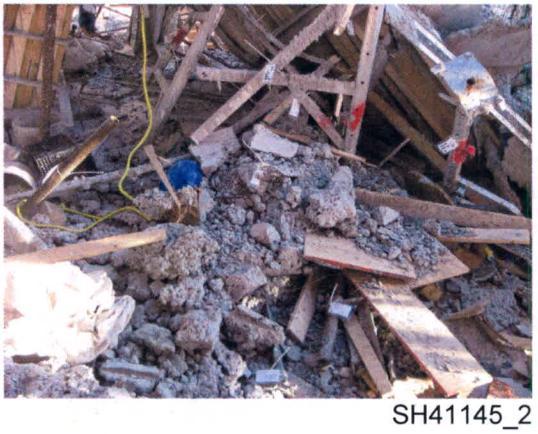
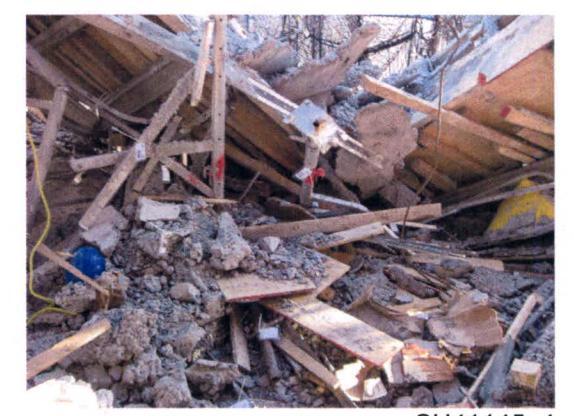
Folder: 08-02-14; 08-02-14; SH 41145

SH 41145 Top Screw Jack Zone 41G

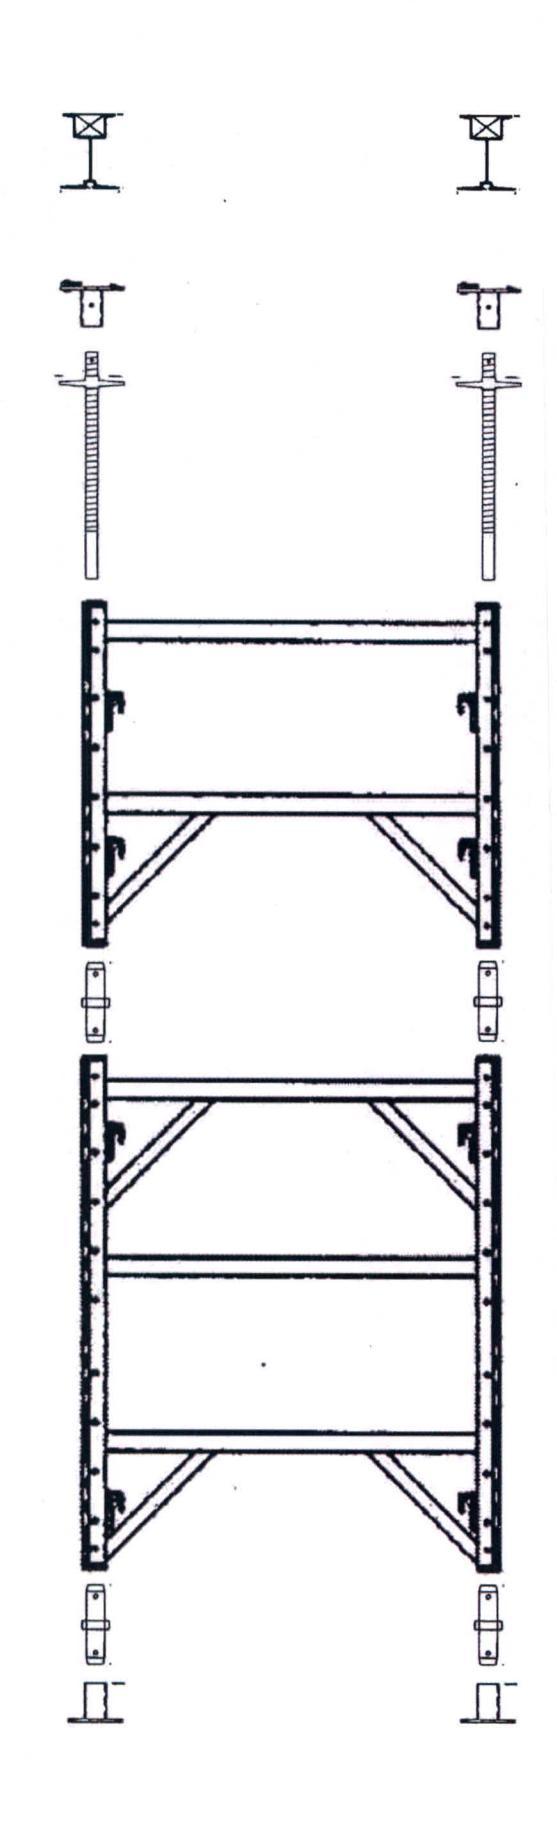
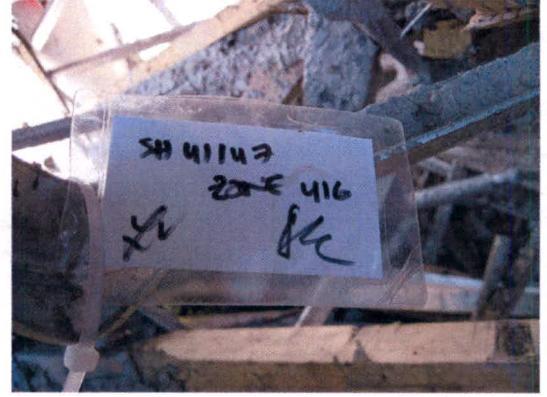
Folder: 08-02-14; 08-02-14; SH 41147

SH 41147 Brace Attached to SH 41135 Zone 41G

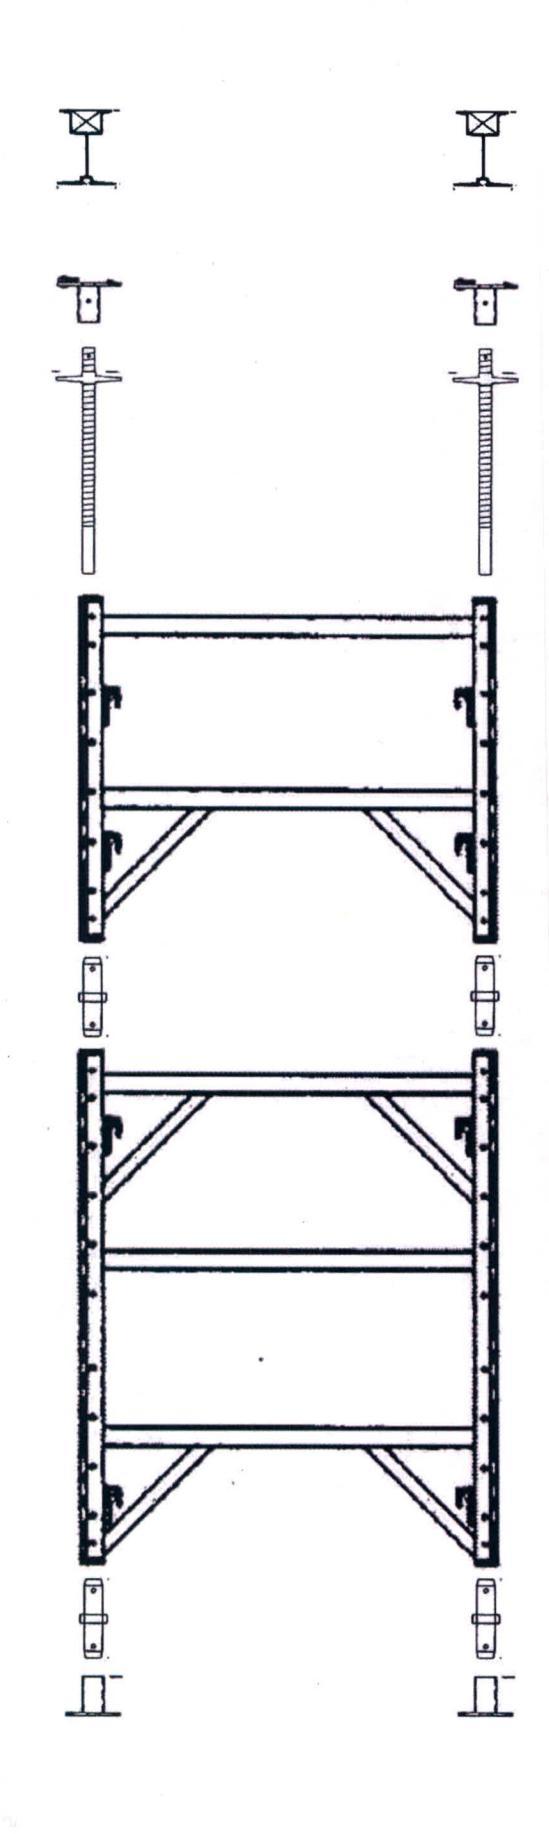
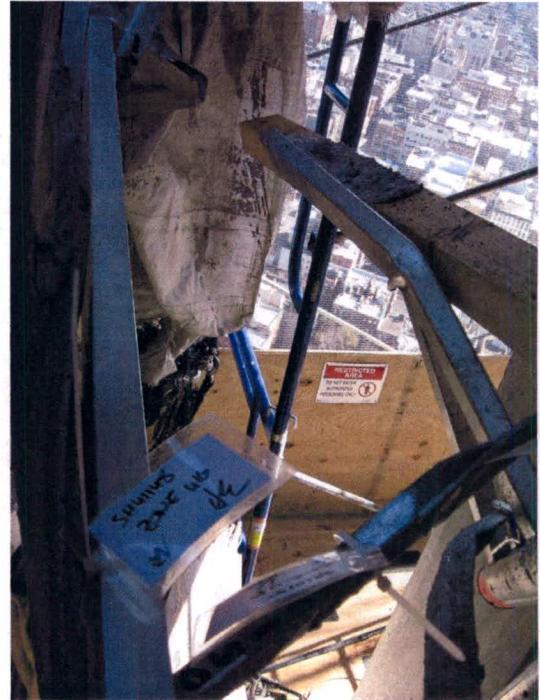
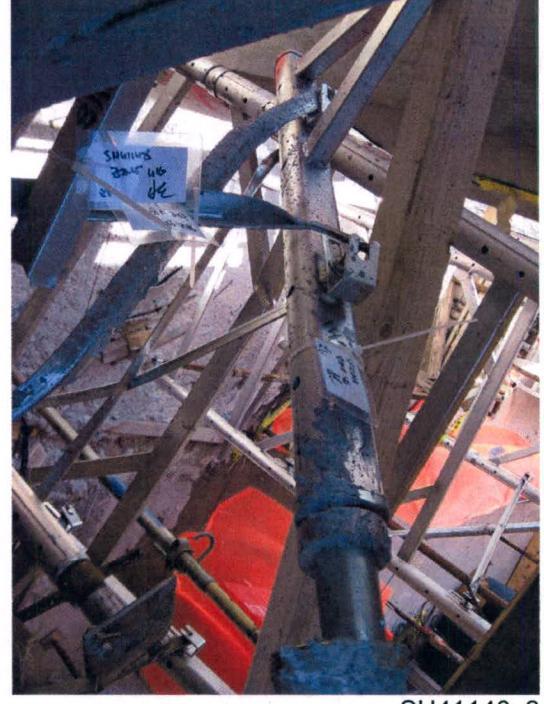
Folder: 08-02-14; 08-02-14; SH 41148

SH 41148 Piece of frame Zone 41G

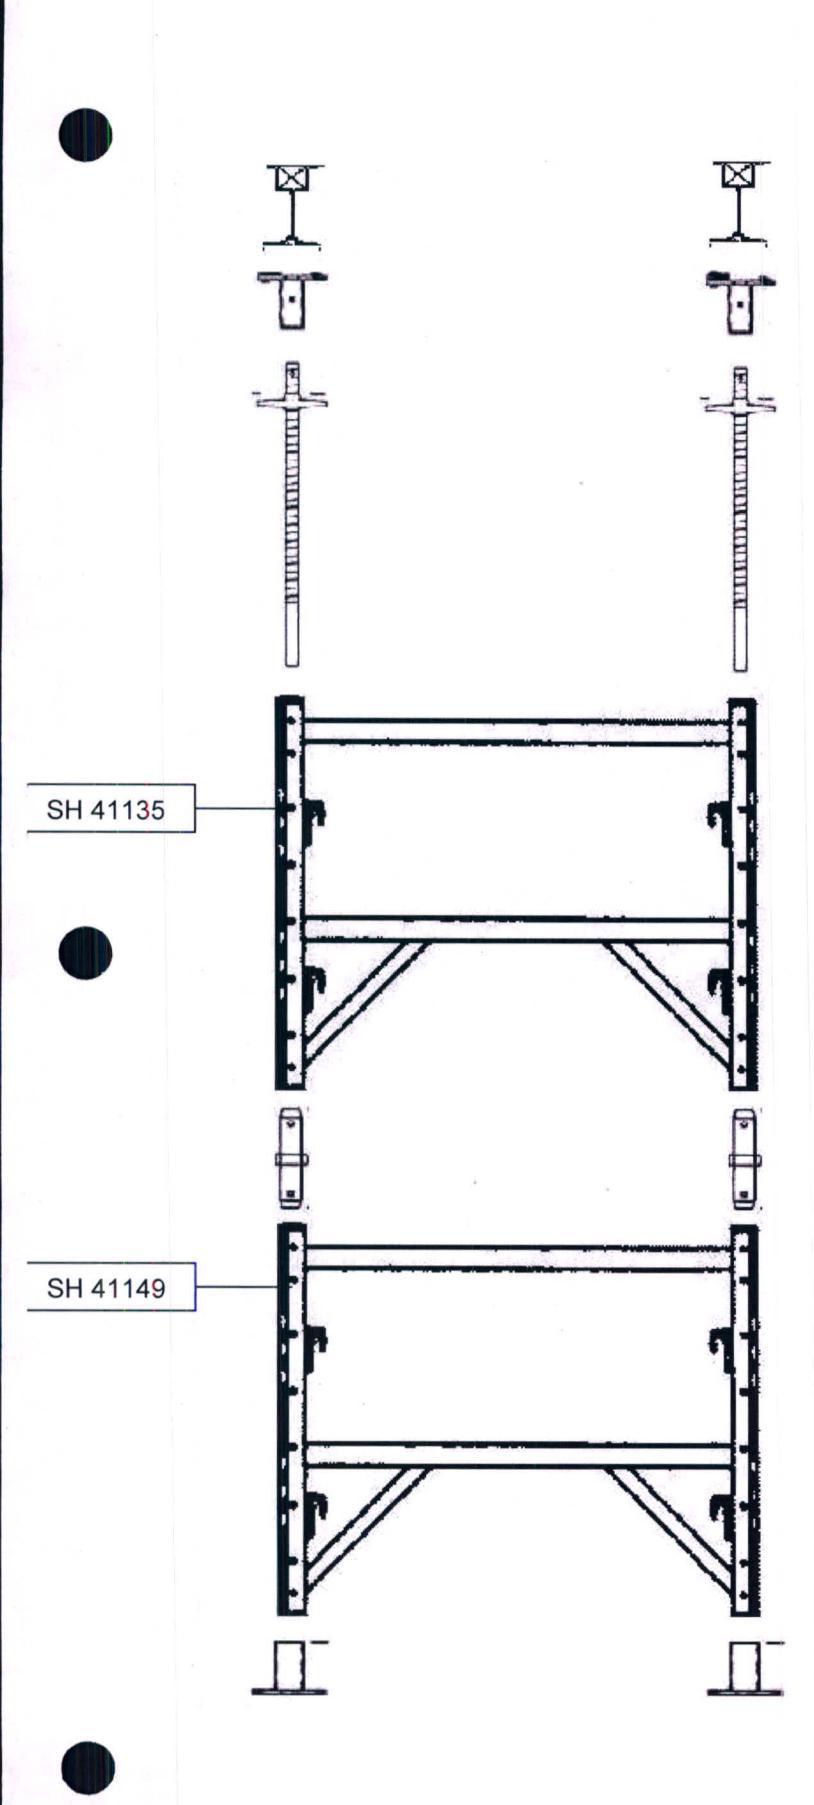
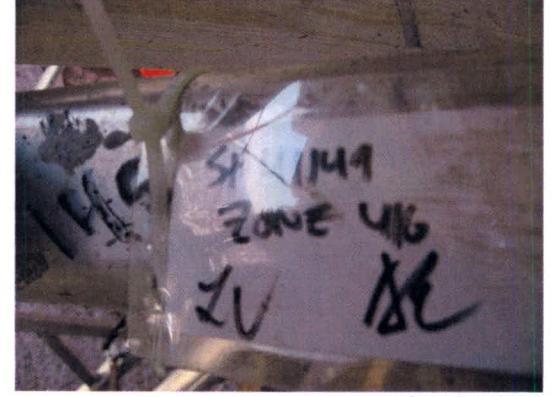
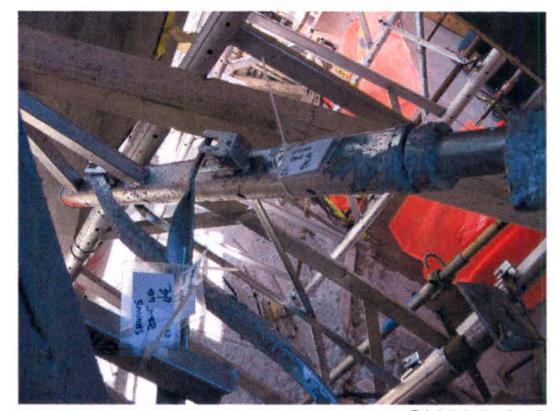
Folder: 08-02-14; 08-02-14; SH 41149

SH 41149 Bottom part of SH 41135 Zone 41G

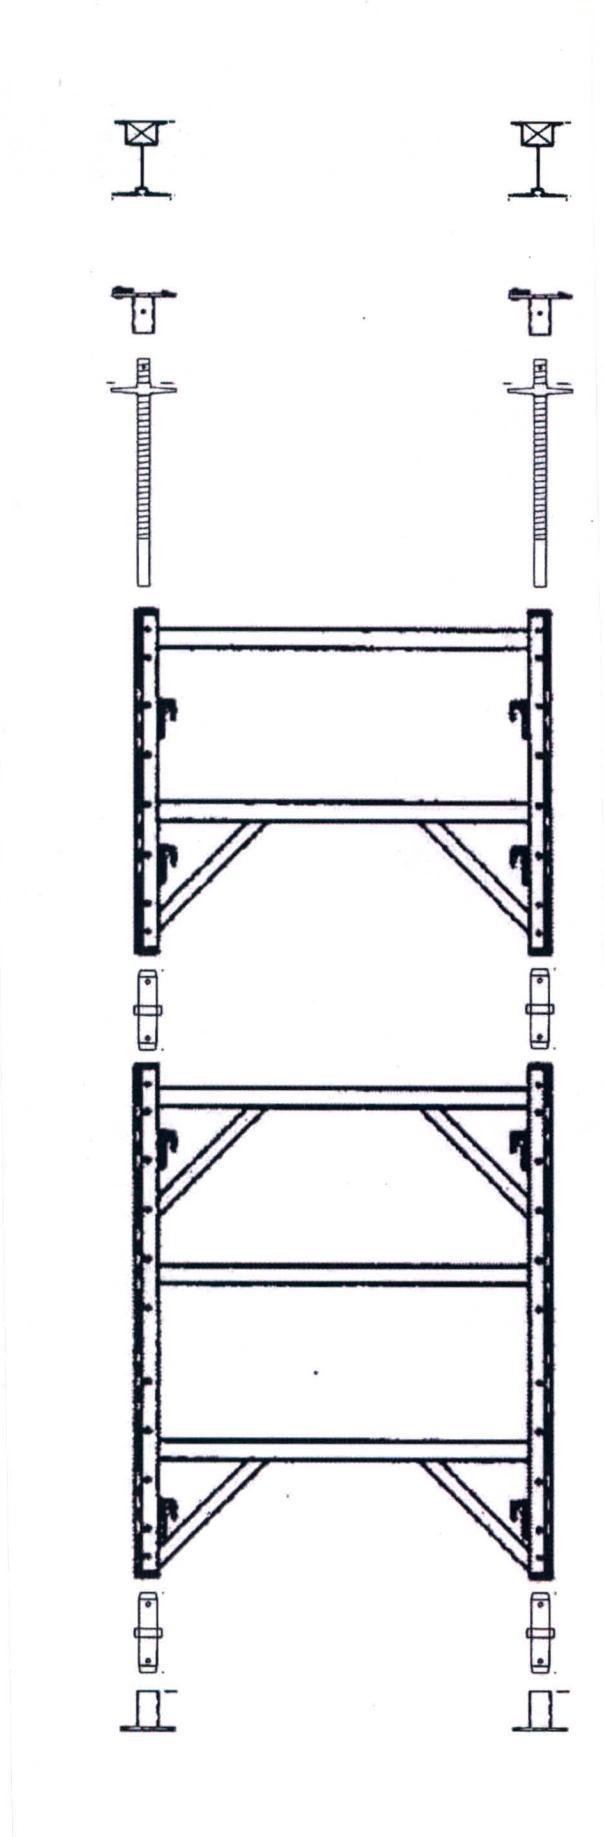
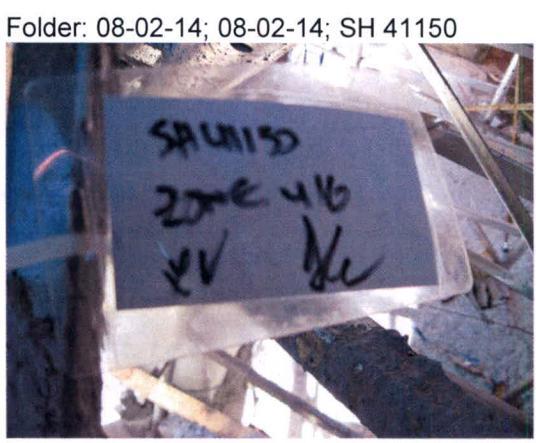
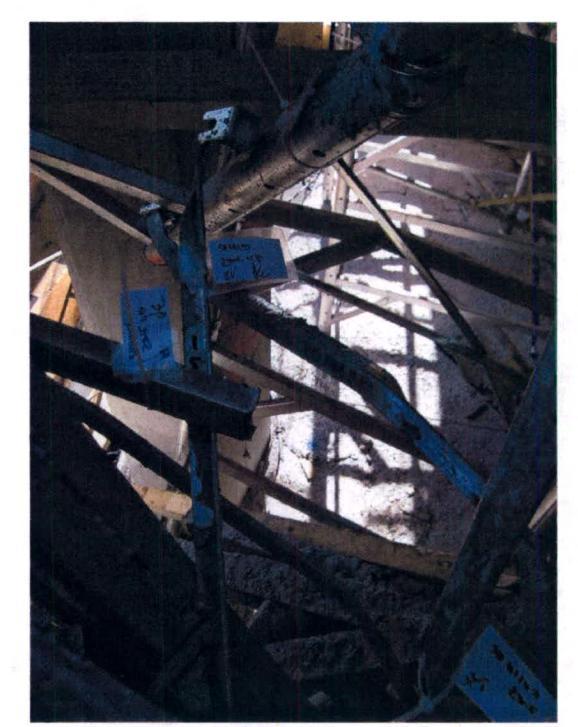
SH 41150 Brace that Connects o SH 41149 Zone 41G

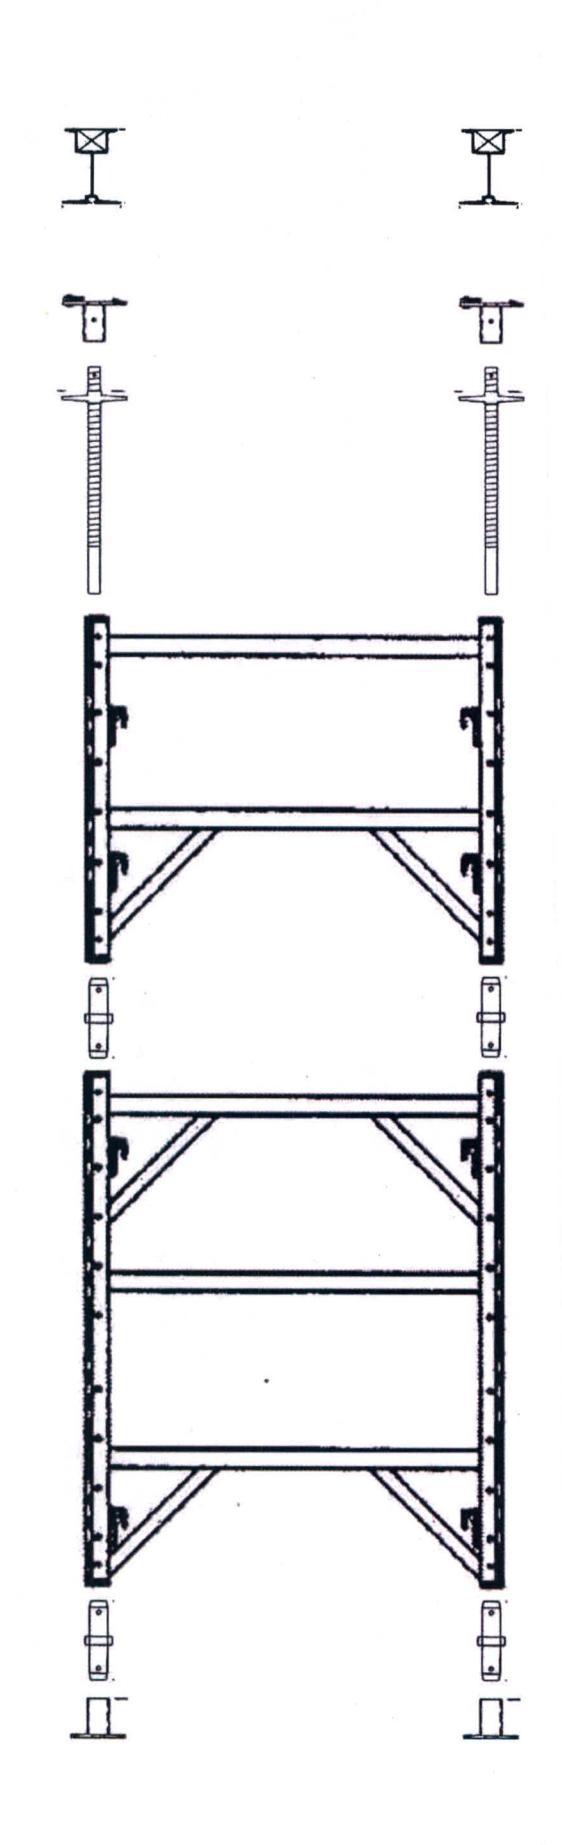
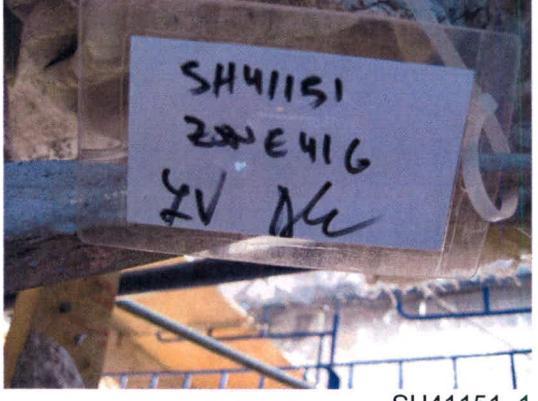
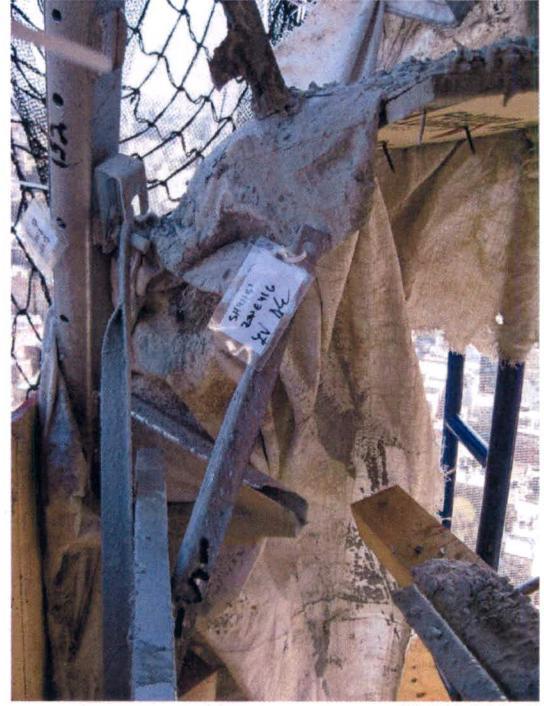
Folder: 08-02-14; 08-02-14; SH 41151

SH 41151 Brace that Connects to SH 41152 Zone 41G

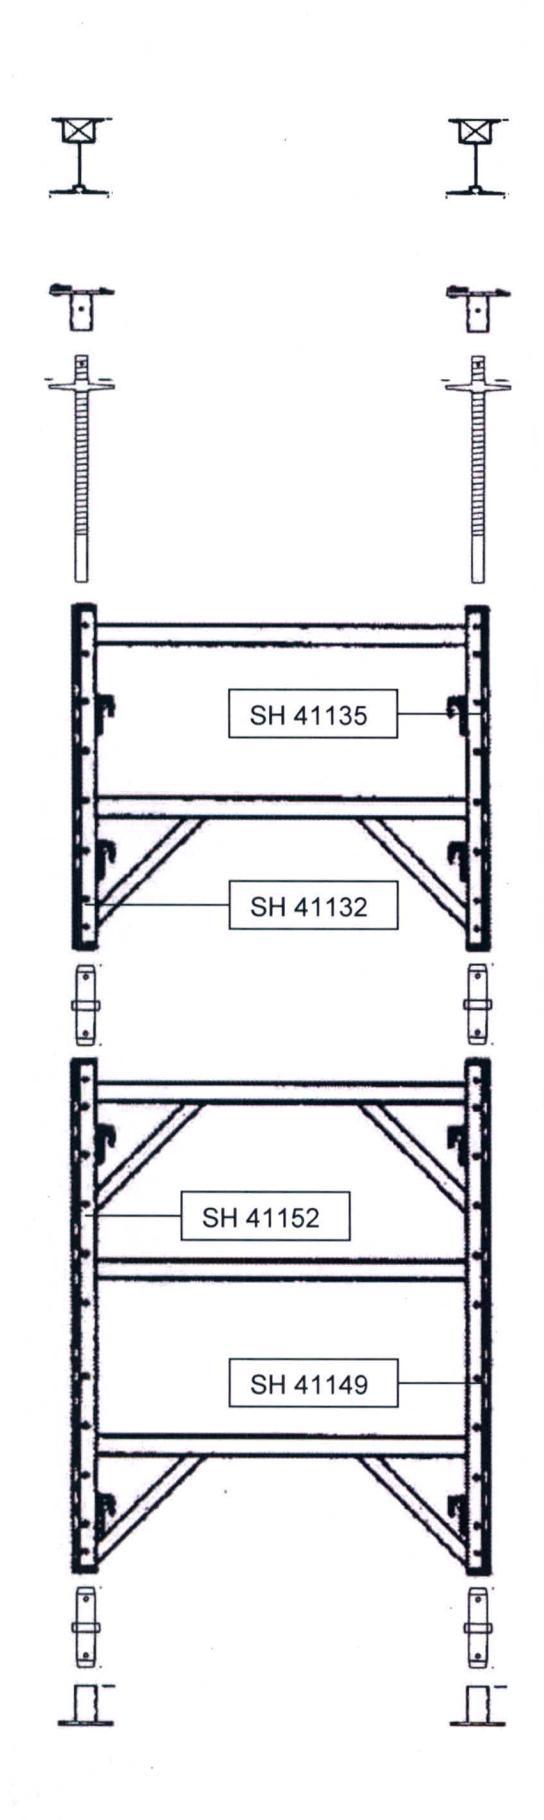
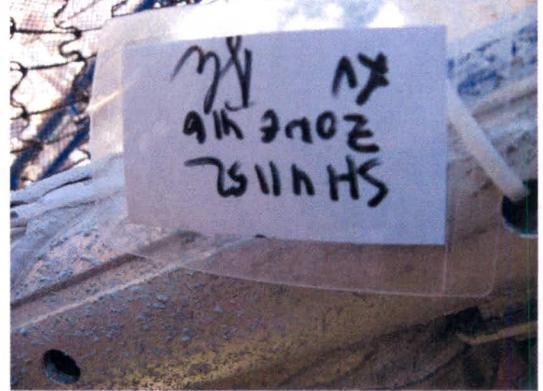
Folder: 08-02-14; 08-02-13; SH 41152

SH 41152 Bottom Frame of SH 41132 Zone 41G

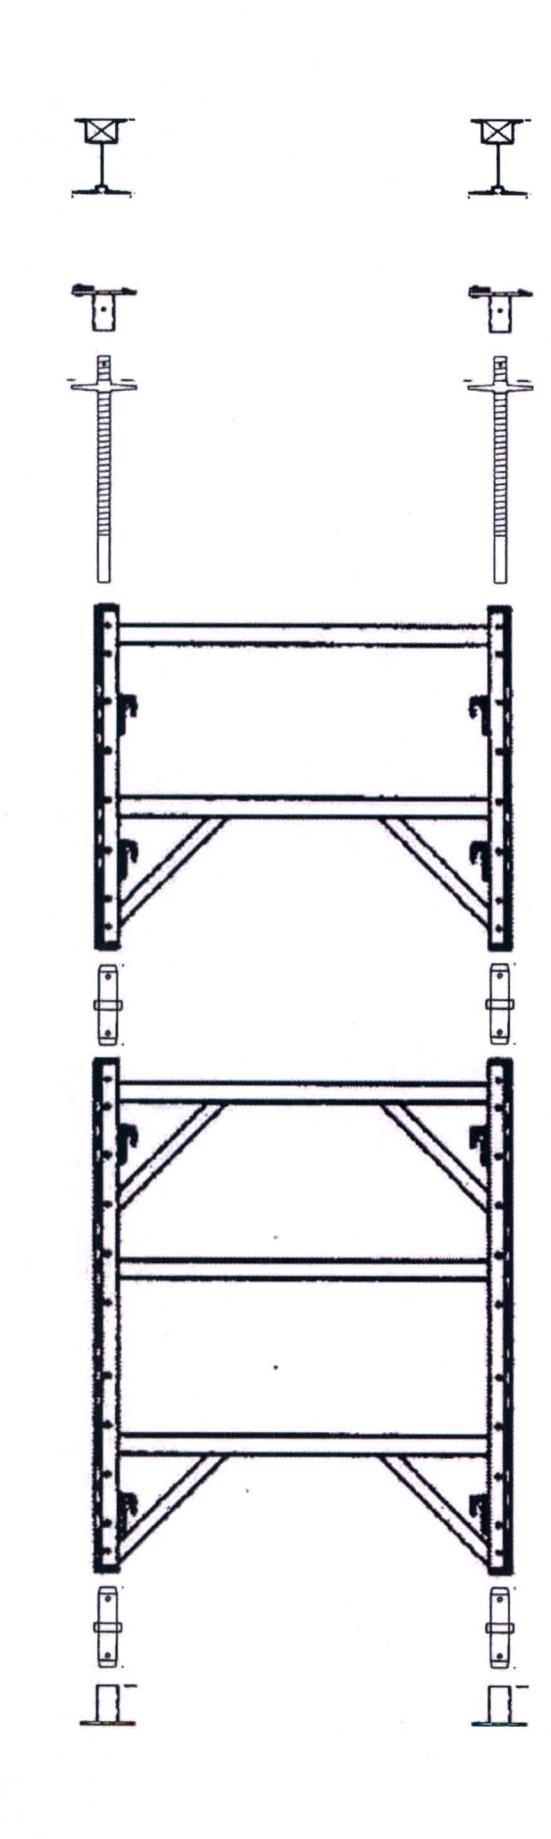
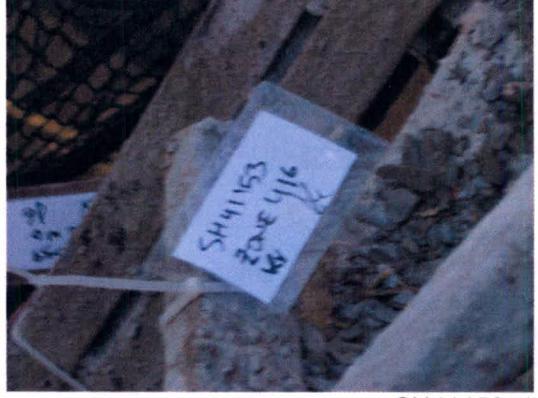
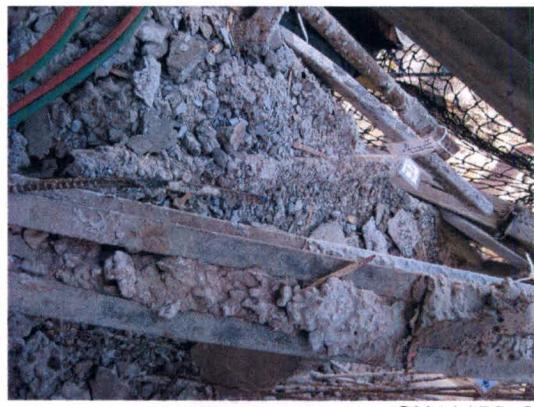
SH41153_1

SH 41153 Piece of frame 41G

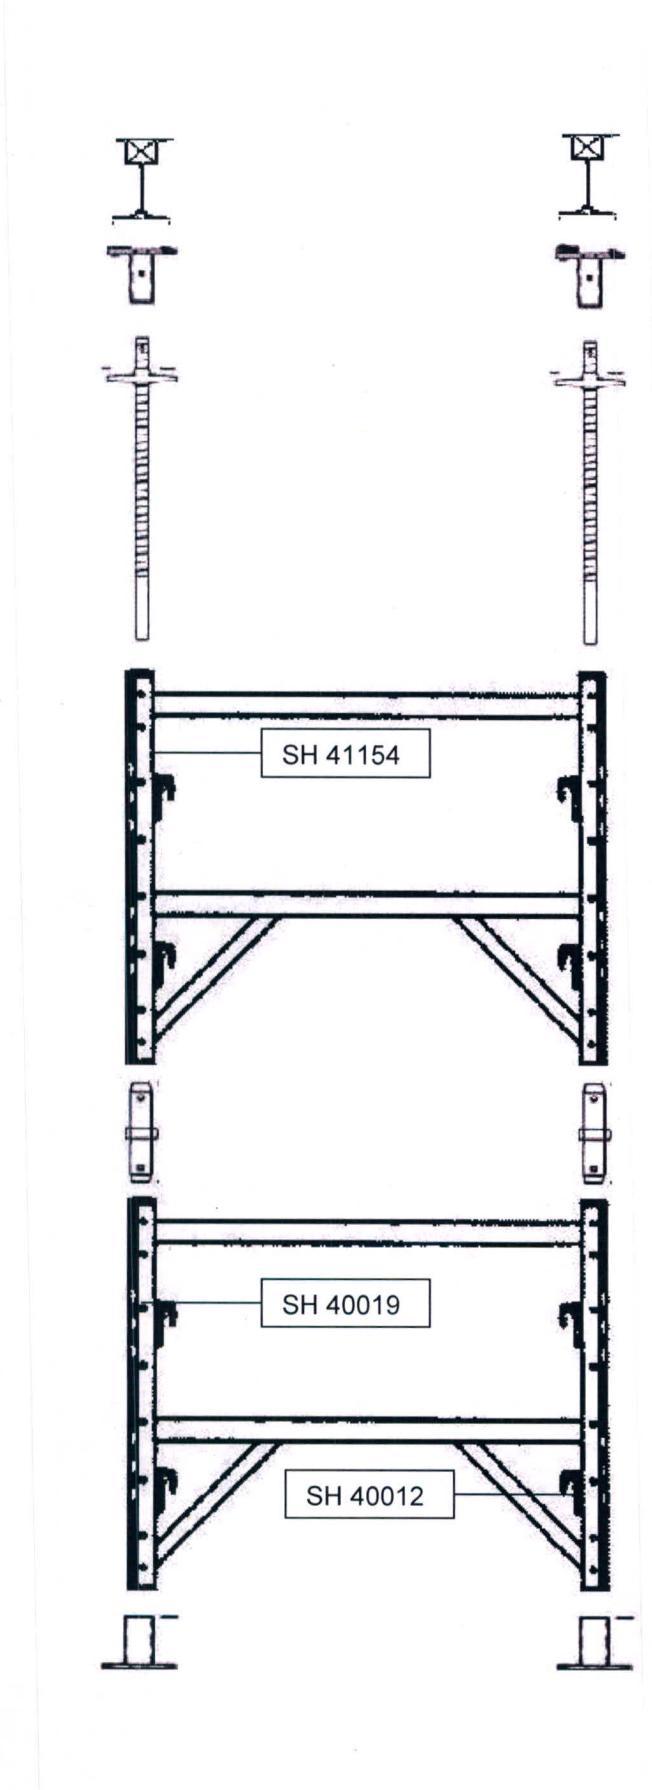
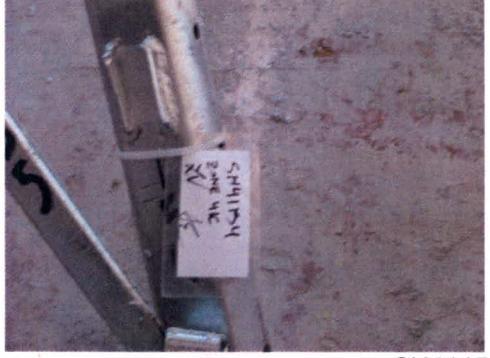
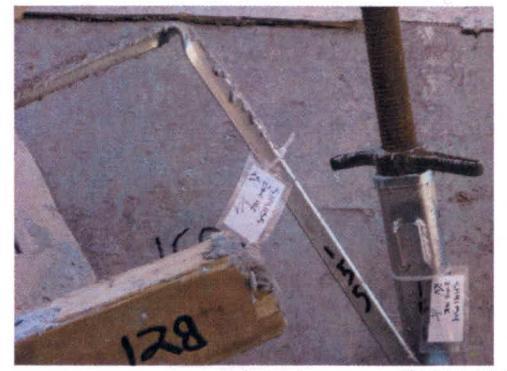
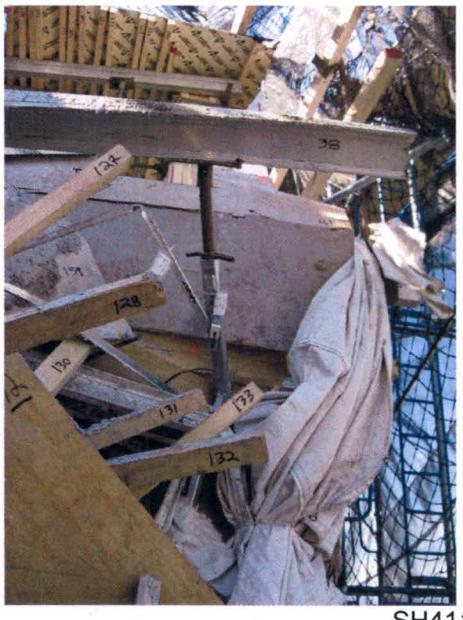
SH41154_1

SH 41154 Top Shore Connect to brace SH 41155 Zone 41C

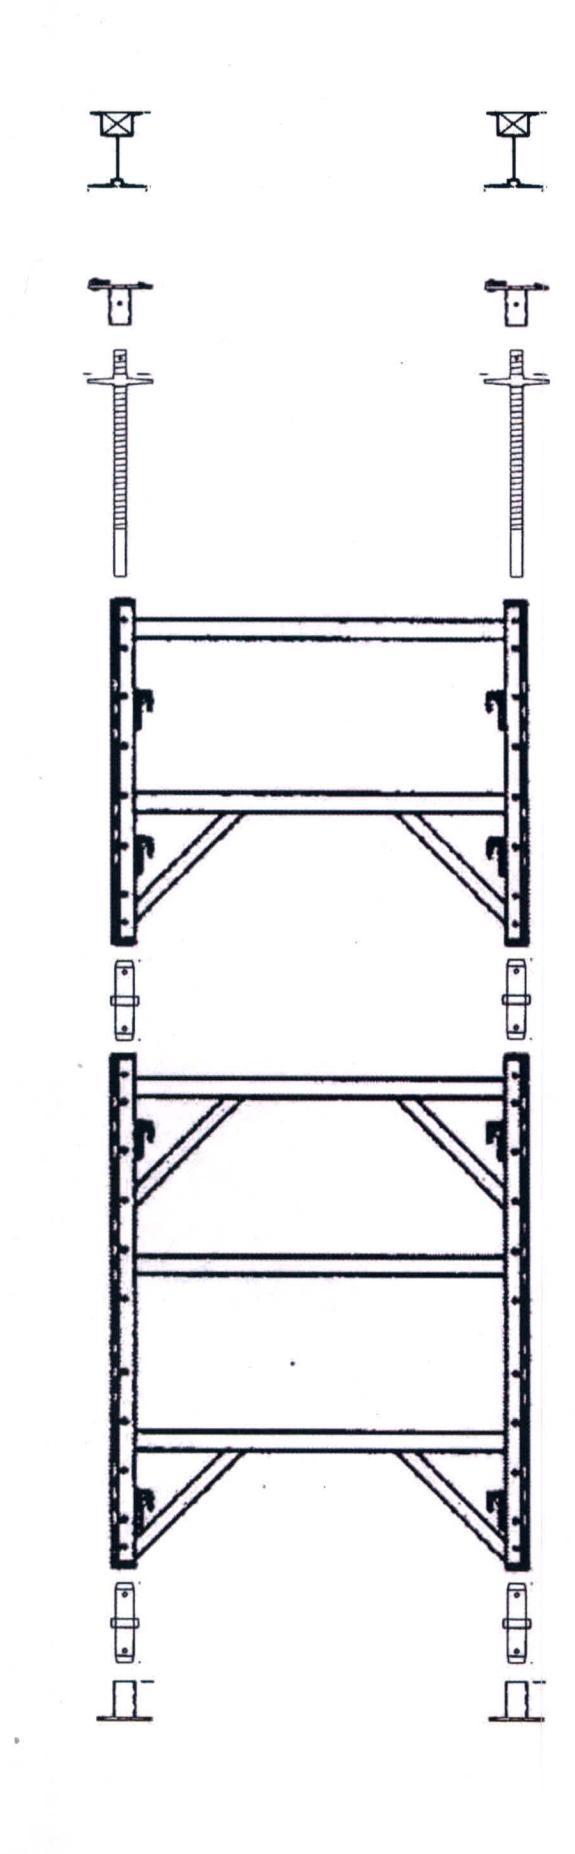
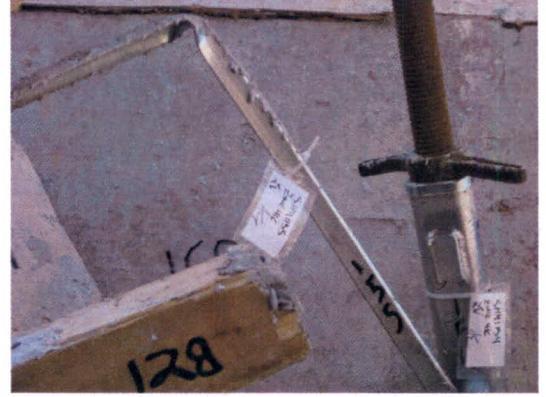
SH41154_3

SH 41155 Brace Connected to leg SH 41154 Zone 41G

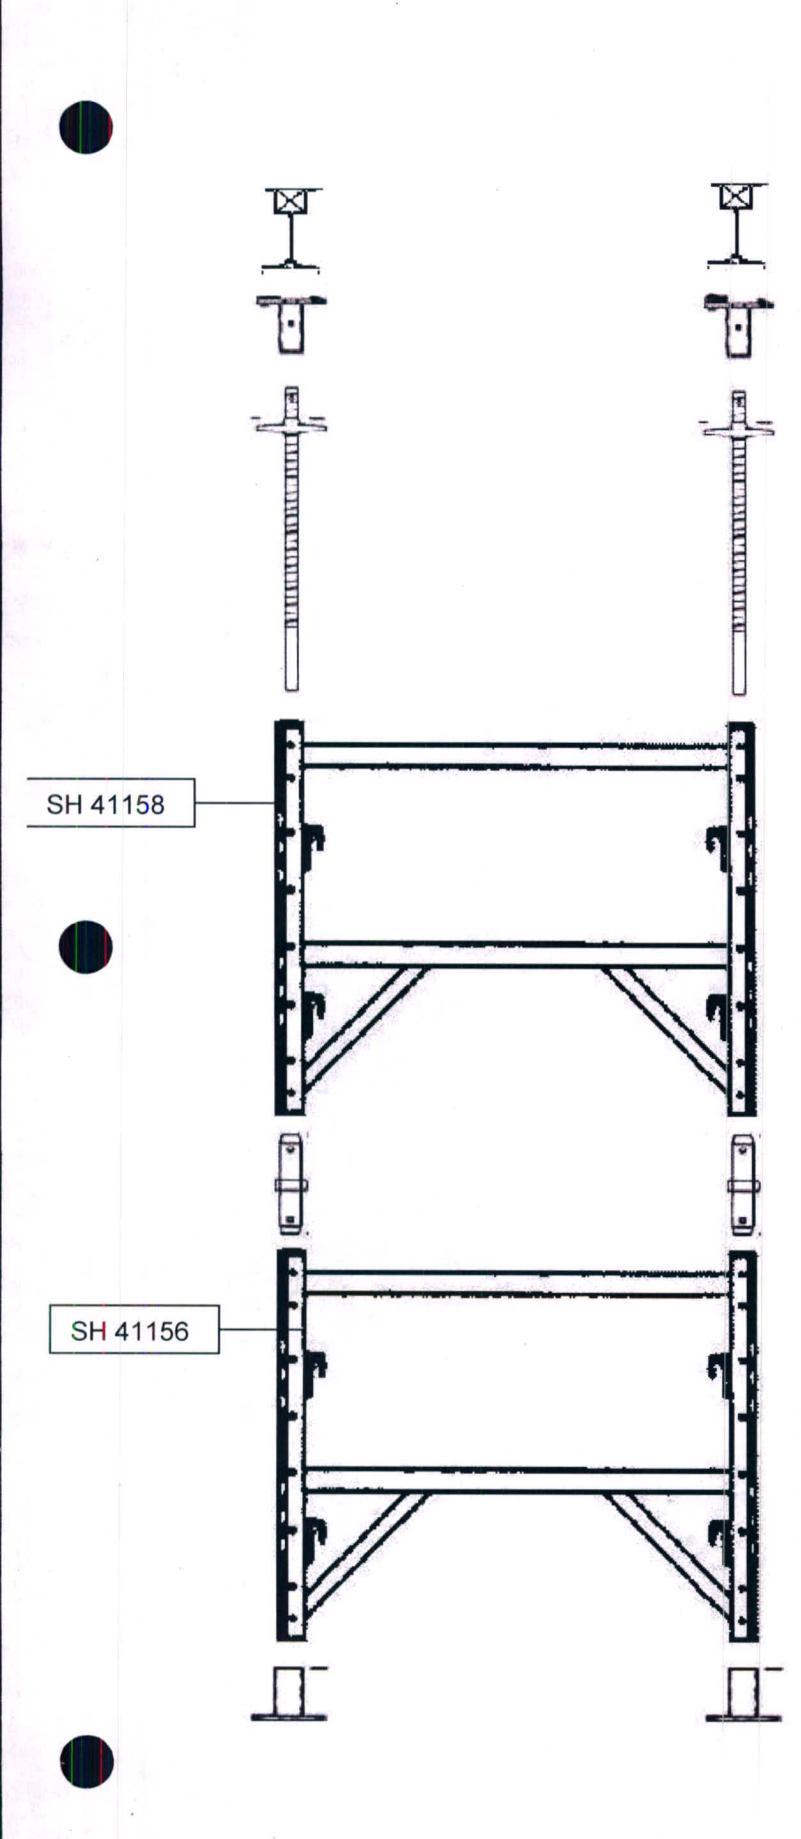
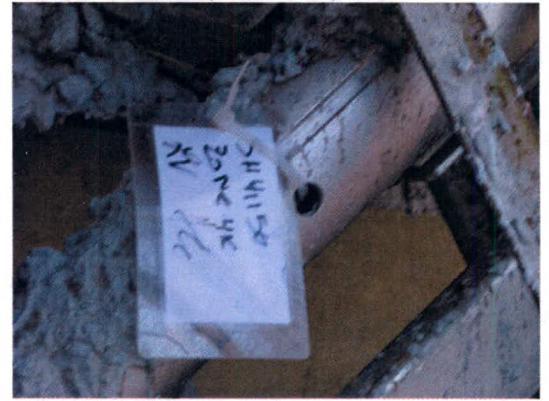
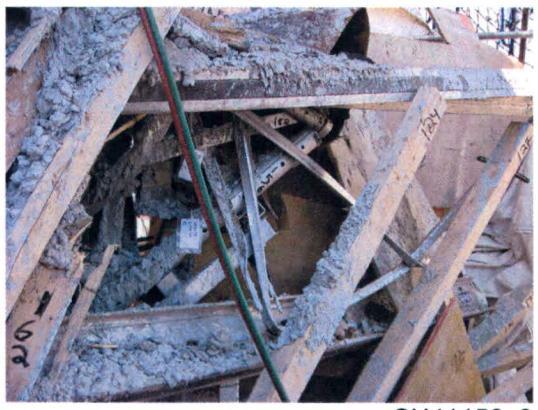
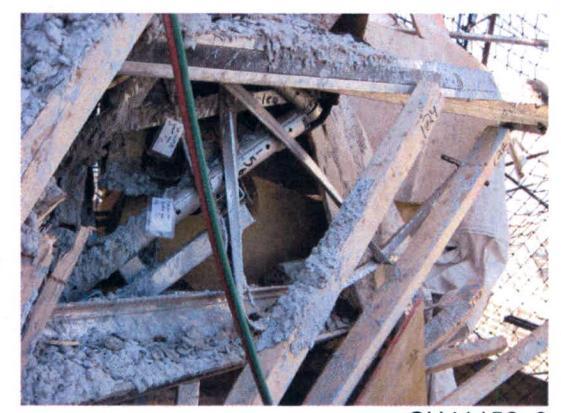
SH41156_1

SH 41156 Bottom Frame of SH 41158 Zone 41C
