INVESTIGATION REPORT:

JANUARY 14, 2008 SHORING COLLAPSE AT 9 DOMINICK ST. (AKA 246 SPRING ST.) MANHATTAN

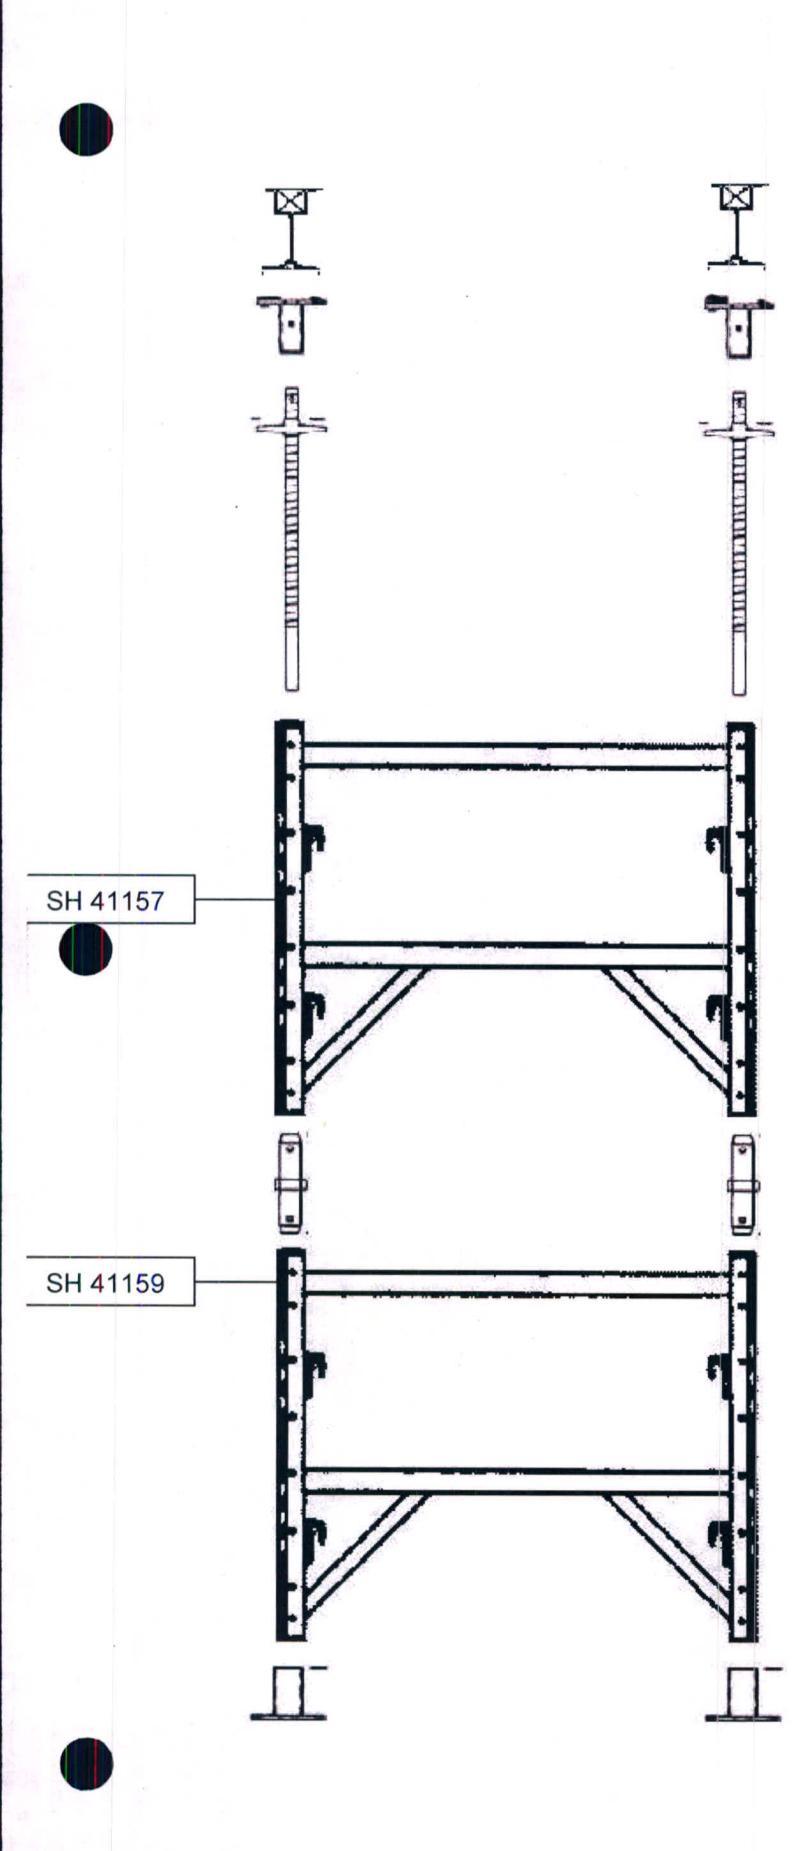
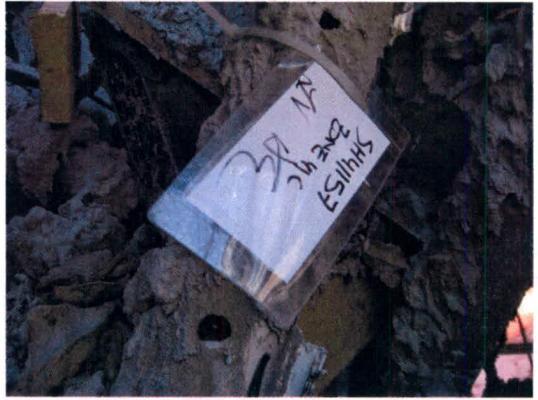
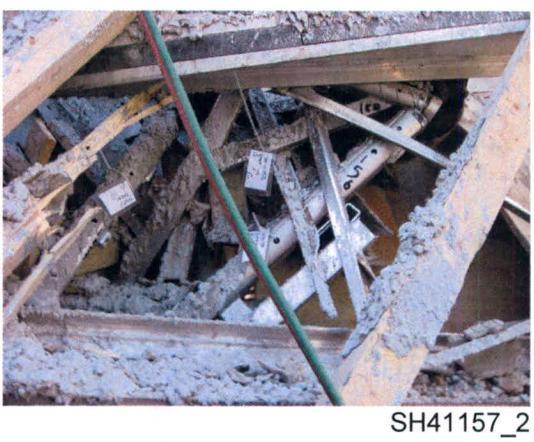
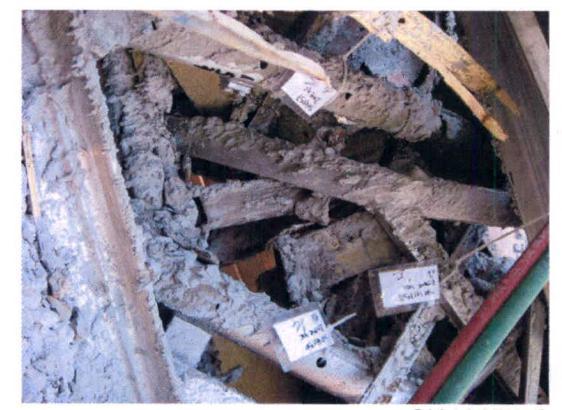
SH41157_1

SH 41157 Top frame of SH 41159 Zone 41C

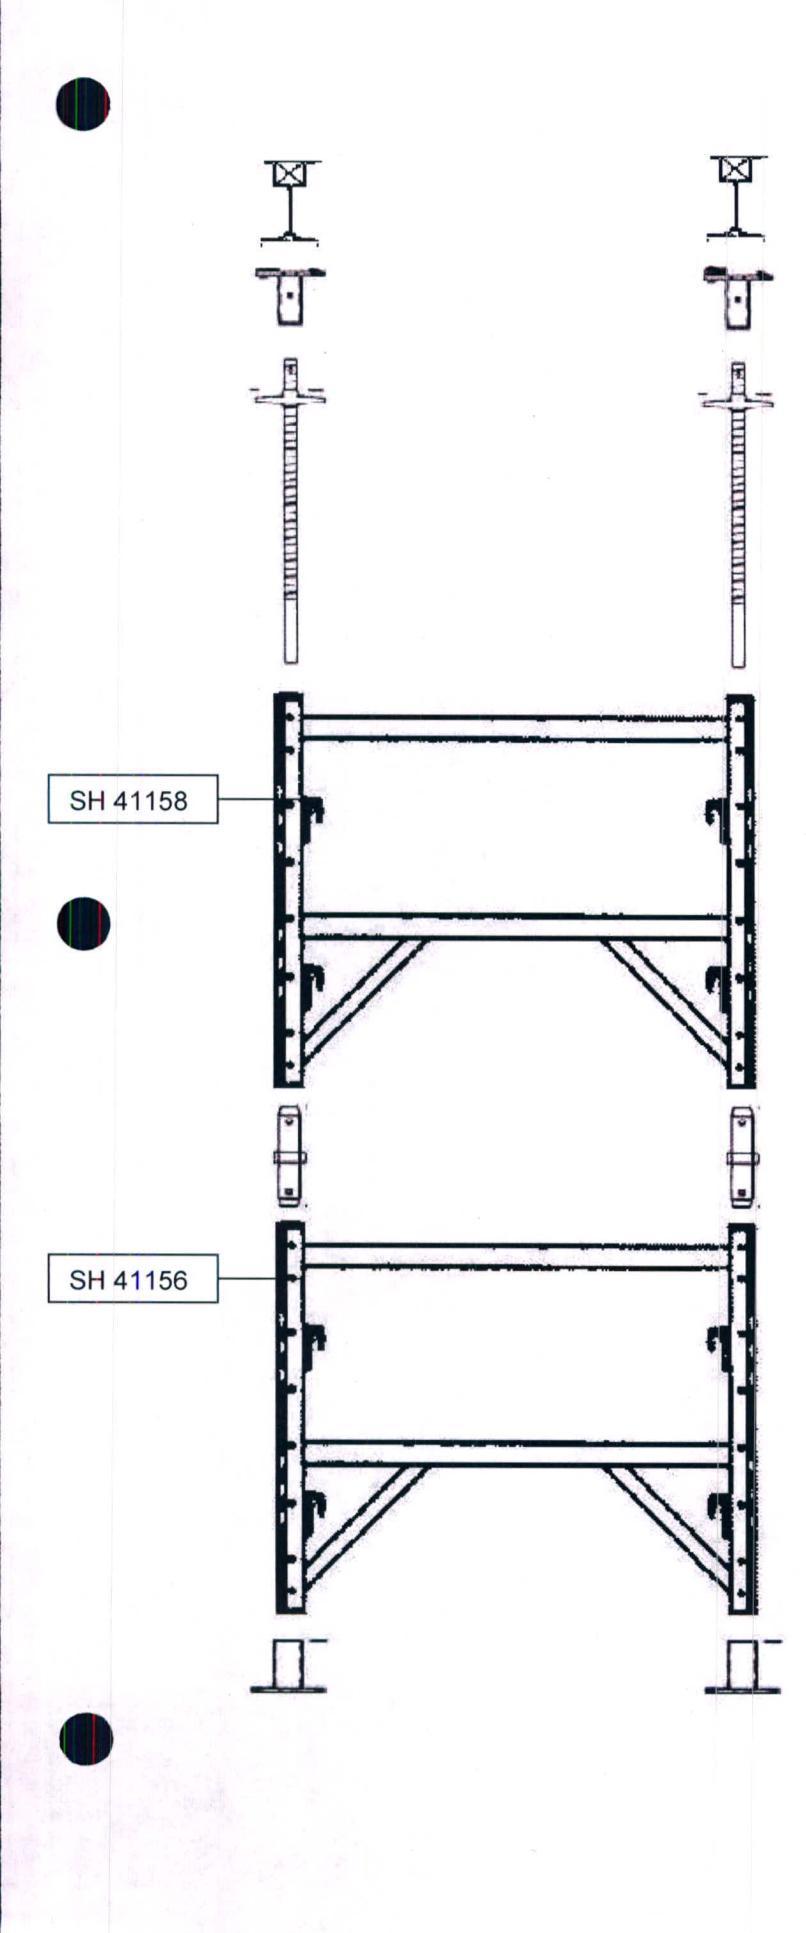
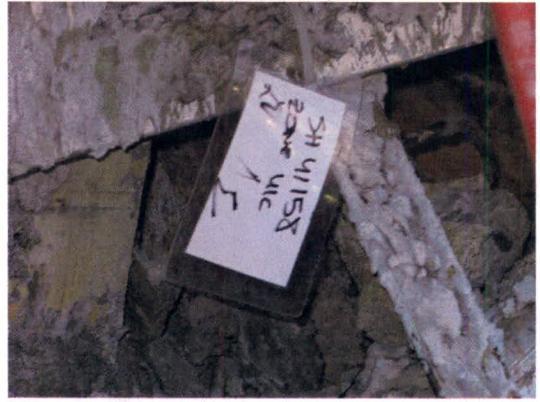
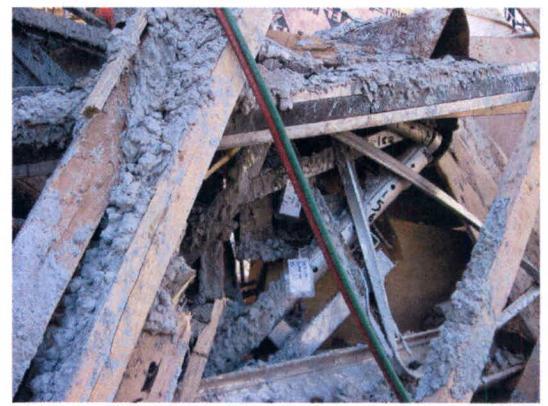
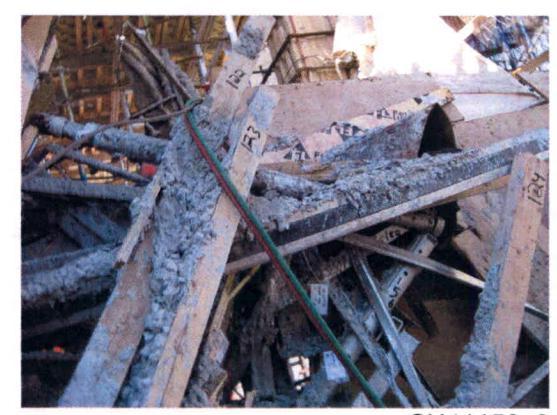
SH41158_1

SH 41158 Top frame of SH 41156 Connected to brace SH 41155 Zone 41C

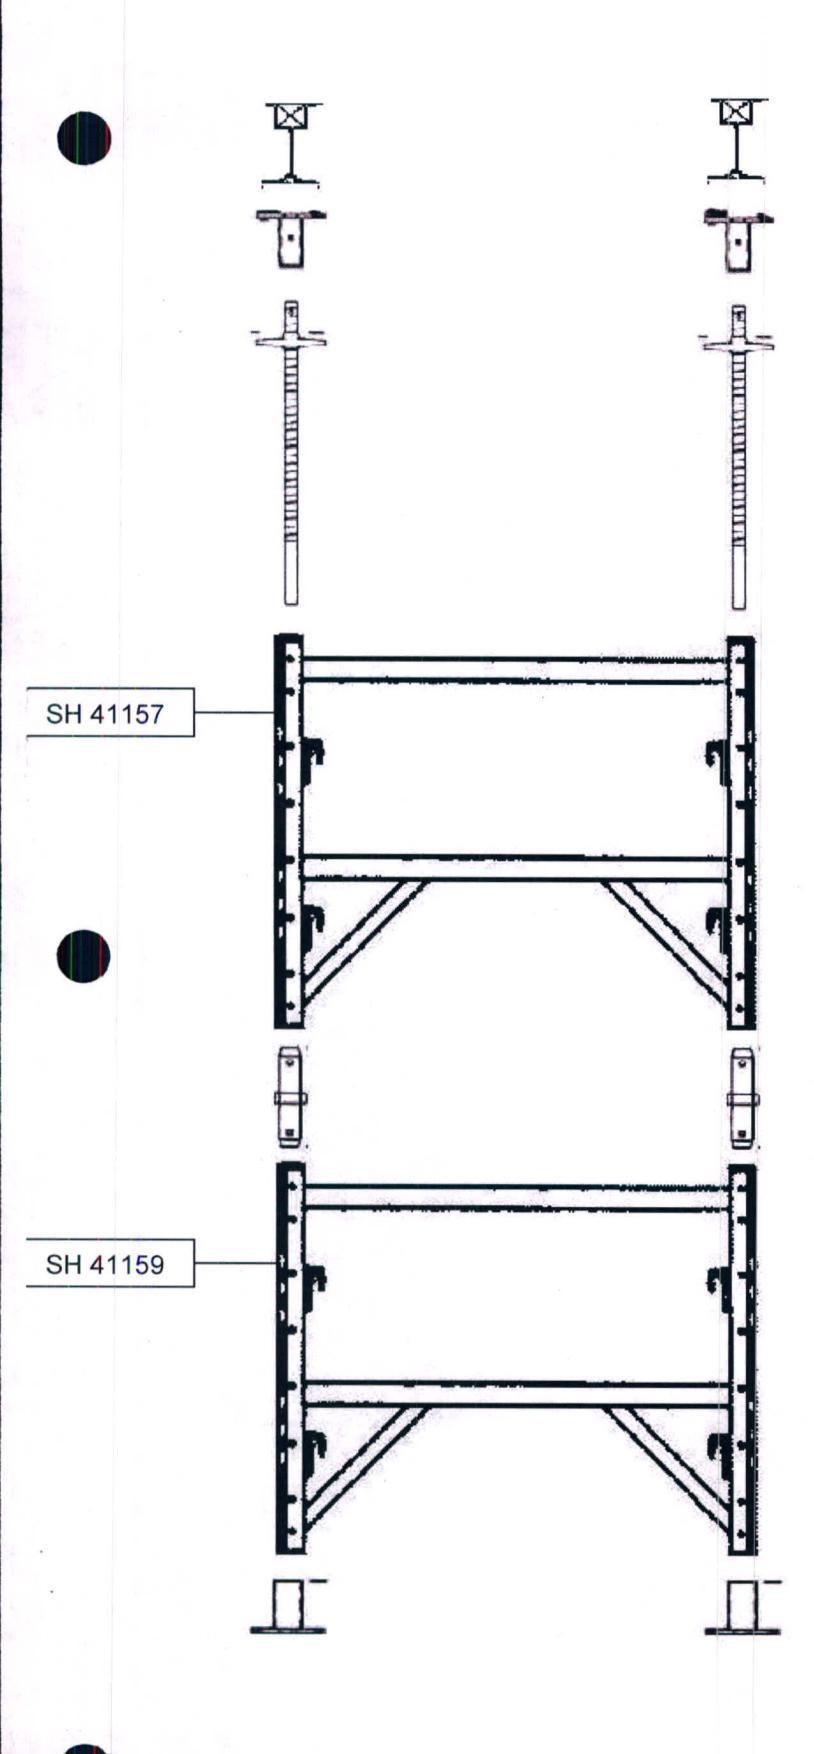
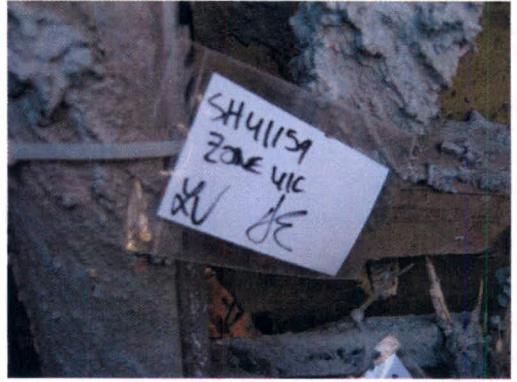
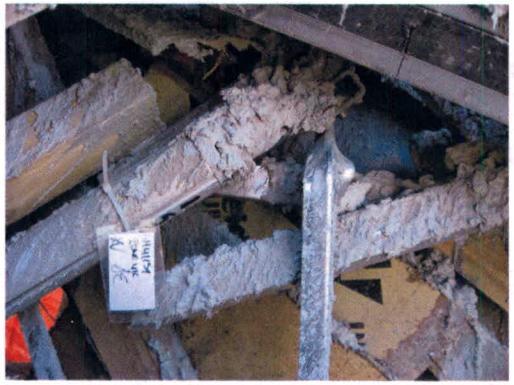
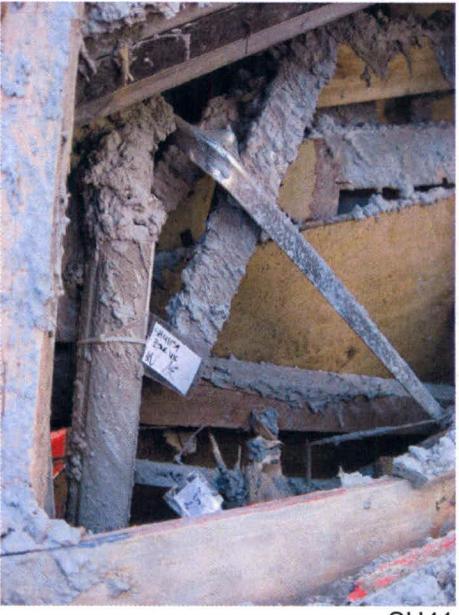
SH41159_2

SH 41159 Bottom Frame of SH 41157 Zone 41C

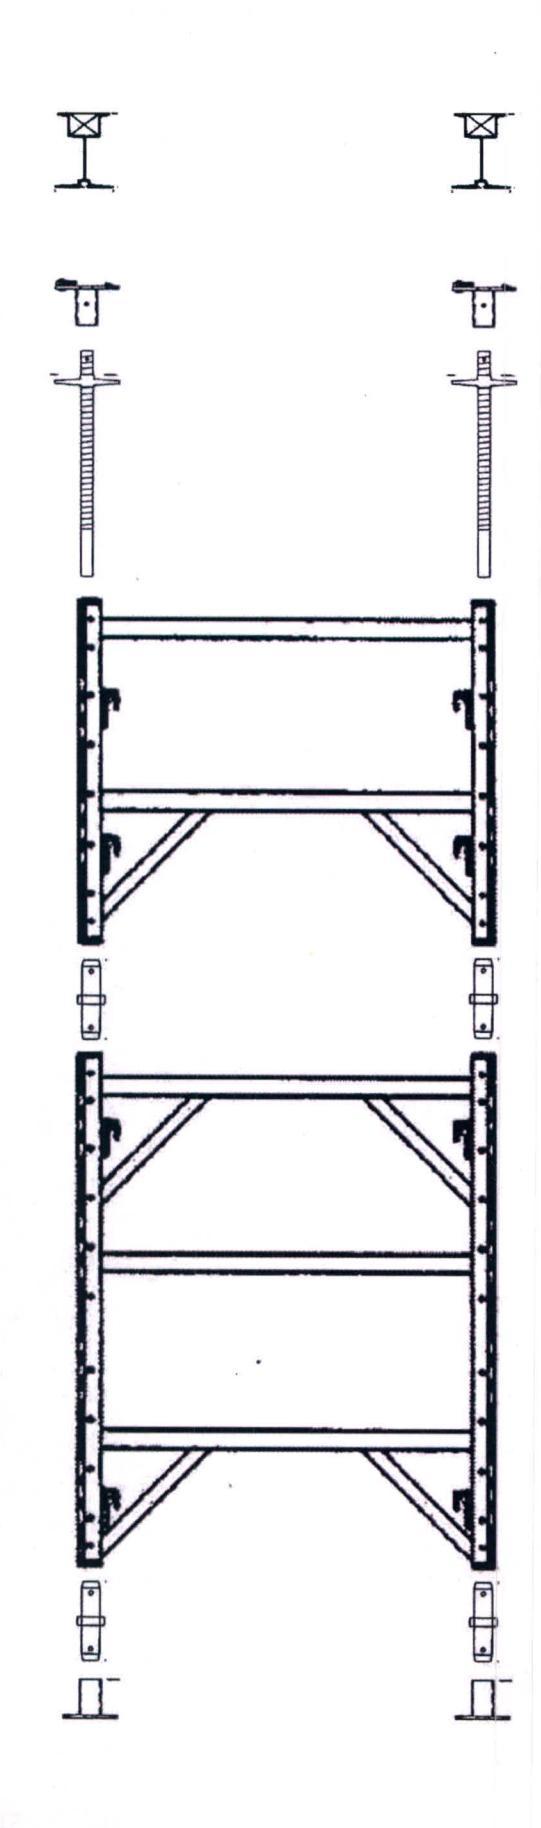
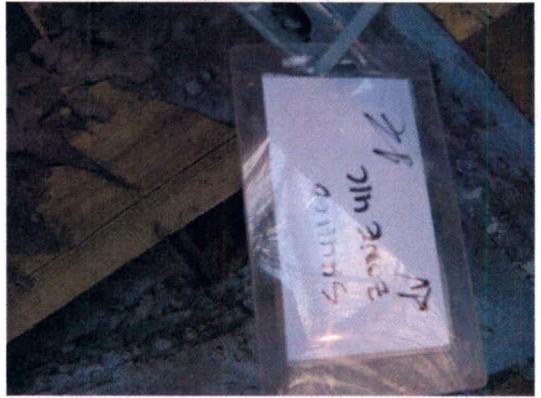
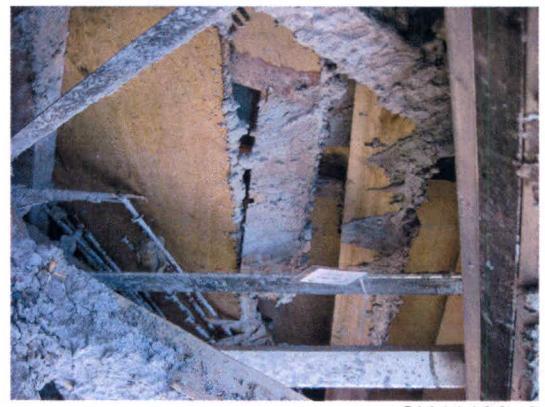
SH41160_1

SH 41160 Brace Connected to SH 41157 Zone 41C

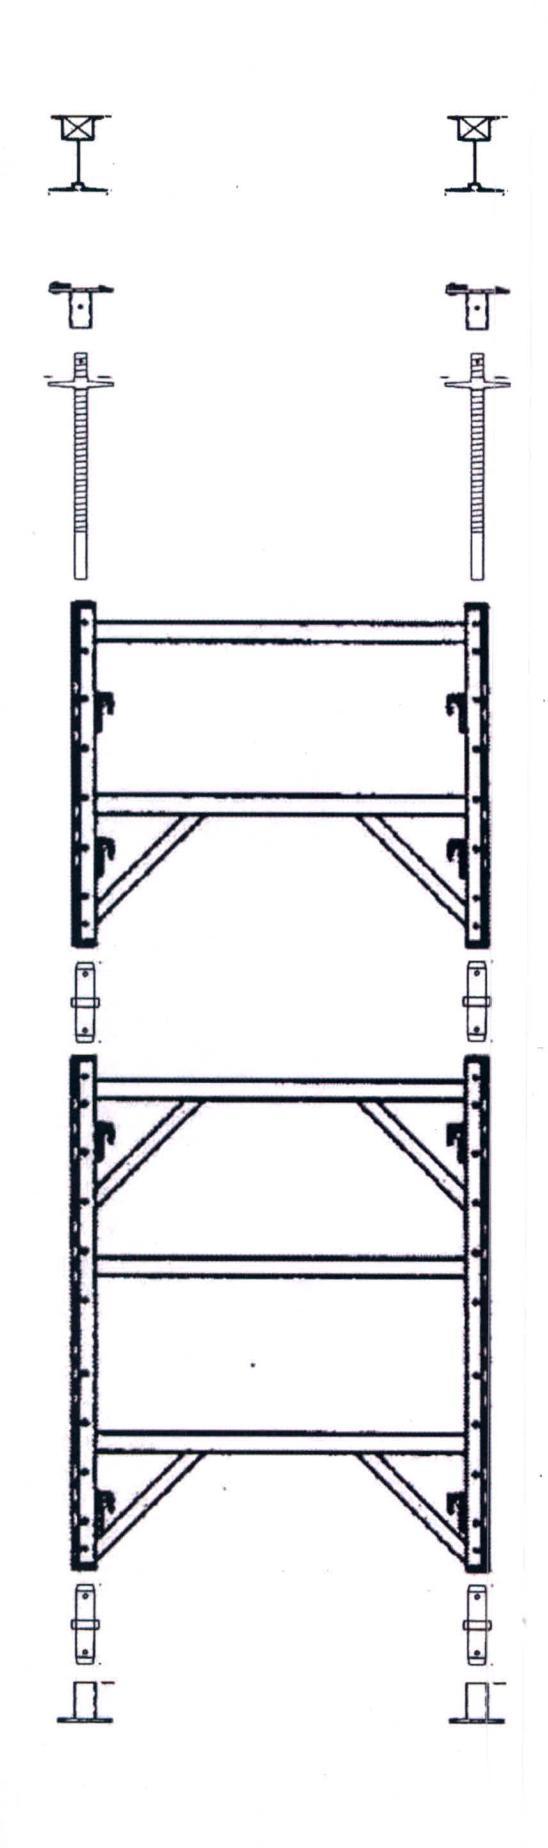
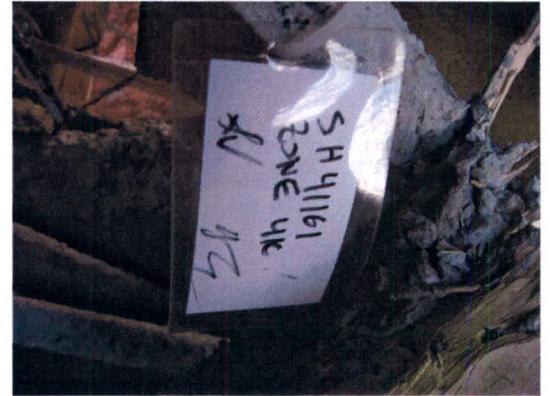
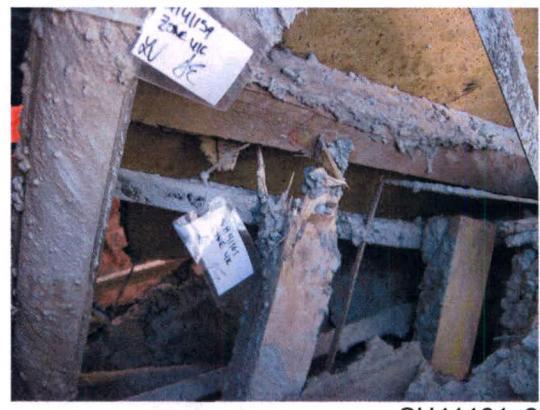
SH41161_1

SH 41161 Brace connected to SH 41159 Zone 41C

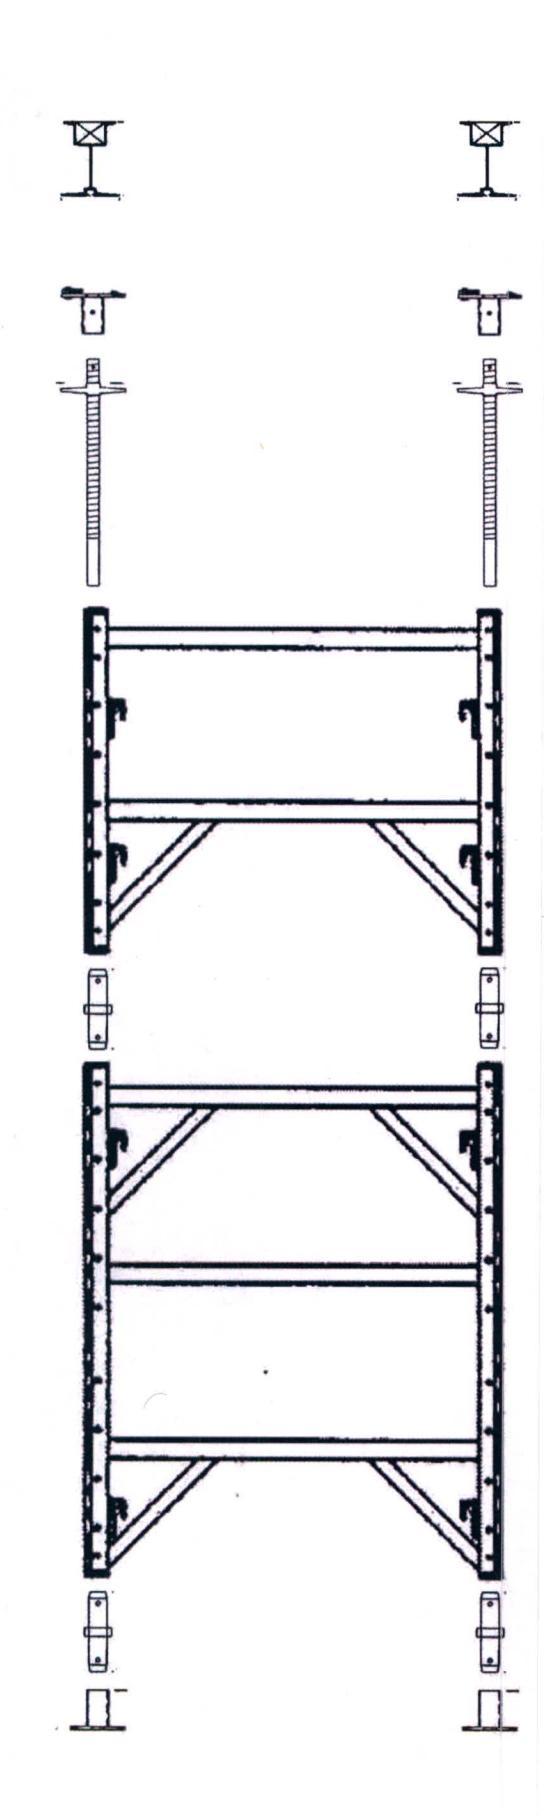
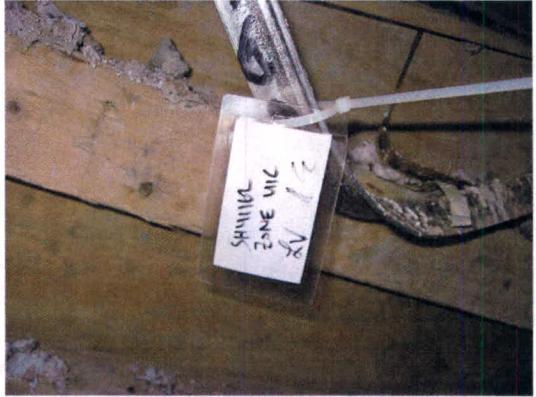
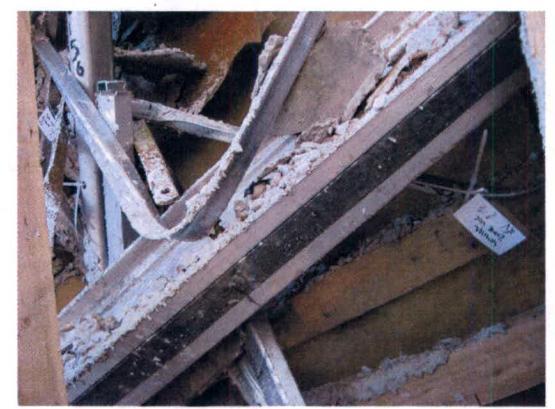
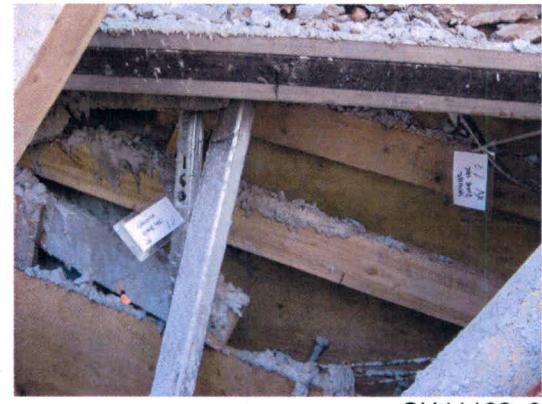
SH41162_1

SH 41162 Brace Connected to SH 41156 Zone 41C

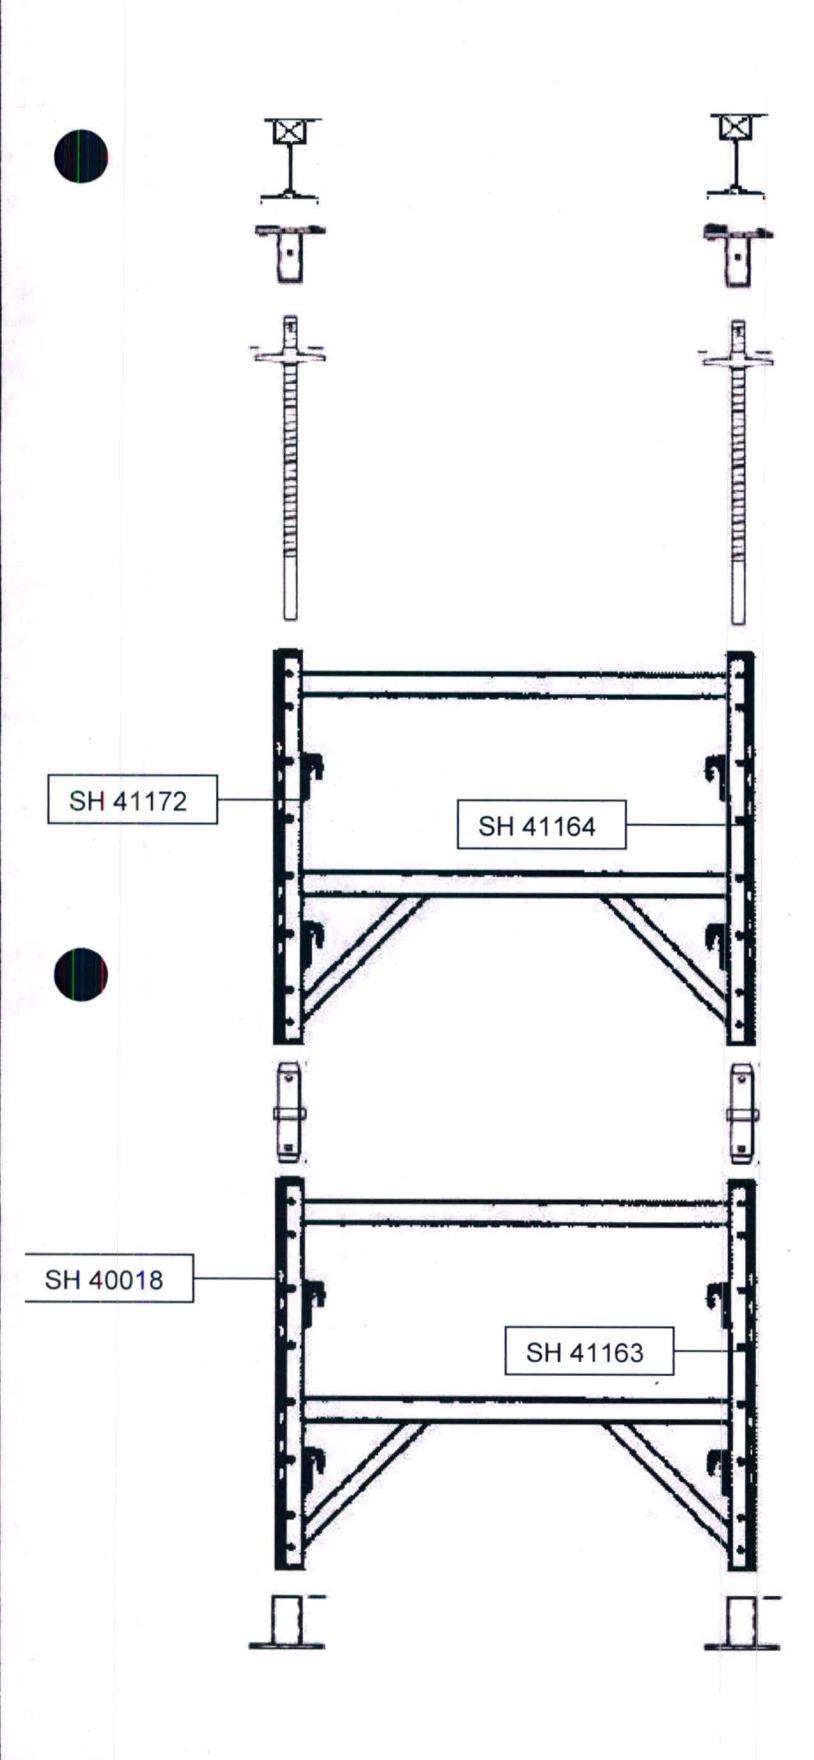
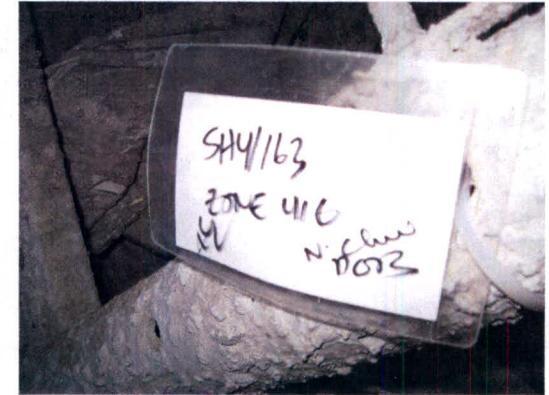
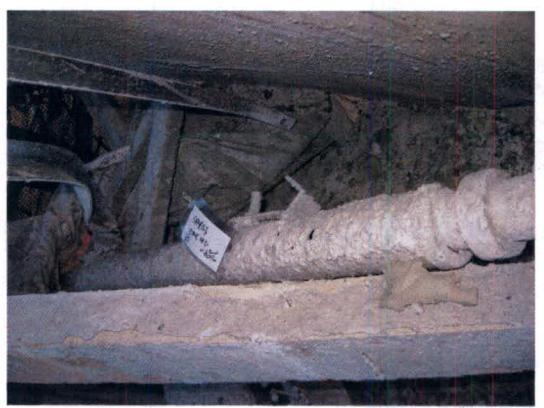
SH41163_1

SH 41163 Bottom Shore Frame attached to brace SH 41164 and SH 41151 Brace Zone 41G

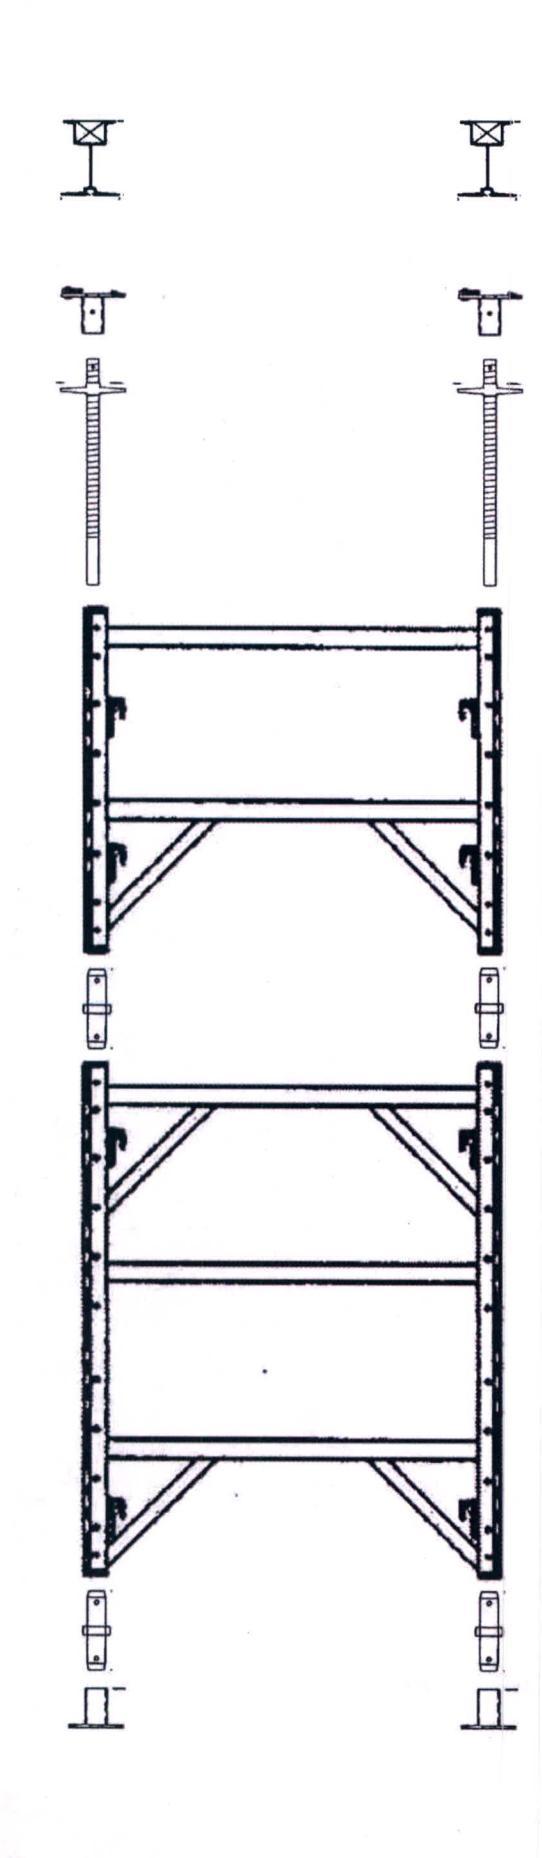
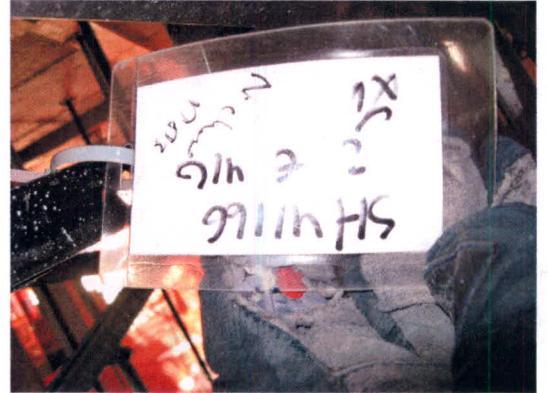
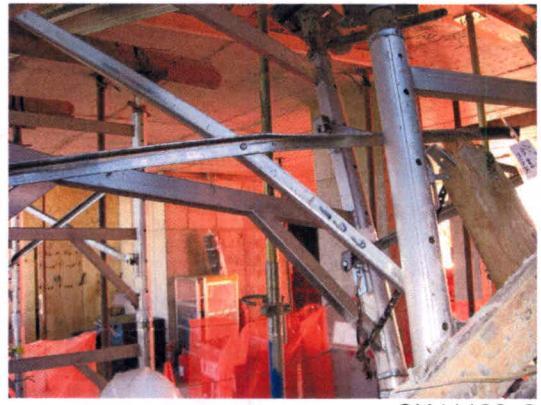
SH41166_1

SH 41166

Brace attached to SH 40003 and SH 40004 Zone 41G

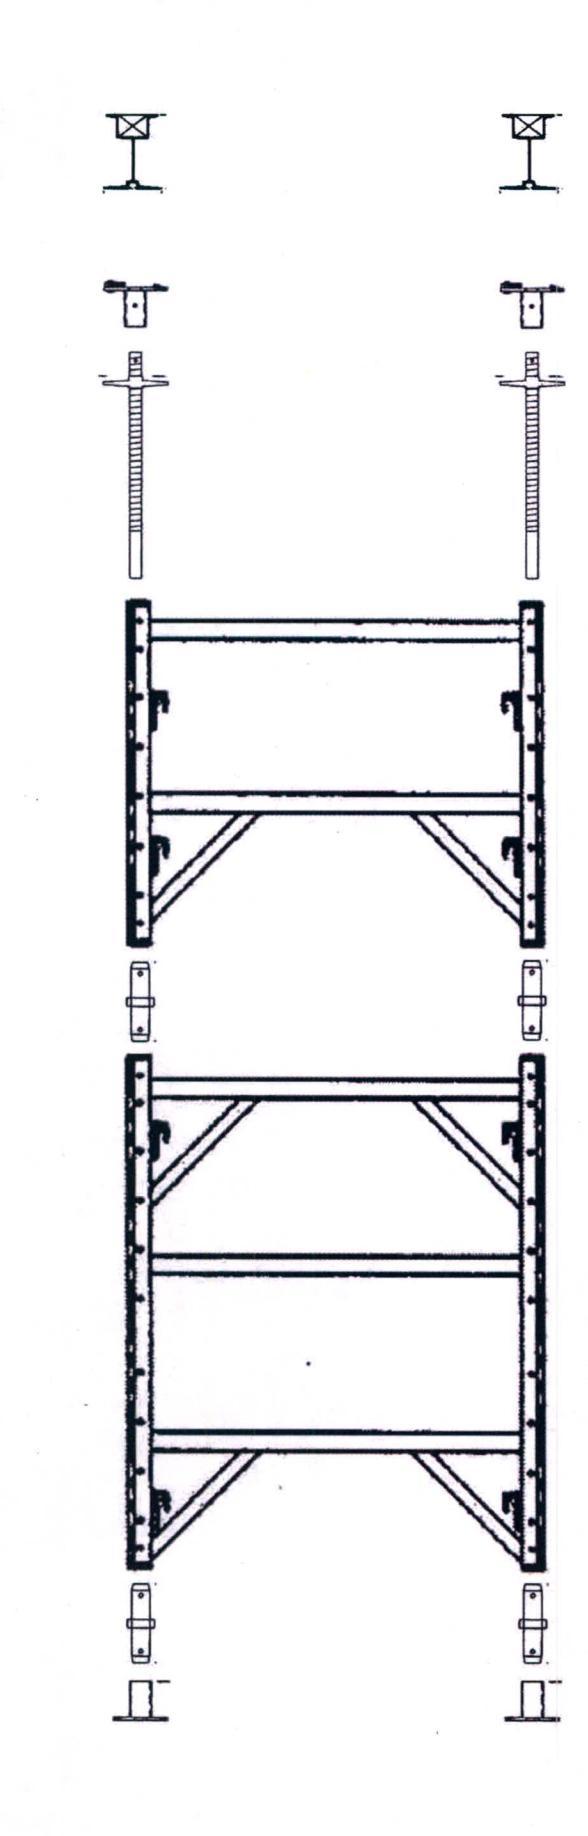
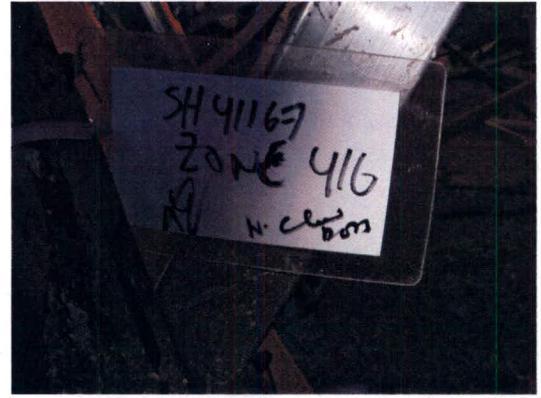
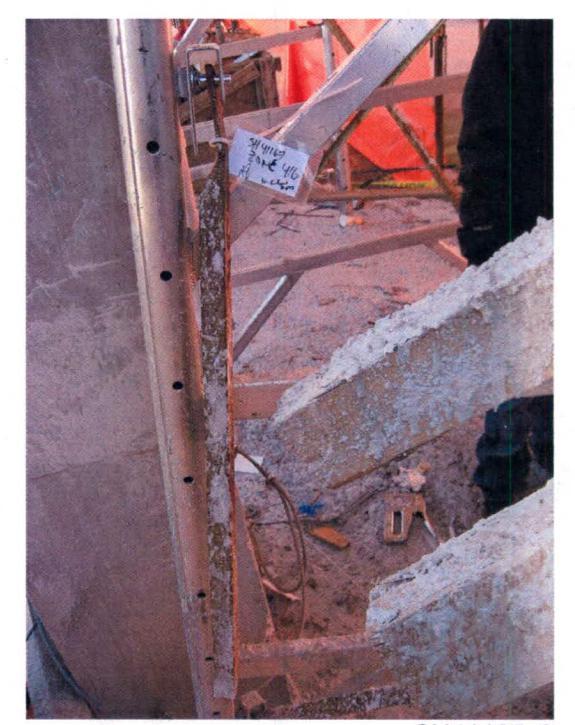
SH41167_1

SH 41167 on 40th Floor Connected to Frame SH 41175 Zone 41G

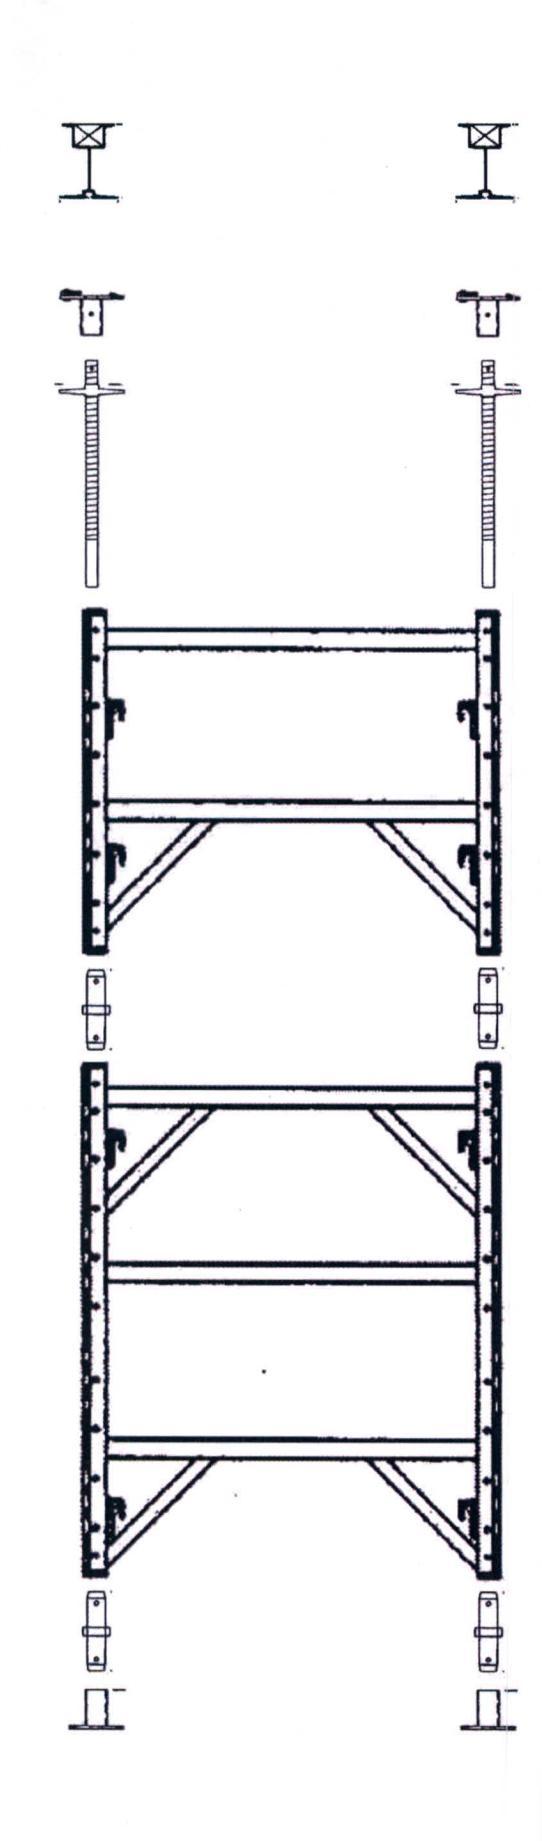
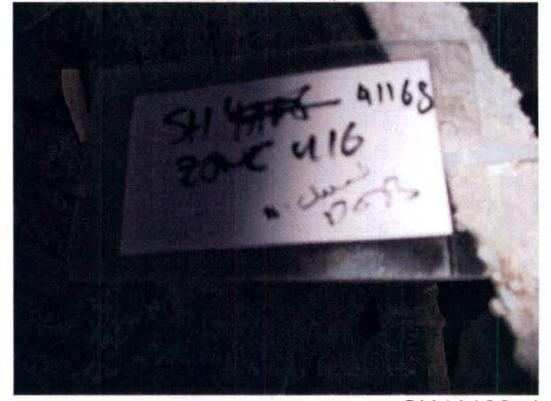
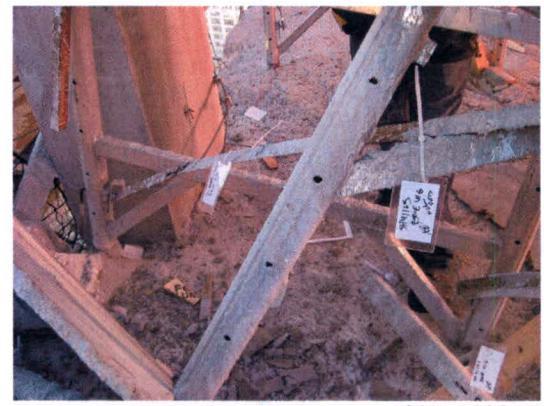
SH41168_1

SH 41168 Bottom Brace connected to SH 41175 Zone 41G

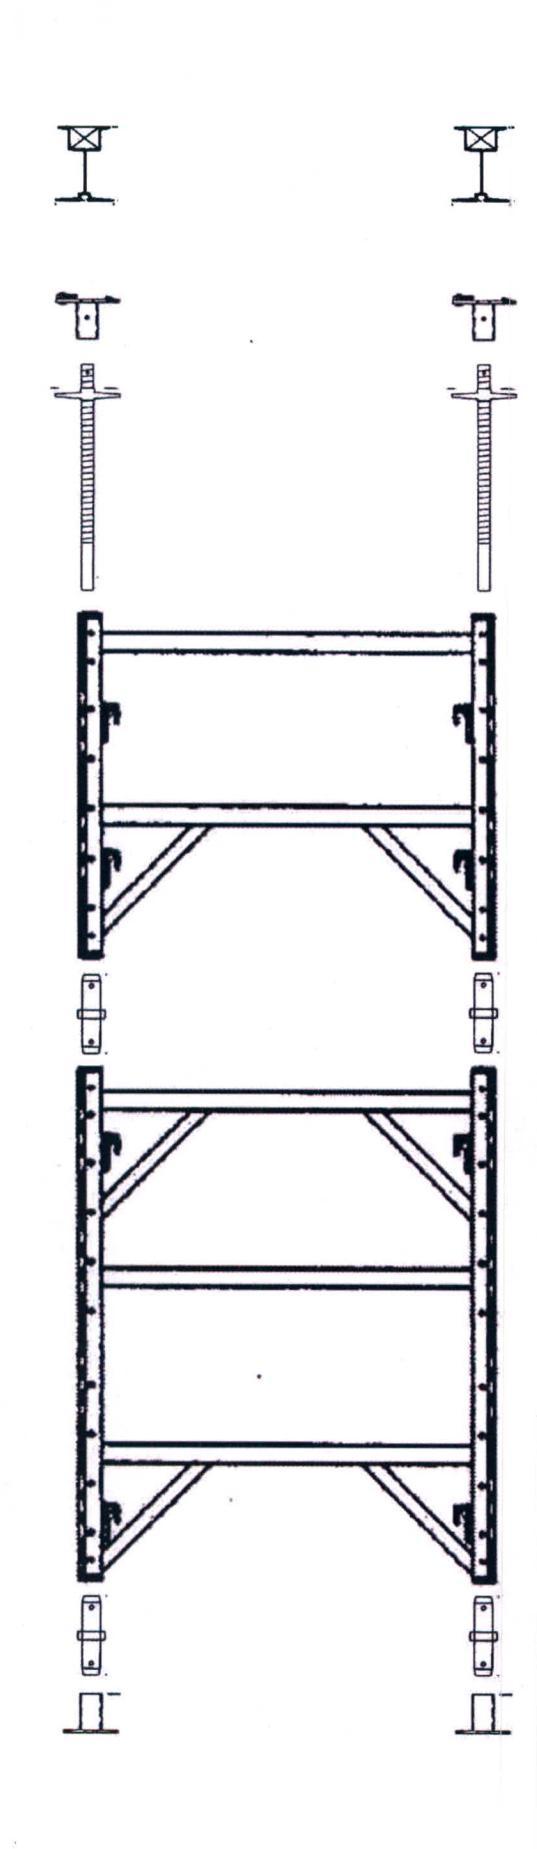
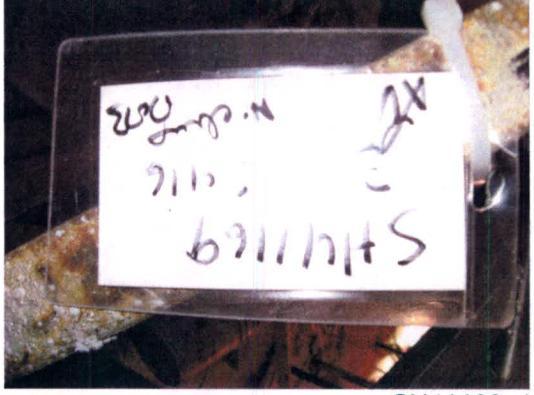
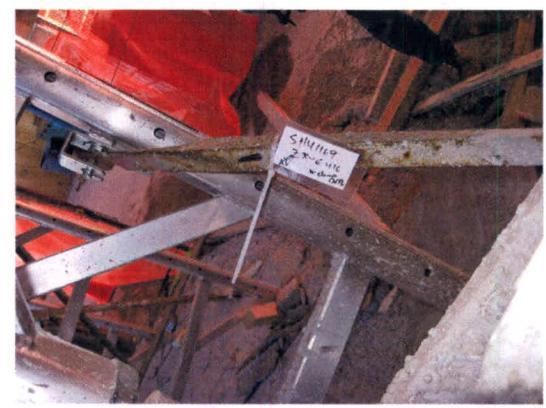
SH41169_1

SH 41169 Brace connects to SH 41175 Zone 41G

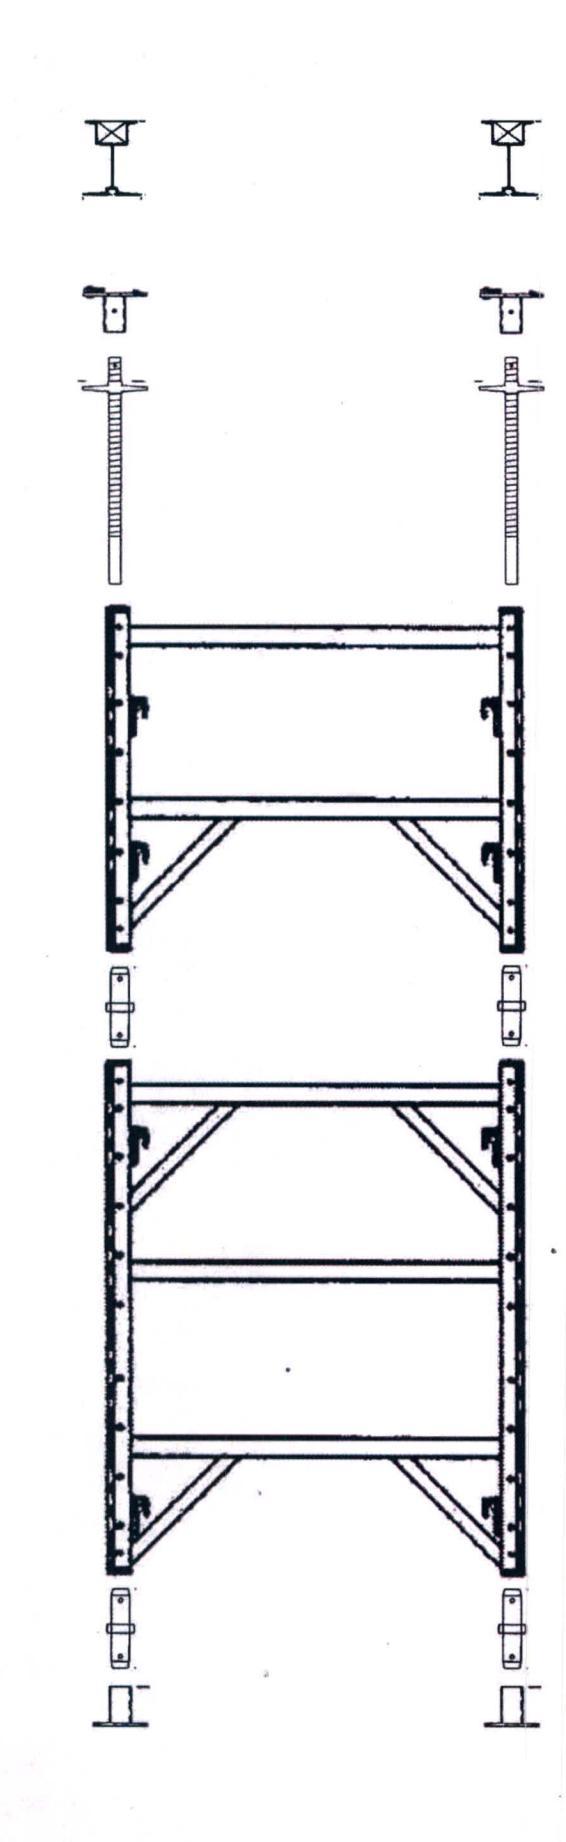
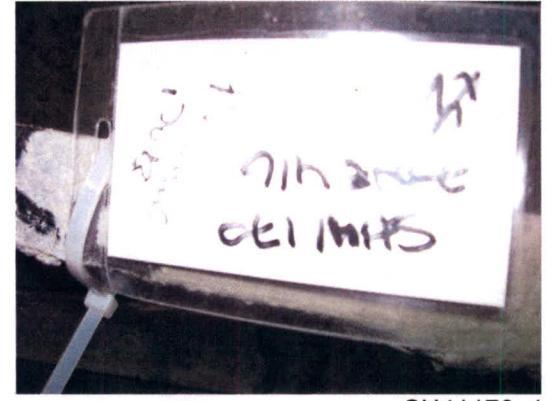
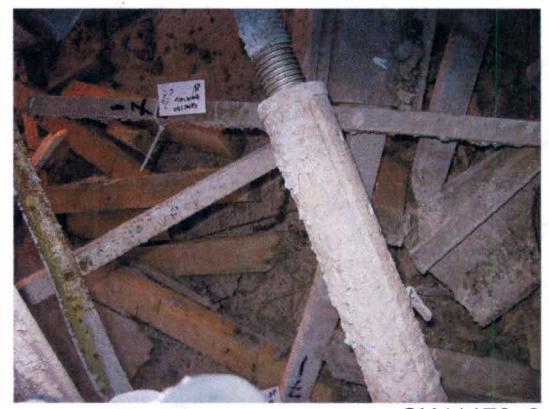
SH41170_1

SH 41170 on 40th Floor Piece of frame leaning SH 41169 Zone 41G

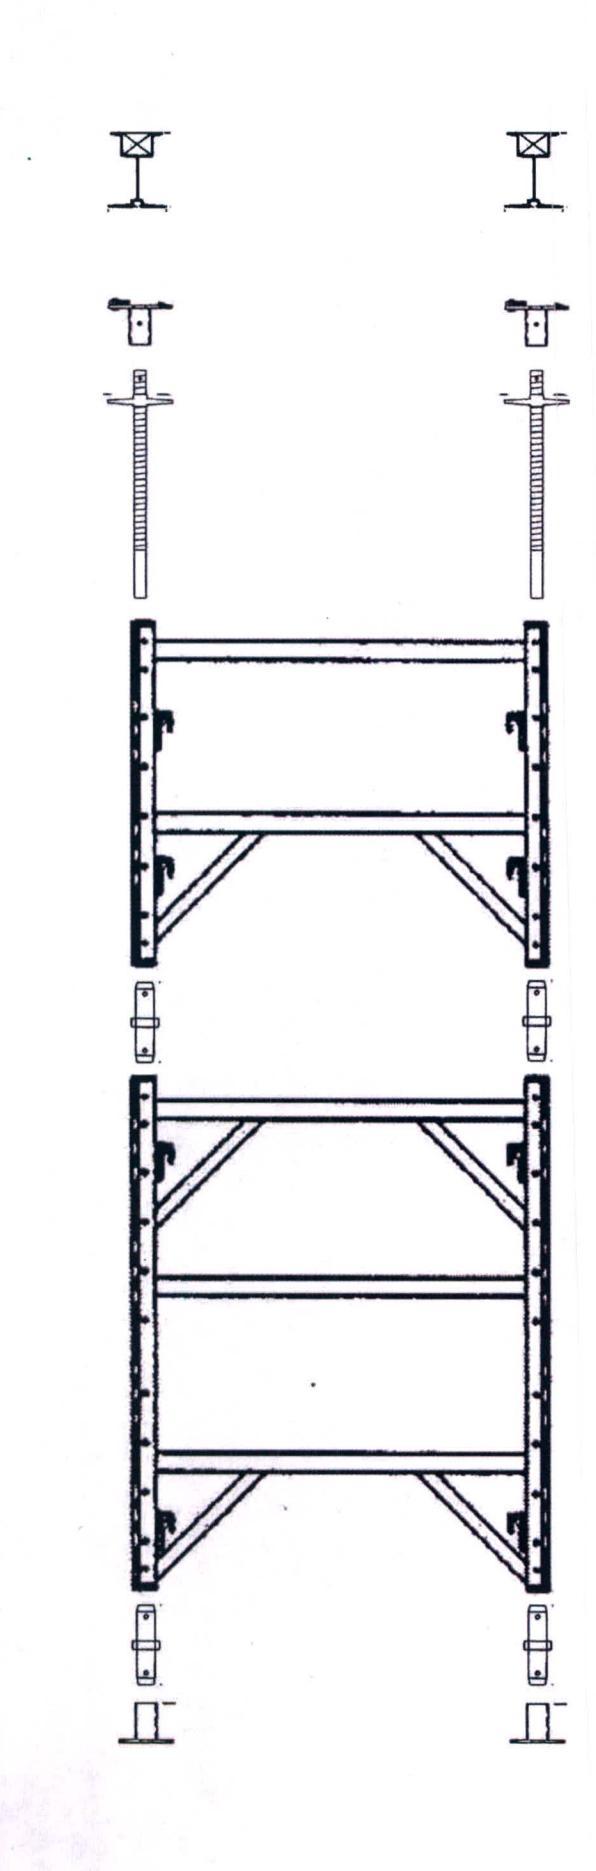
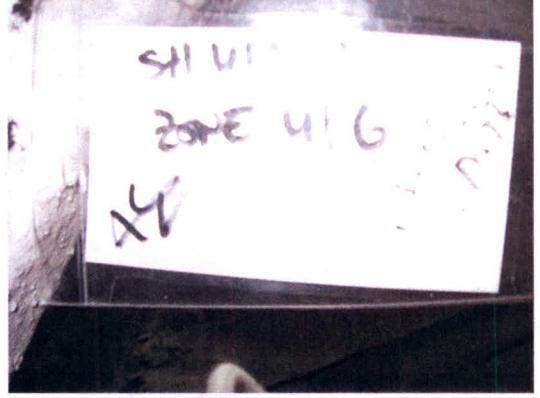
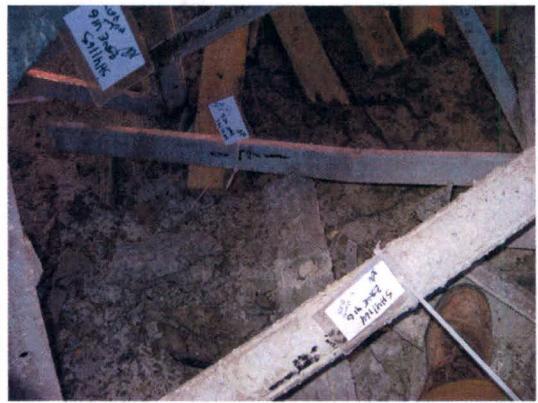
SH41171_1

SH 41171 Piece of Frame Frame Connected to Brace SH 41147 Zone 41G
