INVESTIGATION REPORT:

JANUARY 14, 2008 SHORING COLLAPSE AT 9 DOMINICK ST. (AKA 246 SPRING ST.) MANHATTAN

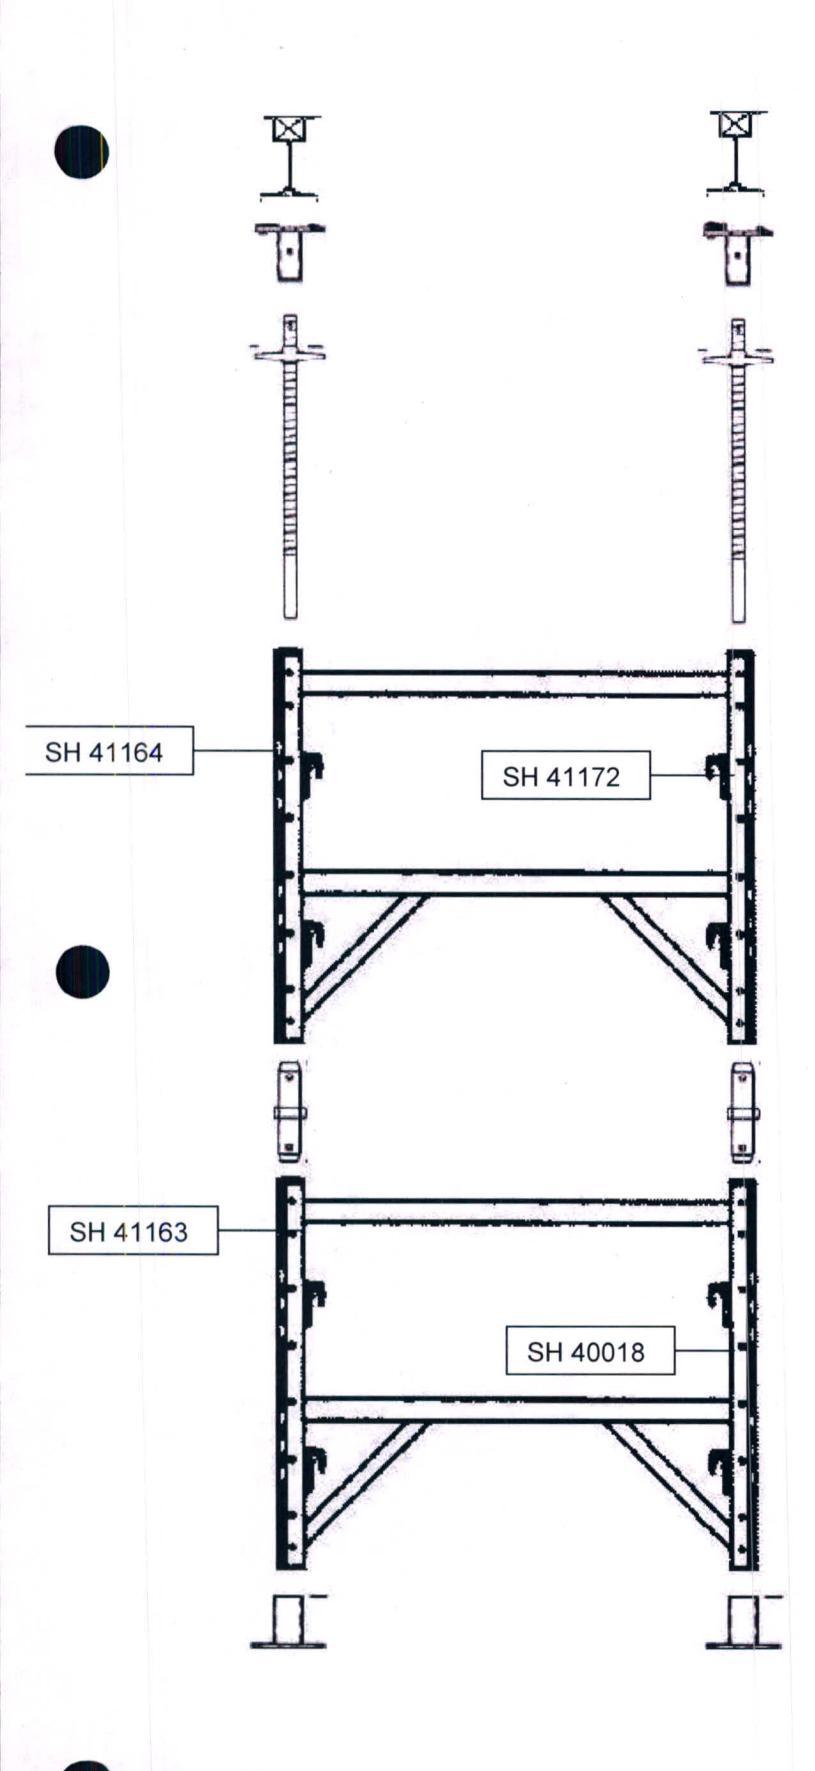
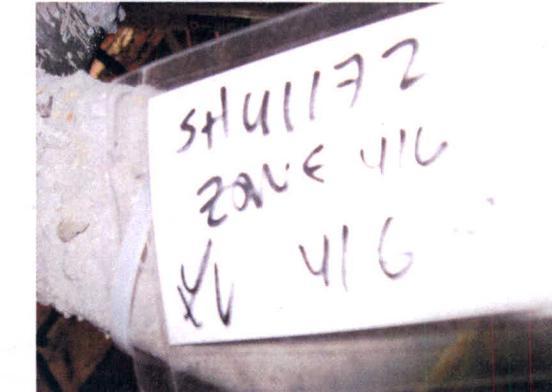
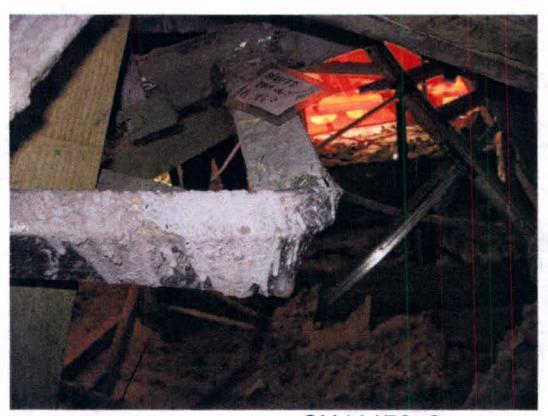
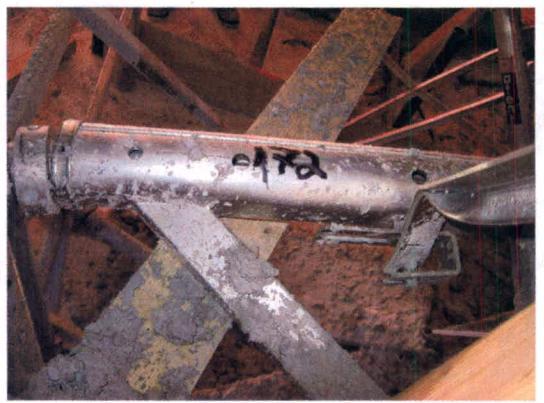
SH41172_1

SH 41172 Top plate below AB 41001 Zone 41G

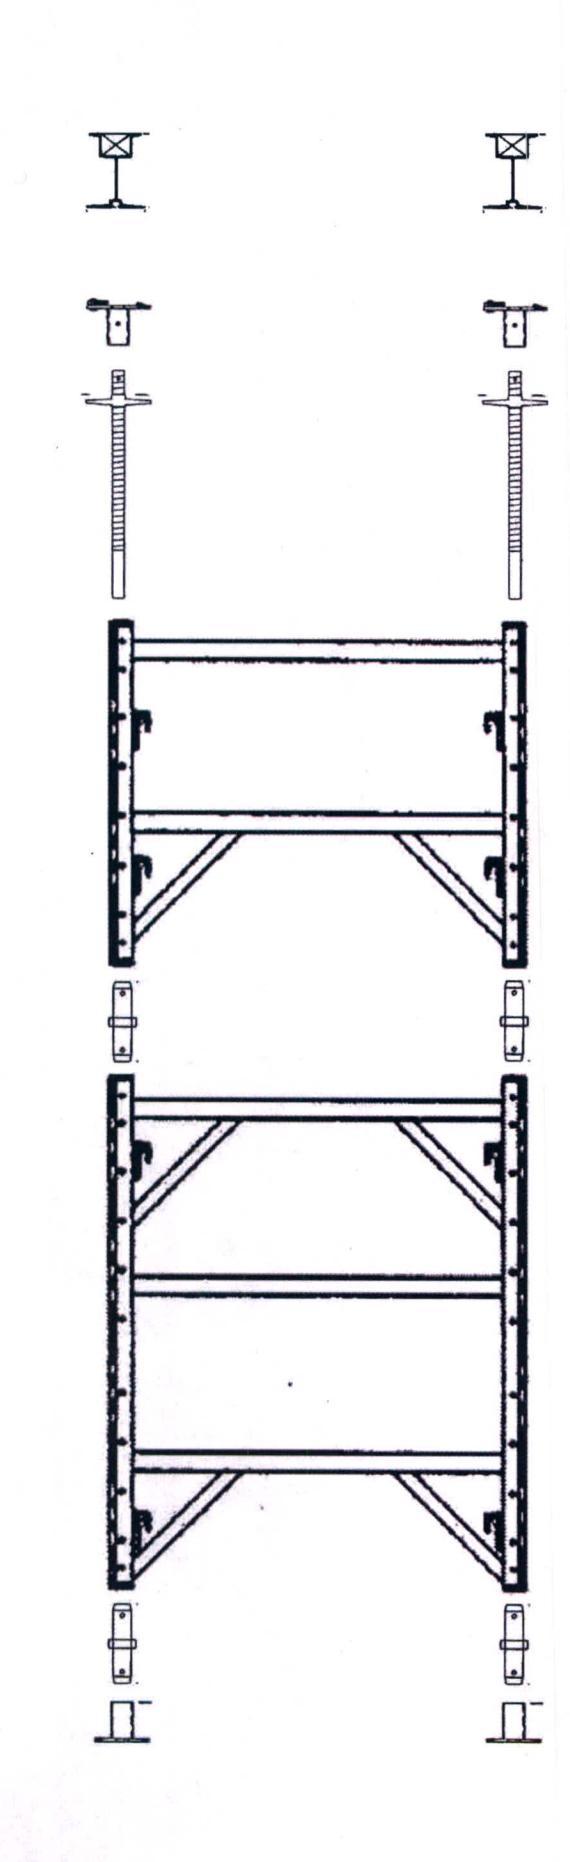
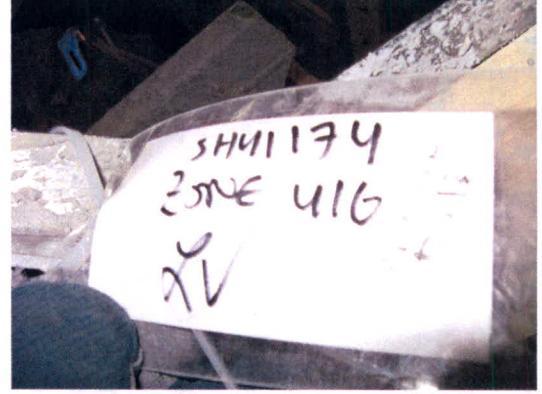
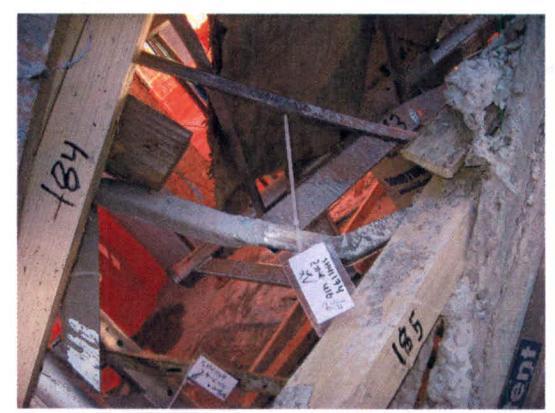
SH41174_1

SH 41174 Brace connects SH 41166 and SH 40004 Zone 41G

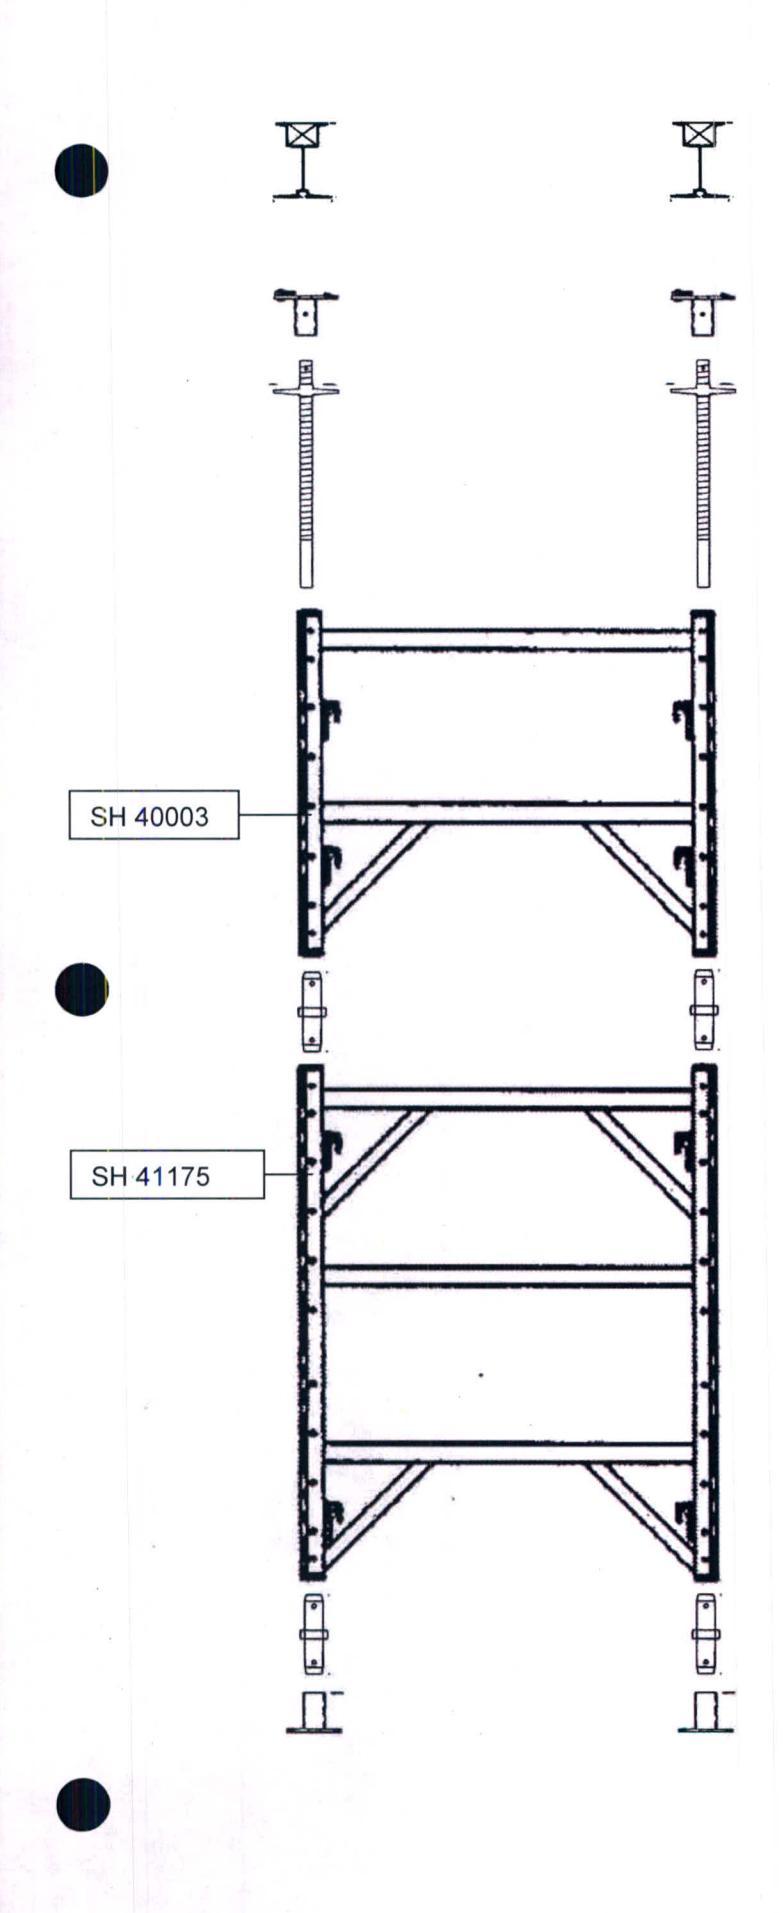
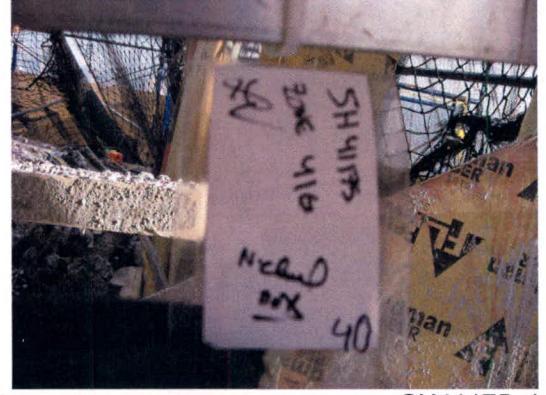
SH41175_1

SH 41175 on 40th floor Bottom Frame of SH 40003 Zone 41G

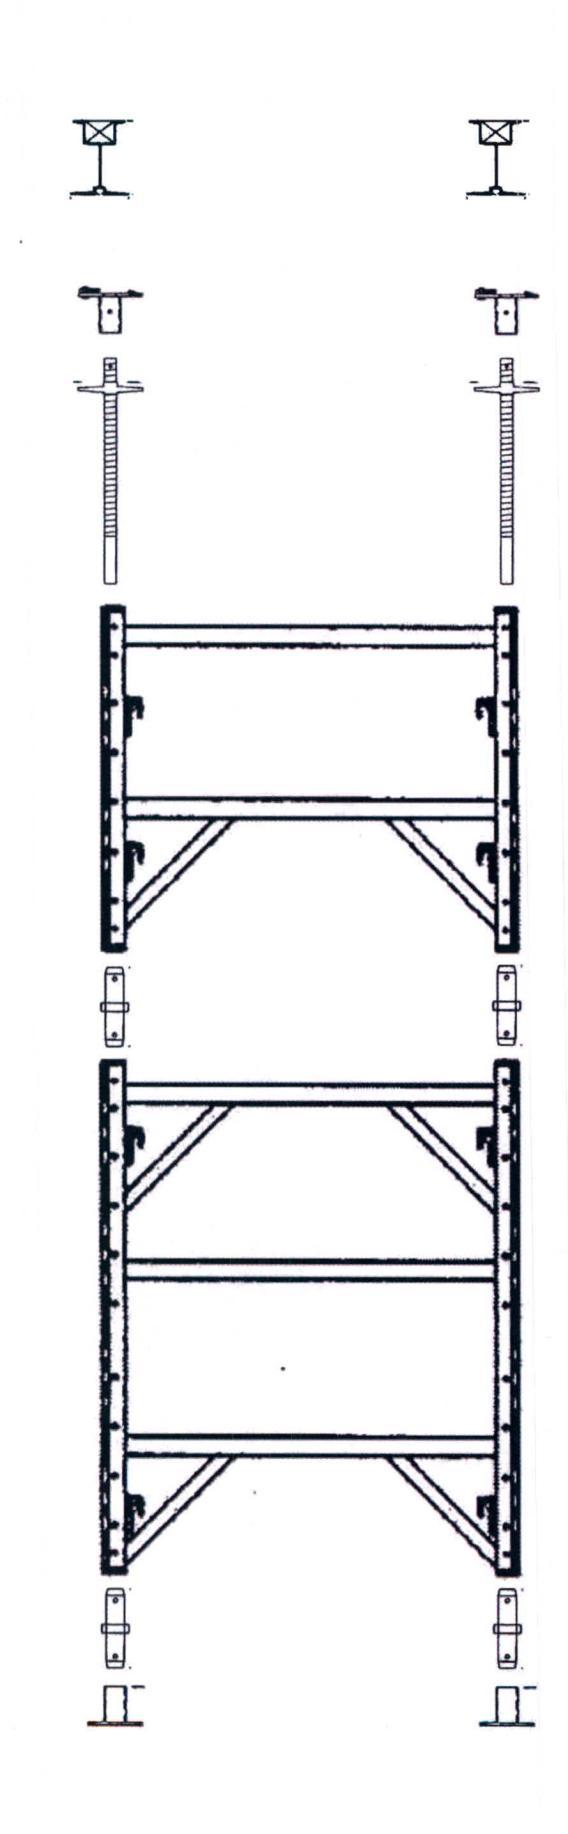
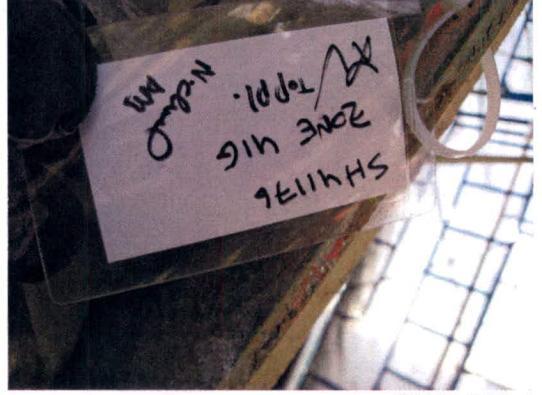
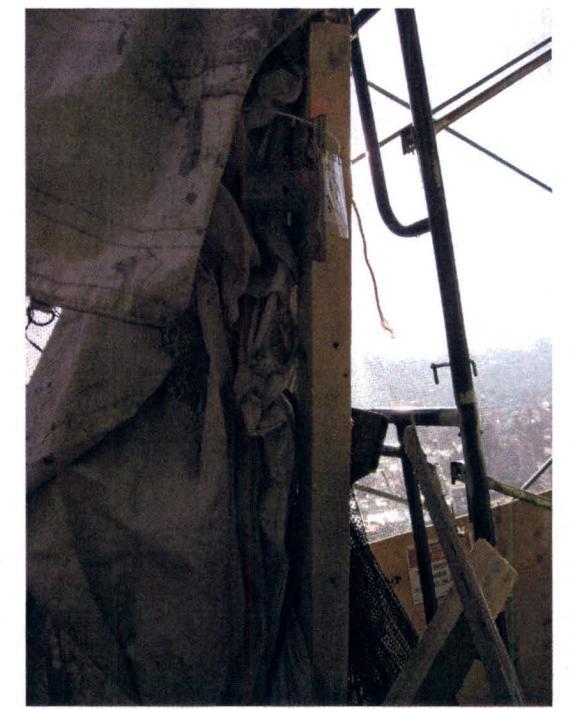
SH41176_1

SH 41176 Top plate Zone 41G

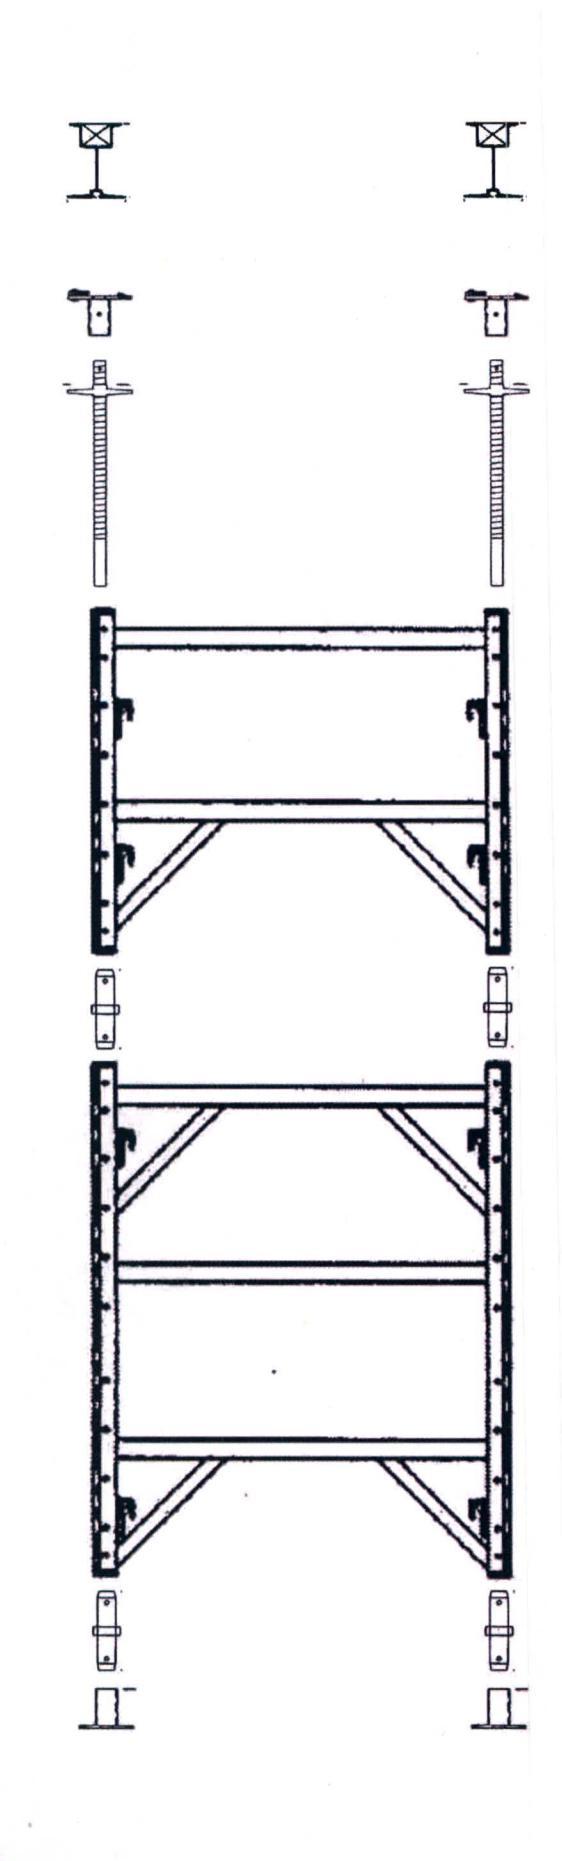
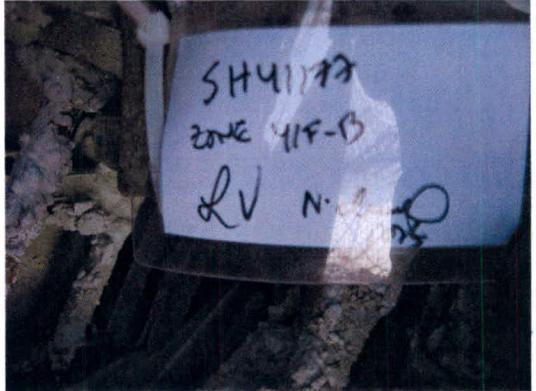
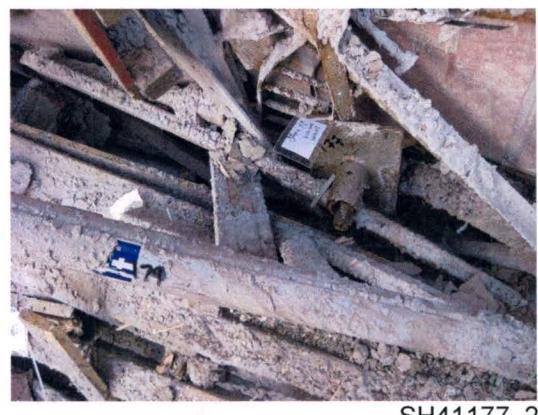
SH41177_1

SH 41177 Top plate with Screw Jack Zone 41F-B

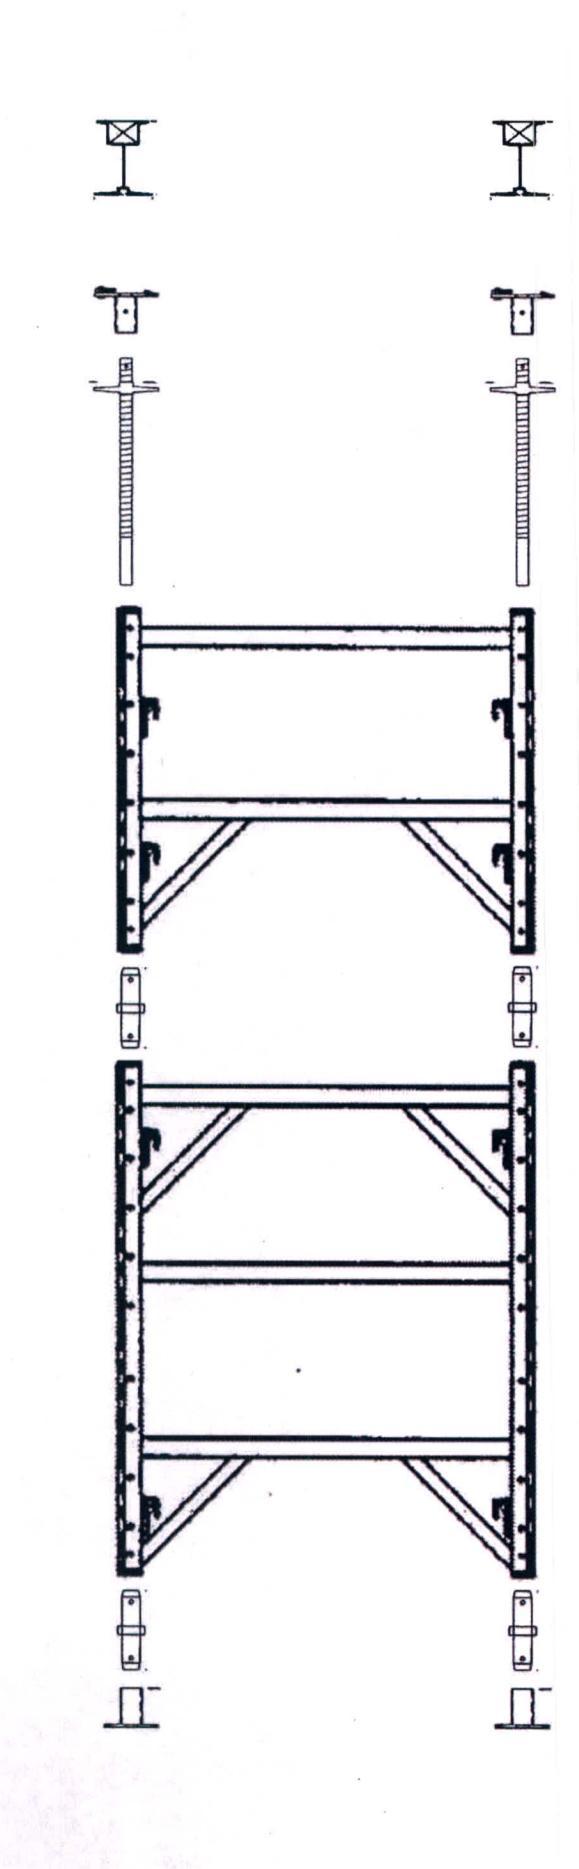
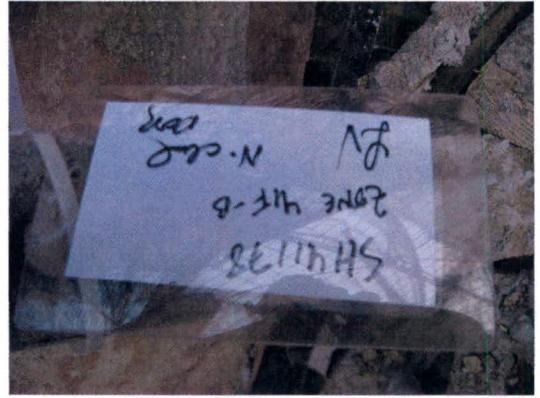
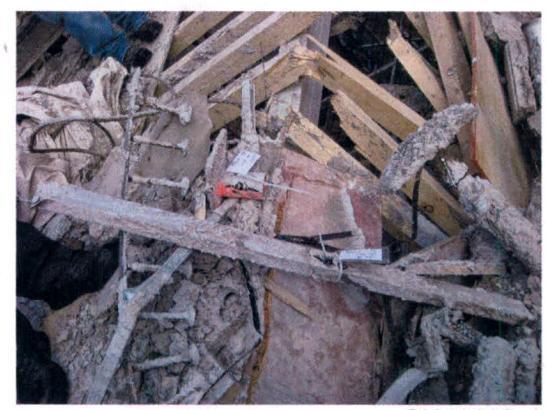
SH41178_1

SH 41178 Piece of Frame Zone 41F-B

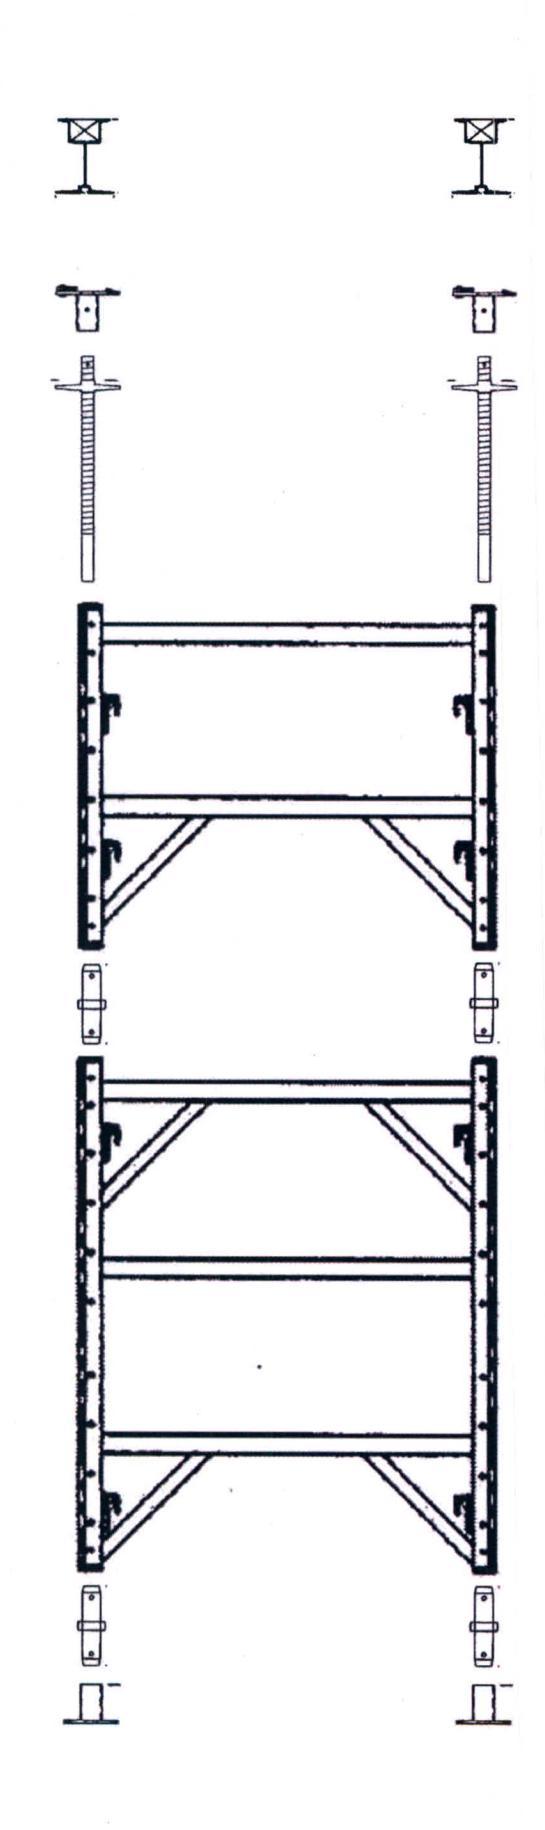
SH 41180 Brace Zone 41F-B

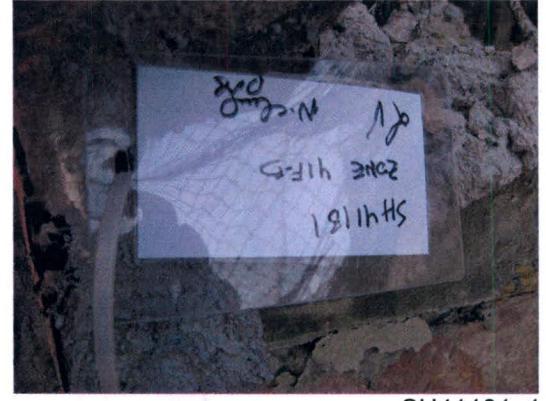
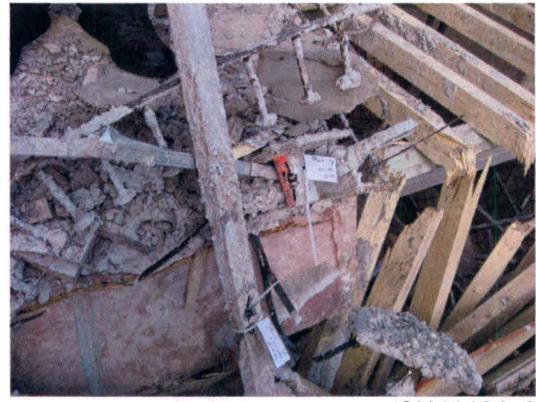
Folder: 08-02-15; SH 41181

SH 41181 Top plate Zone 41F-B

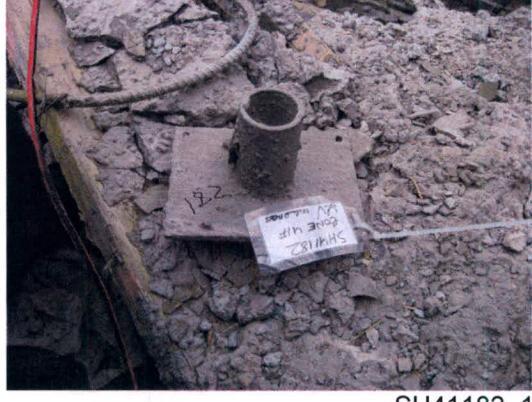
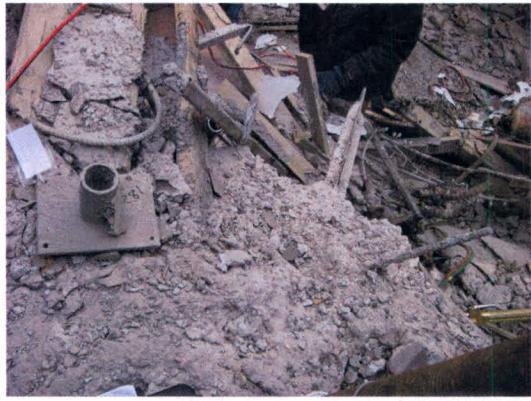
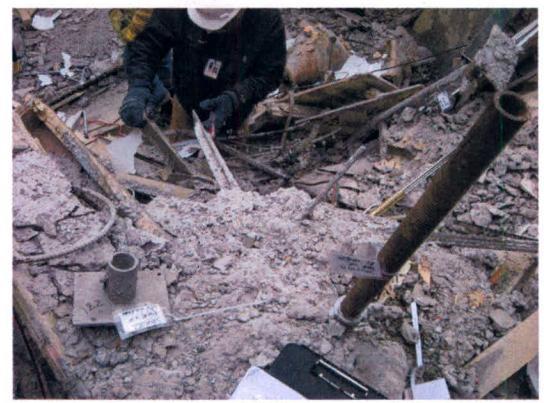
Folder: 08-02-15; SH 41182

SH 41182 Top plate Zone 41F

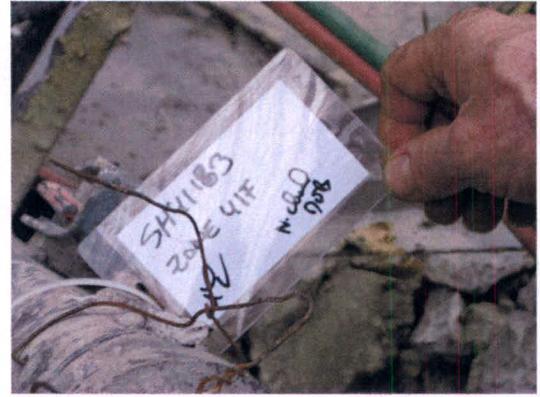
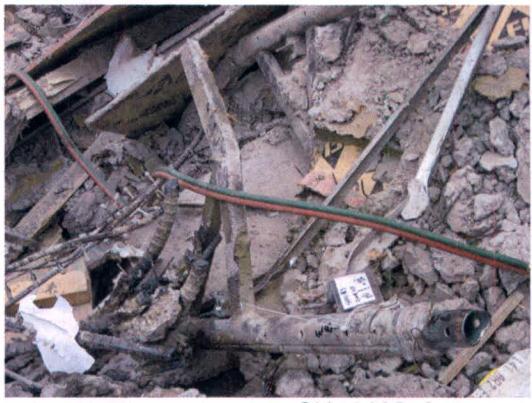
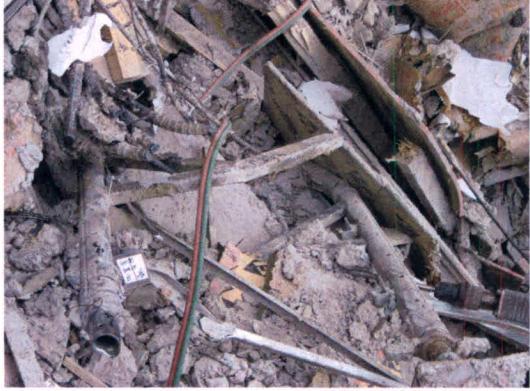
Folder: 08-02-15; SH 41183

SH 41183 Bottom Frame of SH 41092 & SH 41185 Zone 41F

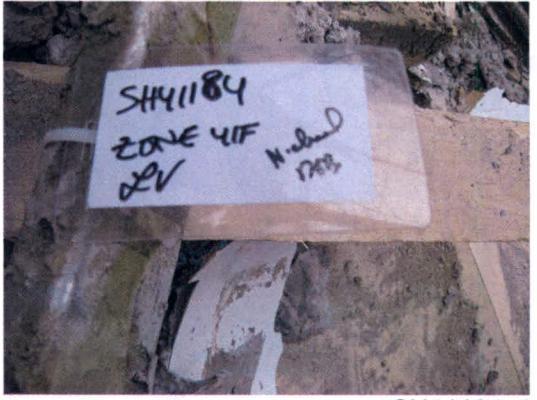
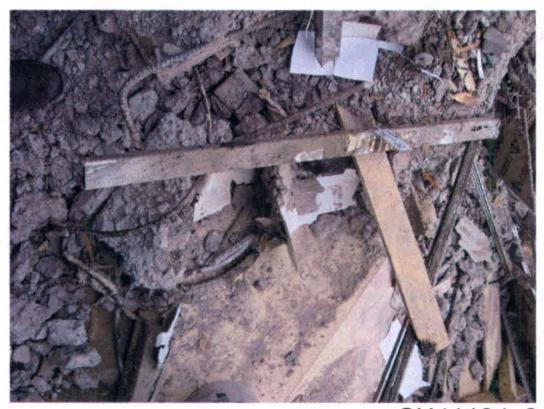
Folder: 08-02-15; SH 41184

SH 41184 Piece of Frame attached to SH 41183 Zone 41F

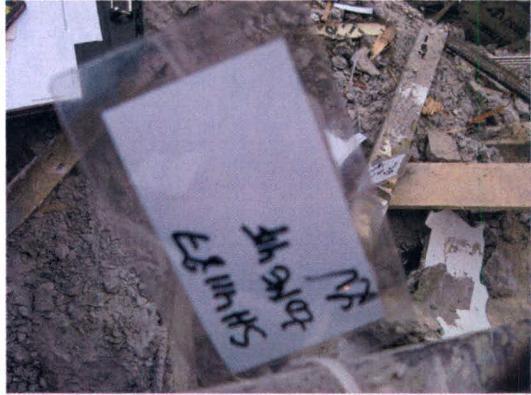
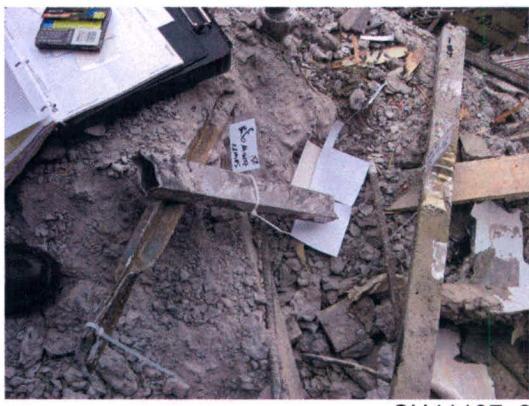
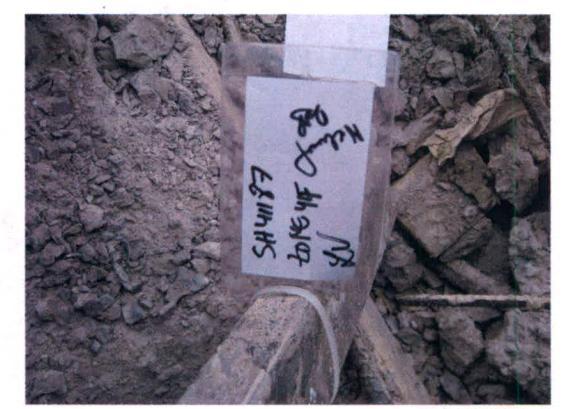
Folder: 08-02-15; SH 41187

SH 41187 Piece of frame Zone 41F

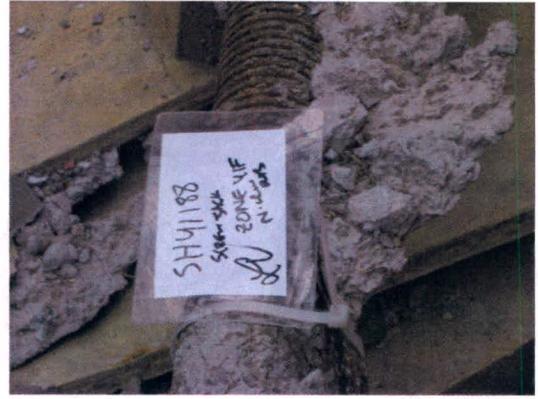
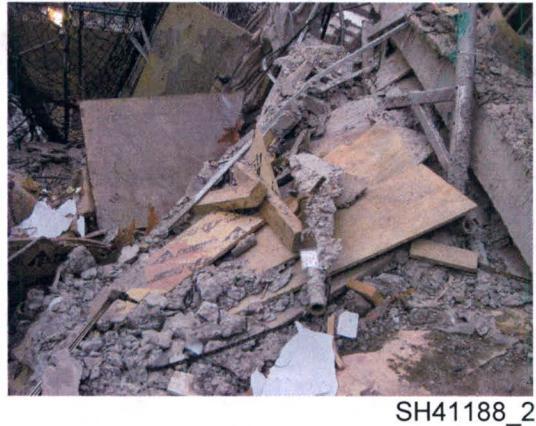
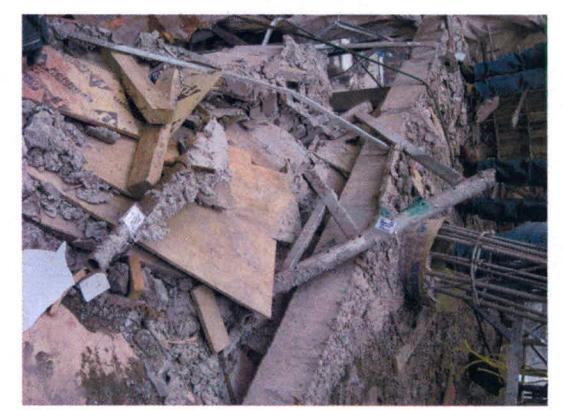
Folder: 08-02-15; SH 41188

SH 41188 Screw Jack Zone 41F

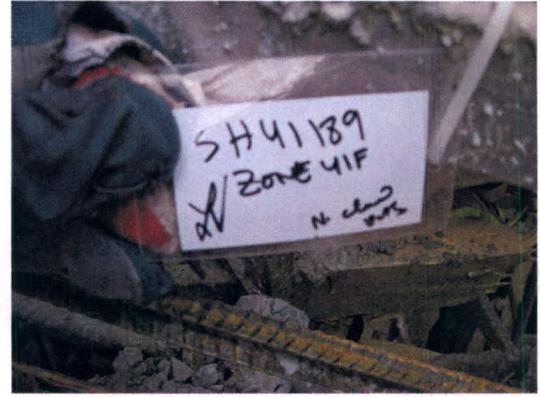
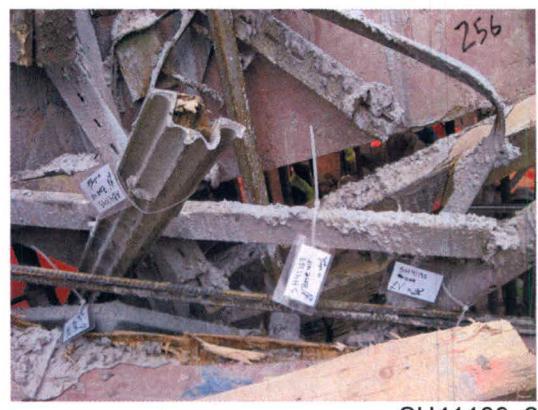
Folder: 08-02-15; SH 41189

SH 41189 Piece of frame SH 41190 Zone 41F

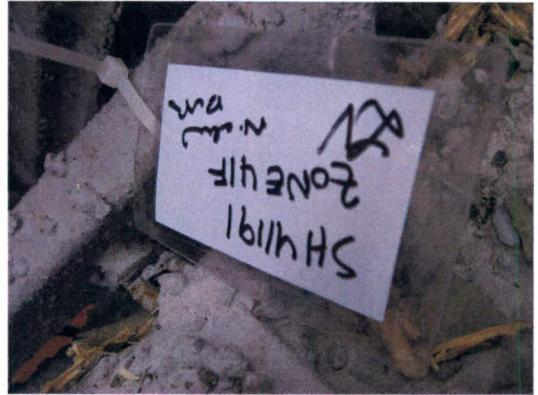
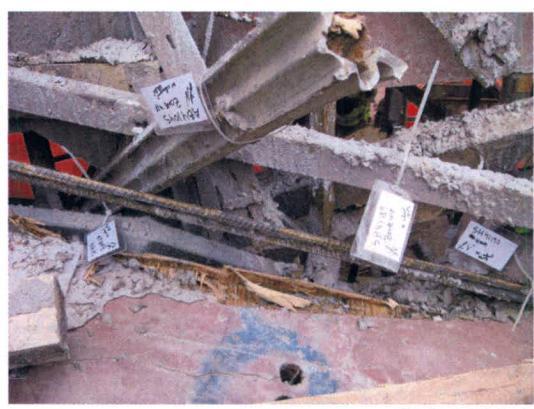
Folder: 08-02-15; SH 41191

SH 411191 Part of SH 41190 Zone 41F

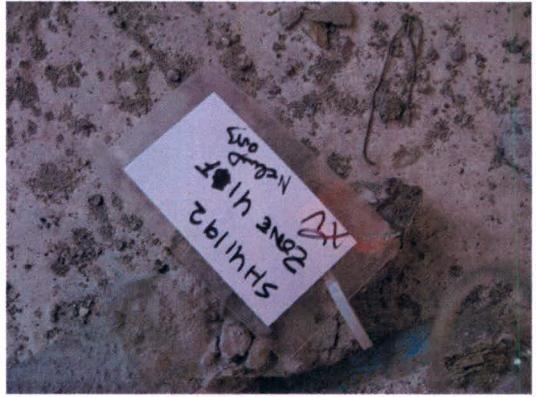
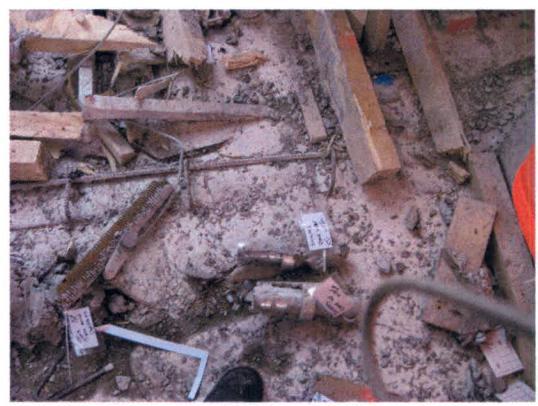
Folder: 08-02-15; SH 41192

SH 41192 Coupler Zone 41F

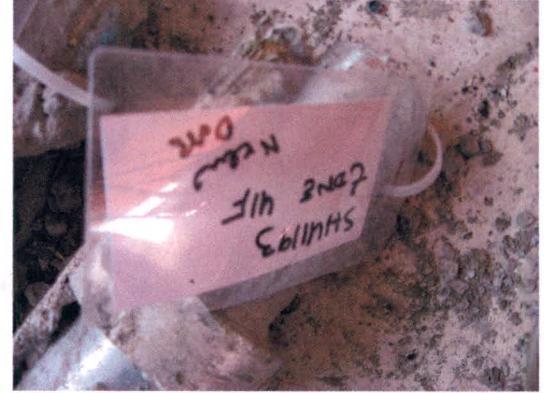
Folder: 08-02-15; SH 41193

SH 41193 Coupler Zone 41F

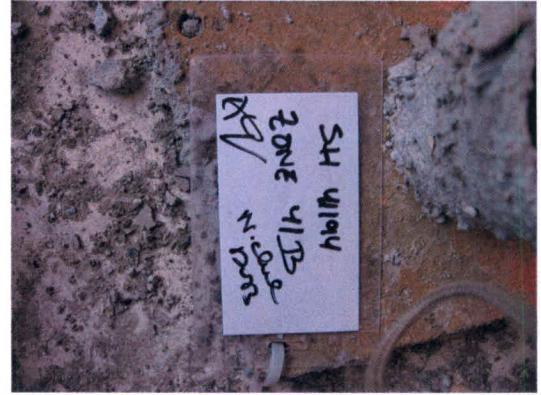
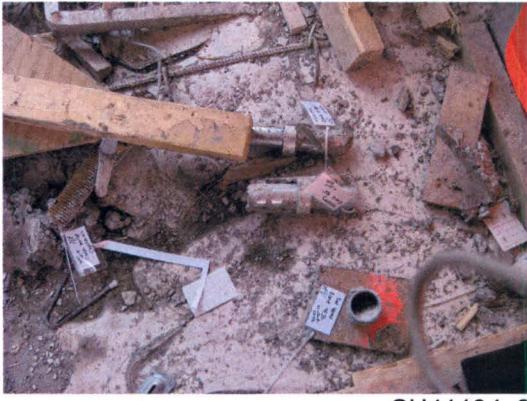
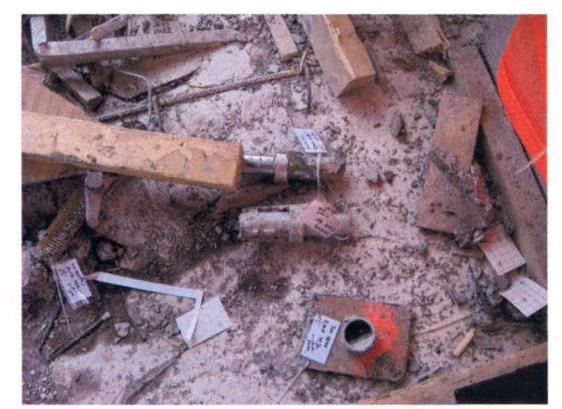
Folder: 08-02-15; SH 41194

SH 41194 Bottom plate Zone 41B

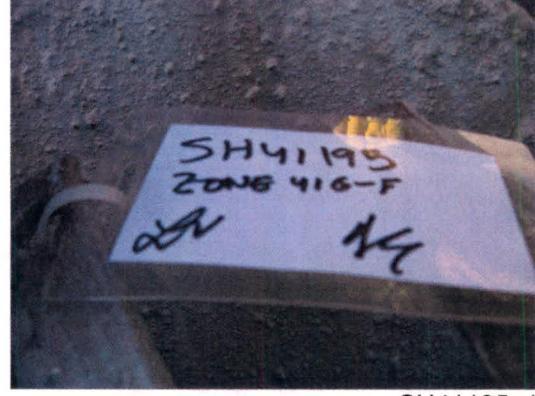
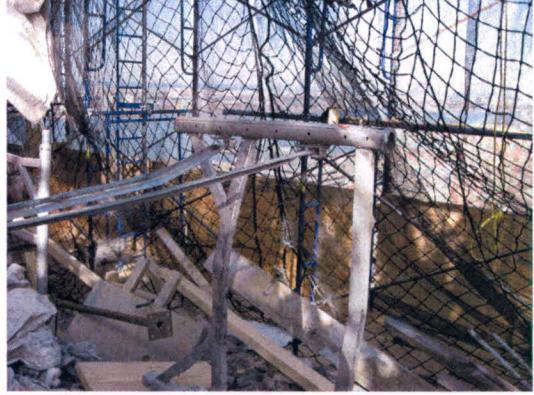
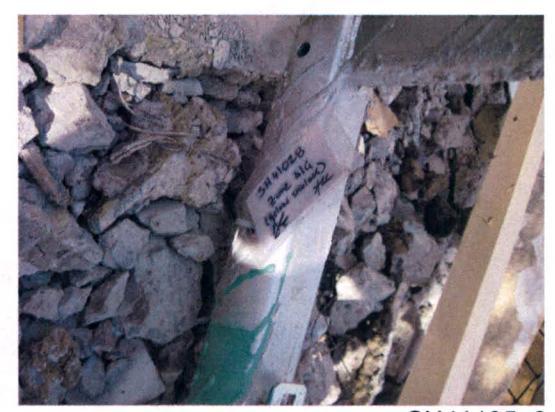
Folder: 08-02-16; SH 41195

SH 41195 Brace Connected to SH 41028 Zone 41G-F

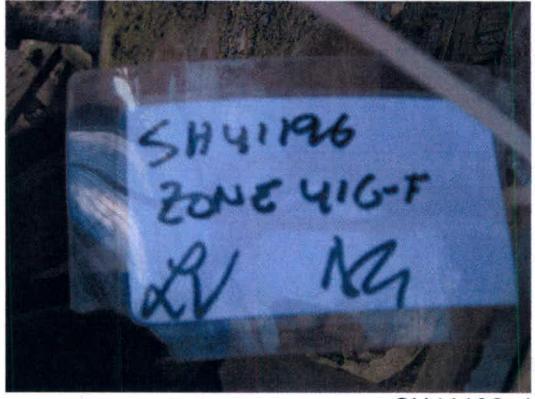
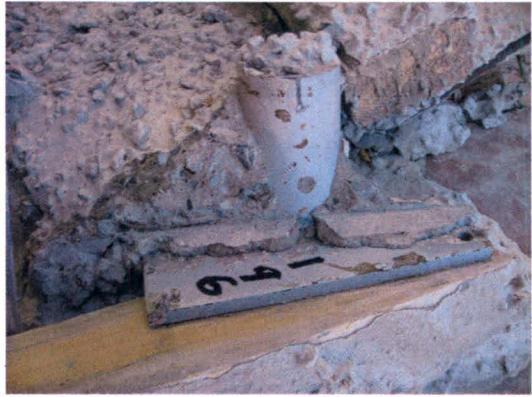
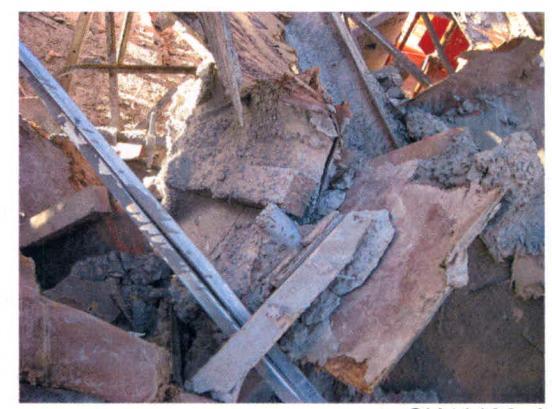
Folder: 08-02-16; SH 41196

SH 41196 Top plate attached to timber beam on top of SH 41195 Zone 41G-F

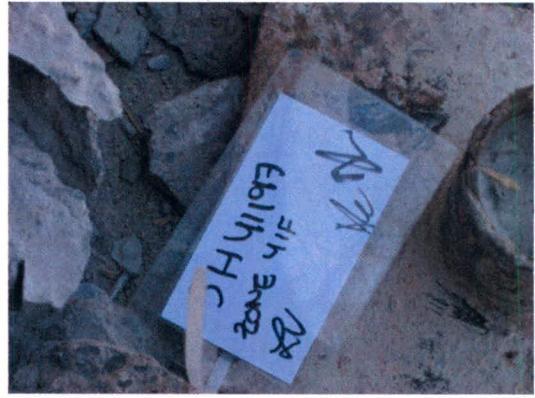
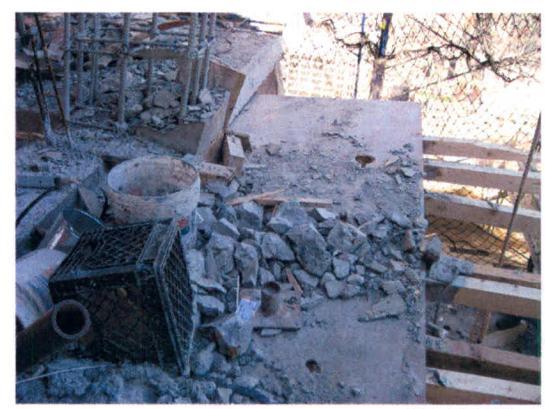
Folder: 08-02-16; SH 41197

SH 41197 Bottom plate 41F

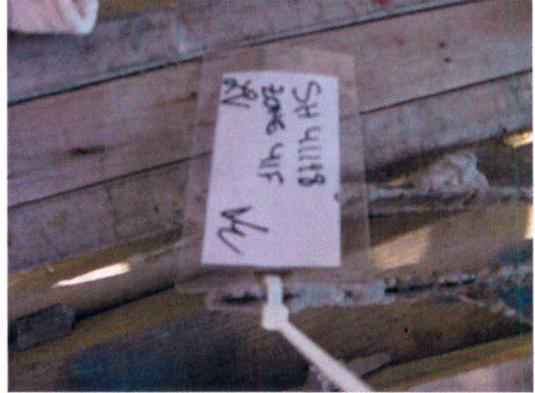
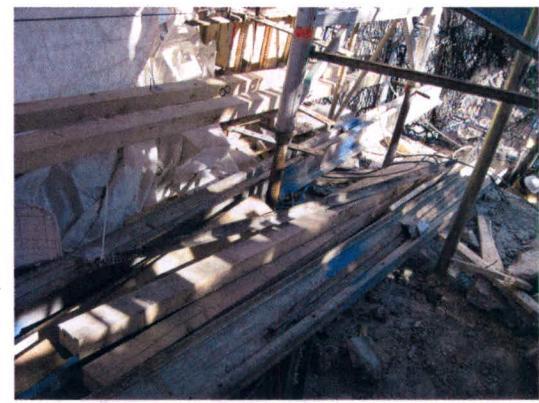
Folder: 08-02-16; SH 41198

SH 41198 Brace Zone 41F

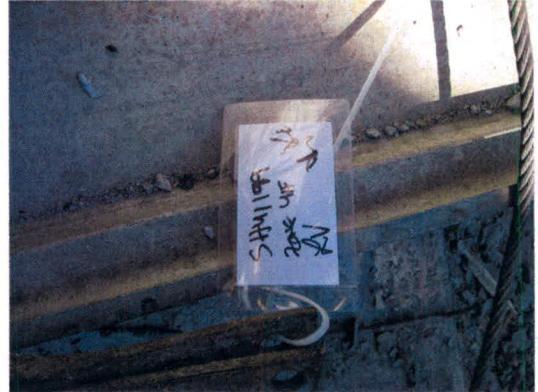
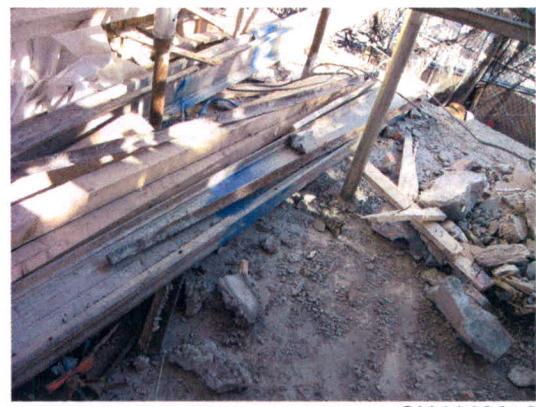
Folder: 08-02-16; SH 41199

SH 41199 Brace Zone 41F
